Weekly Environmental Compliance Summary

Sudbury to Hudson Transmission Reliability Project (USEPA Tracking # MAR1003UW)

Sudbury, Hudson, and Stow, MA

Week of: November 27, 2023 to December 1, 2023

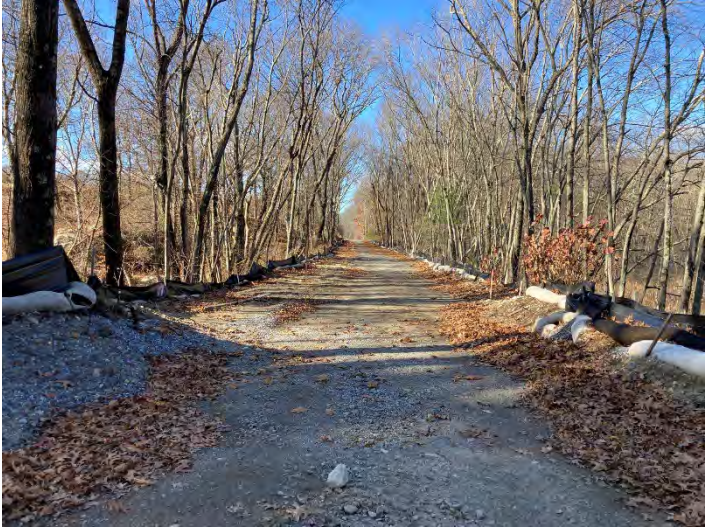
| Photo No.: 1 | Date: 11/28/2023 | | |

| Description: View of Type B E&S controls in segment 1. Facing west. | | | |

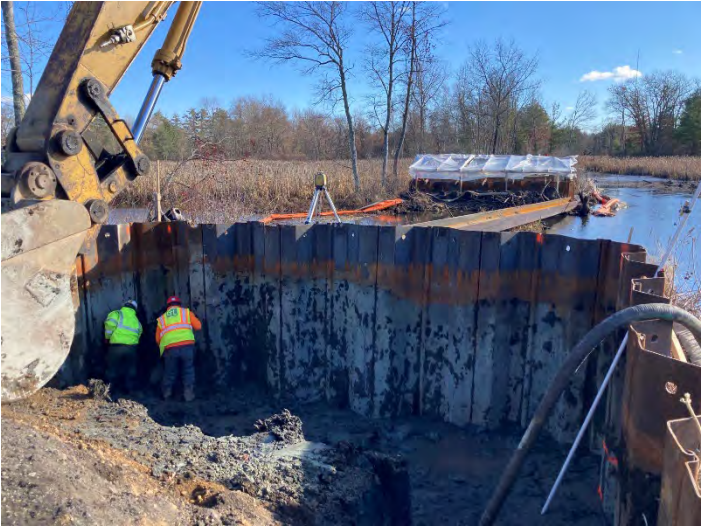
| Photo No.: 2 | Date: 11/28/2023 | | |

| Description: View of ET&L working at bridge 130 in segment 2. See additional dewatering inspection report. Facing east. | | | |

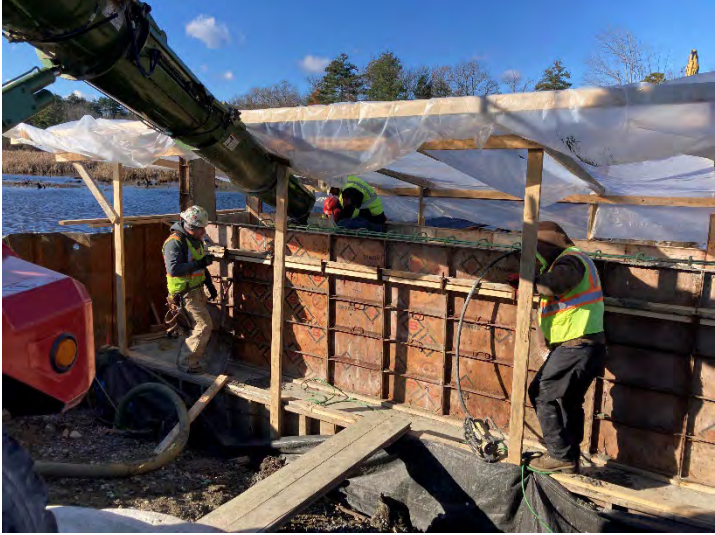
| <p>Photo No.: 3</p> | <p>Date: 11/28/2023</p> | | |

| <p>Description: View of ET&L working at bridge 130 in segment 3. See additional dewatering inspection report. Facing west.</p> | | | |

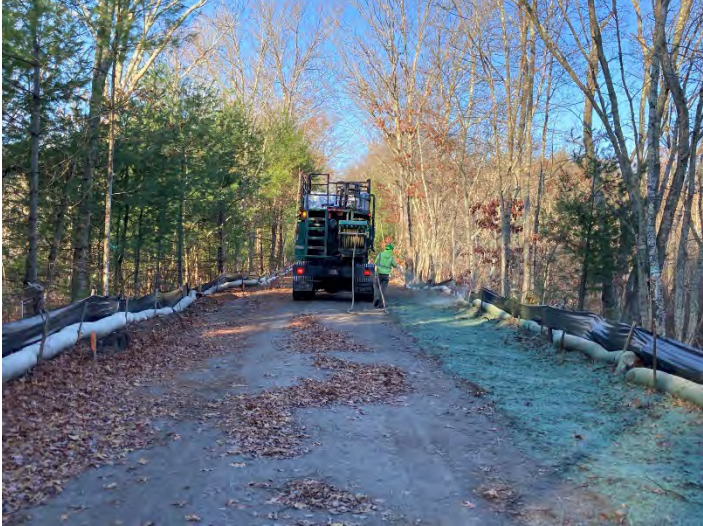
| <p>Photo No.: 4</p> | <p>Date: 11/28/2023</p> | | |

| <p>Description: View of MON applying hydroseed within segment 5. Facing west.</p> | | | |

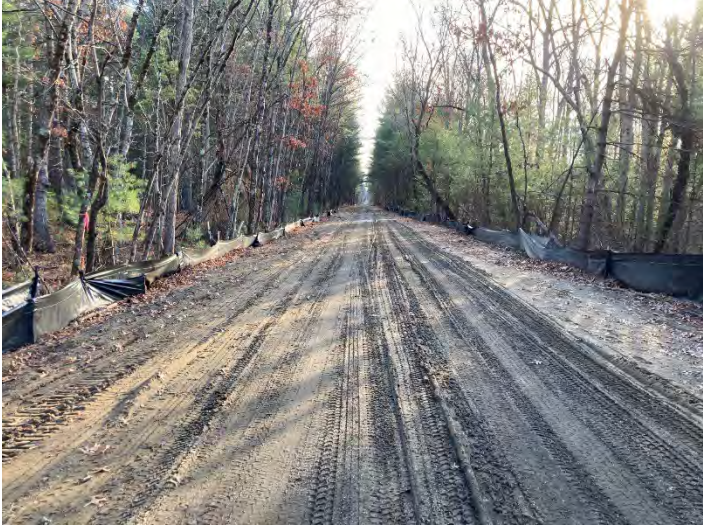
| Photo No.: 5 | Date: 11/28/2023 | | |

| Description: View of syncopated silt fence in segment 6. Facing east. | | | |

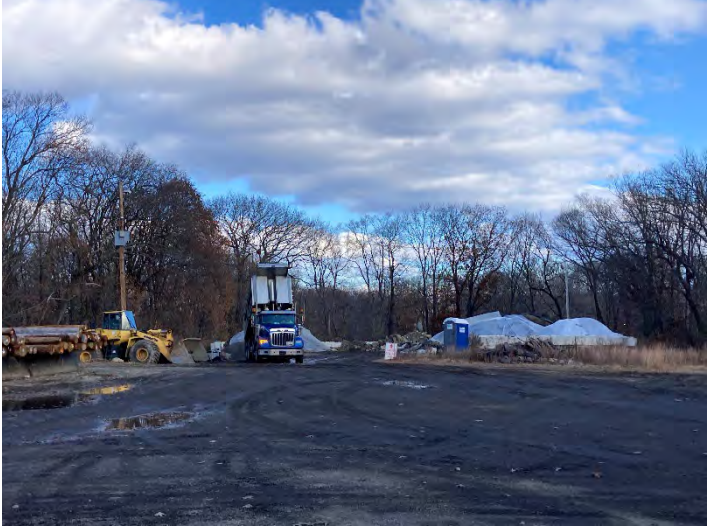
| Photo No.: 6 | Date: 11/28/2023 | | |

| Description: View of activities at Stowe Ct laydown yard. Facing northwest. | | | |

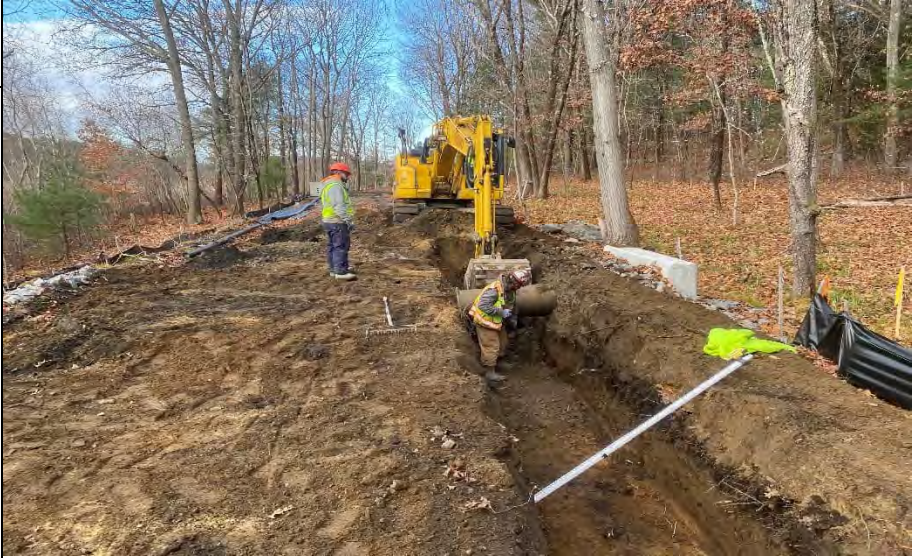
| Photo No.: 1 | Date: 11-28-23 | | |

| Description: Work area within segment 14, conduit work under existing culvert, existing erosion control, looking westward. | | | |

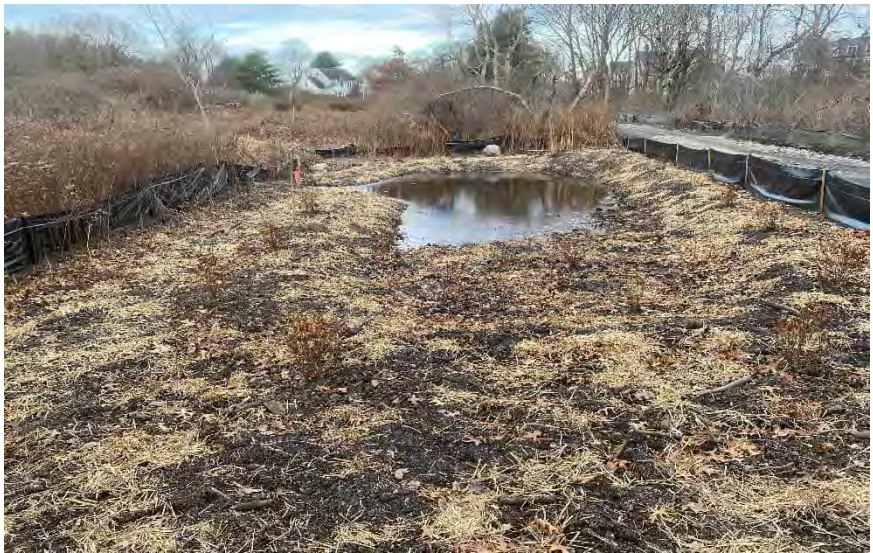
| Photo No.: 2 | Date: 11-28-23 | | |

| Description: Wetland replication area, within Segment 14, looking westward. | | | |

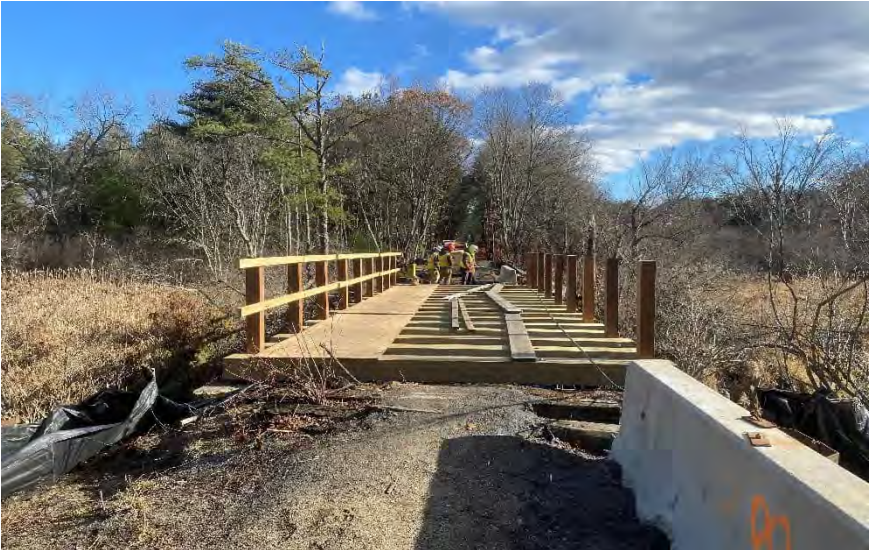
| <p>Photo No.: 3</p> | <p>Date: 11-28-23</p> | | |

| <p>Description:</p> <p>Work area within Segment 7 toward segment 8 over Hop Brook, bridge 128 work, existing erosion control, looking eastward.</p> | | | |

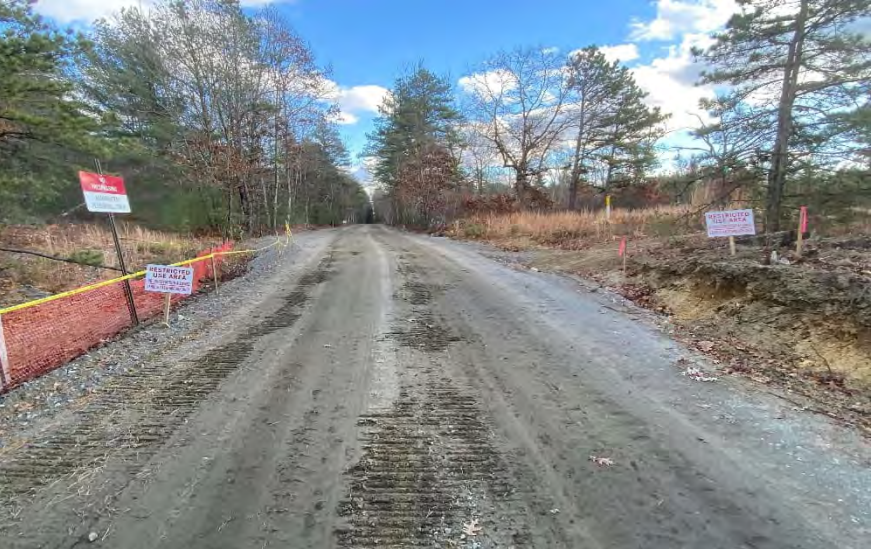
| <p>Photo No.: 4</p> | <p>Date: 11-28-23</p> | | |

| <p>Description:</p> <p>Work area within Segment 7, Sudbury-Hudson town line, black racer restriction area, looking eastward.</p> | | | |

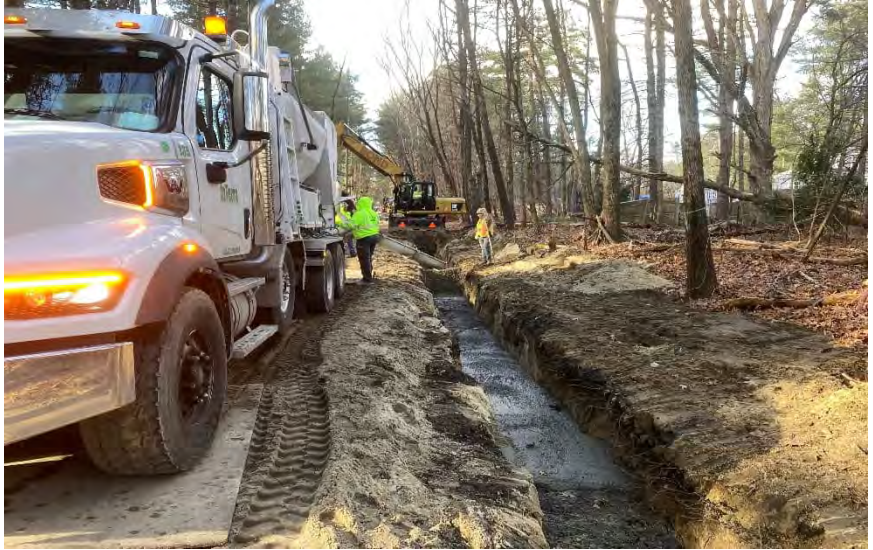
| <p>Photo No.: 6</p> | <p>Date: 11-28-23</p> | | |

| <p>Description:</p> <p>Work area within Segment 10, conduit work, existing erosion control, looking westward.</p> | | | |

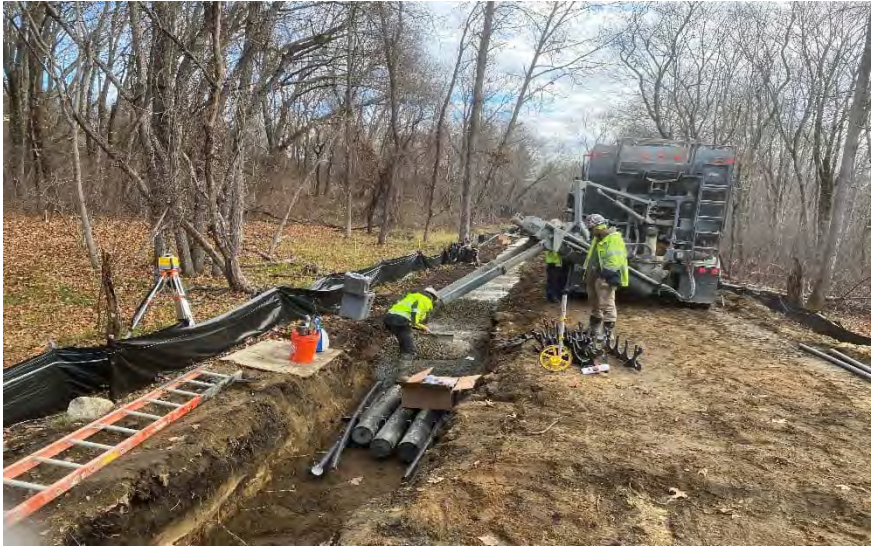
| <p>Photo No.: 7</p> | <p>Date: 11-28-23</p> | | |

| <p>Description:</p> <p>Work area within Segment 14, conduit work area near manhole #26, existing erosion control, looking eastward.</p> | | | |

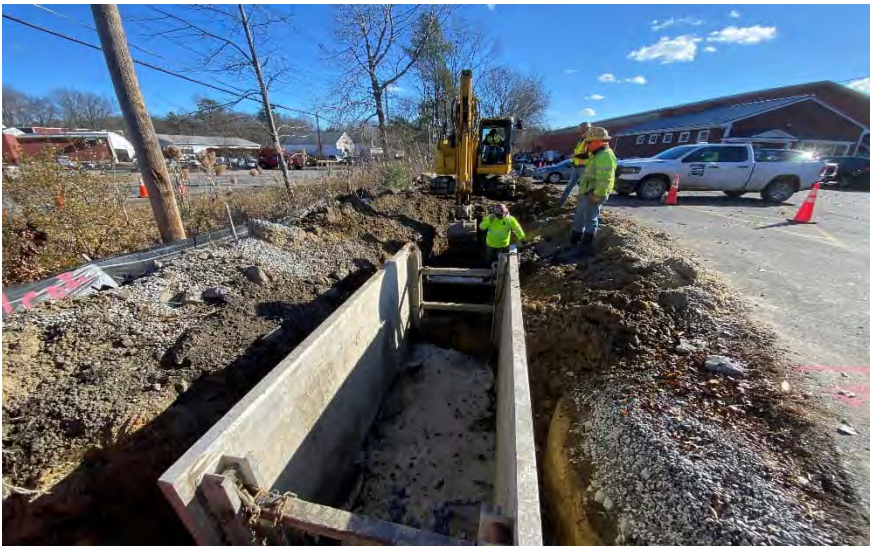
| <p>Photo No.: 8</p> | <p>Date: 11-28-23</p> | | |

| <p>Description:</p> <p>Work area within Segment 12, conduit work – trenching, existing erosion control, looking eastward.</p> | | | |

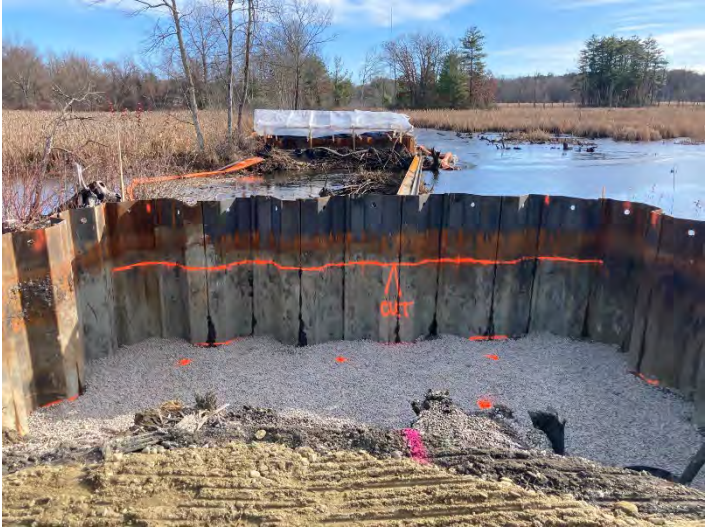
| <p>Photo No.: 1</p> | <p>Date: 11/29/2023</p> | | |

| <p>Description: View of work area at bridge 130 in segment 2. See additional dewatering inspection report. Facing east.</p> | | | |

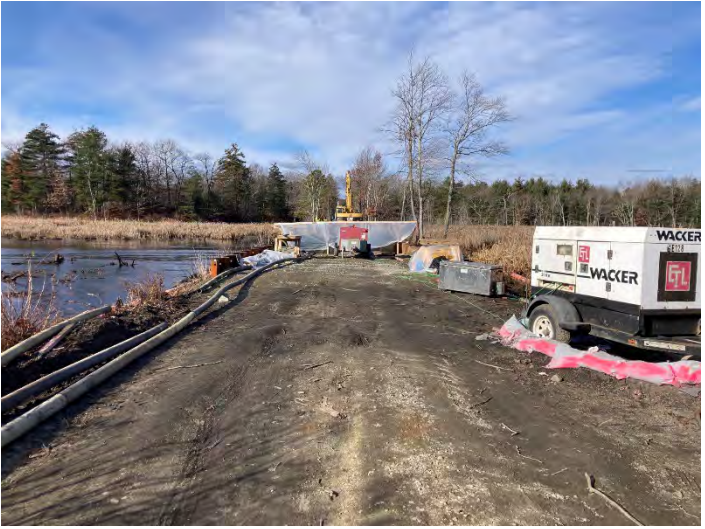
| <p>Photo No.: 2</p> | <p>Date: 11/29/2023</p> | | |

| <p>Description: View of work area at bridge 130 in segment 3. See additional dewatering inspection report. Facing west.</p> | | | |

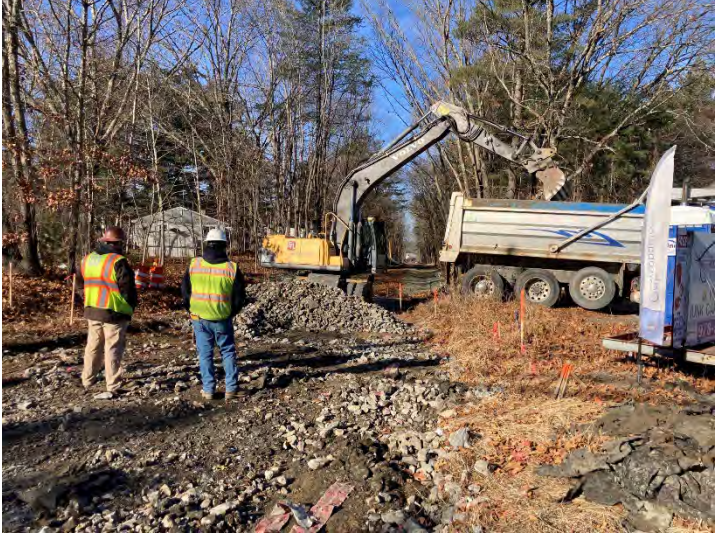
| <p>Photo No.: 3</p> | <p>Date: 11/29/2023</p> | | |

| <p>Description: View of ET&L working at entrance to segment 3 at Main St. Facing west.</p> | | | |

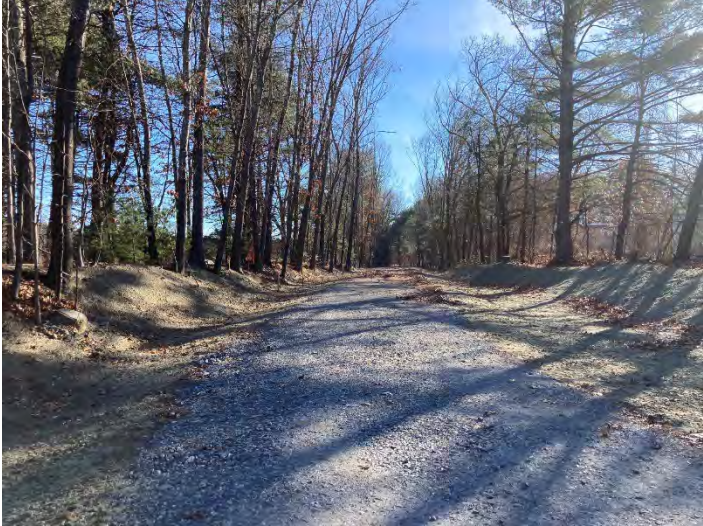
| <p>Photo No.: 4</p> | <p>Date: 11/29/2023</p> | | |

| <p>Description: View of west end of segment 4. Facing east.</p> | | | |

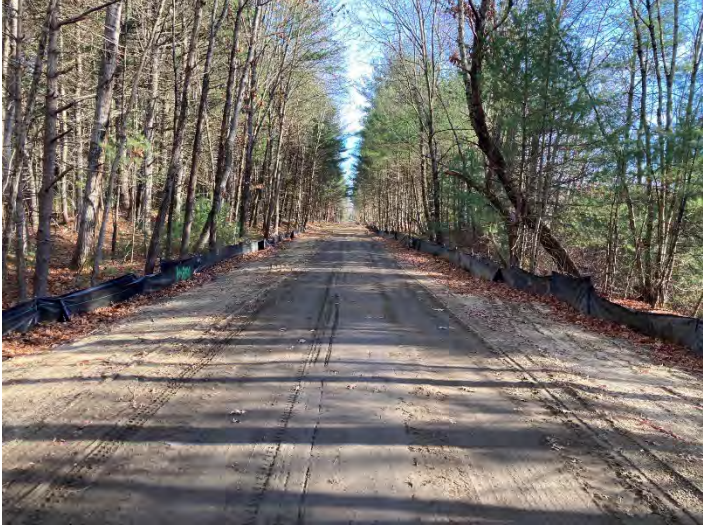
| Photo No.: 5 | Date: 11/29/2023 | | |

| Description: View of syncopated silt fence in segment 6. Facing east. | | | |

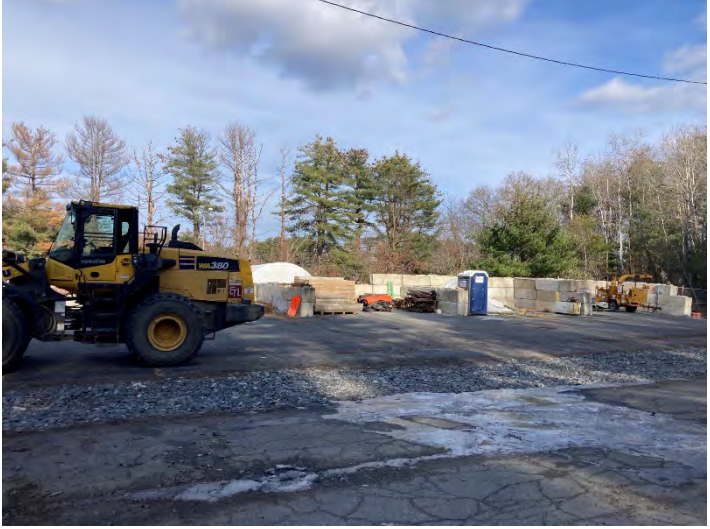
| Photo No.: 6 | Date: 11/29/2023 | | |

| Description: View of 555 Main St laydown yard. Facing northeast. | | | |

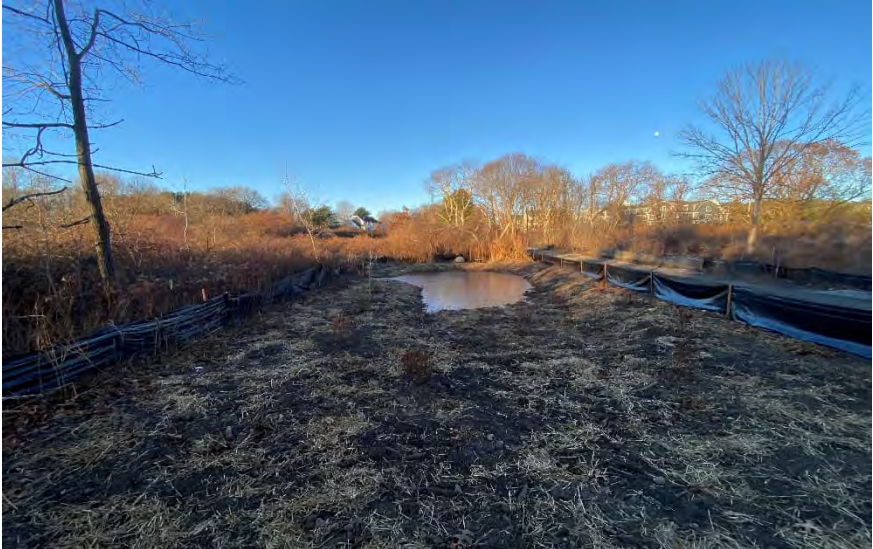
| <p>Photo No.: 2</p> | <p>Date: 11-29-23</p> | | |

| <p>Description:</p> <p>Wetland replication area, within Segment 14, looking westward.</p> | | | |

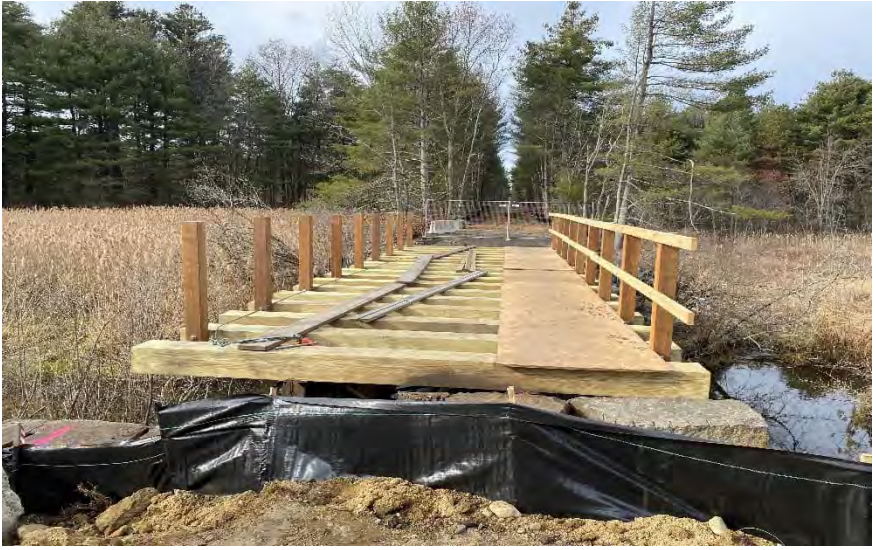
| <p>Photo No.: 3</p> | <p>Date: 11-29-23</p> | | |

| <p>Description:</p> <p>Work area within Segment 8 toward segment 7, bridge 128 work over Hop Brook, existing erosion control, looking westward.</p> | | | |

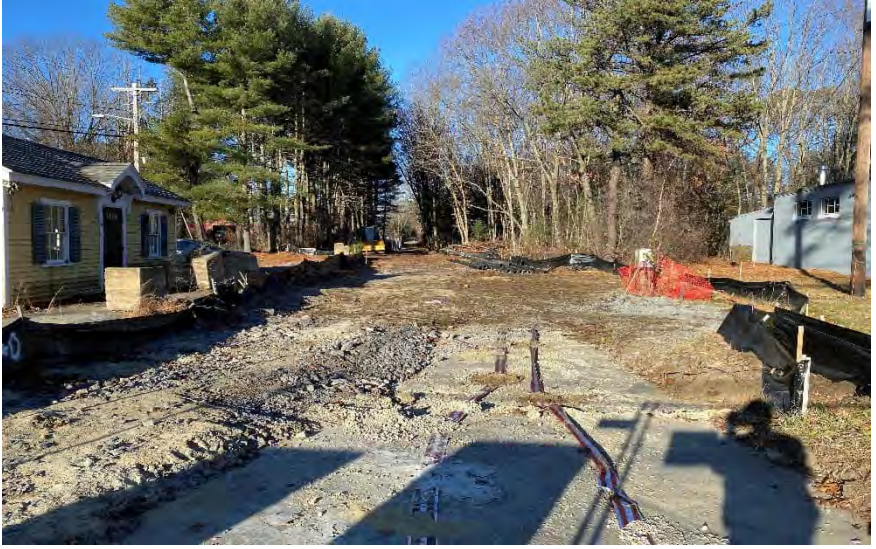
| <p>Photo No.: 4</p> | <p>Date: 11-29-23</p> | | |

| <p>Description:</p> <p>Work area within Segment 11, existing erosion control, looking westward.</p> | | | |

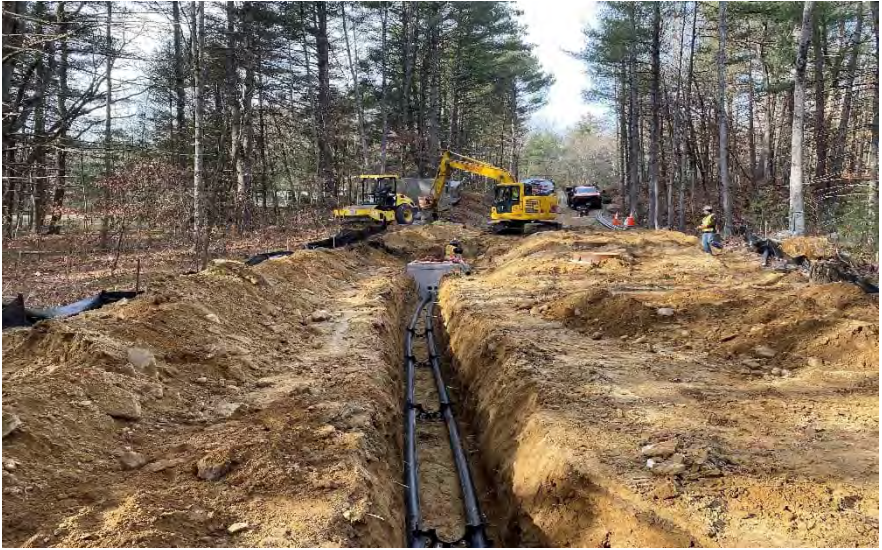
| <p>Photo No.: 5</p> | <p>Date: 11-29-23</p> | | |

| <p>Description:</p> <p>Work area within Segment 10 (off Peakham road), conduit work, existing erosion control, looking westward.</p> | | | |

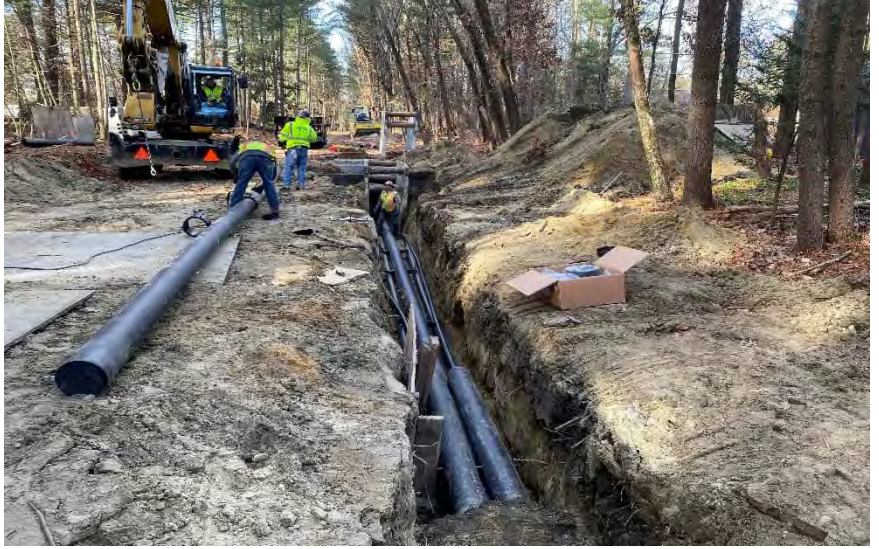
| <p>Photo No.: 6</p> | <p>Date: 11-29-23</p> | | |

| <p>Description:</p> <p>Work area within Segment 10 (off Horsepond road), conduit work, existing erosion control, looking westward.</p> | | | |

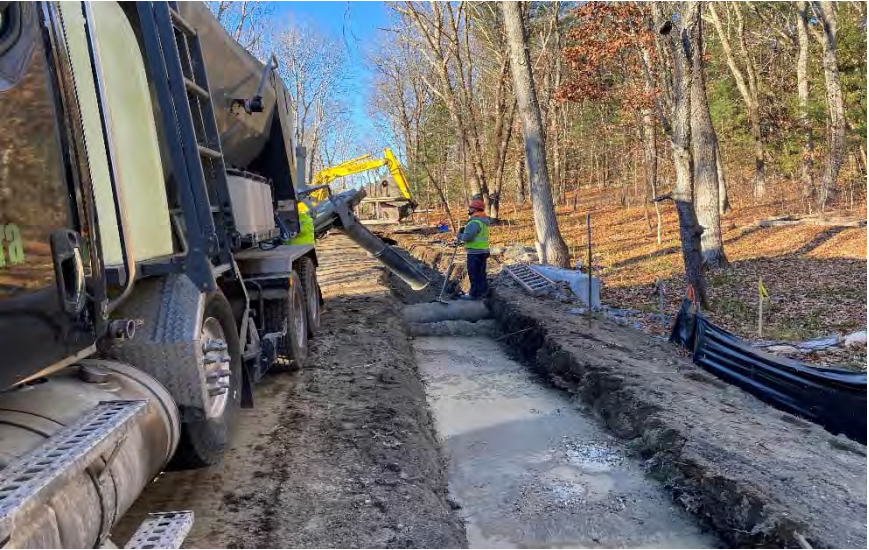
| <p>Photo No.: 7</p> | <p>Date: 11-29-23</p> | | |

| <p>Description:</p> <p>Work area within Segment 14, conduit work area near manhole #26, existing erosion control, looking westward.</p> | | | |

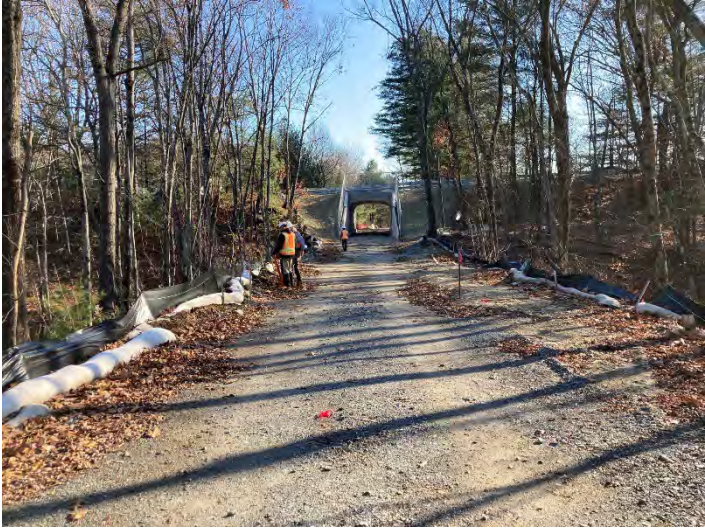
| <p>Photo No.: 1</p> | <p>Date: 11/30/2023</p> | | |

| <p>Description: View of SWCA performing invasive plant removal in segment 1. Facing east.</p> | | | |

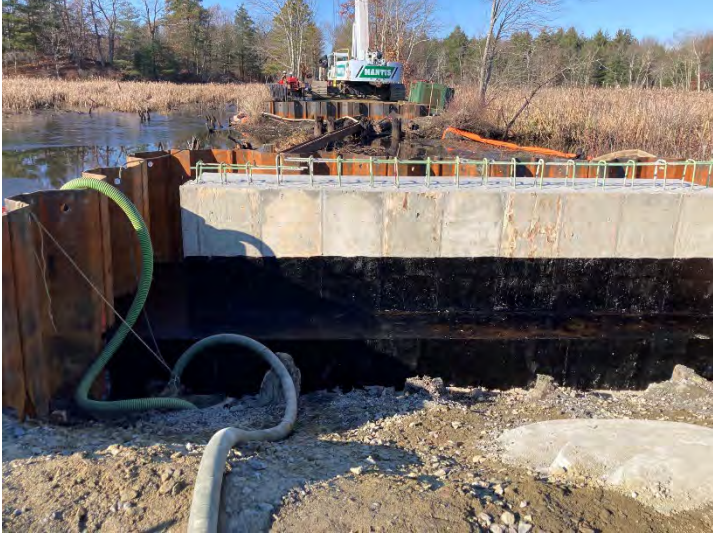
| <p>Photo No.: 3</p> | <p>Date: 11/30/2023</p> | | |

| <p>Description: View of work at bridge 130 in segment 3. See additional dewatering inspection report. Facing west.</p> | | | |

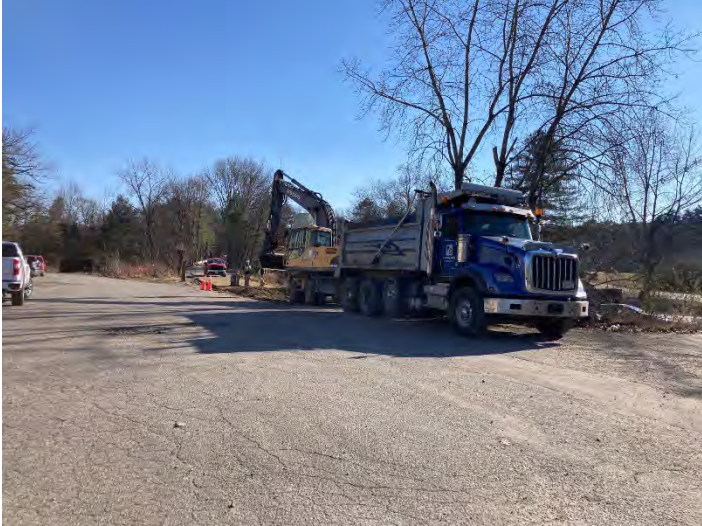
| <p>Photo No.: 4</p> | <p>Date: 11/30/2023</p> | | |

| <p>Description: View of ET&L working in segment 3. Facing east.</p> | | | |

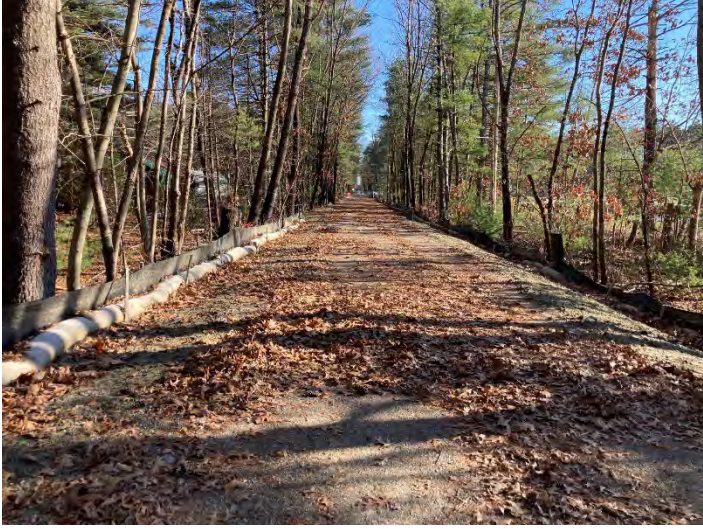
| <p>Photo No.: 5</p> | <p>Date: 11/30/2023</p> | | |

| <p>Description: View of Type B E&S controls in segment 4. Facing east.</p> | | | |

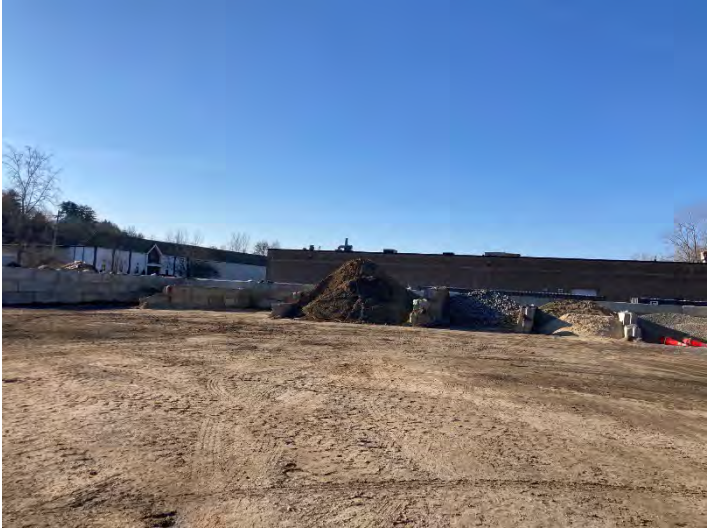
| <p>Photo No.: 6</p> | <p>Date: 11/30/2023</p> | | |

| <p>Description: View of Bonazzoli laydown yard. Facing southwest.</p> | | | |

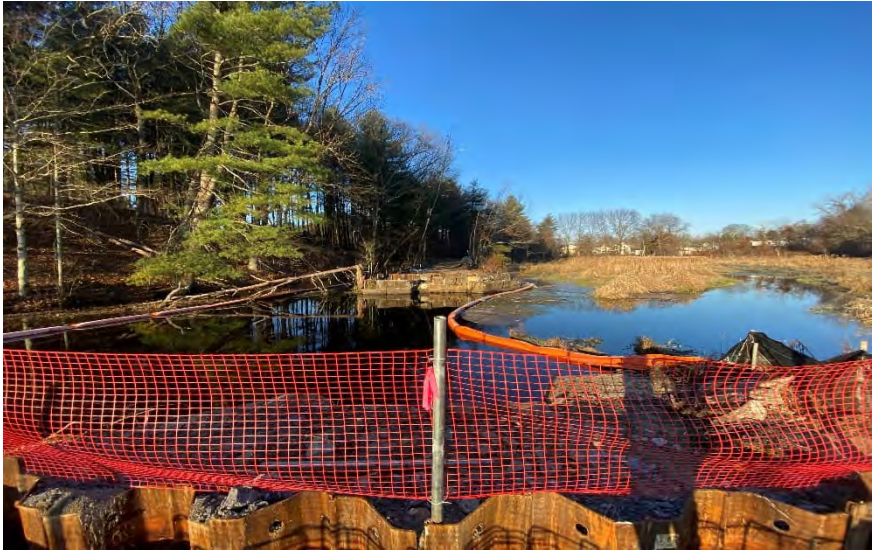
| <p>Photo No.: 1</p> | <p>Date: 11-30-23</p> | | |

| <p>Description:</p> <p>Work area within segment 14 looking toward segment 13 over Hop Brook, existing erosion control, looking westward.</p> | | | |

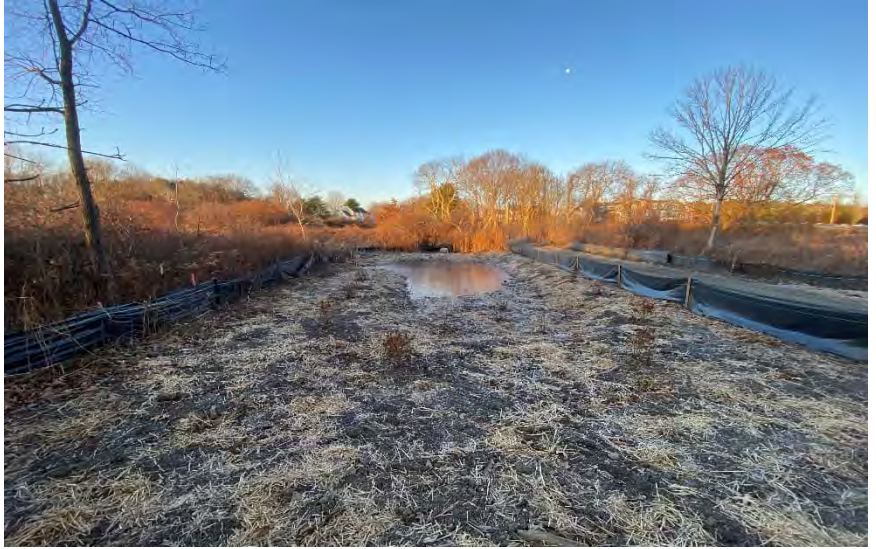
| <p>Photo No.: 2</p> | <p>Date: 11-30-23</p> | | |

| <p>Description:</p> <p>Wetland replication area, within Segment 14, looking westward.</p> | | | |

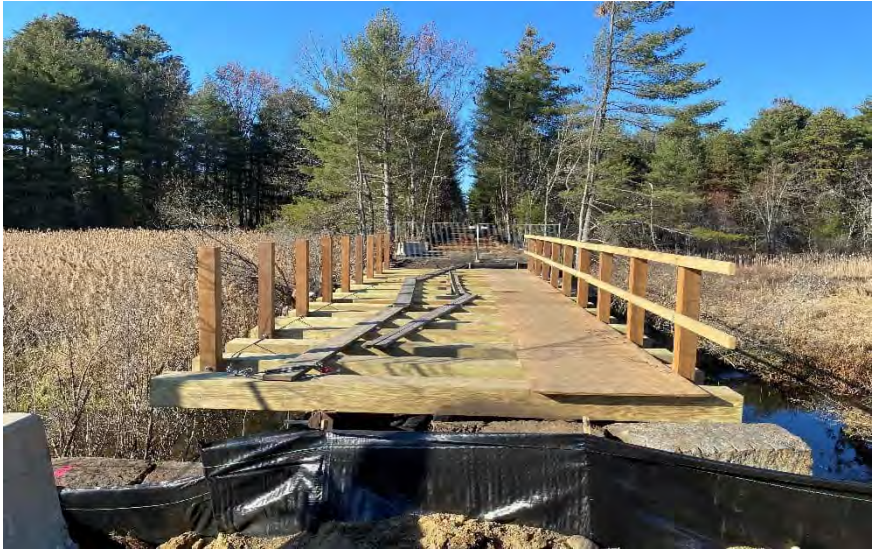
| <p>Photo No.: 3</p> | <p>Date: 11-30-23</p> | | |

| <p>Description: Work area within Segment 8 toward segment 7 over Hop Brook, bridge 128 work, existing erosion control, looking westward.</p> | | | |

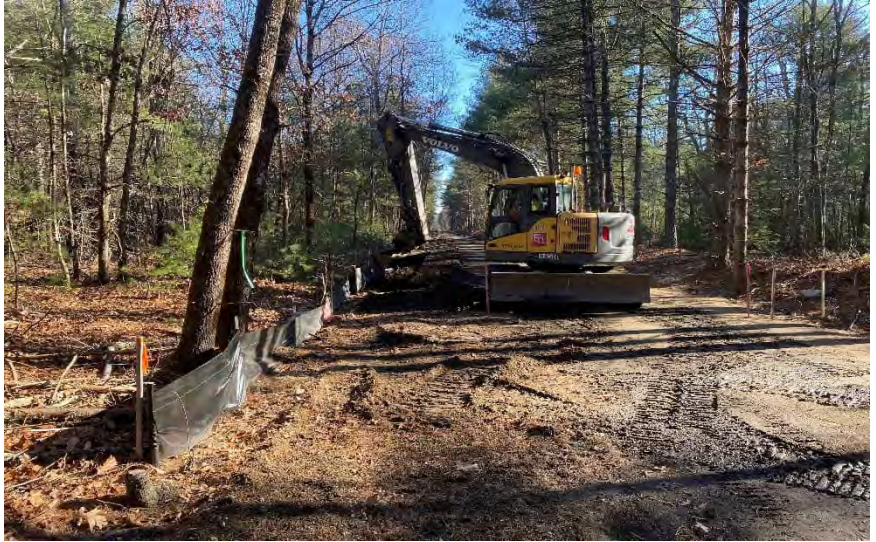
| <p>Photo No.: 4</p> | <p>Date: 11-30-23</p> | | |

| <p>Description: Work area within Segment 7, site grading, existing erosion control, looking eastward.</p> | | | |

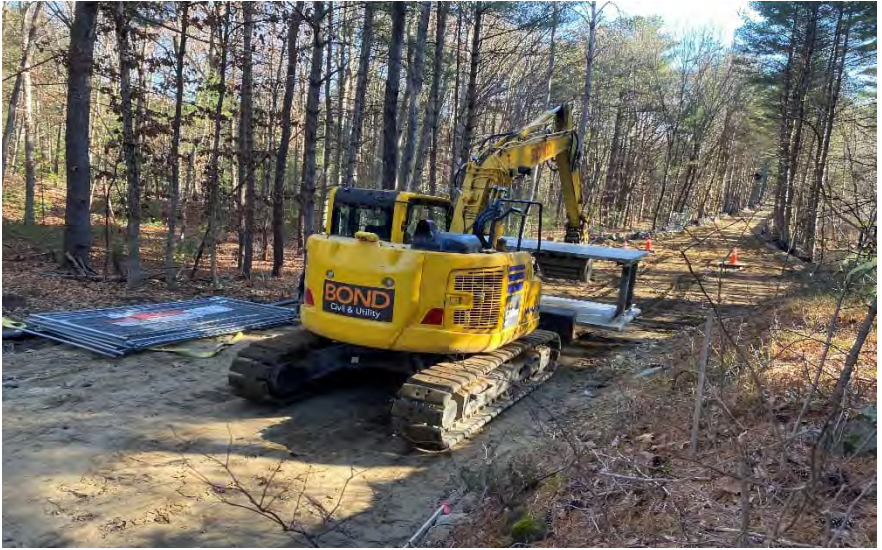
| <p>Photo No.: 5</p> | <p>Date: 11-30-23</p> | | |

| <p>Description:</p> <p>Work area within Segment 10 (off Peakham road), conduit work, existing erosion control, looking eastward.</p> | | | |

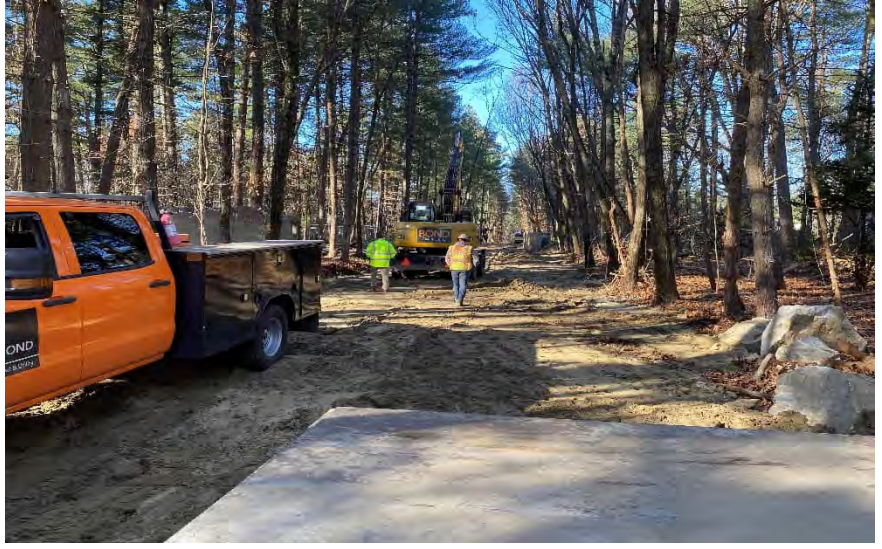
| <p>Photo No.: 6</p> | <p>Date: 11-30-23</p> | | |

| <p>Description:</p> <p>Work area within Segment 10 (off Horsepond road), conduit work, existing erosion control, looking westward.</p> | | | |

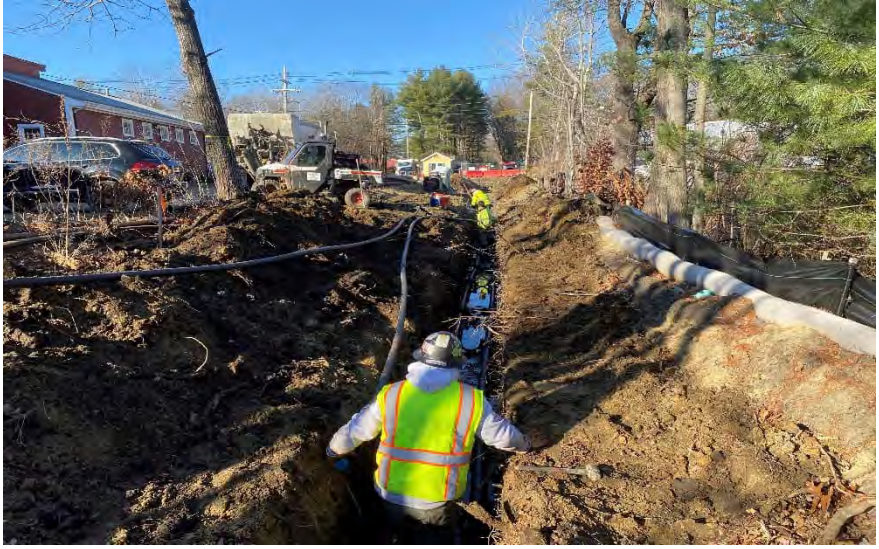
| <p>Photo No.: 8</p> | <p>Date: 11-30-23</p> | | |

| <p>Description:</p> <p>Work area within Segment 12, conduit work – trenching, existing erosion control, looking westward.</p> | | | |

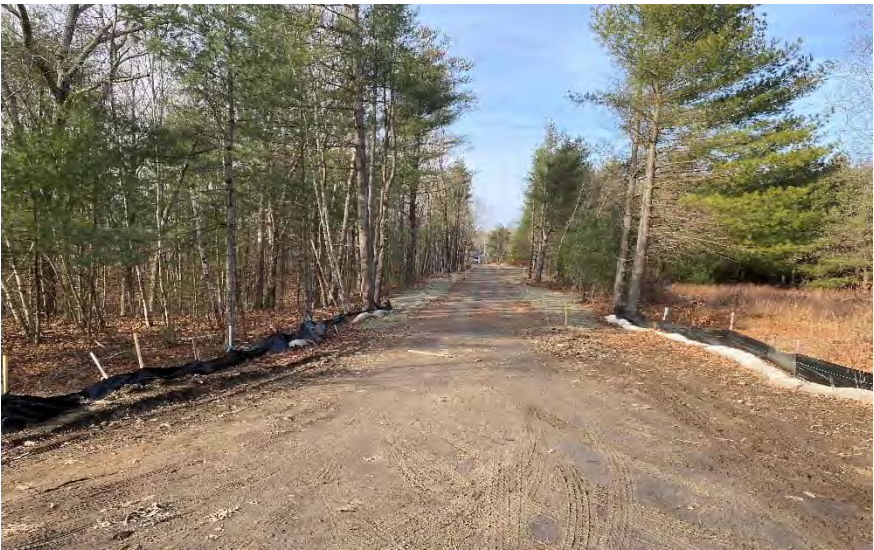
| <p>Photo No.: 2</p> | <p>Date: 12-1-23</p> | | |

| <p>Description:</p> <p>Work area within Segment 2, existing erosion control, previous hydro seeding, looking westward.</p> | | | |

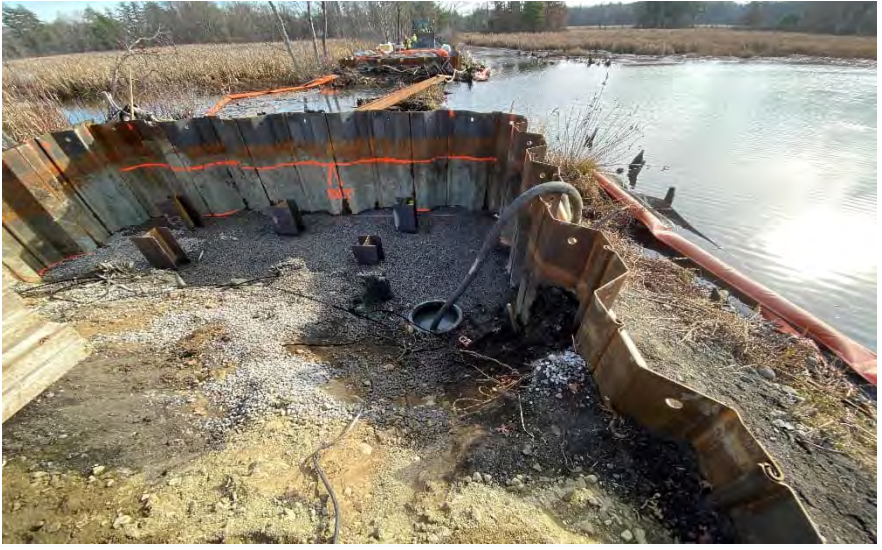
| <p>Photo No.: 3</p> | <p>Date: 12-1-23</p> | | |

| <p>Description:</p> <p>Work area within segment 2 looking across Fort Meadow Brook toward segment 3, newly created coffer dam & "H"-pilings, looking eastward.</p> | | | |

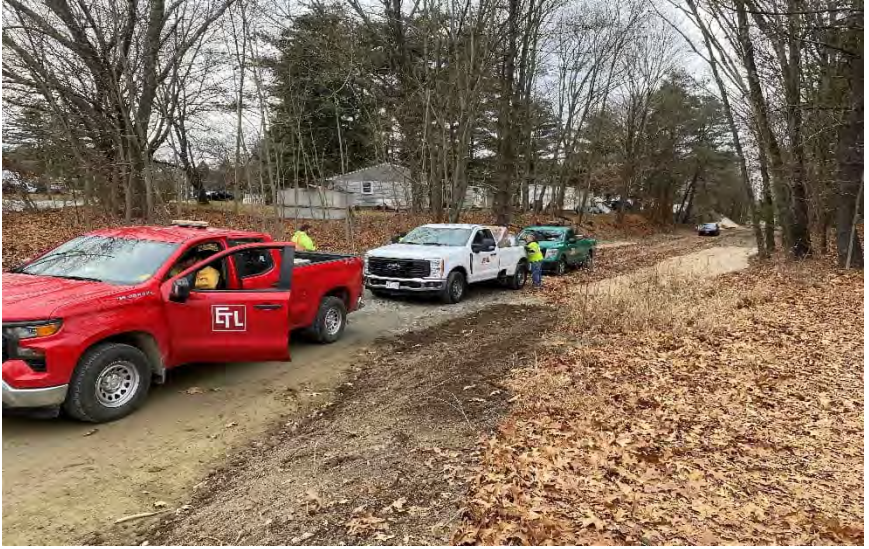
| <p>Photo No.: 4</p> | <p>Date: 12-1-23</p> | | |

| <p>Description:</p> <p>Work area within segment 3, ET&L/MON on-site conducting restorative activities, looking westward.</p> | | | |

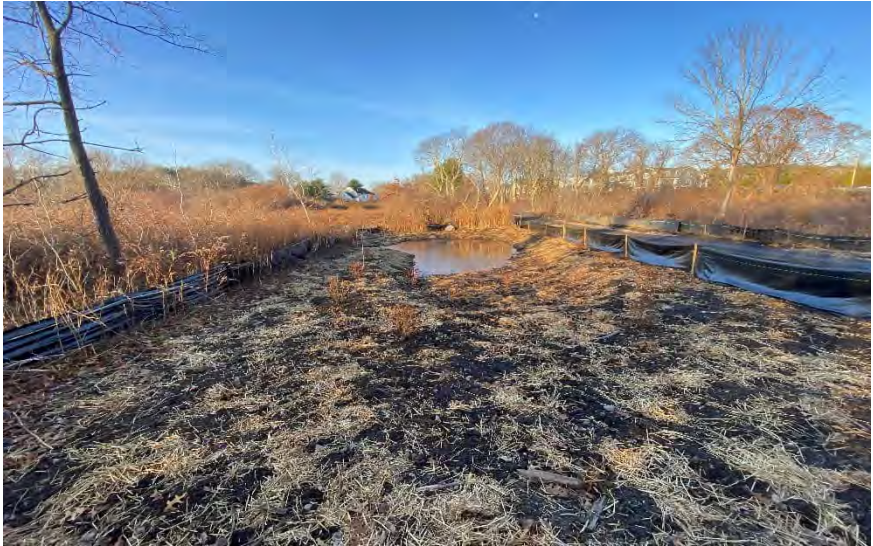
| <p>Photo No.: 5</p> | <p>Date: 12-1-23</p> | | |

| <p>Description:</p> <p>Wetland replication area within segment 14, existing erosion control, looking westward.</p> | | | |

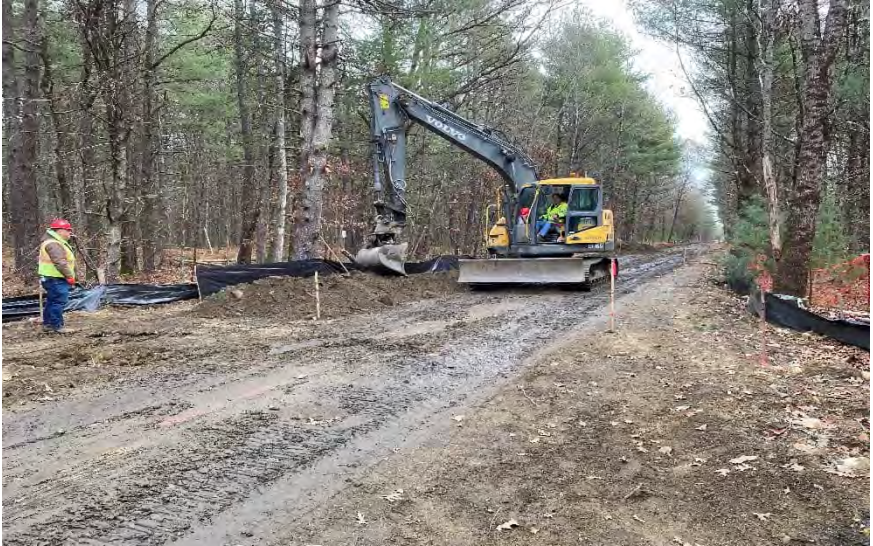
| <p>Photo No.: 6</p> | <p>Date: 12-1-23</p> | | |

| <p>Description:</p> <p>Work area within Segment 7, ET&L conducting grading work, existing erosion control, looking eastward.</p> | | | |

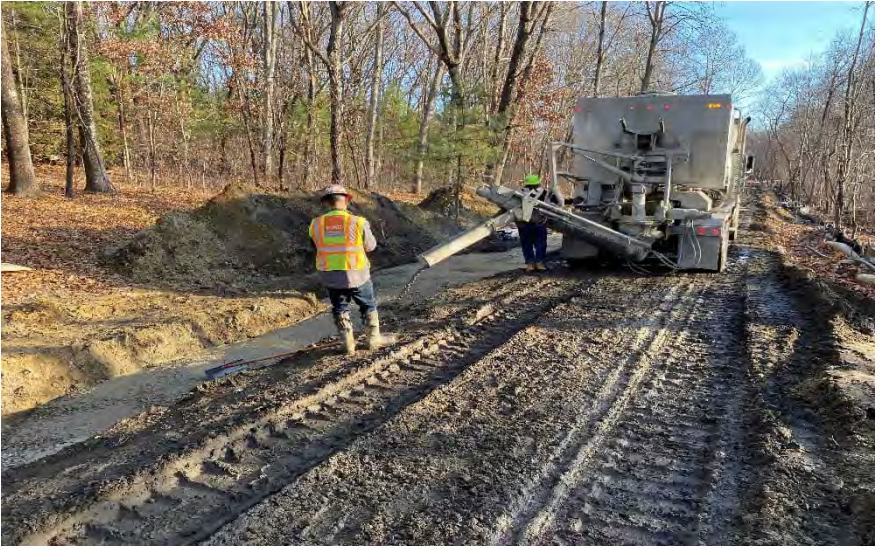
| <p>Photo No.: 7</p> | <p>Date: 12-1-23</p> | | |

| <p>Description:</p> <p>Work area within Segment 14, conduit work – placement of fill over pipe, existing erosion control, looking eastward.</p> | | | |

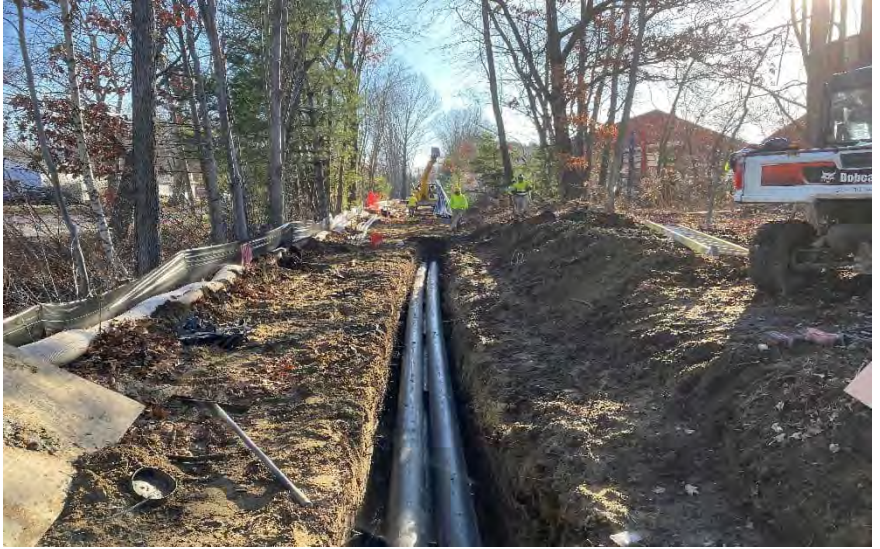
| <p>Photo No.: 8</p> | <p>Date: 12-1-23</p> | | |

| <p>Description:</p> <p>Work area within Segment 12, conduit work, existing erosion control, looking eastward.</p> | | | |

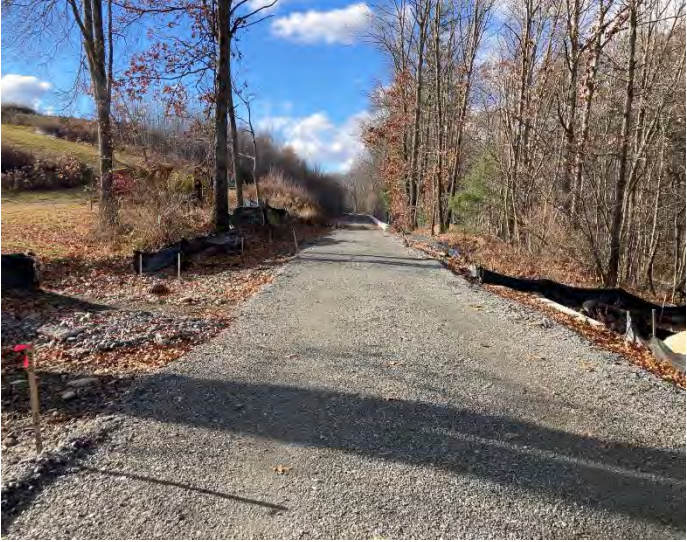
| Photo No.: 1 | Date: 11-27-2023 | | |

| Description: View of stormwater drainage structure in Stow portion of segment 1. Facing west. | | | |

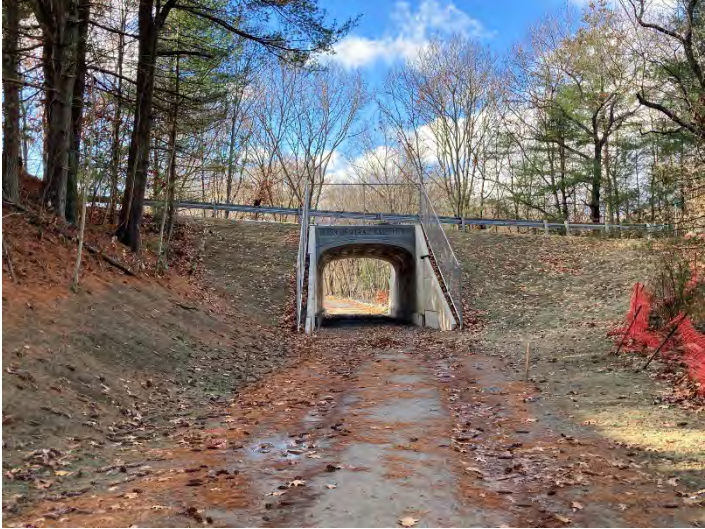
| Photo No.: 2 | Date: 11-27-2023 | | |

| Description: View of Chestnut St tunnel. Facing west. | | | |

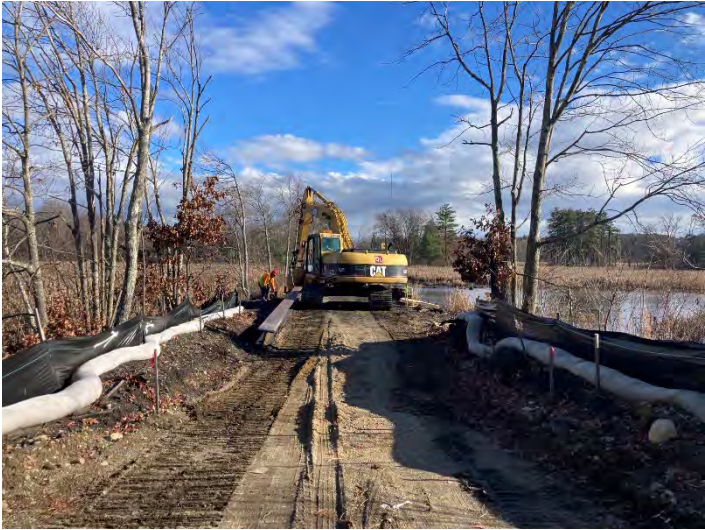
| Photo No.: 3 | Date: 11-27-2023 | | |

| Description: View of work area at bridge 130 in segment 2. Facing east. | | | |

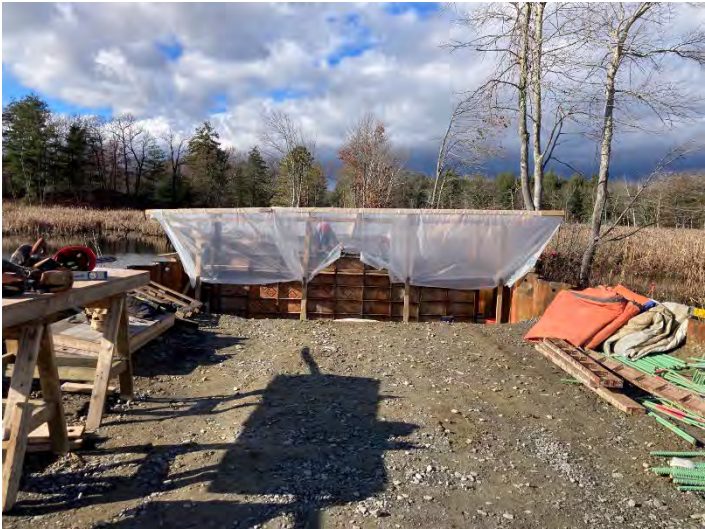
| Photo No.: 4 | Date: 11-27-2023 | | |

| Description: View of work area at bridge 130 in segment 3. See additional dewatering inspection report. Facing west. | | | |
