Weekly Environmental Compliance Summary

Sudbury to Hudson Transmission Reliability Project (USEPA Tracking # MAR1003UW)

Sudbury, Hudson, and Stow, MA

Week of: November 27, 2023 to December 1, 2023

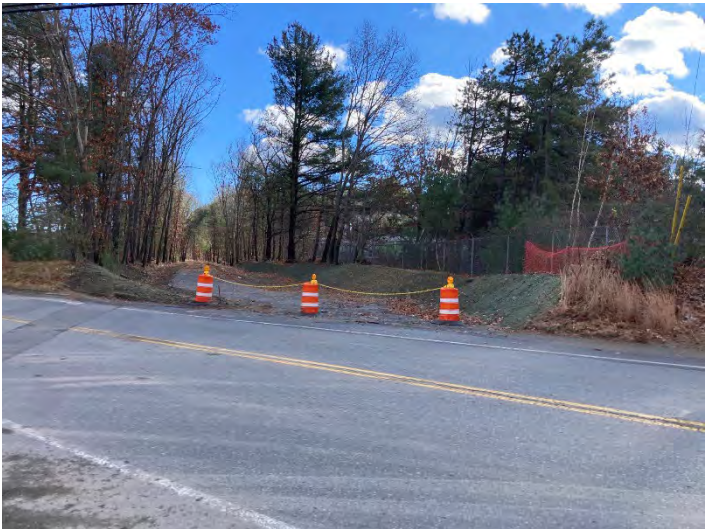
| Photo No.: 5 | Date: 11-27-2023 | | |

| Description: View of entrance to segment 4 at Main St. Facing east. | | | |

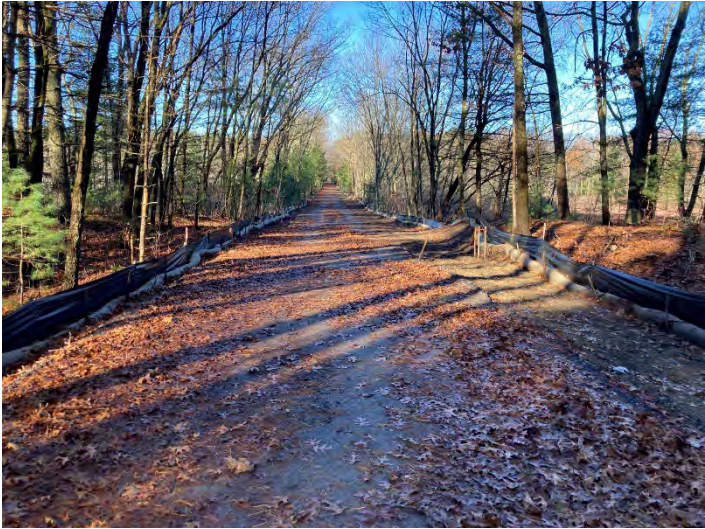
| Photo No.: 6 | Date: 11-27-2023 | | |

| Description: View of Type B E&S controls in segment 5. Facing west. | | | |

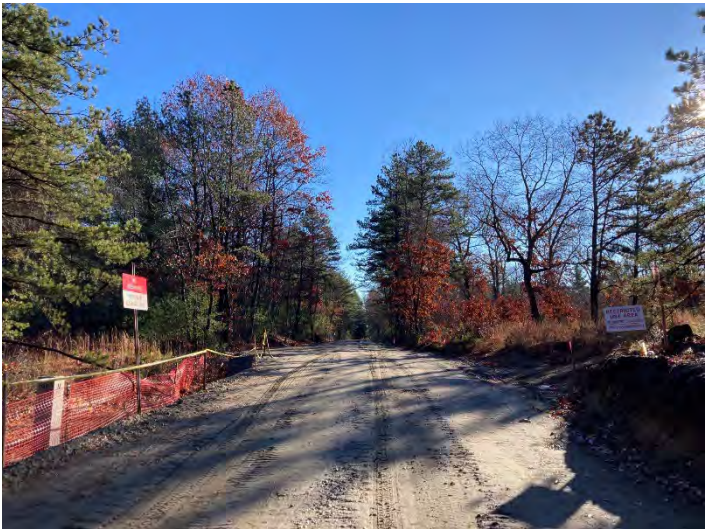
| Photo No.: 7 | Date: 11-27-2023 | | |

| Description: View of Black Racer Snake TOY restricted area at Hudson/Sudbury town line between segments 6 and 7. Facing east. | | | |

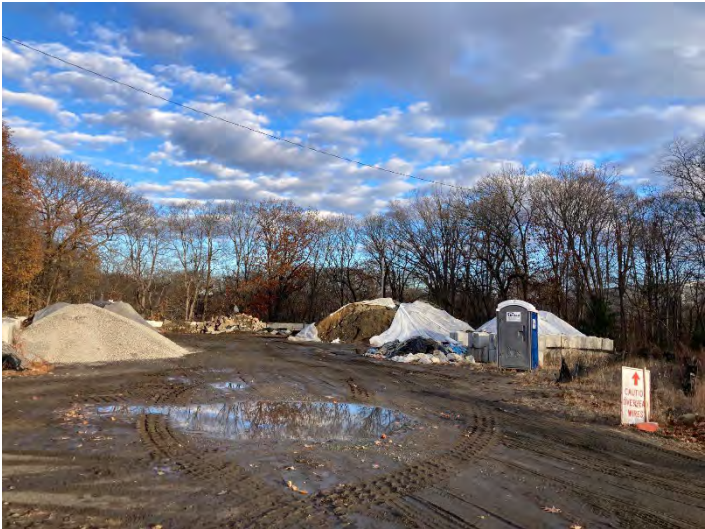
| Photo No.: 8 | Date: 11-27-2023 | | |

| Description: View of Stowe Ct laydown yard. Facing west. | | | |

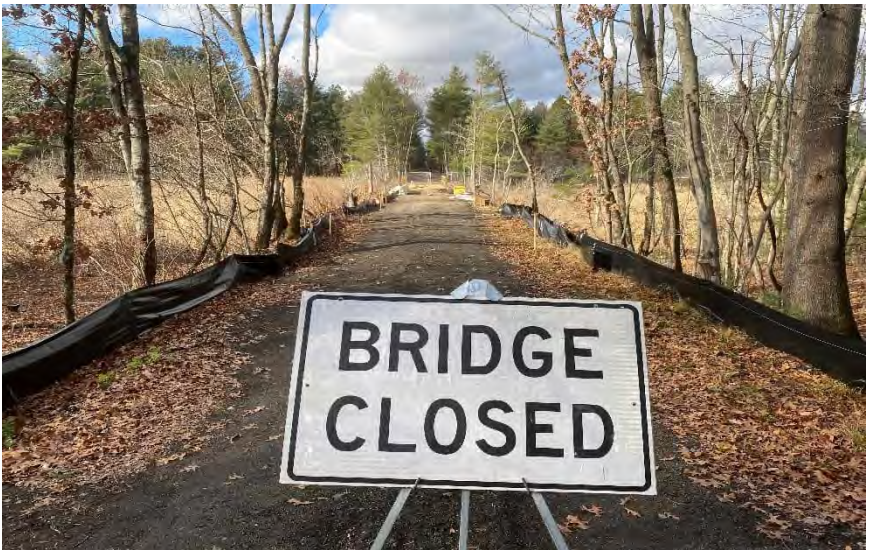
| Photo No.: 2 | Date: 11-27-23 | | |

| Description: Work area from segment 8 toward segment 7, existing erosion control, looking westward. | | | |

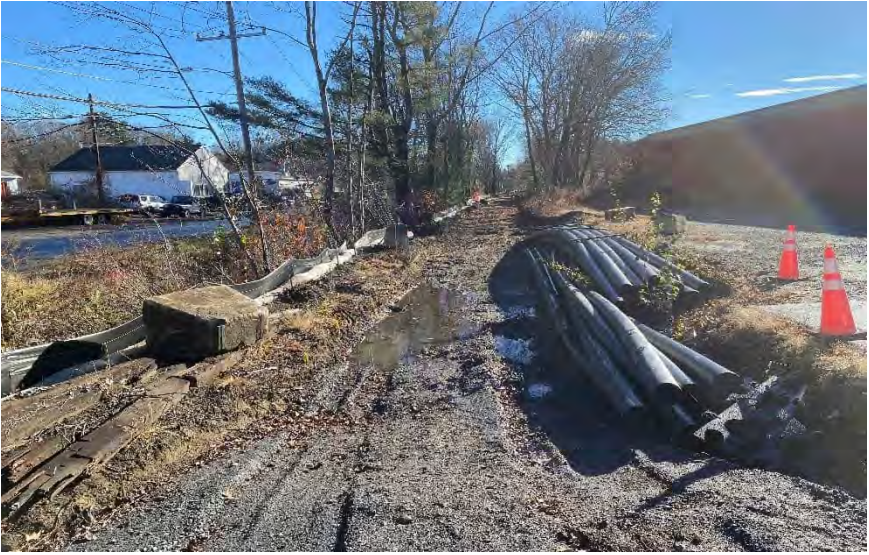
| Photo No.: 3 | Date: 11-27-23 | | |

| Description: Work area within segment 12, existing erosion control, looking eastward. | | | |

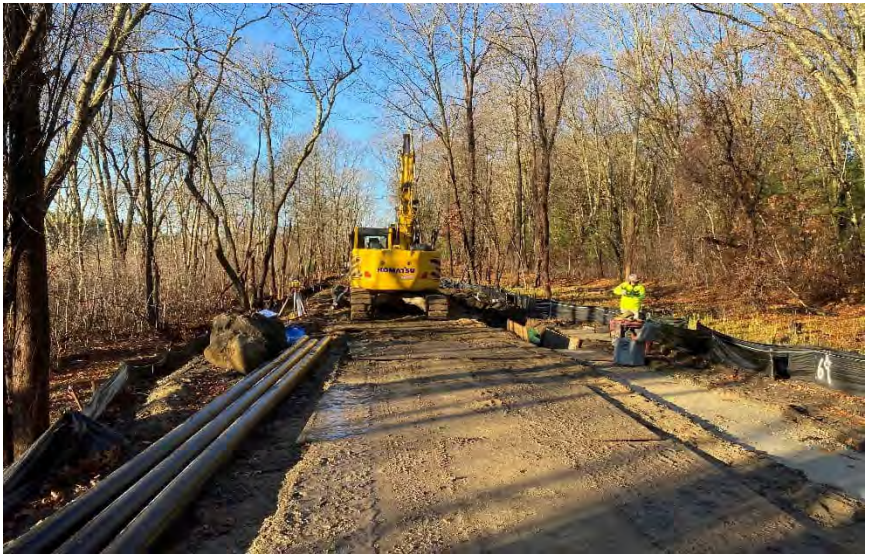
| Photo No.: 4 | Date: 11-27-23 | | |

| Description: Work area within segment 14, conduit work, looking westward. | | | |

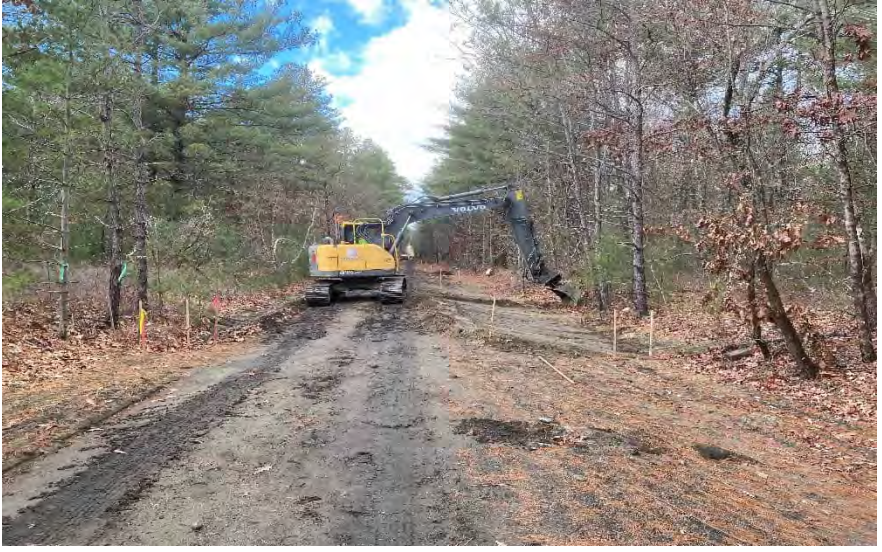
| Photo No.: 5 | Date: 11-27-23 | | |

| Description: Work area, grading work, within segment 7, existing erosion control, looking westward. | | | |

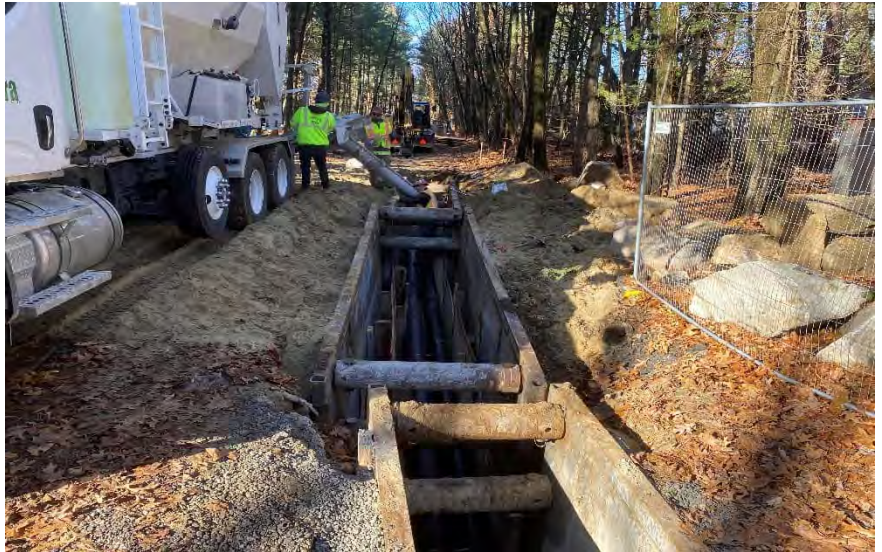
| Photo No.: 6 | Date: 11-27-23 | | |

| Description: Work area within segment 10, conduit work, looking westward. | | | |

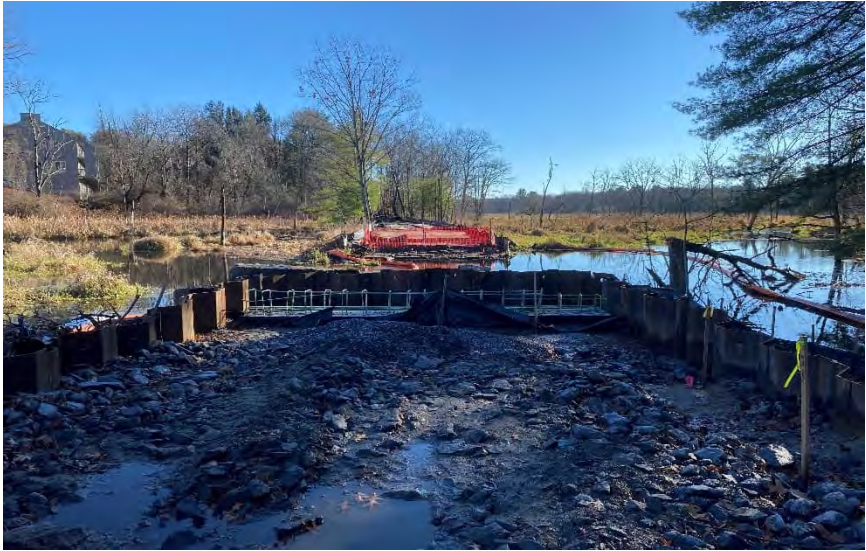
| Photo No.: 7 | Date: 11-27-23 | | |

| Description: Work area looking over Hop Brook from segment 13 toward segment 14 over Hop Brook (bridge 127 area), looking eastward. | | | |

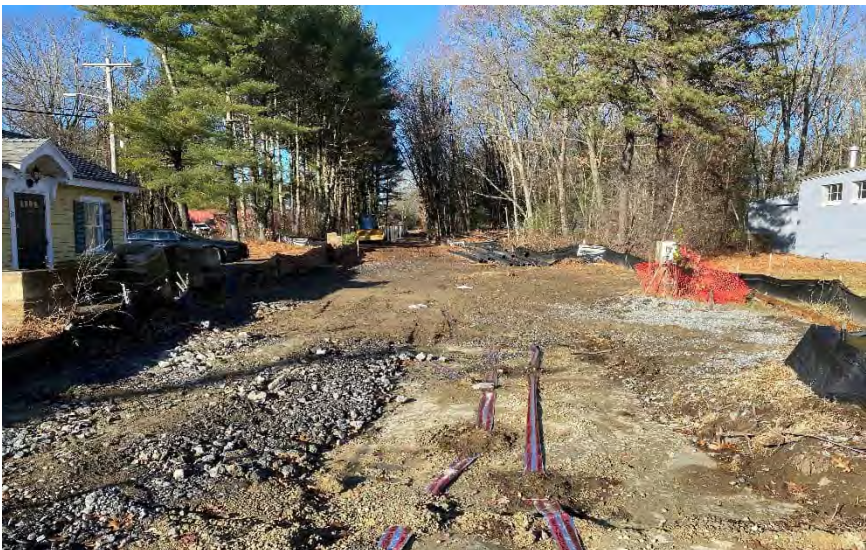
| Photo No.: 8 | Date: 11-27-23 | | |

| Description: Work area, within segment 11, existing erosion control, looking westward. | | | |

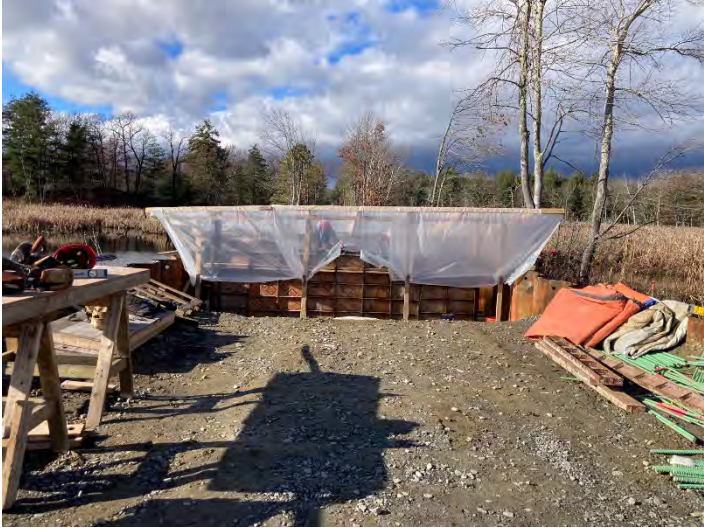
| Photo No.: 1 | Date: 11/27/2023 | | |

| Description: View of work area and pumping operation at bridge 130 in segment 3. Facing west. | | | |

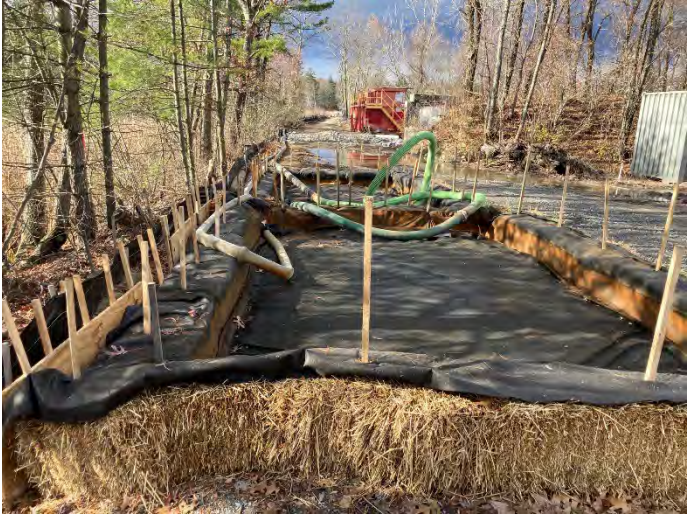
| Photo No.: 3 | Date: 11/27/2023 | | |

| Description: View of dewatering controls (straw bale corral with filter fabric, stone, and silt bag). Frac tank not currently in use. Facing east. | | | |

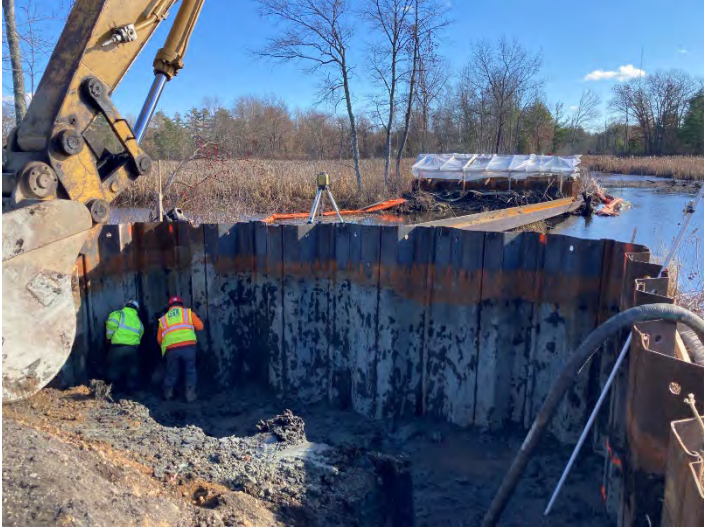
| Photo No.: 1 | Date: 11/28/2023 | | | |

| Description: View of work area and pumping operation at bridge 130 in segment 2. Facing east. | | | | |

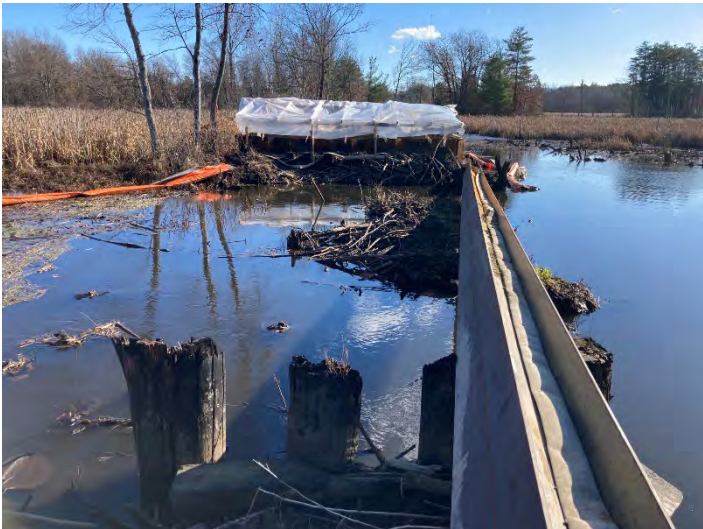
| Photo No.: 2 | Date: 11/28/2023 | | | |

| Description: View of hose in beam across Fort Meadow Brook, transporting water from segment 2 to segment 3. Facing east. | | | | |

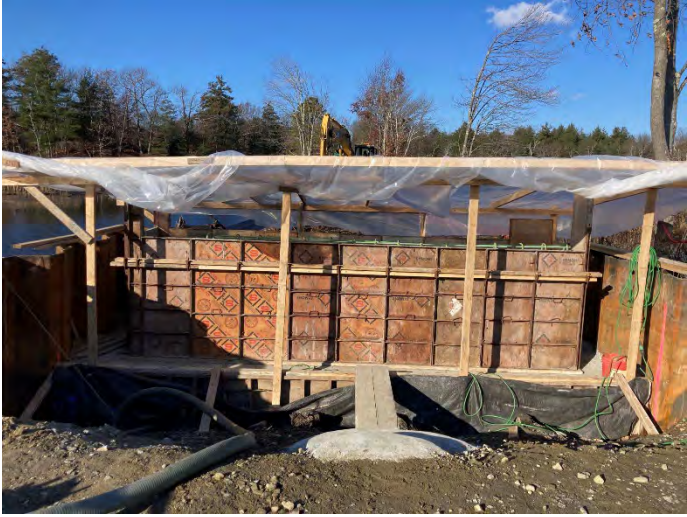
| Photo No.: 3 | Date: 11/28/2023 | | |

| Description: View of work area and pumping operation at bridge 130 in segment 3. Facing west. | | | |

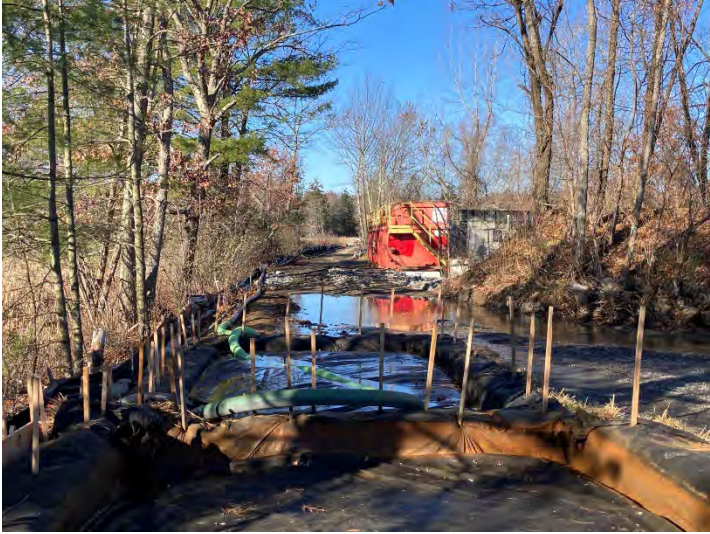
| Photo No.: 5 | Date: 11/28/2023 | | |

| Description: View of dewatering controls in segment 3 (frac tank, straw bale corral with filter fabric, stone, and silt bag). Water from segment 2 is being routed through frac tank. Facing west. | | | |

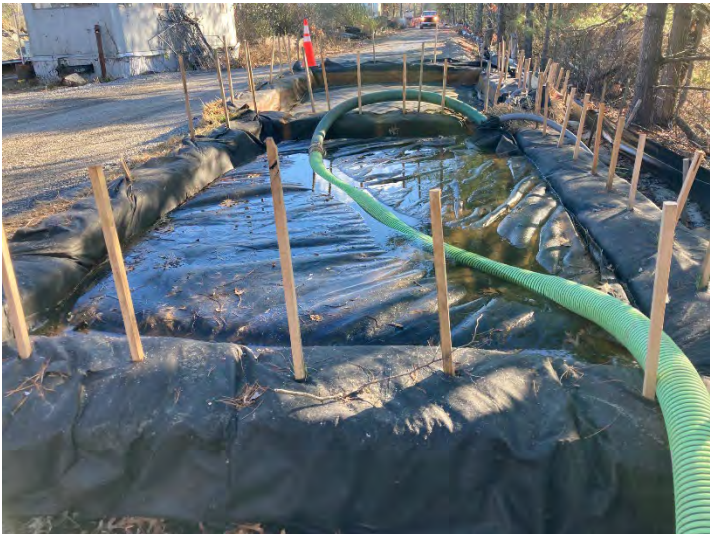
| Photo No.: 6 | Date: 11/28/2023 | | |

| Description: View of dewatering controls in segment 3 (straw bale corral with filter fabric, stone, and silt bag) with both hoses going into filter bag. Facing east. | | | |

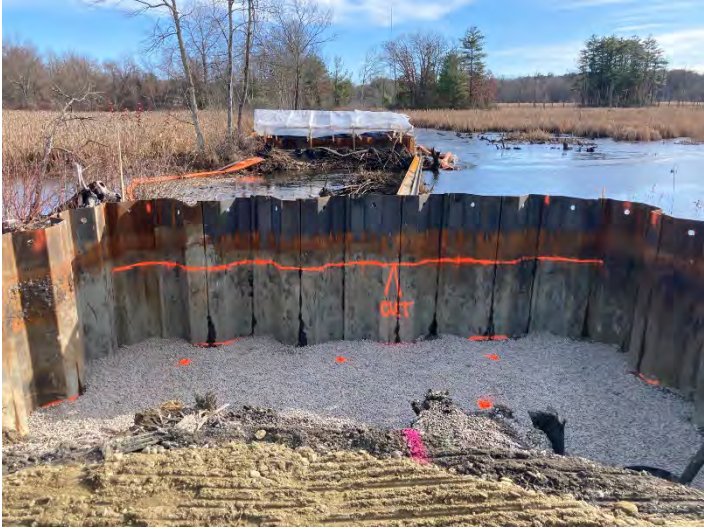
| Photo No.: 1 | Date: 11/29/2023 | | |

| Description: View of work area and pumping operation at bridge 130 in segment 2. Facing east. | | | |

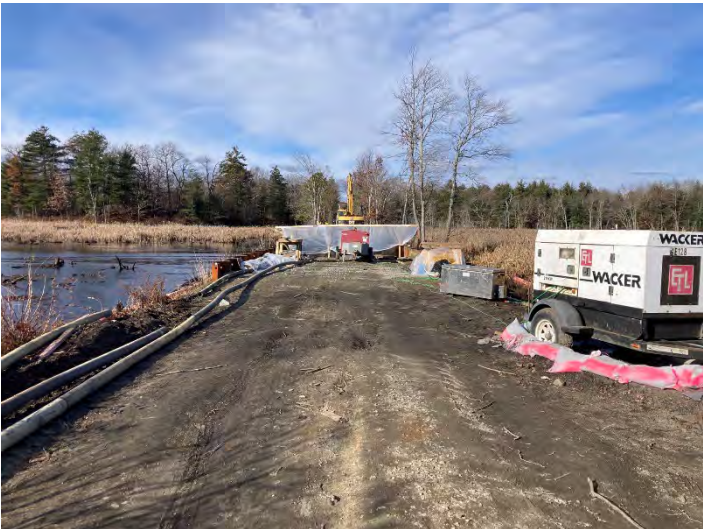
| Photo No.: 2 | Date: 11/29/2023 | | |

| Description: View of work area and pumping operation at bridge 130 in segment 3. Facing west. | | | |

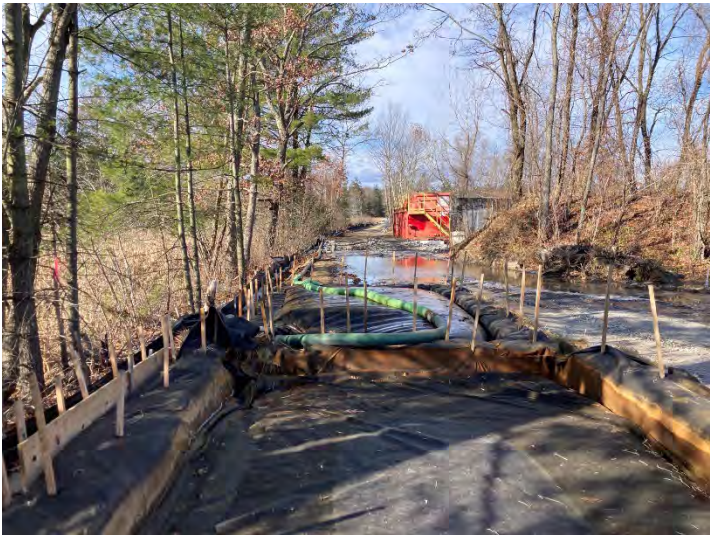
| Photo No.: 4 | Date: 11/29/2023 | | |

| Description: View of dewatering controls in segment 3 (frac tank, straw bale corral with filter fabric, stone, and silt bag). Water from segment 2 is being routed through frac tank. Facing west. | | | |

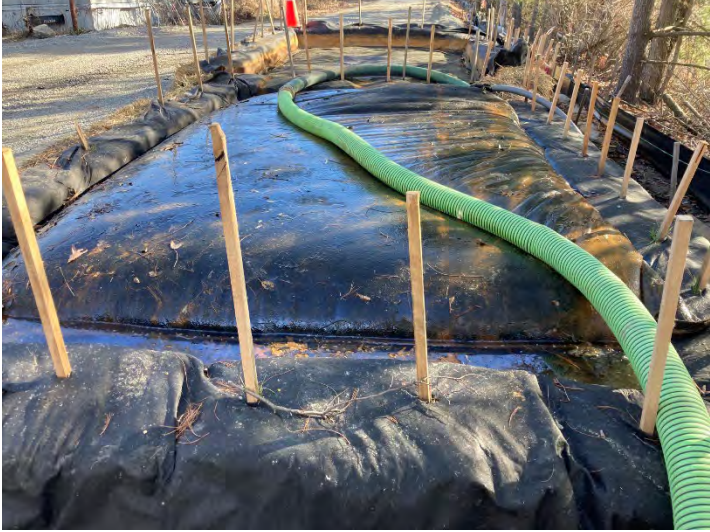
| Photo No.: 5 | Date: 11/29/2023 | | |

| Description: View of dewatering controls in segment 3 (straw bale corral with filter fabric, stone, and silt bag) with both hoses going into filter bag. Facing east. | | | |

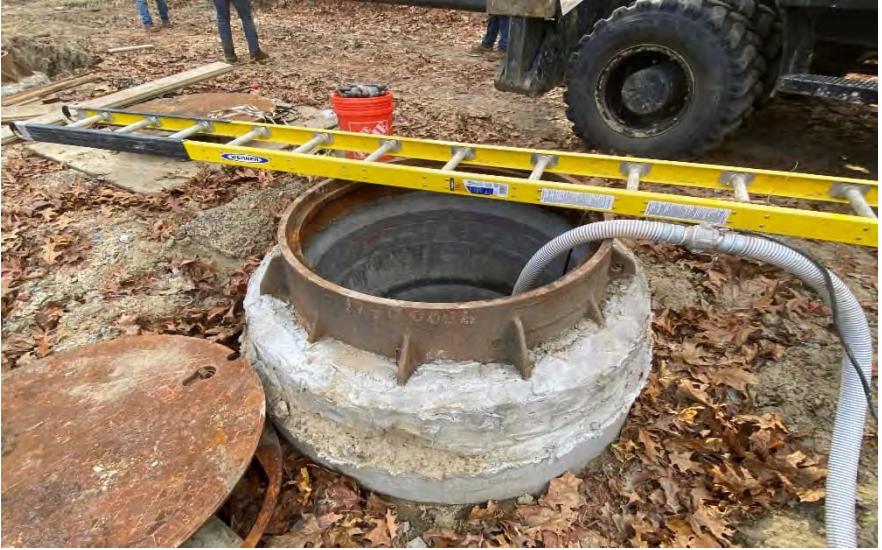
| Photo No.: 1 | Date: 11/29/2023 | | |

| Description: View of area being pumped from manhole #21 within segment 10, looking eastward. | | | |

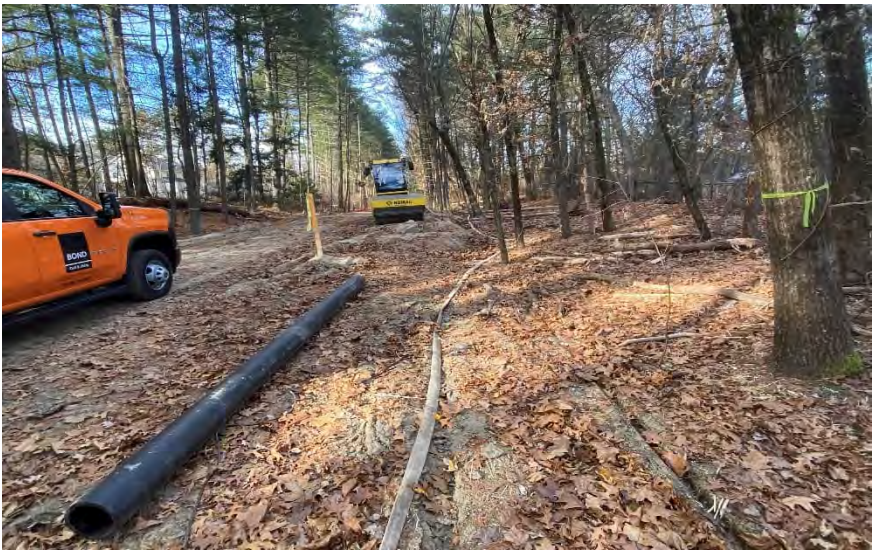
| Photo No.: 2 | Date: 11/29/2023 | | |

| Description: Manhole #21. View of dewatering operation. Looking westward. | | | |

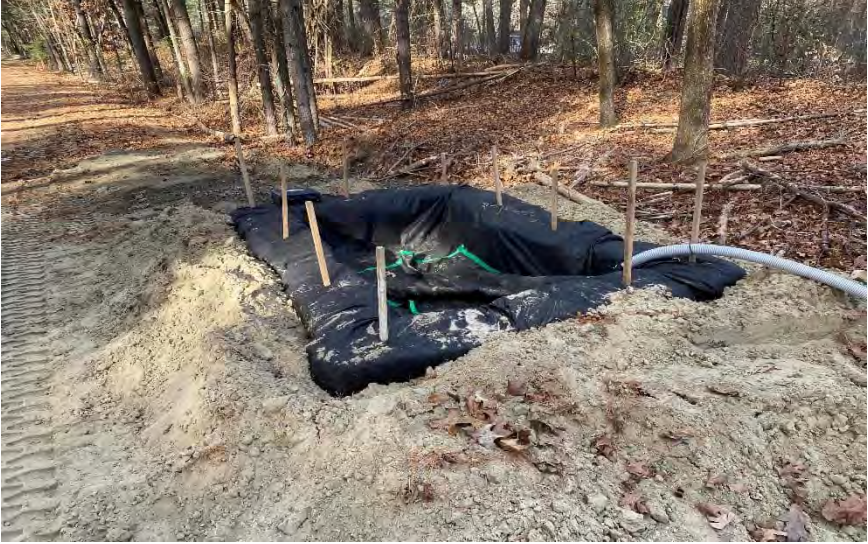
| Photo No.: 3 | Date: 11/29/2023 | | |

| Description: Manhole #21. View of dewatering operation, looking westward. | | | |

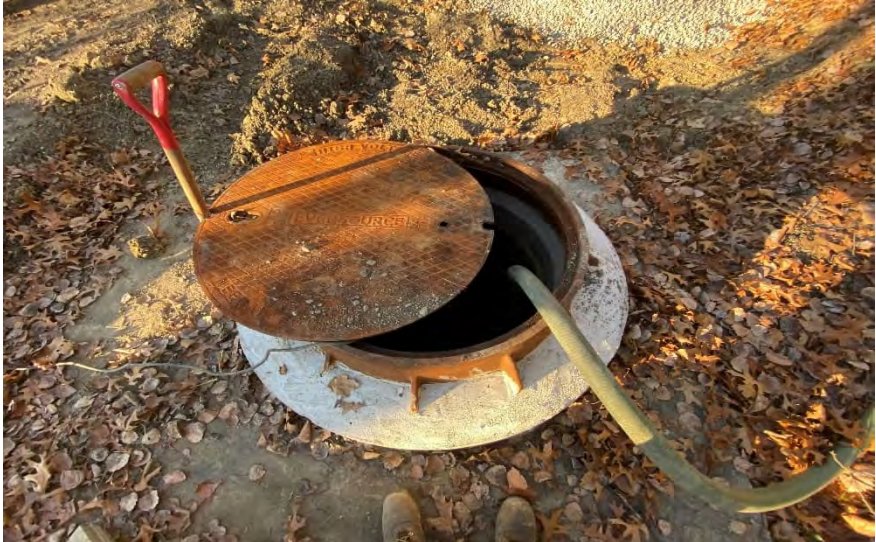
| Photo No.: 1 | Date: 11/29/2023 | | |

| Description: View of area being pumped from trench from manhole #26 within segment 14, looking southward. | | | |

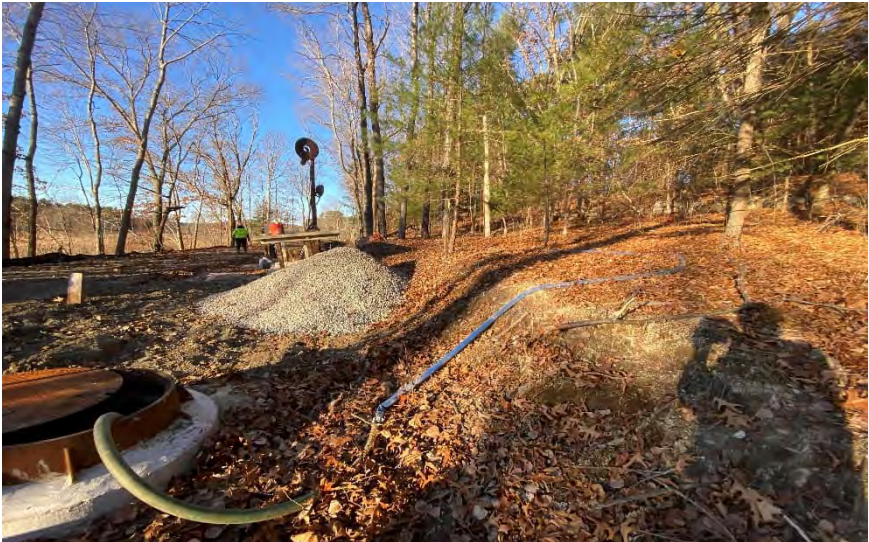
| Photo No.: 2 | Date: 11/29/2023 | | |

| Description: Manhole #26. View of dewatering operation. Looking westward. | | | |

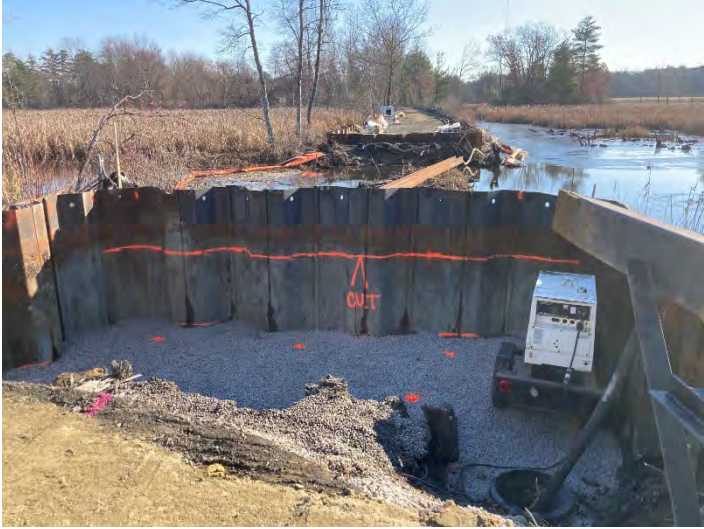
| Photo No.: 1 | Date: 11/30/2023 | | |

| Description: View of work area and pumping operation at bridge 130 in segment 2. Facing east. | | | |

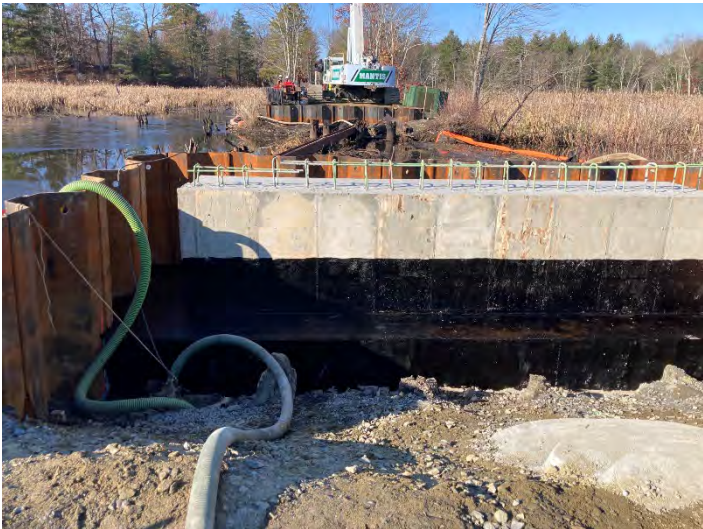
| Photo No.: 2 | Date: 11/30/2023 | | |

| Description: View of work area and pumping operation at bridge 130 in segment 3. Facing west. | | | |

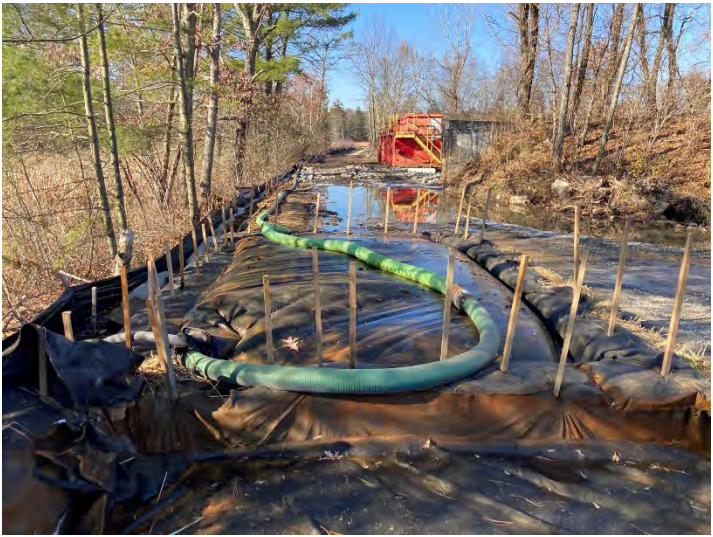
| Photo No.: 4 | Date: 11/30/2023 | | |

| Description: View of dewatering controls in segment 3 (frac tank, straw bale corral with filter fabric, stone, and silt bag). Water from segment 2 is being routed through frac tank. Hoses from segment 2 and segment 3 are going to same filter bag. Facing west. | | | |

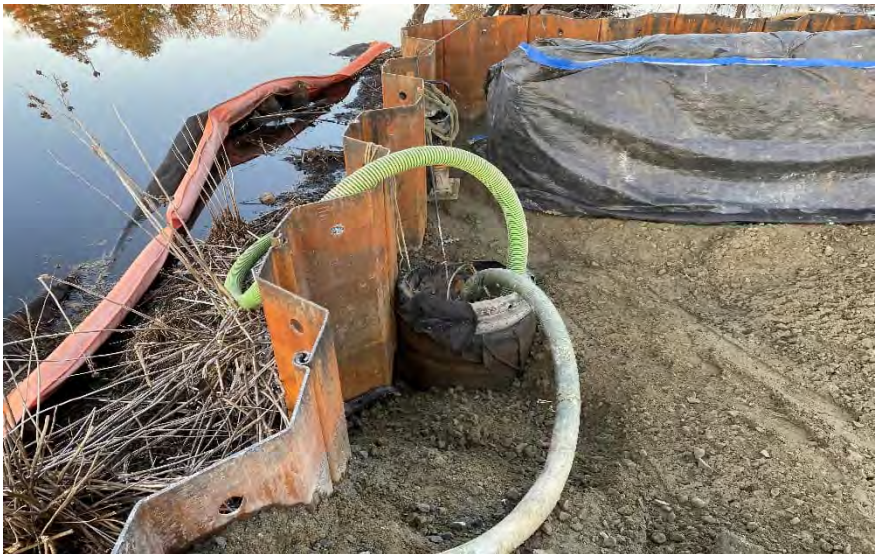
| Photo No.: 1 | Date: 12/1/2023 | | |

| Description: View of area being pumped (i.e., cofferdam within segment 3 off Fort Meadow Brook), looking westward. | | | |

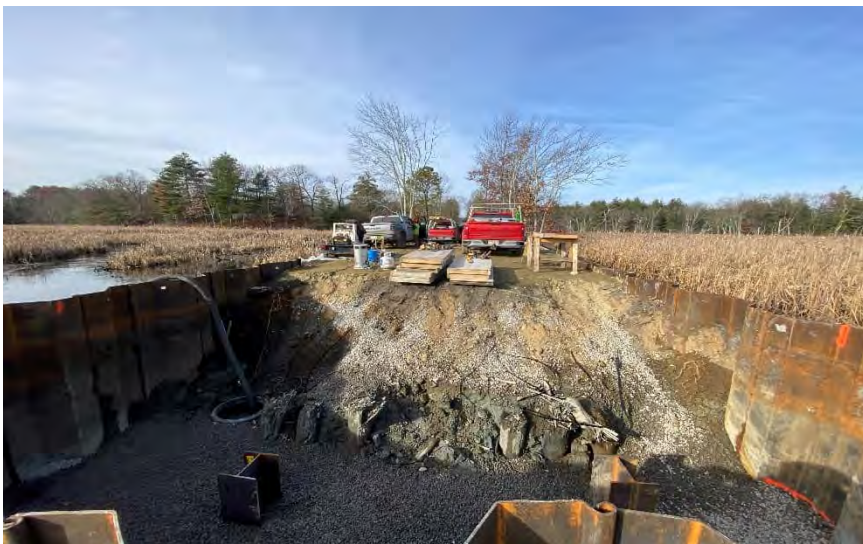
| Photo No.: 2 | Date: 12/1/2023 | | |

| Description: View of area being pumped (i.e., cofferdam within segment 2 off Fort Meadow Brook), looking westward. | | | |

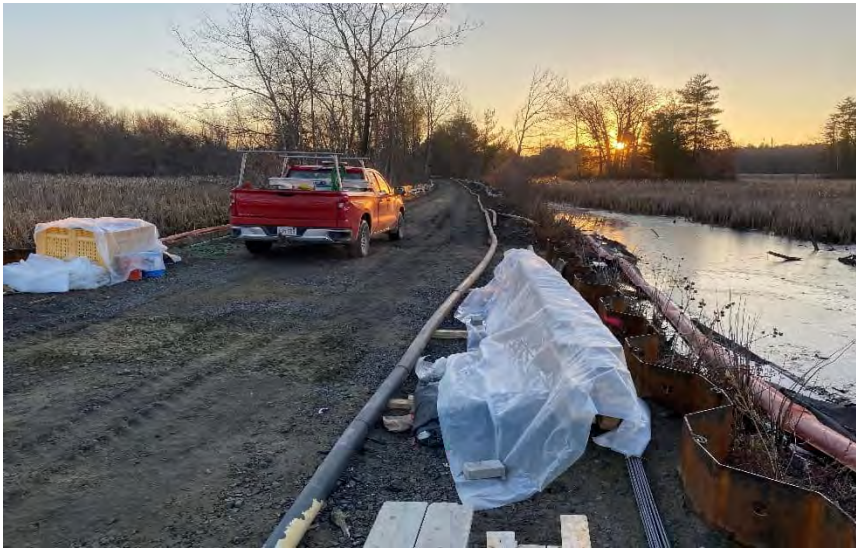
| Photo No.: 3 | Date: 12/1/2023 | | |

| Description: Segment 3. View of discharge dewatering operation, looking eastward. | | | |

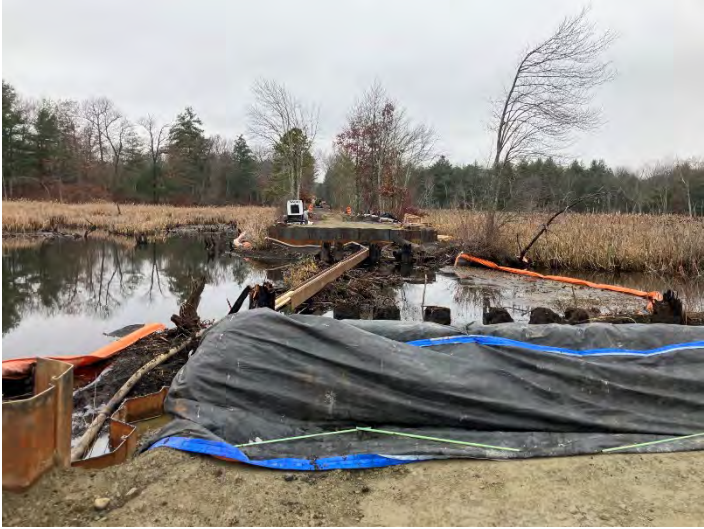
| Photo No.: 1 | Date: 12/02/2023 | | |

| Description: View of work area and pumping operation at bridge 130, from segment 3. Unable to access segment 2 side due to locked gate at water supply road. Facing west. | | | |

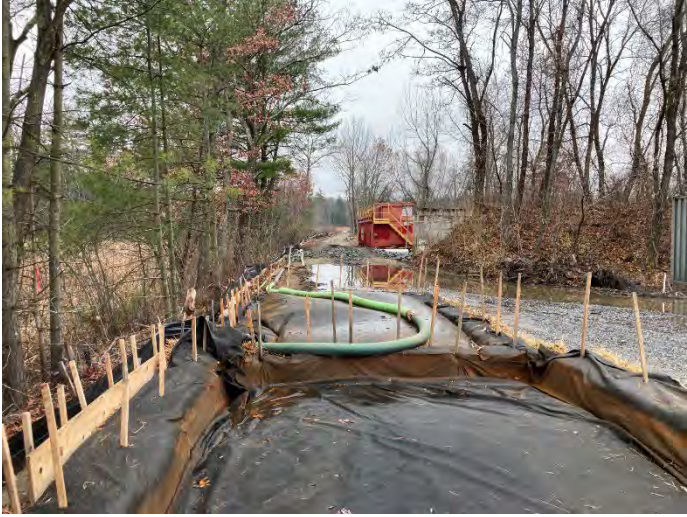
| Photo No.: 3 | Date: 12/02/2023 | | |

| Description: View of dewatering controls in segment 3 (frac tank, straw bale corral with filter fabric, stone, and silt bag). Water from segment 2 is being routed through frac tank. Facing west. | | | |

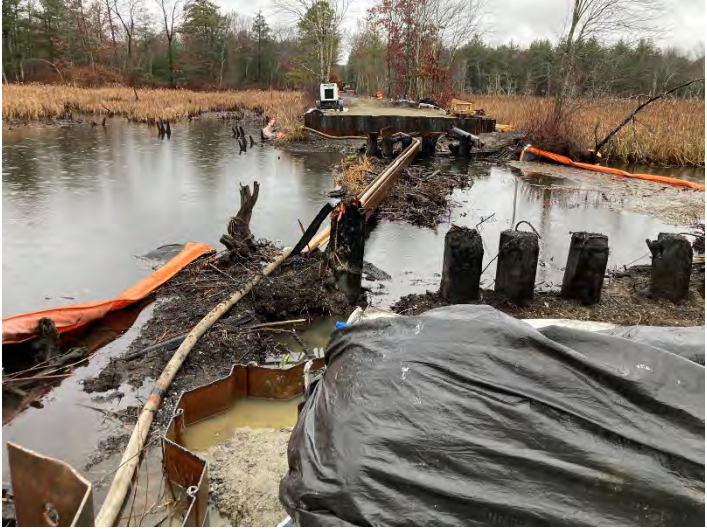
| Photo No.: 1 | Date: 12/03/2023 | | |

| Description: View of work area and pumping operation at bridge 130, from segment 3. Unable to access segment 2 side due to locked gate at water supply road. Facing west. | | | |

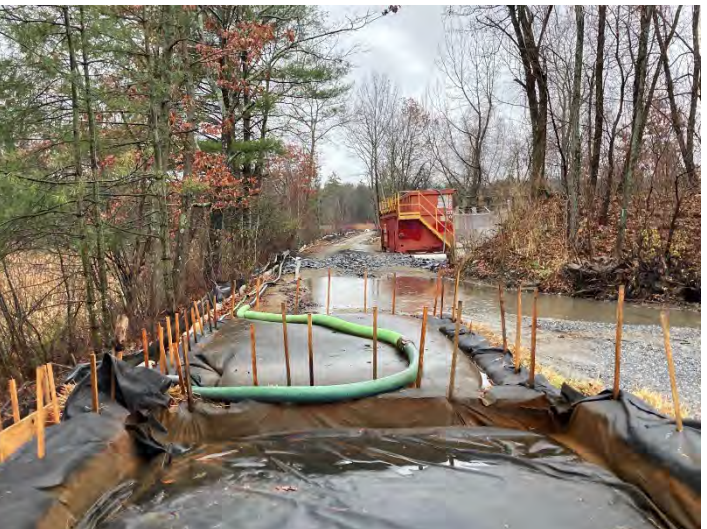
| Photo No.: 2 | Date: 12/03/2023 | | |

| Description: View of dewatering controls in segment 3 (frac tank, straw bale corral with filter fabric, stone, and silt bag). Water from segment 2 is being routed through frac tank. Facing west. | | | |

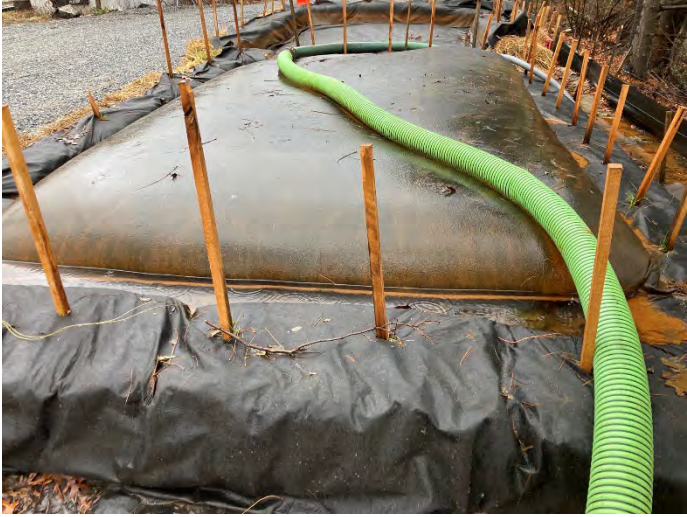
| Photo No.: 3 | Date: 12/03/2023 | | |

| Description: Additional view of dewatering controls in segment 3 (straw bale corral with filter fabric, stone, and silt bag). Facing east. | | | |

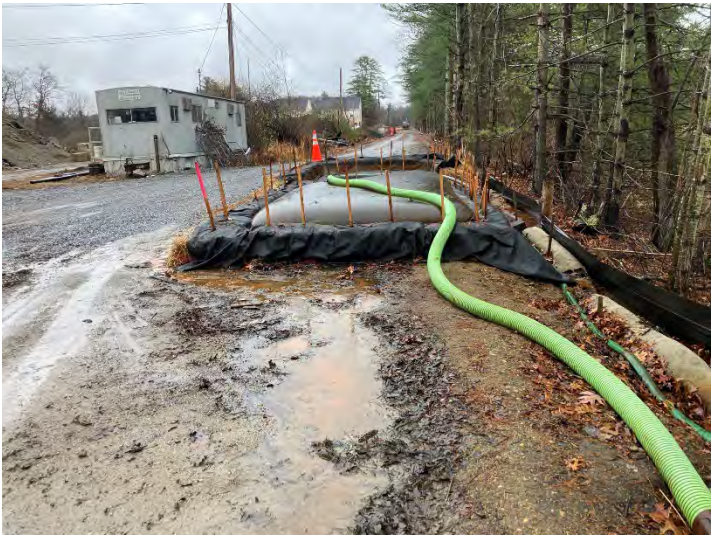
| Photo No.: 4 | Date: 12/03/2023 | | |

| Description: View of discharge from controls. Discharge appeared mostly clear. Turbidity reading was below 50 NTUs. Discharge did not appear to be leaving the project at time of inspection. Facing east. | | | |
