**Weekly Environmental Compliance Summary**

**Sudbury to Hudson Transmission Reliability Project (USEPA Tracking # MAR1003UW)**

Sudbury, Hudson, and Stow, MA

Week of: December 4, 2023 to December 8, 2023

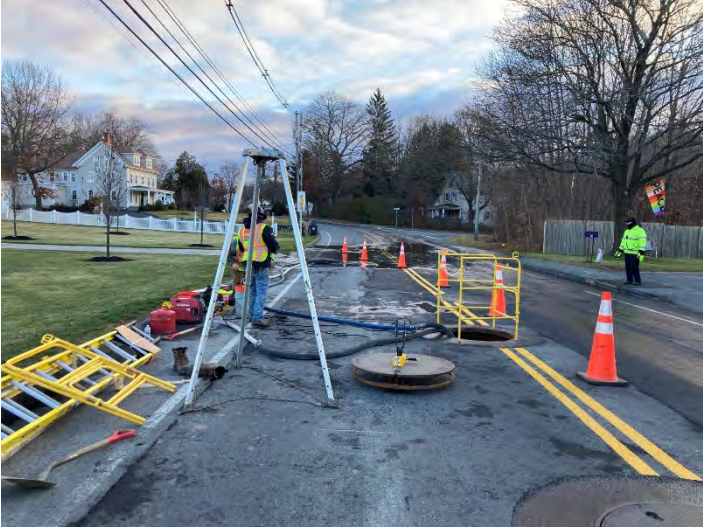
<p><b>PHOTOGRAPHIC LOG</b></p>	
<p>Client Name: Eversource</p>		<p>Site Location: Sudbury to Hudson Transmission Reliability Project</p>	<p>Town: Hudson</p>
<p>Photo No.: 1</p>	<p>Date: 12/05/2023</p>

<p><b>Description:</b> View of Bond working at MH #3 on Forest Ave. See additional dewatering inspection report. Facing north.</p>

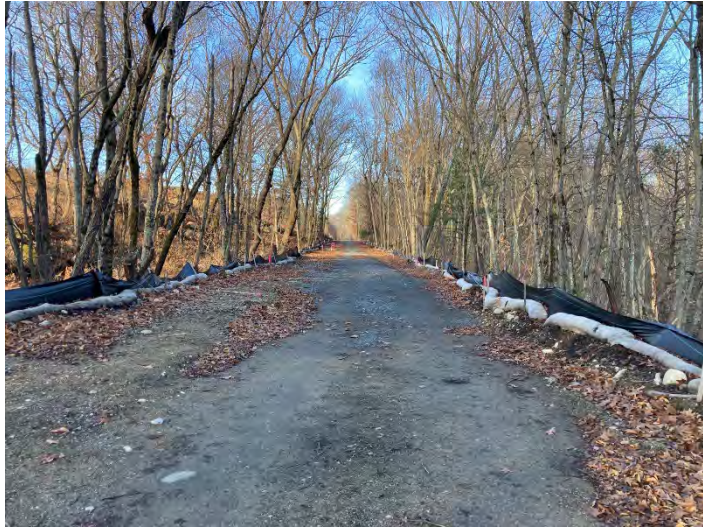
<p><b>PHOTOGRAPHIC LOG</b></p>	
<p>Client Name: Eversource</p>		<p>Site Location: Sudbury to Hudson Transmission Reliability Project</p>	<p>Town: Hudson</p>
<p>Photo No.: 2</p>	<p>Date: 12/05/2023</p>

<p><b>Description:</b> View of Type B E&amp;S controls in segment 1. Facing west.</p>

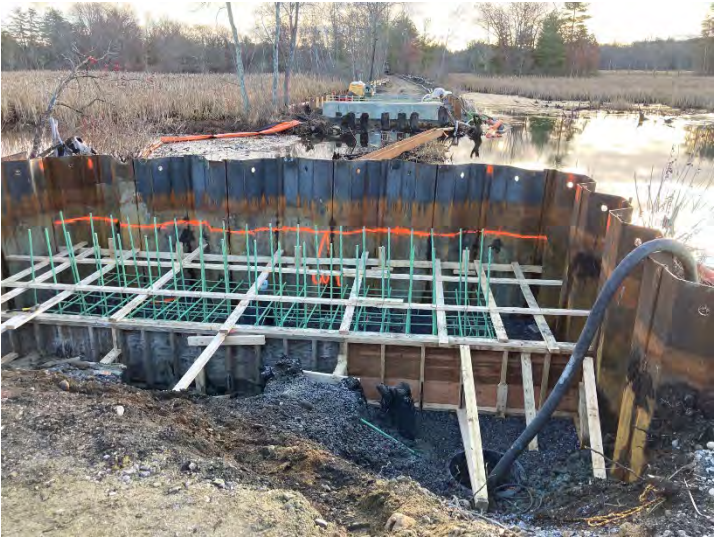
<b>PHOTOGRAPHIC LOG</b>	
Client Name: Eversource		Site Location: Sudbury to Hudson Transmission Reliability Project	Town: Hudson
Photo No.: 3	Date: 12/05/2023

<b>Description:</b> View of work at bridge 130 in segment 2. See additional dewatering inspection report. Facing east.

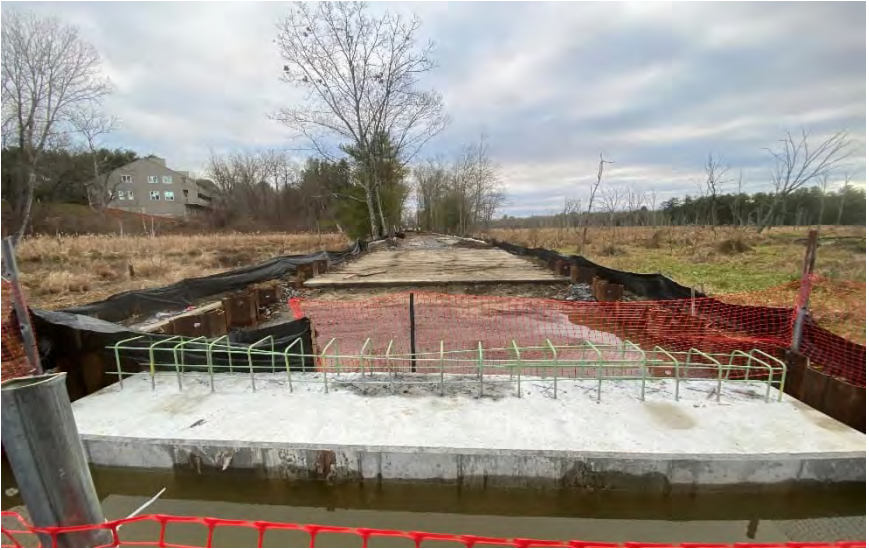
<p>PHOTOGRAPHIC LOG</p>	
<p>Client Name: Eversource</p>		<p>Site Location: Sudbury to Hudson Transmission Reliability Project</p>	<p>Town: Sudbury</p>
<p>Photo No.: 1</p>	<p>Date: 12-5-23</p>

<p>Description:</p> <p>Work area within segment 14 from bridge 127, existing erosion control, looking eastward.</p>

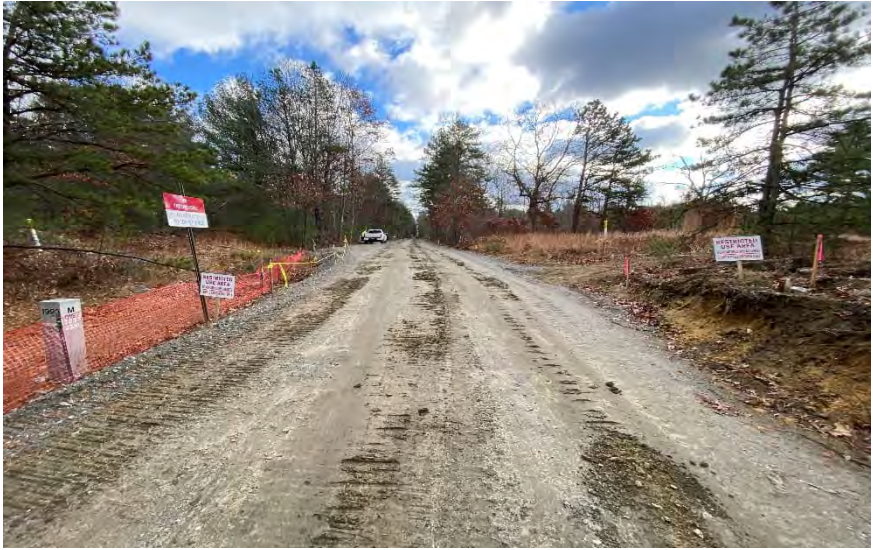
<p>PHOTOGRAPHIC LOG</p>	
<p>Client Name: Eversource</p>		<p>Site Location: Sudbury to Hudson Transmission Reliability Project</p>	<p>Town: Sudbury</p>
<p>Photo No.: 3</p>	<p>Date: 12-5-23</p>

<p>Description:</p> <p>Work area within Segment 7, Black racer restrictive area, looking eastward.</p>

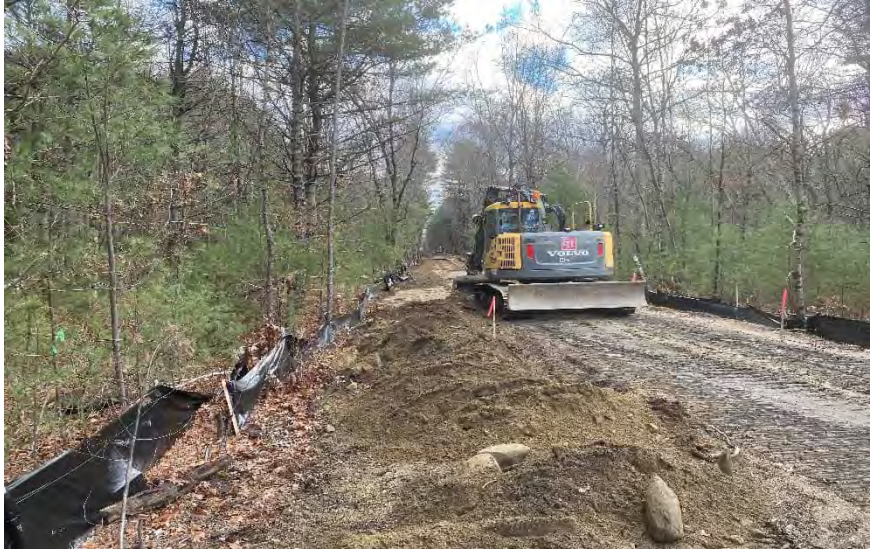
<p>PHOTOGRAPHIC LOG</p>	
<p>Client Name: Eversource</p>		<p>Site Location: Sudbury to Hudson Transmission Reliability Project</p>	<p>Town: Sudbury</p>
<p>Photo No.: 4</p>	<p>Date: 12-5-23</p>

<p>Description:</p> <p>Work area within Segment 7, site grading, existing erosion control, looking eastward.</p>

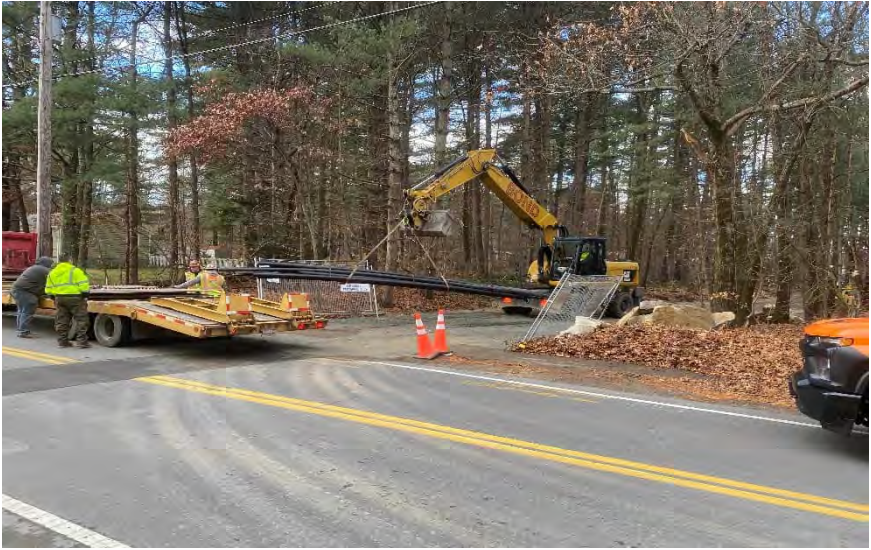
<p>PHOTOGRAPHIC LOG</p>	
<p>Client Name: Eversource</p>		<p>Site Location: Sudbury to Hudson Transmission Reliability Project</p>	<p>Town: Sudbury</p>
<p>Photo No.: 5</p>	<p>Date: 12-5-23</p>

<p>Description:</p> <p>Work area within Segment 10 (off Horsepond road), conduit work, existing erosion control, looking westward.</p>

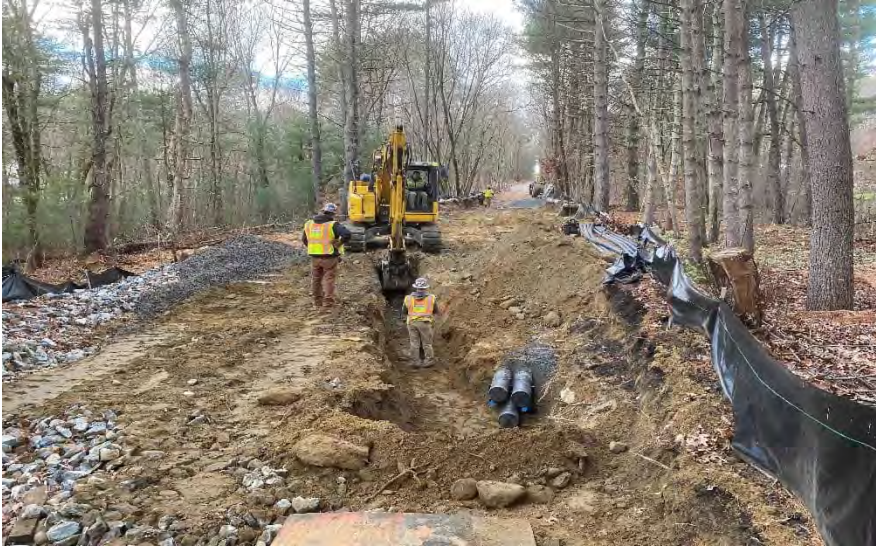
<p>PHOTOGRAPHIC LOG</p>	
<p>Client Name: Eversource</p>		<p>Site Location: Sudbury to Hudson Transmission Reliability Project</p>	<p>Town: Sudbury</p>
<p>Photo No.: 6</p>	<p>Date: 12-5-23</p>

<p>Description:</p> <p>Work area within Segment 9 (off Peakham road), conduit work, existing erosion control, looking westward.</p>

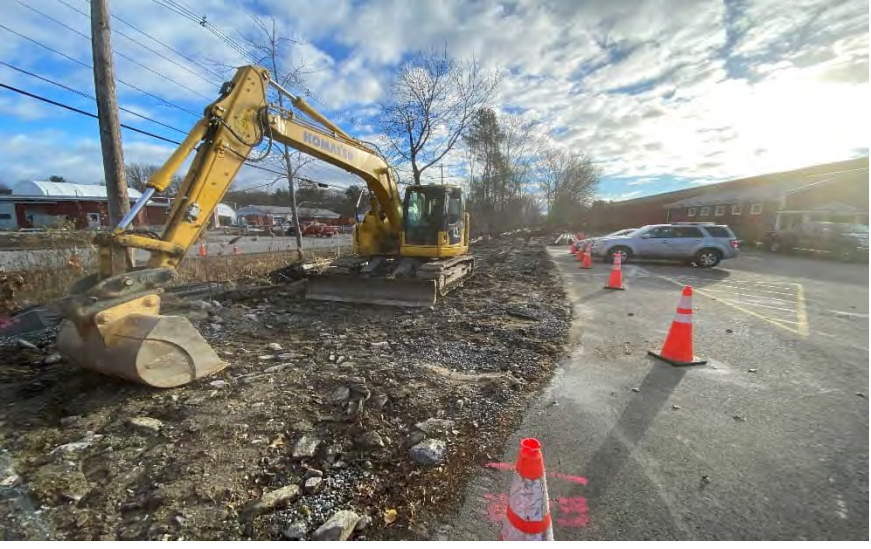
<p>PHOTOGRAPHIC LOG</p>	
<p>Client Name: Eversource</p>		<p>Site Location: Sudbury to Hudson Transmission Reliability Project</p>	<p>Town: Sudbury</p>
<p>Photo No.: 8</p>	<p>Date: 12-5-23</p>

<p>Description:</p> <p>Work area within Segment 12, existing erosion control, looking eastward.</p>

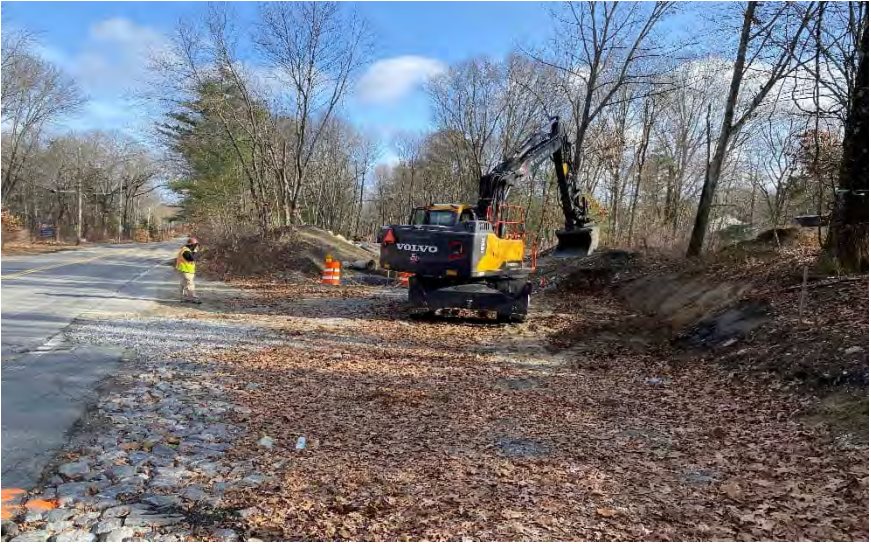
<p>PHOTOGRAPHIC LOG</p>	
<p>Client Name: Eversource</p>		<p>Site Location: Sudbury to Hudson Transmission Reliability Project</p>	<p>Town: Hudson</p>
<p>Photo No.: 1</p>	<p>Date: 12-6-23</p>

<p>Description:</p> <p>Work area looking toward segment 1, Wilkins Street crossing, grading work, looking eastward.</p>

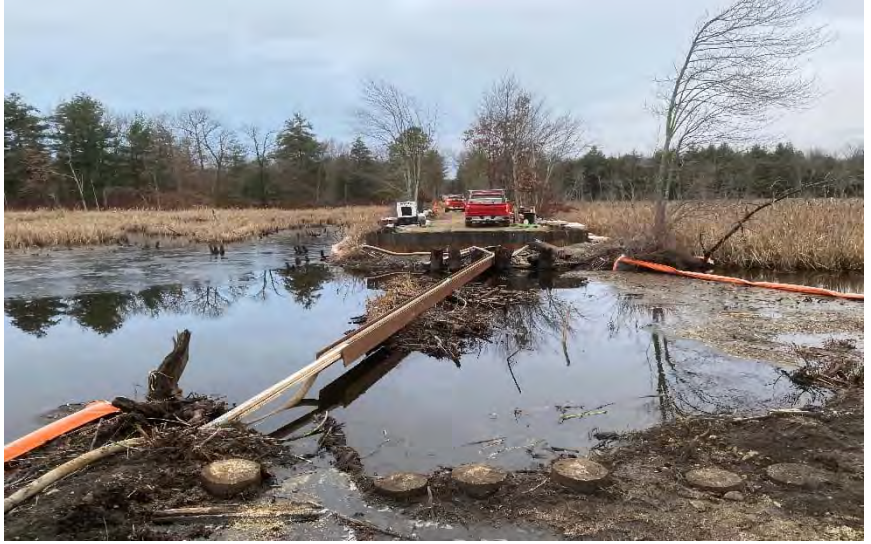
<p>PHOTOGRAPHIC LOG</p>	
<p>Client Name: Eversource</p>		<p>Site Location: Sudbury to Hudson Transmission Reliability Project</p>	<p>Town: Hudson</p>
<p>Photo No.: 2</p>	<p>Date: 12-6-23</p>

<p>Description:</p> <p>Work area from segment 3 toward segment 2 across Fort Meadow Brook, existing erosion control, looking westward.</p>

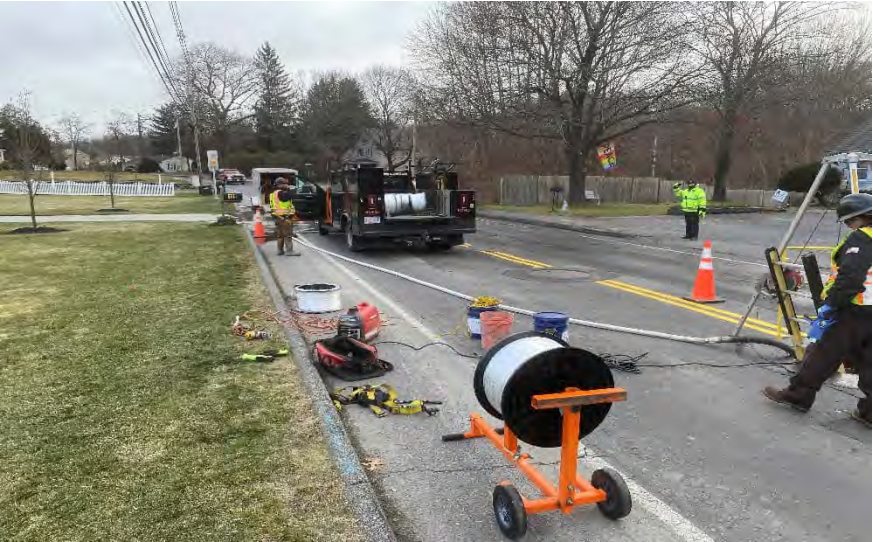
<p>PHOTOGRAPHIC LOG</p>	
<p>Client Name: Eversource</p>		<p>Site Location: Sudbury to Hudson Transmission Reliability Project</p>	<p>Town: Hudson</p>
<p>Photo No.: 3</p>	<p>Date: 12-6-23</p>

<p>Description:</p> <p>Proofing within Forest Avenue at manhole #3, looking northward.</p>

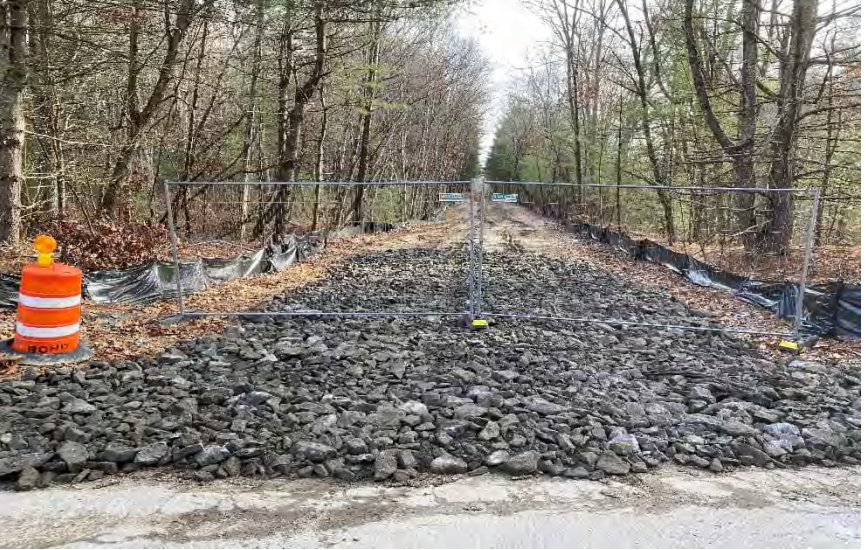
<p>PHOTOGRAPHIC LOG</p>	
<p>Client Name: Eversource</p>		<p>Site Location: Sudbury to Hudson Transmission Reliability Project</p>	<p>Town: Hudson</p>
<p>Photo No.: 4</p>	<p>Date: 12-6-23</p>

<p>Description:</p> <p>Work area within segment 6, existing erosion control &amp; newly placed stabilized construction entrance, looking eastward.</p>

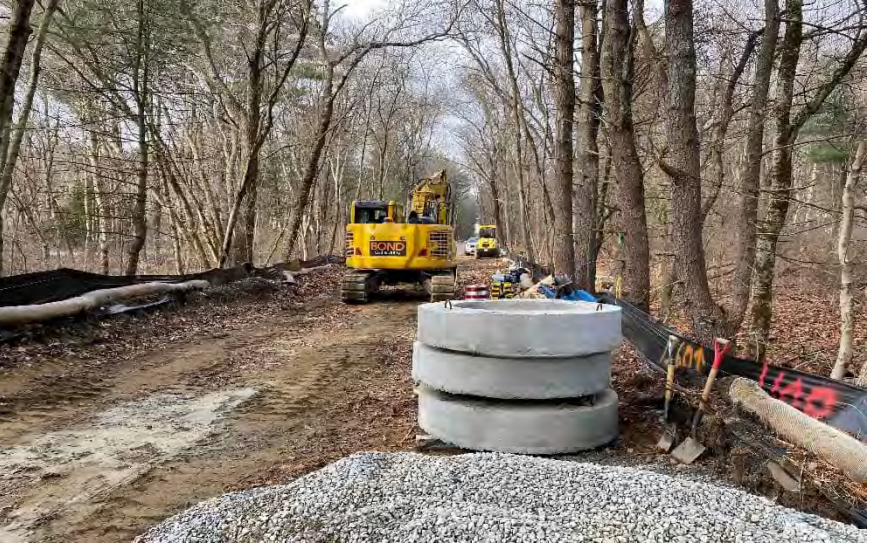
<p>PHOTOGRAPHIC LOG</p>	
<p>Client Name: Eversource</p>		<p>Site Location: Sudbury to Hudson Transmission Reliability Project</p>	<p>Town: Sudbury</p>
<p>Photo No.: 6</p>	<p>Date: 12-6-23</p>

<p>Description:</p> <p>Work area within Segment 9, Bond conducting conduit work, existing erosion control, looking eastward.</p>

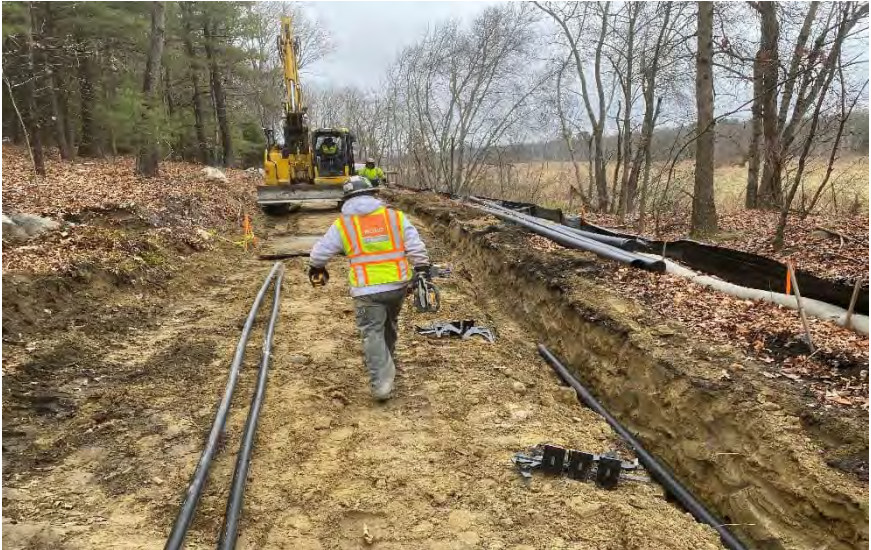
<p>PHOTOGRAPHIC LOG</p>	
<p>Client Name: Eversource</p>		<p>Site Location: Sudbury to Hudson Transmission Reliability Project</p>	<p>Town: Sudbury</p>
<p>Photo No.: 7</p>	<p>Date: 12-6-23</p>

<p>Description:</p> <p>Work area within Segment 14, conduit work, existing erosion control, looking eastward.</p>

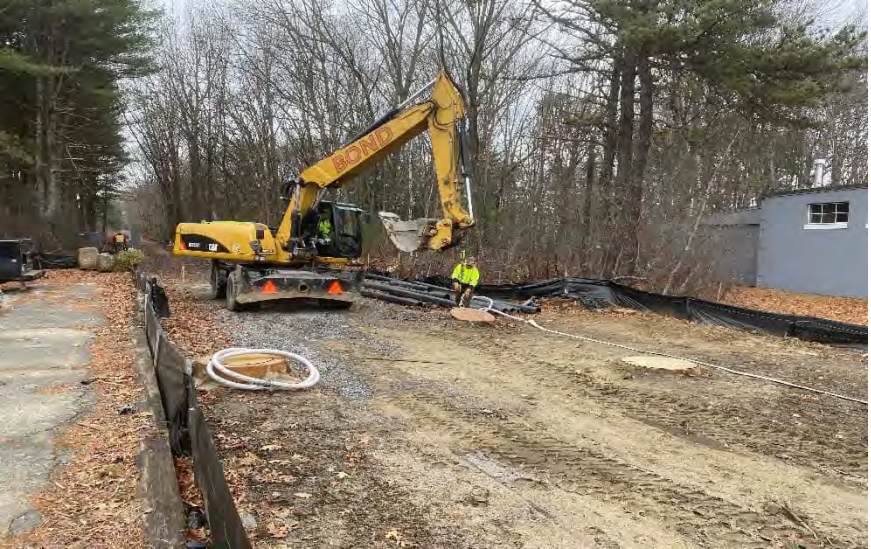
<p>PHOTOGRAPHIC LOG</p>	
<p>Client Name: Eversource</p>		<p>Site Location: Sudbury to Hudson Transmission Reliability Project</p>	<p>Town: Sudbury</p>
<p>Photo No.: 8</p>	<p>Date: 12-6-23</p>

<p>Description:</p> <p>Work area within Segment 11, setup for conduit work, existing erosion control, looking westward.</p>

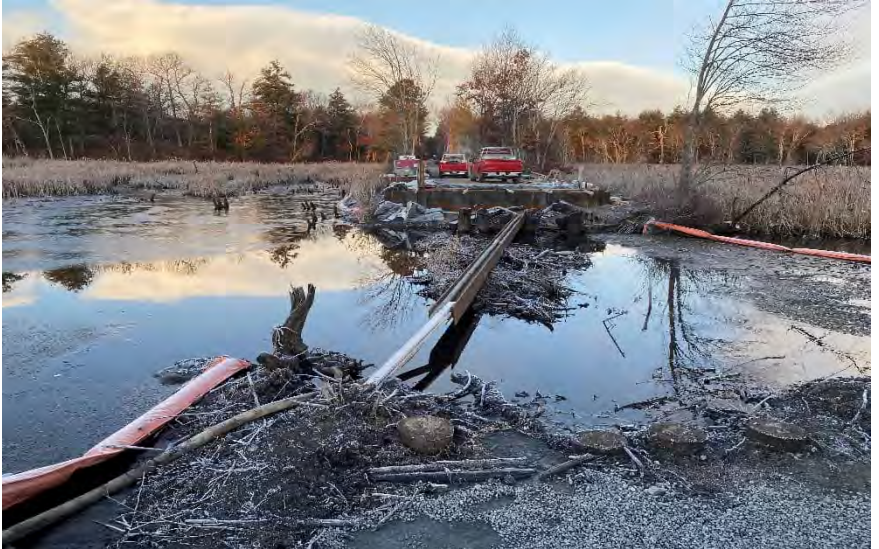
<p>PHOTOGRAPHIC LOG</p>	
<p>Client Name: Eversource</p>		<p>Site Location: Sudbury to Hudson Transmission Reliability Project</p>	<p>Town: Hudson</p>
<p>Photo No.: 2</p>	<p>Date: 12-7-23</p>

<p>Description:</p> <p>Work area from segment 3 toward segment 2 across Fort Meadow Brook, existing erosion control, looking westward.</p>

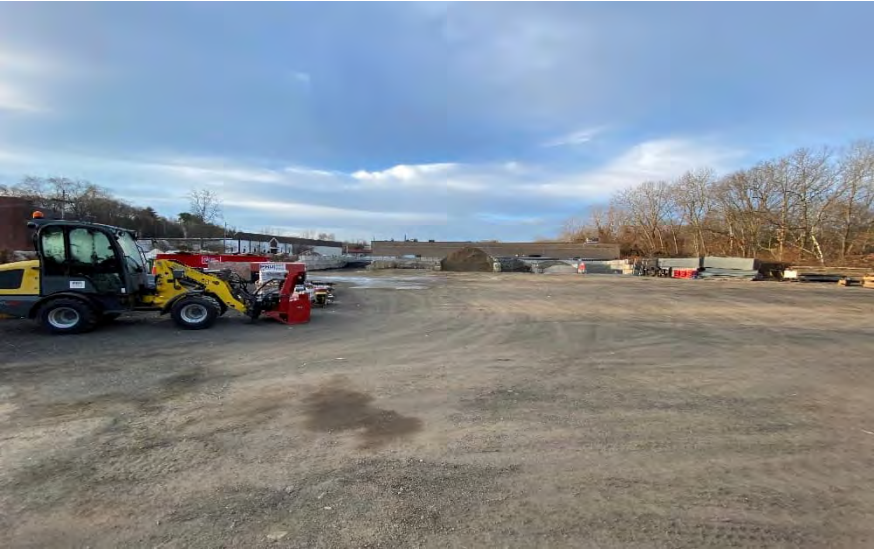
<p>PHOTOGRAPHIC LOG</p>	
<p>Client Name: Eversource</p>		<p>Site Location: Sudbury to Hudson Transmission Reliability Project</p>	<p>Town: Hudson</p>
<p>Photo No.: 3</p>	<p>Date: 12-7-23</p>

<p>Description: Bonazzoli laydown yard, looking westward.</p>

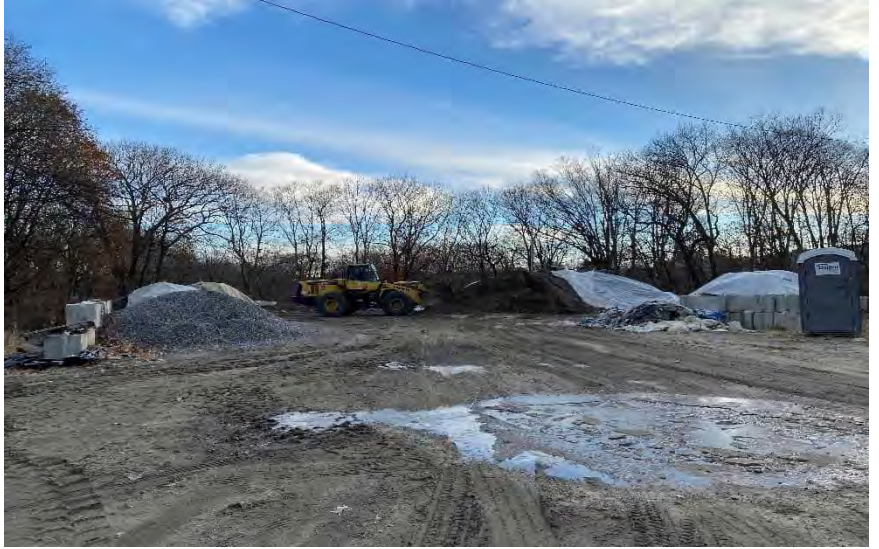
<p>PHOTOGRAPHIC LOG</p>	
<p>Client Name: Eversource</p>		<p>Site Location: Sudbury to Hudson Transmission Reliability Project</p>	<p>Town: Hudson</p>
<p>Photo No.: 4</p>	<p>Date: 12-7-23</p>

<p>Description: Stowe Court laydown yard, looking southward.</p>

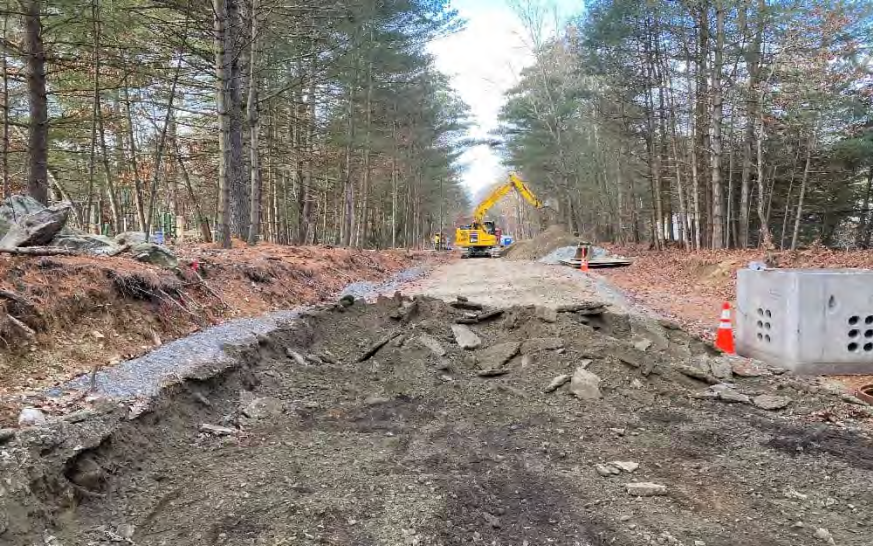
<p>PHOTOGRAPHIC LOG</p>	
<p>Client Name: Eversource</p>		<p>Site Location: Sudbury to Hudson Transmission Reliability Project</p>	<p>Town: Sudbury</p>
<p>Photo No.: 6</p>	<p>Date: 12-7-23</p>

<p>Description:</p> <p>Work area within Segment 9, Bond conducting conduit work, existing erosion control, looking westward.</p>

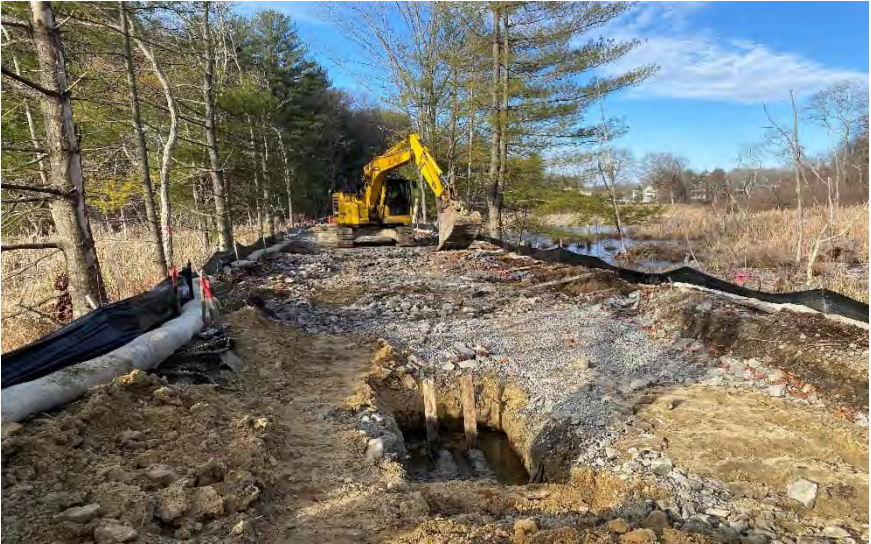
PHOTOGRAPHIC LOG	
Client Name: Eversource		Site Location: Sudbury to Hudson Transmission Reliability Project	Town: Sudbury
Photo No.: 7	Date: 12-7-23

<b>Description:</b> Work area within Segment 14, conduit work, existing erosion control, looking westward.

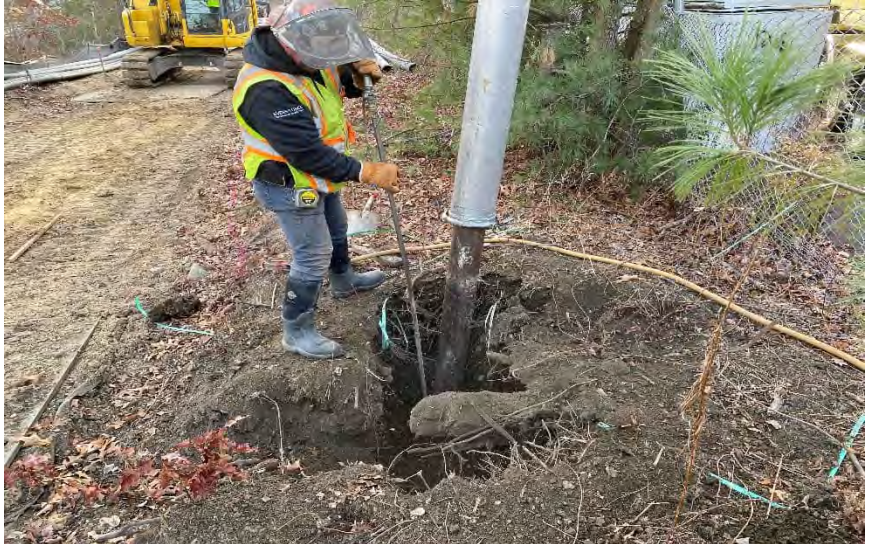
PHOTOGRAPHIC LOG	
Client Name: Eversource		Site Location: Sudbury to Hudson Transmission Reliability Project	Town: Sudbury
Photo No.: 8	Date: 12-7-23

<b>Description:</b> Work area within Segment 12, setup for conduit work, removal of material over existing culvert, looking eastward.

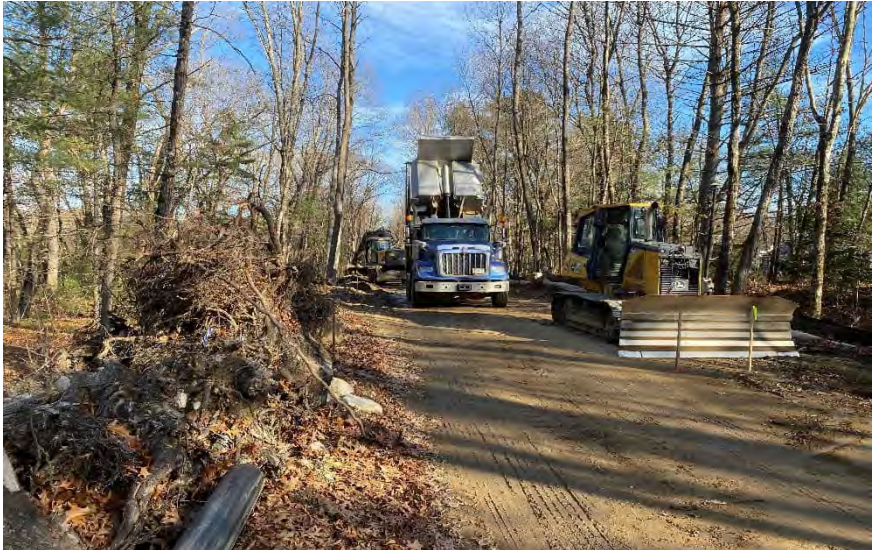
<p>PHOTOGRAPHIC LOG</p>	
<p>Client Name: Eversource</p>		<p>Site Location: Sudbury to Hudson Transmission Reliability Project</p>	<p>Town: Hudson</p>
<p>Photo No.: 1</p>	<p>Date: 12-8-23</p>

<p>Description:</p> <p>Work area within segment 1, existing erosion control, grading work, looking eastward.</p>

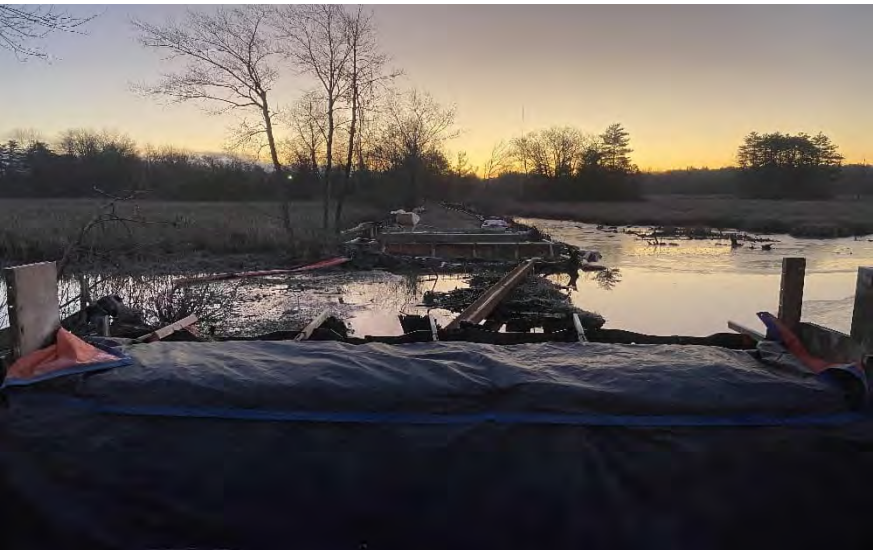
<p>PHOTOGRAPHIC LOG</p>	
<p>Client Name: Eversource</p>		<p>Site Location: Sudbury to Hudson Transmission Reliability Project</p>	<p>Town: Hudson</p>
<p>Photo No.: 2</p>	<p>Date: 12-8-23</p>

<p>Description:</p> <p>Work area from segment 2 toward segment 3 across Fort Meadow Brook, existing erosion control, looking eastward.</p>

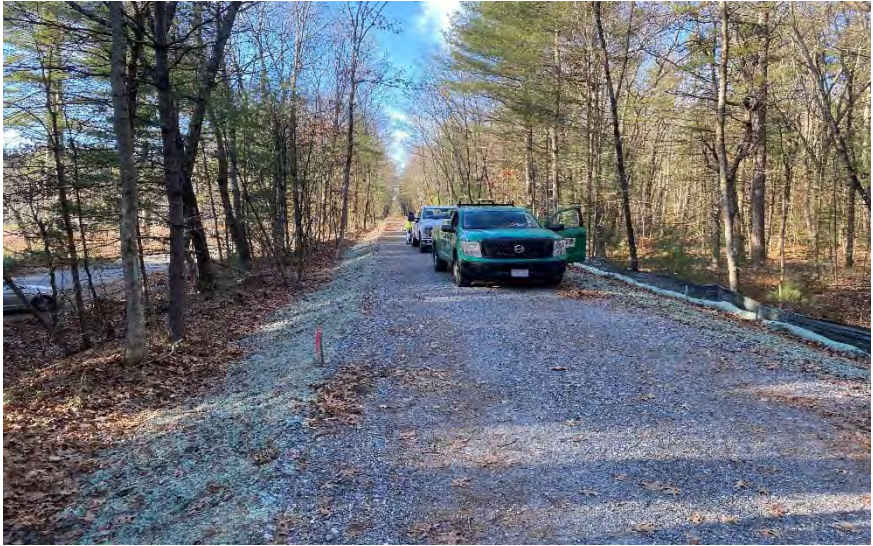
<p>PHOTOGRAPHIC LOG</p>	
<p>Client Name: Eversource</p>		<p>Site Location: Sudbury to Hudson Transmission Reliability Project</p>	<p>Town: Hudson</p>
<p>Photo No.: 3</p>	<p>Date: 12-8-23</p>

<p>Description:</p> <p>MON conducting restorative activities within segment 5, looking westward.</p>

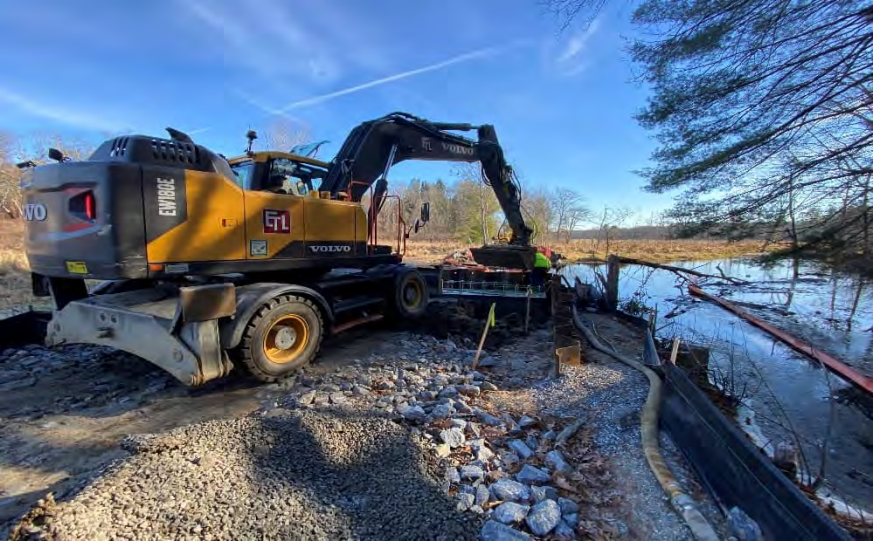
<p>PHOTOGRAPHIC LOG</p>	
<p>Client Name: Eversource</p>		<p>Site Location: Sudbury to Hudson Transmission Reliability Project</p>	<p>Town: Sudbury</p>
<p>Photo No.: 6</p>	<p>Date: 12-8-23</p>

<p>Description:</p> <p>Work area within Segment 13, ET&amp;L conducting bridge 127 work, existing erosion control, looking eastward.</p>

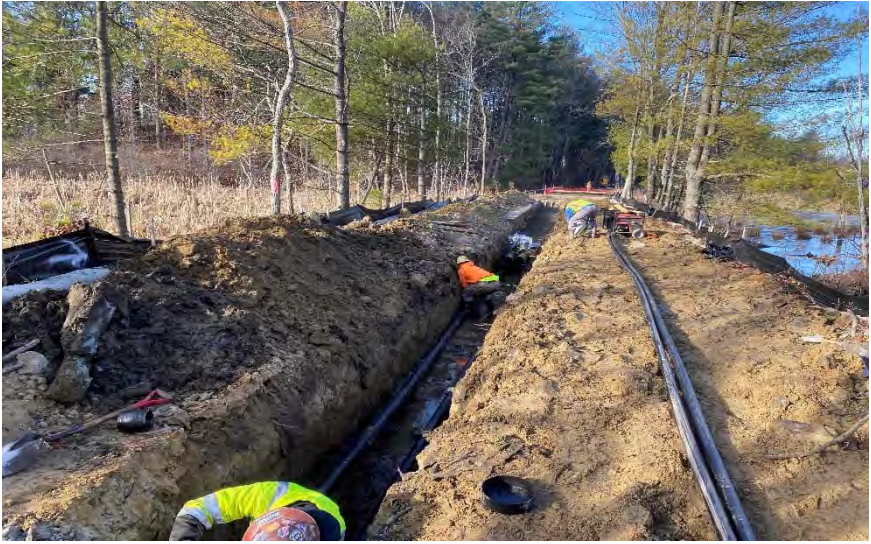
<p>PHOTOGRAPHIC LOG</p>	
<p>Client Name: Eversource</p>		<p>Site Location: Sudbury to Hudson Transmission Reliability Project</p>	<p>Town: Sudbury</p>
<p>Photo No.: 7</p>	<p>Date: 12-8-23</p>

<p>Description:</p> <p>Work area within Segment 14, conduit work, existing erosion control, looking westward.</p>

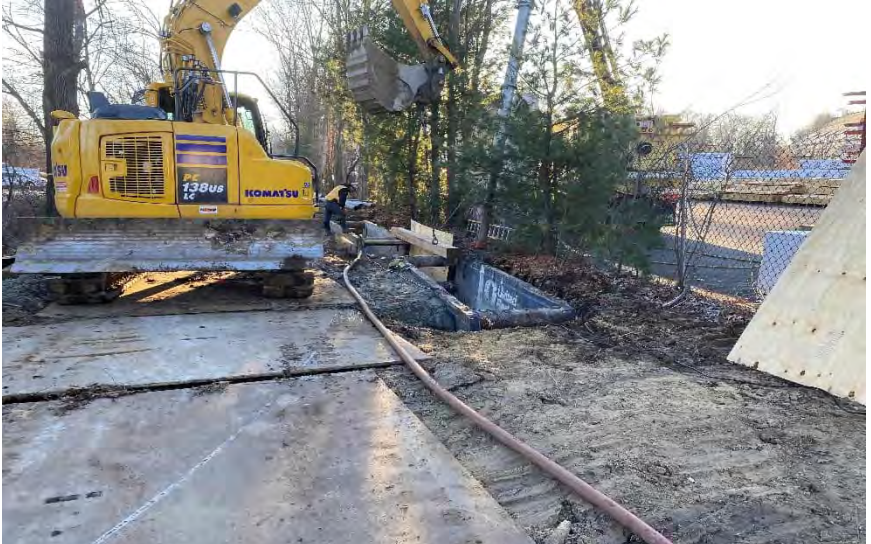
<p>PHOTOGRAPHIC LOG</p>	
<p>Client Name: Eversource</p>		<p>Site Location: Sudbury to Hudson Transmission Reliability Project</p>	<p>Town: Sudbury</p>
<p>Photo No.: 8</p>	<p>Date: 12-8-23</p>

<p>Description:</p> <p>Work area within Segment 12, conduit work, removal of material over existing culvert, looking eastward.</p>

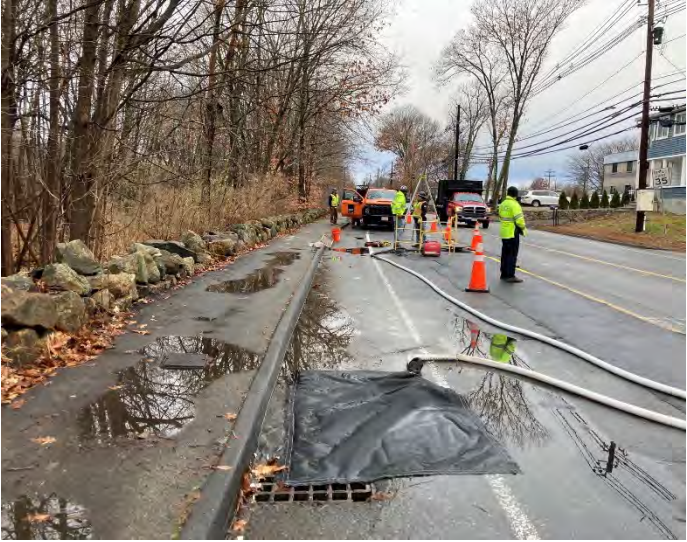
<b>PHOTOGRAPHIC LOG</b>	
Client Name: Eversource		Site Location: Sudbury to Hudson Transmission Reliability Project	Town: Hudson
Photo No.: 1	Date: 12-04-2023

Description: View of Bond working at MH #2 on Forest Ave. See additional dewatering inspection report. Facing southwest.

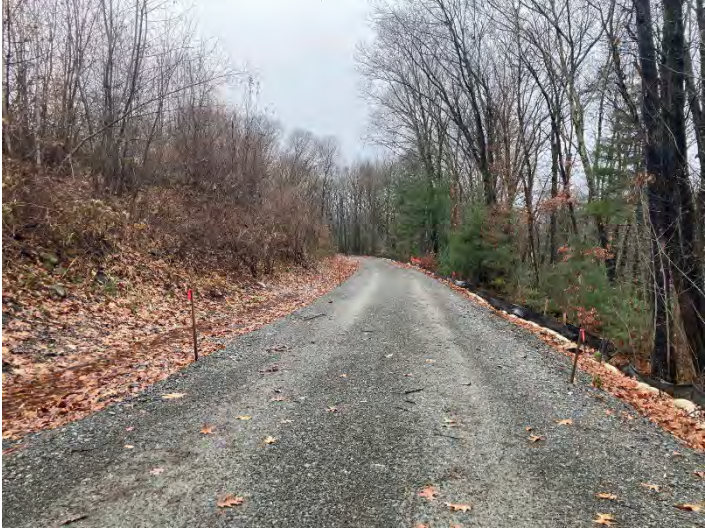
<b>PHOTOGRAPHIC LOG</b>	
Client Name: Eversource		Site Location: Sudbury to Hudson Transmission Reliability Project	Town: Hudson
Photo No.: 2	Date: 12-04-2023

Description: View of swale and E&S controls in segment 1. Facing west.

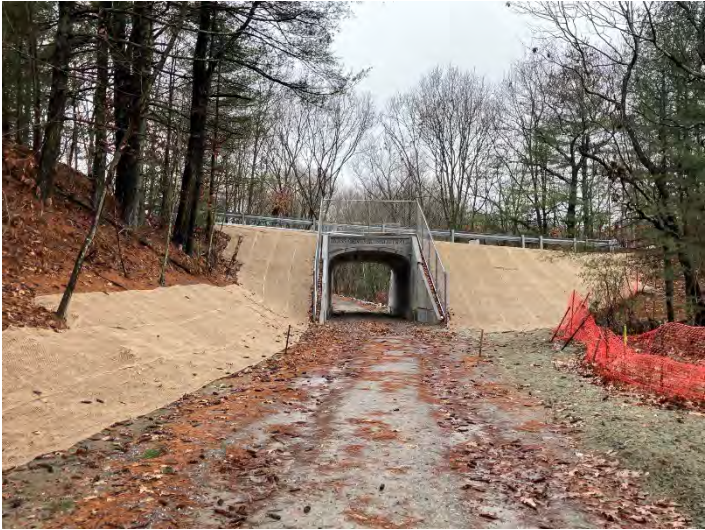
<b>Epsilon</b> ASSOCIATES INC.		<b>PHOTOGRAPHIC LOG</b>	
Client Name: Eversource		Site Location: Sudbury to Hudson Transmission Reliability Project	Town: Hudson
Photo No.: 3	Date: 12-04-2023

Description: View of Chestnut St tunnel. Erosion control matting has been applied to slopes. Facing west.

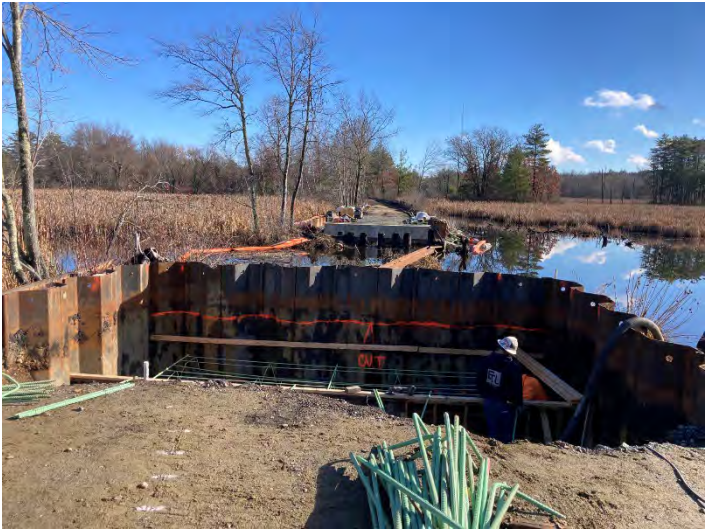
<b>Epsilon</b> ASSOCIATES INC.		<b>PHOTOGRAPHIC LOG</b>	
Client Name: Eversource		Site Location: Sudbury to Hudson Transmission Reliability Project	Town: Hudson
Photo No.: 4	Date: 12-04-2023

Description: View of work area at bridge 130 in segment 2. See additional dewatering inspection report. Facing east.

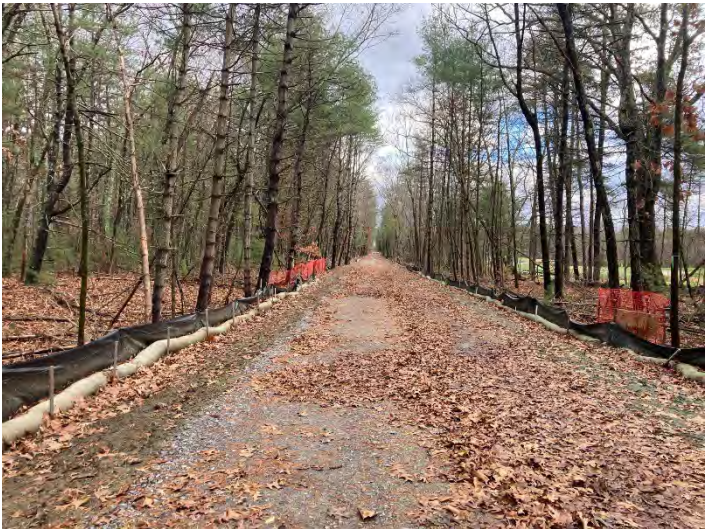
<b>Epsilon</b> ASSOCIATES INC.		<b>PHOTOGRAPHIC LOG</b>	
Client Name: Eversource		Site Location: Sudbury to Hudson Transmission Reliability Project	Town: Hudson
Photo No.: 5	Date: 12-04-2023

Description: View of Type B E&S controls in segment 4. Facing east.

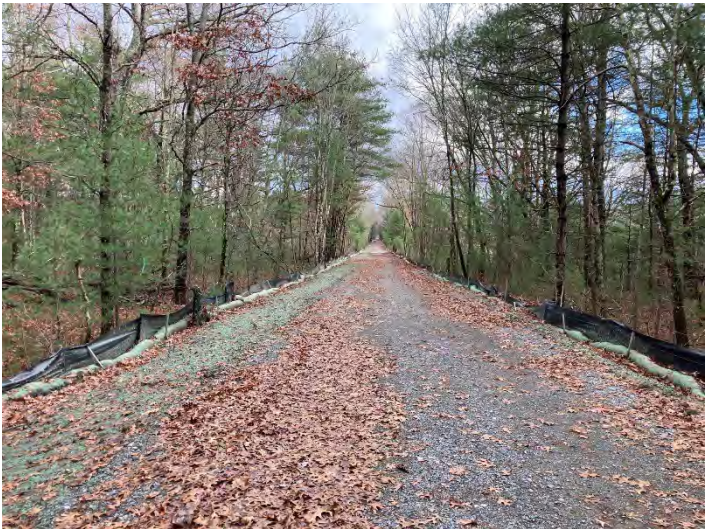
<b>Epsilon</b> ASSOCIATES INC.		<b>PHOTOGRAPHIC LOG</b>	
Client Name: Eversource		Site Location: Sudbury to Hudson Transmission Reliability Project	Town: Hudson
Photo No.: 6	Date: 12-04-2023

Description: View of Type B E&S controls in segment 5. Facing west.

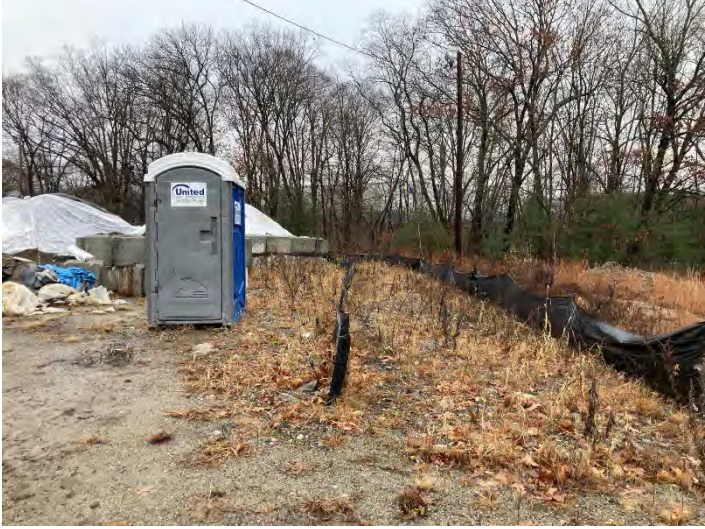
<b>Epsilon</b> ASSOCIATES INC.		<b>PHOTOGRAPHIC LOG</b>	
Client Name: Eversource		Site Location: Sudbury to Hudson Transmission Reliability Project	Town: Hudson
Photo No.: 8	Date: 12-04-2023

Description: View of silt fence at Stowe Ct laydown yard. Facing northeast.

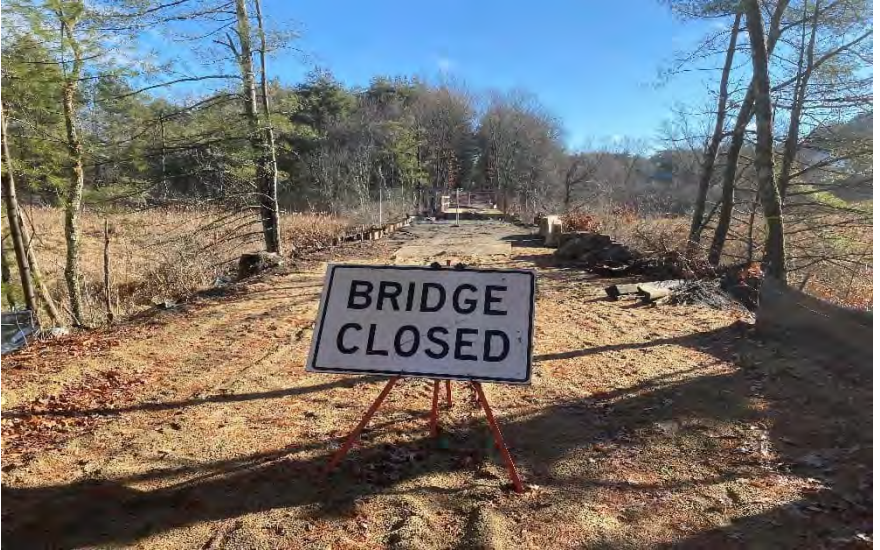
PHOTOGRAPHIC LOG	
Client Name: Eversource		Site Location: Sudbury to Hudson Transmission Reliability Project	Town: Sudbury
Photo No.: 2	Date: 12-4-23

Description:  Work area from segment 7 toward segment 8, existing erosion control, looking eastward.

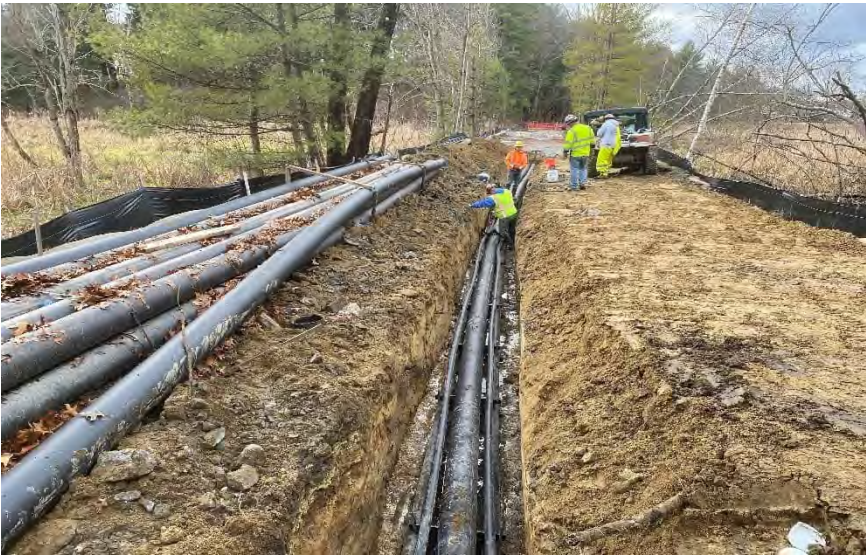
<b>PHOTOGRAPHIC LOG</b>	
<b>Client Name:</b> Eversource		<b>Site Location:</b> Sudbury to Hudson Transmission Reliability Project	<b>Town:</b> Sudbury
<b>Photo No.:</b> 4	<b>Date:</b> 12-4-23

<b>Description:</b>  Work area within segment 14, conduit work, looking westward.

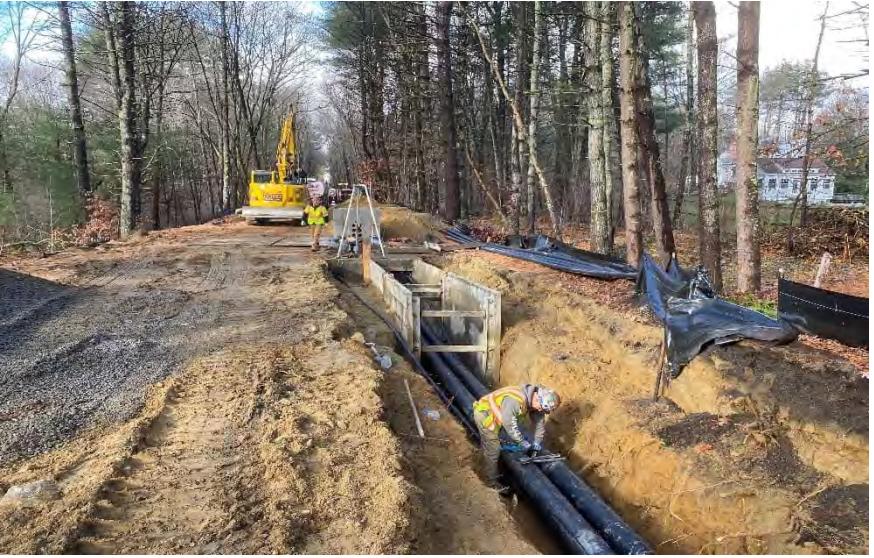
<b>PHOTOGRAPHIC LOG</b>	
<b>Client Name:</b> Eversource		<b>Site Location:</b> Sudbury to Hudson Transmission Reliability Project	<b>Town:</b> Sudbury
<b>Photo No.:</b> 7	<b>Date:</b> 12-4-23

<b>Description:</b>  Work area within segment 9, conduit work, existing erosion control, looking westward.

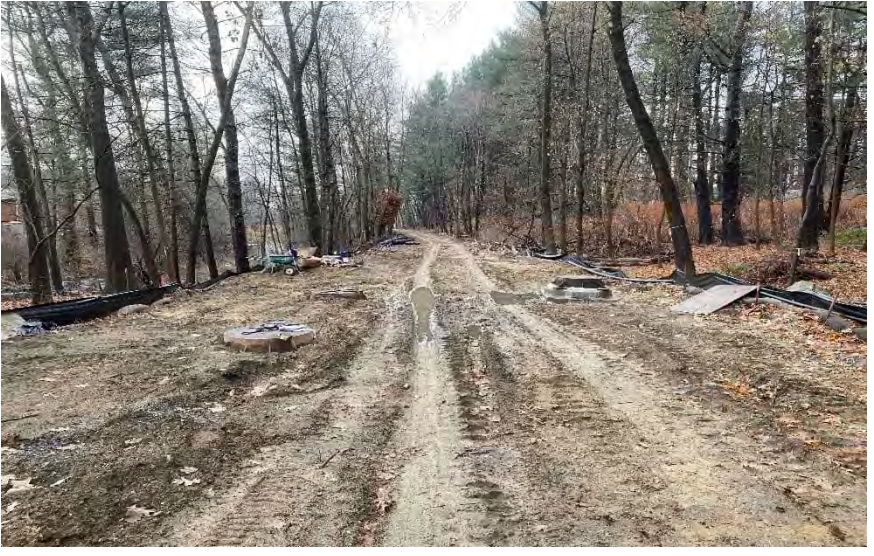
<b>PHOTOGRAPHIC LOG</b>	
<b>Client Name:</b> Eversource		<b>Site Location:</b> Sudbury to Hudson Transmission Reliability Project	<b>Town:</b> Sudbury
<b>Photo No.:</b> 8	<b>Date:</b> 12-4-23

<b>Description:</b>  Work area, within segment 13, existing erosion control, looking eastward.

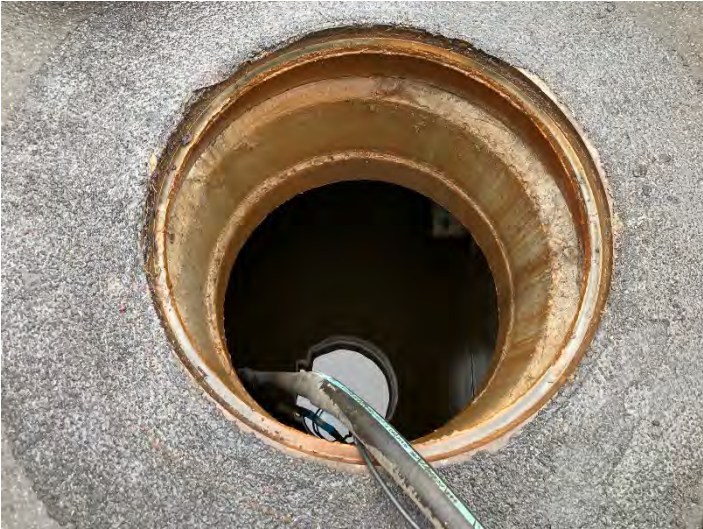
<b>PHOTOGRAPHIC LOG</b>	
Client Name: Eversource		Site Location: Sudbury to Hudson Transmission Reliability Project	
Town: Hudson			
Photo No.: 2	Date: 12/04/2023

<b>Description:</b> View of pump in manhole. Water appeared to be mostly clear prior to treatment.

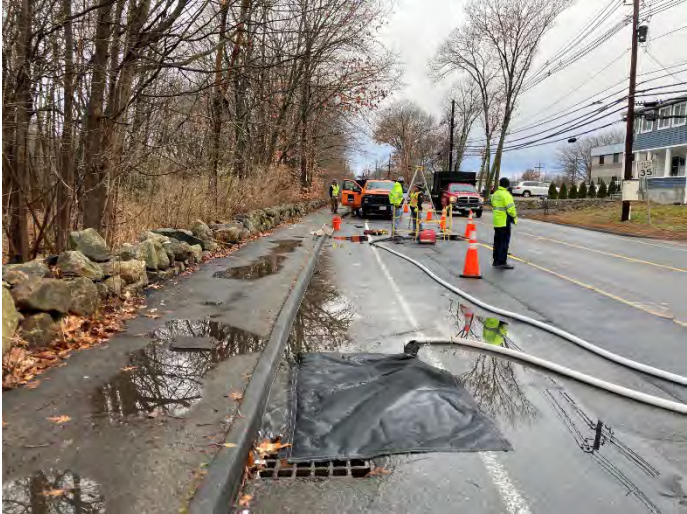
<b>PHOTOGRAPHIC LOG</b>		
Client Name: Eversource		Site Location: Sudbury to Hudson Transmission Reliability Project		Town: Hudson
Photo No.: 3	Date: 12/04/2023

Description: View of dewatering controls (filter bag). Facing southwest.

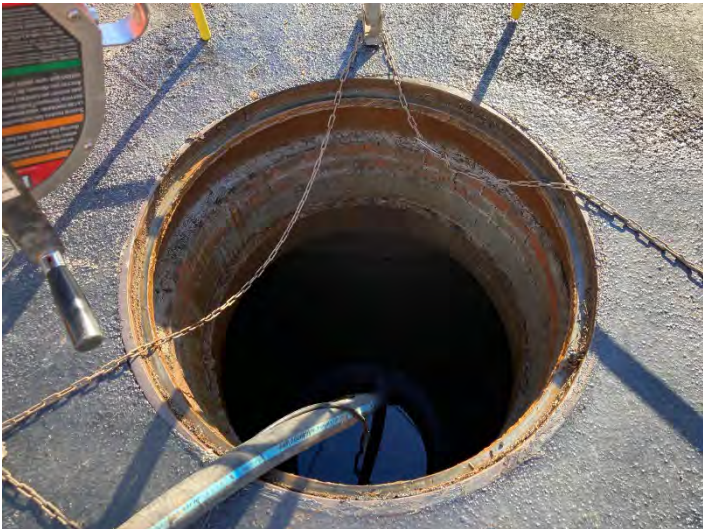
<b>PHOTOGRAPHIC LOG</b>			
Client Name: Eversource		Site Location: Sudbury to Hudson Transmission Reliability Project		Town: Hudson	
Photo No.: 2	Date: 12/04/2023

<b>Description:</b> View of pump in manhole. Water appeared to be mostly clear prior to treatment.

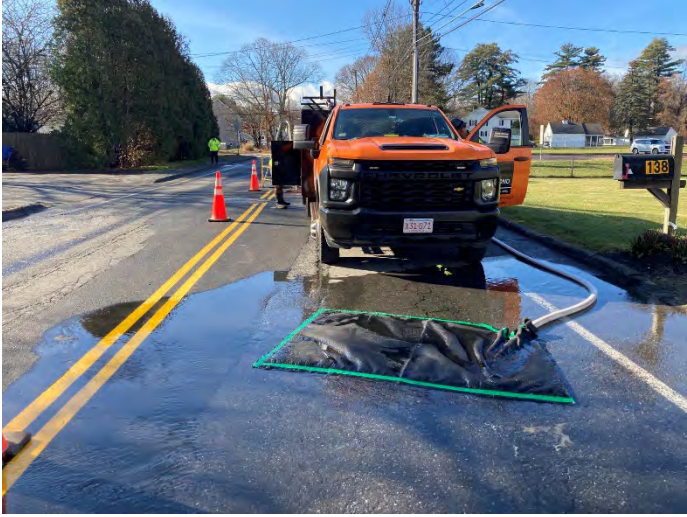
<b>PHOTOGRAPHIC LOG</b>		
Client Name: Eversource		Site Location: Sudbury to Hudson Transmission Reliability Project		Town: Hudson
Photo No.: 3	Date: 12/04/2023

<b>Description:</b> View of dewatering controls (filter bag). Facing south.

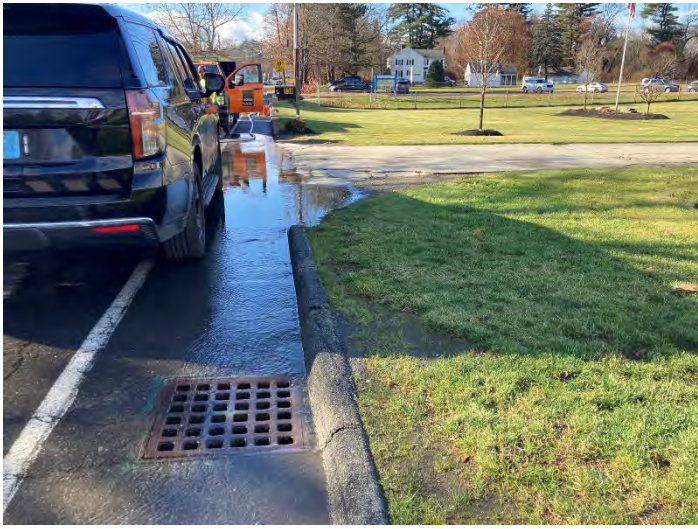
<b>PHOTOGRAPHIC LOG</b>		
Client Name: Eversource		Site Location: Sudbury to Hudson Transmission Reliability Project		Town: Hudson
Photo No.: 4	Date: 12/04/2023

<b>Description:</b> View of discharge point from project (catch basin on Forest Ave). Discharge appeared clear. Turbidity reading was below 50 NTUs. Facing south.
