**Weekly Environmental Compliance Summary**

**Sudbury to Hudson Transmission Reliability Project (USEPA Tracking # MAR1003UW)**

Sudbury, Hudson, and Stow, MA

Week of: December 4, 2023 to December 8, 2023

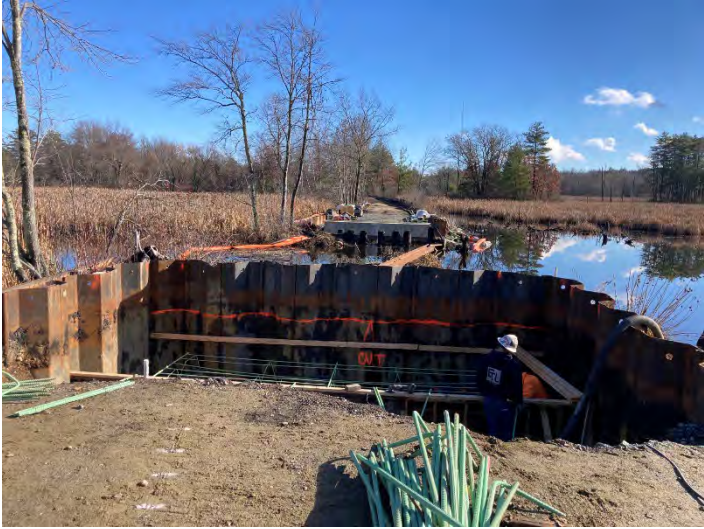
<b>PHOTOGRAPHIC LOG</b>	
Client Name: Eversource		Site Location: Sudbury to Hudson Transmission Reliability Project	Town: Hudson
Photo No.: 1	Date: 12/04/2023

Description: View of work area and pumping operation at bridge 130 in segment 2. Facing east.

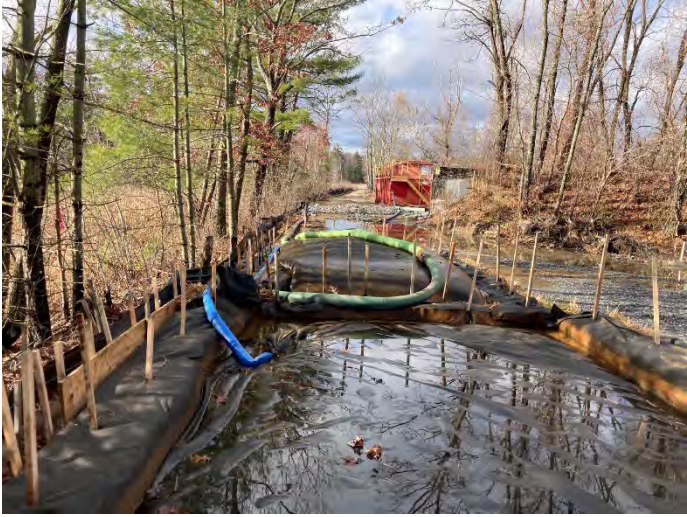
<b>PHOTOGRAPHIC LOG</b>		
<b>Client Name:</b> Eversource		<b>Site Location:</b> Sudbury to Hudson Transmission Reliability Project		<b>Town:</b> Hudson
<b>Photo No.:</b> 3	<b>Date:</b> 12/04/2023

<b>Description:</b> View of dewatering controls in segment 3 (frac tank, straw bale corral with filter fabric, stone, and silt bag). Water from segment 2 is being routed to corral in segment 3. Water is also being drained from frac tank and being routed to different bag in corral. Facing west.

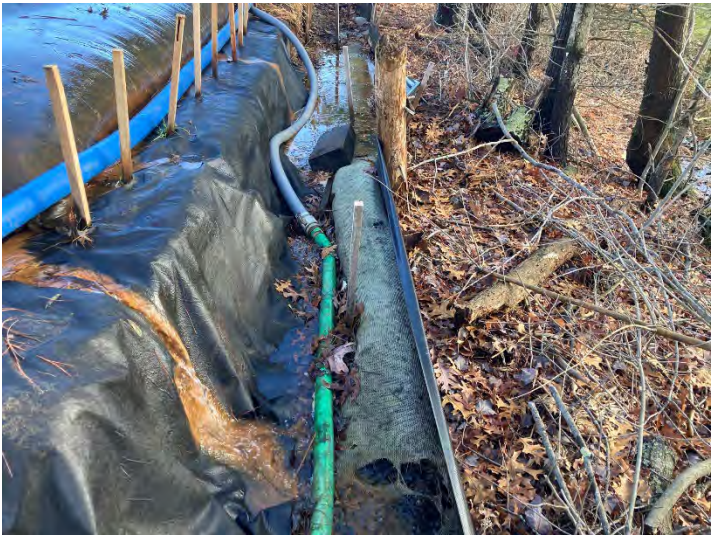
<b>PHOTOGRAPHIC LOG</b>		
<b>Client Name:</b> Eversource		<b>Site Location:</b> Sudbury to Hudson Transmission Reliability Project		<b>Town:</b> Hudson
<b>Photo No.:</b> 4	<b>Date:</b> 12/04/2023

<b>Description:</b> View of discharge from controls. Discharge appeared mostly clear. Turbidity reading was below 50 NTUs. Discharge appeared to be leaving the project at time of inspection. Facing east.

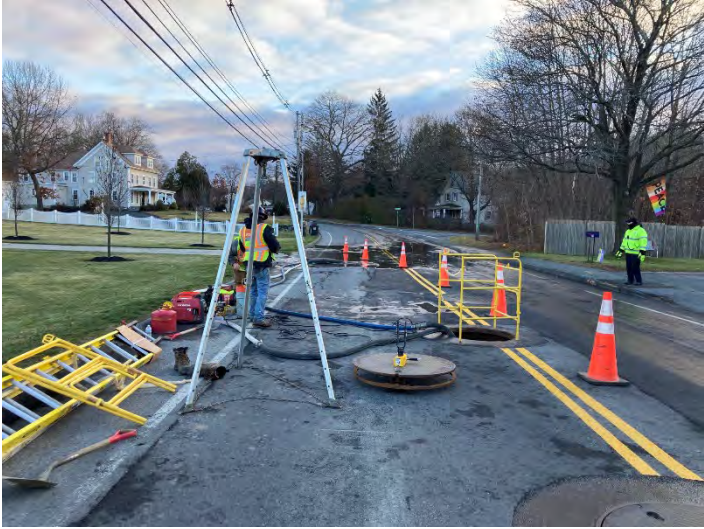
<b>PHOTOGRAPHIC LOG</b>		
Client Name: Eversource		Site Location: Sudbury to Hudson Transmission Reliability Project		Town: Hudson
Photo No.: 1	Date: 12/05/2023

<b>Description:</b> View of work area and pumping operation at MH #3 on Forest Ave in Hudson. Facing north.

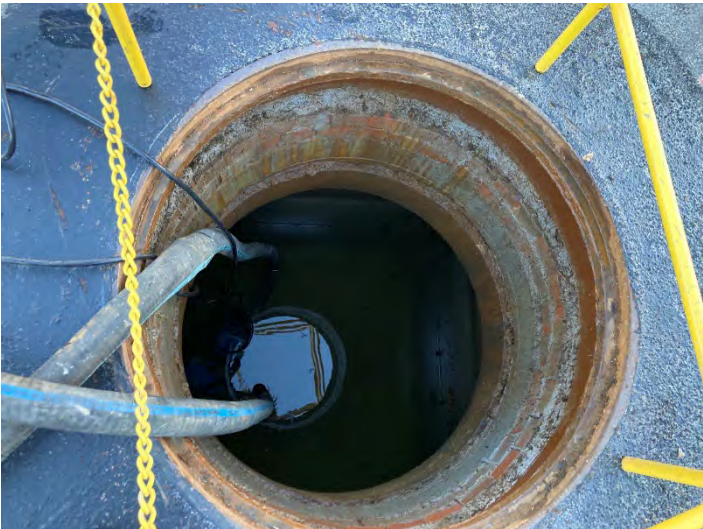
<b>PHOTOGRAPHIC LOG</b>		
Client Name: Eversource		Site Location: Sudbury to Hudson Transmission Reliability Project		Town: Hudson
Photo No.: 2	Date: 12/05/2023

<b>Description:</b> View of pump in manhole. Water appeared to be mostly clear prior to treatment.

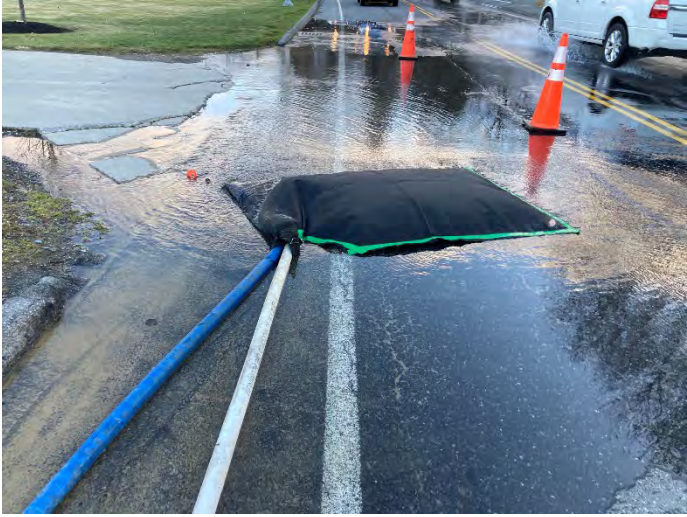
<b>PHOTOGRAPHIC LOG</b>	
Client Name: Eversource		Site Location: Sudbury to Hudson Transmission Reliability Project	
Town: Hudson			
Photo No.: 3	Date: 12/05/2023

<b>Description:</b> View of dewatering controls (filter bag). Facing north.

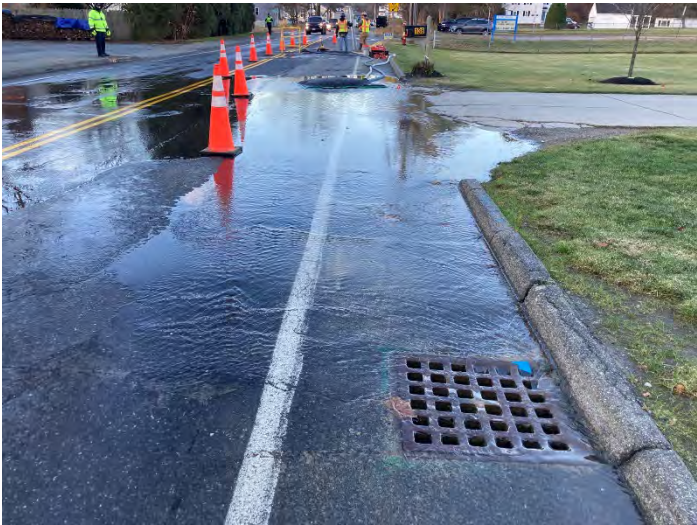
<b>PHOTOGRAPHIC LOG</b>	
Client Name: Eversource		Site Location: Sudbury to Hudson Transmission Reliability Project	
Town: Hudson			
Photo No.: 4	Date: 12/05/2023

<b>Description:</b> View of discharge point from project (catch basin on Forest Ave). Discharge appeared clear. Turbidity reading was below 50 NTUs. Facing south.

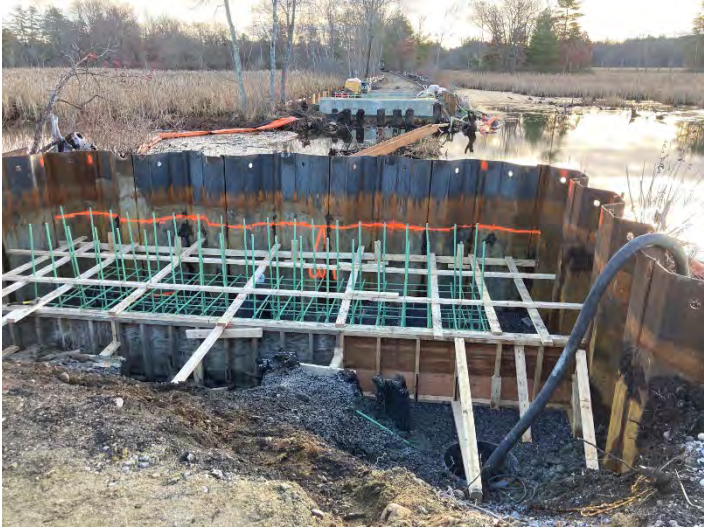
<b>PHOTOGRAPHIC LOG</b>	
Client Name: Eversource		Site Location: Sudbury to Hudson Transmission Reliability Project	Town: Hudson
Photo No.: 1	Date: 12/05/2023

Description: View of work area and pumping operation at bridge 130 in segment 2. Facing east.

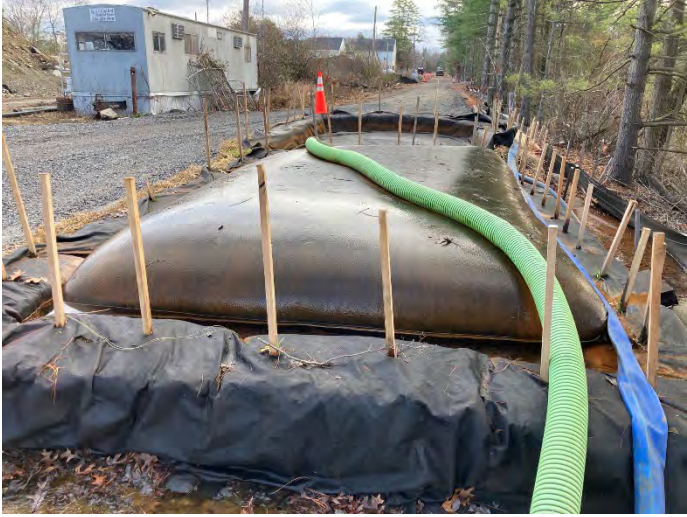
<b>PHOTOGRAPHIC LOG</b>		
Client Name: Eversource		Site Location: Sudbury to Hudson Transmission Reliability Project		Town: Hudson
Photo No.: 3	Date: 12/05/2023

<b>Description:</b> View of dewatering controls in segment 3 (straw bale corral with filter fabric, stone, and silt bag). Water from segment 2 is being routed to corral in segment 3. Frac tank is no longer in use. Facing east.

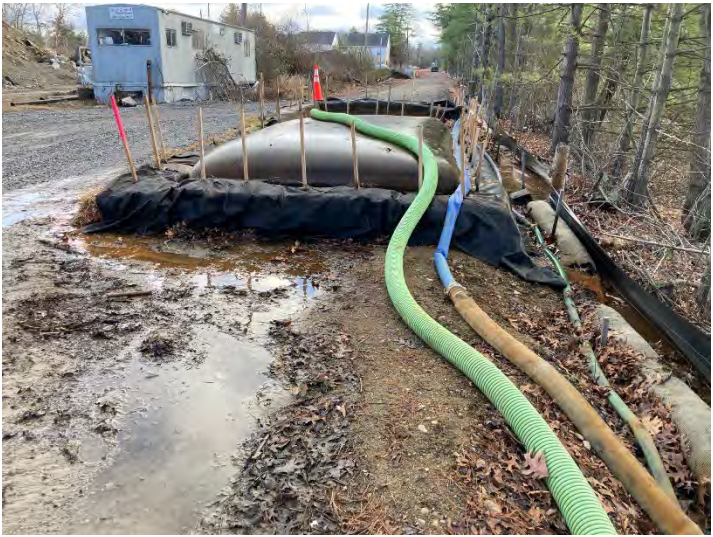
<b>PHOTOGRAPHIC LOG</b>		
Client Name: Eversource		Site Location: Sudbury to Hudson Transmission Reliability Project		Town: Hudson
Photo No.: 4	Date: 12/05/2023

<b>Description:</b> View of discharge from controls. Discharge appeared mostly clear. Turbidity reading was below 50 NTUs. Discharge appeared to be leaving the project at time of inspection. Facing east.

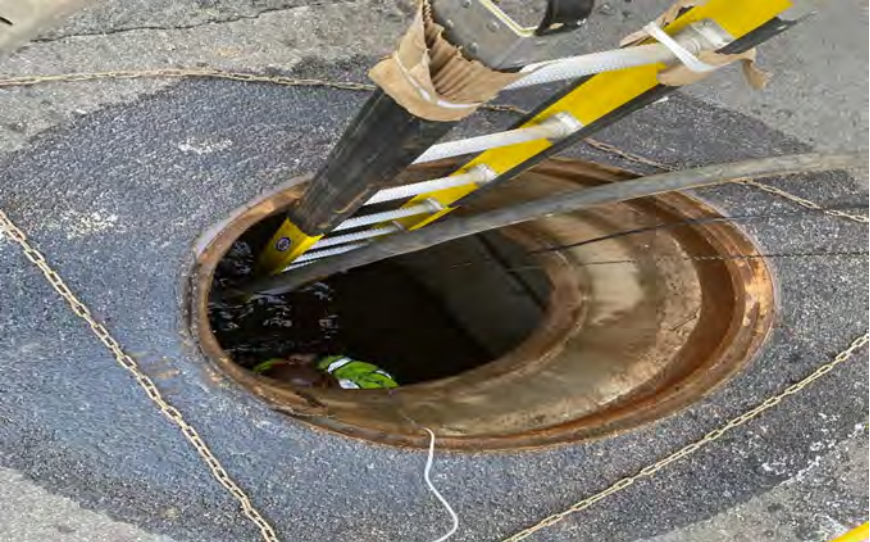
<b>PHOTOGRAPHIC LOG</b>	
Client Name: Eversource		Site Location: Sudbury to Hudson Transmission Reliability Project	Town: Hudson
Photo No.: 1	Date: 12/6/2023

Description: View of area being pumped, manhole #2 within Forest Avenue.

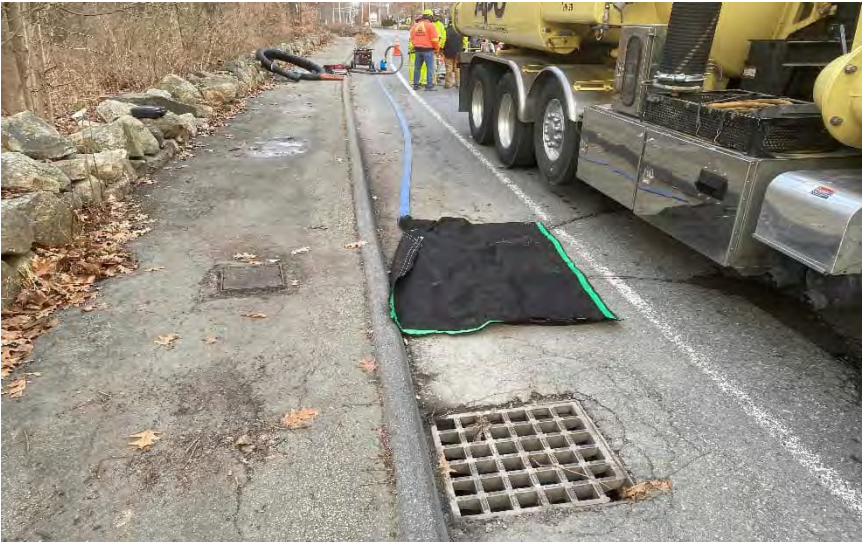
<b>PHOTOGRAPHIC LOG</b>	
Client Name: Eversource		Site Location: Sudbury to Hudson Transmission Reliability Project	Town: Hudson
Photo No.: 2	Date: 12/6/2023

Description: View of discharge operation showing discharge bag at drainage basin within Forest Avenue, looking northward.

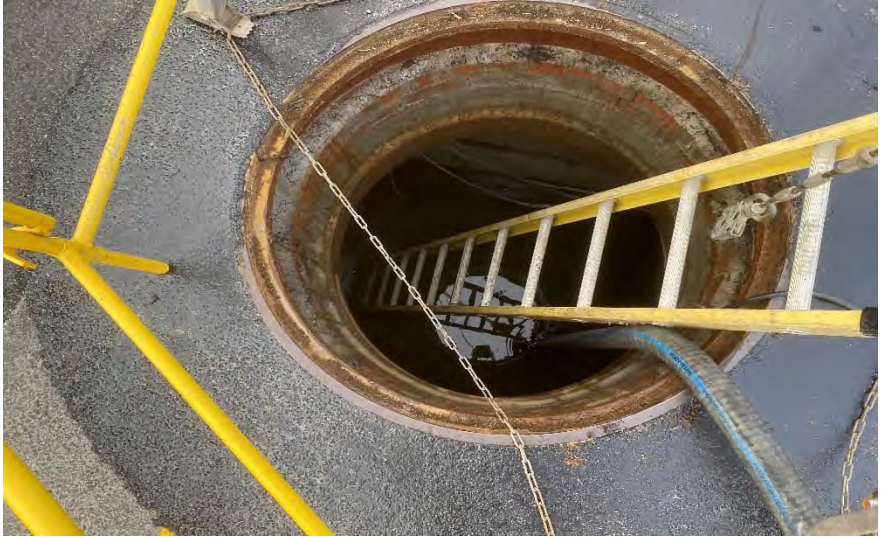
<b>PHOTOGRAPHIC LOG</b>	
Client Name: Eversource		Site Location: Sudbury to Hudson Transmission Reliability Project	Town: Hudson
Photo No.: 1	Date: 12/6/2023

Description: View of area being pumped at manhole #3.

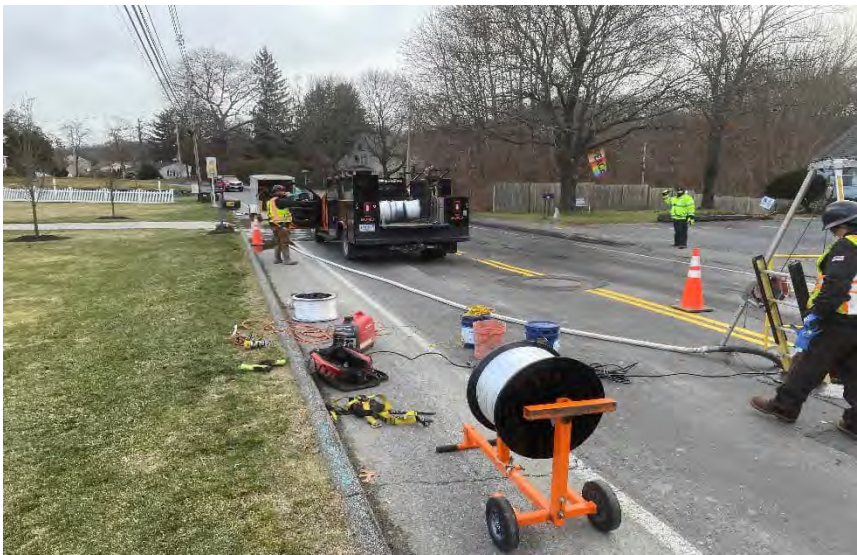
PHOTOGRAPHIC LOG	
Client Name: Eversource		Site Location: Sudbury to Hudson Transmission Reliability Project	Town: Hudson
Photo No.: 3	Date: 12/6/2023

Description: Manhole #3. View of discharge dewatering operation, looking northward.

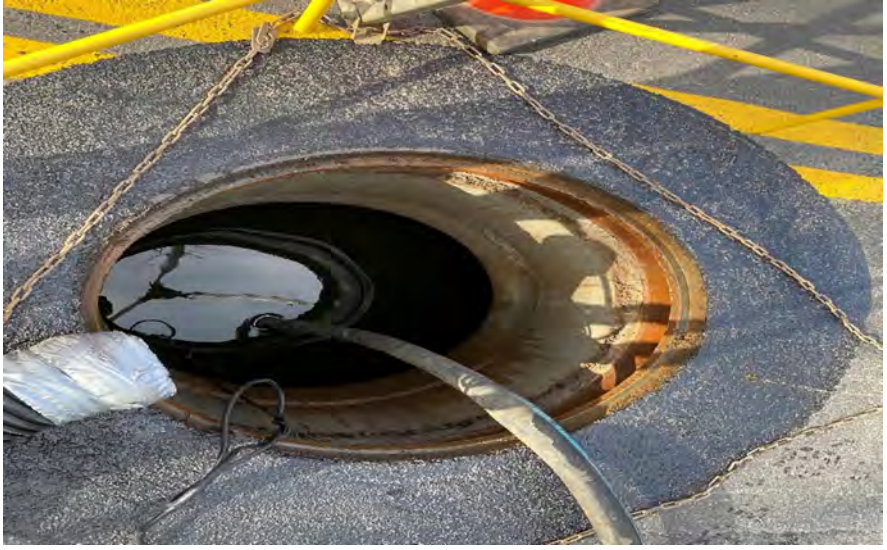
<b>PHOTOGRAPHIC LOG</b>	
Client Name: Eversource		Site Location: Sudbury to Hudson Transmission Reliability Project	Town: Hudson
Photo No.: 1	Date: 12/6/2023

Description: View of area being pumped at manhole #4.

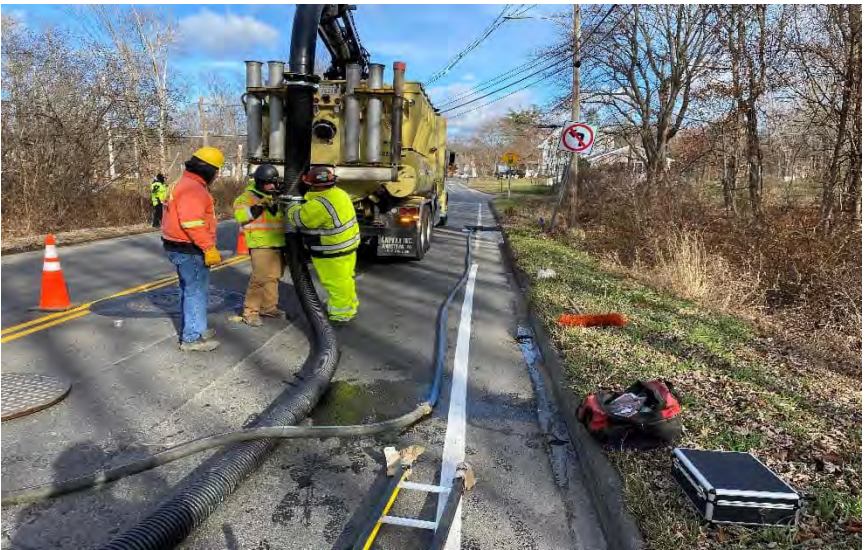
<b>PHOTOGRAPHIC LOG</b>	
Client Name: Eversource		Site Location: Sudbury to Hudson Transmission Reliability Project	Town: Hudson
Photo No.: 2	Date: 12/6/2023

Description: View of pumping operation within Forest Avenue at manhole #4, looking northward.

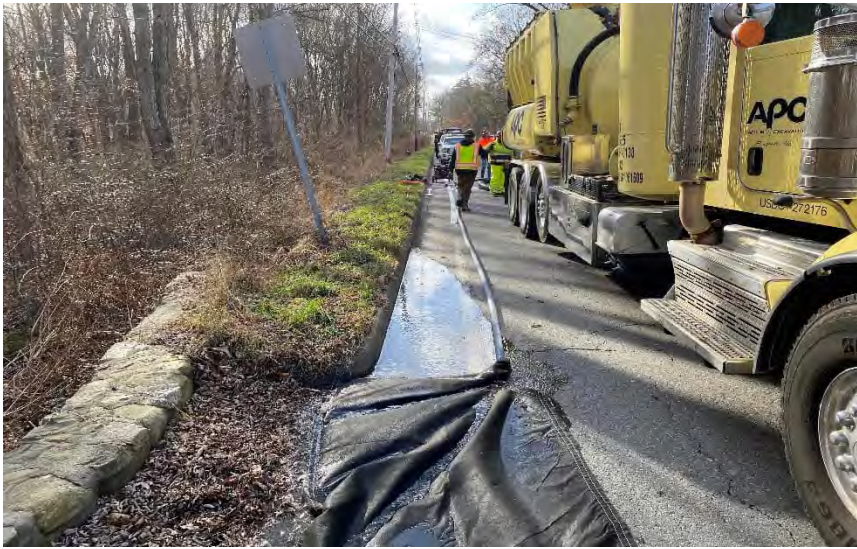
PHOTOGRAPHIC LOG	
Client Name: Eversource		Site Location: Sudbury to Hudson Transmission Reliability Project	Town: Hudson
Photo No.: 3	Date: 12/6/2023

Description: Manhole #4. View of discharge dewatering operation, looking southward.

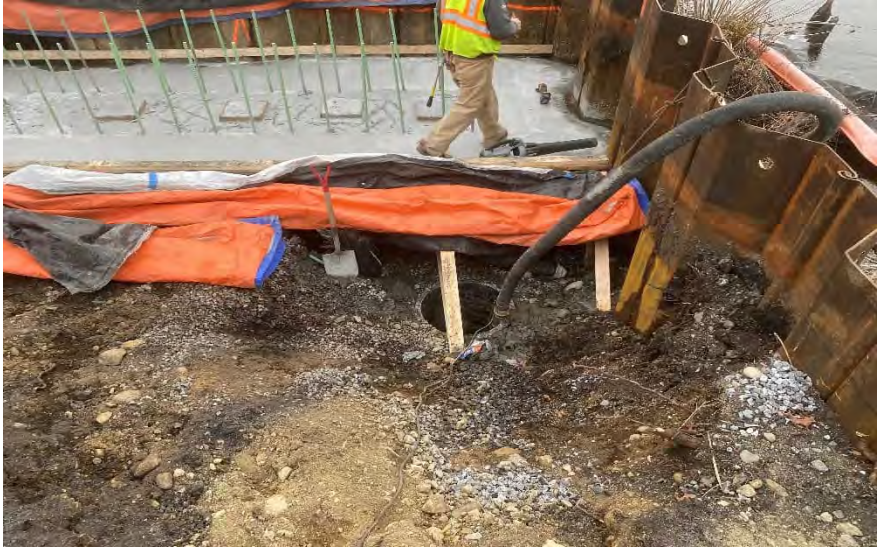
PHOTOGRAPHIC LOG	
Client Name: Eversource		Site Location: Sudbury to Hudson Transmission Reliability Project	Town: Hudson
Photo No.: 1	Date: 12/6/2023

<b>Description:</b> View of area being pumped (i.e., cofferdam within segment 2 off Fort Meadow Brook), looking westward.

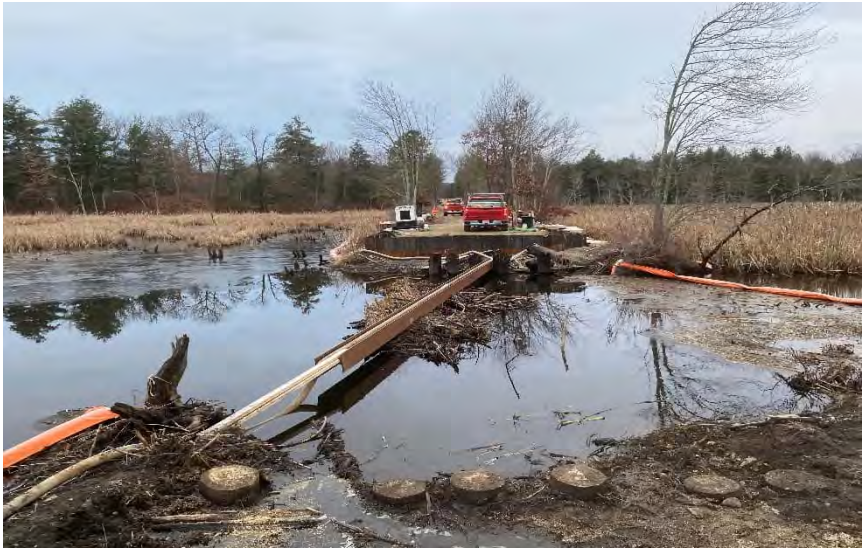
PHOTOGRAPHIC LOG	
Client Name: Eversource		Site Location: Sudbury to Hudson Transmission Reliability Project	Town: Hudson
Photo No.: 2	Date: 12/6/2023

<b>Description:</b> View of dewatering operation across Fort Meadow Brook, discharge hose within H-piling from segment 3 toward segment 2, looking westward.

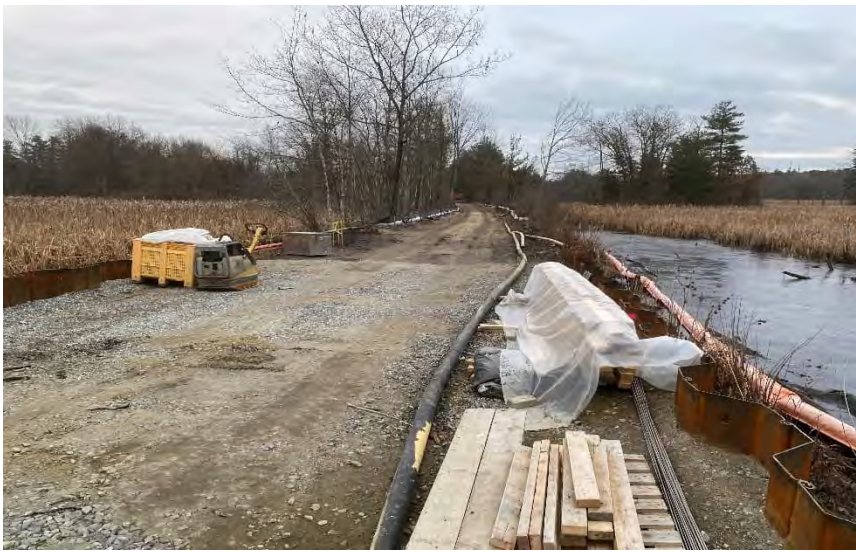
<b>PHOTOGRAPHIC LOG</b>	
<b>Client Name:</b> Eversource		<b>Site Location:</b> Sudbury to Hudson Transmission Reliability Project	
<b>Town:</b> Hudson			
<b>Photo No.:</b> 3	<b>Date:</b> 12/6/2023

<b>Description:</b> Segment 3. View of discharge dewatering operation, looking eastward.

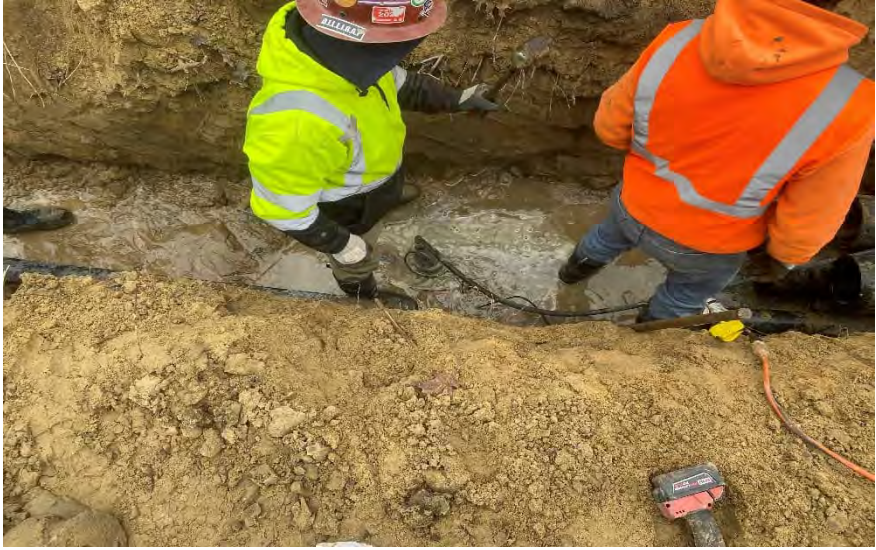
<b>PHOTOGRAPHIC LOG</b>	
Client Name: Eversource		Site Location: Sudbury to Hudson Transmission Reliability Project	Town: Sudbury
Photo No.: 1	Date: 12/6/2023

Description: Segment 14. View of area being pumped (i.e., trench within segment 14).

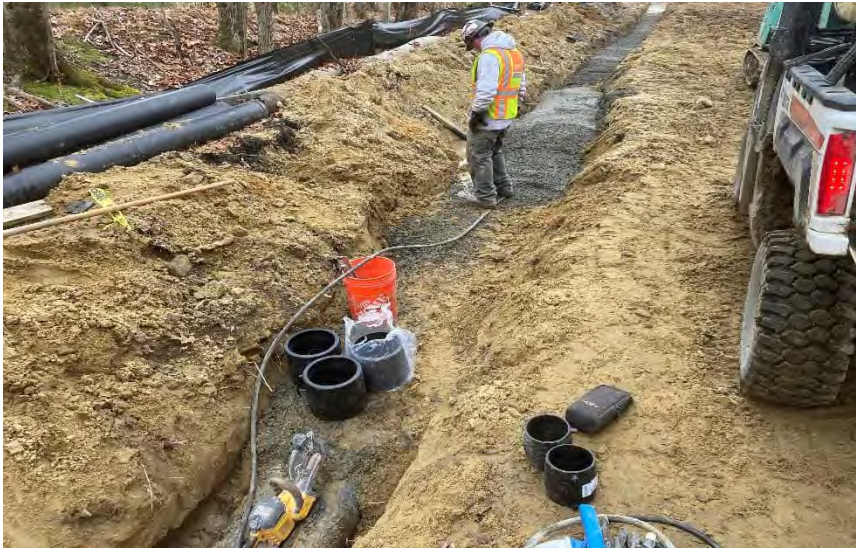
<b>PHOTOGRAPHIC LOG</b>	
Client Name: Eversource		Site Location: Sudbury to Hudson Transmission Reliability Project	Town: Sudbury
Photo No.: 2	Date: 12/6/2023

Description: Segment 14. View of discharge within existing conduit trench, looking westward.

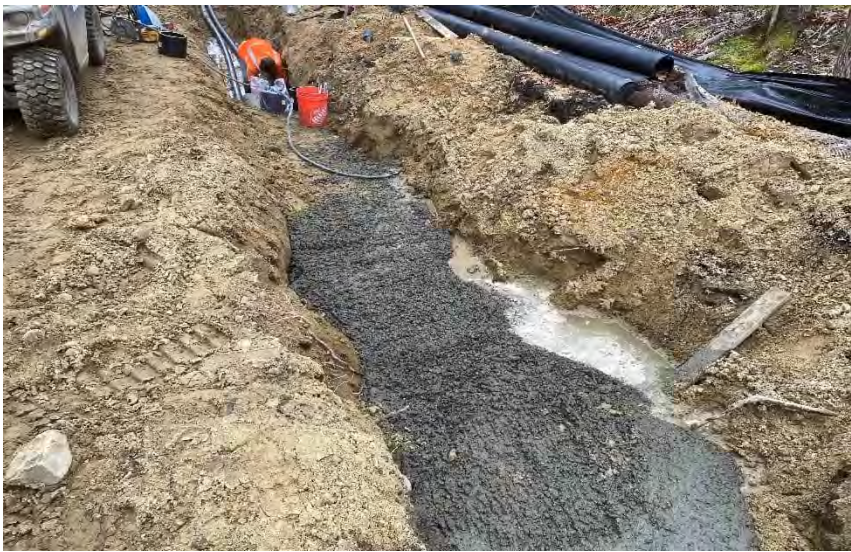
<b>PHOTOGRAPHIC LOG</b>	
Client Name: Eversource		Site Location: Sudbury to Hudson Transmission Reliability Project	Town: Sudbury
Photo No.: 3	Date: 12/6/2023

<b>Description:</b> Segment 14. View of discharge dewatering operation, looking eastward.

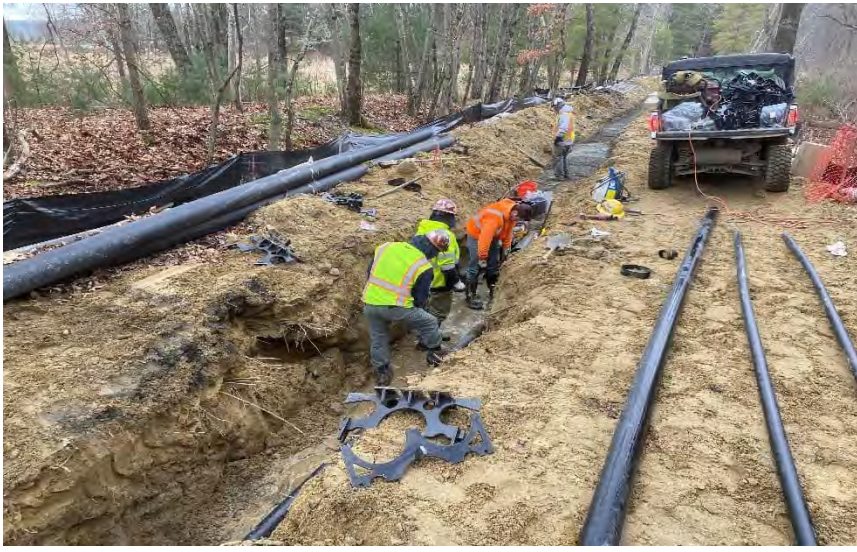
<b>PHOTOGRAPHIC LOG</b>	
Client Name: Eversource		Site Location: Sudbury to Hudson Transmission Reliability Project	Town: Sudbury
Photo No.: 4	Date: 12/6/2023

<b>Description:</b> Segment 3. View of discharge operation area within conduit trench, water moved westward within trench.

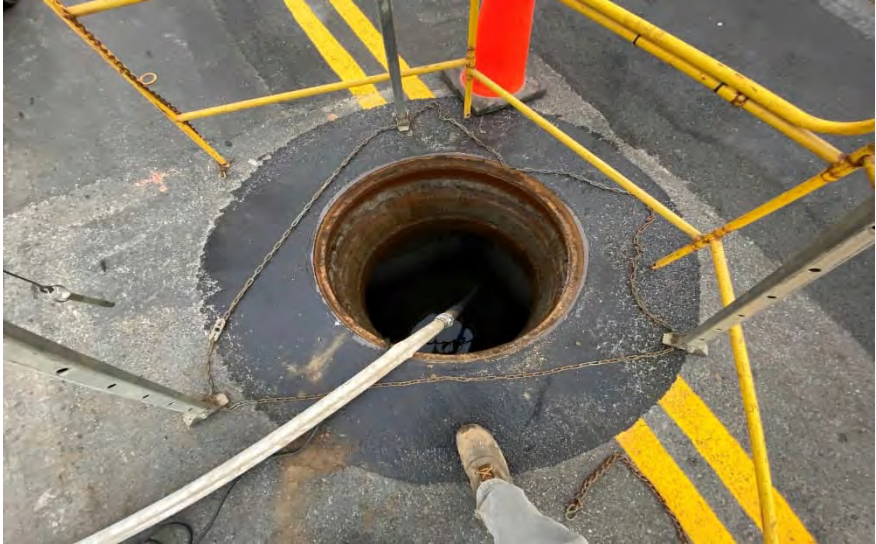
<b>PHOTOGRAPHIC LOG</b>	
Client Name: Eversource		Site Location: Sudbury to Hudson Transmission Reliability Project	Town: Hudson
Photo No.: 1	Date: 12/7/2023

Description: View of area being pumped at manhole #3.

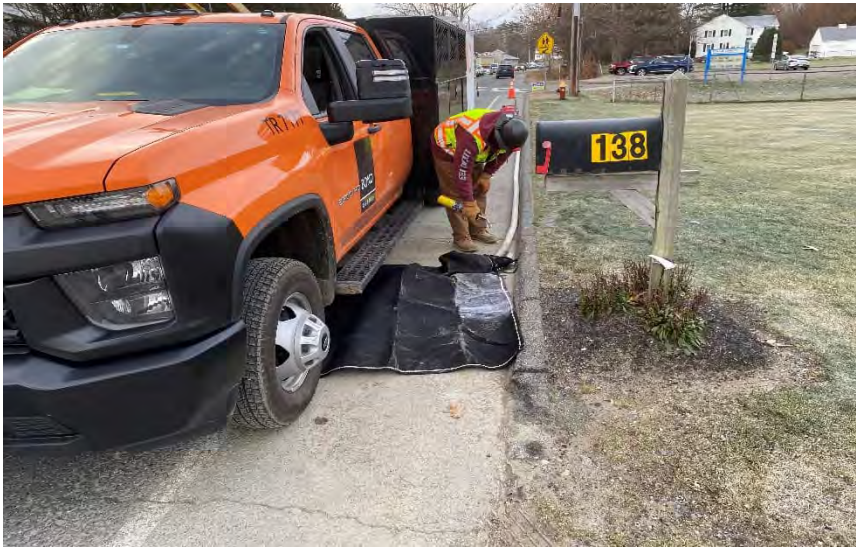
<b>PHOTOGRAPHIC LOG</b>	
Client Name: Eversource		Site Location: Sudbury to Hudson Transmission Reliability Project	
Town: Hudson			
Photo No.: 3	Date: 12/7/2023

<b>Description:</b> Manhole #3. View of discharge dewatering operation, looking southward.

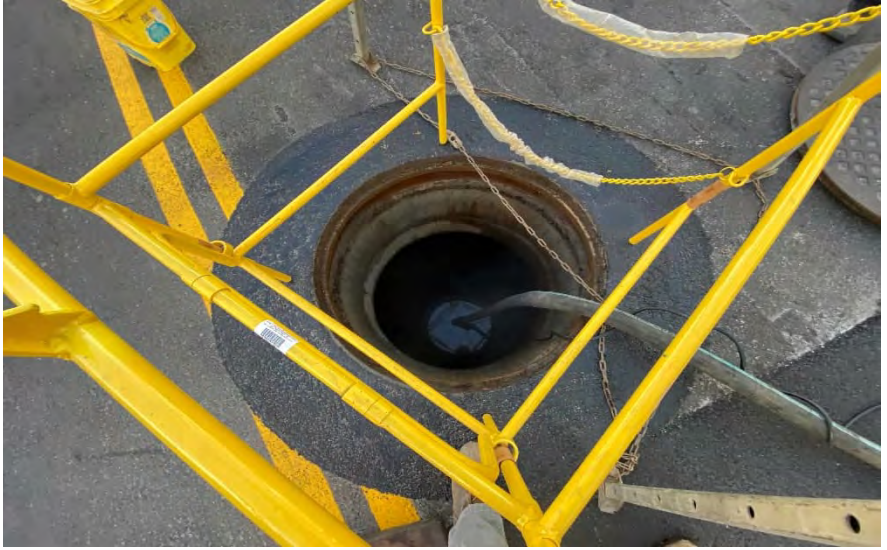
<b>PHOTOGRAPHIC LOG</b>	
Client Name: Eversource		Site Location: Sudbury to Hudson Transmission Reliability Project	Town: Hudson
Photo No.: 1	Date: 12/7/2023

Description: View of area being pumped at manhole #4.

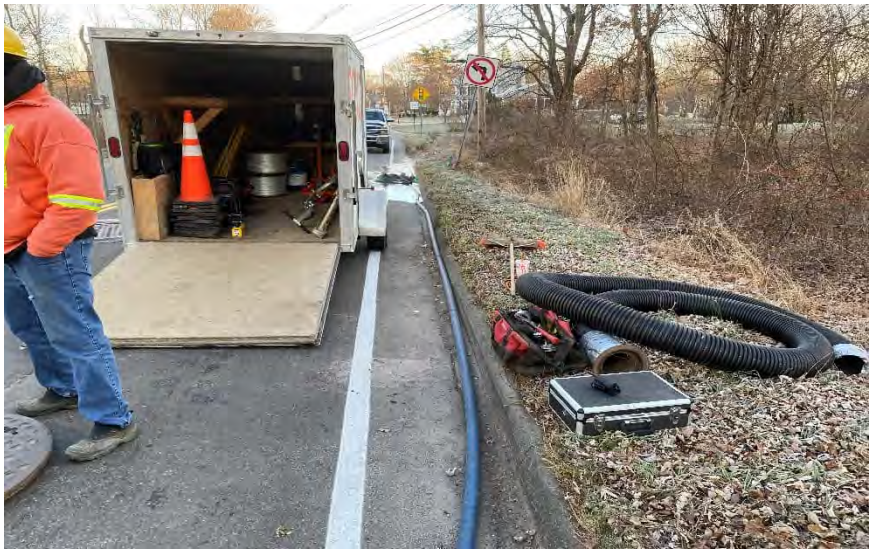
<b>PHOTOGRAPHIC LOG</b>	
Client Name: Eversource		Site Location: Sudbury to Hudson Transmission Reliability Project	Town: Hudson
Photo No.: 2	Date: 12/7/2023

Description: View of pumping operation within Forest Avenue at manhole #4, looking northward.

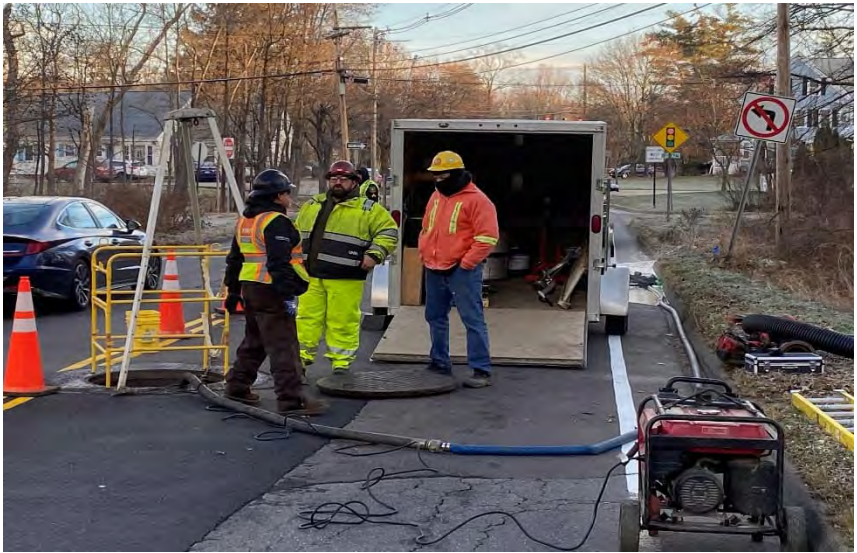
PHOTOGRAPHIC LOG	
Client Name: Eversource		Site Location: Sudbury to Hudson Transmission Reliability Project	Town: Hudson
Photo No.: 3	Date: 12/7/2023

Description: Manhole #4. View of discharge dewatering operation, looking northward.

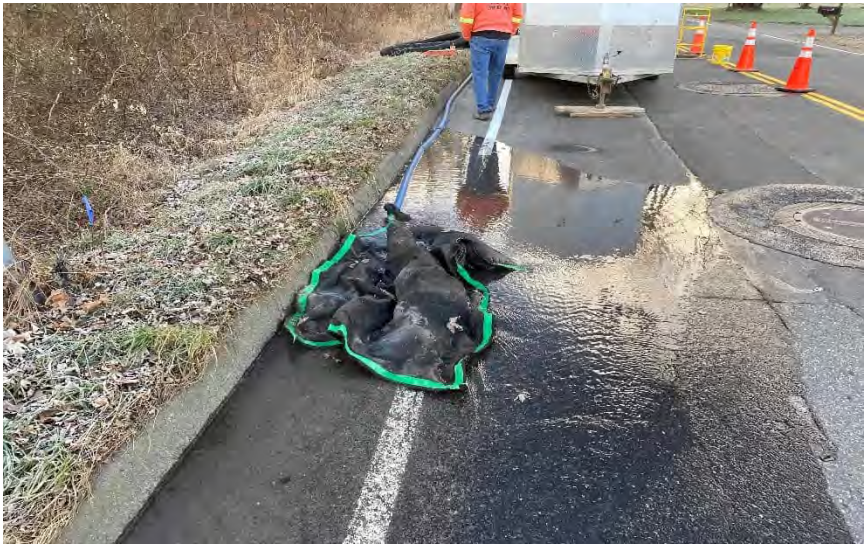
PHOTOGRAPHIC LOG	
Client Name: Eversource		Site Location: Sudbury to Hudson Transmission Reliability Project	Town: Hudson
Photo No.: 4	Date: 12/7/2023

Description: Manhole #4. View of discharge from bag to adjacent stream area off Forest Avenue, looking southward. Water discharge to bag appeared to be slightly turbid.

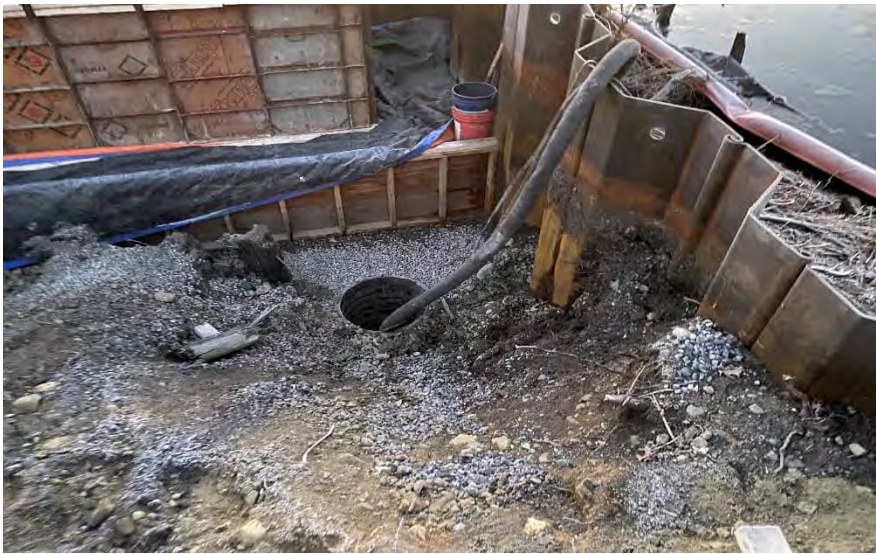
<b>PHOTOGRAPHIC LOG</b>	
<b>Client Name:</b> Eversource		<b>Site Location:</b> Sudbury to Hudson Transmission Reliability Project	<b>Town:</b> Hudson
<b>Photo No.:</b> 1	<b>Date:</b> 12/7/2023

<b>Description:</b> View of area being pumped (i.e., cofferdam within segment 2 off Fort Meadow Brook), looking eastward.

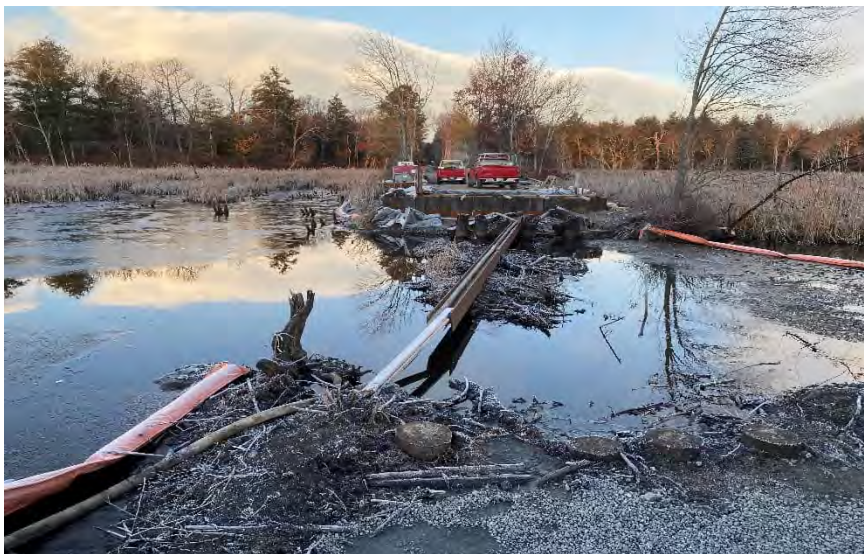
<b>PHOTOGRAPHIC LOG</b>	
<b>Client Name:</b> Eversource		<b>Site Location:</b> Sudbury to Hudson Transmission Reliability Project	<b>Town:</b> Hudson
<b>Photo No.:</b> 2	<b>Date:</b> 12/7/2023

<b>Description:</b> View of dewatering operation across Fort Meadow Brook, discharge hose within H-piling from segment 2 toward segment 3, looking westward.

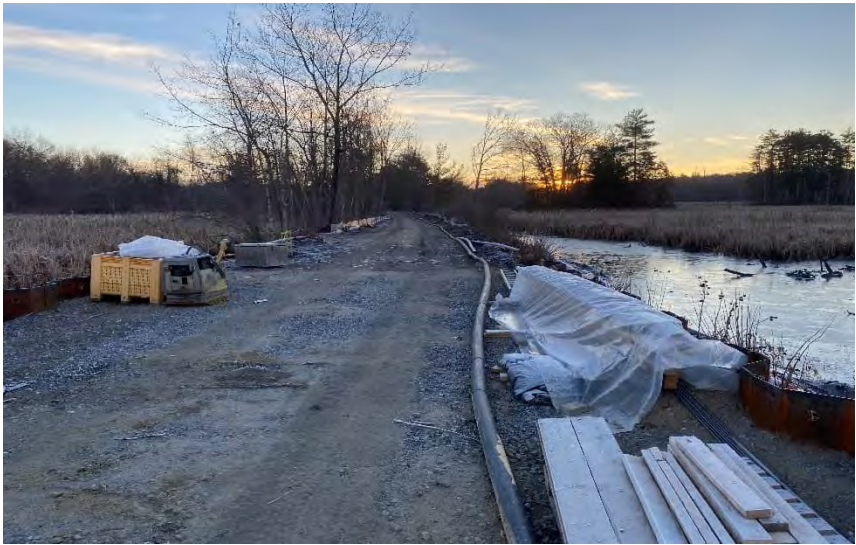
PHOTOGRAPHIC LOG	
Client Name: Eversource		Site Location: Sudbury to Hudson Transmission Reliability Project	Town: Hudson
Photo No.: 3	Date: 12/7/2023

Description: Segment 3. View of discharge dewatering operation, looking eastward.

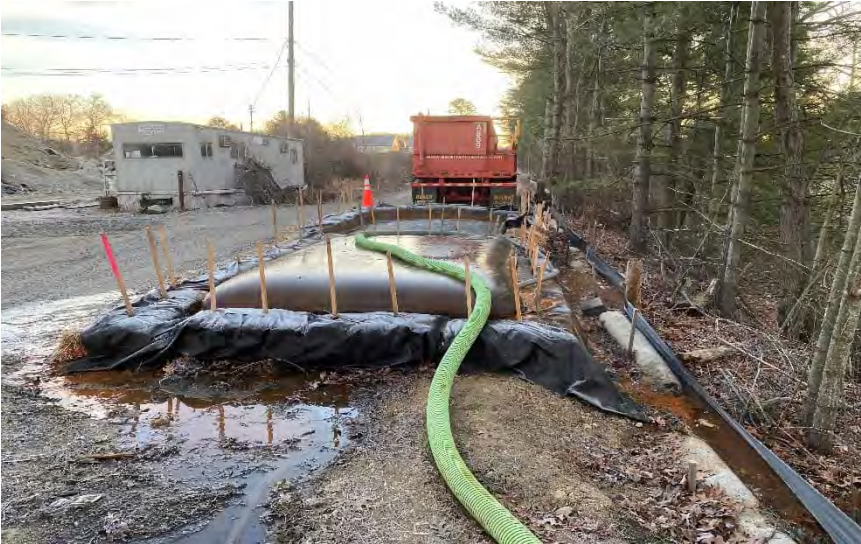
PHOTOGRAPHIC LOG	
Client Name: Eversource		Site Location: Sudbury to Hudson Transmission Reliability Project	Town: Hudson
Photo No.: 4	Date: 12/7/2023

Description: Segment 3. View of discharge from bag/bales to adjacent work area, looking eastward. Water discharge to bag intermittent and appeared to be slightly turbid. Discharge from corral to work area (foreground).

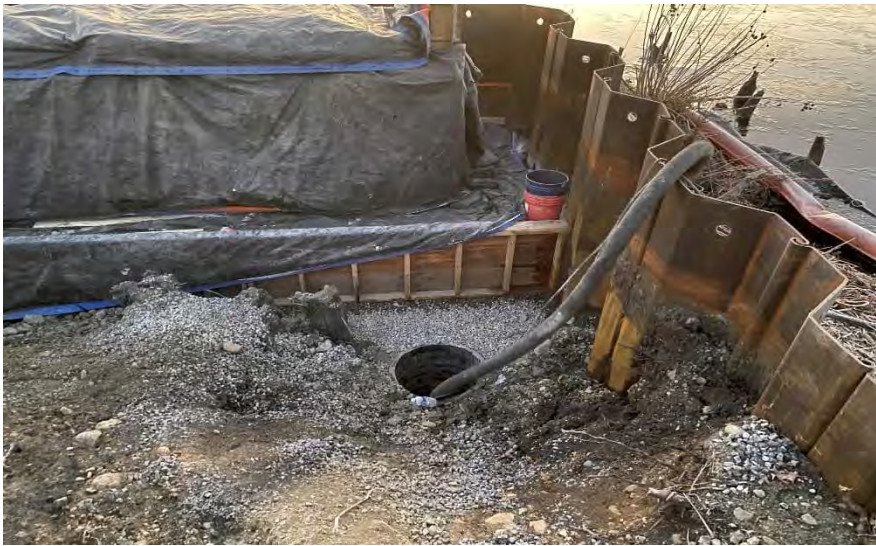
PHOTOGRAPHIC LOG	
Client Name: Eversource		Site Location: Sudbury to Hudson Transmission Reliability Project	Town: Hudson
Photo No.: 1	Date: 12/8/2023

<b>Description:</b> View of area being pumped (i.e., cofferdam within segment 2 off Fort Meadow Brook), looking eastward.

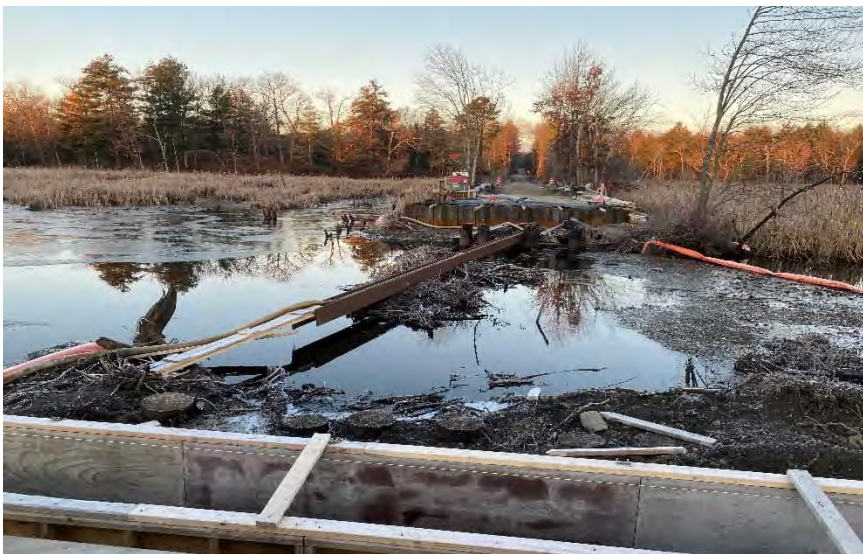
PHOTOGRAPHIC LOG	
Client Name: Eversource		Site Location: Sudbury to Hudson Transmission Reliability Project	Town: Hudson
Photo No.: 2	Date: 12/8/2023

<b>Description:</b> View of dewatering operation across Fort Meadow Brook, discharge hose within H-piling from segment 2 toward segment 3, looking westward.

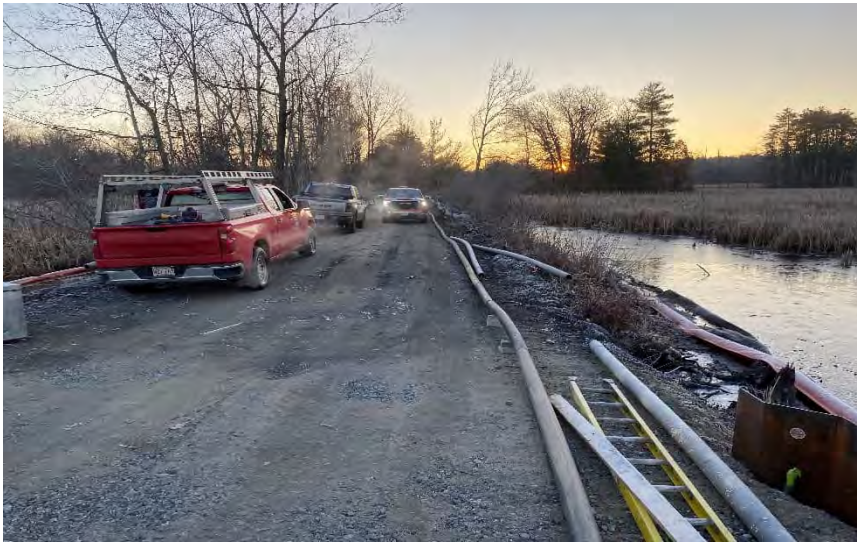
<b>PHOTOGRAPHIC LOG</b>	
<b>Client Name:</b> Eversource		<b>Site Location:</b> Sudbury to Hudson Transmission Reliability Project	
<b>Town:</b> Hudson			
<b>Photo No.:</b> 3	<b>Date:</b> 12/8/2023

<b>Description:</b> Segment 3. View of discharge dewatering operation, looking eastward.

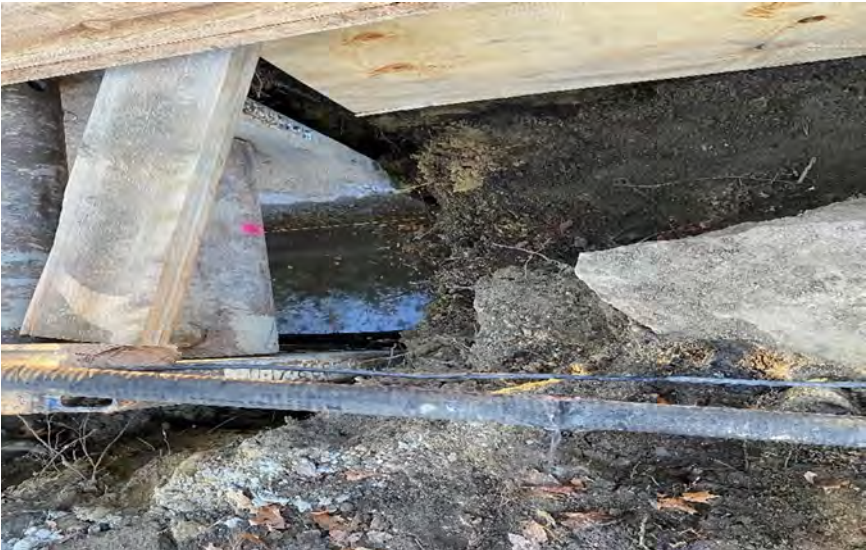
PHOTOGRAPHIC LOG	
Client Name: Eversource		Site Location: Sudbury to Hudson Transmission Reliability Project	Town: Sudbury
Photo No.: 1	Date: 12/8/2023

Description: View of area being pumped from trench within segment 12.

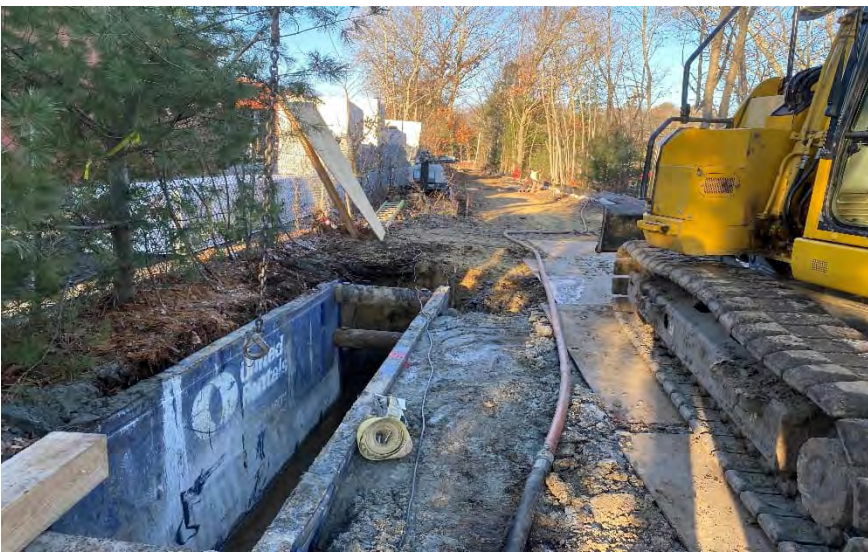
PHOTOGRAPHIC LOG	
Client Name: Eversource		Site Location: Sudbury to Hudson Transmission Reliability Project	Town: Sudbury
Photo No.: 2	Date: 12/8/2023

Description: Segment 12. View of dewatering operation. Looking westward.

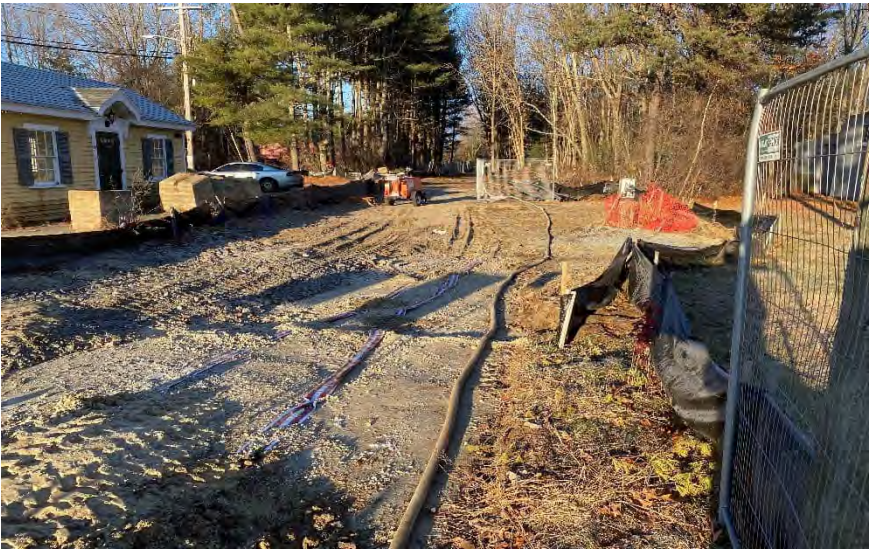
<b>PHOTOGRAPHIC LOG</b>	
Client Name: Eversource		Site Location: Sudbury to Hudson Transmission Reliability Project	Town: Sudbury
Photo No.: 3	Date: 12/8/2023

<b>Description:</b> Segment 11. View of dewatering operation, looking westward.

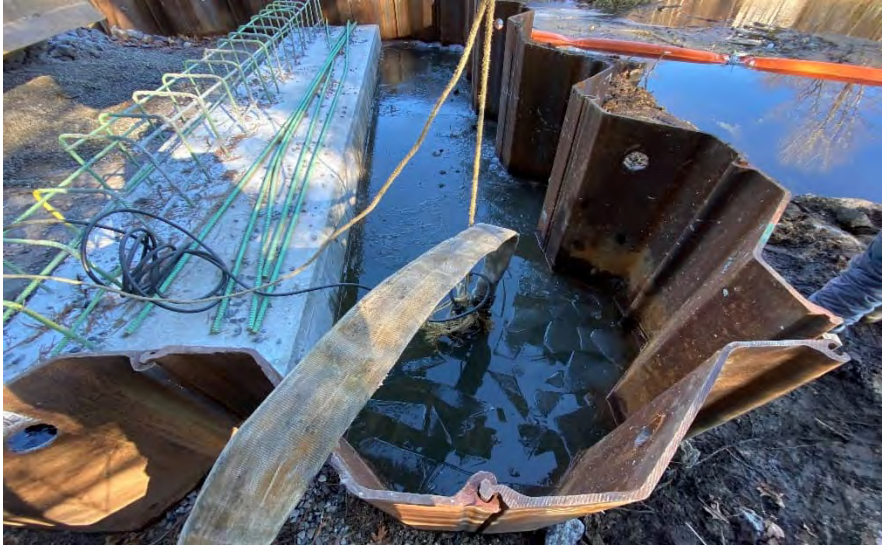
<b>PHOTOGRAPHIC LOG</b>	
Client Name: Eversource		Site Location: Sudbury to Hudson Transmission Reliability Project	Town: Sudbury
Photo No.: 1	Date: 12/8/2023

Description: View of area being pumped from cofferdam at bridge 127 within segment 13.

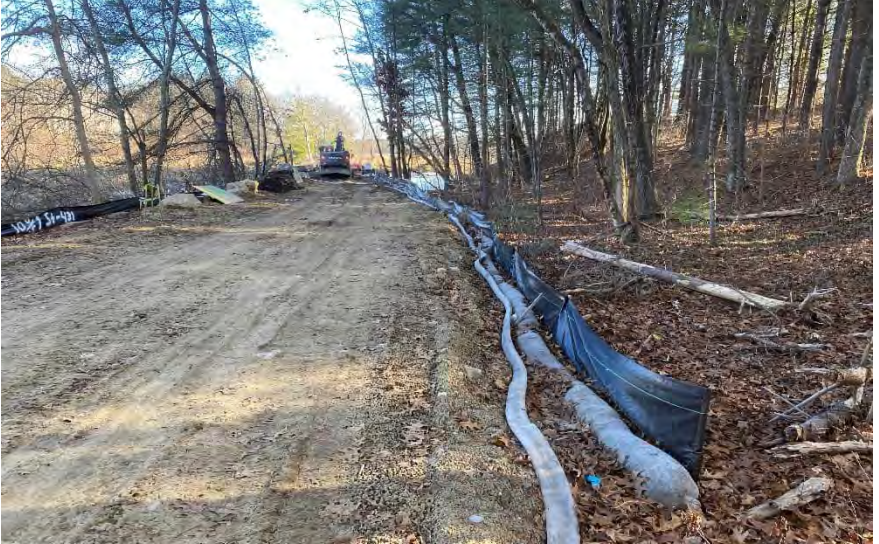
<b>PHOTOGRAPHIC LOG</b>	
Client Name: Eversource		Site Location: Sudbury to Hudson Transmission Reliability Project	
Town: Sudbury			
Photo No.: 3	Date: 12/8/2023

<b>Description:</b> Segment 13. View of dewatering operation, looking eastward.

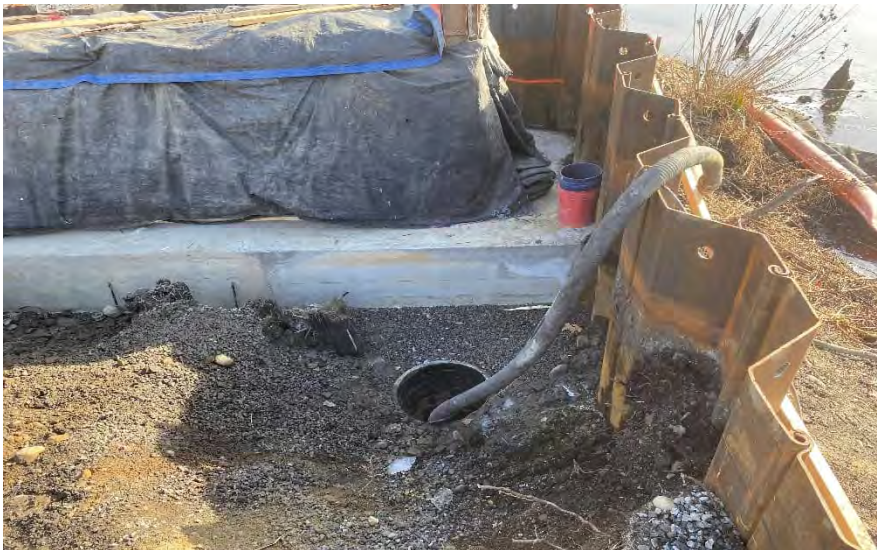
<b>PHOTOGRAPHIC LOG</b>	
Client Name: Eversource		Site Location: Sudbury to Hudson Transmission Reliability Project	Town: Hudson
Photo No.: 1	Date: 12/9/2023

Description: View of area being pumped (i.e., cofferdam within segment 2 off Fort Meadow Brook), looking eastward.
