**Weekly Environmental Compliance Summary**

**Sudbury to Hudson Transmission Reliability Project (USEPA Tracking # MAR1003UW)**

Sudbury, Hudson, and Stow, MA

Week of: December 4, 2023 to December 8, 2023

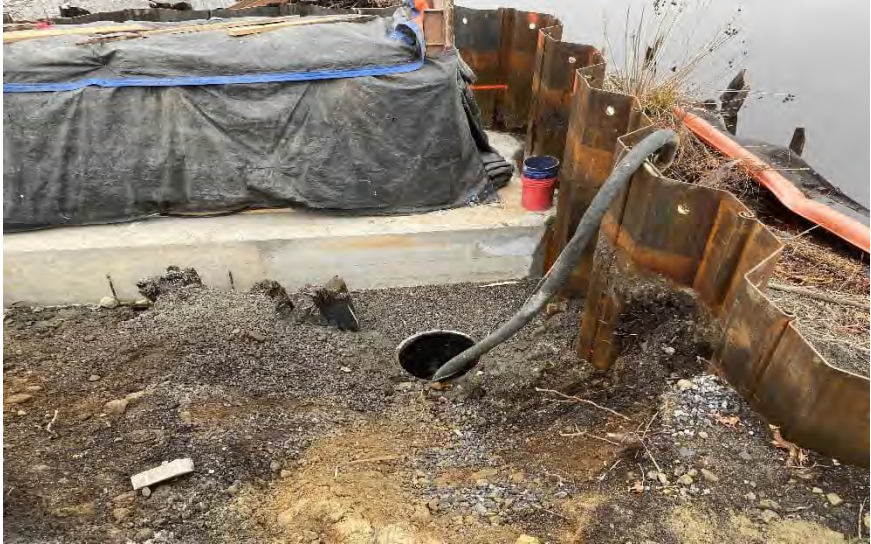
<b>PHOTOGRAPHIC LOG</b>	
<b>Client Name:</b> Eversource		<b>Site Location:</b> Sudbury to Hudson Transmission Reliability Project	<b>Town:</b> Hudson
<b>Photo No.:</b> 1	<b>Date:</b> 12/10/2023

<b>Description:</b> View of area being pumped (i.e., cofferdam within segment 2 off Fort Meadow Brook), looking eastward.

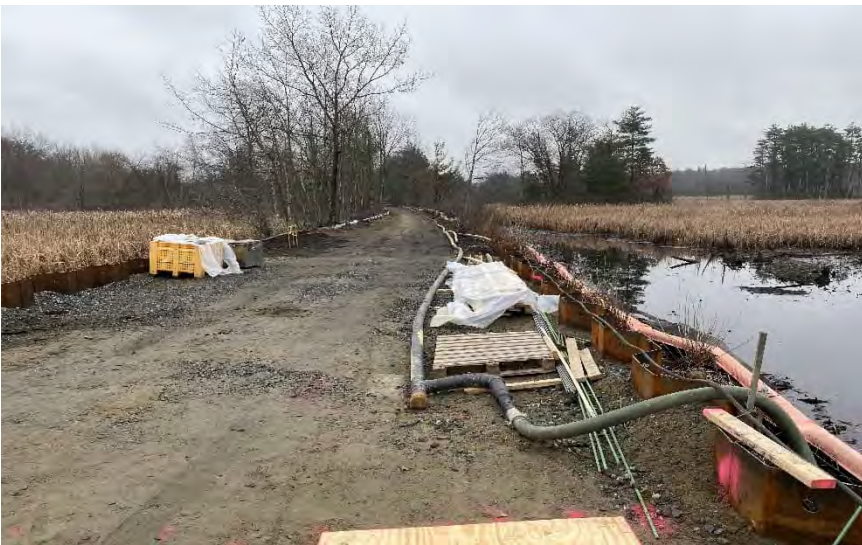
PHOTOGRAPHIC LOG	
Client Name: Eversource		Site Location: Sudbury to Hudson Transmission Reliability Project	Town: Hudson
Photo No.: 3	Date: 12/10/2023

Description: Segment 3. View of discharge dewatering operation, looking eastward.

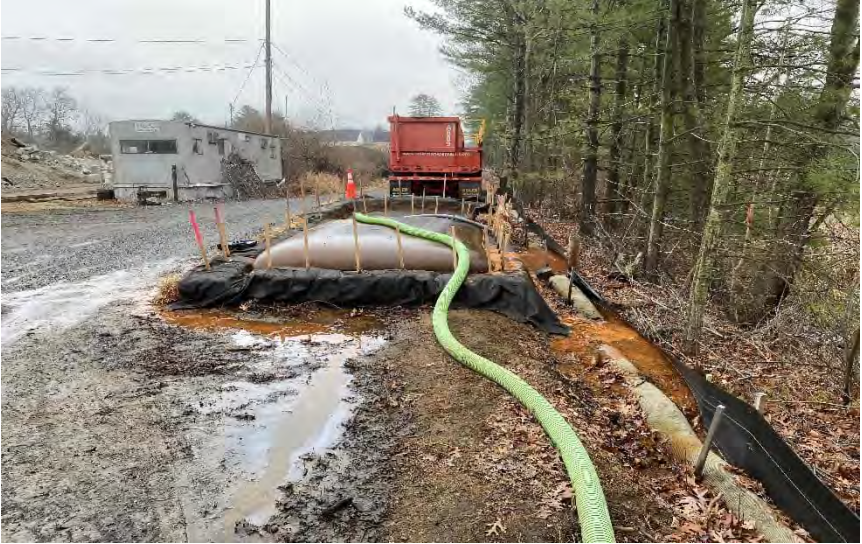
PHOTOGRAPHIC LOG	
Client Name: Eversource		Site Location: Sudbury to Hudson Transmission Reliability Project	Town: Hudson
Photo No.: 4	Date: 12/10/2023

Description: Segment 3. View of discharge from bag/bales to adjacent work area, looking eastward. Water discharge to bag intermittent and appeared to be slightly turbid. Discharge from corral to work area (foreground).
