Weekly Environmental Compliance Summary

Sudbury to Hudson Transmission Reliability Project (USEPA Tracking # MAR1003UW)

Week of: December 11, 2023 to December 15, 2023

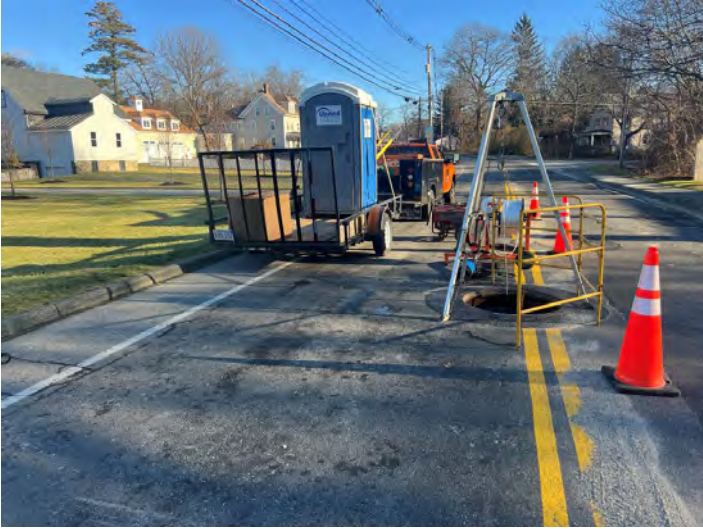
<p align="right">PHOTOGRAPHIC LOG</p>	
<p>Client Name: Eversource</p>		<p>Site Location: Sudbury to Hudson Transmission Reliability Project</p>	<p>Town: Hudson</p>
<p>Photo No.: 1</p>	<p>Date: 12/12/2023</p>

<p>Description: View of Bond working at MH #3 on Forest Ave. See additional dewatering inspection report. Facing north.</p>

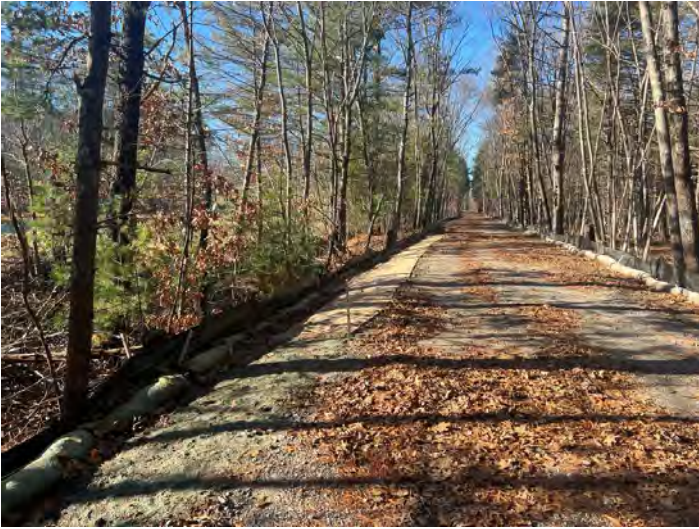
<p align="right">PHOTOGRAPHIC LOG</p>	
<p>Client Name: Eversource</p>		<p>Site Location: Sudbury to Hudson Transmission Reliability Project</p>	<p>Town: Hudson</p>
<p>Photo No.: 2</p>	<p>Date: 12/12/2023</p>

<p>Description: View of Type B E&S controls in segment 4. Facing west.</p>

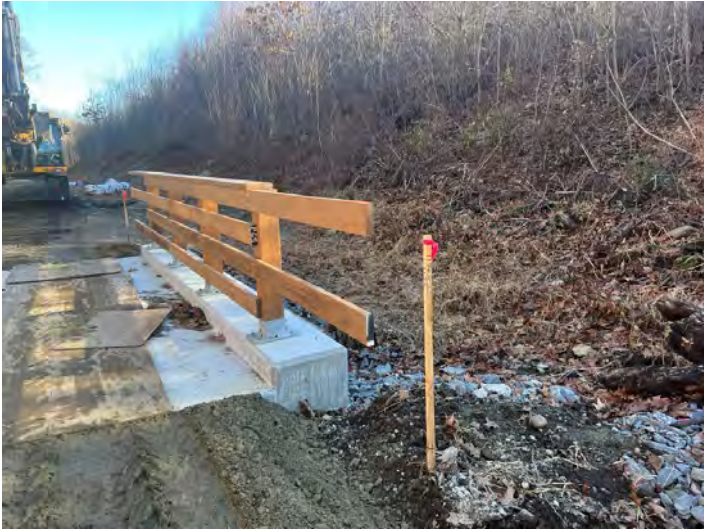
<p>PHOTOGRAPHIC LOG</p>	
<p>Client Name: Eversource</p>		<p>Site Location: Sudbury to Hudson Transmission Reliability Project</p>	<p>Town: Hudson</p>
<p>Photo No.: 5</p>	<p>Date: 12/12/2023</p>

<p>Description: Crews were working at the bridge in Segment 1. Facing northeast.</p>

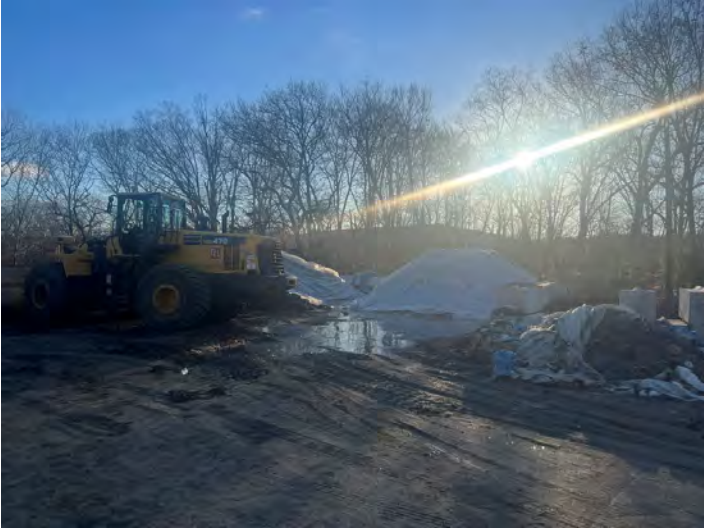
<p>PHOTOGRAPHIC LOG</p>	
<p>Client Name: Eversource</p>		<p>Site Location: Sudbury to Hudson Transmission Reliability Project</p>	<p>Town: Hudson</p>
<p>Photo No.: 6</p>	<p>Date: 12/12/2023</p>

<p>Description: View of Stowe Ct laydown yard. Facing northeast.</p>

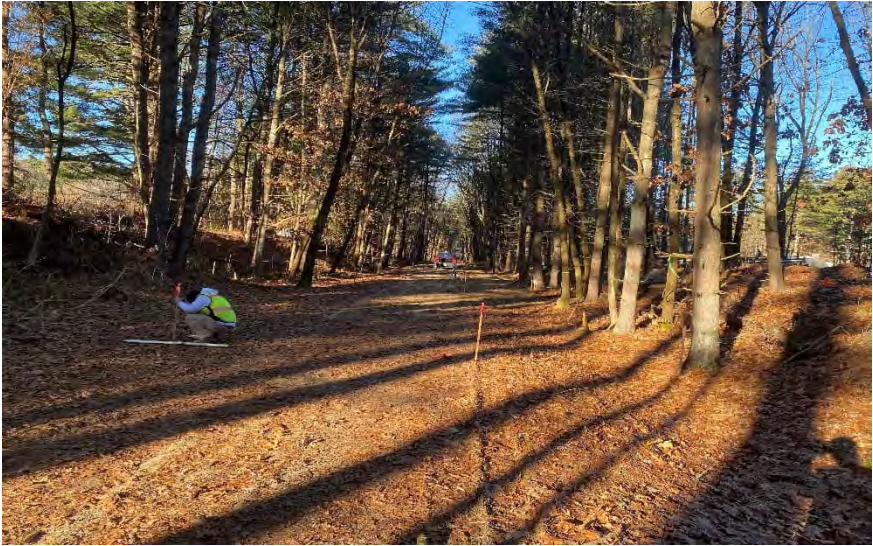
<p>PHOTOGRAPHIC LOG</p>	
<p>Client Name: Eversource</p>		<p>Site Location: Sudbury to Hudson Transmission Reliability Project</p>	<p>Town: Sudbury</p>
<p>Photo No.: 5</p>	<p>Date: 12-12-23</p>

<p>Description:</p> <p>Work area within Segment 10 (off Horsepond road), survey work, looking westward.</p>

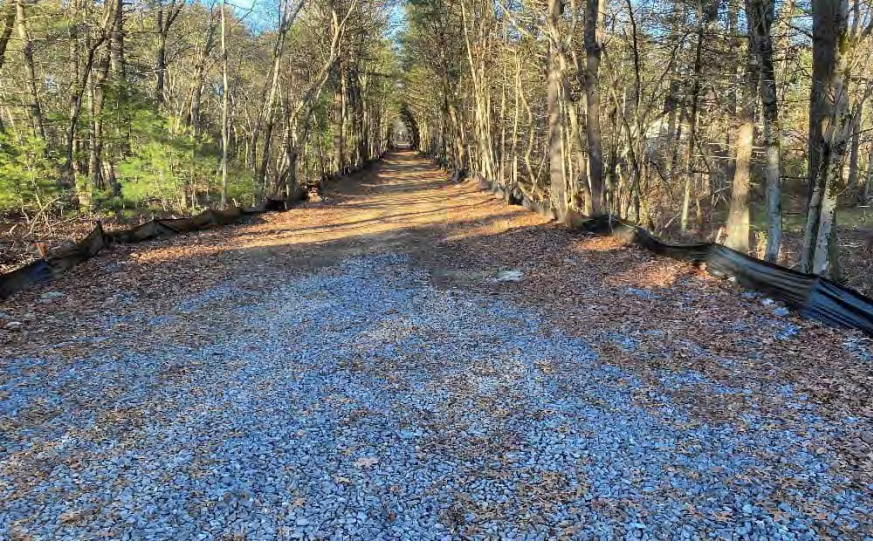
<p>PHOTOGRAPHIC LOG</p>	
<p>Client Name: Eversource</p>		<p>Site Location: Sudbury to Hudson Transmission Reliability Project</p>	<p>Town: Sudbury</p>
<p>Photo No.: 6</p>	<p>Date: 12-12-23</p>

<p>Description:</p> <p>Work area within Segment 9 (off Peakham road), existing erosion control, looking westward.</p>

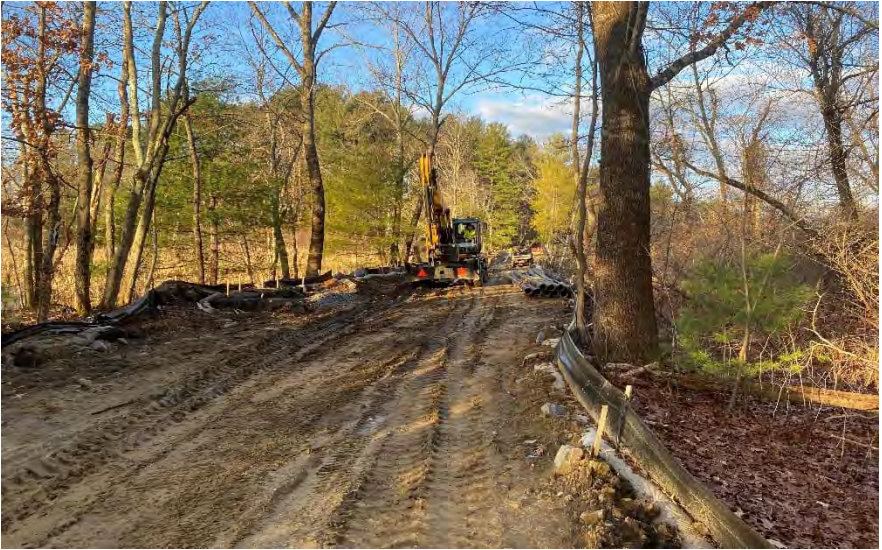
<p>PHOTOGRAPHIC LOG</p>	
<p>Client Name: Eversource</p>		<p>Site Location: Sudbury to Hudson Transmission Reliability Project</p>	<p>Town: Sudbury</p>
<p>Photo No.: 7</p>	<p>Date: 12-12-23</p>

<p>Description:</p> <p>Work area within Segment 14, grading post conduit work, existing erosion control, looking westward.</p>

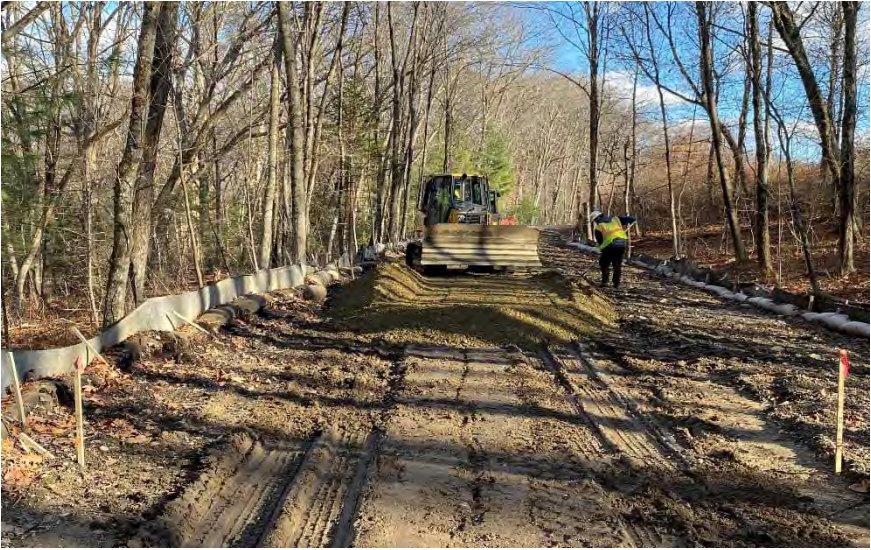
<p>PHOTOGRAPHIC LOG</p>	
<p>Client Name: Eversource</p>		<p>Site Location: Sudbury to Hudson Transmission Reliability Project</p>	<p>Town: Hudson</p>
<p>Photo No.: 1</p>	<p>Date: 12-13-23</p>

<p>Description:</p> <p>Work area within segment 1, existing erosion control, grading work, looking eastward.</p>

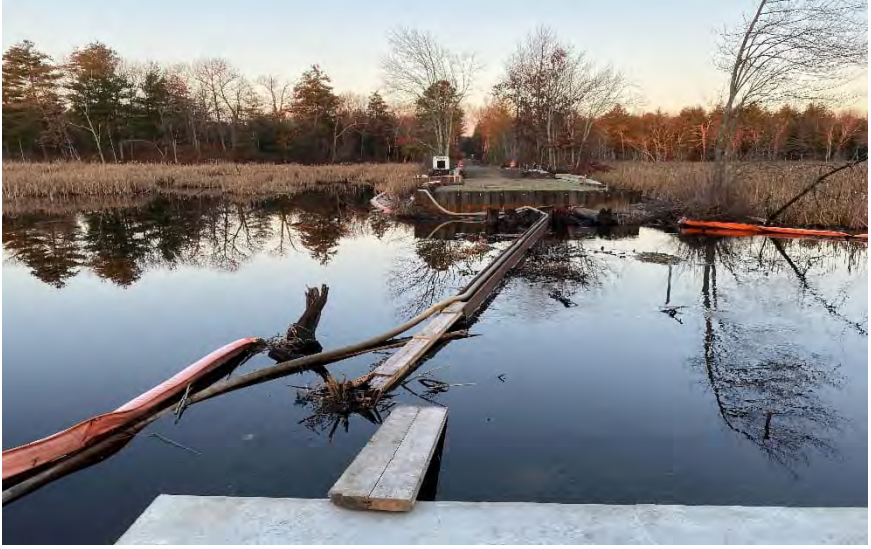
<p>PHOTOGRAPHIC LOG</p>	
<p>Client Name: Eversource</p>		<p>Site Location: Sudbury to Hudson Transmission Reliability Project</p>	<p>Town: Hudson</p>
<p>Photo No.: 2</p>	<p>Date: 12-13-23</p>

<p>Description:</p> <p>Work area from segment 3 toward segment 2 across Fort Meadow Brook, existing erosion control, looking westward.</p>

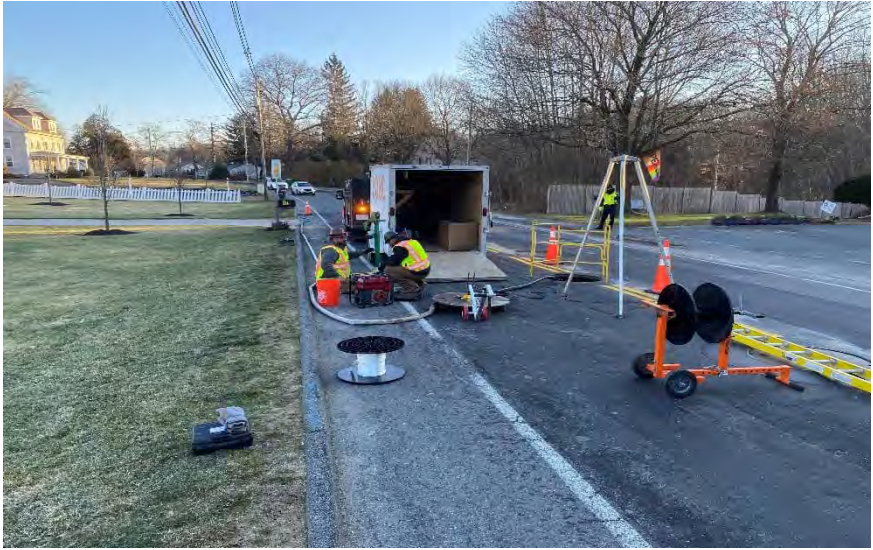
<p>PHOTOGRAPHIC LOG</p>	
<p>Client Name: Eversource</p>		<p>Site Location: Sudbury to Hudson Transmission Reliability Project</p>	<p>Town: Hudson</p>
<p>Photo No.: 3</p>	<p>Date: 12-13-23</p>

<p>Description: Bond conducting proofing work at manhole #3, looking northward.</p>

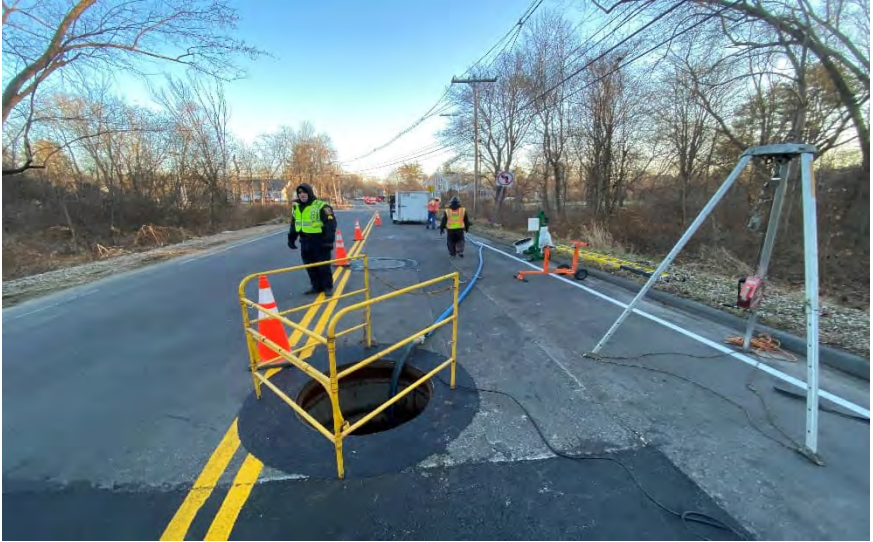
<p>PHOTOGRAPHIC LOG</p>	
<p>Client Name: Eversource</p>		<p>Site Location: Sudbury to Hudson Transmission Reliability Project</p>	<p>Town: Hudson</p>
<p>Photo No.: 4</p>	<p>Date: 12-13-23</p>

<p>Description: Bond conducting proofing work at manhole #4, looking northward.</p>

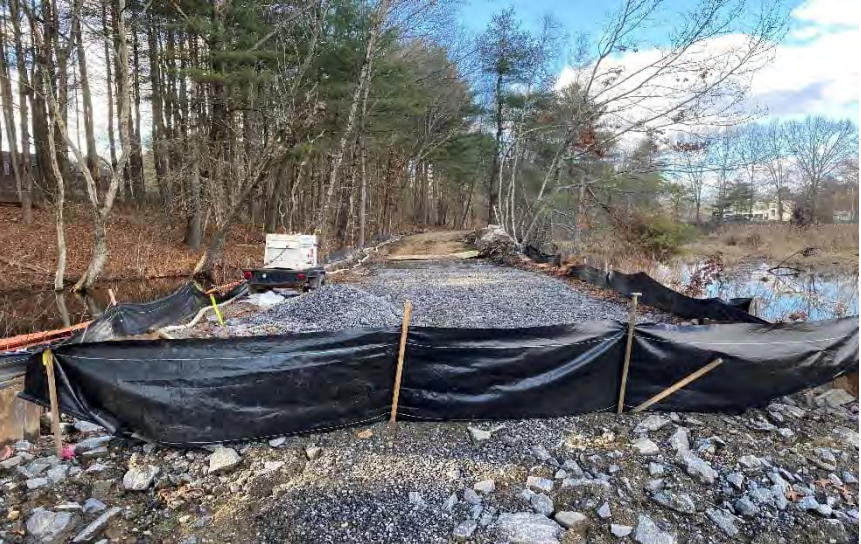
<p>PHOTOGRAPHIC LOG</p>	
<p>Client Name: Eversource</p>		<p>Site Location: Sudbury to Hudson Transmission Reliability Project</p>	<p>Town: Sudbury</p>
<p>Photo No.: 6</p>	<p>Date: 12-13-23</p>

<p>Description: Work area within Segment 13, existing erosion control, looking westward.</p>

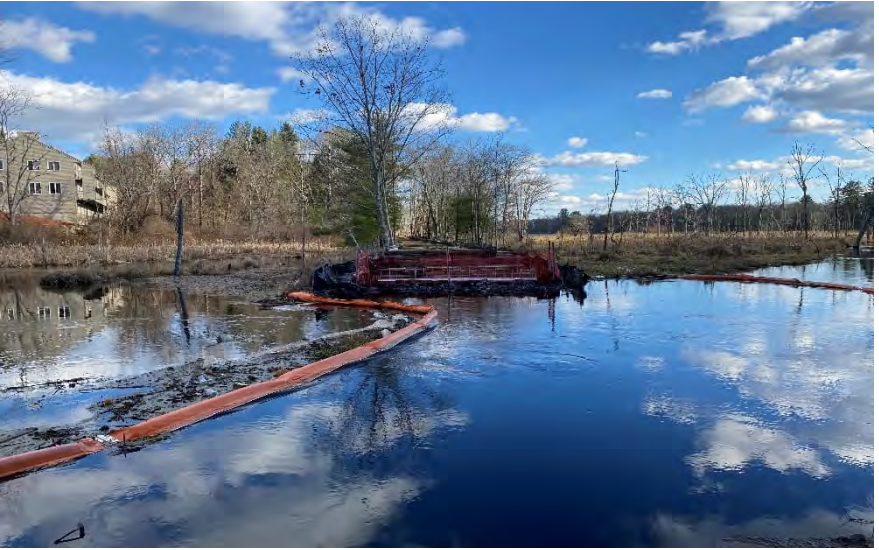
<p>PHOTOGRAPHIC LOG</p>	
<p>Client Name: Eversource</p>		<p>Site Location: Sudbury to Hudson Transmission Reliability Project</p>	<p>Town: Sudbury</p>
<p>Photo No.: 7</p>	<p>Date: 12-13-23</p>

<p>Description: Work area within Segment 13 looking across Hop Brook toward segment 14, existing erosion control, looking eastward.</p>

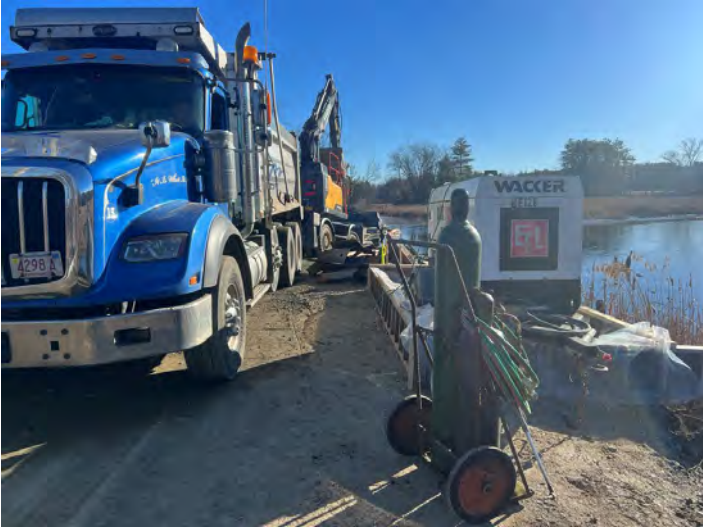
<p align="right">PHOTOGRAPHIC LOG</p>	
<p>Client Name: Eversource</p>		<p>Site Location: Sudbury to Hudson Transmission Reliability Project</p>	<p>Town: Hudson</p>
<p>Photo No.: 1</p>	<p>Date: 12/14/2023</p>

<p>Description: View of work at bridge 130 in segment 2. See additional dewatering inspection report. Facing east.</p>

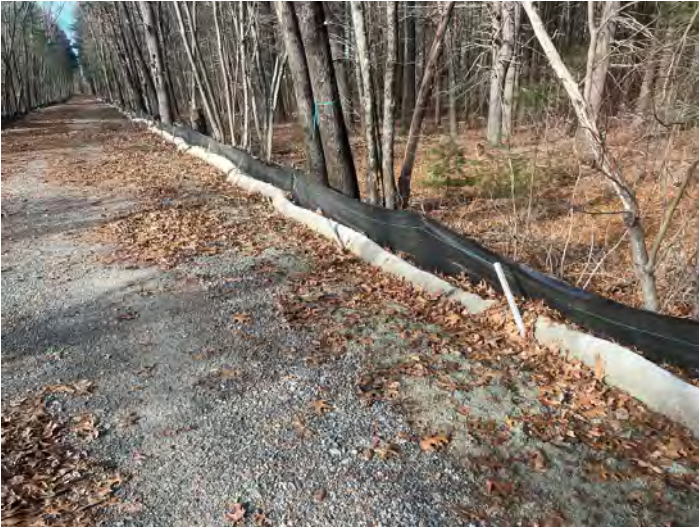
<p align="right">PHOTOGRAPHIC LOG</p>	
<p>Client Name: Eversource</p>		<p>Site Location: Sudbury to Hudson Transmission Reliability Project</p>	<p>Town: Hudson</p>
<p>Photo No.: 2</p>	<p>Date: 12/14/2023</p>

<p>Description: View of Type B E&S controls in segment 4. Facing west.</p>

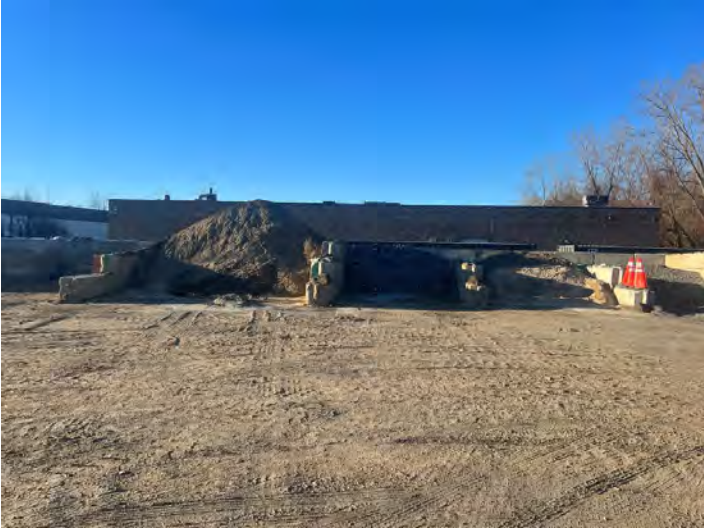
PHOTOGRAPHIC LOG	
Client Name: Eversource		Site Location: Sudbury to Hudson Transmission Reliability Project	Town: Hudson
Photo No.: 6	Date: 12/14/2023

Description: View of Bonazzolli laydown yard. Facing north.

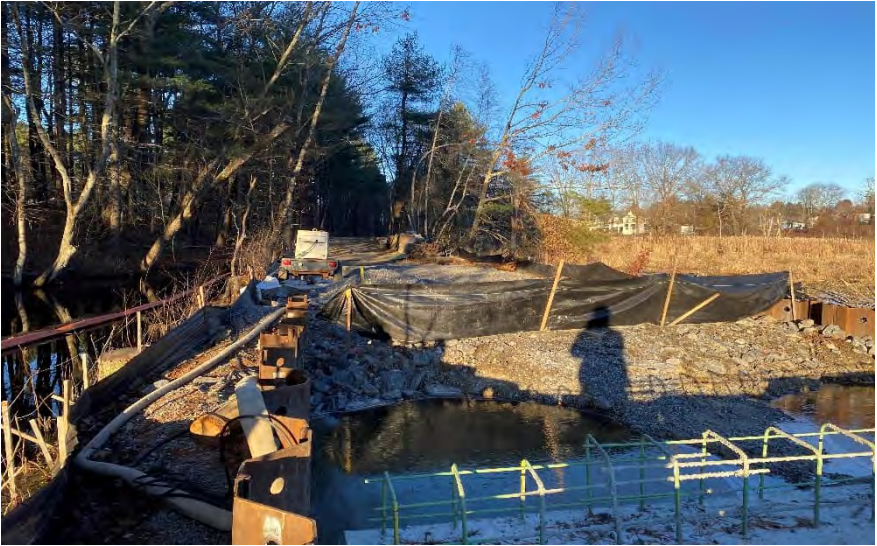
<p>PHOTOGRAPHIC LOG</p>	
<p>Client Name: Eversource</p>		<p>Site Location: Sudbury to Hudson Transmission Reliability Project</p>	<p>Town: Sudbury</p>
<p>Photo No.: 1</p>	<p>Date: 12-14-23</p>

<p>Description: Work area within segment 13, existing erosion control, looking westward.</p>

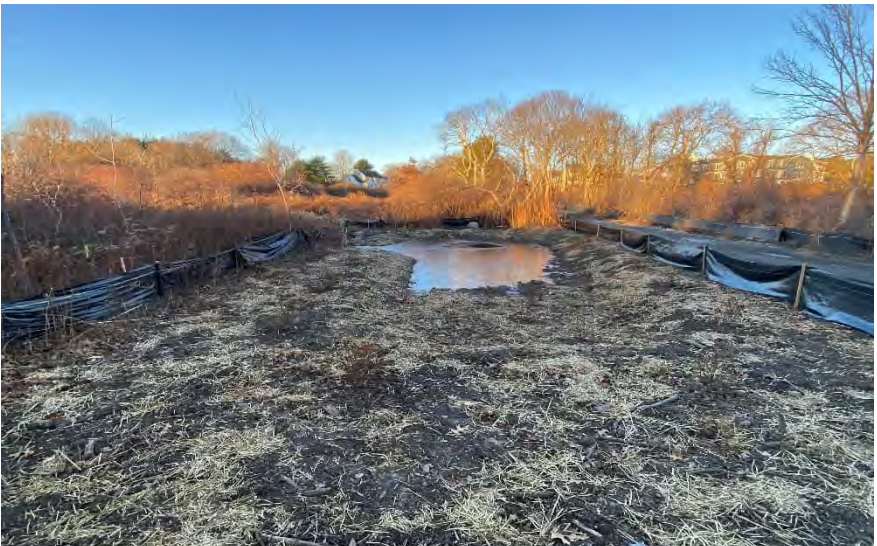
<p>PHOTOGRAPHIC LOG</p>	
<p>Client Name: Eversource</p>		<p>Site Location: Sudbury to Hudson Transmission Reliability Project</p>	<p>Town: Sudbury</p>
<p>Photo No.: 2</p>	<p>Date: 12-14-23</p>

<p>Description: Wetland replication area, within Segment 14, looking westward.</p>

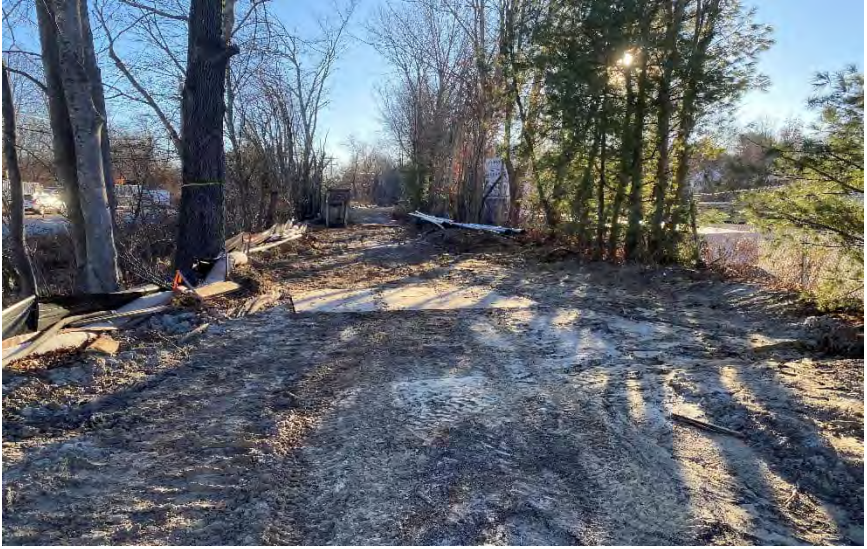
<p>PHOTOGRAPHIC LOG</p>	
<p>Client Name: Eversource</p>		<p>Site Location: Sudbury to Hudson Transmission Reliability Project</p>	<p>Town: Sudbury</p>
<p>Photo No.: 4</p>	<p>Date: 12-14-23</p>

<p>Description:</p> <p>Work area within Segment 12, existing erosion control, looking eastward.</p>

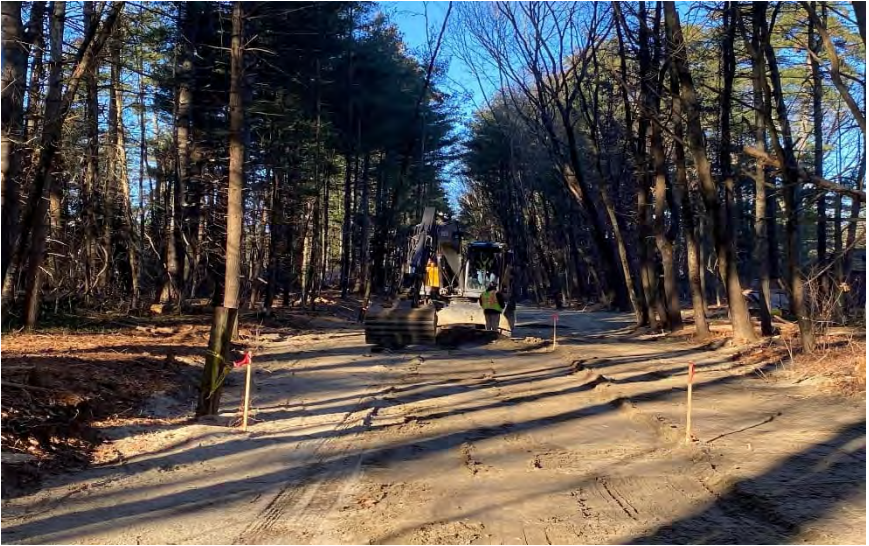
<p>PHOTOGRAPHIC LOG</p>	
<p>Client Name: Eversource</p>		<p>Site Location: Sudbury to Hudson Transmission Reliability Project</p>	<p>Town: Sudbury</p>
<p>Photo No.: 5</p>	<p>Date: 12-14-23</p>

<p>Description:</p> <p>Work area within Segment 10 (off Horsepond road), survey work, looking westward.</p>

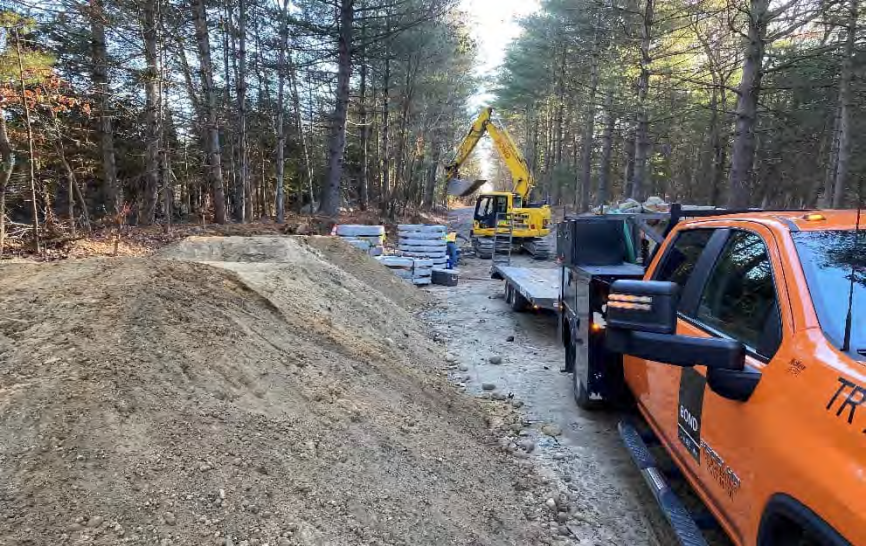
<p>PHOTOGRAPHIC LOG</p>	
<p>Client Name: Eversource</p>		<p>Site Location: Sudbury to Hudson Transmission Reliability Project</p>	<p>Town: Sudbury</p>
<p>Photo No.: 6</p>	<p>Date: 12-14-23</p>

<p>Description:</p> <p>Work area within Segment 9 (off Peakham road), conduit work, existing erosion control, looking eastward.</p>

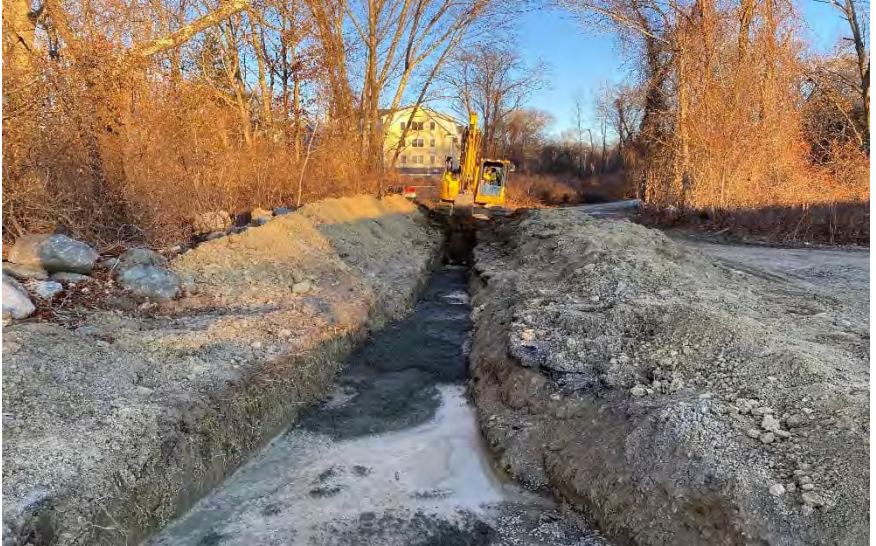
<p>PHOTOGRAPHIC LOG</p>	
<p>Client Name: Eversource</p>		<p>Site Location: Sudbury to Hudson Transmission Reliability Project</p>	<p>Town: Sudbury</p>
<p>Photo No.: 8</p>	<p>Date: 12-14-23</p>

<p>Description:</p> <p>Work area outside substation from manhole #28, conduit work, looking northward.</p>

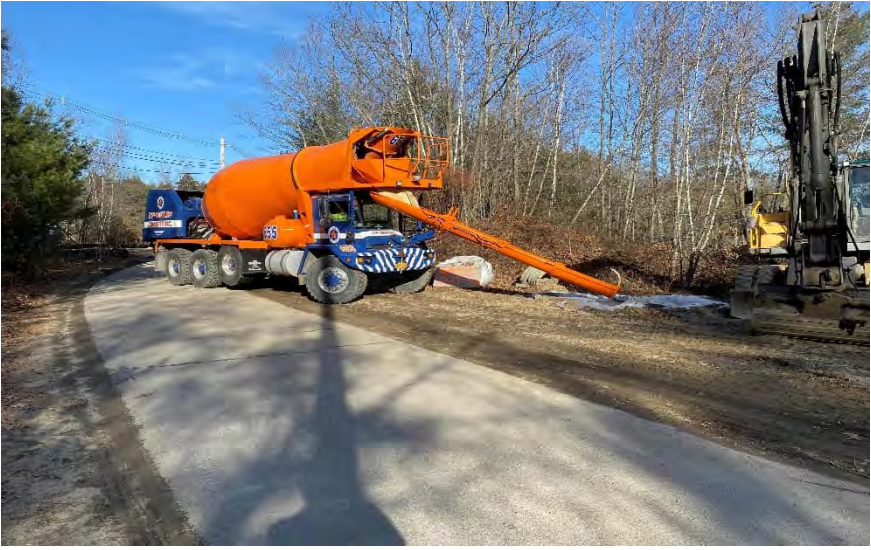
<p>PHOTOGRAPHIC LOG</p>	
<p>Client Name: Eversource</p>		<p>Site Location: Sudbury to Hudson Transmission Reliability Project</p>	<p>Town: Hudson</p>
<p>Photo No.: 1</p>	<p>Date: 12-15-23</p>

<p>Description:</p> <p>Work area within segment 2, concrete washout, looking eastward.</p>

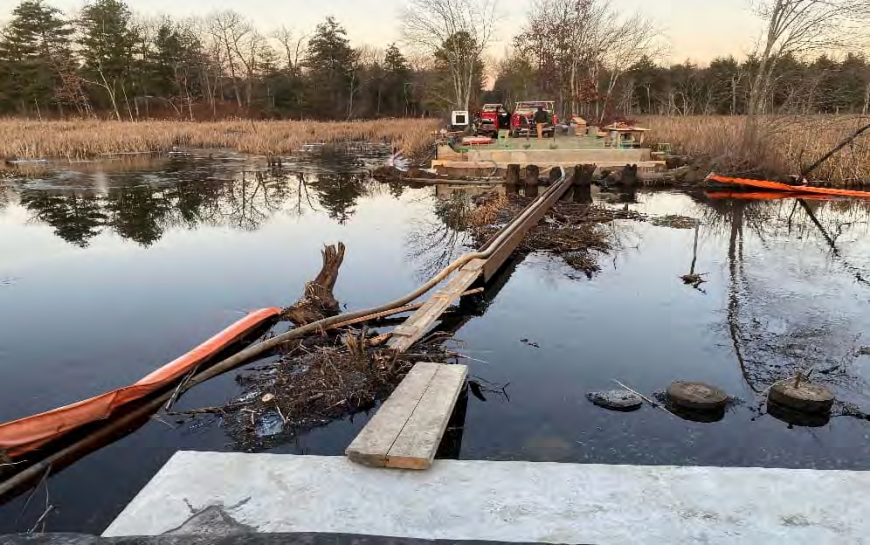
<p>PHOTOGRAPHIC LOG</p>	
<p>Client Name: Eversource</p>		<p>Site Location: Sudbury to Hudson Transmission Reliability Project</p>	<p>Town: Hudson</p>
<p>Photo No.: 2</p>	<p>Date: 12-15-23</p>

<p>Description:</p> <p>Work area from segment 3 toward segment 2 across Fort Meadow Brook, existing erosion control, looking westward.</p>

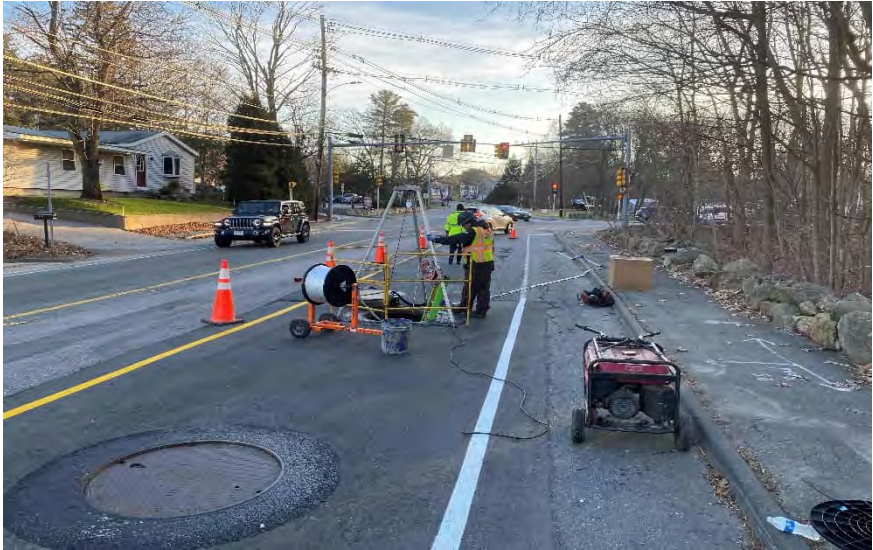
<p>PHOTOGRAPHIC LOG</p>	
<p>Client Name: Eversource</p>		<p>Site Location: Sudbury to Hudson Transmission Reliability Project</p>	<p>Town: Hudson</p>
<p>Photo No.: 3</p>	<p>Date: 12-15-23</p>

<p>Description: Bond conducting proofing work at manhole #3, looking northward.</p>

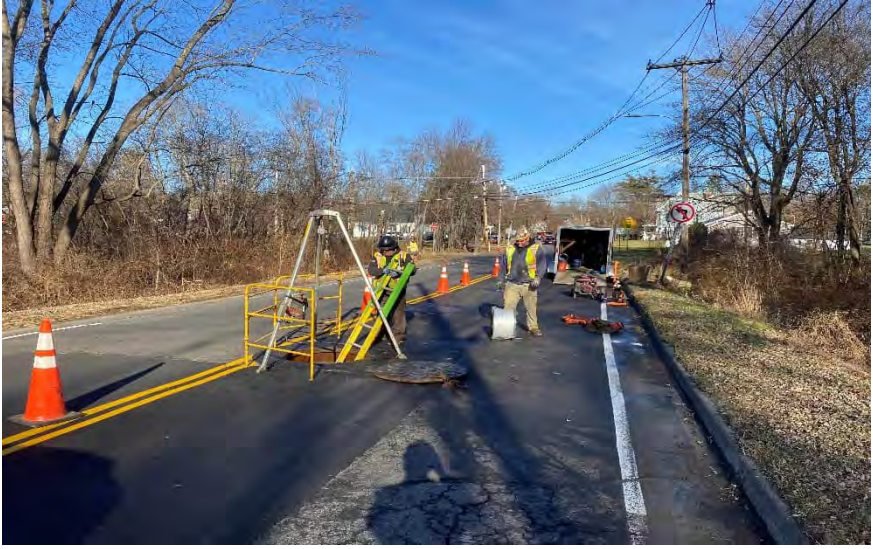
<p>PHOTOGRAPHIC LOG</p>	
<p>Client Name: Eversource</p>		<p>Site Location: Sudbury to Hudson Transmission Reliability Project</p>	<p>Town: Hudson</p>
<p>Photo No.: 4</p>	<p>Date: 12-15-23</p>

<p>Description: Bond conducting proofing work at manhole #4, looking northward.</p>

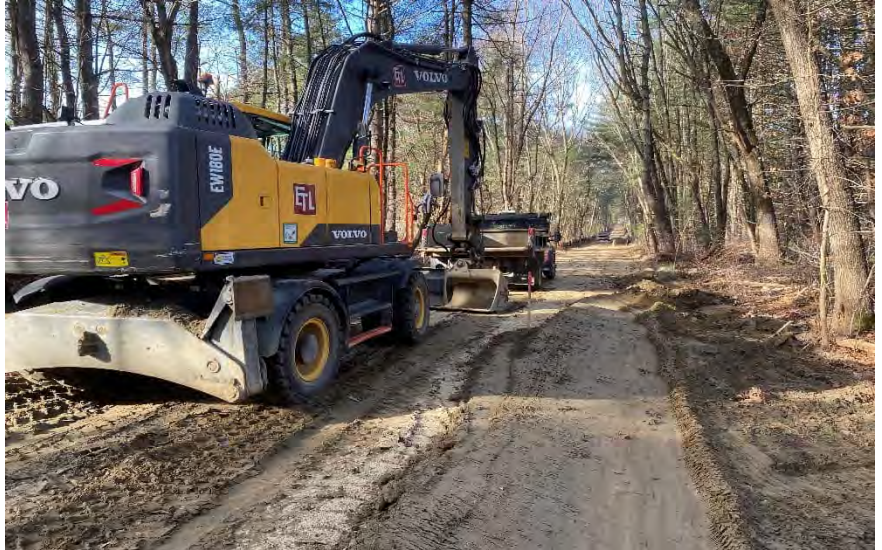
<p>PHOTOGRAPHIC LOG</p>	
<p>Client Name: Eversource</p>		<p>Site Location: Sudbury to Hudson Transmission Reliability Project</p>	<p>Town: Sudbury</p>
<p>Photo No.: 6</p>	<p>Date: 12-15-23</p>

<p>Description: Work area within Segment 10, grading work, looking westward.</p>

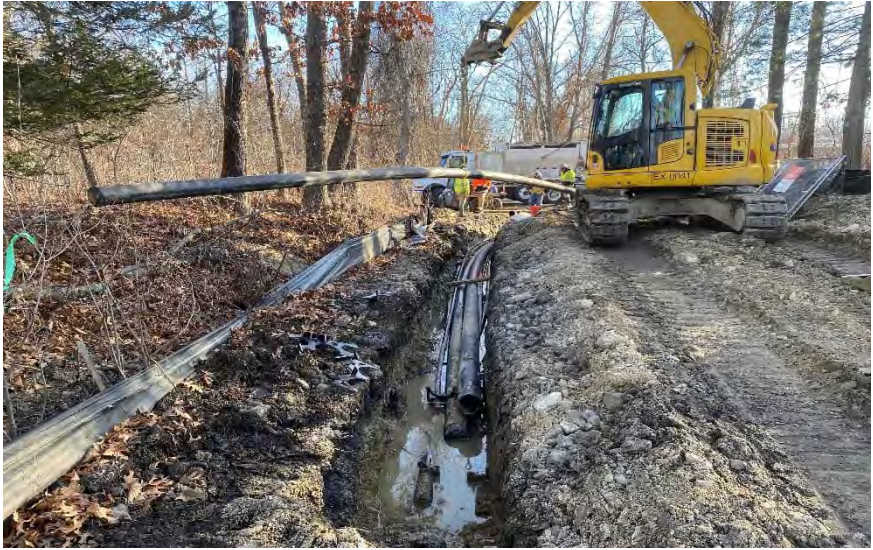
<p>PHOTOGRAPHIC LOG</p>	
<p>Client Name: Eversource</p>		<p>Site Location: Sudbury to Hudson Transmission Reliability Project</p>	<p>Town: Sudbury</p>
<p>Photo No.: 7</p>	<p>Date: 12-15-23</p>

<p>Description:</p> <p>Work area within Segment 14, conduit work, existing erosion control, looking eastward.</p>

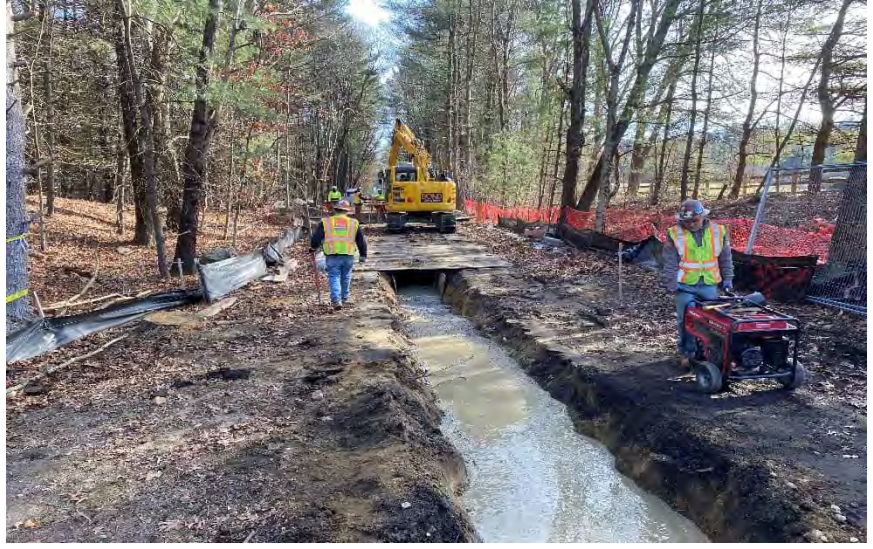
<p>PHOTOGRAPHIC LOG</p>	
<p>Client Name: Eversource</p>		<p>Site Location: Sudbury to Hudson Transmission Reliability Project</p>	<p>Town: Sudbury</p>
<p>Photo No.: 8</p>	<p>Date: 12-15-23</p>

<p>Description:</p> <p>Work area within Segment 8, conduit work, existing erosion control, looking eastward.</p>

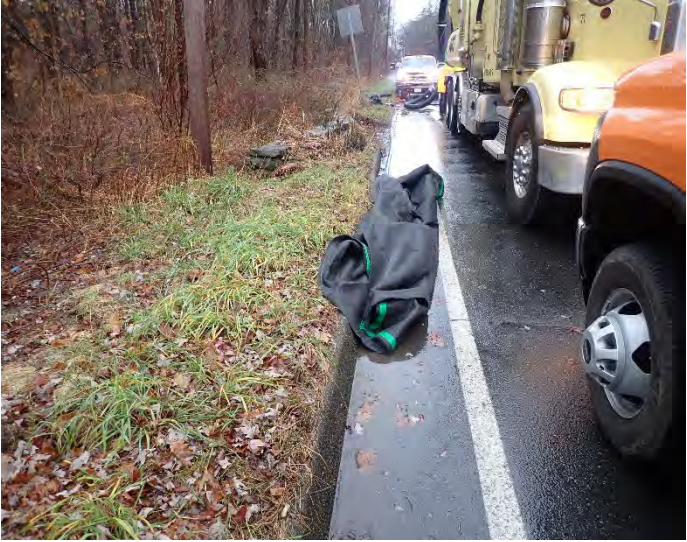
PHOTOGRAPHIC LOG	
Client Name: Eversource		Site Location: Sudbury to Hudson Transmission Reliability Project	Town: Hudson
Photo No.: 1	Date: 12-11-2023

Description: View of Bond working at MH #4 on Forest Ave. See additional dewatering inspection report. Facing southwest.

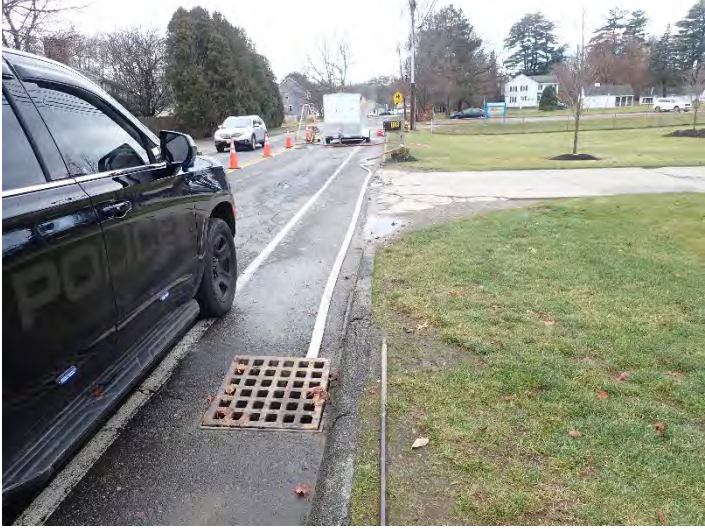
PHOTOGRAPHIC LOG	
Client Name: Eversource		Site Location: Sudbury to Hudson Transmission Reliability Project	Town: Hudson
Photo No.: 2	Date: 12-11-2023

Description: View of Bond working at MH #3 on Forest Ave. See additional dewatering inspection report. Facing southwest.

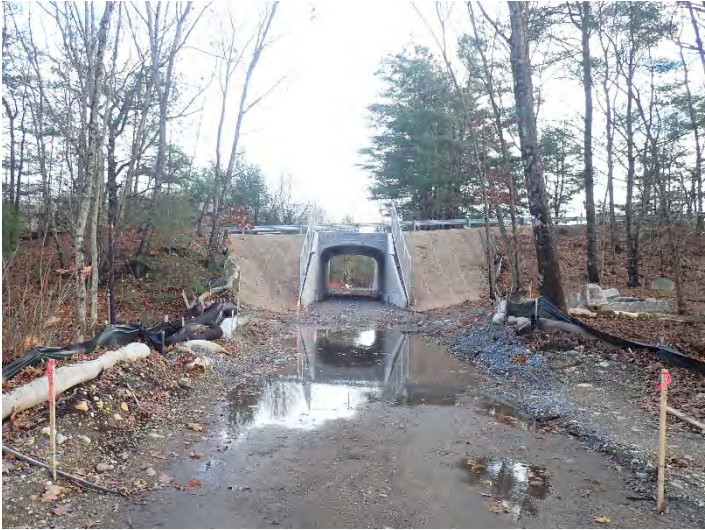
PHOTOGRAPHIC LOG	
Client Name: Eversource		Site Location: Sudbury to Hudson Transmission Reliability Project	Town: Hudson
Photo No.: 3	Date: 12-11-2023

Description: View of Chestnut St tunnel. Erosion control matting has been applied to slopes. Facing east.

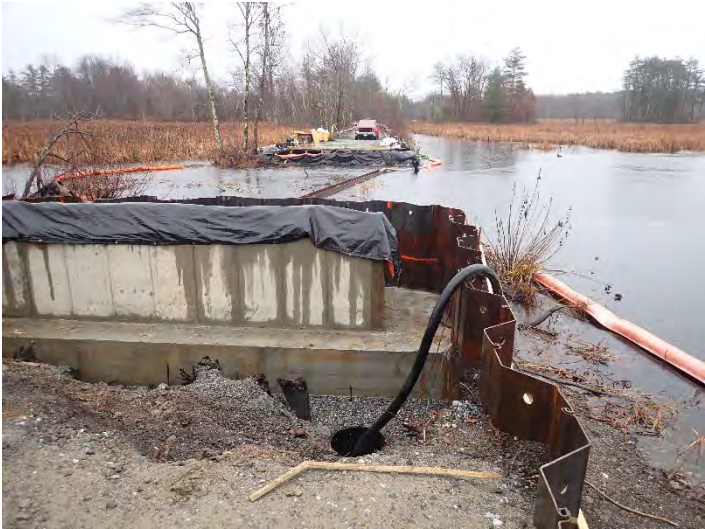
PHOTOGRAPHIC LOG	
Client Name: Eversource		Site Location: Sudbury to Hudson Transmission Reliability Project	Town: Hudson
Photo No.: 4	Date: 12-11-2023

Description: View of work area at bridge 130 in segment 2. See additional dewatering inspection report. Facing east.

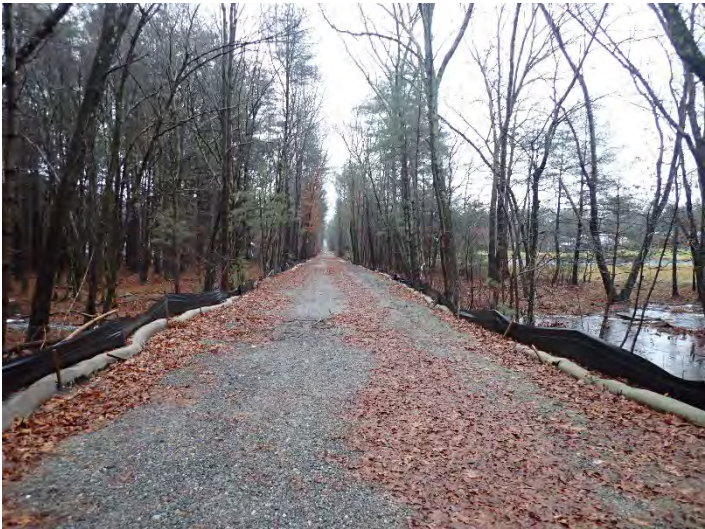
Epsilon ASSOCIATES INC.		PHOTOGRAPHIC LOG	
Client Name: Eversource		Site Location: Sudbury to Hudson Transmission Reliability Project	Town: Hudson
Photo No.: 5	Date: 12-11-2023

Description: View of Type B E&S controls in segment 4. Facing east.

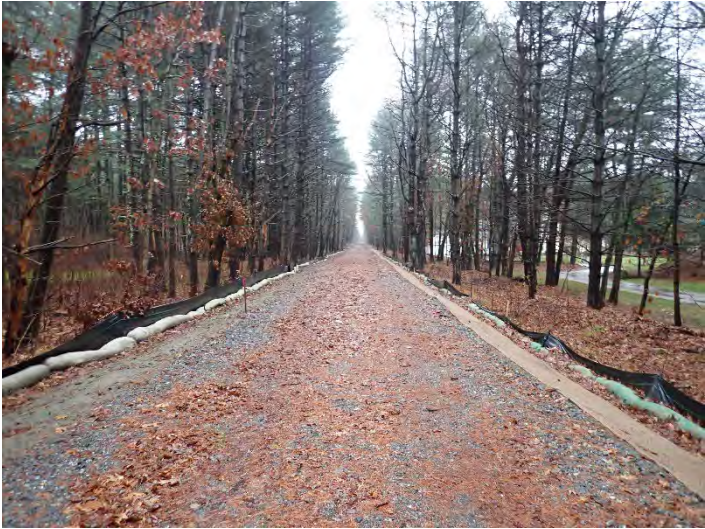
Epsilon ASSOCIATES INC.		PHOTOGRAPHIC LOG	
Client Name: Eversource		Site Location: Sudbury to Hudson Transmission Reliability Project	Town: Hudson
Photo No.: 6	Date: 12-11-2023

Description: View of Type B E&S controls in segment 5. Facing east.

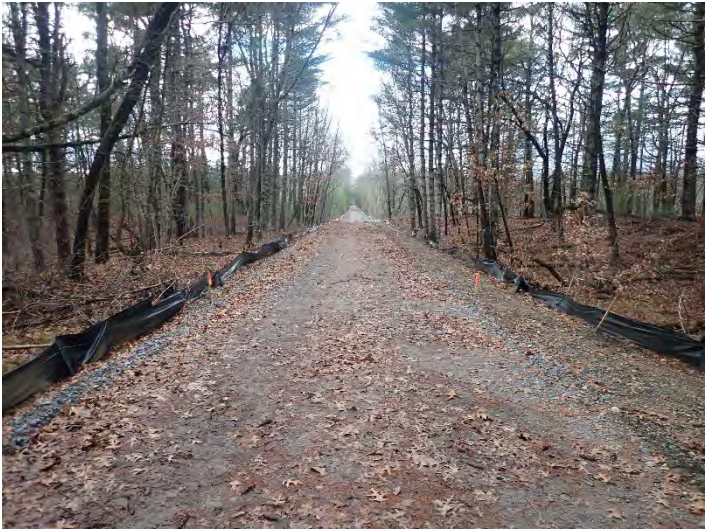
Epsilon ASSOCIATES INC.		PHOTOGRAPHIC LOG	
Client Name: Eversource		Site Location: Sudbury to Hudson Transmission Reliability Project	Town: Hudson/Sudbury
Photo No.: 7	Date: 12-11-2023

Description: View of E&S controls in segment 6. Facing west.

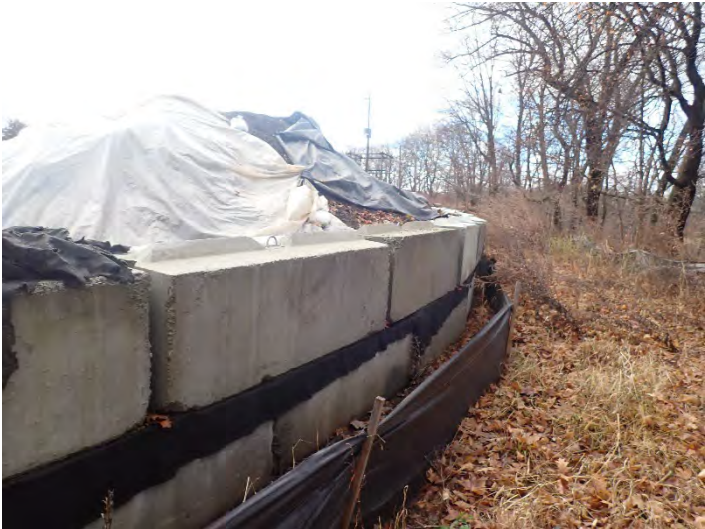
Epsilon ASSOCIATES INC.		PHOTOGRAPHIC LOG	
Client Name: Eversource		Site Location: Sudbury to Hudson Transmission Reliability Project	Town: Hudson
Photo No.: 8	Date: 12-11-2023

Description: View of silt fence at Stowe Ct laydown yard. Facing west.

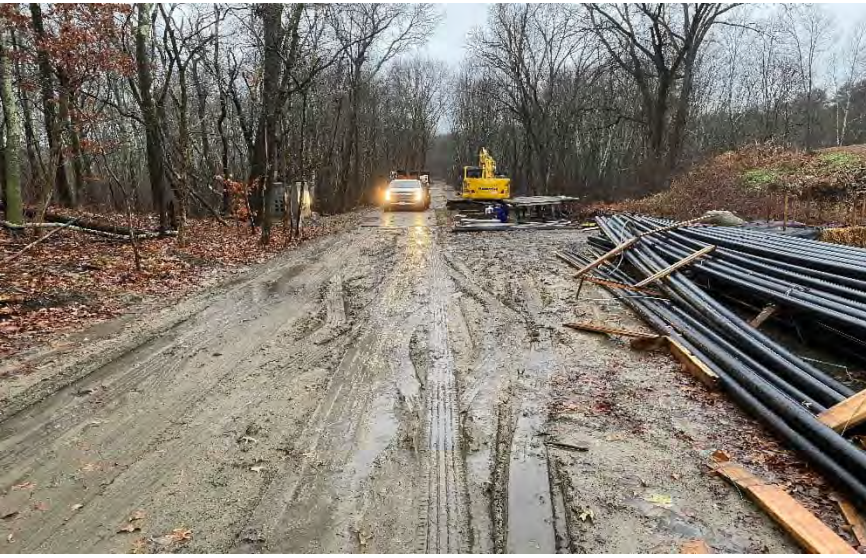
PHOTOGRAPHIC LOG	
Client Name: Eversource		Site Location: Sudbury to Hudson Transmission Reliability Project	Town: Sudbury
Photo No.: 4	Date: 12-11-23

Description: Work area within segment 14, equipment repair work, looking westward.

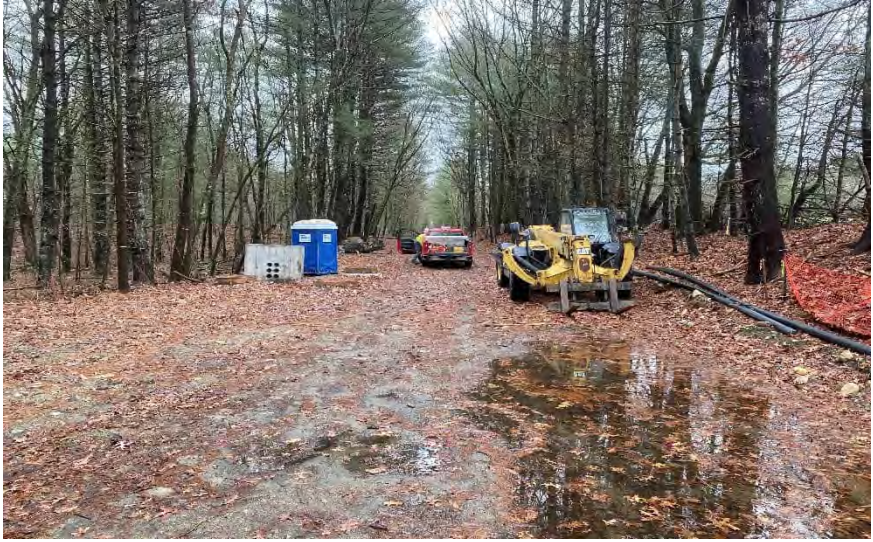
PHOTOGRAPHIC LOG	
Client Name: Eversource		Site Location: Sudbury to Hudson Transmission Reliability Project	Town: Sudbury
Photo No.: 5	Date: 12-11-23

Description: Work area, survey work, within segment 8, looking eastward.

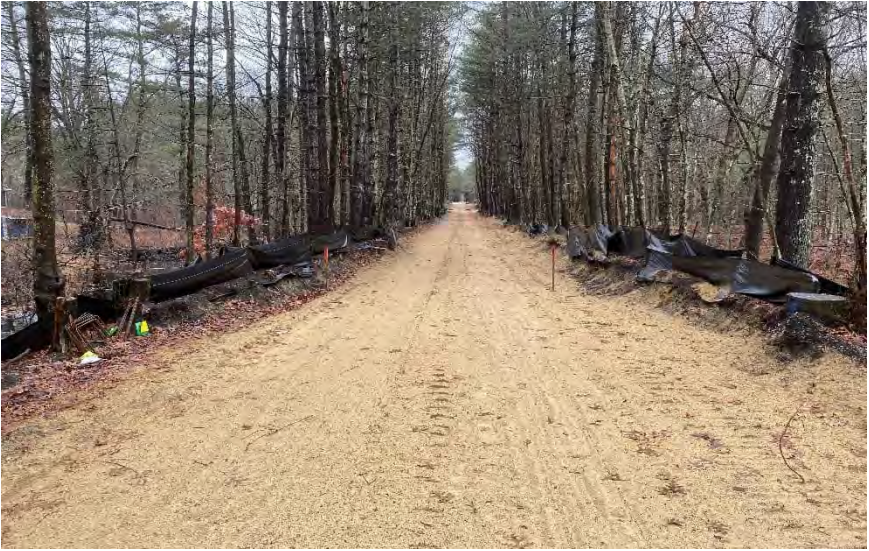
PHOTOGRAPHIC LOG	
Client Name: Eversource		Site Location: Sudbury to Hudson Transmission Reliability Project	Town: Sudbury
Photo No.: 7	Date: 12-11-23

Description: Work area within segment 9, over Dudley Brook culvert, existing erosion control, looking eastward.

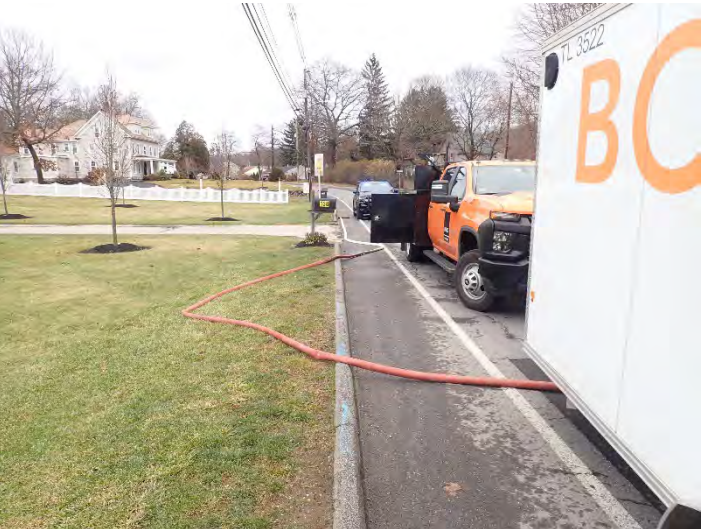
PHOTOGRAPHIC LOG		
Client Name: Eversource		Site Location: Sudbury to Hudson Transmission Reliability Project		Town: Hudson
Photo No.: 2	Date: 12/11/2023

Description: View of water pumping along Forest Avenue. Facing northeast.

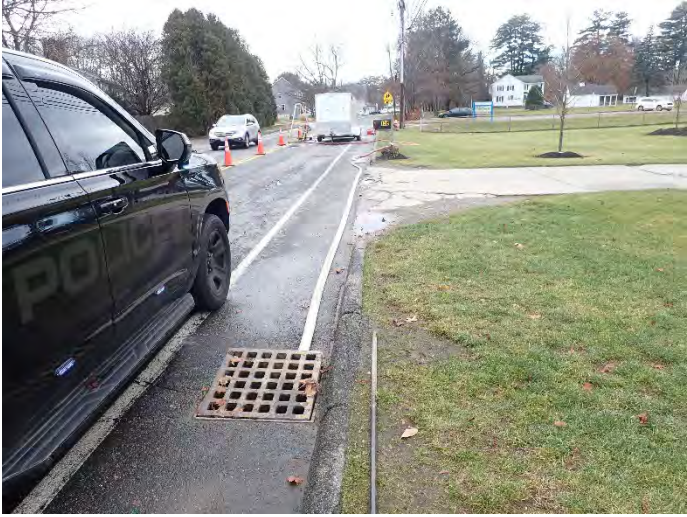
PHOTOGRAPHIC LOG	
Client Name: Eversource		Site Location: Sudbury to Hudson Transmission Reliability Project	
		Town: Hudson	
Photo No.: 3	Date: 12/11/2023

Description: View of dewatering directed into the catch basin per Hudson DPW request. Facing southwest.

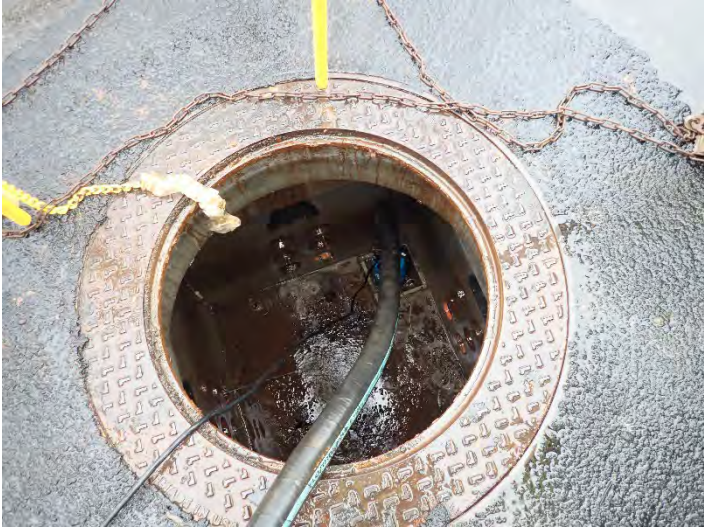
PHOTOGRAPHIC LOG	
Client Name: Eversource		Site Location: Sudbury to Hudson Transmission Reliability Project	Town: Hudson
Photo No.: 1	Date: 12/11/2023

Description: View of water prior to treatment at MH#4. Water appeared turbid. Facing northeast.

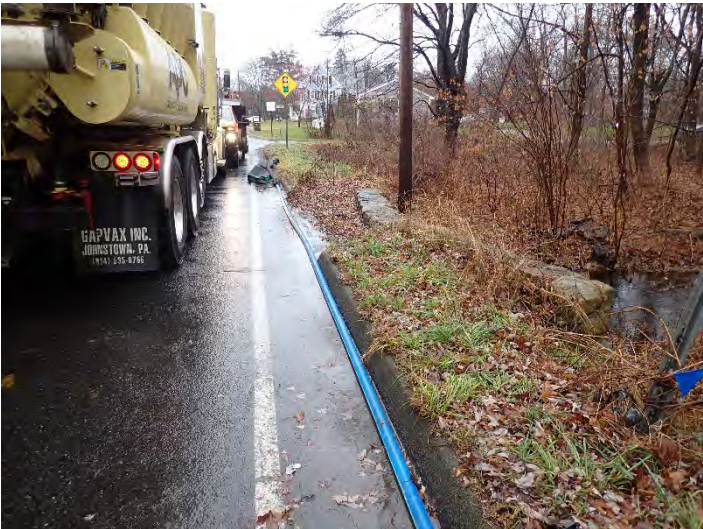
PHOTOGRAPHIC LOG	
Client Name: Eversource		Site Location: Sudbury to Hudson Transmission Reliability Project	Town: Hudson
Photo No.: 2	Date: 12/11/2023

Description: View of water pumping along Forest Avenue. Facing northeast.

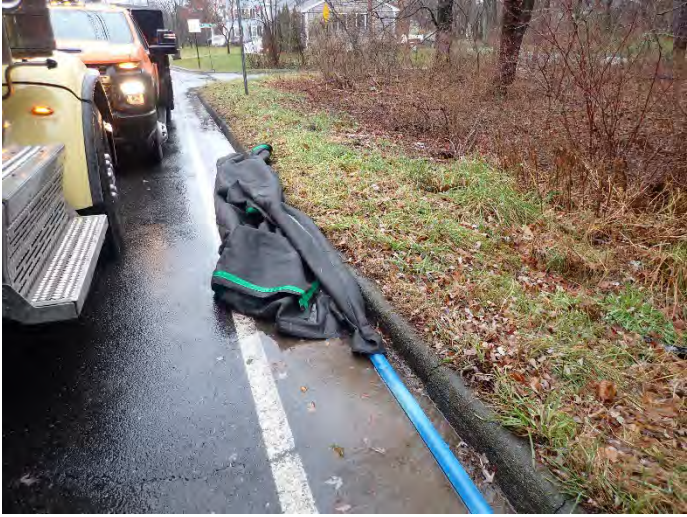
PHOTOGRAPHIC LOG	
Client Name: Eversource		Site Location: Sudbury to Hudson Transmission Reliability Project	
Town: Hudson			
Photo No.: 3	Date: 12/11/2023

Description: View of dewatering directed into a filter bag. Facing northeast.
