Weekly Environmental Compliance Summary

Sudbury to Hudson Transmission Reliability Project (USEPA Tracking # MAR1003UW)

Week of: December 11, 2023 to December 15, 2023

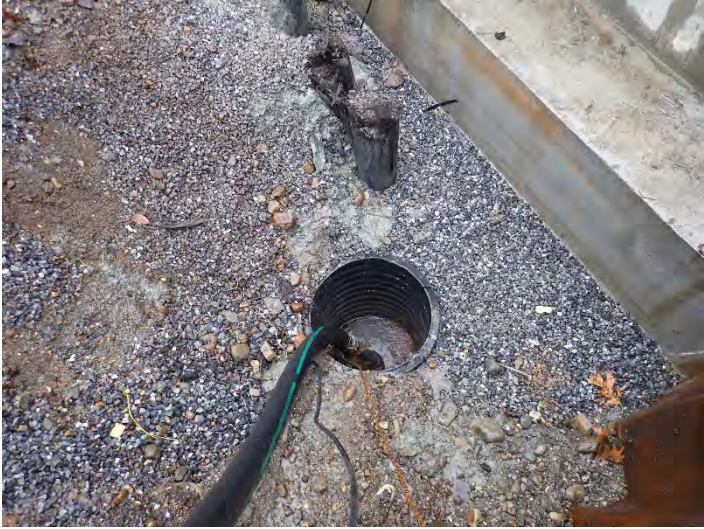
PHOTOGRAPHIC LOG	
Client Name: Eversource		Site Location: Sudbury to Hudson Transmission Reliability Project	Town: Hudson
Photo No.: 1	Date: 12/11/2023

Description: View of water prior to treatment at bridge 130 at eastern side of Fort Meadow Brook. Water appeared turbid. Facing east.

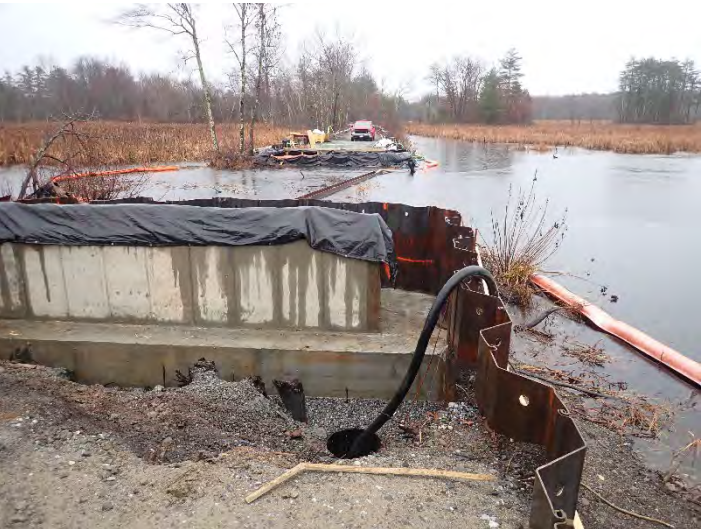
PHOTOGRAPHIC LOG	
Client Name: Eversource		Site Location: Sudbury to Hudson Transmission Reliability Project	Town: Hudson
Photo No.: 2	Date: 12/11/2023

Description: View of water pumping at eastern side of Fort Meadow Brook. Facing east.

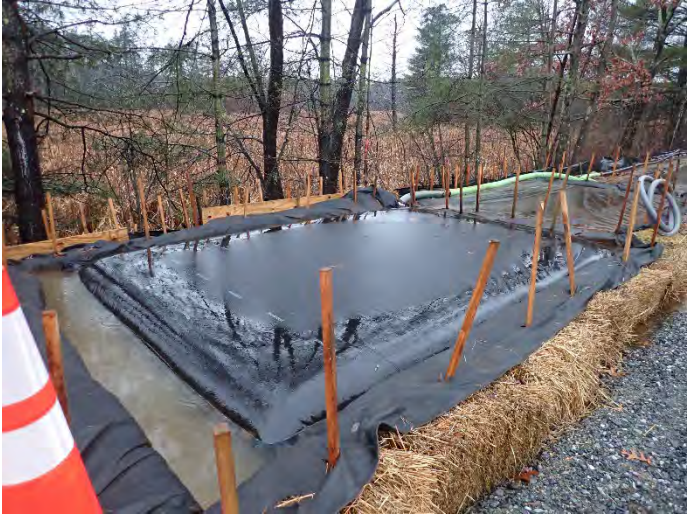
PHOTOGRAPHIC LOG	
Client Name: Eversource		Site Location: Sudbury to Hudson Transmission Reliability Project	Town: Hudson
Photo No.: 3	Date: 12/11/2023

Description: View of dewatering controls (straw bale corral with filter fabric, stone, and silt bag). Facing west.

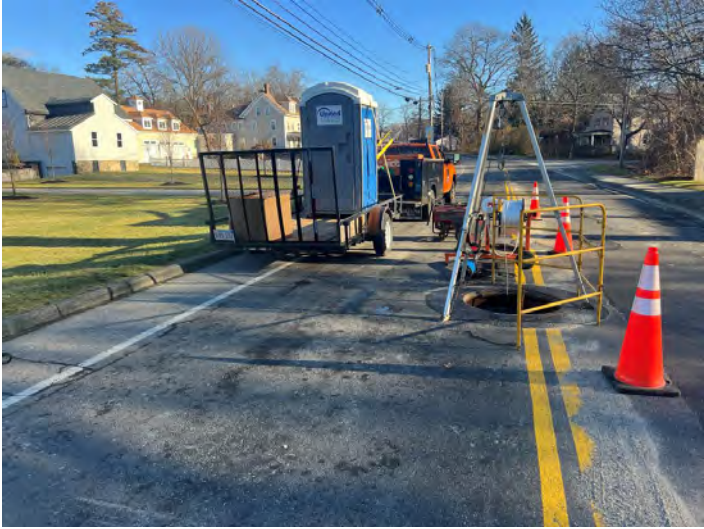
PHOTOGRAPHIC LOG	
Client Name: Eversource		Site Location: Sudbury to Hudson Transmission Reliability Project	Town: Hudson
Photo No.: 1	Date: 12/12/2023

Description: View of work area and pumping operation at Manhole 3 on Forest Avenue. Facing east.

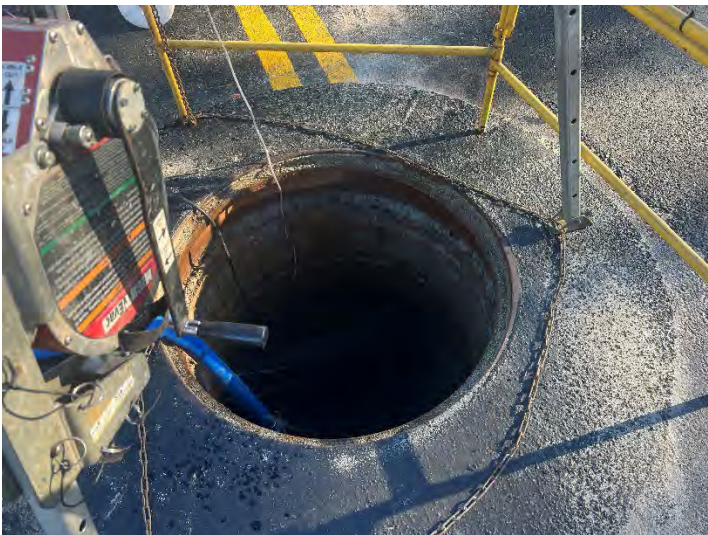
PHOTOGRAPHIC LOG	
Client Name: Eversource		Site Location: Sudbury to Hudson Transmission Reliability Project	Town: Hudson
Photo No.: 2	Date: 12/12/2023

Description: View of pump. Water appeared mostly clear prior to treatment. Facing east.

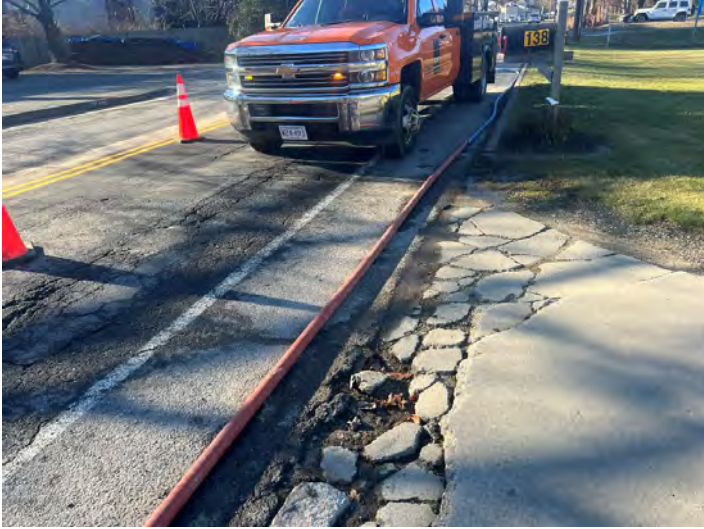
PHOTOGRAPHIC LOG		
Client Name: Eversource		Site Location: Sudbury to Hudson Transmission Reliability Project		Town: Hudson
Photo No.: 3	Date: 12/12/2023

Description: View of dewatering hose along the roadway. Facing south.

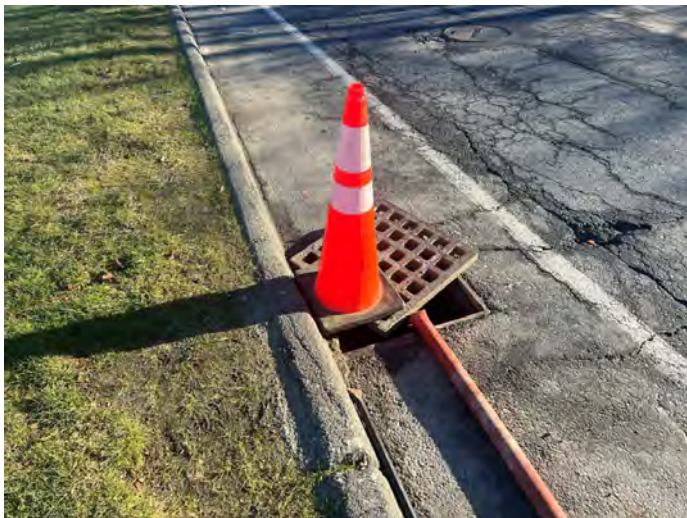
PHOTOGRAPHIC LOG		
Client Name: Eversource		Site Location: Sudbury to Hudson Transmission Reliability Project		Town: Hudson
Photo No.: 4	Date: 12/12/2023

Description: View of water being pumped into storm drain. Discharge appeared mostly clear. Turbidity reading was below 50 NTUs. Facing east.

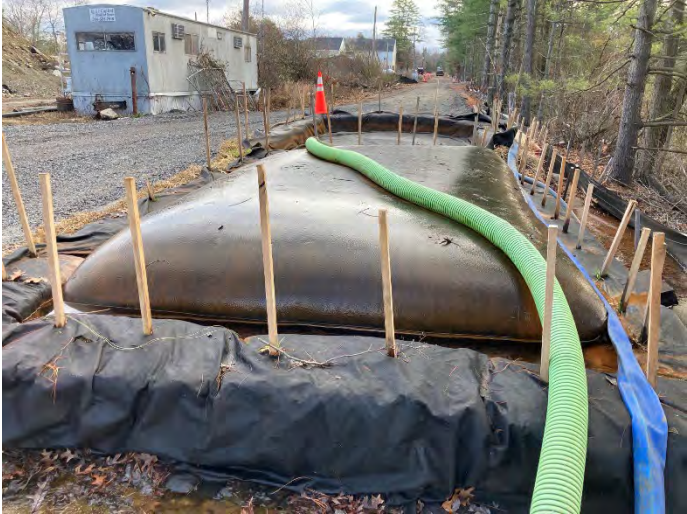
PHOTOGRAPHIC LOG	
Client Name: Eversource		Site Location: Sudbury to Hudson Transmission Reliability Project	Town: Hudson
Photo No.: 3	Date: 12/12/2023

Description: View of dewatering controls in segment 3 (straw bale corral with filter fabric, stone, and silt bag). Water from segment 2 is being routed to corral in segment 3. Frac tank is no longer in use. Facing east.

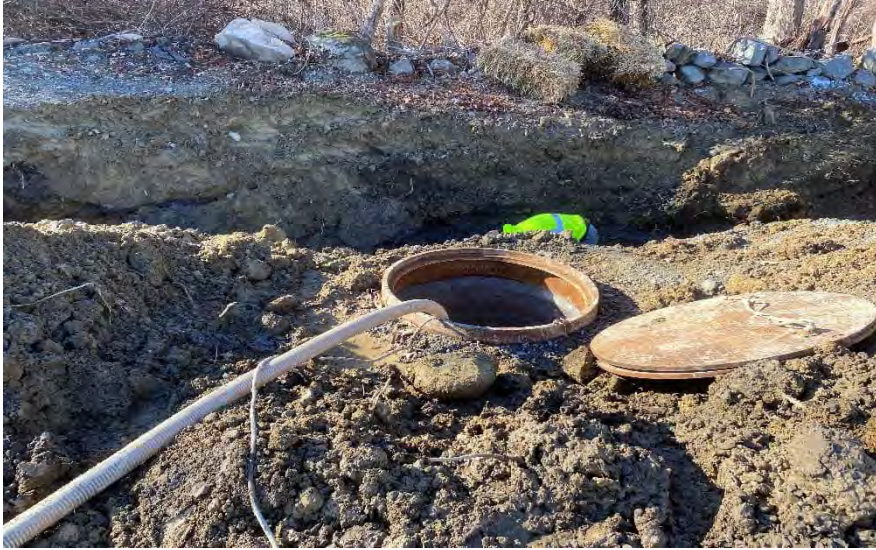
PHOTOGRAPHIC LOG	
Client Name: Eversource		Site Location: Sudbury to Hudson Transmission Reliability Project	Town: Sudbury
Photo No.: 1	Date: 12/12/2023

Description: View of area being pumped from manhole #28 outside substation.

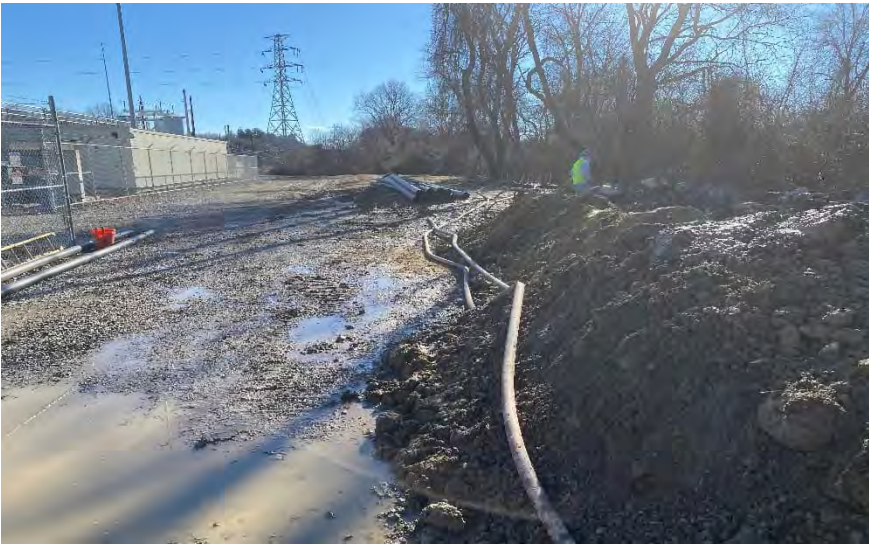
PHOTOGRAPHIC LOG	
Client Name: Eversource		Site Location: Sudbury to Hudson Transmission Reliability Project	Town: Sudbury
Photo No.: 3	Date: 12/12/2023

Description: Manhole #28. View of dewatering operation, looking southward.

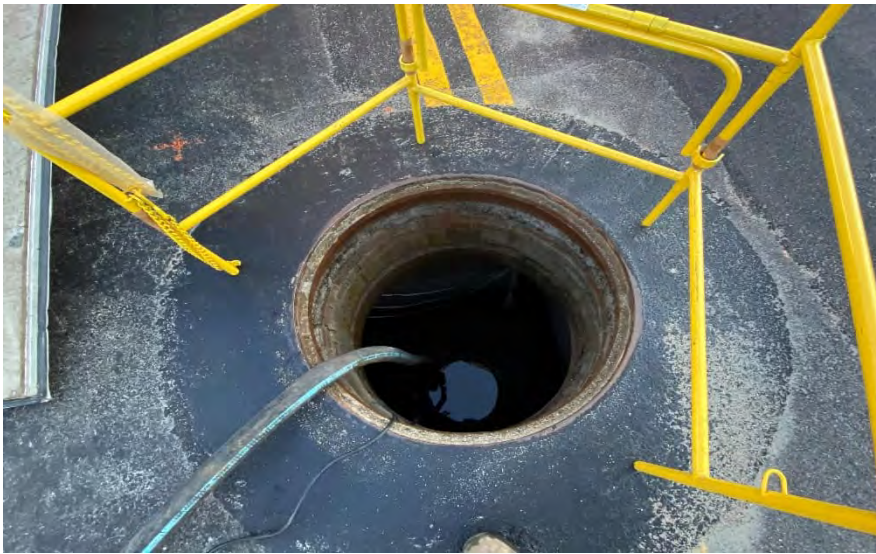
PHOTOGRAPHIC LOG	
Client Name: Eversource		Site Location: Sudbury to Hudson Transmission Reliability Project	Town: Hudson
Photo No.: 1	Date: 12/13/2023

Description: View of area being pumped at manhole #3.

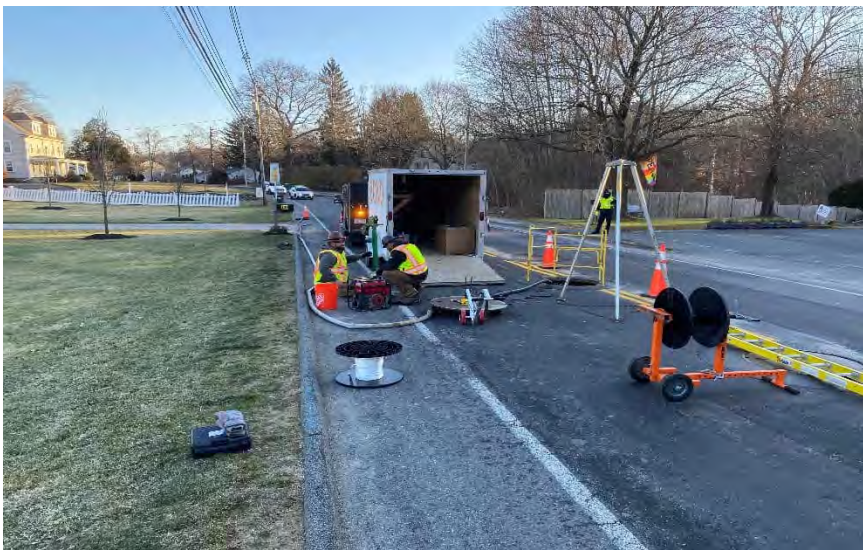
PHOTOGRAPHIC LOG	
Client Name: Eversource		Site Location: Sudbury to Hudson Transmission Reliability Project	Town: Hudson
Photo No.: 2	Date: 12/13/2023

Description: View of pumping operation within Forest Avenue at manhole #3, looking northward.

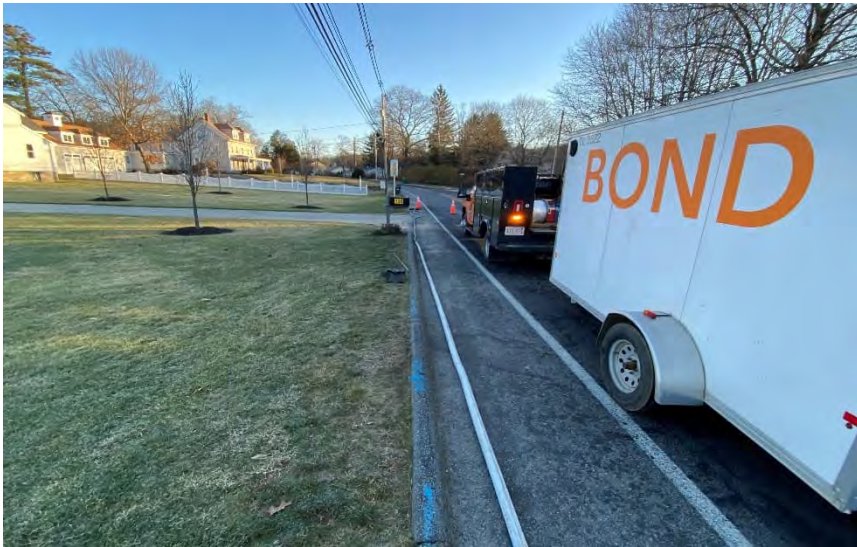
PHOTOGRAPHIC LOG	
Client Name: Eversource		Site Location: Sudbury to Hudson Transmission Reliability Project	
Town: Hudson			
Photo No.: 3	Date: 12/13/2023

Description: Manhole #3. View of discharge dewatering operation, looking northward.

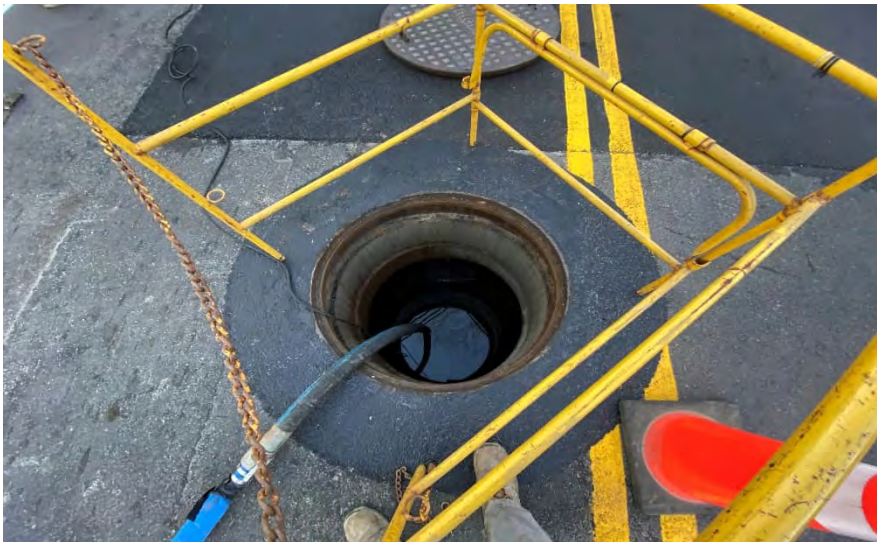
PHOTOGRAPHIC LOG	
Client Name: Eversource		Site Location: Sudbury to Hudson Transmission Reliability Project	Town: Hudson
Photo No.: 1	Date: 12/13/2023

Description: View of area being pumped at manhole #4.

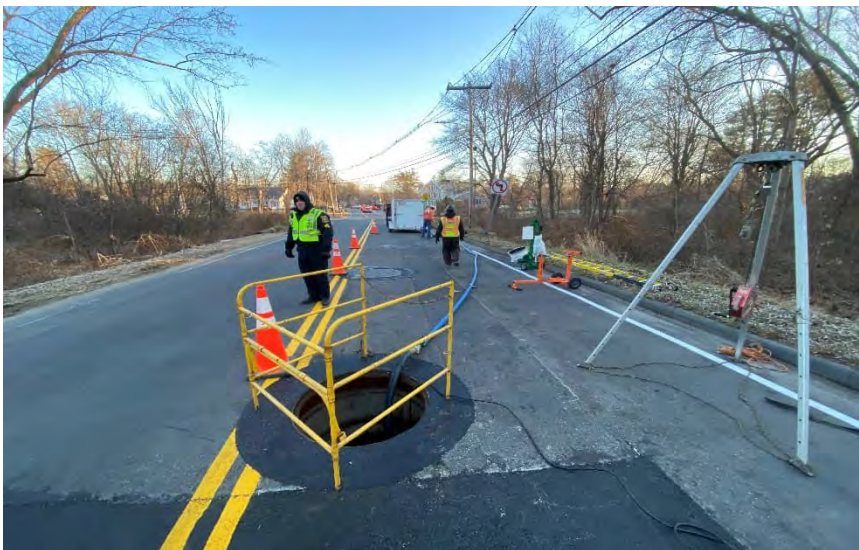
PHOTOGRAPHIC LOG	
Client Name: Eversource		Site Location: Sudbury to Hudson Transmission Reliability Project	Town: Hudson
Photo No.: 2	Date: 12/13/2023

Description: View of pumping operation within Forest Avenue at manhole #4, looking northward.

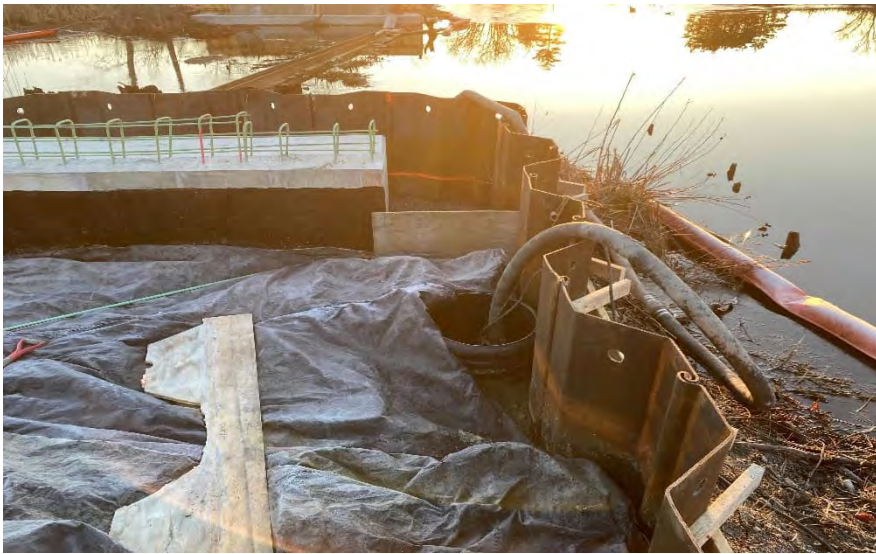
PHOTOGRAPHIC LOG	
Client Name: Eversource		Site Location: Sudbury to Hudson Transmission Reliability Project	Town: Hudson
Photo No.: 1	Date: 12/13/2023

Description: View of area being pumped (i.e., cofferdam within segment 2 off Fort Meadow Brook), looking eastward.

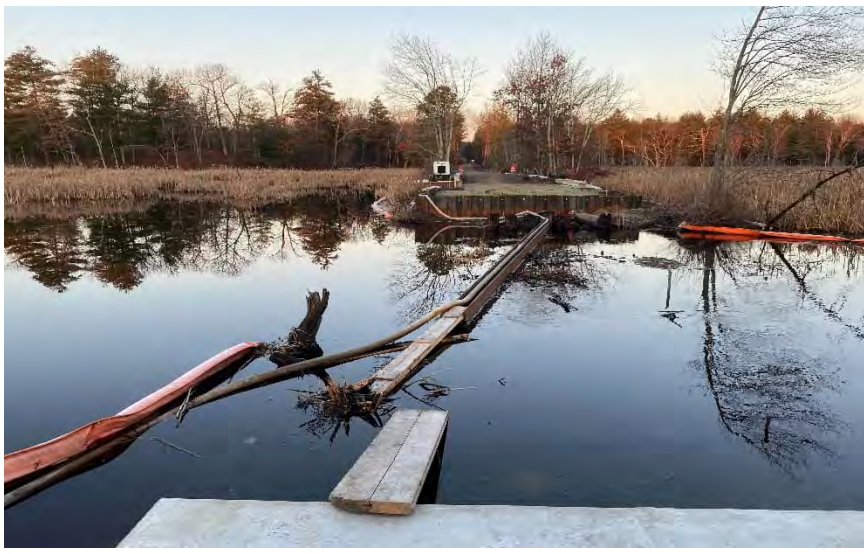
PHOTOGRAPHIC LOG	
Client Name: Eversource		Site Location: Sudbury to Hudson Transmission Reliability Project	Town: Hudson
Photo No.: 2	Date: 12/13/2023

Description: View of dewatering operation across Fort Meadow Brook, discharge hose within H-piling from segment 3 toward segment 2, looking westward.

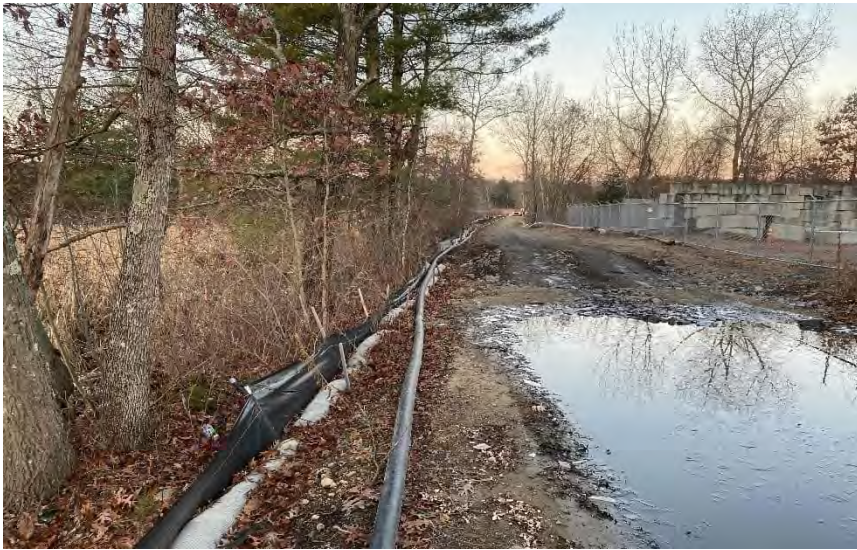
PHOTOGRAPHIC LOG	
Client Name: Eversource		Site Location: Sudbury to Hudson Transmission Reliability Project	
Town: Hudson			
Photo No.: 3	Date: 12/13/2023

Description: Segment 3. View of discharge dewatering operation, looking eastward.

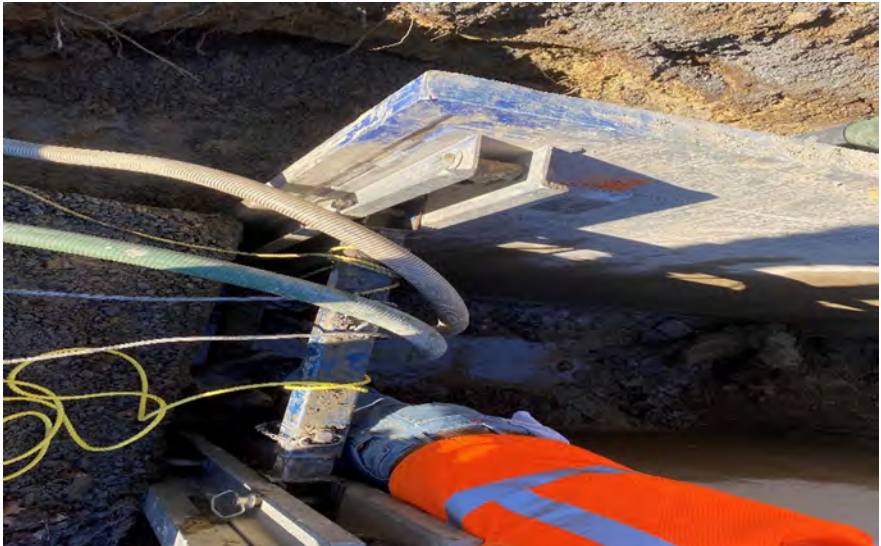
PHOTOGRAPHIC LOG	
Client Name: Eversource		Site Location: Sudbury to Hudson Transmission Reliability Project	Town: Sudbury
Photo No.: 1	Date: 12/13/2023

Description: View of area being pumped from manhole #28 outside substation.

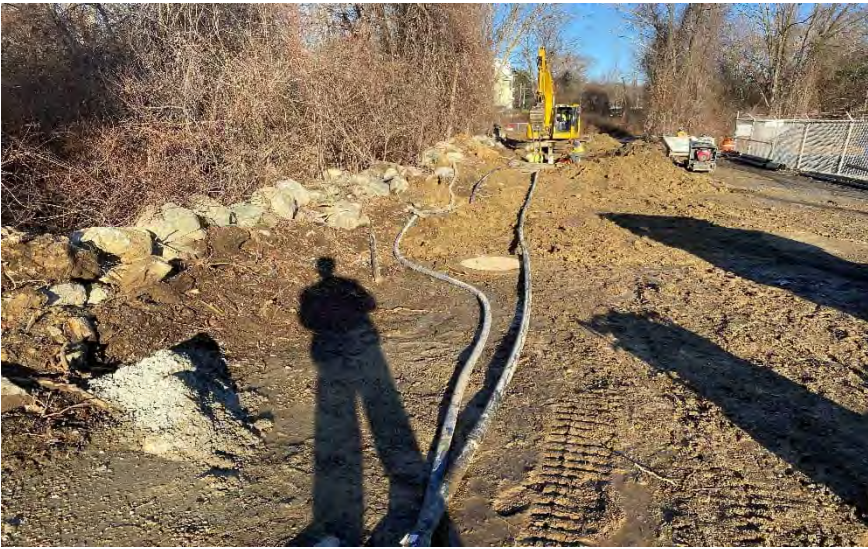
PHOTOGRAPHIC LOG	
Client Name: Eversource		Site Location: Sudbury to Hudson Transmission Reliability Project	Town: Sudbury
Photo No.: 3	Date: 12/13/2023

Description: Manhole #28. View of dewatering operation, looking northward.

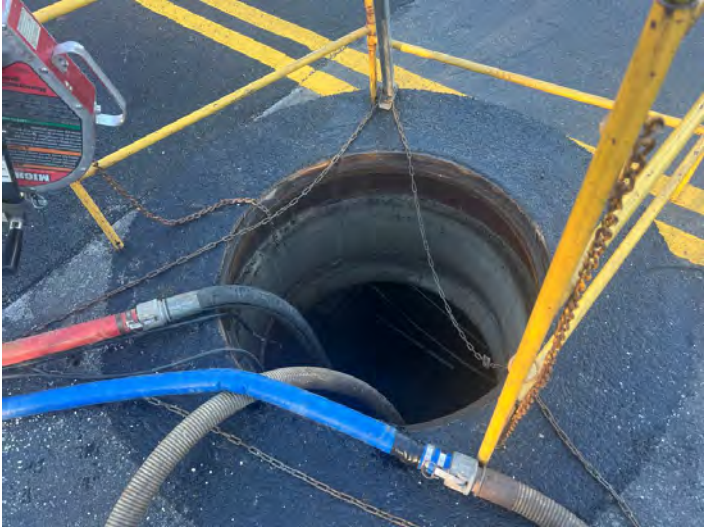
PHOTOGRAPHIC LOG		
Client Name: Eversource		Site Location: Sudbury to Hudson Transmission Reliability Project		Town: Hudson
Photo No.: 1	Date: 12/14/2023

Description: View of work area and pumping operation at Manhole 4 on Forest Avenue. Water appeared mostly clear prior to treatment. Facing north.

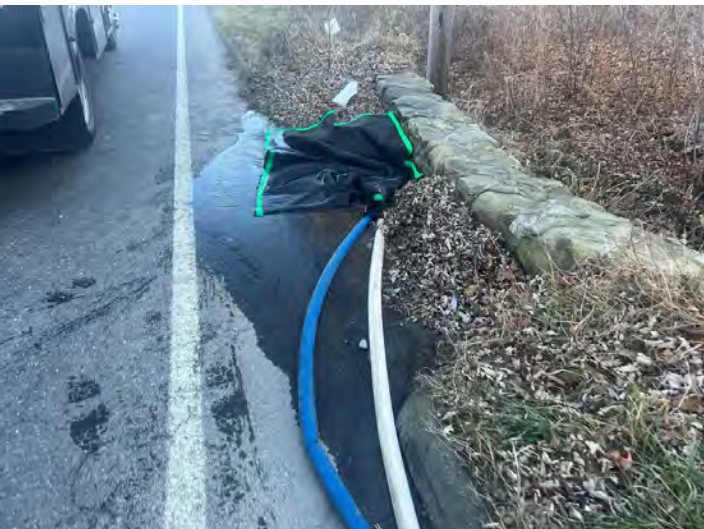
PHOTOGRAPHIC LOG		
Client Name: Eversource		Site Location: Sudbury to Hudson Transmission Reliability Project		Town: Hudson
Photo No.: 2	Date: 12/14/2023

Description: Water was pumped into a filter bag. Facing east.

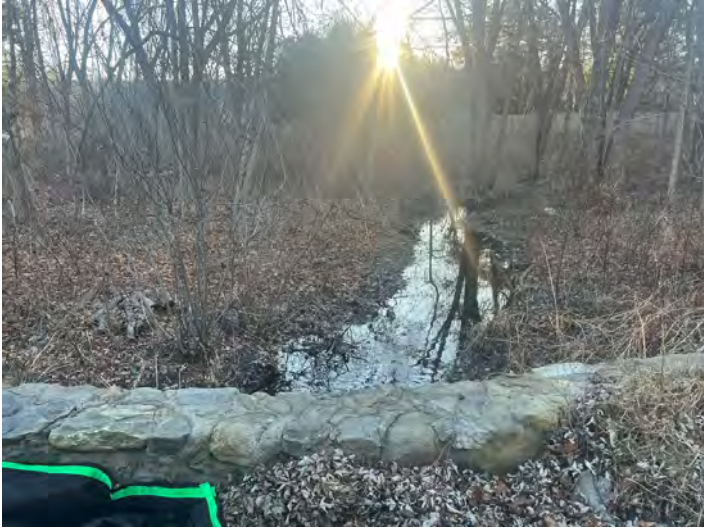
PHOTOGRAPHIC LOG	
Client Name: Eversource		Site Location: Sudbury to Hudson Transmission Reliability Project	
		Town: Hudson	
Photo No.: 3	Date: 12/14/2023

Description: View of discharge point. Filtered water was being discharged into a nearby stream. Discharge appeared clear. Turbidity reading was below 50 NTUs. Facing south.

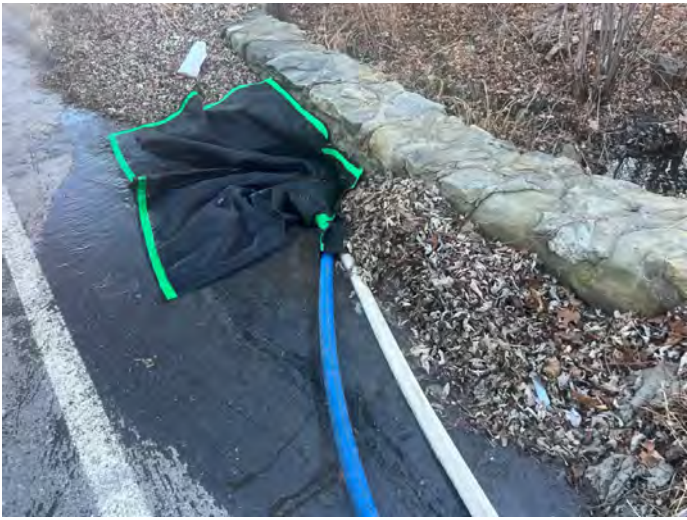
PHOTOGRAPHIC LOG	
Client Name: Eversource		Site Location: Sudbury to Hudson Transmission Reliability Project	
		Town: Hudson	
Photo No.: 4	Date: 12/14/2023

Description: View of storm drain water was being pumped towards. Discharge appeared clear. Facing east.

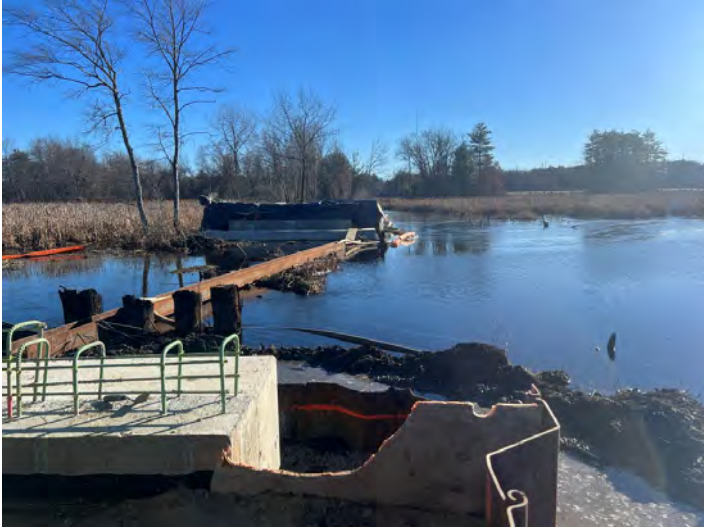
PHOTOGRAPHIC LOG	
Client Name: Eversource		Site Location: Sudbury to Hudson Transmission Reliability Project	Town: Hudson
Photo No.: 1	Date: 12/14/2023

Description: View of work area and pumping operation at bridge 130 in segment 2. Facing east.

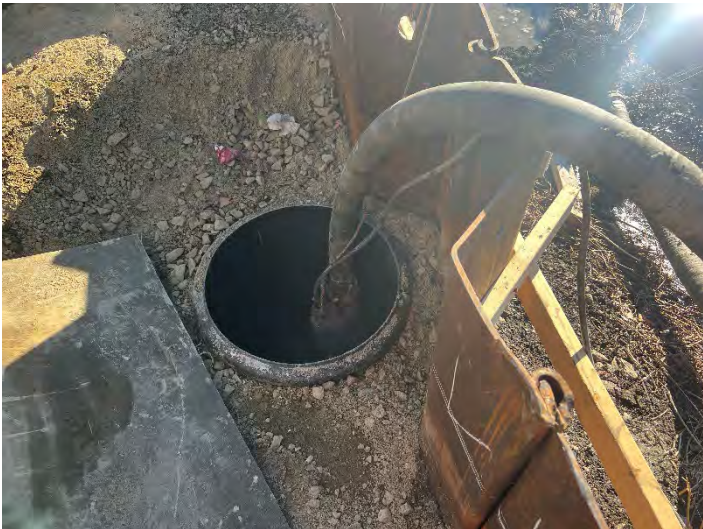
PHOTOGRAPHIC LOG	
Client Name: Eversource		Site Location: Sudbury to Hudson Transmission Reliability Project	Town: Hudson
Photo No.: 2	Date: 12/14/2023

Description: View of pump. Water appeared mostly clear prior to treatment. Facing east.

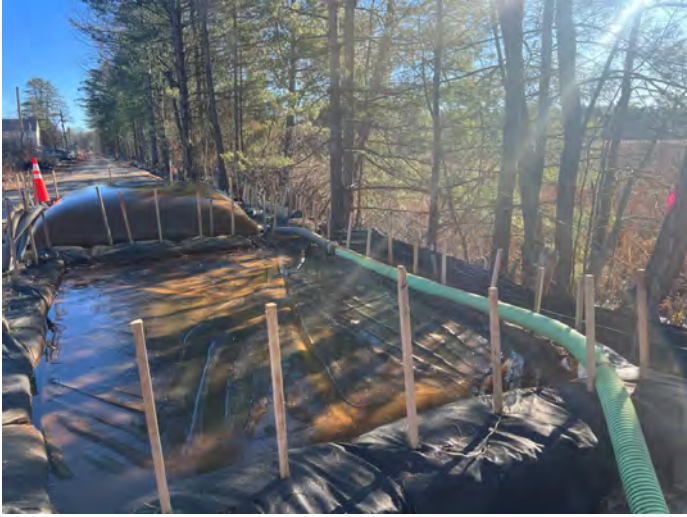
PHOTOGRAPHIC LOG		
Client Name: Eversource		Site Location: Sudbury to Hudson Transmission Reliability Project		Town: Hudson
Photo No.: 3	Date: 12/14/2023

Description: View of dewatering controls in segment 3 (straw bale corral with filter fabric, stone, and silt bag). Water from segment 2 is being routed to corral in segment 3. Frac tank was removed. Facing east.

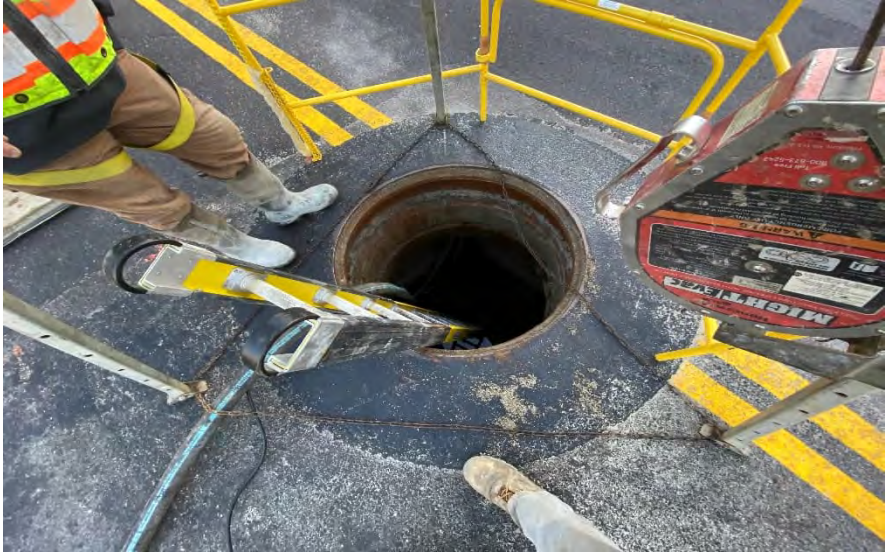
PHOTOGRAPHIC LOG	
Client Name: Eversource		Site Location: Sudbury to Hudson Transmission Reliability Project	Town: Hudson
Photo No.: 1	Date: 12/15/2023

Description: View of area being pumped at manhole #3.

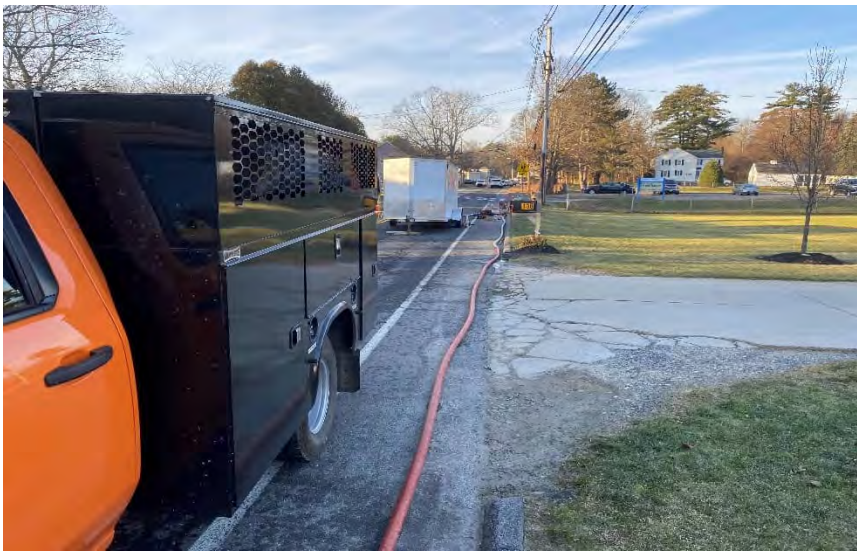
PHOTOGRAPHIC LOG	
Client Name: Eversource		Site Location: Sudbury to Hudson Transmission Reliability Project	
Town: Hudson			
Photo No.: 3	Date: 12/15/2023

Description: Manhole #3. View of discharge dewatering operation, looking southward.

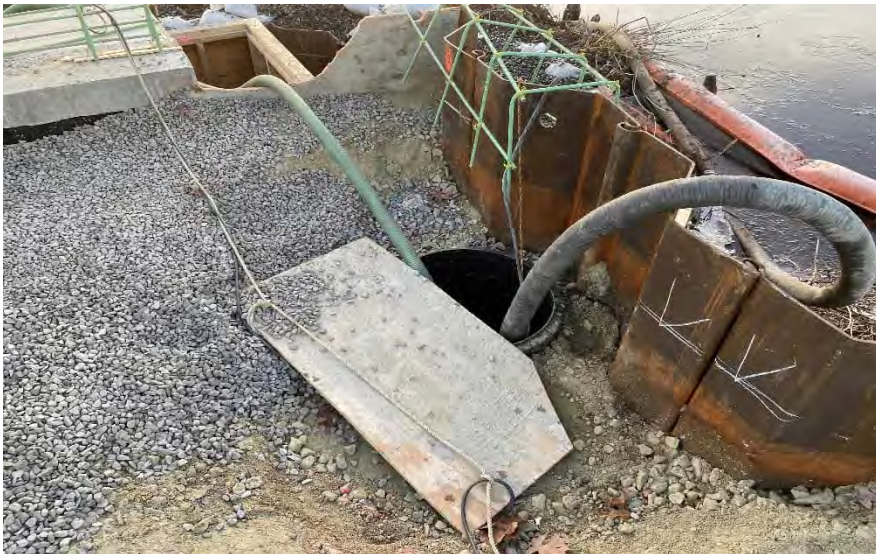
PHOTOGRAPHIC LOG	
Client Name: Eversource		Site Location: Sudbury to Hudson Transmission Reliability Project	Town: Hudson
Photo No.: 1	Date: 12/15/2023

Description: View of area being pumped (i.e., cofferdam within segment 2 off Fort Meadow Brook), looking eastward.

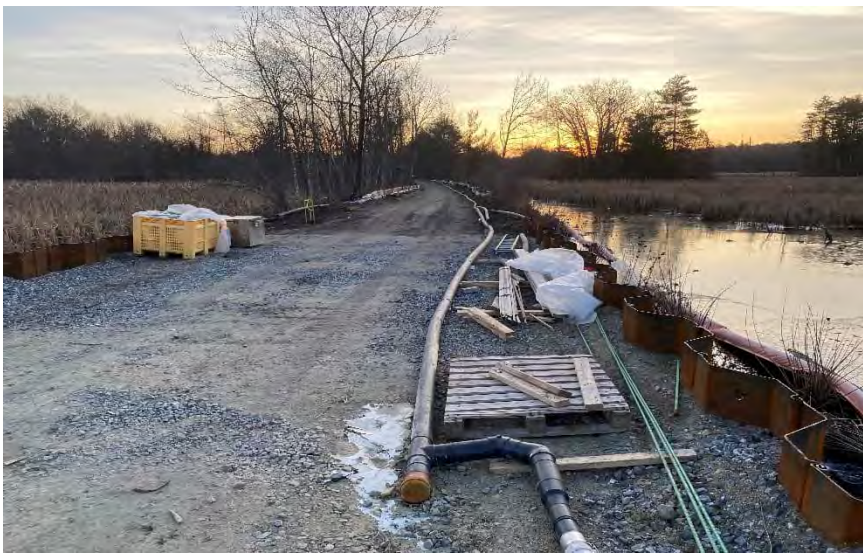
PHOTOGRAPHIC LOG	
Client Name: Eversource		Site Location: Sudbury to Hudson Transmission Reliability Project	Town: Hudson
Photo No.: 2	Date: 12/15/2023

Description: Segment 3. View of discharge dewatering operation, looking eastward.

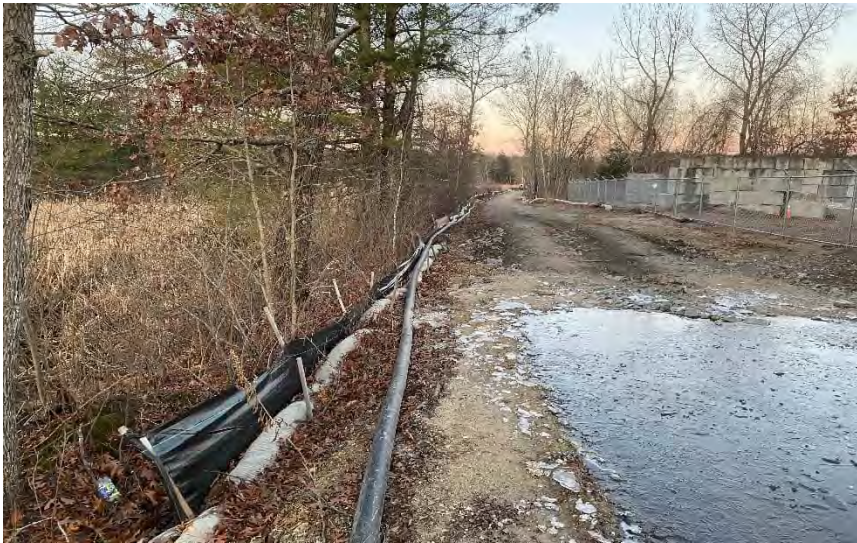
PHOTOGRAPHIC LOG	
Client Name: Eversource		Site Location: Sudbury to Hudson Transmission Reliability Project	Town: Hudson
Photo No.: 3	Date: 12/15/2023

Description: Segment 3. View of discharge dewatering operation, looking westward.
