Weekly Environmental Compliance Summary

Sudbury to Hudson Transmission Reliability Project (USEPA Tracking # MAR1003UW)

Week of: January 8, 2024 to January 12, 2024

**CONSTRUCTION MONITORING REPORT
Sudbury to Hudson Transmission Project**

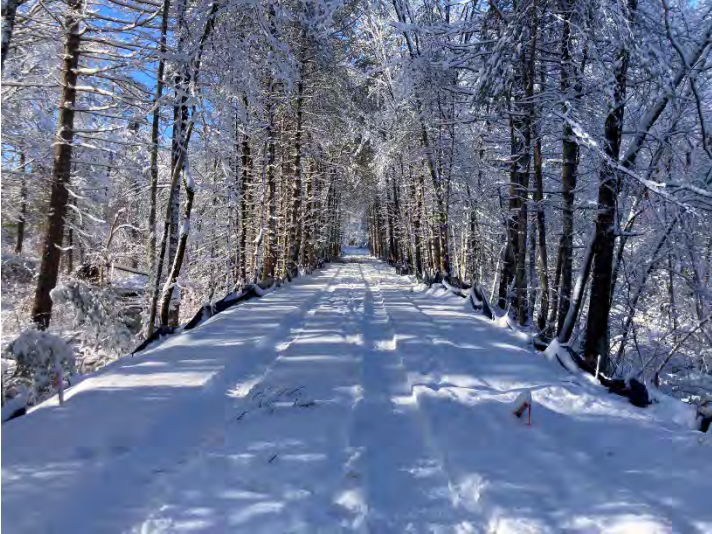
PHOTOGRAPHIC LOG	
Client Name: Eversource		Site Location: Sudbury to Hudson Transmission Reliability Project	Town: Sudbury
Photo No.: 3	Date: 1/08/2024

Description: View of segment 10. Facing west.

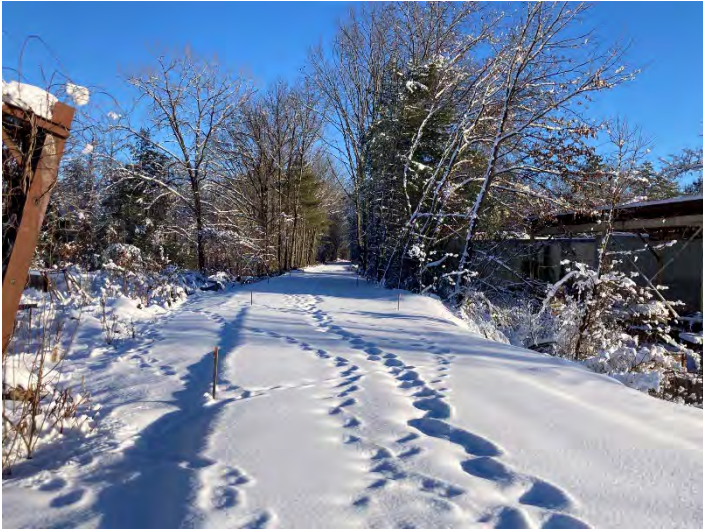
PHOTOGRAPHIC LOG	
Client Name: Eversource		Site Location: Sudbury to Hudson Transmission Reliability Project	Town: Hudson
Photo No.: 5	Date: 1/08/2024

Description: View of segment 3. Facing east.

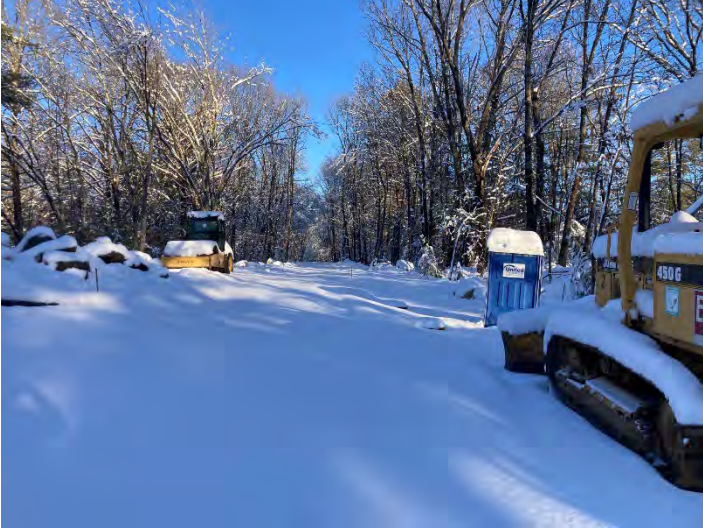
PHOTOGRAPHIC LOG	
Client Name: Eversource		Site Location: Sudbury to Hudson Transmission Reliability Project	Town: Hudson
Photo No.: 6	Date: 1/08/2024

Description: View of segment 1 from entrance at Wilkins St. Facing east.

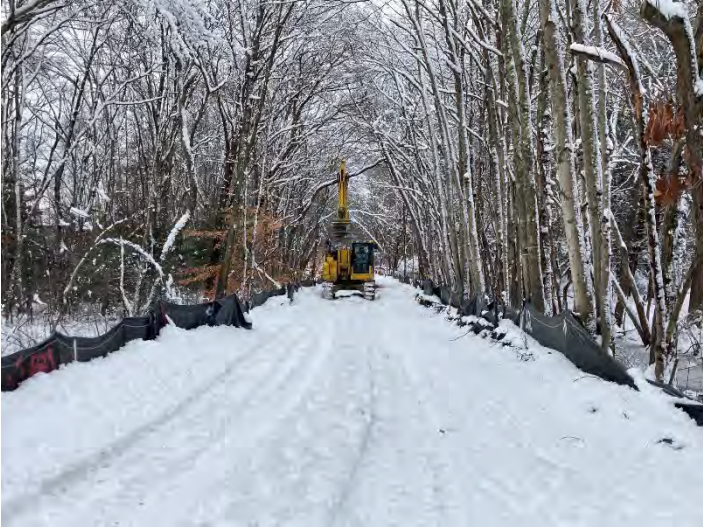
<p>PHOTOGRAPHIC LOG</p>	
<p>Client Name: Eversource</p>		<p>Site Location: Sudbury to Hudson Transmission Reliability Project</p>	<p>Town: Sudbury</p>
<p>Photo No.: 1</p>	<p>Date: 1/09/2024</p>

<p>Description: View of Bond performing storm clean up and snow removal in segment 14. Facing west.</p>

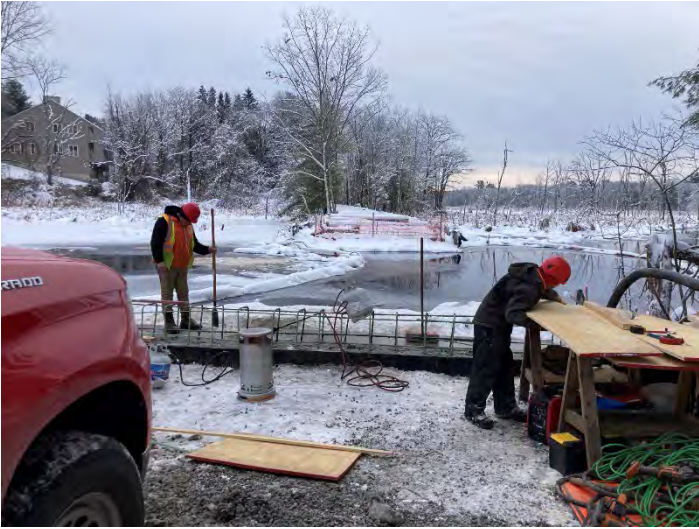
<p>PHOTOGRAPHIC LOG</p>	
<p>Client Name: Eversource</p>		<p>Site Location: Sudbury to Hudson Transmission Reliability Project</p>	<p>Town: Sudbury</p>
<p>Photo No.: 2</p>	<p>Date: 1/09/2024</p>

<p>Description: View of ET&L working at Bridge 127 in segment 13. Facing east.</p>

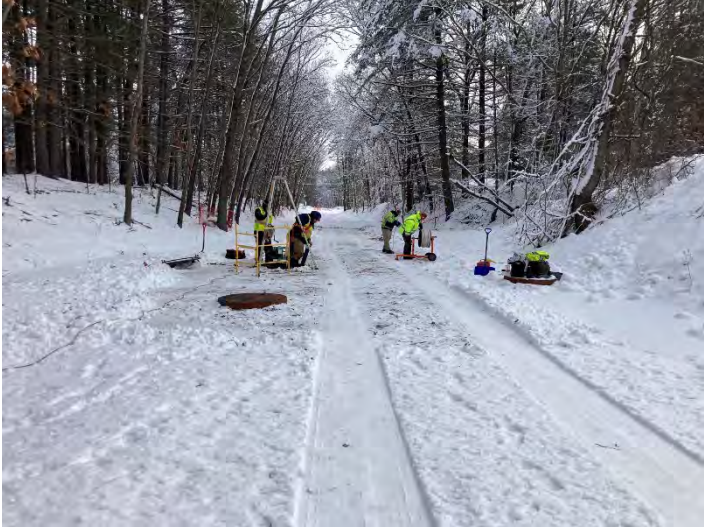
PHOTOGRAPHIC LOG	
Client Name: Eversource		Site Location: Sudbury to Hudson Transmission Reliability Project	Town: Hudson
Photo No.: 5	Date: 1/09/2024

Description: View of Bond duct proofing in segment 3. Facing east.

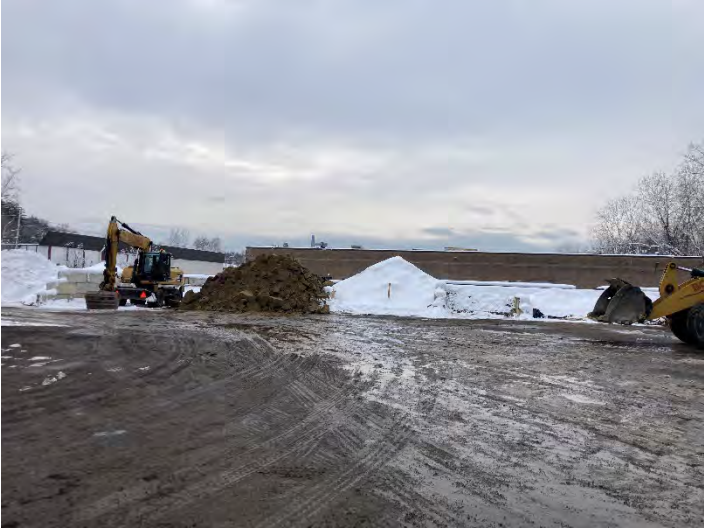
PHOTOGRAPHIC LOG	
Client Name: Eversource		Site Location: Sudbury to Hudson Transmission Reliability Project	Town: Hudson
Photo No.: 6	Date: 1/09/2024

Description: View of Bonazzoli laydown yard. Facing southwest.

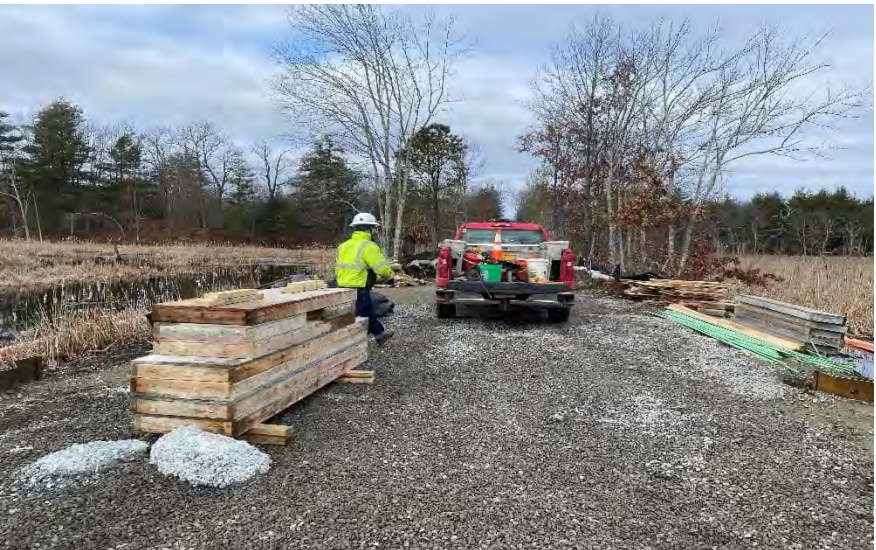
<p>PHOTOGRAPHIC LOG</p>	
<p>Client Name: Eversource</p>		<p>Site Location: Sudbury to Hudson Transmission Reliability Project</p>	<p>Town: Hudson</p>
<p>Photo No.: 2</p>	<p>Date: 1-11-24</p>

<p>Description:</p> <p>ET&L conducting cleanup work within segment 2 at Bridge 130, looking westward.</p>

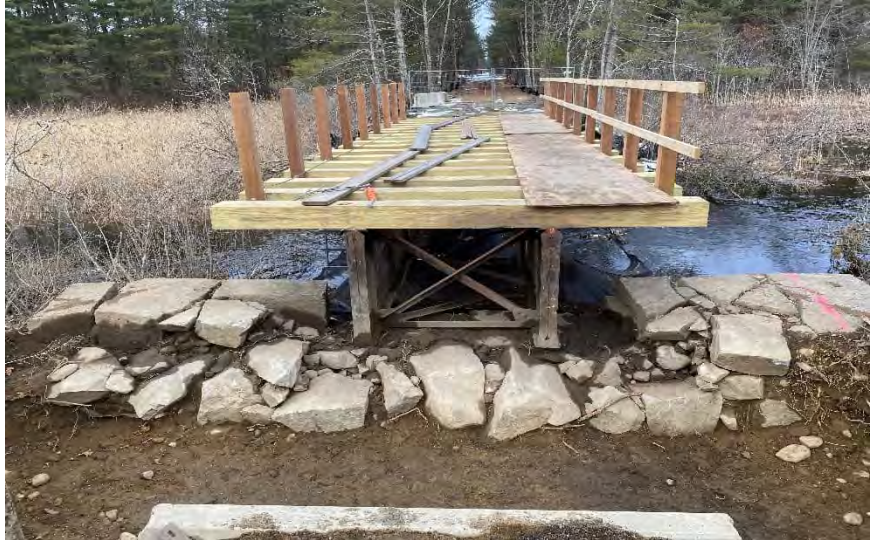
<p>PHOTOGRAPHIC LOG</p>	
<p>Client Name: Eversource</p>		<p>Site Location: Sudbury to Hudson Transmission Reliability Project</p>	<p>Town: Sudbury</p>
<p>Photo No.: 6</p>	<p>Date: 1-11-24</p>

<p>Description:</p> <p>Work area within segment 8, bridge 128, looking westward.</p>

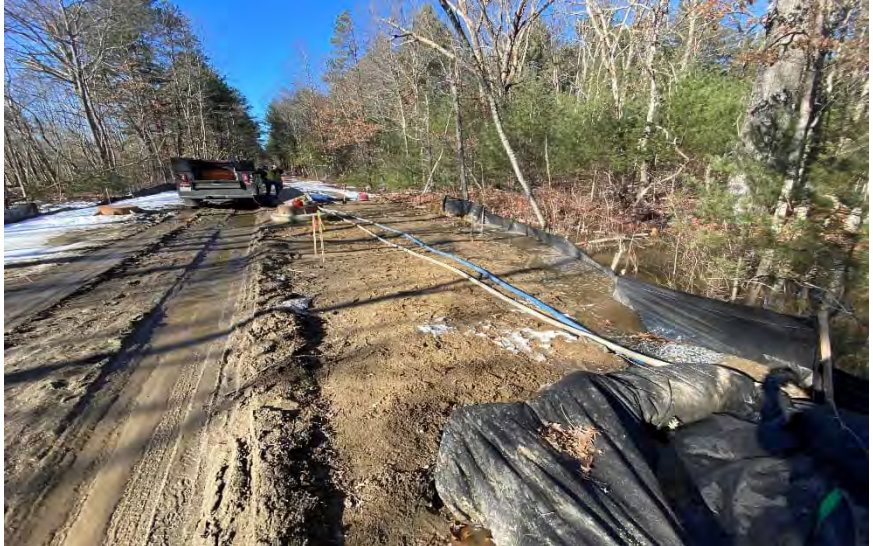
<p>PHOTOGRAPHIC LOG</p>	
<p>Client Name: Eversource</p>		<p>Site Location: Sudbury to Hudson Transmission Reliability Project</p>	<p>Town: Hudson</p>
<p>Photo No.: 2</p>	<p>Date: 1-12-24</p>

<p>Description:</p> <p>Bond conducting proofing work within segment 6 at manhole #14, looking westward.</p>

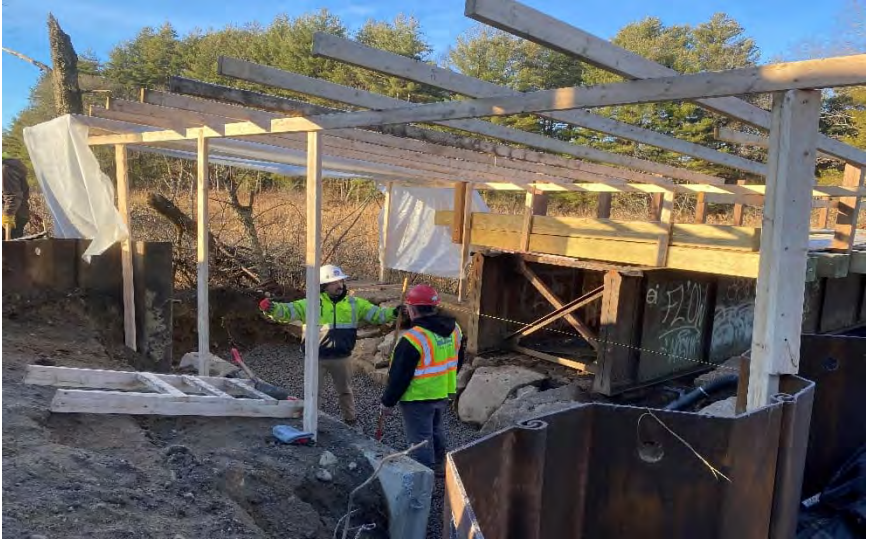
<p>PHOTOGRAPHIC LOG</p>	
<p>Client Name: Eversource</p>		<p>Site Location: Sudbury to Hudson Transmission Reliability Project</p>	<p>Town: Sudbury</p>
<p>Photo No.: 6</p>	<p>Date: 1-12-24</p>

<p>Description:</p> <p>Work area within segment 8, bridge 128 work, looking southward.</p>

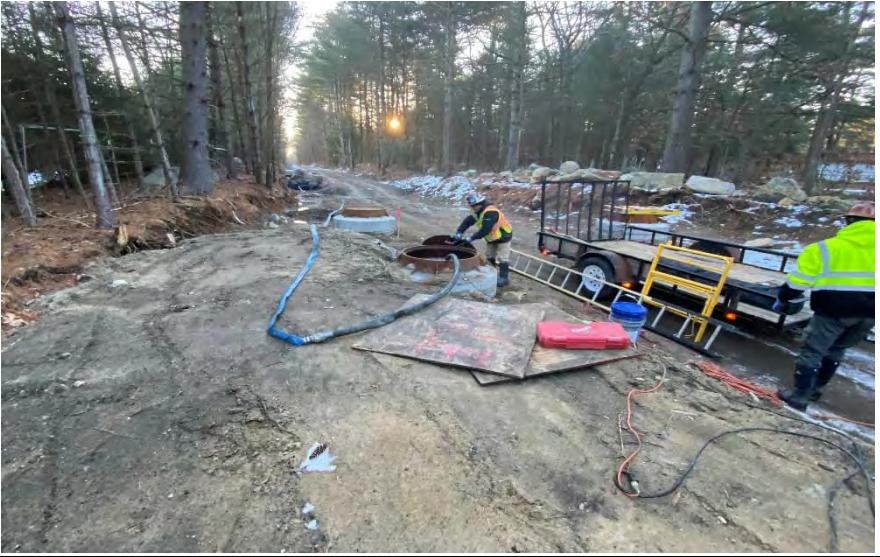
<p>PHOTOGRAPHIC LOG</p>	
<p>Client Name: Eversource</p>		<p>Site Location: Sudbury to Hudson Transmission Reliability Project</p>	<p>Town: Sudbury</p>
<p>Photo No.: 7</p>	<p>Date: 1-12-24</p>

<p>Description:</p> <p>Work area within segment 9, proofing of manhole #18, existing erosion control, looking eastward.</p>

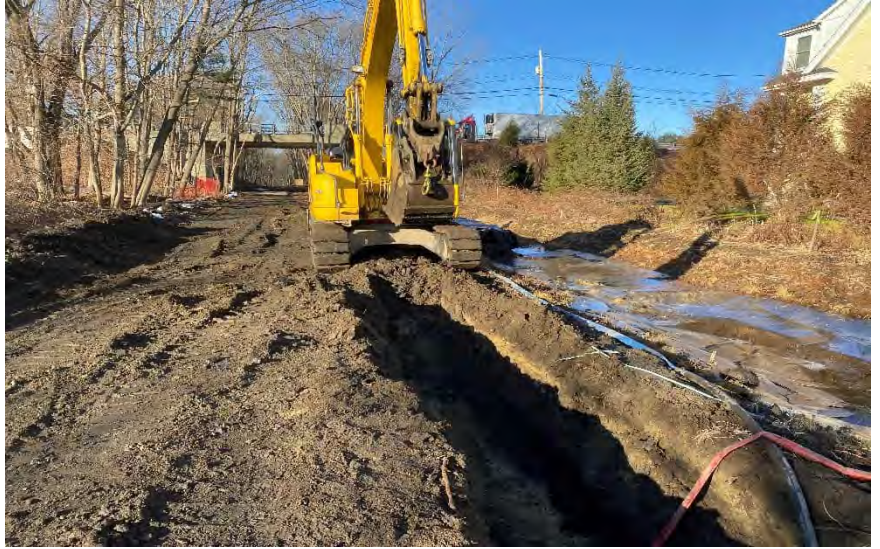
<p>PHOTOGRAPHIC LOG</p>	
<p>Client Name: Eversource</p>		<p>Site Location: Sudbury to Hudson Transmission Reliability Project</p>	<p>Town: Sudbury</p>
<p>Photo No.: 8</p>	<p>Date: 1-12-24</p>

<p>Description:</p> <p>Work area within segment 14, conduit work, looking westward.</p>

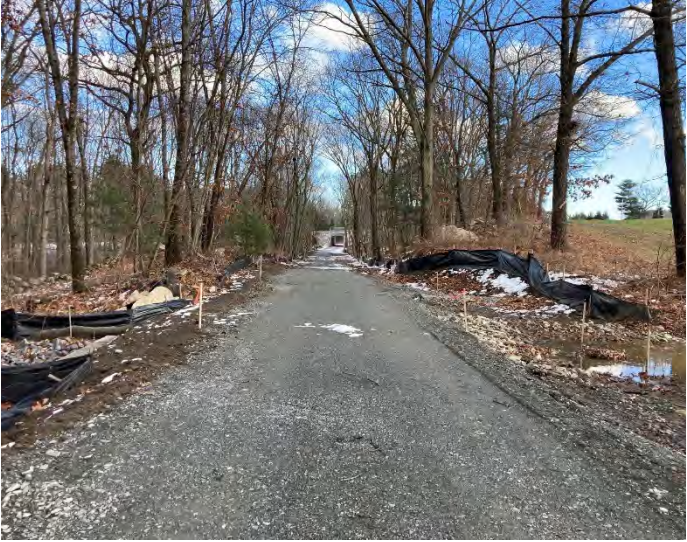
PHOTOGRAPHIC LOG	
Client Name: Eversource		Site Location: Sudbury to Hudson Transmission Reliability Project	Town: Stow
Photo No.: 1	Date: 1-10-2024

Description: View of drainage structures 5 and 6 in segment 1. Facing east.

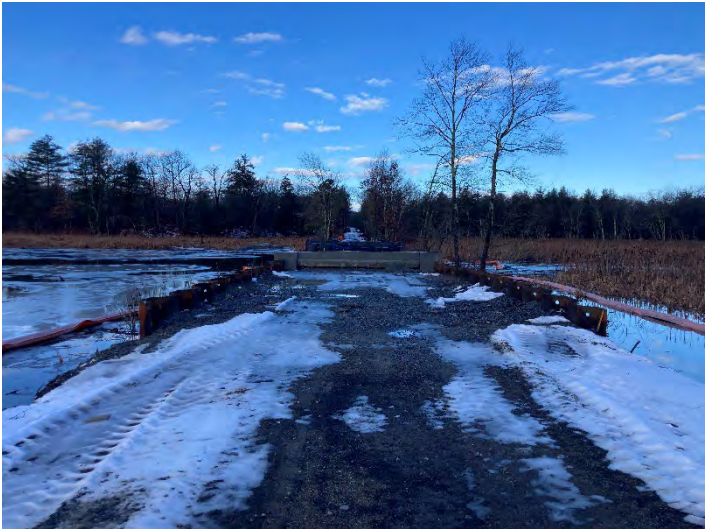
PHOTOGRAPHIC LOG	
Client Name: Eversource		Site Location: Sudbury to Hudson Transmission Reliability Project	Town: Hudson
Photo No.: 2	Date: 1-10-2024

Description: View of bridge 130. Facing west.

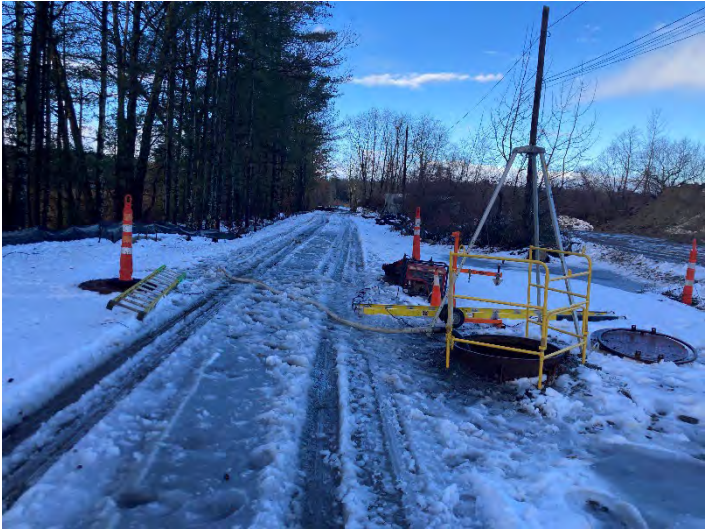
PHOTOGRAPHIC LOG	
Client Name: Eversource		Site Location: Sudbury to Hudson Transmission Reliability Project	Town: Hudson
Photo No.: 3	Date: 1-10-2024

Description: View of pumping operation at MH #8 in segment 3. See additional dewatering inspection report. Facing west.

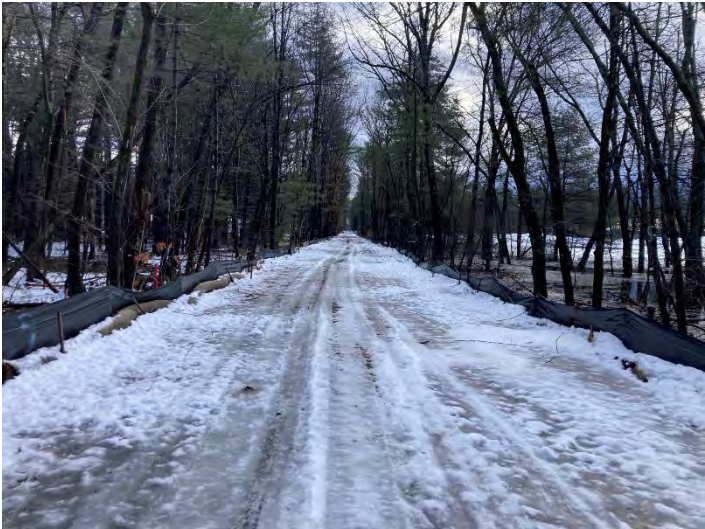
PHOTOGRAPHIC LOG	
Client Name: Eversource		Site Location: Sudbury to Hudson Transmission Reliability Project	Town: Hudson
Photo No.: 4	Date: 1-10-2024

Description: View of E&S controls in segment 4. Facing east.

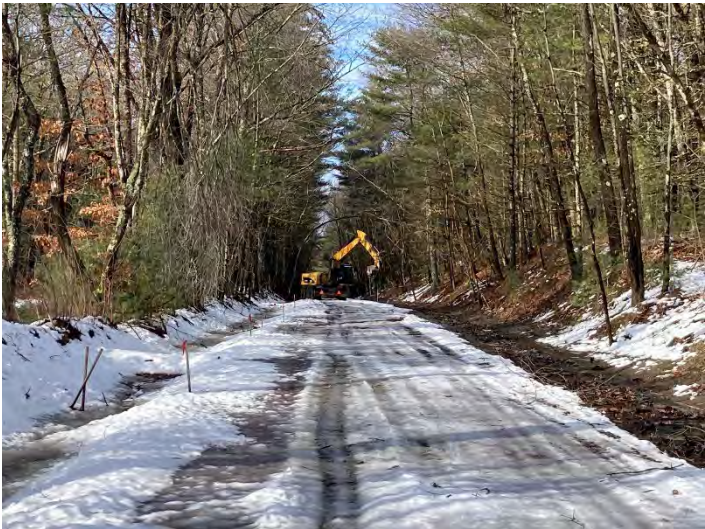
Epsilon ASSOCIATES INC.		PHOTOGRAPHIC LOG	
Client Name: Eversource		Site Location: Sudbury to Hudson Transmission Reliability Project	Town: Hudson
Photo No.: 5	Date: 1-10-2024

Description: View of Bond conducting storm clean up in segment 5. Facing west.

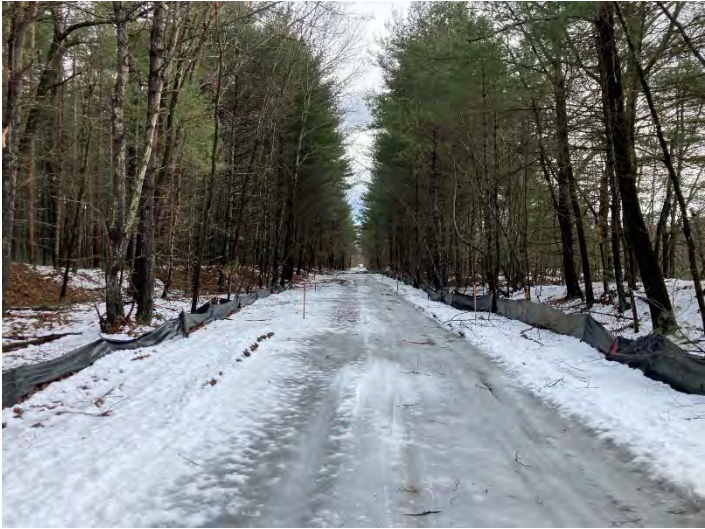
Epsilon ASSOCIATES INC.		PHOTOGRAPHIC LOG	
Client Name: Eversource		Site Location: Sudbury to Hudson Transmission Reliability Project	Town: Hudson
Photo No.: 6	Date: 1-10-2024

Description: View of E&S controls in segment 6. Facing east.

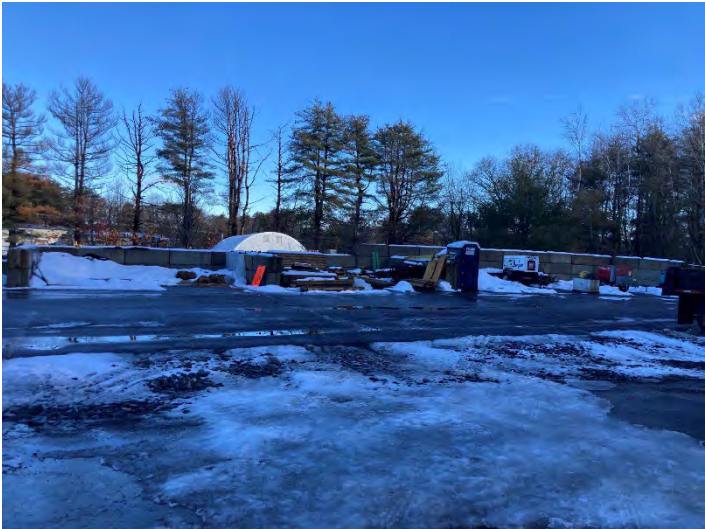
Epsilon ASSOCIATES INC.		PHOTOGRAPHIC LOG	
Client Name: Eversource		Site Location: Sudbury to Hudson Transmission Reliability Project	Town: Hudson
Photo No.: 7	Date: 1-10-2024

Description: View of laydown yard at 555 Main. Facing northwest.

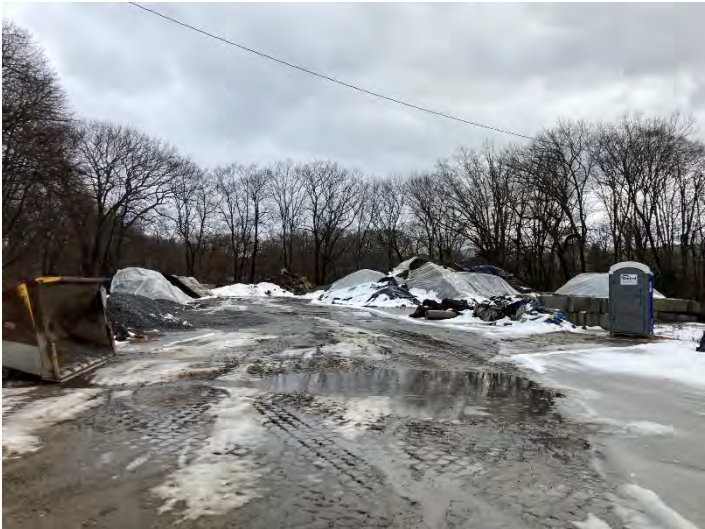
Epsilon ASSOCIATES INC.		PHOTOGRAPHIC LOG	
Client Name: Eversource		Site Location: Sudbury to Hudson Transmission Reliability Project	Town: Hudson
Photo No.: 8	Date: 1-10-2024

Description: View of Stowe Ct laydown yard. Facing west.

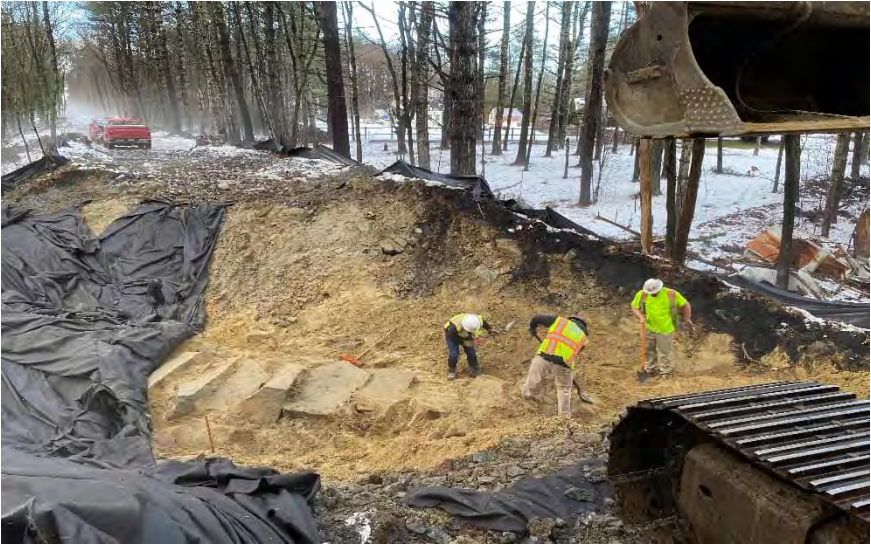
PHOTOGRAPHIC LOG	
Client Name: Eversource		Site Location: Sudbury to Hudson Transmission Reliability Project	Town: Sudbury
Photo No.: 1	Date: 1-10-24

Description: Work area within segment 9, ET&L conducting culvert repair work, existing erosion control, looking westward.

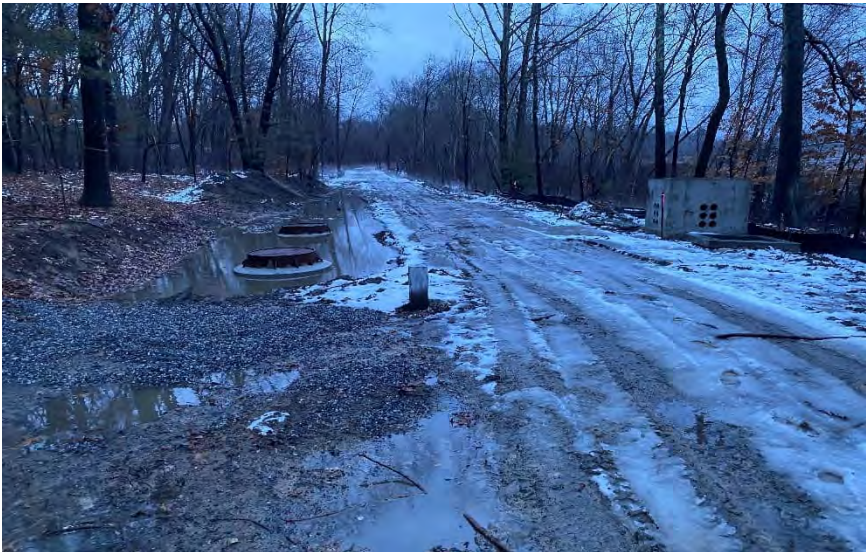
PHOTOGRAPHIC LOG	
Client Name: Eversource		Site Location: Sudbury to Hudson Transmission Reliability Project	Town: Sudbury
Photo No.: 4	Date: 1-10-24

Description: Work area within segment 14, manhole #26 area, looking eastward.

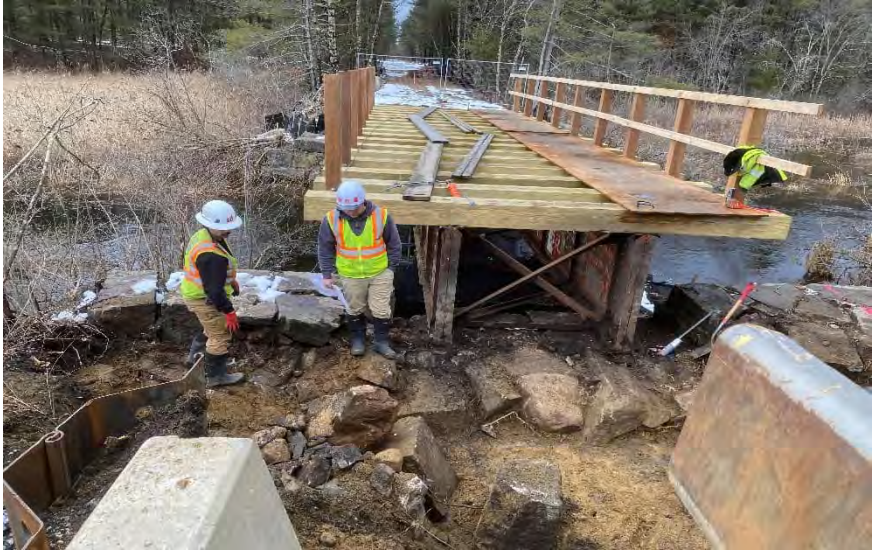
PHOTOGRAPHIC LOG	
Client Name: Eversource		Site Location: Sudbury to Hudson Transmission Reliability Project	Town: Sudbury
Photo No.: 5	Date: 1-10-24

Description: Work area within segment 8, bridge 128 work, looking westward.

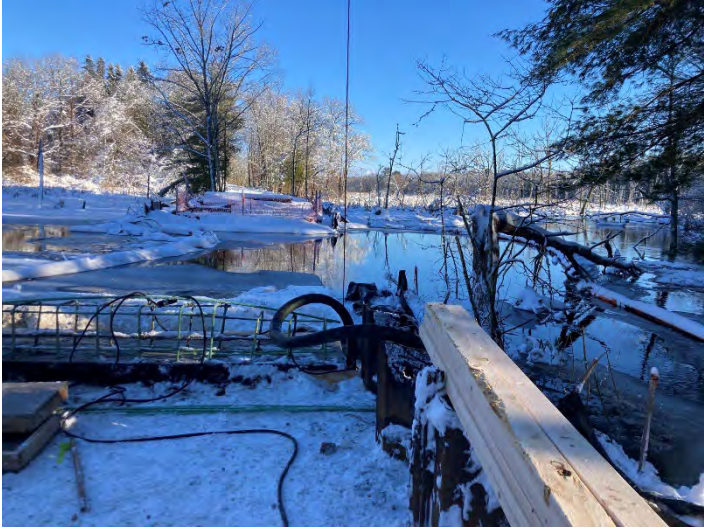
PHOTOGRAPHIC LOG	
Client Name: Eversource		Site Location: Sudbury to Hudson Transmission Reliability Project	Town: Sudbury
Photo No.: 1	Date: 1/08/2024

Description: View of work at bridge 127 in segment 13. Facing east.

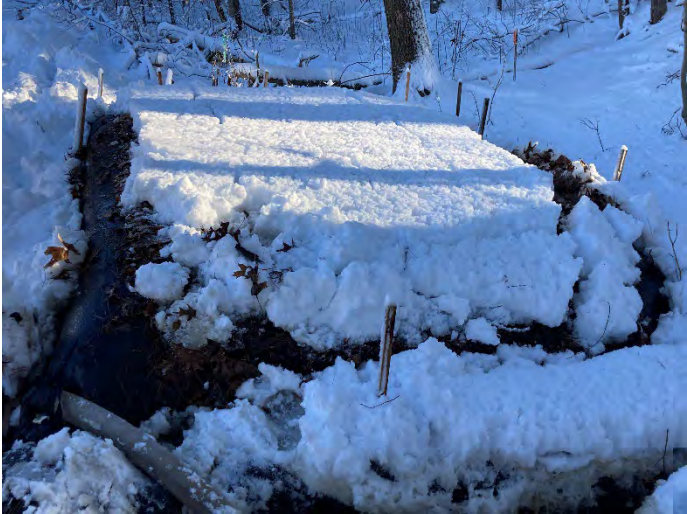
PHOTOGRAPHIC LOG	
Client Name: Eversource		Site Location: Sudbury to Hudson Transmission Reliability Project	Town: Sudbury
Photo No.: 3	Date: 1/08/2024

Description: View of dewatering controls (straw bale corral with filter fabric, stone, and silt bag). Facing east.

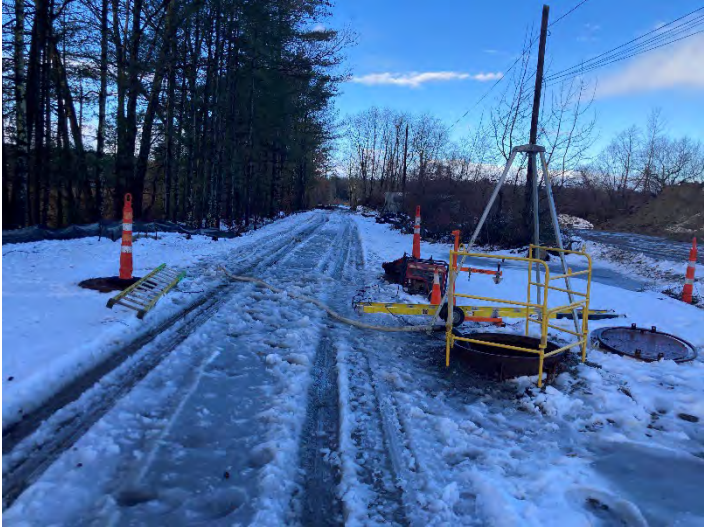
PHOTOGRAPHIC LOG	
Client Name: Eversource		Site Location: Sudbury to Hudson Transmission Reliability Project	Town: Hudson
Photo No.: 1	Date: 1/10/2024

Description: View of pumping operation at MH #8 in segment 3. Facing west.

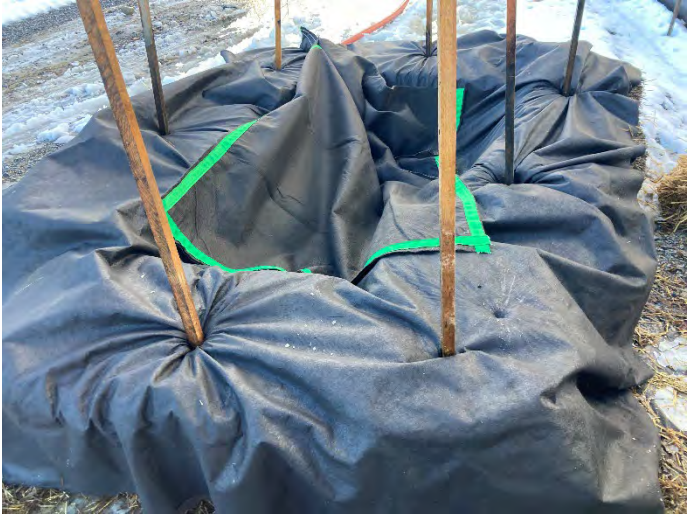
PHOTOGRAPHIC LOG	
Client Name: Eversource		Site Location: Sudbury to Hudson Transmission Reliability Project	Town: Hudson
Photo No.: 3	Date: 1/10/2024

Description: View of dewatering controls (straw bale corral with filter fabric and silt bag). Facing east.

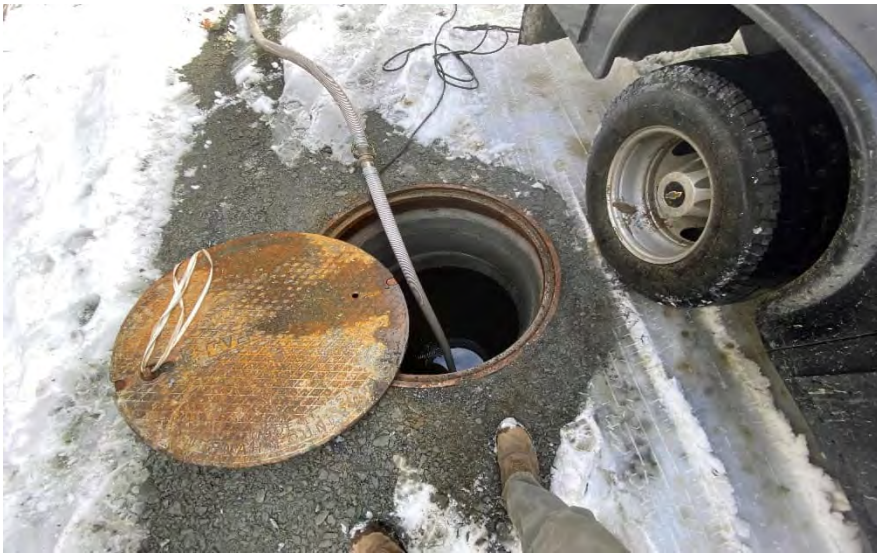
PHOTOGRAPHIC LOG	
Client Name: Eversource		Site Location: Sudbury to Hudson Transmission Reliability Project	Town: Sudbury
Photo No.: 1	Date: 1/11/2024

Description: View of pumping from manhole #15 segment 7.

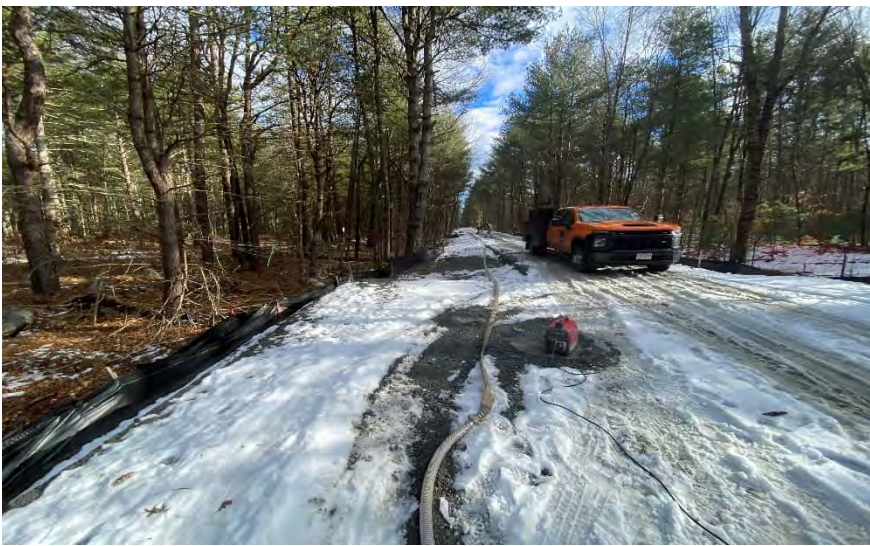
PHOTOGRAPHIC LOG	
Client Name: Eversource		Site Location: Sudbury to Hudson Transmission Reliability Project	Town: Sudbury
Photo No.: 2	Date: 1/11/2024

Description: Manhole #15. View of dewatering operation. Looking eastward.

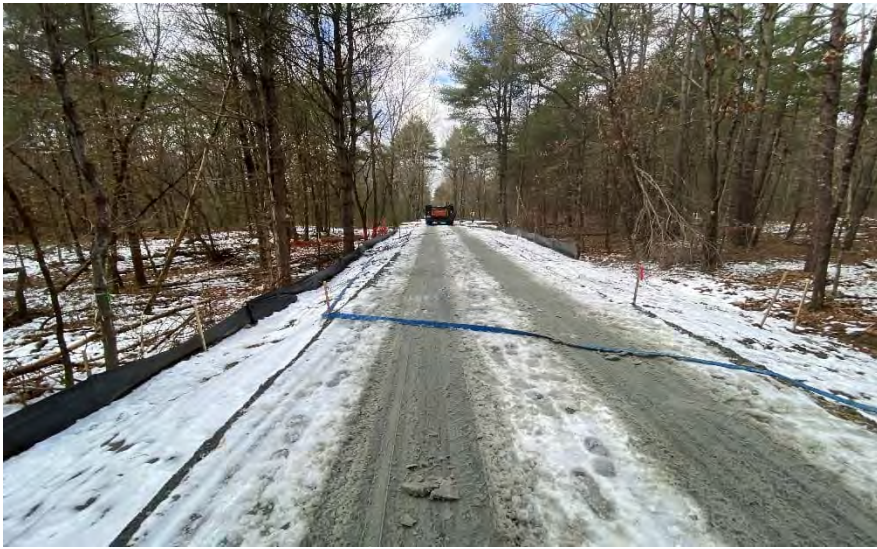
PHOTOGRAPHIC LOG	
Client Name: Eversource		Site Location: Sudbury to Hudson Transmission Reliability Project	Town: Sudbury
Photo No.: 3	Date: 1/11/2024

Description: Manhole #15. View of dewatering operation, looking westward.

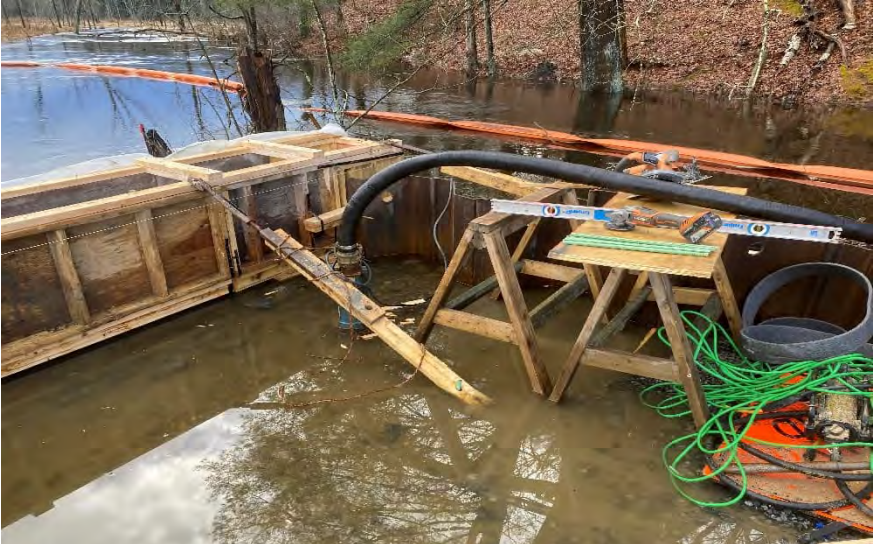
PHOTOGRAPHIC LOG		
Client Name: Eversource		Site Location: Sudbury to Hudson Transmission Reliability Project		Town: Sudbury
Photo No.: 1	Date: 1/10/2024

Description: View of area being pumped from segment 13 at bridge 127.

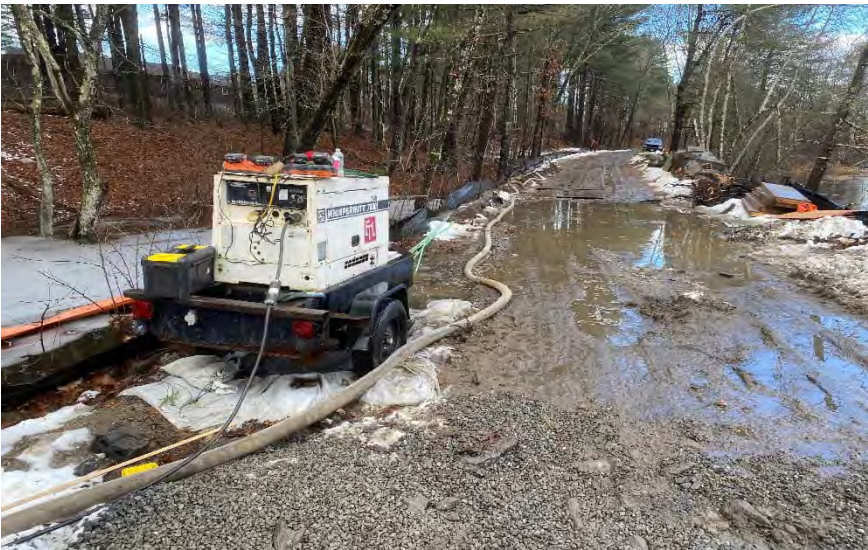
PHOTOGRAPHIC LOG		
Client Name: Eversource		Site Location: Sudbury to Hudson Transmission Reliability Project		Town: Sudbury
Photo No.: 2	Date: 1/10/2024

Description: Segment 13. View of dewatering operation. Looking westward.

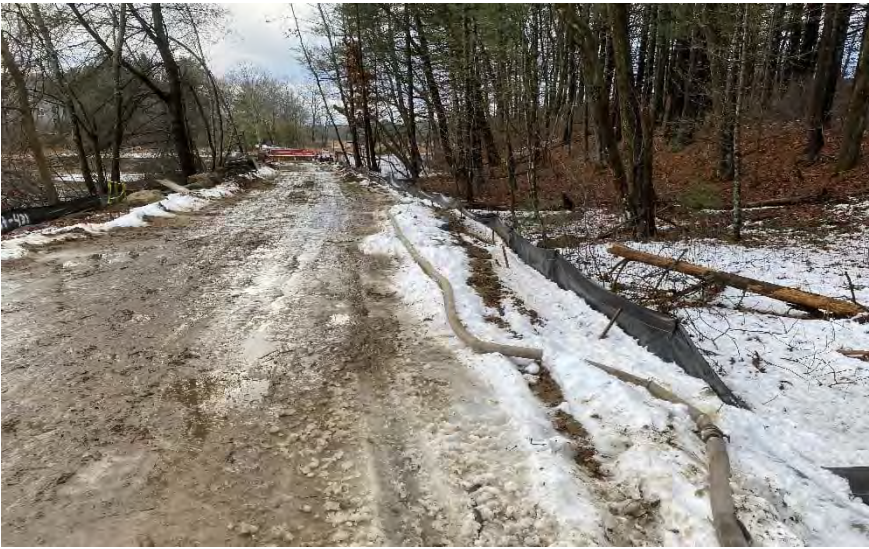
PHOTOGRAPHIC LOG	
Client Name: Eversource		Site Location: Sudbury to Hudson Transmission Reliability Project	Town: Sudbury
Photo No.: 3	Date: 1/10/2024

Description: Segment 13. View of dewatering operation, looking eastward.

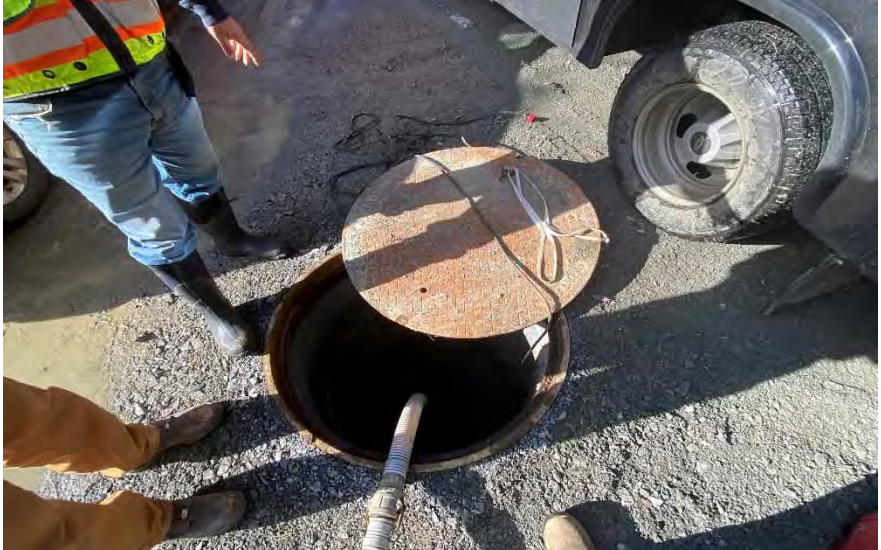
PHOTOGRAPHIC LOG	
Client Name: Eversource		Site Location: Sudbury to Hudson Transmission Reliability Project	Town: Sudbury
Photo No.: 1	Date: 1/11/2024

Description: View of pumping from manhole #16 segment 7.

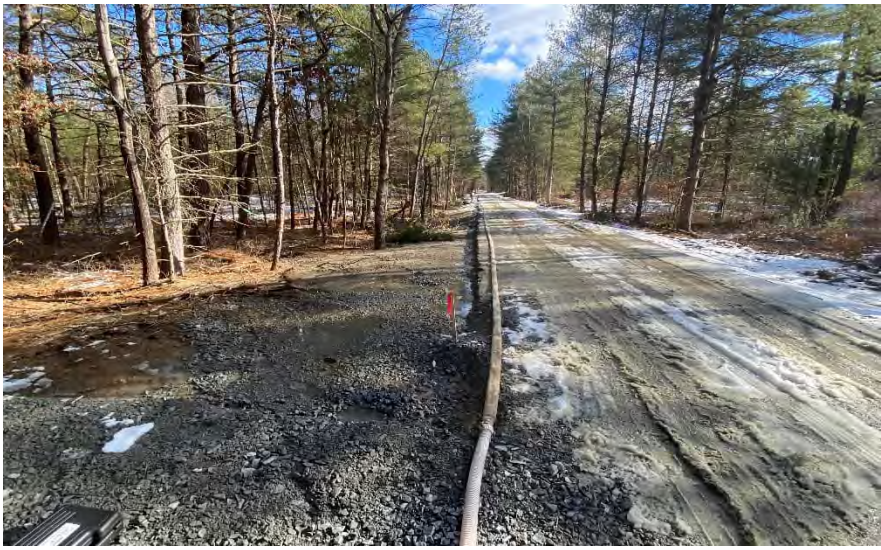
PHOTOGRAPHIC LOG	
Client Name: Eversource		Site Location: Sudbury to Hudson Transmission Reliability Project	Town: Sudbury
Photo No.: 2	Date: 1/11/2024

Description: Manhole #16. View of dewatering operation. Looking eastward.

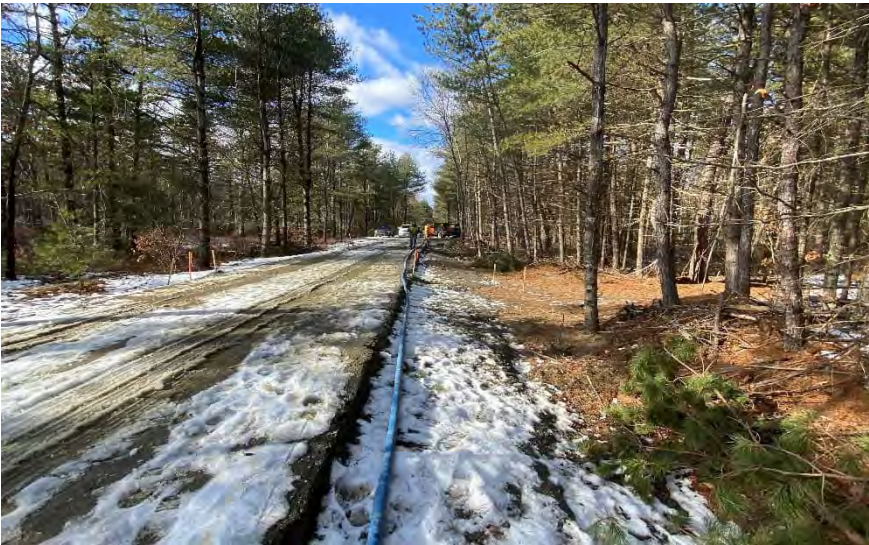
PHOTOGRAPHIC LOG	
Client Name: Eversource		Site Location: Sudbury to Hudson Transmission Reliability Project	
Town: Sudbury			
Photo No.: 3	Date: 1/11/2024

Description: Manhole #16. View of dewatering operation, looking eastward.

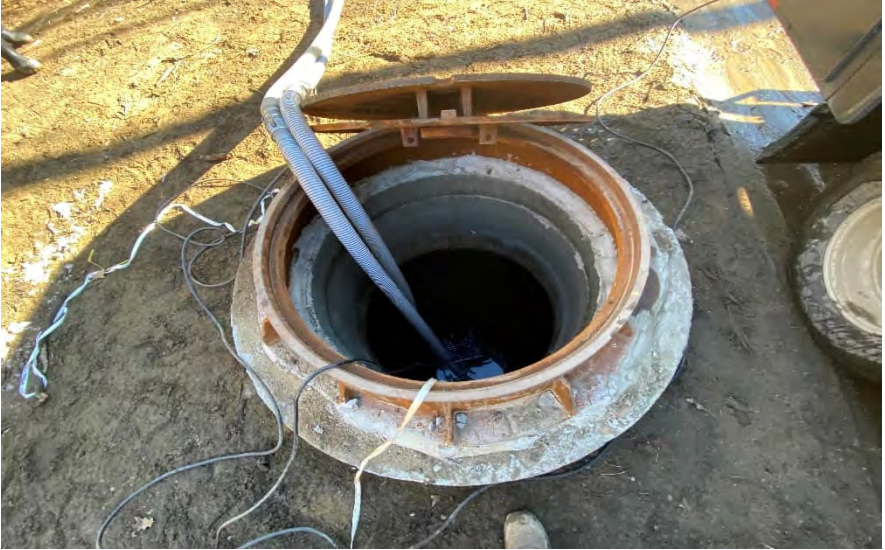
PHOTOGRAPHIC LOG	
Client Name: Eversource		Site Location: Sudbury to Hudson Transmission Reliability Project	Town: Hudson
Photo No.: 1	Date: 1/12/2024

Description: View of pumping from manhole #14 segment 6.

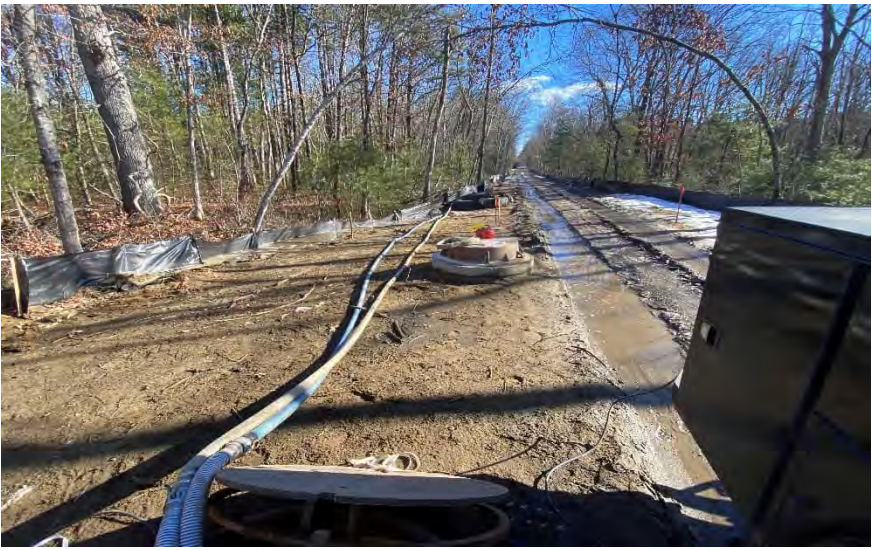
PHOTOGRAPHIC LOG	
Client Name: Eversource		Site Location: Sudbury to Hudson Transmission Reliability Project	Town: Hudson
Photo No.: 2	Date: 1/12/2024

Description: Manhole #14. View of dewatering operation. Looking eastward.

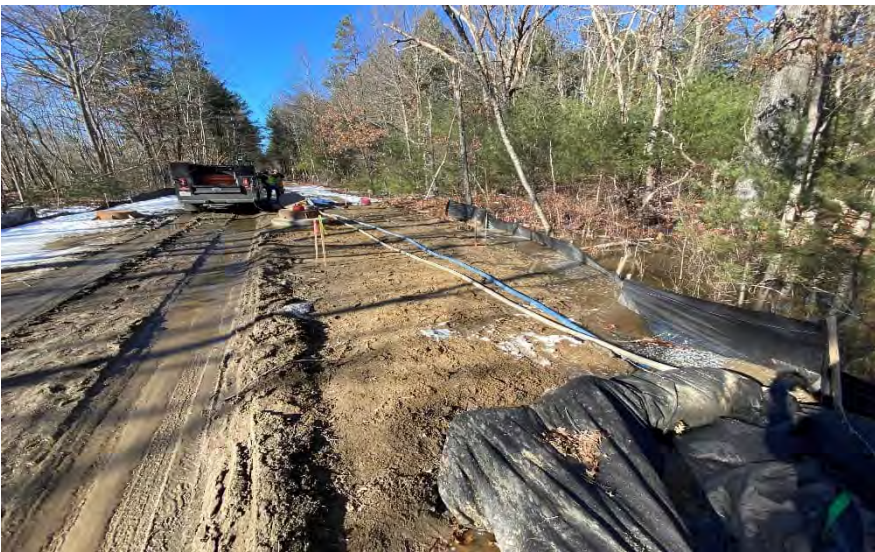
PHOTOGRAPHIC LOG	
Client Name: Eversource		Site Location: Sudbury to Hudson Transmission Reliability Project	Town: Hudson
Photo No.: 3	Date: 1/12/2024

Description: Manhole #14. View of dewatering operation, looking westward.

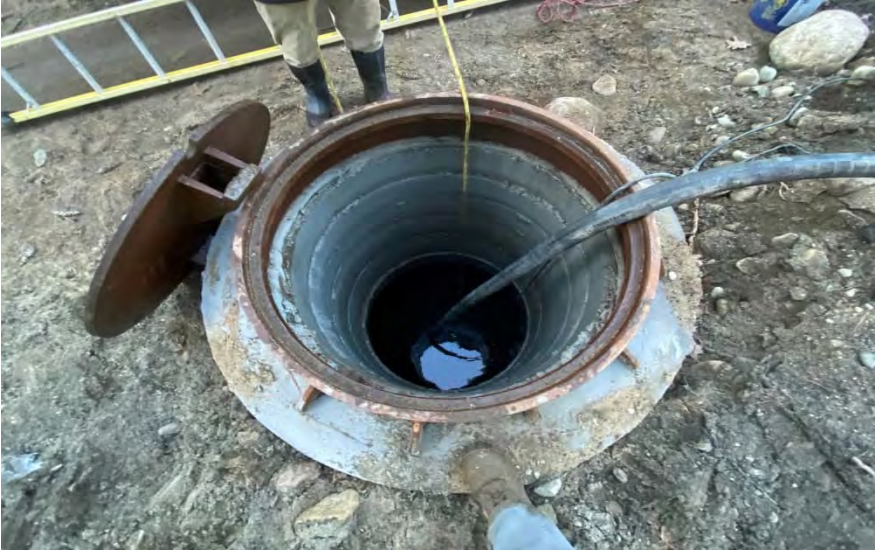
PHOTOGRAPHIC LOG	
Client Name: Eversource		Site Location: Sudbury to Hudson Transmission Reliability Project	Town: Sudbury
Photo No.: 1	Date: 1/12/2024

Description: View of pumping from manhole #18 segment 9.

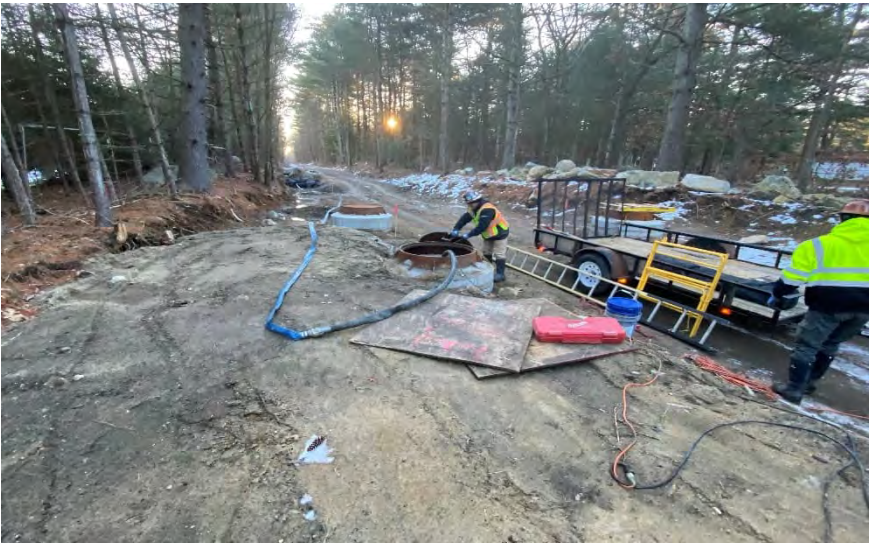
PHOTOGRAPHIC LOG	
Client Name: Eversource		Site Location: Sudbury to Hudson Transmission Reliability Project	Town: Sudbury
Photo No.: 3	Date: 1/11/2024

Description: Manhole #18. View of dewatering operation, looking eastward.

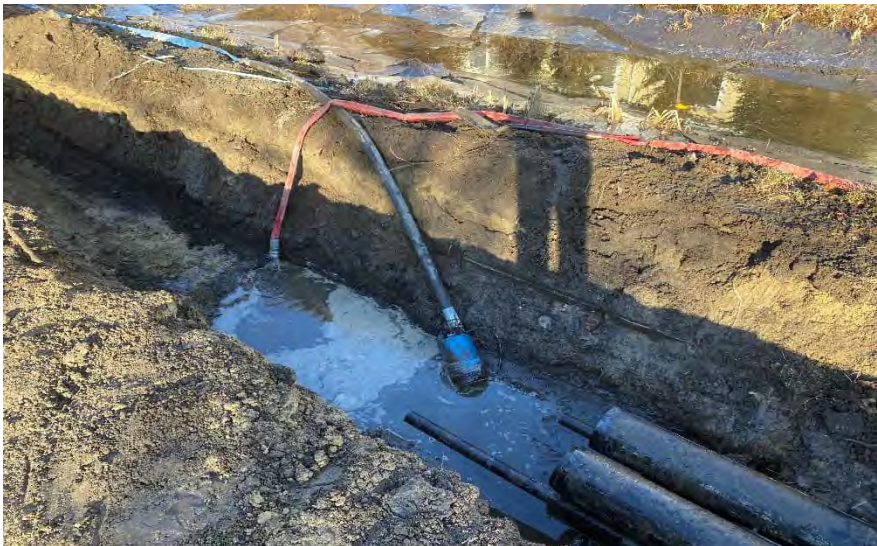
PHOTOGRAPHIC LOG	
Client Name: Eversource		Site Location: Sudbury to Hudson Transmission Reliability Project	Town: Sudbury
Photo No.: 1	Date: 1/12/2024

Description: View of area being pumped from segment 14, trench work.

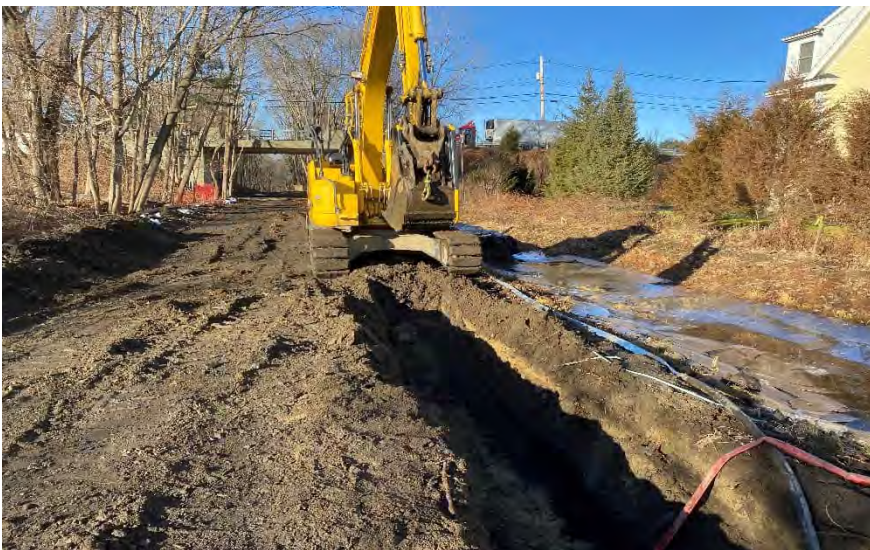
PHOTOGRAPHIC LOG	
Client Name: Eversource		Site Location: Sudbury to Hudson Transmission Reliability Project	Town: Sudbury
Photo No.: 2	Date: 1/12/2024

Description: Segment 14. View of dewatering operation. Looking westward.

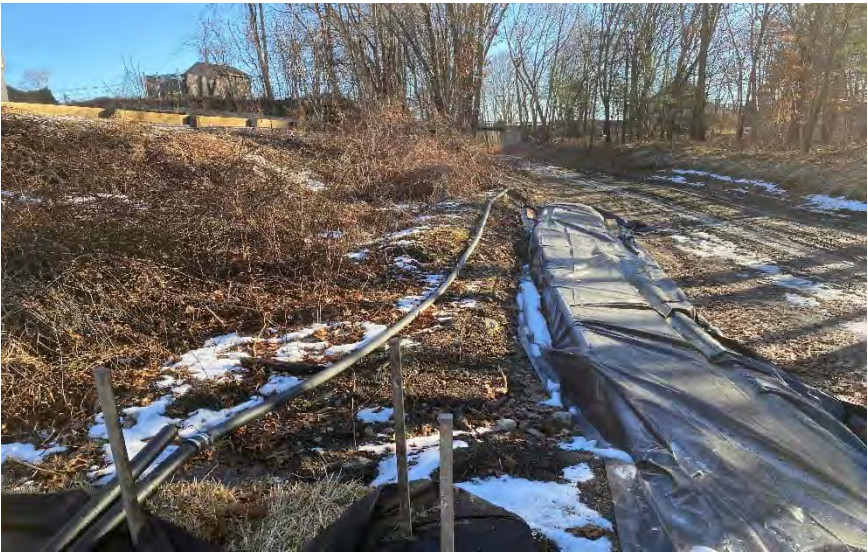
PHOTOGRAPHIC LOG	
Client Name: Eversource		Site Location: Sudbury to Hudson Transmission Reliability Project	Town: Sudbury
Photo No.: 3	Date: 1/12/2024

Description: Segment 14. View of dewatering operation, looking eastward.
