Weekly Environmental Compliance Summary

Sudbury to Hudson Transmission Reliability Project (USEPA Tracking # MAR1003UW)

Sudbury, Hudson, and Stow, MA

Week of: January 15, 2024 to January 19, 2024

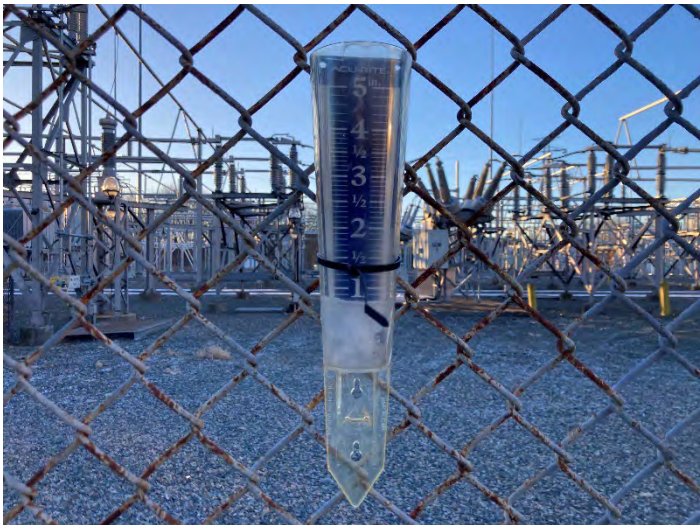
PHOTOGRAPHIC LOG	
Client Name: Eversource		Site Location: Sudbury to Hudson Transmission Reliability Project	
Photo No.: 1 Date: 1-15-2024		Town: Sudbury	
Description: View of rain gauge at Sudbury Substation. 0.80" (frozen) observed in gauge at 8:00am. Facing south.

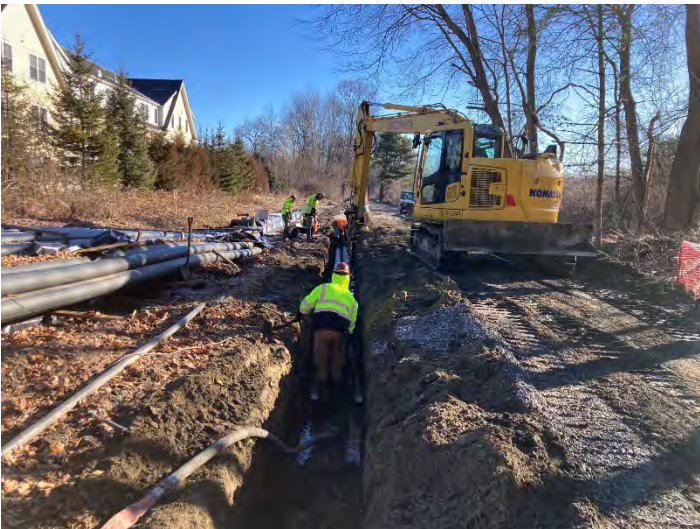
PHOTOGRAPHIC LOG	
Client Name: Eversource		Site Location: Sudbury to Hudson Transmission Reliability Project	
Photo No.: 2 Date: 1-15-2024		Town: Sudbury	
Description: View of Bond installing conduit in segment 14. See additional dewatering inspection report. Facing east.
