Weekly Environmental Compliance Summary

Sudbury to Hudson Transmission Reliability Project (USEPA Tracking # MAR1003UW)

Week of: December 18, 2023 to December 22, 2023

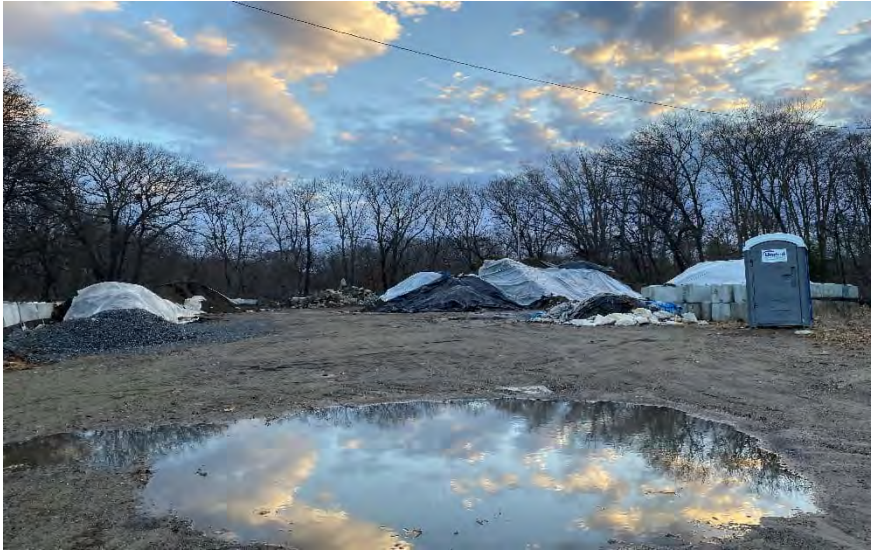
PHOTOGRAPHIC LOG	
Client Name: Eversource		Site Location: Sudbury to Hudson Transmission Reliability Project	
Photo No.: 1		Date: 12-19-23	
Description: Laydown yard at Stowe Court, covered spoil piles, looking southward.

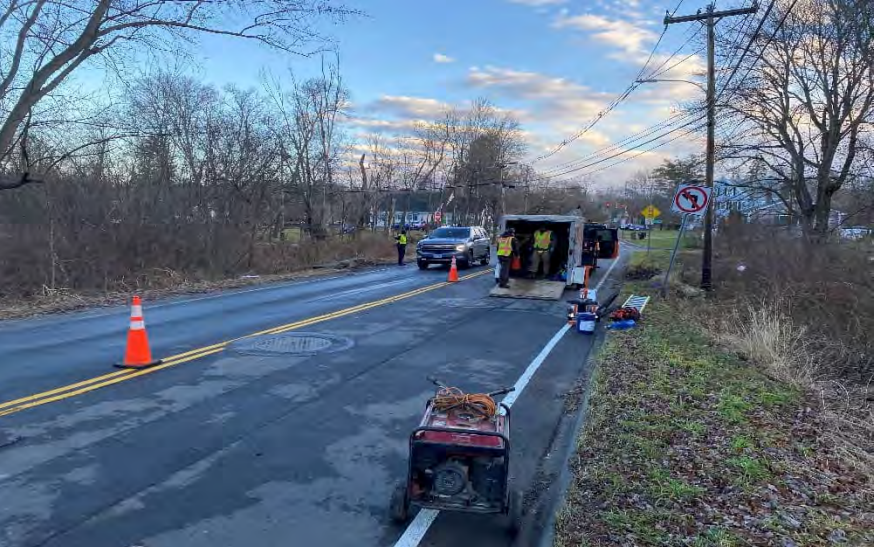
PHOTOGRAPHIC LOG	
Client Name: Eversource		Site Location: Sudbury to Hudson Transmission Reliability Project	
Photo No.: 2		Date: 12-19-23	
Description: Conduit proofing at manhole #4 within Forest Avenue, looking northward.

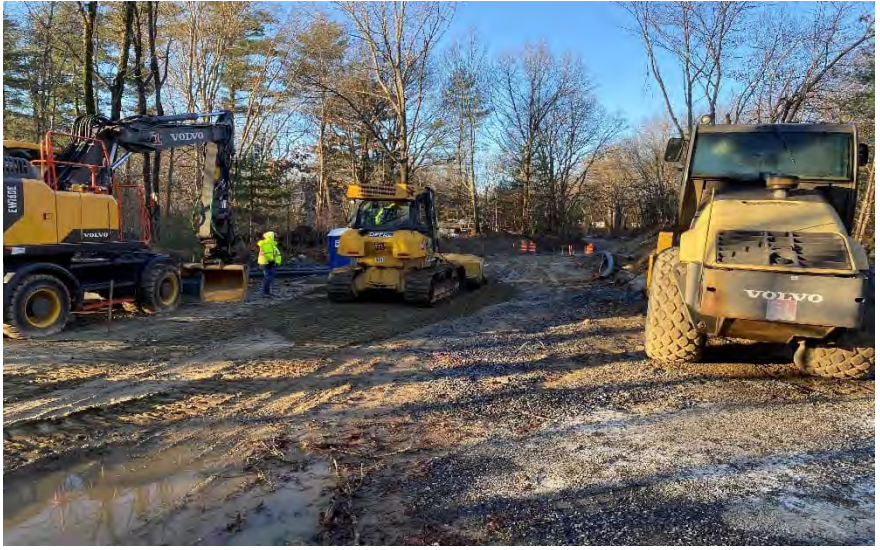
PHOTOGRAPHIC LOG	
Client Name: Eversource		Site Location: Sudbury to Hudson Transmission Reliability Project	
Photo No.: 3		Date: 12-19-23	
Description: Work area within Segment 1, grading work, looking eastward.

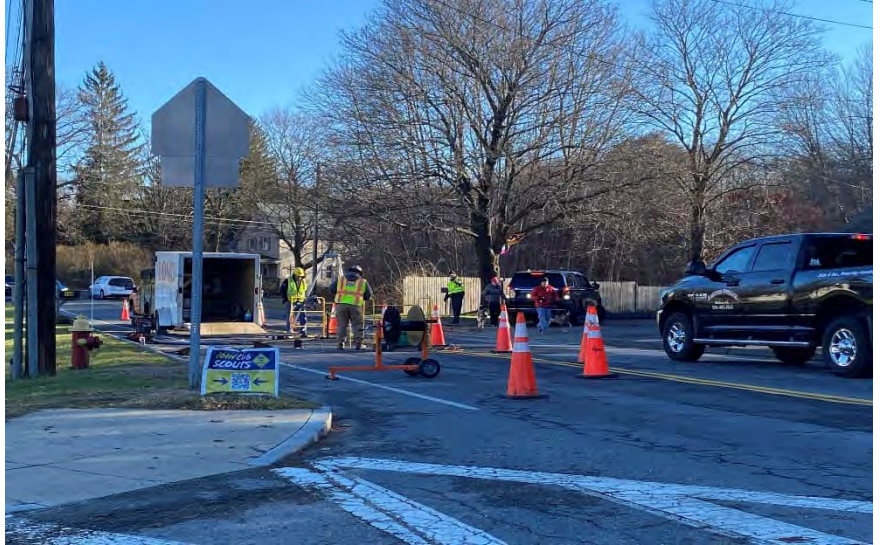
PHOTOGRAPHIC LOG	
Client Name: Eversource		Site Location: Sudbury to Hudson Transmission Reliability Project	
Photo No.: 4		Date: 12-19-23	
Description: Conduit proofing at manhole #3 within Forest Avenue, looking northward.

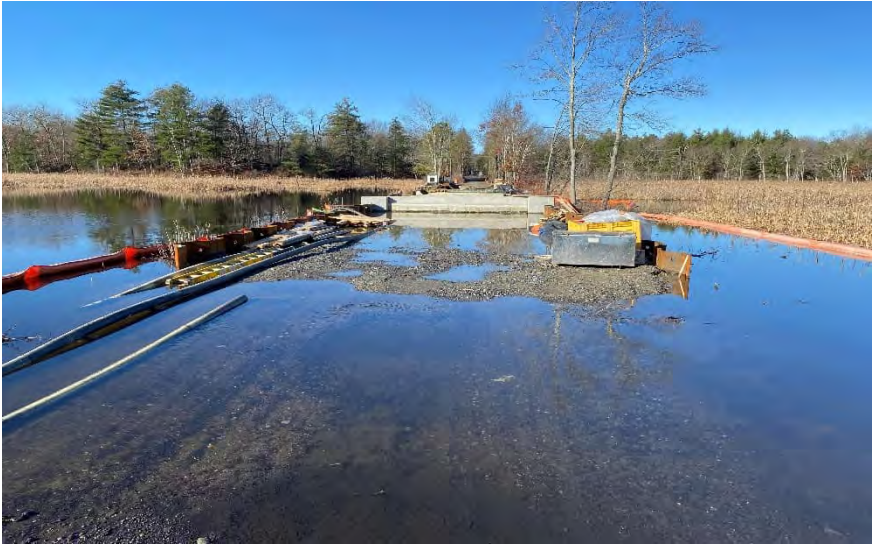
PHOTOGRAPHIC LOG	
Client Name: Eversource		Site Location: Sudbury to Hudson Transmission Reliability Project	
Photo No.: 7		Date: 12-19-23	
Description: Work area within Segments 3 looking across Fort Meadow Brook toward segment 2, existing erosion control (floating silt curtain), looking westward.

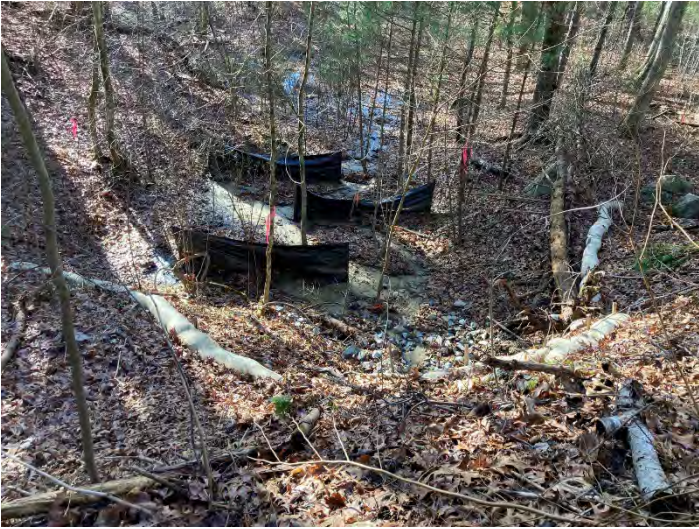
PHOTOGRAPHIC LOG	
Client Name: Eversource		Site Location: Sudbury to Hudson Transmission Reliability Project	
Photo No.: 2 Date: 12/19/2023		Town: Sudbury	
Description: View of sediment that has deposited in wetlands below collapsed culvert in segment 9. Facing south.

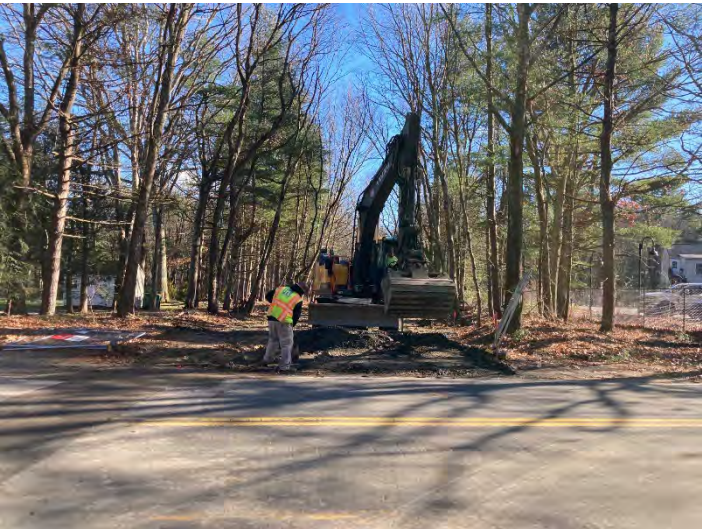
PHOTOGRAPHIC LOG	
Client Name: Eversource		Site Location: Sudbury to Hudson Transmission Reliability Project	
Town: Sudbury			
Photo No.: 4	Date: 12/19/2023

Description: View of ET&L working in segment 11. Facing east.

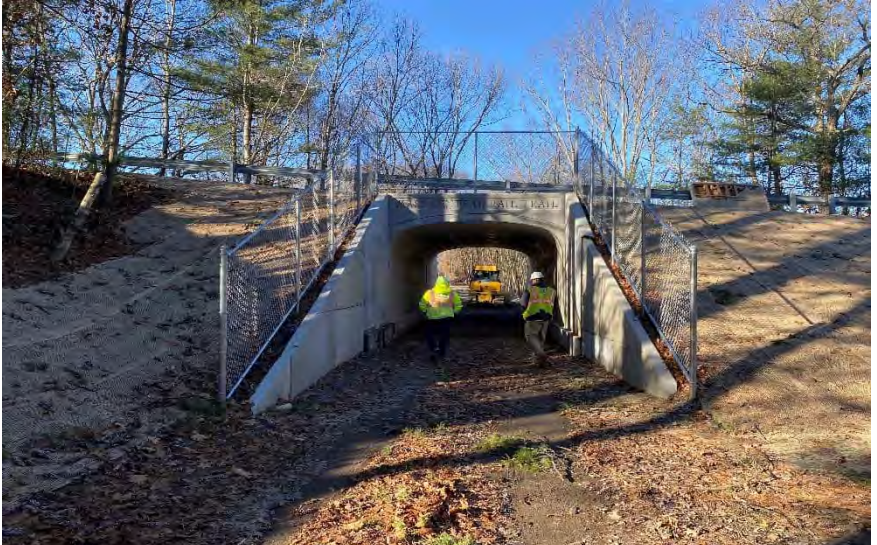
PHOTOGRAPHIC LOG	
Client Name: Eversource		Site Location: Sudbury to Hudson Transmission Reliability Project	
Photo No.: 2		Date: 12-20-23	
Description: Chestnut Street crossing from segment 2 toward segment 1, grading work, looking westward.

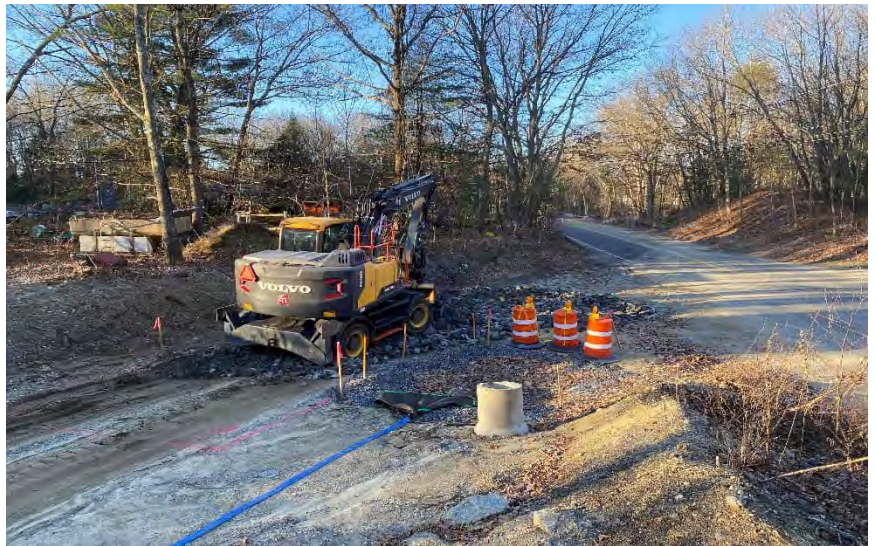
PHOTOGRAPHIC LOG	
Client Name: Eversource		Site Location: Sudbury to Hudson Transmission Reliability Project	
Photo No.: 4		Date: 12-20-23	
Description: Adding more stone to construction entrance within segment 1 at Wilkins Avenue, looking westward.

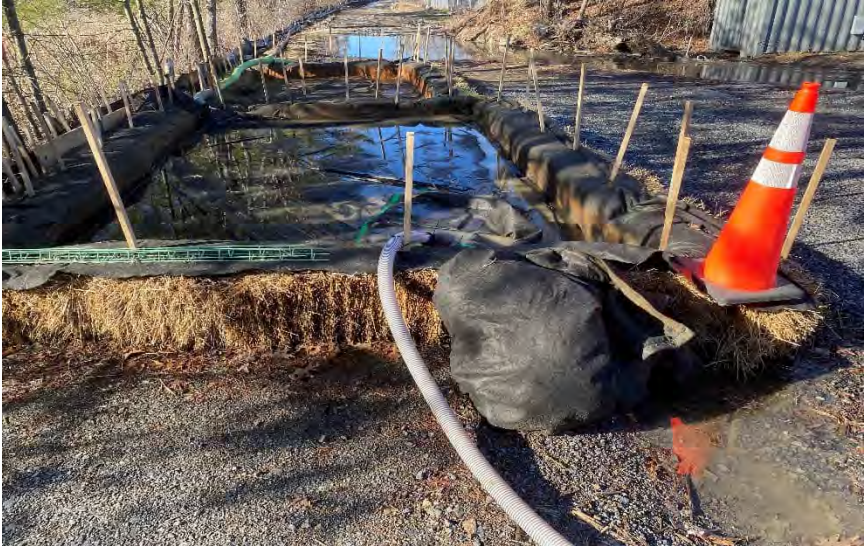
PHOTOGRAPHIC LOG	
Client Name: Eversource		Site Location: Sudbury to Hudson Transmission Reliability Project	
Photo No.: 6 Date: 12-20-23		Town: Hudson	
Description: Work area within Segment 3, dewatering manhole 8, looking westward.

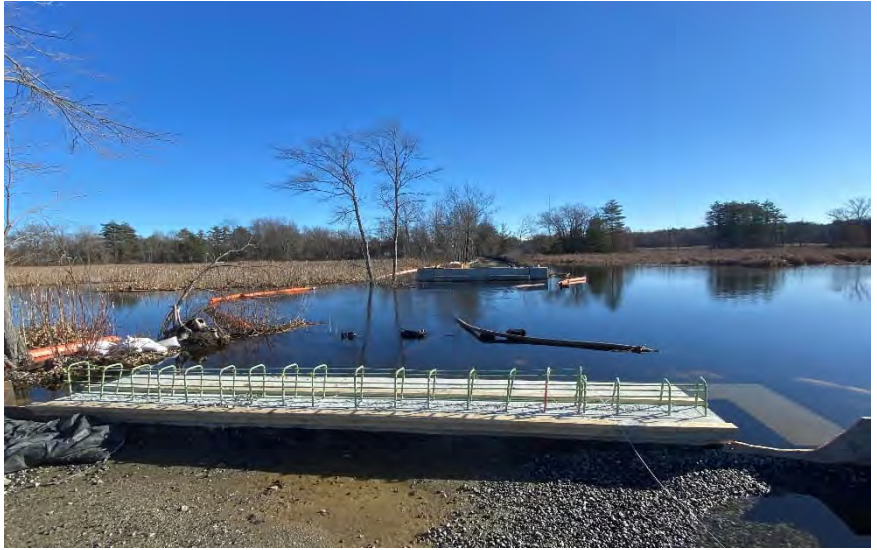
PHOTOGRAPHIC LOG	
Client Name: Eversource		Site Location: Sudbury to Hudson Transmission Reliability Project	
Town: Hudson			
Photo No.: 7	Date: 12-20-23		
Description: Work area within Segment 2 looking across Fort Meadow Brook toward segment 3, existing erosion control (floating silt curtain), looking eastward.

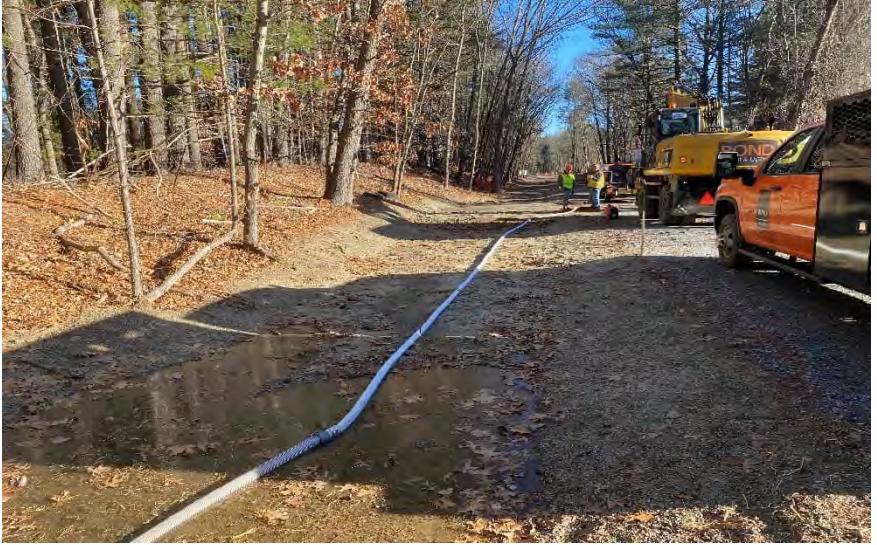
PHOTOGRAPHIC LOG	
Client Name: Eversource		Site Location: Sudbury to Hudson Transmission Reliability Project	
Town: Hudson			
Photo No.: 8	Date: 12-20-23		
Description: Work area within Segment 3, dewatering manhole 9, looking westward.

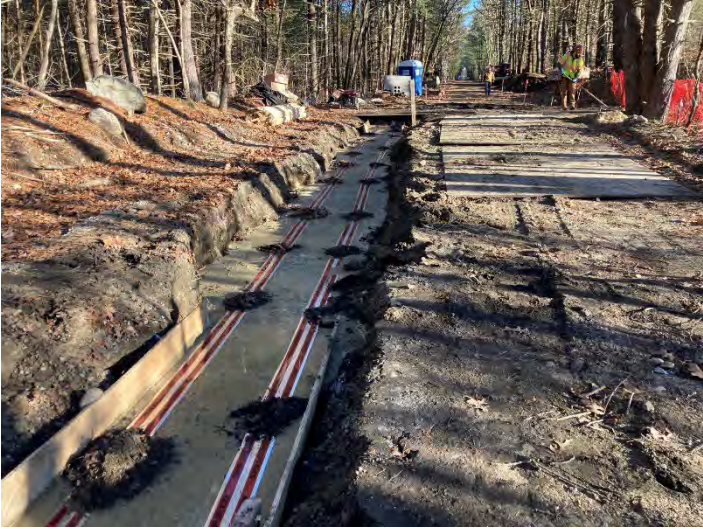
PHOTOGRAPHIC LOG	
Client Name: Eversource		Site Location: Sudbury to Hudson Transmission Reliability Project	
Photo No.: 1 Date: 12/20/2023		Town: Sudbury	
Description: View of Bond installing ductbank in segment 8. Facing east.

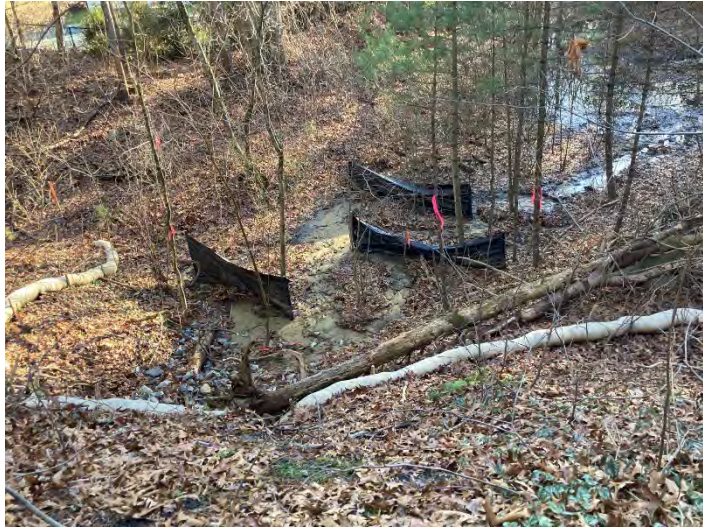
-Sediment is present beyond limit of work in segments 9 and 12. Silt fence repair and sediment removal are needed.

PHOTOGRAPHIC LOG	
Client Name: Eversource		Site Location: Sudbury to Hudson Transmission Reliability Project	
Photo No.: 2 Date: 12/20/2023		Town: Sudbury	
Description: View of sediment that has deposited in wetlands below collapsed culvert in segment 9. Facing southeast.

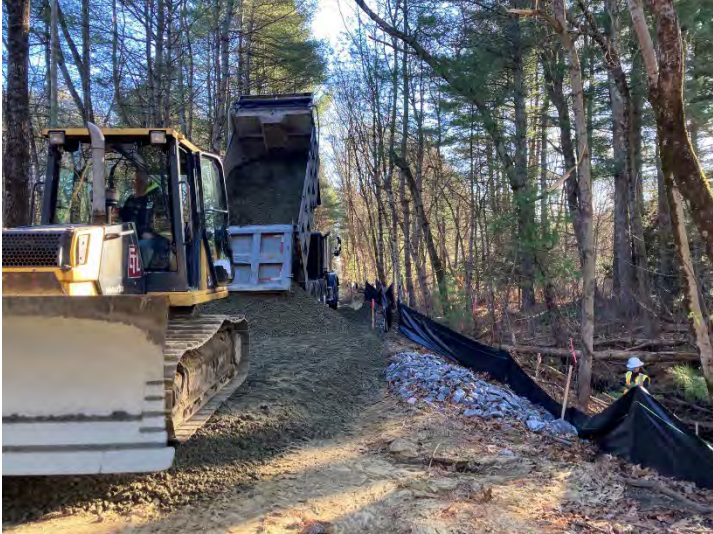
PHOTOGRAPHIC LOG	
Client Name: Eversource		Site Location: Sudbury to Hudson Transmission Reliability Project	
Photo No.: 3		Date: 12/20/2023	
Description: View of ET&L spreading gravel above Dudley Brook culvert in sement 10. Lori Capone (Sudbury CC) and I (Ariel Leclerc, SWCA) monitored work. Facing east.

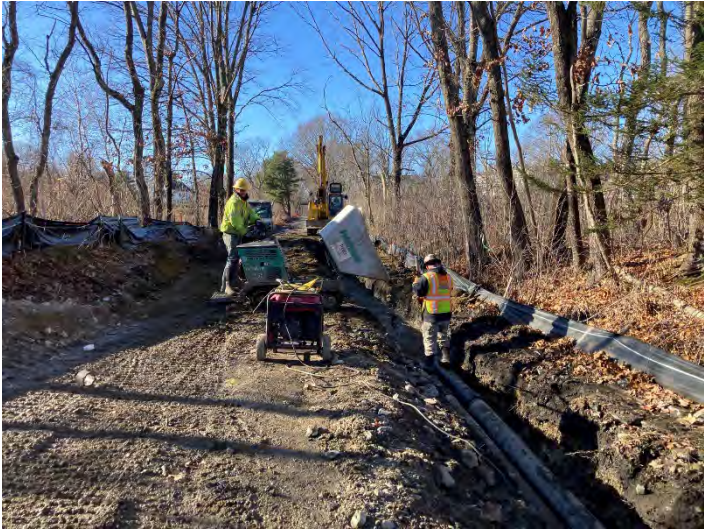
PHOTOGRAPHIC LOG	
Client Name: Eversource		Site Location: Sudbury to Hudson Transmission Reliability Project	
Photo No.: 5 Date: 12/20/2023		Town: Sudbury	
Description: View of Bond installing conduit and ductbank in segment 14. See additional dewatering inspection report. Facing west.

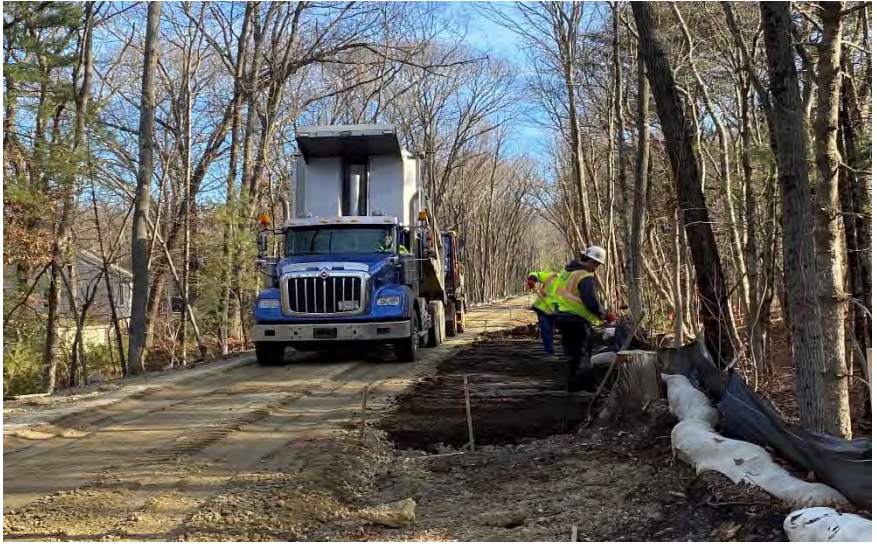
PHOTOGRAPHIC LOG	
Client Name: Eversource		Site Location: Sudbury to Hudson Transmission Reliability Project	
Photo No.: 1		Date: 12-22-23	
Description: Work area within segment 1, grading work, looking eastward.

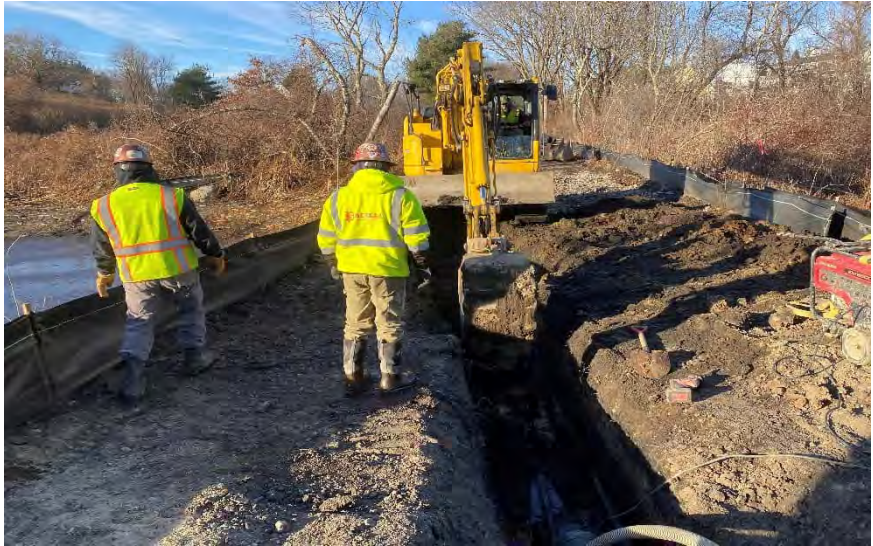
PHOTOGRAPHIC LOG	
Client Name: Eversource		Site Location: Sudbury to Hudson Transmission Reliability Project	
Photo No.: 7		Date: 12-22-23	
Description: Work area within Segment 14, conduit work, existing erosion control, looking westward.

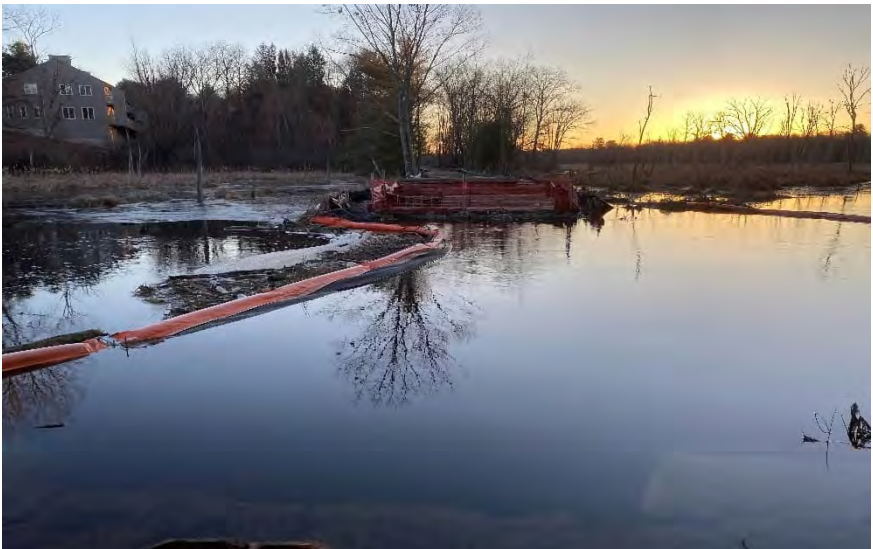
PHOTOGRAPHIC LOG	
Client Name: Eversource		Site Location: Sudbury to Hudson Transmission Reliability Project	
Photo No.: 8		Date: 12-22-23	
Description: Bridge 127 work area looking eastward from segment 13 across Hop Brook toward segment 14, existing erosion control (floating silt curtain), looking eastward.

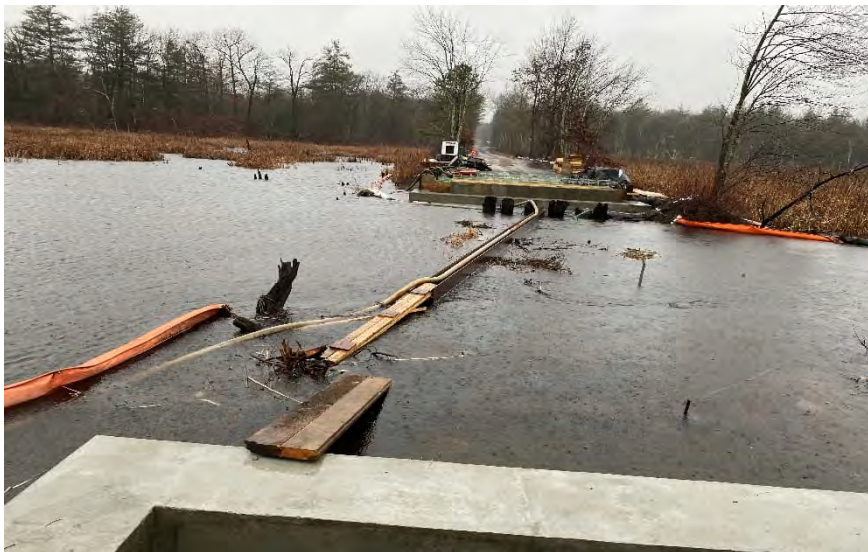
PHOTOGRAPHIC LOG	
Client Name: Eversource		Site Location: Sudbury to Hudson Transmission Reliability Project	
Photo No.: 1		Date: 12-18-23	
Description: Work area from segment 3 looking across Fort Meadow Brook toward segment 2 (bridge 130 area), looking westward.

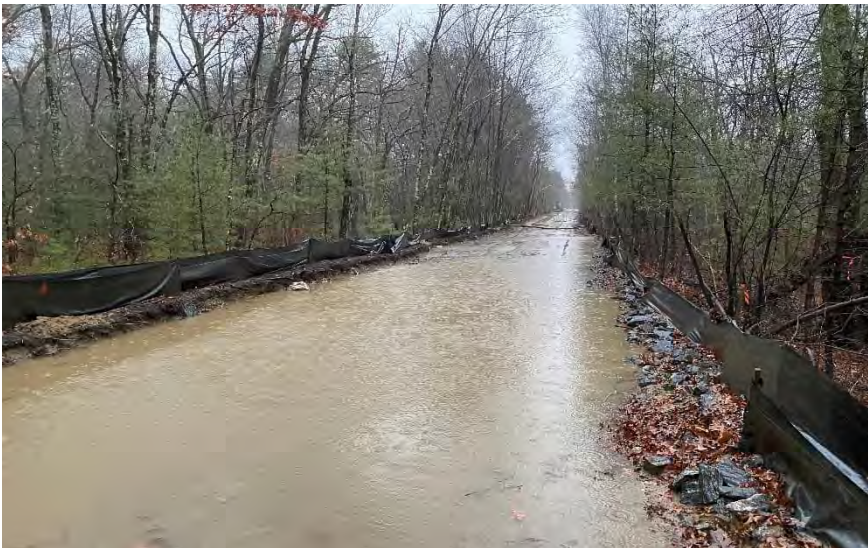
PHOTOGRAPHIC LOG	
Client Name: Eversource		Site Location: Sudbury to Hudson Transmission Reliability Project	
Photo No.: 2		Date: 12-18-23	
Description: Work area within segment 6, area flooded, existing erosion control, looking eastward.

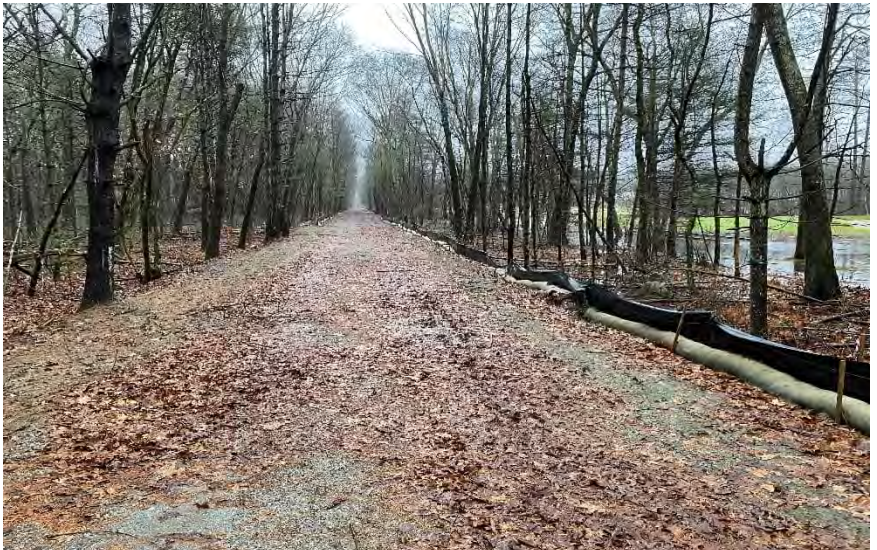
PHOTOGRAPHIC LOG	
Client Name: Eversource		Site Location: Sudbury to Hudson Transmission Reliability Project	
Town: Hudson			
Photo No.: 4	Date: 12-18-23

Description: Work area within segment 4, completed hydroseeding work, existing erosion control, looking eastward.

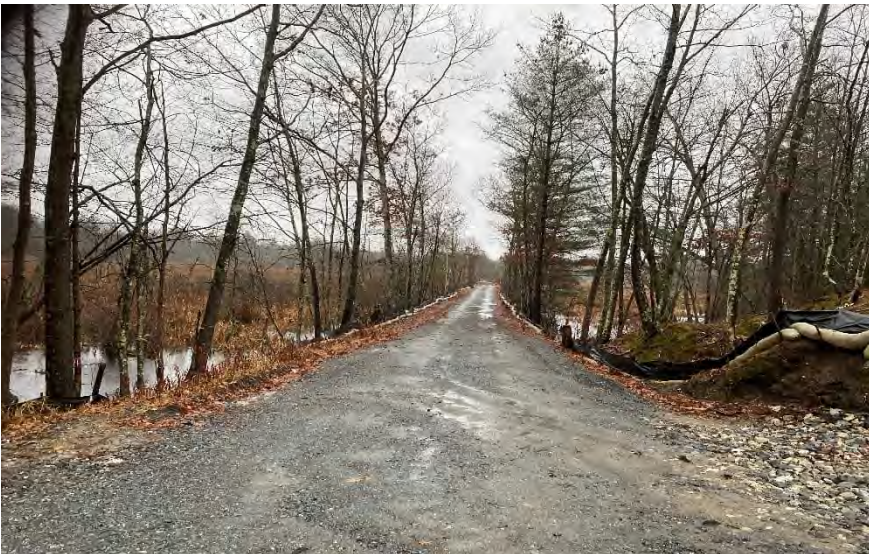
PHOTOGRAPHIC LOG	
Client Name: Eversource		Site Location: Sudbury to Hudson Transmission Reliability Project	
Photo No.: 5 Date: 12-18-23		Town: Hudson	
Description: Work area within segment 2, existing erosion control, looking eastward.

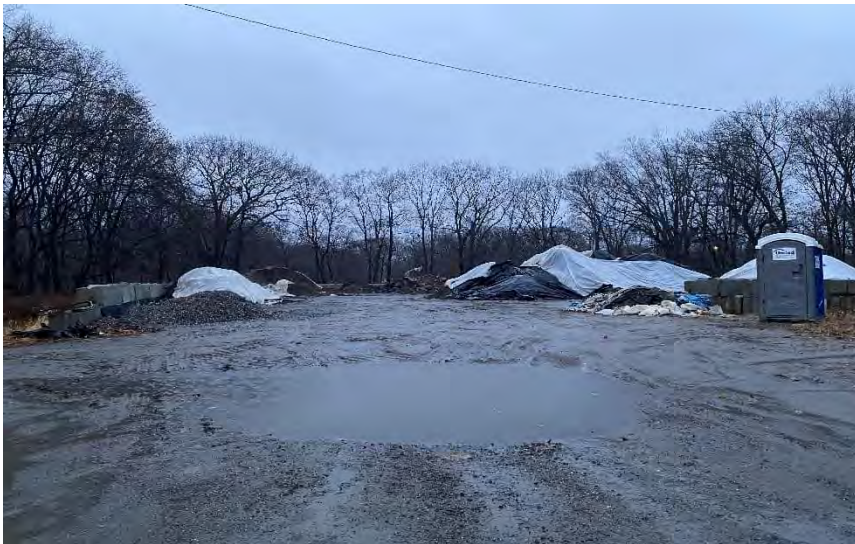
PHOTOGRAPHIC LOG	
Client Name: Eversource		Site Location: Sudbury to Hudson Transmission Reliability Project	
Photo No.: 6 Date: 12-18-23		Town: Hudson	
Description: Stowe Court laydown yard, area flooded, spoil piles covered, looking southward.

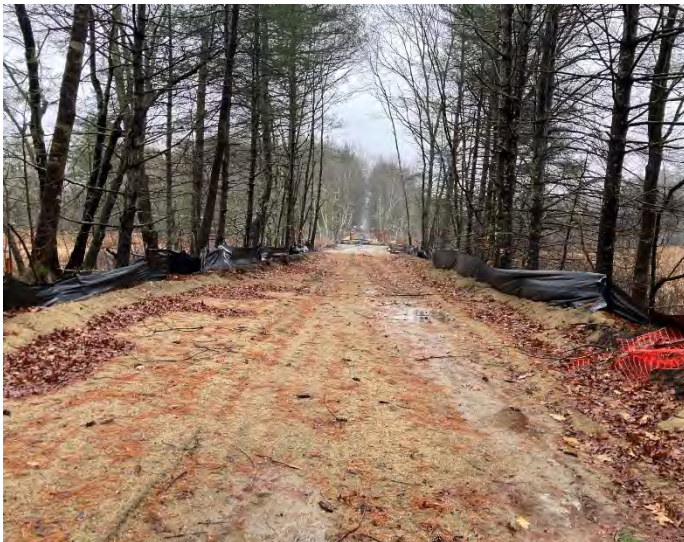
PHOTOGRAPHIC LOG	
Client Name: Eversource		Site Location: Sudbury to Hudson Transmission Reliability Project	
Town: Sudbury			
Photo No.: 1	Date: 12-18-2023

Description: View of E&S controls in segment 7. Facing east.

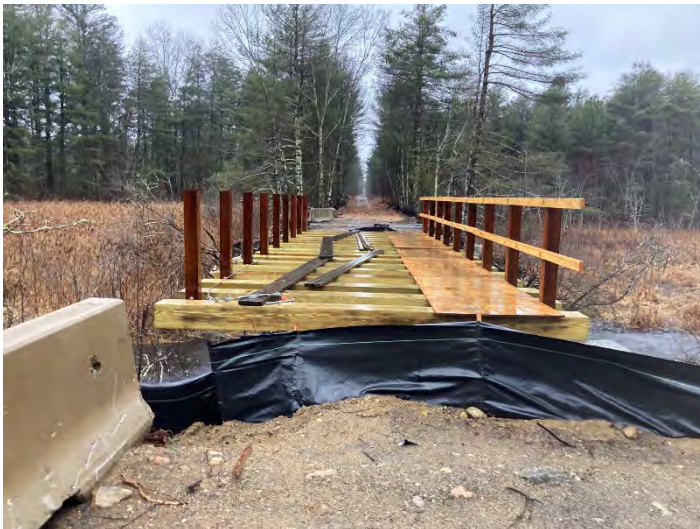
PHOTOGRAPHIC LOG	
Client Name: Eversource		Site Location: Sudbury to Hudson Transmission Reliability Project	
Town: Sudbury			
Photo No.: 2	Date: 12-18-2023

Description: View of Bridge 128. Facing west.

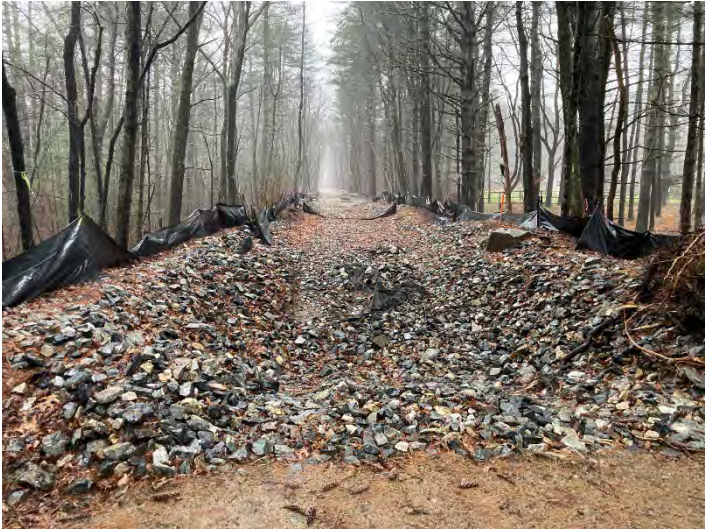
PHOTOGRAPHIC LOG	
Client Name: Eversource		Site Location: Sudbury to Hudson Transmission Reliability Project	
Town: Sudbury			
Photo No.: 3	Date: 12-18-2023

Description: View of collapsed culvert area in segment 9. No issues noted at time of inspection. Facing west.

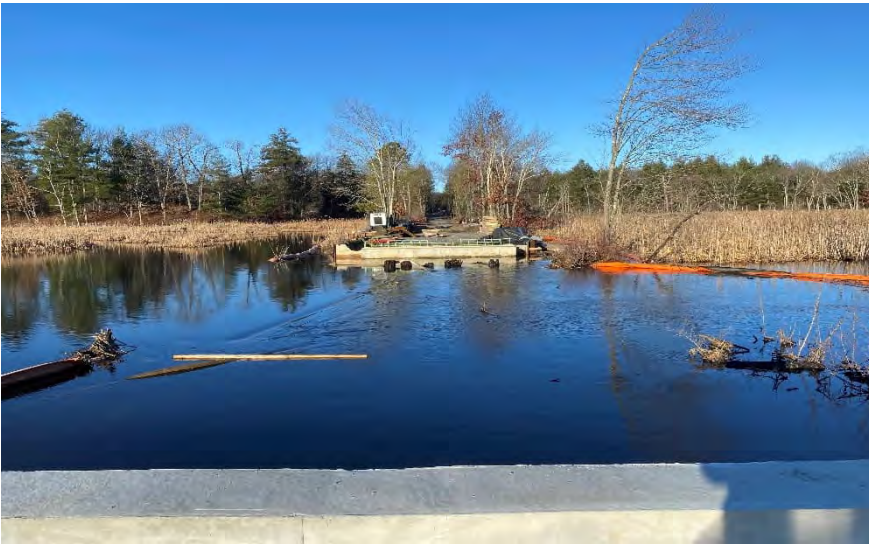
PHOTOGRAPHIC LOG	
Client Name: Eversource		Site Location: Sudbury to Hudson Transmission Reliability Project	
Town: Hudson			
Photo No.: 1	Date: 12-21-23

Description: Work area from segment 3 across Fort Meadow Brook toward segment 2 (bridge 130 area), looking westward.

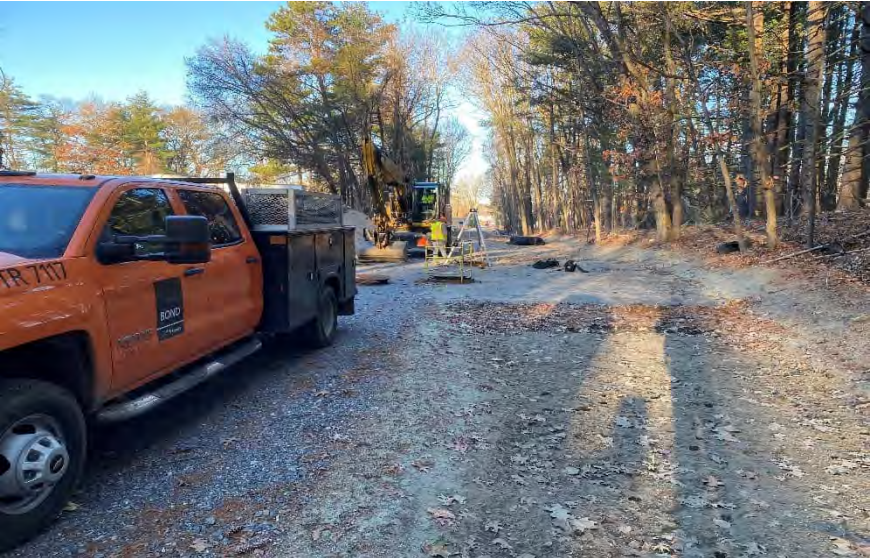
PHOTOGRAPHIC LOG	
Client Name: Eversource		Site Location: Sudbury to Hudson Transmission Reliability Project	
Town: Hudson			
Photo No.: 3	Date: 12-21-23

Description: Proofing at manhole #9, segment 3, looking westward.

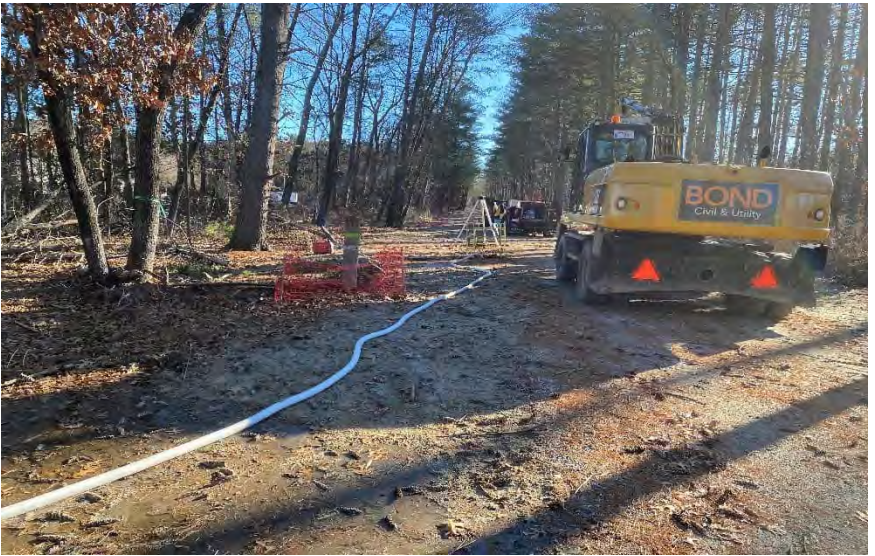
PHOTOGRAPHIC LOG	
Client Name: Eversource		Site Location: Sudbury to Hudson Transmission Reliability Project	
Town: Hudson			
Photo No.: 4	Date: 12-21-23

Description: Proofing at manhole #10, segment 4, looking eastward.

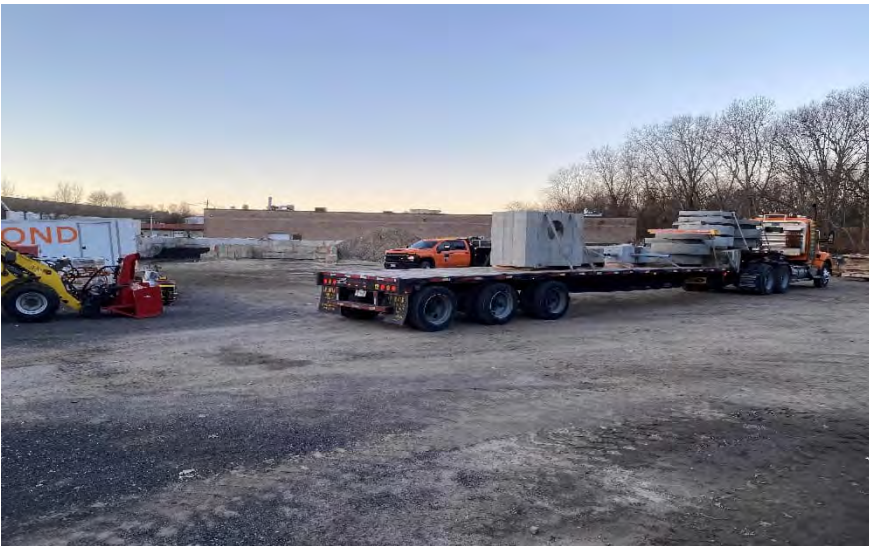
PHOTOGRAPHIC LOG	
Client Name: Eversource		Site Location: Sudbury to Hudson Transmission Reliability Project	
Town: Hudson			
Photo No.: 5	Date: 12-21-23

Description: Laydown yard at Bonazzoli Avenue, looking westward.

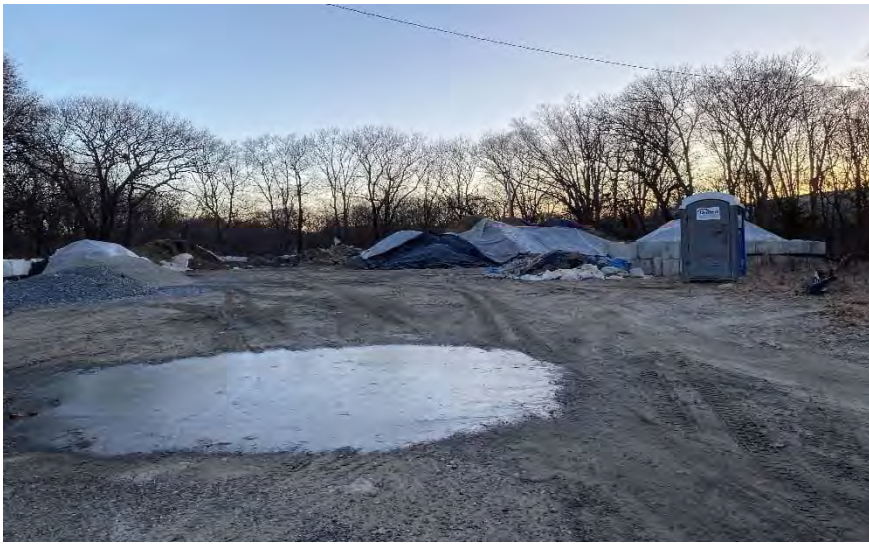
PHOTOGRAPHIC LOG	
Client Name: Eversource		Site Location: Sudbury to Hudson Transmission Reliability Project	
Town: Hudson			
Photo No.: 6	Date: 12-21-23

Description: Stowe Court laydown yard, spoil piles covered, looking southward.

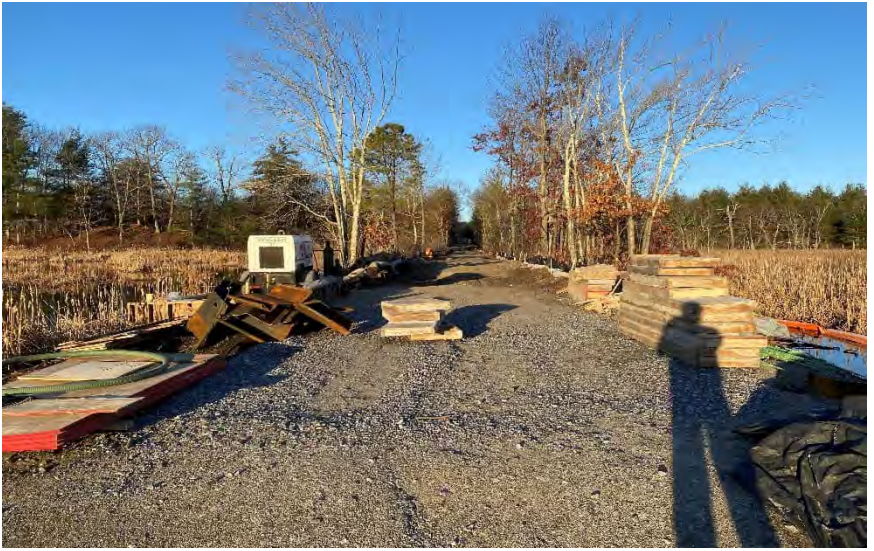
PHOTOGRAPHIC LOG	
Client Name: Eversource		Site Location: Sudbury to Hudson Transmission Reliability Project	
Town: Hudson			
Photo No.: 7	Date: 12-21-23

Description: Work area within segment 2, existing erosion control, looking westward.

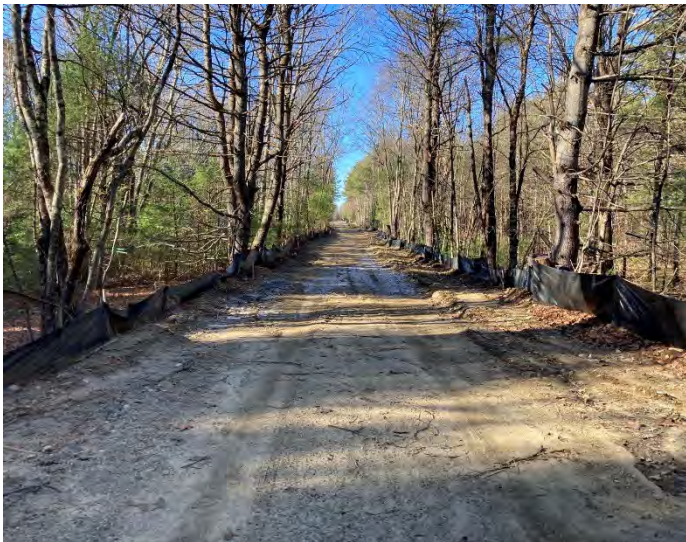
PHOTOGRAPHIC LOG	
Client Name: Eversource		Site Location: Sudbury to Hudson Transmission Reliability Project	
Town: Sudbury			
Photo No.: 1	Date: 12-21-2023		
Description: View of E&S controls in segment 7. Facing west.

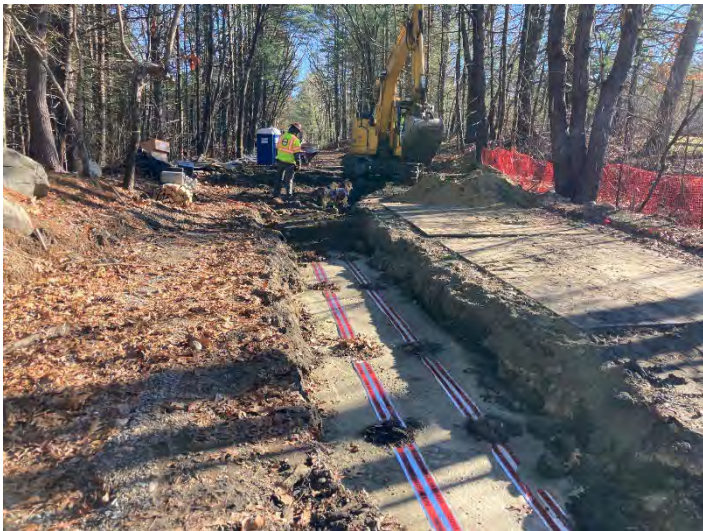
PHOTOGRAPHIC LOG	
Client Name: Eversource		Site Location: Sudbury to Hudson Transmission Reliability Project	
Town: Sudbury			
Photo No.: 2	Date: 12-21-2023		
Description: View of Bond installing ductbank in segment 8. See additional dewatering inspection report. Facing east.

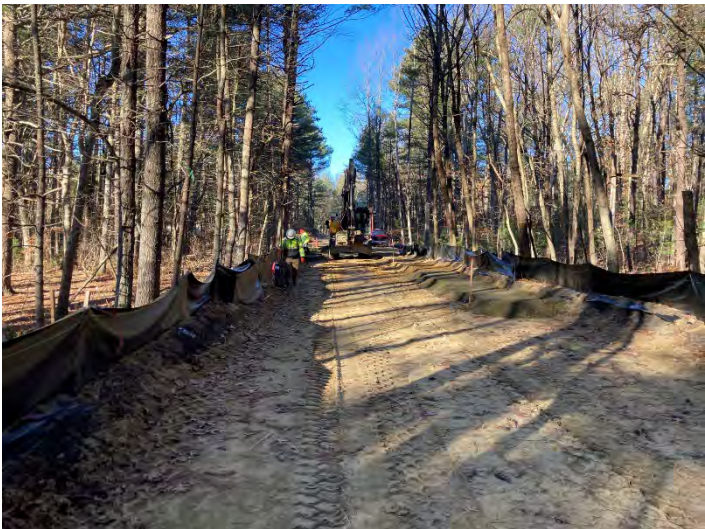
PHOTOGRAPHIC LOG	
Client Name: Eversource		Site Location: Sudbury to Hudson Transmission Reliability Project	
Town: Sudbury			
Photo No.: 4	Date: 12-21-2023

Description: View of ET&L working in segment 10. Facing west.

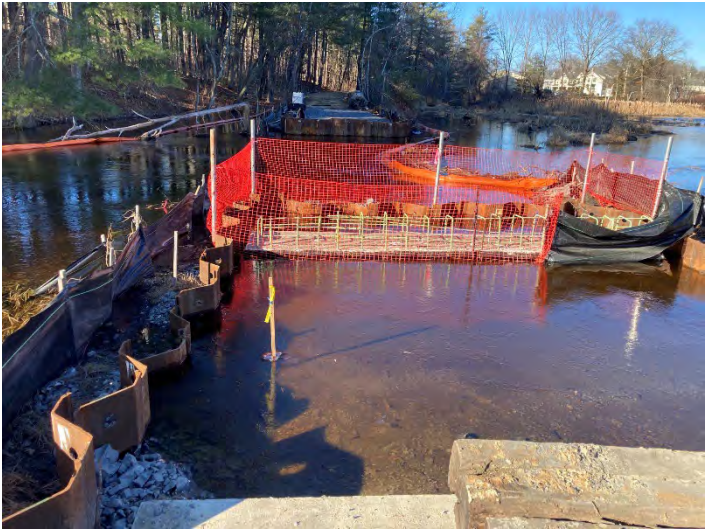
PHOTOGRAPHIC LOG	
Client Name: Eversource		Site Location: Sudbury to Hudson Transmission Reliability Project	
Town: Sudbury			
Photo No.: 7	Date: 12-21-2023

Description: View of Bridge 127. Facing west.

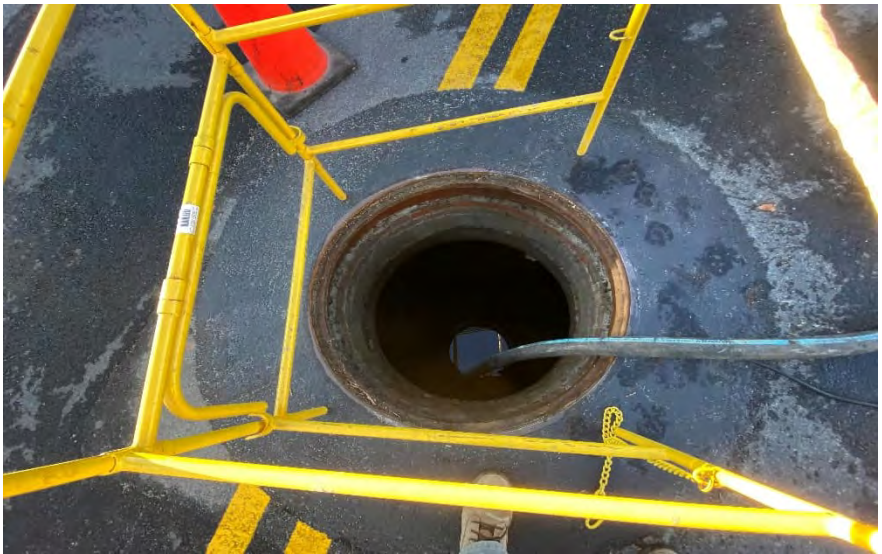
PHOTOGRAPHIC LOG	
Client Name: Eversource		Site Location: Sudbury to Hudson Transmission Reliability Project	
Town: Hudson			
Photo No.: 1	Date: 12/19/2023

Description: View of area being pumped at manhole #3.

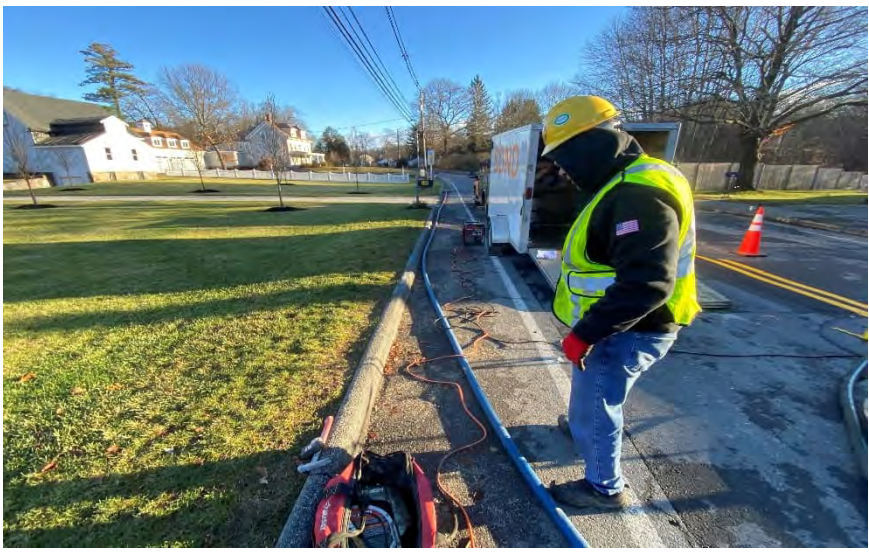
PHOTOGRAPHIC LOG	
Client Name: Eversource		Site Location: Sudbury to Hudson Transmission Reliability Project	
Town: Hudson			
Photo No.: 2	Date: 12/19/2023

Description: View of pumping operation within Forest Avenue at manhole #3, looking northward.

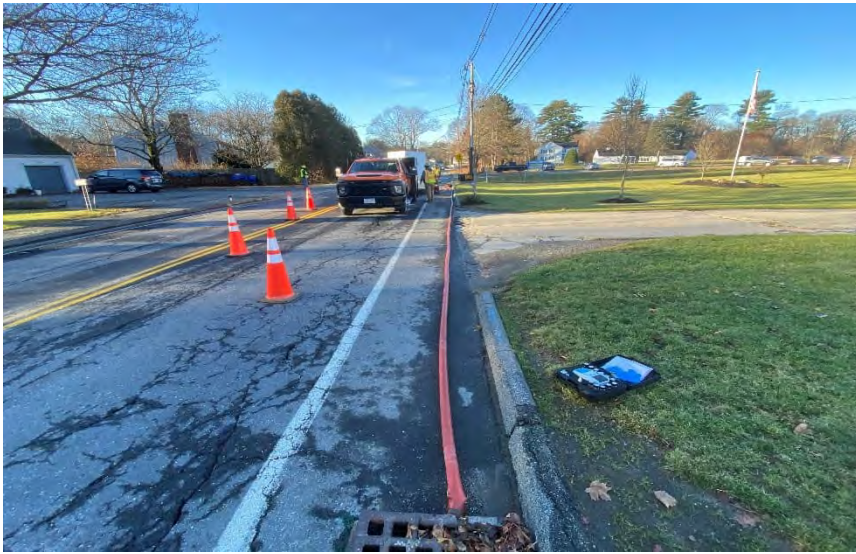
PHOTOGRAPHIC LOG	
Client Name: Eversource		Site Location: Sudbury to Hudson Transmission Reliability Project	
Photo No.: 3 Date: 12/19/2023

Description: Manhole #3. View of discharge dewatering operation, looking southward.

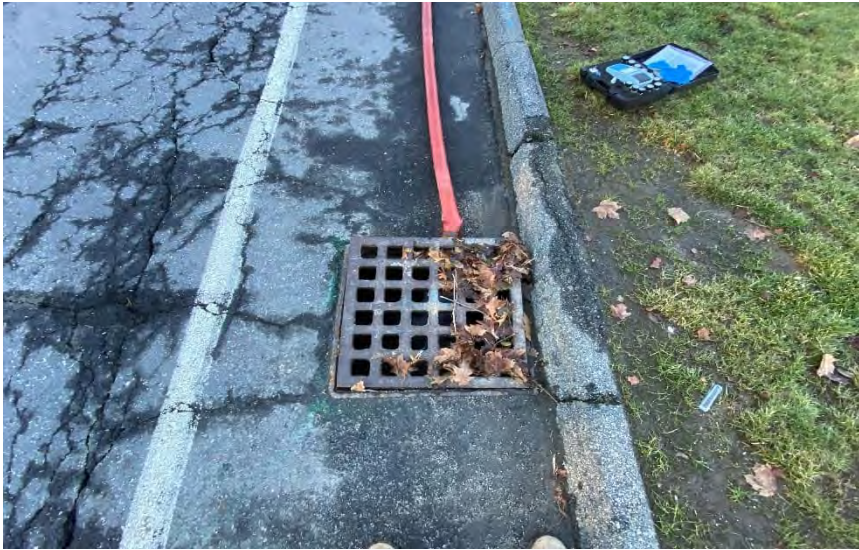
PHOTOGRAPHIC LOG	
Client Name: Eversource		Site Location: Sudbury to Hudson Transmission Reliability Project	
Photo No.: 4 Date: 12/19/2023

Description: Manhole #3. View of discharge from manhole to adjacent catch basin within Forest Avenue. Water discharge to basin appeared to be clear.

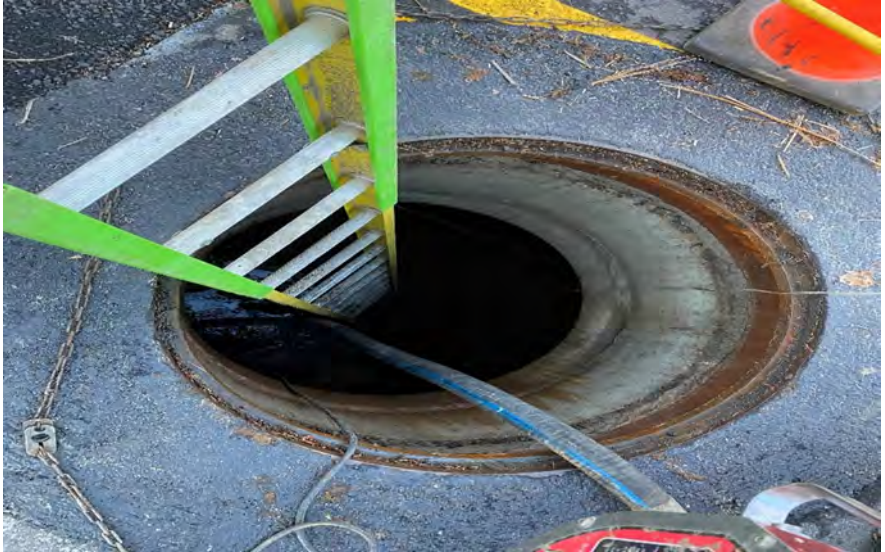
PHOTOGRAPHIC LOG	
Client Name: Eversource		Site Location: Sudbury to Hudson Transmission Reliability Project	
Photo No.: 1		Town: Hudson	
Date: 12/19/2023

Description: View of area being pumped at manhole #4.

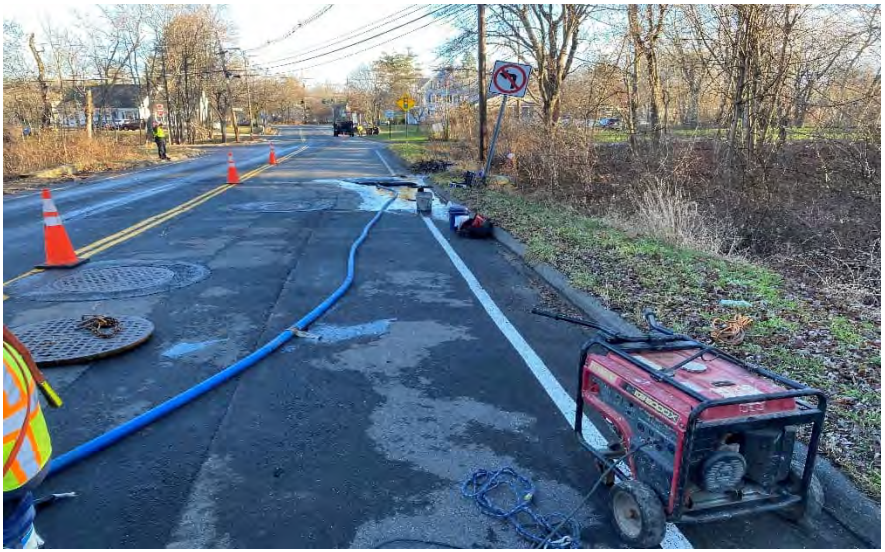
PHOTOGRAPHIC LOG	
Client Name: Eversource		Site Location: Sudbury to Hudson Transmission Reliability Project	
Photo No.: 2		Town: Hudson	
Date: 12/19/2023

Description: View of pumping operation within Forest Avenue at manhole #4, looking northward.

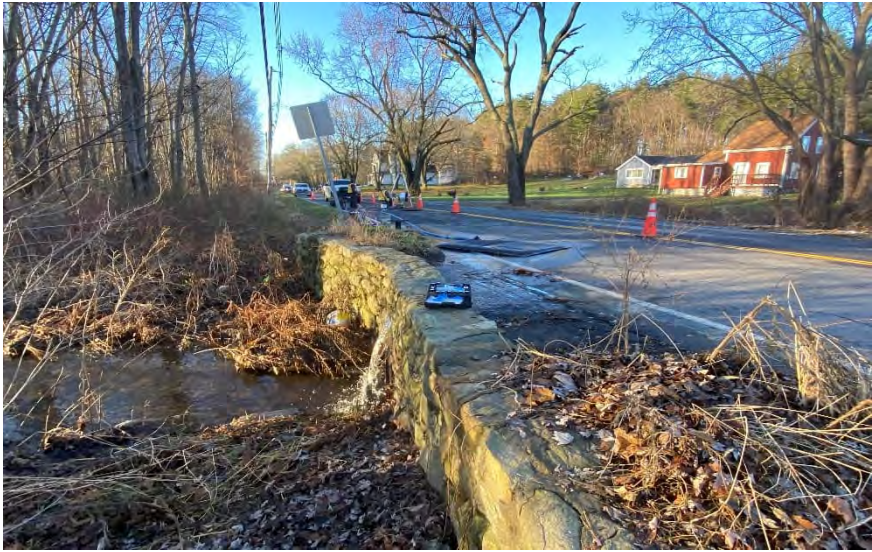
Description: Manhole #4. View of discharge from bag to adjacent stream area off Forest Avenue, looking southward. Water discharge from bag appeared to be clear.
