Weekly Environmental Compliance Summary

Sudbury to Hudson Transmission Reliability Project (USEPA Tracking # MAR1003UW)

Week of: December 18, 2023 to December 22, 2023

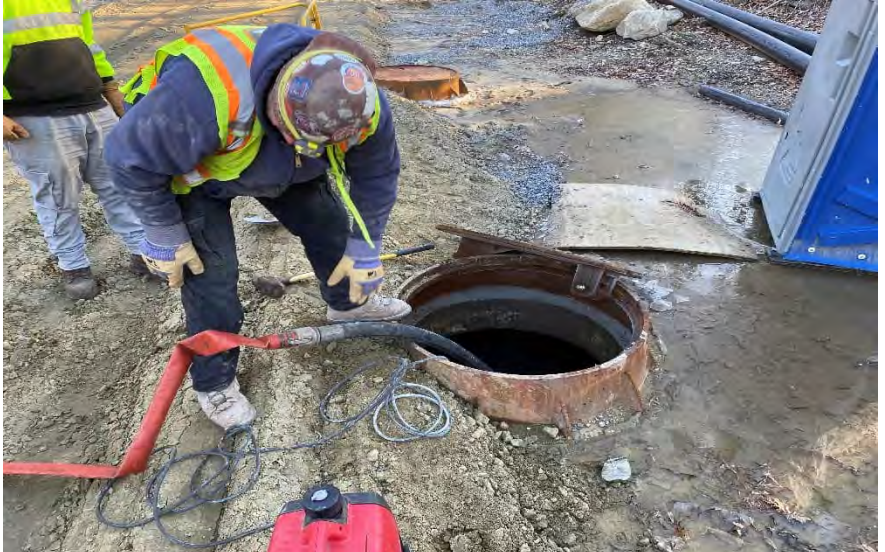
PHOTOGRAPHIC LOG	
Client Name: Eversource		Site Location: Sudbury to Hudson Transmission Reliability Project	
Photo No.: 1		Date: 12/20/2023	
Description: View of area being pumped from manhole #5 segment 1, looking eastward.

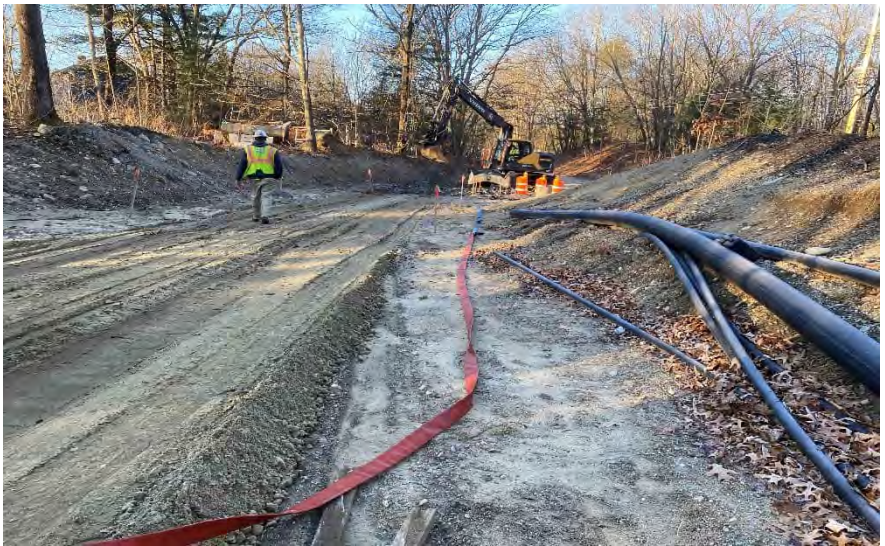
PHOTOGRAPHIC LOG	
Client Name: Eversource		Site Location: Sudbury to Hudson Transmission Reliability Project	
Photo No.: 2		Date: 12/20/2023	
Description: Manhole #5. View of dewatering operation. Looking westward.

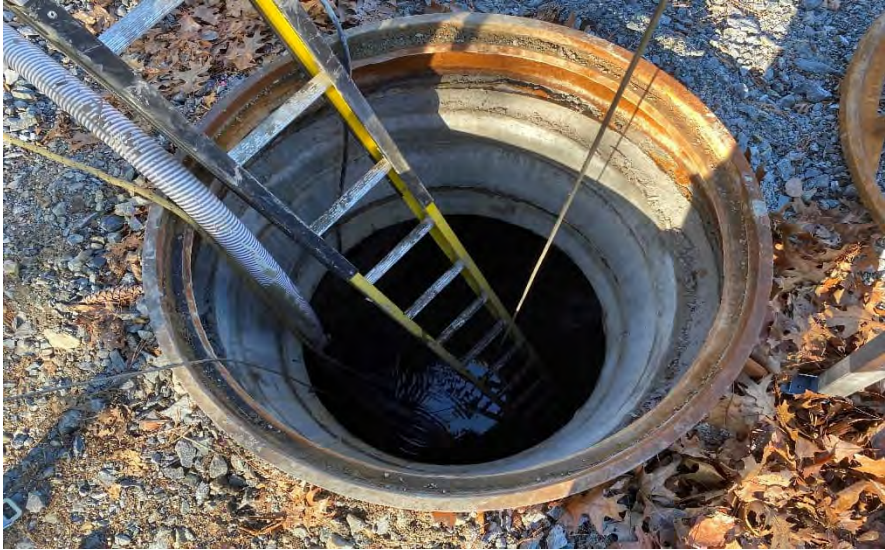
PHOTOGRAPHIC LOG	
Client Name: Eversource		Site Location: Sudbury to Hudson Transmission Reliability Project	
Photo No.: 1		Town: Hudson	
Date: 12/20/2023			
Description: View of area being pumped from manhole #8 segment 3, looking westward.

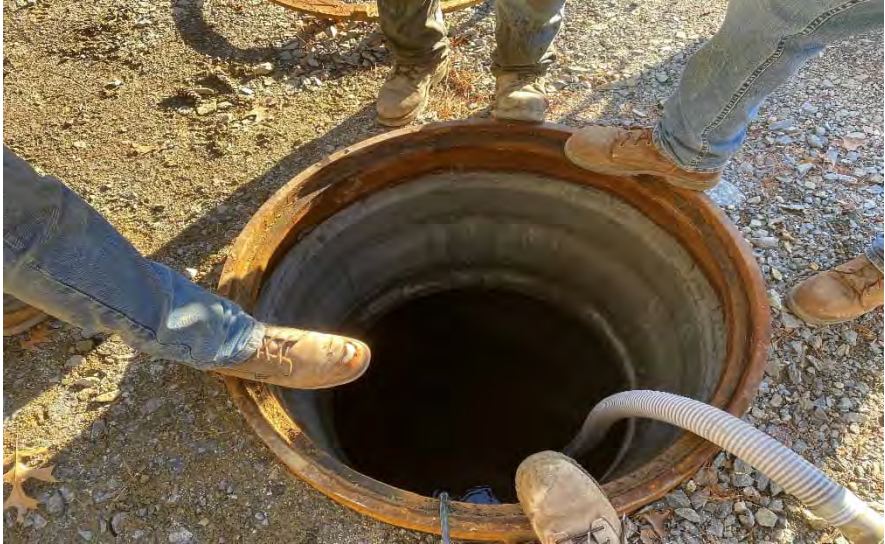
PHOTOGRAPHIC LOG	
Client Name: Eversource		Site Location: Sudbury to Hudson Transmission Reliability Project	
Photo No.: 1		Date: 12/20/2023	
Description: View of area being pumped from manhole #9 segment 3, looking eastward.

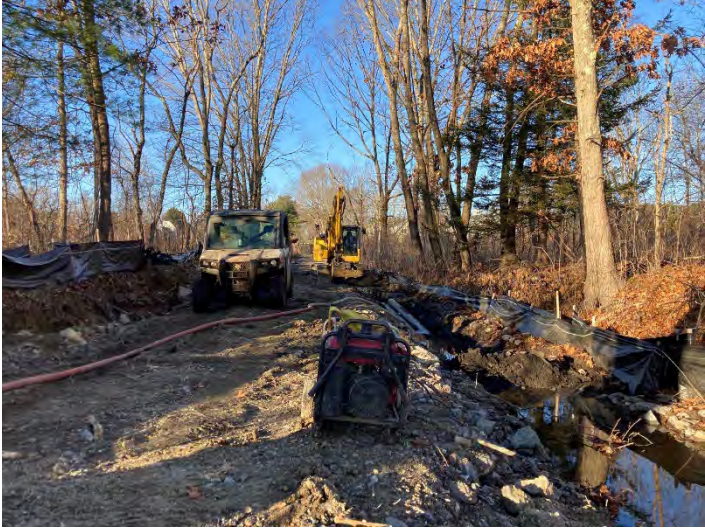
PHOTOGRAPHIC LOG	
Client Name: Eversource		Site Location: Sudbury to Hudson Transmission Reliability Project	
Town: Sudbury			
Photo No.: 1	Date: 12/20/2023

Description: View of Bond working in trench in segment 14. Facing west.

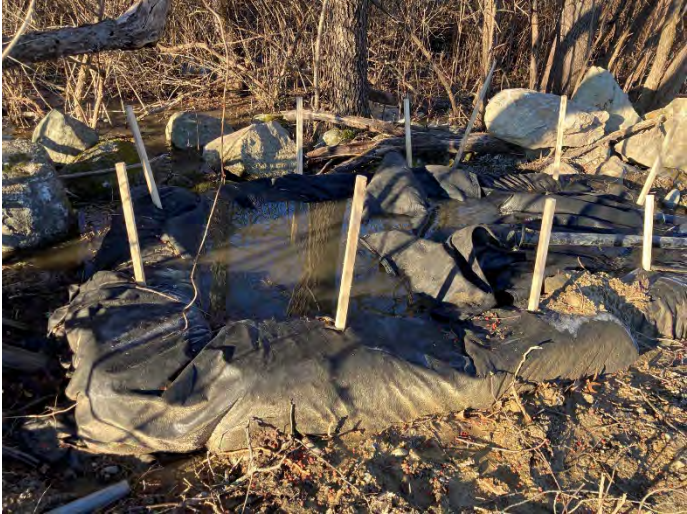
PHOTOGRAPHIC LOG	
Client Name: Eversource		Site Location: Sudbury to Hudson Transmission Reliability Project	
Photo No.: 3		Date: 12/20/2023	
Description: View of dewatering controls (straw bale corral with filter fabric and silt bag). Facing west.

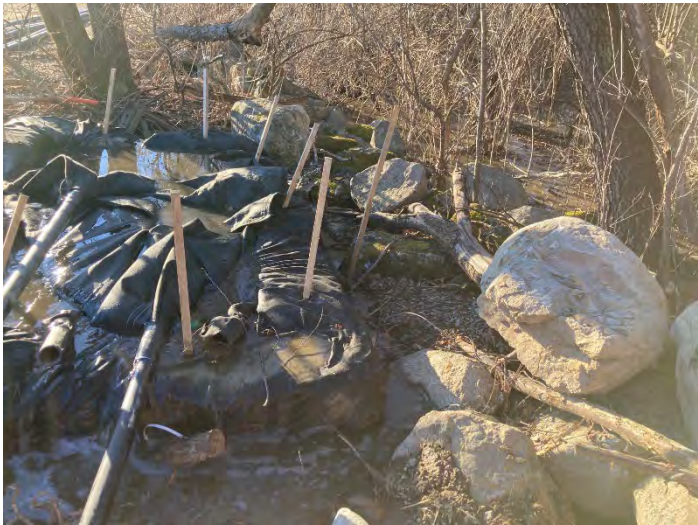
PHOTOGRAPHIC LOG	
Client Name: Eversource		Site Location: Sudbury to Hudson Transmission Reliability Project	
Photo No.: 4		Date: 12/20/2023	
Description: View of discharge from corral. Turbidity reading was higher than 50 NTUs, but discharge did not appear to be entering wetlands. Facing south.

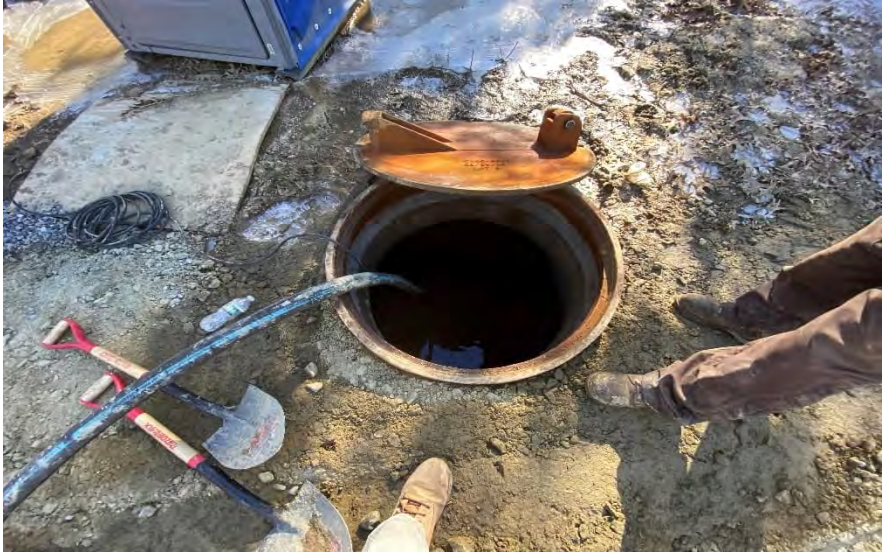
PHOTOGRAPHIC LOG	
Client Name: Eversource		Site Location: Sudbury to Hudson Transmission Reliability Project	
Photo No.: 1		Town: Hudson	
Date: 12/21/2023

Description: View of area being pumped from manhole #5 segment 1, looking westward.

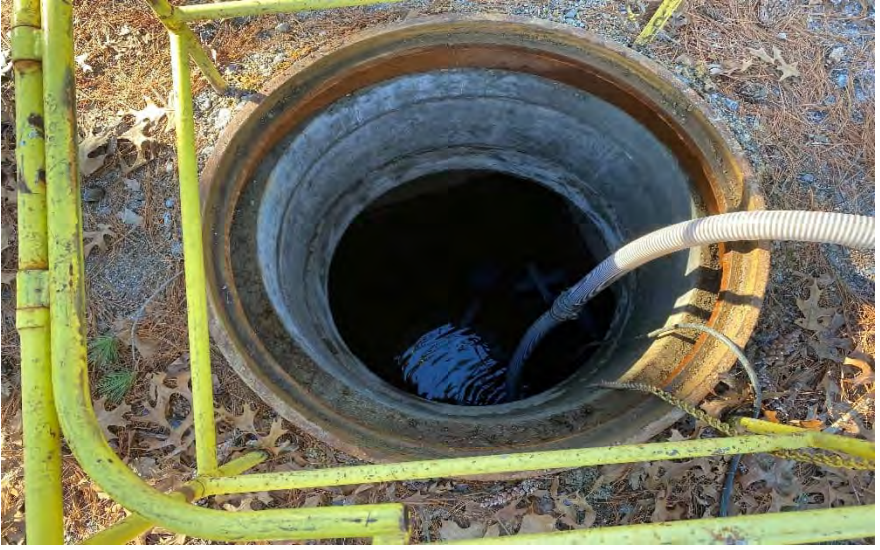
PHOTOGRAPHIC LOG	
Client Name: Eversource		Site Location: Sudbury to Hudson Transmission Reliability Project	
Photo No.: 1		Date: 12/21/2023	
Description: View of area being pumped from manhole #10 segment 4, looking eastward.

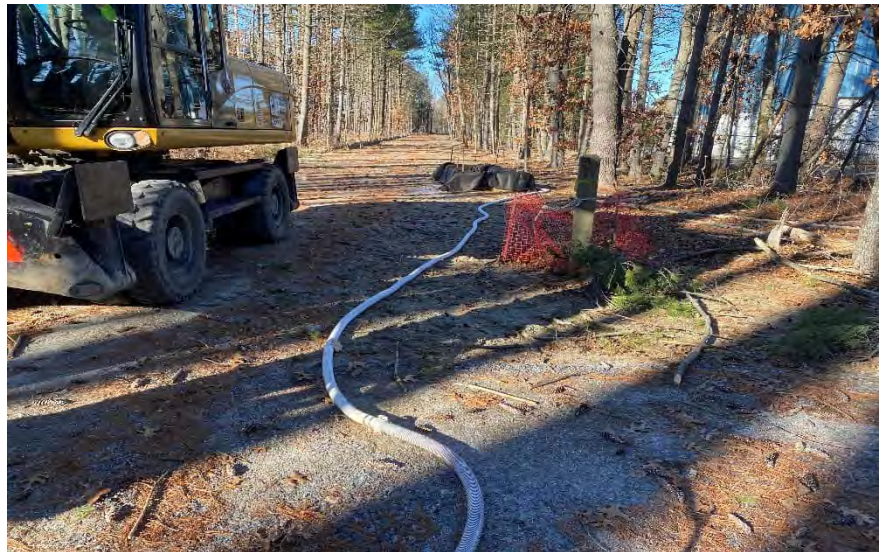
PHOTOGRAPHIC LOG	
Client Name: Eversource		Site Location: Sudbury to Hudson Transmission Reliability Project	
Photo No.: 2		Date: 12/21/2023	
Description: Manhole #10. View of dewatering operation. Looking westward.

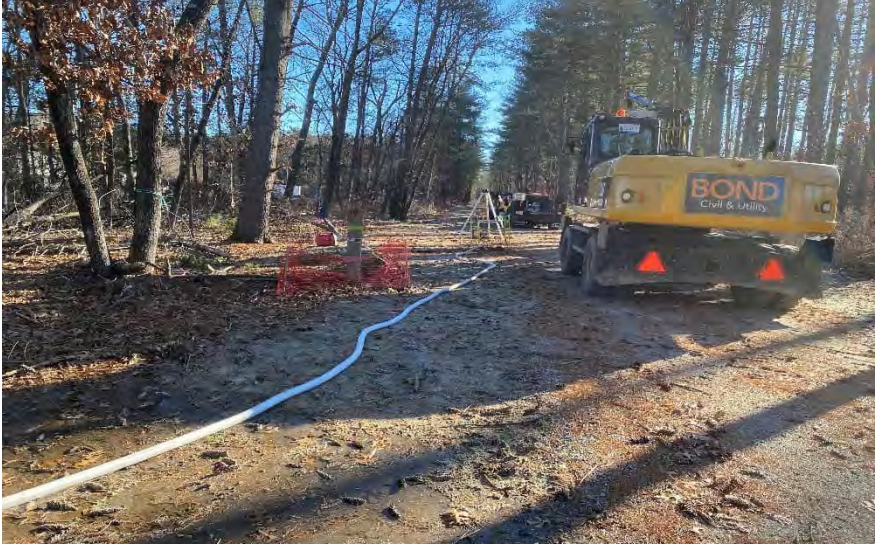
PHOTOGRAPHIC LOG	
Client Name: Eversource		Site Location: Sudbury to Hudson Transmission Reliability Project	
Photo No.: 3 Date: 12/21/2023		Town: Hudson	
Description: Manhole #10. View of dewatering operation, looking eastward.

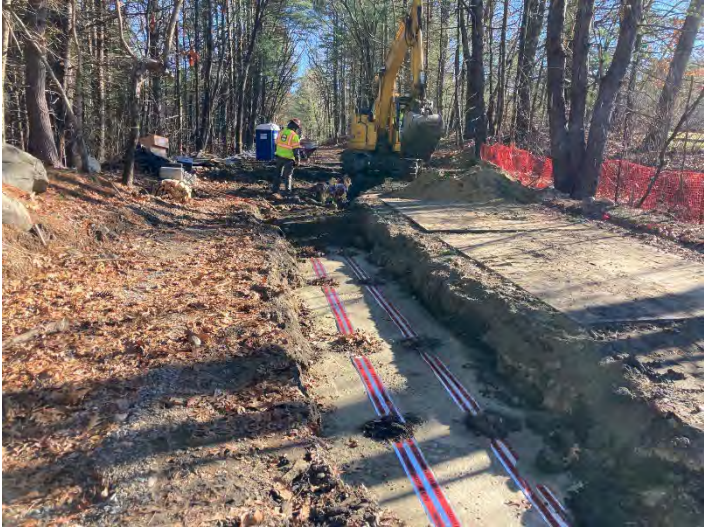
PHOTOGRAPHIC LOG	
Client Name: Eversource		Site Location: Sudbury to Hudson Transmission Reliability Project	
Photo No.: 1		Town: Sudbury	
Date: 12/21/2023

Description: View of Bond working in trench in segment 8. Facing east.

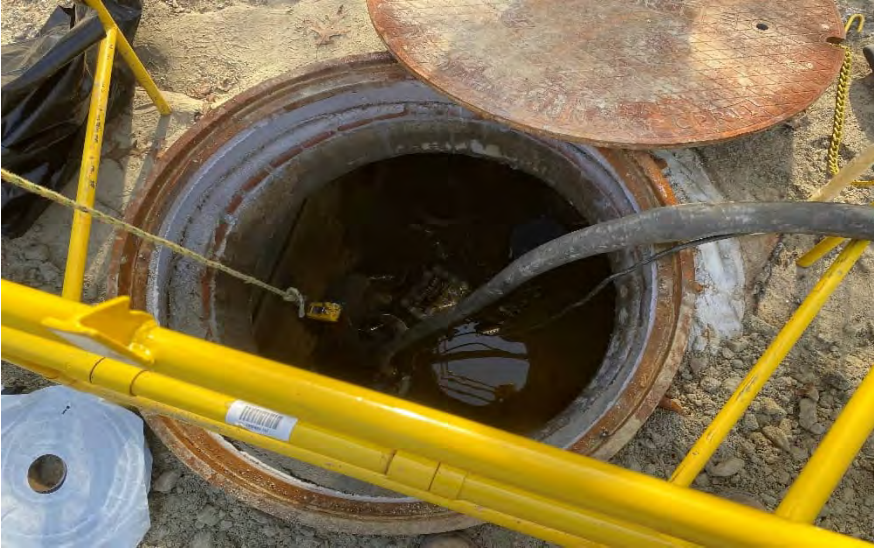
PHOTOGRAPHIC LOG	
Client Name: Eversource		Site Location: Sudbury to Hudson Transmission Reliability Project	
Photo No.: 1		Town: Hudson	
Date: 12/22/2023

Description: View of area being pumped from manhole #5 segment 1, looking westward.

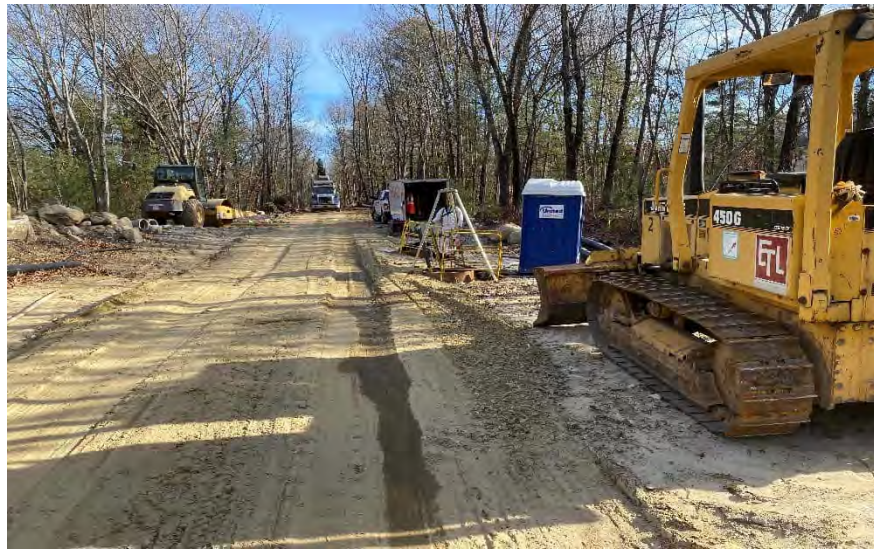
PHOTOGRAPHIC LOG	
Client Name: Eversource		Site Location: Sudbury to Hudson Transmission Reliability Project	
Photo No.: 2		Town: Hudson	
Date: 12/22/2023

Description: Manhole #5. View of dewatering operation. Looking eastward. Dewatering hose removed to allow trucks to pass by. Pump subsequently replaced in manhole.

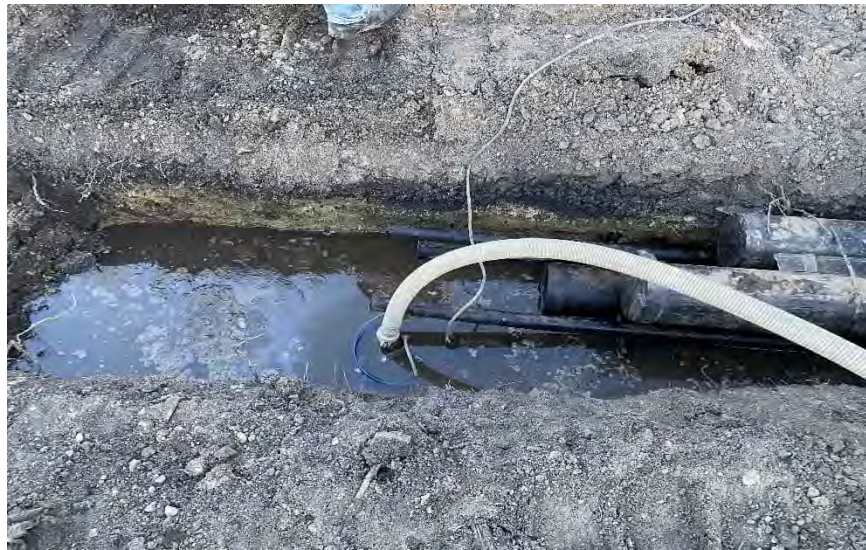
PHOTOGRAPHIC LOG	
Client Name: Eversource		Site Location: Sudbury to Hudson Transmission Reliability Project	
Photo No.: 2		Date: 12/22/2023	
Description: Segment 14. View of dewatering operation in trench. Looking northward.
