Weekly Environmental Compliance Summary

Sudbury to Hudson Transmission Reliability Project (USEPA Tracking # MAR1003UW)

Week of: December 25, 2023 to December 29, 2023

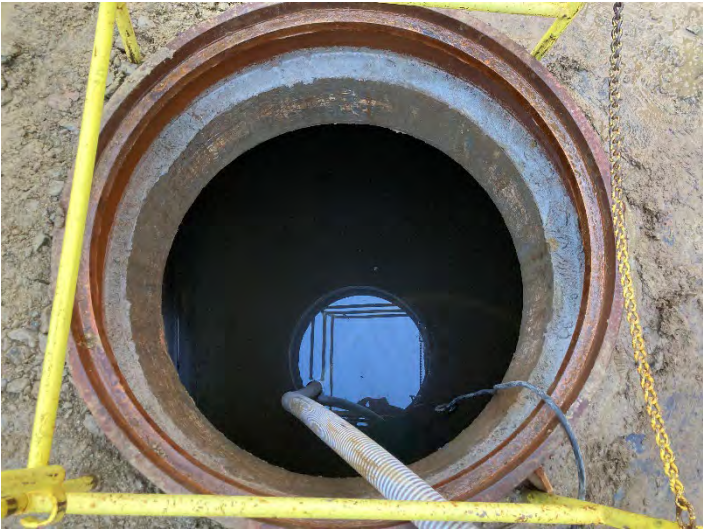
| <p>Photo No.: 1</p> | <p>Date: 12/26/2023</p> | | |

| <p>Description: View of pumping operation at MH #5 in segment 1. See additional dewatering inspection reports.</p> | | | |

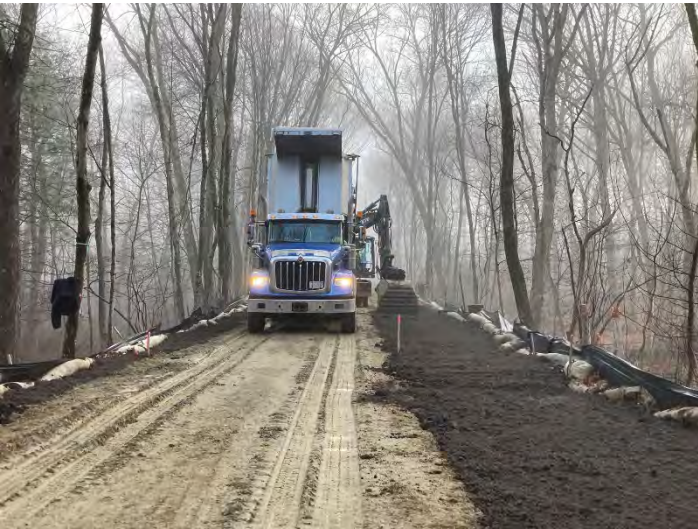
| <p>Photo No.: 2</p> | <p>Date: 12/26/2023</p> | | |

| <p>Description: View of ET&L installing loam in segment 1. Facing east.</p> | | | |

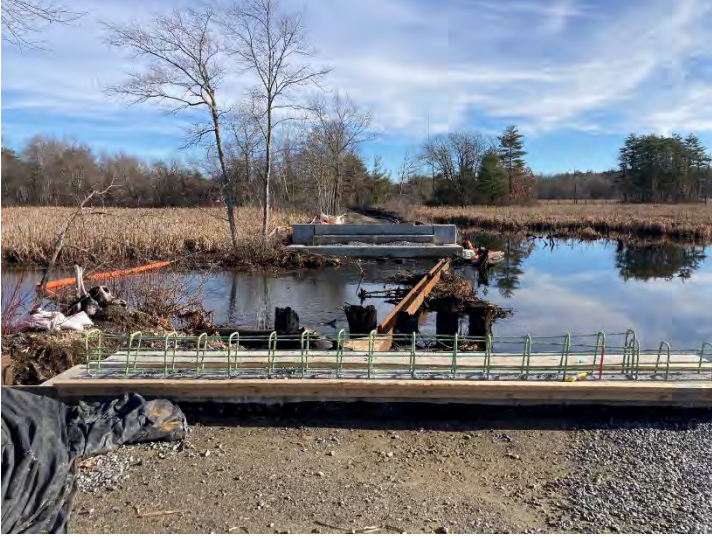
| <p>Photo No.: 3</p> | <p>Date: 12/26/2023</p> | | |

| <p>Description: View of Bridge 130. Facing east.</p> | | | |

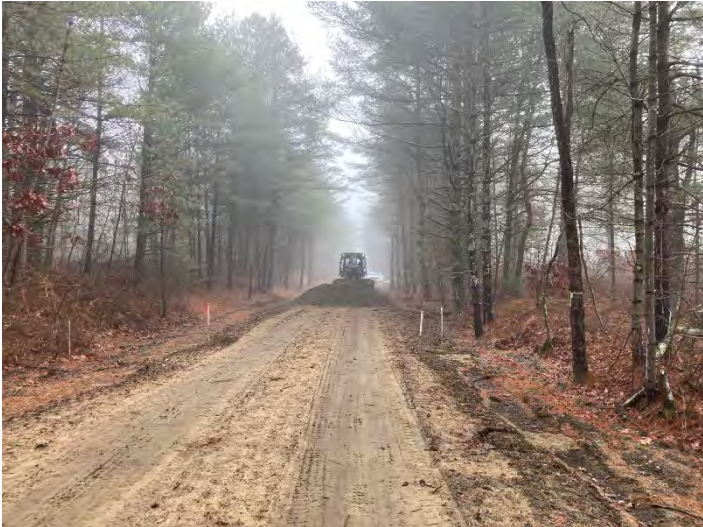
| <p>Photo No.: 4</p> | <p>Date: 12/26/2023</p> | | |

| <p>Description: View of ET&L working in segment 7. Facing west.</p> | | | |

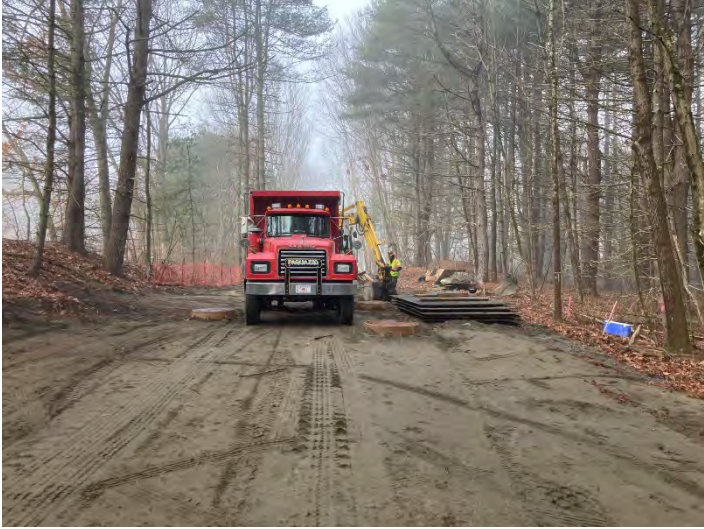
| <p>Photo No.: 5</p> | <p>Date: 12/26/2023</p> | | |

| <p>Description: View of Bond working in segment 8. Facing west.</p> | | | |

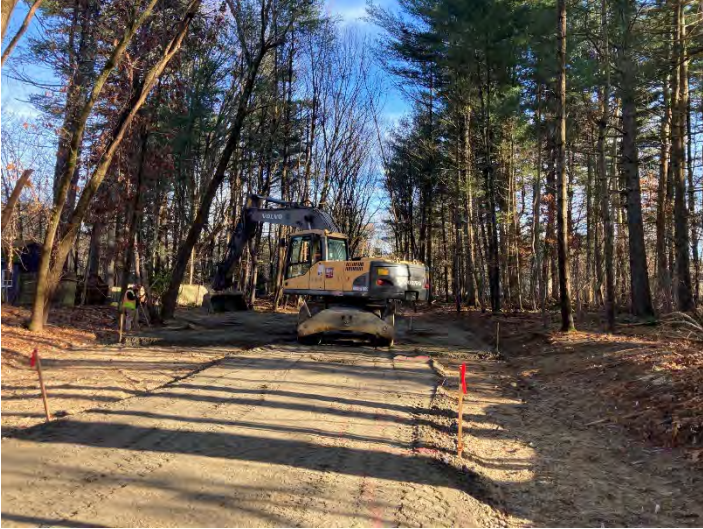
| <p>Photo No.: 7</p> | <p>Date: 12/26/2023</p> | | |

| <p>Description: View of ET&L working in segment 10. Facing east.</p> | | | |

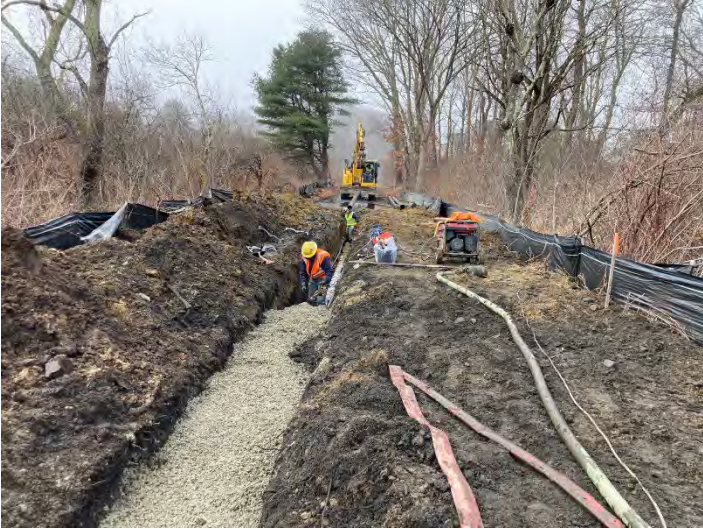
| <p>Photo No.: 8</p> | <p>Date: 12/26/2023</p> | | |

| <p>Description: View of Bond installing conduit and ductbank in segment 14. See additional dewatering inspection report. Facing west.</p> | | | |

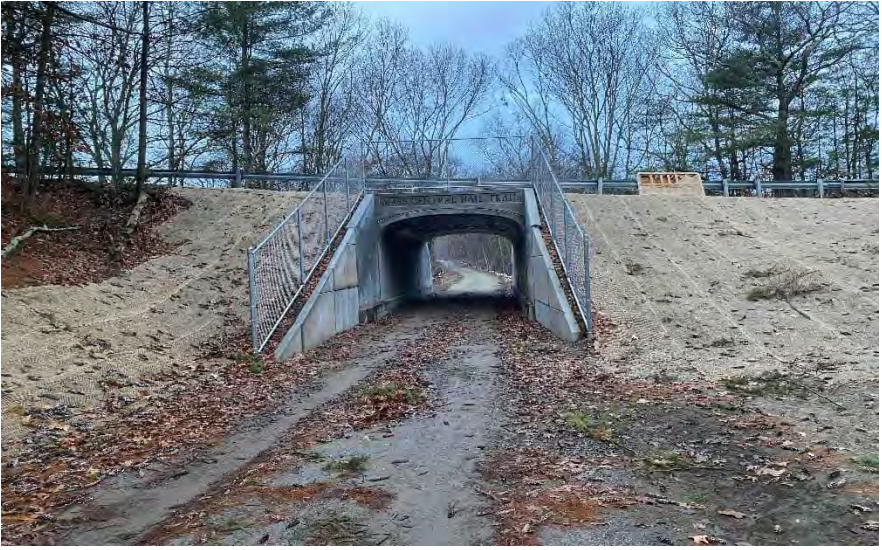
| <p>Photo No.: 1</p> | <p>Date: 12-27-23</p> | | |

| <p>Description:</p> <p>Work area within segment 2, Chestnut Street crossing, looking westward.</p> | | | |

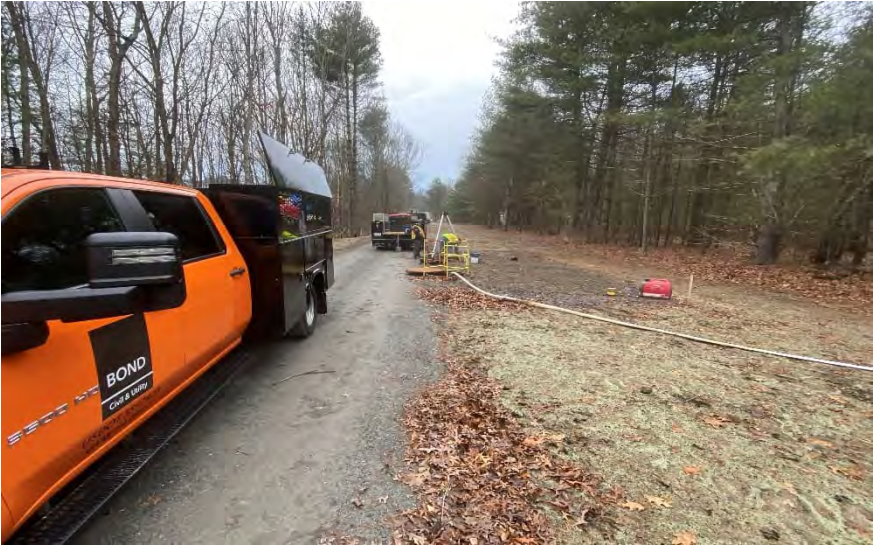
| <p>Photo No.: 3</p> | <p>Date: 12-27-23</p> | | |

| <p>Description:</p> <p>Bond conducting proofing work at manhole #7 (segment 2), looking westward.</p> | | | |

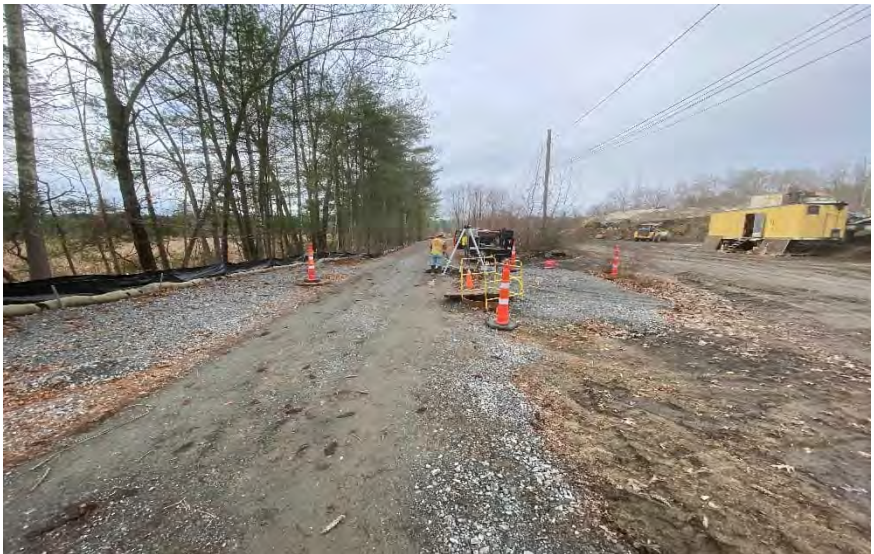
| <p>Photo No.: 4</p> | <p>Date: 12-27-23</p> | | |

| <p>Description:</p> <p>Bond conducting proofing work at manhole #8 (segment 3), looking westward.</p> | | | |

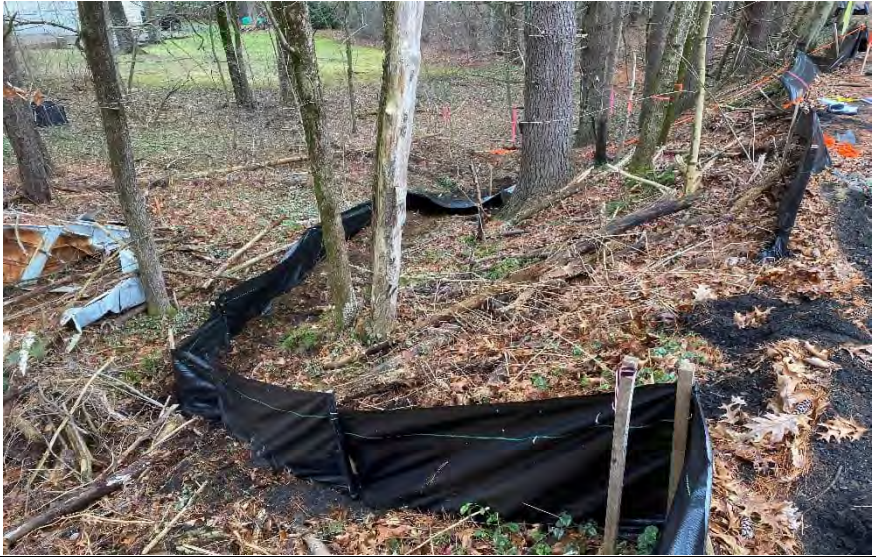
| <p>Photo No.: 5</p> | <p>Date: 12-27-23</p> | | |

| <p>Description:</p> <p>Work area within segment 9, additional silt fencing prior to culvert replacement, looking eastward.</p> | | | |

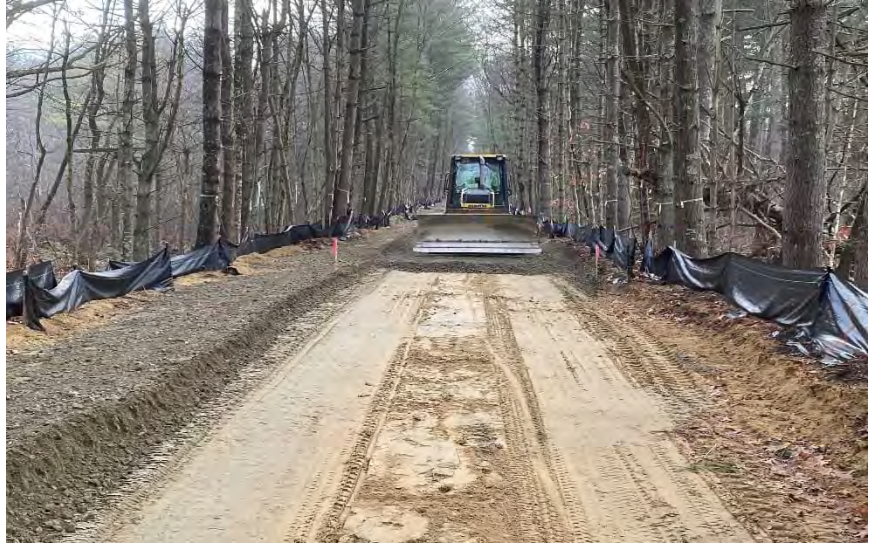
| <p>Photo No.: 6</p> | <p>Date: 12-27-23</p> | | |

| <p>Description:</p> <p>Work area within segment 10, grading work, existing erosion control, looking eastward.</p> | | | |

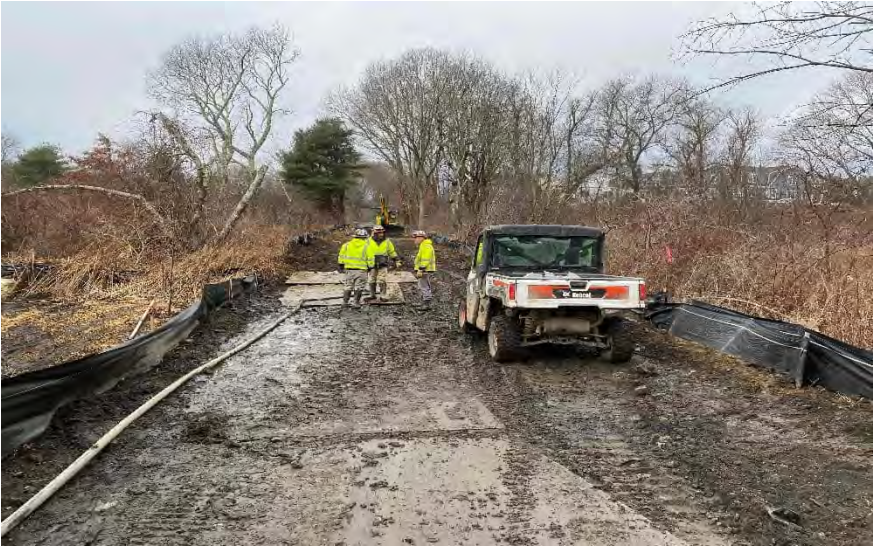
| <p>Photo No.: 7</p> | <p>Date: 12-27-23</p> | | |

| <p>Description:</p> <p>Work area within Segment 14, conduit work, existing erosion control, looking westward.</p> | | | |

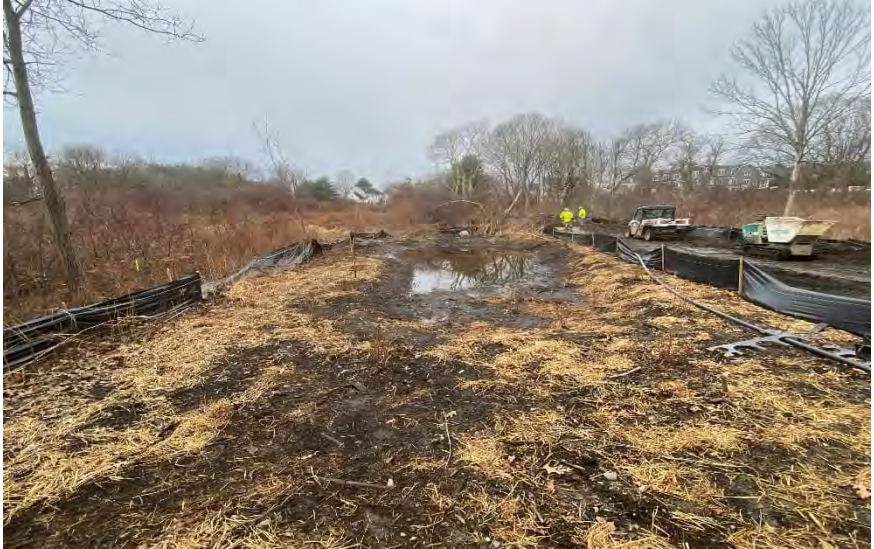
| <p>Photo No.: 8</p> | <p>Date: 12-27-23</p> | | |

| <p>Description:</p> <p>Wetland replication area within Segment 14, existing erosion control, looking westward.</p> | | | |

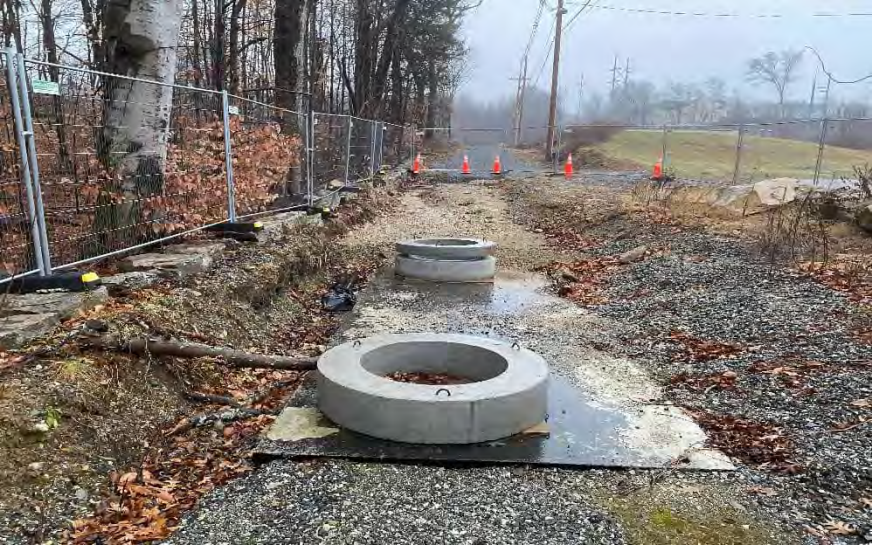
| <p>Photo No.: 2</p> | <p>Date: 12-29-23</p> | | |

| <p>Description:</p> <p>Manhole #1, off Forest Avenue, looking eastward.</p> | | | |

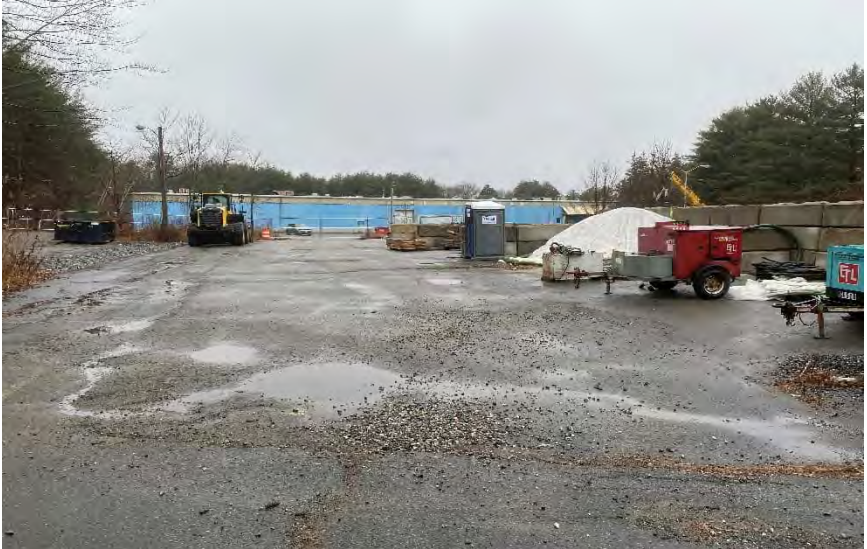
| Photo No.: 4 | Date: 12-29-23 | | |

| Description: Main Street laydown yard, looking northward. | | | |

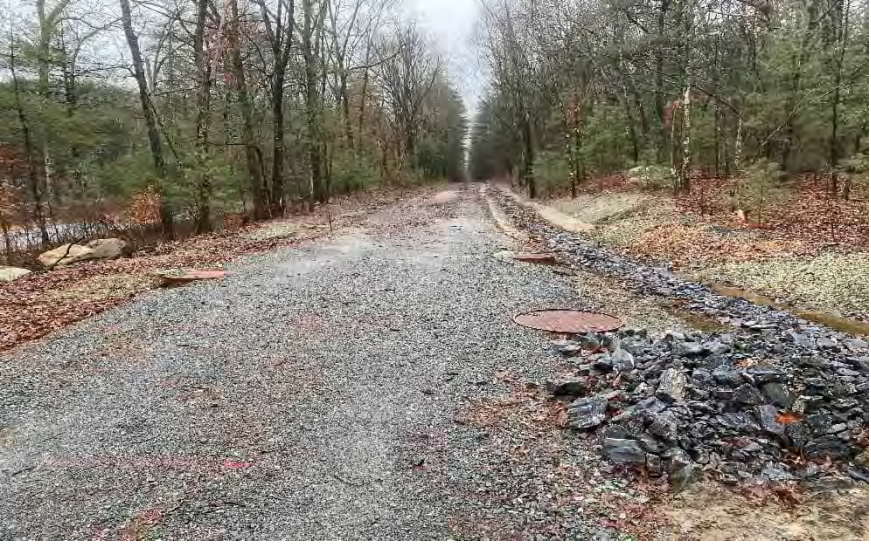
| Photo No.: 6 | Date: 12-29-23 | | |

| Description: Work area within Segment 5, manhole #12 area, looking westward. | | | |

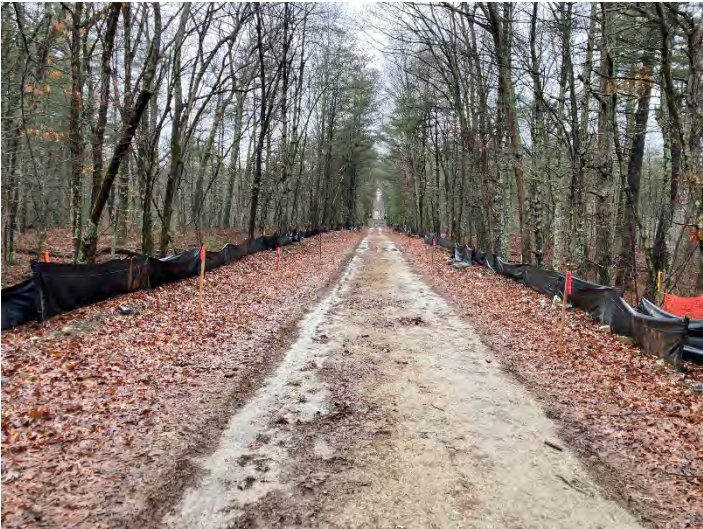
| <p>Photo No.: 1</p> | <p>Date: 12/29/2023</p> | | |

| <p>Description: View of E&S controls in segment 8. Facing west.</p> | | | |

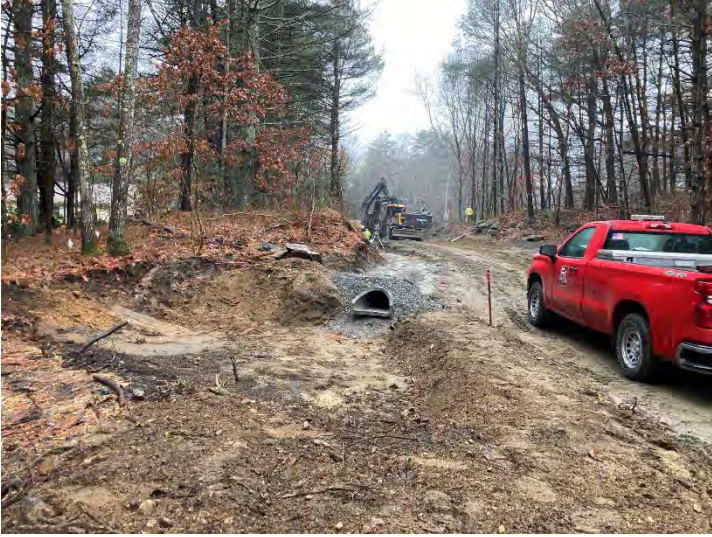
| <p>Photo No.: 3</p> | <p>Date: 12/29/2023</p> | | |

| <p>Description: View of newly installed storm drainage in segment 10. Facing west.</p> | | | |

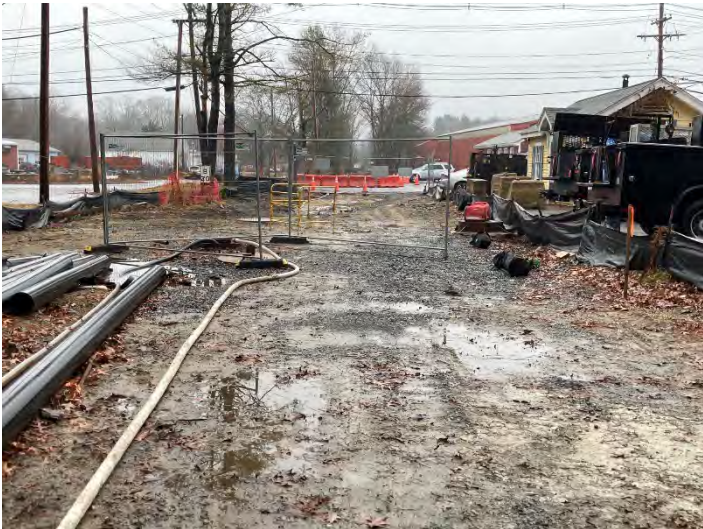
| <p>Photo No.: 4</p> | <p>Date: 12/29/2023</p> | | |

| <p>Description: View of pumping operation at MH #24 in segment 11. See additional dewatering inspection report. Facing east.</p> | | | |

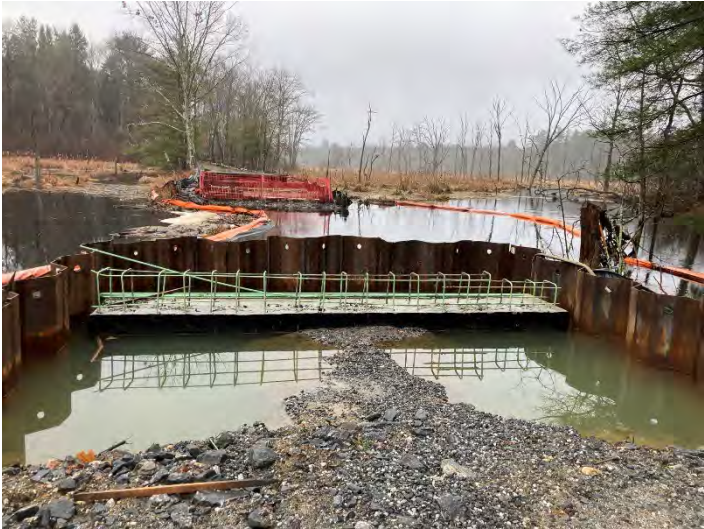
| <p>Photo No.: 5</p> | <p>Date: 12/29/2023</p> | | |

| <p>Description: View of Bridge 127. Facing east.</p> | | | |

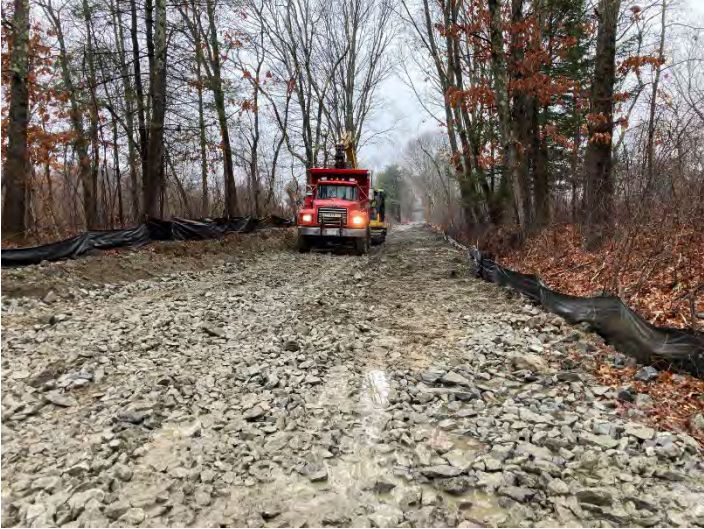
| <p>Photo No.: 6</p> | <p>Date: 12/29/2023</p> | | |

| <p>Description: View of Bond working at east end of in segment 14. Facing west.</p> | | | |

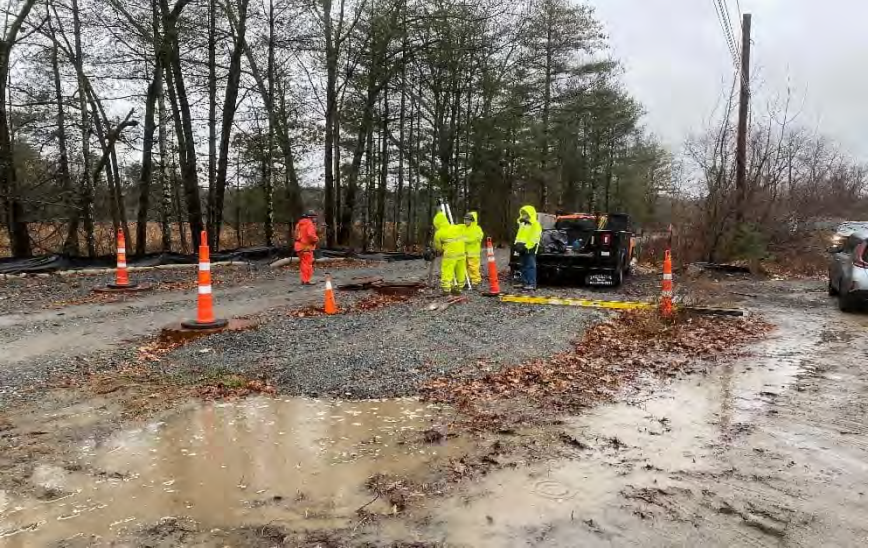
| Photo No.: 2 | Date: 12-28-23 | | |

| Description: Proofing at manhole #8, segment 3, looking westward. | | | |

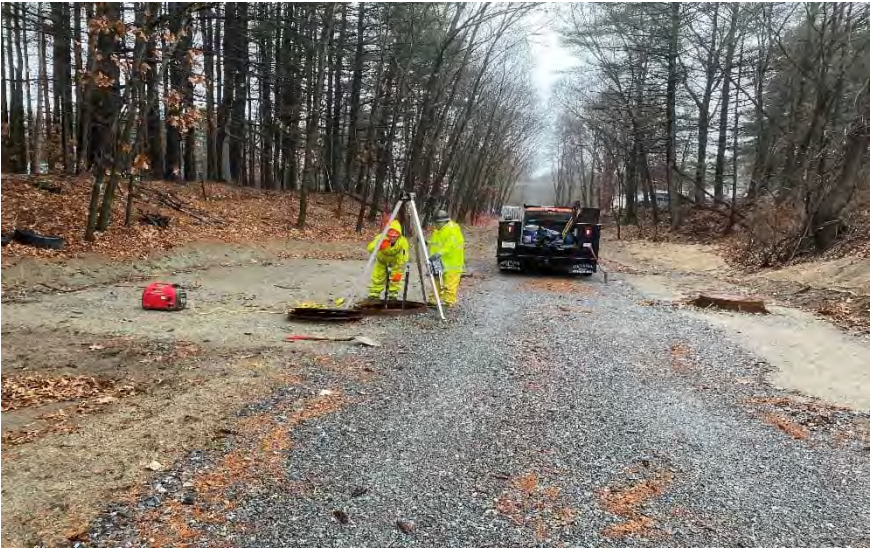
| Photo No.: 3 | Date: 12-28-23 | | |

| Description: Proofing at manhole #9, segment 3, looking westward. | | | |

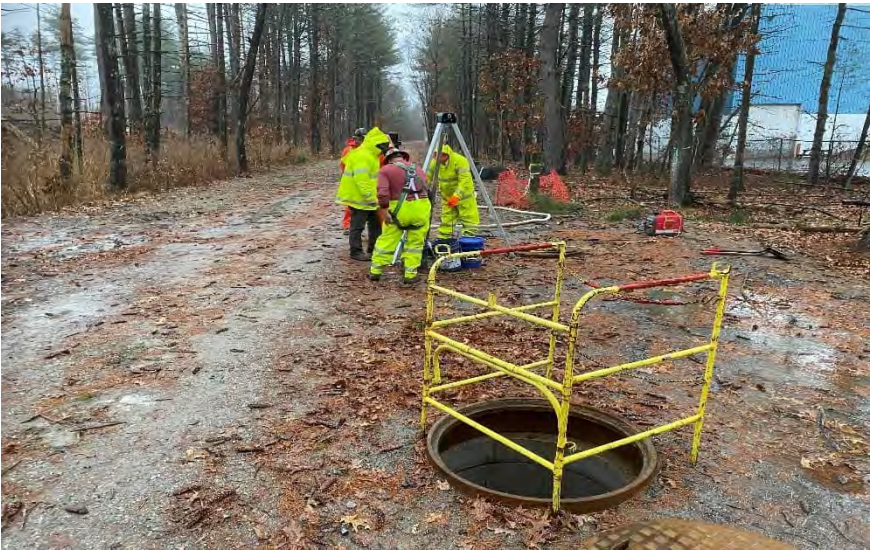
| Photo No.: 4 | Date: 12-28-23 | | |

| Description: Proofing at manhole #10, segment 4, looking eastward. | | | |

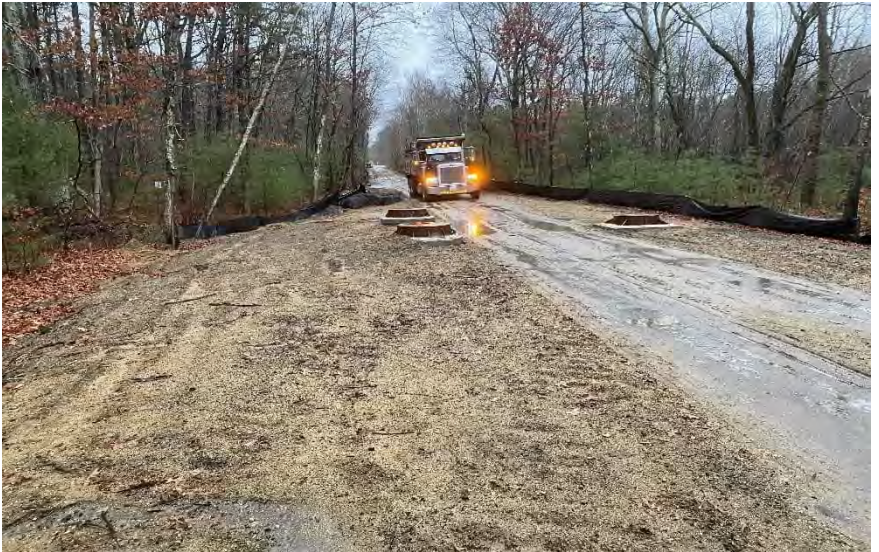
| Photo No.: 6 | Date: 12-28-23 | | |

| Description: Work area within segment 6, manhole #14 area, looking eastward. | | | |

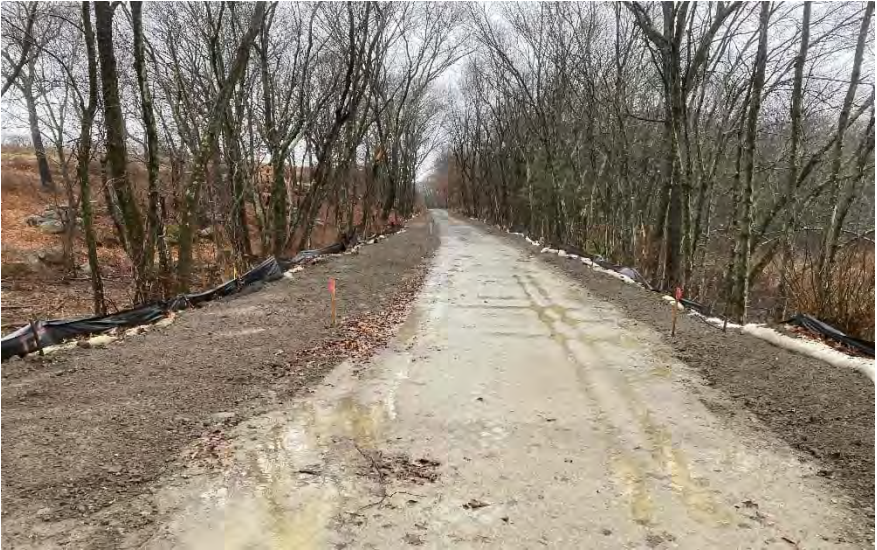
| Photo No.: 8 | Date: 12-28-23 | | |

| Description: Work area within segment 1, existing erosion control, looking westward. | | | |

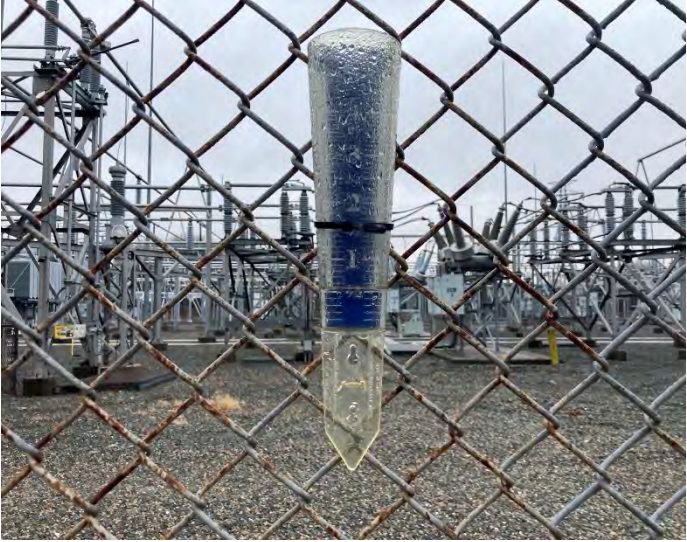
| Photo No.: 1 | Date: 12-28-2023 | | |

| Description: View of rain gauge at Sudbury Substation. 0.50" observed in gauge. Facing south. | | | |

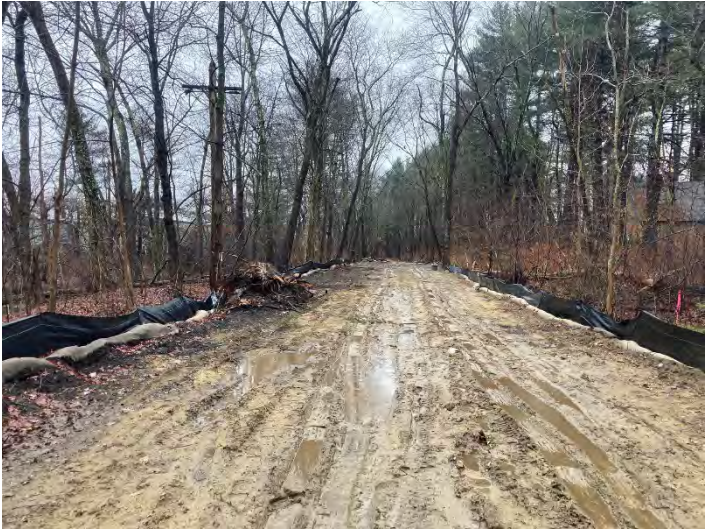
| Photo No.: 3 | Date: 12-28-2023 | | |

| Description: View of E&S controls in segment 13. Facing east. | | | |

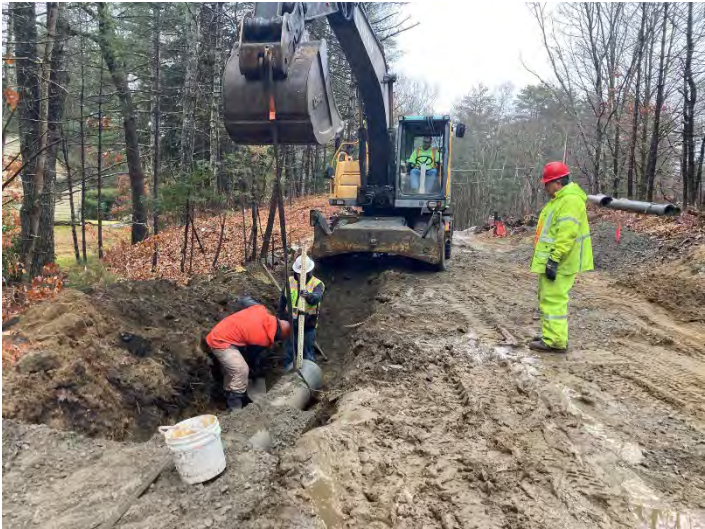
| Photo No.: 4 | Date: 12-28-2023 | | |

| Description: View of ET&L installing storm drainage structure in segment 10. Facing west. | | | |

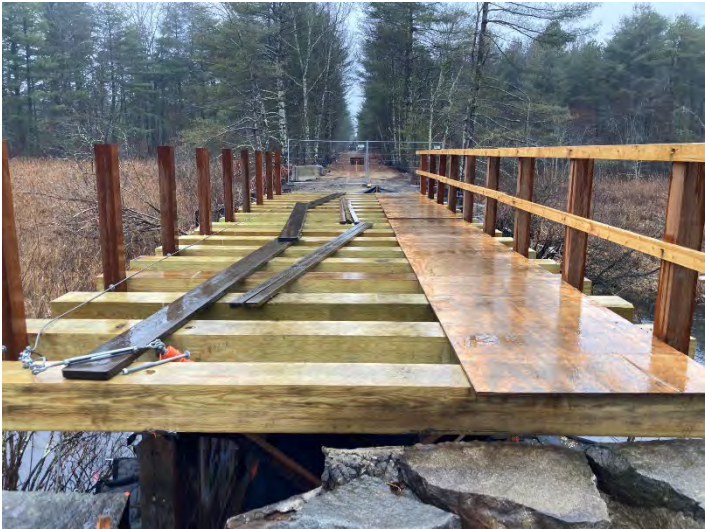
| Photo No.: 7 | Date: 12-28-2023 | | |

| Description: View of Bridge 128. Facing west. | | | |

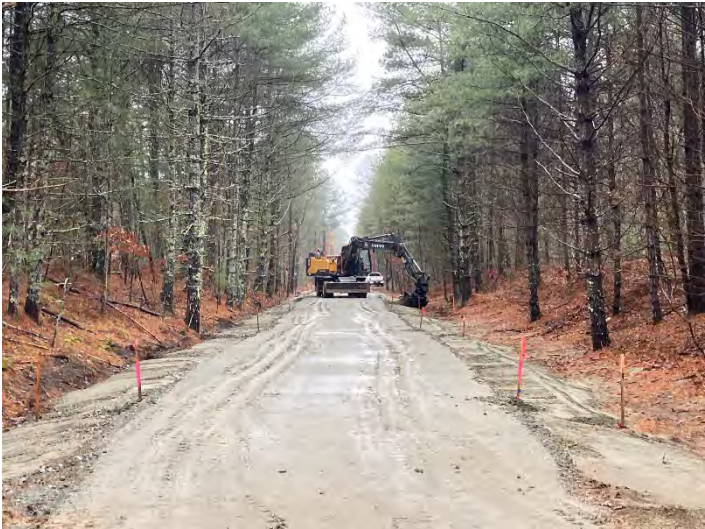
| Photo No.: 8 | Date: 12-28-2023 | | |

| Description: View of ET&L working in segment 7. Facing west. | | | |

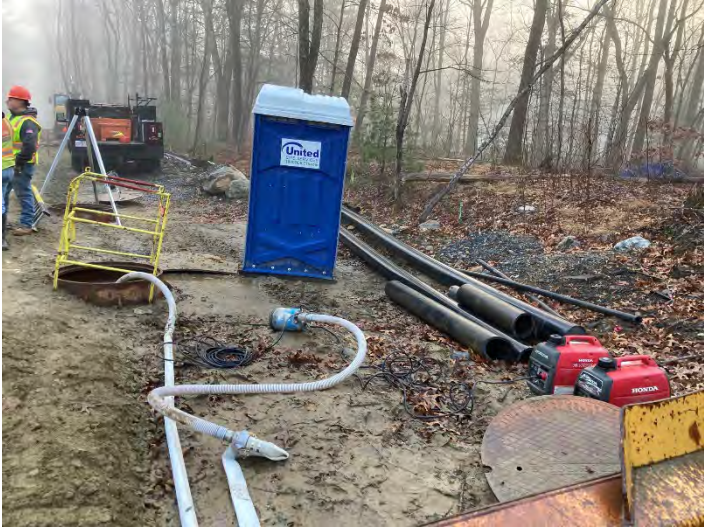
| Photo No.: 1 | Date: 12/26/2023 | | |

| Description: View of pumping operation at MH #5 in segment 1. Facing east. | | | |

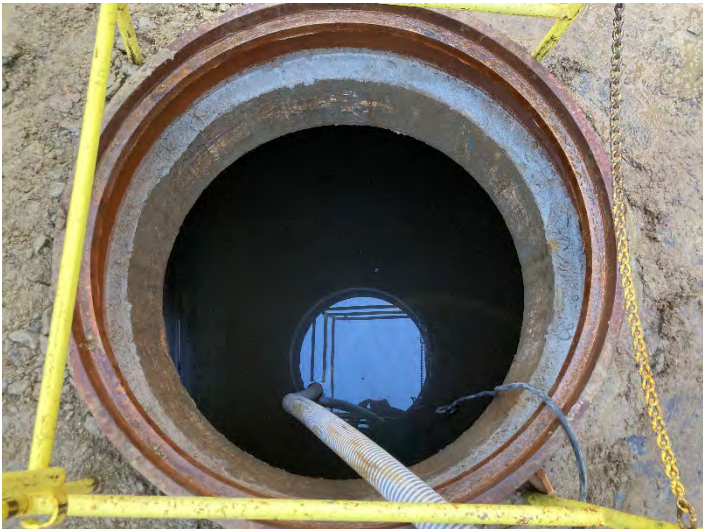
| Photo No.: 2 | Date: 12/26/2023 | | |

| Description: View of pump in MH #5. Water appeared mostly clear prior to treatment. | | | |

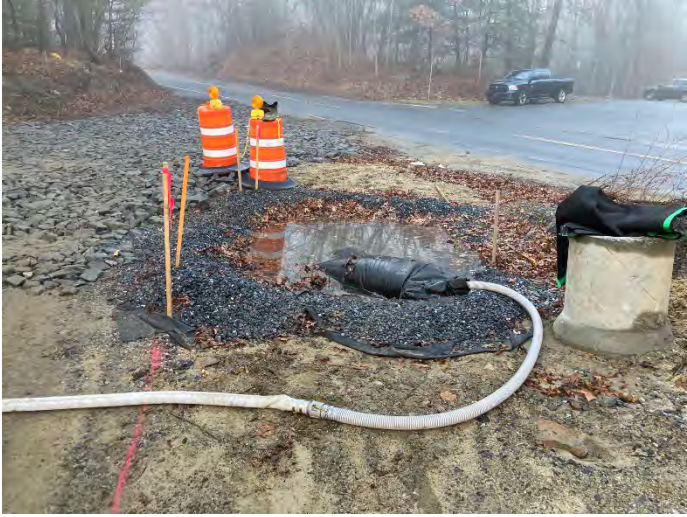
| Photo No.: 3 | Date: 12/26/2023 | | |

| Description: View of filter bag and discharge. Facing southwest. | | | |

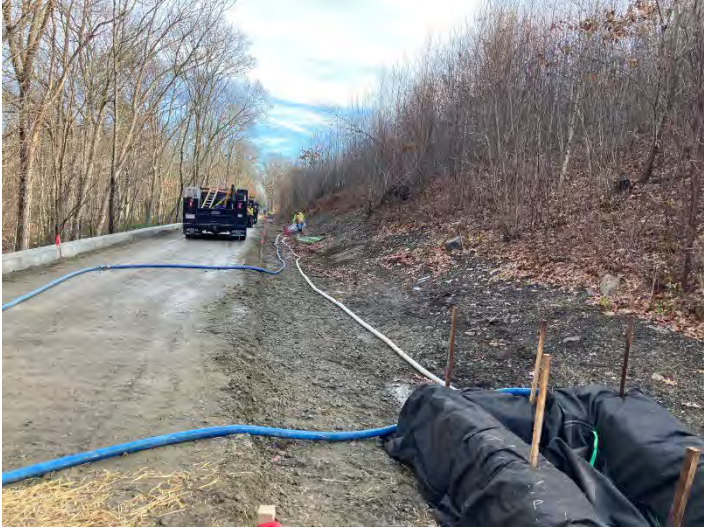
| Photo No.: 1 | Date: 12/26/2023 | | |

| Description: View of pumping operation at MH #6 in segment 1. Facing east. | | | |

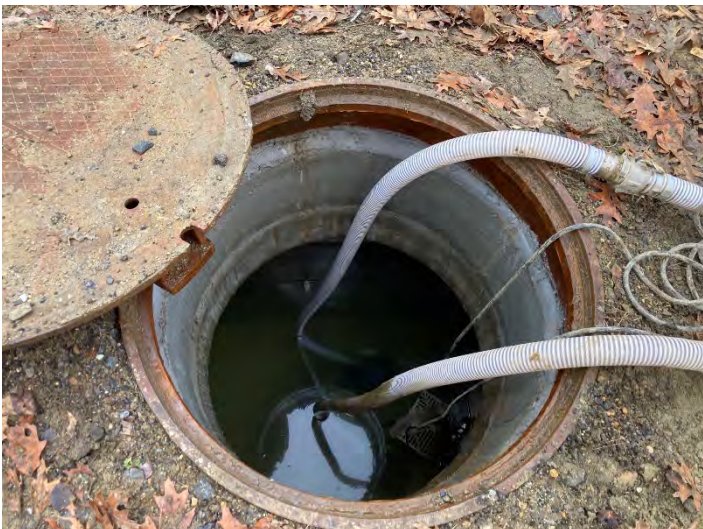
| Photo No.: 2 | Date: 12/26/2023 | | |

| Description: View of pump in MH #6. Water appeared mostly clear prior to treatment. | | | |

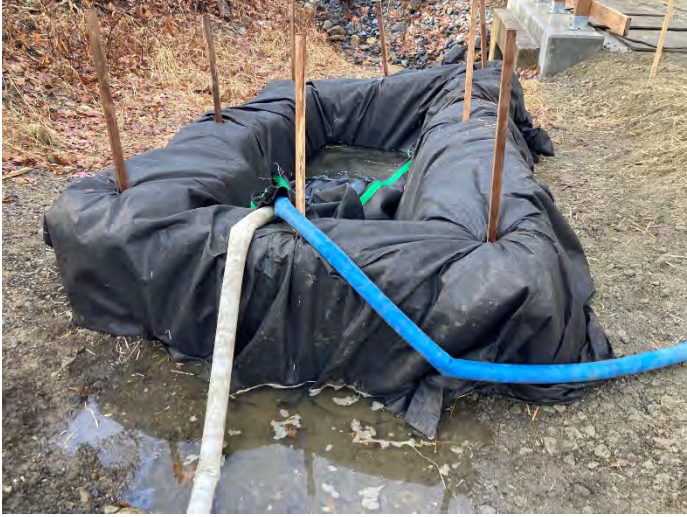
| Photo No.: 3 | Date: 12/26/2023 | | |

| Description: View of dewatering controls (straw bale corral with filter fabric and silt bag). Facing west. | | | |

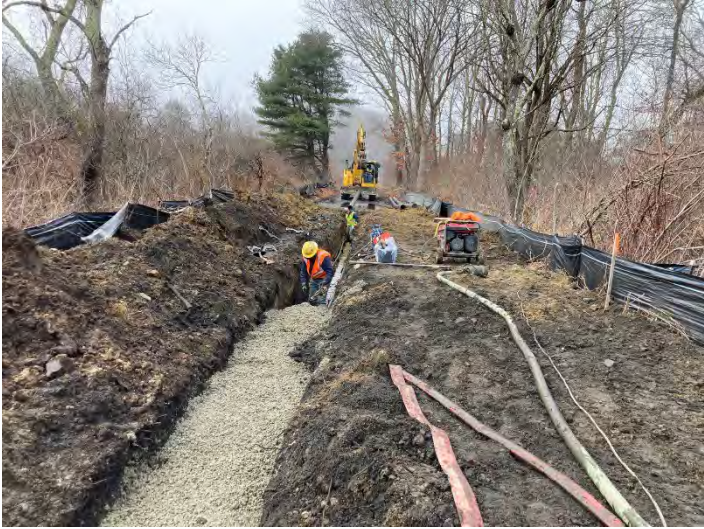
| Photo No.: 1 | Date: 12/26/2023 | | |

| Description: View of Bond working in trench in segment 14. Facing west. | | | |

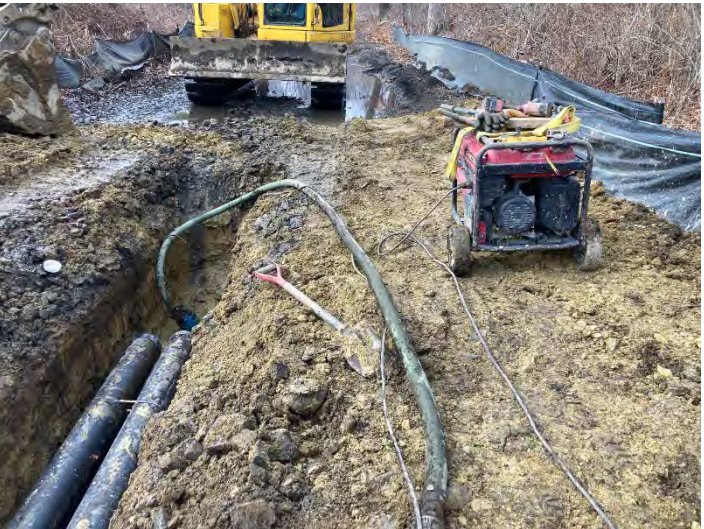
| Photo No.: 2 | Date: 12/26/2023 | | |

| Description: View of pumping operation. Facing west. | | | |

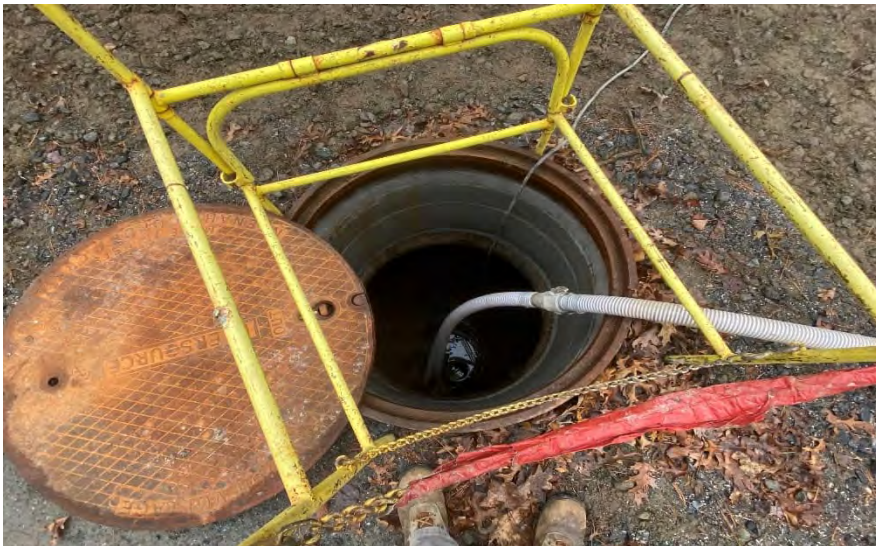
| Photo No.: 1 | Date: 12/27/2023 | | |

| Description: View of pumping from manhole #7 segment 2, looking eastward. | | | |

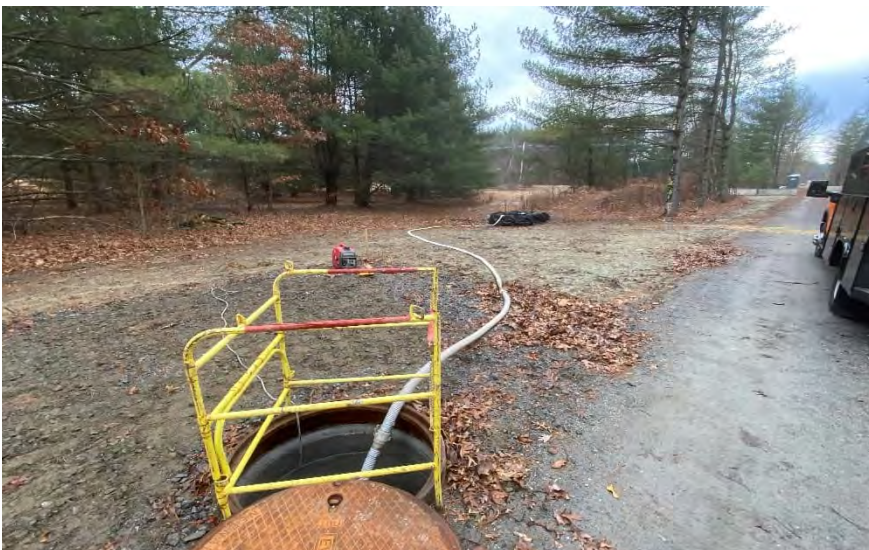
| Photo No.: 2 | Date: 12/27/2023 | | |

| Description: Manhole #7. View of dewatering operation. Looking eastward. | | | |

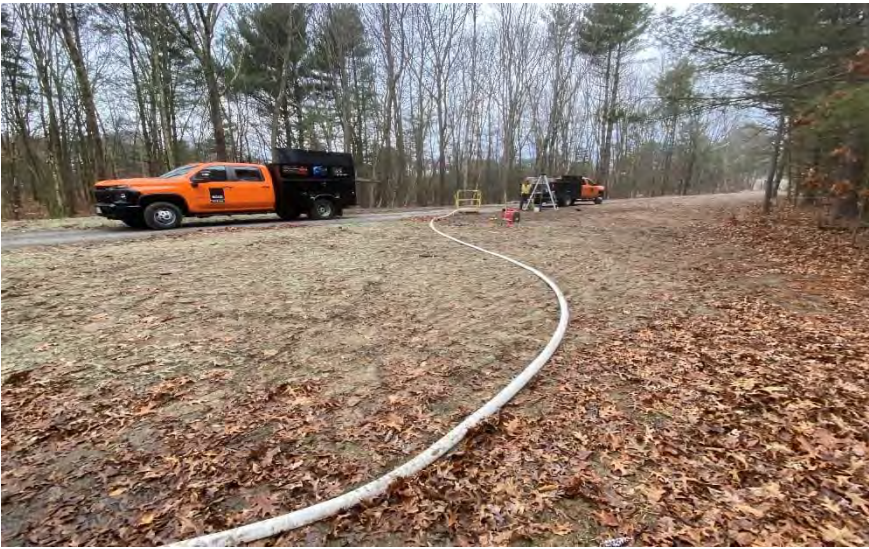
| Photo No.: 3 | Date: 12/27/2023 | | |

| Description: Manhole #7. View of dewatering operation, looking westward. | | | |

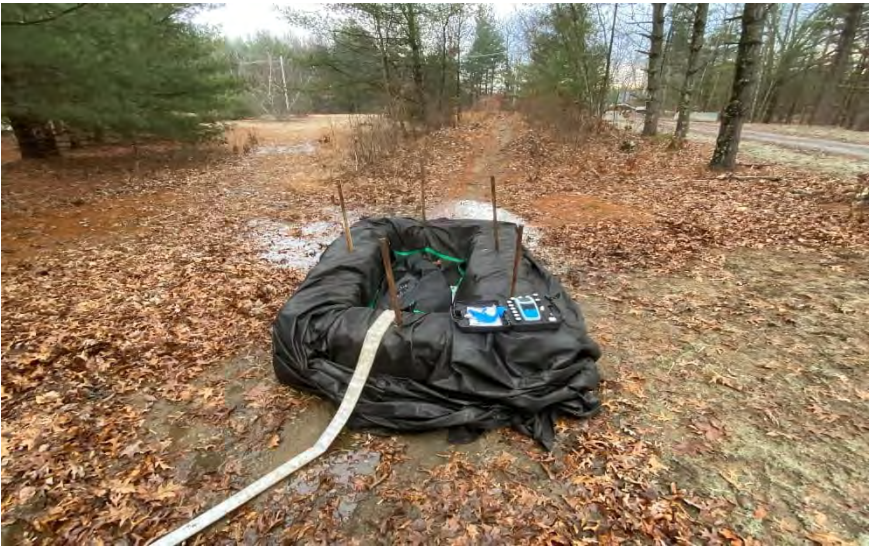
| Photo No.: 4 | Date: 12/27/2023 | | |

| Description: Manhole #7. View of discharge bag, looking eastward. Water from bag discharged to adjacent work area, water appeared clear, looking eastward. | | | |

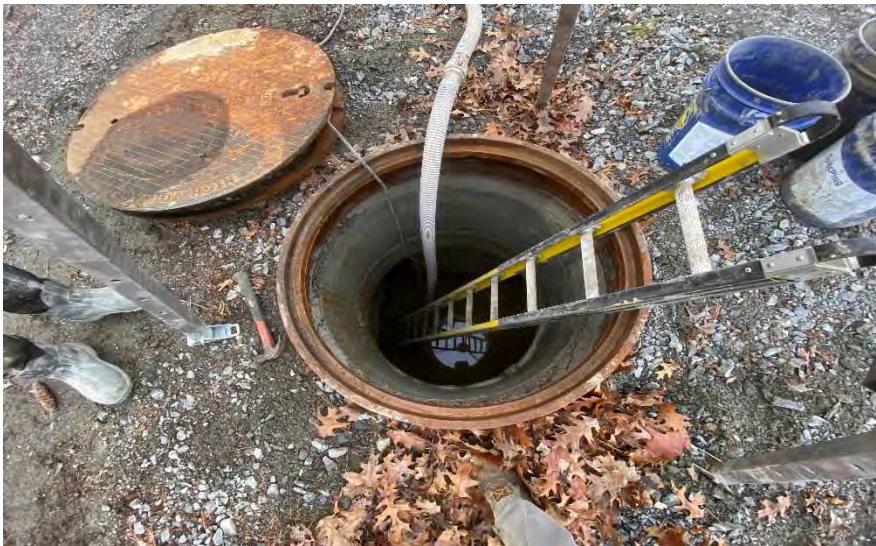
| Photo No.: 1 | Date: 12/27/2023 | | |

| Description: View of area being pumped from manhole #8 segment 3, looking eastward. | | | |

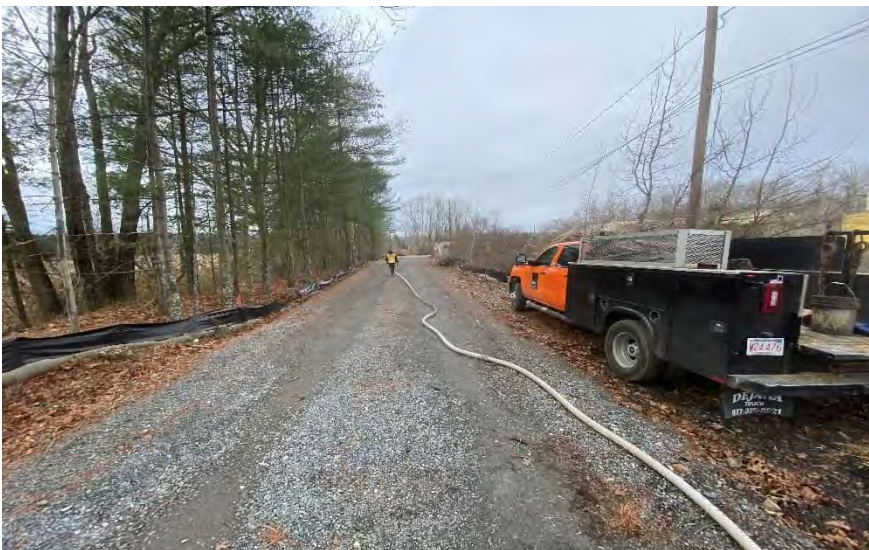
| Photo No.: 2 | Date: 12/27/2023 | | |

| Description: Manhole #8. View of dewatering operation. Looking westward. | | | |

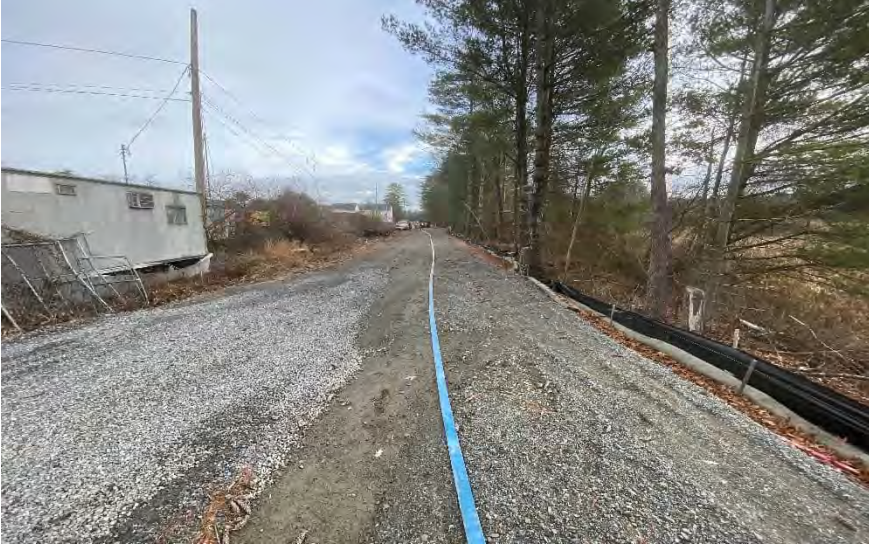
| Photo No.: 3 | Date: 12/27/2023 | | |

| Description: Manhole #8. View of dewatering operation, looking eastward. | | | |

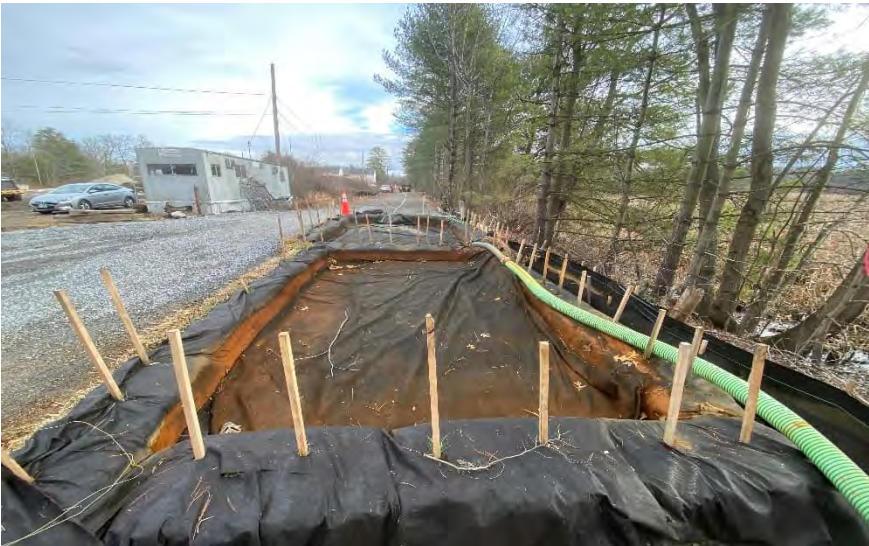
| Photo No.: 4 | Date: 12/27/2023 | | |

| Description: Manhole #8. View of discharge corral/bag, looking eastward. Water from bag discharged to adjacent work area. Water appeared clear, looking eastward. | | | |

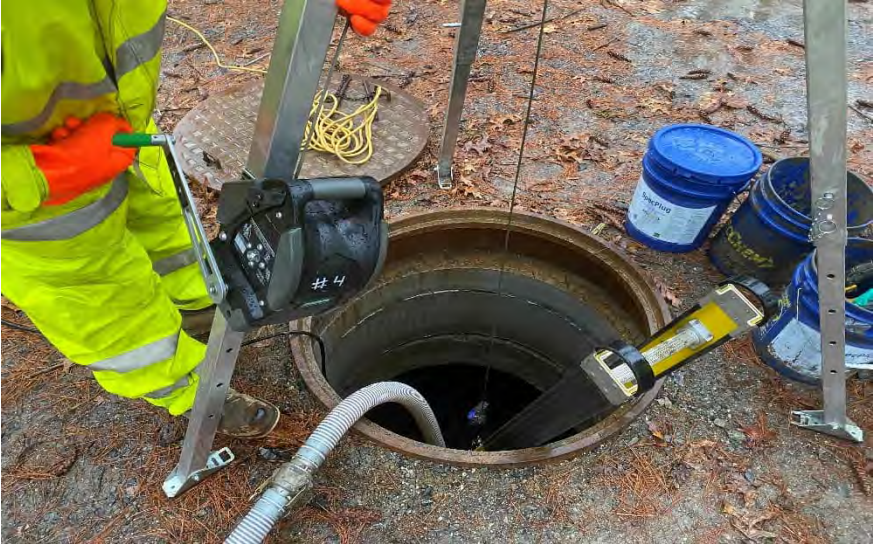
| Photo No.: 1 | Date: 12/28/2023 | | |

| Description: View of area being pumped from manhole #10 segment 4, looking eastward. | | | |
