Weekly Environmental Compliance Summary

Sudbury to Hudson Transmission Reliability Project (USEPA Tracking # MAR1003UW)

Week of: December 25, 2023 to December 29, 2023

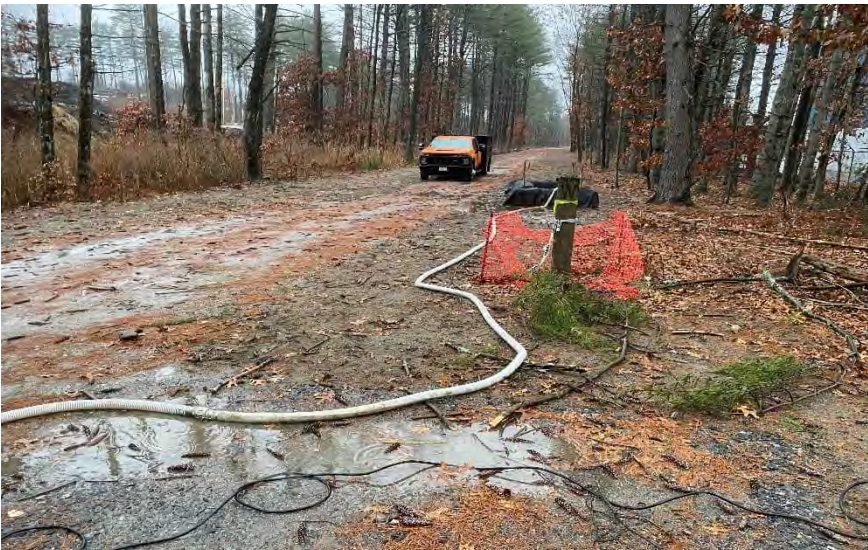
| Photo No.: 2 | Date: 12/28/2023 | | |

| Description: Manhole #10. View of dewatering operation. Looking westward. | | | |

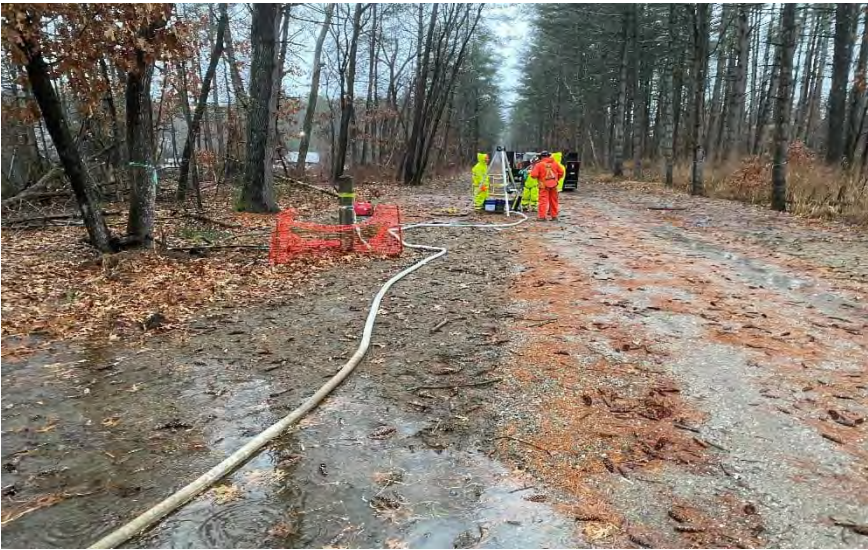
| Photo No.: 3 | Date: 12/28/2023 | | |

| Description: Manhole #10. View of dewatering operation, looking eastward. | | | |

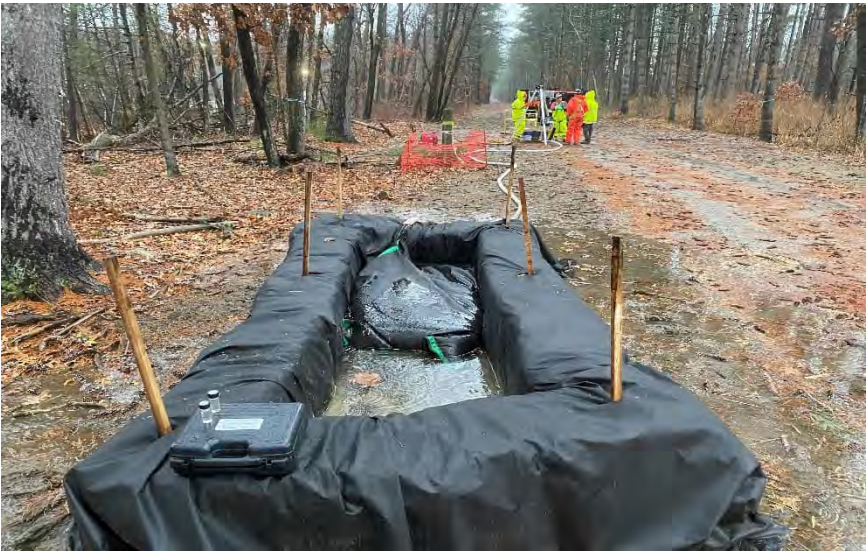
| Photo No.: 4 | Date: 12/28/2023 | | |

| Description: Manhole #10. View of discharge bag/corral, looking eastward. Water from bag/corral discharged to work area within segment 4. | | | |

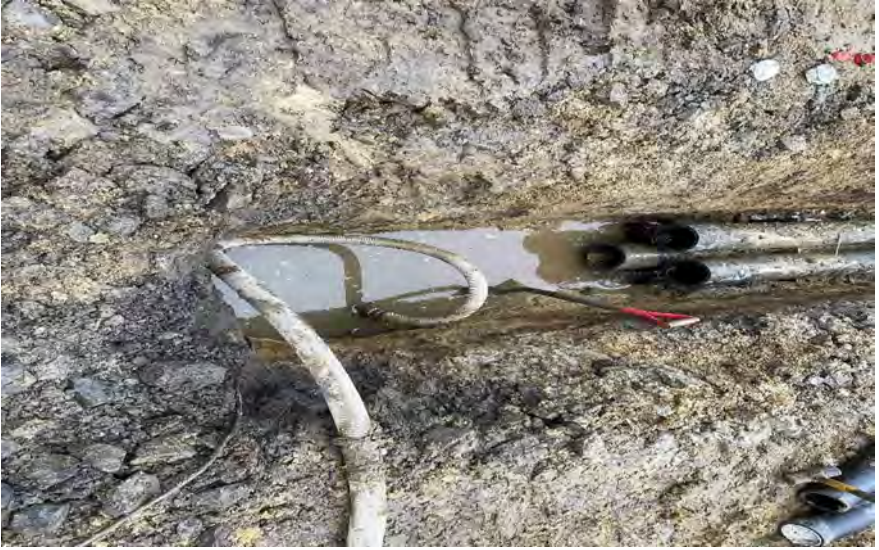
| Photo No.: 1 | Date: 12/27/2023 | | | |

| Description: View of area being pumped from segment 14 trench, looking northward. | | | | |

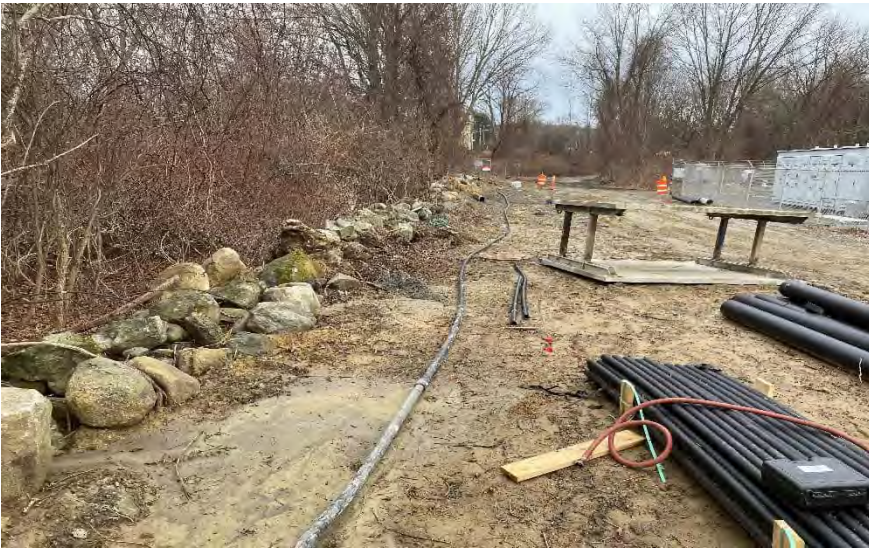
| Photo No.: 3 | Date: 12/27/2023 | | |

| Description: Segment 14. View of dewatering operation, looking northward. | | | |

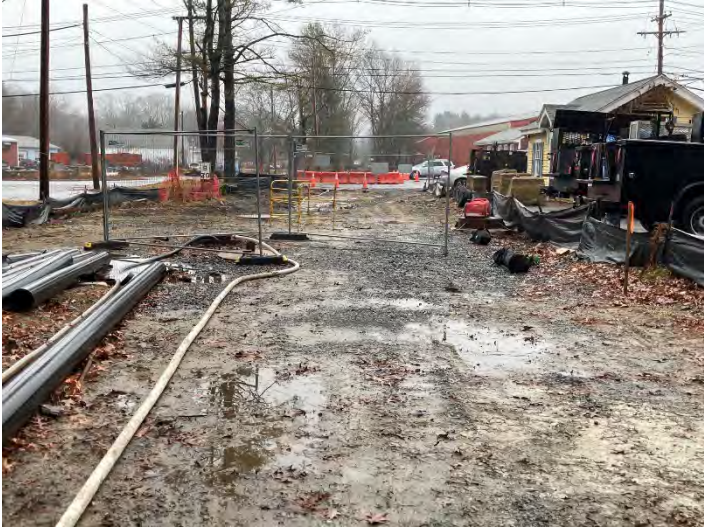
| Photo No.: 1 | Date: 12/29/2023 | | |

| Description: View of pumping operation at MH #24 in segment 11. Facing east. | | | |

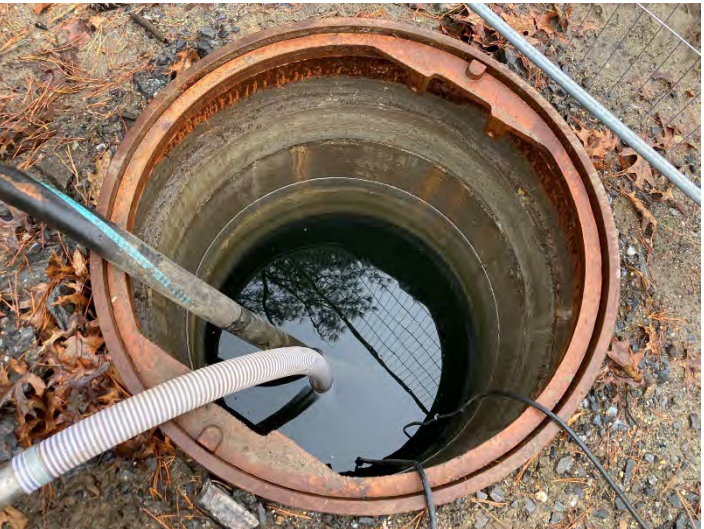
| Photo No.: 2 | Date: 12/29/2023 | | |

| Description: View of pumps in MH #24. Water appeared clear prior to treatment. | | | |

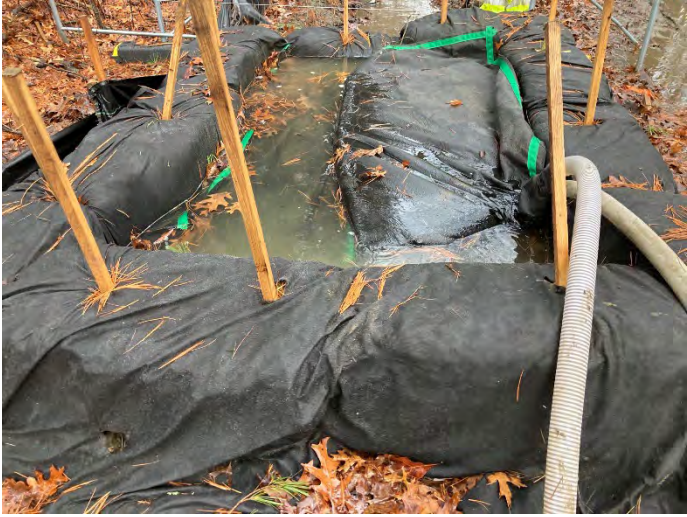
| Photo No.: 3 | Date: 12/29/2023 | | |

| Description: View of dewatering controls (straw bale corral with filter fabric and silt bag). Facing west. | | | |
