Weekly Environmental Compliance Summary

Sudbury to Hudson Transmission Reliability Project (USEPA Tracking # MAR1003UW)

Week of: January 22, 2024 to January 26, 2024

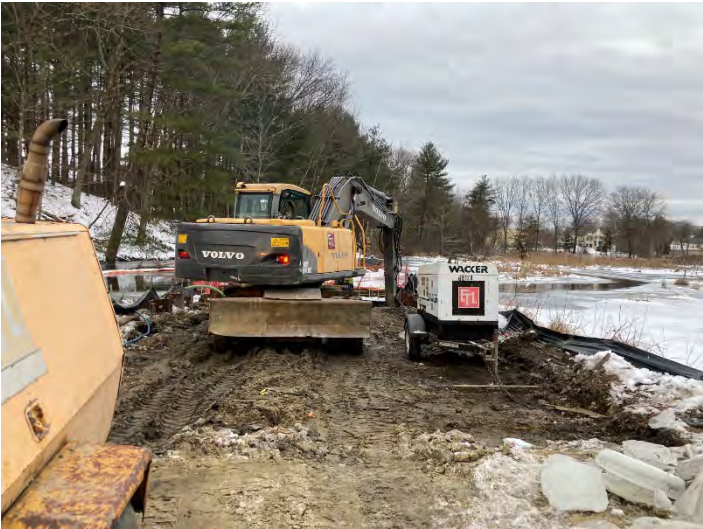
PHOTOGRAPHIC LOG	
Client Name: Eversource		Site Location: Sudbury to Hudson Transmission Reliability Project	Town: Sudbury
Photo No.: 1	Date: 1/23/2024

Description: View of ET&L working at bridge 127 in segment 14. See additional dewatering inspection report. Facing west.

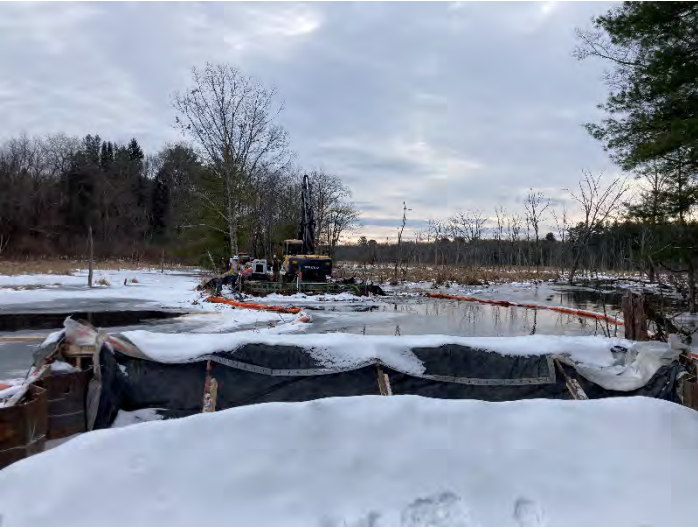
PHOTOGRAPHIC LOG	
Client Name: Eversource		Site Location: Sudbury to Hudson Transmission Reliability Project	Town: Sudbury
Photo No.: 2	Date: 1/23/2024

Description: View of bridge 127 from segment 13. Facing east.

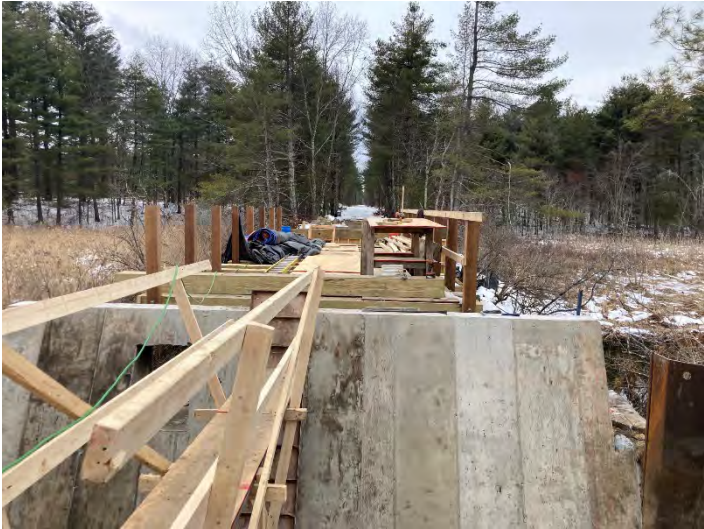
<p>PHOTOGRAPHIC LOG</p>	
<p>Client Name: Eversource</p>		<p>Site Location: Sudbury to Hudson Transmission Reliability Project</p>	<p>Town: Sudbury</p>
<p>Photo No.: 5</p>	<p>Date: 1/23/2024</p>

<p>Description: View of bridge 128 from segment 8. Facing west.</p>

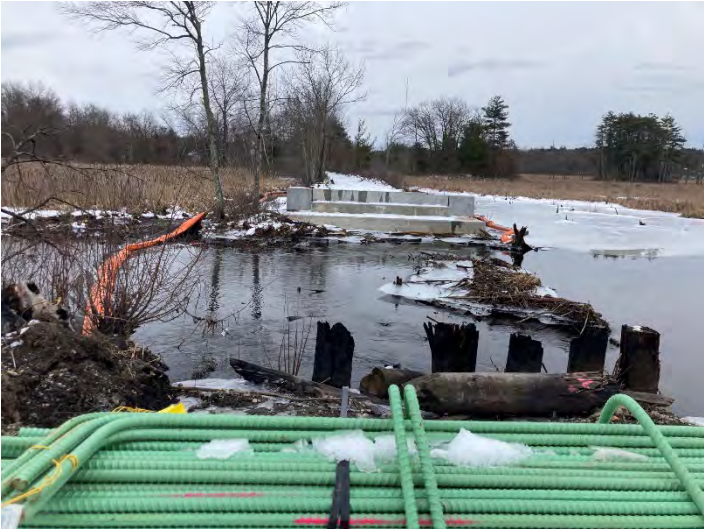
<p>PHOTOGRAPHIC LOG</p>	
<p>Client Name: Eversource</p>		<p>Site Location: Sudbury to Hudson Transmission Reliability Project</p>	<p>Town: Hudson</p>
<p>Photo No.: 6</p>	<p>Date: 1/23/2024</p>

<p>Description: View of bridge 130 from segment 2. Facing east.</p>

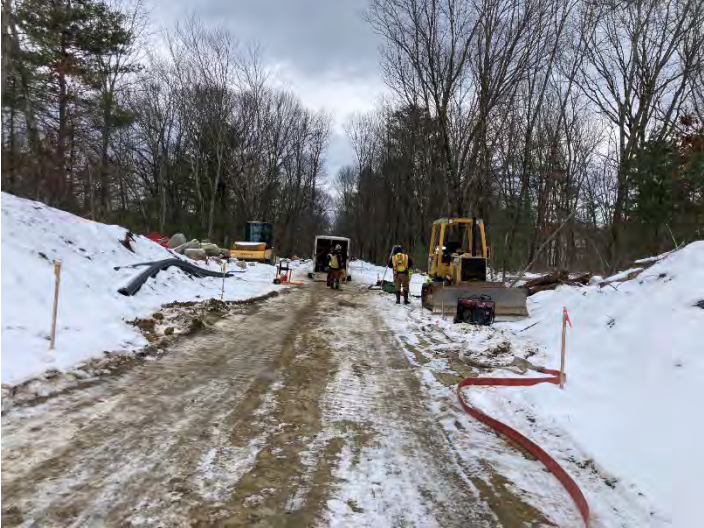
PHOTOGRAPHIC LOG	
Client Name: Eversource		Site Location: Sudbury to Hudson Transmission Reliability Project	
Town: Hudson			
Photo No.: 7	Date: 1/23/2024

Description: View of Bond working at MH #5 in segment 1. See additional dewatering inspection report. Facing east.

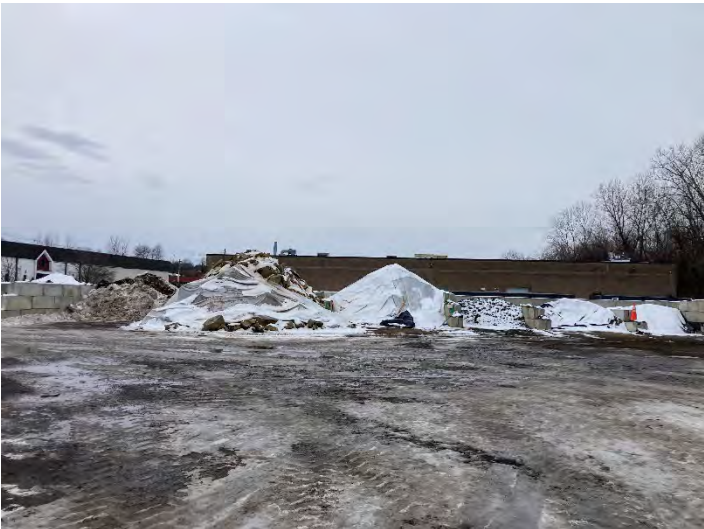
PHOTOGRAPHIC LOG	
Client Name: Eversource		Site Location: Sudbury to Hudson Transmission Reliability Project	
Town: Hudson			
Photo No.: 8	Date: 1/23/2024

Description: View of Bonazzoli laydown yard. Facing west.

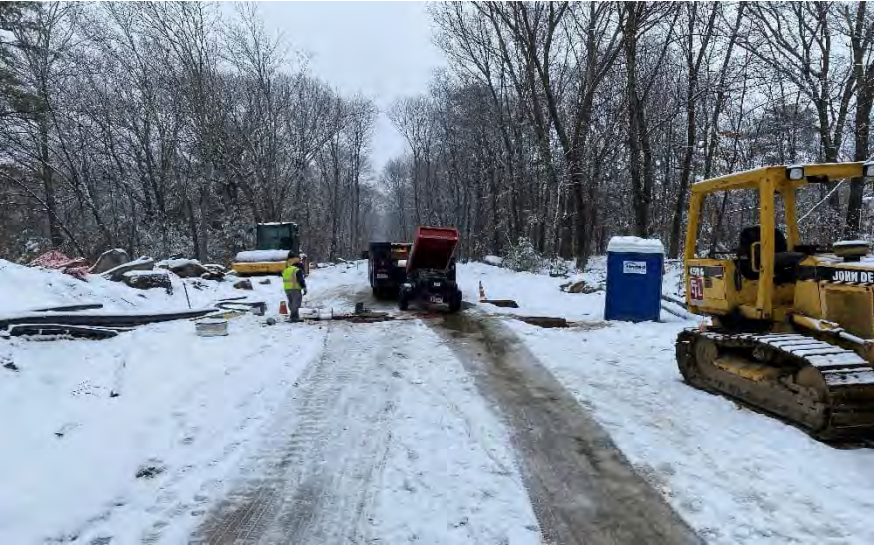
<p>PHOTOGRAPHIC LOG</p>	
<p>Client Name: Eversource</p>		<p>Site Location: Sudbury to Hudson Transmission Reliability Project</p>	<p>Town: Hudson</p>
<p>Photo No.: 1</p>	<p>Date: 1-24-24</p>

<p>Description:</p> <p>Bond conducting proofing work within segment 1 at manhole #5, looking eastward.</p>

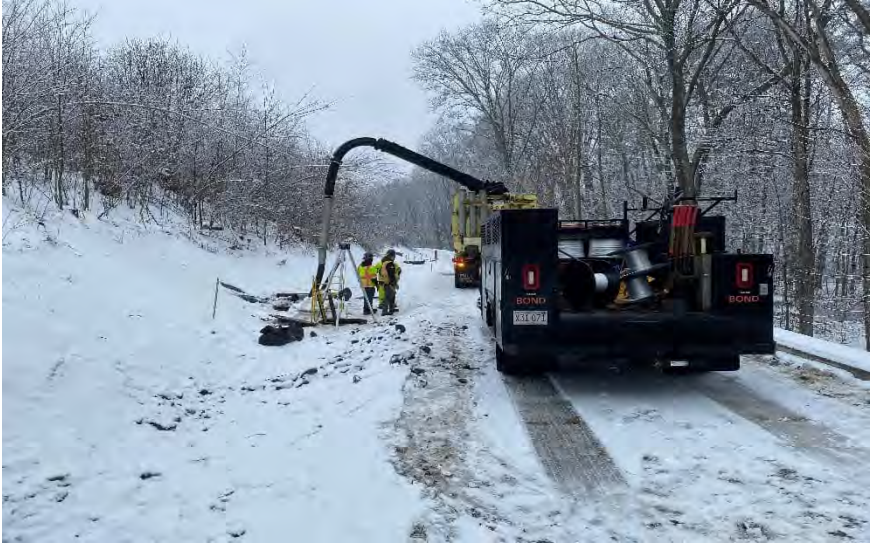
<p>PHOTOGRAPHIC LOG</p>	
<p>Client Name: Eversource</p>		<p>Site Location: Sudbury to Hudson Transmission Reliability Project</p>	<p>Town: Hudson</p>
<p>Photo No.: 2</p>	<p>Date: 1-24-24</p>

<p>Description:</p> <p>Bond conducting proofing work within segment 1 at manhole #6, looking westward.</p>

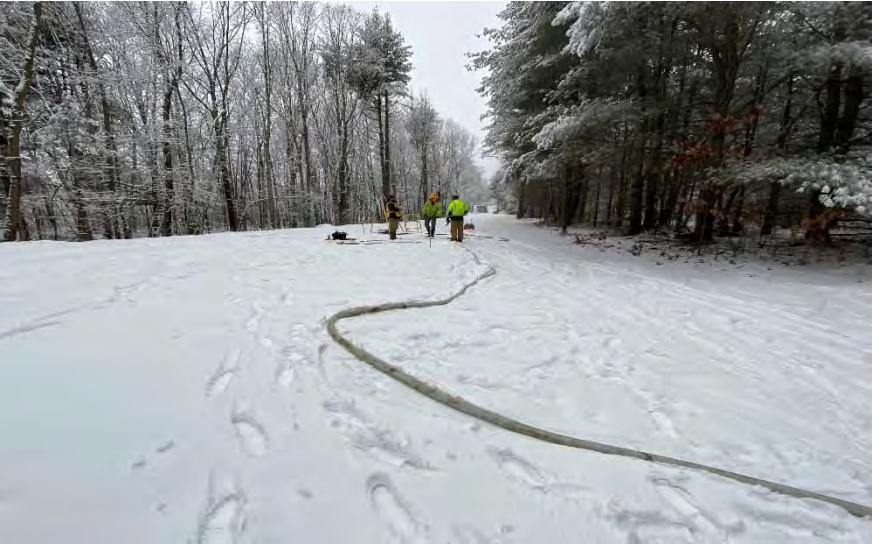
<p>PHOTOGRAPHIC LOG</p>	
<p>Client Name: Eversource</p>		<p>Site Location: Sudbury to Hudson Transmission Reliability Project</p>	<p>Town: Hudson</p>
<p>Photo No.: 3</p>	<p>Date: 1-24-24</p>

<p>Description:</p> <p>Bond conducting proofing work within segment 2 at manhole #7, looking westward.</p>

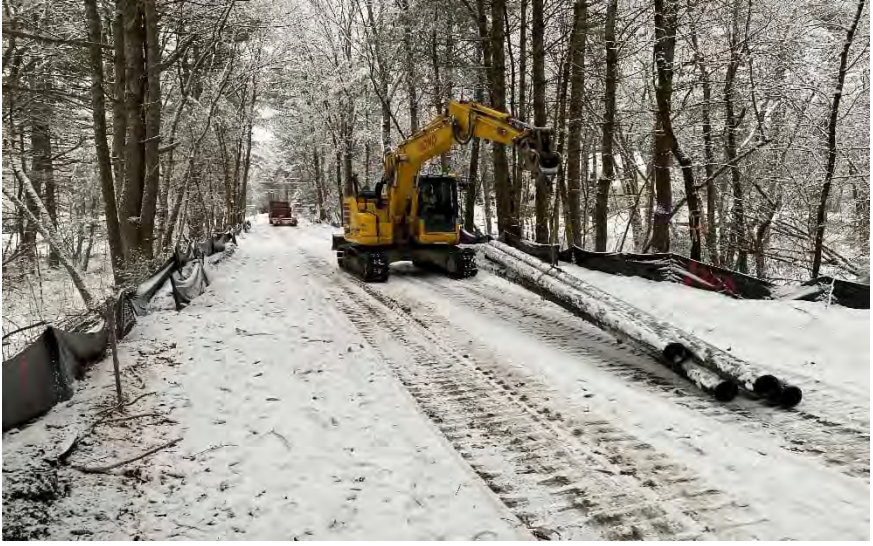
<p>PHOTOGRAPHIC LOG</p>	
<p>Client Name: Eversource</p>		<p>Site Location: Sudbury to Hudson Transmission Reliability Project</p>	<p>Town: Sudbury</p>
<p>Photo No.: 6</p>	<p>Date: 1-24-24</p>

<p>Description:</p> <p>Work area within segment 9, conduit work, looking eastward.</p>

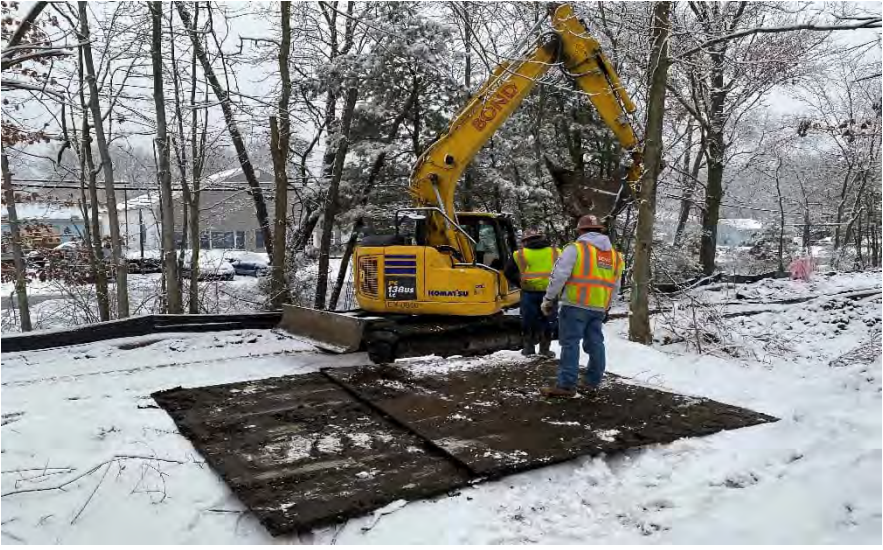
<p>PHOTOGRAPHIC LOG</p>	
<p>Client Name: Eversource</p>		<p>Site Location: Sudbury to Hudson Transmission Reliability Project</p>	<p>Town: Sudbury</p>
<p>Photo No.: 7</p>	<p>Date: 1-24-24</p>

<p>Description:</p> <p>Work area within segment 12, conduit work, looking eastward.</p>

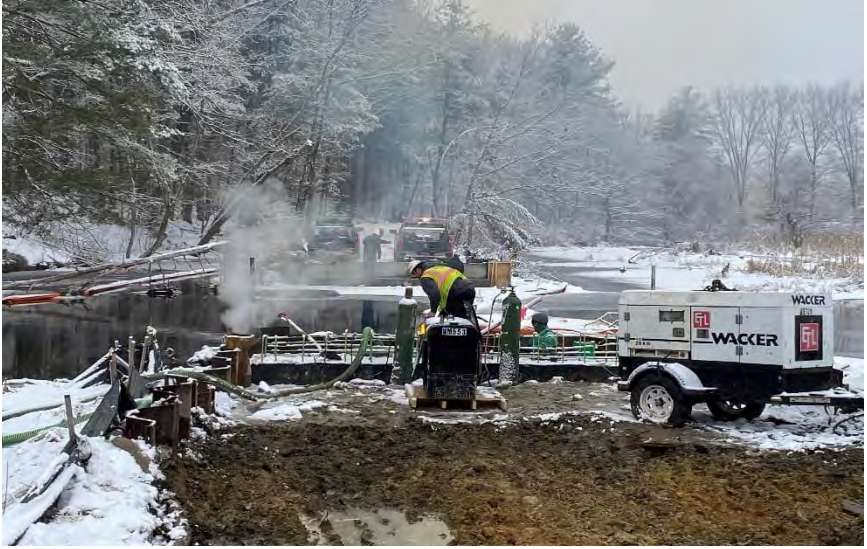
<p>PHOTOGRAPHIC LOG</p>	
<p>Client Name: Eversource</p>		<p>Site Location: Sudbury to Hudson Transmission Reliability Project</p>	<p>Town: Sudbury</p>
<p>Photo No.: 8</p>	<p>Date: 1-24-24</p>

<p>Description:</p> <p>Work area within segment 14, bridge 127 area, looking westward.</p>

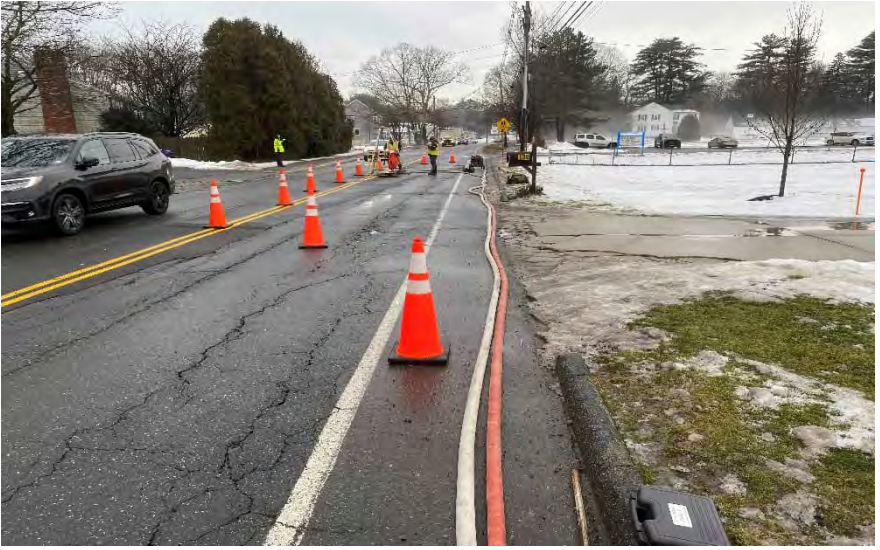
<p>PHOTOGRAPHIC LOG</p>	
<p>Client Name: Eversource</p>		<p>Site Location: Sudbury to Hudson Transmission Reliability Project</p>	<p>Town: Hudson</p>
<p>Photo No.: 1</p>	<p>Date: 1-25-24</p>

<p>Description:</p> <p>Bond conducting proofing work within Forest Avenue at manhole #3, looking southward.</p>

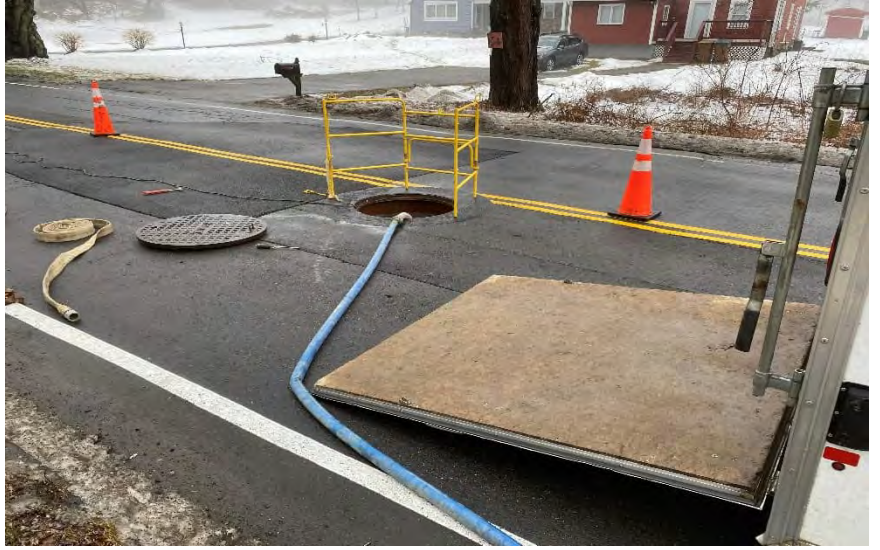
<p>PHOTOGRAPHIC LOG</p>	
<p>Client Name: Eversource</p>		<p>Site Location: Sudbury to Hudson Transmission Reliability Project</p>	<p>Town: Hudson</p>
<p>Photo No.: 2</p>	<p>Date: 1-25-24</p>

<p>Description:</p> <p>Bond conducting proofing work within Forest Avenue at manhole #4, looking southward.</p>

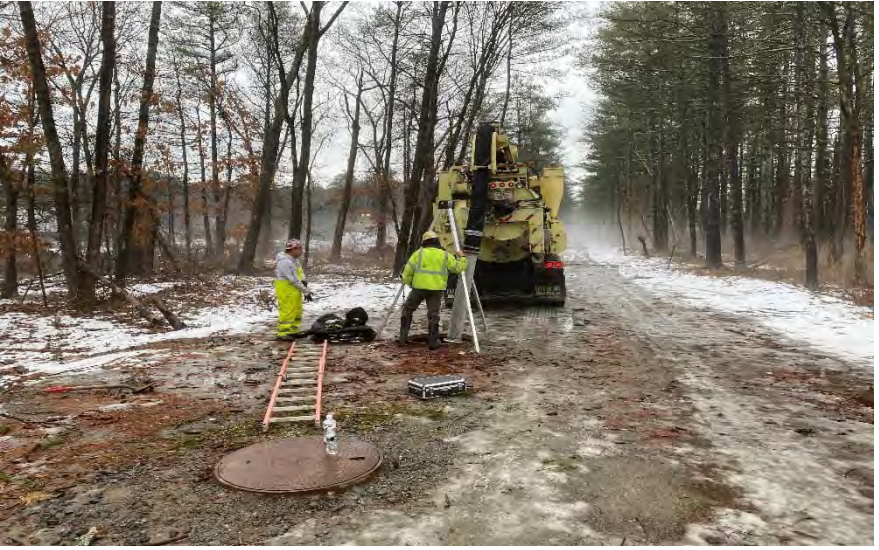
<p>PHOTOGRAPHIC LOG</p>	
<p>Client Name: Eversource</p>		<p>Site Location: Sudbury to Hudson Transmission Reliability Project</p>	<p>Town: Hudson</p>
<p>Photo No.: 3</p>	<p>Date: 1-25-24</p>

<p>Description:</p> <p>Bond conducting proofing work within segment 4 at manhole #10, looking eastward.</p>

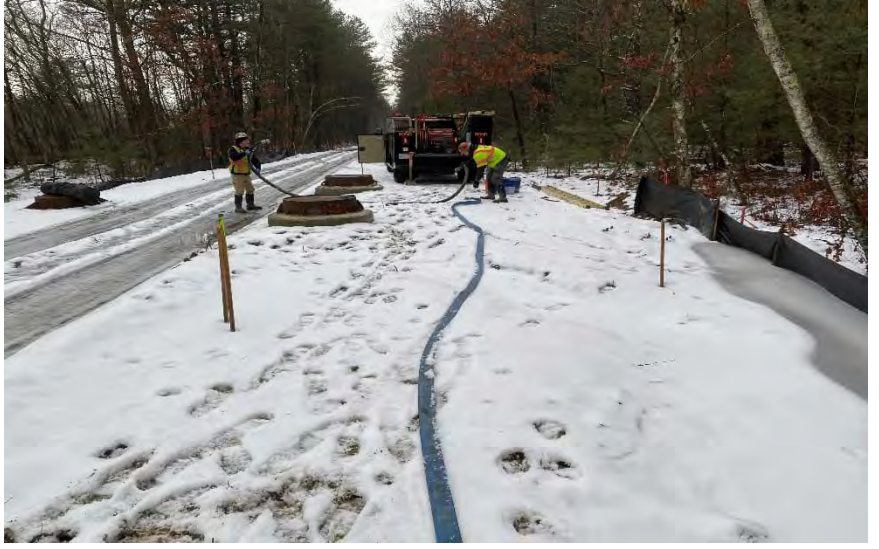
<p>PHOTOGRAPHIC LOG</p>	
<p>Client Name: Eversource</p>		<p>Site Location: Sudbury to Hudson Transmission Reliability Project</p>	<p>Town: Hudson</p>
<p>Photo No.: 4</p>	<p>Date: 1-25-24</p>

<p>Description:</p> <p>Bond conducting proofing work within segment 5 at manhole #14, looking westward.</p>

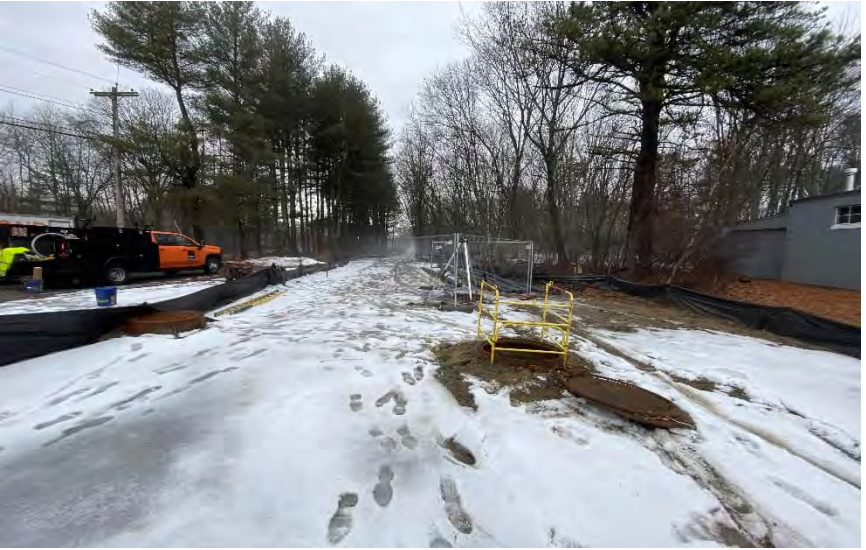
<p>PHOTOGRAPHIC LOG</p>	
<p>Client Name: Eversource</p>		<p>Site Location: Sudbury to Hudson Transmission Reliability Project</p>	<p>Town: Sudbury</p>
<p>Photo No.: 5</p>	<p>Date: 1-25-24</p>

<p>Description: Bond conducting proofing work within segment 11 at manhole #24, looking westward.</p>

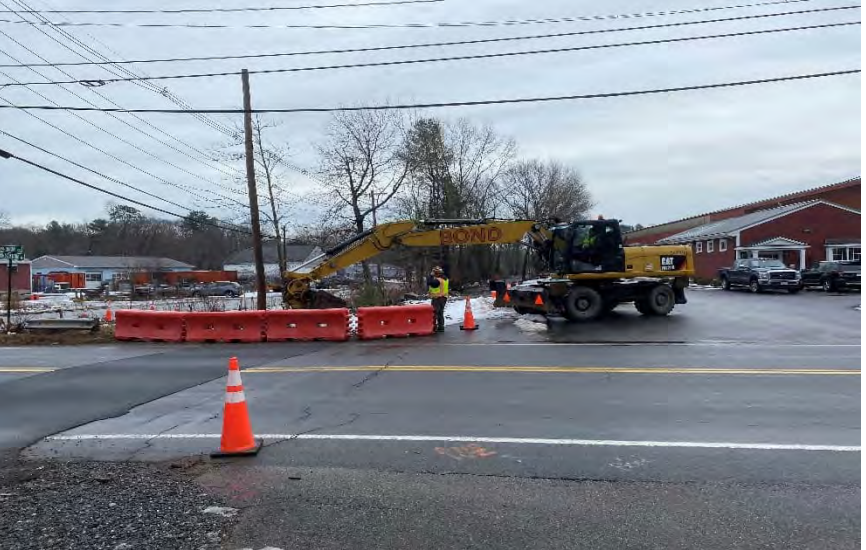
<p>PHOTOGRAPHIC LOG</p>	
<p>Client Name: Eversource</p>		<p>Site Location: Sudbury to Hudson Transmission Reliability Project</p>	<p>Town: Sudbury</p>
<p>Photo No.: 6</p>	<p>Date: 1-25-24</p>

<p>Description: Work area within segment 12, conduit work, looking eastward.</p>

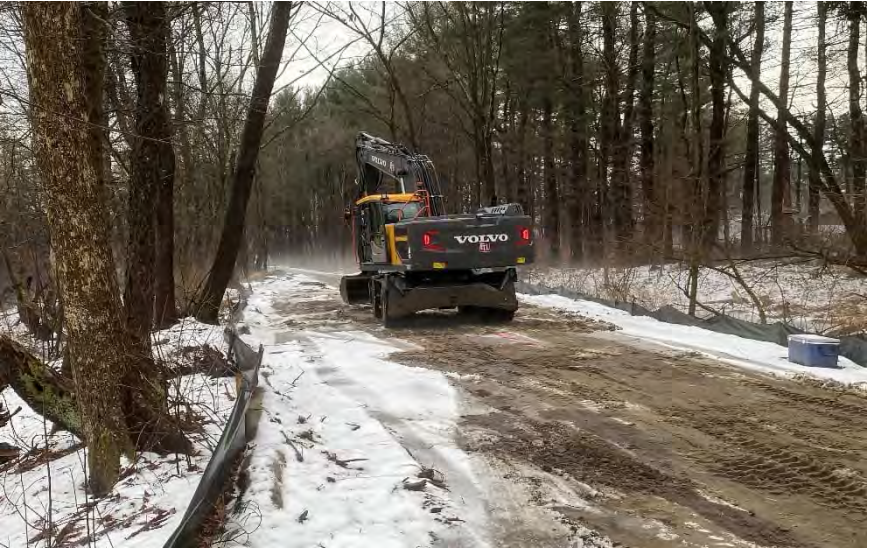
<p>PHOTOGRAPHIC LOG</p>	
<p>Client Name: Eversource</p>		<p>Site Location: Sudbury to Hudson Transmission Reliability Project</p>	<p>Town: Sudbury</p>
<p>Photo No.: 7</p>	<p>Date: 1-25-24</p>

<p>Description:</p> <p>Work area within segment 13, preparations for bridge 127 work, looking eastward.</p>

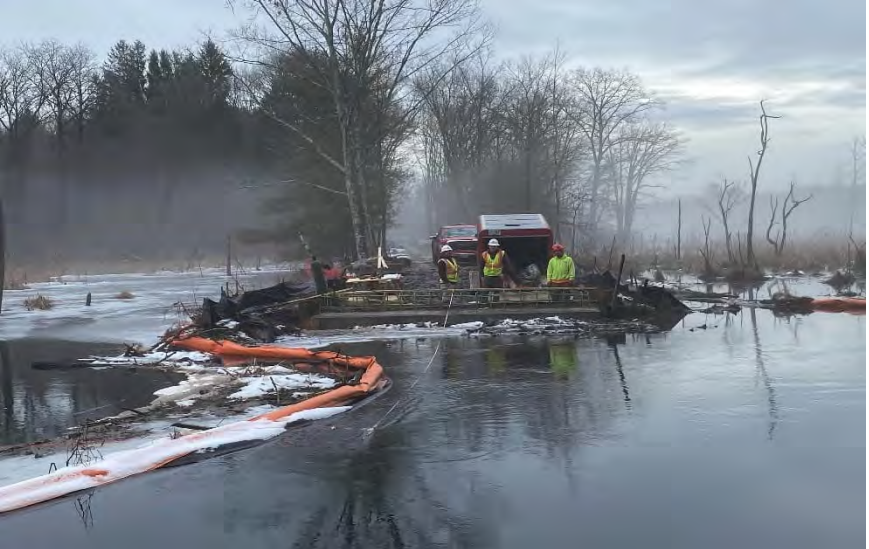
<p>PHOTOGRAPHIC LOG</p>	
<p>Client Name: Eversource</p>		<p>Site Location: Sudbury to Hudson Transmission Reliability Project</p>	<p>Town: Sudbury</p>
<p>Photo No.: 8</p>	<p>Date: 1-25-24</p>

<p>Description:</p> <p>Work area within segment 14 looking across Hop Brook from segment 13, bridge 127 area, looking eastward.</p>

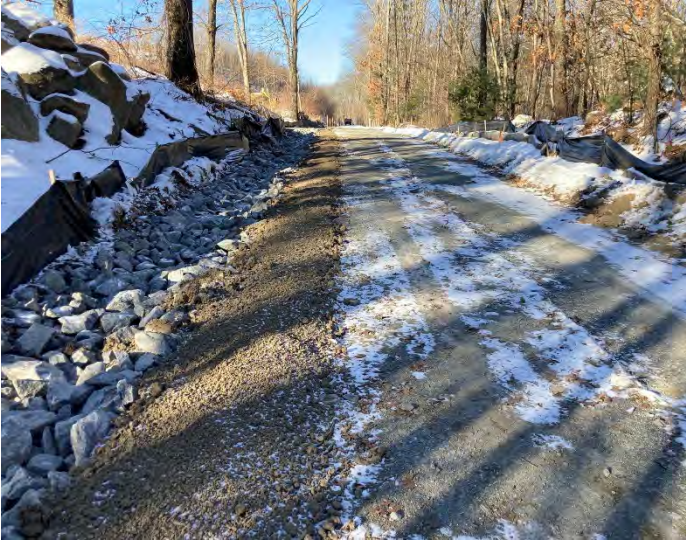
PHOTOGRAPHIC LOG	
Client Name: Eversource		Site Location: Sudbury to Hudson Transmission Reliability Project	Town: Hudson/Stow town line
Photo No.: 1	Date: 1-22-2024

Description: View of newly installed rock swale and loam in segment 1. Facing west.

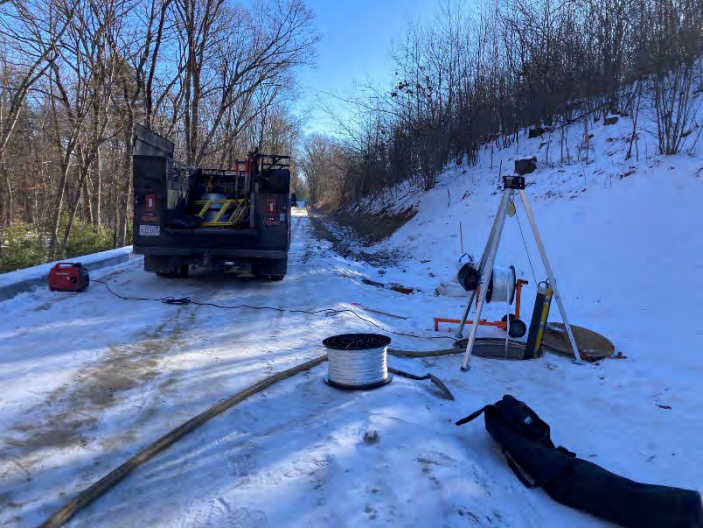
PHOTOGRAPHIC LOG	
Client Name: Eversource		Site Location: Sudbury to Hudson Transmission Reliability Project	Town: Hudson
Photo No.: 2	Date: 1-22-2024

Description: View of Bond's work area at MH #6 in segment 1. See additional dewatering inspection reports. Facing east.

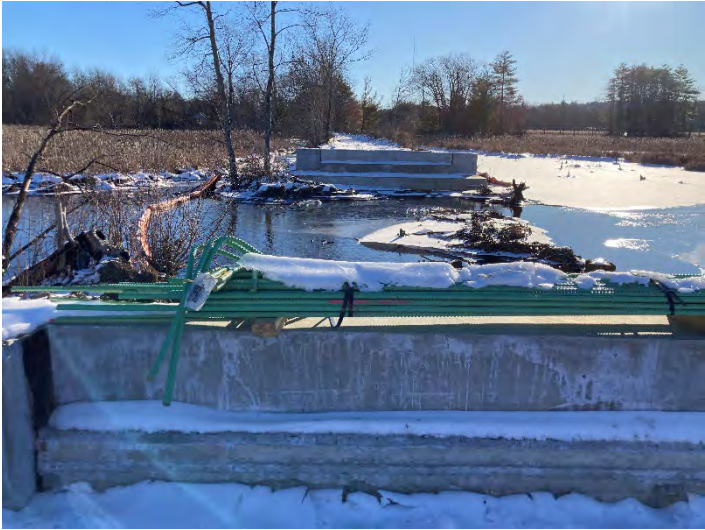
PHOTOGRAPHIC LOG	
Client Name: Eversource		Site Location: Sudbury to Hudson Transmission Reliability Project	Town: Hudson
Photo No.: 3	Date: 1-22-2024

Description: View of Bridge 130. Facing east.

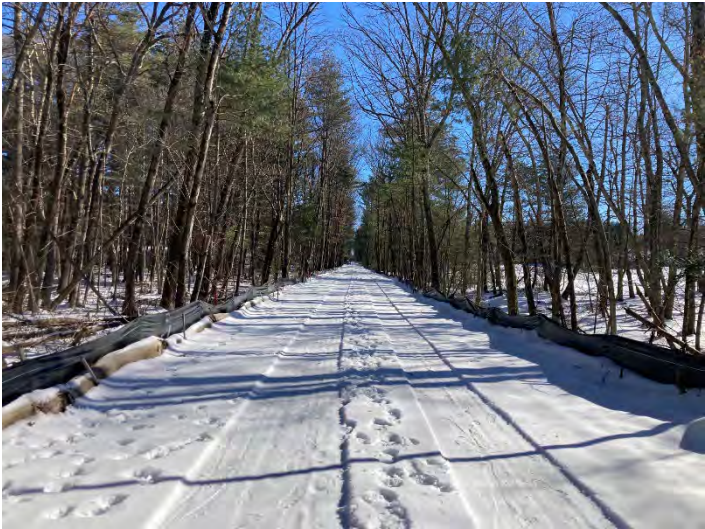
PHOTOGRAPHIC LOG	
Client Name: Eversource		Site Location: Sudbury to Hudson Transmission Reliability Project	Town: Hudson
Photo No.: 4	Date: 1-22-2024

Description: View of E&S controls in segment 4. Facing east.

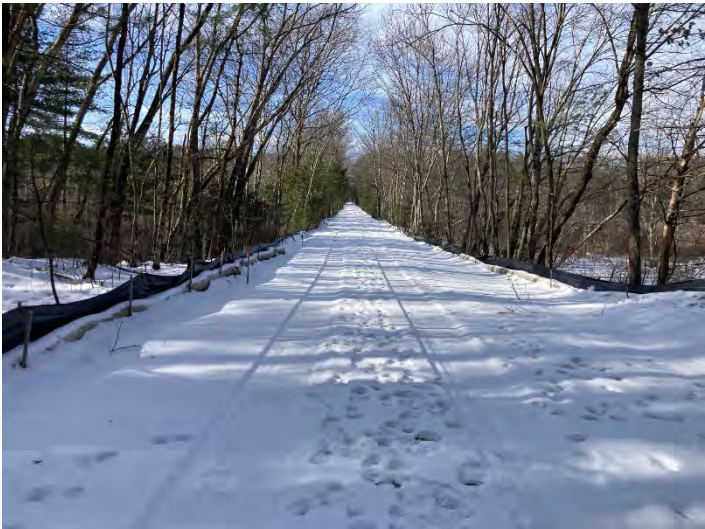
Epsilon ASSOCIATES INC.		PHOTOGRAPHIC LOG	
Client Name: Eversource		Site Location: Sudbury to Hudson Transmission Reliability Project	Town: Hudson
Photo No.: 5	Date: 1-22-2024

Description: View of E&S controls in segment 5. Facing west.

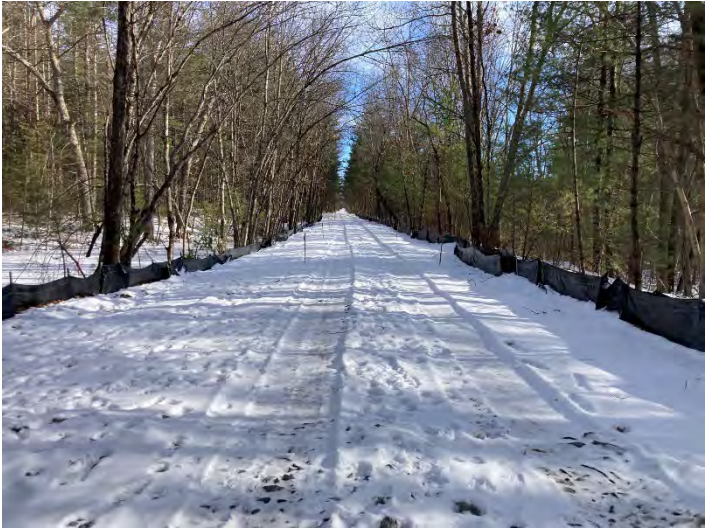
Epsilon ASSOCIATES INC.		PHOTOGRAPHIC LOG	
Client Name: Eversource		Site Location: Sudbury to Hudson Transmission Reliability Project	Town: Hudson
Photo No.: 6	Date: 1-22-2024

Description: View of E&S controls in segment 6. Facing east.

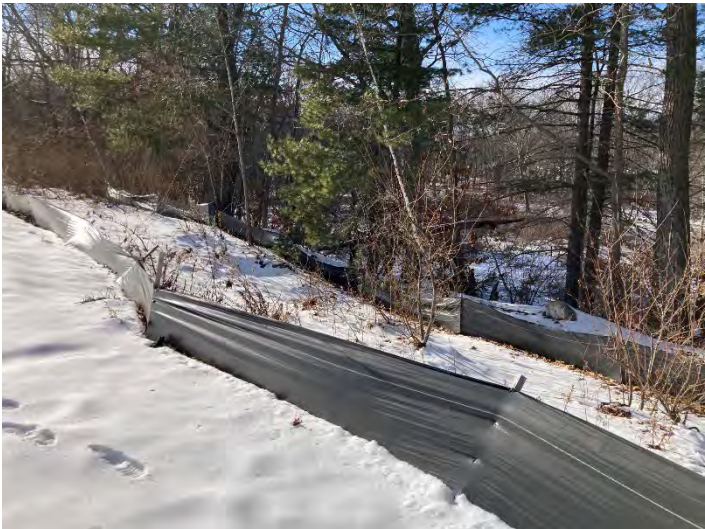
Epsilon ASSOCIATES INC.		PHOTOGRAPHIC LOG	
Client Name: Eversource		Site Location: Sudbury to Hudson Transmission Reliability Project	Town: Hudson
Photo No.: 7	Date: 1-22-2024

Description: View of silt fence at Bonazzoli laydown yard. Facing west.

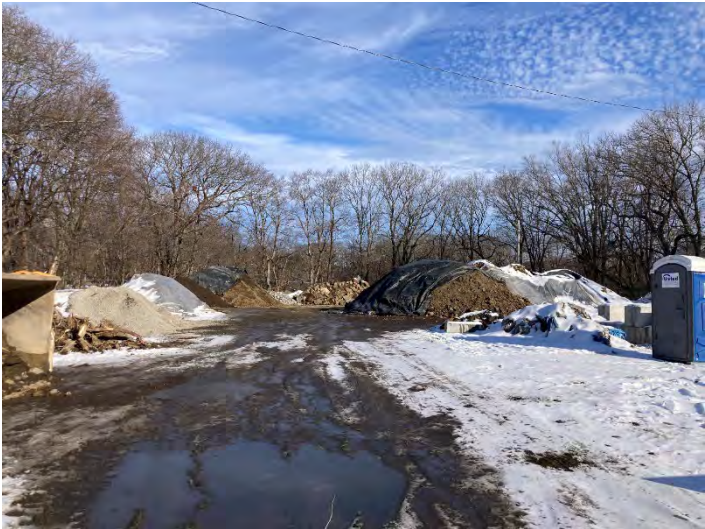
Epsilon ASSOCIATES INC.		PHOTOGRAPHIC LOG	
Client Name: Eversource		Site Location: Sudbury to Hudson Transmission Reliability Project	Town: Hudson
Photo No.: 8	Date: 1-22-2024

Description: View of Stowe Ct laydown yard. Facing northeast.

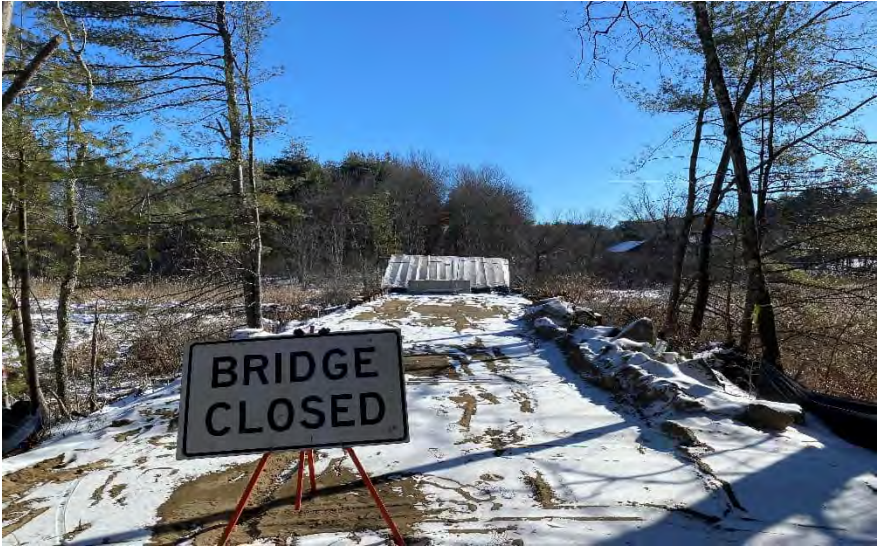
PHOTOGRAPHIC LOG	
Client Name: Eversource		Site Location: Sudbury to Hudson Transmission Reliability Project	Town: Sudbury
Photo No.: 1	Date: 1-22-24

Description: Work area, within segment 7, bridge 128, existing erosion control, looking eastward.

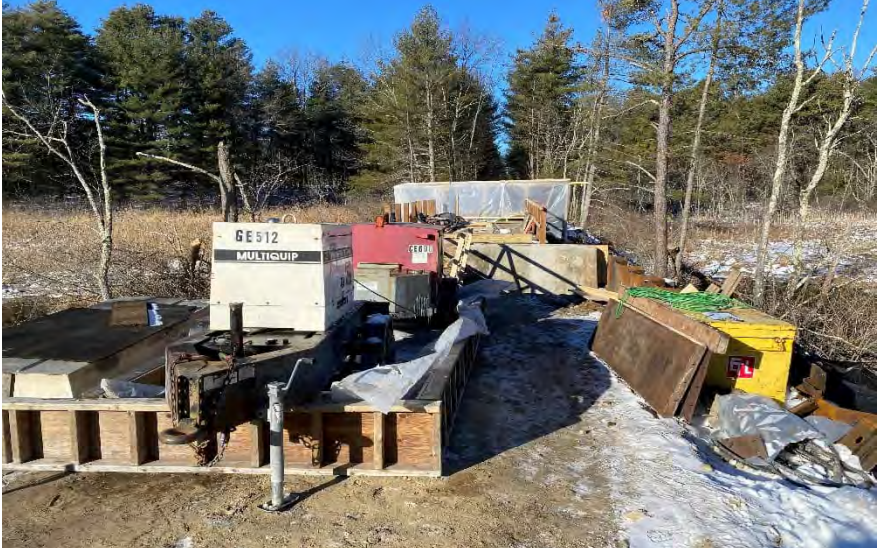
PHOTOGRAPHIC LOG	
Client Name: Eversource		Site Location: Sudbury to Hudson Transmission Reliability Project	Town: Sudbury
Photo No.: 2	Date: 1-22-24

Description: Work area within segment 8, Bridge 128 work, existing erosion control, looking westward.

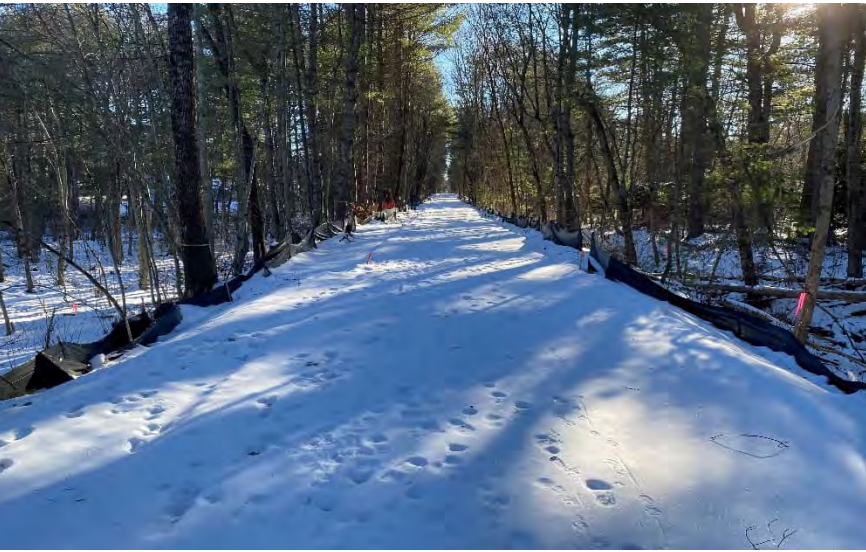
PHOTOGRAPHIC LOG	
Client Name: Eversource		Site Location: Sudbury to Hudson Transmission Reliability Project	Town: Sudbury
Photo No.: 4	Date: 1-22-24

Description: Work area within segment 10, across Dudley Brook culvert area, existing erosion control, looking eastward.

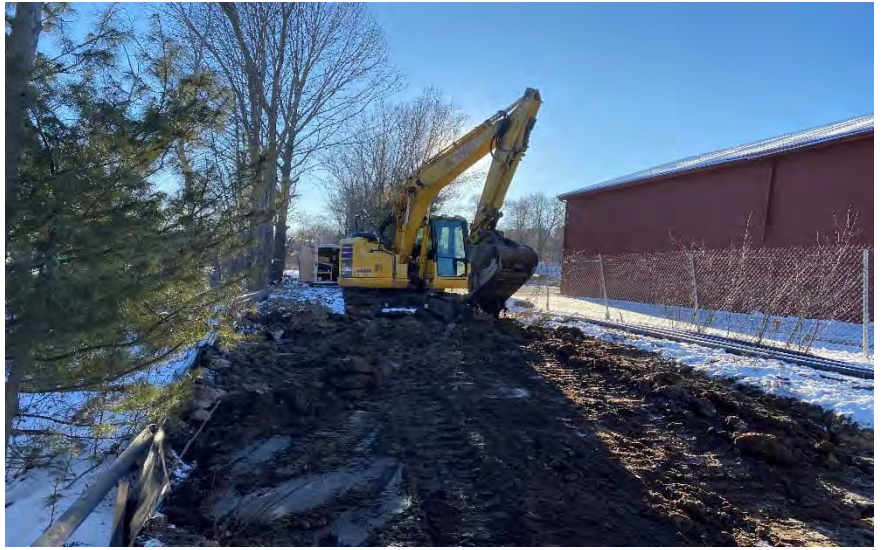
PHOTOGRAPHIC LOG	
Client Name: Eversource		Site Location: Sudbury to Hudson Transmission Reliability Project	Town: Sudbury
Photo No.: 6	Date: 1-22-24

Description: Work area within segment 12, conduit work, existing erosion control, looking eastward.

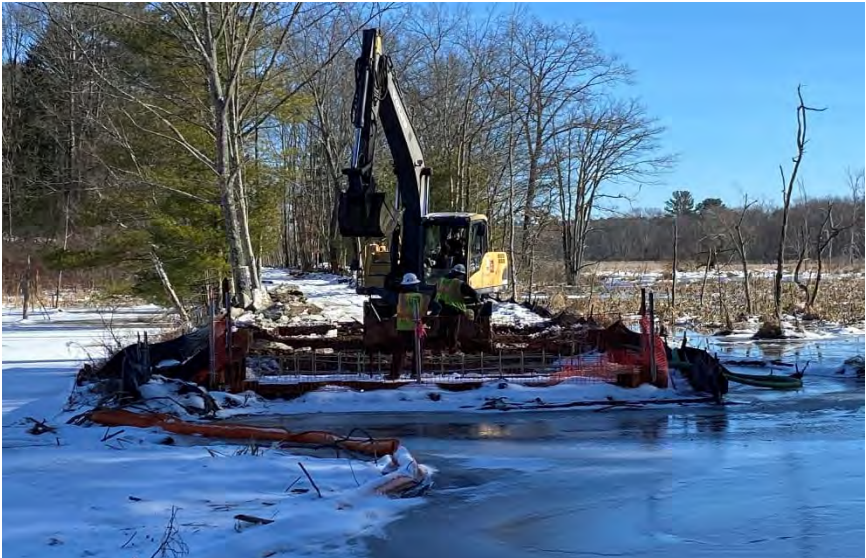
PHOTOGRAPHIC LOG	
Client Name: Eversource		Site Location: Sudbury to Hudson Transmission Reliability Project	Town: Sudbury
Photo No.: 7	Date: 1-22-24

Description: Work area within segment 14 looking across Hop Brook from segment 13, removal of crane mats, looking eastward.

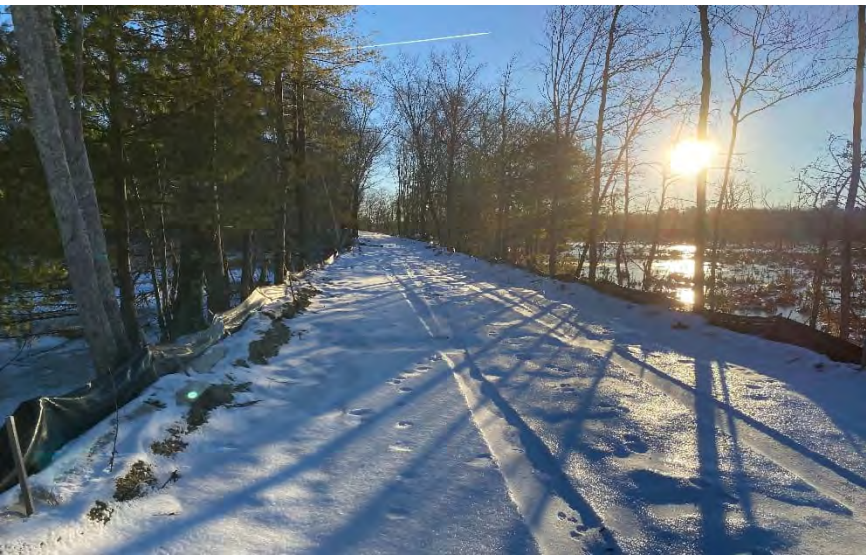
PHOTOGRAPHIC LOG	
Client Name: Eversource		Site Location: Sudbury to Hudson Transmission Reliability Project	Town: Sudbury
Photo No.: 8	Date: 1-22-24

Description: Work area within segment 14, existing erosion control, looking eastward.

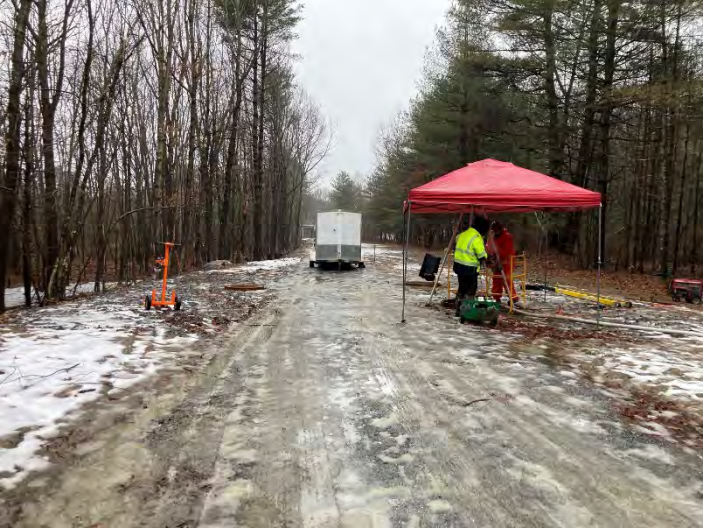
PHOTOGRAPHIC LOG	
Client Name: Eversource		Site Location: Sudbury to Hudson Transmission Reliability Project	Town: Hudson
Photo No.: 2	Date: 1-26-2024

Description: View of Bond's work area at MH #7 in segment 2. See additional dewatering inspection report. Facing west.

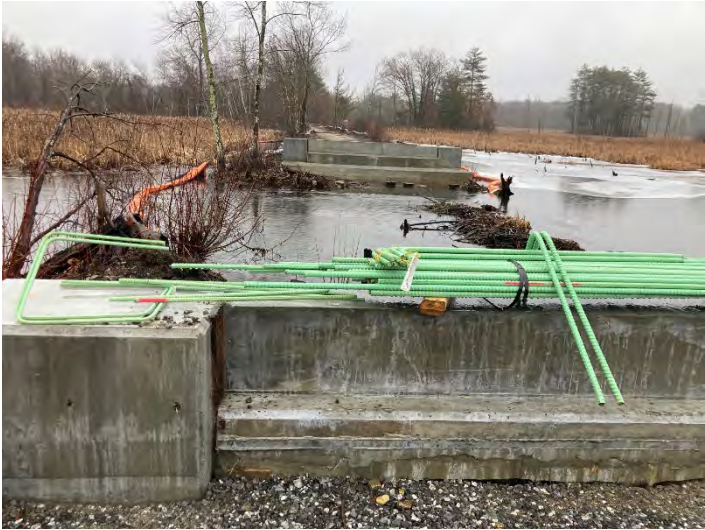
PHOTOGRAPHIC LOG	
Client Name: Eversource		Site Location: Sudbury to Hudson Transmission Reliability Project	Town: Hudson
Photo No.: 3	Date: 1-26-2024

Description: View of Bridge 130. Facing east.

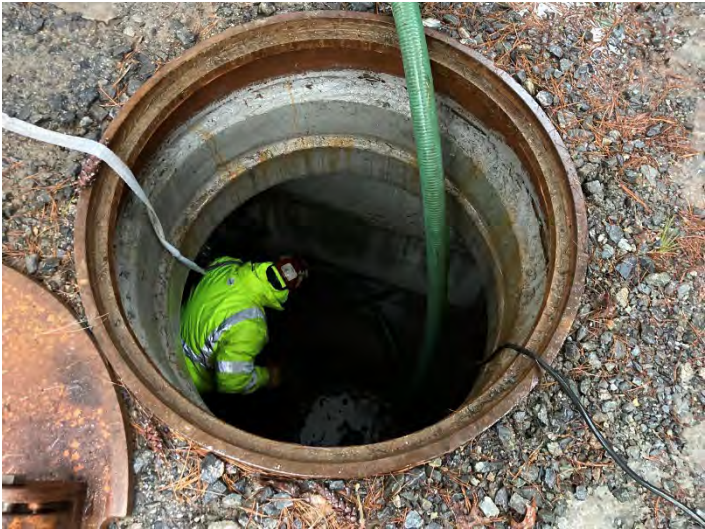
Client Name: Eversource		Site Location: Sudbury to Hudson Transmission Reliability Project	Town: Hudson
Photo No.: 5	Date: 1-26-2024

Description: View of Bond working in MH #11 in segment 5. See additional dewatering report.

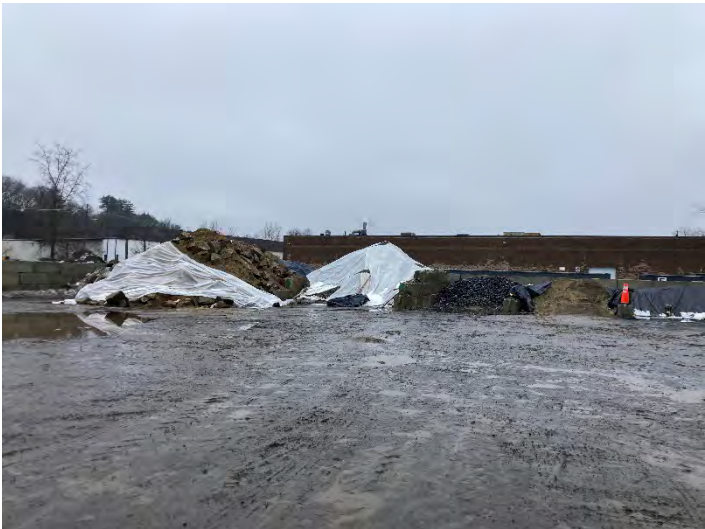
Epsilon ASSOCIATES INC.		PHOTOGRAPHIC LOG	
Client Name: Eversource		Site Location: Sudbury to Hudson Transmission Reliability Project	Town: Hudson
Photo No.: 7	Date: 1-26-2024

Description: View of silt fence at Bonazzoli laydown yard. Facing west.

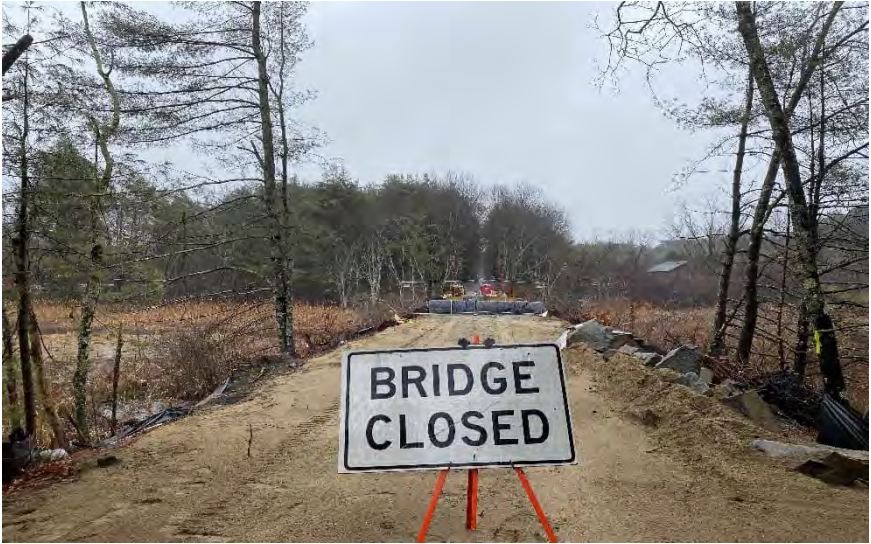
PHOTOGRAPHIC LOG	
Client Name: Eversource		Site Location: Sudbury to Hudson Transmission Reliability Project	Town: Sudbury
Photo No.: 1	Date: 1-26-24

Description: Work area, within segment 7, bridge 128, existing erosion control, looking eastward.

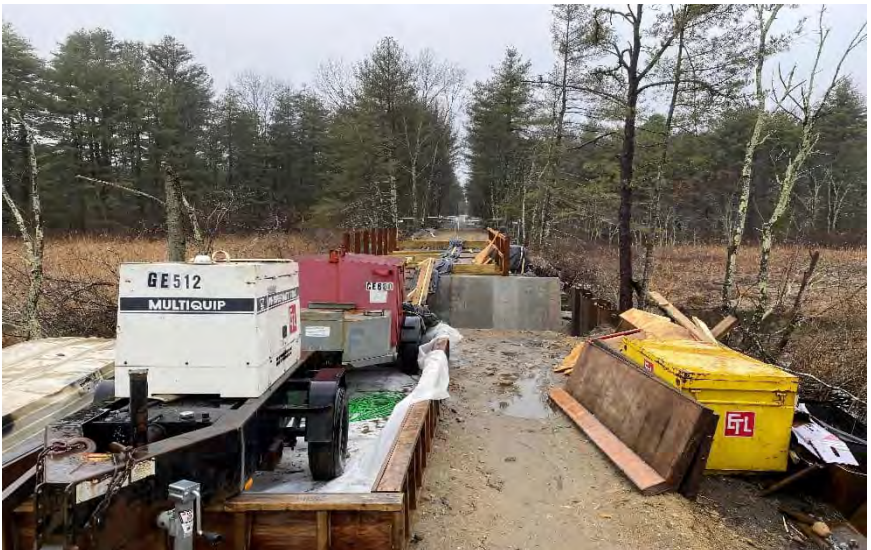
PHOTOGRAPHIC LOG	
Client Name: Eversource		Site Location: Sudbury to Hudson Transmission Reliability Project	Town: Sudbury
Photo No.: 2	Date: 1-26-24

Description: Work area within segment 8, Bridge 128 work, existing erosion control, looking westward.

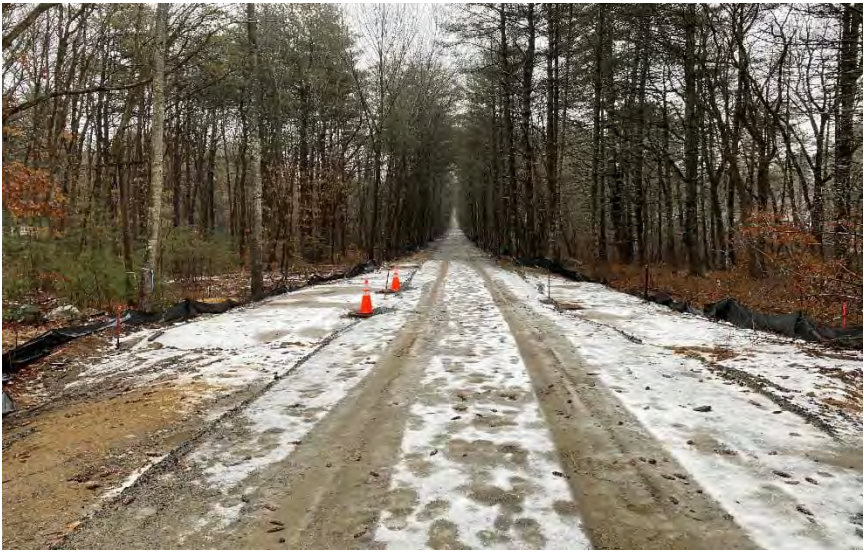
PHOTOGRAPHIC LOG	
Client Name: Eversource		Site Location: Sudbury to Hudson Transmission Reliability Project	Town: Sudbury
Photo No.: 4	Date: 1-26-24

Description: Work area within segment 10, manhole area, existing erosion control, looking eastward.

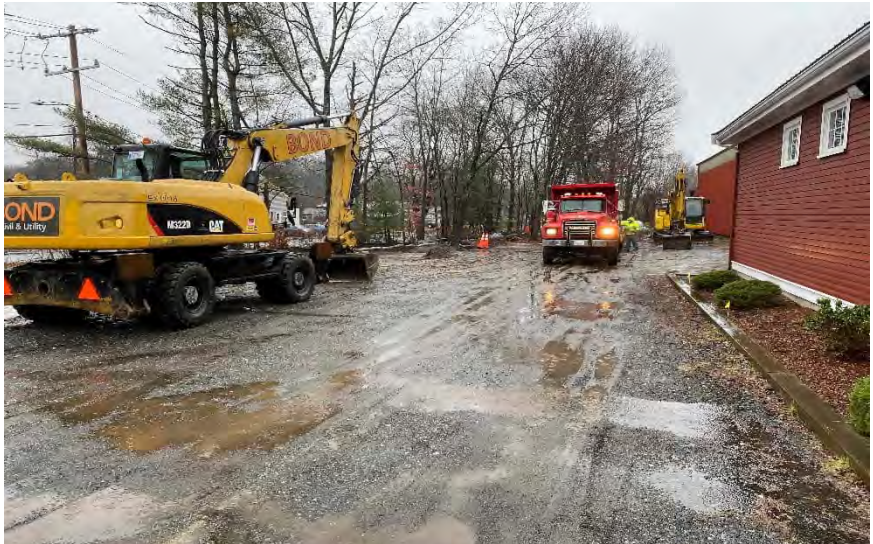
PHOTOGRAPHIC LOG	
Client Name: Eversource		Site Location: Sudbury to Hudson Transmission Reliability Project	Town: Sudbury
Photo No.: 6	Date: 1-26-24

Description: Work area within segment 12, cleanup following conduit work, looking eastward.

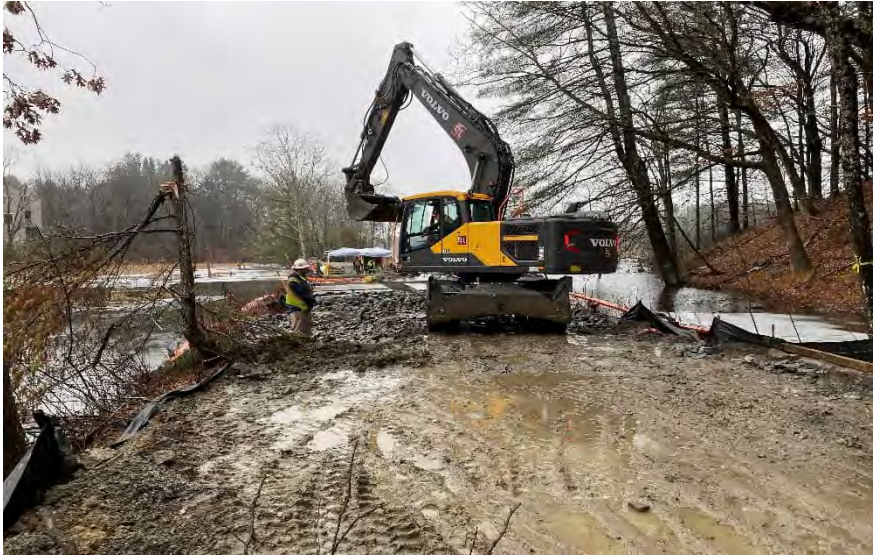
PHOTOGRAPHIC LOG	
Client Name: Eversource		Site Location: Sudbury to Hudson Transmission Reliability Project	Town: Sudbury
Photo No.: 7	Date: 1-26-24

Description: Work area within segment 13 looking across Hop Brook, placement of crane mats for upcoming Bridge 127 work, looking eastward.

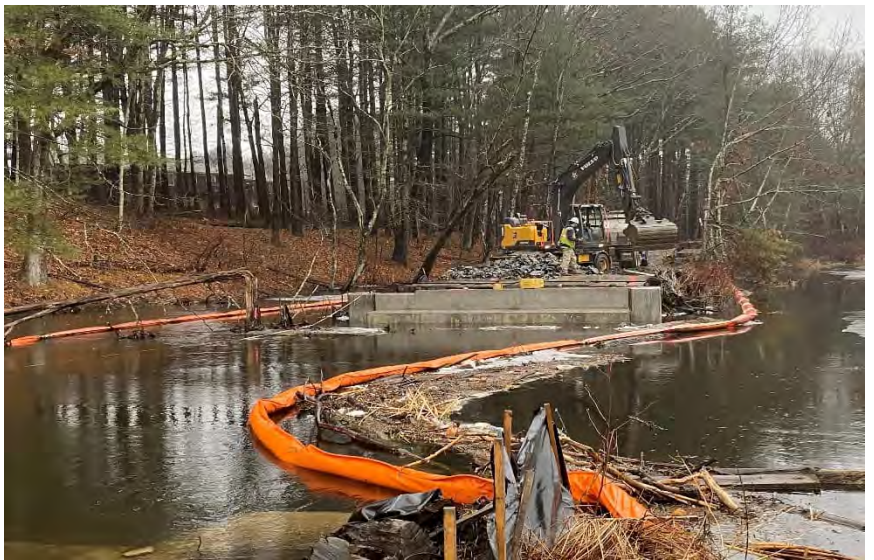
PHOTOGRAPHIC LOG	
Client Name: Eversource		Site Location: Sudbury to Hudson Transmission Reliability Project	Town: Sudbury
Photo No.: 8	Date: 1-26-24

Description: Work area within segment 13 looking across Hop brook from segment 14, existing erosion control (floating silt curtain), looking westward.

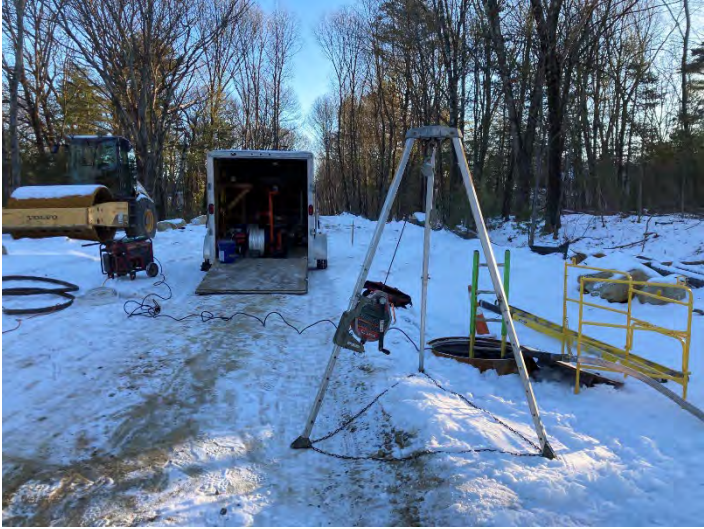
PHOTOGRAPHIC LOG	
Client Name: Eversource		Site Location: Sudbury to Hudson Transmission Reliability Project	Town: Hudson
Photo No.: 1	Date: 1/22/2024

Description: View of pumping operation at MH #5 in segment 1. Facing east.
