Weekly Environmental Compliance Summary

Sudbury to Hudson Transmission Reliability Project (USEPA Tracking # MAR1003UW)

Week of: January 22, 2024 to January 26, 2024

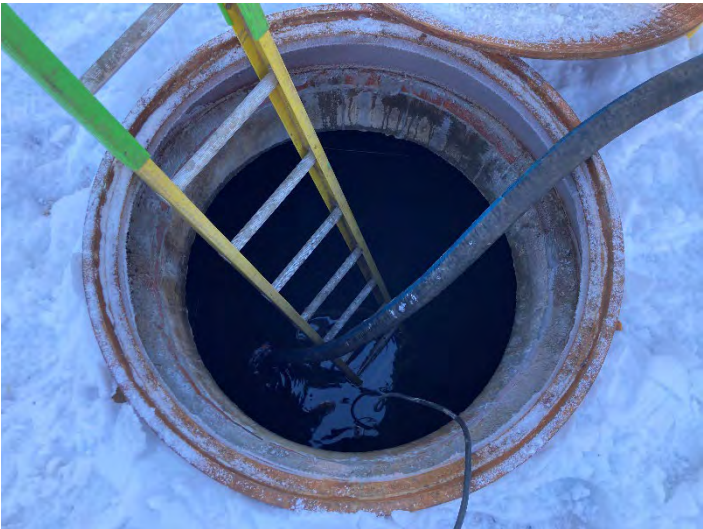
PHOTOGRAPHIC LOG	
Client Name: Eversource		Site Location: Sudbury to Hudson Transmission Reliability Project	Town: Hudson
Photo No.: 2	Date: 1/22/2024

Description: View of pump in MH #5. Water appeared mostly clear prior to treatment.

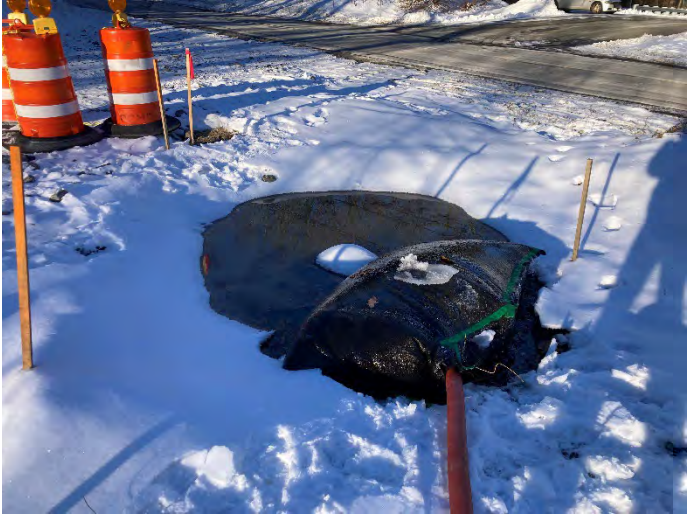
PHOTOGRAPHIC LOG		
Client Name: Eversource		Site Location: Sudbury to Hudson Transmission Reliability Project		Town: Hudson
Photo No.: 3	Date: 1/22/2024

Description: View of filter bag and discharge. Facing southwest.

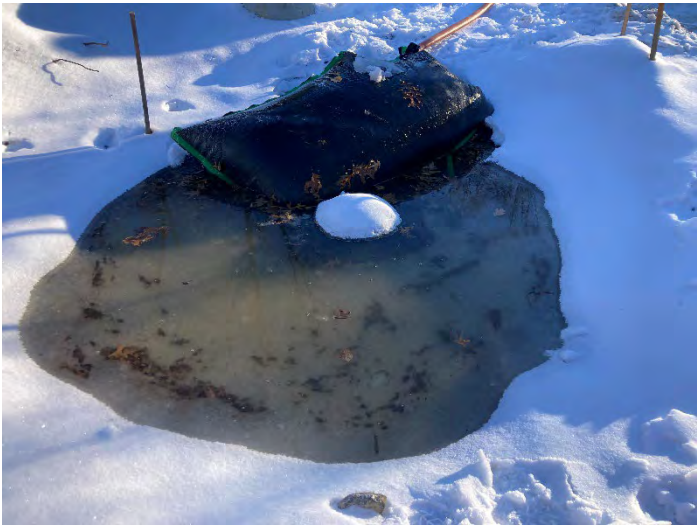
PHOTOGRAPHIC LOG		
Client Name: Eversource		Site Location: Sudbury to Hudson Transmission Reliability Project		Town: Hudson
Photo No.: 4	Date: 1/22/2024

Description: Additional view of filter bag and discharge. Dewatering water sent to filter bag before being discharged into catch basin within segment 1. Water appeared slightly turbid. Turbidity reading was higher than 50 NTUs. Facing east.

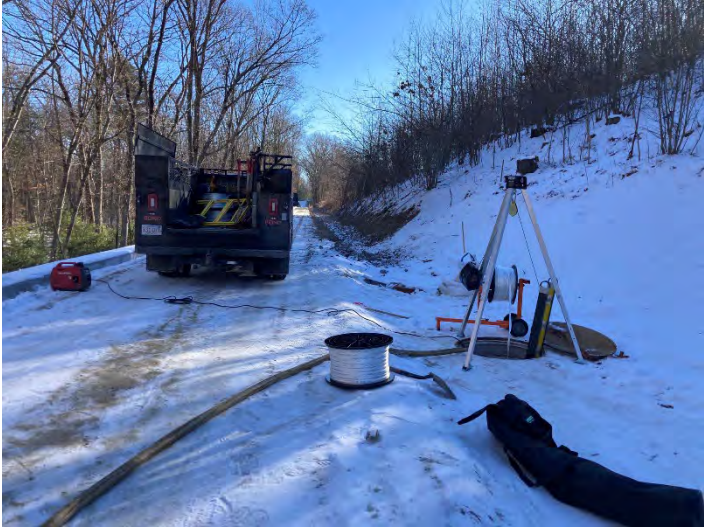
PHOTOGRAPHIC LOG	
Client Name: Eversource		Site Location: Sudbury to Hudson Transmission Reliability Project	Town: Hudson
Photo No.: 1	Date: 1/22/2024

Description: View of pumping operation at MH #6 in segment 1. Facing east.

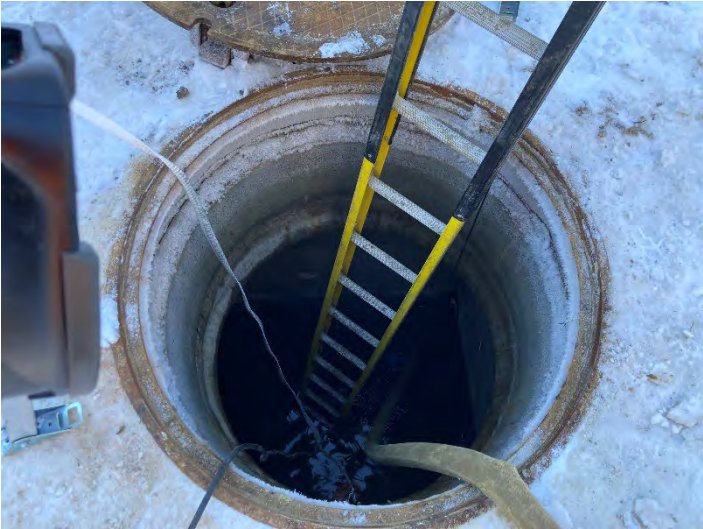
PHOTOGRAPHIC LOG	
Client Name: Eversource		Site Location: Sudbury to Hudson Transmission Reliability Project	Town: Hudson
Photo No.: 2	Date: 1/22/2024

Description: View of pump in MH #6. Water appeared mostly clear prior to treatment.

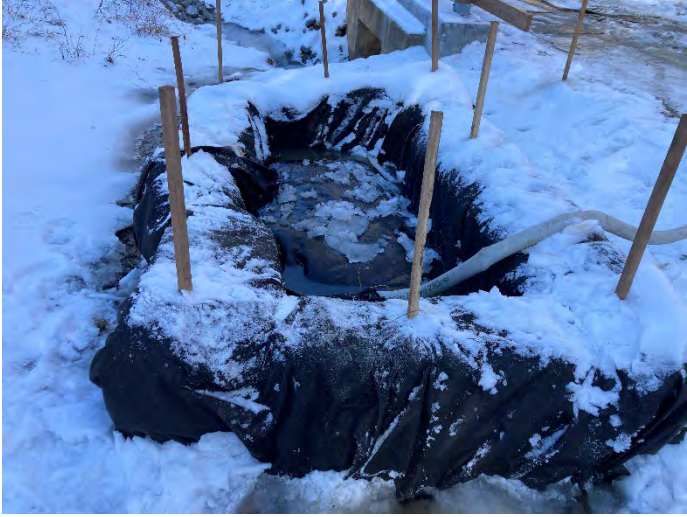
PHOTOGRAPHIC LOG	
Client Name: Eversource		Site Location: Sudbury to Hudson Transmission Reliability Project	
Town: Hudson			
Photo No.: 3	Date: 1/22/2024

Description: View of dewatering controls (straw bale corral with filter fabric and silt bag). Facing west.

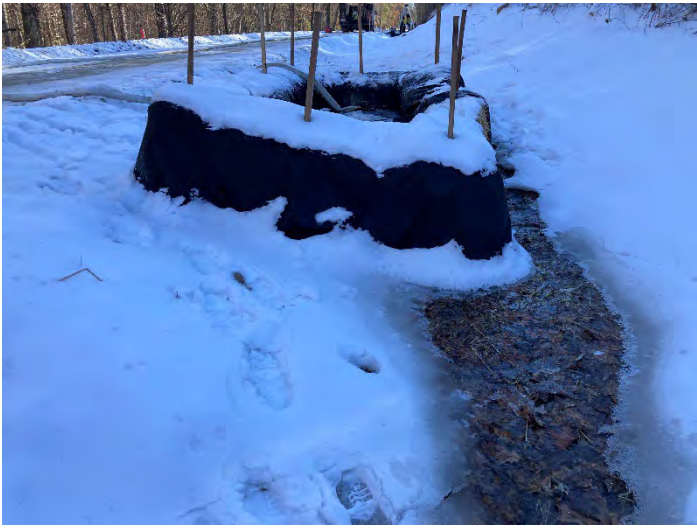
PHOTOGRAPHIC LOG	
Client Name: Eversource		Site Location: Sudbury to Hudson Transmission Reliability Project	
Town: Hudson			
Photo No.: 4	Date: 1/22/2024

Description: View of discharge from controls. Water appeared mostly clear. Discharge may have reached jurisdictional areas below cattle crossing. Turbidity reading was below 50 NTUs. Facing east.

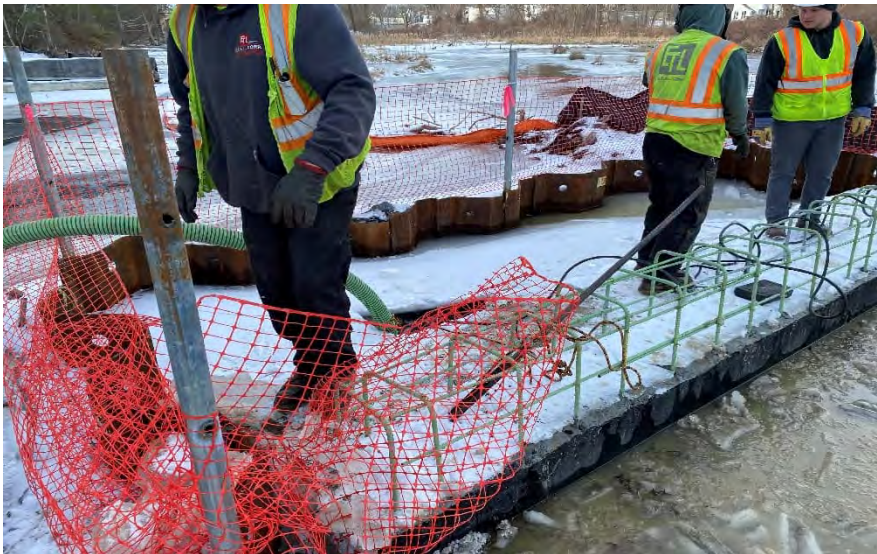
PHOTOGRAPHIC LOG	
Client Name: Eversource		Site Location: Sudbury to Hudson Transmission Reliability Project	Town: Sudbury
Photo No.: 1	Date: 1/22/2024

Description: View of area (cofferdam) being pumped at Bridge 127 - segment 14 area, looking westward.

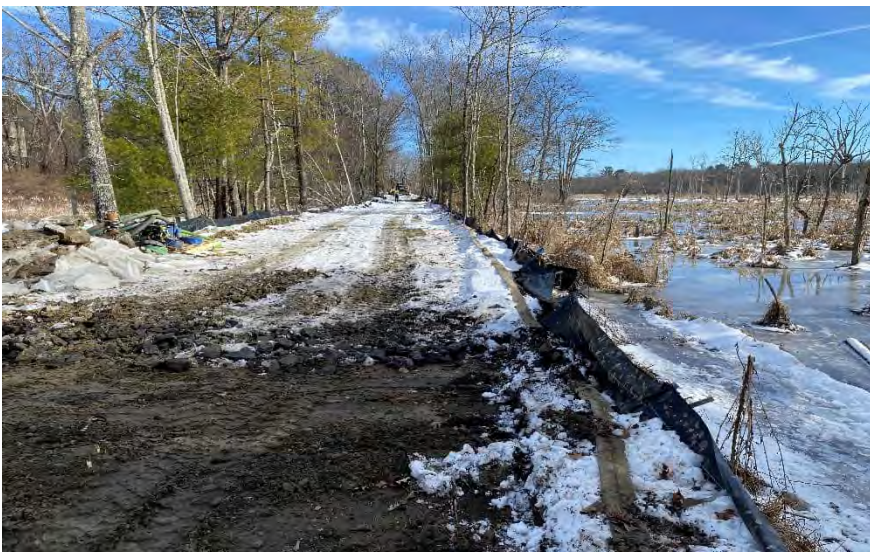
PHOTOGRAPHIC LOG	
Client Name: Eversource		Site Location: Sudbury to Hudson Transmission Reliability Project	Town: Sudbury
Photo No.: 2	Date: 1/22/2024

Description: Segment 14. View of dewatering operation, looking eastward.

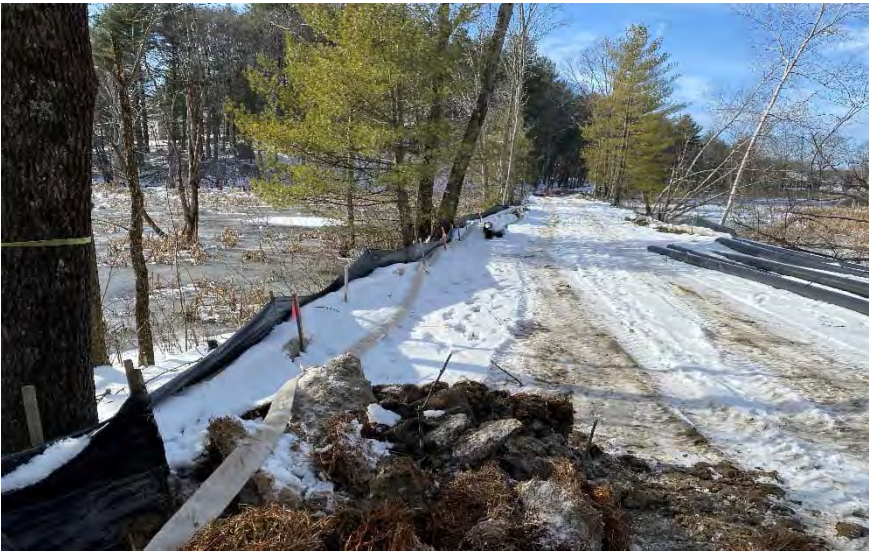
PHOTOGRAPHIC LOG	
Client Name: Eversource		Site Location: Sudbury to Hudson Transmission Reliability Project	
Town: Sudbury			
Photo No.: 3	Date: 1/22/2024

Description: Segment 14. View of dewatering operation, looking westward.

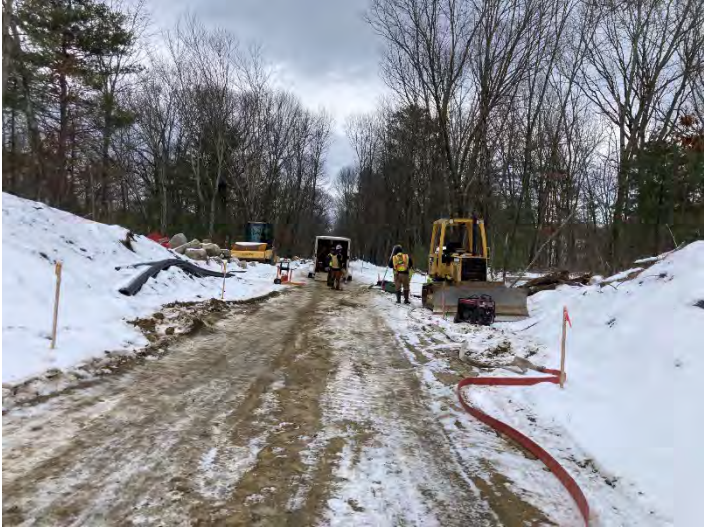
Epsilon <small>ASSOCIATES INC.</small>		PHOTOGRAPHIC LOG	
Client Name: Eversource		Site Location: Sudbury to Hudson Transmission Reliability Project	Town: Hudson
Photo No.: 1	Date: 1/23/2024

Description: View of pumping operation at MH #5 in segment 1. Facing east.

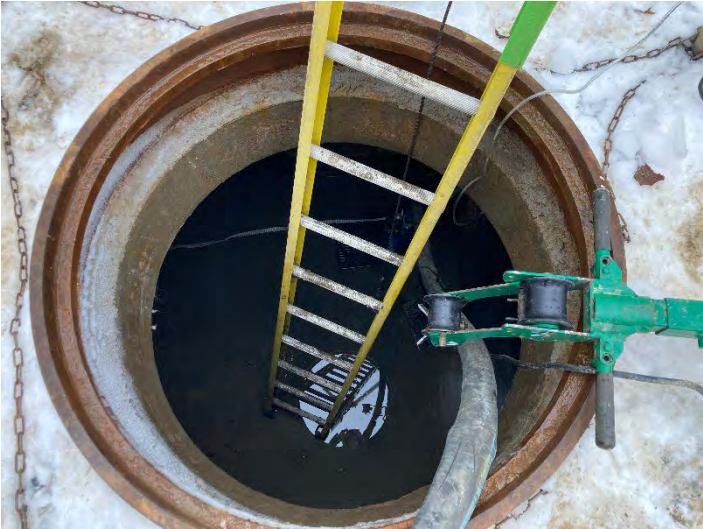
Epsilon <small>ASSOCIATES INC.</small>		PHOTOGRAPHIC LOG	
Client Name: Eversource		Site Location: Sudbury to Hudson Transmission Reliability Project	Town: Hudson
Photo No.: 2	Date: 1/23/2024

Description: View of pump in MH #5. Water appeared mostly clear prior to treatment.

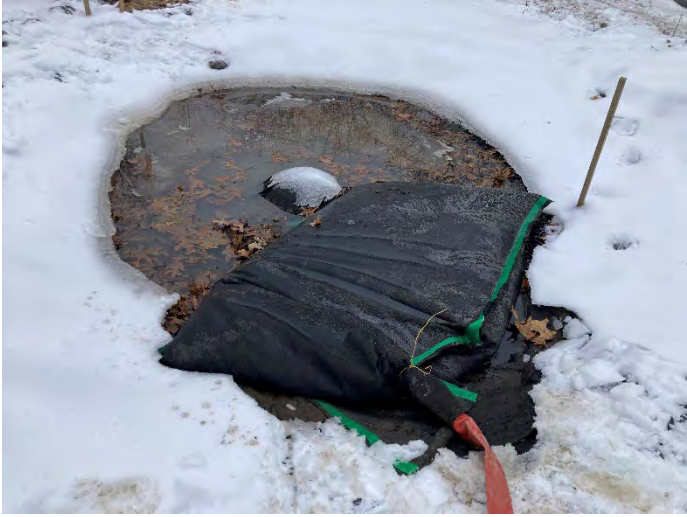
PHOTOGRAPHIC LOG	
Client Name: Eversource		Site Location: Sudbury to Hudson Transmission Reliability Project	Town: Hudson
Photo No.: 3	Date: 1/23/2024

Description: View of filter bag and discharge. Facing southwest.

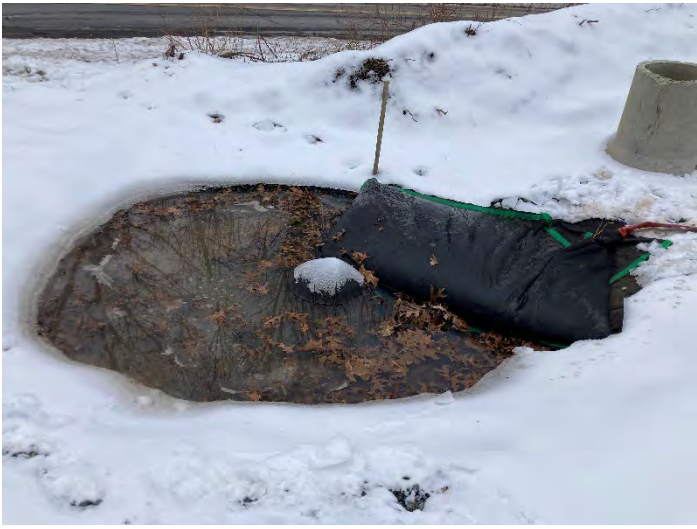
PHOTOGRAPHIC LOG	
Client Name: Eversource		Site Location: Sudbury to Hudson Transmission Reliability Project	Town: Hudson
Photo No.: 4	Date: 1/23/2024

Description: Additional view of filter bag and discharge. Dewatering water sent to filter bag before being discharged into catch basin within segment 1. Water appeared mostly clear. Turbidity reading was below 50 NTUs. Facing northeast.

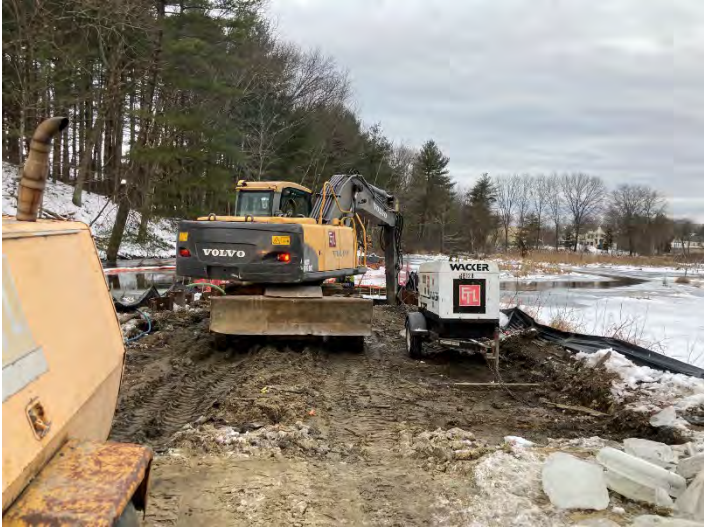
PHOTOGRAPHIC LOG	
Client Name: Eversource		Site Location: Sudbury to Hudson Transmission Reliability Project	Town: Sudbury
Photo No.: 1	Date: 1/23/2024

Description: View of work area at Bridge 127 at Hop Brook. Facing west.

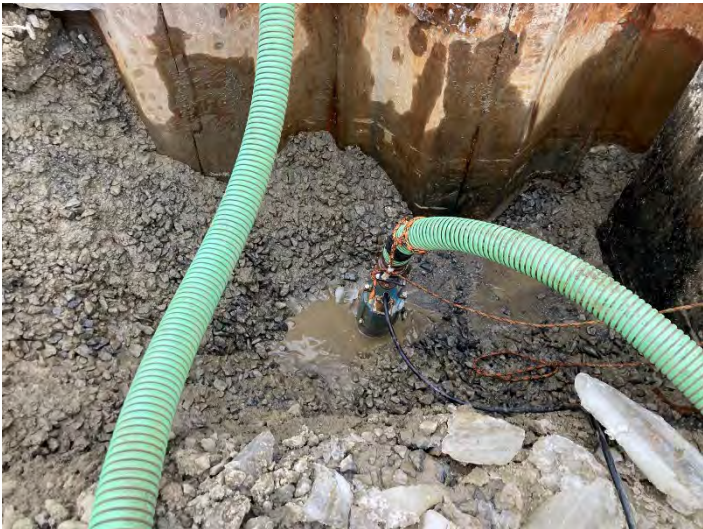
PHOTOGRAPHIC LOG	
Client Name: Eversource		Site Location: Sudbury to Hudson Transmission Reliability Project	Town: Sudbury
Photo No.: 2	Date: 1/23/2024

Description: View of pump at bridge. Water appeared turbid prior to treatment.

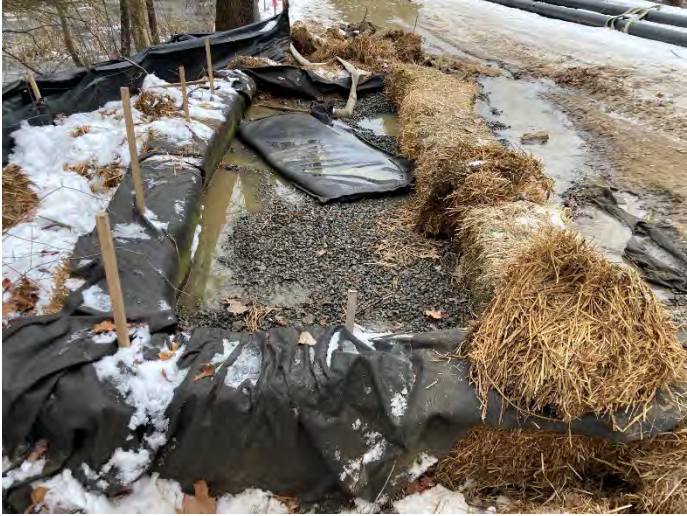
PHOTOGRAPHIC LOG	
Client Name: Eversource		Site Location: Sudbury to Hudson Transmission Reliability Project	Town: Sudbury
Photo No.: 3	Date: 1/23/2024

Description: View of dewatering controls (straw bale corral with filter fabric, stone, and silt bag). Facing west.

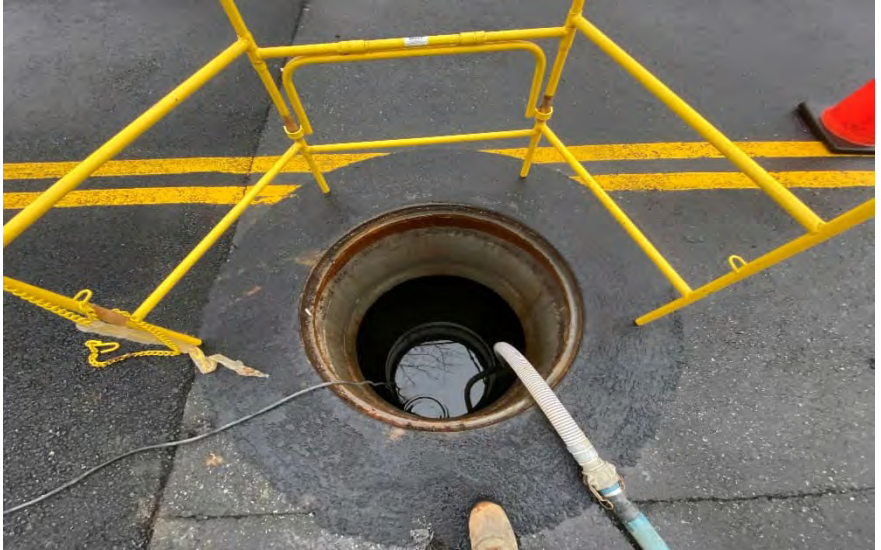
PHOTOGRAPHIC LOG		
Client Name: Eversource		Site Location: Sudbury to Hudson Transmission Reliability Project		Town: Hudson
Photo No.: 1	Date: 1/25/2024

Description: View of area being pumped from Manhole #4 – Forest Avenue.

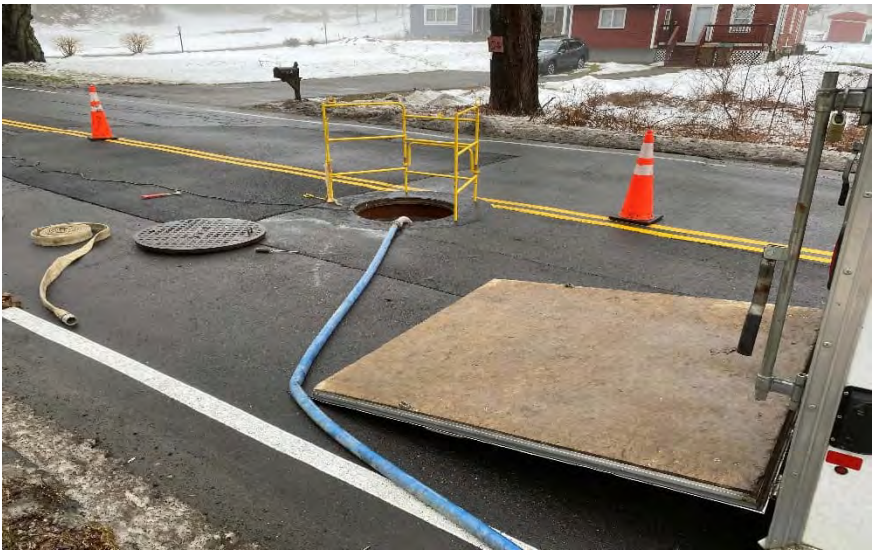
PHOTOGRAPHIC LOG		
Client Name: Eversource		Site Location: Sudbury to Hudson Transmission Reliability Project		Town: Hudson
Photo No.: 2	Date: 1/25/2024

Description: Manhole #4. View of dewatering operation, looking southward.

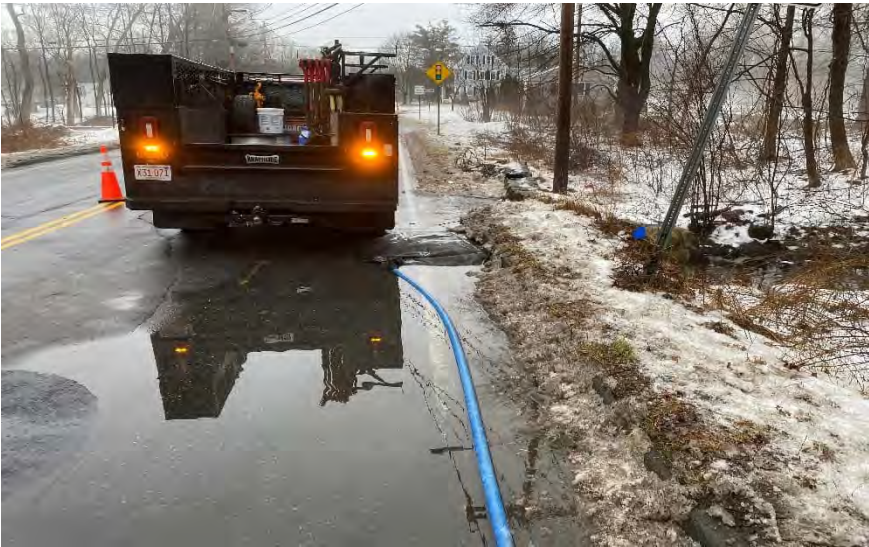
PHOTOGRAPHIC LOG	
Client Name: Eversource		Site Location: Sudbury to Hudson Transmission Reliability Project	
Town: Hudson			
Photo No.: 3	Date: 1/25/2024

Description: Manhole #4. View of dewatering operation, looking northward.

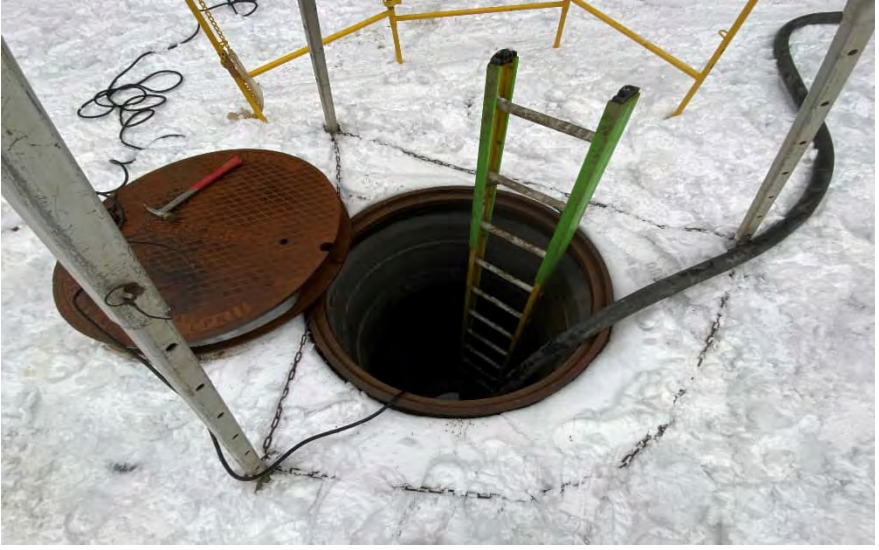
PHOTOGRAPHIC LOG	
Client Name: Eversource		Site Location: Sudbury to Hudson Transmission Reliability Project	Town: Hudson
Photo No.: 1	Date: 1/24/2024

Description: View of pumping from manhole #7 segment 2.

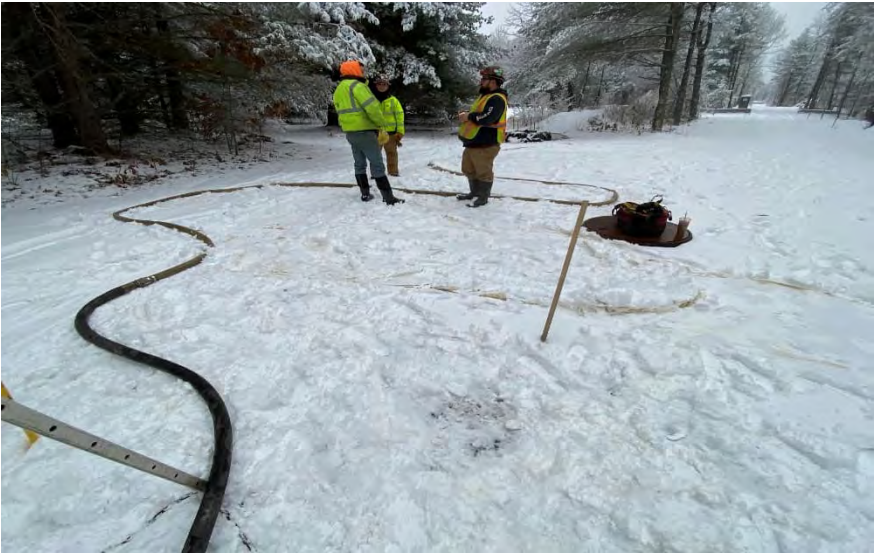
PHOTOGRAPHIC LOG	
Client Name: Eversource		Site Location: Sudbury to Hudson Transmission Reliability Project	Town: Hudson
Photo No.: 2	Date: 1/24/2024

Description: Manhole #7. View of dewatering operation. Looking eastward.

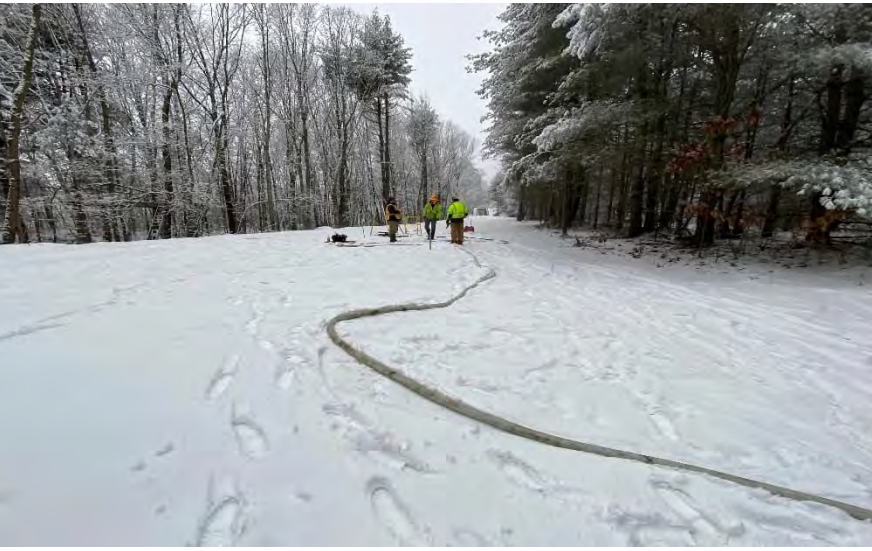
PHOTOGRAPHIC LOG	
Client Name: Eversource		Site Location: Sudbury to Hudson Transmission Reliability Project	
Town: Hudson			
Photo No.: 3	Date: 1/24/2024

Description: Manhole #7. View of dewatering operation, looking westward.

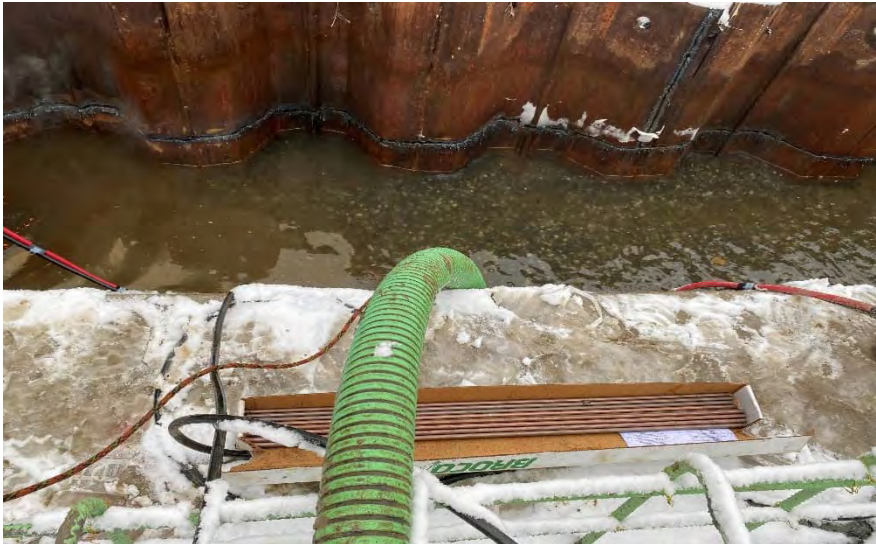
PHOTOGRAPHIC LOG	
Client Name: Eversource		Site Location: Sudbury to Hudson Transmission Reliability Project	Town: Sudbury
Photo No.: 1	Date: 1/24/2024

Description: View of area being pumped from Bridge 127 - segment 14 area, looking westward.

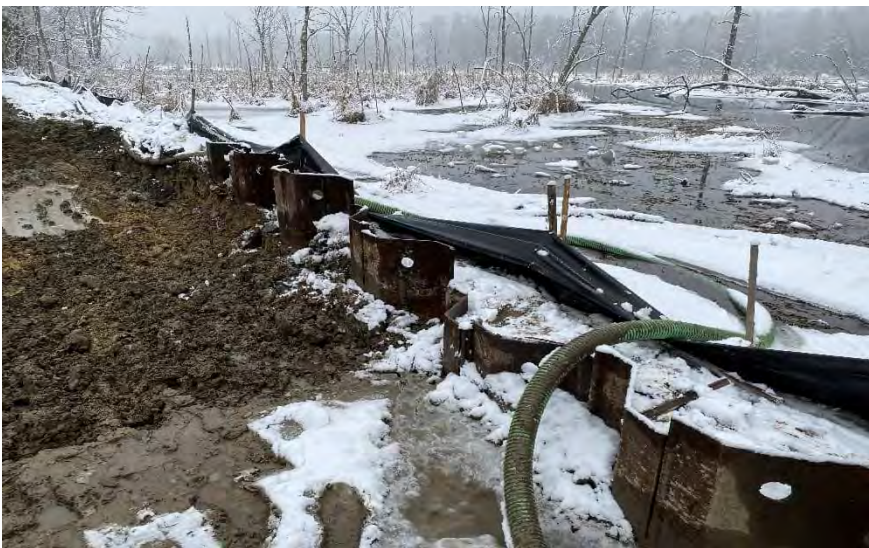
PHOTOGRAPHIC LOG	
Client Name: Eversource		Site Location: Sudbury to Hudson Transmission Reliability Project	Town: Sudbury
Photo No.: 2	Date: 1/24/2024

Description: Segment 14. View of dewatering operation, looking eastward.

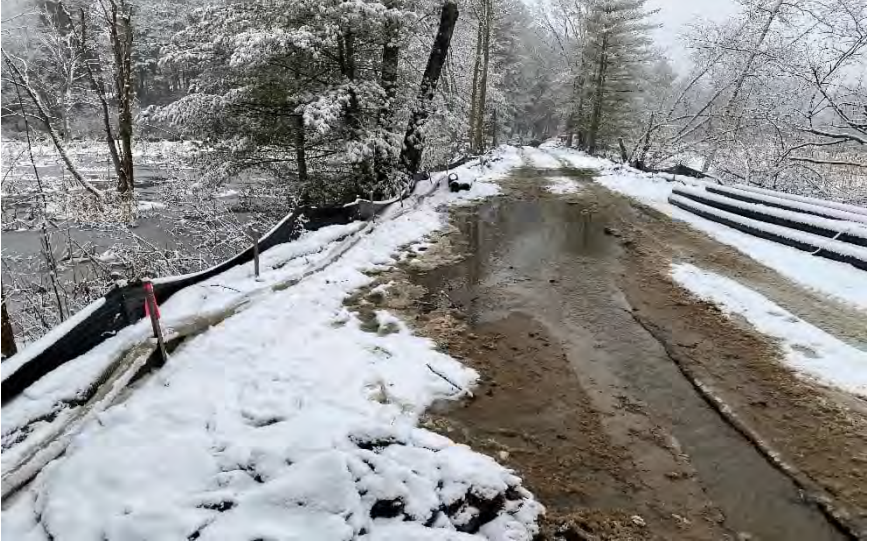
PHOTOGRAPHIC LOG	
Client Name: Eversource		Site Location: Sudbury to Hudson Transmission Reliability Project	Town: Sudbury
Photo No.: 3	Date: 1/24/2024

Description: Segment 14. View of dewatering operation, looking westward.

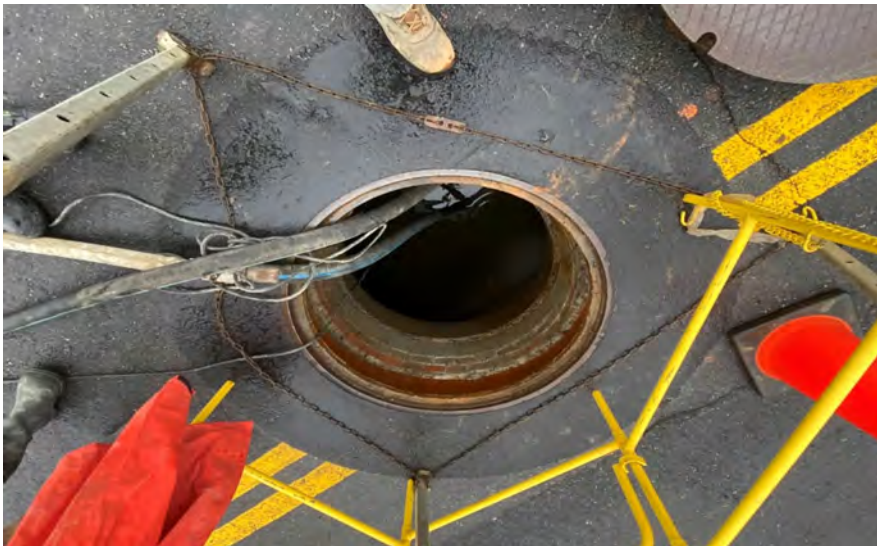
PHOTOGRAPHIC LOG	
Client Name: Eversource		Site Location: Sudbury to Hudson Transmission Reliability Project	Town: Hudson
Photo No.: 1	Date: 1/25/2024

Description: View of pumping from manhole #3 Forest Avenue.

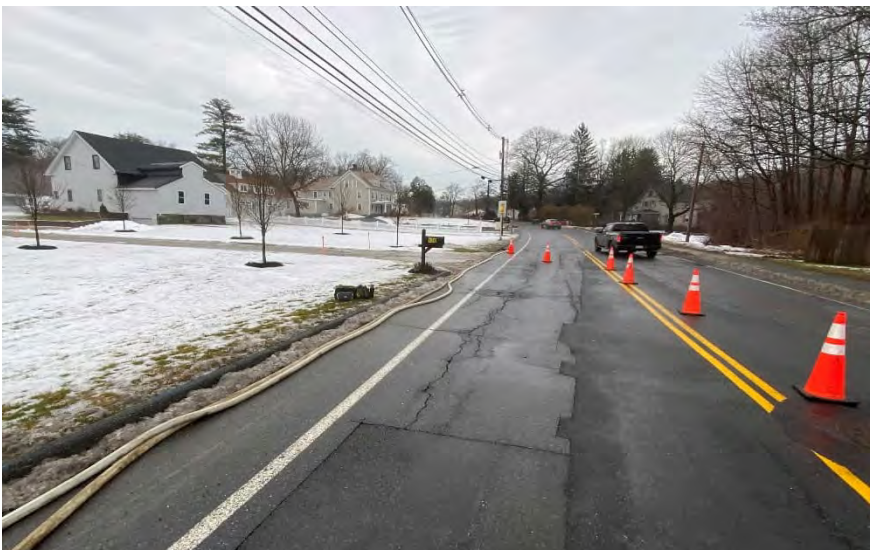
PHOTOGRAPHIC LOG	
Client Name: Eversource		Site Location: Sudbury to Hudson Transmission Reliability Project	Town: Hudson
Photo No.: 2	Date: 1/25/2024

Description: Manhole #3. View of dewatering operation. Looking northward.

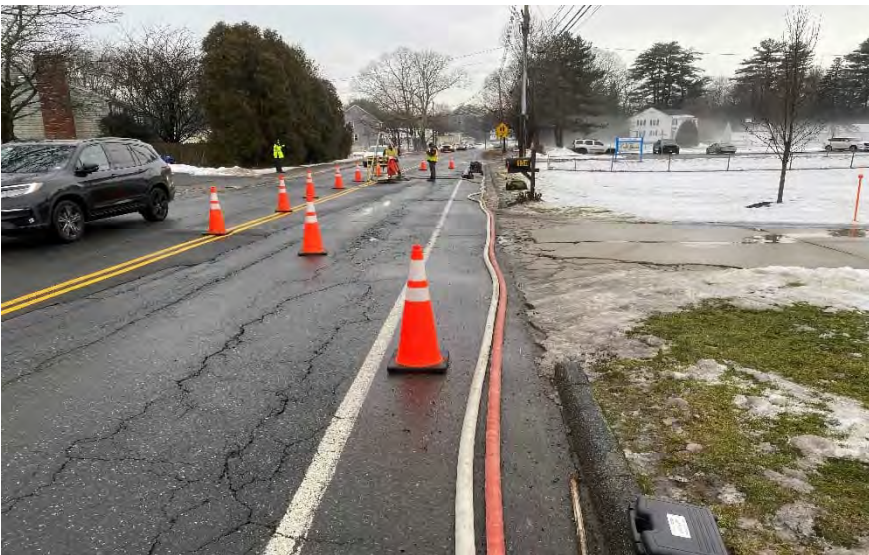
PHOTOGRAPHIC LOG	
Client Name: Eversource		Site Location: Sudbury to Hudson Transmission Reliability Project	
Town: Hudson			
Photo No.: 3	Date: 1/25/2024

Description: Manhole #3. View of dewatering operation, looking southward.

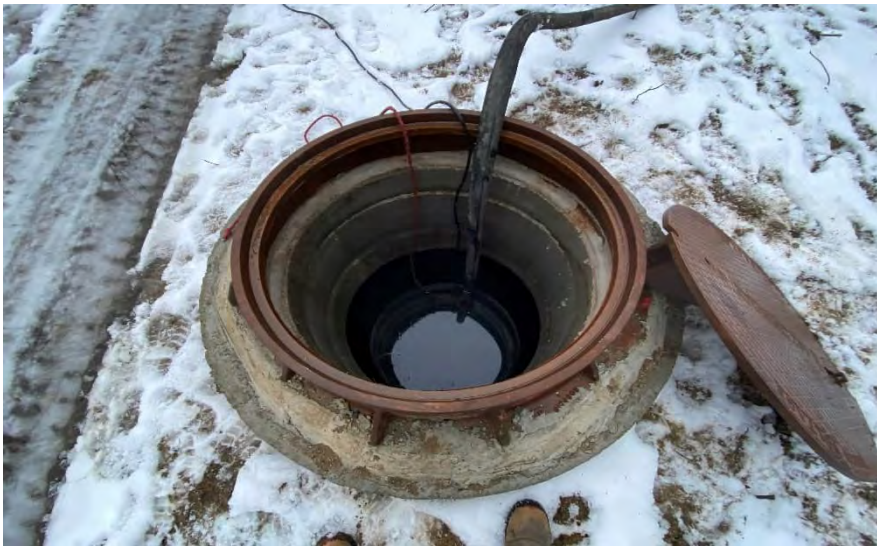
PHOTOGRAPHIC LOG	
Client Name: Eversource		Site Location: Sudbury to Hudson Transmission Reliability Project	Town: Hudson
Photo No.: 1	Date: 1/25/2024

Description: View of area being pumped from Manhole #14 - segment 6 area.

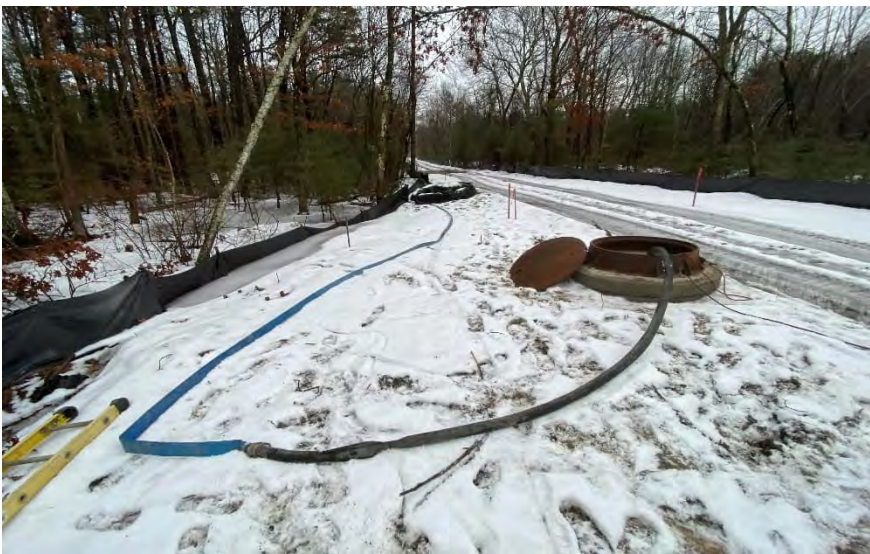
PHOTOGRAPHIC LOG	
Client Name: Eversource		Site Location: Sudbury to Hudson Transmission Reliability Project	Town: Hudson
Photo No.: 2	Date: 1/25/2024

Description: Manhole #14. View of dewatering operation, looking eastward.

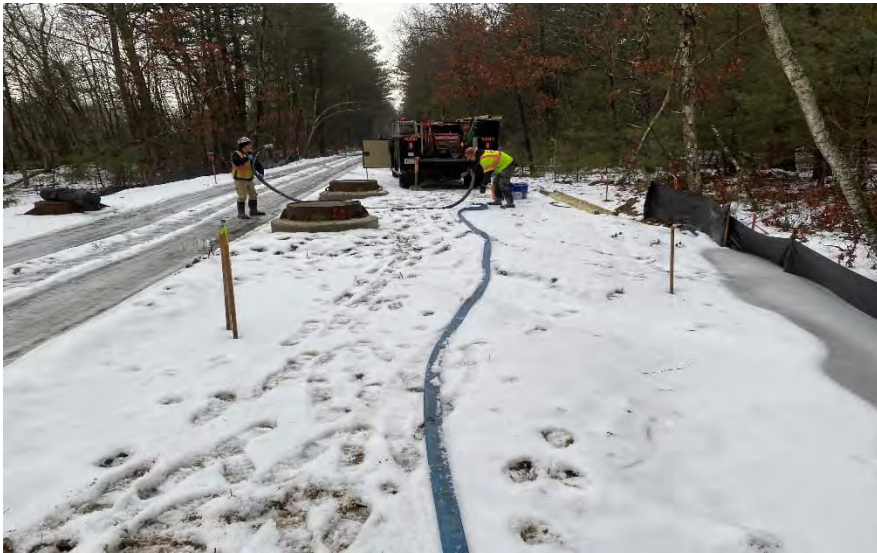
PHOTOGRAPHIC LOG	
Client Name: Eversource		Site Location: Sudbury to Hudson Transmission Reliability Project	Town: Hudson
Photo No.: 3	Date: 1/25/2024

Description: Manhole #14. View of dewatering operation, looking westward.

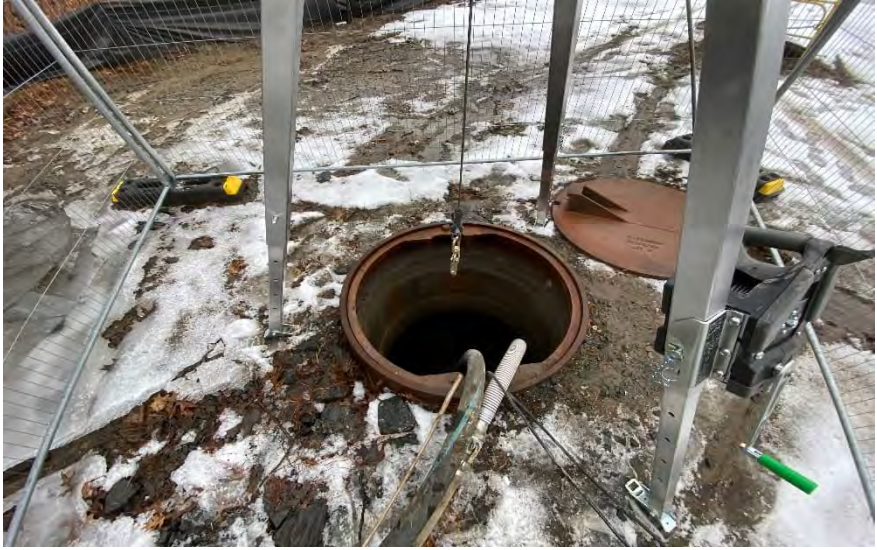
PHOTOGRAPHIC LOG	
Client Name: Eversource		Site Location: Sudbury to Hudson Transmission Reliability Project	Town: Sudbury
Photo No.: 1	Date: 1/25/2024

Description: View of area being pumped from segment 11-manhole #24, looking westward.

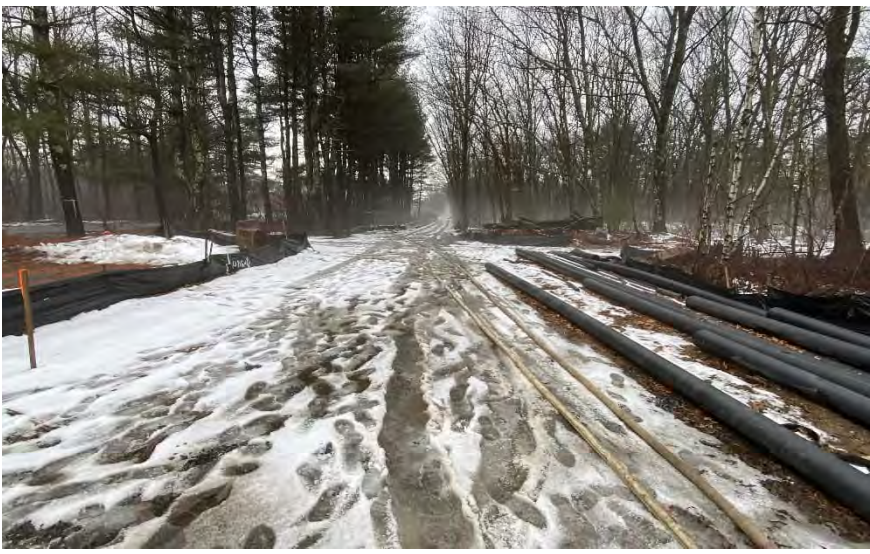
PHOTOGRAPHIC LOG	
Client Name: Eversource		Site Location: Sudbury to Hudson Transmission Reliability Project	Town: Sudbury
Photo No.: 2	Date: 1/25/2024

Description: Manhole #24. View of dewatering operation. Looking westward.

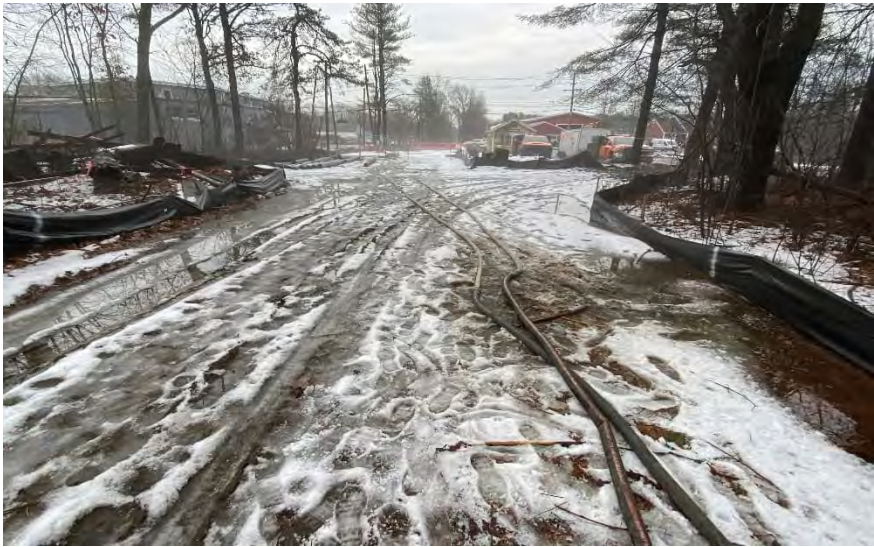
PHOTOGRAPHIC LOG	
Client Name: Eversource		Site Location: Sudbury to Hudson Transmission Reliability Project	Town: Sudbury
Photo No.: 3	Date: 1/18/2024

Description: Manhole #24. View of dewatering operation, looking eastward.

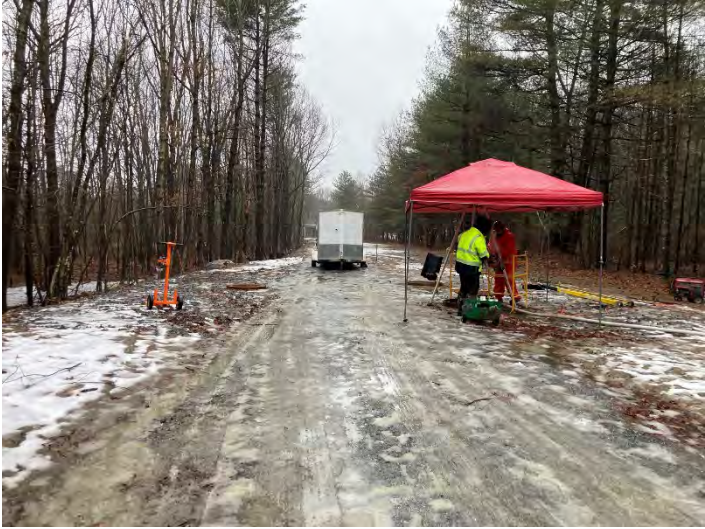
PHOTOGRAPHIC LOG	
Client Name: Eversource		Site Location: Sudbury to Hudson Transmission Reliability Project	Town: Hudson
Photo No.: 1	Date: 1/26/2024

Description: View of Bond working at MH #7 in segment 2. Facing west.

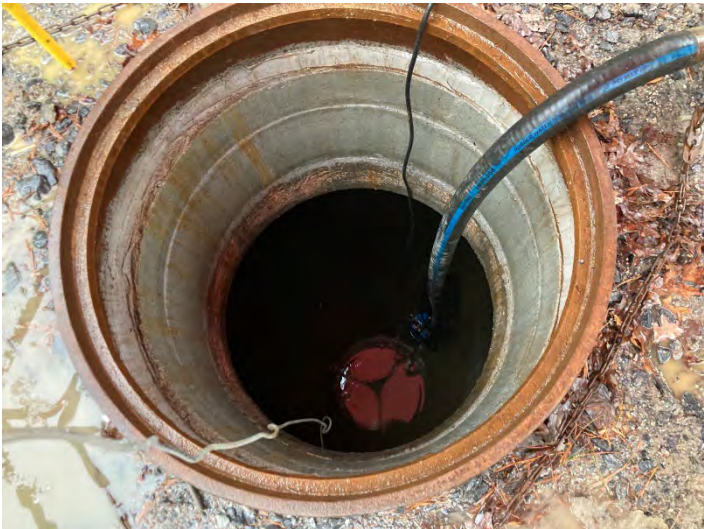
PHOTOGRAPHIC LOG	
Client Name: Eversource		Site Location: Sudbury to Hudson Transmission Reliability Project	Town: Hudson
Photo No.: 2	Date: 1/26/2024

Description: View of pump in MH #7. Water appeared mostly clear prior to treatment.

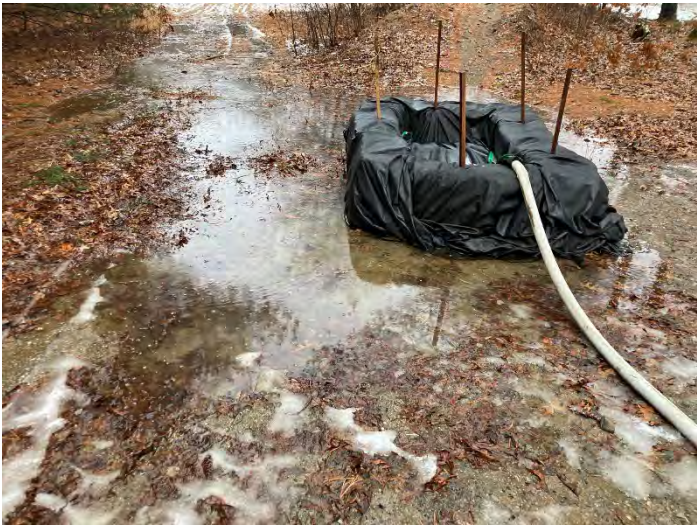
PHOTOGRAPHIC LOG	
Client Name: Eversource		Site Location: Sudbury to Hudson Transmission Reliability Project	Town: Hudson
Photo No.: 4	Date: 1/26/2024

Description: Additional view of dewatering controls and discharge. Discharge appeared mostly clear. Turbidity reading was below 50 NTUs. Facing east.

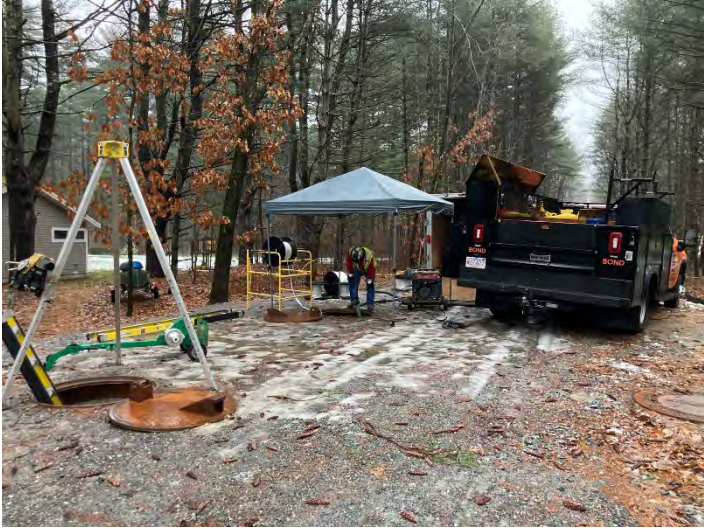
PHOTOGRAPHIC LOG	
Client Name: Eversource		Site Location: Sudbury to Hudson Transmission Reliability Project	Town: Hudson
Photo No.: 1	Date: 1/26/2024

Description: View of Bond working at MH #11 in segment 5. Facing east.

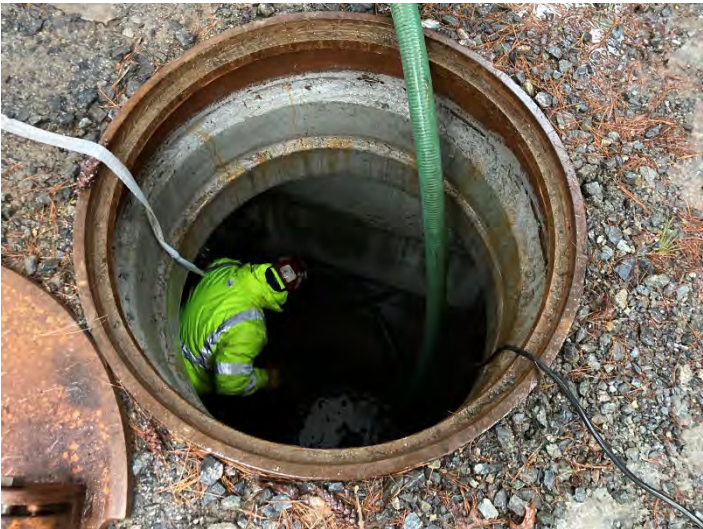
PHOTOGRAPHIC LOG	
Client Name: Eversource		Site Location: Sudbury to Hudson Transmission Reliability Project	Town: Hudson
Photo No.: 2	Date: 1/26/2024

Description: View of pump in MH #11. Water appeared mostly clear prior to treatment.

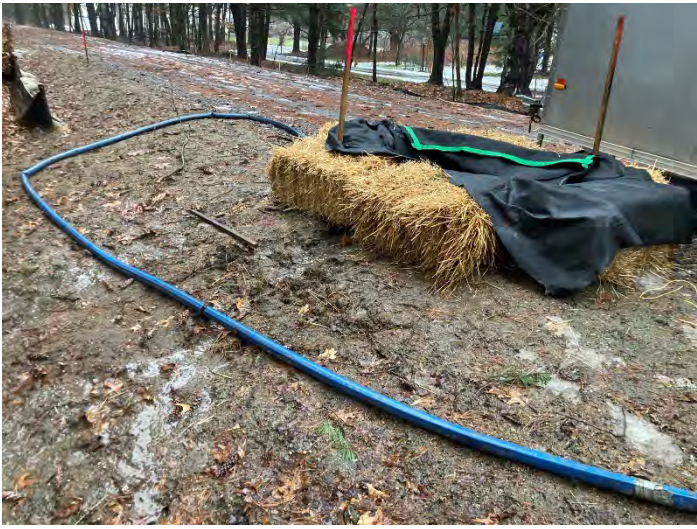
PHOTOGRAPHIC LOG			
Client Name: Eversource		Site Location: Sudbury to Hudson Transmission Reliability Project		Town: Hudson	
Photo No.: 4	Date: 1/26/2024

Description: Additional view of dewatering controls and discharge. Very little water was discharged and discharge did not reach any jurisdictional areas. No turbidity sample collected. Facing southeast.
