Weekly Environmental Compliance Summary

Sudbury to Hudson Transmission Reliability Project (USEPA Tracking # MAR1003UW)

Sudbury, Hudson, and Stow, MA

Week of: January 29, 2024 to February 2, 2024

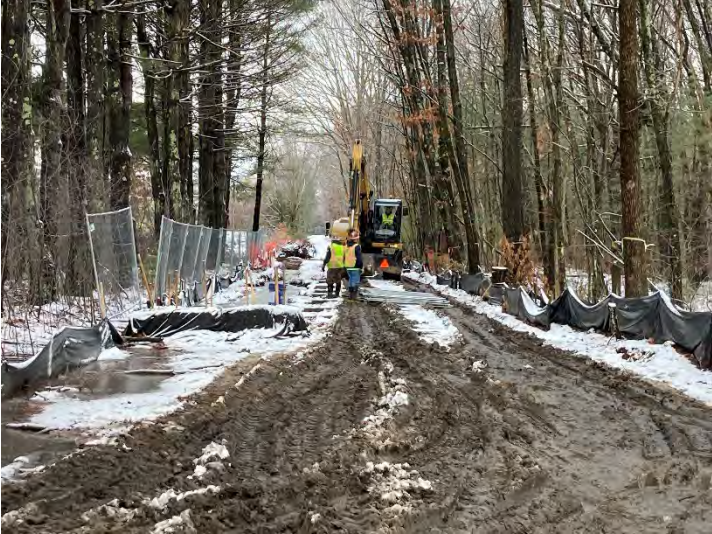
PHOTOGRAPHIC LOG	
Client Name: Eversource		Site Location: Sudbury to Hudson Transmission Reliability Project	Town: Sudbury
Photo No.: 3	Date: 1/29/2024

Description: View of Bond working in segment 11. Facing west.

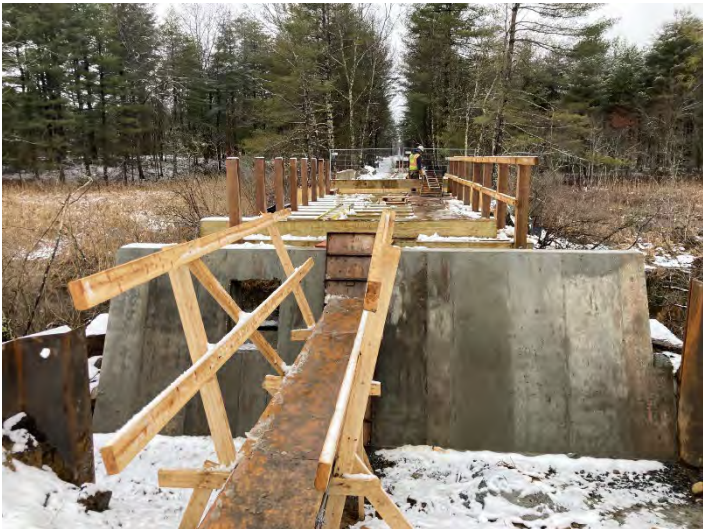
PHOTOGRAPHIC LOG	
Client Name: Eversource		Site Location: Sudbury to Hudson Transmission Reliability Project	Town: Sudbury
Photo No.: 4	Date: 1/29/2024

Description: View of ET&L working at Bridge 128. Facing west.

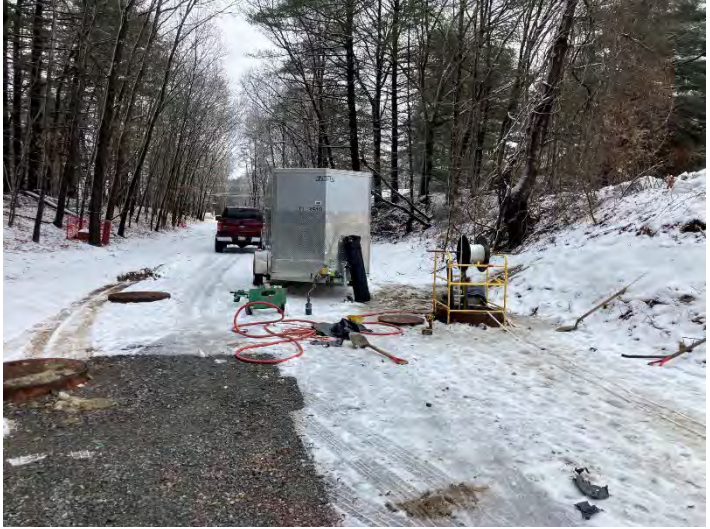
<p>PHOTOGRAPHIC LOG</p>	
<p>Client Name: Eversource</p>		<p>Site Location: Sudbury to Hudson Transmission Reliability Project</p>	<p>Town: Hudson</p>
<p>Photo No.: 5</p>	<p>Date: 1/29/2024</p>

<p>Description: View of Bond working at MH #9 in segment 3. Facing east.</p>

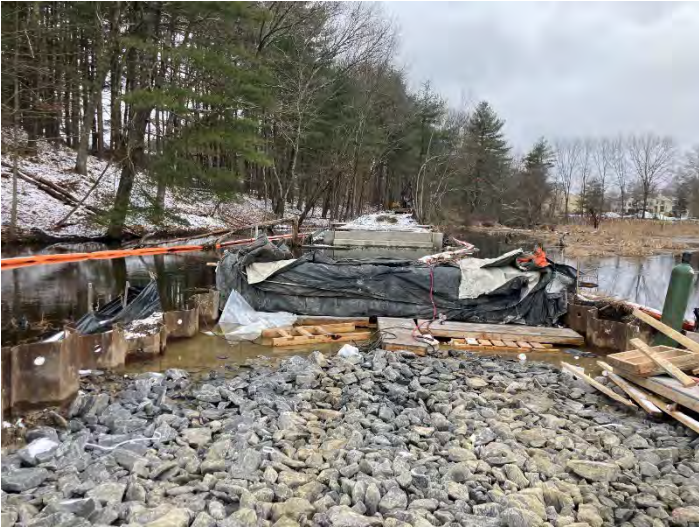
<p>PHOTOGRAPHIC LOG</p>	
<p>Client Name: Eversource</p>		<p>Site Location: Sudbury to Hudson Transmission Reliability Project</p>	<p>Town: Sudbury</p>
<p>Photo No.: 2</p>	<p>Date: 1/30/2024</p>

<p>Description: View of bridge 127 from segment 14. Facing west.</p>

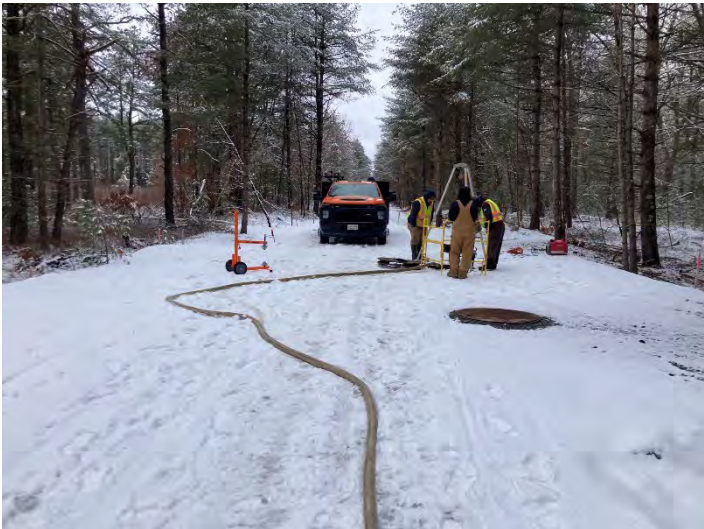
PHOTOGRAPHIC LOG	
Client Name: Eversource		Site Location: Sudbury to Hudson Transmission Reliability Project	Town: Sudbury
Photo No.: 4	Date: 1/30/2024

Description: View of Bond working at MH #16 in segment 7. See additional dewatering inspection report. Facing west.

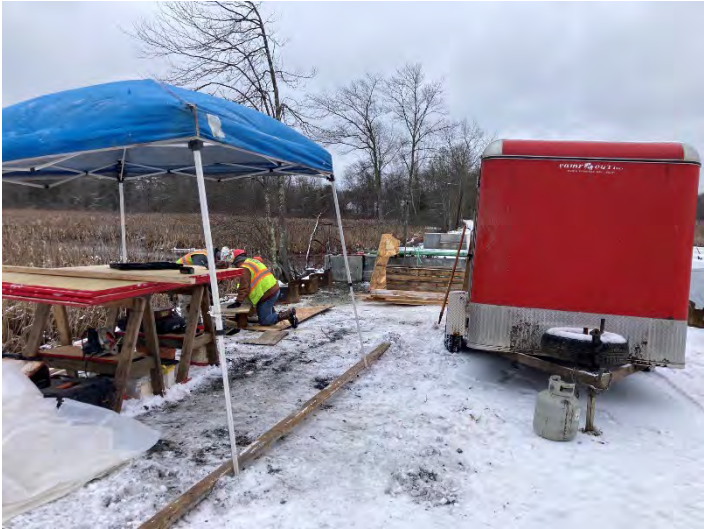
PHOTOGRAPHIC LOG	
Client Name: Eversource		Site Location: Sudbury to Hudson Transmission Reliability Project	Town: Hudson
Photo No.: 5	Date: 1/30/2024

Description: View of ET&L working at bridge 130 in segment 2. Facing east.

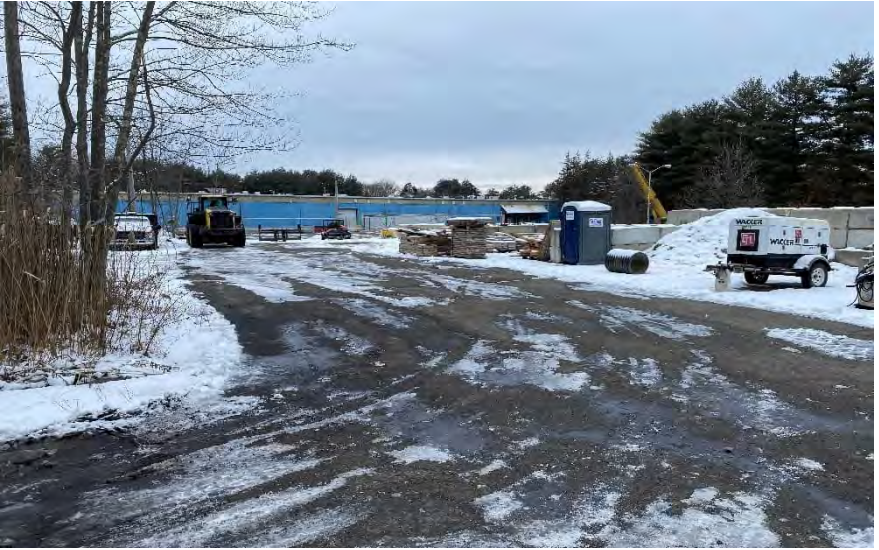
<p>PHOTOGRAPHIC LOG</p>	
<p>Client Name: Eversource</p>		<p>Site Location: Sudbury to Hudson Transmission Reliability Project</p>	<p>Town: Hudson</p>
<p>Photo No.: 1</p>	<p>Date: 1-31-24</p>

<p>Description:</p> <p>Main Street laydown yard, looking northward.</p>

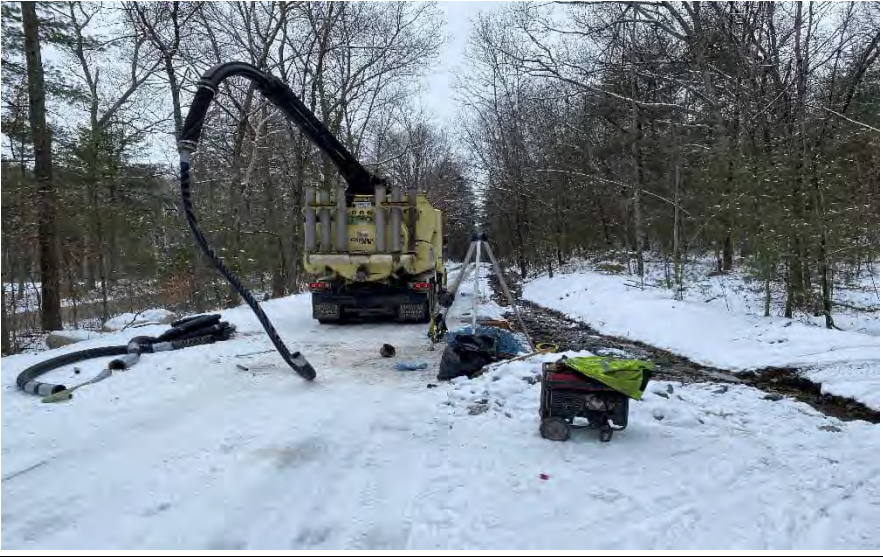
<p>PHOTOGRAPHIC LOG</p>	
<p>Client Name: Eversource</p>		<p>Site Location: Sudbury to Hudson Transmission Reliability Project</p>	<p>Town: Hudson</p>
<p>Photo No.: 3</p>	<p>Date: 1-31-24</p>

<p>Description:</p> <p>Bond conducting proofing work within segment 5 at manhole #12, looking westward.</p>

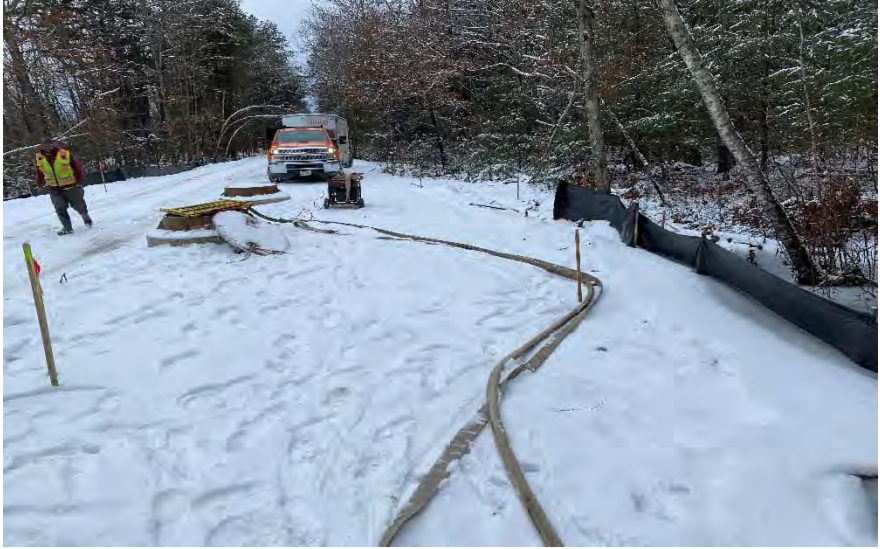
<p>PHOTOGRAPHIC LOG</p>	
<p>Client Name: Eversource</p>		<p>Site Location: Sudbury to Hudson Transmission Reliability Project</p>	<p>Town: Hudson</p>
<p>Photo No.: 4</p>	<p>Date: 1-31-24</p>

<p>Description:</p> <p>Bond conducting proofing work within segment 6 at manhole #14, looking westward.</p>

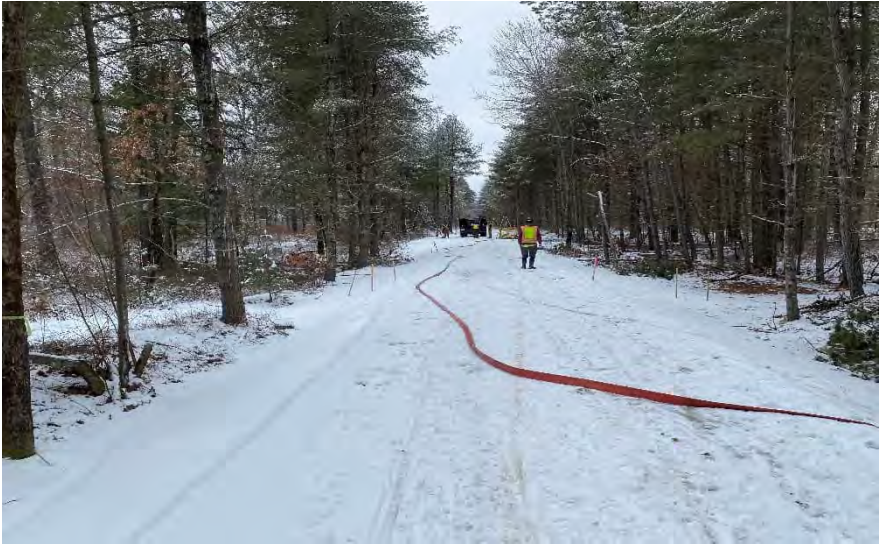
<p>PHOTOGRAPHIC LOG</p>	
<p>Client Name: Eversource</p>		<p>Site Location: Sudbury to Hudson Transmission Reliability Project</p>	<p>Town: Sudbury</p>
<p>Photo No.: 5</p>	<p>Date: 1-31-24</p>

<p>Description:</p> <p>Bond conducting proofing work within segment 7 at manhole #16, looking westward.</p>

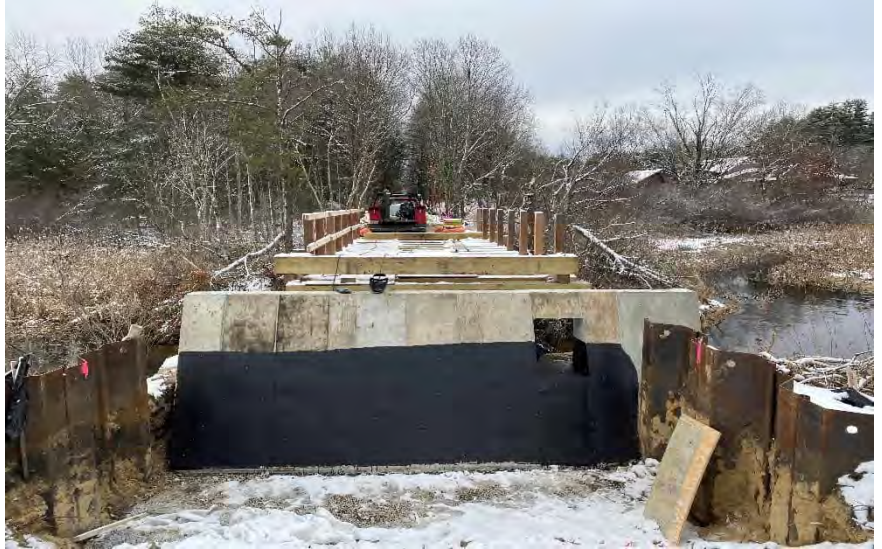
<p>PHOTOGRAPHIC LOG</p>	
<p>Client Name: Eversource</p>		<p>Site Location: Sudbury to Hudson Transmission Reliability Project</p>	<p>Town: Sudbury</p>
<p>Photo No.: 6</p>	<p>Date: 1-31-24</p>

<p>Description:</p> <p>Work area within segments 7/8, Bridge 128 area, looking eastward.</p>

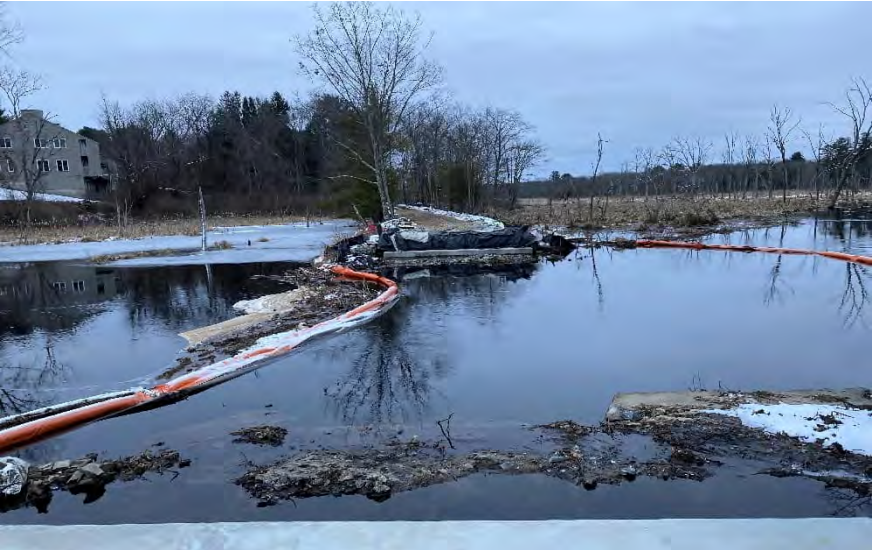
<p>PHOTOGRAPHIC LOG</p>	
<p>Client Name: Eversource</p>		<p>Site Location: Sudbury to Hudson Transmission Reliability Project</p>	<p>Town: Sudbury</p>
<p>Photo No.: 7</p>	<p>Date: 1-31-24</p>

<p>Description:</p> <p>Work area within segments 13/14 looking across Hop Brook from segment 13, bridge 127 area, looking eastward.</p>

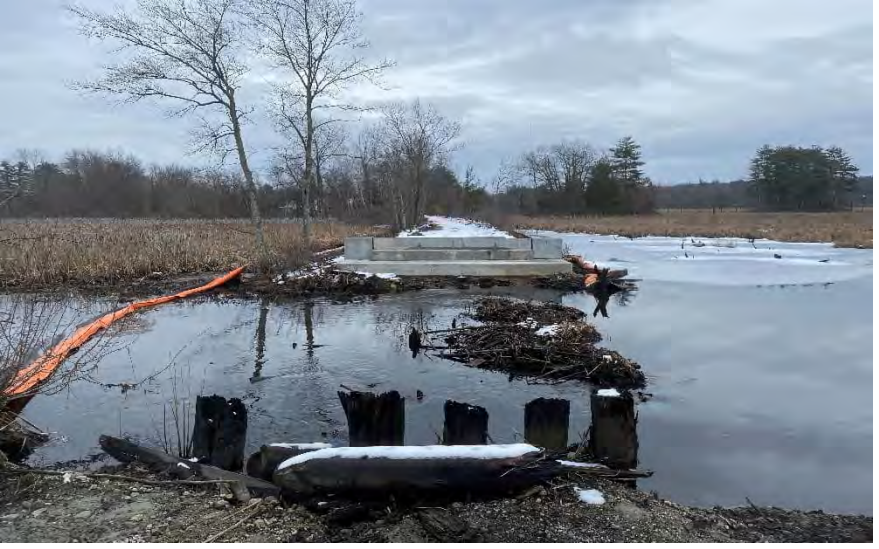
<p>PHOTOGRAPHIC LOG</p>	
<p>Client Name: Eversource</p>		<p>Site Location: Sudbury to Hudson Transmission Reliability Project</p>	<p>Town: Hudson</p>
<p>Photo No.: 2</p>	<p>Date: 2-2-24</p>

<p>Description:</p> <p>Work area at Bridge 130 from segment 2 toward segment 3 across Fort Meadow Brook, looking eastward.</p>

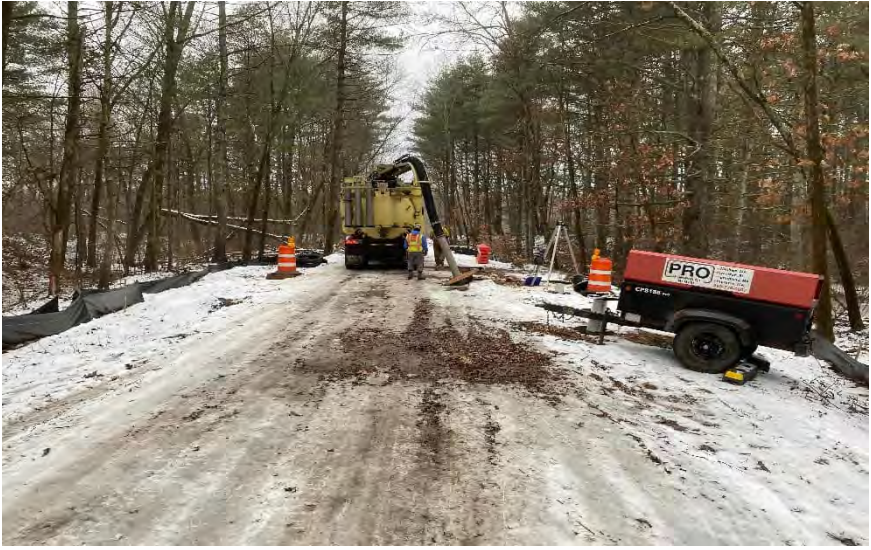
<p>PHOTOGRAPHIC LOG</p>	
<p>Client Name: Eversource</p>		<p>Site Location: Sudbury to Hudson Transmission Reliability Project</p>	<p>Town: Hudson</p>
<p>Photo No.: 3</p>	<p>Date: 2-2-24</p>

<p>Description:</p> <p>Bond conducting proofing work within segment 5 at manhole #13, looking westward.</p>

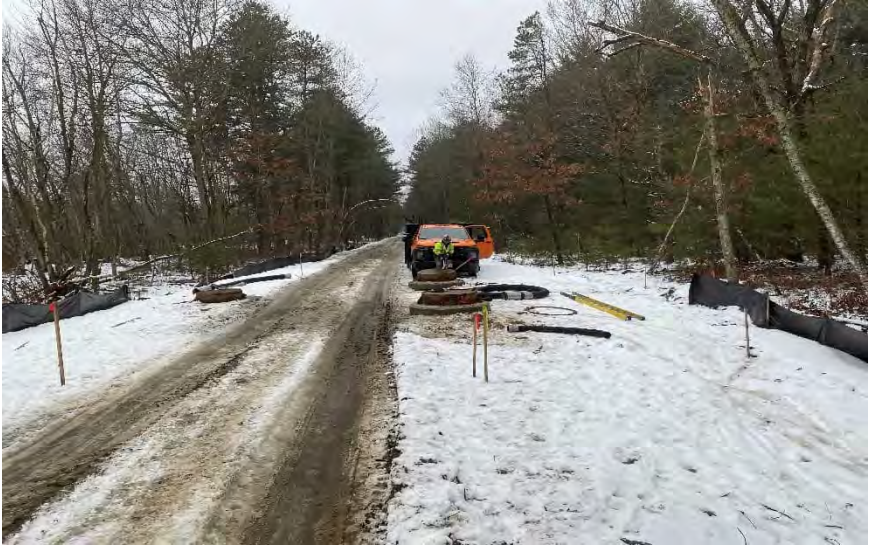
<p>PHOTOGRAPHIC LOG</p>	
<p>Client Name: Eversource</p>		<p>Site Location: Sudbury to Hudson Transmission Reliability Project</p>	<p>Town: Hudson</p>
<p>Photo No.: 4</p>	<p>Date: 2-2-24</p>

<p>Description:</p> <p>Bond conducting proofing work within segment 6 at manhole #14, looking westward.</p>

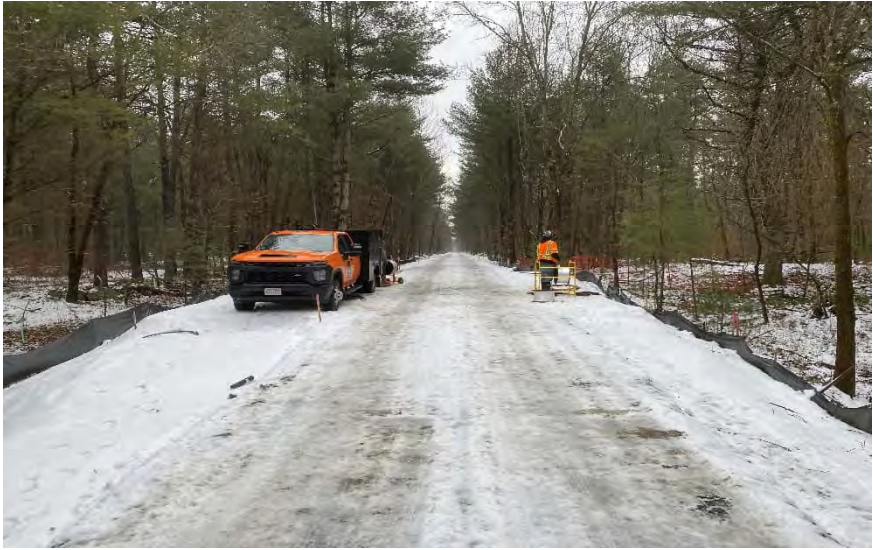
<p>PHOTOGRAPHIC LOG</p>	
<p>Client Name: Eversource</p>		<p>Site Location: Sudbury to Hudson Transmission Reliability Project</p>	<p>Town: Sudbury</p>
<p>Photo No.: 5</p>	<p>Date: 2-2-24</p>

<p>Description:</p> <p>Bond conducting proofing work within segment 7 at manhole #15, looking eastward.</p>

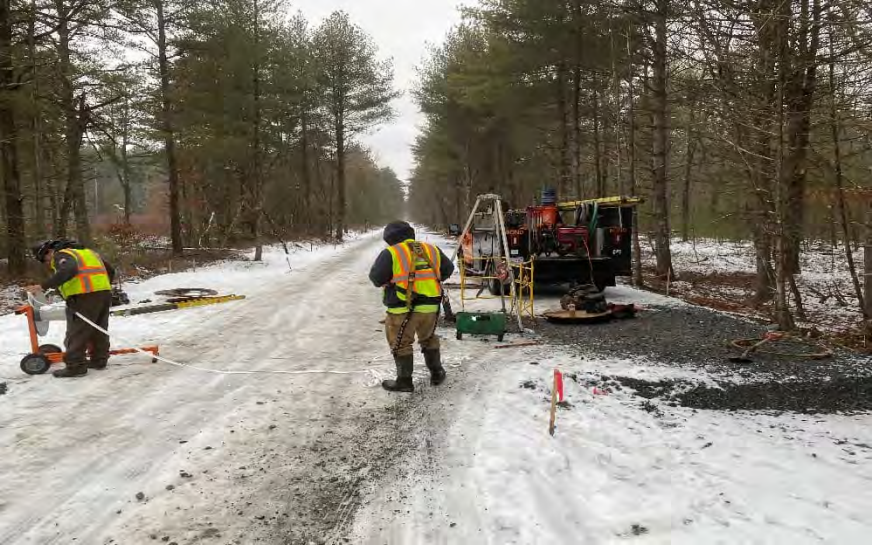
<p>PHOTOGRAPHIC LOG</p>	
<p>Client Name: Eversource</p>		<p>Site Location: Sudbury to Hudson Transmission Reliability Project</p>	<p>Town: Sudbury</p>
<p>Photo No.: 6</p>	<p>Date: 2-2-24</p>

<p>Description:</p> <p>Bond conducting proofing work within segment 7 at manhole #16, looking eastward.</p>

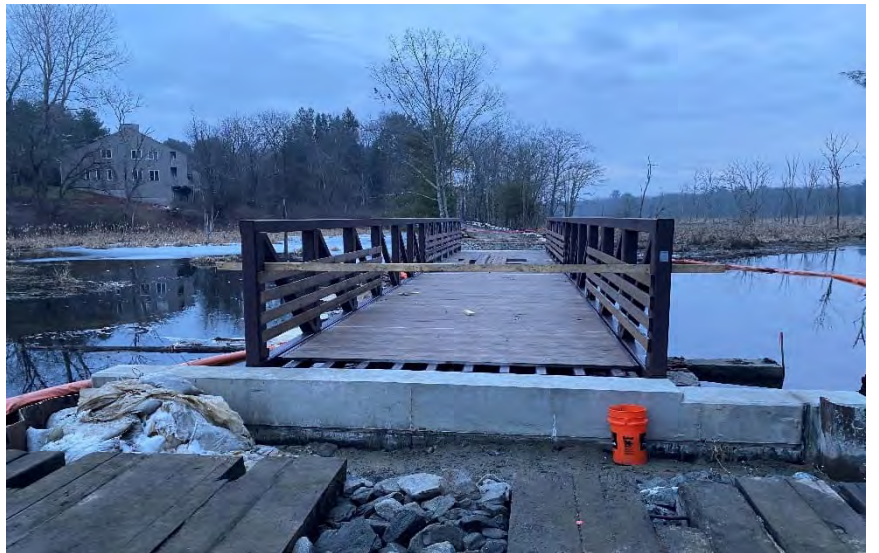
<p>PHOTOGRAPHIC LOG</p>	
<p>Client Name: Eversource</p>		<p>Site Location: Sudbury to Hudson Transmission Reliability Project</p>	<p>Town: Sudbury</p>
<p>Photo No.: 8</p>	<p>Date: 2-2-24</p>

<p>Description:</p> <p>Work area within segments 13/14 looking across Hop Brook from segment 13, newly placed bridge 127, looking eastward.</p>

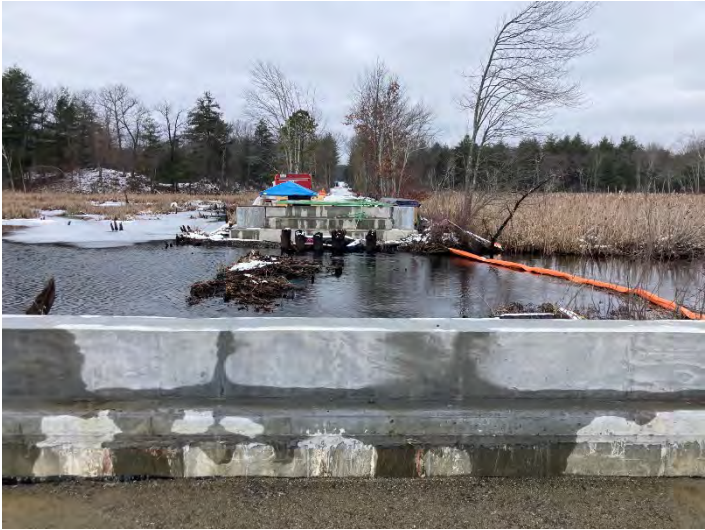
PHOTOGRAPHIC LOG	
Client Name: Eversource		Site Location: Sudbury to Hudson Transmission Reliability Project	Town: Hudson
Photo No.: 3	Date: 2-01-2024

Description: View of Bridge 130. Facing west.

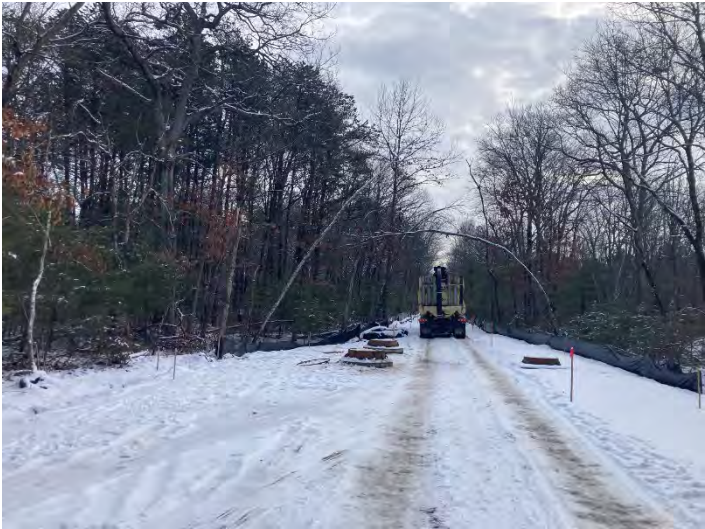
Epsilon ASSOCIATES INC.		PHOTOGRAPHIC LOG	
Client Name: Eversource		Site Location: Sudbury to Hudson Transmission Reliability Project	Town: Hudson
Photo No.: 7	Date: 2-01-2024

Description: View of Bond working in segment 6. Facing east.

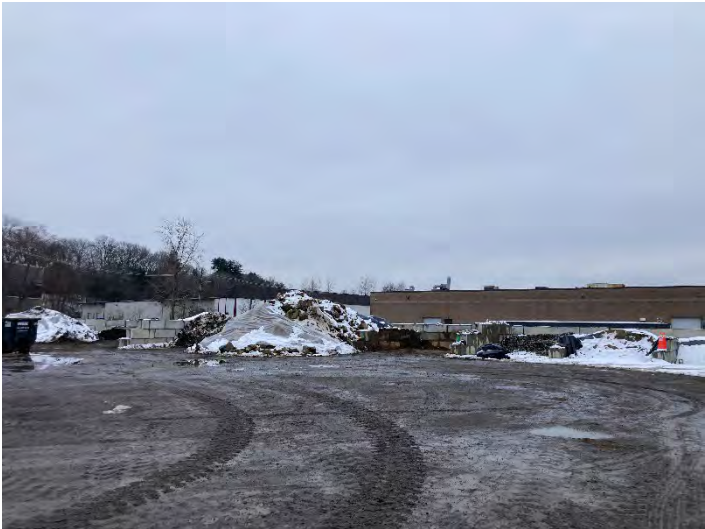
Epsilon ASSOCIATES INC.		PHOTOGRAPHIC LOG	
Client Name: Eversource		Site Location: Sudbury to Hudson Transmission Reliability Project	Town: Hudson
Photo No.: 8	Date: 2-01-2024

Description: View of Bonazzoli laydown yard. Facing south.

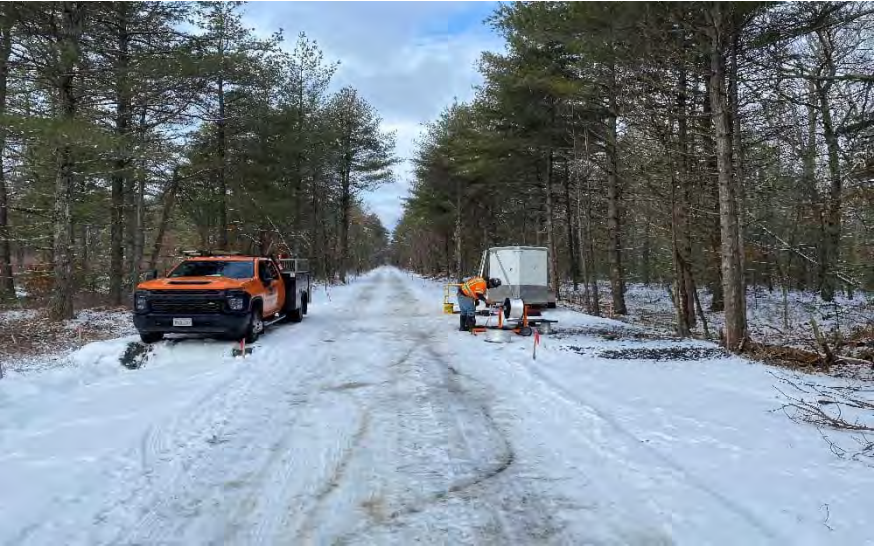
PHOTOGRAPHIC LOG	
Client Name: Eversource		Site Location: Sudbury to Hudson Transmission Reliability Project	Town: Sudbury
Photo No.: 1	Date: 2-1-24

Description: Work area, within segment 7, utility hole #16 proofing, looking westward.

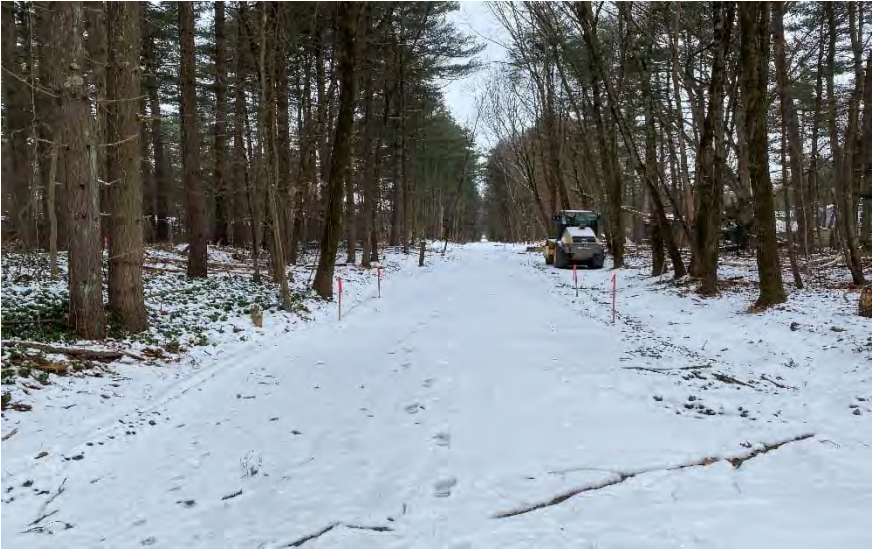
PHOTOGRAPHIC LOG	
Client Name: Eversource		Site Location: Sudbury to Hudson Transmission Reliability Project	Town: Sudbury
Photo No.: 3	Date: 2-1-24

Description: Work area within segment 10, looking westward.

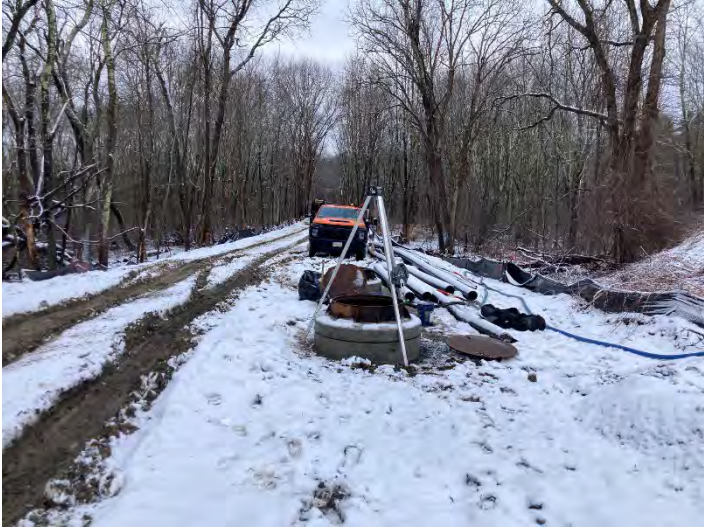
PHOTOGRAPHIC LOG	
Client Name: Eversource		Site Location: Sudbury to Hudson Transmission Reliability Project	Town: Sudbury
Photo No.: 1	Date: 1/29/2024

Description: View of Bond working at MH #27 in segment 14. Facing west.

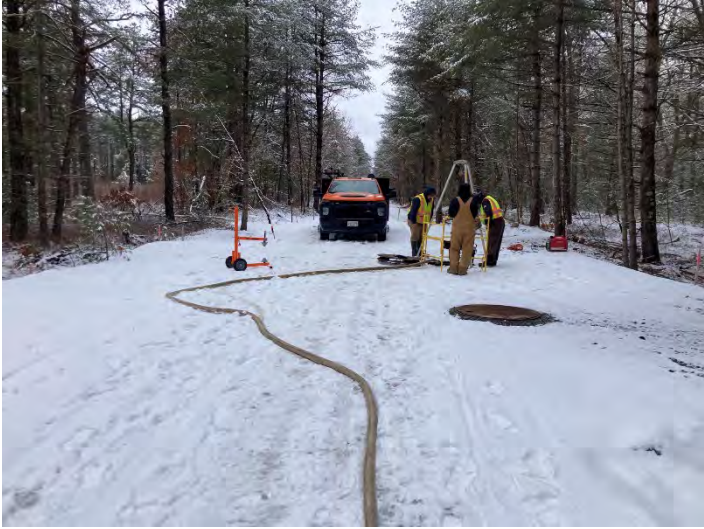
PHOTOGRAPHIC LOG	
Client Name: Eversource		Site Location: Sudbury to Hudson Transmission Reliability Project	Town: Sudbury
Photo No.: 1	Date: 1/30/2024

Description: View of pumping operation at MH #16 in segment 7. Facing west.

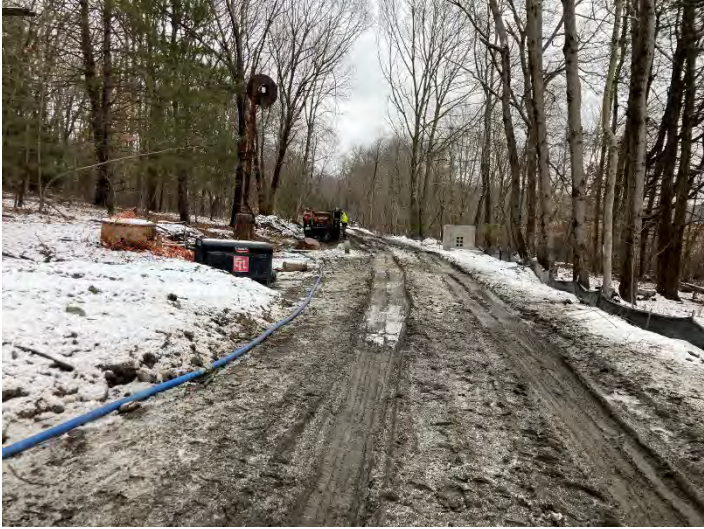
PHOTOGRAPHIC LOG	
Client Name: Eversource		Site Location: Sudbury to Hudson Transmission Reliability Project	Town: Sudbury
Photo No.: 1	Date: 1/30/2024

Description: View of Bond working at MH #26 in segment 14. Facing east.

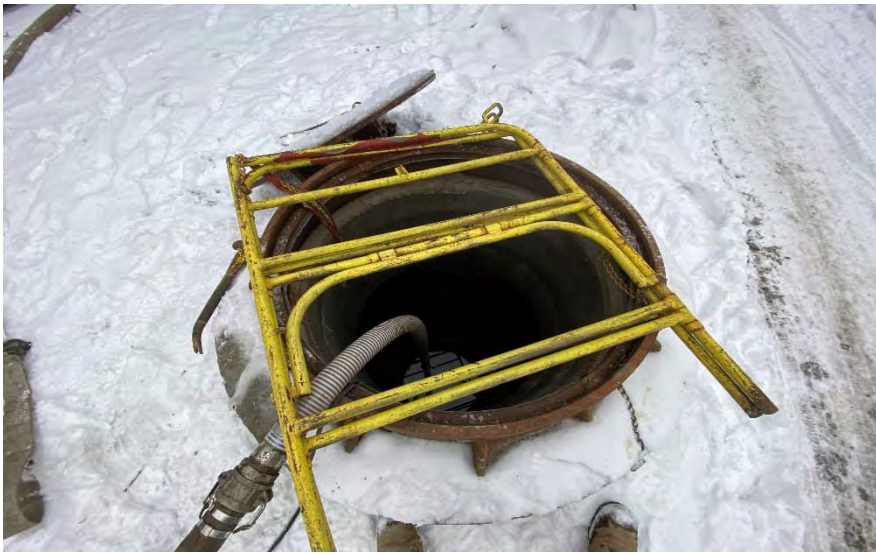
PHOTOGRAPHIC LOG	
Client Name: Eversource		Site Location: Sudbury to Hudson Transmission Reliability Project	Town: Hudson
Photo No.: 1	Date: 1/31/2024

Description: View of area being pumped from Manhole #14 - segment 6 area.

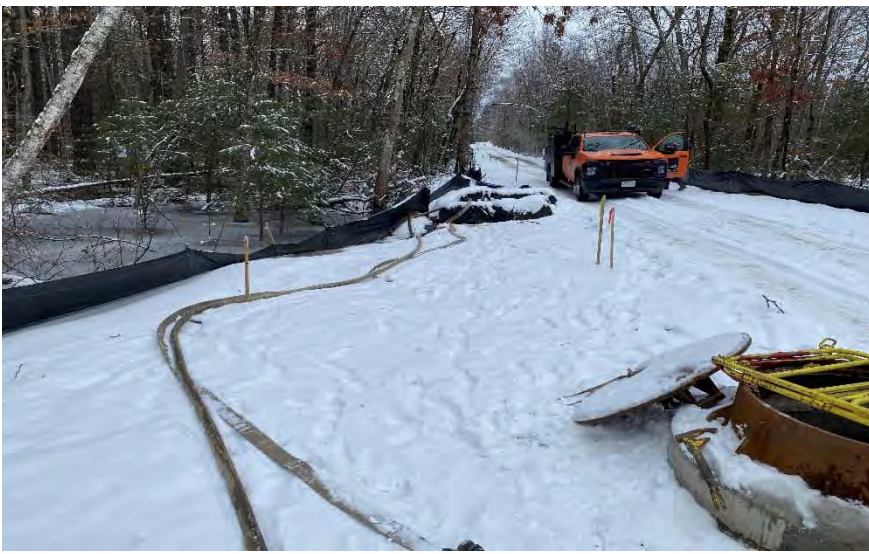
PHOTOGRAPHIC LOG	
Client Name: Eversource		Site Location: Sudbury to Hudson Transmission Reliability Project	Town: Hudson
Photo No.: 2	Date: 1/31/2024

Description: Manhole #14. View of dewatering operation, looking eastward.

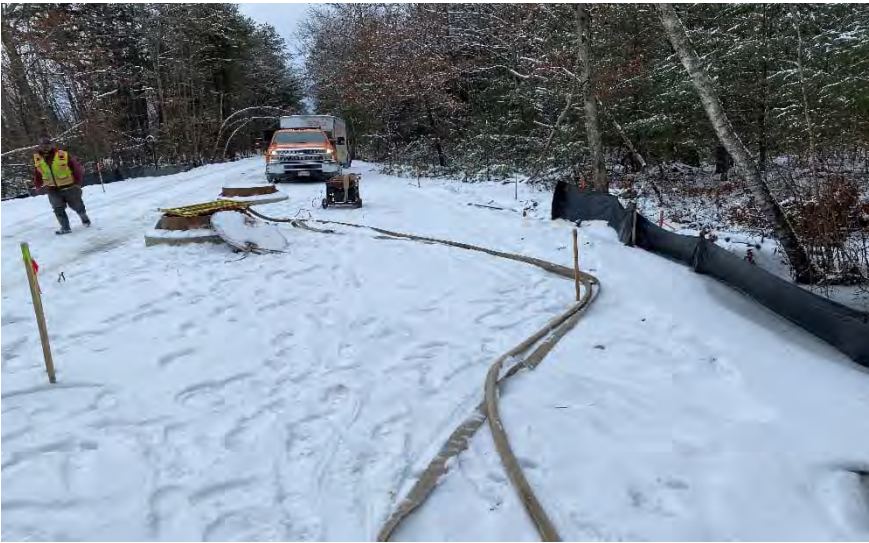
PHOTOGRAPHIC LOG	
Client Name: Eversource		Site Location: Sudbury to Hudson Transmission Reliability Project	
Town: Hudson			
Photo No.: 3	Date: 1/31/2024

Description: Manhole #14. View of dewatering operation, looking westward.

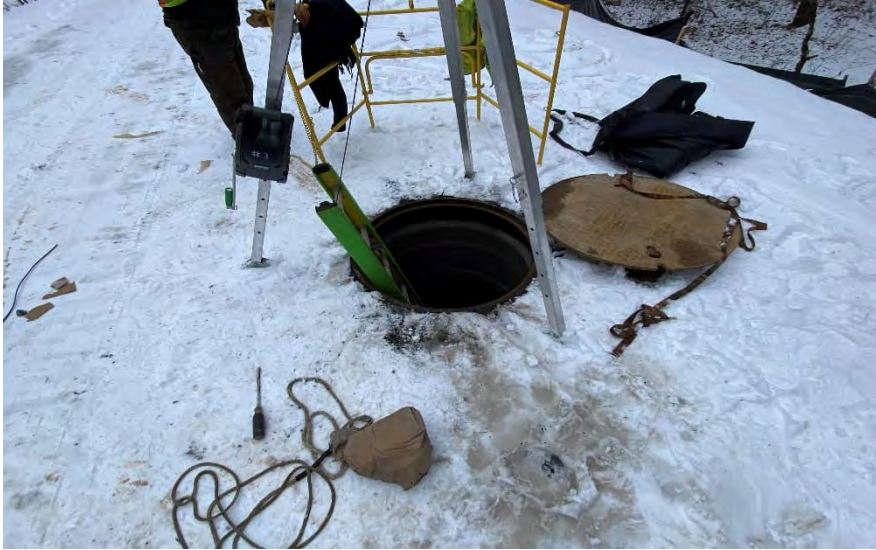
PHOTOGRAPHIC LOG	
Client Name: Eversource		Site Location: Sudbury to Hudson Transmission Reliability Project	Town: Sudbury
Photo No.: 1	Date: 1/31/2024

Description: View of area being pumped from Manhole #15 - segment 7 area.

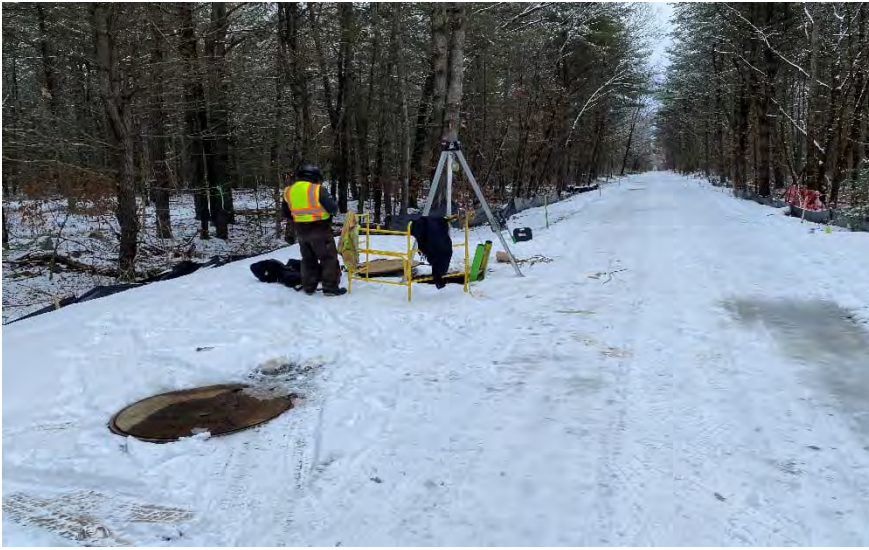
PHOTOGRAPHIC LOG	
Client Name: Eversource		Site Location: Sudbury to Hudson Transmission Reliability Project	Town: Sudbury
Photo No.: 2	Date: 1/31/2024

Description: Manhole #15. View of dewatering operation, looking eastward.

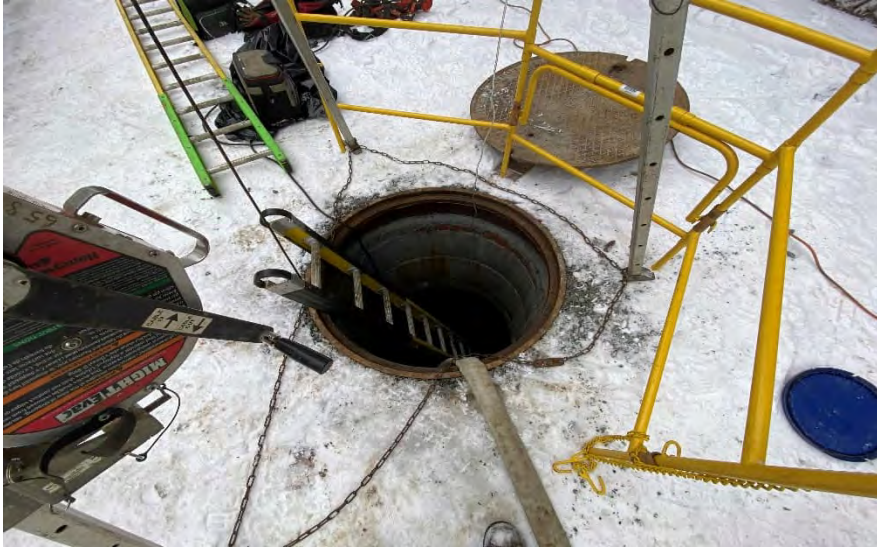
PHOTOGRAPHIC LOG	
Client Name: Eversource		Site Location: Sudbury to Hudson Transmission Reliability Project	Town: Sudbury
Photo No.: 1	Date: 1/31/2024

Description: View of area being pumped from segment 7- manhole #16.

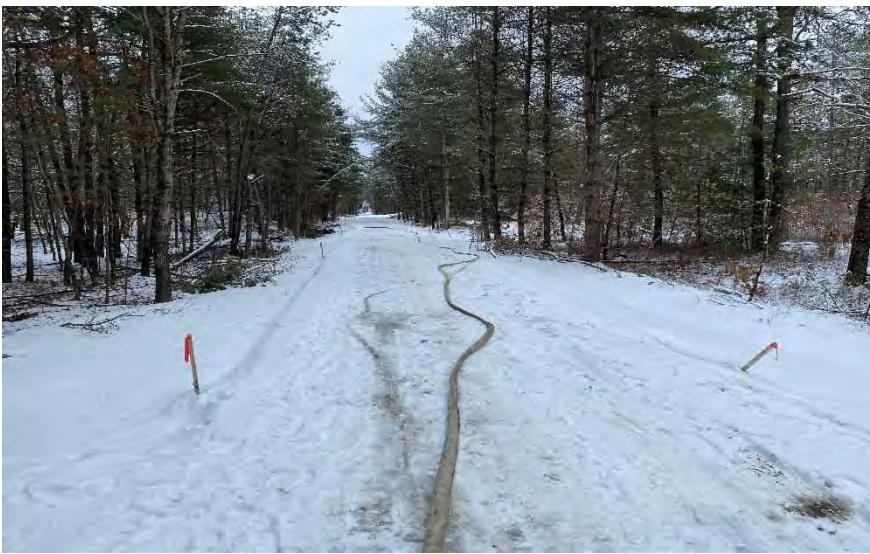
PHOTOGRAPHIC LOG	
Client Name: Eversource		Site Location: Sudbury to Hudson Transmission Reliability Project	Town: Sudbury
Photo No.: 2	Date: 1/31/2024

Description: Manhole #16. View of dewatering operation. Looking eastward.

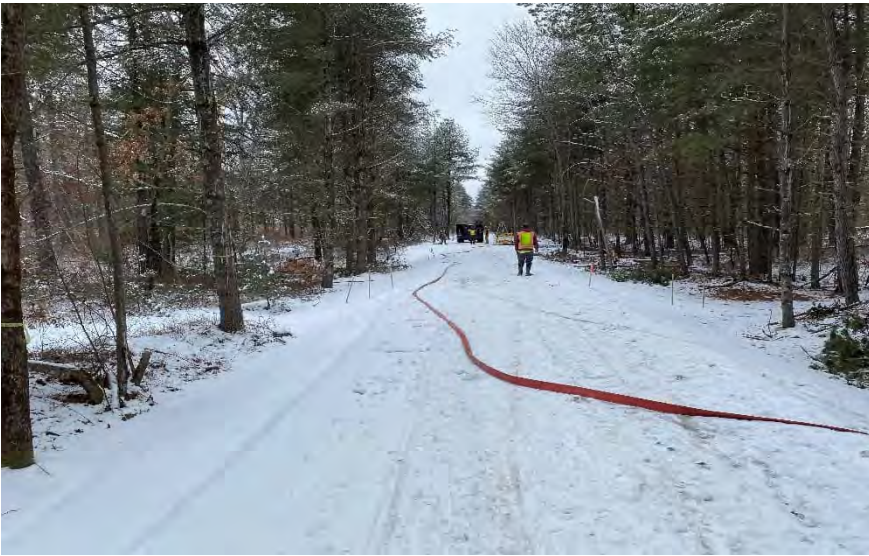
PHOTOGRAPHIC LOG	
Client Name: Eversource		Site Location: Sudbury to Hudson Transmission Reliability Project	Town: Sudbury
Photo No.: 3	Date: 1/31/2024

Description: Manhole #16. View of dewatering operation, looking westward.

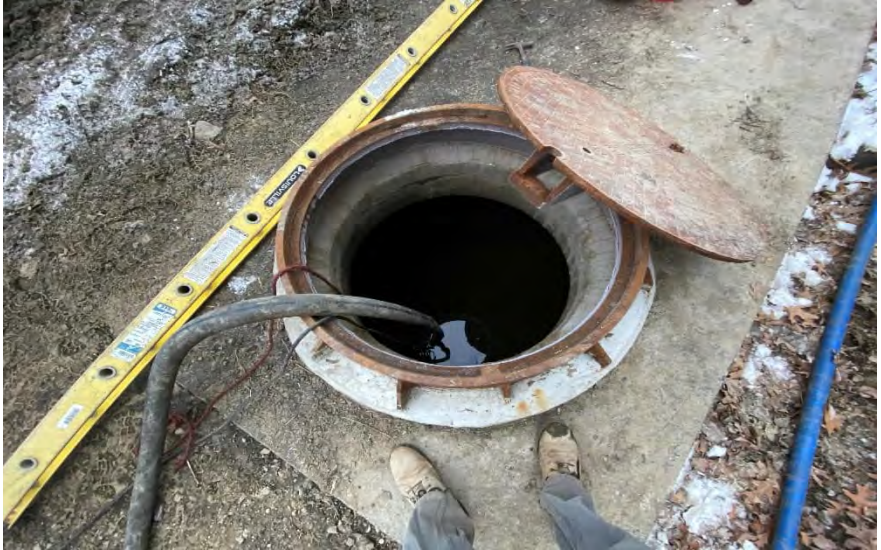
PHOTOGRAPHIC LOG	
Client Name: Eversource		Site Location: Sudbury to Hudson Transmission Reliability Project	Town: Sudbury
Photo No.: 1	Date: 1/31/2024

Description: View of pumping from manhole #26, segment 14.

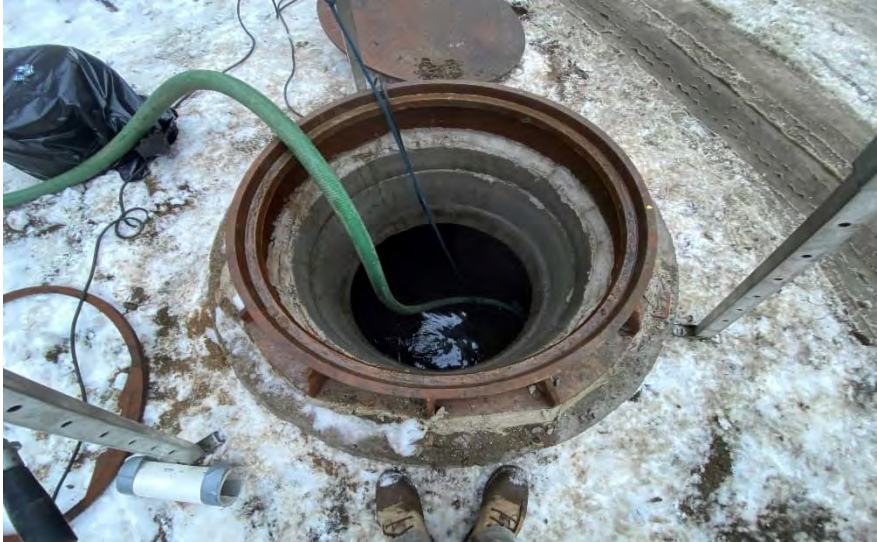
PHOTOGRAPHIC LOG	
Client Name: Eversource		Site Location: Sudbury to Hudson Transmission Reliability Project	Town: Hudson
Photo No.: 1	Date: 2/2/2024

Description: View of area being pumped from Manhole #14 - segment 6 area.

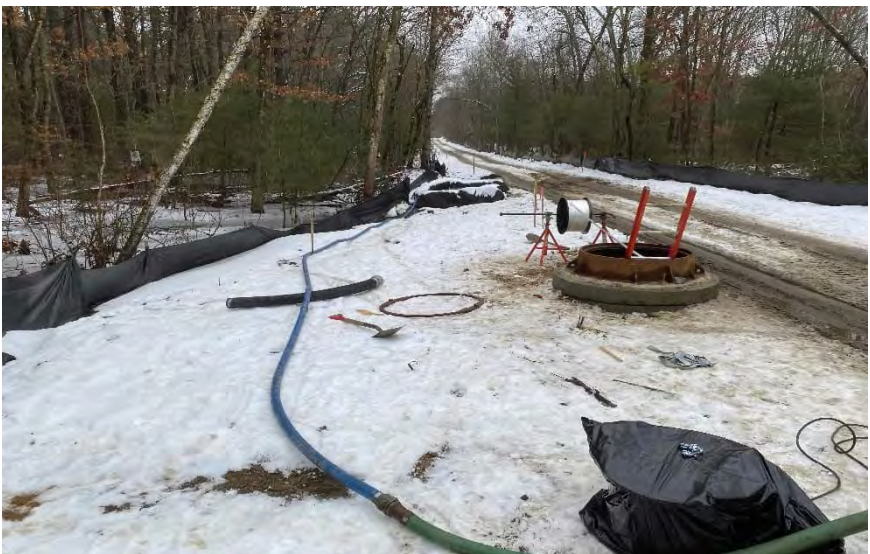
PHOTOGRAPHIC LOG	
Client Name: Eversource		Site Location: Sudbury to Hudson Transmission Reliability Project	Town: Hudson
Photo No.: 2	Date: 2/2/2024

Description: Manhole #14. View of dewatering operation, looking eastward.

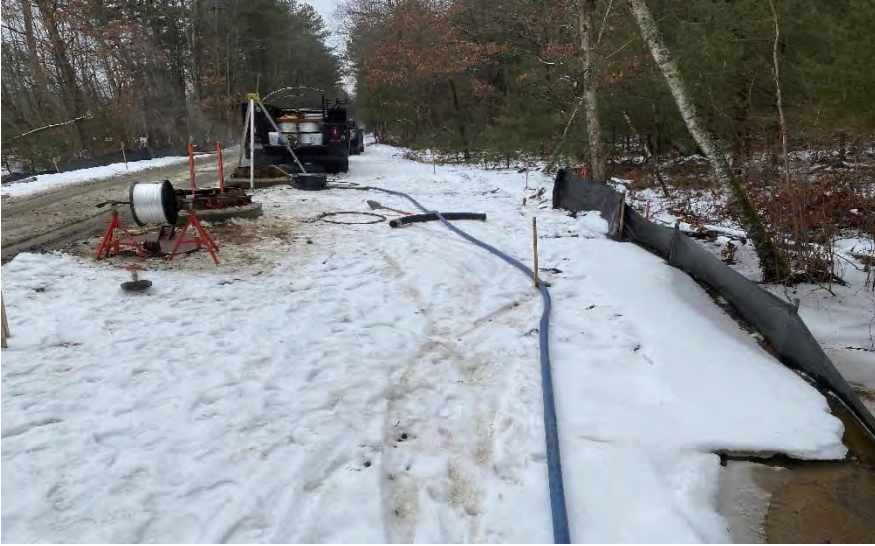
PHOTOGRAPHIC LOG	
Client Name: Eversource		Site Location: Sudbury to Hudson Transmission Reliability Project	Town: Hudson
Photo No.: 3	Date: 2/2/2024

Description: Manhole #14. View of dewatering operation, looking westward.
