Weekly Environmental Compliance Summary

Sudbury to Hudson Transmission Reliability Project (USEPA Tracking # MAR1003UW)

Sudbury, Hudson, and Stow, MA

Week of: February 5, 2024 to February 9, 2024

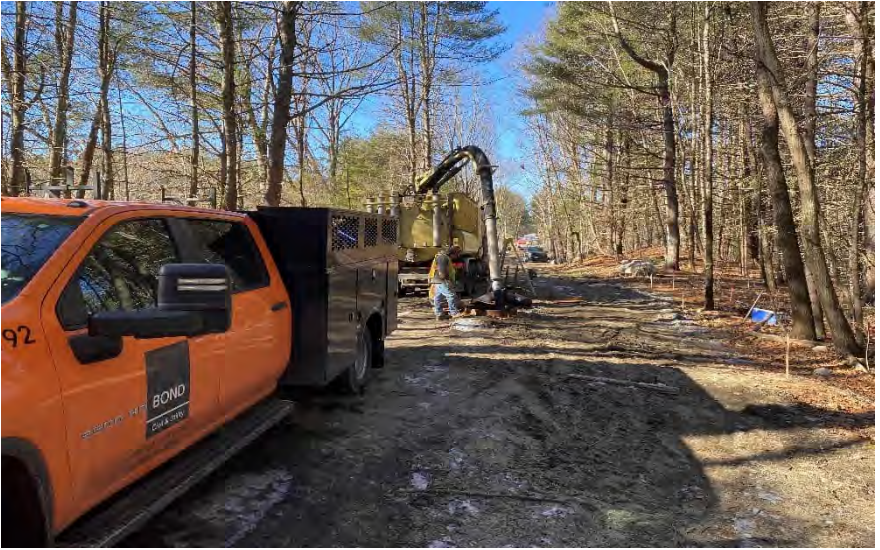
<p>PHOTOGRAPHIC LOG</p>	
<p>Client Name: Eversource</p>		<p>Site Location: Sudbury to Hudson Transmission Reliability Project</p>	<p>Town: Sudbury</p>
<p>Photo No.: 5</p>	<p>Date: 2-5-24</p>

<p>Description:</p> <p>Bond conducting proofing work within segment 8 at manhole #17, looking westward.</p>

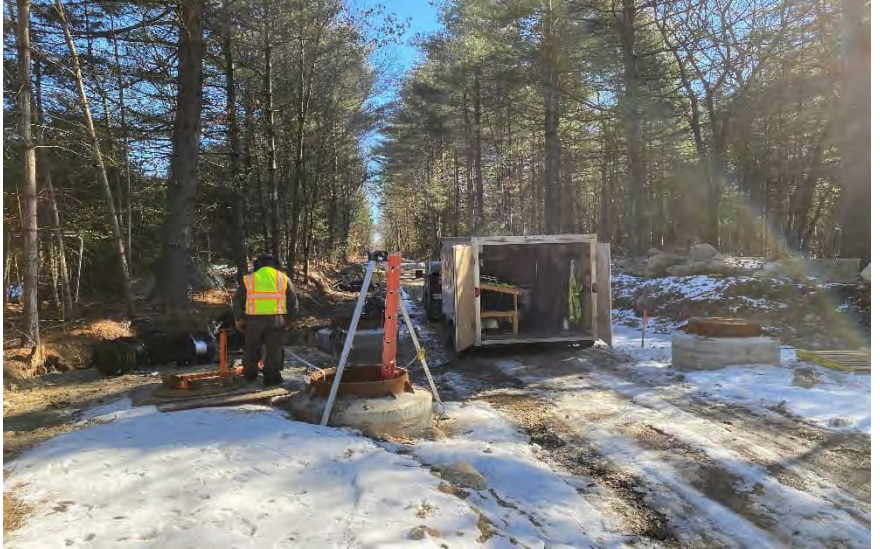
<p>PHOTOGRAPHIC LOG</p>	
<p>Client Name: Eversource</p>		<p>Site Location: Sudbury to Hudson Transmission Reliability Project</p>	<p>Town: Sudbury</p>
<p>Photo No.: 6</p>	<p>Date: 2-5-24</p>

<p>Description:</p> <p>Bond conducting proofing work within segment 9 at manhole #18, looking eastward.</p>

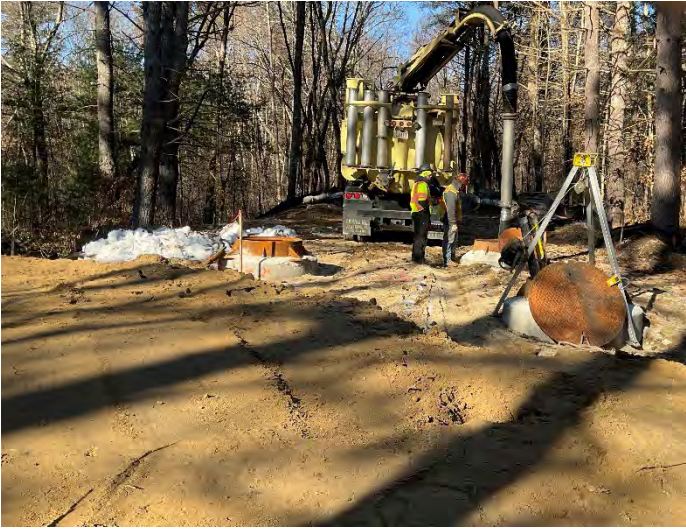
<p align="right">PHOTOGRAPHIC LOG</p>	
<p>Client Name: Eversource</p>		<p>Site Location: Sudbury to Hudson Transmission Reliability Project</p>	<p>Town: Sudbury</p>
<p>Photo No.: 2</p>	<p>Date: 2/06/2024</p>

<p>Description: View of Bond working in segment 9. Facing west.</p>

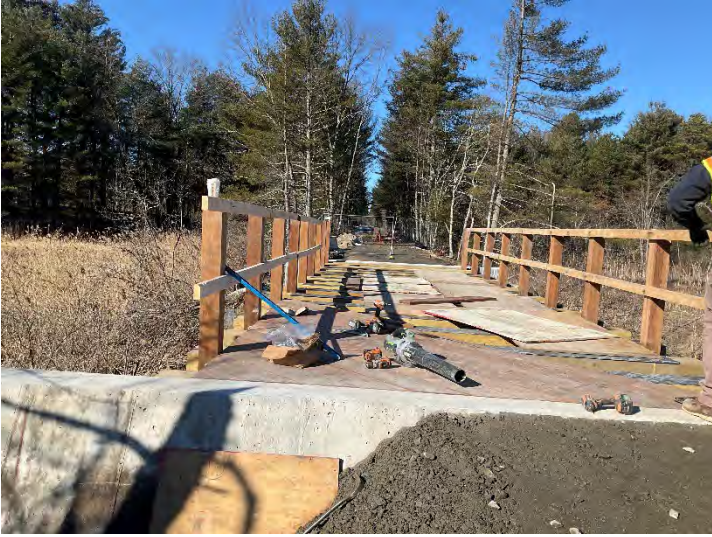
<p>PHOTOGRAPHIC LOG</p>	
<p>Client Name: Eversource</p>		<p>Site Location: Sudbury to Hudson Transmission Reliability Project</p>	<p>Town: Sudbury</p>
<p>Photo No.: 3</p>	<p>Date: 2/06/2024</p>

<p>Description: View of ET&L working at bridge 128. Facing west.</p>

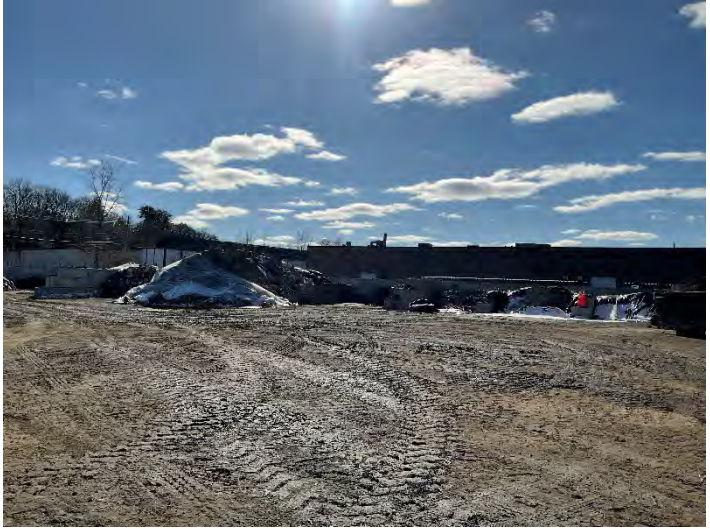
<p>PHOTOGRAPHIC LOG</p>	
<p>Client Name: Eversource</p>		<p>Site Location: Sudbury to Hudson Transmission Reliability Project</p>	<p>Town: Hudson</p>
<p>Photo No.: 5</p>	<p>Date: 2/06/2024</p>

<p>Description: View of Bonazzoli laydown yard. Facing southwest.</p>

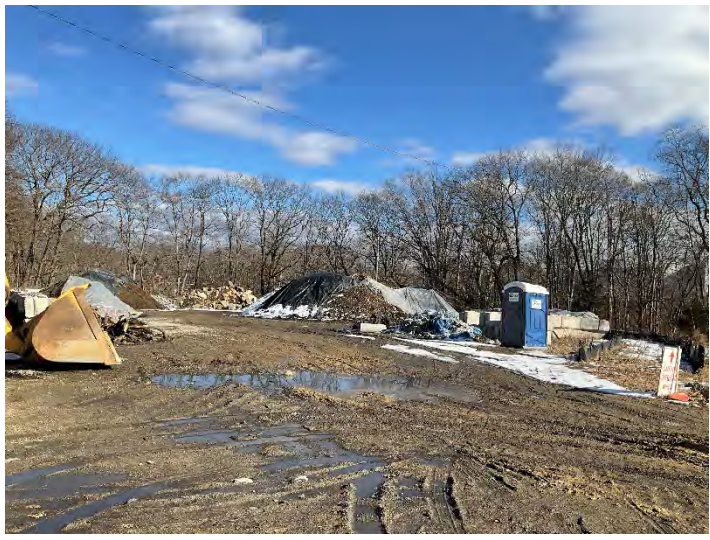
<p>PHOTOGRAPHIC LOG</p>	
<p>Client Name: Eversource</p>		<p>Site Location: Sudbury to Hudson Transmission Reliability Project</p>	<p>Town: Hudson</p>
<p>Photo No.: 6</p>	<p>Date: 2/06/2024</p>

<p>Description: View of Stowe Ct laydown yard. Facing northeast.</p>

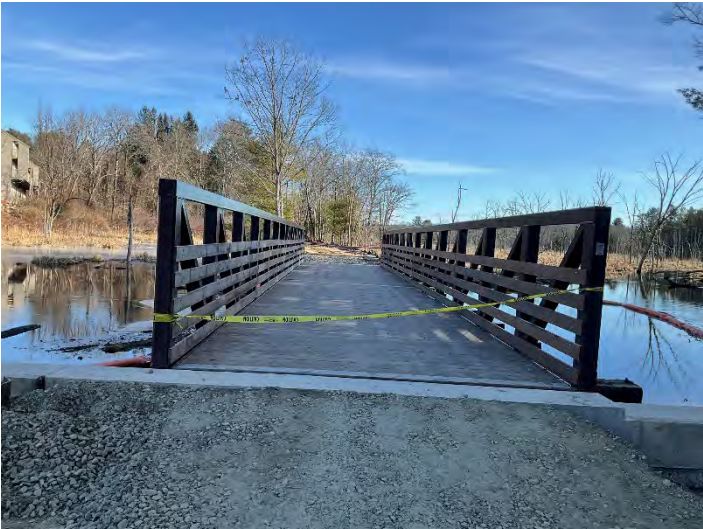
PHOTOGRAPHIC LOG	
Client Name: Eversource		Site Location: Sudbury to Hudson Transmission Reliability Project	Town: Sudbury
Photo No.: 1	Date: 2/07/2024

Description: View of bridge 127 from segment 13. Facing east.

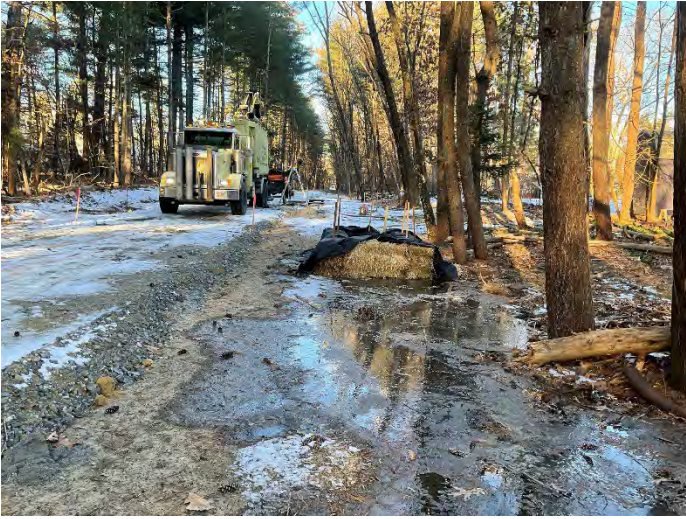
PHOTOGRAPHIC LOG	
Client Name: Eversource		Site Location: Sudbury to Hudson Transmission Reliability Project	Town: Sudbury
Photo No.: 2	Date: 2/07/2024

Description: View of Bond working at MH #21 in segment 10. See additional dewatering inspection report. Facing west.

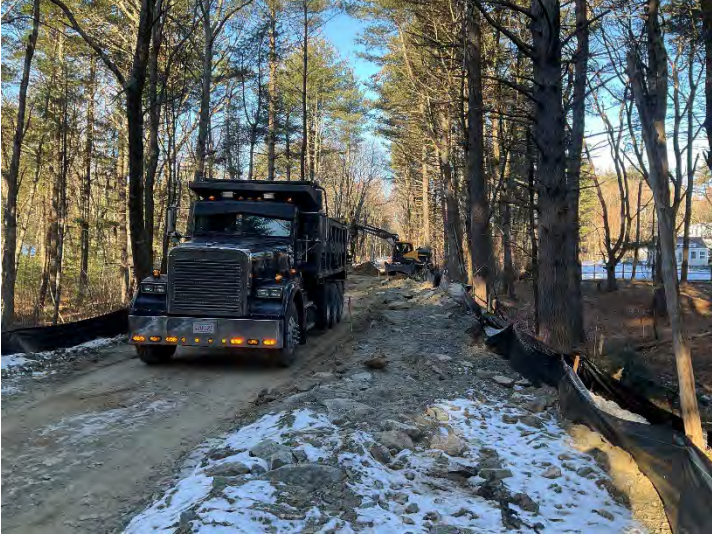
PHOTOGRAPHIC LOG	
Client Name: Eversource		Site Location: Sudbury to Hudson Transmission Reliability Project	Town: Sudbury
Photo No.: 3	Date: 2/07/2024

Description: View of ET&L grading in segment 9. Facing west.

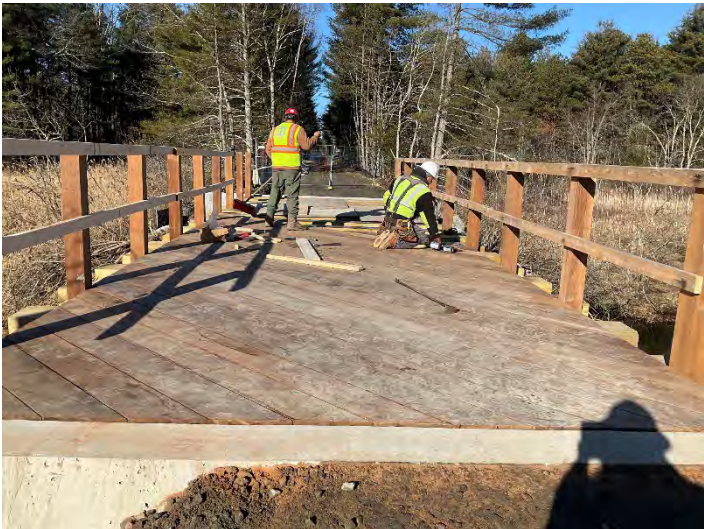
PHOTOGRAPHIC LOG	
Client Name: Eversource		Site Location: Sudbury to Hudson Transmission Reliability Project	Town: Sudbury
Photo No.: 4	Date: 2/07/2024

Description: View of ET&L working at bridge 128. Facing west.

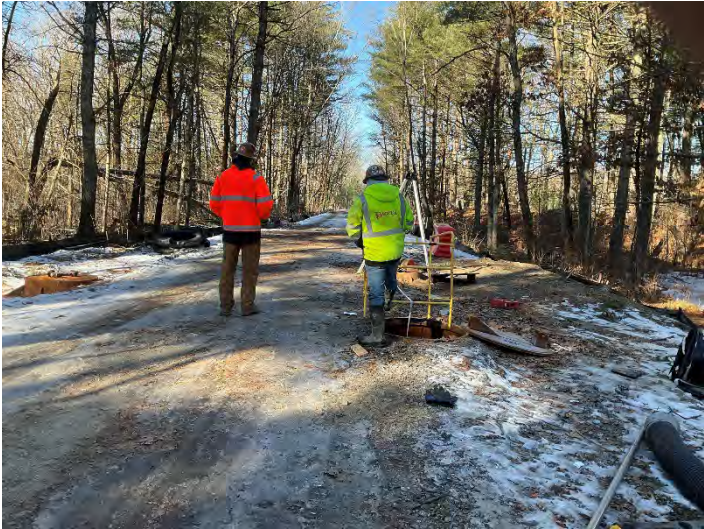
<p>PHOTOGRAPHIC LOG</p>	
<p>Client Name: Eversource</p>		<p>Site Location: Sudbury to Hudson Transmission Reliability Project</p>	<p>Town: Hudson</p>
<p>Photo No.: 5</p>	<p>Date: 2/07/2024</p>

<p>Description: View of Bond working in segment 5. Facing west.</p>

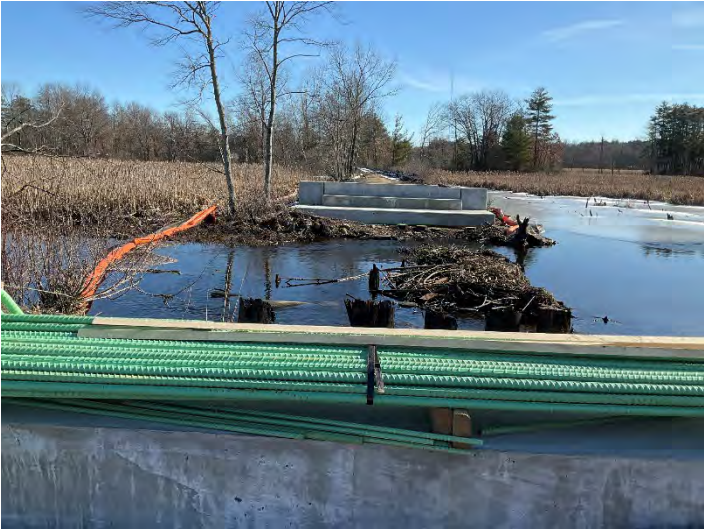
<p>PHOTOGRAPHIC LOG</p>	
<p>Client Name: Eversource</p>		<p>Site Location: Sudbury to Hudson Transmission Reliability Project</p>	<p>Town: Hudson</p>
<p>Photo No.: 6</p>	<p>Date: 2/07/2024</p>

<p>Description: View of bridge 130 from segment 2. Facing east.</p>

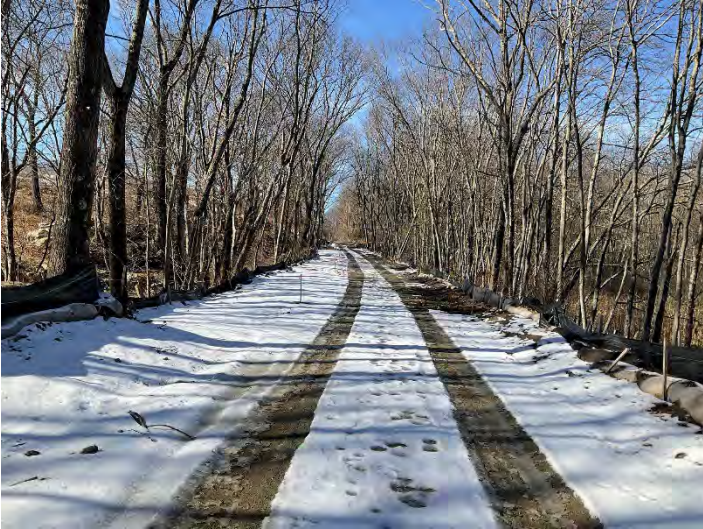
<p>PHOTOGRAPHIC LOG</p>	
<p>Client Name: Eversource</p>		<p>Site Location: Sudbury to Hudson Transmission Reliability Project</p>	<p>Town: Hudson</p>
<p>Photo No.: 7</p>	<p>Date: 2/07/2024</p>

<p>Description: View of east end of segment 1. Facing west.</p>

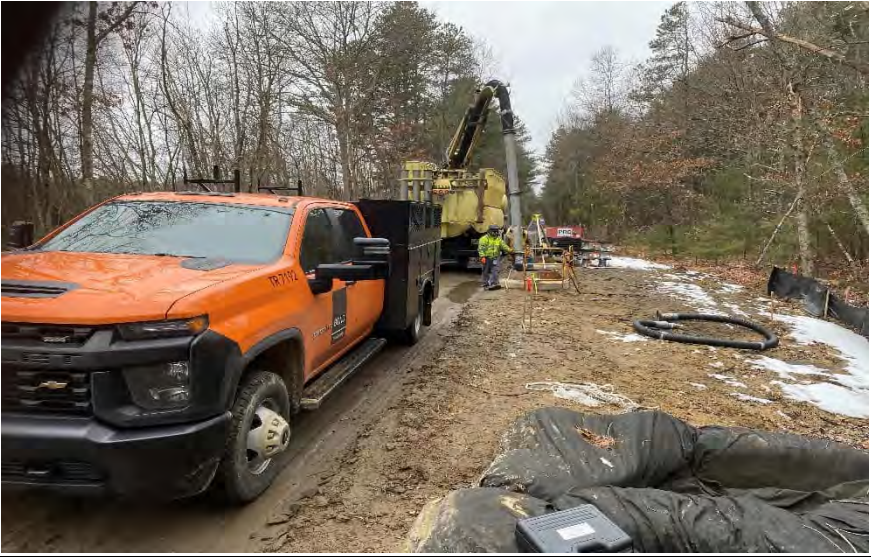
<p>PHOTOGRAPHIC LOG</p>	
<p>Client Name: Eversource</p>		<p>Site Location: Sudbury to Hudson Transmission Reliability Project</p>	<p>Town: Hudson</p>
<p>Photo No.: 3</p>	<p>Date: 2-9-24</p>

<p>Description:</p> <p>Bond conducting proofing work within segment 6 at manhole #14, existing erosion control, looking westward.</p>

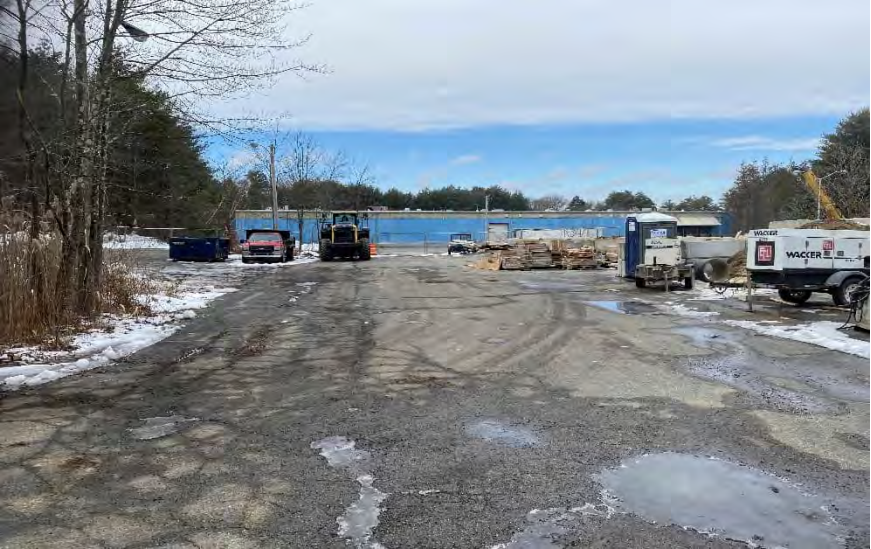
<p>PHOTOGRAPHIC LOG</p>	
<p>Client Name: Eversource</p>		<p>Site Location: Sudbury to Hudson Transmission Reliability Project</p>	<p>Town: Hudson</p>
<p>Photo No.: 4</p>	<p>Date: 2-9-24</p>

<p>Description:</p> <p>Laydown yard at Main Street, looking westward.</p>

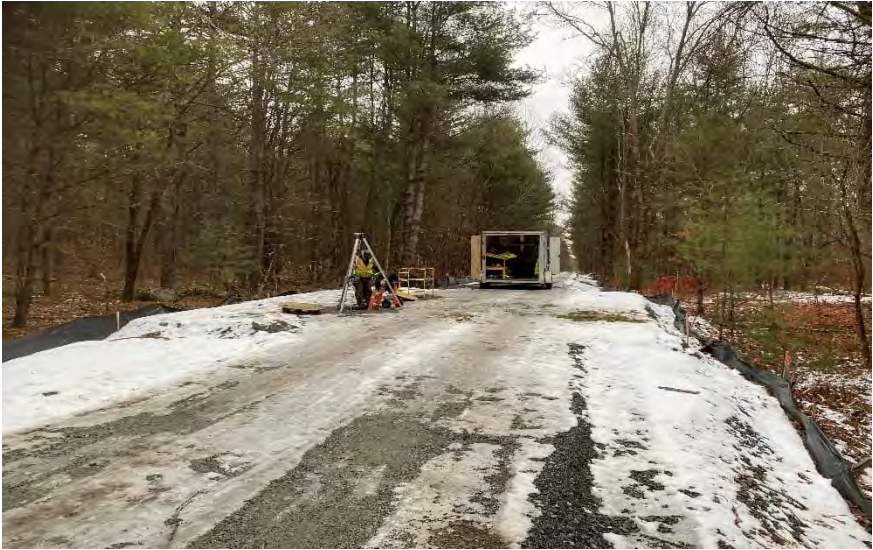
<p>PHOTOGRAPHIC LOG</p>	
<p>Client Name: Eversource</p>		<p>Site Location: Sudbury to Hudson Transmission Reliability Project</p>	<p>Town: Sudbury</p>
<p>Photo No.: 5</p>	<p>Date: 2-9-24</p>

<p>Description:</p> <p>Bond conducting proofing work within segment 7 at manhole #15, existing erosion control, looking eastward.</p>

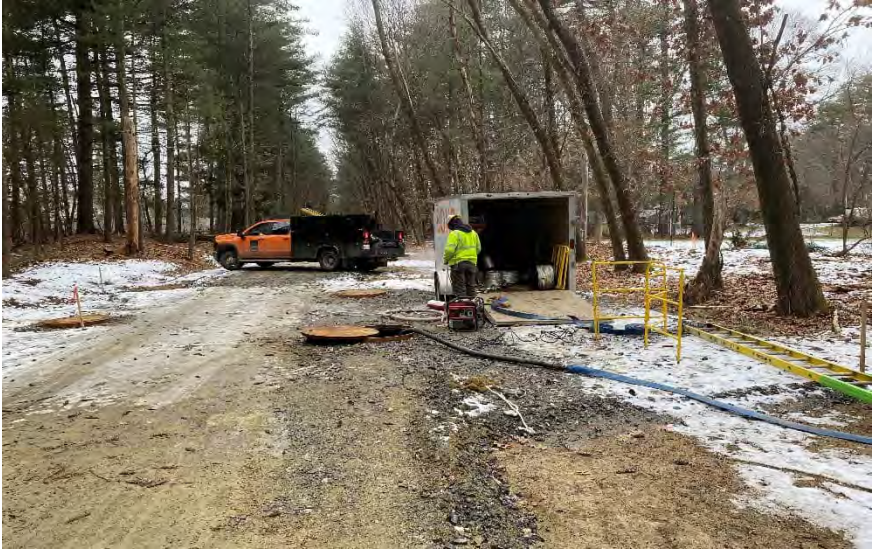
<p>PHOTOGRAPHIC LOG</p>	
<p>Client Name: Eversource</p>		<p>Site Location: Sudbury to Hudson Transmission Reliability Project</p>	<p>Town: Sudbury</p>
<p>Photo No.: 6</p>	<p>Date: 2-9-24</p>

<p>Description:</p> <p>Bond conducting proofing work within segment 10 at manhole #21, looking westward.</p>

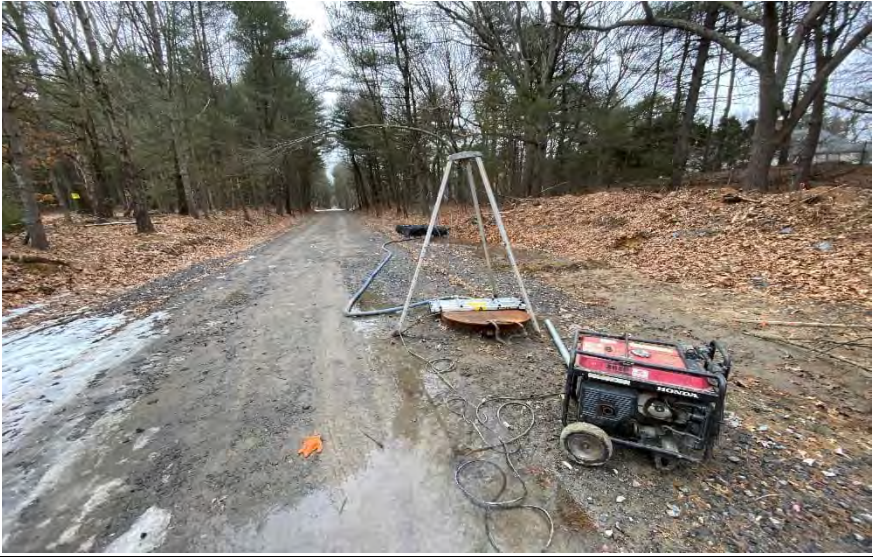
<p align="center">PHOTOGRAPHIC LOG</p>	
<p>Client Name: Eversource</p>		<p>Site Location: Sudbury to Hudson Transmission Reliability Project</p>	<p>Town: Sudbury</p>
<p>Photo No.: 7</p>	<p>Date: 2-9-24</p>

<p>Description:</p> <p>Bond conducting proofing work within segment 11 at manhole #22, looking westward</p>

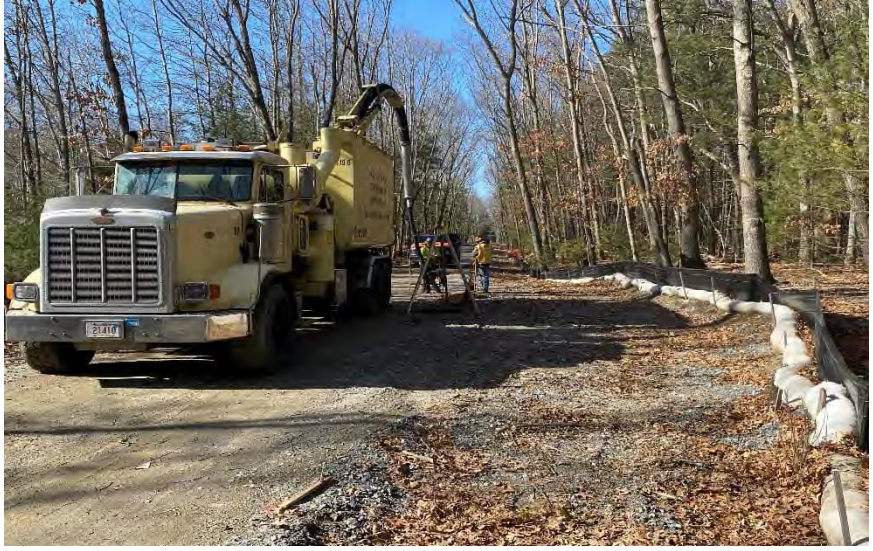
<p align="center">PHOTOGRAPHIC LOG</p>	
<p>Client Name: Eversource</p>		<p>Site Location: Sudbury to Hudson Transmission Reliability Project</p>	<p>Town: Sudbury</p>
<p>Photo No.: 8</p>	<p>Date: 2-9-24</p>

<p>Description:</p> <p>Bond conducting proofing work within segment 11 at manhole #23, existing erosion control, looking westward</p>

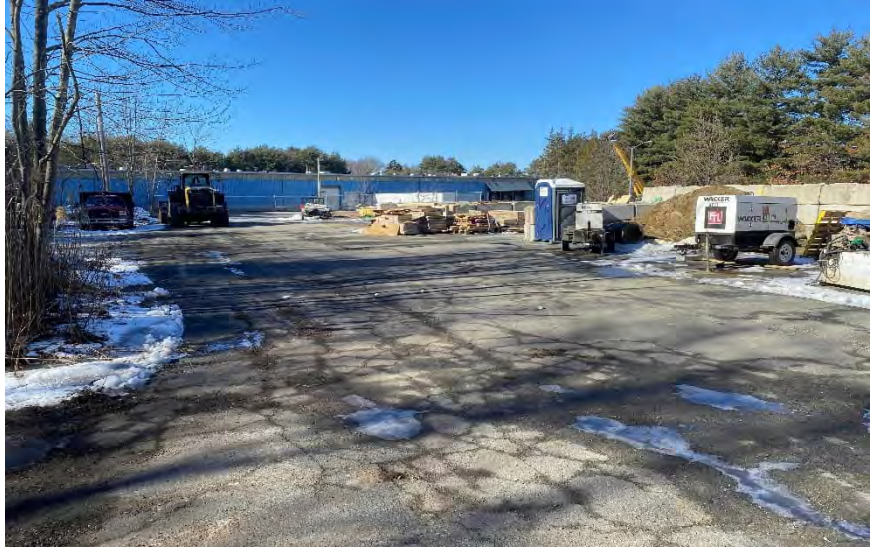
PHOTOGRAPHIC LOG	
Client Name: Eversource		Site Location: Sudbury to Hudson Transmission Reliability Project	Town: Hudson
Photo No.: 2	Date: 2-8-24

Description: Main Street laydown yard, looking westward.

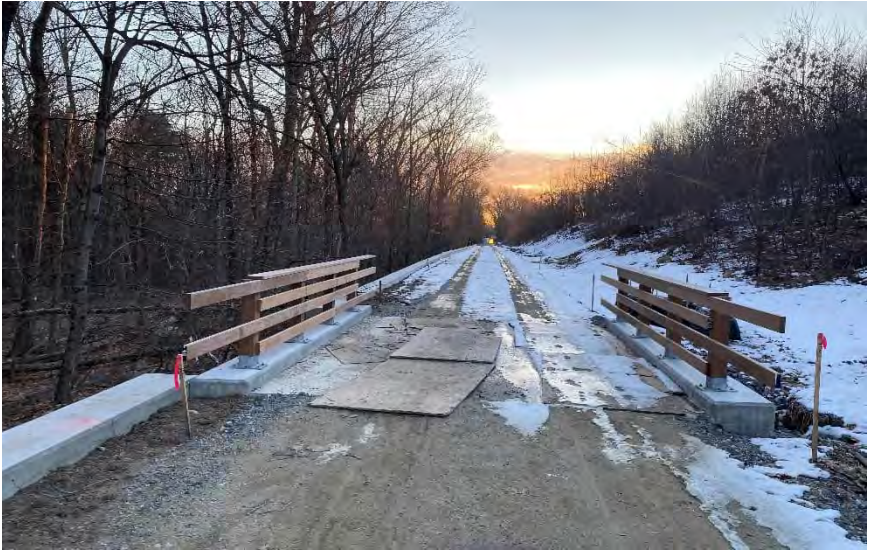
PHOTOGRAPHIC LOG	
Client Name: Eversource		Site Location: Sudbury to Hudson Transmission Reliability Project	Town: Hudson
Photo No.: 3	Date: 2-8-24

Description: Work area within segment 1, looking eastward.

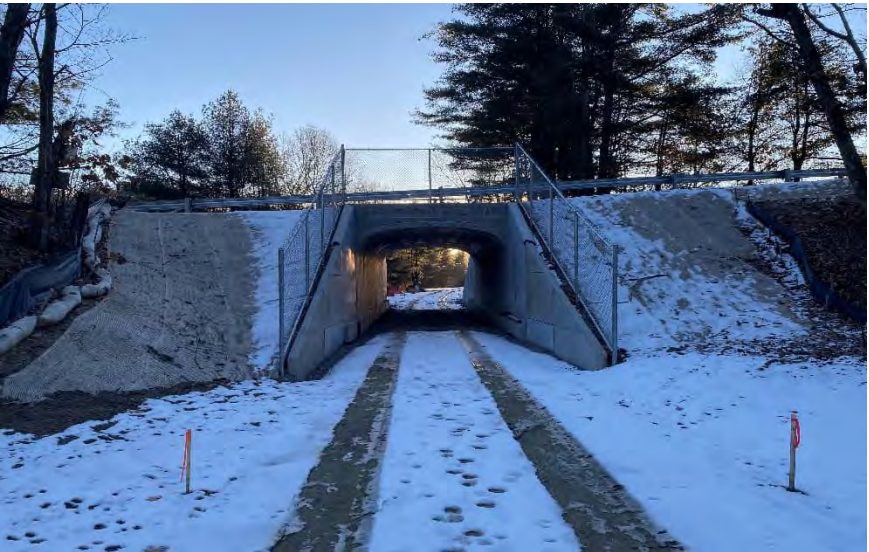
PHOTOGRAPHIC LOG	
Client Name: Eversource		Site Location: Sudbury to Hudson Transmission Reliability Project	Town: Hudson
Photo No.: 4	Date: 2-8-24

Description: Work area at Chestnut Street, looking westward.

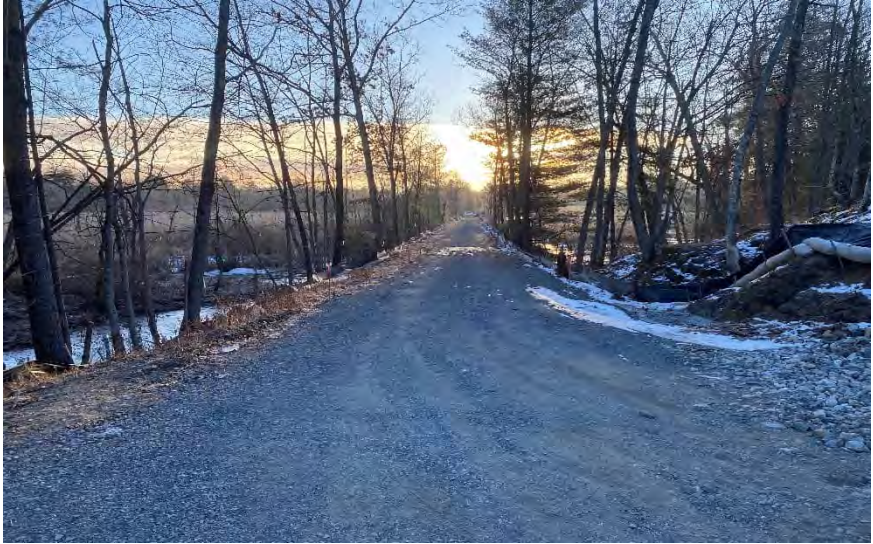
PHOTOGRAPHIC LOG	
Client Name: Eversource		Site Location: Sudbury to Hudson Transmission Reliability Project	Town: Hudson
Photo No.: 5	Date: 2-8-24

Description: Work area within segment 2, existing erosion control, looking eastward.

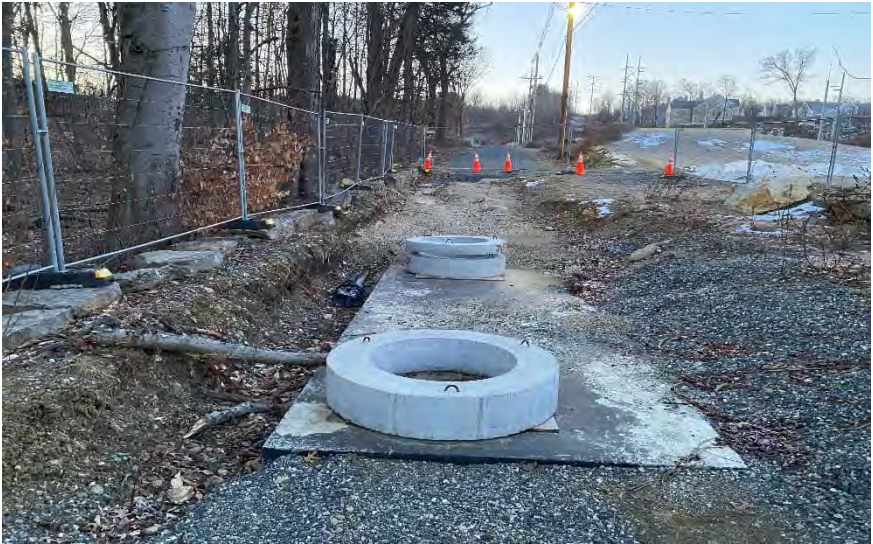
PHOTOGRAPHIC LOG	
Client Name: Eversource		Site Location: Sudbury to Hudson Transmission Reliability Project	Town: Hudson
Photo No.: 6	Date: 2-8-24

Description: Work area at manhole #1 area, looking eastward.

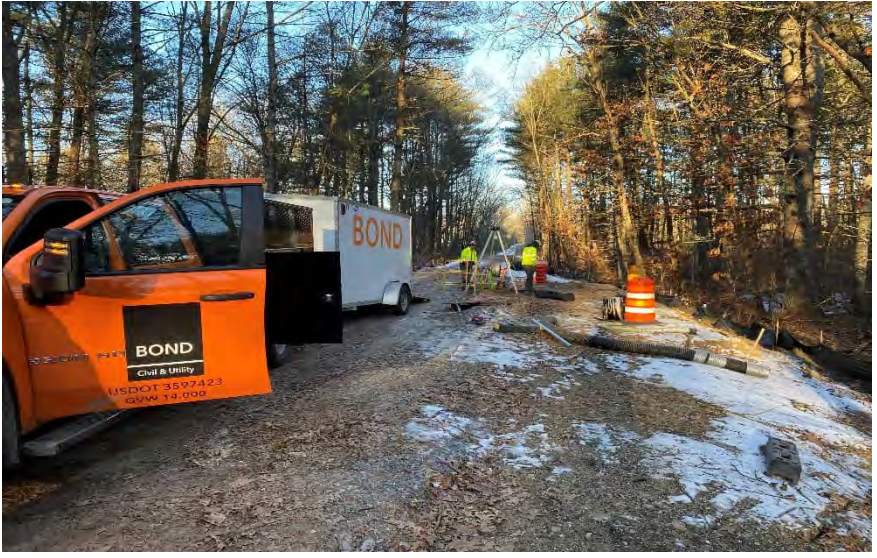
PHOTOGRAPHIC LOG	
Client Name: Eversource		Site Location: Sudbury to Hudson Transmission Reliability Project	Town: Hudson
Photo No.: 7	Date: 2-8-24

Description: Proofing at manhole #13, segment 5, existing erosion control, looking westward.

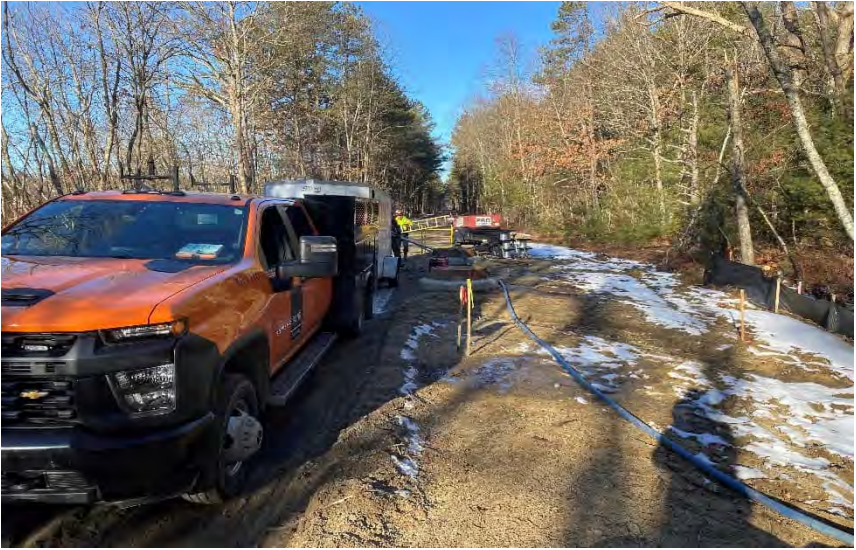
PHOTOGRAPHIC LOG	
Client Name: Eversource		Site Location: Sudbury to Hudson Transmission Reliability Project	Town: Hudson
Photo No.: 8	Date: 2-8-24

Description: Proofing at manhole #14, segment 6, existing erosion control, looking westward.

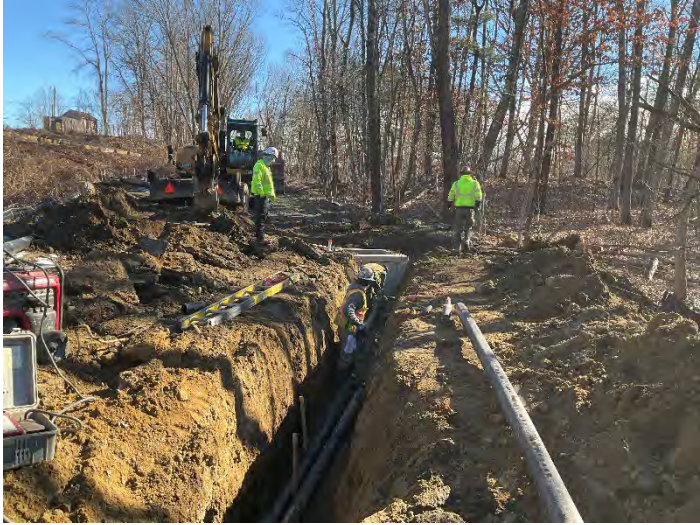
PHOTOGRAPHIC LOG	
Client Name: Eversource		Site Location: Sudbury to Hudson Transmission Reliability Project	Town: Sudbury
Photo No.: 1	Date: 2-08-2024

Description: View of Bond installing HH #27 and conduit in segment 14. Facing east.

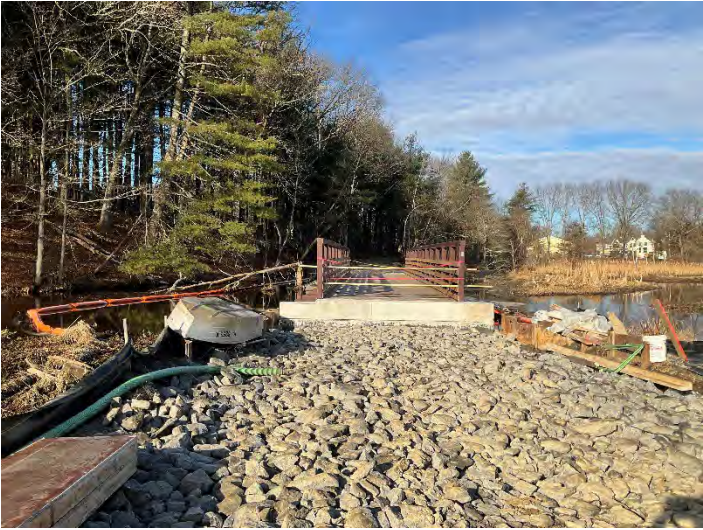
PHOTOGRAPHIC LOG	
Client Name: Eversource		Site Location: Sudbury to Hudson Transmission Reliability Project	Town: Sudbury
Photo No.: 3	Date: 2-08-2024

Description: View of bridge 127 area from segment 14. Facing west.

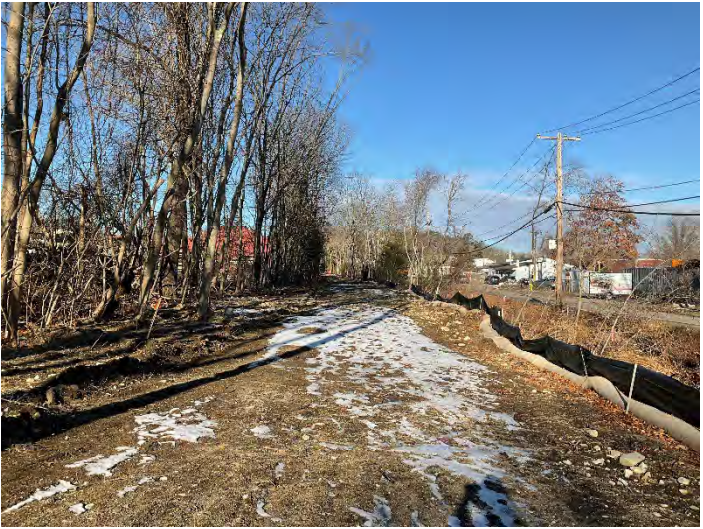
PHOTOGRAPHIC LOG	
Client Name: Eversource		Site Location: Sudbury to Hudson Transmission Reliability Project	Town: Sudbury
Photo No.: 4	Date: 2-08-2024

Description: View of E&S controls in segment 12. Facing west.

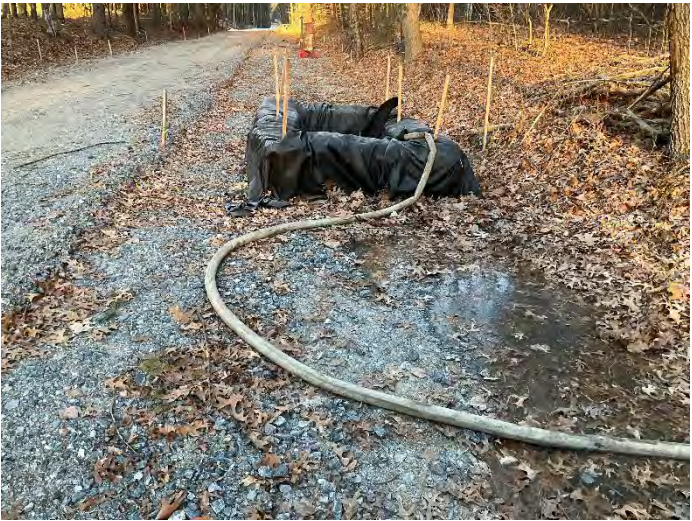
Epsilon ASSOCIATES INC.		PHOTOGRAPHIC LOG	
Client Name: Eversource		Site Location: Sudbury to Hudson Transmission Reliability Project	Town: Sudbury
Photo No.: 5	Date: 2-08-2024

Description: View of dewatering controls in segment 11. See additional dewatering inspection report. Facing west.

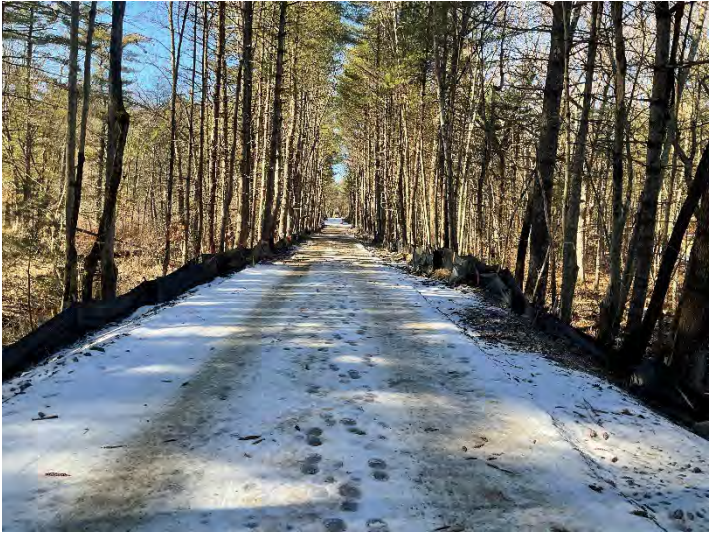
Epsilon ASSOCIATES INC.		PHOTOGRAPHIC LOG	
Client Name: Eversource		Site Location: Sudbury to Hudson Transmission Reliability Project	Town: Sudbury
Photo No.: 6	Date: 2-08-2024

Description: View of E&S controls in segment 10. Facing west.

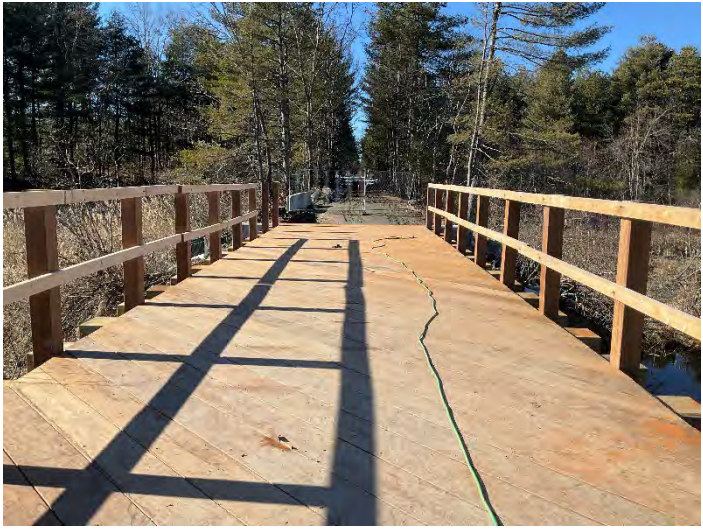
Epsilon ASSOCIATES INC.		PHOTOGRAPHIC LOG	
Client Name: Eversource		Site Location: Sudbury to Hudson Transmission Reliability Project	Town: Sudbury
Photo No.: 8	Date: 2-08-2024

Description: View of Bridge 128 from segment 8. Facing west.

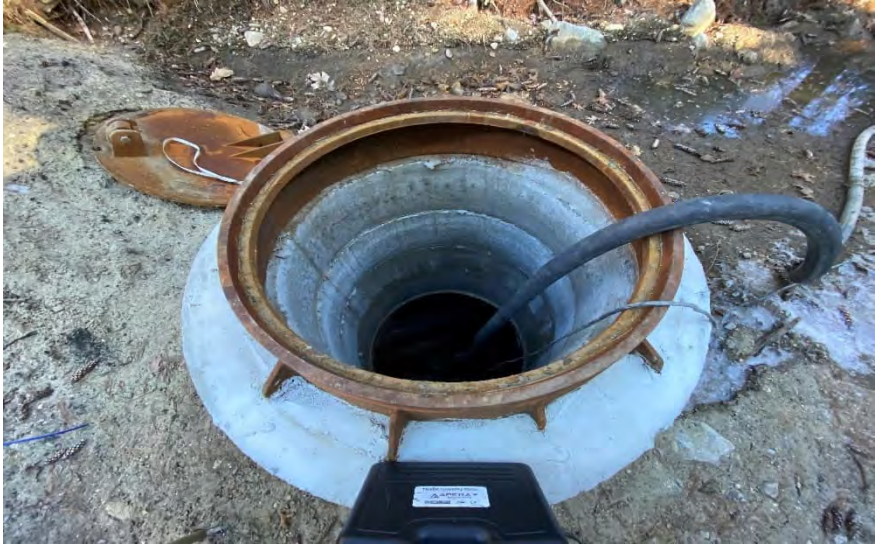
PHOTOGRAPHIC LOG	
Client Name: Eversource		Site Location: Sudbury to Hudson Transmission Reliability Project	Town: Sudbury
Photo No.: 1	Date: 2/5/2024

Description: View of area being pumped from Manhole #18 - segment 9 area.

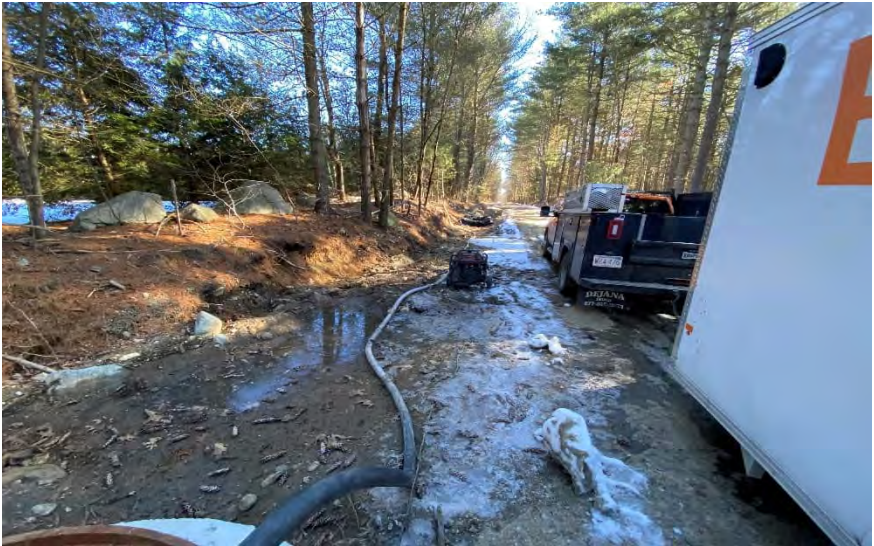
PHOTOGRAPHIC LOG	
Client Name: Eversource		Site Location: Sudbury to Hudson Transmission Reliability Project	Town: Sudbury
Photo No.: 2	Date: 2/5/2024

Description: Manhole #18. View of dewatering operation, looking eastward.

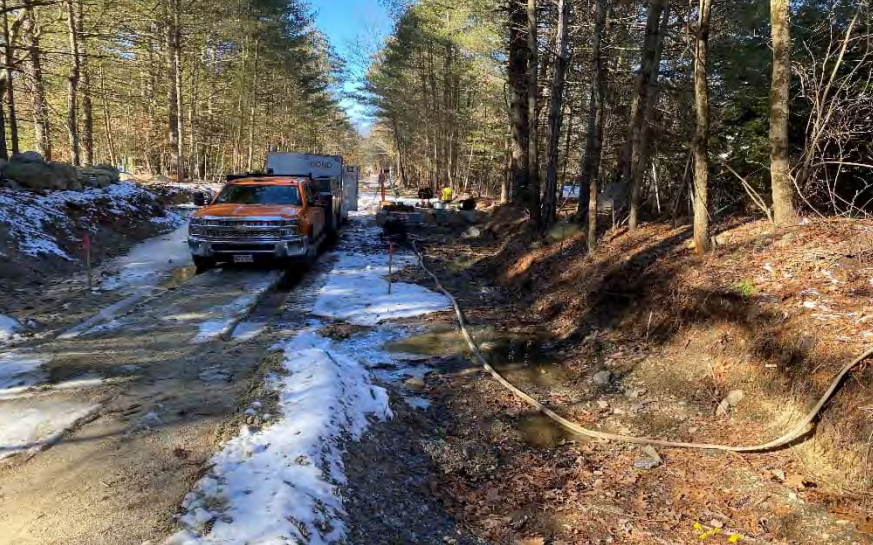
PHOTOGRAPHIC LOG	
Client Name: Eversource		Site Location: Sudbury to Hudson Transmission Reliability Project	
Town: Sudbury			
Photo No.: 3	Date: 2/5/2024

Description: Manhole #18. View of dewatering operation, looking westward.

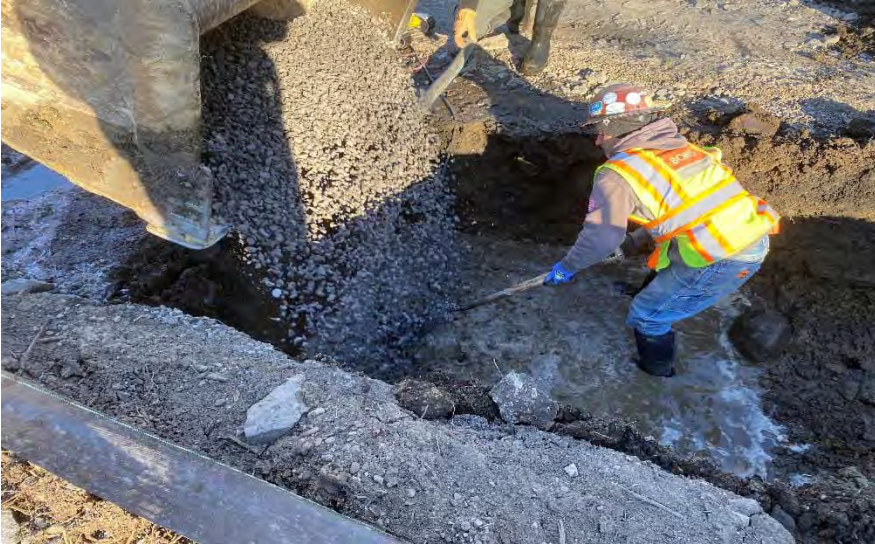
PHOTOGRAPHIC LOG	
Client Name: Eversource		Site Location: Sudbury to Hudson Transmission Reliability Project	Town: Sudbury
Photo No.: 1	Date: 2/5/2024

Description: View of area being pumped from wetland replication area associated culvert - segment 14.

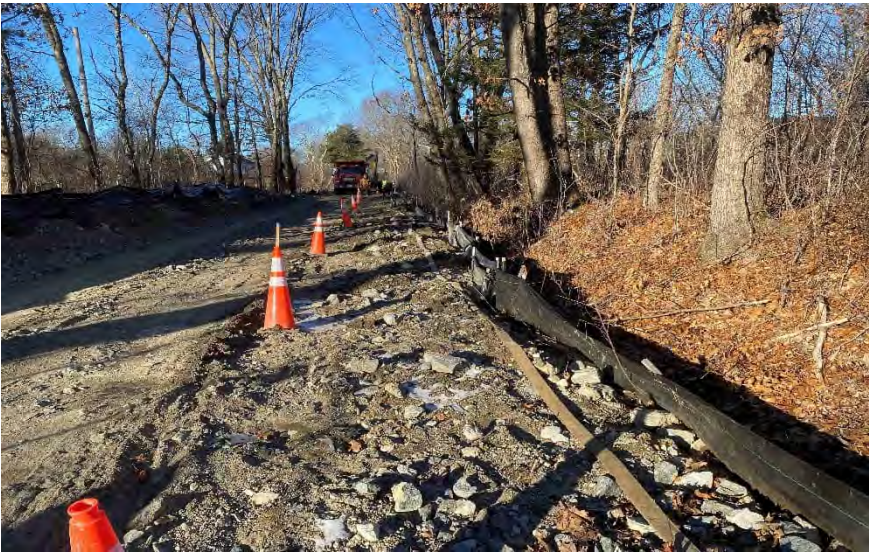
PHOTOGRAPHIC LOG	
Client Name: Eversource		Site Location: Sudbury to Hudson Transmission Reliability Project	Town: Sudbury
Photo No.: 3	Date: 2/5/2024

Description: Segment 14. View of dewatering operation, looking westward.

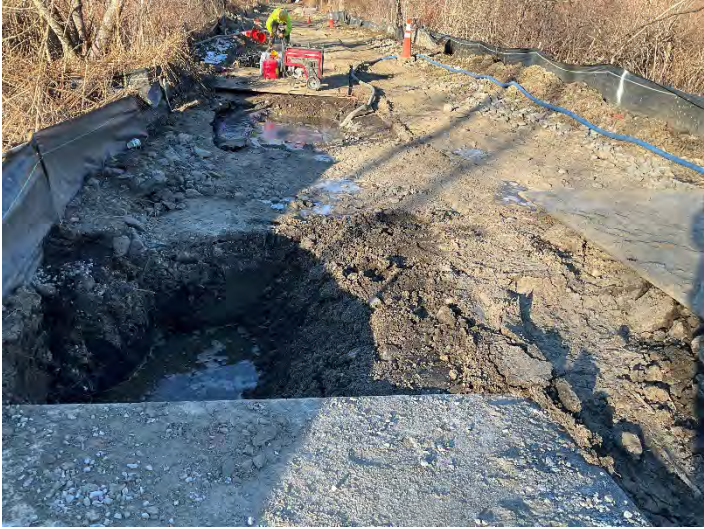
PHOTOGRAPHIC LOG	
Client Name: Eversource		Site Location: Sudbury to Hudson Transmission Reliability Project	
Town: Sudbury			
Photo No.: 1	Date: 2/06/2024

Description: View of Bond's work area in segment 14. Facing west.

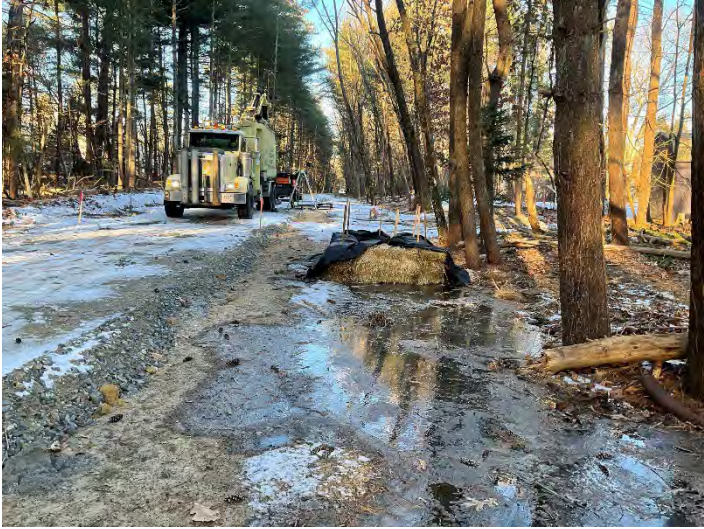
PHOTOGRAPHIC LOG	
Client Name: Eversource		Site Location: Sudbury to Hudson Transmission Reliability Project	Town: Sudbury
Photo No.: 1	Date: 2/07/2024

Description: View of Bond's work area at MH #21 in segment 10. Facing west.

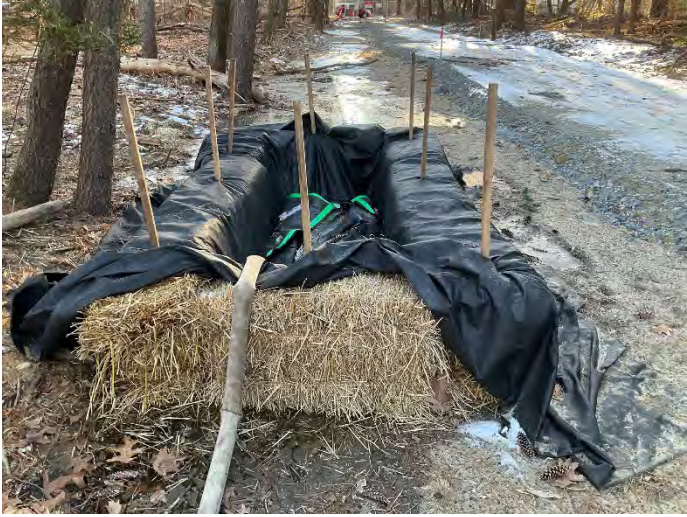
PHOTOGRAPHIC LOG	
Client Name: Eversource		Site Location: Sudbury to Hudson Transmission Reliability Project	
Town: Sudbury			
Photo No.: 3	Date: 2/07/2024

Description: View of dewatering controls (straw bale corral with filter fabric and silt bag). Facing east.

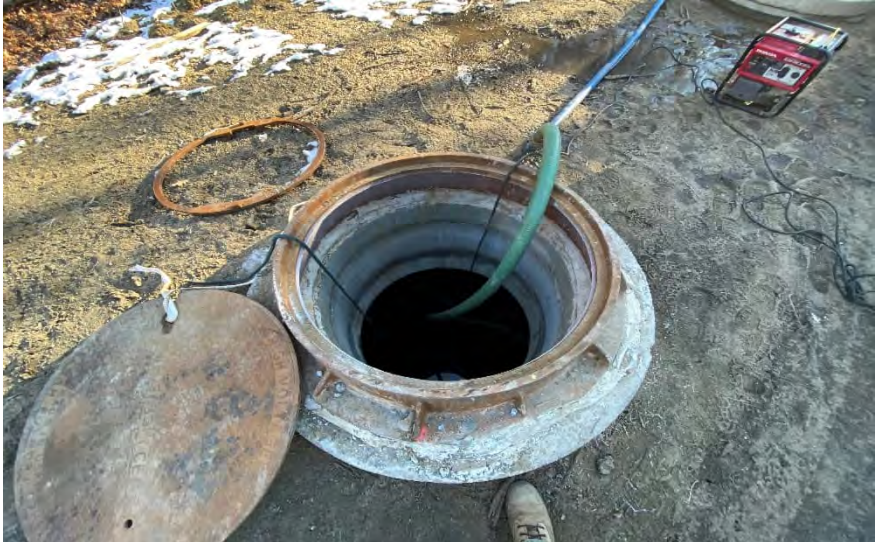
PHOTOGRAPHIC LOG	
Client Name: Eversource		Site Location: Sudbury to Hudson Transmission Reliability Project	Town: Hudson
Photo No.: 1	Date: 2/8/2024

Description: View of area being pumped from Manhole #14 - segment 6 area.

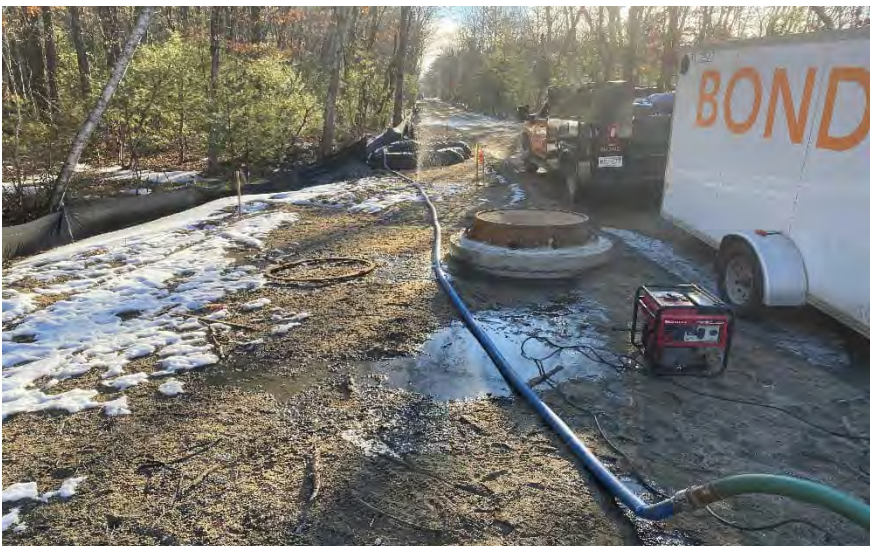
PHOTOGRAPHIC LOG	
Client Name: Eversource		Site Location: Sudbury to Hudson Transmission Reliability Project	Town: Hudson
Photo No.: 2	Date: 2/8/2024

Description: Manhole #14. View of dewatering operation, looking eastward.

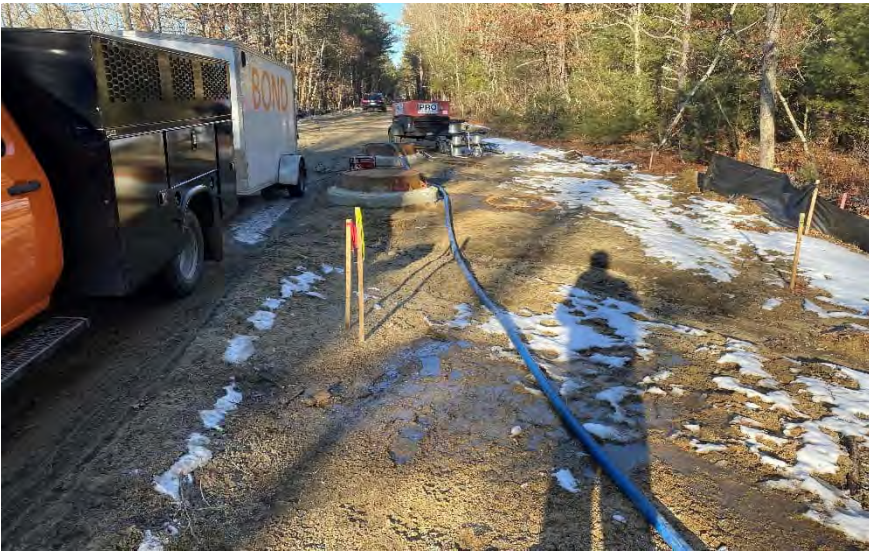
PHOTOGRAPHIC LOG	
Client Name: Eversource		Site Location: Sudbury to Hudson Transmission Reliability Project	Town: Hudson
Photo No.: 3	Date: 2/8/2024

Description: Manhole #14. View of dewatering operation, looking westward.

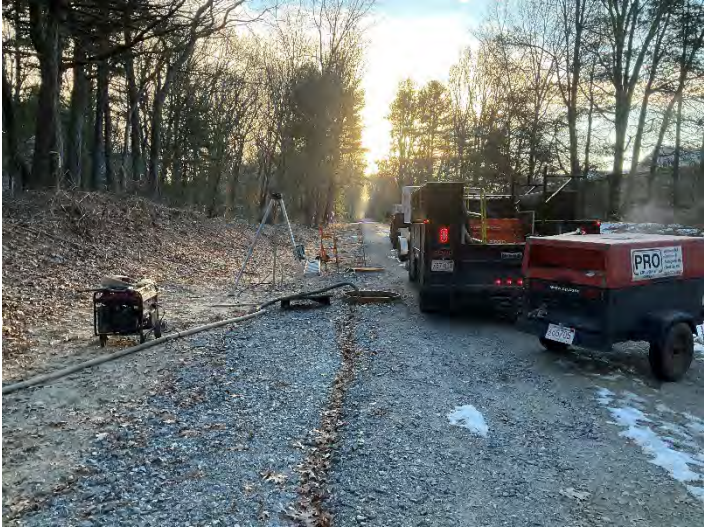
PHOTOGRAPHIC LOG	
Client Name: Eversource		Site Location: Sudbury to Hudson Transmission Reliability Project	
		Town: Sudbury	
Photo No.: 1	Date: 2/08/2024

Description: View of Bond's work area at MH #22 in segment 11. Facing east.

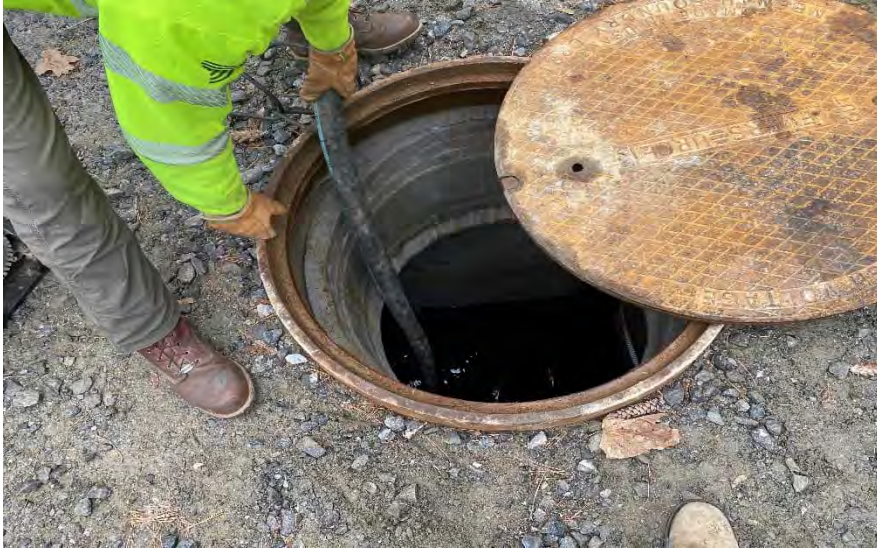
PHOTOGRAPHIC LOG	
Client Name: Eversource		Site Location: Sudbury to Hudson Transmission Reliability Project	Town: Sudbury
Photo No.: 1	Date: 2/9/2024

Description: View of area being pumped from Manhole #21 - segment 10 area.

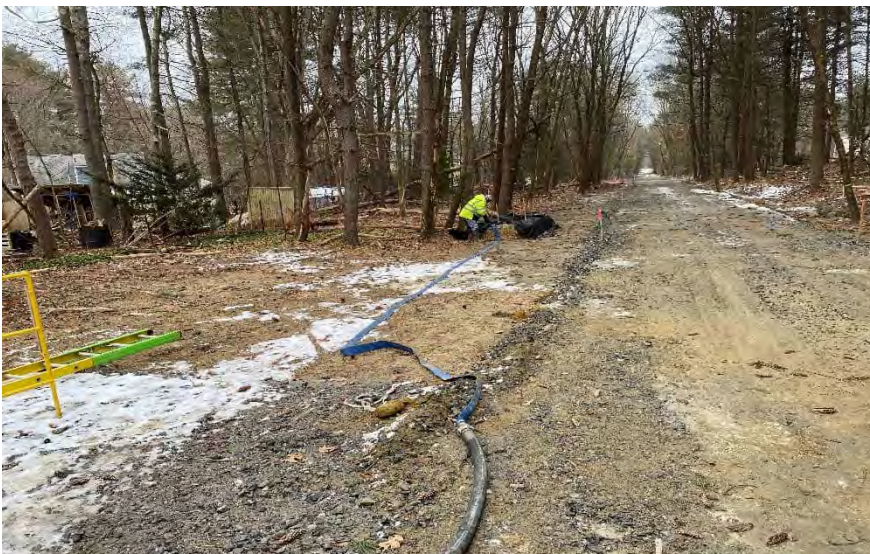
PHOTOGRAPHIC LOG	
Client Name: Eversource		Site Location: Sudbury to Hudson Transmission Reliability Project	Town: Sudbury
Photo No.: 2	Date: 2/9/2024

Description: Manhole #21. View of dewatering operation, looking eastward.
