Weekly Environmental Compliance Summary

Sudbury to Hudson Transmission Reliability Project (USEPA Tracking # MAR1003UW)

Sudbury, Hudson, and Stow, MA

Week of: February 5, 2024 to February 9, 2024

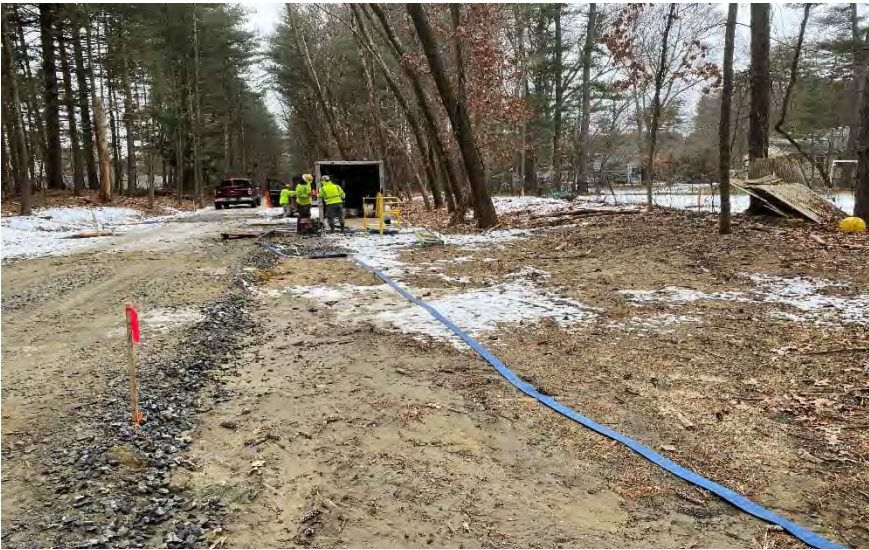
PHOTOGRAPHIC LOG	
Client Name: Eversource		Site Location: Sudbury to Hudson Transmission Reliability Project	Town: Sudbury
Photo No.: 3	Date: 2/9/2024

Description: Manhole #21. View of dewatering operation, looking westward.

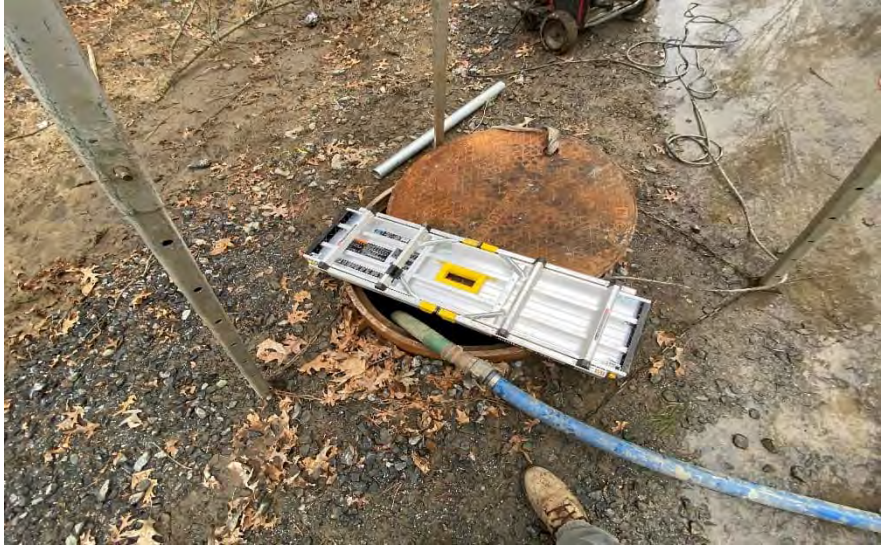
PHOTOGRAPHIC LOG		
Client Name: Eversource		Site Location: Sudbury to Hudson Transmission Reliability Project		Town: Sudbury
Photo No.: 1	Date: 2/9/2024

Description: View of area being pumped from Manhole #22 - segment 11 area.

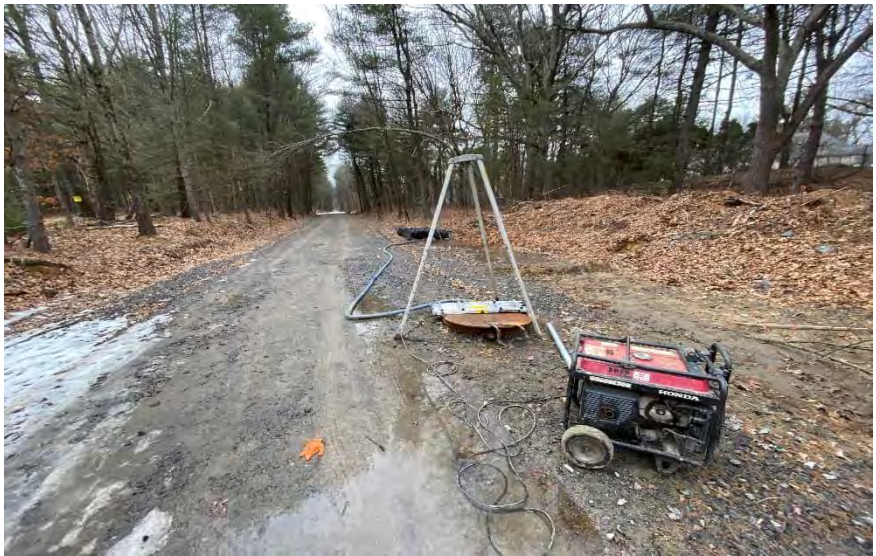
PHOTOGRAPHIC LOG		
Client Name: Eversource		Site Location: Sudbury to Hudson Transmission Reliability Project		Town: Sudbury
Photo No.: 2	Date: 2/9/2024

Description: Manhole #22. View of dewatering operation, looking westward.

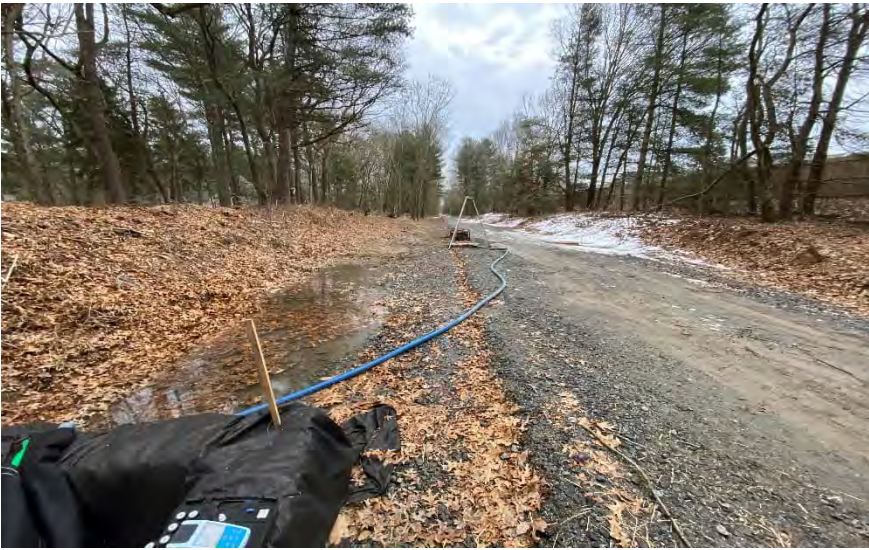
PHOTOGRAPHIC LOG	
Client Name: Eversource		Site Location: Sudbury to Hudson Transmission Reliability Project	
Town: Sudbury			
Photo No.: 3	Date: 2/9/2024

Description: Manhole #22. View of dewatering operation, looking eastward.
