Weekly Environmental Compliance Summary

Sudbury to Hudson Transmission Reliability Project (USEPA Tracking # MAR1003UW)

Week of: February 12, 2024 to February 16, 2024

CONSTRUCTION MONITORING REPORT

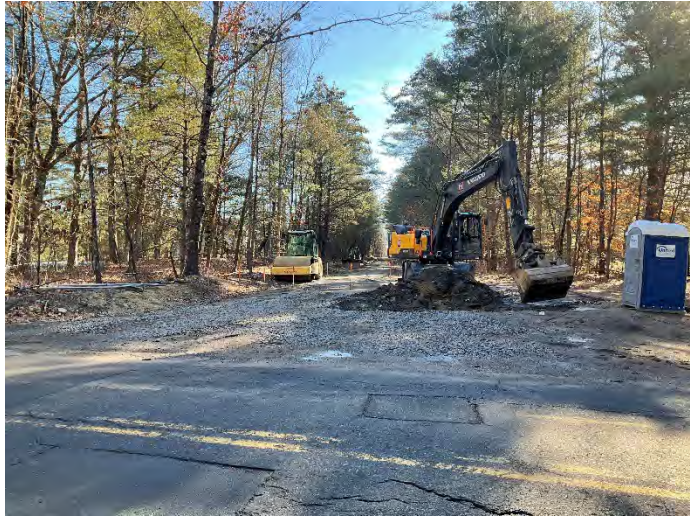
<p>PHOTOGRAPHIC LOG</p>	
<p>Client Name: Eversource</p>		<p>Site Location: Sudbury to Hudson Transmission Reliability Project</p>	<p>Town: Sudbury</p>
<p>Photo No.: 2</p>	<p>Date: 2/12/2024</p>

<p>Description: View of ET&L working in segment 9 at Dutton Rd. Facing east.</p>

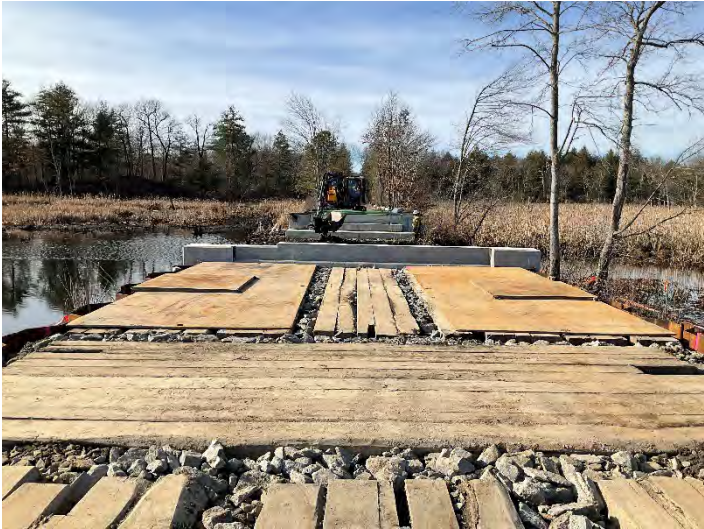
<p>PHOTOGRAPHIC LOG</p>	
<p>Client Name: Eversource</p>		<p>Site Location: Sudbury to Hudson Transmission Reliability Project</p>	<p>Town: Hudson</p>
<p>Photo No.: 5</p>	<p>Date: 2/12/2024</p>

<p>Description: View of crane mats installed at bridge 130 in segment 3. Facing west.</p>

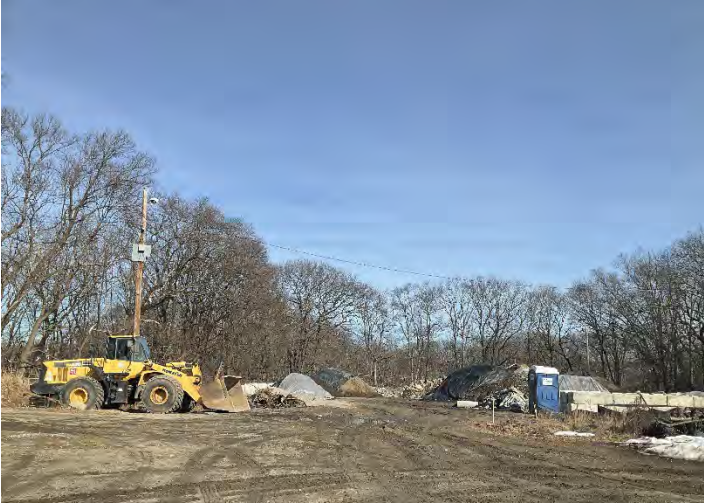
<p>PHOTOGRAPHIC LOG</p>	
<p>Client Name: Eversource</p>		<p>Site Location: Sudbury to Hudson Transmission Reliability Project</p>	<p>Town: Hudson</p>
<p>Photo No.: 6</p>	<p>Date: 2/12/2024</p>

<p>Description: View of Stowe Ct laydown yard. Facing northeast.</p>

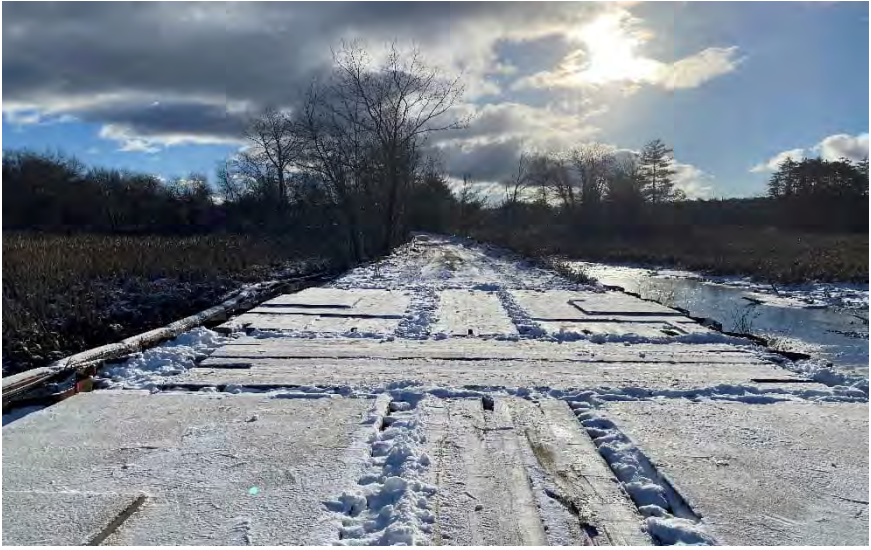
<p>PHOTOGRAPHIC LOG</p>	
<p>Client Name: Eversource</p>		<p>Site Location: Sudbury to Hudson Transmission Reliability Project</p>	<p>Town: Hudson</p>
<p>Photo No.: 1</p>	<p>Date: 2-14-24</p>

<p>Description:</p> <p>Work area within segment 3, recently placed crane mats for bridge 130 work, existing erosion control, looking eastward.</p>

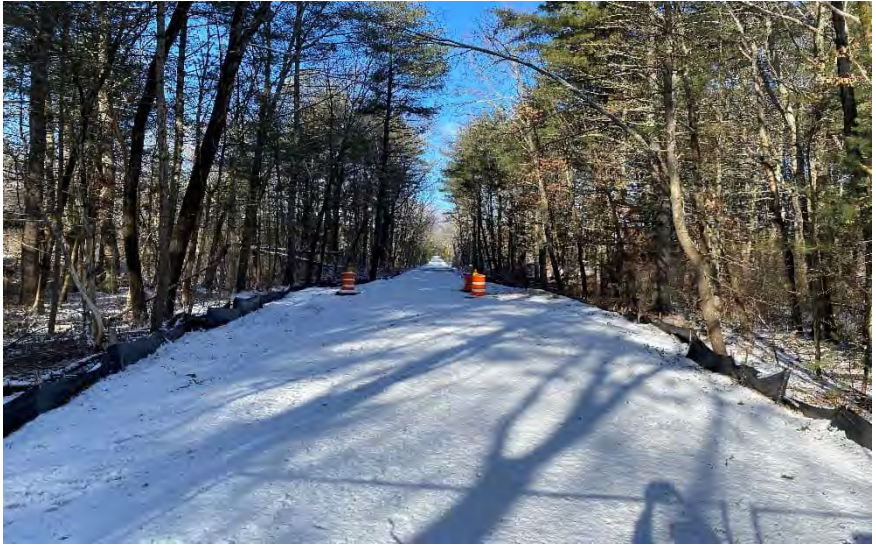
<p>PHOTOGRAPHIC LOG</p>	
<p>Client Name: Eversource</p>		<p>Site Location: Sudbury to Hudson Transmission Reliability Project</p>	<p>Town: Hudson</p>
<p>Photo No.: 3</p>	<p>Date: 2-14-24</p>

<p>Description:</p> <p>Work area within segment 5, manhole #13, existing erosion control, looking westward.</p>

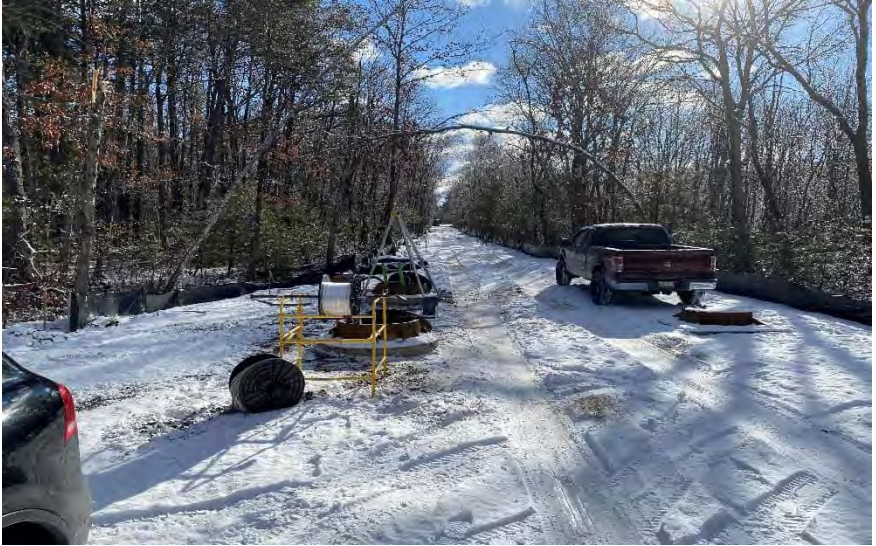
<p>PHOTOGRAPHIC LOG</p>	
<p>Client Name: Eversource</p>		<p>Site Location: Sudbury to Hudson Transmission Reliability Project</p>	<p>Town: Hudson</p>
<p>Photo No.: 4</p>	<p>Date: 2-14-24</p>

<p>Description:</p> <p>Bond conducting proofing work within segment 6 at manhole #14, existing erosion control, looking eastward.</p>

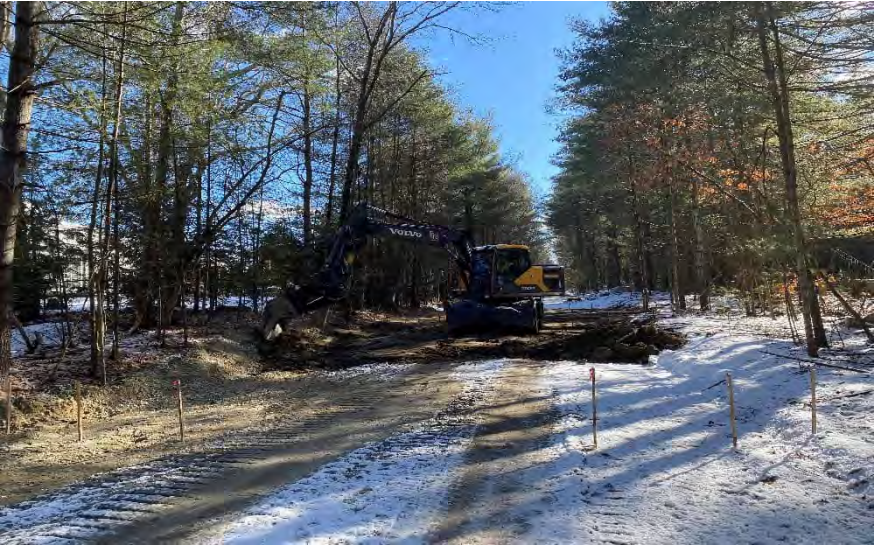
<p>PHOTOGRAPHIC LOG</p>	
<p>Client Name: Eversource</p>		<p>Site Location: Sudbury to Hudson Transmission Reliability Project</p>	<p>Town: Sudbury</p>
<p>Photo No.: 5</p>	<p>Date: 2-14-24</p>

<p>Description:</p> <p>ET&L conducting grading work within segment 9, looking eastward.</p>

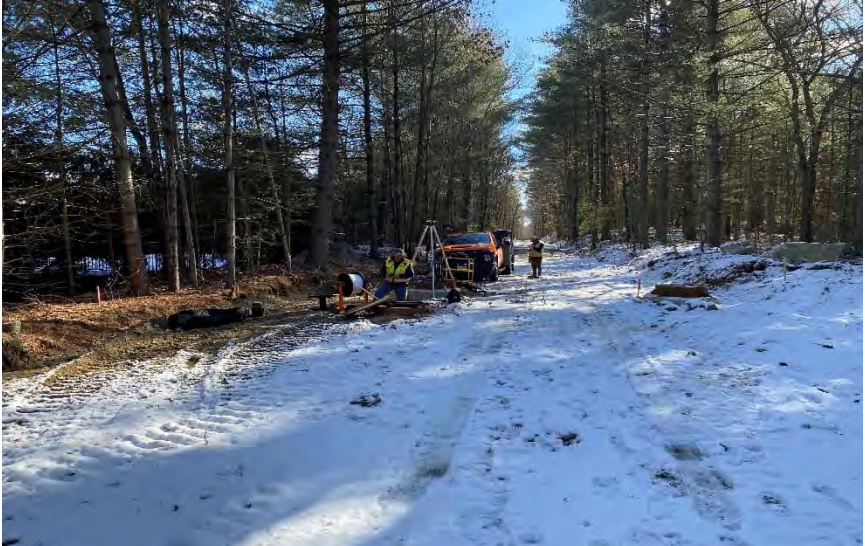
<p>PHOTOGRAPHIC LOG</p>	
<p>Client Name: Eversource</p>		<p>Site Location: Sudbury to Hudson Transmission Reliability Project</p>	<p>Town: Sudbury</p>
<p>Photo No.: 6</p>	<p>Date: 2-14-24</p>

<p>Description:</p> <p>Bond conducting proofing work within segment 9 at manhole #18, looking eastward.</p>

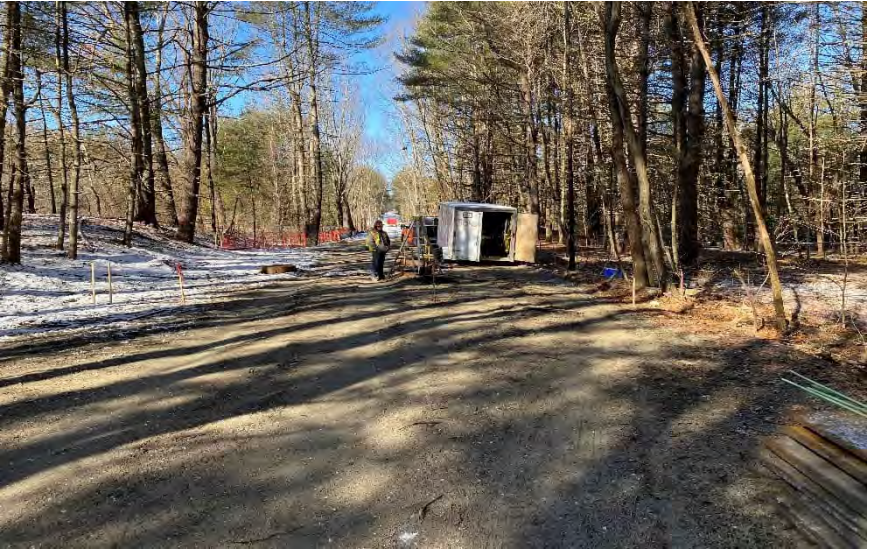
<p>PHOTOGRAPHIC LOG</p>	
<p>Client Name: Eversource</p>		<p>Site Location: Sudbury to Hudson Transmission Reliability Project</p>	<p>Town: Sudbury</p>
<p>Photo No.: 7</p>	<p>Date: 2-14-24</p>

<p>Description:</p> <p>Bond conducting proofing work within segment 8 at manhole #17, looking westward</p>

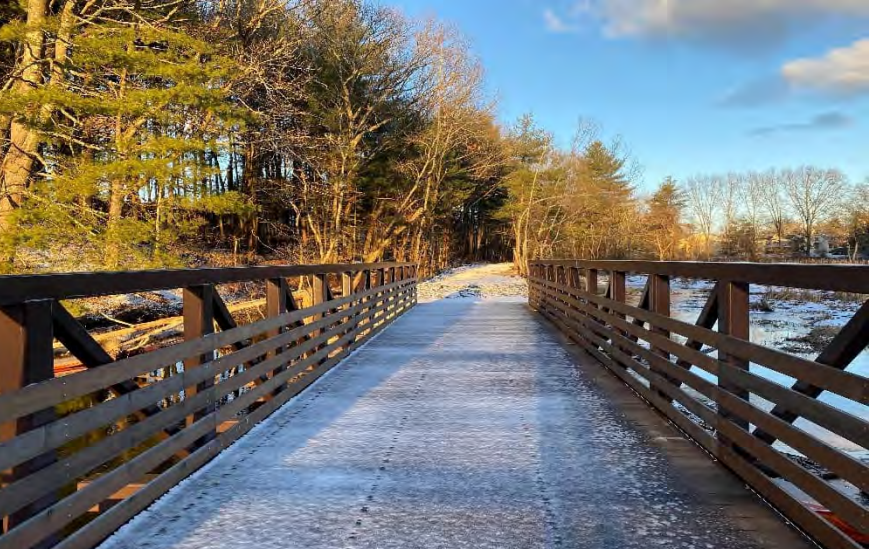
<p>PHOTOGRAPHIC LOG</p>	
<p>Client Name: Eversource</p>		<p>Site Location: Sudbury to Hudson Transmission Reliability Project</p>	<p>Town: Sudbury</p>
<p>Photo No.: 8</p>	<p>Date: 2-14-24</p>

<p>Description:</p> <p>Work area at Bridge 127 looking from segment 14 toward segment 13 over Hop Brook, looking westward</p>

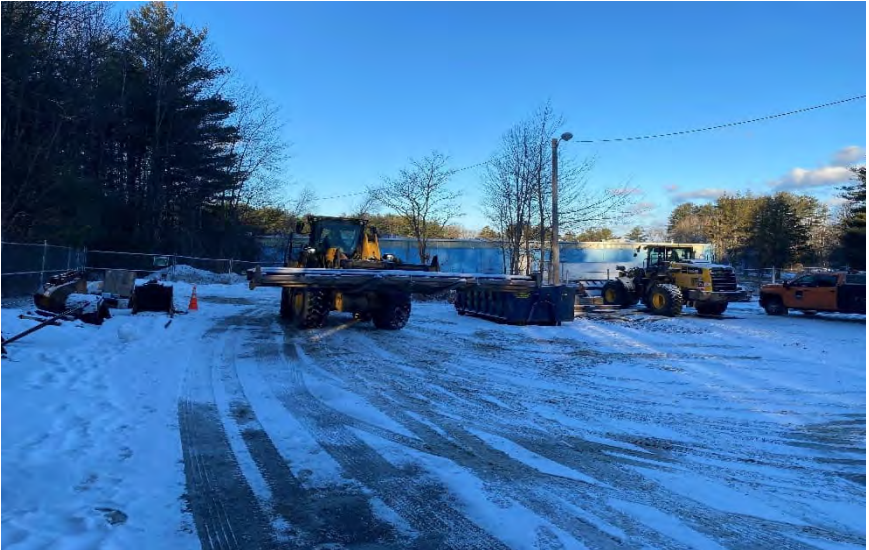
<p>PHOTOGRAPHIC LOG</p>	
<p>Client Name: Eversource</p>		<p>Site Location: Sudbury to Hudson Transmission Reliability Project</p>	<p>Town: Hudson</p>
<p>Photo No.: 1</p>	<p>Date: 2-16-24</p>

<p>Description:</p> <p>Main Street laydown yard, Bond removing conduit, looking westward.</p>

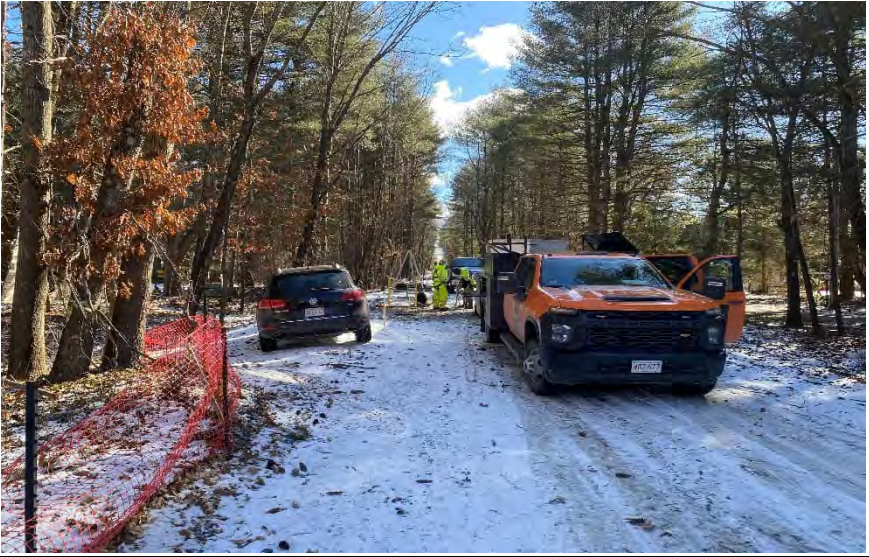
<p>PHOTOGRAPHIC LOG</p>	
<p>Client Name: Eversource</p>		<p>Site Location: Sudbury to Hudson Transmission Reliability Project</p>	<p>Town: Hudson</p>
<p>Photo No.: 3</p>	<p>Date: 2-16-24</p>

<p>Description:</p> <p>Bond conducting proofing work within segment 5 at manhole #11, existing erosion control, looking eastward.</p>

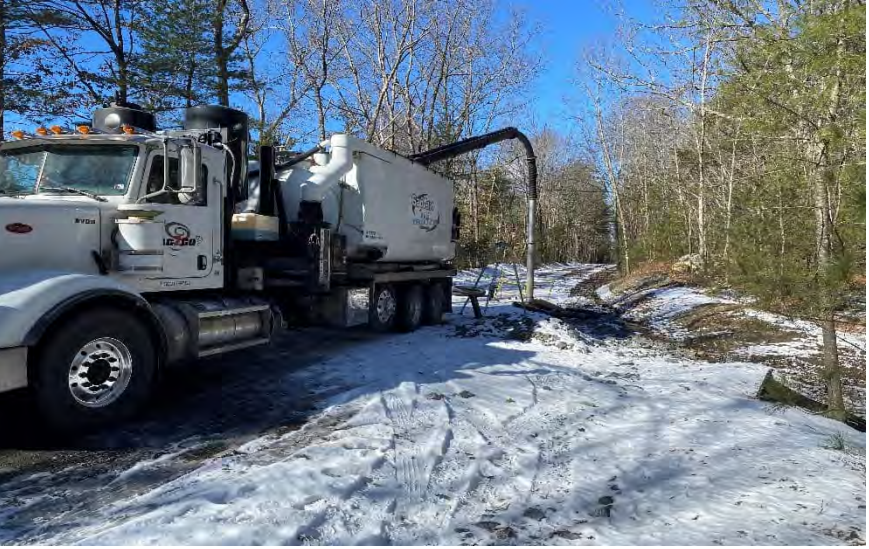
<p>PHOTOGRAPHIC LOG</p>	
<p>Client Name: Eversource</p>		<p>Site Location: Sudbury to Hudson Transmission Reliability Project</p>	<p>Town: Hudson</p>
<p>Photo No.: 4</p>	<p>Date: 2-16-24</p>

<p>Description:</p> <p>Bond conducting proofing work within segment 5 at manhole #12, existing erosion control, looking westward.</p>

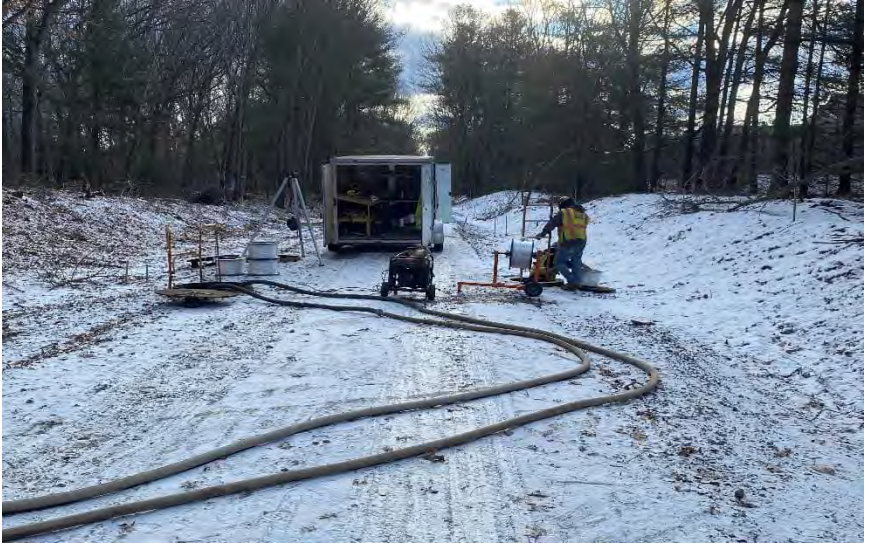
<p>PHOTOGRAPHIC LOG</p>	
<p>Client Name: Eversource</p>		<p>Site Location: Sudbury to Hudson Transmission Reliability Project</p>	<p>Town: Sudbury</p>
<p>Photo No.: 6</p>	<p>Date: 2-16-24</p>

<p>Description:</p> <p>Bond conducting proofing work within segment 11 at manhole #22, looking eastward.</p>

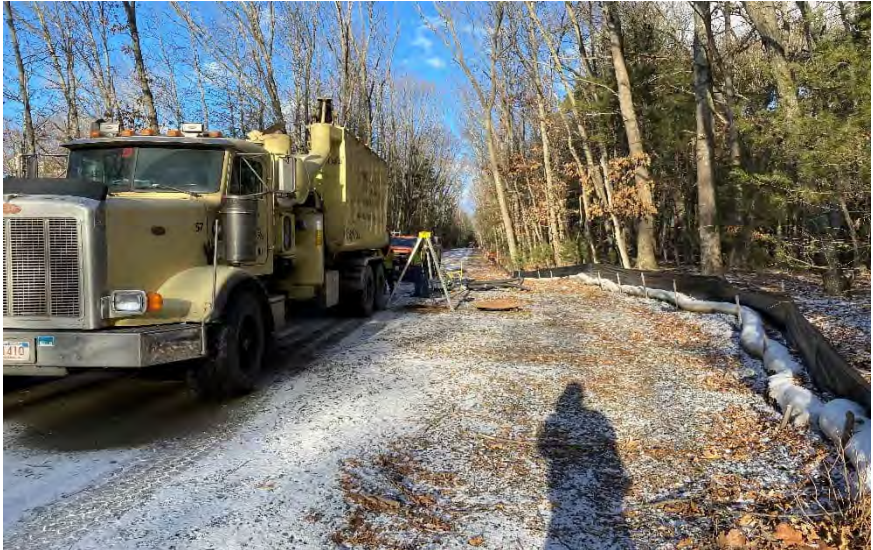
<p>PHOTOGRAPHIC LOG</p>	
<p>Client Name: Eversource</p>		<p>Site Location: Sudbury to Hudson Transmission Reliability Project</p>	<p>Town: Sudbury</p>
<p>Photo No.: 7</p>	<p>Date: 2-16-24</p>

<p>Description:</p> <p>Bond conducting proofing work within segment 11 at manhole #23, looking westward</p>

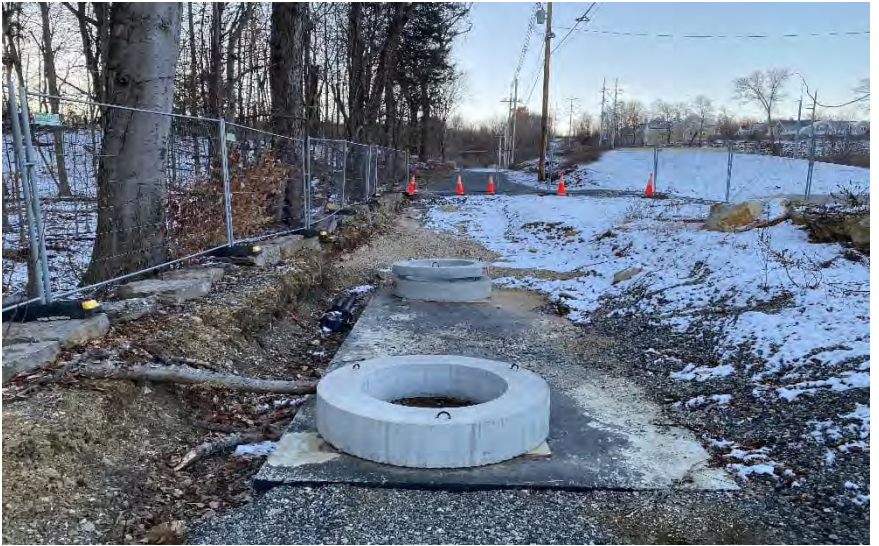
PHOTOGRAPHIC LOG	
Client Name: Eversource		Site Location: Sudbury to Hudson Transmission Reliability Project	Town: Hudson
Photo No.: 2	Date: 2-15-24

Description: Manhole #1 off Forest Avenue, adjacent to the Hudson Power & Light facility, looking eastward.

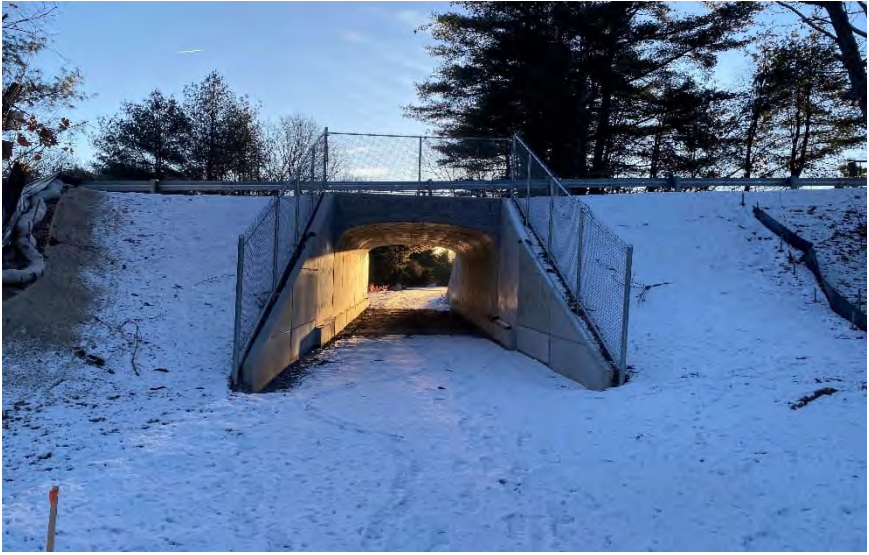
PHOTOGRAPHIC LOG	
Client Name: Eversource		Site Location: Sudbury to Hudson Transmission Reliability Project	Town: Hudson
Photo No.: 3	Date: 2-15-24

Description: Work area within segment 1, looking eastward toward Chestnut Street crossing, looking eastward.

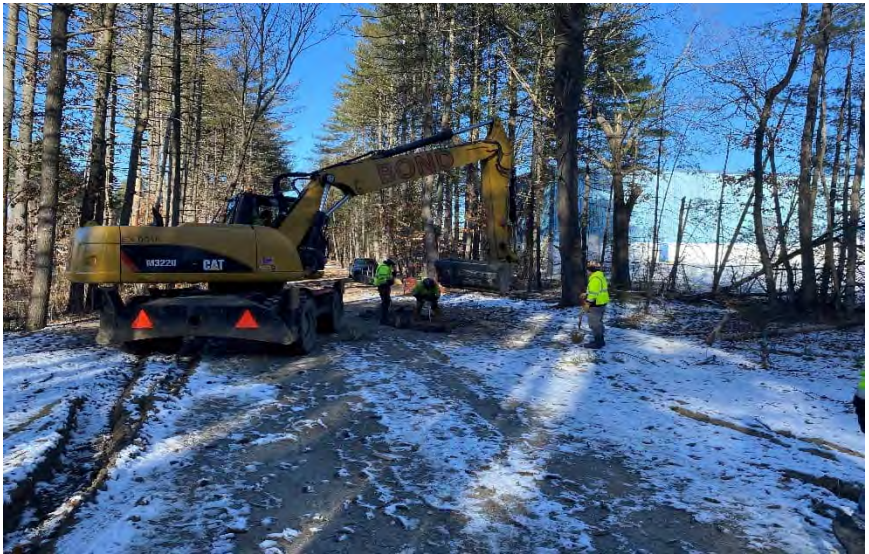
PHOTOGRAPHIC LOG	
Client Name: Eversource		Site Location: Sudbury to Hudson Transmission Reliability Project	Town: Hudson
Photo No.: 4	Date: 2-15-24

Description: Work area within segment 4 at manhole #10, Bond conducting manhole work, looking westward.

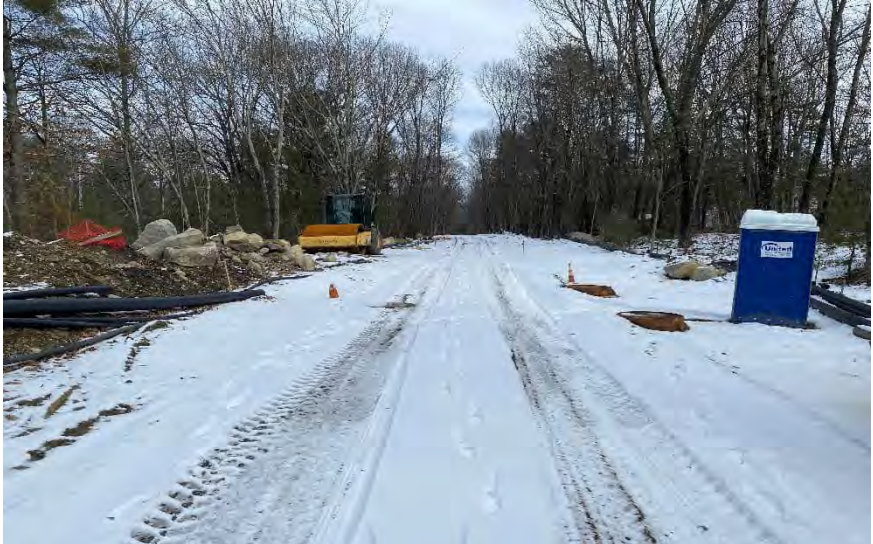
PHOTOGRAPHIC LOG	
Client Name: Eversource		Site Location: Sudbury to Hudson Transmission Reliability Project	Town: Hudson
Photo No.: 5	Date: 2-15-24

Description: Work area within segment 1, manhole #5, existing erosion control, looking eastward.

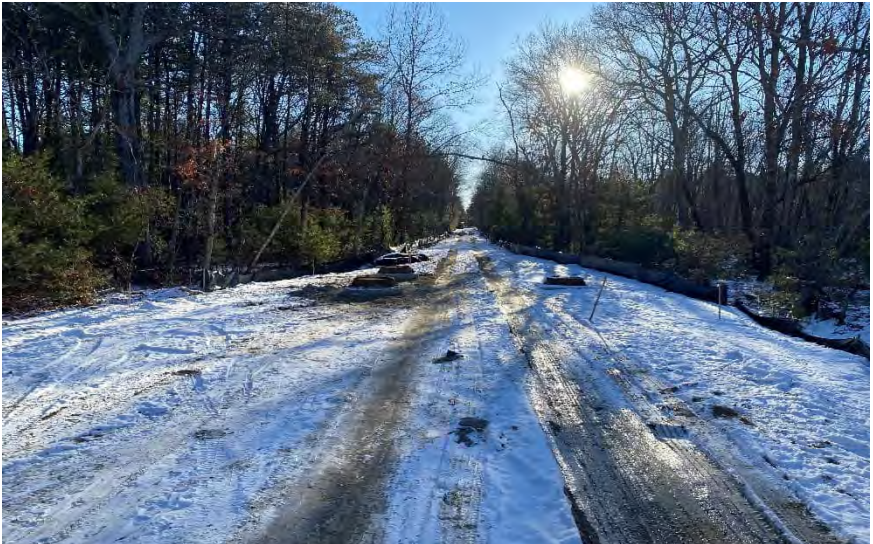
PHOTOGRAPHIC LOG	
Client Name: Eversource		Site Location: Sudbury to Hudson Transmission Reliability Project	Town: Hudson
Photo No.: 6	Date: 2-15-24

Description: Work area within segment 6, manhole #14, existing erosion control, looking eastward.

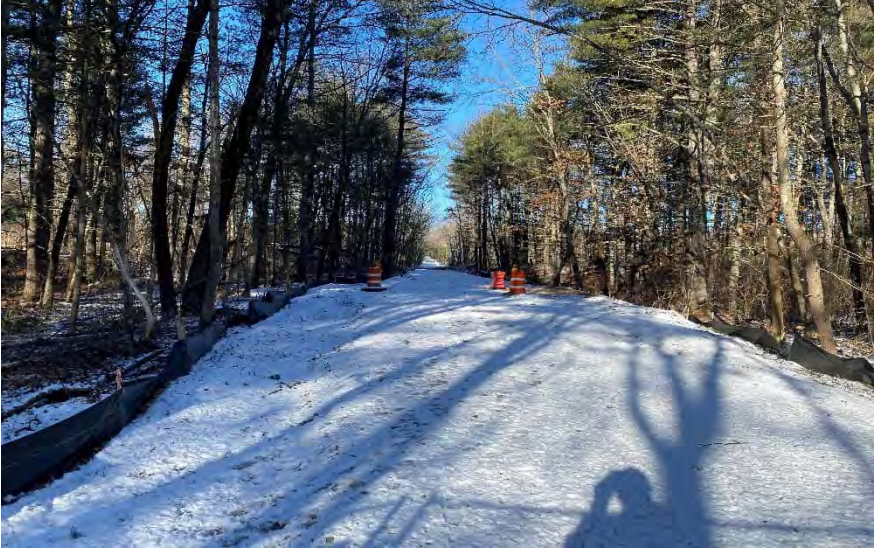
PHOTOGRAPHIC LOG	
Client Name: Eversource		Site Location: Sudbury to Hudson Transmission Reliability Project	Town: Hudson
Photo No.: 7	Date: 2-15-24

Description: Work area within segment 5, manhole #13, existing erosion control, looking westward.

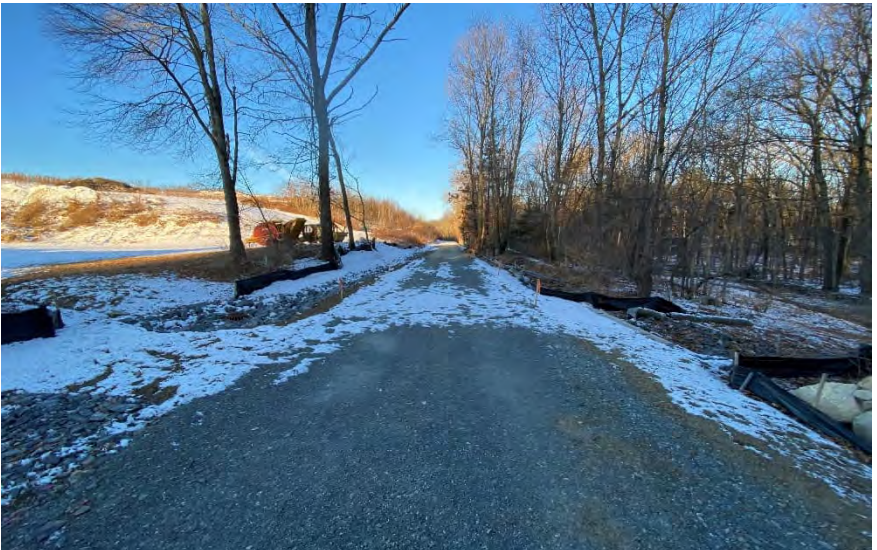
PHOTOGRAPHIC LOG	
Client Name: Eversource		Site Location: Sudbury to Hudson Transmission Reliability Project	Town: Stow
Photo No.: 8	Date: 2-15-24

Description: Work area within segment 1, existing erosion control, looking westward.

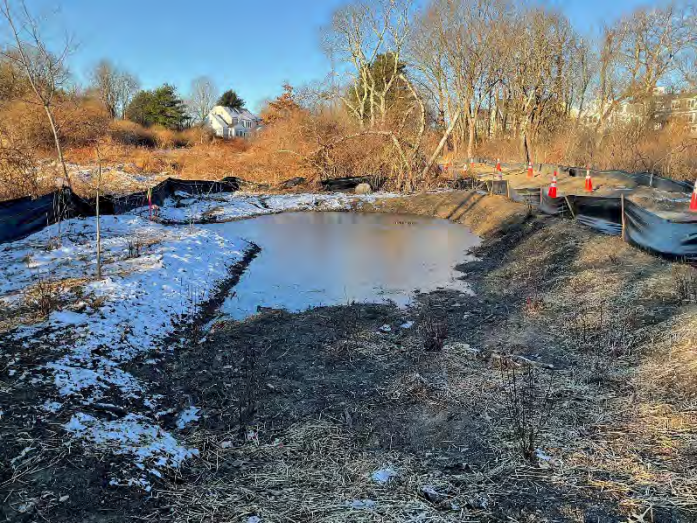
PHOTOGRAPHIC LOG	
Client Name: Eversource		Site Location: Sudbury to Hudson Transmission Reliability Project	Town: Sudbury
Photo No.: 1	Date: 2-15-2024

Description: View of wetland replication area in segment 14. Facing west.

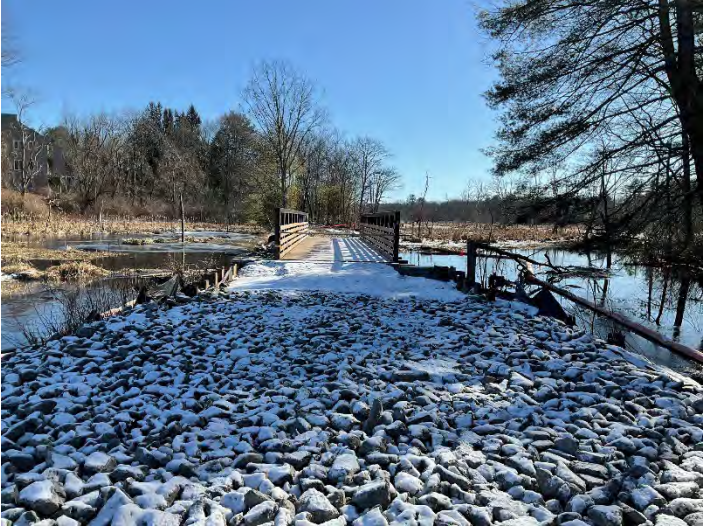
PHOTOGRAPHIC LOG	
Client Name: Eversource		Site Location: Sudbury to Hudson Transmission Reliability Project	Town: Sudbury
Photo No.: 3	Date: 2-15-2024

Description: View of bridge 127 area from segment 13. Facing east.

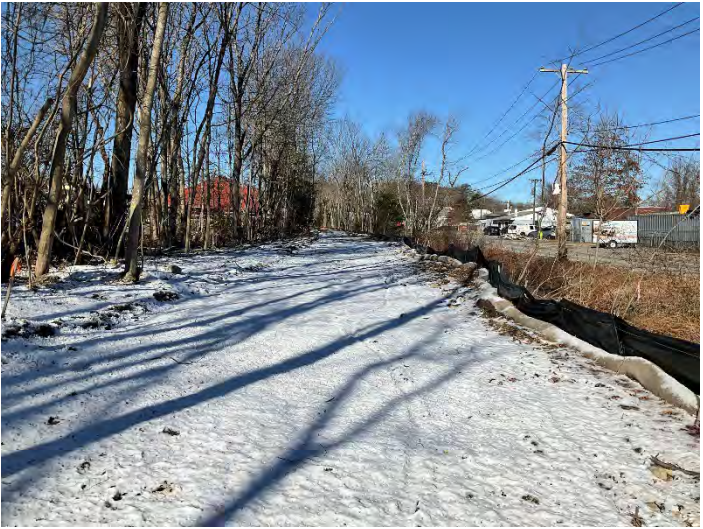
PHOTOGRAPHIC LOG	
Client Name: Eversource		Site Location: Sudbury to Hudson Transmission Reliability Project	Town: Sudbury
Photo No.: 4	Date: 2-15-2024

Description: View of E&S controls in segment 12. Facing west.

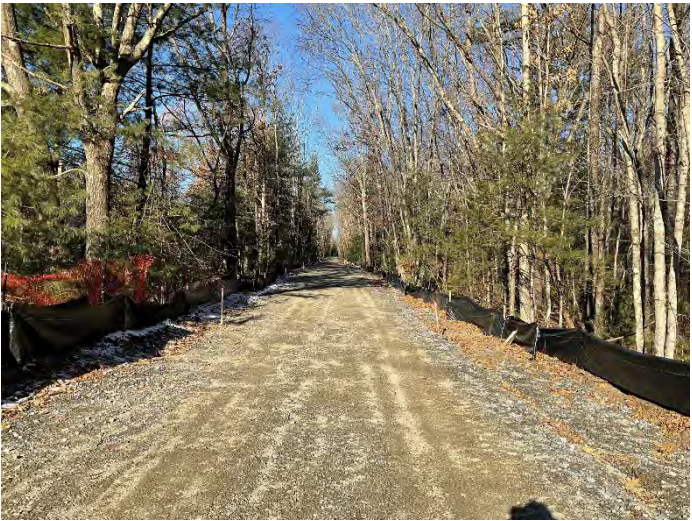
Epsilon ASSOCIATES INC.		PHOTOGRAPHIC LOG	
Client Name: Eversource		Site Location: Sudbury to Hudson Transmission Reliability Project	Town: Sudbury
Photo No.: 5	Date: 2-15-2024

Description: View of E&S controls in segment 11. Facing west.

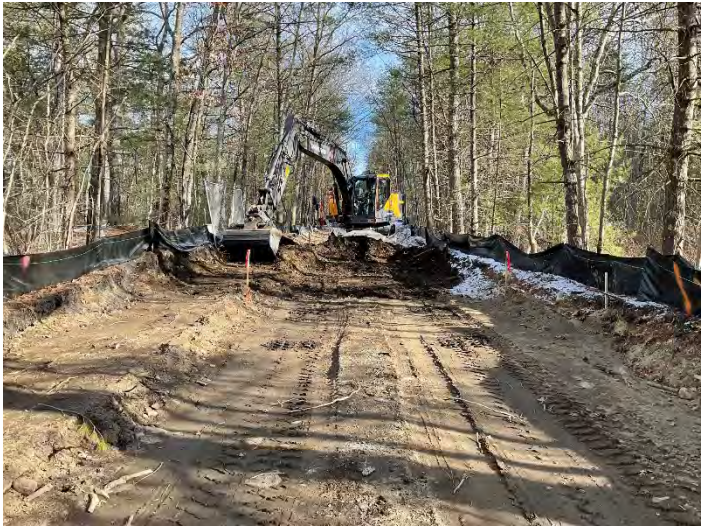
Epsilon ASSOCIATES INC.		PHOTOGRAPHIC LOG	
Client Name: Eversource		Site Location: Sudbury to Hudson Transmission Reliability Project	Town: Sudbury
Photo No.: 8	Date: 2-15-2024

Description: View of ET&L working in segment 8. Facing west.

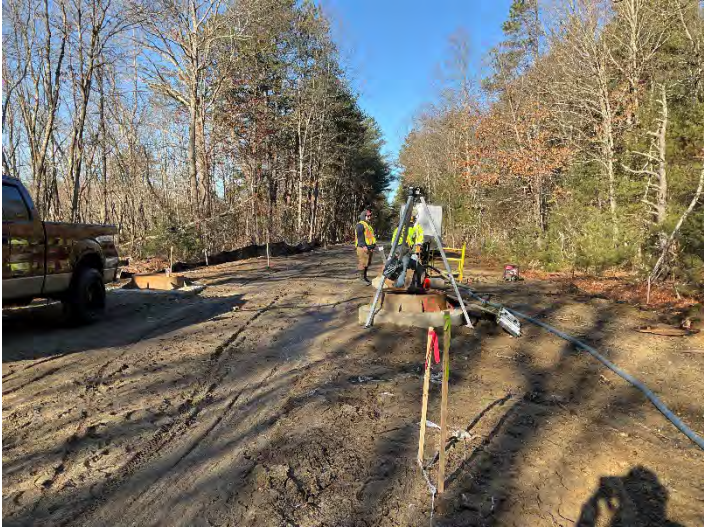
PHOTOGRAPHIC LOG	
Client Name: Eversource		Site Location: Sudbury to Hudson Transmission Reliability Project	Town: Hudson
Photo No.: 1	Date: 2/12/2024

Description: View of pumping operation at MH #14 in segment 6. Facing west.

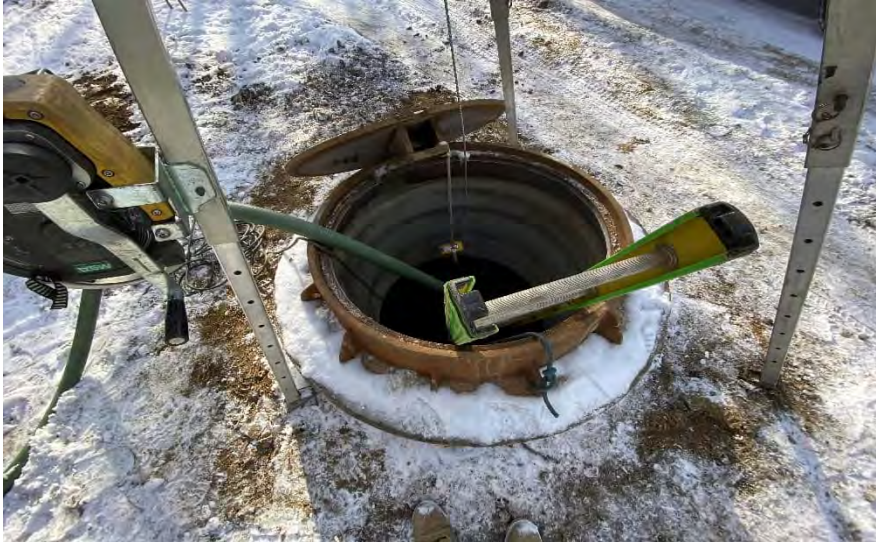
PHOTOGRAPHIC LOG	
Client Name: Eversource		Site Location: Sudbury to Hudson Transmission Reliability Project	Town: Hudson
Photo No.: 1	Date: 2/14/2024

Description: View of area being pumped from Manhole #14 - segment 6 area.

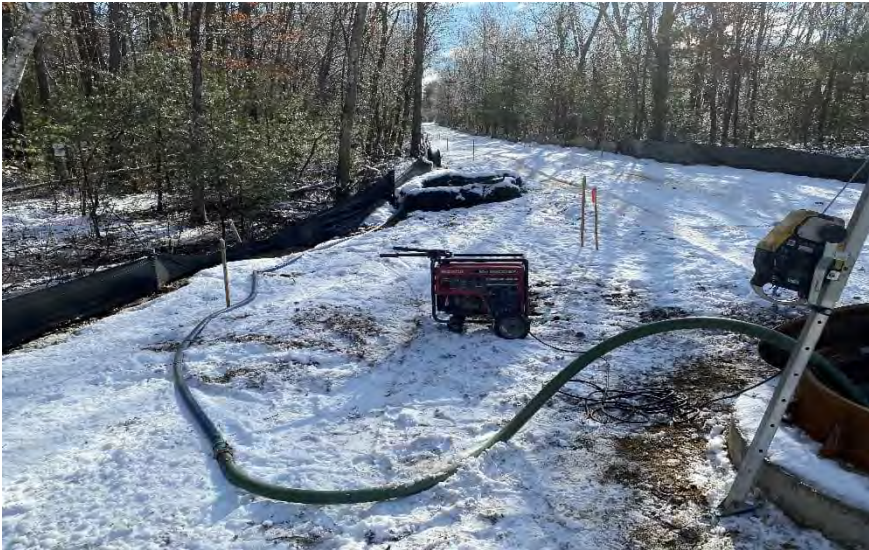
PHOTOGRAPHIC LOG	
Client Name: Eversource		Site Location: Sudbury to Hudson Transmission Reliability Project	Town: Hudson
Photo No.: 2	Date: 2/14/2024

Description: Manhole #14. View of dewatering operation, looking eastward.

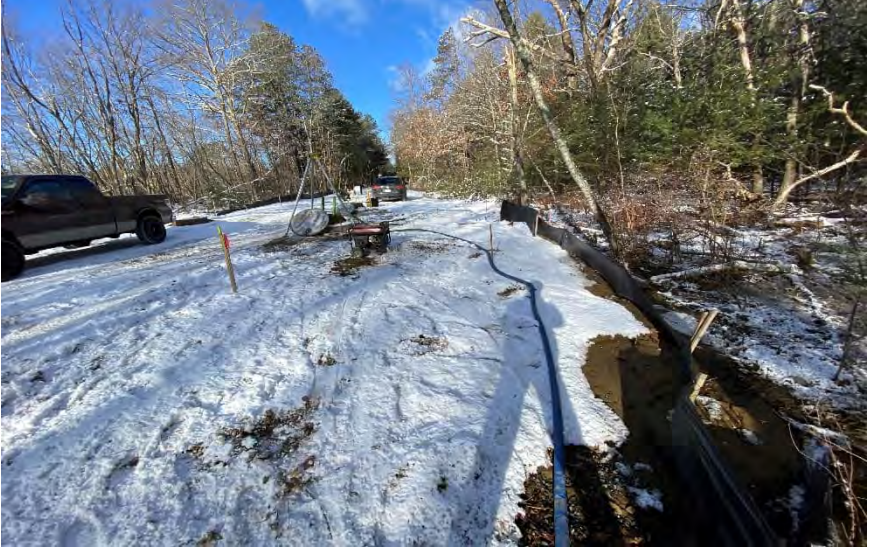
PHOTOGRAPHIC LOG	
Client Name: Eversource		Site Location: Sudbury to Hudson Transmission Reliability Project	
Client Name: Eversource		Town: Hudson	
Photo No.: 3	Date: 2/14/2024

Description: Manhole #14. View of dewatering operation, looking westward.

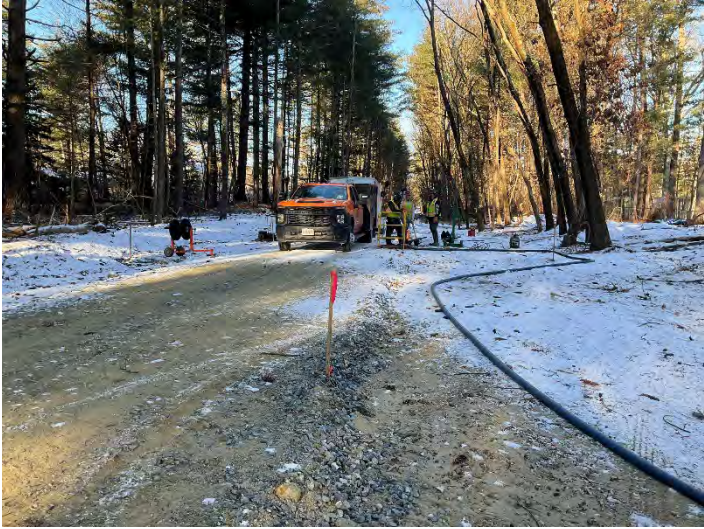
PHOTOGRAPHIC LOG	
Client Name: Eversource		Site Location: Sudbury to Hudson Transmission Reliability Project	Town: Sudbury
Photo No.: 1	Date: 2/15/2024

Description: View of Bond working at MH #21 in segment 10. Facing west.

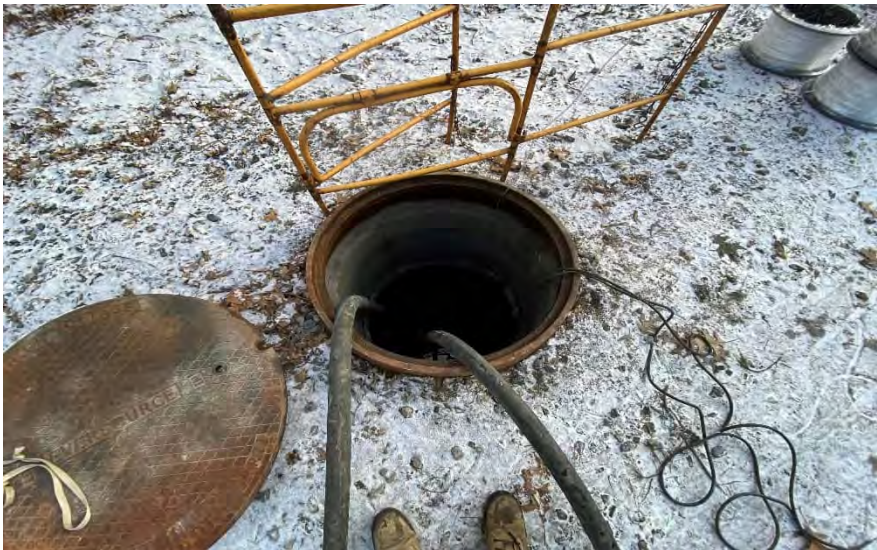
PHOTOGRAPHIC LOG	
Client Name: Eversource		Site Location: Sudbury to Hudson Transmission Reliability Project	Town: Sudbury
Photo No.: 1	Date: 2/16/2024

Description: View of area being pumped from Manhole #22 - segment 11 area.

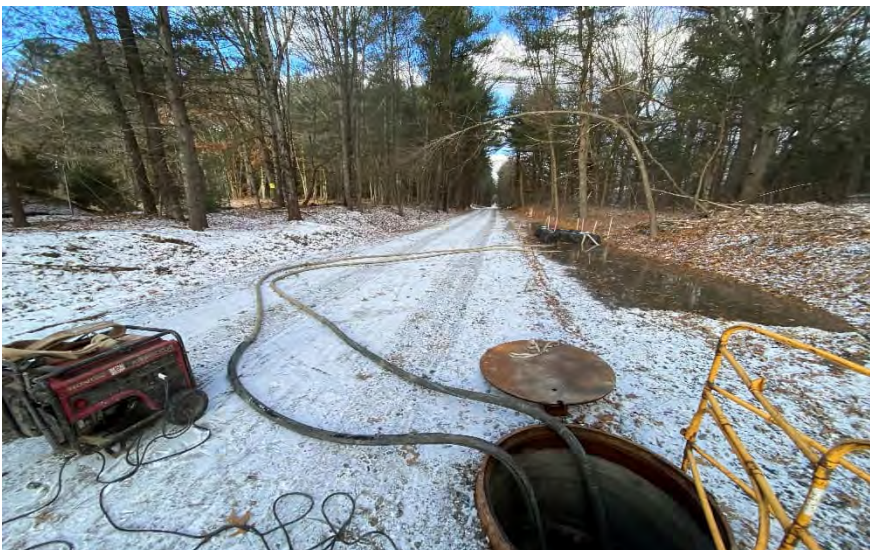
PHOTOGRAPHIC LOG	
Client Name: Eversource		Site Location: Sudbury to Hudson Transmission Reliability Project	Town: Sudbury
Photo No.: 2	Date: 2/16/2024

Description: Manhole #22. View of dewatering operation, looking westward.
