**Weekly Environmental Compliance Summary**

**Sudbury to Hudson Transmission Reliability Project (USEPA Tracking # MAR1003UW)**

Sudbury, Hudson, and Stow, MA

Week of: February 19, 2024 to February 23, 2024

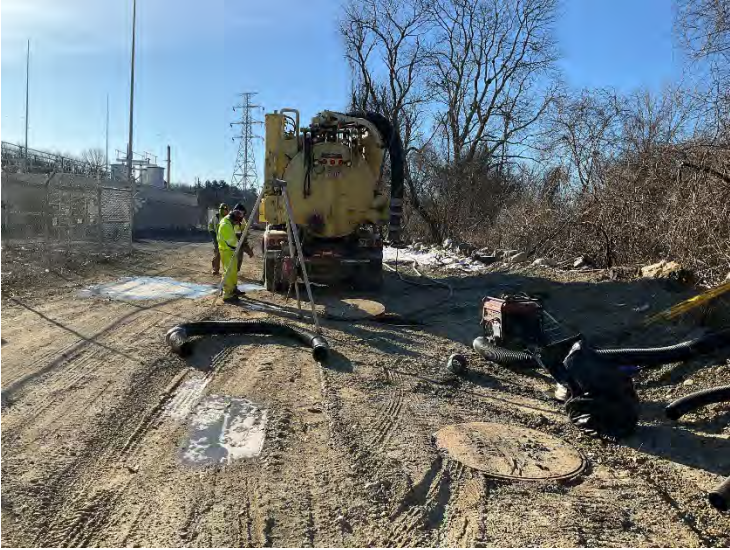
<p align="right"><b>PHOTOGRAPHIC LOG</b></p>	
<p>Client Name: Eversource</p>		<p>Site Location: Sudbury to Hudson Transmission Reliability Project</p>	<p>Town: Sudbury</p>
<p>Photo No.: 1</p>	<p>Date: 2/20/2024</p>

<p><b>Description:</b> View of Bond working at MH #28 outside of Sudbury Substation. See additional dewatering inspection report. Facing south.</p>

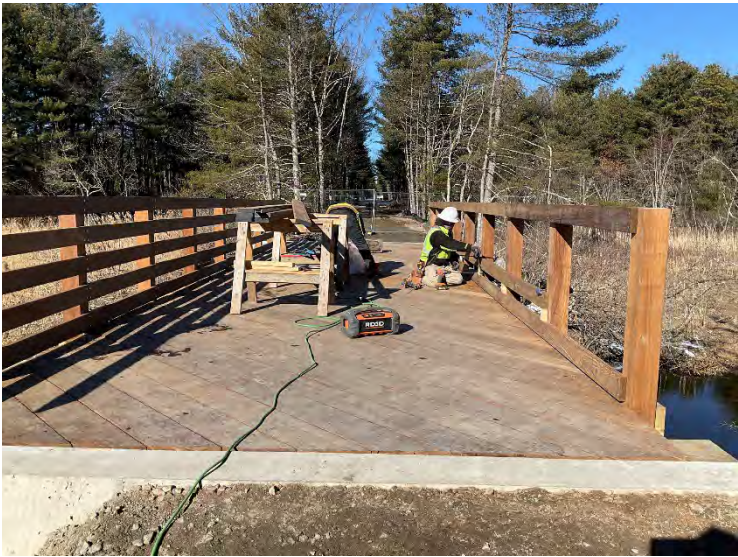
<b>PHOTOGRAPHIC LOG</b>	
Client Name: Eversource		Site Location: Sudbury to Hudson Transmission Reliability Project	Town: Sudbury
Photo No.: 4	Date: 2/20/2024

Description: View of ET&L working at bridge 128. Facing west.

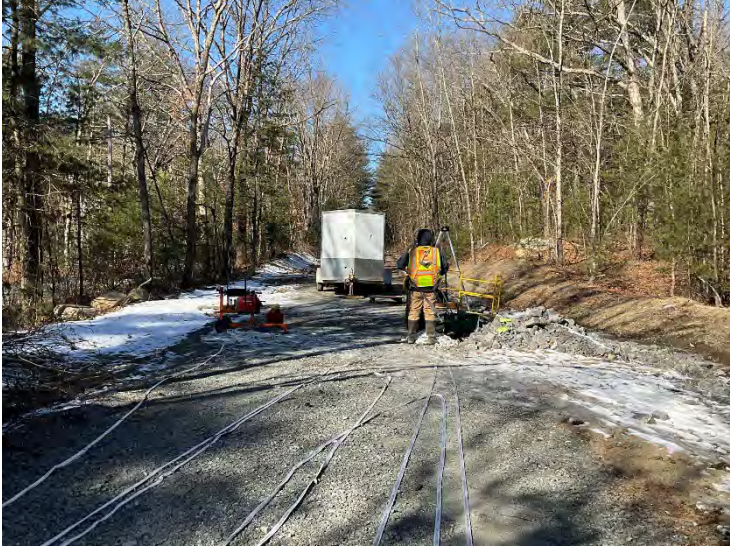
<p><b>PHOTOGRAPHIC LOG</b></p>	
<p>Client Name: Eversource</p>		<p>Site Location: Sudbury to Hudson Transmission Reliability Project</p>	<p>Town: Hudson</p>
<p>Photo No.: 5</p>	<p>Date: 2/20/2024</p>

<p>Description: View of Bond working in segment 5. Facing west.</p>

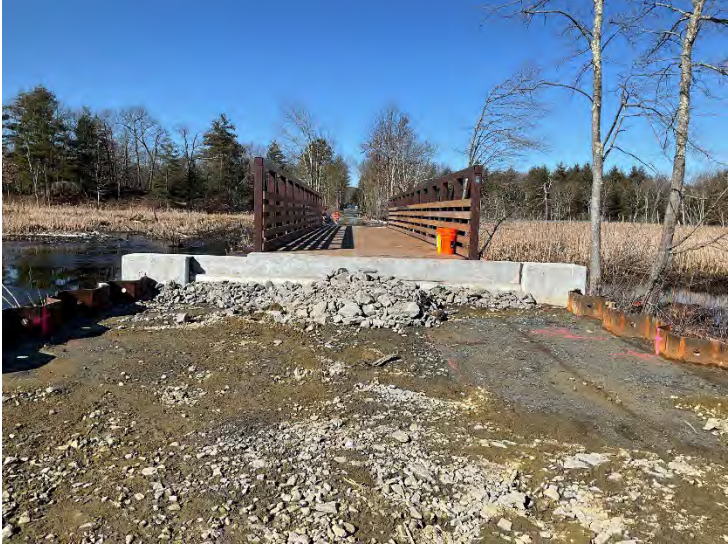
<p><b>PHOTOGRAPHIC LOG</b></p>	
<p>Client Name: Eversource</p>		<p>Site Location: Sudbury to Hudson Transmission Reliability Project</p>	<p>Town: Hudson</p>
<p>Photo No.: 6</p>	<p>Date: 2/20/2024</p>

<p>Description: View of Bridge 130 from segment 3. Facing west.</p>

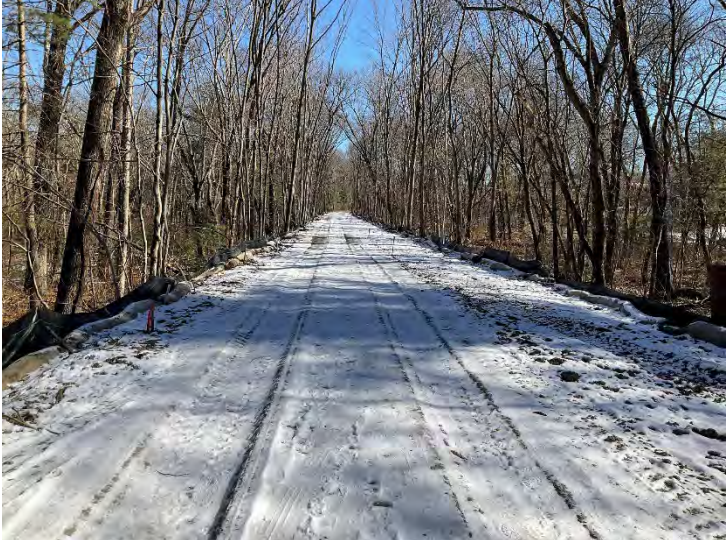
<p><b>PHOTOGRAPHIC LOG</b></p>	
<p>Client Name: Eversource</p>		<p>Site Location: Sudbury to Hudson Transmission Reliability Project</p>	<p>Town: Hudson</p>
<p>Photo No.: 7</p>	<p>Date: 2/20/2024</p>

<p>Description: View of west end of segment 1. Facing east.</p>

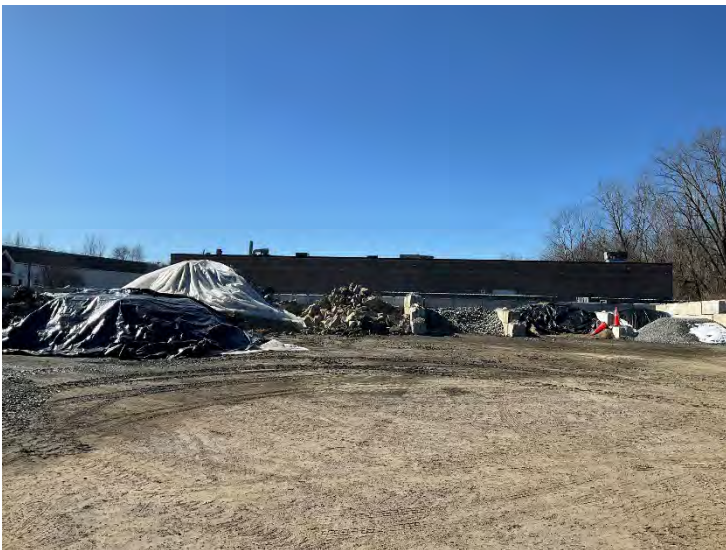
<p><b>PHOTOGRAPHIC LOG</b></p>	
<p>Client Name: Eversource</p>		<p>Site Location: Sudbury to Hudson Transmission Reliability Project</p>	<p>Town: Hudson</p>
<p>Photo No.: 8</p>	<p>Date: 2/20/2024</p>

<p>Description: View of Bonazzoli laydown yard. Facing southwest.</p>

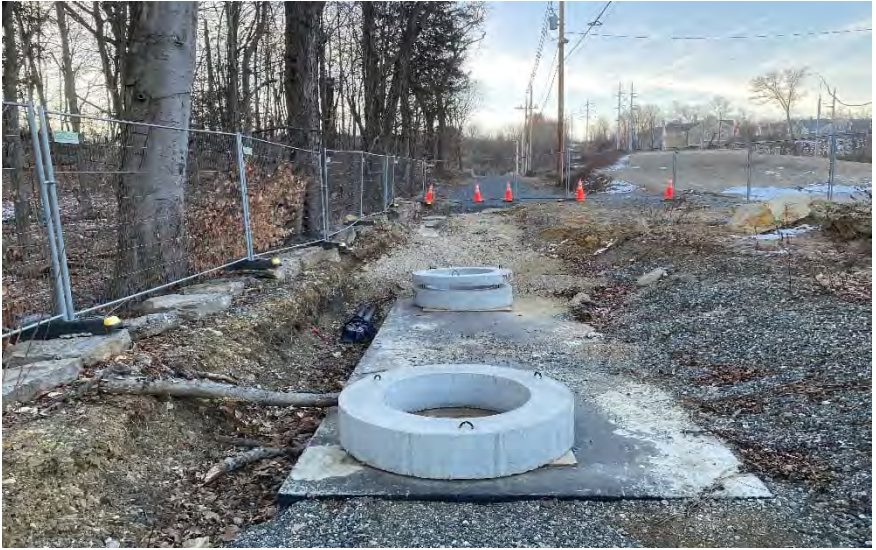
<p>PHOTOGRAPHIC LOG</p>	
<p>Client Name: Eversource</p>		<p>Site Location: Sudbury to Hudson Transmission Reliability Project</p>	<p>Town: Hudson</p>
<p>Photo No.: 1</p>	<p>Date: 2-21-24</p>

<p>Description:</p> <p>Manhole #1, at Hudson Power &amp; Light facility off Forest Avenue, looking eastward.</p>

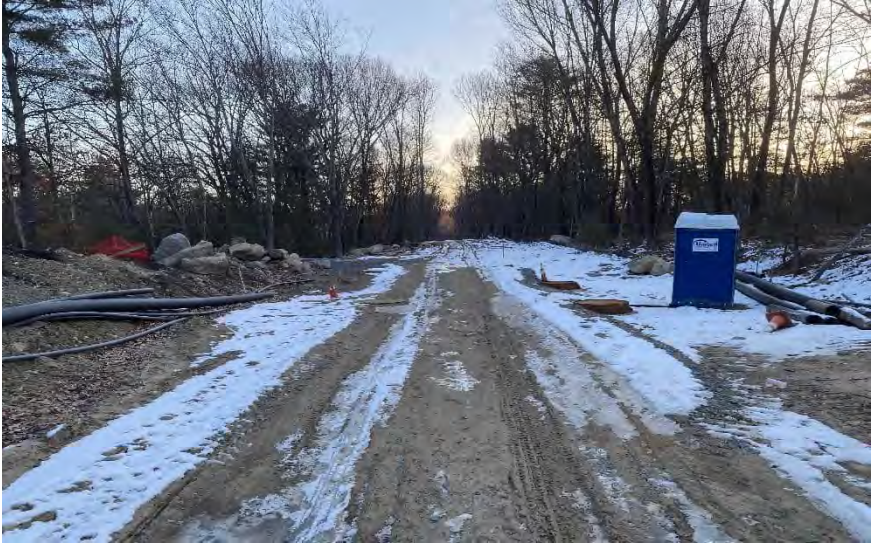
<p>PHOTOGRAPHIC LOG</p>	
<p>Client Name: Eversource</p>		<p>Site Location: Sudbury to Hudson Transmission Reliability Project</p>	<p>Town: Hudson</p>
<p>Photo No.: 2</p>	<p>Date: 2-21-24</p>

<p>Description:</p> <p>Work area within Segment 1, at manhole #5, looking eastward.</p>

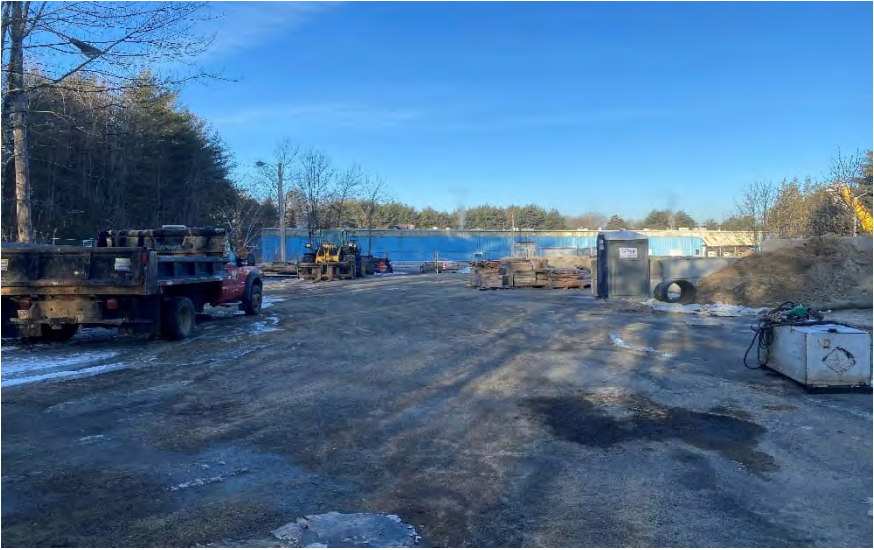
PHOTOGRAPHIC LOG	
Client Name: Eversource		Site Location: Sudbury to Hudson Transmission Reliability Project	Town: Hudson
Photo No.: 5	Date: 2-21-24

Description:  Main Street laydown yard, looking westward.

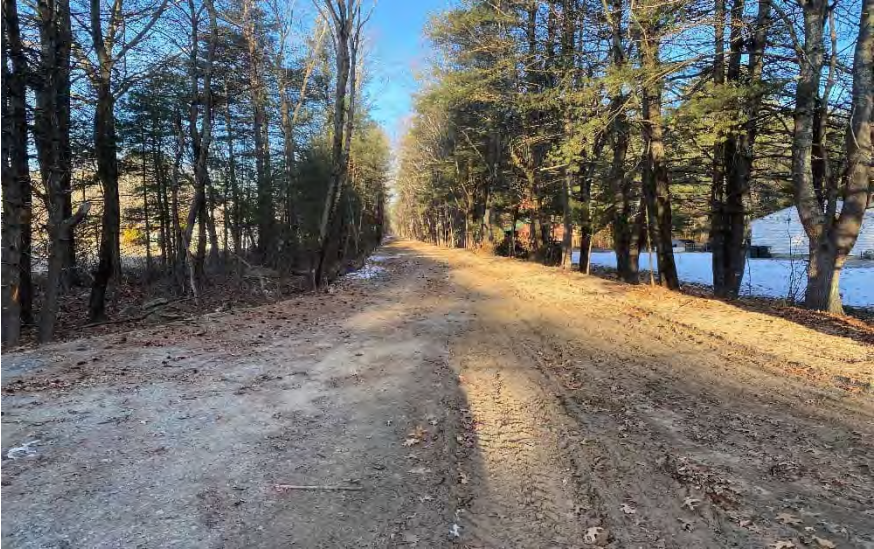
PHOTOGRAPHIC LOG	
Client Name: Eversource		Site Location: Sudbury to Hudson Transmission Reliability Project	Town: Hudson
Photo No.: 6	Date: 2-21-24

Description:  Work area within Segment 4, existing erosion control, looking westward.

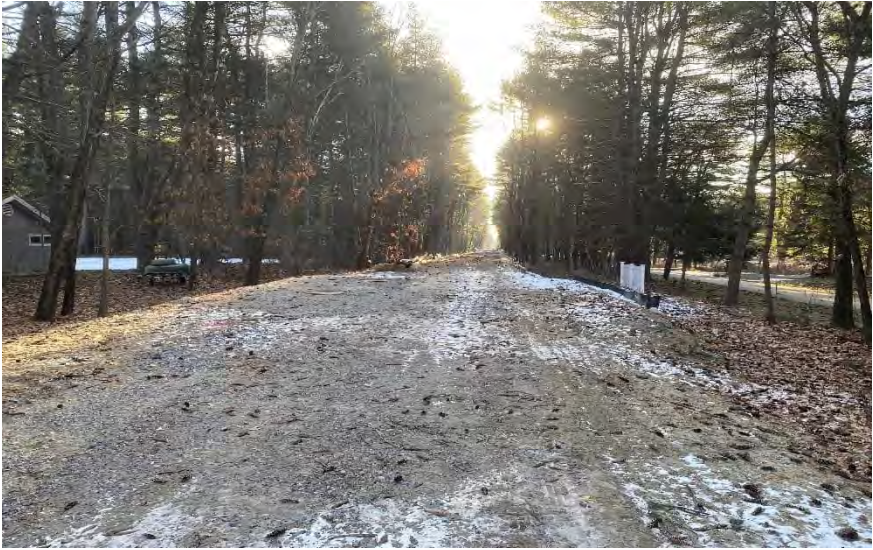
<p>PHOTOGRAPHIC LOG</p>	
<p>Client Name: Eversource</p>		<p>Site Location: Sudbury to Hudson Transmission Reliability Project</p>	<p>Town: Hudson</p>
<p>Photo No.: 7</p>	<p>Date: 2-21-24</p>

<p>Description:                  Work area within Segment 5, at manhole # 11, looking eastward.</p>

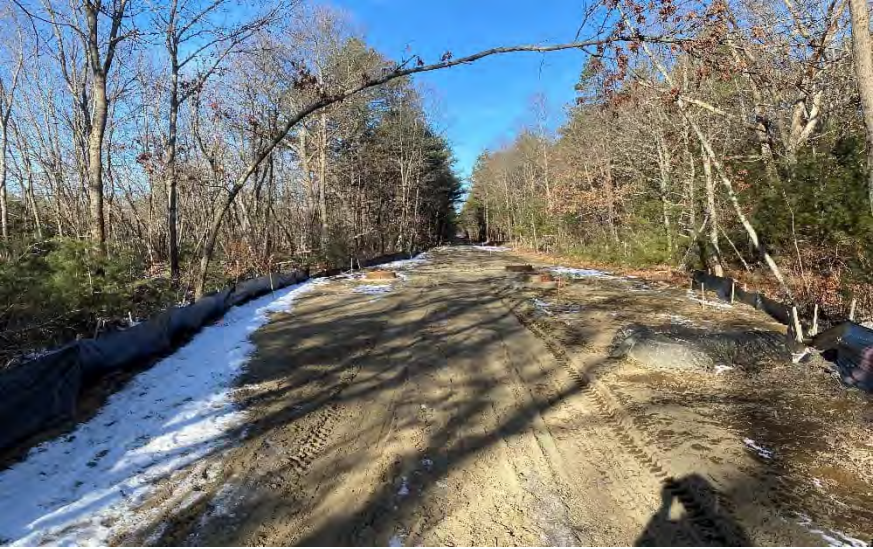
<p>PHOTOGRAPHIC LOG</p>	
<p>Client Name: Eversource</p>		<p>Site Location: Sudbury to Hudson Transmission Reliability Project</p>	<p>Town: Hudson</p>
<p>Photo No.: 8</p>	<p>Date: 2-21-24</p>

<p>Description:                  Work area within Segment 6, at manhole # 14, existing erosion control, looking westward.</p>

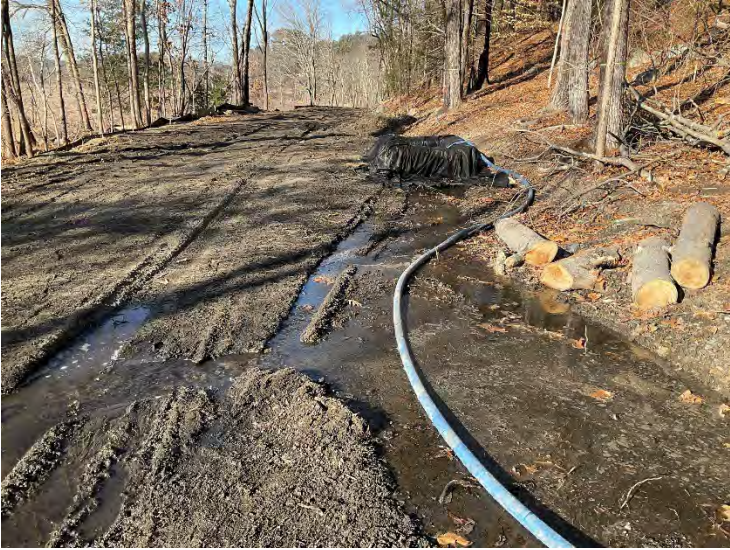
<p><b>PHOTOGRAPHIC LOG</b></p>	
<p>Client Name: Eversource</p>		<p>Site Location: Sudbury to Hudson Transmission Reliability Project</p>	<p>Town: Sudbury</p>
<p>Photo No.: 1</p>	<p>Date: 2/21/2024</p>

<p>Description: View of dewatering controls at MH #26 in segment 14. See additional dewatering inspection report. Facing west.</p>

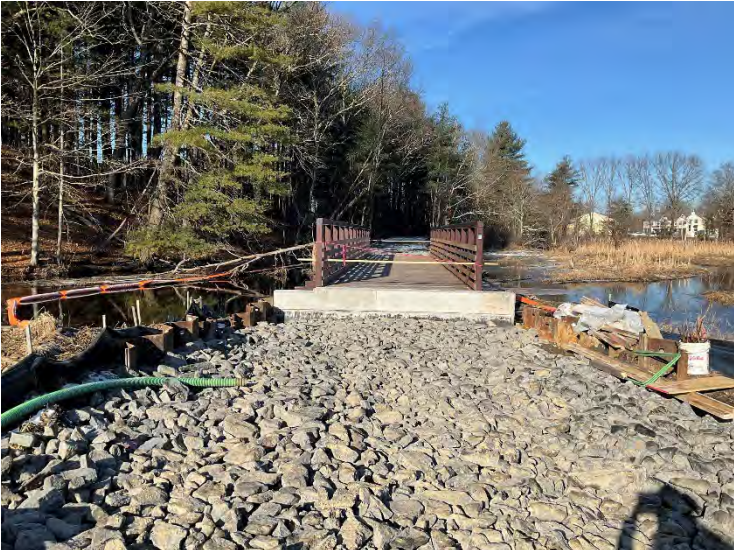
<p><b>PHOTOGRAPHIC LOG</b></p>	
<p>Client Name: Eversource</p>		<p>Site Location: Sudbury to Hudson Transmission Reliability Project</p>	<p>Town: Sudbury</p>
<p>Photo No.: 2</p>	<p>Date: 2/21/2024</p>

<p>Description: View of Bridge 127 from segment 14. Facing west.</p>

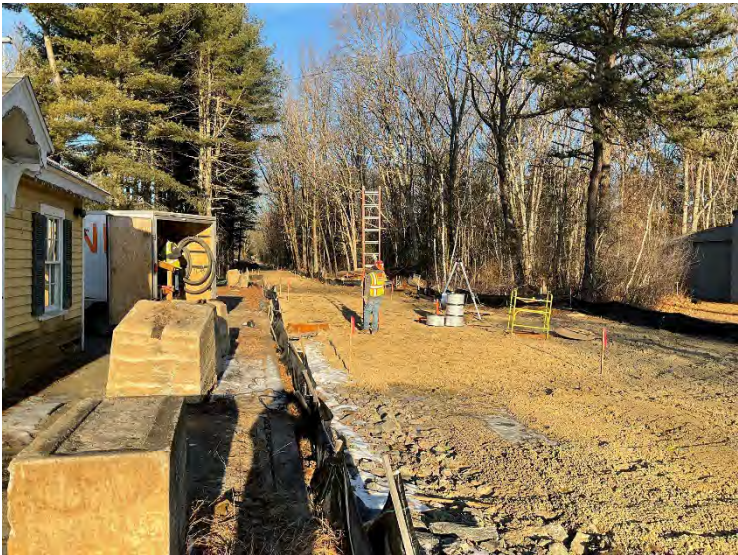
<p><b>PHOTOGRAPHIC LOG</b></p>	
<p>Client Name: Eversource</p>		<p>Site Location: Sudbury to Hudson Transmission Reliability Project</p>	<p>Town: Sudbury</p>
<p>Photo No.: 4</p>	<p>Date: 2/21/2024</p>

<p><b>Description:</b> View of Bond working at MH #24 in segment 11. Facing west.</p>

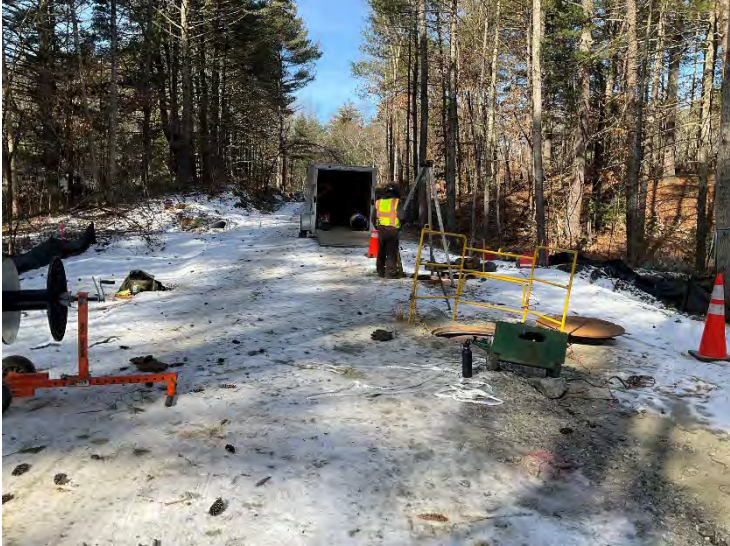
<p><b>PHOTOGRAPHIC LOG</b></p>	
<p>Client Name: Eversource</p>		<p>Site Location: Sudbury to Hudson Transmission Reliability Project</p>	<p>Town: Sudbury</p>
<p>Photo No.: 5</p>	<p>Date: 2/21/2024</p>

<p>Description: View of Bond working at MH #20 in segment 10. Facing west.</p>

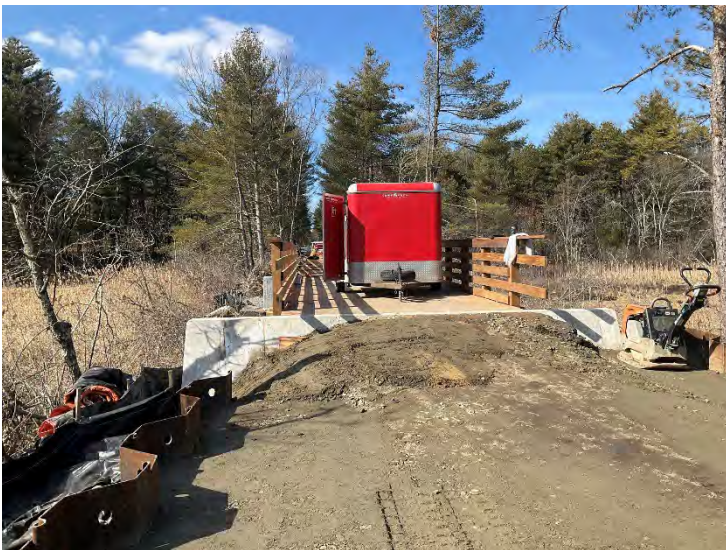
<p><b>PHOTOGRAPHIC LOG</b></p>	
<p>Client Name: Eversource</p>		<p>Site Location: Sudbury to Hudson Transmission Reliability Project</p>	<p>Town: Sudbury</p>
<p>Photo No.: 8</p>	<p>Date: 2/21/2024</p>

<p>Description: View of ET&amp;L working at bridge 128. Facing west.</p>

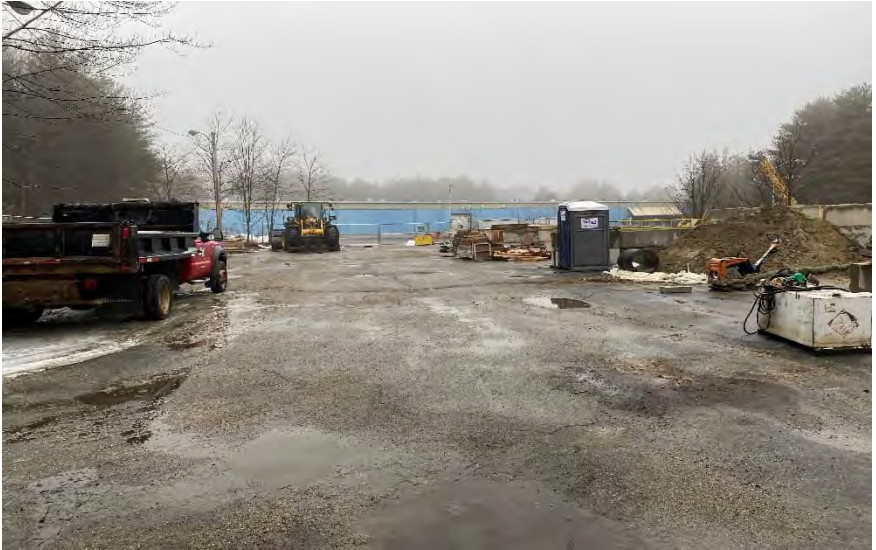
<p>PHOTOGRAPHIC LOG</p>	
<p>Client Name: Eversource</p>		<p>Site Location: Sudbury to Hudson Transmission Reliability Project</p>	<p>Town: Hudson</p>
<p>Photo No.: 1</p>	<p>Date: 2-23-24</p>

<p>Description:</p> <p>Main Street laydown yard, looking westward.</p>

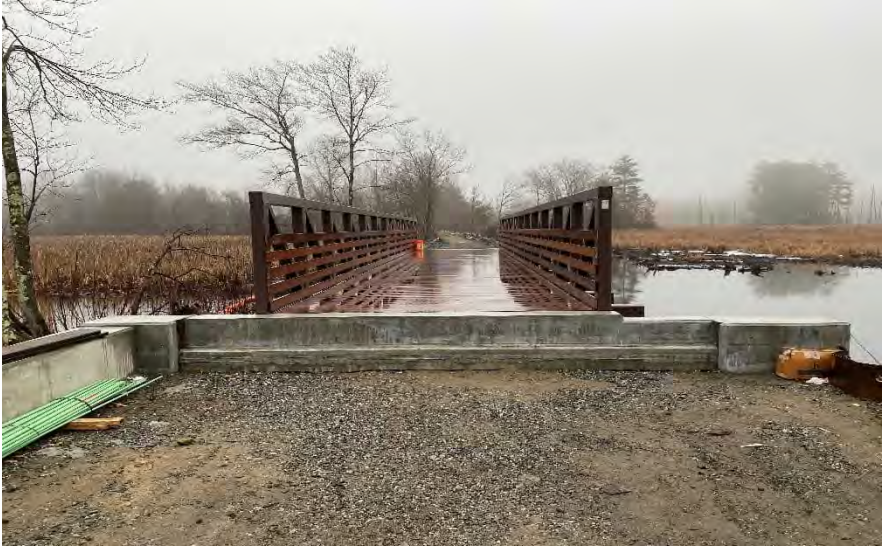
<p>PHOTOGRAPHIC LOG</p>	
<p>Client Name: Eversource</p>		<p>Site Location: Sudbury to Hudson Transmission Reliability Project</p>	<p>Town: Hudson</p>
<p>Photo No.: 2</p>	<p>Date: 2-23-24</p>

<p>Description:</p> <p>Work area at newly installed Bridge 130 looking from segment 2 toward segment 3 across Fort Meadow Brook, existing erosion control (floating silt curtain), looking eastward.</p>

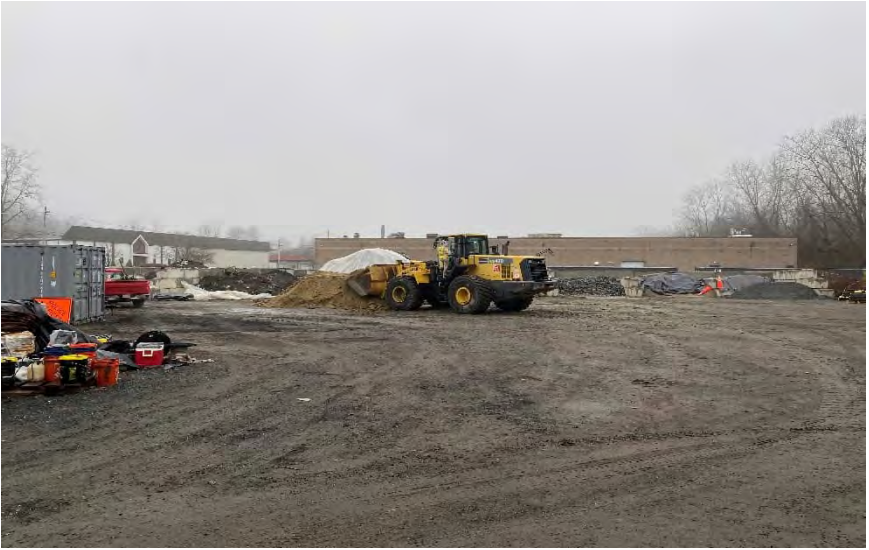
PHOTOGRAPHIC LOG	
Client Name: Eversource		Site Location: Sudbury to Hudson Transmission Reliability Project	Town: Hudson
Photo No.: 3	Date: 2-23-24

Description:  Laydown yard off Bonnazoli, looking westward.

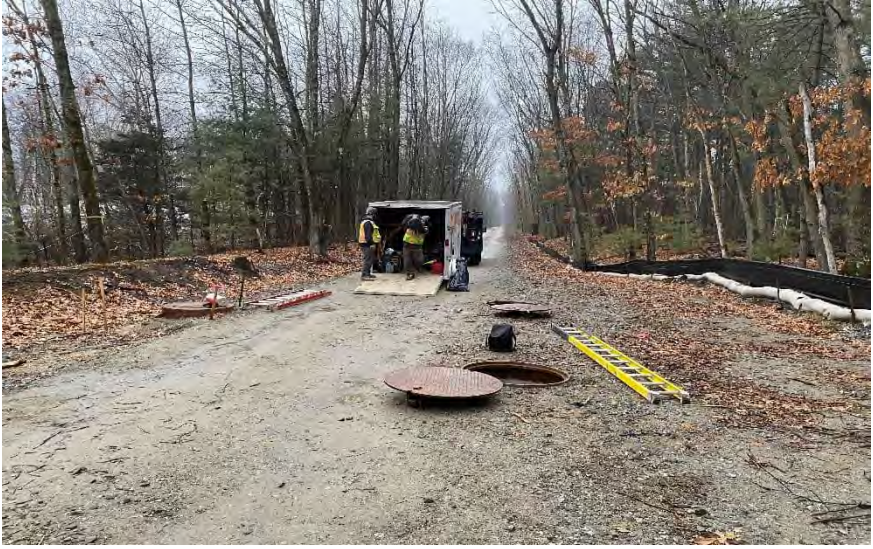
<p>PHOTOGRAPHIC LOG</p>	
<p>Client Name: Eversource</p>		<p>Site Location: Sudbury to Hudson Transmission Reliability Project</p>	<p>Town: Sudbury</p>
<p>Photo No.: 6</p>	<p>Date: 2-23-24</p>

<p>Description:</p> <p>Bond conducting proofing work within segment 11 at manhole #23, looking westward.</p>

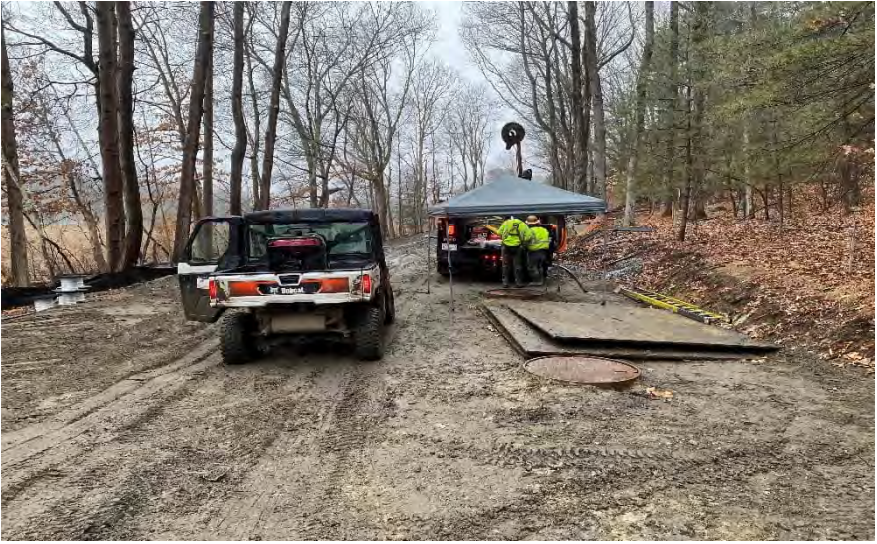
<p>PHOTOGRAPHIC LOG</p>	
<p>Client Name: Eversource</p>		<p>Site Location: Sudbury to Hudson Transmission Reliability Project</p>	<p>Town: Sudbury</p>
<p>Photo No.: 7</p>	<p>Date: 2-23-24</p>

<p>Description:</p> <p>Bond conducting proofing work within segment 14 at manhole #26, looking westward</p>

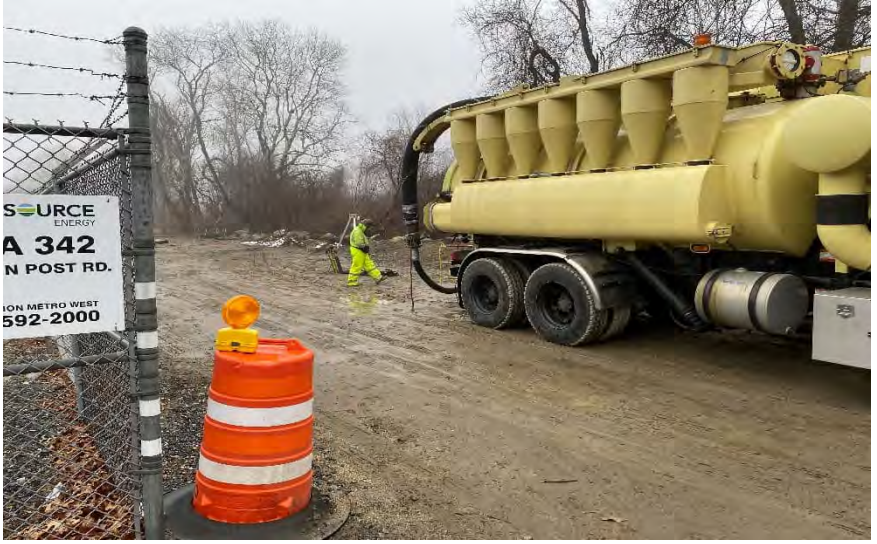
<p>PHOTOGRAPHIC LOG</p>	
<p>Client Name: Eversource</p>		<p>Site Location: Sudbury to Hudson Transmission Reliability Project</p>	<p>Town: Sudbury</p>
<p>Photo No.: 8</p>	<p>Date: 2-23-24</p>

<p>Description:</p> <p>Bond conducting proofing work outside substation at manhole #28, looking southward.</p>

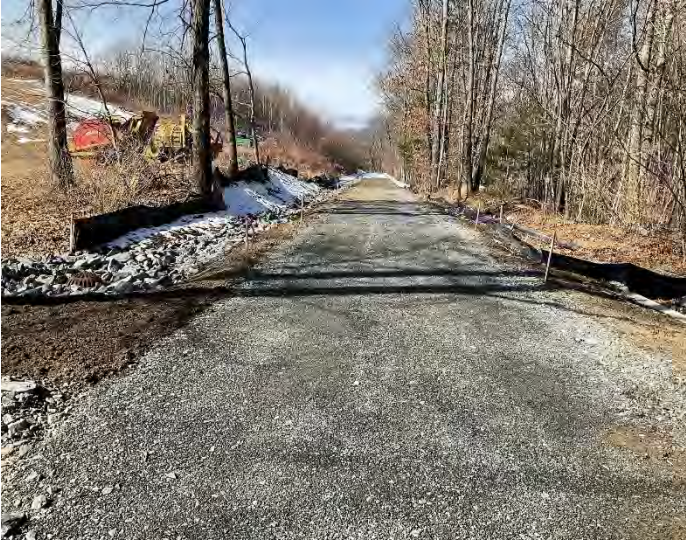
<b>PHOTOGRAPHIC LOG</b>	
Client Name: Eversource		Site Location: Sudbury to Hudson Transmission Reliability Project	Town: Stow
Photo No.: 1	Date: 2-22-2024

Description: View of Drainage Structures 5 & 6 in segment 1. Facing west.

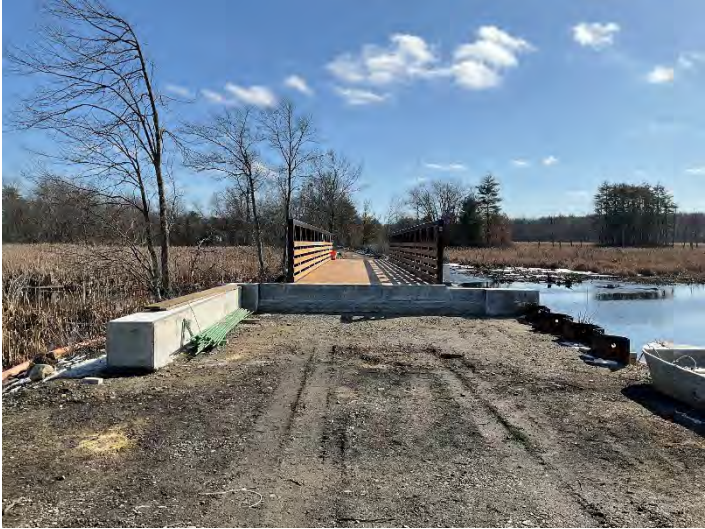
<b>PHOTOGRAPHIC LOG</b>	
Client Name: Eversource		Site Location: Sudbury to Hudson Transmission Reliability Project	Town: Hudson
Photo No.: 2	Date: 2-22-2024

Description: View of Bridge 130. Facing east.

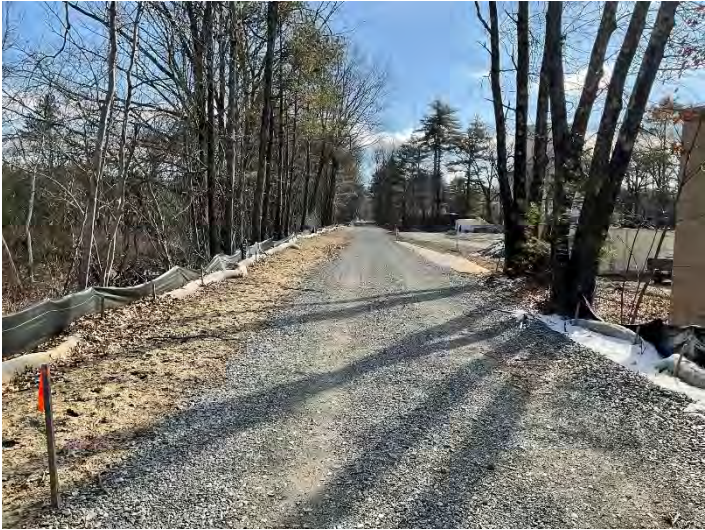
<b>PHOTOGRAPHIC LOG</b>	
Client Name: Eversource		Site Location: Sudbury to Hudson Transmission Reliability Project	Town: Hudson
Photo No.: 3	Date: 2-22-2024

Description: View of E&S controls in segment 3. Facing east.

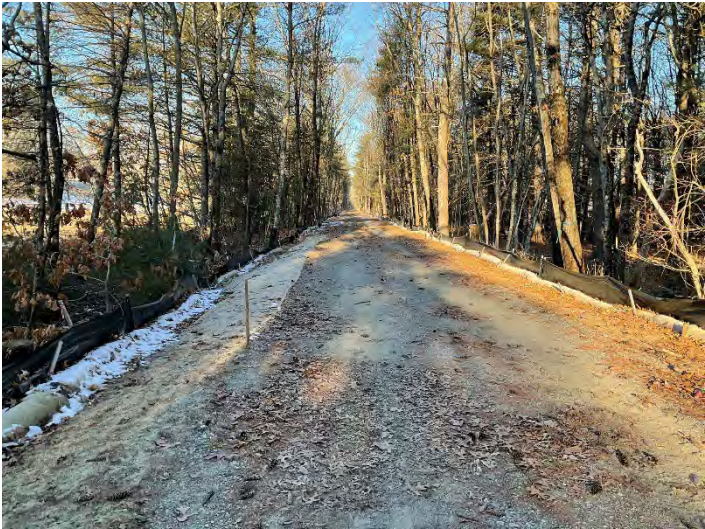
<b>PHOTOGRAPHIC LOG</b>	
Client Name: Eversource		Site Location: Sudbury to Hudson Transmission Reliability Project	Town: Hudson
Photo No.: 4	Date: 2-22-2024

Description: View of E&S controls in segment 4. Facing west.

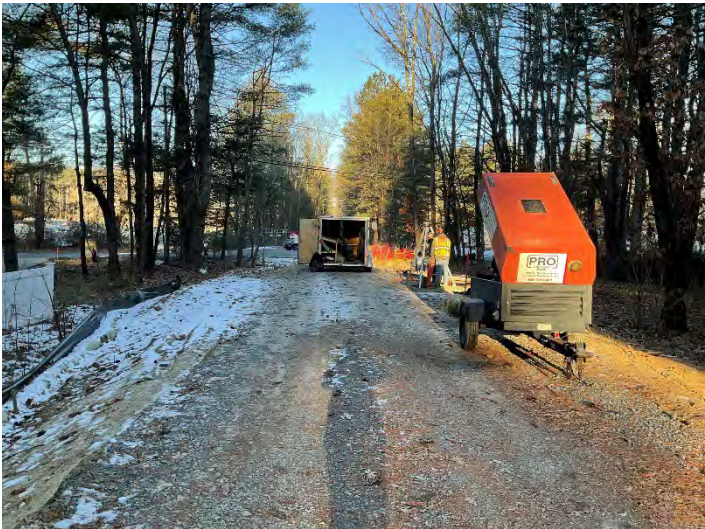
<b>Epsilon</b> ASSOCIATES INC.		<b>PHOTOGRAPHIC LOG</b>	
Client Name: Eversource		Site Location: Sudbury to Hudson Transmission Reliability Project	Town: Hudson
Photo No.: 5	Date: 2-22-2024

Description: View of Bond working in segment 5. Facing west.

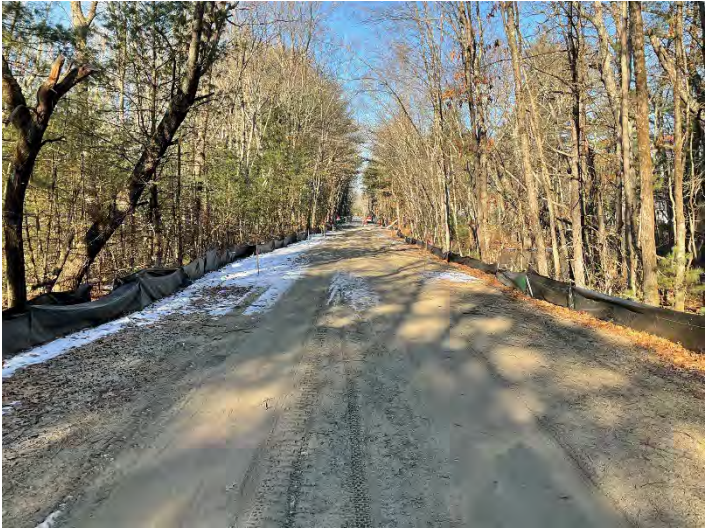
<b>Epsilon</b> ASSOCIATES INC.		<b>PHOTOGRAPHIC LOG</b>	
Client Name: Eversource		Site Location: Sudbury to Hudson Transmission Reliability Project	Town: Hudson
Photo No.: 6	Date: 2-22-2024

Description: View of E&S controls in segment 6. Facing west.

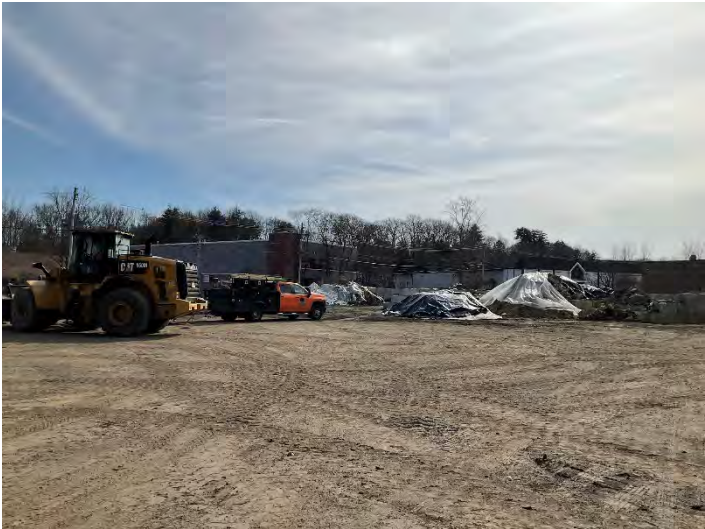
<b>Epsilon</b> ASSOCIATES INC.		<b>PHOTOGRAPHIC LOG</b>	
Client Name: Eversource		Site Location: Sudbury to Hudson Transmission Reliability Project	Town: Hudson
Photo No.: 8	Date: 2-22-2024

Description: View of activities at Bonazzoli laydown yard. Facing south.

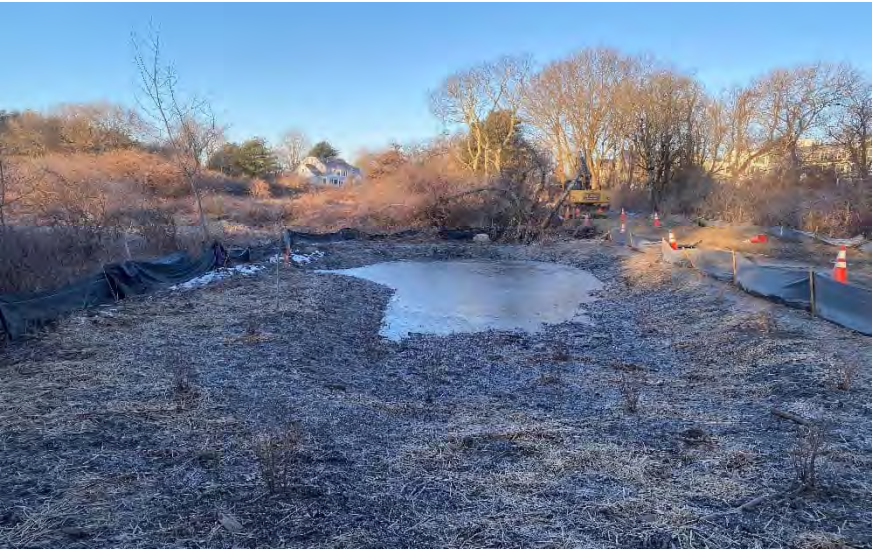
PHOTOGRAPHIC LOG	
Client Name: Eversource		Site Location: Sudbury to Hudson Transmission Reliability Project	Town: Sudbury
Photo No.: 2	Date: 2-22-24

Description:  Wetland replication area within segment 14, existing erosion control, looking westward.

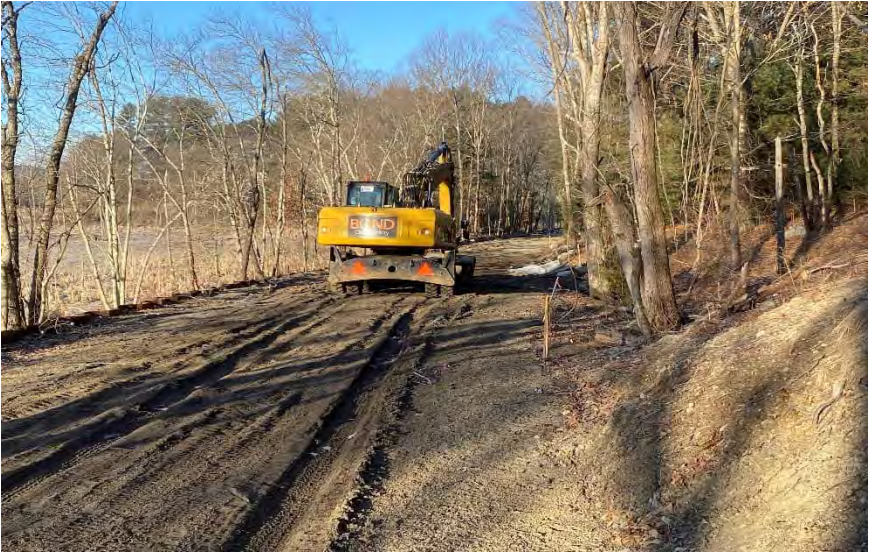
<b>PHOTOGRAPHIC LOG</b>	
<b>Client Name:</b> Eversource		<b>Site Location:</b> Sudbury to Hudson Transmission Reliability Project	<b>Town:</b> Sudbury
<b>Photo No.:</b> 3	<b>Date:</b> 2-22-24

<b>Description:</b>  Work area within segment 14, Bond conducting grading work, looking westward.

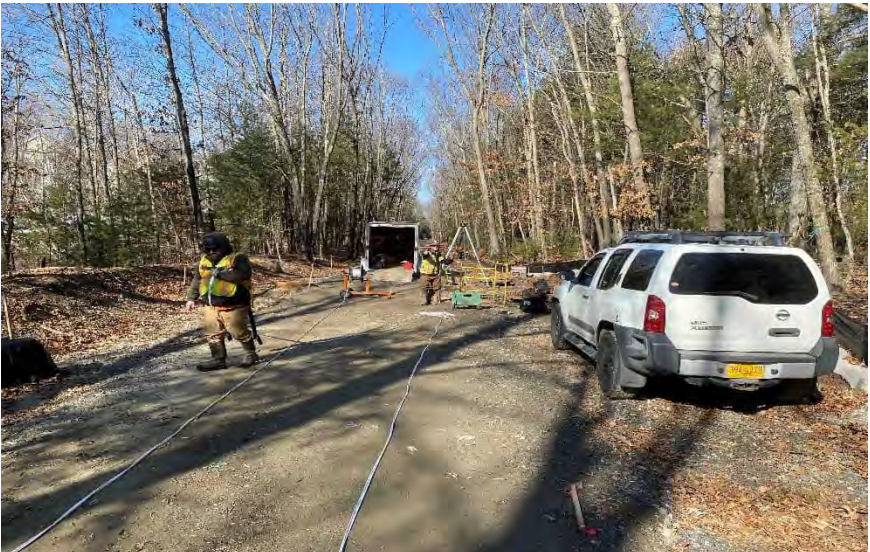
<b>PHOTOGRAPHIC LOG</b>	
<b>Client Name:</b> Eversource		<b>Site Location:</b> Sudbury to Hudson Transmission Reliability Project	<b>Town:</b> Sudbury
<b>Photo No.:</b> 4	<b>Date:</b> 2-22-24

<b>Description:</b>  Proofing work at manhole #23 within segment 11, existing erosion control, looking westward.

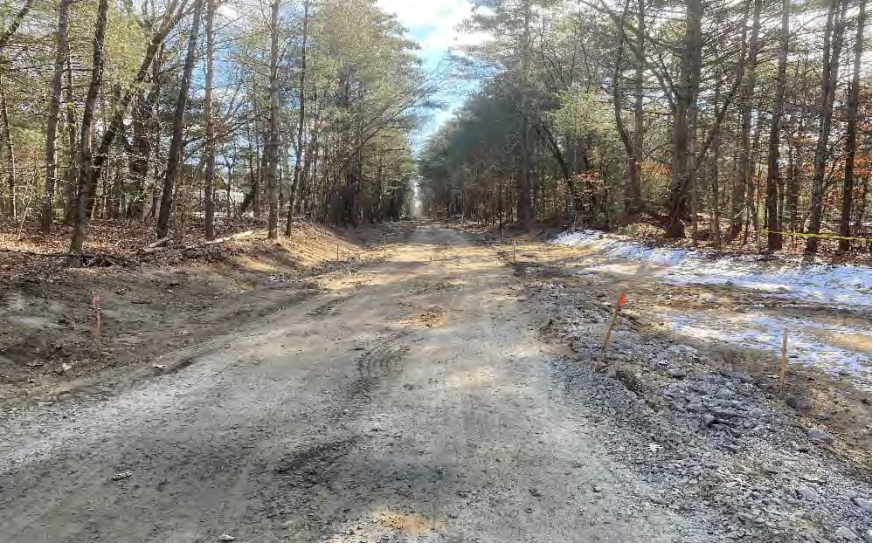
<b>PHOTOGRAPHIC LOG</b>	
Client Name: Eversource		Site Location: Sudbury to Hudson Transmission Reliability Project	Town: Sudbury
Photo No.: 5	Date: 2-22-24

Description:  Work area within segment 9, looking eastward.

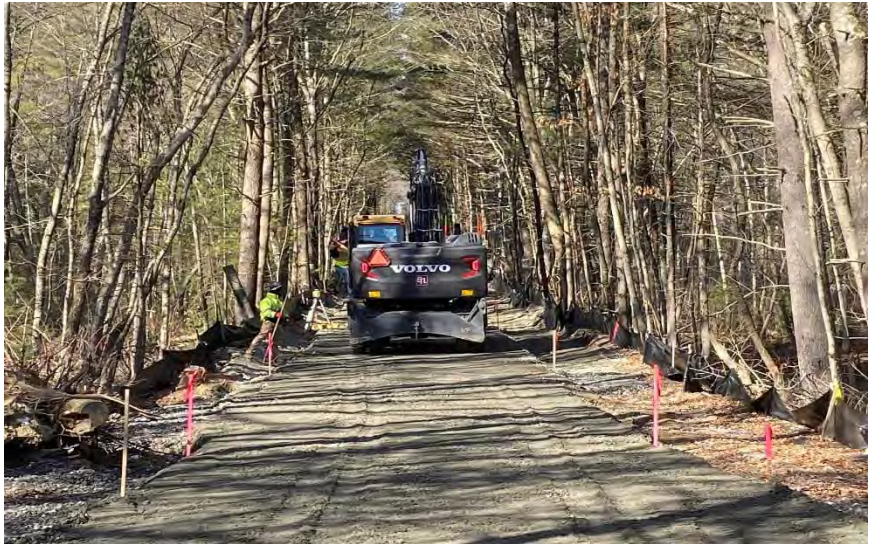
<b>PHOTOGRAPHIC LOG</b>	
Client Name: Eversource		Site Location: Sudbury to Hudson Transmission Reliability Project	Town: Sudbury
Photo No.: 6	Date: 2-22-24

Description:  Work area within segment 9, ET&L grading, existing erosion control, looking westward.

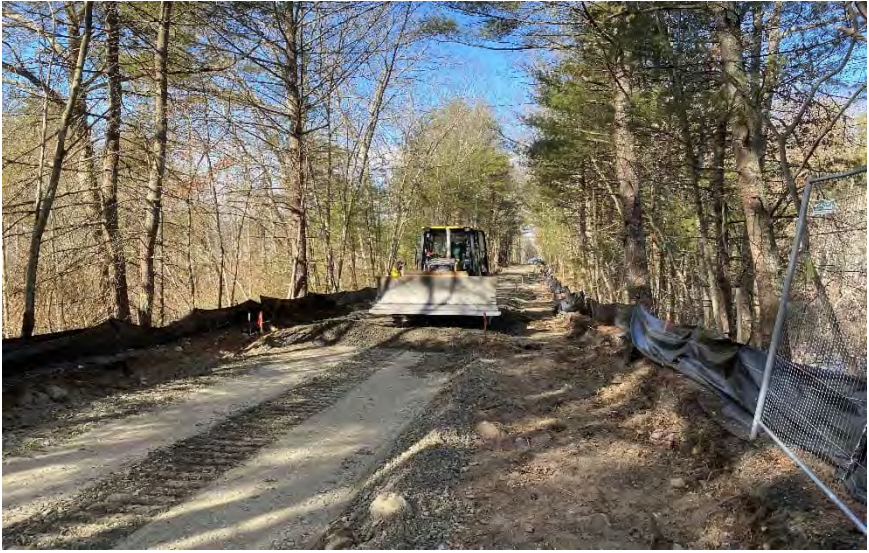
<b>PHOTOGRAPHIC LOG</b>	
<b>Client Name:</b> Eversource		<b>Site Location:</b> Sudbury to Hudson Transmission Reliability Project	<b>Town:</b> Sudbury
<b>Photo No.:</b> 7	<b>Date:</b> 2-22-24

<b>Description:</b>  Work area within segment 8, ET&L conducting grading work, existing erosion control, looking westward.

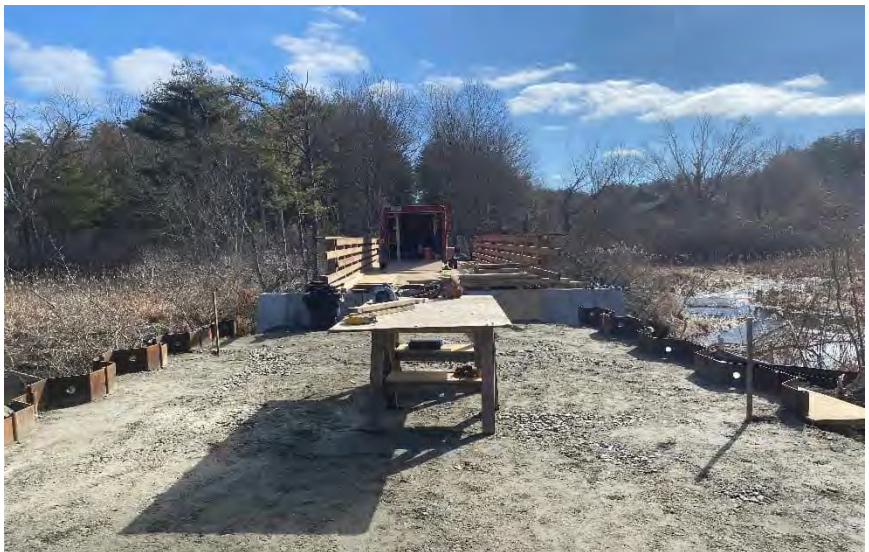
<b>PHOTOGRAPHIC LOG</b>	
<b>Client Name:</b> Eversource		<b>Site Location:</b> Sudbury to Hudson Transmission Reliability Project	<b>Town:</b> Sudbury
<b>Photo No.:</b> 8	<b>Date:</b> 2-22-24

<b>Description:</b>  ET&L conducting carpentry work within segment 7 looking across Hop brook toward segment 8, Bridge 128, existing erosion control, looking eastward.

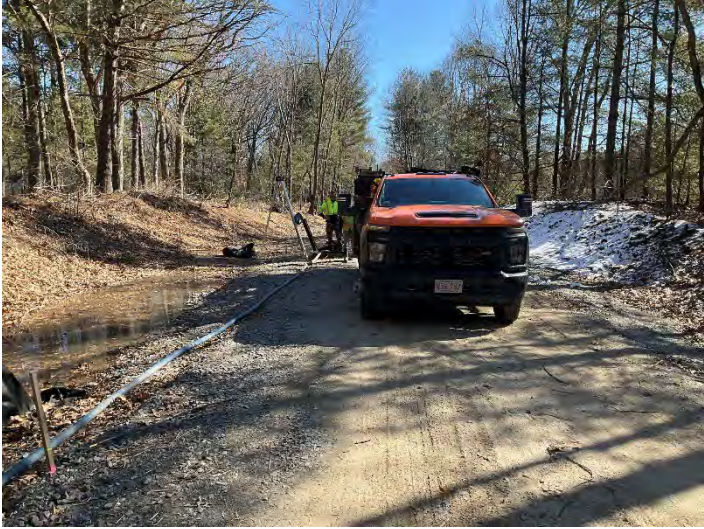
<b>PHOTOGRAPHIC LOG</b>	
Client Name: Eversource		Site Location: Sudbury to Hudson Transmission Reliability Project	Town: Sudbury
Photo No.: 1	Date: 2/20/2024

Description: View of Bond's work area at MH #22 in segment 11. Facing east.

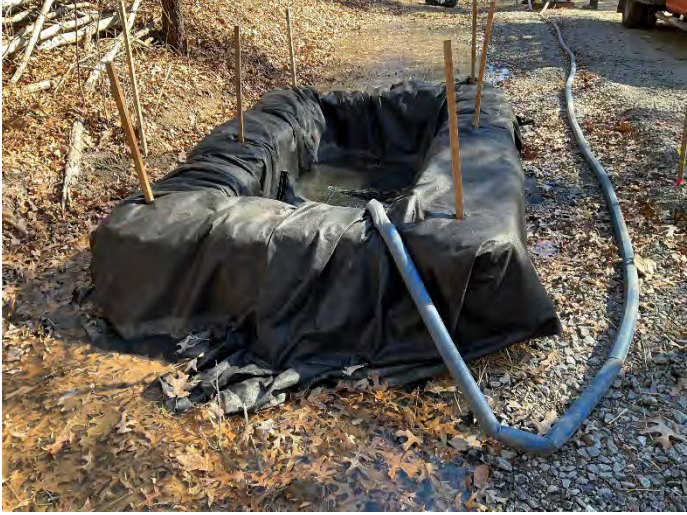
PHOTOGRAPHIC LOG	
Client Name: Eversource		Site Location: Sudbury to Hudson Transmission Reliability Project	
Town: Sudbury			
Photo No.: 3	Date: 2/20/2024

<b>Description:</b> View of dewatering controls (straw bale corral with filter fabric and silt bag). Facing east.

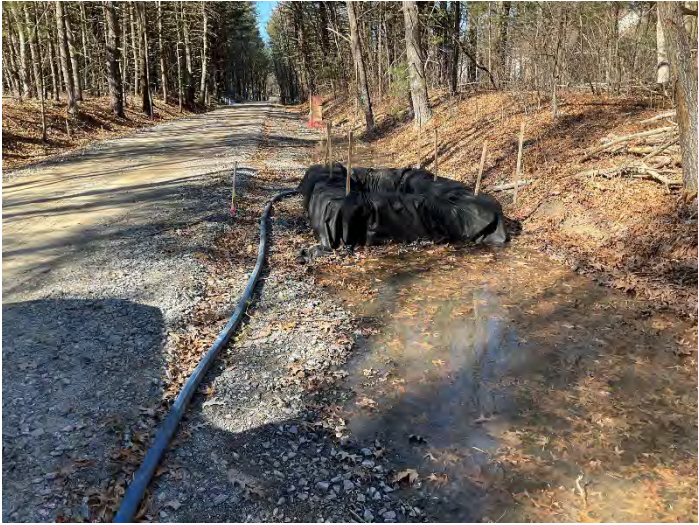
PHOTOGRAPHIC LOG	
Client Name: Eversource		Site Location: Sudbury to Hudson Transmission Reliability Project	
Town: Sudbury			
Photo No.: 4	Date: 2/20/2024

<b>Description:</b> View of dewatering controls (straw bale corral with filter fabric and silt bag) and discharge from corral. Discharge remained inside project work area. Discharge appeared mostly clear and turbidity reading was below 50 NTUs. Facing west.

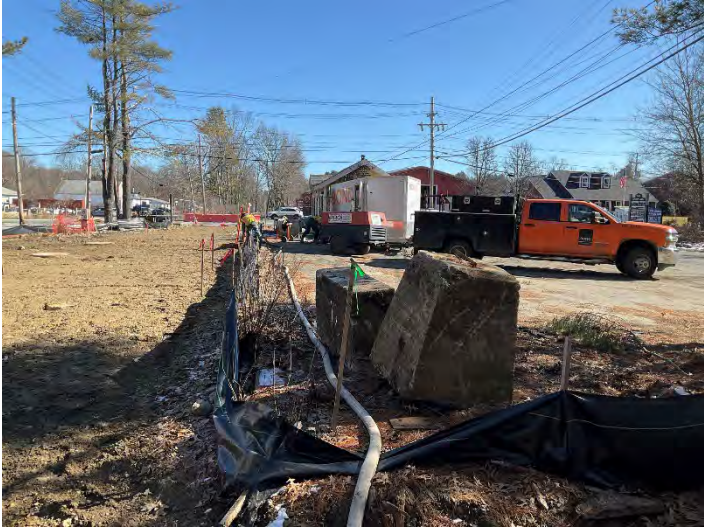
<b>PHOTOGRAPHIC LOG</b>	
Client Name: Eversource		Site Location: Sudbury to Hudson Transmission Reliability Project	
		Town: Sudbury	
Photo No.: 1	Date: 2/20/2024

<b>Description:</b> View of Bond working at MH #24 in segment 11. Facing east.

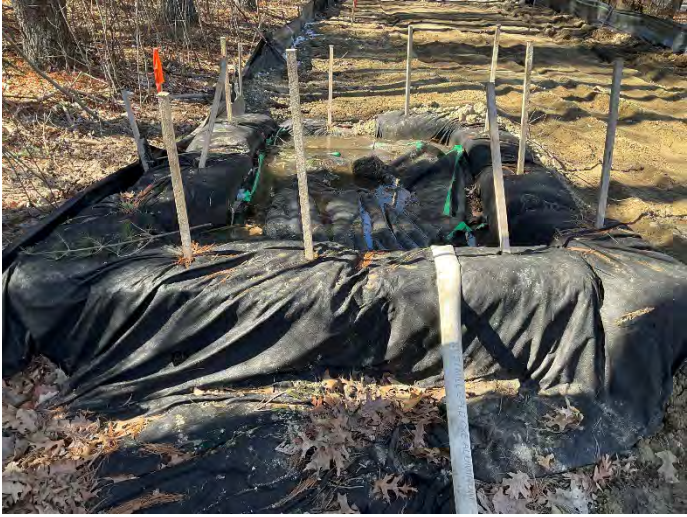
<b>PHOTOGRAPHIC LOG</b>	
Client Name: Eversource		Site Location: Sudbury to Hudson Transmission Reliability Project	Town: Sudbury
Photo No.: 3	Date: 2/20/2024

<b>Description:</b> View of dewatering controls (straw bale corral with filter fabric and silt bag). Facing west.

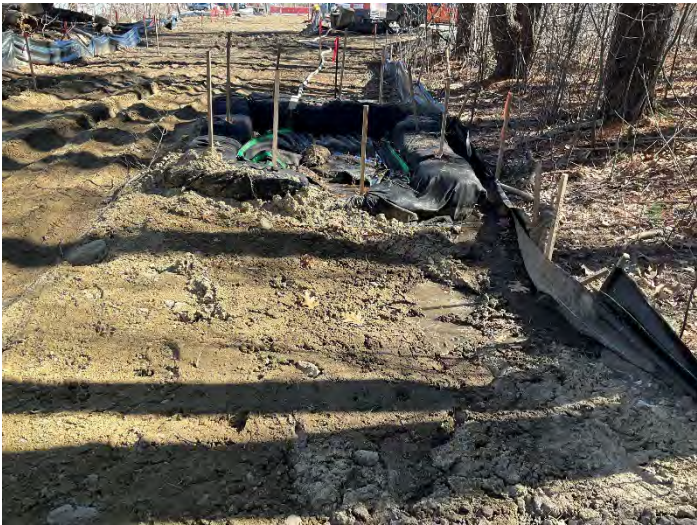
<b>PHOTOGRAPHIC LOG</b>	
Client Name: Eversource		Site Location: Sudbury to Hudson Transmission Reliability Project	Town: Sudbury
Photo No.: 4	Date: 2/20/2024

<b>Description:</b> View of dewatering controls (straw bale corral with filter fabric and silt bag) and discharge from corral. Discharge appeared to be contained onsite. Water appeared turbid. Turbidity reading was slightly above 50 NTUs. Facing east.

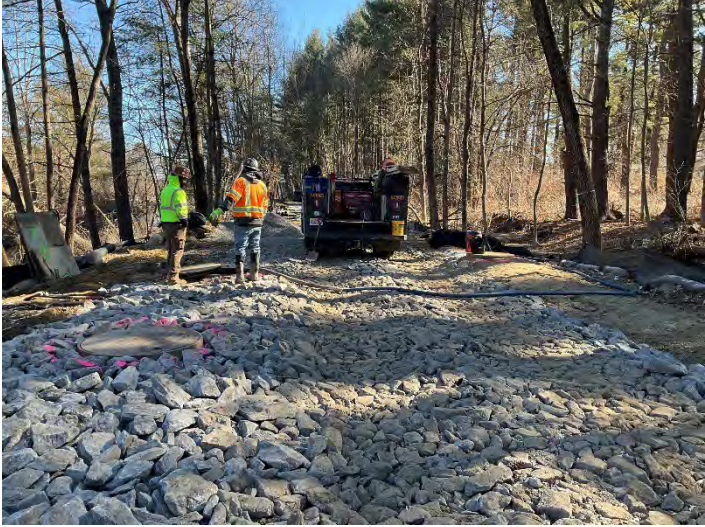
<b>PHOTOGRAPHIC LOG</b>	
Client Name: Eversource		Site Location: Sudbury to Hudson Transmission Reliability Project	Town: Sudbury
Photo No.: 1	Date: 2/20/2024

Description: View of Bond working at MH #25 in segment 13. Facing east.

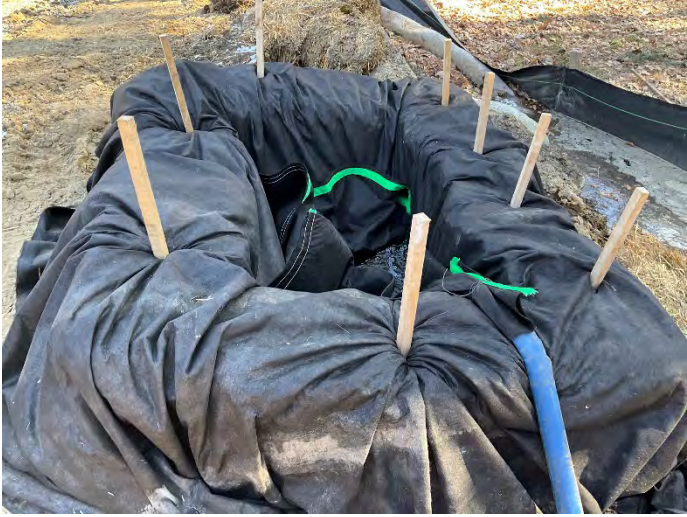
<b>PHOTOGRAPHIC LOG</b>	
Client Name: Eversource		Site Location: Sudbury to Hudson Transmission Reliability Project	Town: Sudbury
Photo No.: 3	Date: 2/20/2024

<b>Description:</b> View of dewatering controls (straw bale corral with filter fabric and silt bag). Facing east.

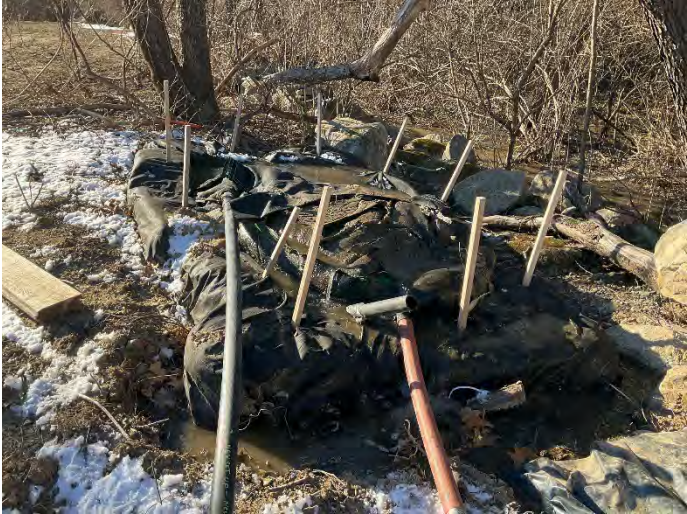
<b>PHOTOGRAPHIC LOG</b>	
Client Name: Eversource		Site Location: Sudbury to Hudson Transmission Reliability Project	
		Town: Sudbury	
Photo No.: 3	Date: 2/20/2024

<b>Description:</b> View of dewatering controls (straw bale corral with filter fabric and silt bag). Facing south.
