**Weekly Environmental Compliance Summary**

**Sudbury to Hudson Transmission Reliability Project (USEPA Tracking # MAR1003UW)**

Sudbury, Hudson, and Stow, MA

Week of: February 19, 2024 to February 23, 2024

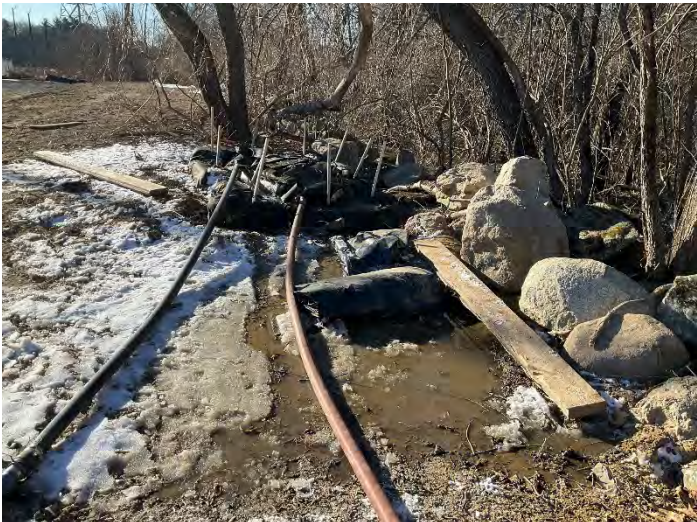
<b>PHOTOGRAPHIC LOG</b>	
Client Name: Eversource		Site Location: Sudbury to Hudson Transmission Reliability Project	
		Town: Sudbury	
Photo No.: 4	Date: 2/20/2024

<b>Description:</b> View of dewatering controls (straw bale corral with filter fabric and silt bag) and discharge from corral. Discharge appeared turbid. Turbidity reading was above 50 NTUs, but discharge did not reach any receiving waters. Facing south.

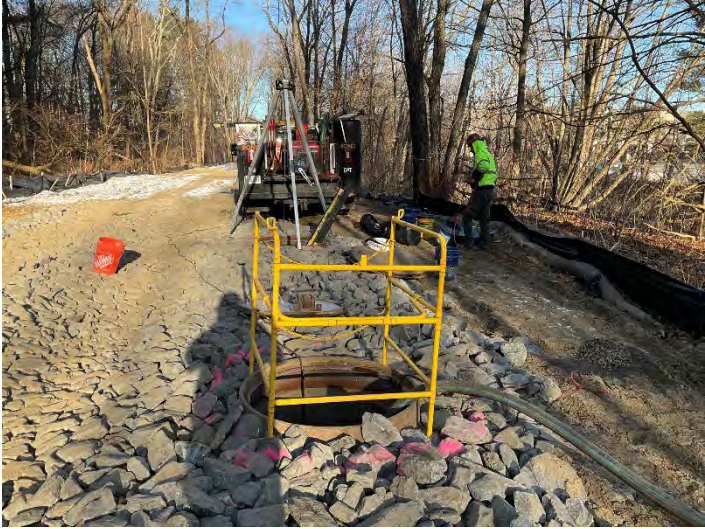
<b>PHOTOGRAPHIC LOG</b>	
Client Name: Eversource		Site Location: Sudbury to Hudson Transmission Reliability Project	Town: Sudbury
Photo No.: 1	Date: 2/21/2024

<b>Description:</b> View of Bond working at MH #25 in segment 13. Facing west.

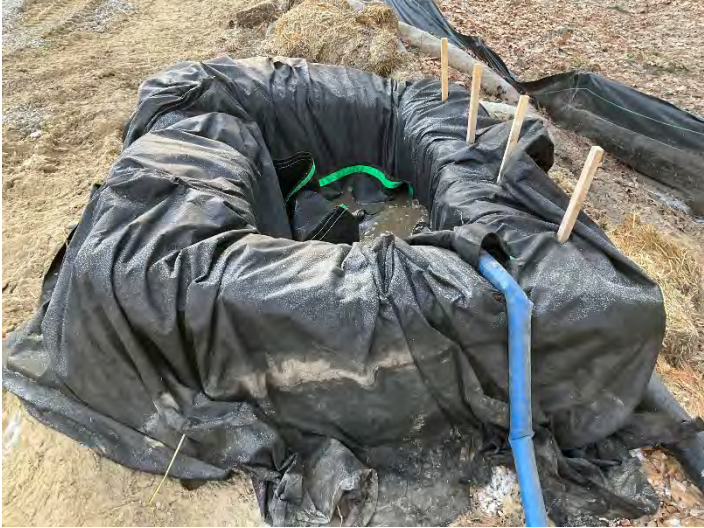
<b>PHOTOGRAPHIC LOG</b>		
Client Name: Eversource		Site Location: Sudbury to Hudson Transmission Reliability Project		Town: Sudbury
Photo No.: 3	Date: 2/21/2024

<b>Description:</b> View of dewatering controls (straw bale corral with filter fabric and silt bag). Facing east.

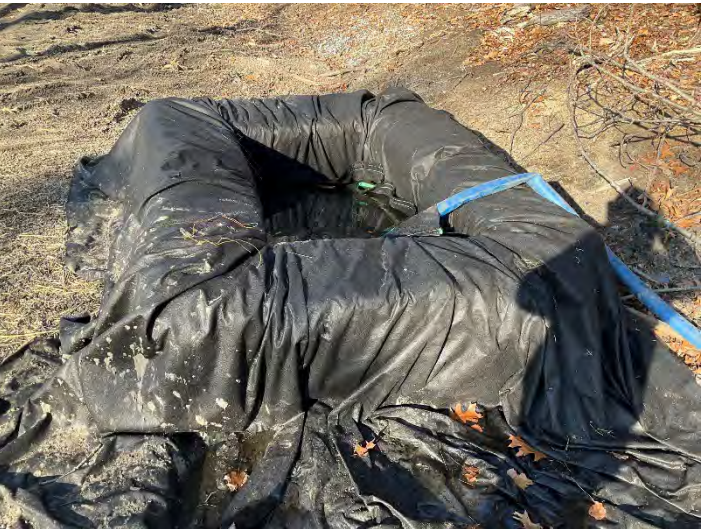
<b>PHOTOGRAPHIC LOG</b>		
Client Name: Eversource		Site Location: Sudbury to Hudson Transmission Reliability Project		Town: Sudbury
Photo No.: 2	Date: 2/21/2024

<b>Description:</b> View of dewatering controls (straw bale corral with filter fabric and silt bag). Facing west.

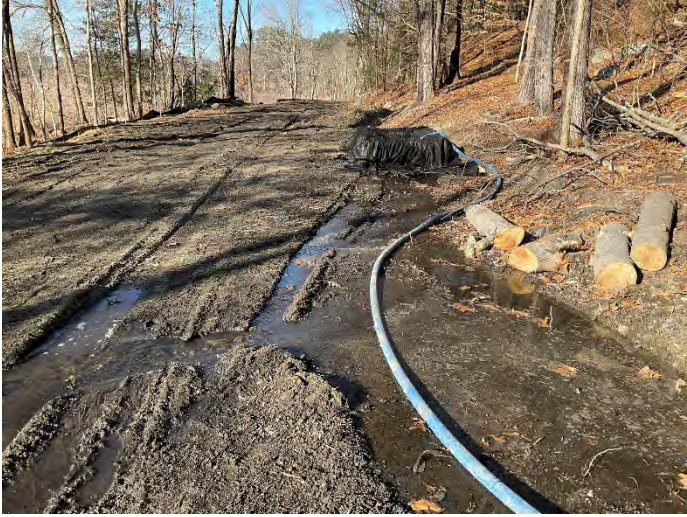
<b>PHOTOGRAPHIC LOG</b>	
Client Name: Eversource		Site Location: Sudbury to Hudson Transmission Reliability Project	Town: Sudbury
Photo No.: 3	Date: 2/21/2024

<b>Description:</b> View of dewatering controls (straw bale corral with filter fabric and silt bag) and discharge from corral. Discharge appeared mostly clear. Facing west.

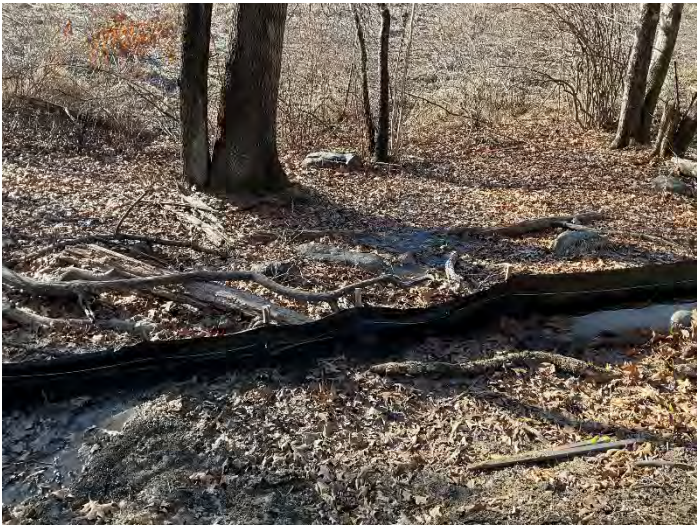
<b>PHOTOGRAPHIC LOG</b>	
Client Name: Eversource		Site Location: Sudbury to Hudson Transmission Reliability Project	Town: Sudbury
Photo No.: 4	Date: 2/21/2024

<b>Description:</b> View of discharge from project. Water traveled across project ROW and discharged through silt fence and into wetland adjacent to project. Discharge appeared mostly clear and turbidity reading was below 50 NTUs. Facing south.

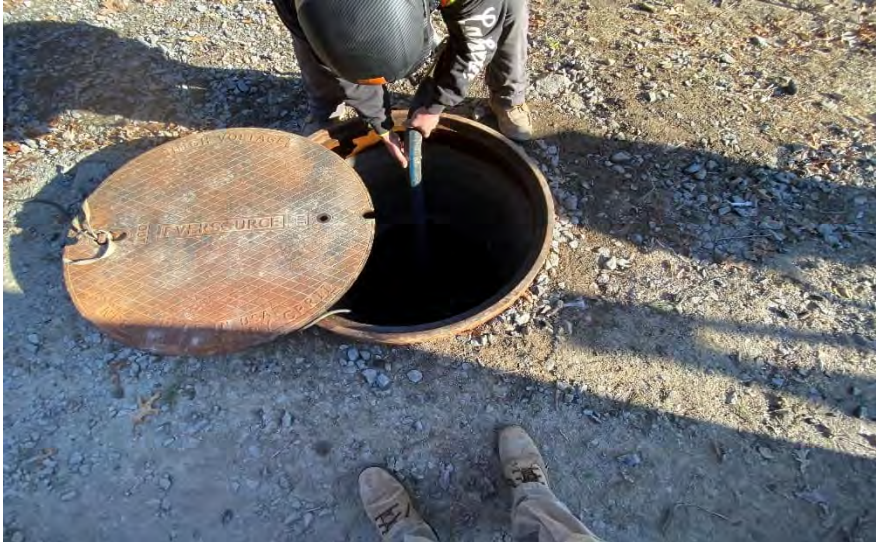
<b>PHOTOGRAPHIC LOG</b>	
Client Name: Eversource		Site Location: Sudbury to Hudson Transmission Reliability Project	Town: Sudbury
Photo No.: 1	Date: 2/22/2024

Description: View of area being pumped from Manhole #22 - segment 11 area.

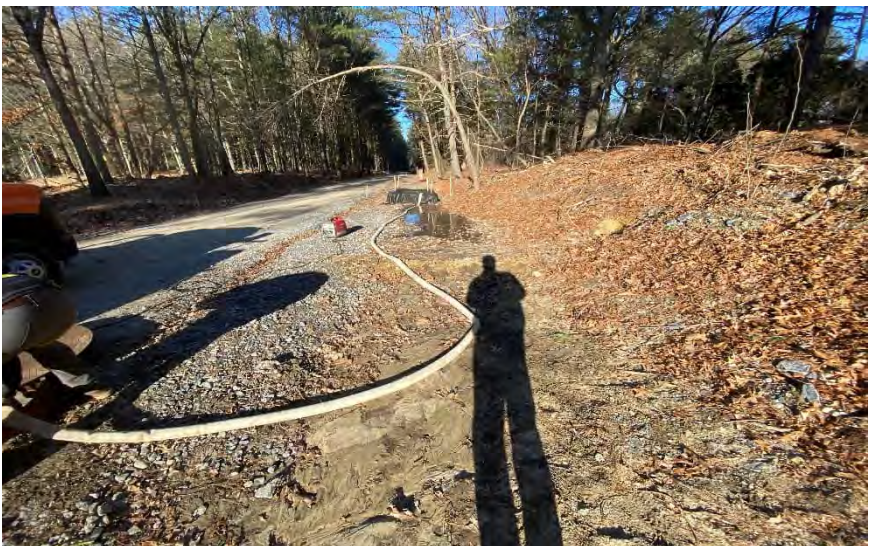
<b>PHOTOGRAPHIC LOG</b>	
Client Name: Eversource		Site Location: Sudbury to Hudson Transmission Reliability Project	Town: Sudbury
Photo No.: 2	Date: 2/22/2024

Description: Manhole #22. View of dewatering operation, looking westward.

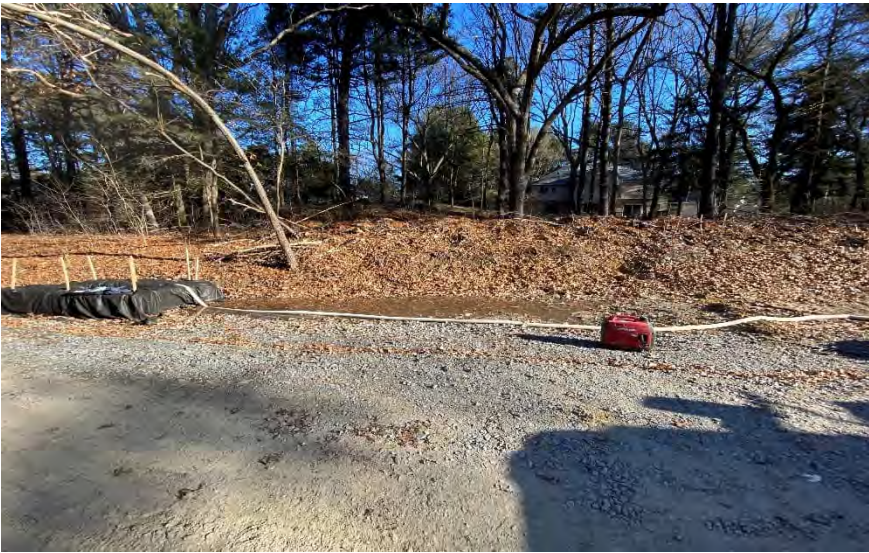
<b>PHOTOGRAPHIC LOG</b>	
Client Name: Eversource		Site Location: Sudbury to Hudson Transmission Reliability Project	Town: Sudbury
Photo No.: 3	Date: 2/22/2024

<b>Description:</b> Manhole #22. View of dewatering operation, looking eastward.

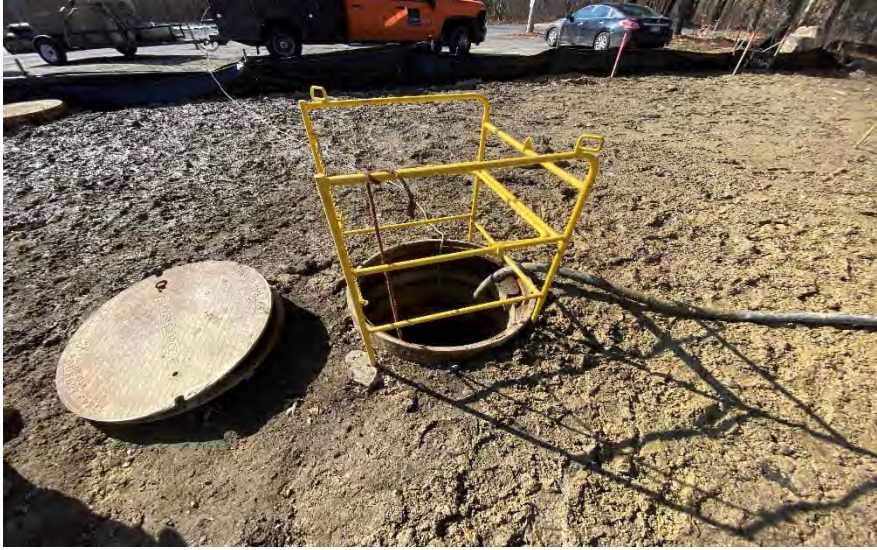
<b>PHOTOGRAPHIC LOG</b>	
Client Name: Eversource		Site Location: Sudbury to Hudson Transmission Reliability Project	Town: Sudbury
Photo No.: 1	Date: 2/22/2024

Description: View of area being pumped from manhole #24, segment 11.

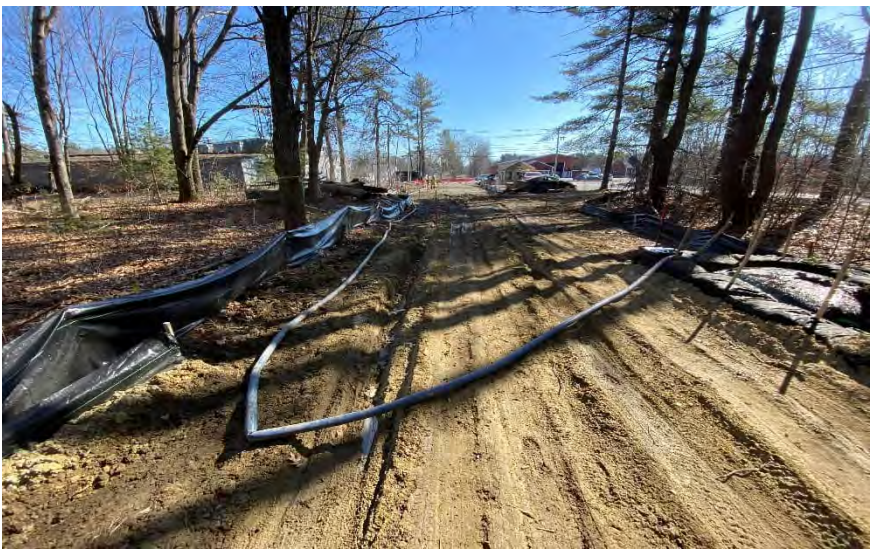
<b>PHOTOGRAPHIC LOG</b>	
Client Name: Eversource		Site Location: Sudbury to Hudson Transmission Reliability Project	Town: Sudbury
Photo No.: 2	Date: 2/22/2024

Description: Manhole #24. View of dewatering operation, looking eastward.

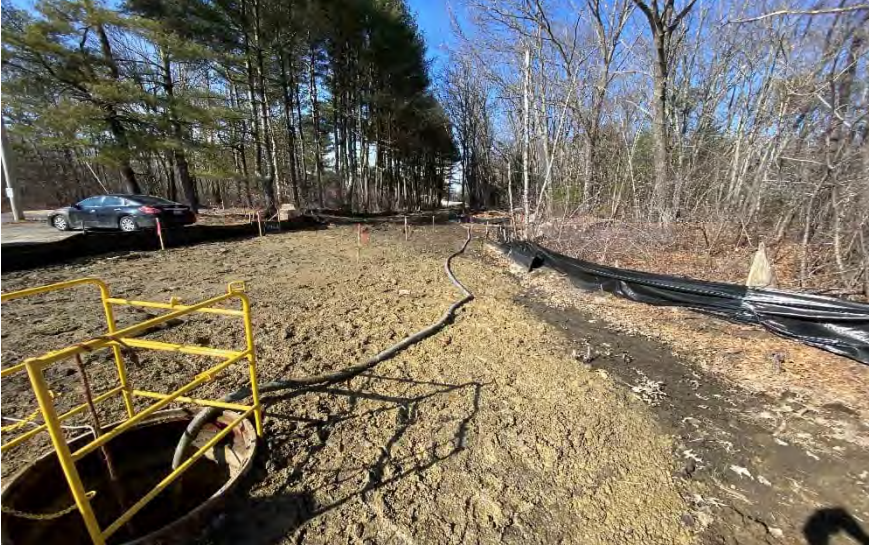
<b>PHOTOGRAPHIC LOG</b>	
<b>Client Name:</b> Eversource		<b>Site Location:</b> Sudbury to Hudson Transmission Reliability Project	
<b>Town:</b> Sudbury			
<b>Photo No.:</b> 3	<b>Date:</b> 2/22/2024

<b>Description:</b> Manhole #24. View of dewatering operation, looking westward.

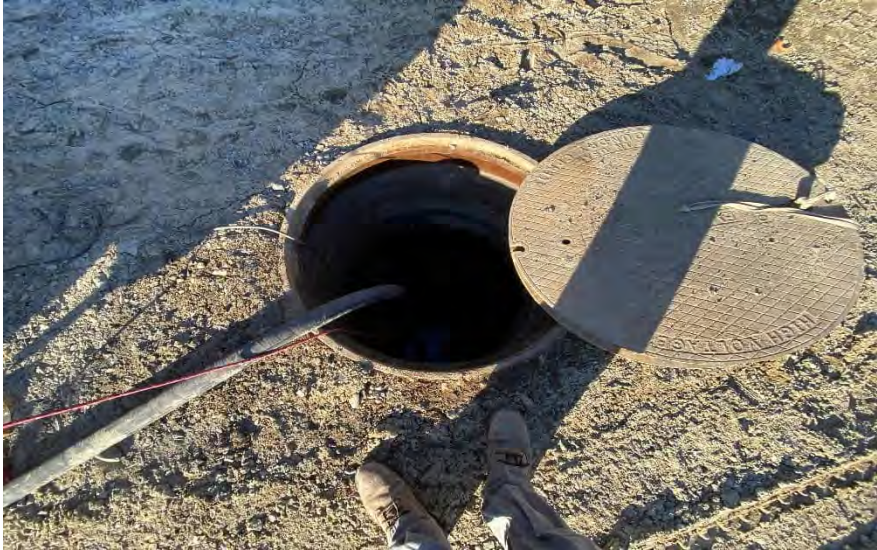
<b>PHOTOGRAPHIC LOG</b>	
Client Name: Eversource		Site Location: Sudbury to Hudson Transmission Reliability Project	Town: Sudbury
Photo No.: 1	Date: 2/22/2024

Description: View of area being pumped from manhole #28, outside substation.

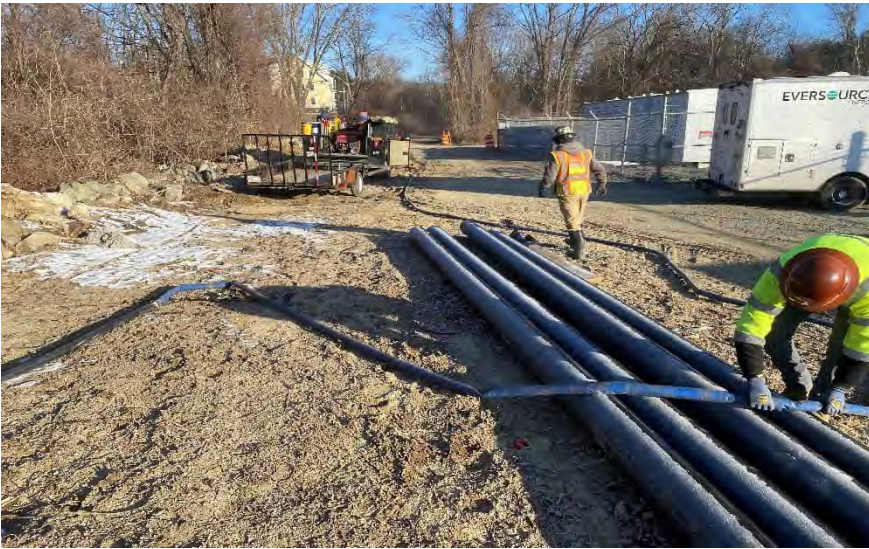
<b>PHOTOGRAPHIC LOG</b>	
Client Name: Eversource		Site Location: Sudbury to Hudson Transmission Reliability Project	Town: Sudbury
Photo No.: 3	Date: 2/22/2024

<b>Description:</b> Manhole #28. View of dewatering operation, looking northward.

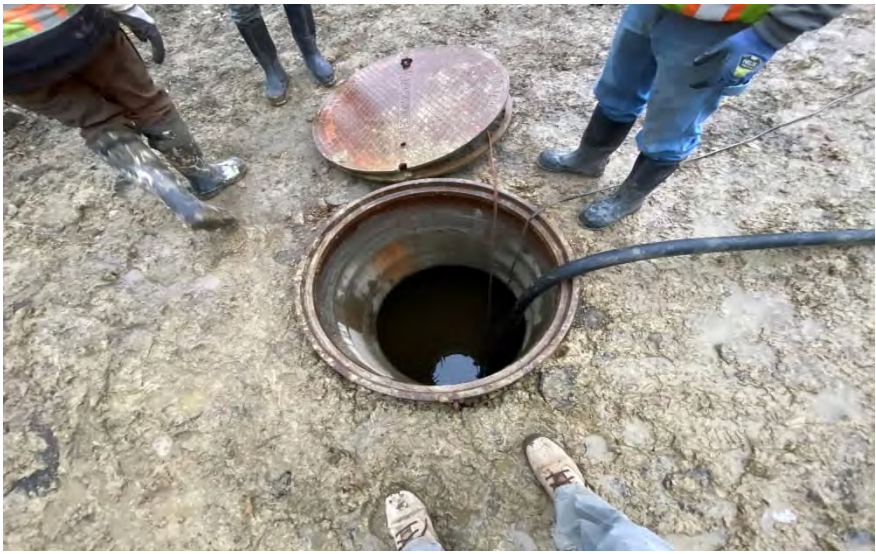
PHOTOGRAPHIC LOG	
Client Name: Eversource		Site Location: Sudbury to Hudson Transmission Reliability Project	Town: Sudbury
Photo No.: 1	Date: 2/23/2024

Description: View of area being pumped from manhole #24, segment 11.

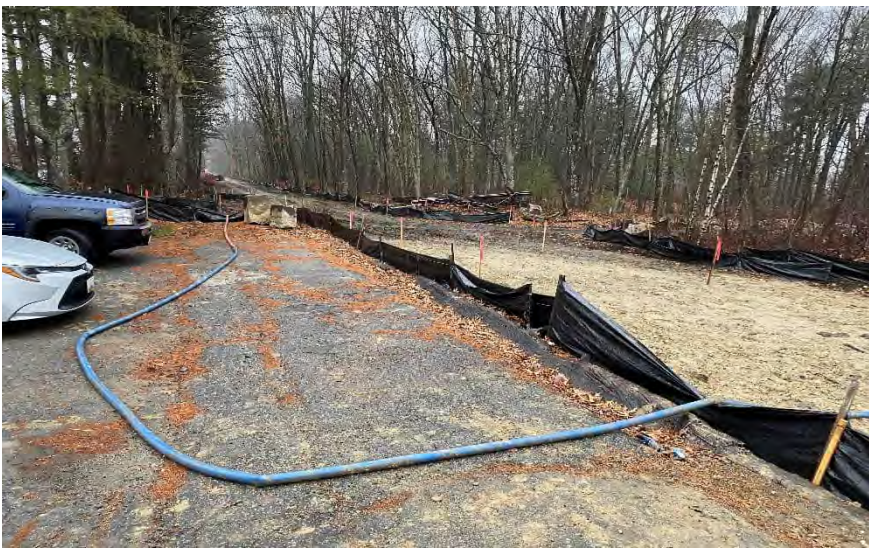
PHOTOGRAPHIC LOG	
Client Name: Eversource		Site Location: Sudbury to Hudson Transmission Reliability Project	Town: Sudbury
Photo No.: 2	Date: 2/23/2024

Description: Manhole #24. View of dewatering operation, looking westward.

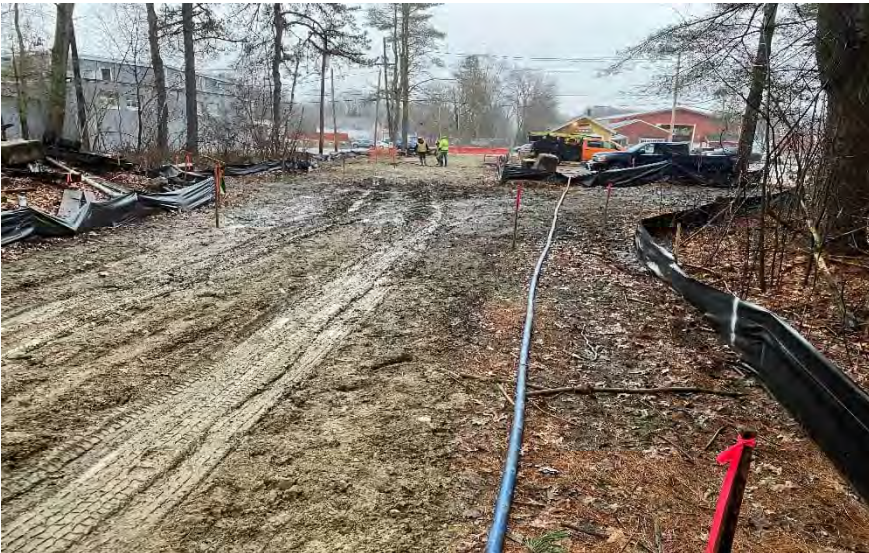
PHOTOGRAPHIC LOG	
Client Name: Eversource		Site Location: Sudbury to Hudson Transmission Reliability Project	Town: Sudbury
Photo No.: 3	Date: 2/23/2024

Description: Manhole #24. View of dewatering operation, looking eastward.
