Weekly Environmental Compliance Summary

Sudbury to Hudson Transmission Reliability Project (USEPA Tracking # MAR1003UW)

Sudbury, Hudson, and Stow, MA

Week of: March 25, 2024 to March 30, 2024

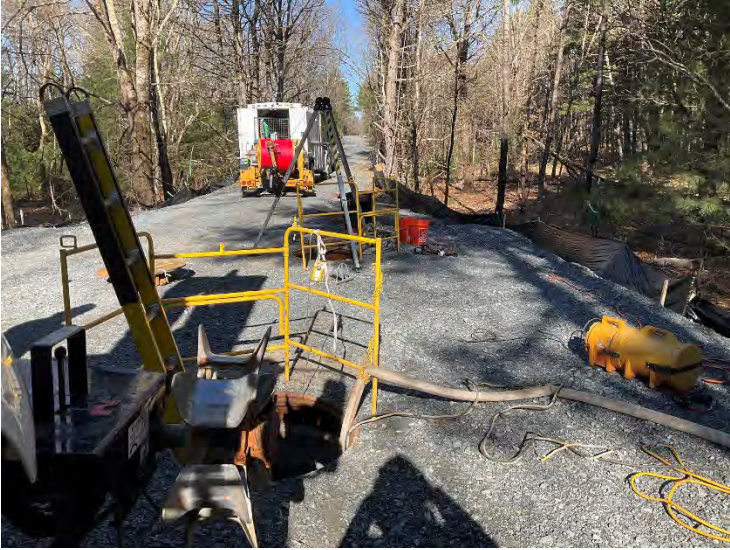
<p>PHOTOGRAPHIC LOG</p>	
<p>Client Name: Eversource</p>		<p>Site Location: Sudbury to Hudson Transmission Reliability Project</p>	<p>Town: Sudbury</p>
<p>Photo No.: 1</p>	<p>Date: 3/30/2024</p>

<p>Description: View of Haugland's work area at MH #15 in segment 7. Facing west.</p>

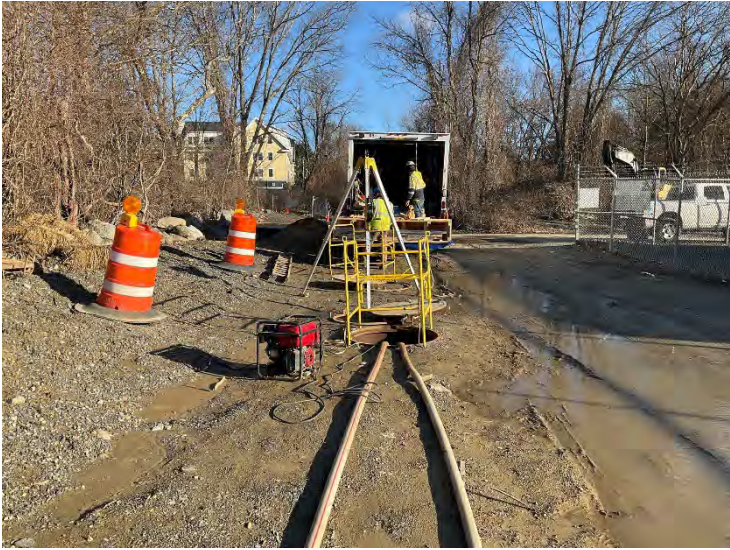
PHOTOGRAPHIC LOG	
Client Name: Eversource		Site Location: Sudbury to Hudson Transmission Reliability Project	Town: Sudbury
Photo No.: 5	Date: 3/30/2024

Description: View of Haugland's work area at MH #28 at Sudbury Substation. Facing north.

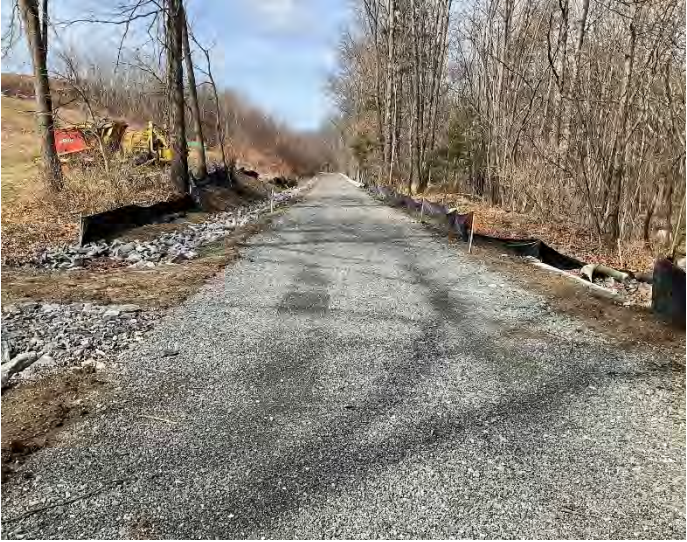
PHOTOGRAPHIC LOG	
Client Name: Eversource		Site Location: Sudbury to Hudson Transmission Reliability Project	Town: Stow
Photo No.: 1	Date: 3-25-2024

Description: View of drainage structures 5 and 6 and E&S controls in segment 1. Facing west.

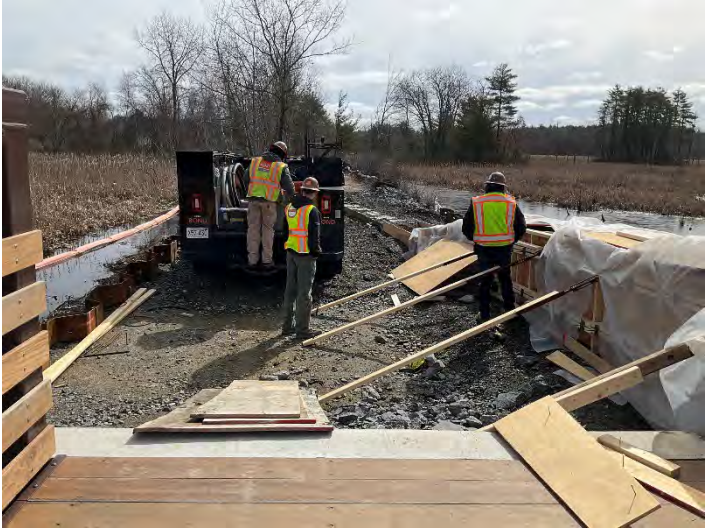
PHOTOGRAPHIC LOG	
Client Name: Eversource		Site Location: Sudbury to Hudson Transmission Reliability Project	Town: Hudson
Photo No.: 2	Date: 3-25-2024

Description: View of Bond working at Bridge 130. Facing east.

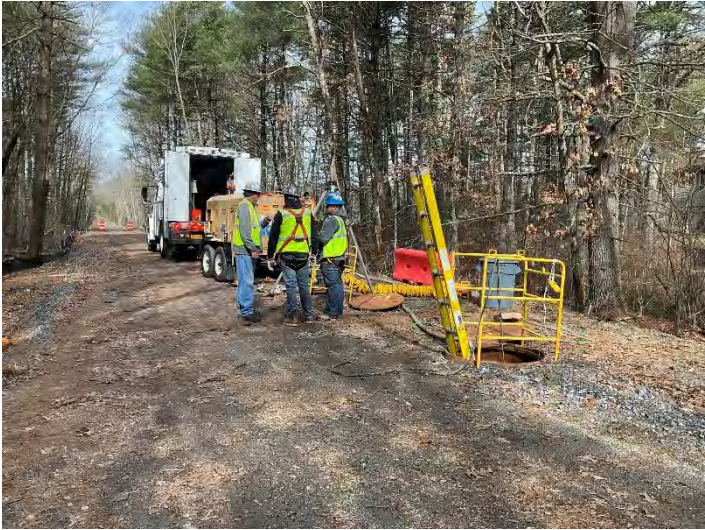
PHOTOGRAPHIC LOG	
Client Name: Eversource		Site Location: Sudbury to Hudson Transmission Reliability Project	Town: Hudson
Photo No.: 3	Date: 3-25-2024

Description: View of Haugland working at MH #13 in segment 5. See additional dewatering inspection reports. Facing west.

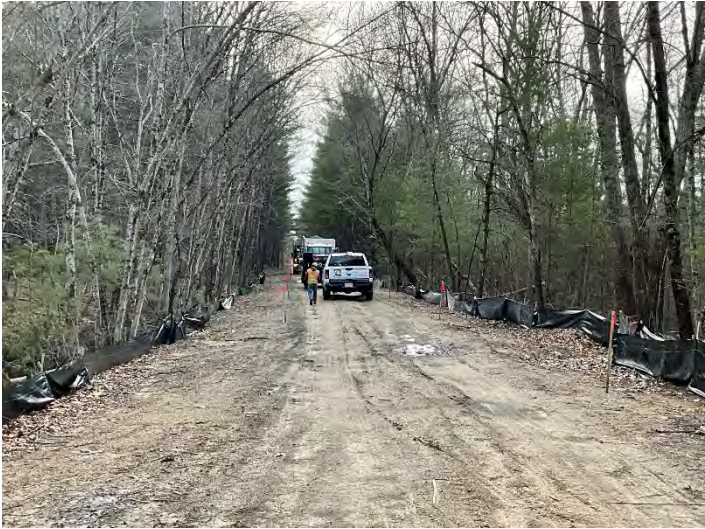
Epsilon ASSOCIATES INC.		PHOTOGRAPHIC LOG	
Client Name: Eversource		Site Location: Sudbury to Hudson Transmission Reliability Project	Town: Hudson
Photo No.: 6	Date: 3-25-2024

Description: View of Bond being escorted through vernal pool TOY restriction zone in segment 6 (monitor out of frame in front of vehicles, Bond personnel walking behind vehicles). Facing east.

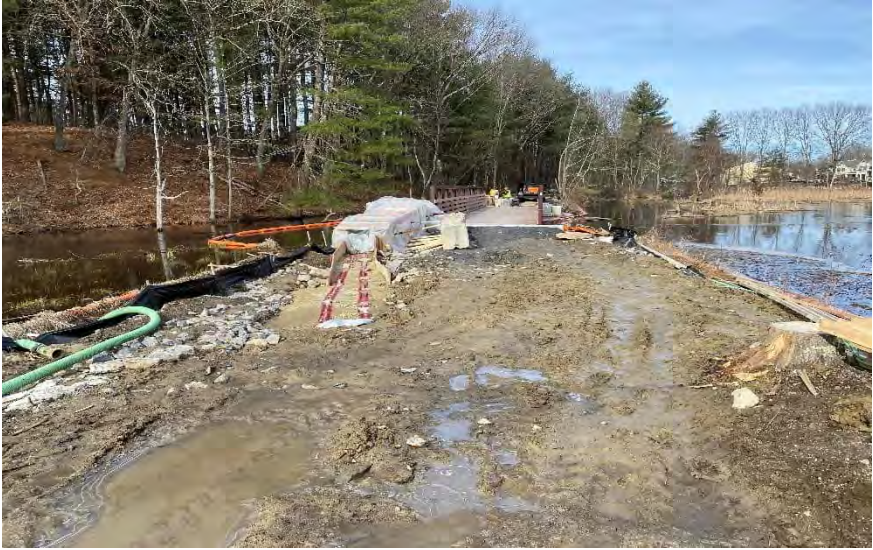
PHOTOGRAPHIC LOG	
Client Name: Eversource		Site Location: Sudbury to Hudson Transmission Reliability Project	
Town: Sudbury			
Photo No.: 2	Date: 3-25-24

Description: Work area within segment 14 looking across Hop Brook into segment 13, Bridge 127, existing erosion control, post-conduit work, looking westward.

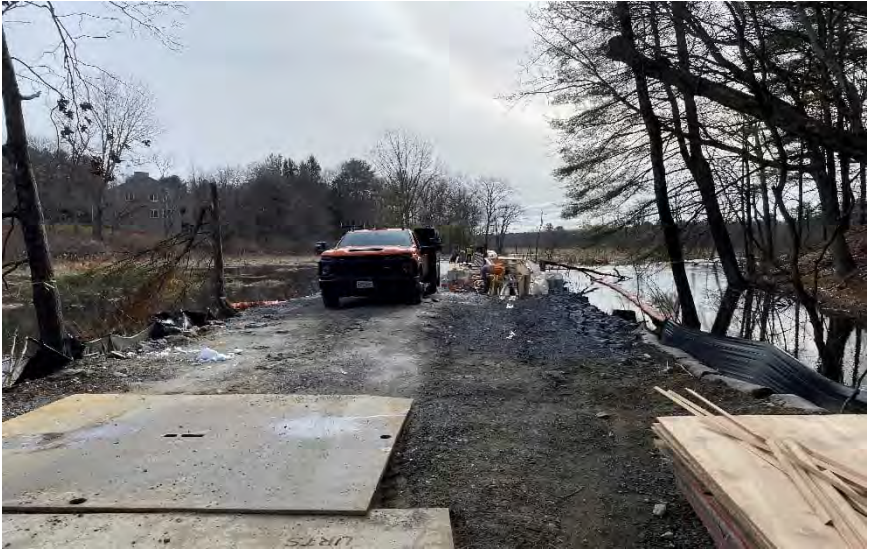
PHOTOGRAPHIC LOG	
Client Name: Eversource		Site Location: Sudbury to Hudson Transmission Reliability Project	Town: Sudbury
Photo No.: 3	Date: 3-25-24

Description: Work area looking across Hop Brook from segment 13, Bridge 127, existing erosion control, post-conduit work, looking eastward.

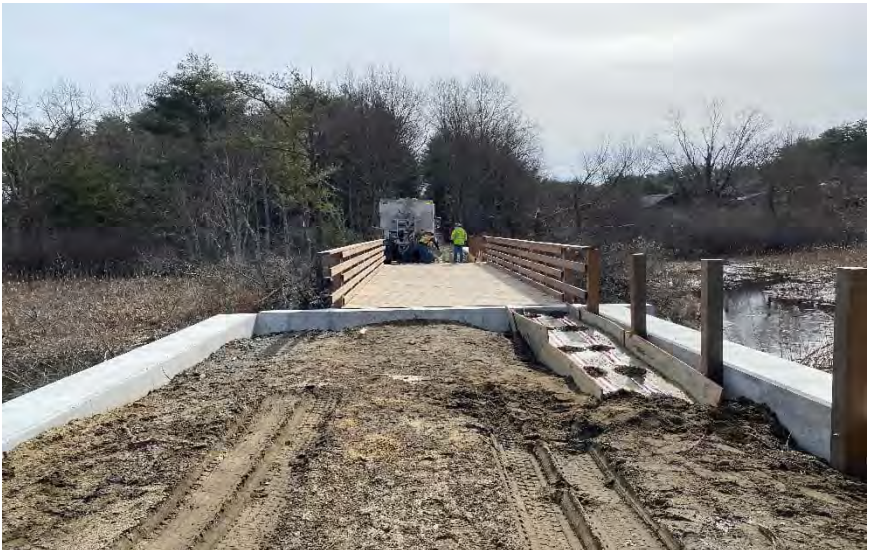
PHOTOGRAPHIC LOG	
Client Name: Eversource		Site Location: Sudbury to Hudson Transmission Reliability Project	Town: Sudbury
Photo No.: 4	Date: 3-25-24

Description: Work area within segment 7, looking across Hop Brook, Bridge 128, existing erosion control, conduit work, looking eastward.

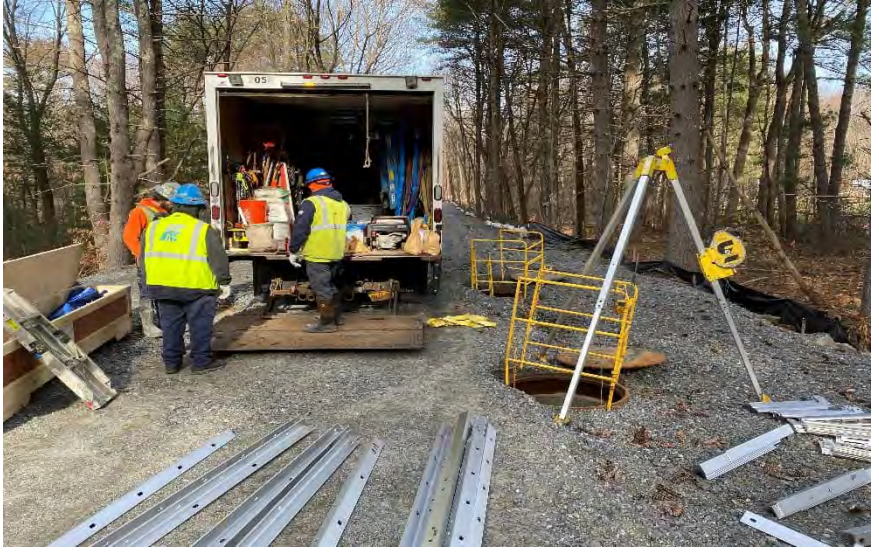
PHOTOGRAPHIC LOG	
Client Name: Eversource		Site Location: Sudbury to Hudson Transmission Reliability Project	Town: Sudbury
Photo No.: 5	Date: 3-25-24

Description: Work area within segment 9, wire pulling work (racking) at manhole #19, existing erosion control, looking westward.

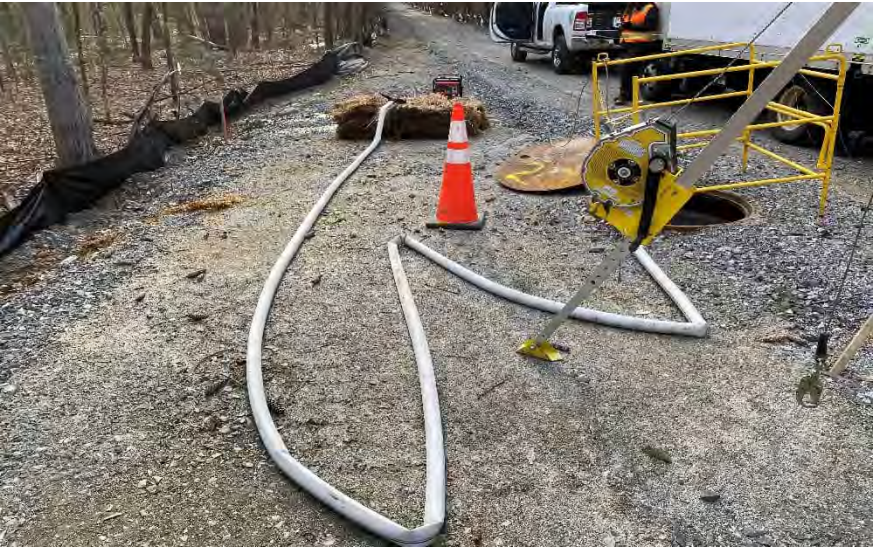
PHOTOGRAPHIC LOG	
Client Name: Eversource		Site Location: Sudbury to Hudson Transmission Reliability Project	Town: Sudbury
Photo No.: 6	Date: 3-25-24

Description: Work area within segment 10, wire pulling work (racking) at manhole #20, existing erosion control, looking eastward.

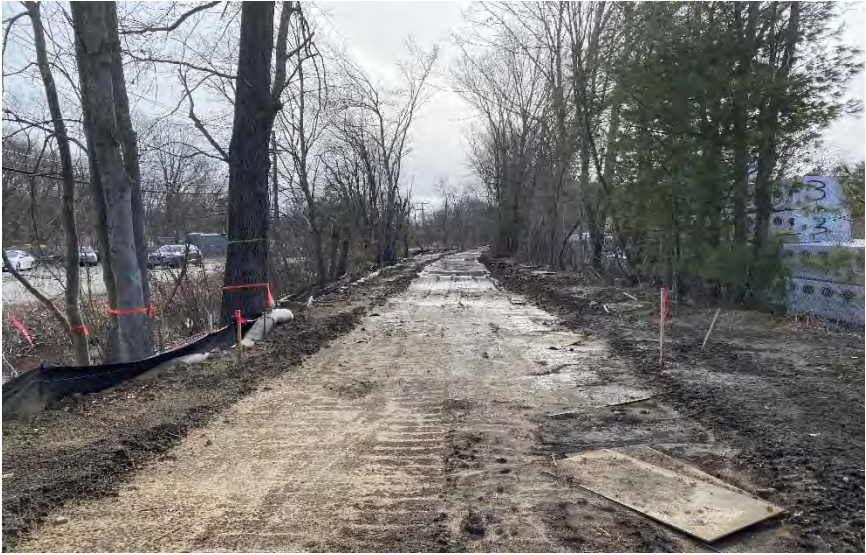
PHOTOGRAPHIC LOG	
Client Name: Eversource		Site Location: Sudbury to Hudson Transmission Reliability Project	Town: Sudbury
Photo No.: 7	Date: 3-25-24

Description: Work area within segment 12, existing erosion control, looking eastward.

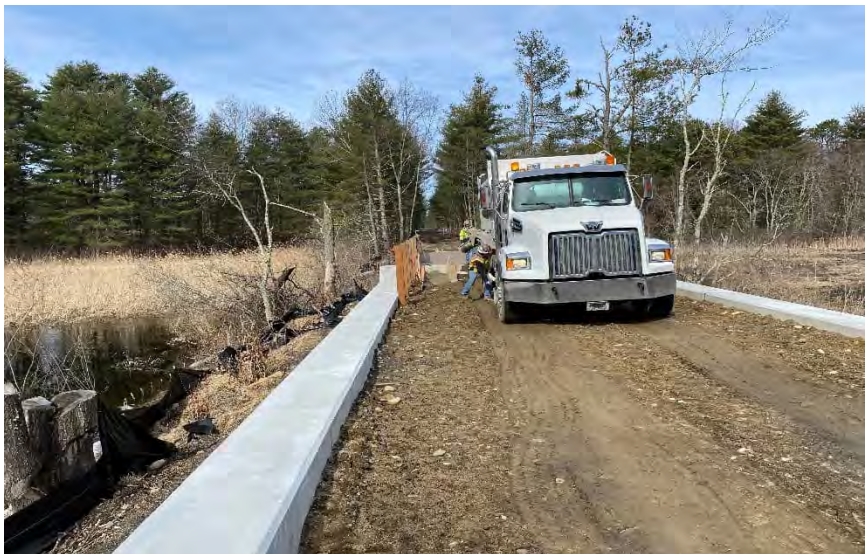
PHOTOGRAPHIC LOG	
Client Name: Eversource		Site Location: Sudbury to Hudson Transmission Reliability Project	Town: Sudbury
Photo No.: 8	Date: 3-25-24

Description: Work area within segment 8, looking across Hop Brook, Bridge 128, existing erosion control, conduit work, looking westward.

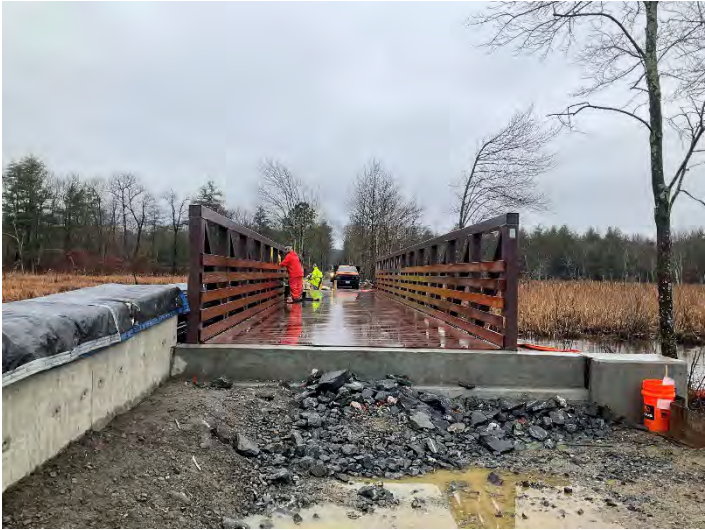
PHOTOGRAPHIC LOG	
Client Name: Eversource		Site Location: Sudbury to Hudson Transmission Reliability Project	Town: Hudson
Photo No.: 3	Date: 3-28-2024

Description: View of Bond working at Bridge 130. Facing west.

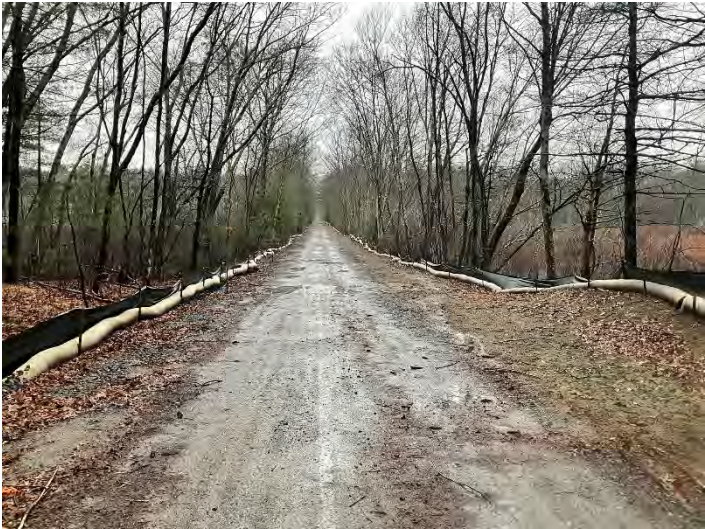
PHOTOGRAPHIC LOG	
Client Name: Eversource		Site Location: Sudbury to Hudson Transmission Reliability Project	Town: Hudson
Photo No.: 4	Date: 3-28-2024

Description: View of E&S controls in segment 5. Facing west.

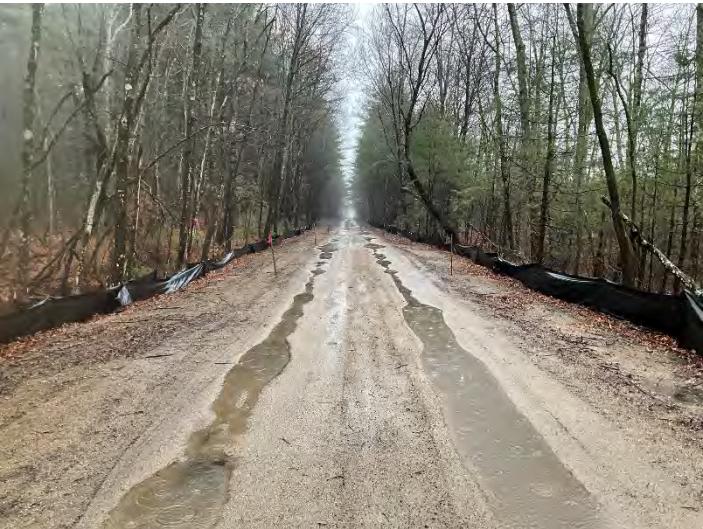
Epsilon ASSOCIATES INC.		PHOTOGRAPHIC LOG	
Client Name: Eversource		Site Location: Sudbury to Hudson Transmission Reliability Project	Town: Hudson
Photo No.: 5	Date: 3-28-2024

Description: View of E&S controls in segment 6. Facing east.

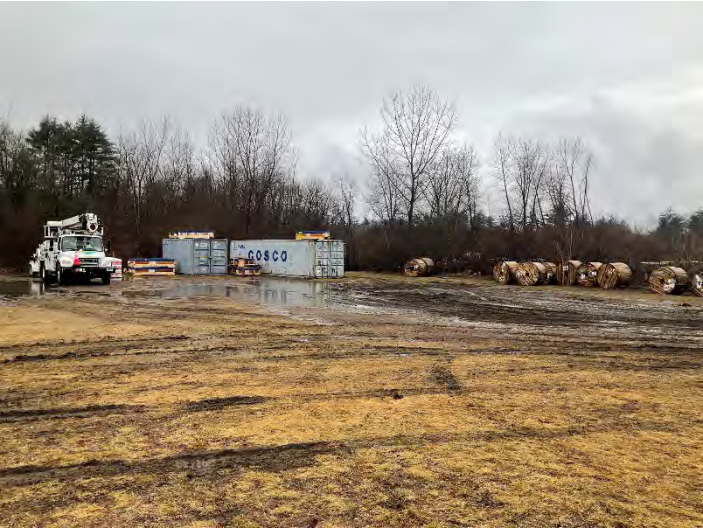
Epsilon ASSOCIATES INC.		PHOTOGRAPHIC LOG	
Client Name: Eversource		Site Location: Sudbury to Hudson Transmission Reliability Project	Town: Hudson
Photo No.: 6	Date: 3-28-2024

Description: View of Haugland's laydown yard on Perkin's property. Facing west.

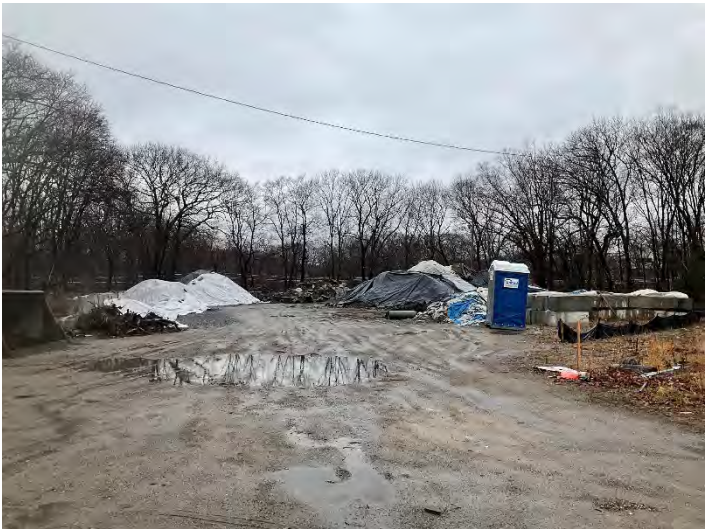
Client Name: Eversource		Site Location: Sudbury to Hudson Transmission Reliability Project	Town: Hudson
Photo No.: 7	Date: 3-28-2024

Description: View of Stowe Ct laydown yard. Facing northeast.

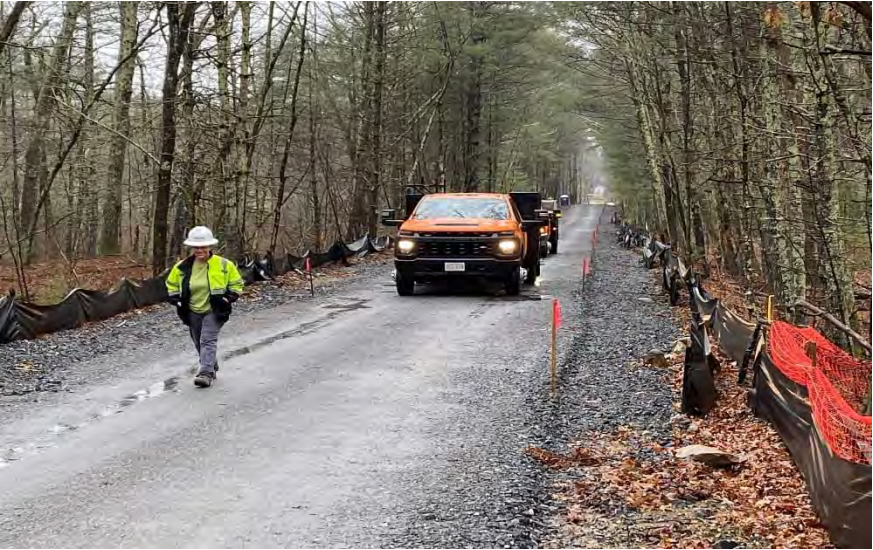
PHOTOGRAPHIC LOG	
Client Name: Eversource		Site Location: Sudbury to Hudson Transmission Reliability Project	Town: Sudbury
Photo No.: 1	Date: 3-28-24

Description: Work area within segment 8, vernal pool monitor leading equipment out of exclusion zone, existing erosion control, looking westward.

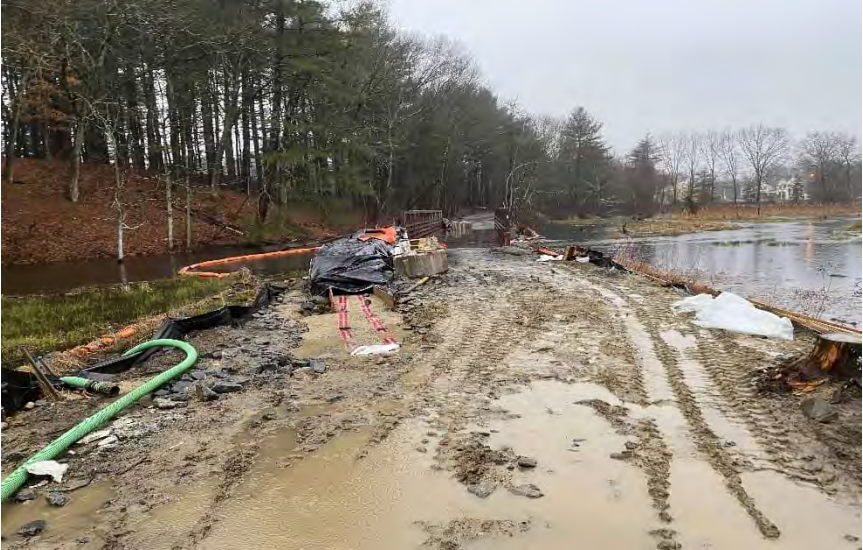
PHOTOGRAPHIC LOG	
Client Name: Eversource		Site Location: Sudbury to Hudson Transmission Reliability Project	Town: Sudbury
Photo No.: 2	Date: 3-28-24

Description: Work area within segment 14 looking across Hop Brook into segment 13, Bridge 127, existing erosion control, post-conduit work, looking westward.

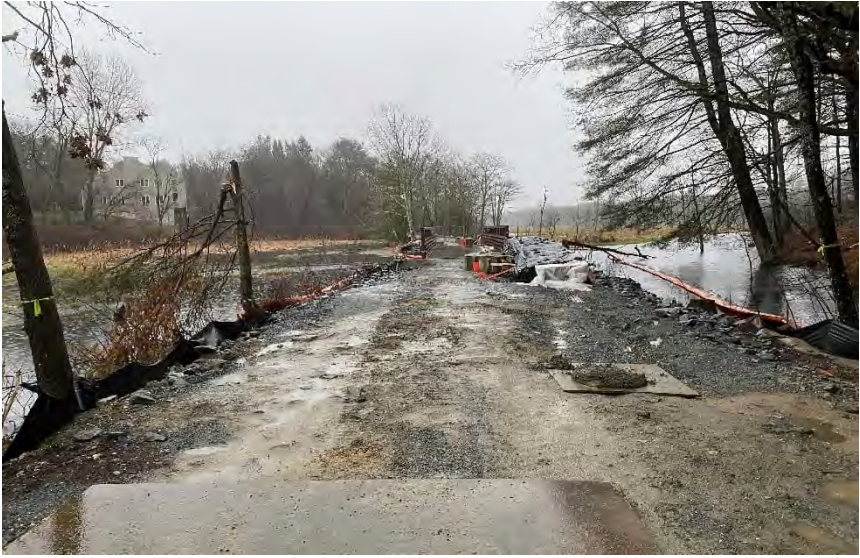
PHOTOGRAPHIC LOG	
Client Name: Eversource		Site Location: Sudbury to Hudson Transmission Reliability Project	Town: Sudbury
Photo No.: 3	Date: 3-28-24

Description: Work area looking across Hop Brook from segment 13, Bridge 127, existing erosion control, post-conduit work, looking eastward.

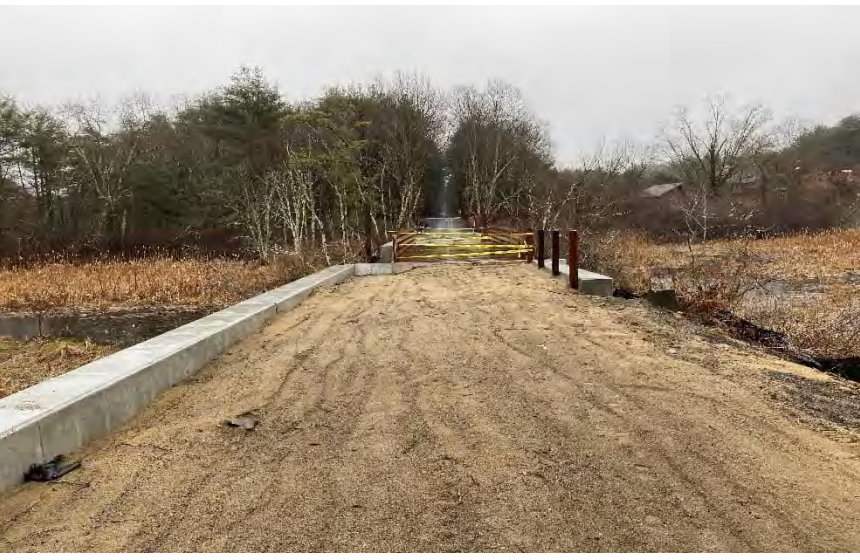
PHOTOGRAPHIC LOG	
Client Name: Eversource		Site Location: Sudbury to Hudson Transmission Reliability Project	Town: Sudbury
Photo No.: 4	Date: 3-28-24

Description: Work area within segment 7, looking across Hop Brook, Bridge 128, existing erosion control, post-conduit work, looking eastward.

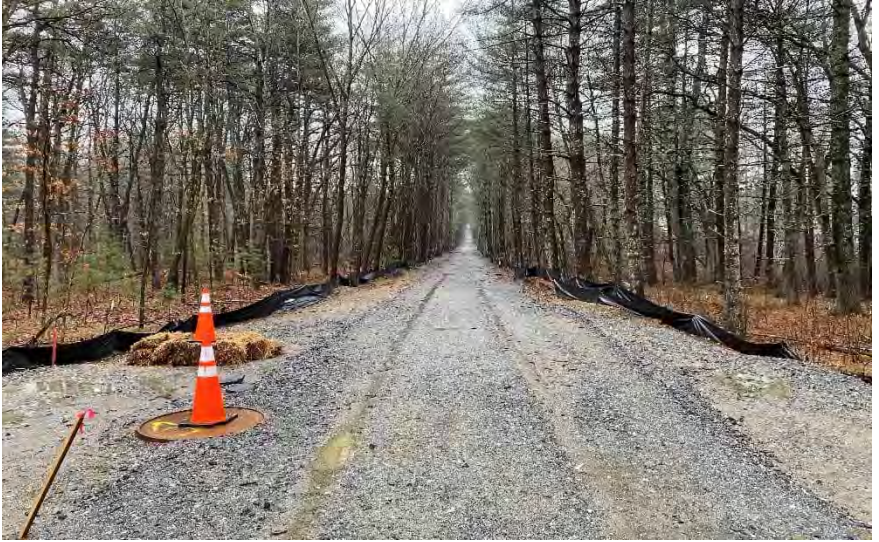
PHOTOGRAPHIC LOG	
Client Name: Eversource		Site Location: Sudbury to Hudson Transmission Reliability Project	Town: Sudbury
Photo No.: 5	Date: 3-28-24

Description: Work area within segment 10, at manhole #20, existing erosion control, looking eastward.

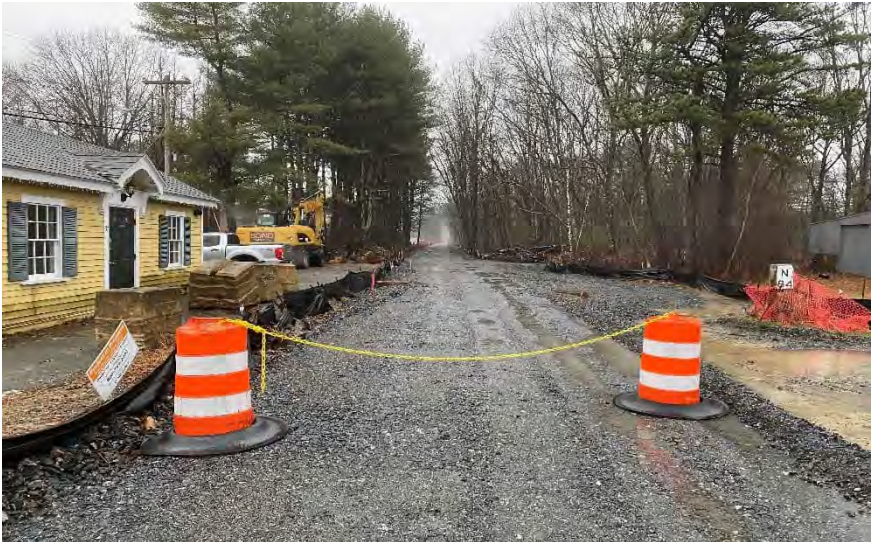
PHOTOGRAPHIC LOG	
Client Name: Eversource		Site Location: Sudbury to Hudson Transmission Reliability Project	Town: Sudbury
Photo No.: 6	Date: 3-28-24

Description: Work area within segment 11, existing erosion control, looking westward.

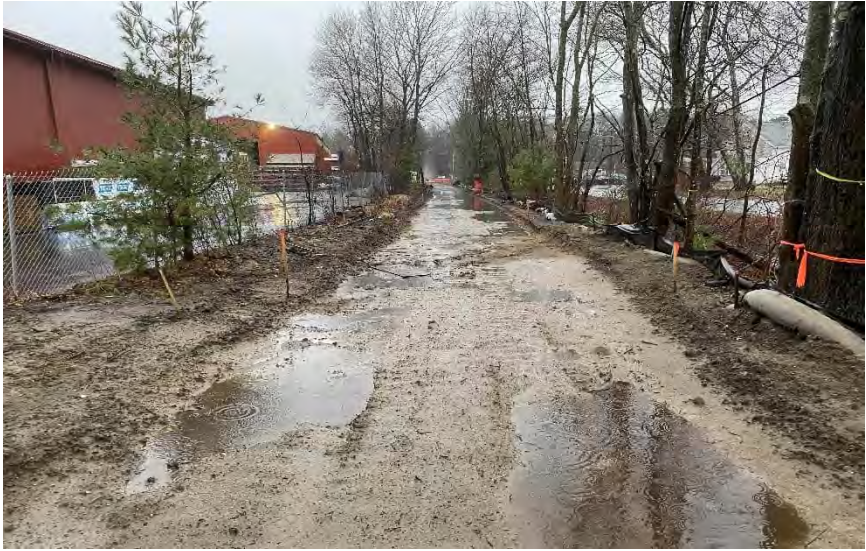
PHOTOGRAPHIC LOG	
Client Name: Eversource		Site Location: Sudbury to Hudson Transmission Reliability Project	Town: Sudbury
Photo No.: 7	Date: 3-28-24

Description: Work area within segment 12, existing erosion control, looking westward.

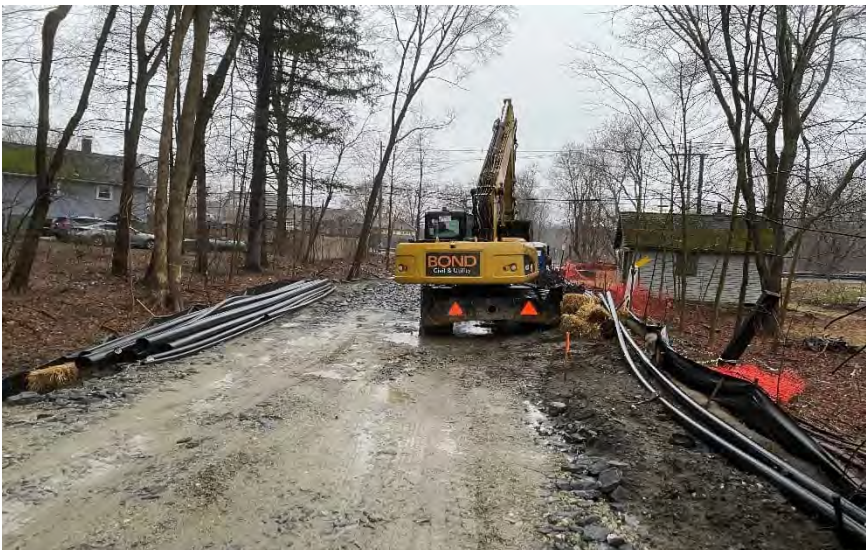
PHOTOGRAPHIC LOG	
Client Name: Eversource		Site Location: Sudbury to Hudson Transmission Reliability Project	Town: Sudbury
Photo No.: 8	Date: 3-28-24

Description: Work area within segment 13, existing erosion control, looking eastward.

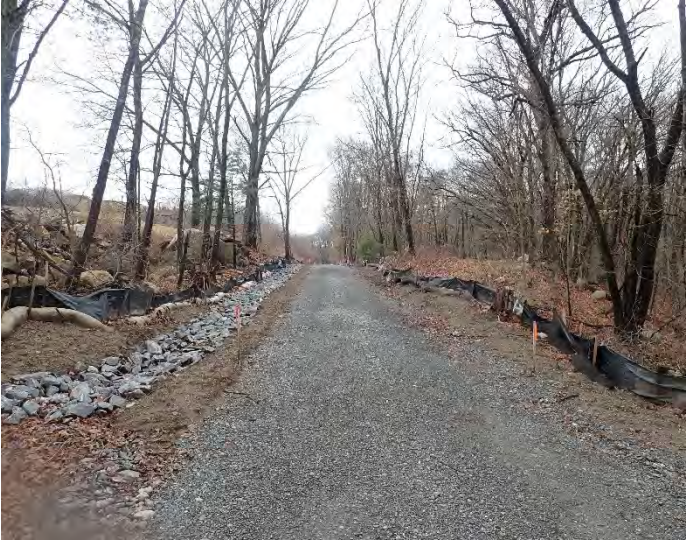
PHOTOGRAPHIC LOG	
Client Name: Eversource		Site Location: Sudbury to Hudson Transmission Reliability Project	Town: Hudson
Photo No.: 1	Date: 3-29-2024

Description: View of E&S controls in segment 1. Facing west.

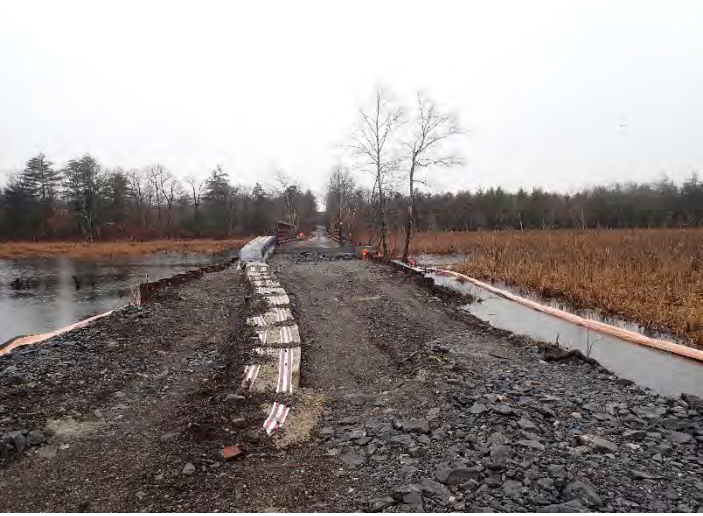
PHOTOGRAPHIC LOG	
Client Name: Eversource		Site Location: Sudbury to Hudson Transmission Reliability Project	Town: Stow/Hudson Town Line
Photo No.: 2	Date: 3-29-2024

Description: View of turbidity curtains at Bridge 130. Facing west.

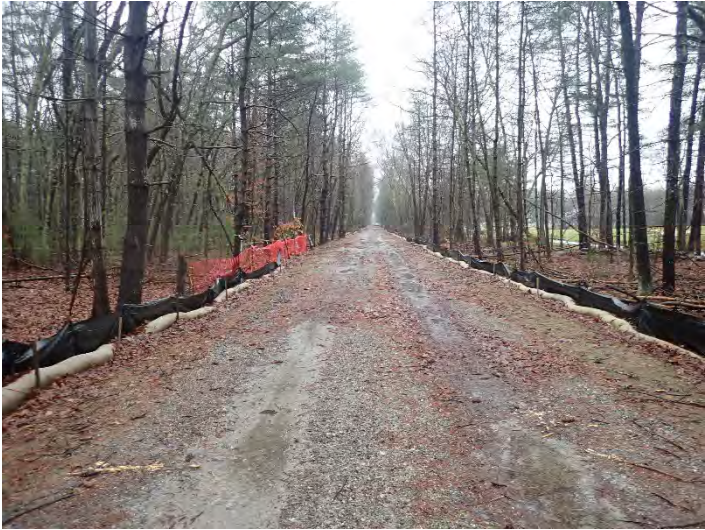
Epsilon ASSOCIATES INC.		PHOTOGRAPHIC LOG	
Client Name: Eversource		Site Location: Sudbury to Hudson Transmission Reliability Project	Town: Hudson
Photo No.: 3	Date: 3-29-2024

Description: View of E&S controls in segment 5. Facing east.

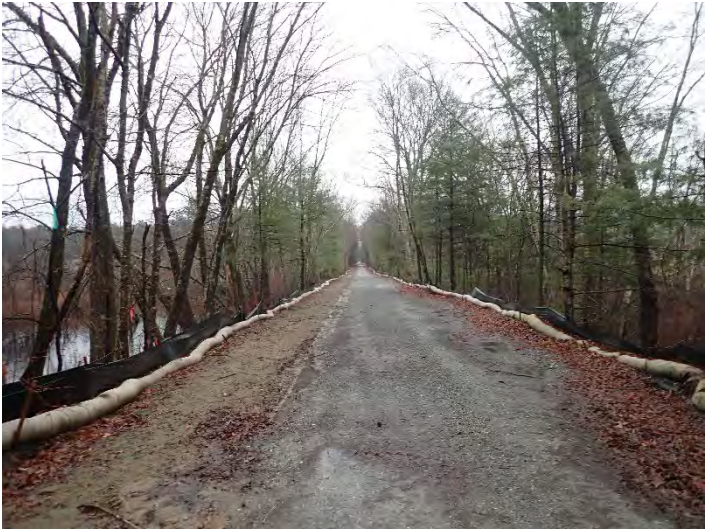
Epsilon ASSOCIATES INC.		PHOTOGRAPHIC LOG	
Client Name: Eversource		Site Location: Sudbury to Hudson Transmission Reliability Project	Town: Hudson
Photo No.: 4	Date: 3-29-2024

Description: View of E&S controls in segment 5. Facing east.

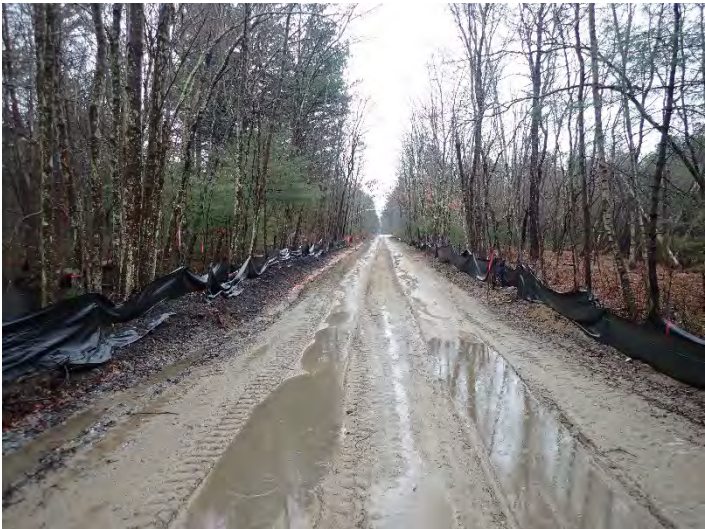
Epsilon ASSOCIATES INC.		PHOTOGRAPHIC LOG	
Client Name: Eversource		Site Location: Sudbury to Hudson Transmission Reliability Project	Town: Hudson
Photo No.: 5	Date: 3-29-2024

Description: View of E&S controls in segment 6. Facing east.

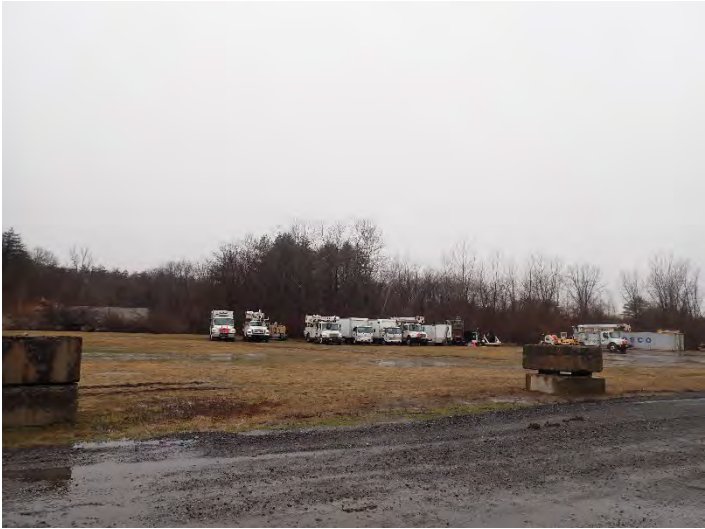
Epsilon ASSOCIATES INC.		PHOTOGRAPHIC LOG	
Client Name: Eversource		Site Location: Sudbury to Hudson Transmission Reliability Project	Town: Hudson
Photo No.: 6	Date: 3-29-2024

Description: View of Haugland's laydown yard on Perkin's property. Facing west.

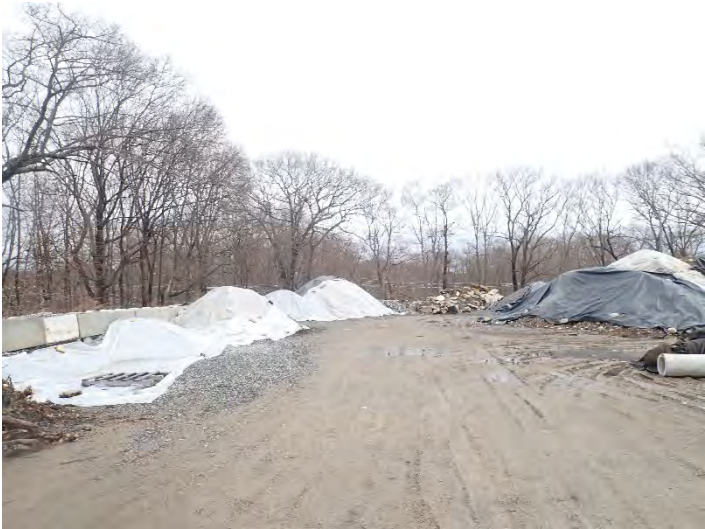
Epsilon ASSOCIATES INC.		PHOTOGRAPHIC LOG	
Client Name: Eversource		Site Location: Sudbury to Hudson Transmission Reliability Project	Town: Hudson
Photo No.: 7	Date: 3-29-2024

Description: View of Stowe Ct laydown yard. Facing northeast.

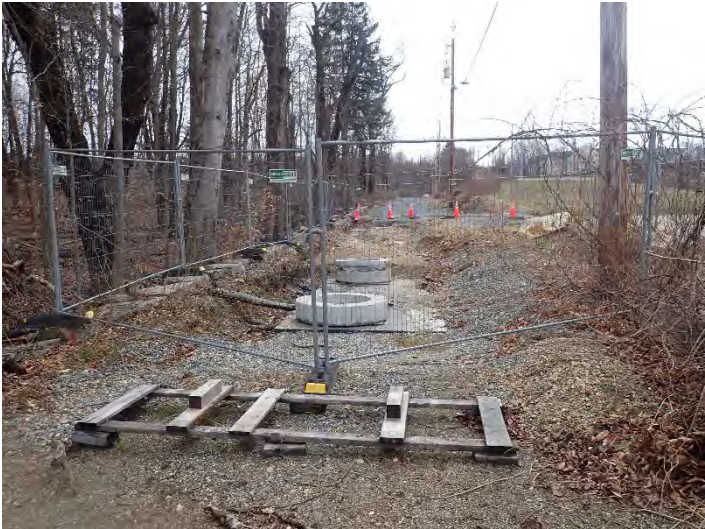
Epsilon ASSOCIATES INC.		PHOTOGRAPHIC LOG	
Client Name: Eversource		Site Location: Sudbury to Hudson Transmission Reliability Project	Town: Hudson
Photo No.: 8	Date: 3-29-2024

Description: View of MH #1 at Hudson Light & Power. Facing north.

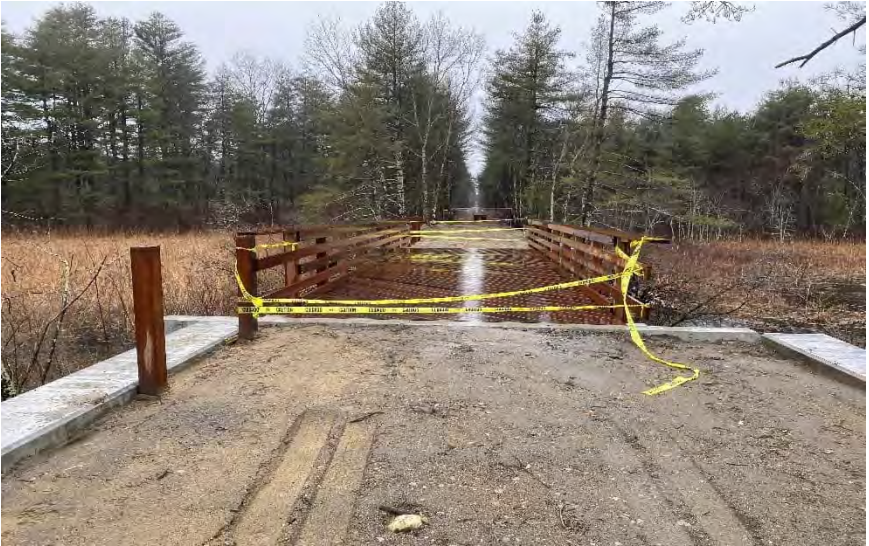
PHOTOGRAPHIC LOG	
Client Name: Eversource		Site Location: Sudbury to Hudson Transmission Reliability Project	Town: Sudbury
Photo No.: 1	Date: 3-29-24

Description: Work area within segment 8, bridge 128, looking westward.

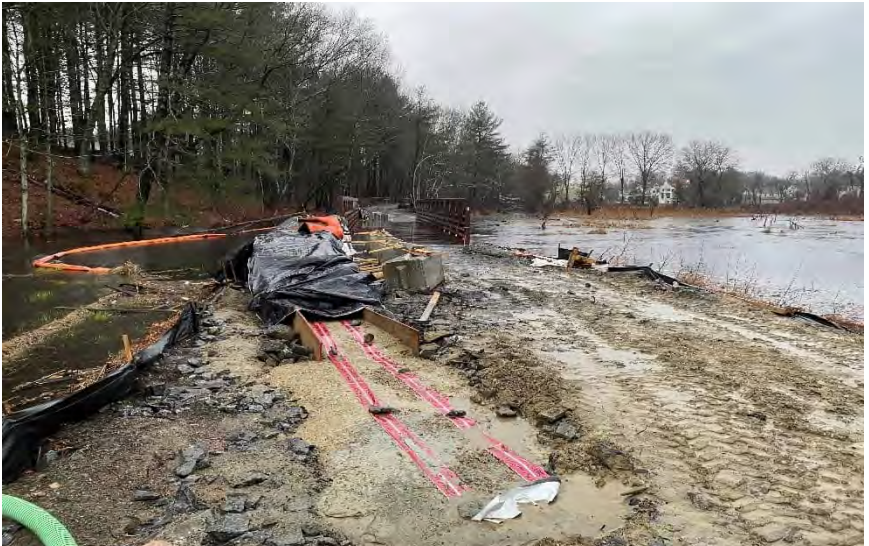
PHOTOGRAPHIC LOG	
Client Name: Eversource		Site Location: Sudbury to Hudson Transmission Reliability Project	Town: Sudbury
Photo No.: 2	Date: 3-29-24

Description: Work area within segment 14 looking across Hop Brook into segment 13, Bridge 127, existing erosion control, post-conduit work, looking westward.

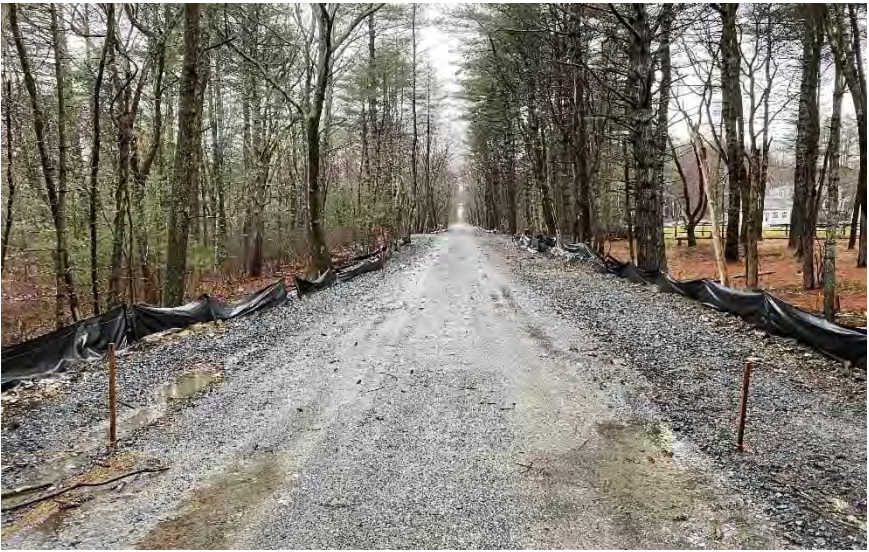
PHOTOGRAPHIC LOG	
Client Name: Eversource		Site Location: Sudbury to Hudson Transmission Reliability Project	Town: Sudbury
Photo No.: 4	Date: 3-29-24

Description: Work area within segment 9, existing erosion control, looking westward.

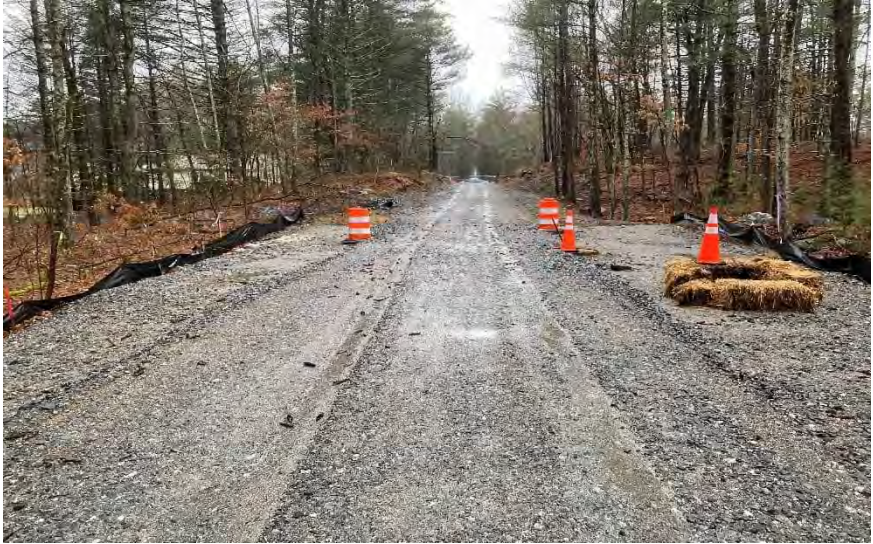
PHOTOGRAPHIC LOG	
Client Name: Eversource		Site Location: Sudbury to Hudson Transmission Reliability Project	Town: Sudbury
Photo No.: 5	Date: 3-29-24

Description: Work area within segment 10, at manhole #20, existing erosion control, looking westward.

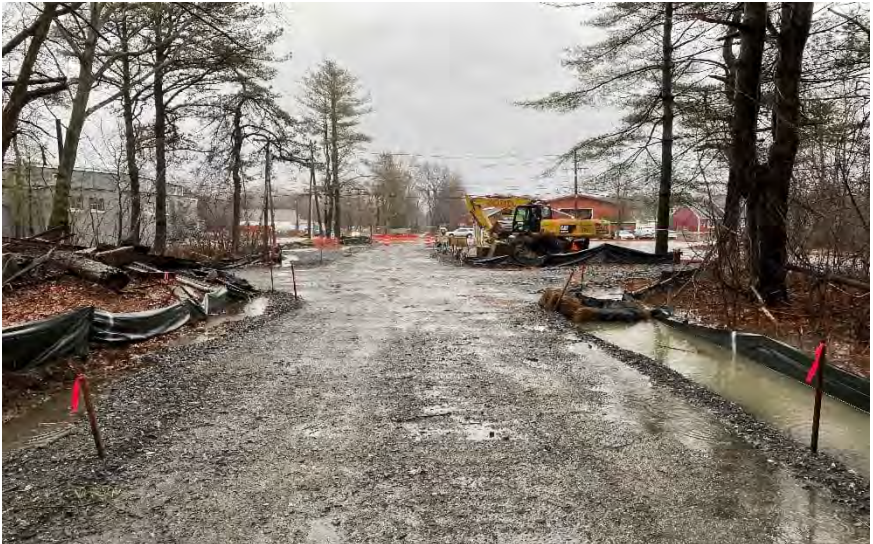
PHOTOGRAPHIC LOG	
Client Name: Eversource		Site Location: Sudbury to Hudson Transmission Reliability Project	Town: Sudbury
Photo No.: 6	Date: 3-29-24

Description: Work area within segment 11 (diamond junction area), existing erosion control, looking eastward.

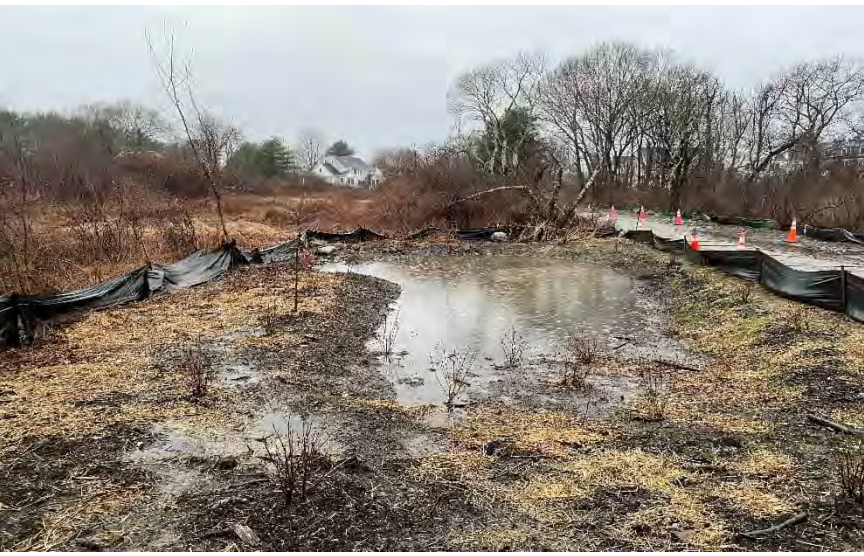
PHOTOGRAPHIC LOG	
Client Name: Eversource		Site Location: Sudbury to Hudson Transmission Reliability Project	Town: Sudbury
Photo No.: 8	Date: 3-28-24

Description: Wetland replication area within segment 14, existing erosion control, looking westward.

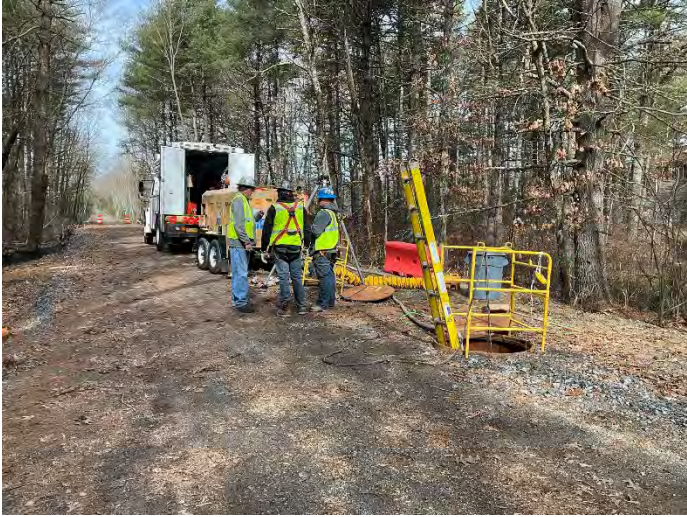
PHOTOGRAPHIC LOG	
Client Name: Eversource		Site Location: Sudbury to Hudson Transmission Reliability Project	Town: Hudson
Photo No.: 1	Date: 3/25/2024

Description: View of Haugland working at MH #13. Facing west.

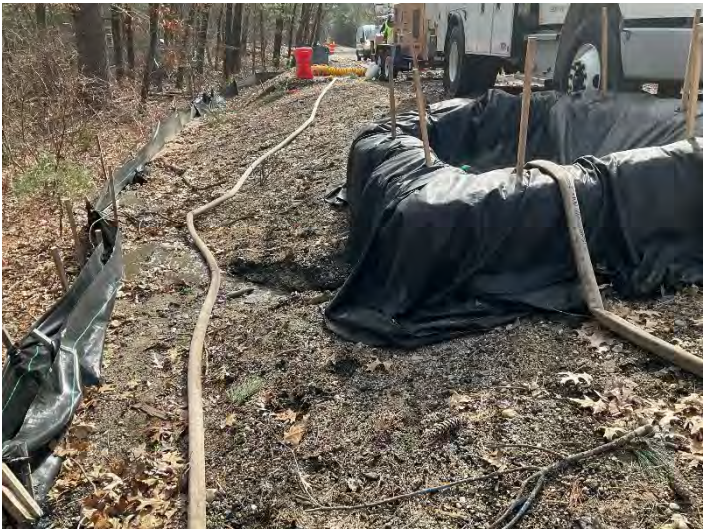
PHOTOGRAPHIC LOG	
Client Name: Eversource		Site Location: Sudbury to Hudson Transmission Reliability Project	Town: Hudson
Photo No.: 4	Date: 3/25/2024

Description: View of dewatering controls (straw bale corral with filter fabric and silt bag) and discharge from project. Discharge appeared slightly turbid. Turbidity reading was higher than 50 NTUs, but discharge did not reach any jurisdictional areas. Facing east.

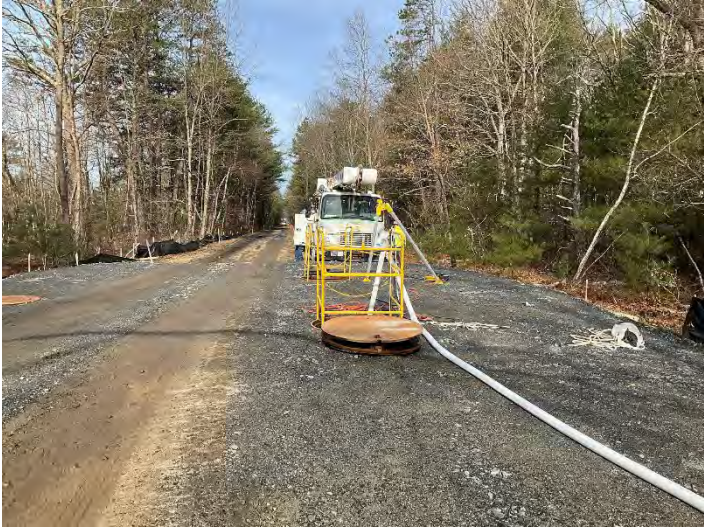
PHOTOGRAPHIC LOG	
Client Name: Eversource		Site Location: Sudbury to Hudson Transmission Reliability Project	Town: Hudson
Photo No.: 1	Date: 3/25/2024

Description: View of pumping operation at MH #14 in segment 6. Facing west.

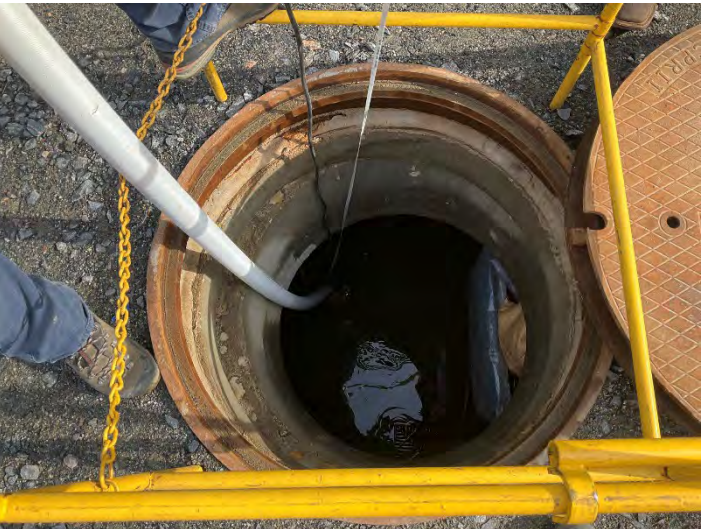
PHOTOGRAPHIC LOG	
Client Name: Eversource		Site Location: Sudbury to Hudson Transmission Reliability Project	Town: Hudson
Photo No.: 2	Date: 3/25/2024

Description: View of pump in MH #14. Water appeared mostly clear prior to treatment.

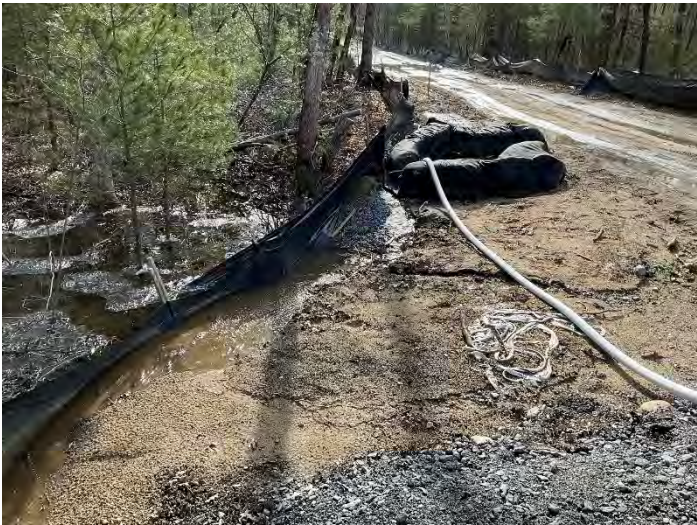
PHOTOGRAPHIC LOG	
Client Name: Eversource		Site Location: Sudbury to Hudson Transmission Reliability Project	Town: Hudson
Photo No.: 4	Date: 3/25/2024

Description: View of dewatering controls (straw bale corral with filter fabric and silt bag) and discharge from project. Discharge appeared mostly clear and turbidity reading was below 50 NTUs. Facing east.

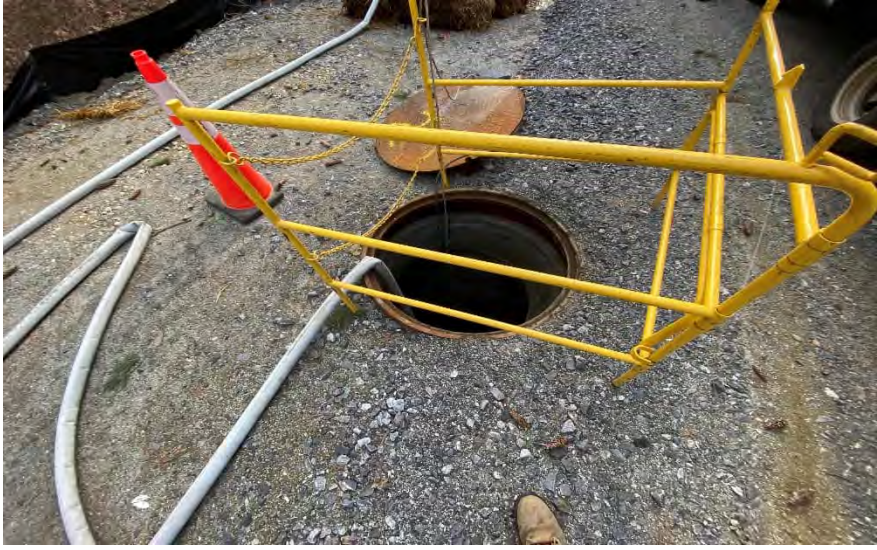
PHOTOGRAPHIC LOG	
Client Name: Eversource		Site Location: Sudbury to Hudson Transmission Reliability Project	Town: Sudbury
Photo No.: 1	Date: 3/25/2024

Description: View of area being pumped from manhole #20, segment 10.
