Weekly Environmental Compliance Summary

Sudbury to Hudson Transmission Reliability Project (USEPA Tracking # MAR1003UW)

Sudbury, Hudson, and Stow, MA

Week of: March 25, 2024 to March 30, 2024

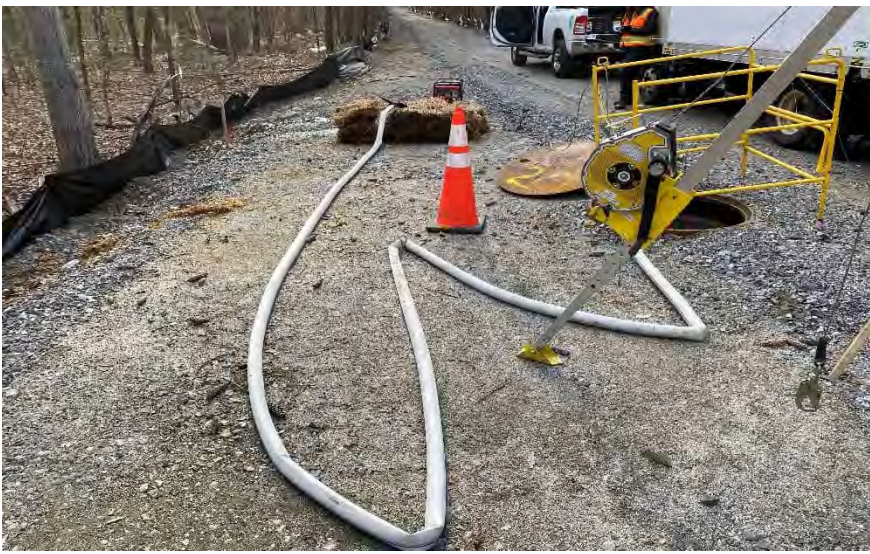
PHOTOGRAPHIC LOG	
Client Name: Eversource		Site Location: Sudbury to Hudson Transmission Reliability Project	Town: Sudbury
Photo No.: 2	Date: 3/25/2024

Description: Manhole #20. View of dewatering operation. Looking eastward.

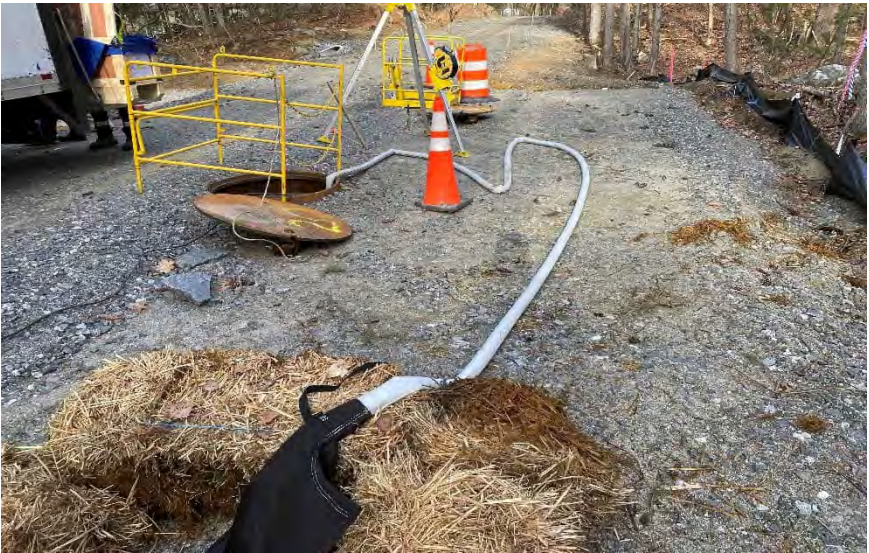
PHOTOGRAPHIC LOG	
Client Name: Eversource		Site Location: Sudbury to Hudson Transmission Reliability Project	Town: Sudbury
Photo No.: 3	Date: 3/25/2024

Description: Manhole #20. View of dewatering operation, looking westward.

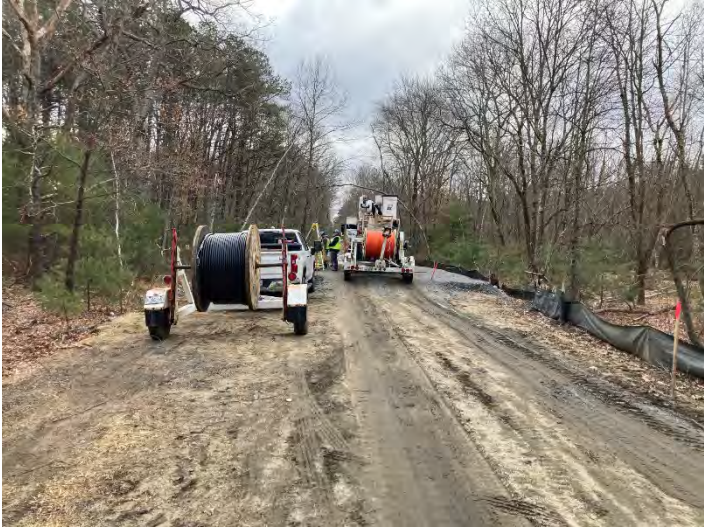
PHOTOGRAPHIC LOG		
Client Name: Eversource		Site Location: Sudbury to Hudson Transmission Reliability Project		Town: Hudson
Photo No.: 1	Date: 3/26/2024

Description: View of pumping operation at MH #14 in segment 6. Facing east.

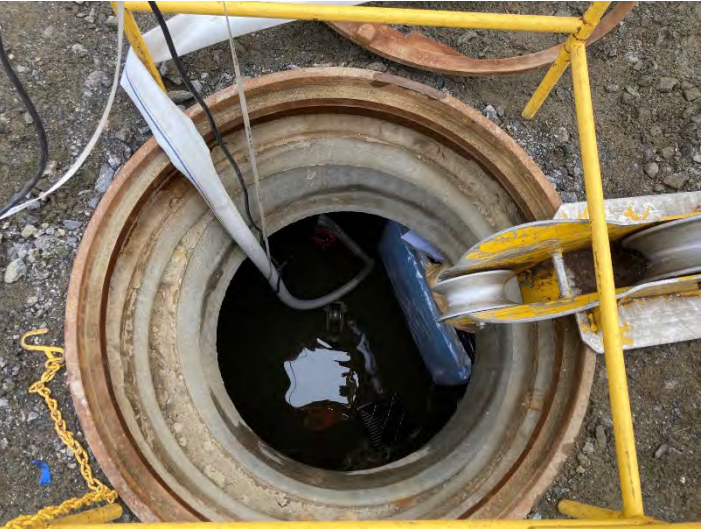
PHOTOGRAPHIC LOG		
Client Name: Eversource		Site Location: Sudbury to Hudson Transmission Reliability Project		Town: Hudson
Photo No.: 2	Date: 3/26/2024

Description: View of pump in MH #14. Water appeared mostly clear prior to treatment.

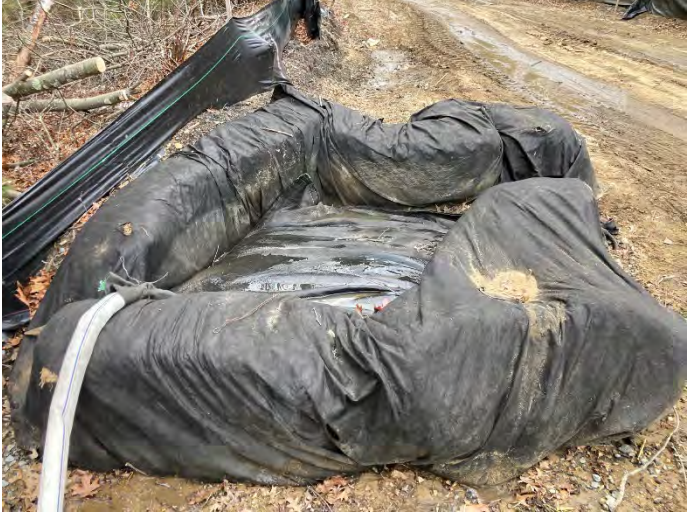
PHOTOGRAPHIC LOG	
Client Name: Eversource		Site Location: Sudbury to Hudson Transmission Reliability Project	Town: Hudson
Photo No.: 3	Date: 3/26/2024

Description: View of dewatering controls (straw bale corral with filter fabric and silt bag). Facing east.

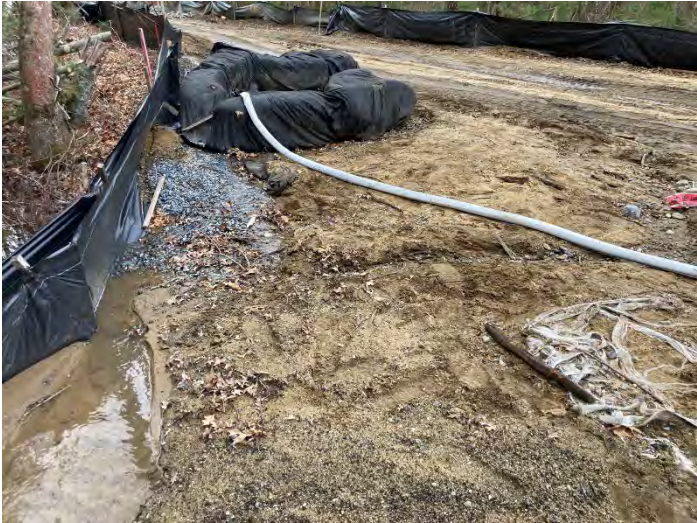
PHOTOGRAPHIC LOG	
Client Name: Eversource		Site Location: Sudbury to Hudson Transmission Reliability Project	Town: Hudson
Photo No.: 4	Date: 3/26/2024

Description: View of dewatering controls (straw bale corral with filter fabric and silt bag) and discharge from project. Discharge appeared mostly clear and turbidity reading was below 50 NTUs. Facing east.

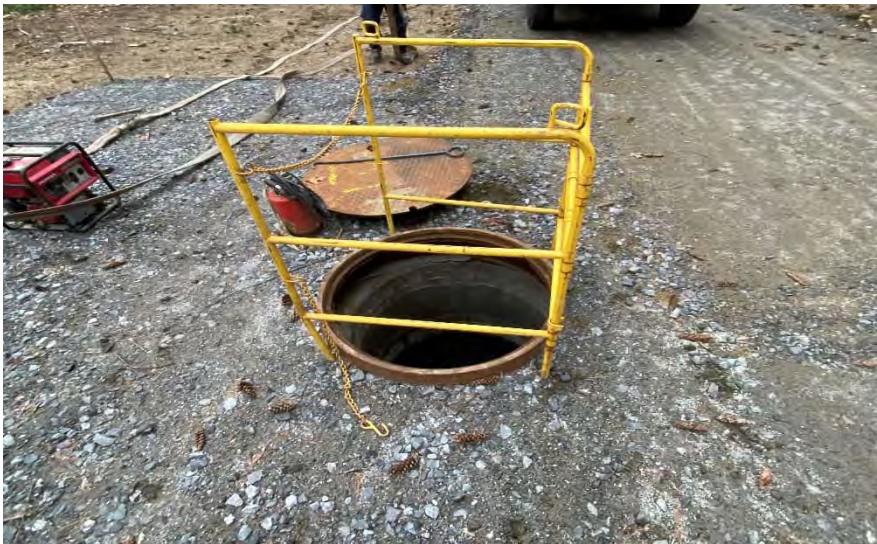
PHOTOGRAPHIC LOG	
Client Name: Eversource		Site Location: Sudbury to Hudson Transmission Reliability Project	Town: Sudbury
Photo No.: 1	Date: 3/26/2024

Description: View of area being pumped from manhole #21, segment 10.

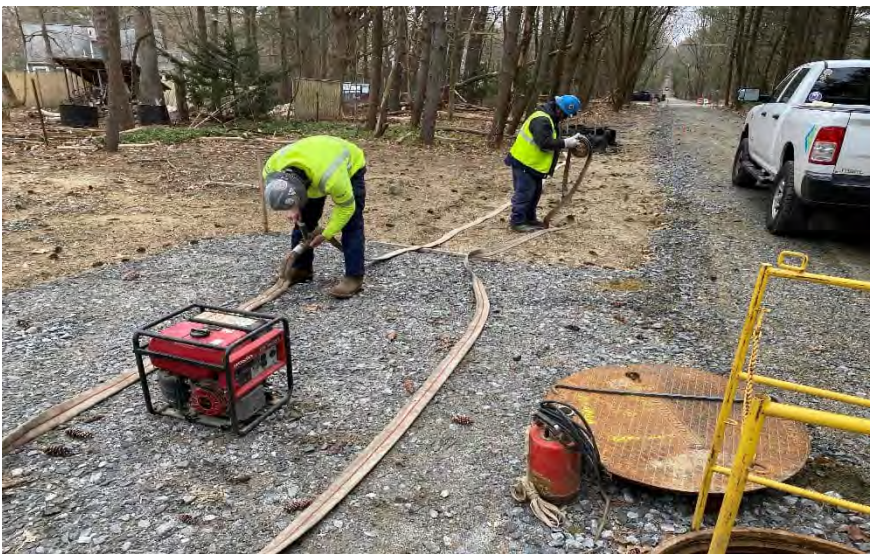
PHOTOGRAPHIC LOG	
Client Name: Eversource		Site Location: Sudbury to Hudson Transmission Reliability Project	Town: Sudbury
Photo No.: 2	Date: 3/26/2024

Description: Manhole #21. View of dewatering operation. Looking eastward.

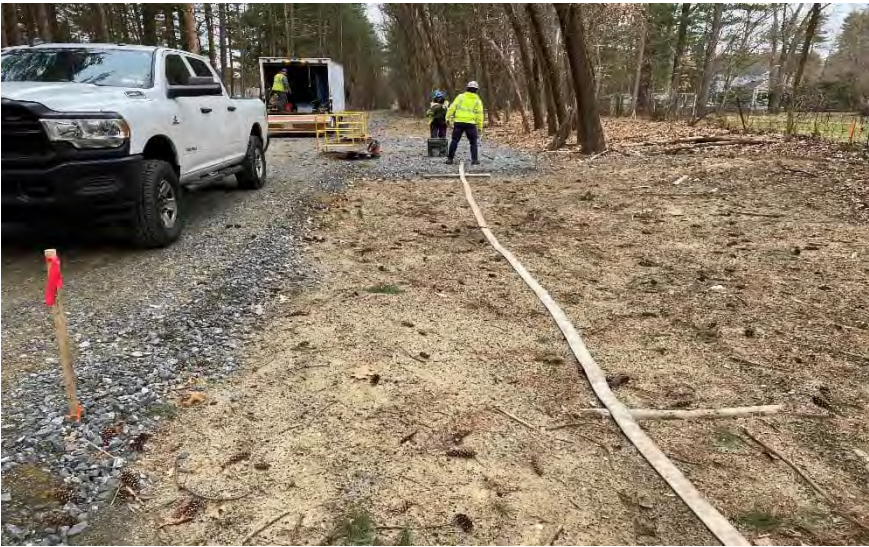
PHOTOGRAPHIC LOG	
Client Name: Eversource		Site Location: Sudbury to Hudson Transmission Reliability Project	
Town: Sudbury			
Photo No.: 3	Date: 3/26/2024

Description: Manhole #21. View of dewatering operation, looking westward.

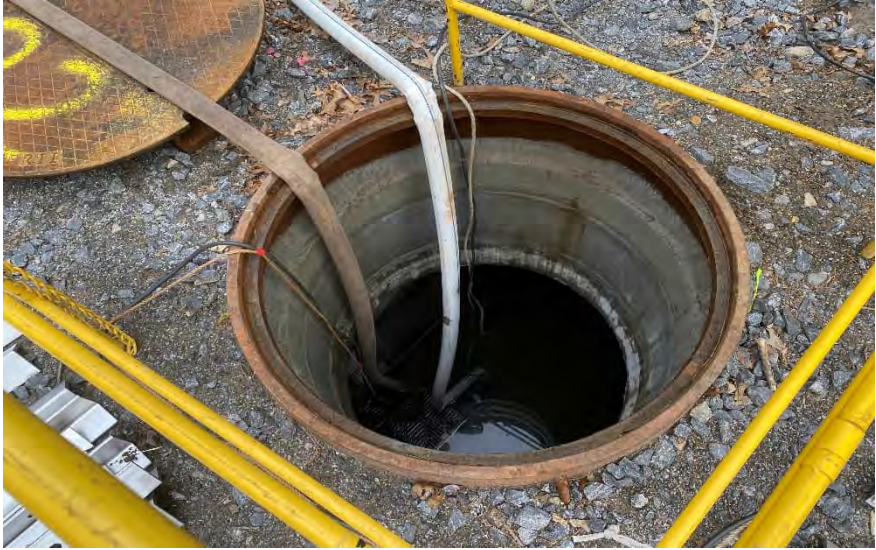
PHOTOGRAPHIC LOG	
Client Name: Eversource		Site Location: Sudbury to Hudson Transmission Reliability Project	Town: Sudbury
Photo No.: 1	Date: 3/26/2024

Description: View of area being pumped from manhole #22, segment 11.

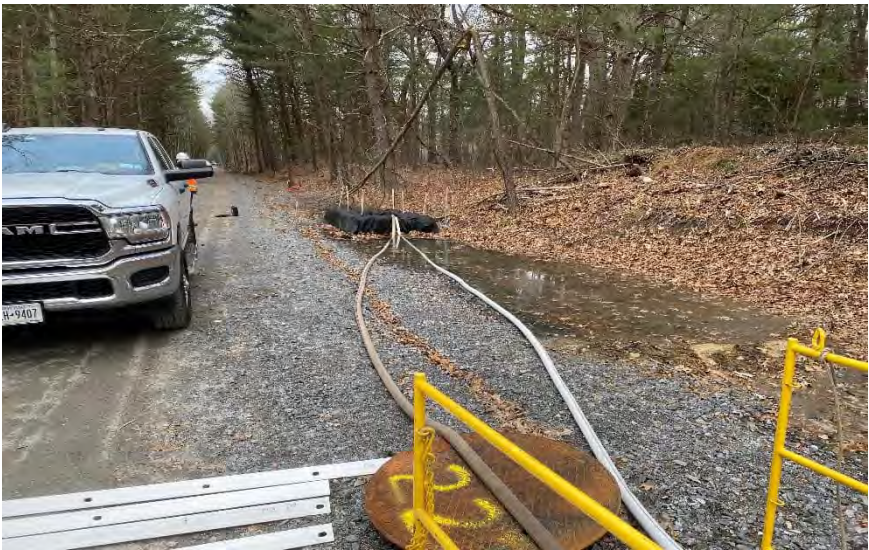
PHOTOGRAPHIC LOG	
Client Name: Eversource		Site Location: Sudbury to Hudson Transmission Reliability Project	Town: Sudbury
Photo No.: 2	Date: 3/26/2024

Description: Manhole #22. View of dewatering operation. Looking westward.

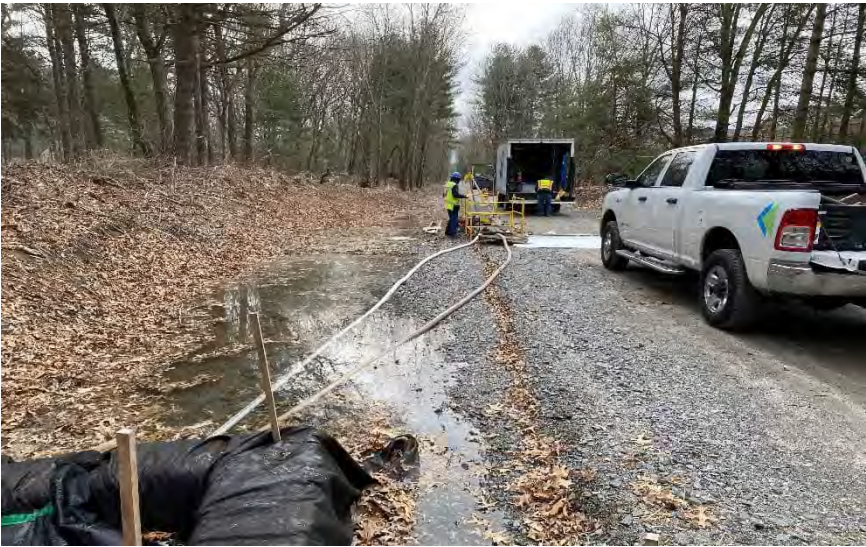
PHOTOGRAPHIC LOG	
Client Name: Eversource		Site Location: Sudbury to Hudson Transmission Reliability Project	
Town: Sudbury			
Photo No.: 3	Date: 3/26/2024

Description: Manhole #22. View of dewatering operation, looking eastward.

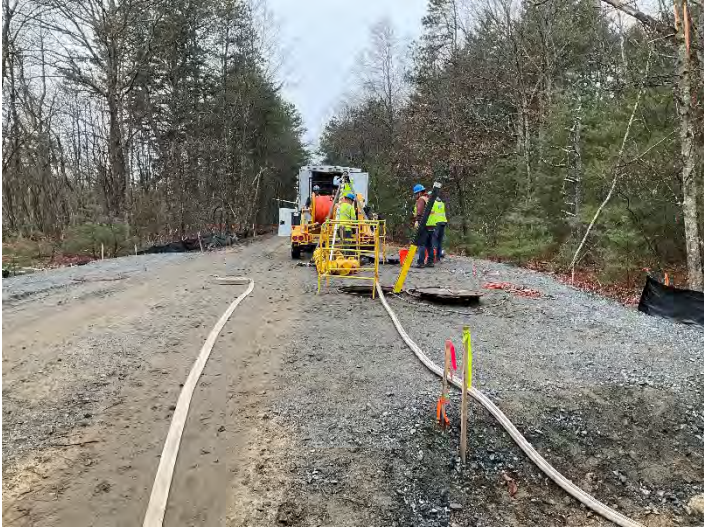
PHOTOGRAPHIC LOG	
Client Name: Eversource		Site Location: Sudbury to Hudson Transmission Reliability Project	Town: Hudson
Photo No.: 1	Date: 3/27/2024

Description: View of pumping operation at MH #14 in segment 6. Facing east.

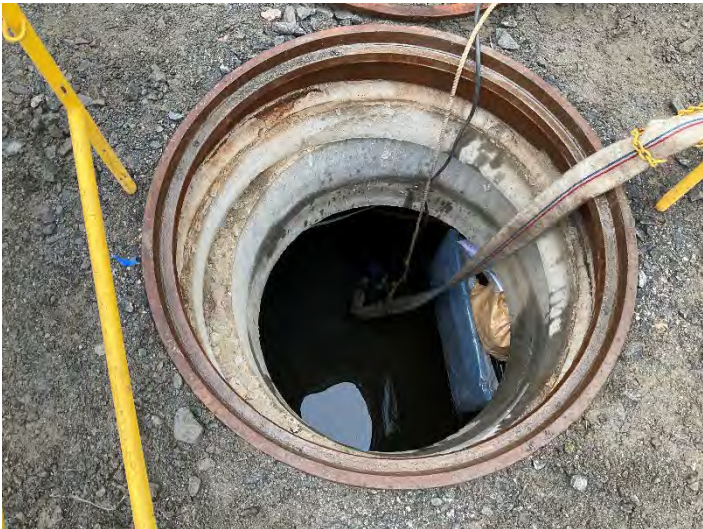
PHOTOGRAPHIC LOG	
Client Name: Eversource		Site Location: Sudbury to Hudson Transmission Reliability Project	Town: Hudson
Photo No.: 2	Date: 3/27/2024

Description: View of pump in MH #14. Water appeared mostly clear prior to treatment.

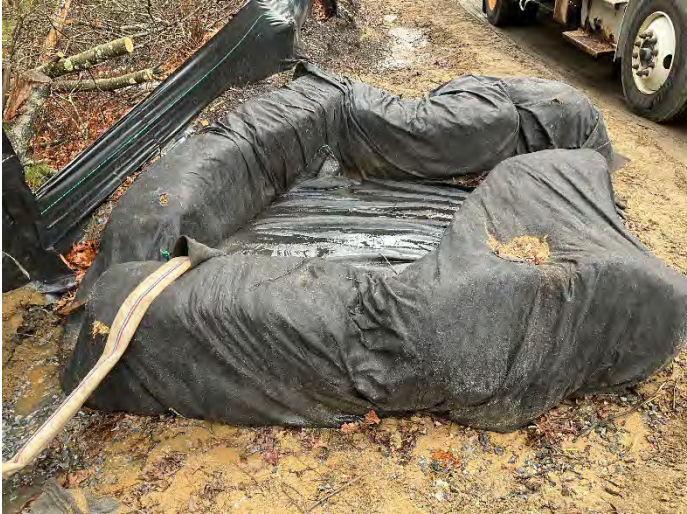
PHOTOGRAPHIC LOG	
Client Name: Eversource		Site Location: Sudbury to Hudson Transmission Reliability Project	Town: Hudson
Photo No.: 3	Date: 3/27/2024

Description: View of dewatering controls (straw bale corral with filter fabric and silt bag). Facing east.

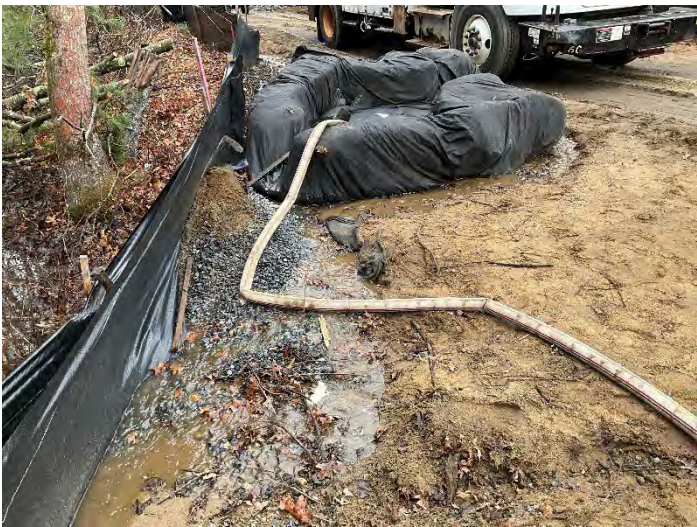
PHOTOGRAPHIC LOG	
Client Name: Eversource		Site Location: Sudbury to Hudson Transmission Reliability Project	Town: Hudson
Photo No.: 4	Date: 3/27/2024

Description: View of dewatering controls (straw bale corral with filter fabric and silt bag) and discharge from project. Discharge appeared mostly clear and turbidity reading was below 50 NTUs. Facing east.

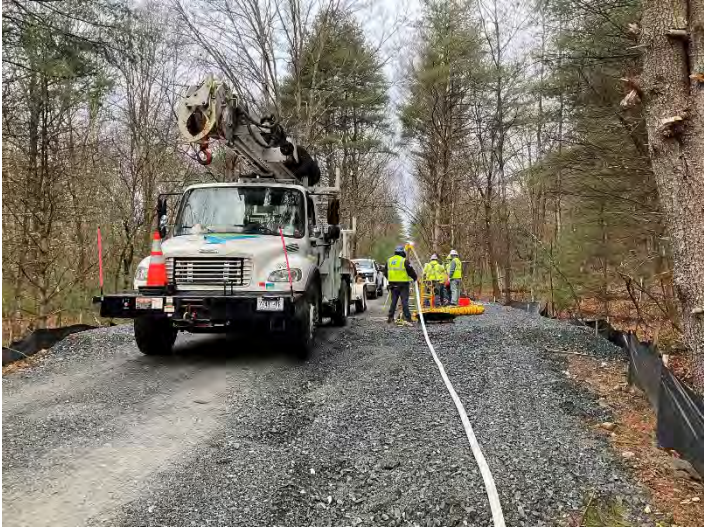
PHOTOGRAPHIC LOG	
Client Name: Eversource		Site Location: Sudbury to Hudson Transmission Reliability Project	
		Town: Sudbury	
Photo No.: 1	Date: 3/27/2024

Description: View of pumping operation at MH #15 in segment 7. Facing west.

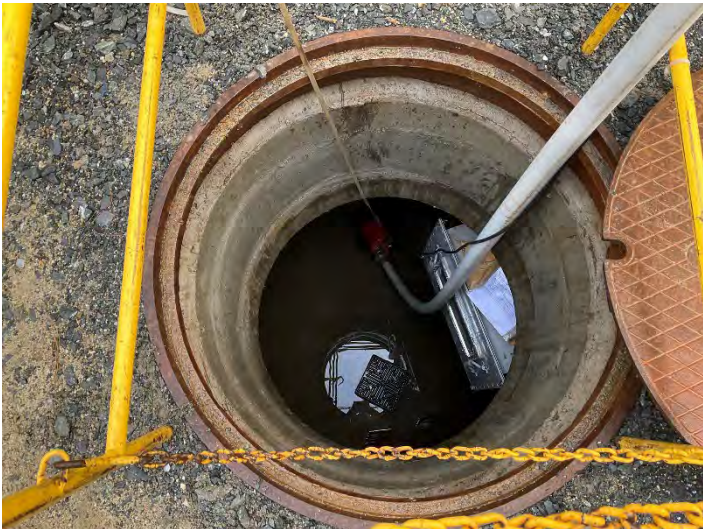
PHOTOGRAPHIC LOG	
Client Name: Eversource		Site Location: Sudbury to Hudson Transmission Reliability Project	
		Town: Sudbury	
Photo No.: 2	Date: 3/27/2024

Description: View of pump in MH #15. Water appeared mostly clear prior to treatment.

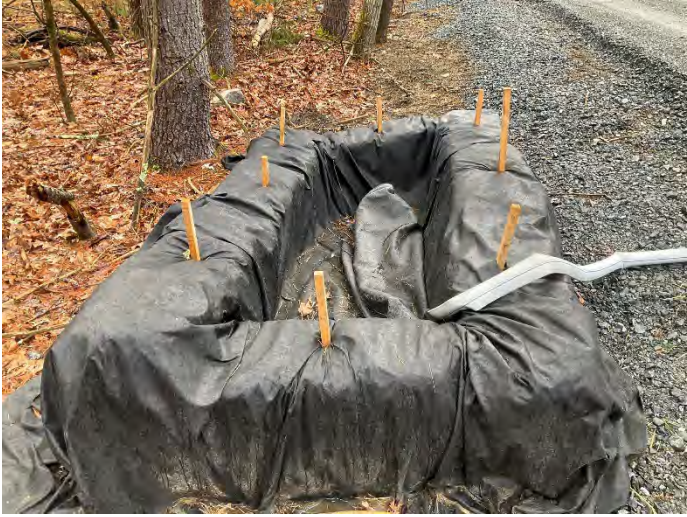
PHOTOGRAPHIC LOG	
Client Name: Eversource		Site Location: Sudbury to Hudson Transmission Reliability Project	
Town: Sudbury			
Photo No.: 3	Date: 3/27/2024

Description: View of dewatering controls (straw bale corral with filter fabric and silt bag). Facing east.

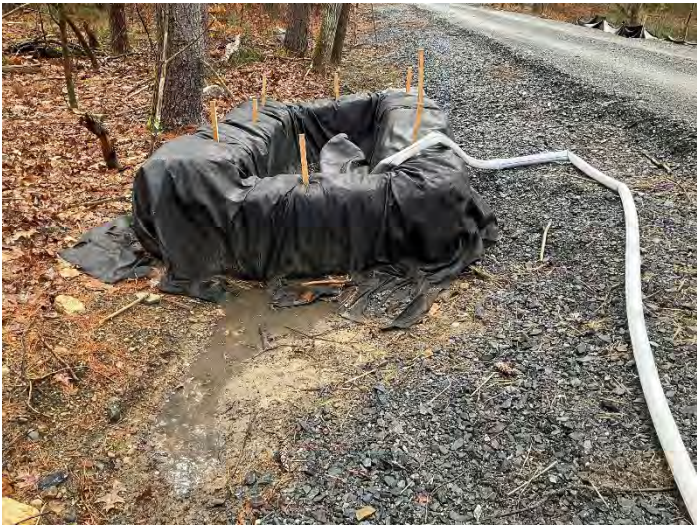
PHOTOGRAPHIC LOG	
Client Name: Eversource		Site Location: Sudbury to Hudson Transmission Reliability Project	
Town: Sudbury			
Photo No.: 4	Date: 3/27/2024

Description: View of dewatering controls (straw bale corral with filter fabric and silt bag) and discharge from project. Discharge appeared mostly clear and turbidity reading was below 50 NTUs. Facing east.

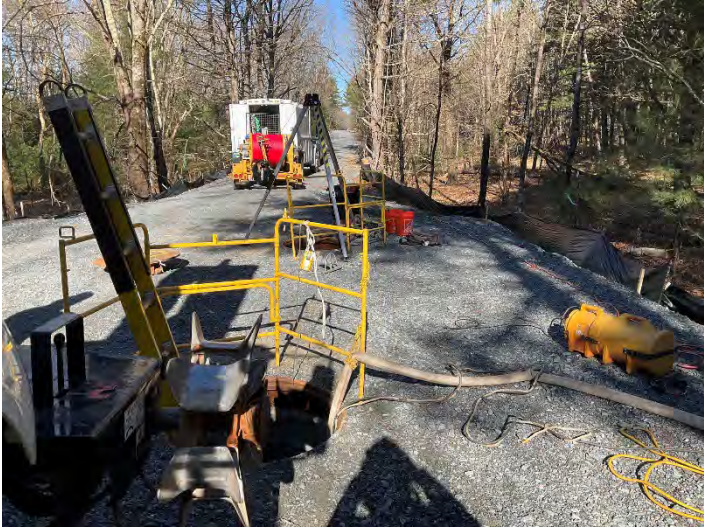
PHOTOGRAPHIC LOG		
Client Name: Eversource		Site Location: Sudbury to Hudson Transmission Reliability Project		Town: Sudbury
Photo No.: 1	Date: 3/30/2024

Description: View of pumping operation at MH #15 in segment 7. Facing west.

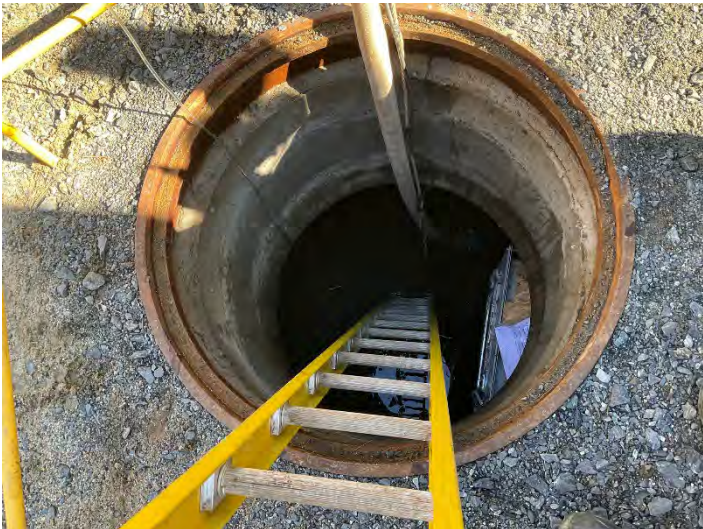
PHOTOGRAPHIC LOG		
Client Name: Eversource		Site Location: Sudbury to Hudson Transmission Reliability Project		Town: Sudbury
Photo No.: 2	Date: 3/30/2024

Description: View of pump in MH #15. Water appeared mostly clear prior to treatment.

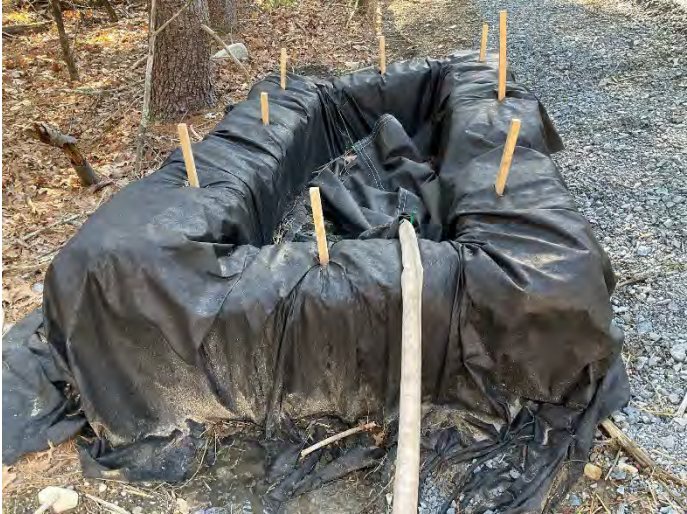
PHOTOGRAPHIC LOG	
Client Name: Eversource		Site Location: Sudbury to Hudson Transmission Reliability Project	Town: Sudbury
Photo No.: 3	Date: 3/30/2024

Description: View of dewatering controls (straw bale corral with filter fabric and silt bag). Facing east.

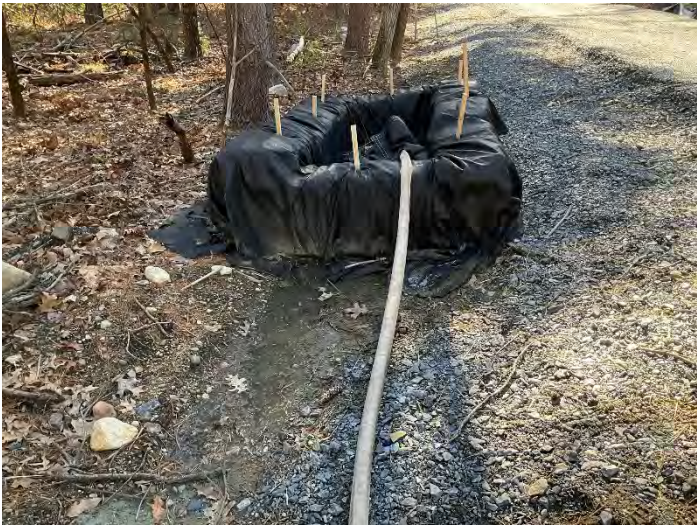
PHOTOGRAPHIC LOG	
Client Name: Eversource		Site Location: Sudbury to Hudson Transmission Reliability Project	Town: Sudbury
Photo No.: 4	Date: 3/30/2024

Description: View of dewatering controls (straw bale corral with filter fabric and silt bag) and discharge from project. Discharge appeared mostly clear and turbidity reading was below 50 NTUs. Facing east.

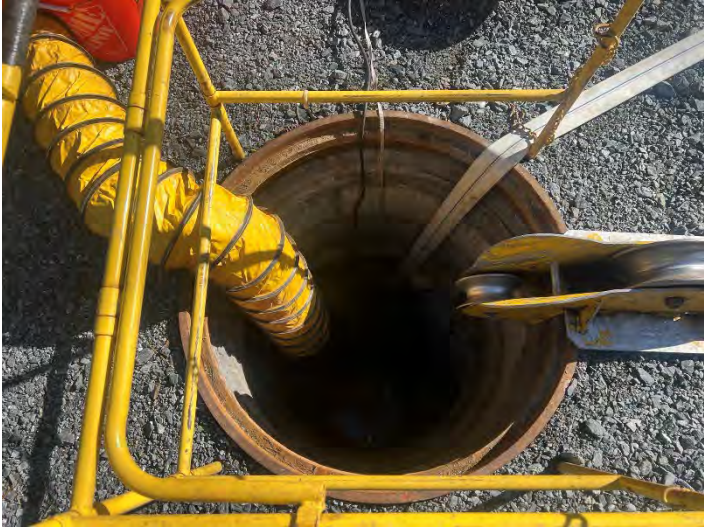
PHOTOGRAPHIC LOG		
Client Name: Eversource		Site Location: Sudbury to Hudson Transmission Reliability Project		Town: Sudbury
Photo No.: 1	Date: 3/30/2024

Description: View of pump in MH #16. Water appeared mostly clear prior to treatment.

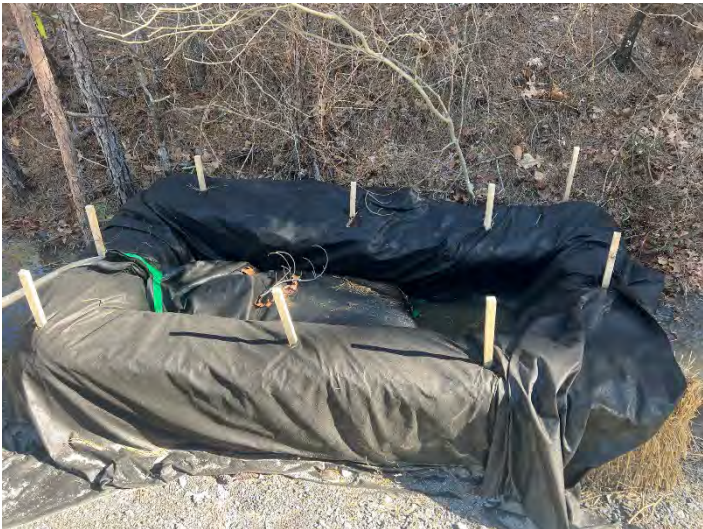
PHOTOGRAPHIC LOG		
Client Name: Eversource		Site Location: Sudbury to Hudson Transmission Reliability Project		Town: Sudbury
Photo No.: 2	Date: 3/30/2024

Description: View of dewatering controls (straw bale corral with filter fabric and silt bag). Facing north.

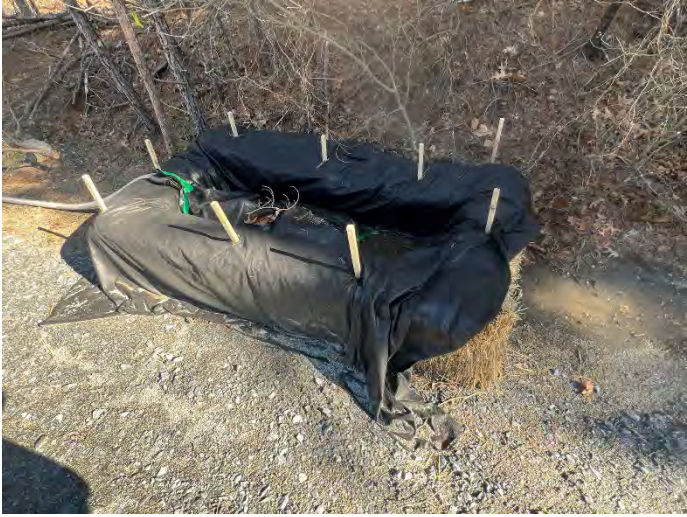
PHOTOGRAPHIC LOG	
Client Name: Eversource		Site Location: Sudbury to Hudson Transmission Reliability Project	Town: Sudbury
Photo No.: 3	Date: 3/30/2024

Description: View of dewatering controls (straw bale corral with filter fabric and silt bag) and discharge from corral. Facing north.

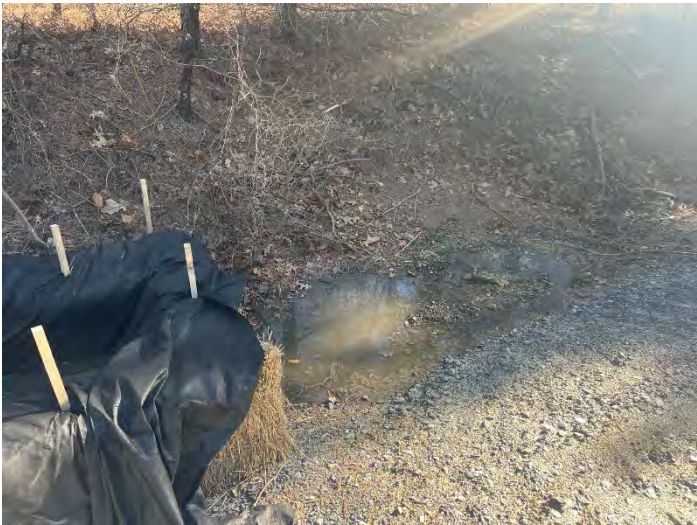
PHOTOGRAPHIC LOG	
Client Name: Eversource		Site Location: Sudbury to Hudson Transmission Reliability Project	Town: Sudbury
Photo No.: 4	Date: 3/30/2024

Description: Additional view of discharge from corral. Discharge appeared slightly turbid. Turbidity reading was slightly above 50 NTUs, but discharge did not reach jurisdictional areas. Facing north.

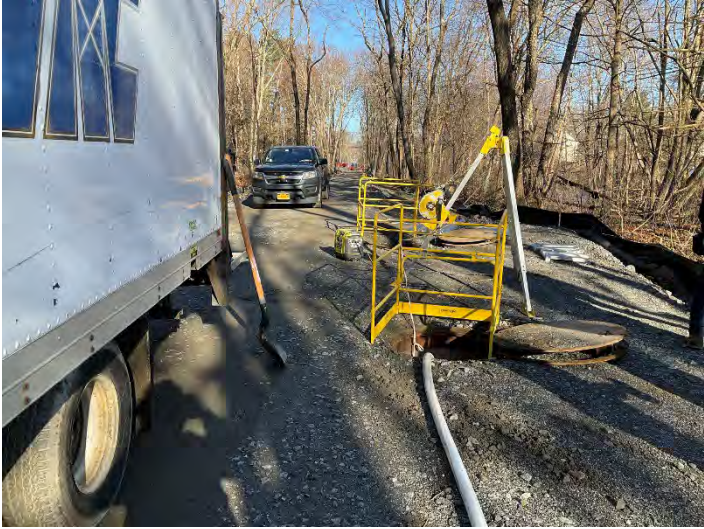
PHOTOGRAPHIC LOG	
Client Name: Eversource		Site Location: Sudbury to Hudson Transmission Reliability Project	Town: Sudbury
Photo No.: 1	Date: 3/30/2024

Description: View of Haugland working at MH #25 in segment 13. Facing west.

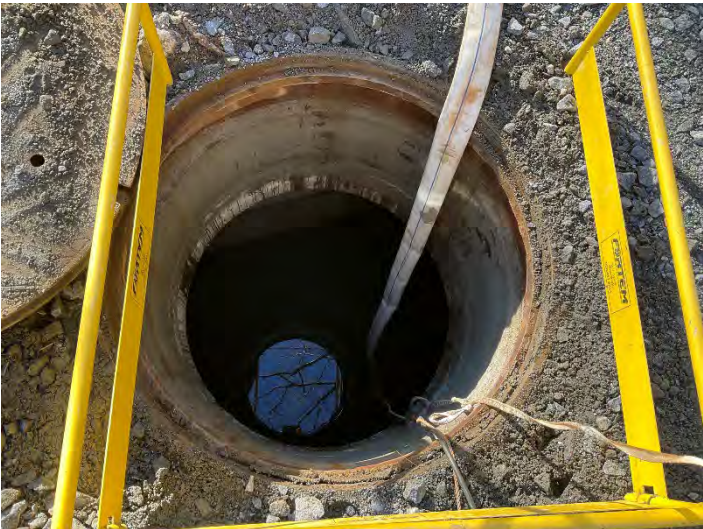
PHOTOGRAPHIC LOG	
Client Name: Eversource		Site Location: Sudbury to Hudson Transmission Reliability Project	Town: Sudbury
Photo No.: 2	Date: 3/30/2024

Description: View of pump in MH #25. Water appeared mostly clear prior to treatment.

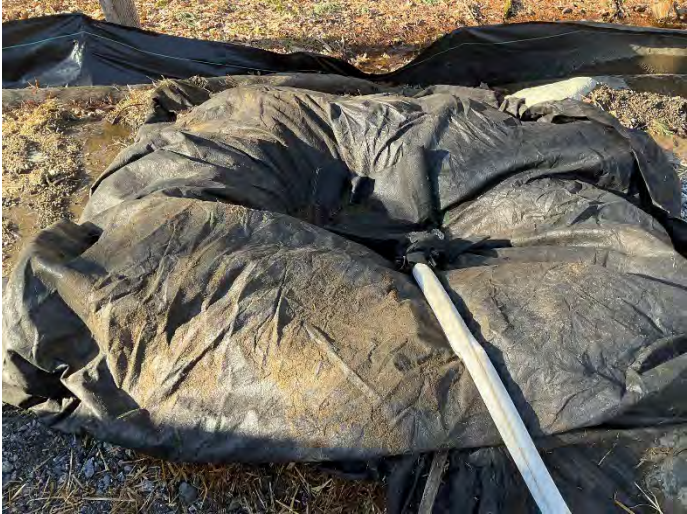
PHOTOGRAPHIC LOG		
Client Name: Eversource		Site Location: Sudbury to Hudson Transmission Reliability Project		Town: Sudbury
Photo No.: 3	Date: 3/30/2024

Description: View of dewatering controls (straw bale corral with filter fabric and silt bag). Facing south.

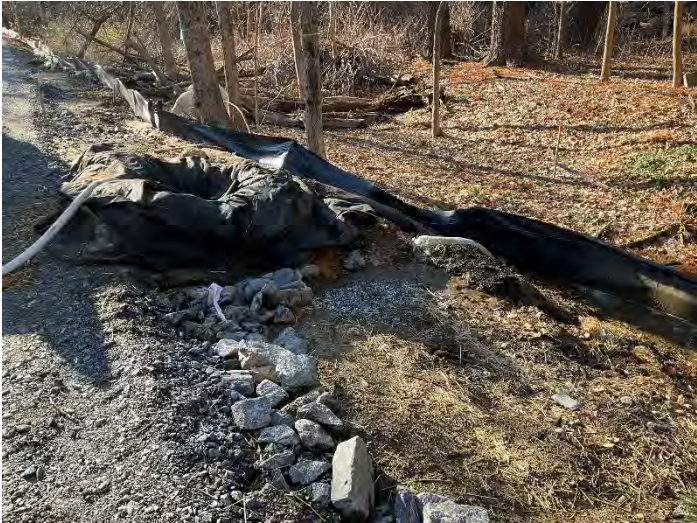
PHOTOGRAPHIC LOG		
Client Name: Eversource		Site Location: Sudbury to Hudson Transmission Reliability Project		Town: Sudbury
Photo No.: 4	Date: 3/30/2024

Description: View of dewatering controls (straw bale corral with filter fabric and silt bag) and discharge from corral. Discharge appeared mostly clear and turbidity was below 50 NTUs. Discharge did not reach jurisdictional areas. Facing southeast.

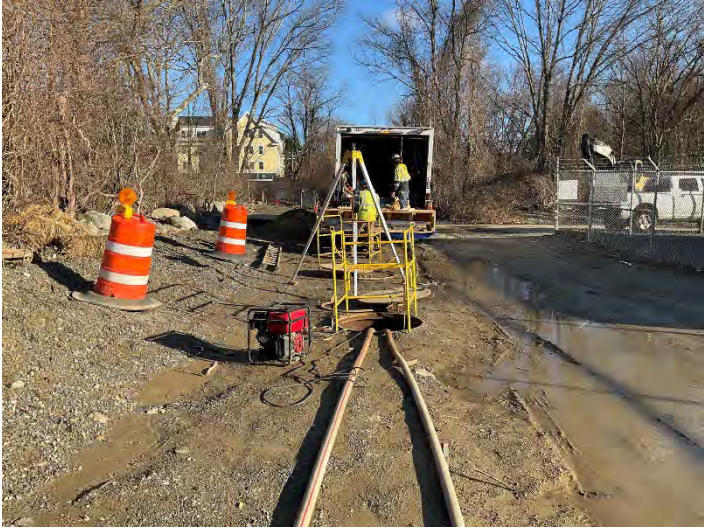
PHOTOGRAPHIC LOG		
Client Name: Eversource		Site Location: Sudbury to Hudson Transmission Reliability Project		Town: Sudbury
Photo No.: 1	Date: 3/30/2024

Description: View of Haugland working at MH #28 outside of Sudbury Substation. Facing north.

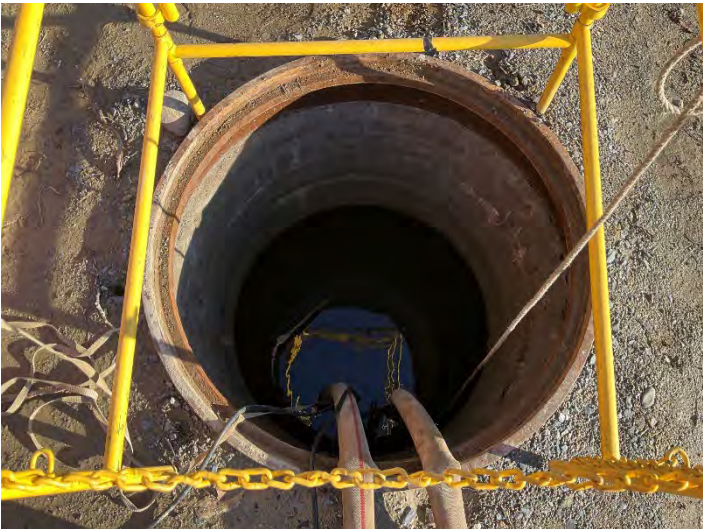
PHOTOGRAPHIC LOG		
Client Name: Eversource		Site Location: Sudbury to Hudson Transmission Reliability Project		Town: Sudbury
Photo No.: 2	Date: 3/30/2024

Description: View of pump in MH #28. Water appeared mostly clear prior to treatment.

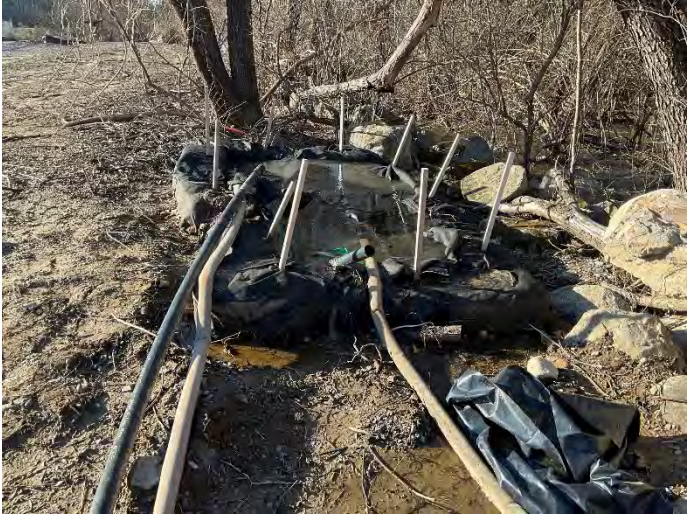
PHOTOGRAPHIC LOG	
Client Name: Eversource		Site Location: Sudbury to Hudson Transmission Reliability Project	
Town: Sudbury			
Photo No.: 3	Date: 3/30/2024

Description: View of dewatering controls (straw bale corral with filter fabric and silt bag). Facing south.

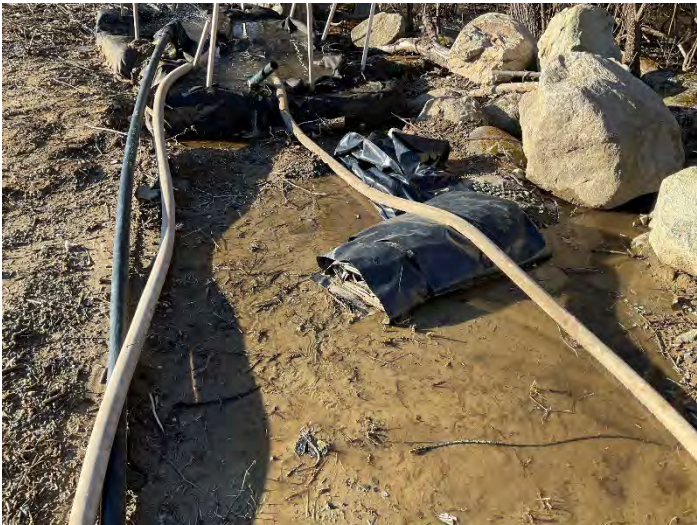
PHOTOGRAPHIC LOG	
Client Name: Eversource		Site Location: Sudbury to Hudson Transmission Reliability Project	
Town: Sudbury			
Photo No.: 4	Date: 3/30/2024

Description: View of dewatering controls (straw bale corral with filter fabric and silt bag) and discharge from corral. Discharge appeared mostly clear and turbidity was below 50 NTUs. Discharge did not reach jurisdictional areas. Facing south.
