Weekly Environmental Compliance Summary

Sudbury to Hudson Transmission Reliability Project (USEPA Tracking # MAR1003UW)

Sudbury, Hudson, and Stow, MA

Week of: April 1, 2024 to April 6, 2024

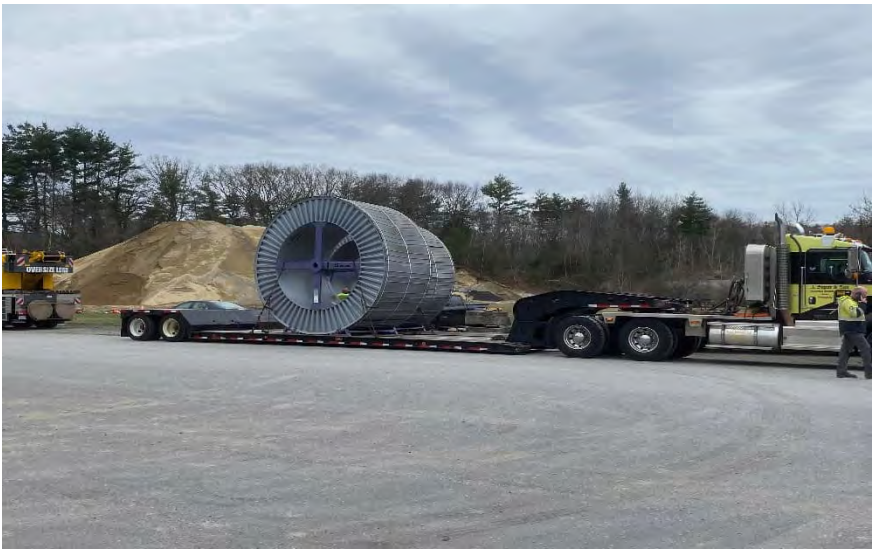
<p>PHOTOGRAPHIC LOG</p>	
<p>Client Name: Eversource</p>		<p>Site Location: Sudbury to Hudson Transmission Reliability Project</p>	<p>Town: Hudson</p>
<p>Photo No.: 6</p>	<p>Date: 4-1-24</p>

<p>Description:</p> <p>Haugland laydown yard off Main Street, delivery of cable, looking westward.</p>

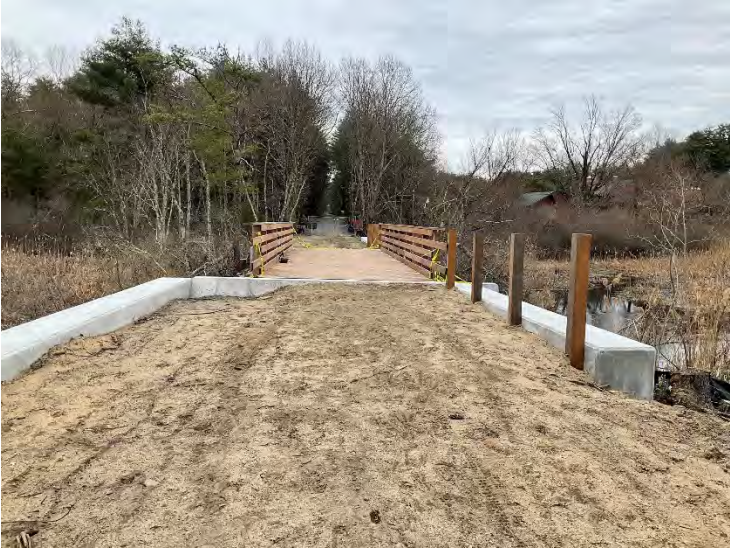
<p>PHOTOGRAPHIC LOG</p>	
<p>Client Name: Eversource</p>		<p>Site Location: Sudbury to Hudson Transmission Reliability Project</p>	<p>Town: Sudbury</p>
<p>Photo No.: 1</p>	<p>Date: 4/01/2024</p>

<p>Description: View of bridge 128. Facing east.</p>

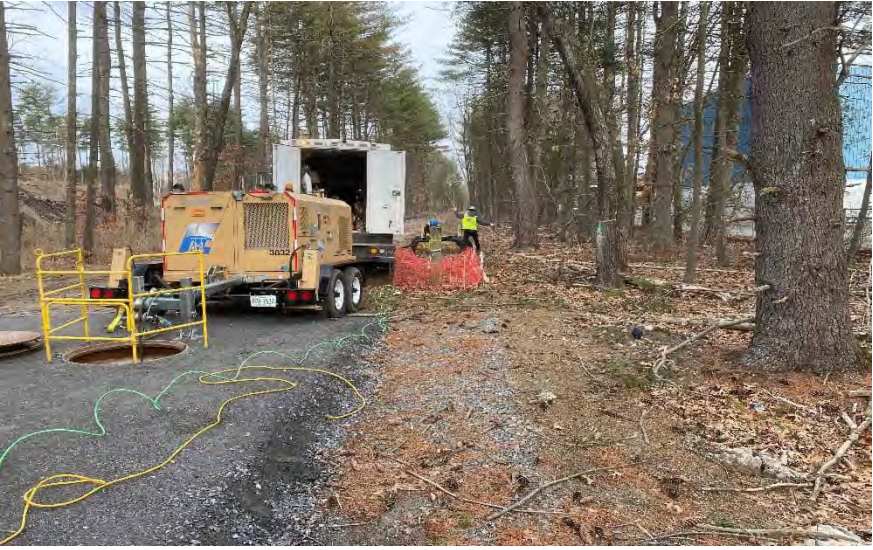
<p>PHOTOGRAPHIC LOG</p>	
<p>Client Name: Eversource</p>		<p>Site Location: Sudbury to Hudson Transmission Reliability Project</p>	<p>Town: Hudson</p>
<p>Photo No.: 1</p>	<p>Date: 4-2-24</p>

<p>Description:</p> <p>Work area within Segment 4, manhole #10, cable pulling work, looking westward.</p>

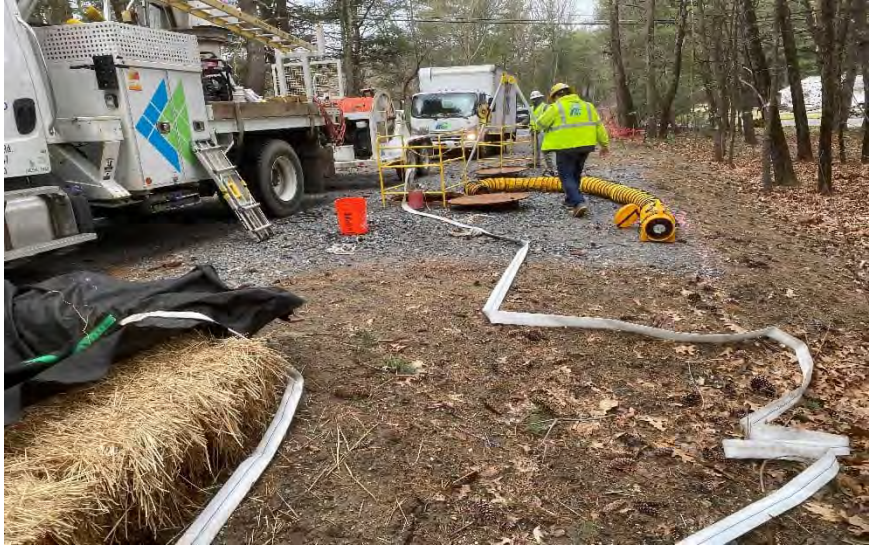
<p>PHOTOGRAPHIC LOG</p>	
<p>Client Name: Eversource</p>		<p>Site Location: Sudbury to Hudson Transmission Reliability Project</p>	<p>Town: Hudson</p>
<p>Photo No.: 2</p>	<p>Date: 4-2-24</p>

<p>Description:</p> <p>Work area within Segment 5, manhole #11, cable pulling work, looking westward.</p>

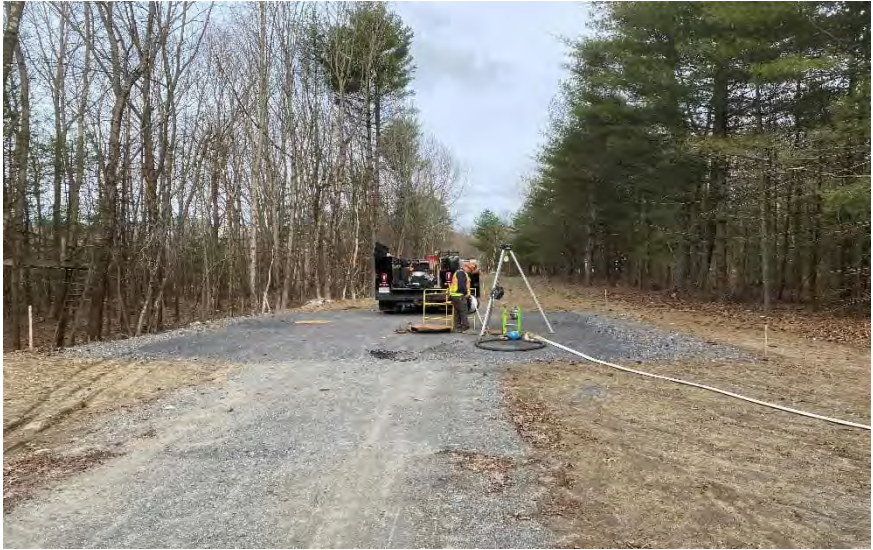
<p>PHOTOGRAPHIC LOG</p>	
<p>Client Name: Eversource</p>		<p>Site Location: Sudbury to Hudson Transmission Reliability Project</p>	<p>Town: Hudson</p>
<p>Photo No.: 3</p>	<p>Date: 4-2-24</p>

<p>Description:</p> <p>Work area within Segment 2, manhole #7, proofing work, looking westward.</p>

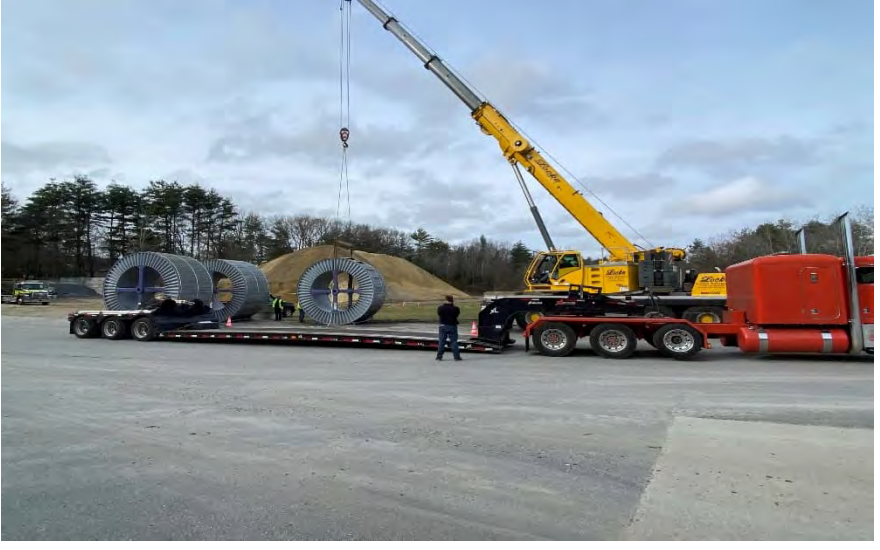
<p>PHOTOGRAPHIC LOG</p>	
<p>Client Name: Eversource</p>		<p>Site Location: Sudbury to Hudson Transmission Reliability Project</p>	<p>Town: Hudson</p>
<p>Photo No.: 6</p>	<p>Date: 4-2-24</p>

<p>Description: Haugland laydown yard off Main Street, delivery of cable, looking westward.</p>

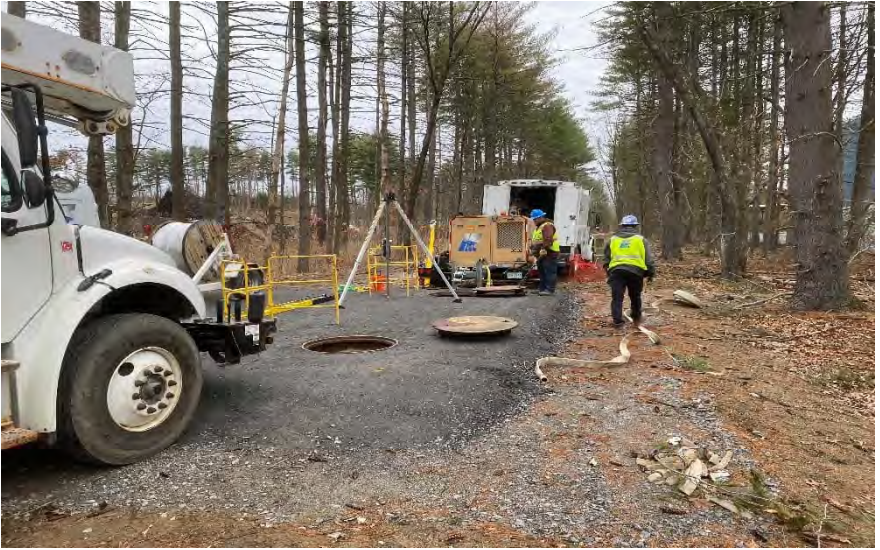
<p>PHOTOGRAPHIC LOG</p>	
<p>Client Name: Eversource</p>		<p>Site Location: Sudbury to Hudson Transmission Reliability Project</p>	<p>Town: Hudson</p>
<p>Photo No.: 1</p>	<p>Date: 4-3-24</p>

<p>Description:</p> <p>Work area within Segment 4, manhole #10, cable pulling work, looking westward.</p>

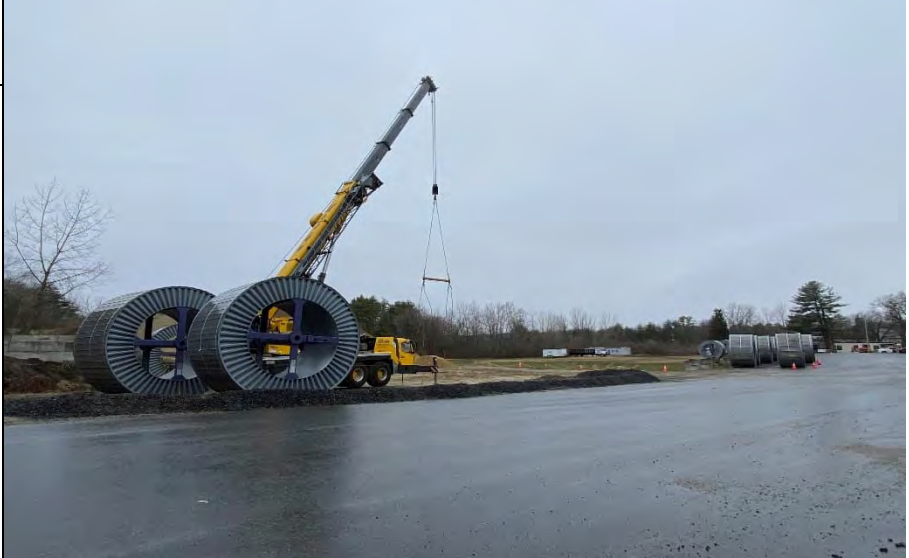
<p>PHOTOGRAPHIC LOG</p>	
<p>Client Name: Eversource</p>		<p>Site Location: Sudbury to Hudson Transmission Reliability Project</p>	<p>Town: Hudson</p>
<p>Photo No.: 6</p>	<p>Date: 4-3-24</p>

<p>Description:</p> <p>Laydown yard off Main Street, delivery of cable, looking westward.</p>

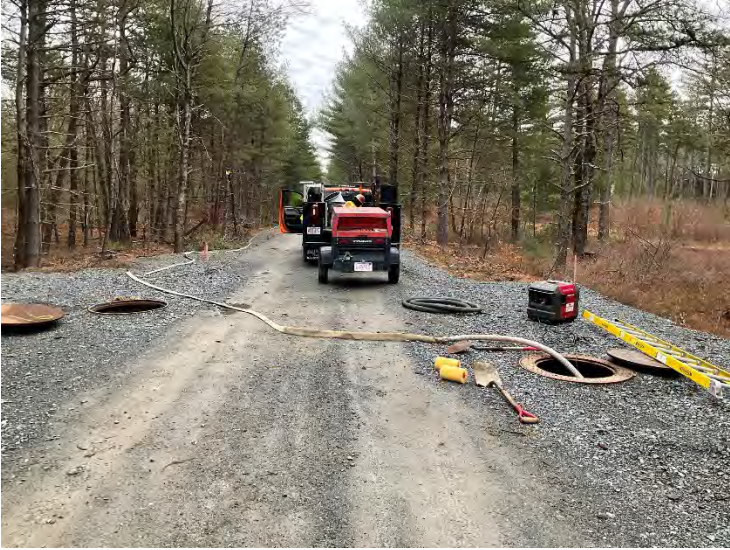
<p>PHOTOGRAPHIC LOG</p>	
<p>Client Name: Eversource</p>		<p>Site Location: Sudbury to Hudson Transmission Reliability Project</p>	<p>Town: Sudbury</p>
<p>Photo No.: 1</p>	<p>Date: 4/03/2024</p>

<p>Description: View of Bond working at MH #16 in segment 7. See additional dewatering inspection report. Facing east.</p>

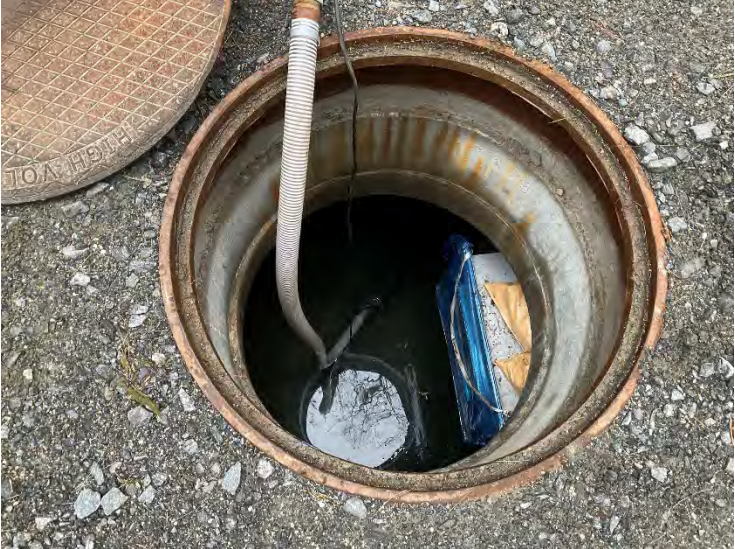
<p>PHOTOGRAPHIC LOG</p>	
<p>Client Name: Eversource</p>		<p>Site Location: Sudbury to Hudson Transmission Reliability Project</p>	<p>Town: Sudbury</p>
<p>Photo No.: 3</p>	<p>Date: 4/03/2024</p>

<p>Description: View of pump in MH #17 in segment 8. See additional dewatering inspection report.</p>

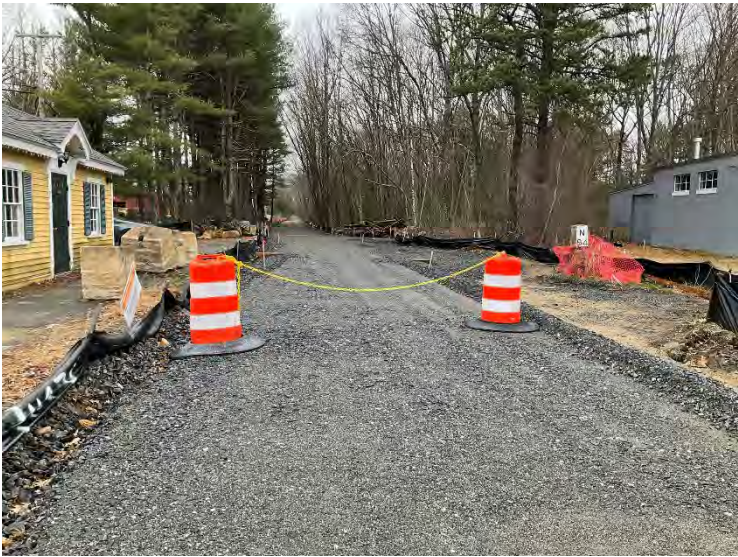
<p>PHOTOGRAPHIC LOG</p>	
<p>Client Name: Eversource</p>		<p>Site Location: Sudbury to Hudson Transmission Reliability Project</p>	<p>Town: Sudbury</p>
<p>Photo No.: 4</p>	<p>Date: 4/03/2024</p>

<p>Description: View of entrance to segment 11 off Union Ave. Barrels, chains, and flags are in place to demarcate vernal pool TOY restriction zones. Facing west.</p>

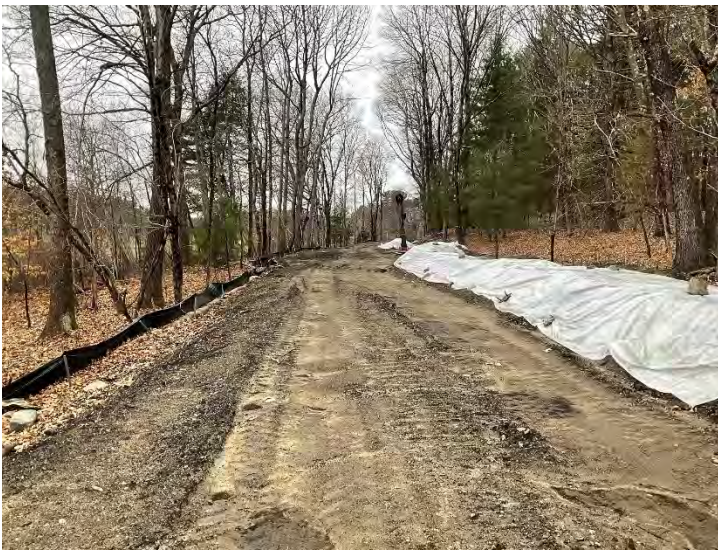
<p>PHOTOGRAPHIC LOG</p>	
<p>Client Name: Eversource</p>		<p>Site Location: Sudbury to Hudson Transmission Reliability Project</p>	<p>Town: Sudbury</p>
<p>Photo No.: 6</p>	<p>Date: 4/03/2024</p>

<p>Description: View of stockpile/spoil berm at Sta. #738 in segment 14. Facing west.</p>

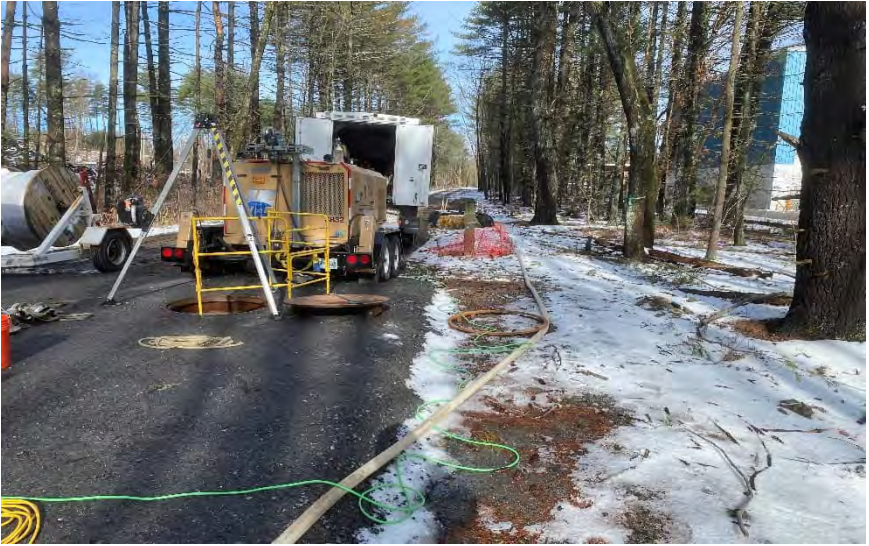
<p align="center">PHOTOGRAPHIC LOG</p>	
<p>Client Name: Eversource</p>		<p>Site Location: Sudbury to Hudson Transmission Reliability Project</p>	<p>Town: Hudson</p>
<p>Photo No.: 1</p>	<p>Date: 4-5-24</p>

<p>Description:</p> <p>Work area within Segment 4, manhole #10, cable pulling work, looking westward.</p>

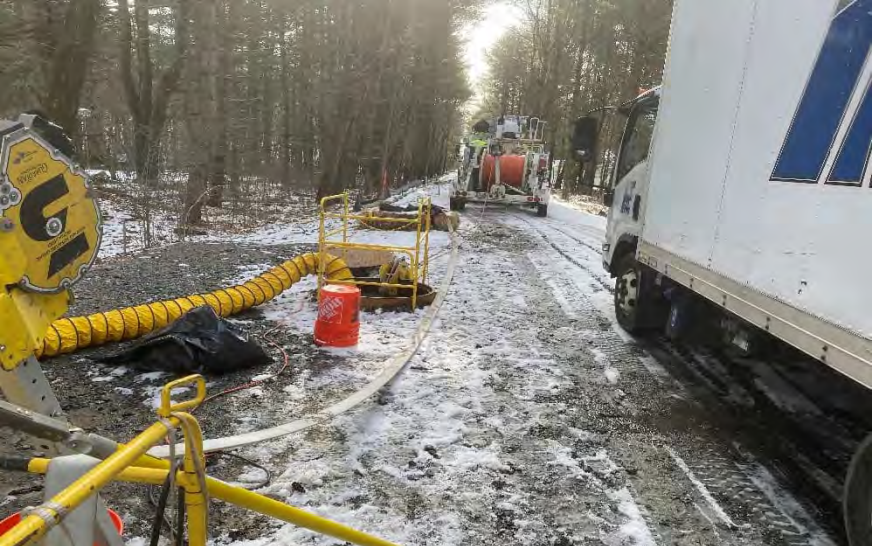
<p align="center">PHOTOGRAPHIC LOG</p>	
<p>Client Name: Eversource</p>		<p>Site Location: Sudbury to Hudson Transmission Reliability Project</p>	<p>Town: Hudson</p>
<p>Photo No.: 2</p>	<p>Date: 4-5-24</p>

<p>Description:</p> <p>Work area within Segment 5, manhole #11, cable pulling work, looking eastward.</p>

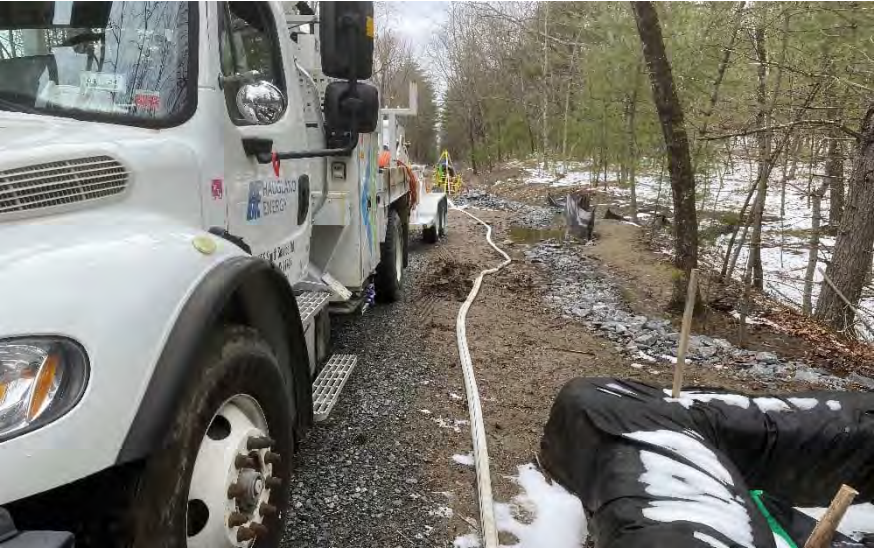
<p align="center">PHOTOGRAPHIC LOG</p>	
<p>Client Name: Eversource</p>		<p>Site Location: Sudbury to Hudson Transmission Reliability Project</p>	<p>Town: Hudson</p>
<p>Photo No.: 3</p>	<p>Date: 4-5-24</p>

<p>Description:</p> <p>Work area within Segment 5, manhole #12, cable pulling work, looking westward.</p>

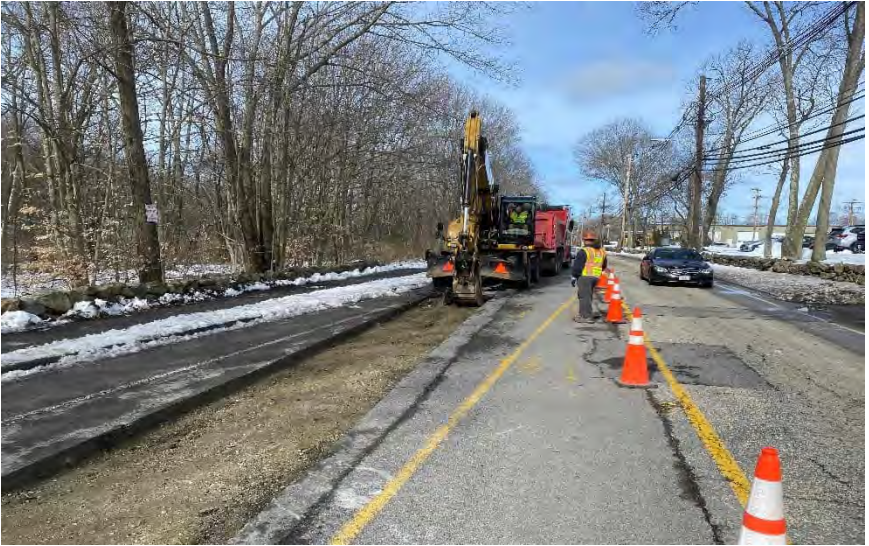
<p>PHOTOGRAPHIC LOG</p>	
<p>Client Name: Eversource</p>		<p>Site Location: Sudbury to Hudson Transmission Reliability Project</p>	<p>Town: Hudson</p>
<p>Photo No.: 7</p>	<p>Date: 4-5-24</p>

<p>Description:</p> <p>Conduit trench work within Forest Avenue, looking southward.</p>

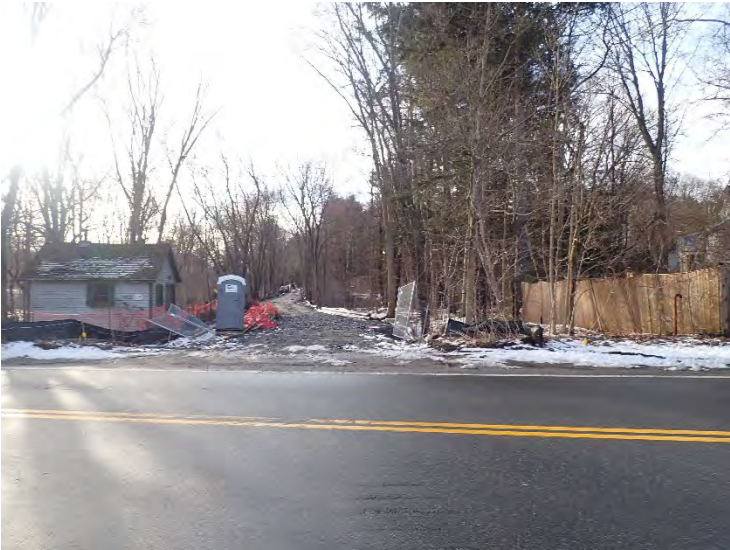
PHOTOGRAPHIC LOG	
Client Name: Eversource		Site Location: Sudbury to Hudson Transmission Reliability Project	Town: Sudbury
Photo No.: 1	Date: 4/05/2024

Description: View of construction entrance to segment 13 off Boston Post Road. Facing east.

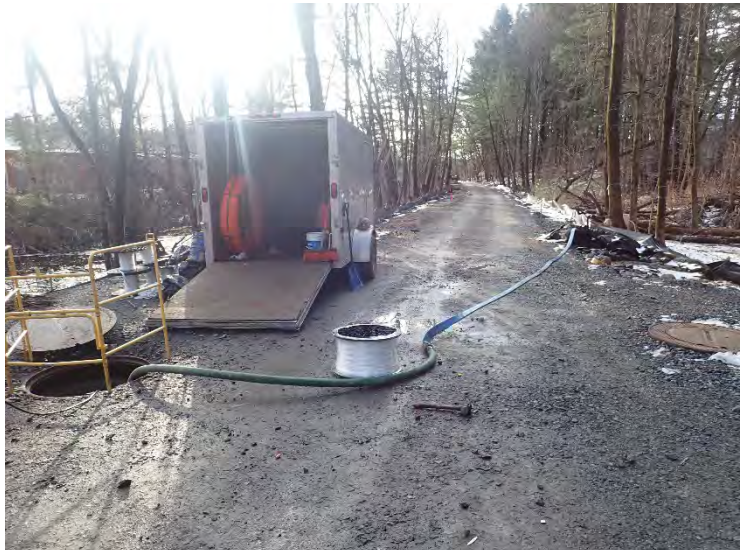
PHOTOGRAPHIC LOG	
Client Name: Eversource		Site Location: Sudbury to Hudson Transmission Reliability Project	Town: Sudbury
Photo No.: 2	Date: 4/05/2024

Description: View of Bond working at MH #25 in segment 13. See additional dewatering inspection report. Facing east.

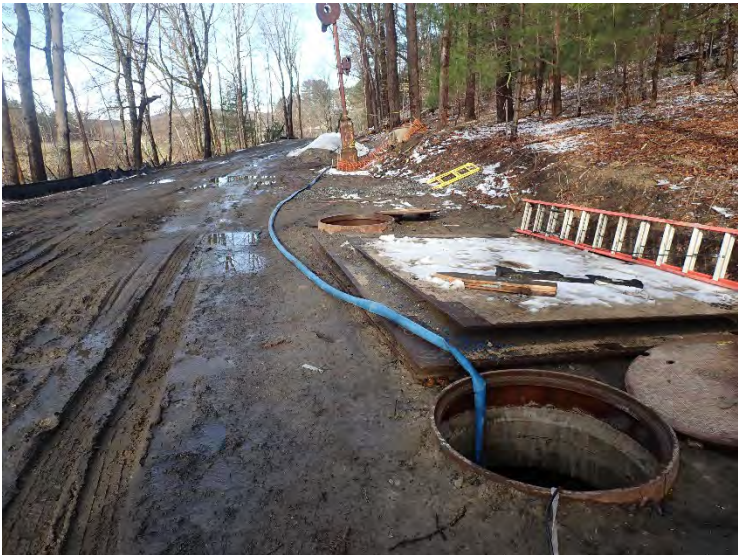
<p>PHOTOGRAPHIC LOG</p>	
<p>Client Name: Eversource</p>		<p>Site Location: Sudbury to Hudson Transmission Reliability Project</p>	<p>Town: Sudbury</p>
<p>Photo No.: 4</p>	<p>Date: 4/05/2024</p>

<p>Description: View of Bond working at MH #26 in segment 14. See additional dewatering inspection report. Facing west.</p>

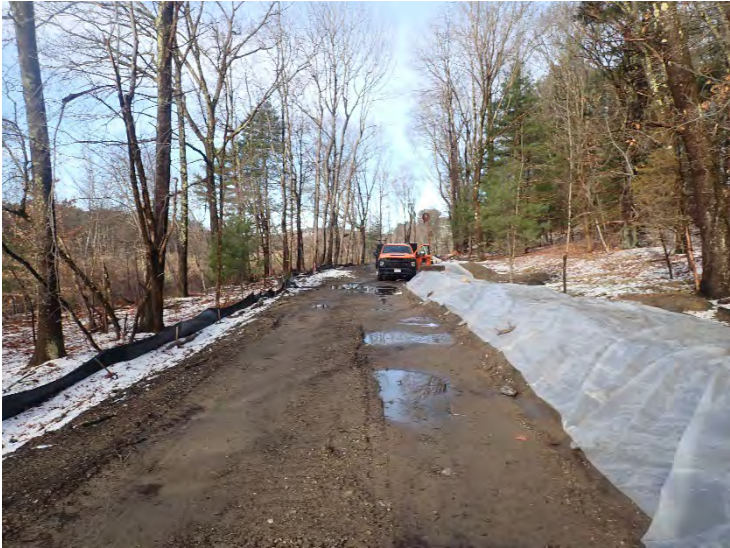
<p>PHOTOGRAPHIC LOG</p>	
<p>Client Name: Eversource</p>		<p>Site Location: Sudbury to Hudson Transmission Reliability Project</p>	<p>Town: Sudbury</p>
<p>Photo No.: 5</p>	<p>Date: 4/05/2024</p>

<p>Description: View of stockpile/spoil berm at Sta. #738 in segment 14. Facing west.</p>

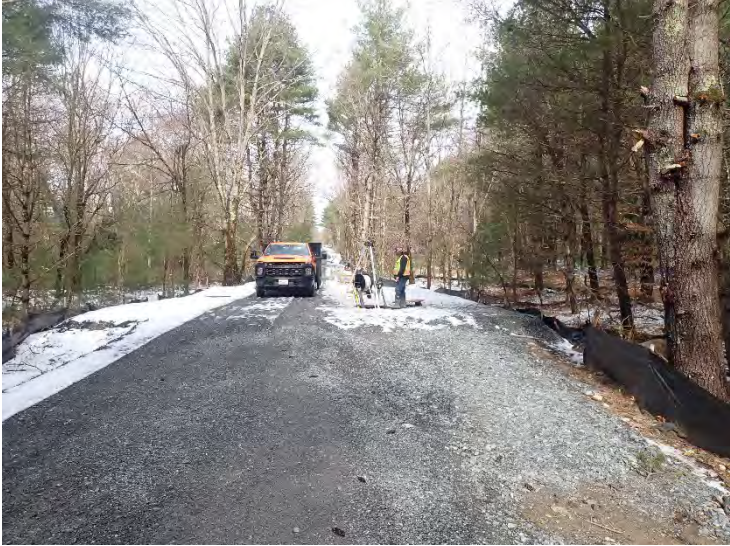
PHOTOGRAPHIC LOG	
Client Name: Eversource		Site Location: Sudbury to Hudson Transmission Reliability Project	Town: Sudbury
Photo No.: 7	Date: 4/05/2024

Description: View of Bond working at MH#15 in segment 7. See additional dewatering inspection report. Facing west.

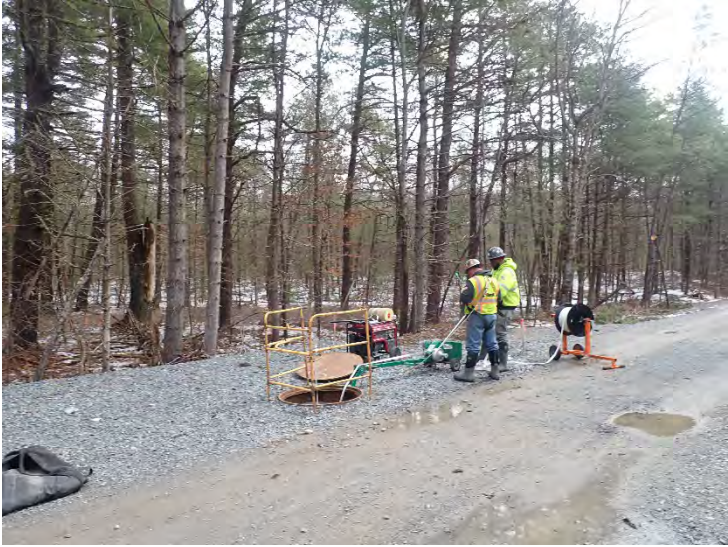
PHOTOGRAPHIC LOG	
Client Name: Eversource		Site Location: Sudbury to Hudson Transmission Reliability Project	Town: Sudbury
Photo No.: 8	Date: 4/05/2024

Description: View Bond working at MH#16 in segment 7. See additional dewatering inspection report. Facing northeast.

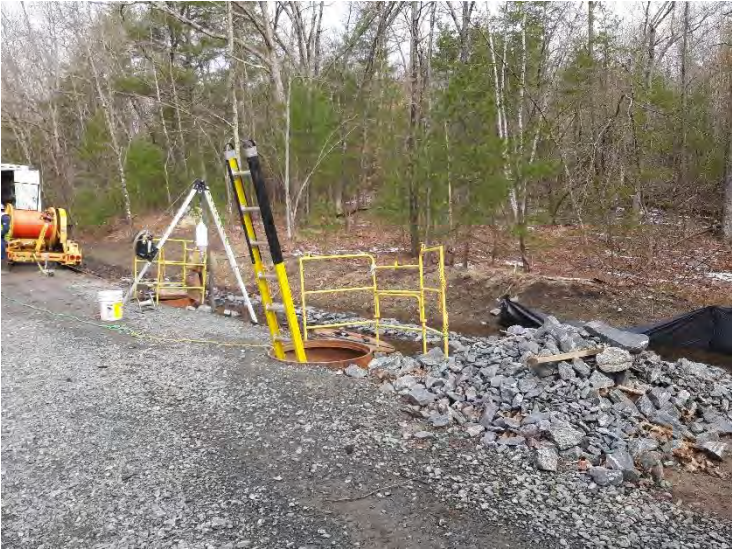
<p align="center">PHOTOGRAPHIC LOG</p>	
Client Name: Eversource		Site Location: Sudbury to Hudson Transmission Reliability Project	Town: Hudson
Photo No.: 1	Date: 4-6-24

Description: Work area within segment 5, manhole #12 work (swabbing, mandrel, GCC), dewatering. Looking northwestward after dewatering concluded.

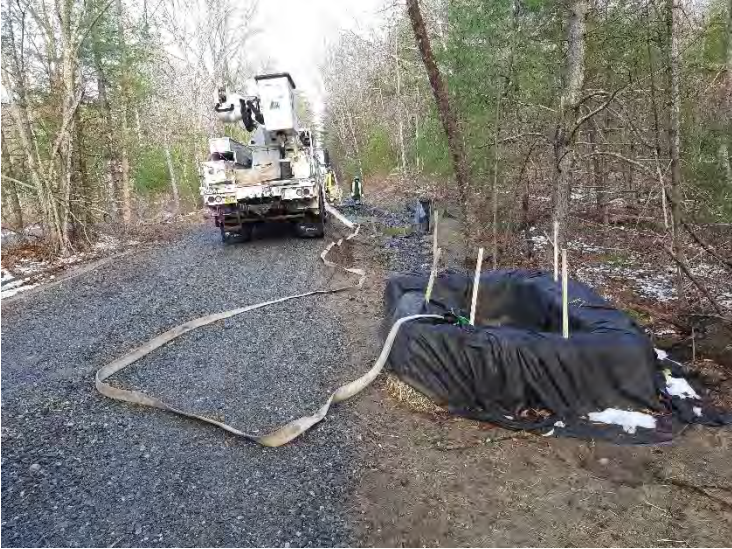
<p align="center">PHOTOGRAPHIC LOG</p>	
Client Name: Eversource		Site Location: Sudbury to Hudson Transmission Reliability Project	Town: Hudson
Photo No.: 2	Date: 4-6-24

Description: Work area within segment 5, manhole #12 work (mandrel, swab, GCC), dewatering bag/corral, looking westward.

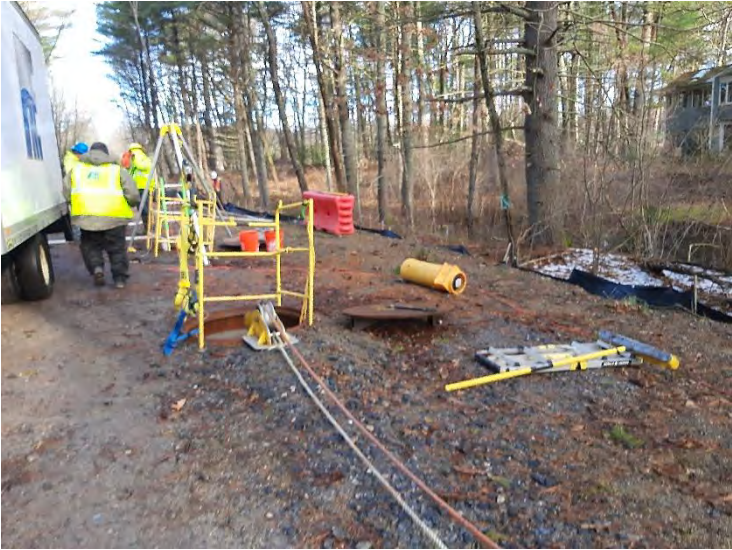
<p align="center">PHOTOGRAPHIC LOG</p>	
<p>Client Name: Eversource</p>		<p>Site Location: Sudbury to Hudson Transmission Reliability Project</p>	<p>Town: Hudson</p>
<p>Photo No.: 3</p>	<p>Date: 4-6-24</p>

<p>Description:</p> <p>Work area within segment 5, manhole #13 work (mandrel, swab, GCC installation), dewatering, looking westward.</p>

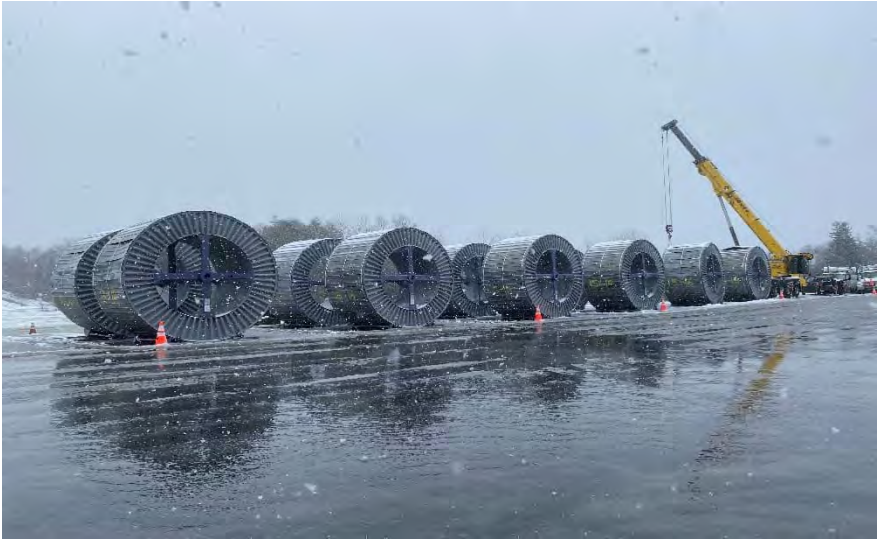
PHOTOGRAPHIC LOG	
Client Name: Eversource		Site Location: Sudbury to Hudson Transmission Reliability Project	Town: Hudson
Photo No.: 1	Date: 4-4-24

Description: Haugland laydown yard, recently delivered cable, looking westward.

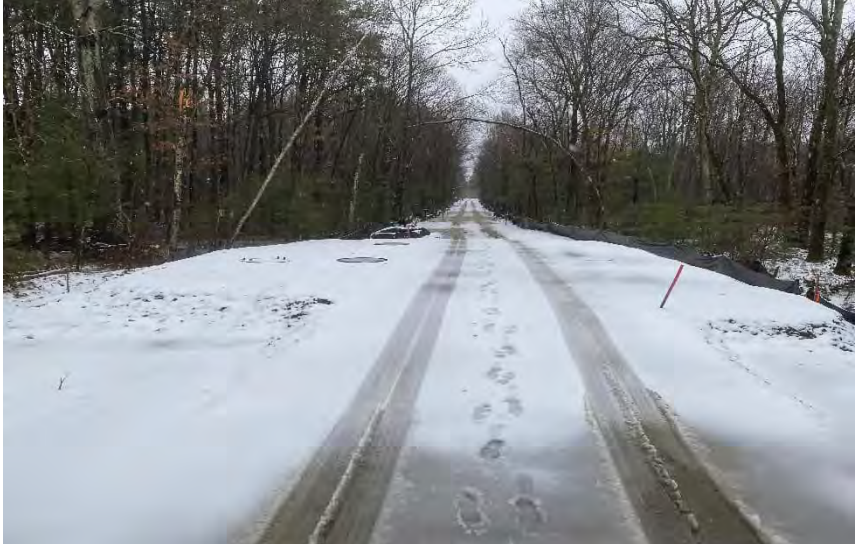
PHOTOGRAPHIC LOG	
Client Name: Eversource		Site Location: Sudbury to Hudson Transmission Reliability Project	Town: Hudson
Photo No.: 2	Date: 4-4-24

Description: Work area within segment 6, manhole #14, existing erosion control, looking eastward.

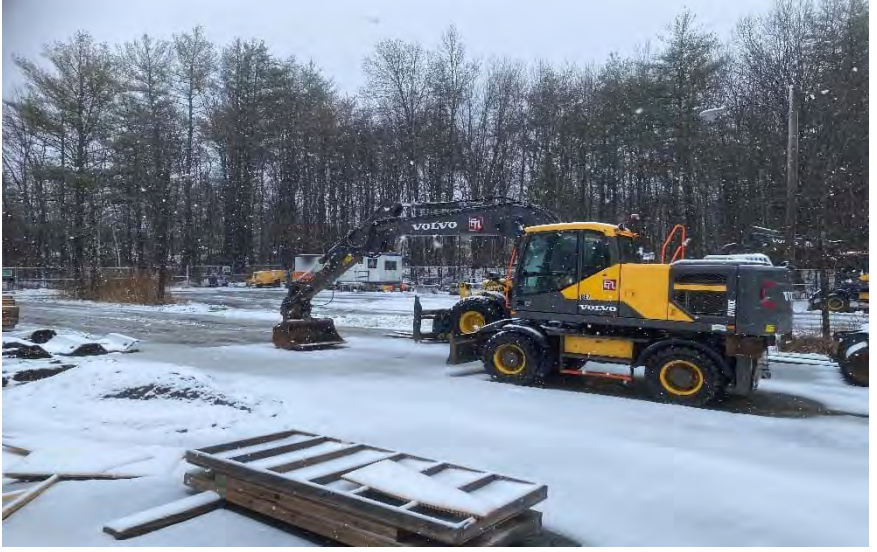
PHOTOGRAPHIC LOG	
Client Name: Eversource		Site Location: Sudbury to Hudson Transmission Reliability Project	Town: Hudson
Photo No.: 5	Date: 4-4-24

Description: Laydown yard off Main Street, looking westward.

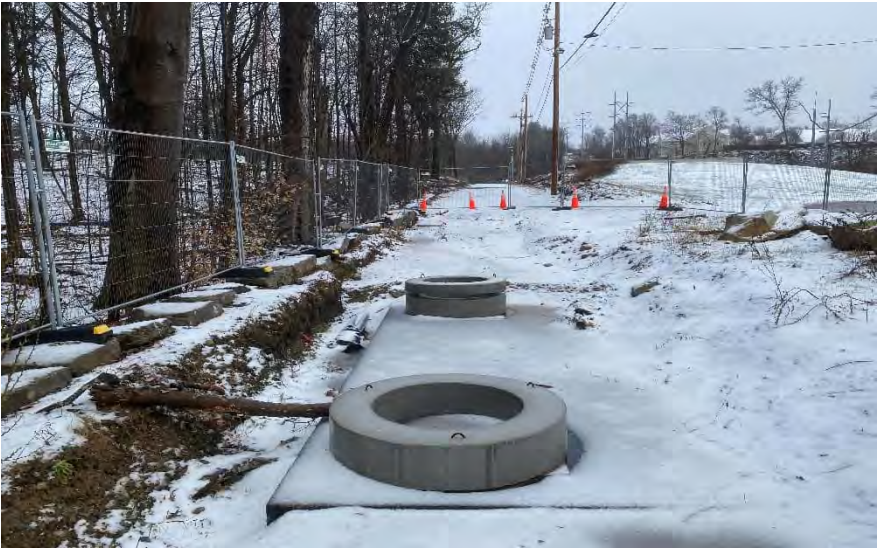
PHOTOGRAPHIC LOG	
Client Name: Eversource		Site Location: Sudbury to Hudson Transmission Reliability Project	Town: Hudson
Photo No.: 6	Date: 4-4-24

Description: Manhole #1, off Forest Avenue, looking eastward.

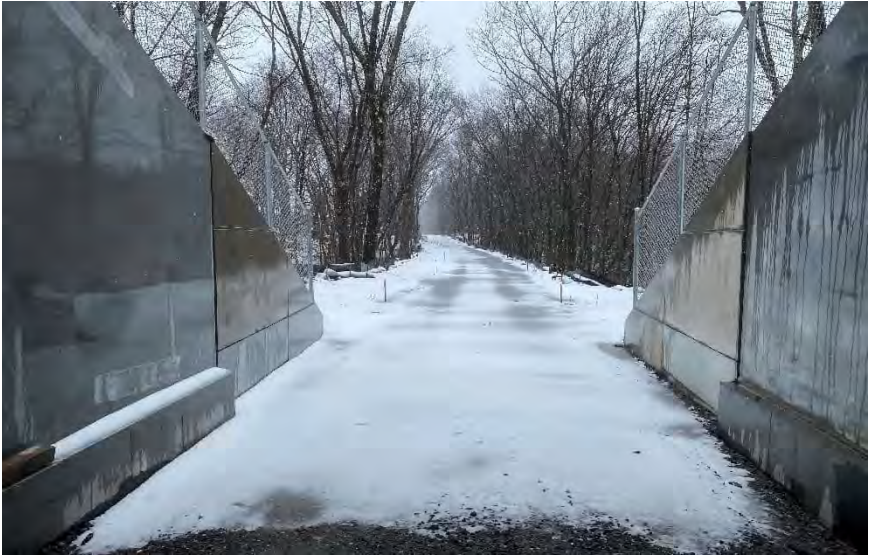
PHOTOGRAPHIC LOG	
Client Name: Eversource		Site Location: Sudbury to Hudson Transmission Reliability Project	Town: Hudson
Photo No.: 8	Date: 4-4-24

Description: Work area within segment 1, looking from Chestnut Street overpass, looking westward.

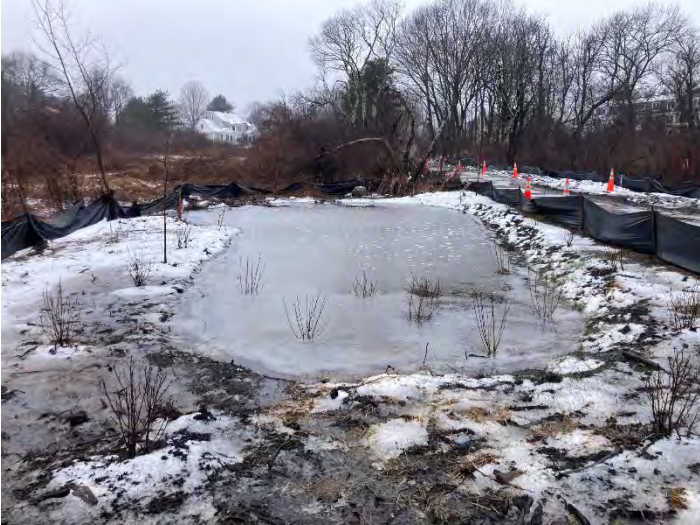
PHOTOGRAPHIC LOG	
Client Name: Eversource		Site Location: Sudbury to Hudson Transmission Reliability Project	Town: Sudbury
Photo No.: 2	Date: 4-04-2024

Description: View of wetland replication area in segment 14. Facing west.

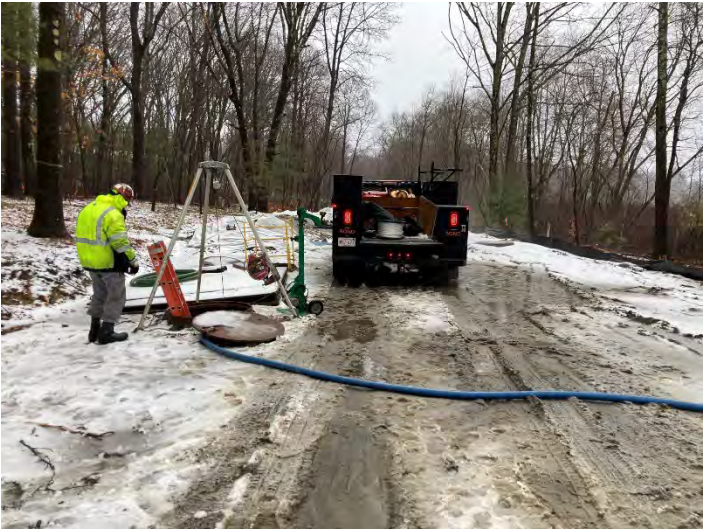
Epsilon ASSOCIATES INC.		PHOTOGRAPHIC LOG	
Client Name: Eversource		Site Location: Sudbury to Hudson Transmission Reliability Project	Town: Sudbury
Photo No.: 3	Date: 4-04-2024

Description: View of Bond working at MH #26 in segment 14. See additional dewatering report. Facing east.

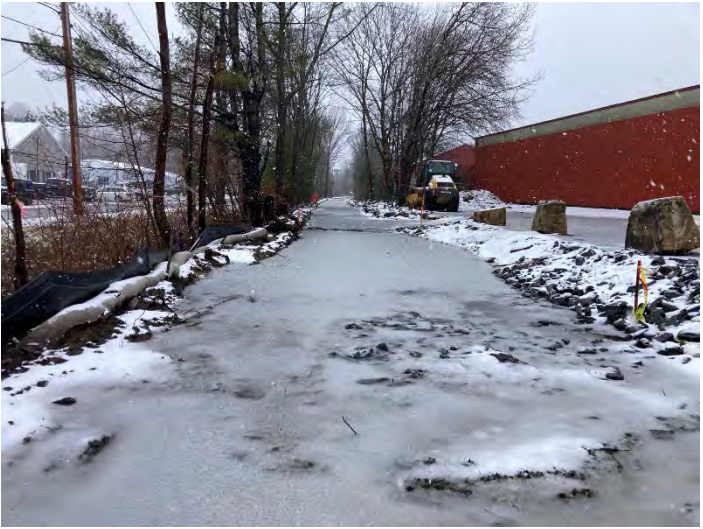
Epsilon ASSOCIATES INC.		PHOTOGRAPHIC LOG	
Client Name: Eversource		Site Location: Sudbury to Hudson Transmission Reliability Project	Town: Sudbury
Photo No.: 4	Date: 4-04-2024

Description: View of E&S controls in segment 12. Facing east.

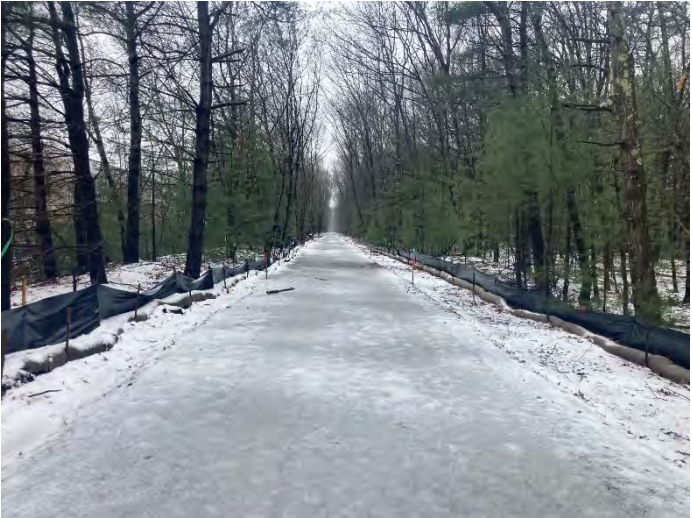
Epsilon ASSOCIATES INC.		PHOTOGRAPHIC LOG	
Client Name: Eversource		Site Location: Sudbury to Hudson Transmission Reliability Project	Town: Sudbury
Photo No.: 5	Date: 4-04-2024

Description: View of E&S controls in segment 11. Facing west.

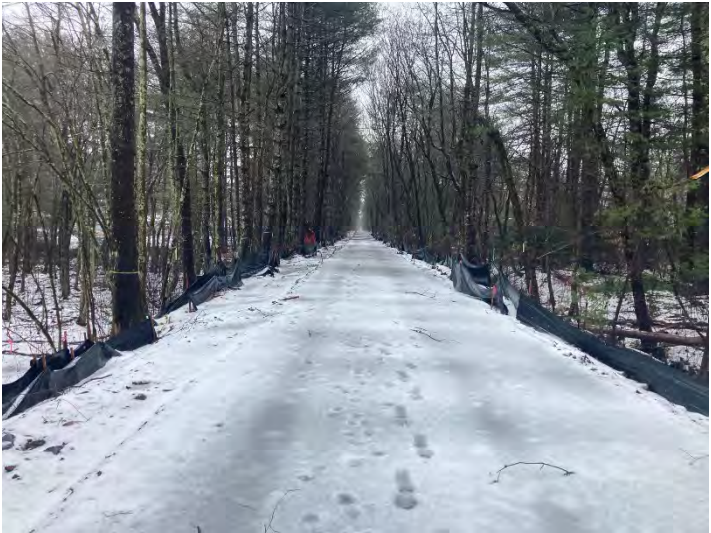
Epsilon ASSOCIATES INC.		PHOTOGRAPHIC LOG	
Client Name: Eversource		Site Location: Sudbury to Hudson Transmission Reliability Project	Town: Sudbury
Photo No.: 6	Date: 4-04-2024

Description: View of E&S controls near Dudley Brook culvert in segment 10. Facing east.

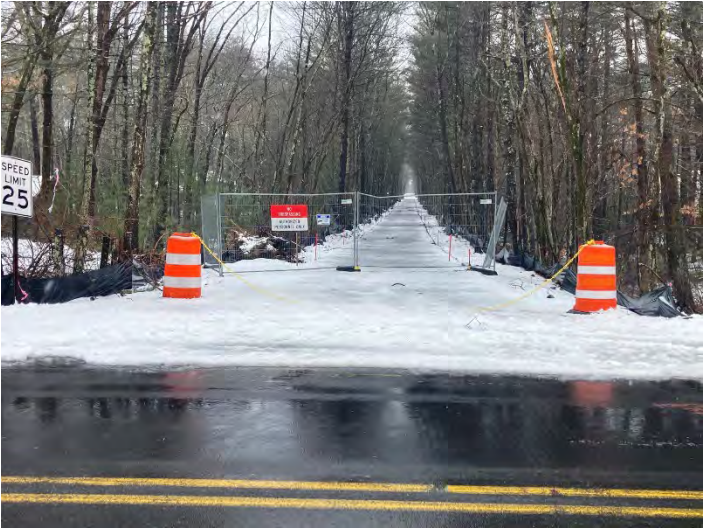
PHOTOGRAPHIC LOG	
Client Name: Eversource		Site Location: Sudbury to Hudson Transmission Reliability Project	Town: Sudbury
Photo No.: 7	Date: 4-04-2024

Description: View of entrance to segment 9 off Peakham Rd. Barrels, chains, and flags are in place to demarcate vernal pool TOY restriction zones. Facing west.

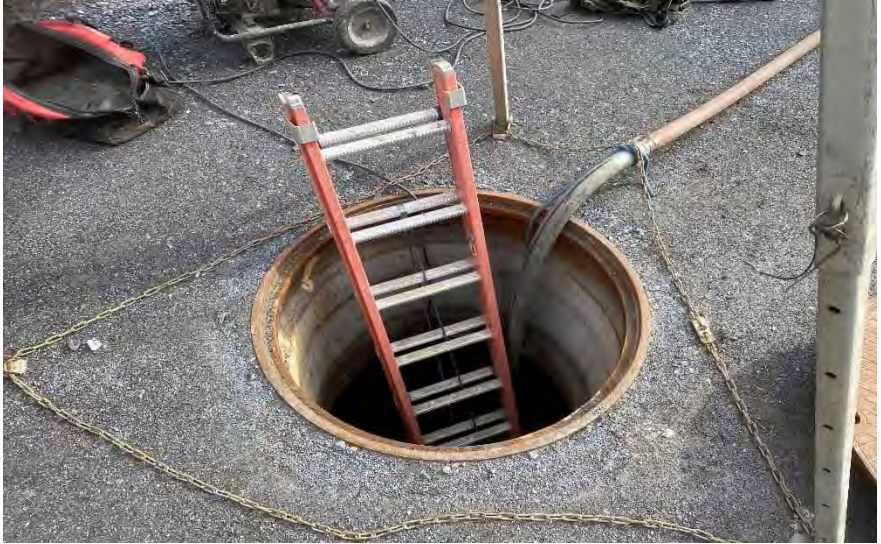
PHOTOGRAPHIC LOG	
Client Name: Eversource		Site Location: Sudbury to Hudson Transmission Reliability Project	Town: Hudson
Photo No.: 1	Date: 4/1/2024

Description: View of area being pumped from manhole #7, segment 2.

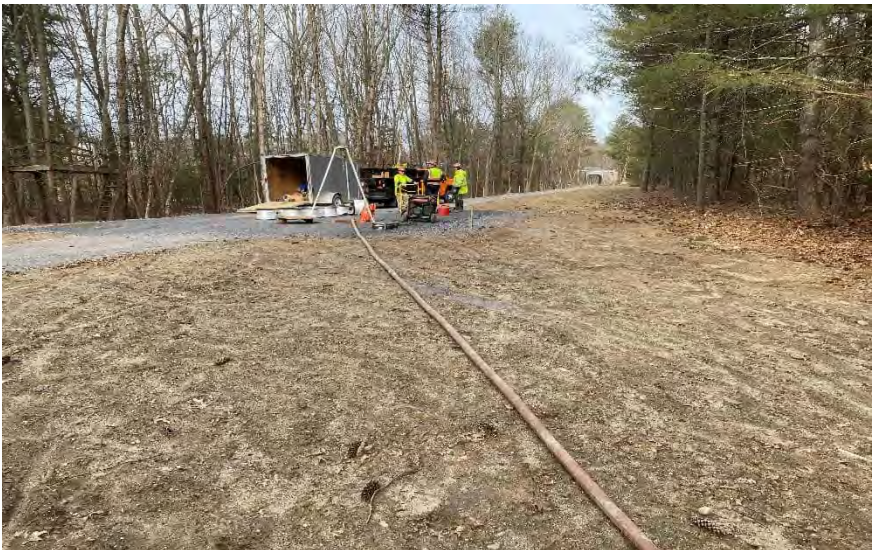
PHOTOGRAPHIC LOG	
Client Name: Eversource		Site Location: Sudbury to Hudson Transmission Reliability Project	Town: Hudson
Photo No.: 2	Date: 4/1/2024

Description: Manhole #7. View of dewatering operation. Looking westward.

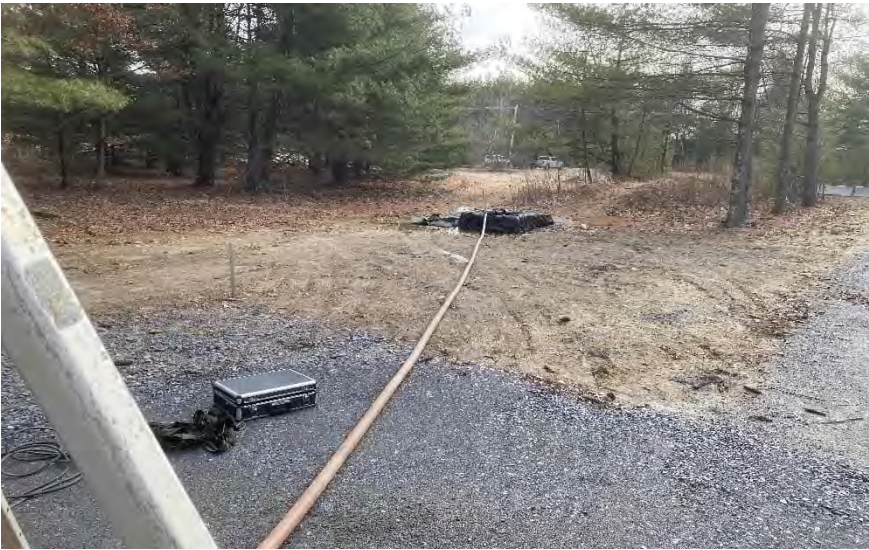
PHOTOGRAPHIC LOG	
Client Name: Eversource		Site Location: Sudbury to Hudson Transmission Reliability Project	Town: Hudson
Photo No.: 3	Date: 4/1/2024

Description: Manhole #7. View of dewatering operation, looking eastward.

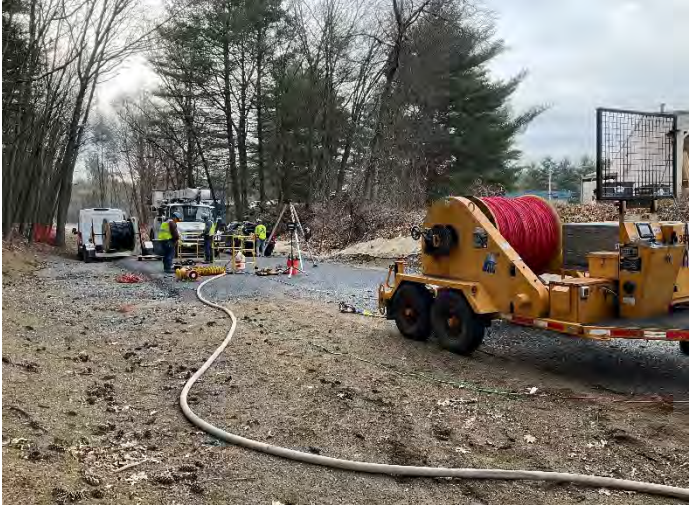
PHOTOGRAPHIC LOG		
Client Name: Eversource		Site Location: Sudbury to Hudson Transmission Reliability Project		Town: Hudson
Photo No.: 1	Date: 4/01/2024

Description: View of Haugland working at MH #9 in segment 3. Facing southeast.

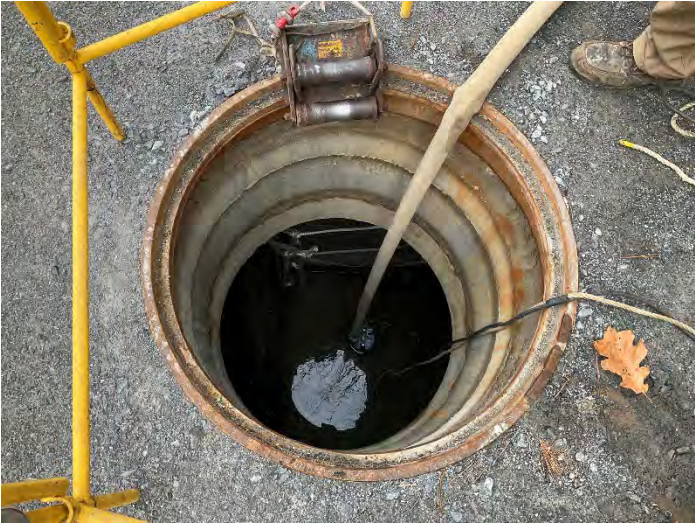
PHOTOGRAPHIC LOG		
Client Name: Eversource		Site Location: Sudbury to Hudson Transmission Reliability Project		Town: Hudson
Photo No.: 2	Date: 4/01/2024

Description: View of pump in MH #9. Water appeared mostly clear prior to treatment.

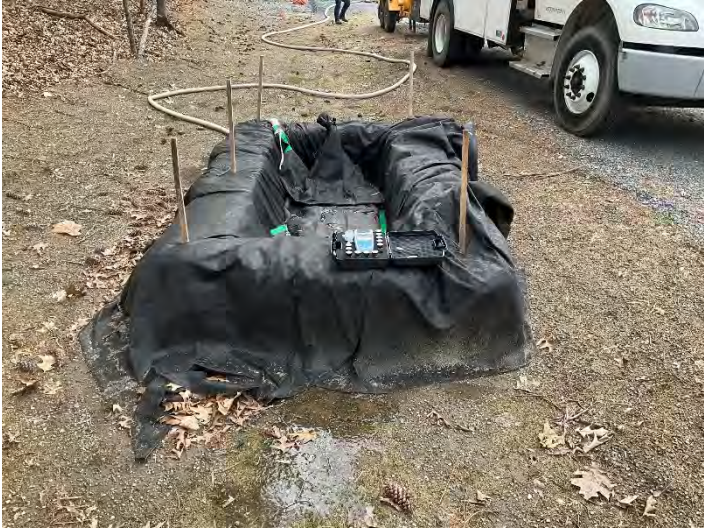
PHOTOGRAPHIC LOG	
Client Name: Eversource		Site Location: Sudbury to Hudson Transmission Reliability Project	
Town: Hudson			
Photo No.: 3	Date: 4/01/2024

Description: View of dewatering controls (straw bale corral with filter fabric and silt bag). Facing east.

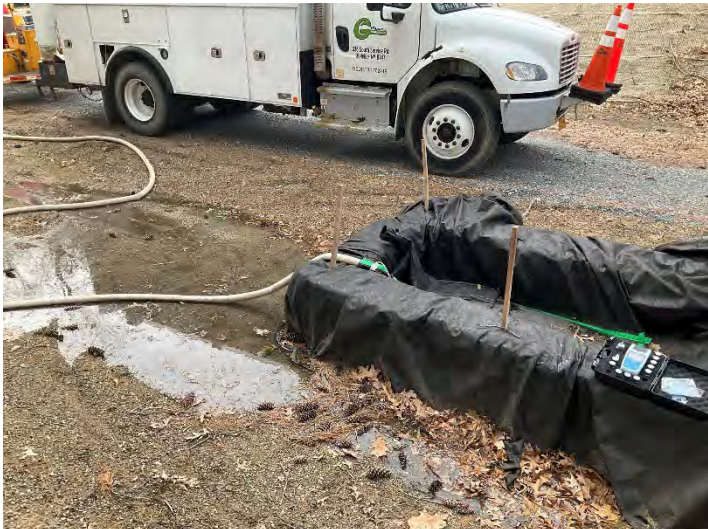
PHOTOGRAPHIC LOG	
Client Name: Eversource		Site Location: Sudbury to Hudson Transmission Reliability Project	
Town: Hudson			
Photo No.: 4	Date: 4/01/2024

Description: View of dewatering controls (straw bale corral with filter fabric and silt bag) and discharge from corral. Discharge appeared clear and turbidity reading was below 50 NTUs. Discharge did not appear to reach any jurisdictional resource areas. Facing southeast.

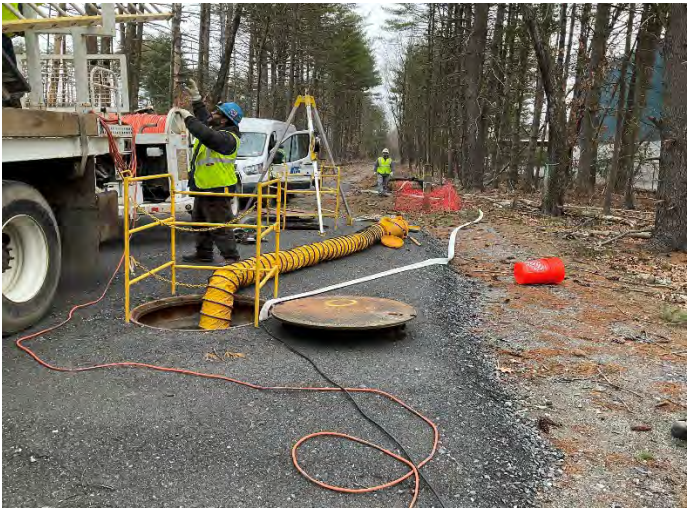
PHOTOGRAPHIC LOG	
Client Name: Eversource		Site Location: Sudbury to Hudson Transmission Reliability Project	Town: Hudson
Photo No.: 1	Date: 4/01/2024

Description: View of Haugland working at MH #10. Facing west.

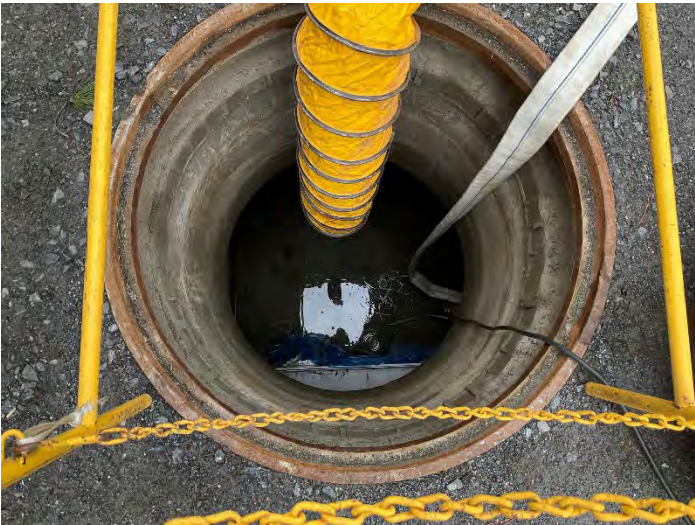
PHOTOGRAPHIC LOG	
Client Name: Eversource		Site Location: Sudbury to Hudson Transmission Reliability Project	Town: Hudson
Photo No.: 2	Date: 4/01/2024

Description: View of pump in MH #10. Water appeared mostly clear prior to treatment.

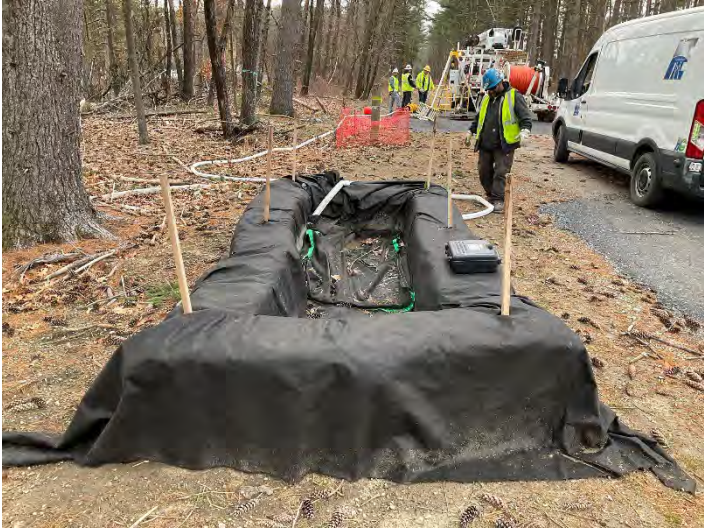
PHOTOGRAPHIC LOG	
Client Name: Eversource		Site Location: Sudbury to Hudson Transmission Reliability Project	
Town: Hudson			
Photo No.: 3	Date: 4/01/2024

Description: View of dewatering controls (straw bale corral with filter fabric and silt bag). Facing east.
