Weekly Environmental Compliance Summary

Sudbury to Hudson Transmission Reliability Project (USEPA Tracking # MAR1003UW)

Sudbury, Hudson, and Stow, MA

Week of: April 1, 2024 to April 6, 2024

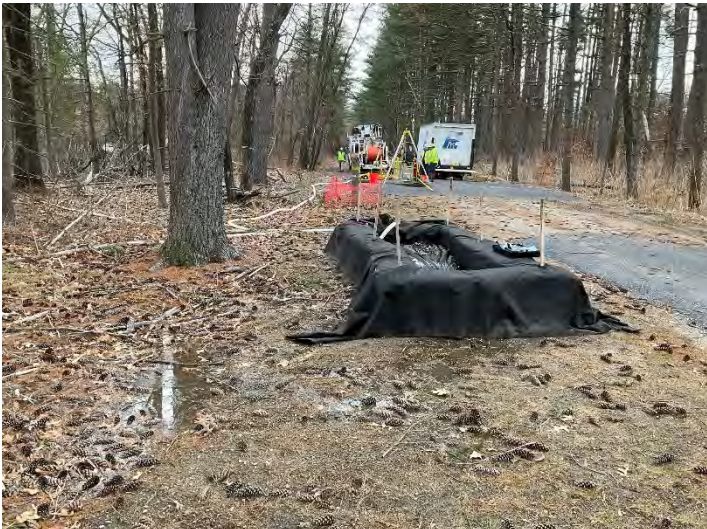
PHOTOGRAPHIC LOG	
Client Name: Eversource		Site Location: Sudbury to Hudson Transmission Reliability Project	
Town: Hudson			
Photo No.: 4	Date: 4/01/2024

Description: View of dewatering controls (straw bale corral with filter fabric and silt bag) and discharge from project. Discharge appeared clear and turbidity reading was below 50 NTUs. Discharge did not appear to reach any jurisdictional resource areas. Facing east.

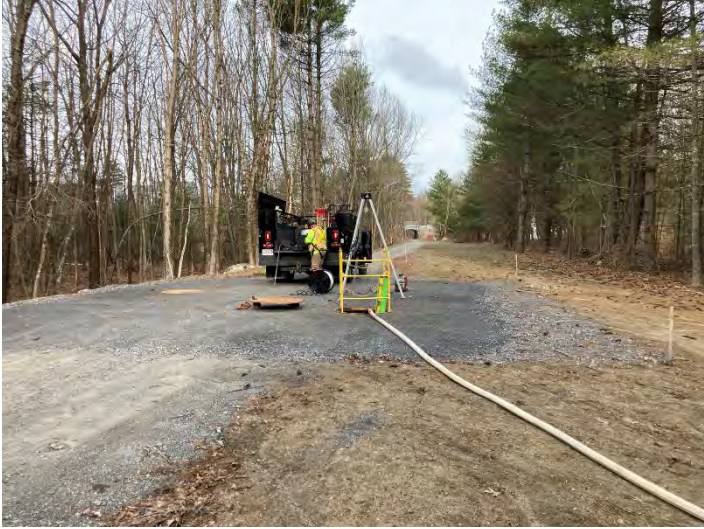
PHOTOGRAPHIC LOG	
Client Name: Eversource		Site Location: Sudbury to Hudson Transmission Reliability Project	Town: Hudson
Photo No.: 1	Date: 4/02/2024

Description: View of Bond working at MH #7 in segment 2. Facing west.

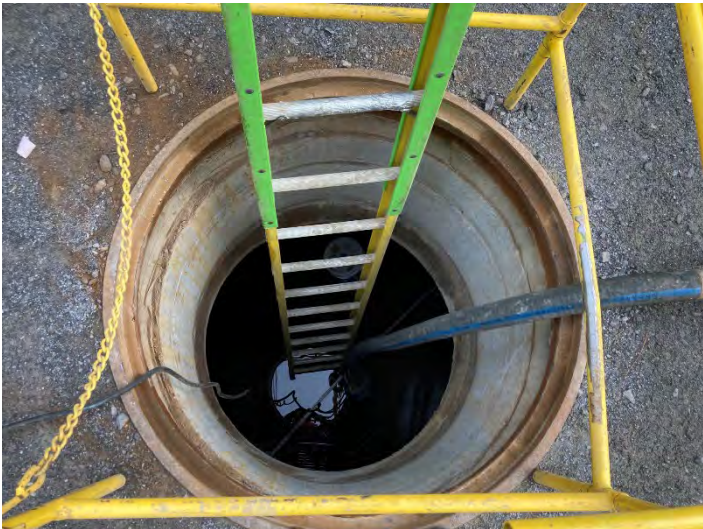
PHOTOGRAPHIC LOG	
Client Name: Eversource		Site Location: Sudbury to Hudson Transmission Reliability Project	Town: Hudson
Photo No.: 2	Date: 4/02/2024

Description: View of pump in MH #7. Water appeared mostly clear prior to treatment.

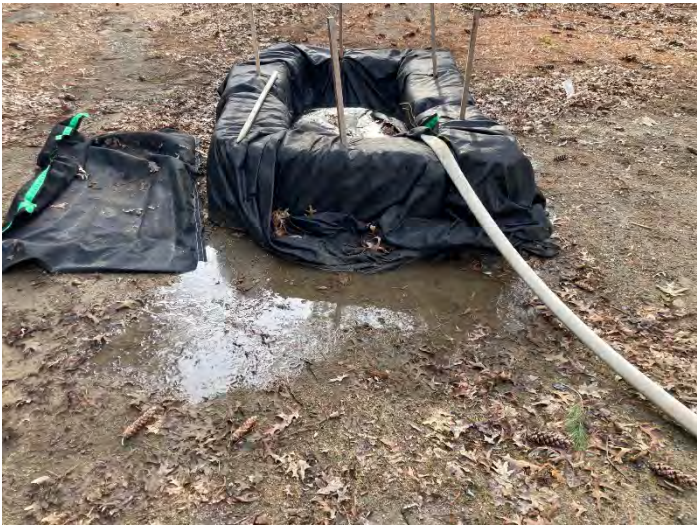
PHOTOGRAPHIC LOG		
Client Name: Eversource		Site Location: Sudbury to Hudson Transmission Reliability Project		Town: Hudson
Photo No.: 4	Date: 4/02/2024

Description: Additional view of dewatering controls and discharge. Discharge appeared mostly clear. Turbidity reading was below 50 NTUs. Facing east.

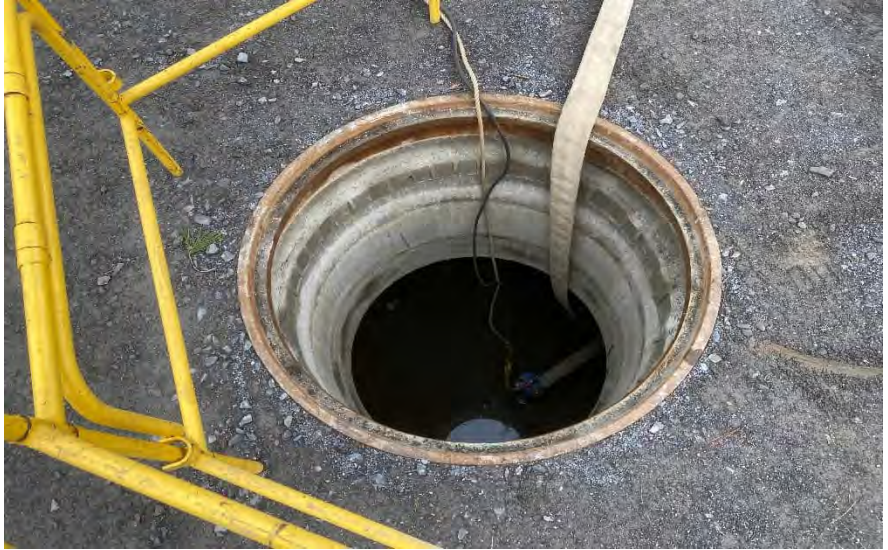
PHOTOGRAPHIC LOG		
Client Name: Eversource		Site Location: Sudbury to Hudson Transmission Reliability Project		Town: Hudson
Photo No.: 1	Date: 4/2/2024

Description: View of area being pumped from manhole #10, segment 4.

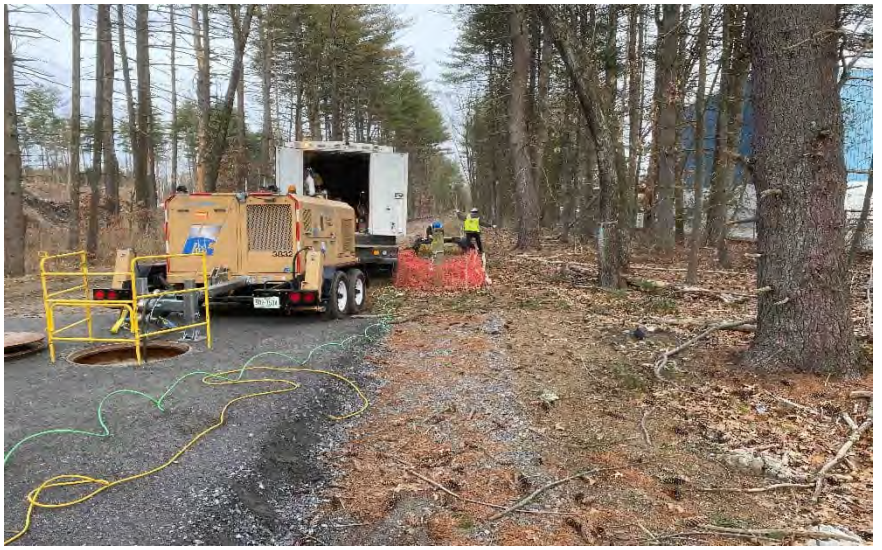
PHOTOGRAPHIC LOG		
Client Name: Eversource		Site Location: Sudbury to Hudson Transmission Reliability Project		Town: Hudson
Photo No.: 2	Date: 4/2/2024

Description: Manhole #10. View of dewatering operation. Looking westward.

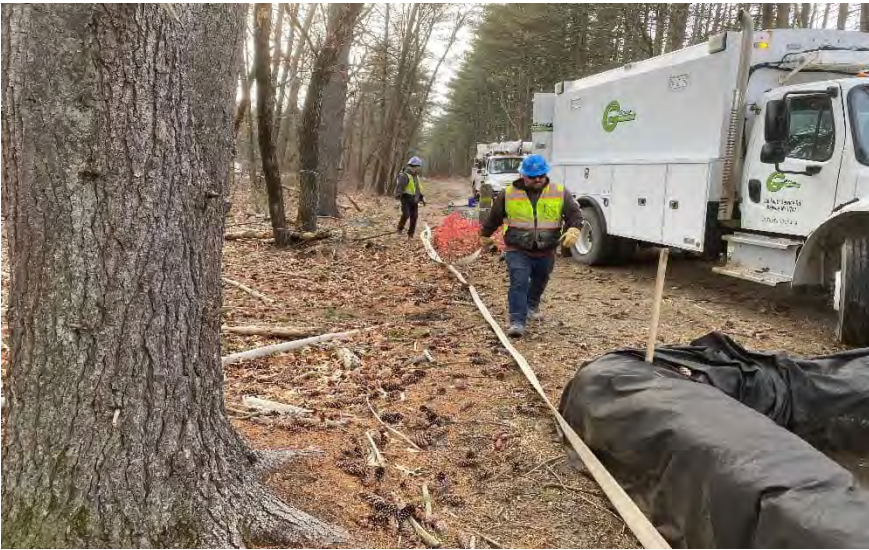
<h2 style="margin: 0;">PHOTOGRAPHIC LOG</h2>	
Client Name: Eversource		Site Location: Sudbury to Hudson Transmission Reliability Project	Town: Hudson
Photo No.: 3	Date: 4/2/2024

Description: Manhole #10. View of dewatering operation, looking eastward.

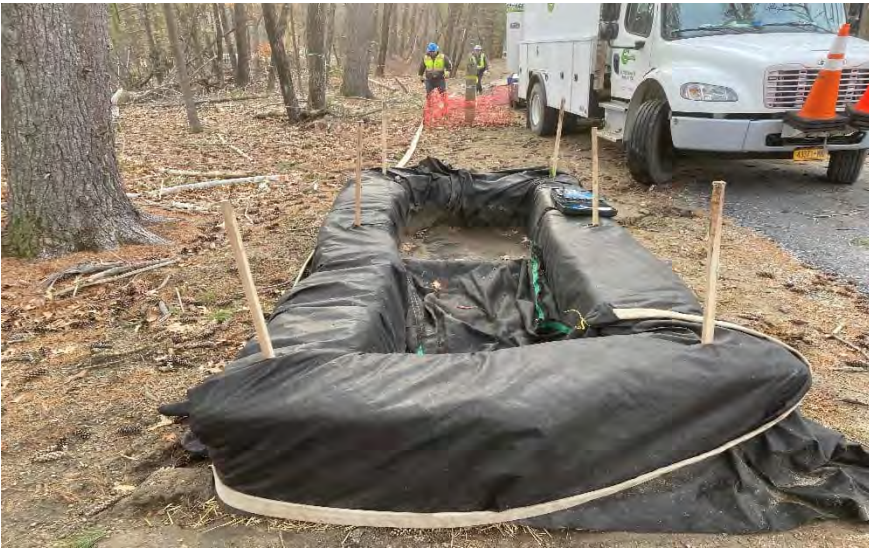
<h2 style="margin: 0;">PHOTOGRAPHIC LOG</h2>	
Client Name: Eversource		Site Location: Sudbury to Hudson Transmission Reliability Project	Town: Hudson
Photo No.: 4	Date: 4/2/2024

Description: Manhole #10. View of discharge bag/corral, looking eastward. Water from bag/corral discharged to adjacent area.

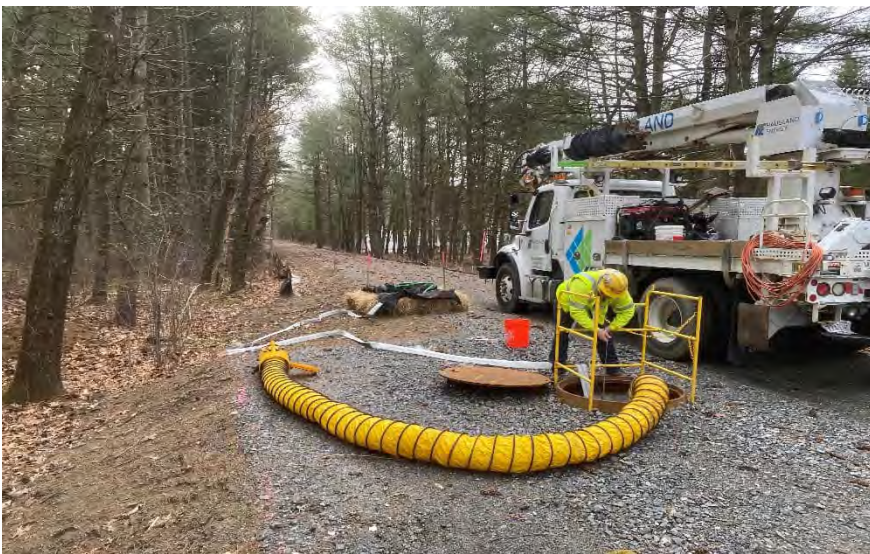
PHOTOGRAPHIC LOG	
Client Name: Eversource		Site Location: Sudbury to Hudson Transmission Reliability Project	Town: Hudson
Photo No.: 2	Date: 4/2/2024

Description: Manhole #11. View of dewatering operation. Looking eastward.

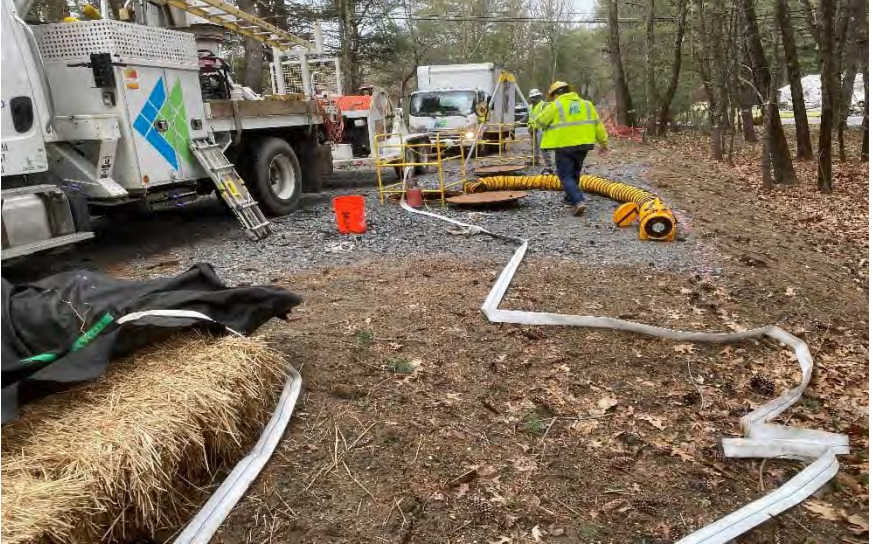
PHOTOGRAPHIC LOG	
Client Name: Eversource		Site Location: Sudbury to Hudson Transmission Reliability Project	
Town: Hudson			
Photo No.: 3	Date: 4/2/2024

Description: Manhole #11. View of dewatering operation, looking westward.

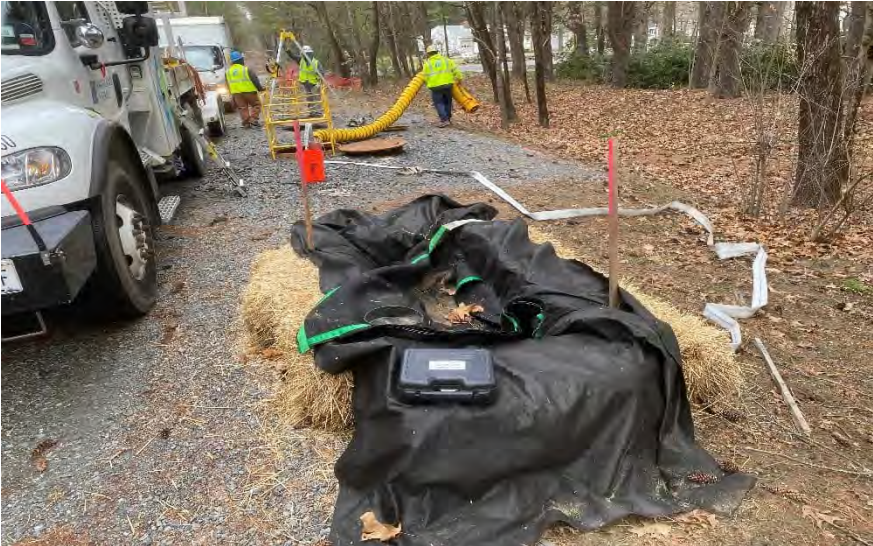
PHOTOGRAPHIC LOG	
Client Name: Eversource		Site Location: Sudbury to Hudson Transmission Reliability Project	
Town: Hudson			
Photo No.: 4	Date: 4/2/2024

Description: Manhole #11. View of discharge bag/corral, looking westward. Water from bag/corral discharged to adjacent area.

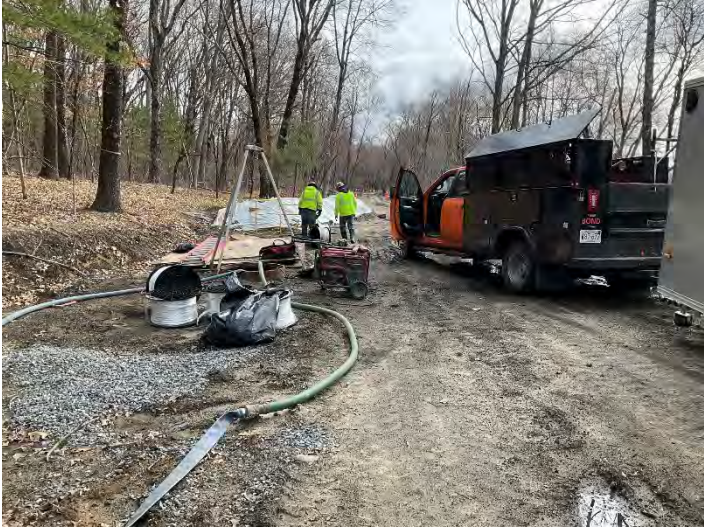
PHOTOGRAPHIC LOG	
Client Name: Eversource		Site Location: Sudbury to Hudson Transmission Reliability Project	
Town: Sudbury			
Photo No.: 1	Date: 4/02/2024

Description: View of Bond working at MH #26 in segment 14. Facing east.

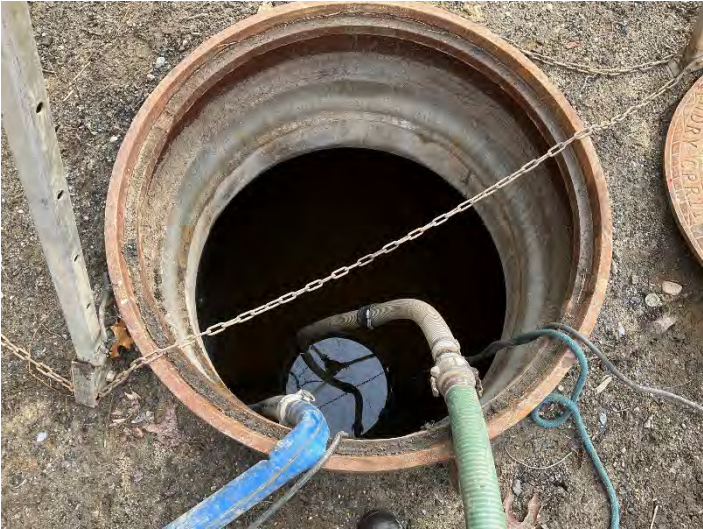
PHOTOGRAPHIC LOG	
Client Name: Eversource		Site Location: Sudbury to Hudson Transmission Reliability Project	
Town: Sudbury			
Photo No.: 2	Date: 4/02/2024

Description: View of pump in MH #26 in segment 14. Water appeared clear prior to treatment.

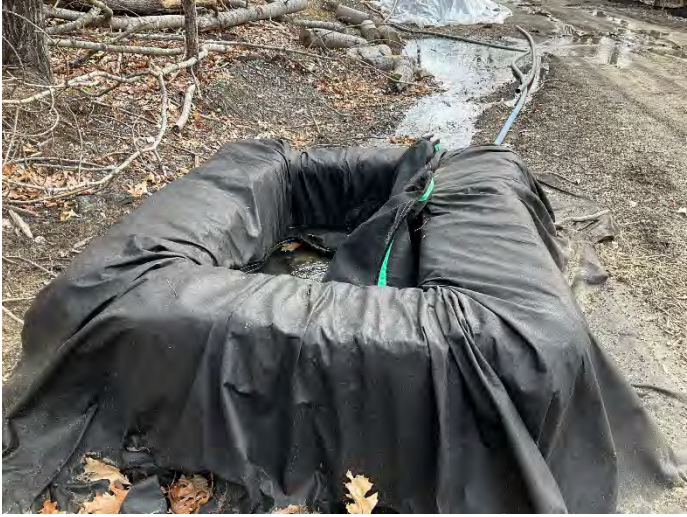
PHOTOGRAPHIC LOG	
Client Name: Eversource		Site Location: Sudbury to Hudson Transmission Reliability Project	
Town: Sudbury			
Photo No.: 3	Date: 4/02/2024

Description: View of dewatering controls (straw bale corral with filter fabric and silt bag) and discharge from corral. Discharge appeared mostly clear. Facing east.

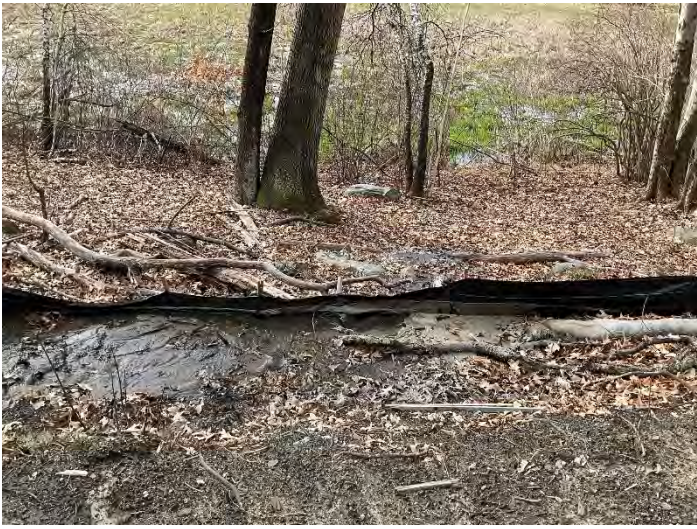
PHOTOGRAPHIC LOG	
Client Name: Eversource		Site Location: Sudbury to Hudson Transmission Reliability Project	
Town: Sudbury			
Photo No.: 4	Date: 4/02/2024

Description: View of discharge from project. Water traveled across project ROW and discharged through silt fence and into wetland adjacent to project. Discharge appeared mostly clear and turbidity reading was below 50 NTUs. Facing south.

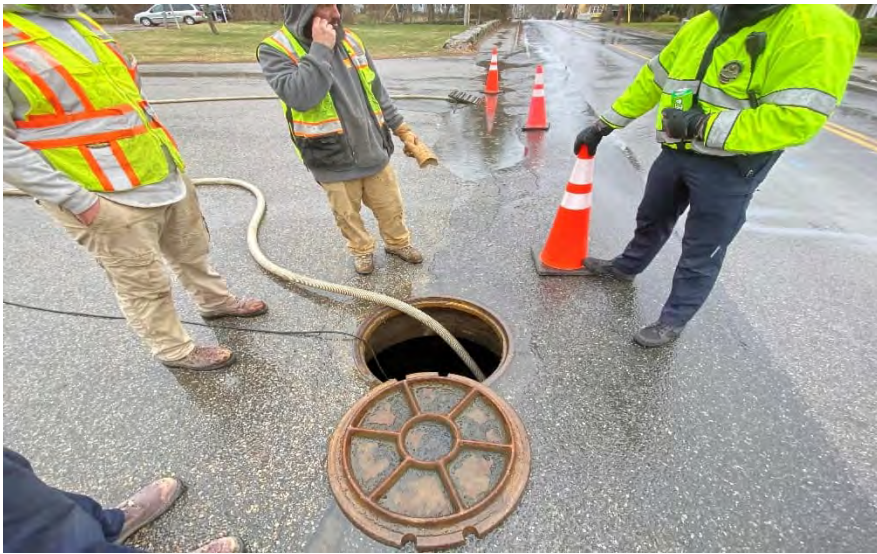
PHOTOGRAPHIC LOG	
Client Name: Eversource		Site Location: Sudbury to Hudson Transmission Reliability Project	Town: Hudson
Photo No.: 1	Date: 4/3/2024

Description: View of area being pumped from manhole @ Hudson PLF (1).

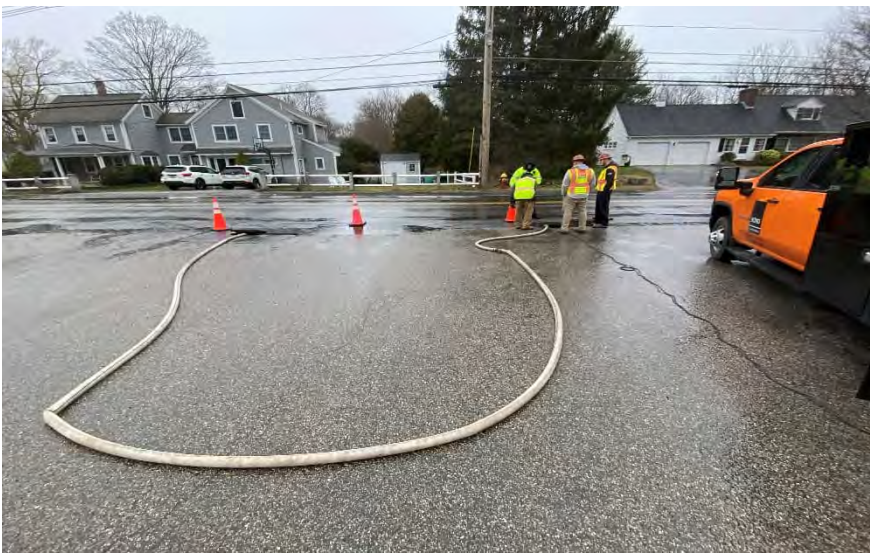
PHOTOGRAPHIC LOG	
Client Name: Eversource		Site Location: Sudbury to Hudson Transmission Reliability Project	Town: Hudson
Photo No.: 2	Date: 4/3/2024

Description: Manhole @ Hudson PLF (1). View of dewatering operation. Looking westward.

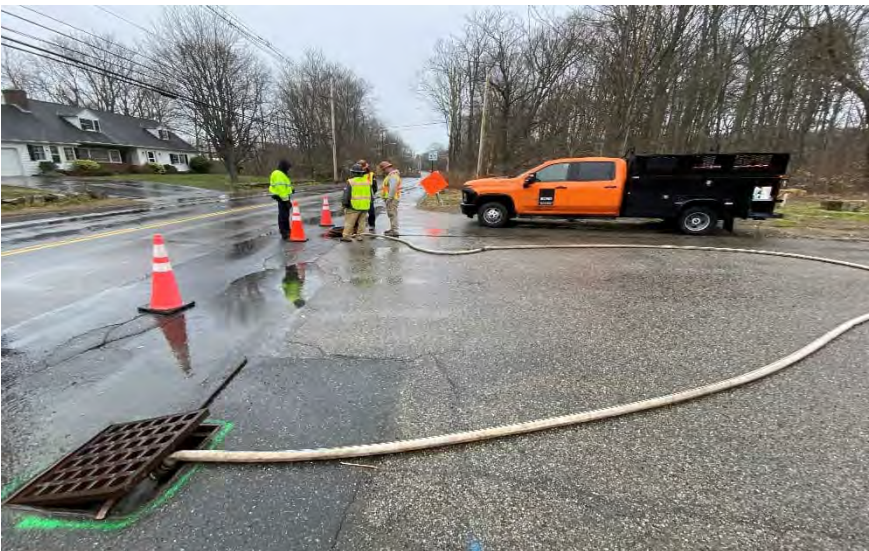
PHOTOGRAPHIC LOG	
Client Name: Eversource		Site Location: Sudbury to Hudson Transmission Reliability Project	Town: Hudson
Photo No.: 3	Date: 4/3/2024

Description: Manhole @ Hudson PLF (1). View of dewatering operation, looking northward.

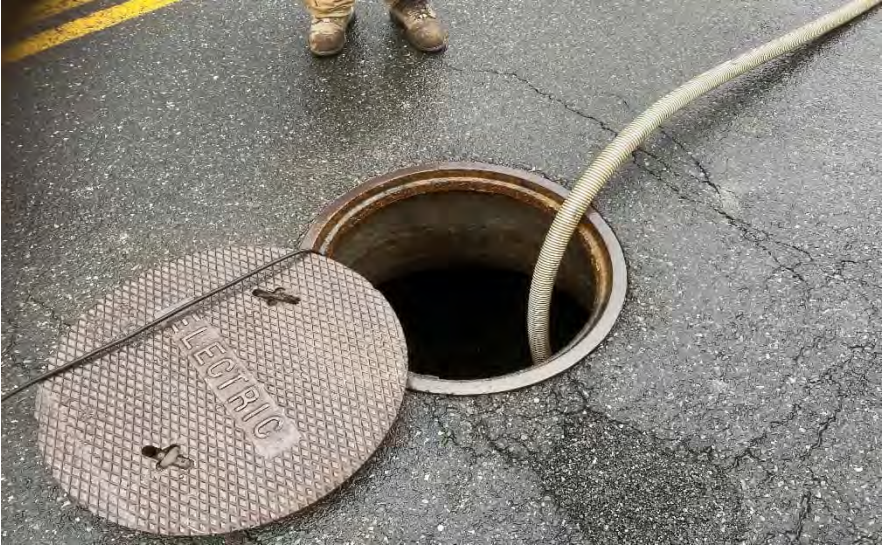
PHOTOGRAPHIC LOG	
Client Name: Eversource		Site Location: Sudbury to Hudson Transmission Reliability Project	Town: Hudson
Photo No.: 1	Date: 4/3/2024

Description: View of area being pumped from manhole @ Hudson PLF (2).

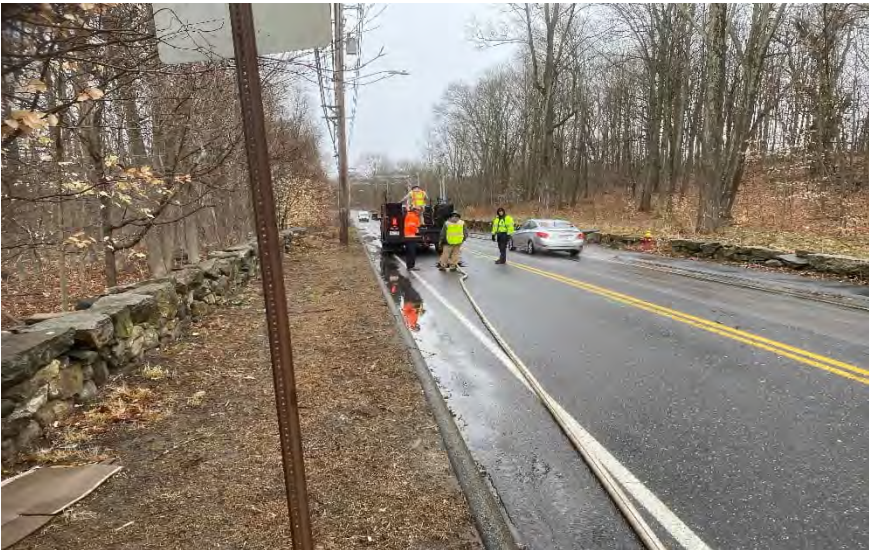
PHOTOGRAPHIC LOG	
Client Name: Eversource		Site Location: Sudbury to Hudson Transmission Reliability Project	Town: Hudson
Photo No.: 3	Date: 4/3/2024

Description: Manhole @ Hudson PLF (2). View of dewatering operation, looking northward.

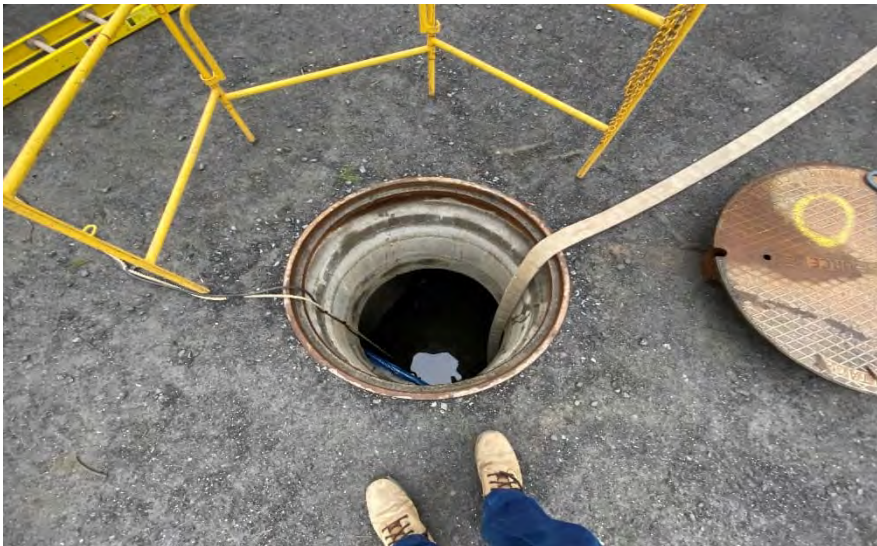
PHOTOGRAPHIC LOG	
Client Name: Eversource		Site Location: Sudbury to Hudson Transmission Reliability Project	Town: Hudson
Photo No.: 1	Date: 4/3/2024

Description: View of area being pumped from manhole #10, segment 4.

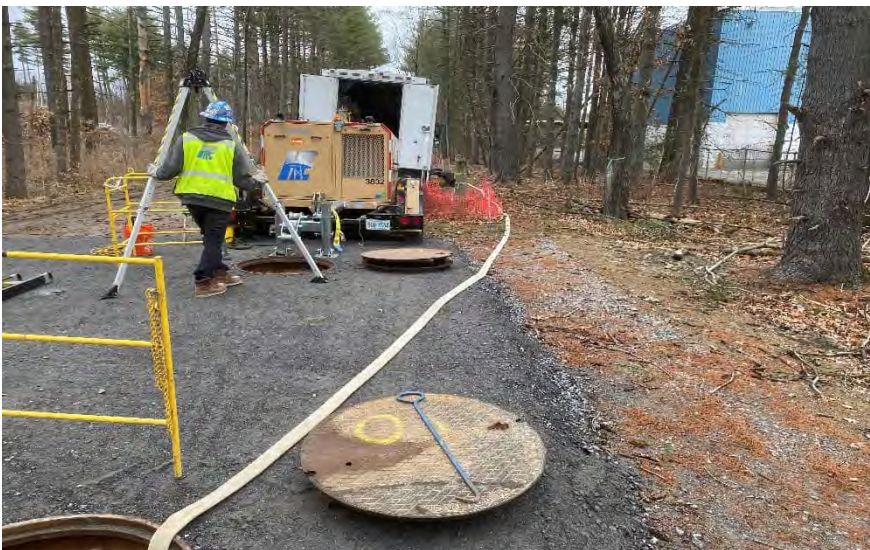
PHOTOGRAPHIC LOG	
Client Name: Eversource		Site Location: Sudbury to Hudson Transmission Reliability Project	Town: Hudson
Photo No.: 2	Date: 4/3/2024

Description: Manhole #10. View of dewatering operation. Looking westward.

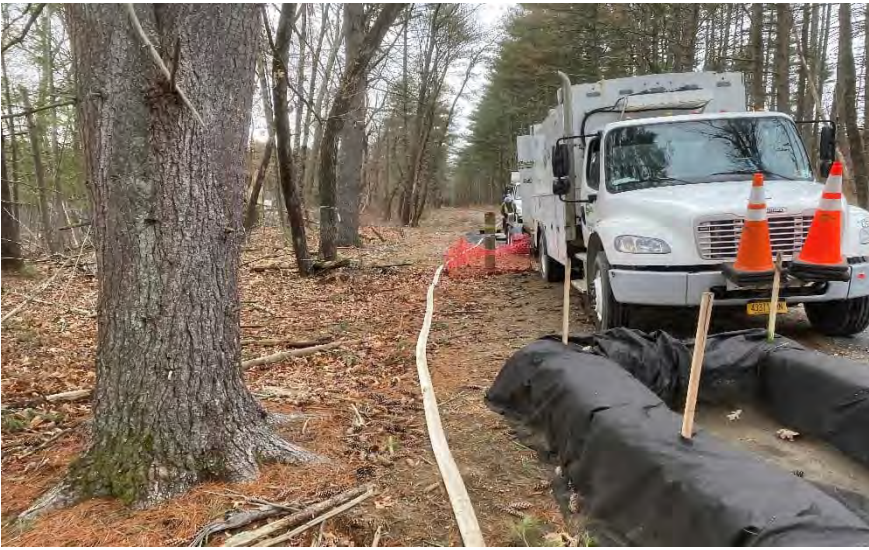
PHOTOGRAPHIC LOG	
Client Name: Eversource		Site Location: Sudbury to Hudson Transmission Reliability Project	
Town: Hudson			
Photo No.: 3	Date: 4/3/2024

Description: Manhole #10. View of dewatering operation, looking eastward.

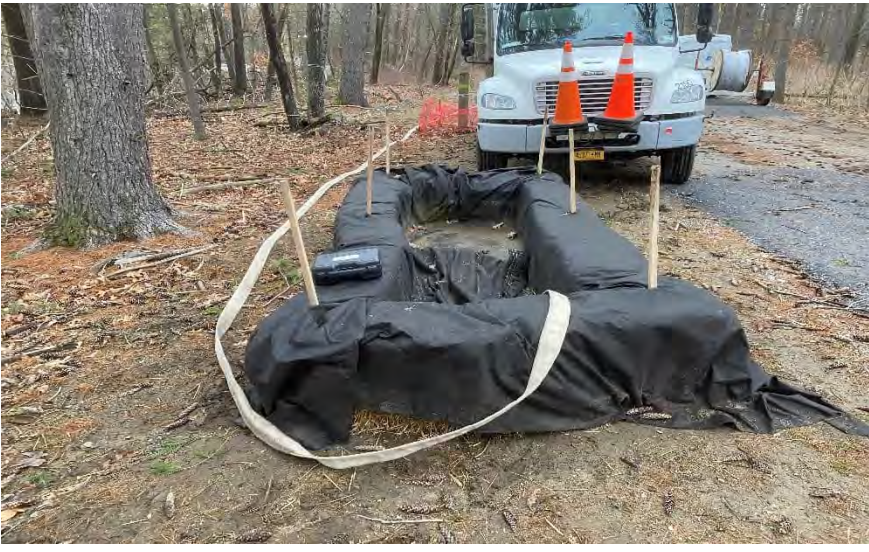
PHOTOGRAPHIC LOG	
Client Name: Eversource		Site Location: Sudbury to Hudson Transmission Reliability Project	
Town: Hudson			
Photo No.: 4	Date: 4/3/2024

Description: Manhole #10. View of discharge bag/corral, looking eastward. Water from bag/corral discharged to adjacent area.

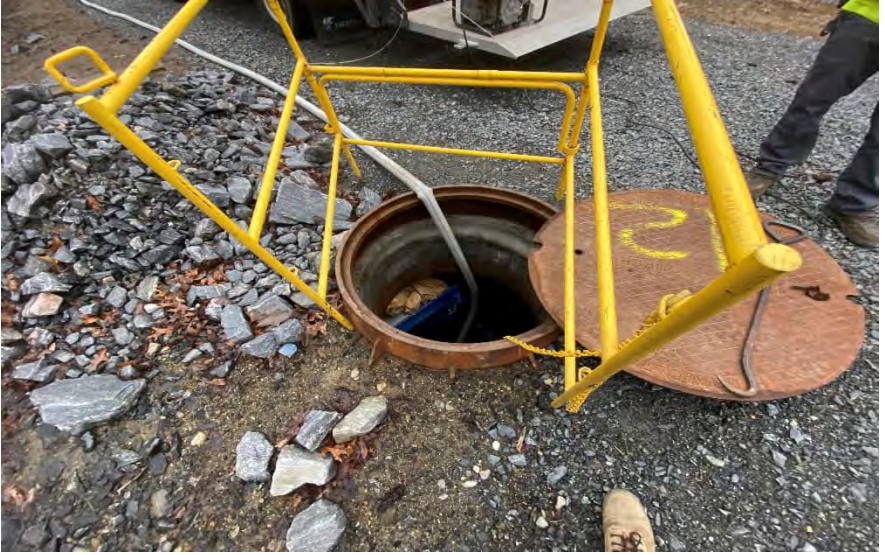
PHOTOGRAPHIC LOG	
Client Name: Eversource		Site Location: Sudbury to Hudson Transmission Reliability Project	Town: Hudson
Photo No.: 1	Date: 4/3/2024

Description: View of area being pumped from manhole #12, segment 5.

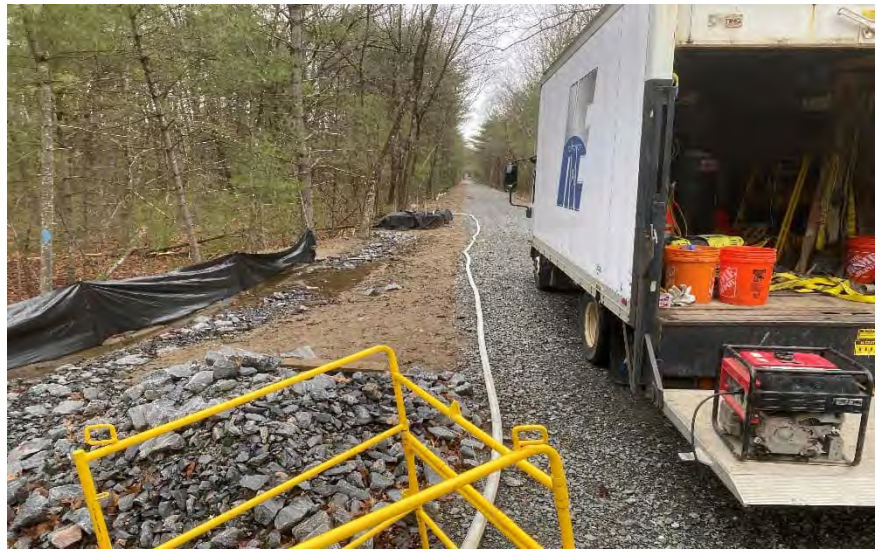
PHOTOGRAPHIC LOG	
Client Name: Eversource		Site Location: Sudbury to Hudson Transmission Reliability Project	Town: Hudson
Photo No.: 2	Date: 4/3/2024

Description: Manhole #12. View of dewatering operation. Looking eastward.

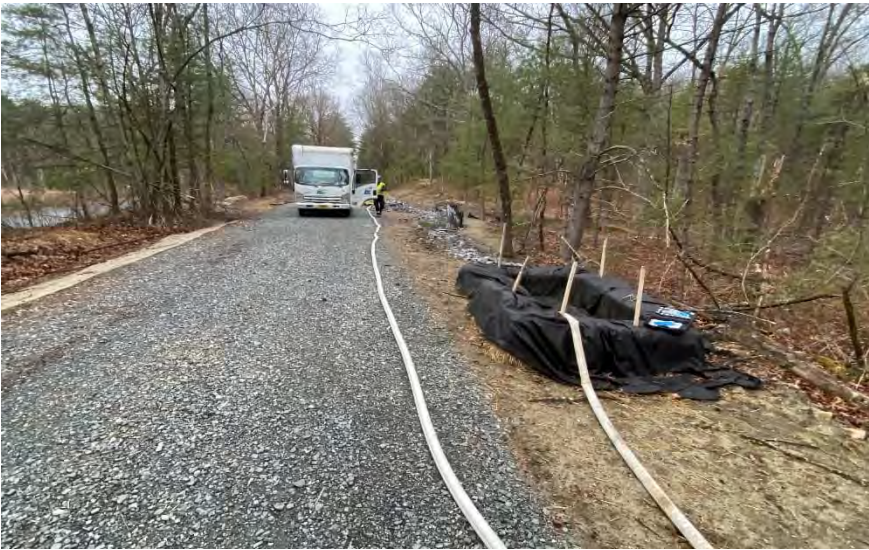
<h2 style="margin: 0;">PHOTOGRAPHIC LOG</h2>	
Client Name: Eversource		Site Location: Sudbury to Hudson Transmission Reliability Project	Town: Hudson
Photo No.: 3	Date: 4/3/2024

Description: Manhole #12. View of dewatering operation, looking westward.

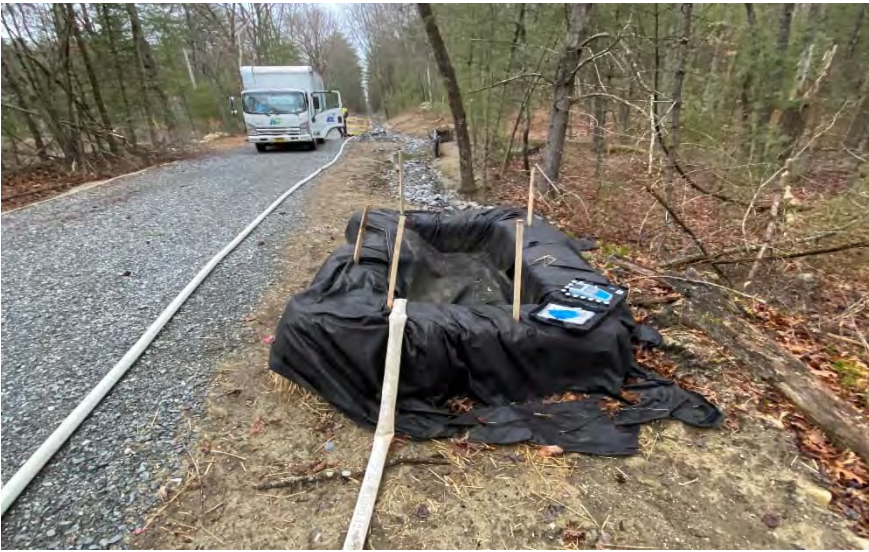
<h2 style="margin: 0;">PHOTOGRAPHIC LOG</h2>	
Client Name: Eversource		Site Location: Sudbury to Hudson Transmission Reliability Project	Town: Hudson
Photo No.: 4	Date: 4/3/2024

Description: Manhole #12. View of discharge bag/corral, looking westward. Water from bag/corral discharged to adjacent area.

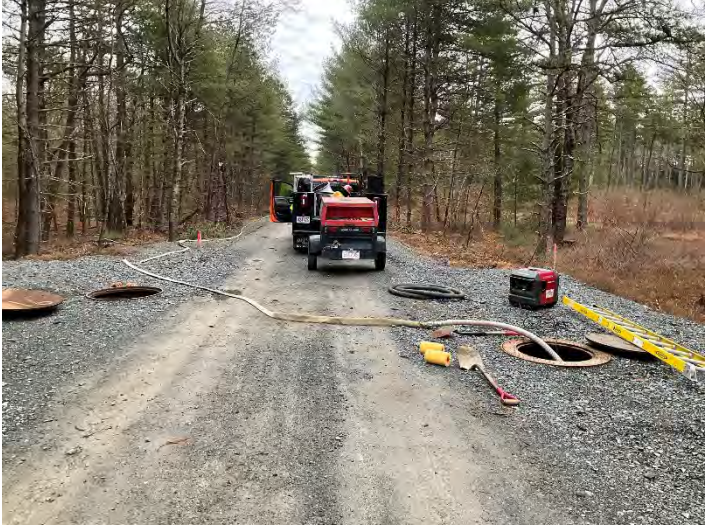
PHOTOGRAPHIC LOG	
Client Name: Eversource		Site Location: Sudbury to Hudson Transmission Reliability Project	Town: Sudbury
Photo No.: 1	Date: 4/03/2024

Description: View of Bond working at MH/HH #16 in segment 7. Facing east.

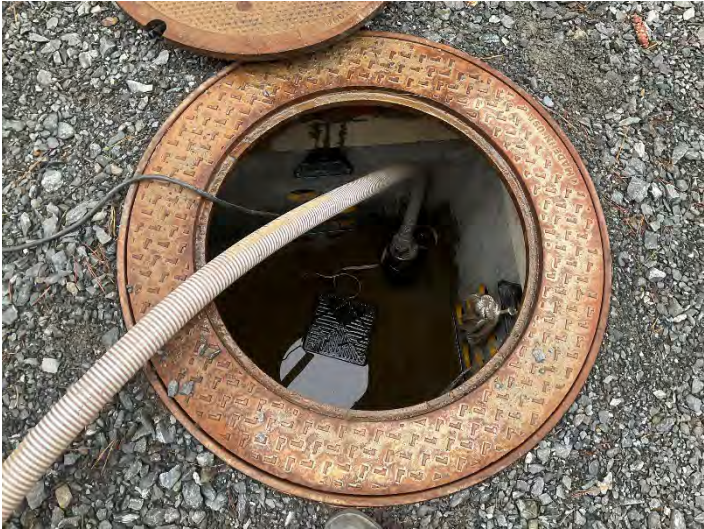
PHOTOGRAPHIC LOG	
Client Name: Eversource		Site Location: Sudbury to Hudson Transmission Reliability Project	Town: Sudbury
Photo No.: 2	Date: 4/03/2024

Description: View of pump in HH #16. Water appeared mostly clear prior to treatment.

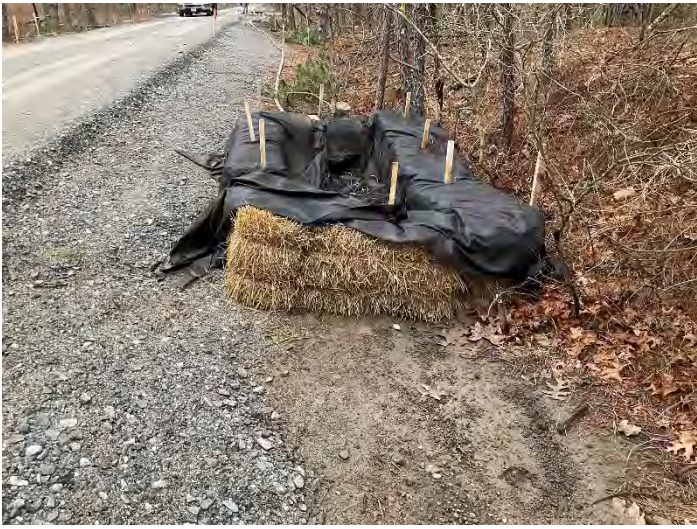
PHOTOGRAPHIC LOG	
Client Name: Eversource		Site Location: Sudbury to Hudson Transmission Reliability Project	Town: Sudbury
Photo No.: 4	Date: 4/03/2024

Description: Additional view of controls. Pump was only on for 10 minutes. Discharge did not leave corral, so no sample was taken. Facing west.

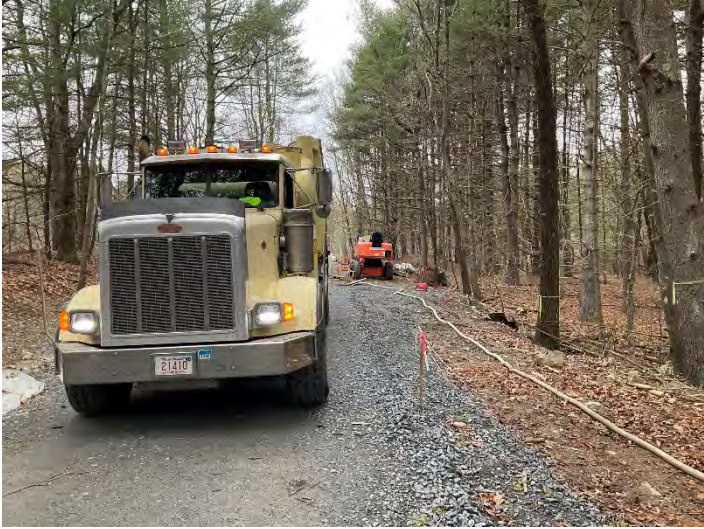
PHOTOGRAPHIC LOG	
Client Name: Eversource		Site Location: Sudbury to Hudson Transmission Reliability Project	Town: Sudbury
Photo No.: 1	Date: 4/03/2024

Description: View of Bond working at MH #17 in segment 8. Facing west.

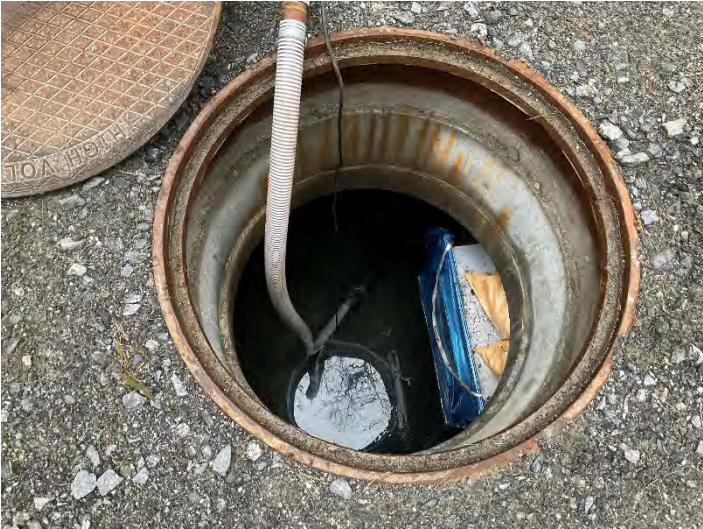
PHOTOGRAPHIC LOG	
Client Name: Eversource		Site Location: Sudbury to Hudson Transmission Reliability Project	Town: Sudbury
Photo No.: 2	Date: 4/03/2024

Description: View of pump in MH #17. Water appeared mostly clear prior to treatment.

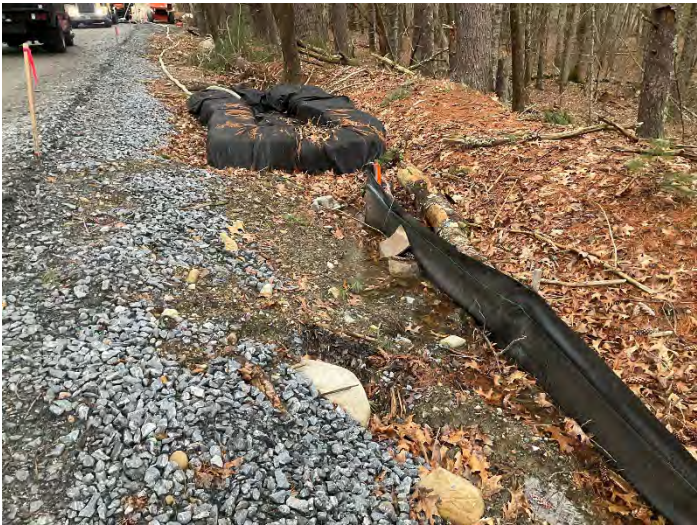
PHOTOGRAPHIC LOG	
Client Name: Eversource		Site Location: Sudbury to Hudson Transmission Reliability Project	Town: Sudbury
Photo No.: 4	Date: 4/03/2024

Description: Additional view of controls and discharge from project. Discharge appeared mostly clear. Turbidity reading was below 50 NTUs. Discharge traveled east outside of silt fence but did not appear to reach any jurisdictional resource areas. Facing west.

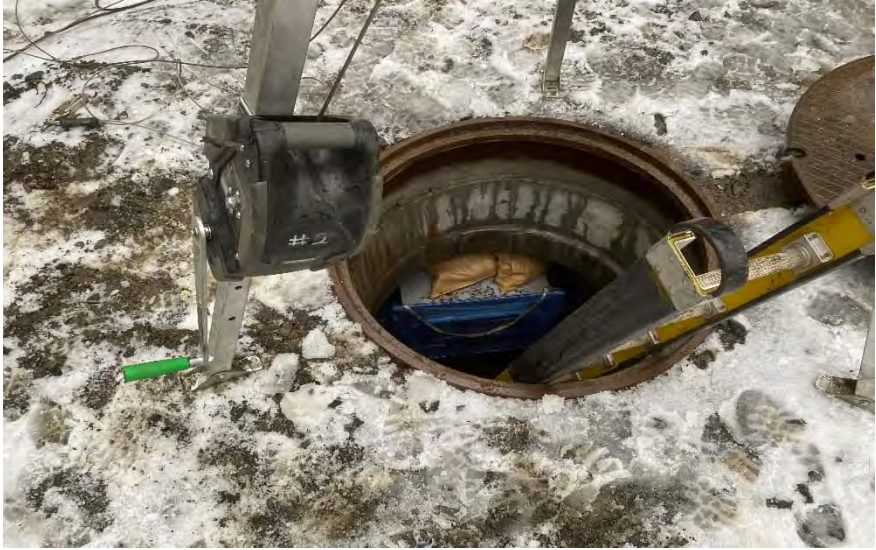
PHOTOGRAPHIC LOG	
Client Name: Eversource		Site Location: Sudbury to Hudson Transmission Reliability Project	Town: Sudbury
Photo No.: 1	Date: 4/4/2024

Description: View of area being pumped from manhole #17, segment 8.

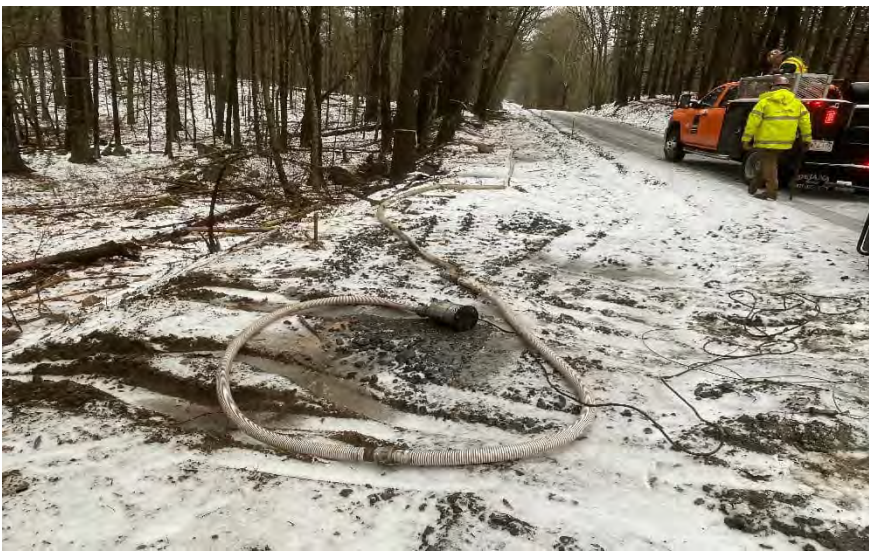
PHOTOGRAPHIC LOG	
Client Name: Eversource		Site Location: Sudbury to Hudson Transmission Reliability Project	Town: Sudbury
Photo No.: 2	Date: 4/4/2024

Description: Manhole #17. View of dewatering operation. Looking eastward.

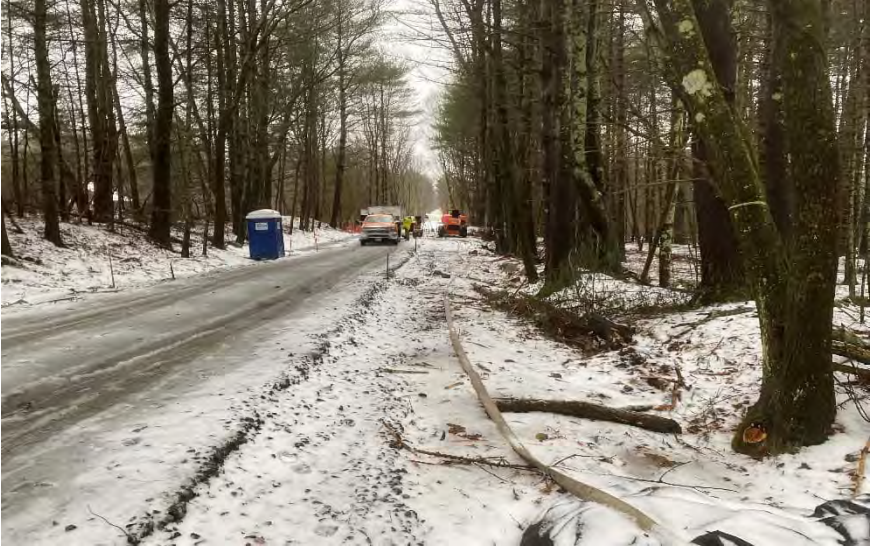
PHOTOGRAPHIC LOG	
Client Name: Eversource		Site Location: Sudbury to Hudson Transmission Reliability Project	Town: Sudbury
Photo No.: 3	Date: 4/4/2024

Description: Manhole #17. View of dewatering operation, looking westward.

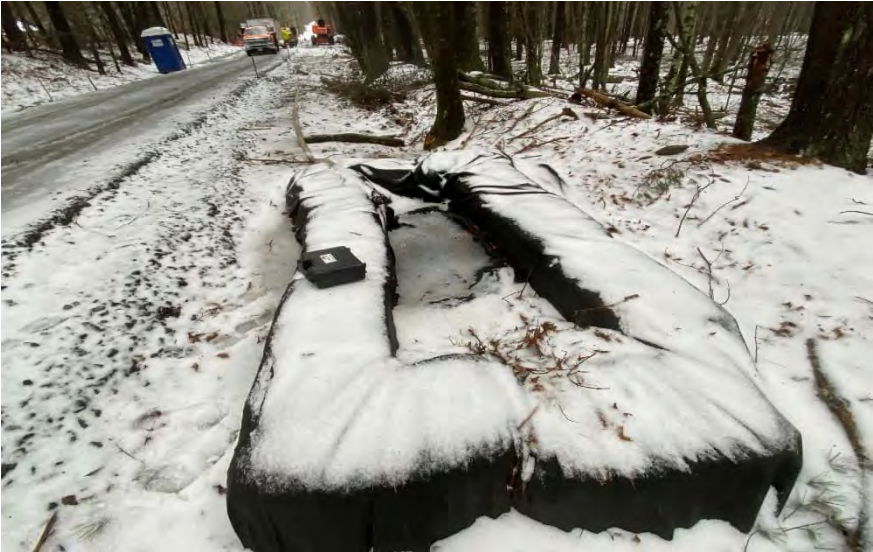
PHOTOGRAPHIC LOG	
Client Name: Eversource		Site Location: Sudbury to Hudson Transmission Reliability Project	Town: Sudbury
Photo No.: 4	Date: 4/4/2024

Description: Manhole #17. View of discharge bag/corral, looking westward. Water from bag/corral discharged to adjacent area.

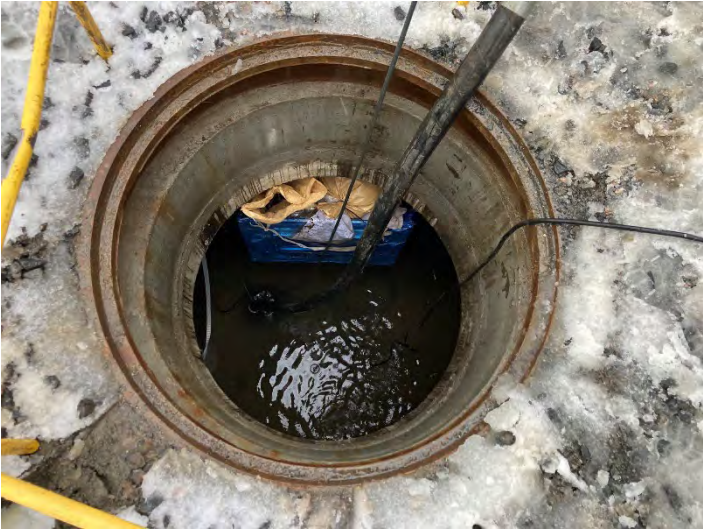
PHOTOGRAPHIC LOG	
Client Name: Eversource		Site Location: Sudbury to Hudson Transmission Reliability Project	
		Town: Sudbury	
Photo No.: 2	Date: 4/04/2024

Description: View of pump in MH #25. Water appeared slightly turbid prior to treatment.

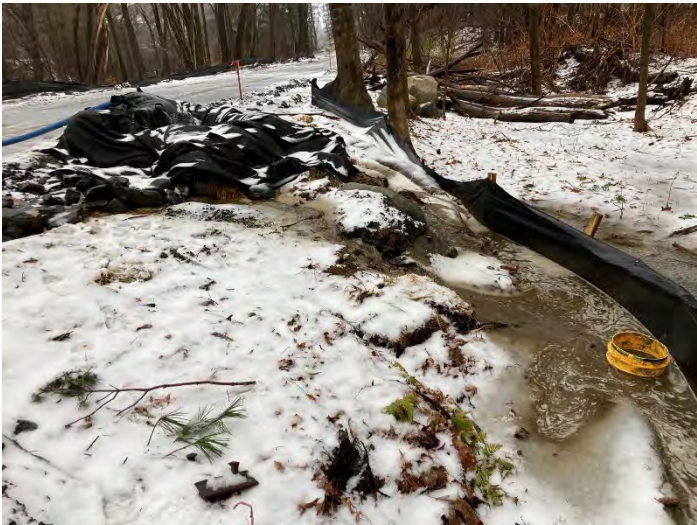
PHOTOGRAPHIC LOG	
Client Name: Eversource		Site Location: Sudbury to Hudson Transmission Reliability Project	Town: Sudbury
Photo No.: 4	Date: 4/04/2024

Description: View of dewatering controls (straw bale corral with filter fabric and silt bag) and discharge from corral. Discharge appeared turbid. Turbidity reading was higher than 50 NTUs, but discharge did not reach any jurisdictional resource areas. Facing east.

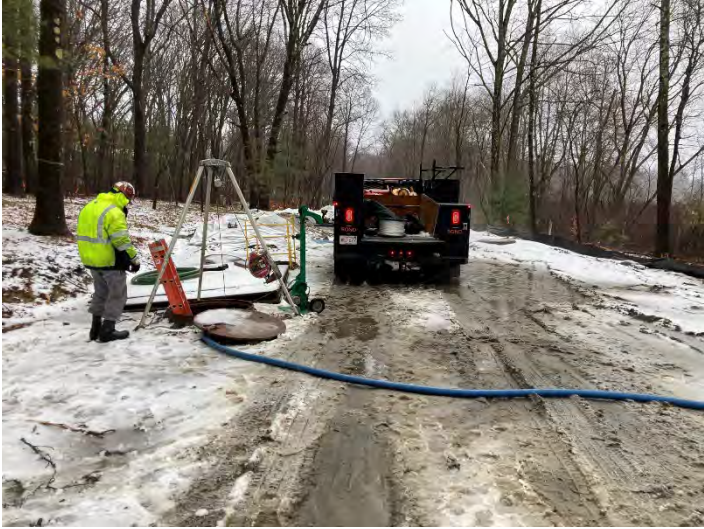
Epsilon <small>ASSOCIATES INC.</small>		PHOTOGRAPHIC LOG	
Client Name: Eversource		Site Location: Sudbury to Hudson Transmission Reliability Project	Town: Sudbury
Photo No.: 1	Date: 4/04/2024

Description: View of Bond working at MH #26 in segment 14. Facing east.

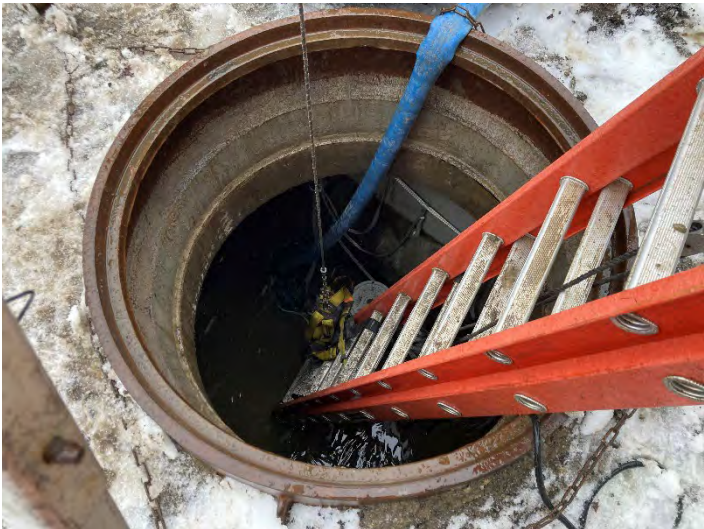
Epsilon <small>ASSOCIATES INC.</small>		PHOTOGRAPHIC LOG	
Client Name: Eversource		Site Location: Sudbury to Hudson Transmission Reliability Project	Town: Sudbury
Photo No.: 2	Date: 4/04/2024

Description: View of pump in MH #26 in segment 14. Water appeared mostly clear prior to treatment.

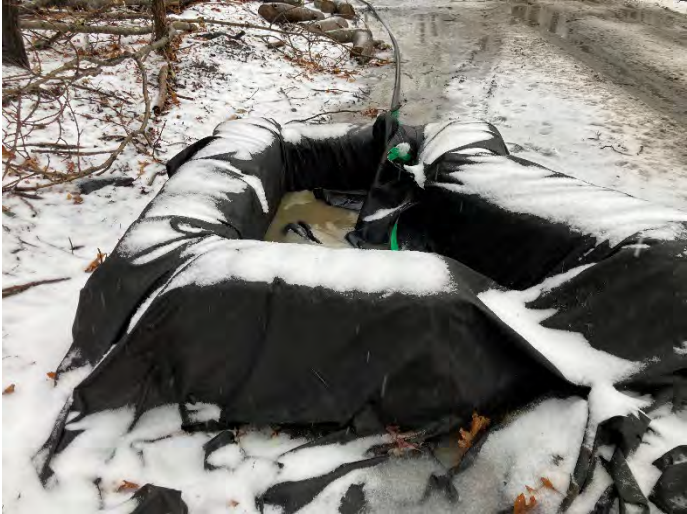
PHOTOGRAPHIC LOG	
Client Name: Eversource		Site Location: Sudbury to Hudson Transmission Reliability Project	Town: Sudbury
Photo No.: 3	Date: 4/04/2024

Description: View of dewatering controls (straw bale corral with filter fabric and silt bag). Facing east.

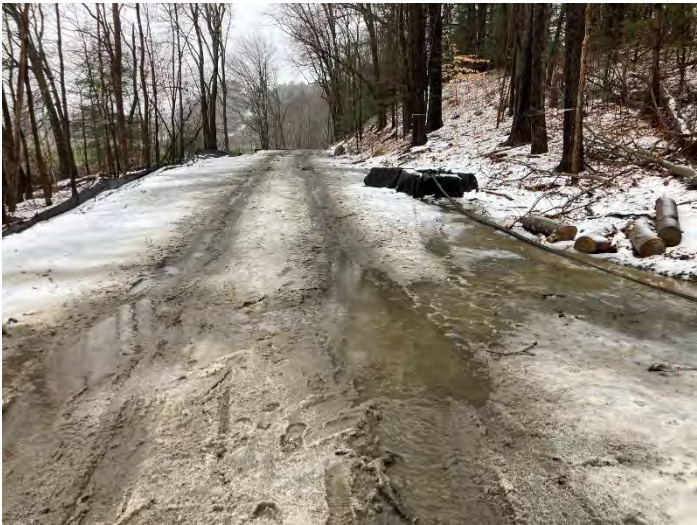
PHOTOGRAPHIC LOG	
Client Name: Eversource		Site Location: Sudbury to Hudson Transmission Reliability Project	Town: Sudbury
Photo No.: 4	Date: 4/04/2024

Description: View of discharge from corral. Water traveled across project ROW and discharged through silt fence and into wetland adjacent to project. Discharge appeared turbid and turbidity reading was higher than 50 NTUs. Pump was turned off after short period of time, so corrective action not needed. Facing west.

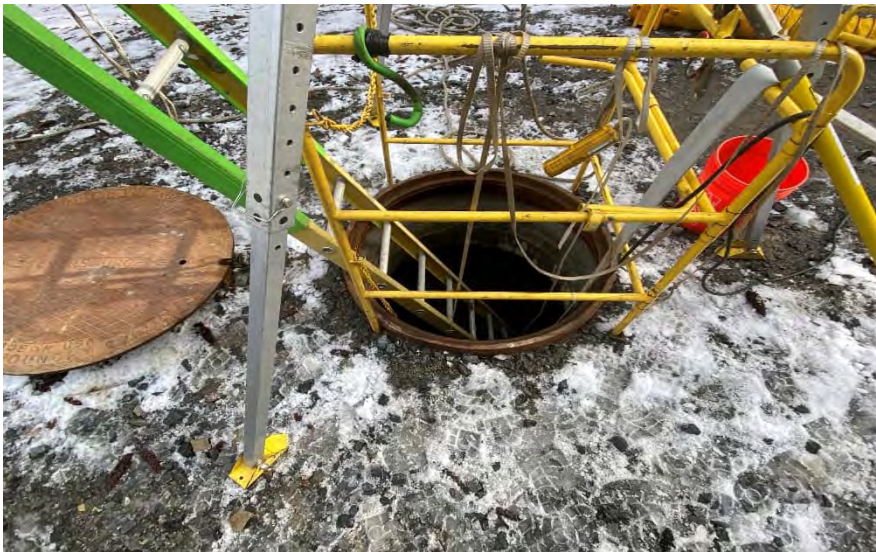
PHOTOGRAPHIC LOG	
Client Name: Eversource		Site Location: Sudbury to Hudson Transmission Reliability Project	Town: Hudson
Photo No.: 1	Date: 4/5/2024

Description: View of area being pumped from manhole #11, segment 5.
