Weekly Environmental Compliance Summary

Sudbury to Hudson Transmission Reliability Project (USEPA Tracking # MAR1003UW)

Sudbury, Hudson, and Stow, MA

Week of: April 1, 2024 to April 6, 2024

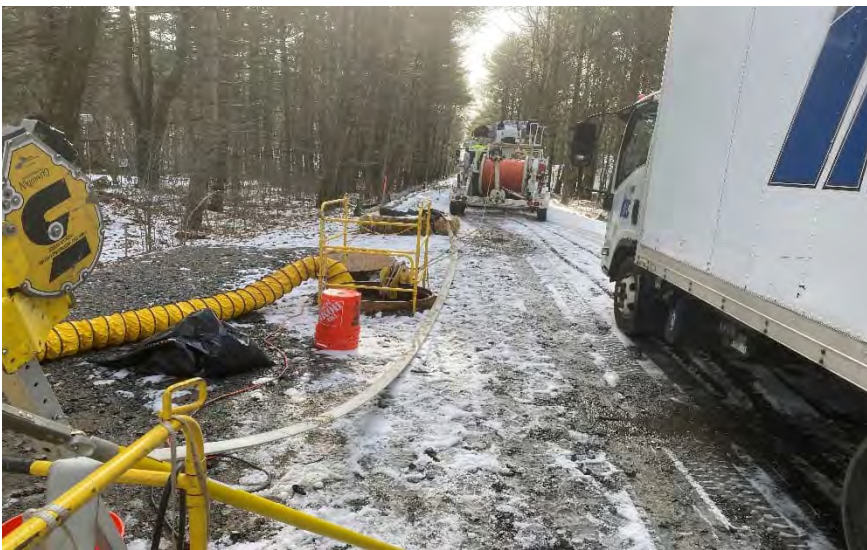
PHOTOGRAPHIC LOG	
Client Name: Eversource		Site Location: Sudbury to Hudson Transmission Reliability Project	Town: Hudson
Photo No.: 2	Date: 4/5/2024

Description: Manhole #11. View of dewatering operation. Looking eastward.

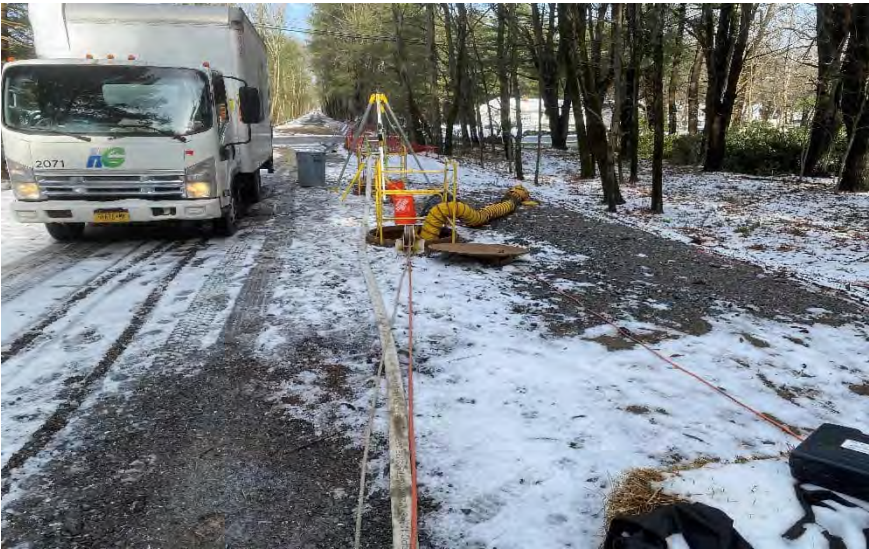
PHOTOGRAPHIC LOG	
Client Name: Eversource		Site Location: Sudbury to Hudson Transmission Reliability Project	
Town: Hudson			
Photo No.: 3	Date: 4/5/2024

Description: Manhole #11. View of dewatering operation, looking westward.

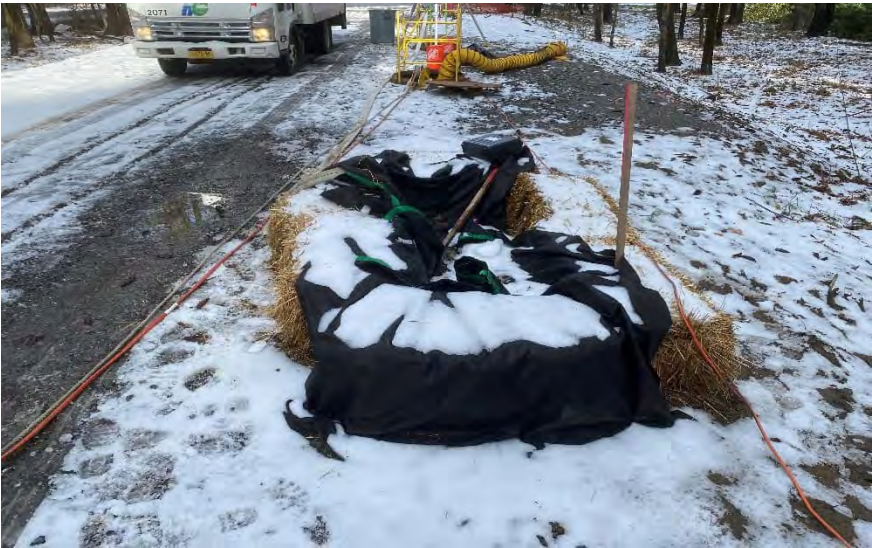
PHOTOGRAPHIC LOG	
Client Name: Eversource		Site Location: Sudbury to Hudson Transmission Reliability Project	
Town: Hudson			
Photo No.: 4	Date: 4/5/2024

Description: Manhole #11. View of discharge bag/corral, looking westward. Water from bag/corral discharged to adjacent area.

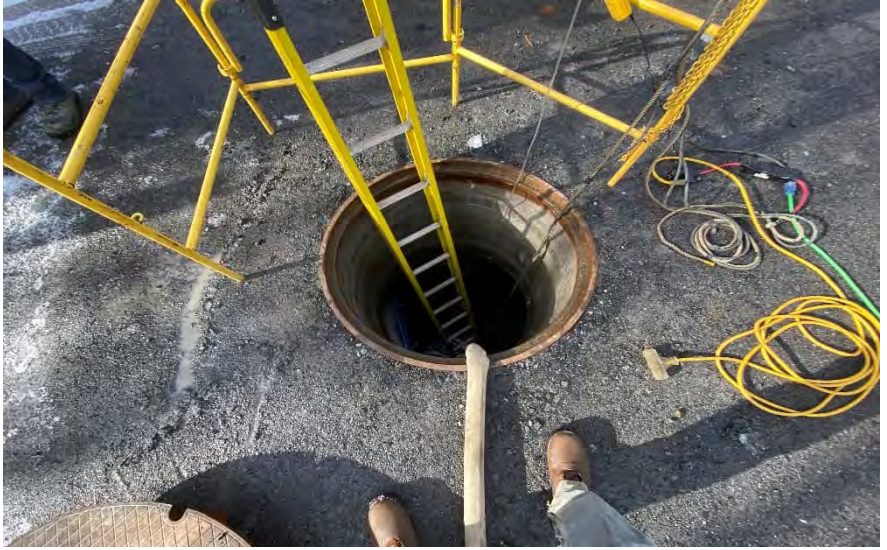
PHOTOGRAPHIC LOG	
Client Name: Eversource		Site Location: Sudbury to Hudson Transmission Reliability Project	
		Town: Hudson	
Photo No.: 1	Date: 4/5/2024

Description: View of area being pumped from manhole #10, segment 4.

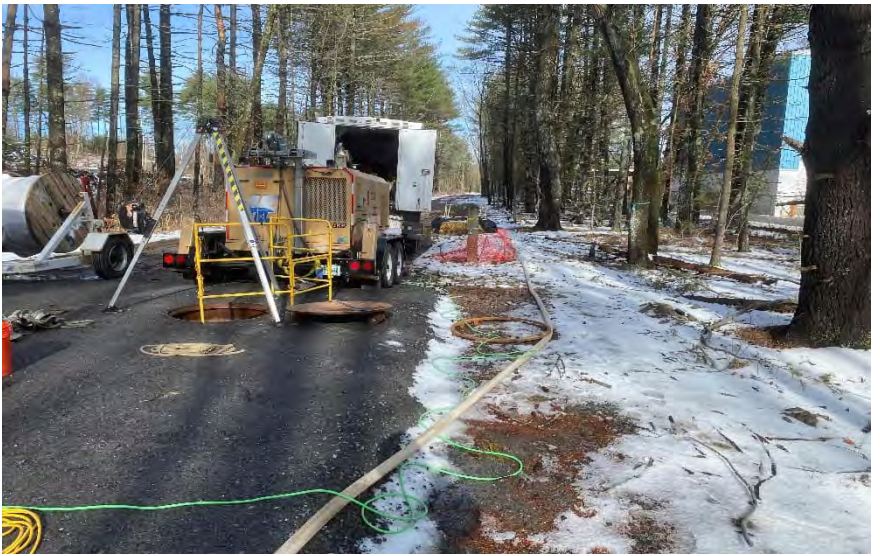
PHOTOGRAPHIC LOG	
Client Name: Eversource		Site Location: Sudbury to Hudson Transmission Reliability Project	
		Town: Hudson	
Photo No.: 2	Date: 4/5/2024

Description: Manhole #10. View of dewatering operation. Looking westward.

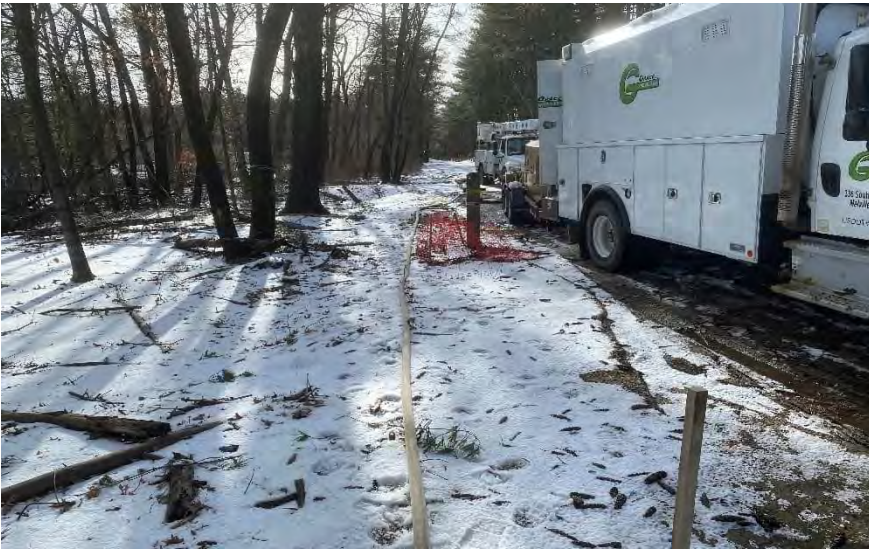
PHOTOGRAPHIC LOG	
Client Name: Eversource		Site Location: Sudbury to Hudson Transmission Reliability Project	
Town: Hudson			
Photo No.: 3	Date: 4/5/2024

Description: Manhole #10. View of dewatering operation, looking eastward.

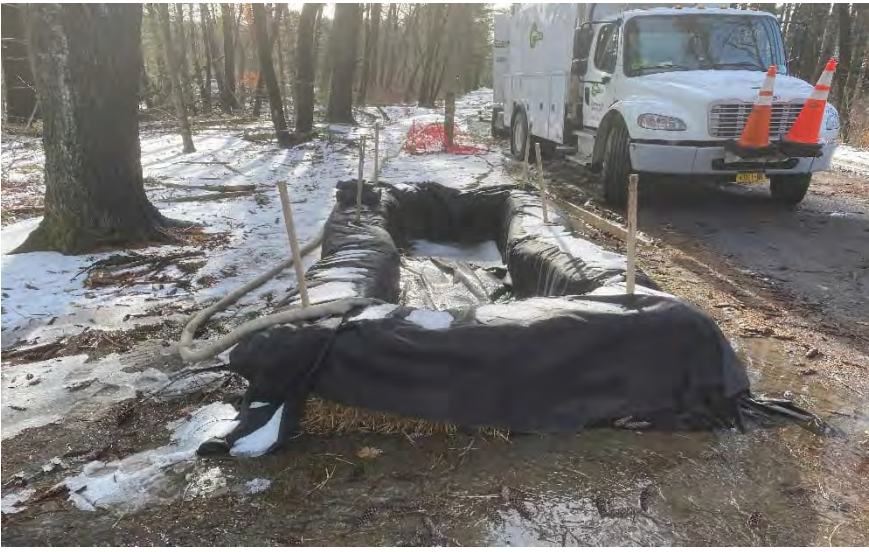
PHOTOGRAPHIC LOG	
Client Name: Eversource		Site Location: Sudbury to Hudson Transmission Reliability Project	
Town: Hudson			
Photo No.: 4	Date: 4/5/2024

Description: Manhole #10. View of discharge bag/corral, looking eastward. Water from bag/corral discharged to adjacent area.

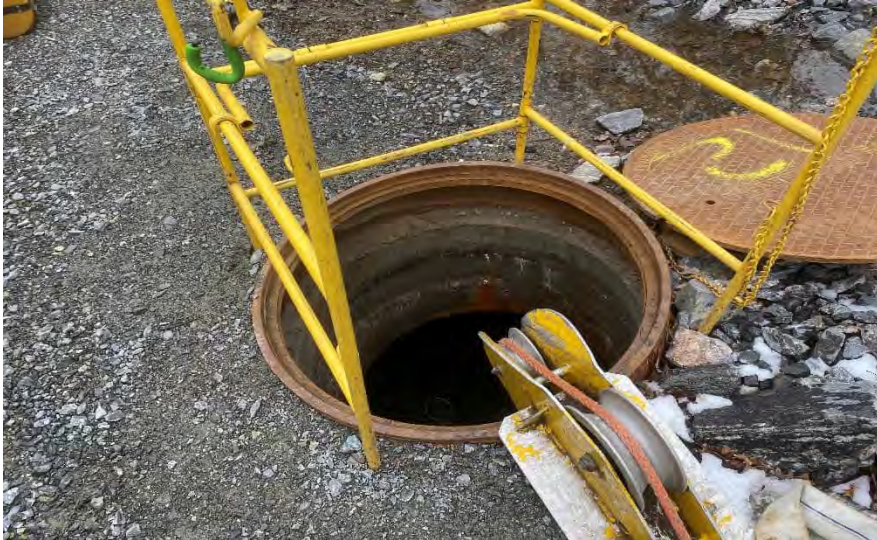
PHOTOGRAPHIC LOG	
Client Name: Eversource		Site Location: Sudbury to Hudson Transmission Reliability Project	Town: Hudson
Photo No.: 1	Date: 4/5/2024

Description: View of area being pumped from manhole #12, segment 5.

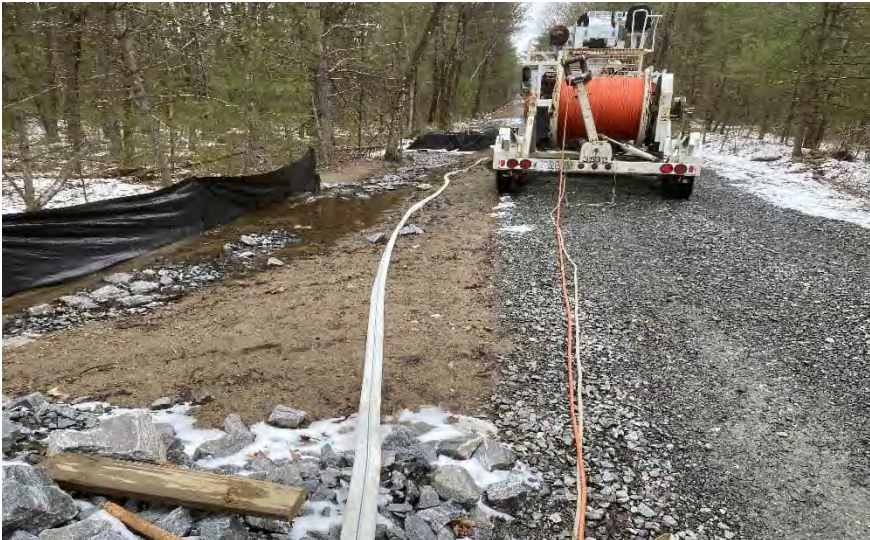
PHOTOGRAPHIC LOG	
Client Name: Eversource		Site Location: Sudbury to Hudson Transmission Reliability Project	Town: Hudson
Photo No.: 2	Date: 4/5/2024

Description: Manhole #12. View of dewatering operation. Looking eastward.

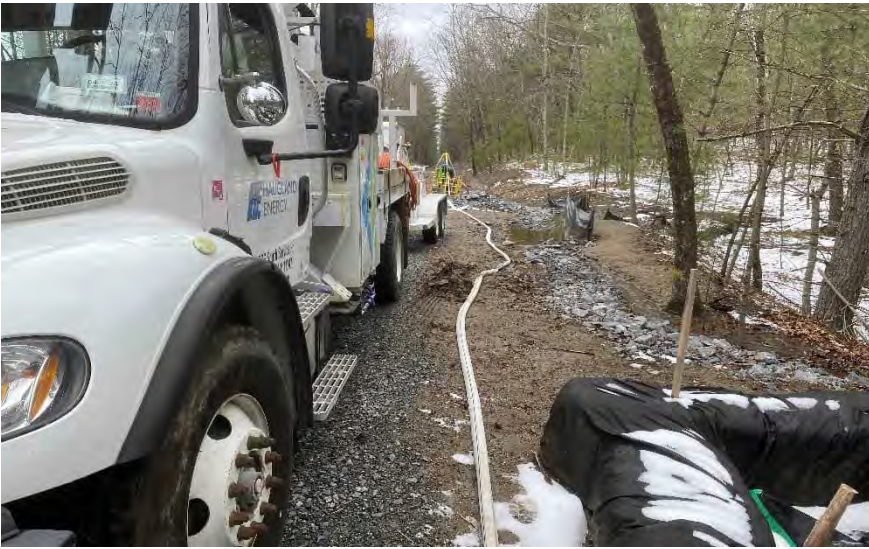
PHOTOGRAPHIC LOG	
Client Name: Eversource		Site Location: Sudbury to Hudson Transmission Reliability Project	Town: Hudson
Photo No.: 3	Date: 4/5/2024

Description: Manhole #12. View of dewatering operation, looking westward.

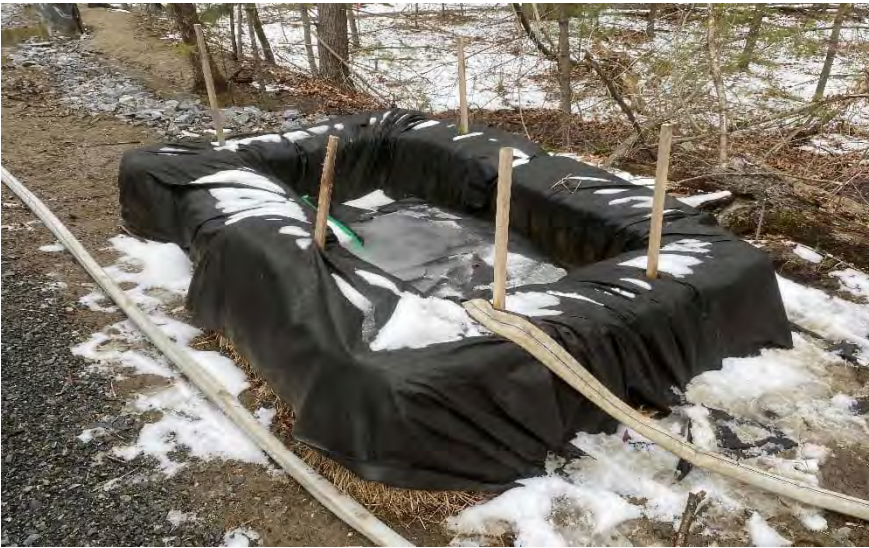
PHOTOGRAPHIC LOG	
Client Name: Eversource		Site Location: Sudbury to Hudson Transmission Reliability Project	Town: Hudson
Photo No.: 4	Date: 4/5/2024

Description: Manhole #12. View of discharge bag/corral, looking westward. Water from bag/corral discharged to adjacent area.

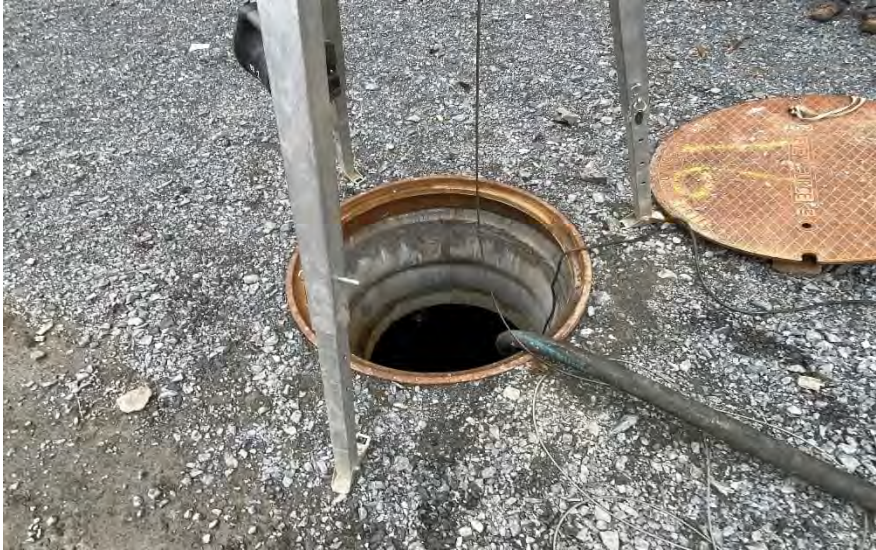
PHOTOGRAPHIC LOG	
Client Name: Eversource		Site Location: Sudbury to Hudson Transmission Reliability Project	Town: Sudbury
Photo No.: 1	Date: 4/5/2024

Description: View of area being pumped from manhole #16, segment 7.

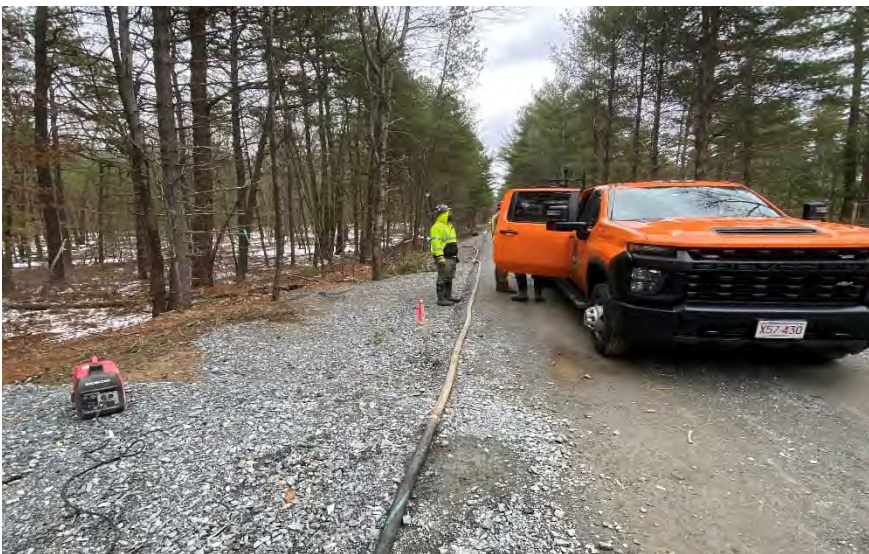
PHOTOGRAPHIC LOG	
Client Name: Eversource		Site Location: Sudbury to Hudson Transmission Reliability Project	Town: Sudbury
Photo No.: 2	Date: 4/5/2024

Description: Manhole #16. View of dewatering operation. Looking eastward.

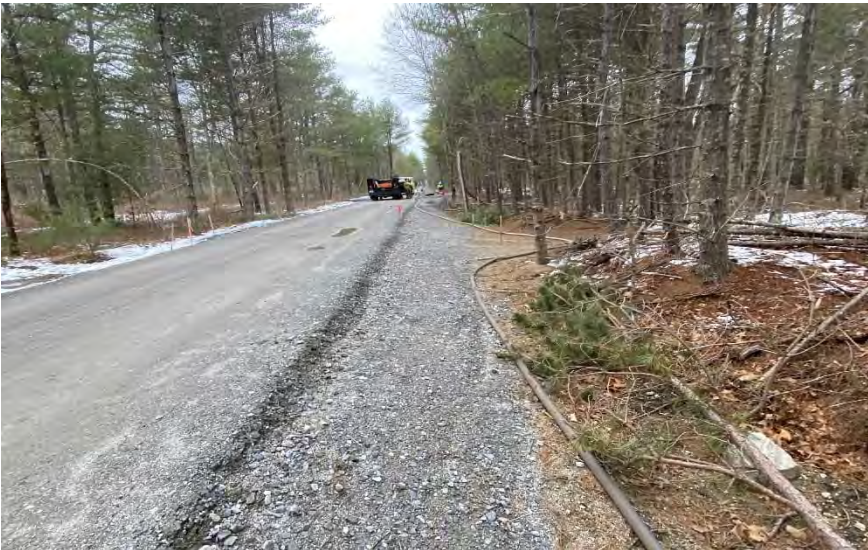
PHOTOGRAPHIC LOG	
Client Name: Eversource		Site Location: Sudbury to Hudson Transmission Reliability Project	Town: Sudbury
Photo No.: 3	Date: 4/5/2024

Description: Manhole #16. View of dewatering operation, looking westward.

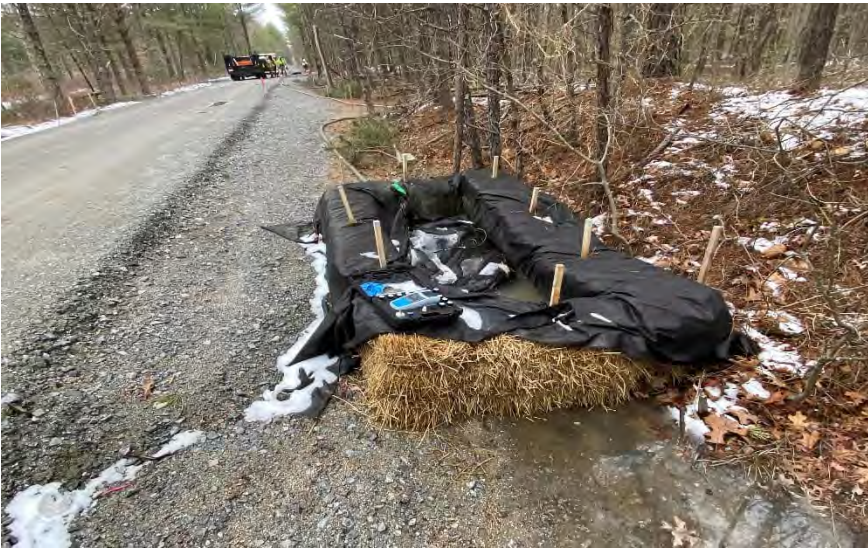
PHOTOGRAPHIC LOG	
Client Name: Eversource		Site Location: Sudbury to Hudson Transmission Reliability Project	Town: Sudbury
Photo No.: 4	Date: 4/5/2024

Description: Manhole #16. View of discharge bag/corral, looking westward. Water from bag/corral discharged to adjacent area.

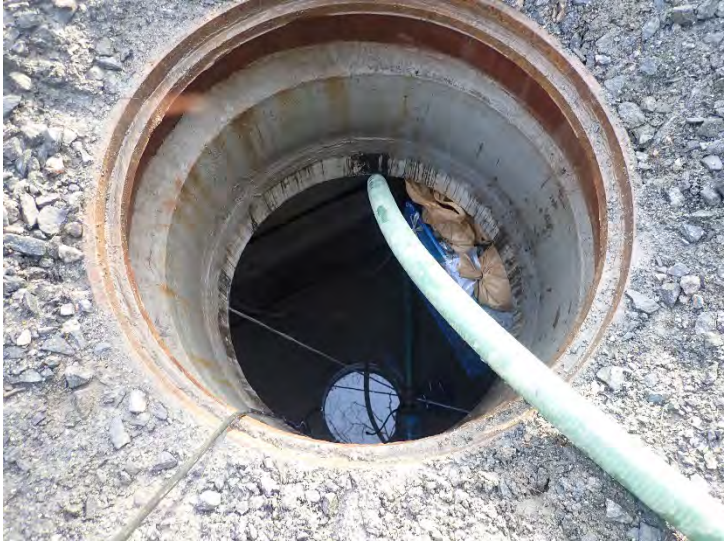
PHOTOGRAPHIC LOG	
Client Name: Eversource		Site Location: Sudbury to Hudson Transmission Reliability Project	Town: Sudbury
Photo No.: 1	Date: 4/5/24

Description: View of area being pumped at work operation at MH#25, off Boston Post Road in segment 13. This is the location of dewatering water prior to treatment. Water appeared to be slightly turbid. Facing northward.

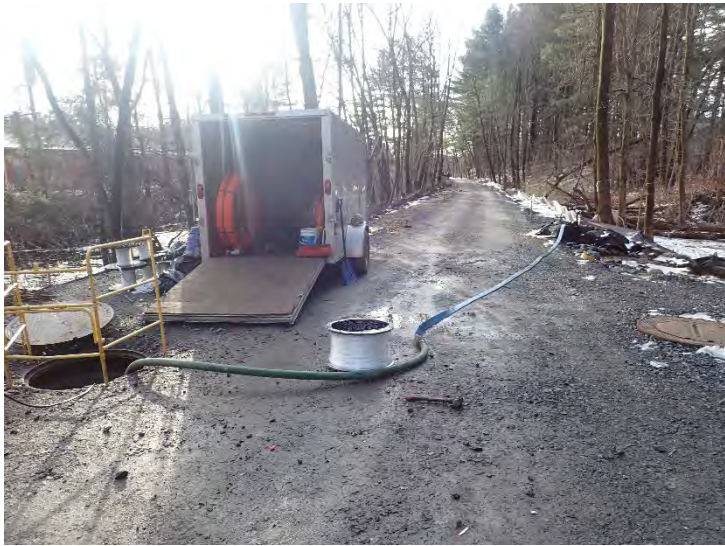
PHOTOGRAPHIC LOG	
Client Name: Eversource		Site Location: Sudbury to Hudson Transmission Reliability Project	Town: Sudbury
Photo No.: 2	Date: 4/5/24

Description: View of pumping operation at MH#25. Facing eastward.

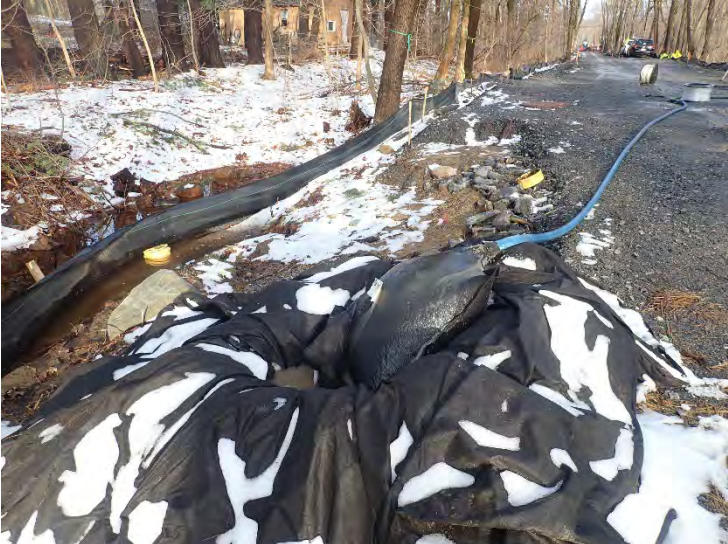
PHOTOGRAPHIC LOG	
Client Name: Eversource		Site Location: Sudbury to Hudson Transmission Reliability Project	Town: Sudbury
Photo No.: 3	Date: 4/5/24

Description: View of dewatering basin for MH#25. Water appears turbid within the basin. Facing westward.

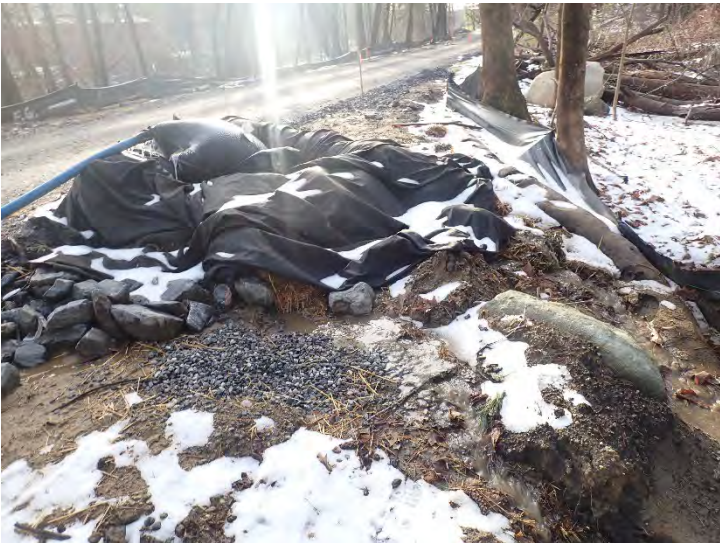
PHOTOGRAPHIC LOG	
Client Name: Eversource		Site Location: Sudbury to Hudson Transmission Reliability Project	Town: Sudbury
Photo No.: 4	Date: 4/5/24

Section A – Dewatering Discharges (CGP Part 4.6.3) Complete this section <u>within 24 hours</u> of completing the inspection. (If necessary, complete additional inspection reports for each separate inspection location.)	
Inspector Information	
Inspector Name: Polina Safran (SWCA), EPA (CGP) Site Inspector	Title: Environmental Scientist
Company Name: SWCA	Email: polina.safran@swca.com
Address: 153 Cordaville Road, Suite 130, Southborough, MA 01772	Phone Number: 781-801-4973
Inspection Details	
Inspection Date: 4/5/24	Inspection Location: MH#25 (Off Boston Post Road, segment 13)
Discharge Start Time: 8 AM	Discharge End Time: 8:05 AM
Rate of Discharge (gallons per day): 435 (87 gallons per minute)	Corrective Action Required? ¹ <input type="checkbox"/> Yes <input checked="" type="checkbox"/> No
Describe Indicators of Pollutant Discharge at Point of Dewatering Discharge: ¹ Turbidity sampling conducted, dewatering setup to discharge to right-of-way east of the manhole #25. Turbidity sampling was high than 50 NTUs but discharge did not reach any resource areas.

Description: View of water discharging from dewatering basin associated with manhole #25. Water is slightly turbid after treatment, as it runs through exposed soils. Facing eastward.

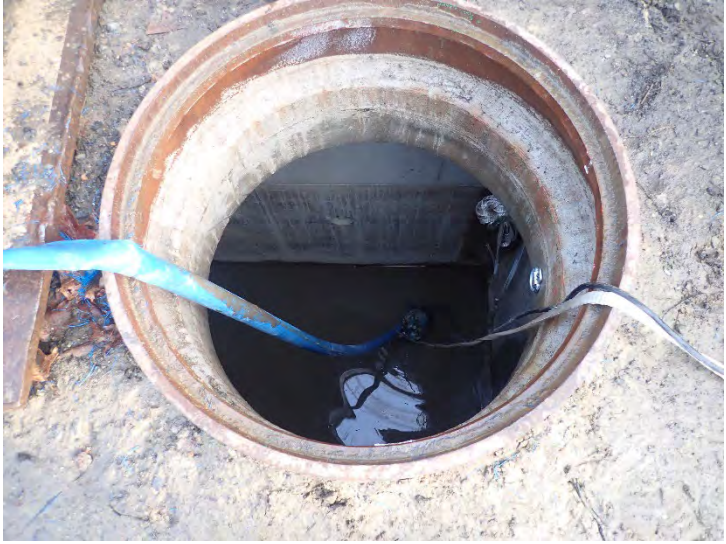
PHOTOGRAPHIC LOG	
Client Name: Eversource		Site Location: Sudbury to Hudson Transmission Reliability Project	Town: Sudbury
Photo No.: 1	Date: 4/5/24

Description: View of area being pumped at work operation at MH#26, off Boston Post Road in segment 14. This is the location of dewatering water prior to treatment. Water appeared to be slightly turbid. Facing northward.

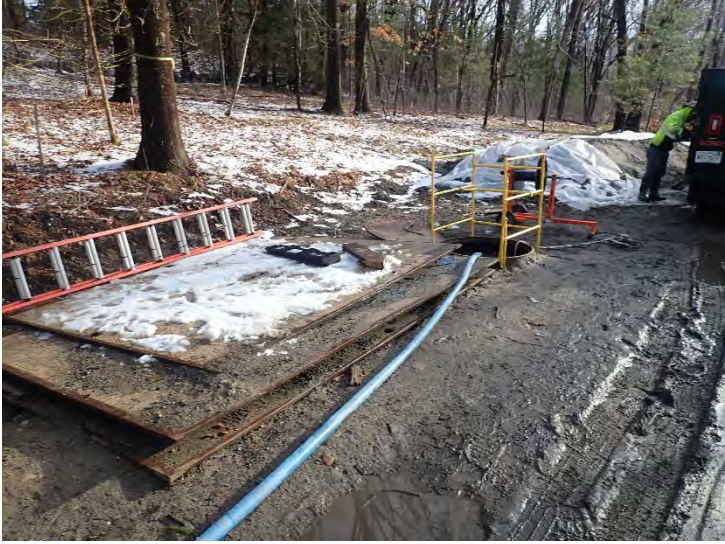
PHOTOGRAPHIC LOG	
Client Name: Eversource		Site Location: Sudbury to Hudson Transmission Reliability Project	Town: Sudbury
Photo No.: 2	Date: 4/5/24

Description: View of pumping operation at MH#26. Facing eastward.

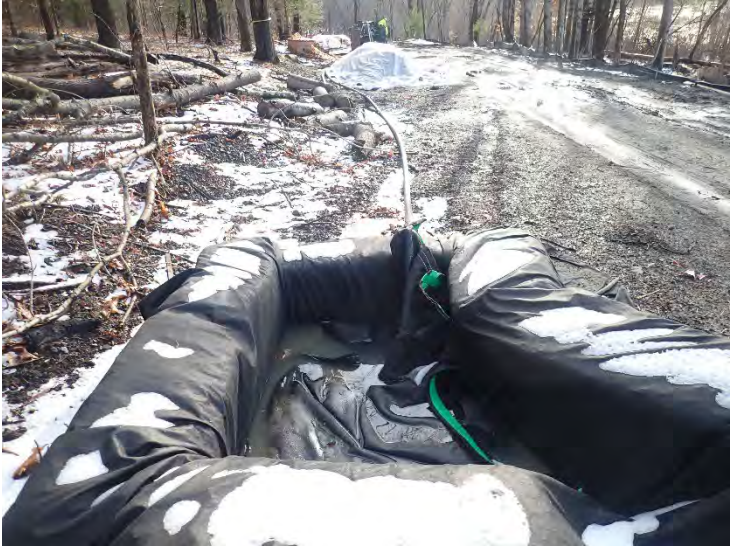
PHOTOGRAPHIC LOG	
Client Name: Eversource		Site Location: Sudbury to Hudson Transmission Reliability Project	Town: Sudbury
Photo No.: 3	Date: 4/5/24

Description: View of dewatering basin for MH#26. Water appears slightly turbid within the basin. Facing eastward.

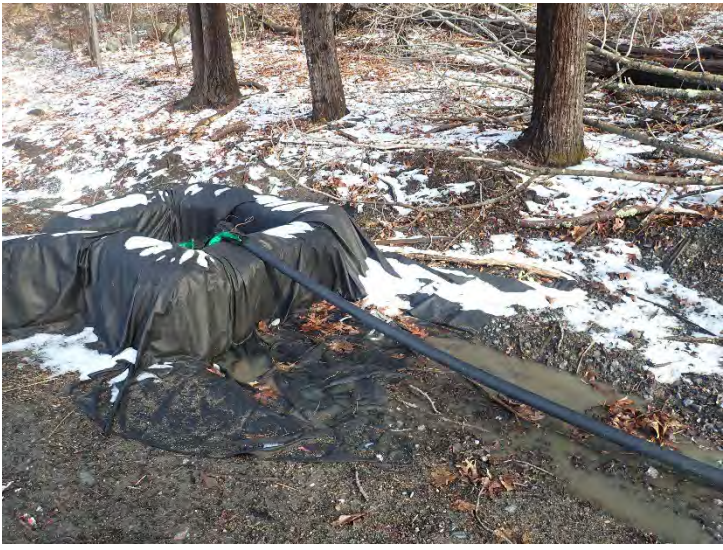
PHOTOGRAPHIC LOG	
Client Name: Eversource		Site Location: Sudbury to Hudson Transmission Reliability Project	Town: Sudbury
Photo No.: 4	Date: 4/5/24

Section A – Dewatering Discharges (CGP Part 4.6.3) Complete this section <u>within 24 hours</u> of completing the inspection. (If necessary, complete additional inspection reports for each separate inspection location.)	
Inspector Information	
Inspector Name: Polina Safran (SWCA), EPA (CGP) Site Inspector	Title: Environmental Scientist
Company Name: SWCA	Email: polina.safran@swca.com
Address: 153 Cordaville Road, Suite 130, Southborough, MA 01772	Phone Number: 781-801-4973
Inspection Details	
Inspection Date: 4/5/24	Inspection Location: MH#26 (Off Boston Post Road, segment 14)
Discharge Start Time: 8:10 AM	Discharge End Time: 8:20 AM
Rate of Discharge (gallons per day): 870 (87 gallons per minute)	Corrective Action Required? ¹ <input type="checkbox"/> Yes <input checked="" type="checkbox"/> No
Describe Indicators of Pollutant Discharge at Point of Dewatering Discharge: ¹ Turbidity sampling conducted, dewatering setup to discharge to right-of-way east of the manhole #26. Turbidity sampling was higher than 50 NTUs.

Description: View of water discharging from dewatering basin associated with manhole #26. Water is clear until it reaches the ground and picks up exposed soils. Facing northward.

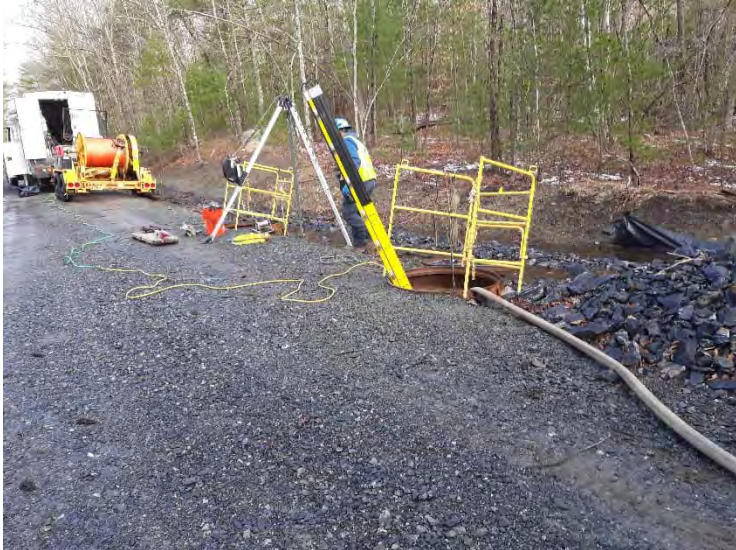
PHOTOGRAPHIC LOG	
Client Name: Eversource		Site Location: Sudbury to Hudson Transmission Reliability Project	Town: Hudson
Photo No.: 1	Date: 4/6/2024

Description: View of area being pumped from manhole #12, segment 5. Looking westward.

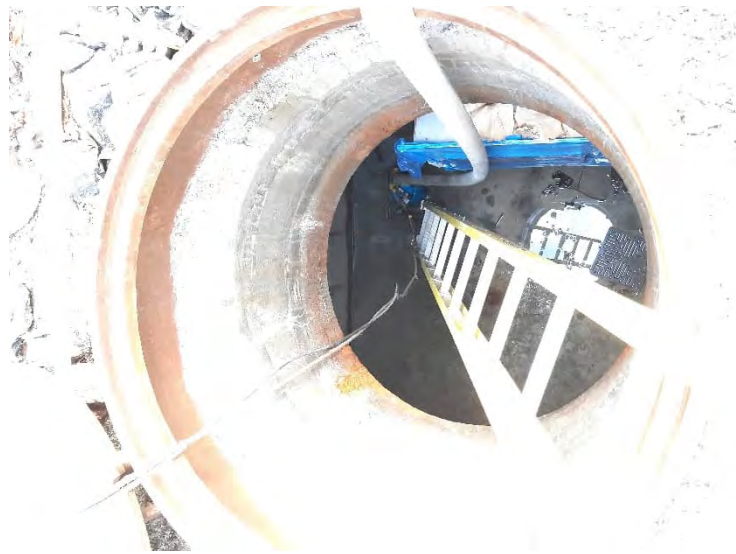
PHOTOGRAPHIC LOG	
Client Name: Eversource		Site Location: Sudbury to Hudson Transmission Reliability Project	Town: Hudson
Photo No.: 2	Date: 4/6/2024

Description: Manhole #12. View of dewatering source. Looking downward into manhole. West is bottom of image.

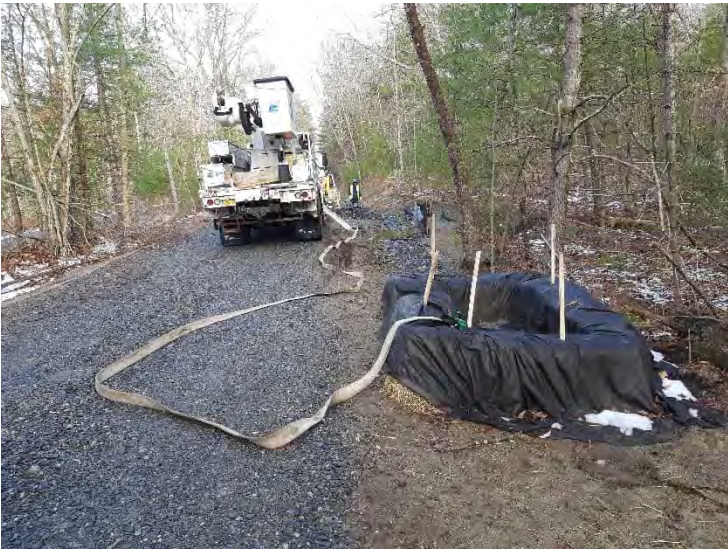
PHOTOGRAPHIC LOG	
Client Name: Eversource		Site Location: Sudbury to Hudson Transmission Reliability Project	Town: Hudson
Photo No.: 3	Date: 4/6/2024

Description: Manhole #12. View of dewatering operation, looking westward.

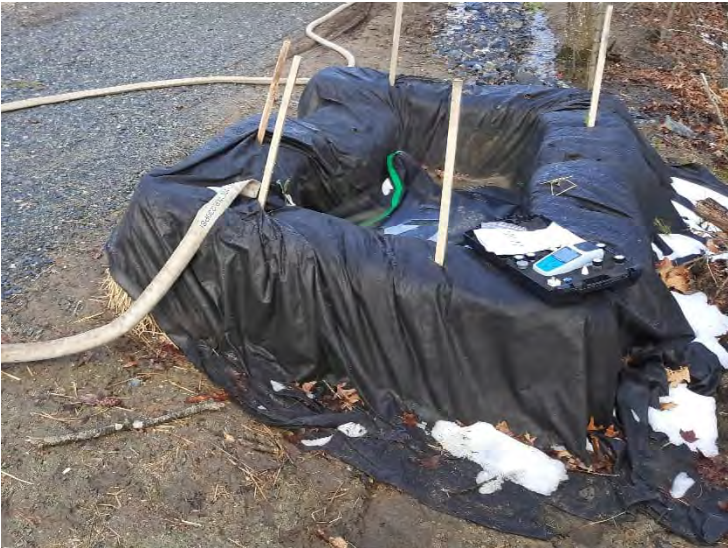
PHOTOGRAPHIC LOG	
Client Name: Eversource		Site Location: Sudbury to Hudson Transmission Reliability Project	Town: Hudson
Photo No.: 4	Date: 4/6/2024

Description: Manhole #12. View of discharge bag/corral, looking westward. Water from bag/corral discharged to adjacent area.

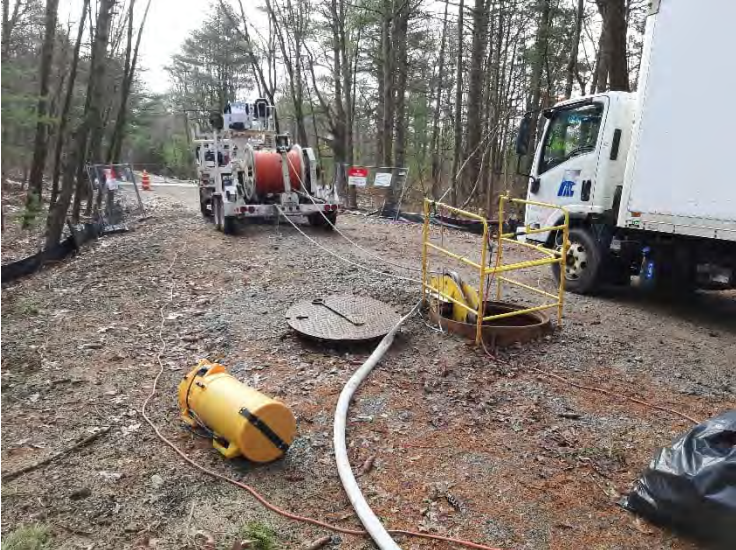
PHOTOGRAPHIC LOG	
Client Name: Eversource		Site Location: Sudbury to Hudson Transmission Reliability Project	Town: Hudson
Photo No.: 1	Date: 4/6/2024

Description: View of area being pumped from manhole #13, segment 5. Looking eastward.

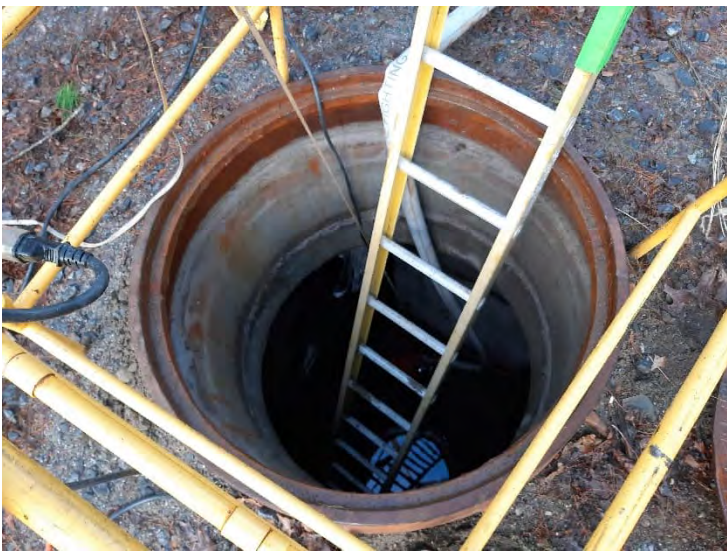
PHOTOGRAPHIC LOG	
Client Name: Eversource		Site Location: Sudbury to Hudson Transmission Reliability Project	Town: Hudson
Photo No.: 2	Date: 4/6/2024

Description: Manhole #13. View of dewatering source. Looking downward into manhole. East is bottom of image. Hose switched from westward manhole entry point to eastward manhole entry point between Photo No. 1 and Photo No. 2. Both points access same chamber.
