Weekly Environmental Compliance Summary

Sudbury to Hudson Transmission Reliability Project (USEPA Tracking # MAR1003UW)

Sudbury, Hudson, and Stow, MA

Week of: April 15, 2024 to April 20, 2024

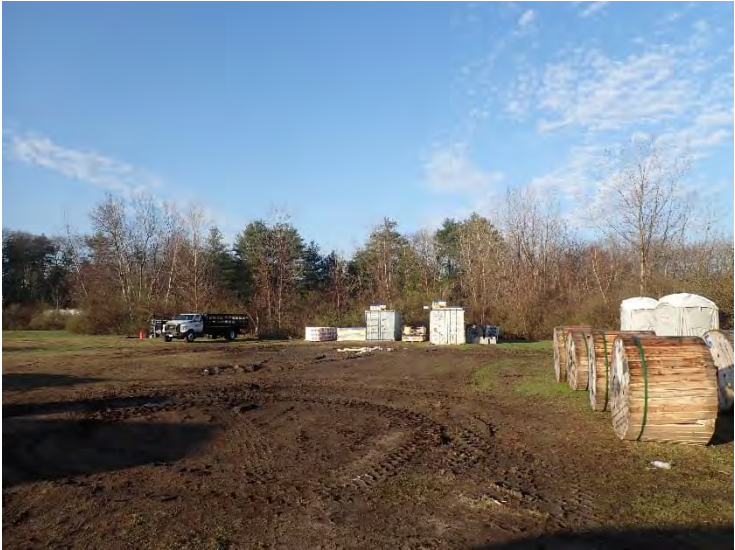
<p>PHOTOGRAPHIC LOG</p>	
<p>Client Name: Eversource</p>		<p>Site Location: Sudbury to Hudson Transmission Reliability Project</p>	<p>Town: Hudson</p>
<p>Photo No.: 1</p>	<p>Date: 4-15-24</p>

<p>Description:</p> <p>Work area within Haugland laydown yard. Facing west.</p>

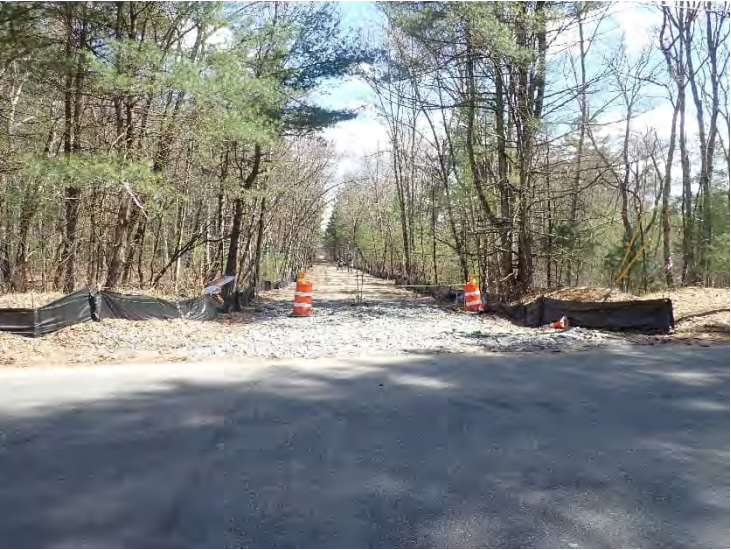
<p>PHOTOGRAPHIC LOG</p>	
<p>Client Name: Eversource</p>		<p>Site Location: Sudbury to Hudson Transmission Reliability Project</p>	<p>Town: Hudson</p>
<p>Photo No.: 3</p>	<p>Date: 4-15-24</p>

<p>Description:</p> <p>View of construction entrance to Segment 6 off White Pond Road. Facing east.</p>

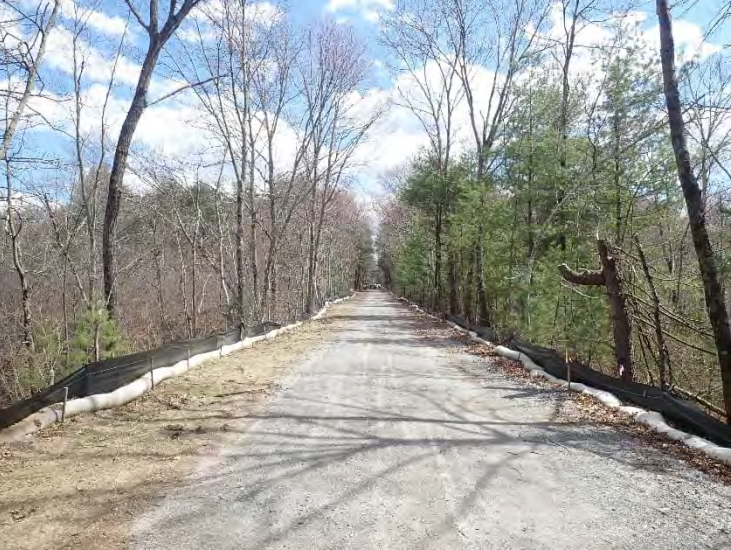
<p>PHOTOGRAPHIC LOG</p>	
<p>Client Name: Eversource</p>		<p>Site Location: Sudbury to Hudson Transmission Reliability Project</p>	<p>Town: Hudson</p>
<p>Photo No.: 4</p>	<p>Date: 4-15-24</p>

<p>Description:</p> <p>View of E&S controls in Segment 5. Facing West.</p>

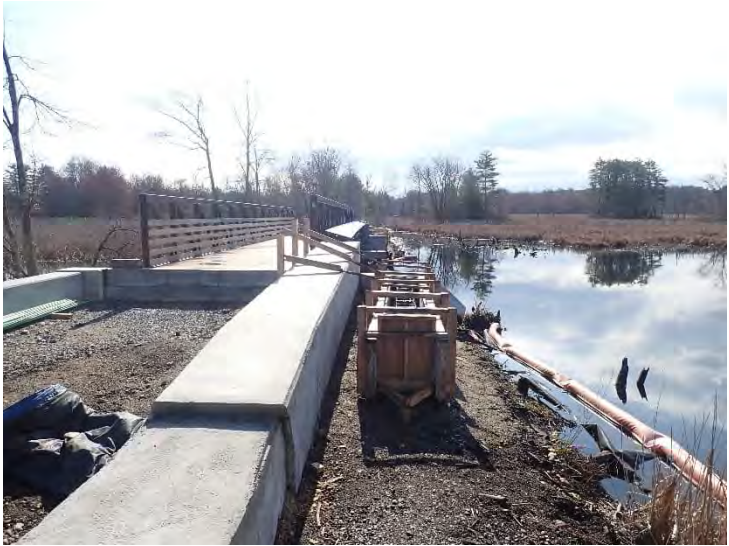
<p>PHOTOGRAPHIC LOG</p>	
<p>Client Name: Eversource</p>		<p>Site Location: Sudbury to Hudson Transmission Reliability Project</p>	<p>Town: Hudson</p>
<p>Photo No.: 5</p>	<p>Date: 4-15-24</p>

<p>Description: View of turbidity curtain by Bridge 130. Facing east.</p>

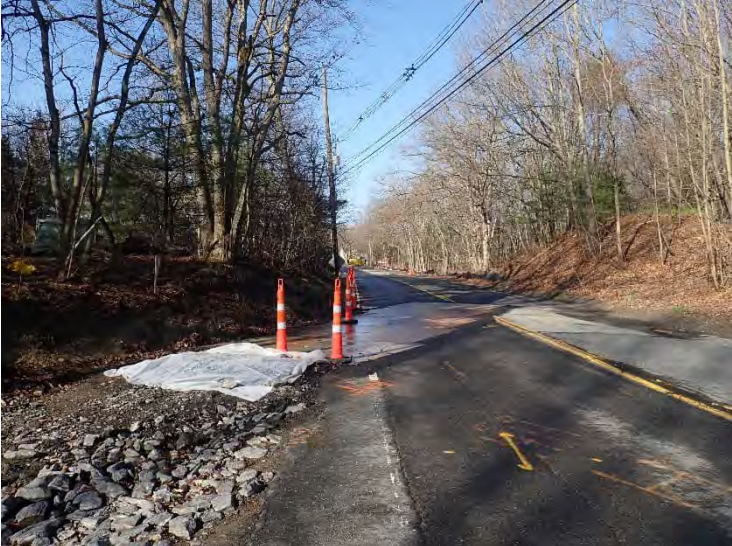
<p>PHOTOGRAPHIC LOG</p>	
<p>Client Name: Eversource</p>		<p>Site Location: Sudbury to Hudson Transmission Reliability Project</p>	<p>Town: Hudson</p>
<p>Photo No.: 6</p>	<p>Date: 4-15-24</p>

<p>Description: View of steel plates and covered asphalt on Wilkins Street at the entrance to Segment 1. Facing southwest.</p>

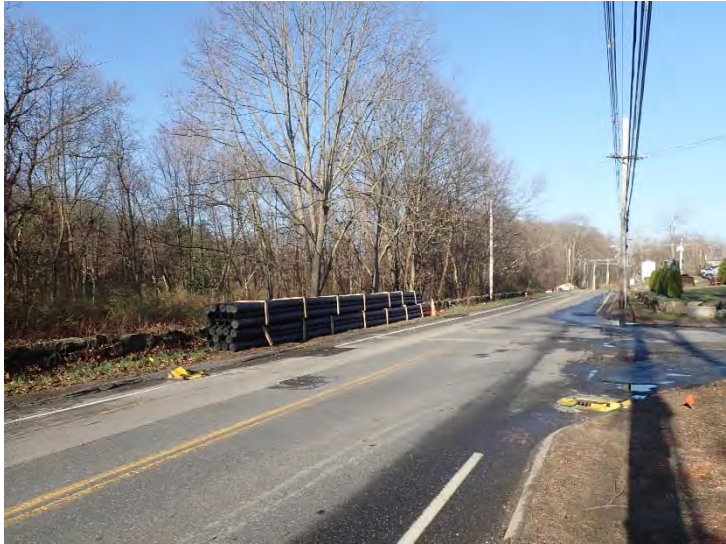
<p>PHOTOGRAPHIC LOG</p>	
<p>Client Name: Eversource</p>		<p>Site Location: Sudbury to Hudson Transmission Reliability Project</p>	<p>Town: Hudson</p>
<p>Photo No.: 7</p>	<p>Date: 4-15-24</p>

<p>Description: View of installed silt sacks along Forest Ave. No active construction along the roadway. Facing west.</p>

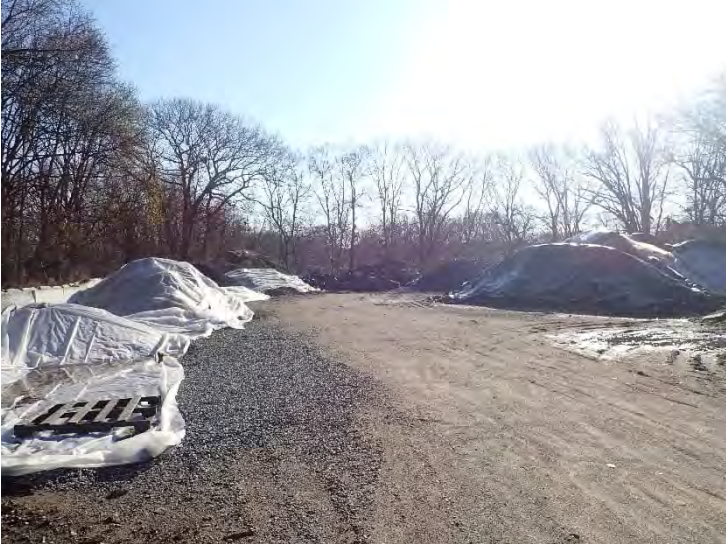
<p>PHOTOGRAPHIC LOG</p>	
<p>Client Name: Eversource</p>		<p>Site Location: Sudbury to Hudson Transmission Reliability Project</p>	<p>Town: Hudson</p>
<p>Photo No.: 8</p>	<p>Date: 4-15-24</p>

<p>Description: View of Stowe Court laydown yard, covered spoil piles. Facing northeast.</p>

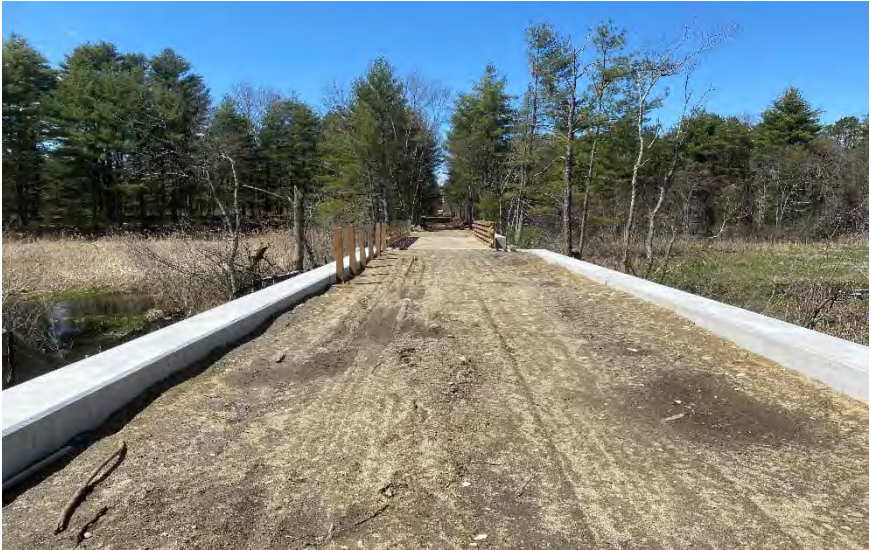
<p>PHOTOGRAPHIC LOG</p>	
<p>Client Name: Eversource</p>		<p>Site Location: Sudbury to Hudson Transmission Reliability Project</p>	<p>Town: Sudbury</p>
<p>Photo No.: 1</p>	<p>Date: 4-15-24</p>

<p>Description:</p> <p>Work area within segment 8, existing erosion control, looking westward.</p>

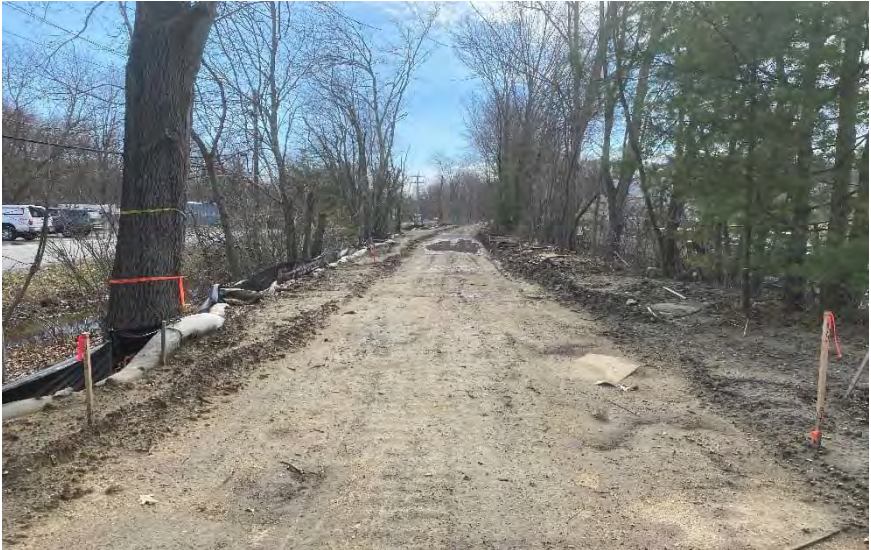
<p align="center">PHOTOGRAPHIC LOG</p>	
<p>Client Name: Eversource</p>		<p>Site Location: Sudbury to Hudson Transmission Reliability Project</p>	<p>Town: Sudbury</p>
<p>Photo No.: 3</p>	<p>Date: 4-15-24</p>

<p>Description:</p> <p>Work area within Segment 12, existing erosion control, looking eastward.</p>

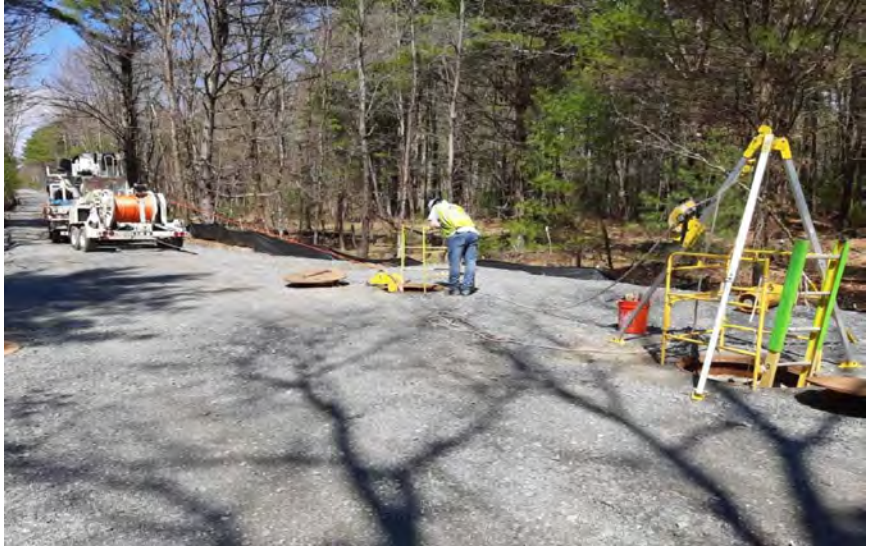
<p align="center">PHOTOGRAPHIC LOG</p>	
<p>Client Name: Eversource</p>		<p>Site Location: Sudbury to Hudson Transmission Reliability Project</p>	<p>Town: Sudbury</p>
<p>Photo No.: 4</p>	<p>Date: 4-15-24</p>

<p>Description:</p> <p>Work area within Segment 7, wire pulling work at manhole #15, looking westward.</p>

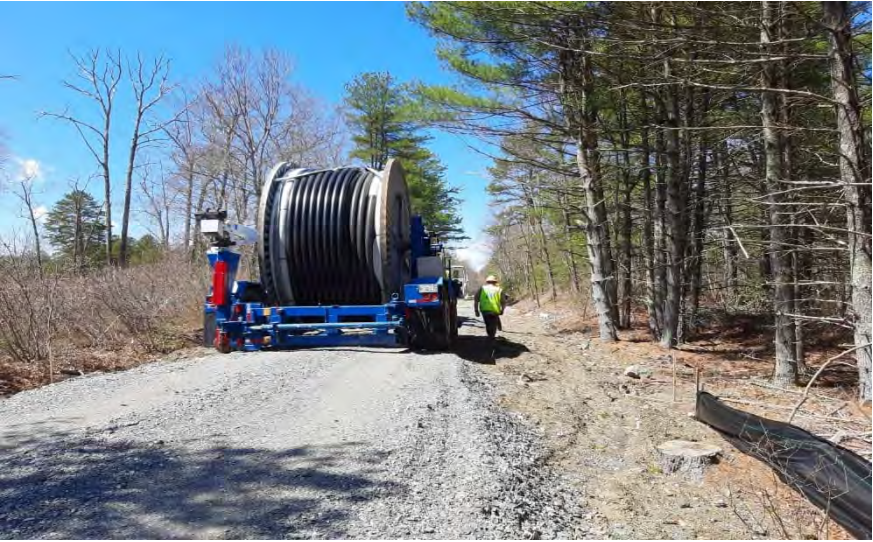
<p>PHOTOGRAPHIC LOG</p>	
<p>Client Name: Eversource</p>		<p>Site Location: Sudbury to Hudson Transmission Reliability Project</p>	<p>Town: Sudbury</p>
<p>Photo No.: 5</p>	<p>Date: 4-15-24</p>

<p>Description:</p> <p>Work area within Segment 7, wire pulling work (mirk with cable), looking westward.</p>

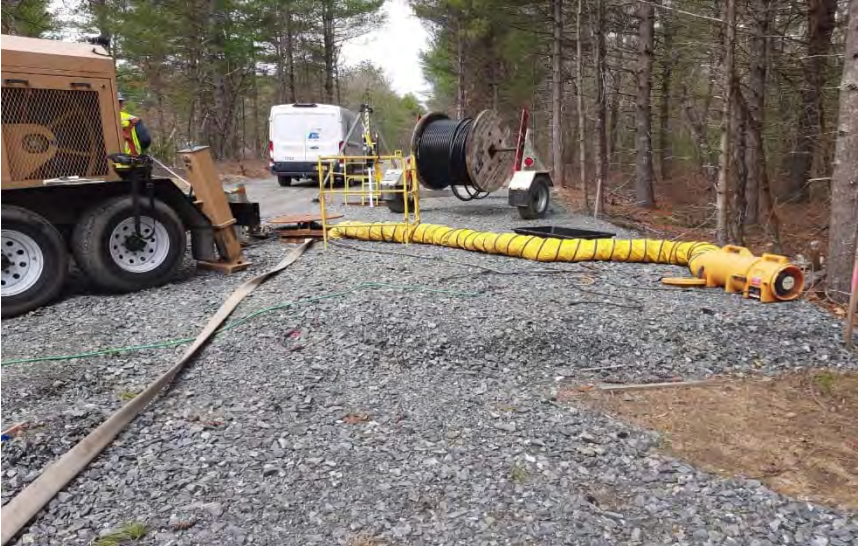
<p>PHOTOGRAPHIC LOG</p>	
<p>Client Name: Eversource</p>		<p>Site Location: Sudbury to Hudson Transmission Reliability Project</p>	<p>Town: Sudbury</p>
<p>Photo No.: 6</p>	<p>Date: 4-15-24</p>

<p>Description:</p> <p>Work area within Segment 7, wire pulling work at manhole #16, looking westward.</p>

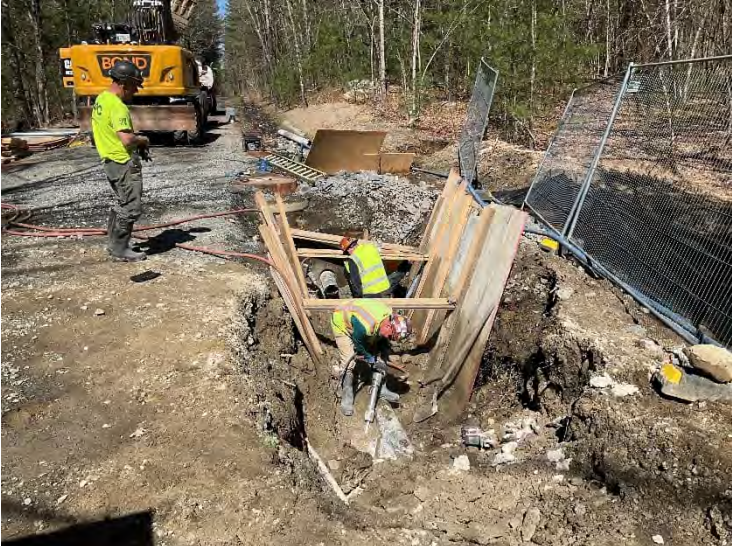
<p>PHOTOGRAPHIC LOG</p>	
<p>Client Name: Eversource</p>		<p>Site Location: Sudbury to Hudson Transmission Reliability Project</p>	<p>Town: Hudson</p>
<p>Photo No.: 6</p>	<p>Date: 4-16-24</p>

<p>Description:</p> <p>Bond work area within segment 5 at manhole #12 repairing conduit. Facing west.</p>

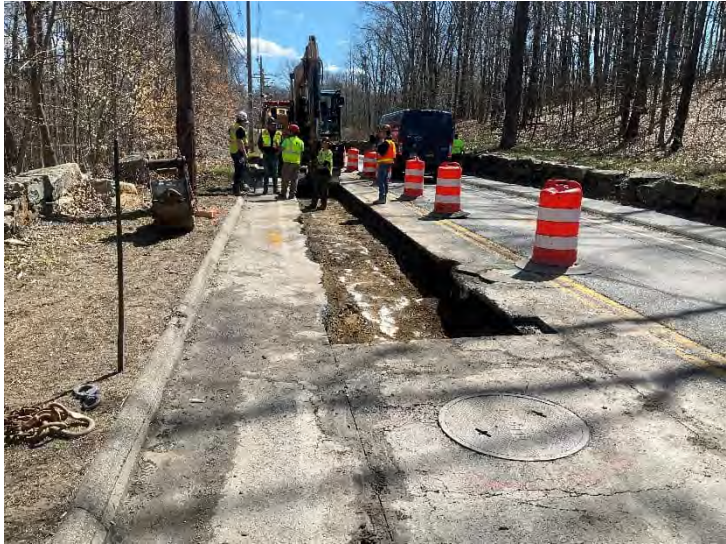
<p>PHOTOGRAPHIC LOG</p>	
<p>Client Name: Eversource</p>		<p>Site Location: Sudbury to Hudson Transmission Reliability Project</p>	<p>Town: Hudson</p>
<p>Photo No.: 7</p>	<p>Date: 4-16-24</p>

<p>Description: Vinagro work area within Forest Avenue in preparation for asbestos pipe removal. Facing east.</p>

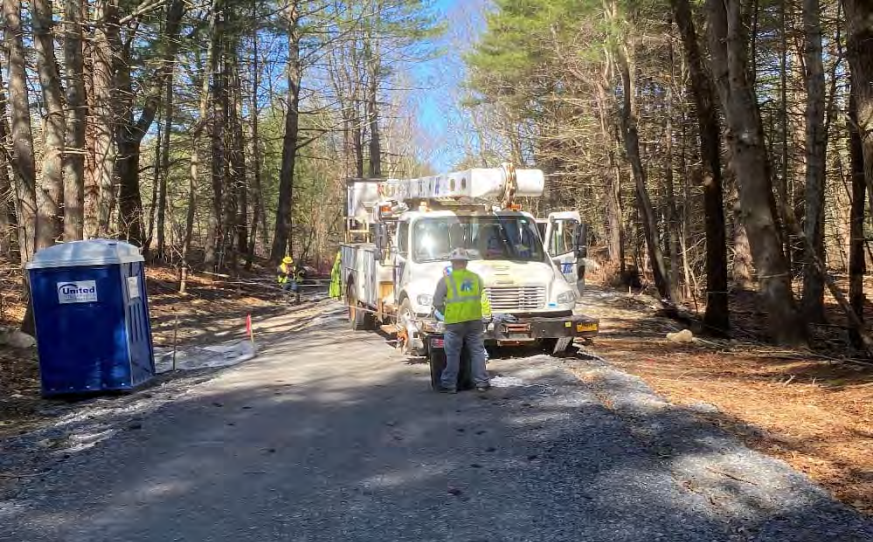
<p>PHOTOGRAPHIC LOG</p>	
<p>Client Name: Eversource</p>		<p>Site Location: Sudbury to Hudson Transmission Reliability Project</p>	<p>Town: Sudbury</p>
<p>Photo No.: 4</p>	<p>Date: 4-16-24</p>

<p>Description:</p> <p>Work area within Segment 8, wire pulling work at manhole #17, looking westward.</p>

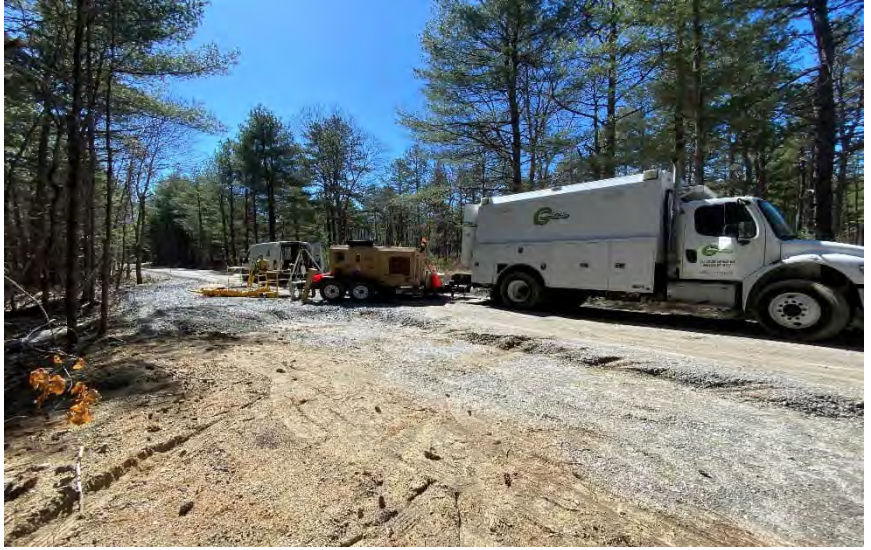
<p align="center">PHOTOGRAPHIC LOG</p>	
<p>Client Name: Eversource</p>		<p>Site Location: Sudbury to Hudson Transmission Reliability Project</p>	<p>Town: Sudbury</p>
<p>Photo No.: 6</p>	<p>Date: 4-16-24</p>

<p>Description:</p> <p>Work area within Segment 7, wire pulling work at manhole #16, looking eastward.</p>

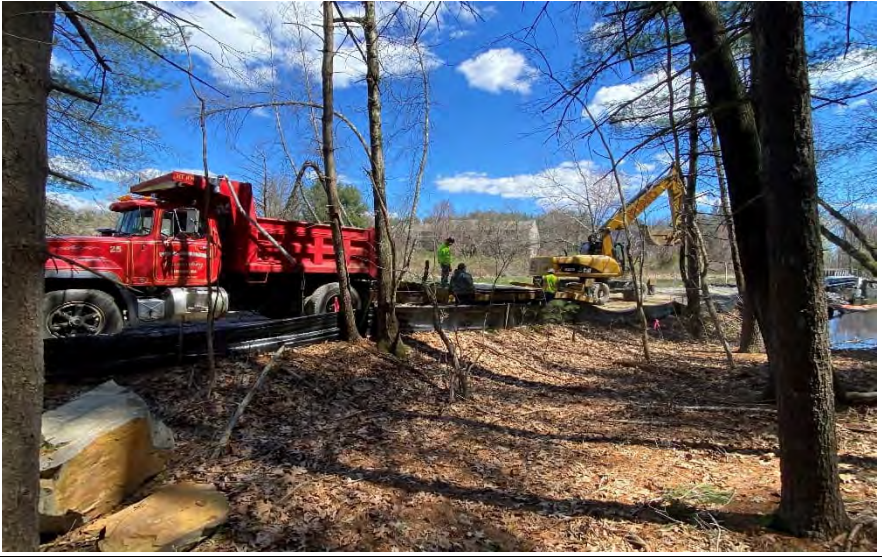
<p>PHOTOGRAPHIC LOG</p>	
<p>Client Name: Eversource</p>		<p>Site Location: Sudbury to Hudson Transmission Reliability Project</p>	<p>Town: Sudbury</p>
<p>Photo No.: 7</p>	<p>Date: 4-16-24</p>

<p>Description:</p> <p>Work area within Segment 13, cleanup work, bridge 127, existing erosion control, looking eastward.</p>

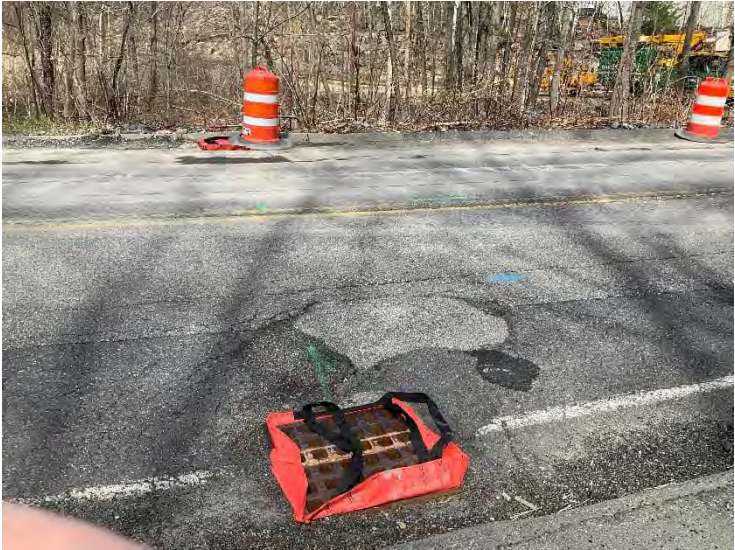
<p>PHOTOGRAPHIC LOG</p>	
<p>Client Name: Eversource</p>		<p>Site Location: Sudbury to Hudson Transmission Reliability Project</p>	<p>Town: Hudson</p>
<p>Photo No.: 1</p>	<p>Date: 4-17-24</p>

<p>Description:</p> <p>View of silt sacks installed within Forest Avenue by active work areas. Facing north.</p>

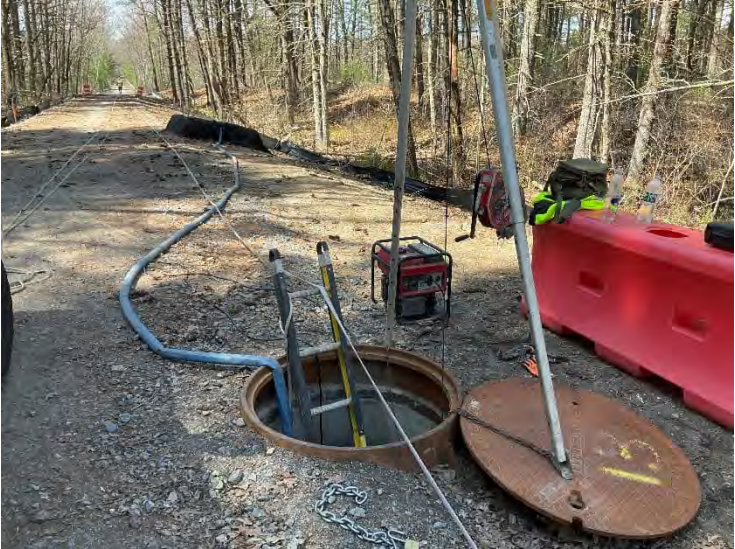
<p>PHOTOGRAPHIC LOG</p>	
<p>Client Name: Eversource</p>		<p>Site Location: Sudbury to Hudson Transmission Reliability Project</p>	<p>Town: Hudson</p>
<p>Photo No.: 2</p>	<p>Date: 4-17-24</p>

<p>Description:</p> <p>Bond working in MH #13 pulling mule tape. Facing west.</p>

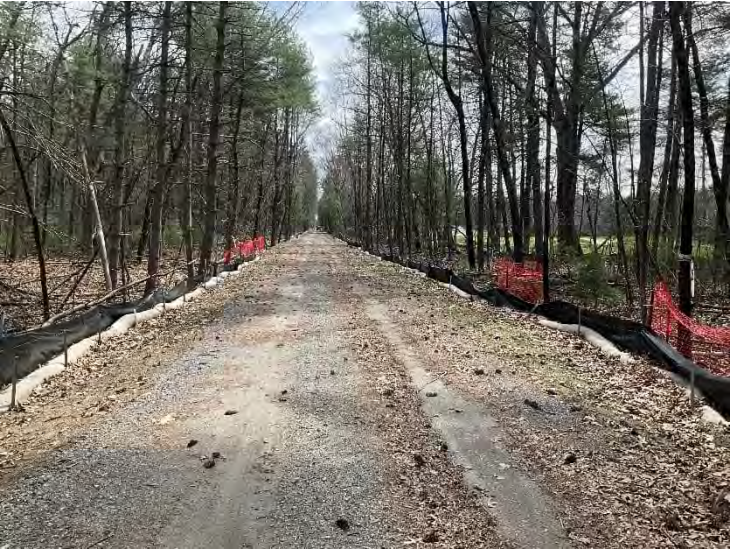
<p>PHOTOGRAPHIC LOG</p>	
<p>Client Name: Eversource</p>		<p>Site Location: Sudbury to Hudson Transmission Reliability Project</p>	<p>Town: Hudson</p>
<p>Photo No.: 3</p>	<p>Date: 4-17-24</p>

<p>Description: View of E&S controls within segment 4. Facing east.</p>

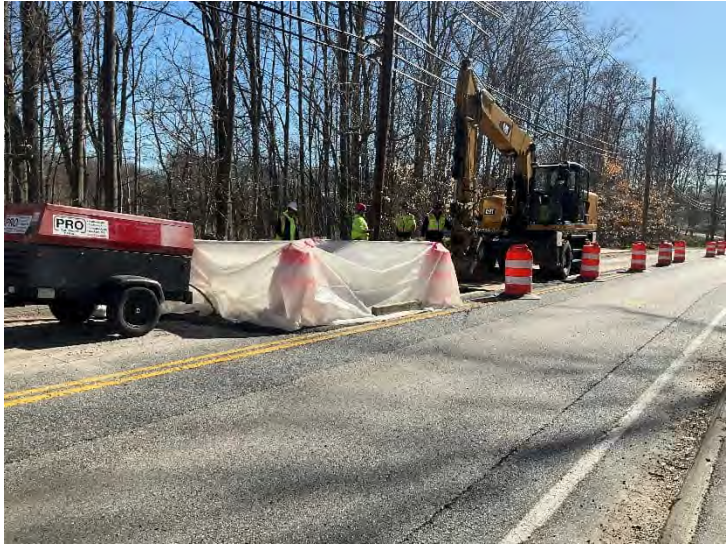
<p>PHOTOGRAPHIC LOG</p>	
<p>Client Name: Eversource</p>		<p>Site Location: Sudbury to Hudson Transmission Reliability Project</p>	<p>Town: Hudson</p>
<p>Photo No.: 7</p>	<p>Date: 4-17-24</p>

<p>Description:</p> <p>View of Vinagro work area within Forest Avenue. Facing northeast.</p>

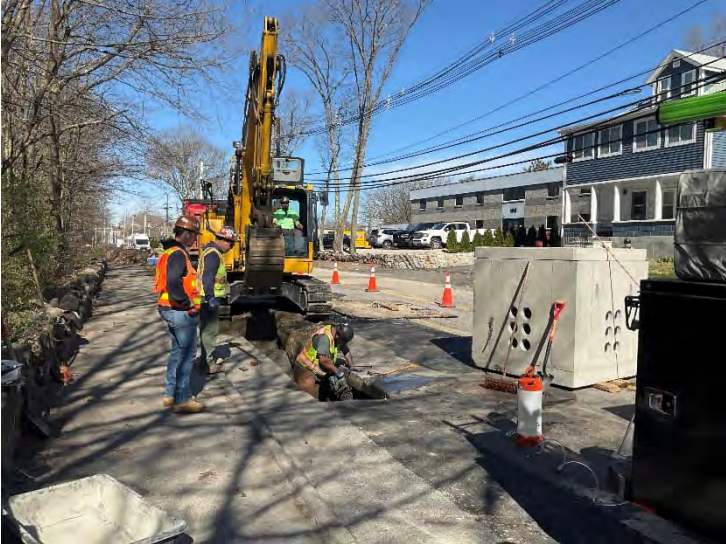
<p>PHOTOGRAPHIC LOG</p>	
<p>Client Name: Eversource</p>		<p>Site Location: Sudbury to Hudson Transmission Reliability Project</p>	<p>Town: Hudson</p>
<p>Photo No.: 8</p>	<p>Date: 4-17-24</p>

<p>Description:</p> <p>View of Bond working near manhole #2 trenching for handhole installation. Facing west.</p>

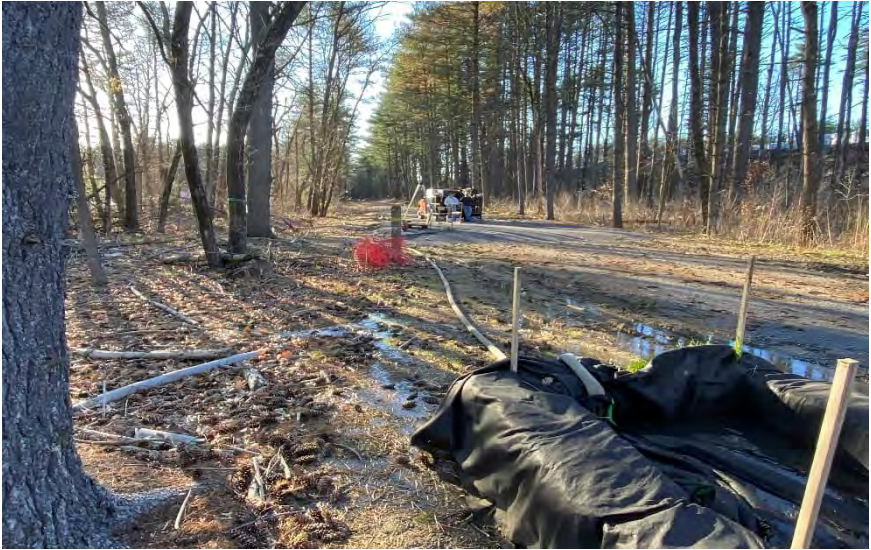
<p align="center">PHOTOGRAPHIC LOG</p>	
<p>Client Name: Eversource</p>		<p>Site Location: Sudbury to Hudson Transmission Reliability Project</p>	<p>Town: Sudbury</p>
<p>Photo No.: 3</p>	<p>Date: 4-17-24</p>

<p>Description:</p> <p>Work area within Segment 4, manhole #10 conduit work, existing erosion control, looking eastward.</p>

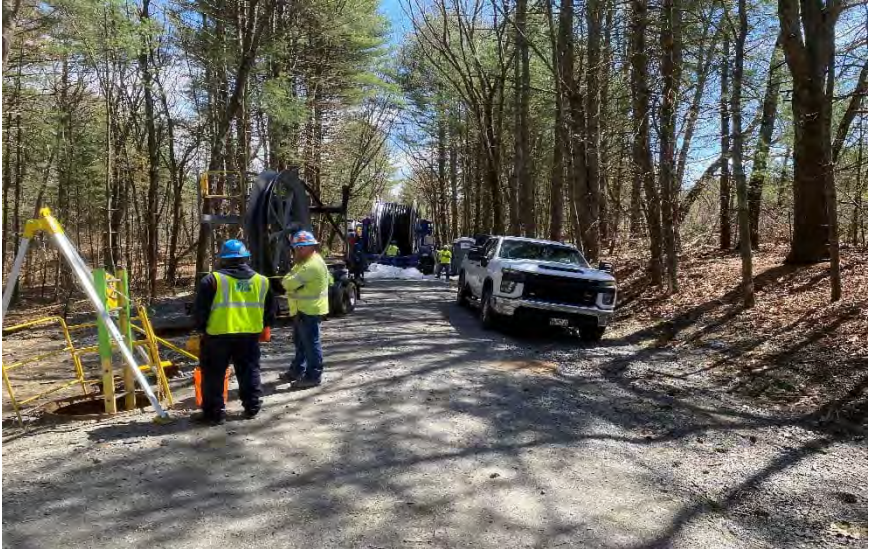
<p align="center">PHOTOGRAPHIC LOG</p>	
<p>Client Name: Eversource</p>		<p>Site Location: Sudbury to Hudson Transmission Reliability Project</p>	<p>Town: Sudbury</p>
<p>Photo No.: 4</p>	<p>Date: 4-17-24</p>

<p>Description:</p> <p>Work area within Segment 8, wire pulling work at manhole #17, looking eastward.</p>

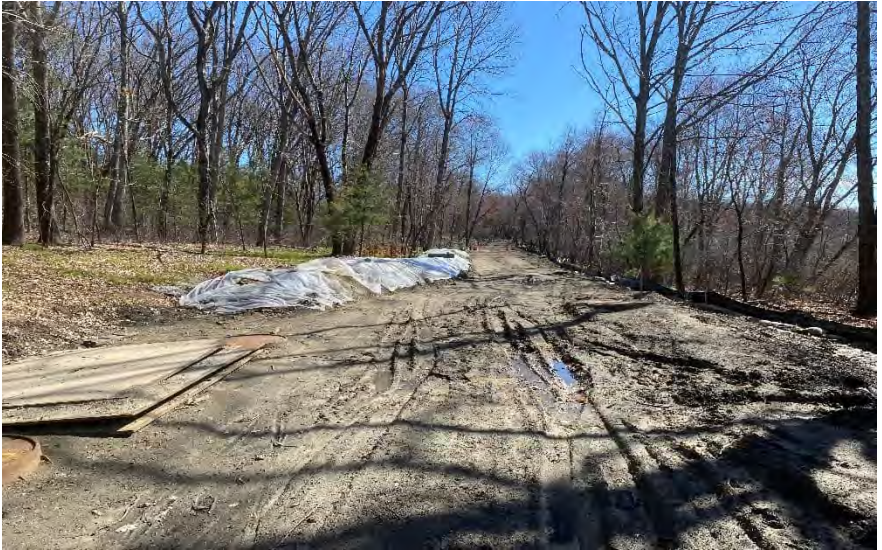
<p>PHOTOGRAPHIC LOG</p>	
<p>Client Name: Eversource</p>		<p>Site Location: Sudbury to Hudson Transmission Reliability Project</p>	<p>Town: Sudbury</p>
<p>Photo No.: 5</p>	<p>Date: 4-17-24</p>

Spoil Berm noted within segment 14, berm created 3-8-24. See photo #5.

<p>Description:</p> <p>Work area within Segment 14, covered spoil berm, existing erosion control, looking eastward.</p>

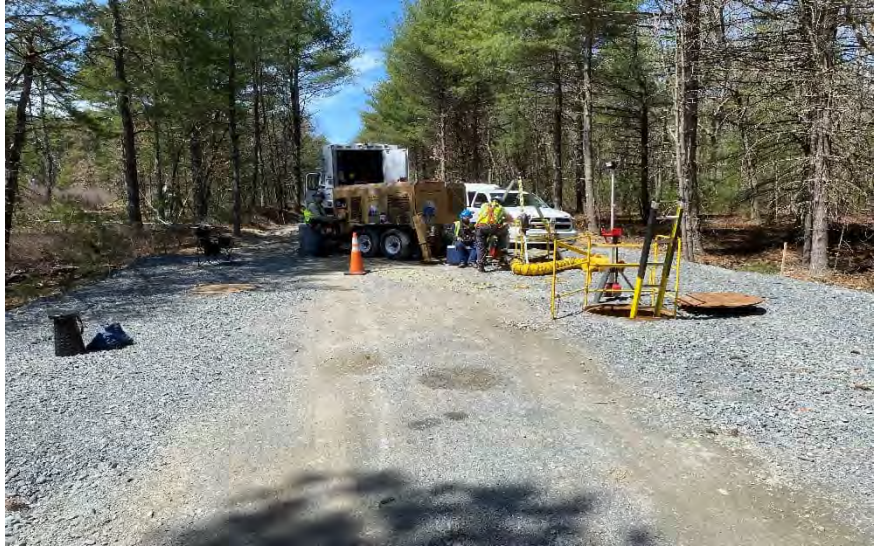
<p>PHOTOGRAPHIC LOG</p>	
<p>Client Name: Eversource</p>		<p>Site Location: Sudbury to Hudson Transmission Reliability Project</p>	<p>Town: Sudbury</p>
<p>Photo No.: 6</p>	<p>Date: 4-17-24</p>

<p>Description:</p> <p>Work area within Segment 7, wire pulling work at manhole #16, looking westward.</p>

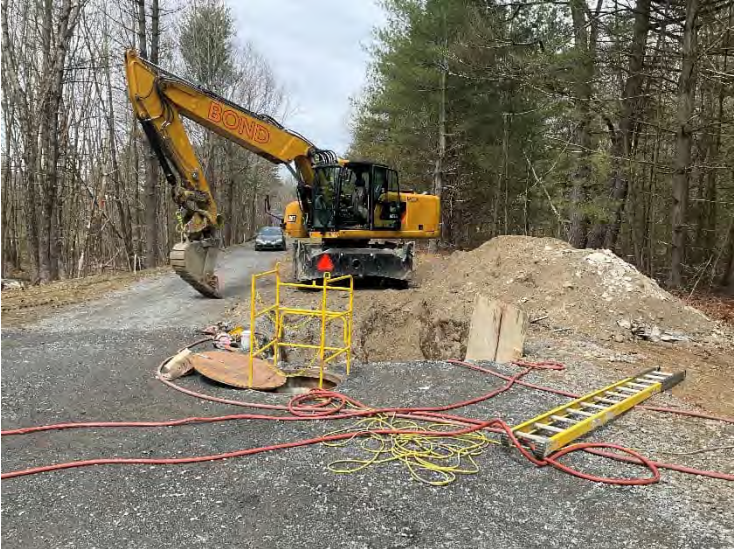
<p align="center">PHOTOGRAPHIC LOG</p>	
<p>Client Name: Eversource</p>		<p>Site Location: Sudbury to Hudson Transmission Reliability Project</p>	<p>Town: Hudson</p>
<p>Photo No.: 2</p>	<p>Date: 4-19-24</p>

<p>Description:</p> <p>Bond working by MH #7 inspecting the conduit. Facing west.</p>

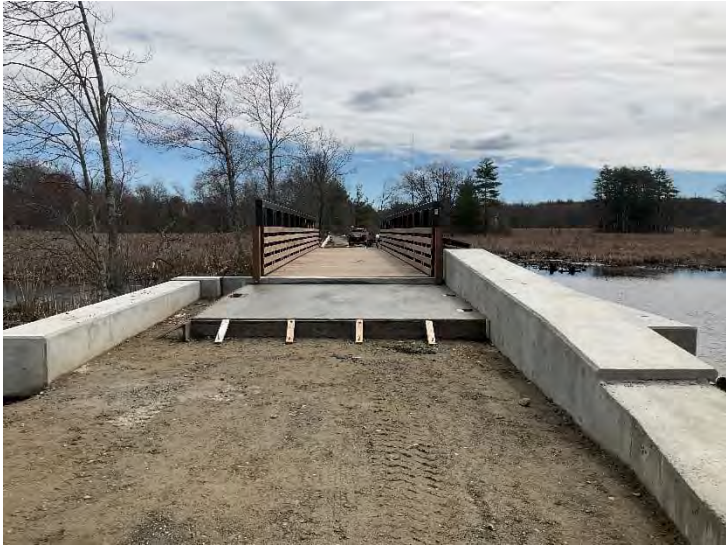
<p>PHOTOGRAPHIC LOG</p>	
<p>Client Name: Eversource</p>		<p>Site Location: Sudbury to Hudson Transmission Reliability Project</p>	<p>Town: Hudson</p>
<p>Photo No.: 5</p>	<p>Date: 4-19-24</p>

<p>Description: ET&L working within segment 3 at Bridge 130. View from segment 2. Facing east.</p>

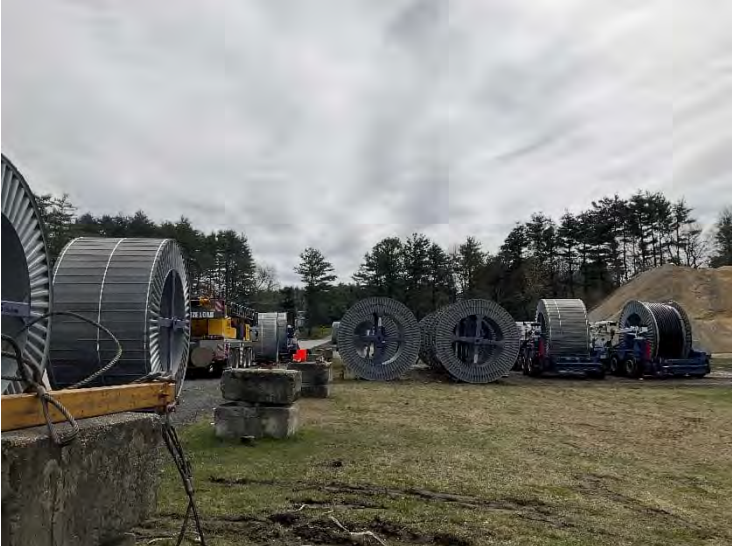
<p>PHOTOGRAPHIC LOG</p>	
<p>Client Name: Eversource</p>		<p>Site Location: Sudbury to Hudson Transmission Reliability Project</p>	<p>Town: Hudson</p>
<p>Photo No.: 6</p>	<p>Date: 4-19-24</p>

<p>Description: View of reels staged in Haugland laydown yard. Facing south.</p>

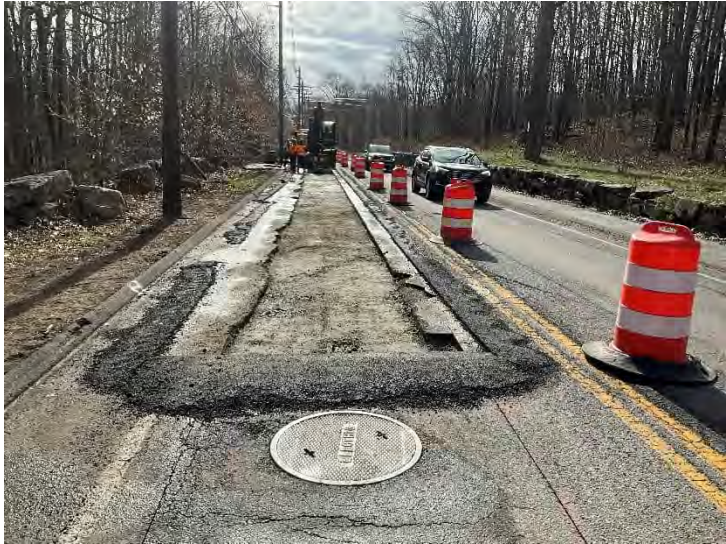
<p>PHOTOGRAPHIC LOG</p>	
<p>Client Name: Eversource</p>		<p>Site Location: Sudbury to Hudson Transmission Reliability Project</p>	<p>Town: Hudson</p>
<p>Photo No.: 7</p>	<p>Date: 4-19-24</p>

<p>Description:</p> <p>View of Vinagro work area within Forest Avenue. Facing east.</p>

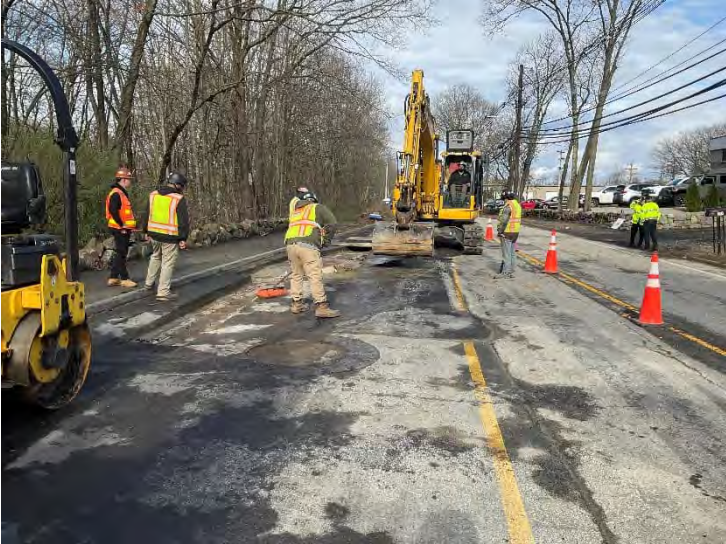
<p>PHOTOGRAPHIC LOG</p>	
<p>Client Name: Eversource</p>		<p>Site Location: Sudbury to Hudson Transmission Reliability Project</p>	<p>Town: Hudson</p>
<p>Photo No.: 8</p>	<p>Date: 4-19-24</p>

<p>Description:</p> <p>View of Bond working near manhole #2 paving the roadway. Facing west.</p>

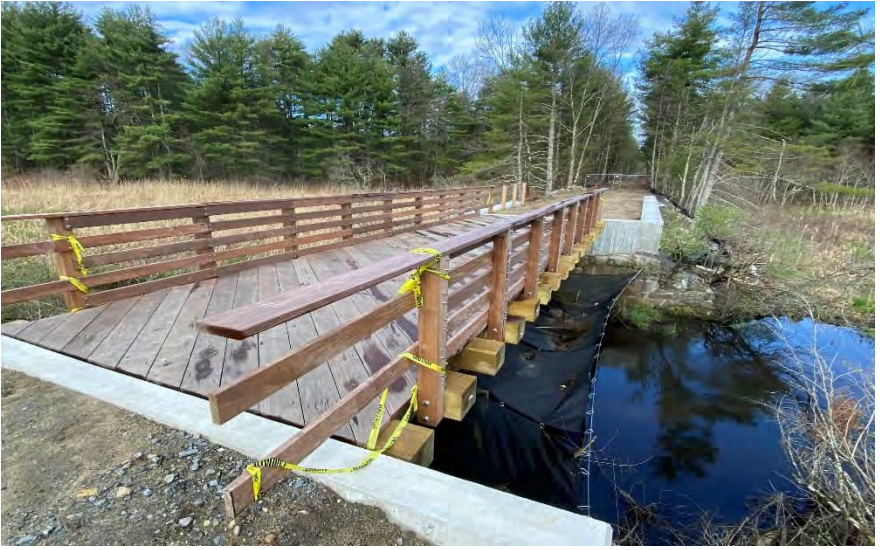
<p align="center">PHOTOGRAPHIC LOG</p>	
<p>Client Name: Eversource</p>		<p>Site Location: Sudbury to Hudson Transmission Reliability Project</p>	<p>Town: Sudbury</p>
<p>Photo No.: 1</p>	<p>Date: 4-19-24</p>

<p>Description:</p> <p>Work area at Bridge 128, existing erosion control, looking westward.</p>

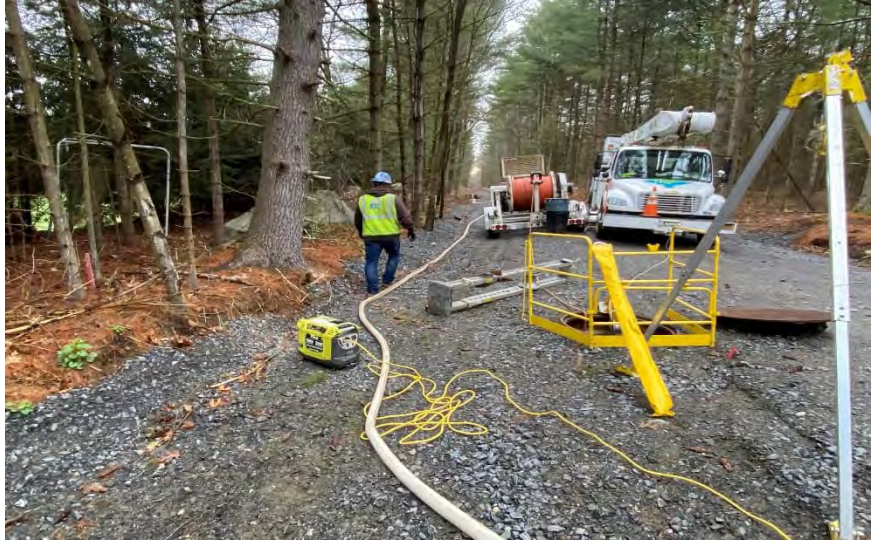
<p align="center">PHOTOGRAPHIC LOG</p>	
<p>Client Name: Eversource</p>		<p>Site Location: Sudbury to Hudson Transmission Reliability Project</p>	<p>Town: Sudbury</p>
<p>Photo No.: 2</p>	<p>Date: 4-19-24</p>

<p>Description:</p> <p>Work area within Segment 9, wire pulling work at manhole #18, looking eastward.</p>

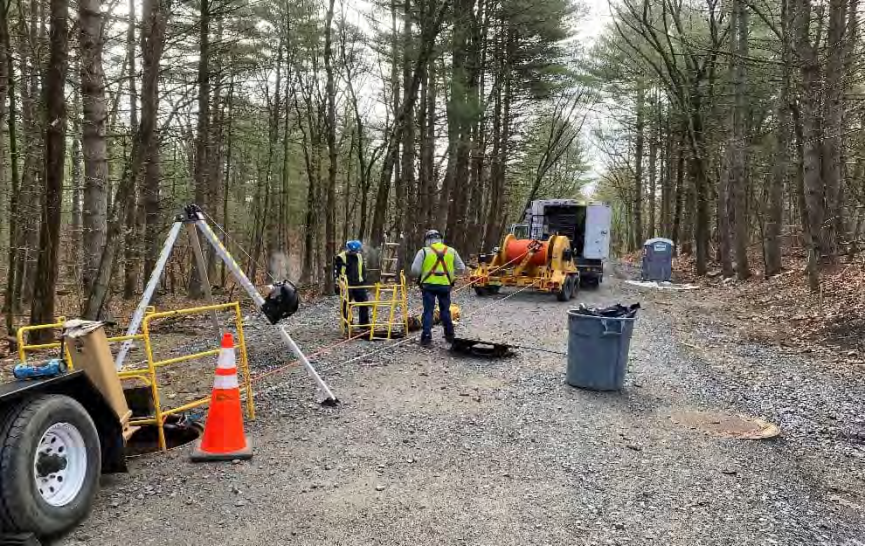
<p>PHOTOGRAPHIC LOG</p>	
<p>Client Name: Eversource</p>		<p>Site Location: Sudbury to Hudson Transmission Reliability Project</p>	<p>Town: Sudbury</p>
<p>Photo No.: 4</p>	<p>Date: 4-19-24</p>

<p>Description: Work area within Segment 8, wire pulling work at manhole #17, looking eastward.</p>

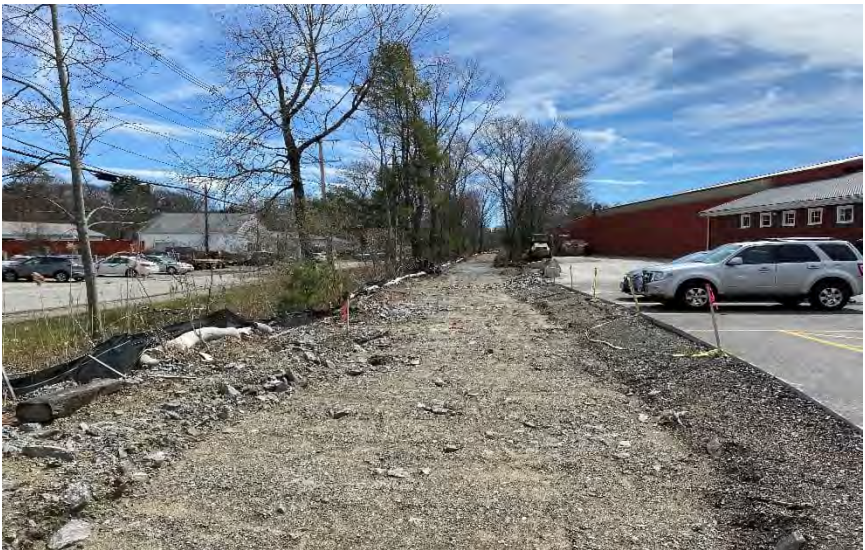
<p>PHOTOGRAPHIC LOG</p>	
<p>Client Name: Eversource</p>		<p>Site Location: Sudbury to Hudson Transmission Reliability Project</p>	<p>Town: Sudbury</p>
<p>Photo No.: 6</p>	<p>Date: 4-19-24</p>

<p>Description: Work area within Segment 12, existing erosion control, looking eastward.</p>

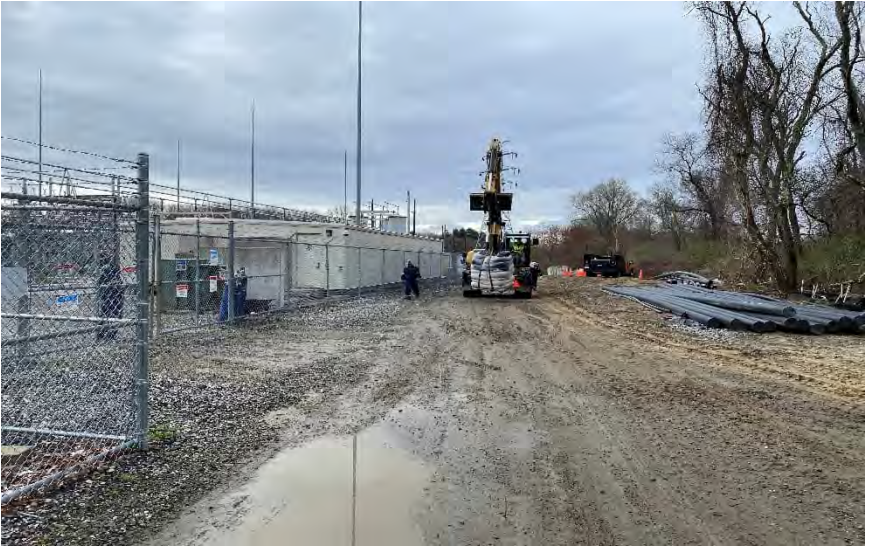
<p>PHOTOGRAPHIC LOG</p>	
<p>Client Name: Eversource</p>		<p>Site Location: Sudbury to Hudson Transmission Reliability Project</p>	<p>Town: Sudbury</p>
<p>Photo No.: 7</p>	<p>Date: 4-19-24</p>

<p>Description:</p> <p>Work area adjacent to Sudbury substation, preparations for conduit work within the substation, looking southward.</p>

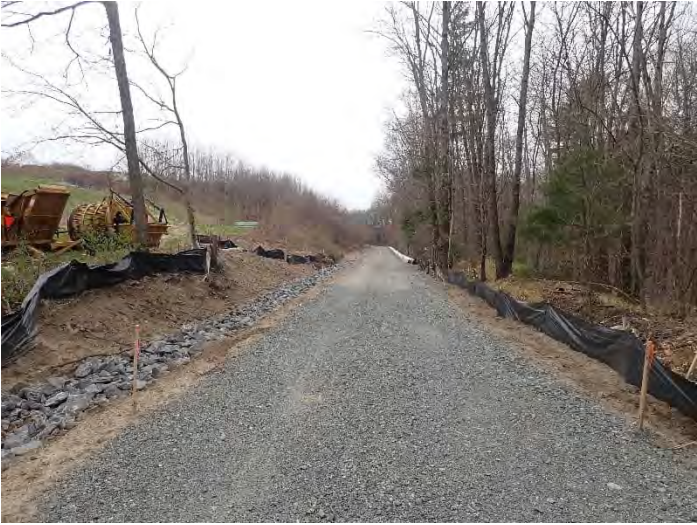
PHOTOGRAPHIC LOG	
Client Name: Eversource		Site Location: Sudbury to Hudson Transmission Reliability Project	Town: Hudson/Stow
Photo No.: 1	Date: 4-18-2024

Description: View of E&S controls and drainage swale in segment 1. Facing west.

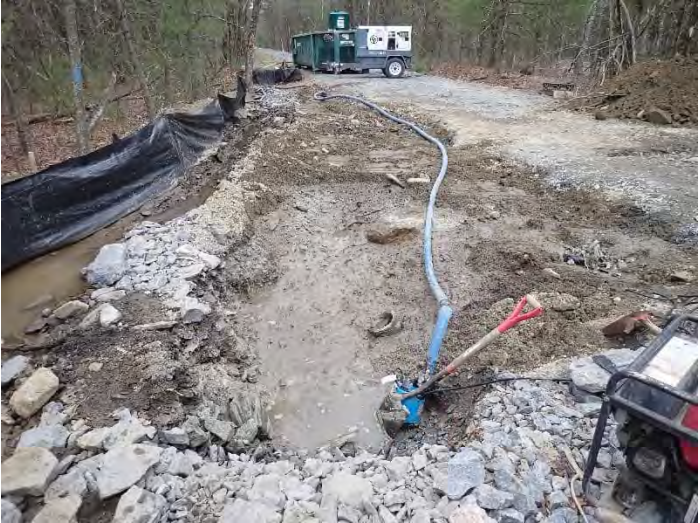
PHOTOGRAPHIC LOG	
Client Name: Eversource		Site Location: Sudbury to Hudson Transmission Reliability Project	Town: Hudson
Photo No.: 8	Date: 4-18-2024

Discharge Location	Observations
1. Dewatering occurring in Segment 5 at Manhole #12.	Discharge of stormwater and groundwater seep occurring at time of inspection, but no issues noted. Discharge appeared clear with no signs of pollutants. See dewatering report for details.
2.	
3.	
4.	
5.

Description: View of Bond actively dewatering at Manhole #12 into a frac tank. Facing east.

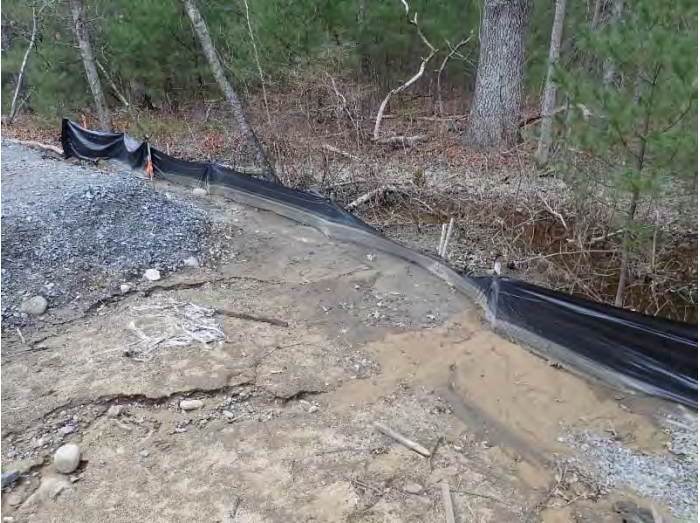
PHOTOGRAPHIC LOG	
Client Name: Eversource		Site Location: Sudbury to Hudson Transmission Reliability Project	Town: Hudson
Photo No.: 10	Date: 4-18-2024

-Silt fencing at Manhole #14 in Segment 6 has accumulated sediment greater than half the height of the fencing. Sediment should be removed. Additional routine maintenance items are needed onsite. Full list of needed repairs has been submitted to project contractors.

Description: View of accumulated sediment near Manhole #14 in segment 6. Facing northwest.

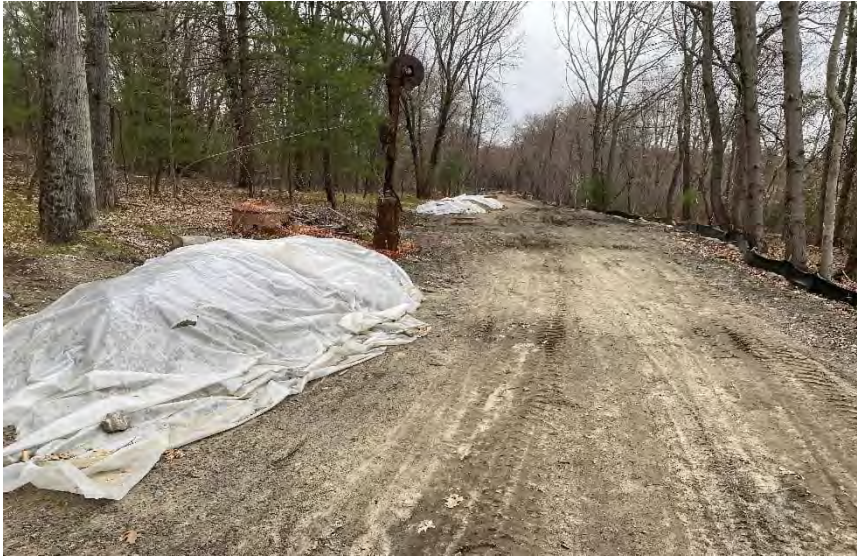
PHOTOGRAPHIC LOG	
Client Name: Eversource		Site Location: Sudbury to Hudson Transmission Reliability Project	Town: Sudbury
Photo No.: 7	Date: 4-18-24

Spoil Berm noted within segment 14, berm created 3-8-24. See photo #7.

Description: Work area within segment 14, covered spoil pile, existing erosion control, looking eastward.

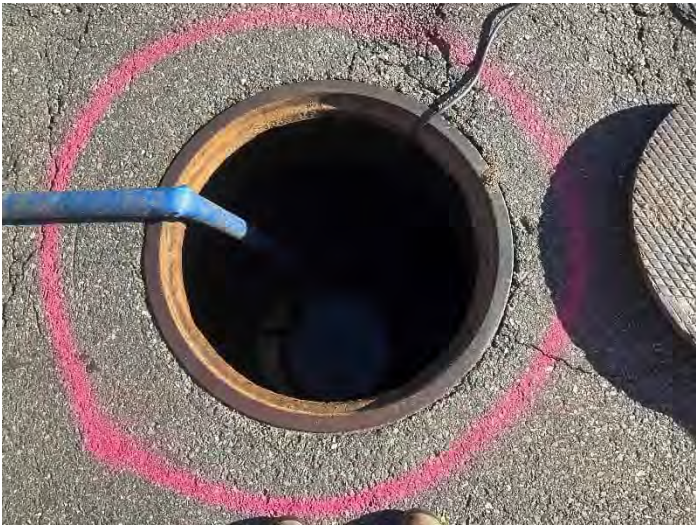
PHOTOGRAPHIC LOG	
Client Name: Eversource		Site Location: Sudbury to Hudson Transmission Reliability Project	Town: Hudson
Photo No.: 2	Date: 4/16/2024

Description: View of pump in manhole. Water appeared mostly clear prior to treatment.

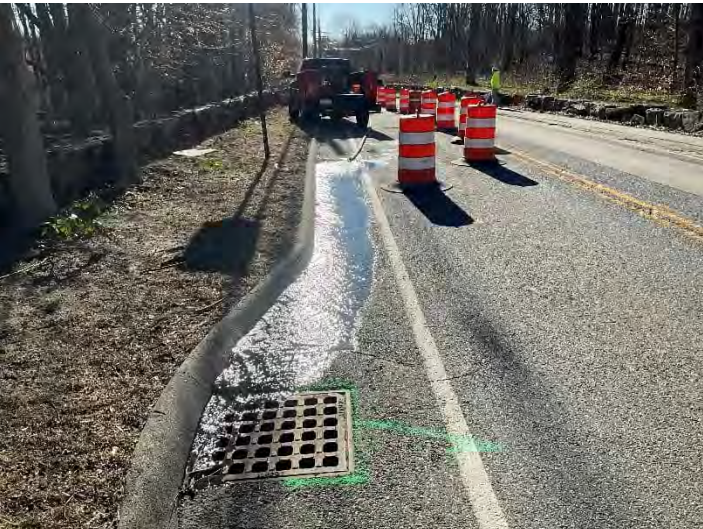
PHOTOGRAPHIC LOG	
Client Name: Eversource		Site Location: Sudbury to Hudson Transmission Reliability Project	Town: Hudson
Photo No.: 4	Date: 4/16/2024

Description: View of discharging water to catch basin. Discharge appeared clear and turbidity reading was below 50 NTUs. Facing east.

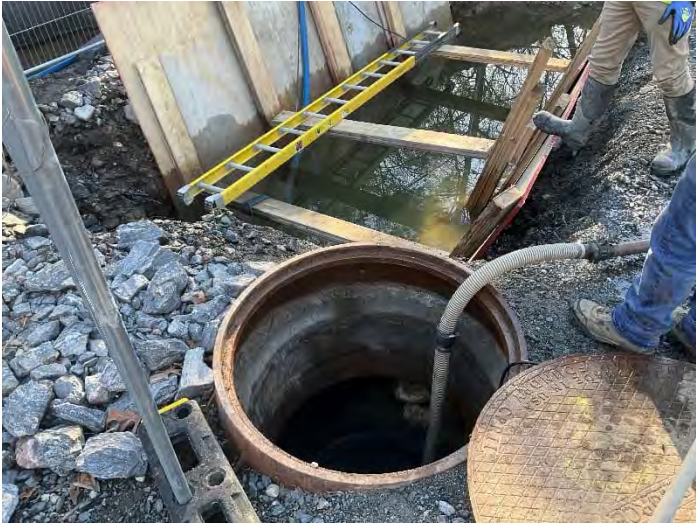
PHOTOGRAPHIC LOG	
Client Name: Eversource		Site Location: Sudbury to Hudson Transmission Reliability Project	Town: Hudson
Photo No.: 2	Date: 4/16/2024

Description: View of pump in MH #12. Water appeared mostly clear prior to treatment. Both MH and trench were dewatered. Water in trench appeared cloudy. Facing east.

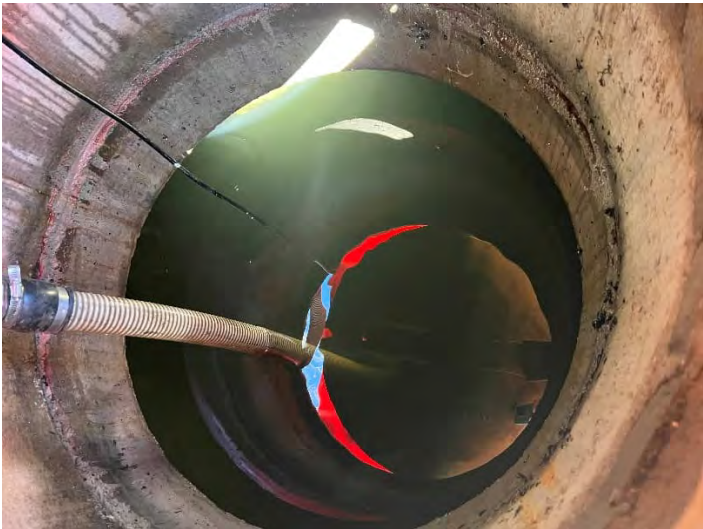
PHOTOGRAPHIC LOG	
Client Name: Eversource		Site Location: Sudbury to Hudson Transmission Reliability Project	Town: Hudson
Photo No.: 2	Date: 4/16/2024

Description: View of pump in MH #13. Water appeared clear prior to treatment.

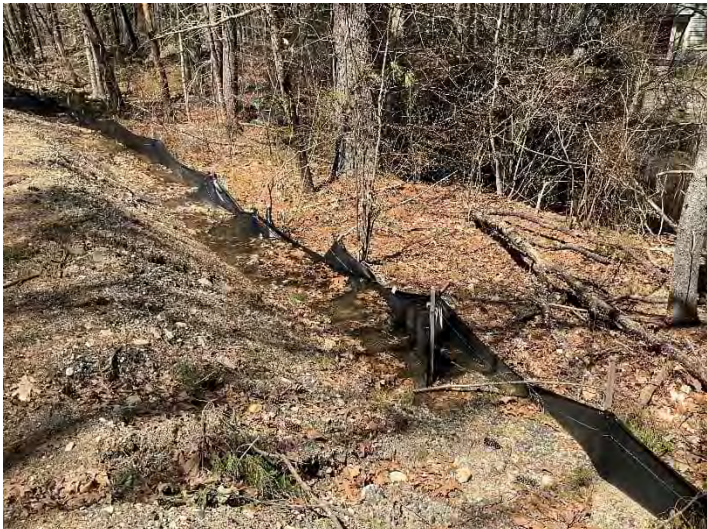
PHOTOGRAPHIC LOG	
Client Name: Eversource		Site Location: Sudbury to Hudson Transmission Reliability Project	Town: Hudson
Photo No.: 4	Date: 4/16/2024

Description: View of discharging water from corral. Discharge appeared clear and turbidity reading was below 50 NTUs. Discharge did not appear to reach any jurisdictional resource areas. Facing northwest.
