Weekly Environmental Compliance Summary

Sudbury to Hudson Transmission Reliability Project (USEPA Tracking # MAR1003UW)

Sudbury, Hudson, and Stow, MA

Week of: April 15, 2024 to April 20, 2024

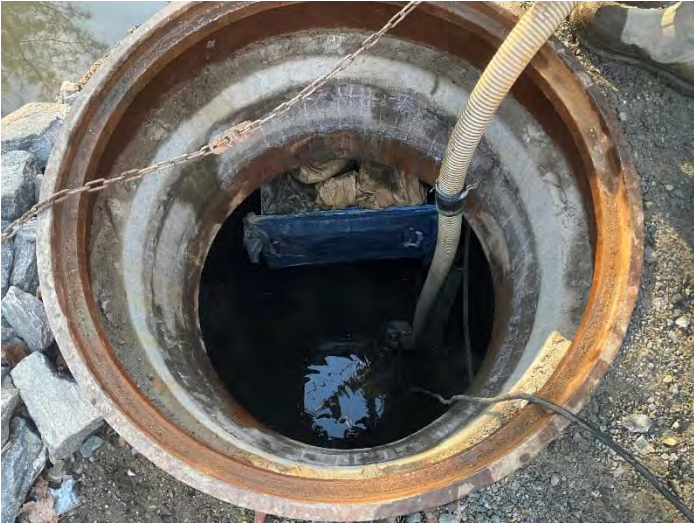
PHOTOGRAPHIC LOG	
Client Name: Eversource		Site Location: Sudbury to Hudson Transmission Reliability Project	Town: Hudson
Photo No.: 2	Date: 4/17/2024

Description: View of pump in MH #12. Water appeared mostly clear prior to treatment. MH dewatered into filtration tank.

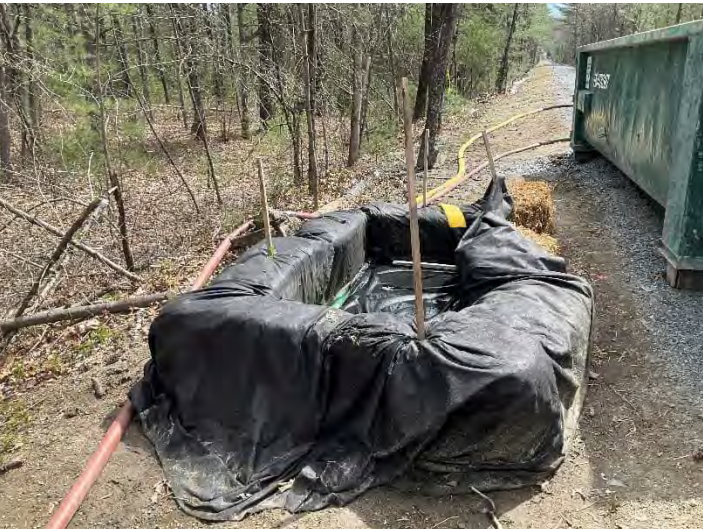
PHOTOGRAPHIC LOG	
Client Name: Eversource		Site Location: Sudbury to Hudson Transmission Reliability Project	
Town: Hudson			
Photo No.: 4	Date: 4/17/2024

Description: View of dewatering controls (filtration tank, straw bale corral with filter fabric and silt bag) and discharge from corral. Dewatered from tank for 5 minutes in order for water samples to be collected, the rest of the water remains in tank. Discharge appeared clear and turbidity reading was below 50 NTUs. Discharge did not appear to reach any jurisdictional resource areas. Facing east.

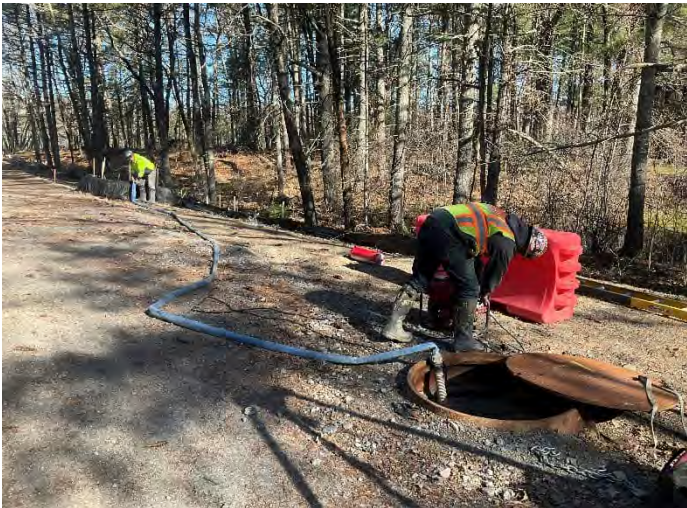
PHOTOGRAPHIC LOG	
Client Name: Eversource		Site Location: Sudbury to Hudson Transmission Reliability Project	Town: Hudson
Photo No.: 1	Date: 4/17/2024

Description: View of MH #13 in segment 5. Bond dewatering in preparation for pulling mule tape and mandrel. Facing northwest.

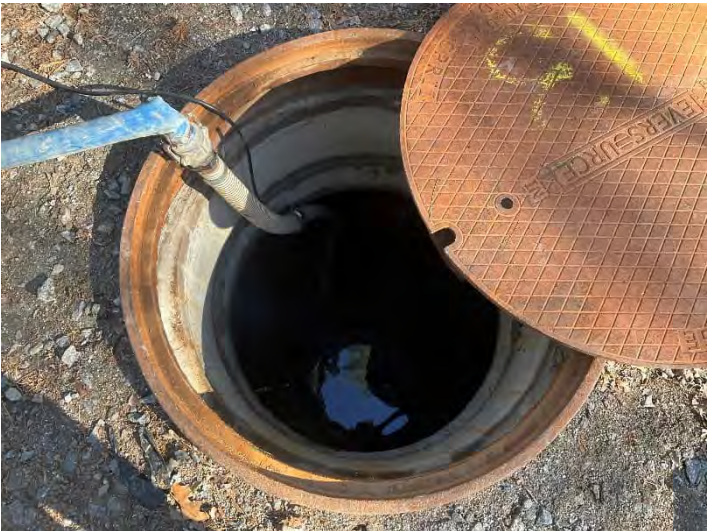
PHOTOGRAPHIC LOG	
Client Name: Eversource		Site Location: Sudbury to Hudson Transmission Reliability Project	Town: Hudson
Photo No.: 2	Date: 4/17/2024

Description: View of pump in MH #13. Water appeared clear prior to treatment.

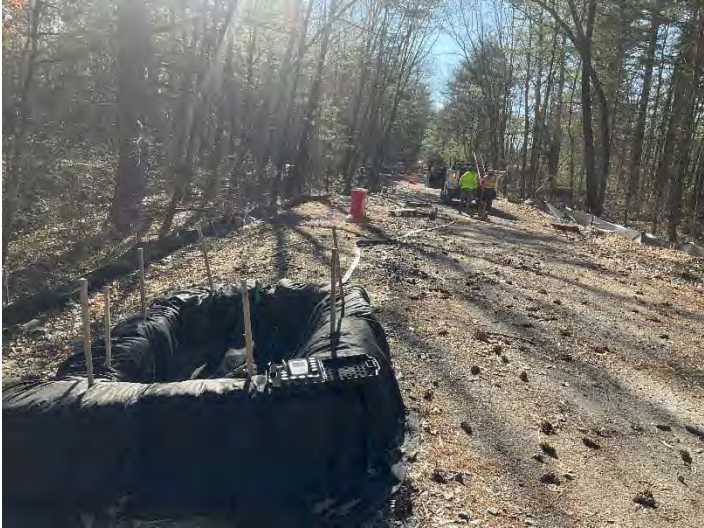
PHOTOGRAPHIC LOG	
Client Name: Eversource		Site Location: Sudbury to Hudson Transmission Reliability Project	Town: Hudson
Photo No.: 3	Date: 4/17/2024

Description: View of dewatering controls (straw bale corral with filter fabric and silt bag). Facing west.

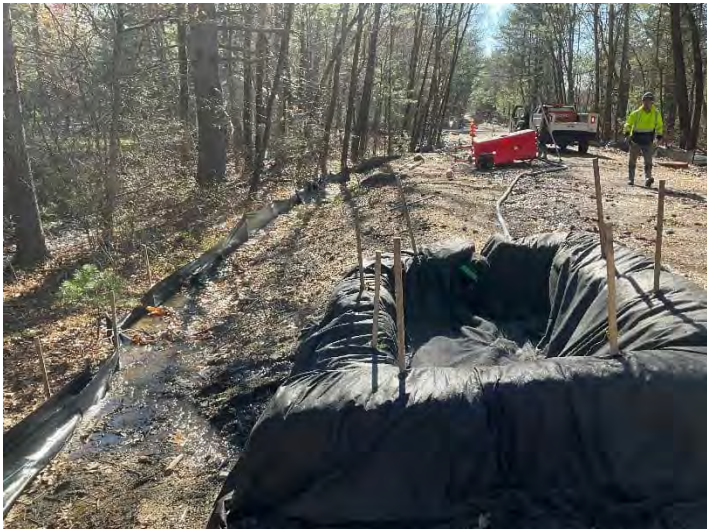
PHOTOGRAPHIC LOG	
Client Name: Eversource		Site Location: Sudbury to Hudson Transmission Reliability Project	Town: Hudson
Photo No.: 4	Date: 4/17/2024

Description: View of discharging water from corral. Discharge appeared clear and turbidity reading was below 50 NTUs. Discharge did not appear to reach any jurisdictional resource areas. Facing east.

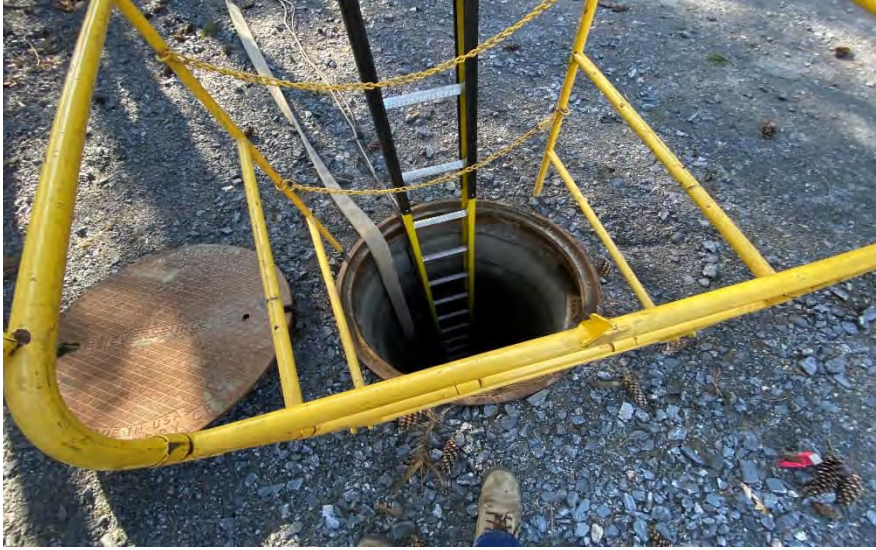
PHOTOGRAPHIC LOG	
Client Name: Eversource		Site Location: Sudbury to Hudson Transmission Reliability Project	Town: Sudbury
Photo No.: 1	Date: 4/17/2024

Description: View of area being pumped from manhole #18, segment 9, looking westward.

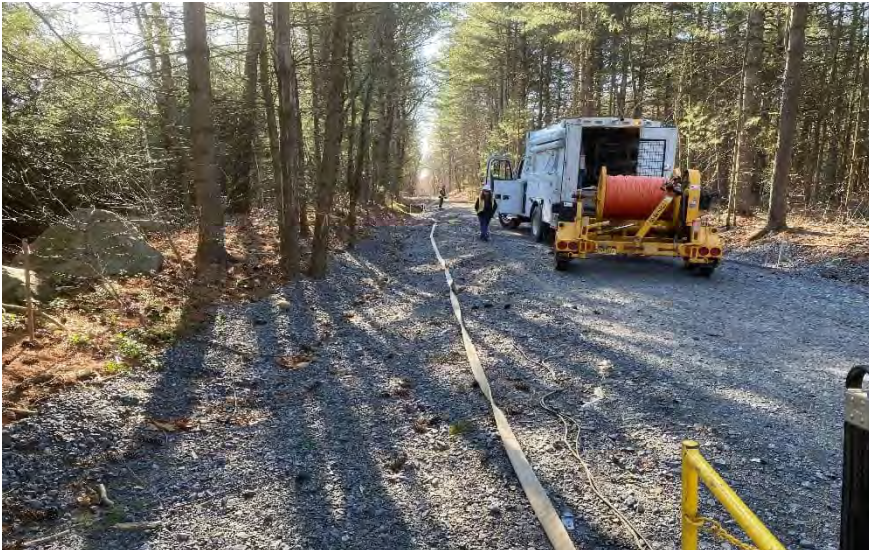
PHOTOGRAPHIC LOG	
Client Name: Eversource		Site Location: Sudbury to Hudson Transmission Reliability Project	Town: Sudbury
Photo No.: 2	Date: 4/17/2024

Description: Segment 9, manhole #18. View of dewatering operation. Looking eastward.

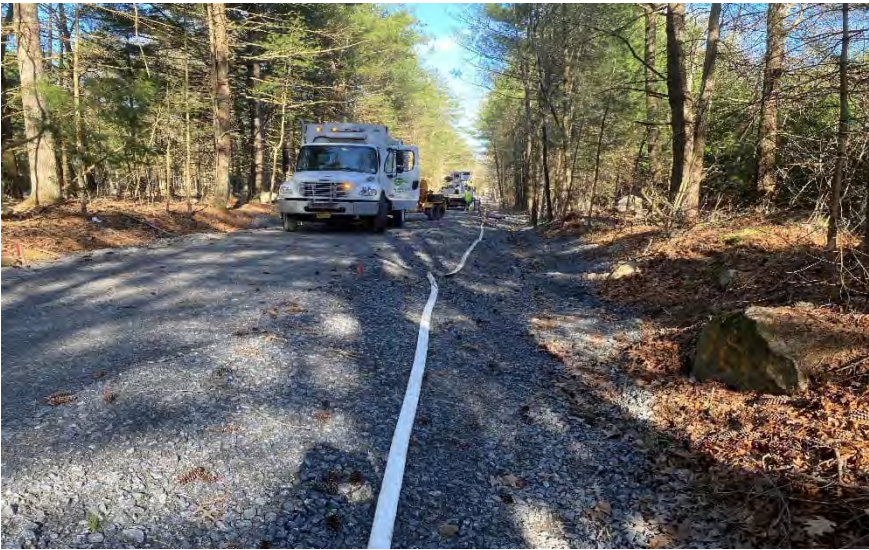
PHOTOGRAPHIC LOG	
Client Name: Eversource		Site Location: Sudbury to Hudson Transmission Reliability Project	Town: Sudbury
Photo No.: 3	Date: 4/17/2024

Description: Manhole #18, Segment 9. View of dewatering operation, looking westward.

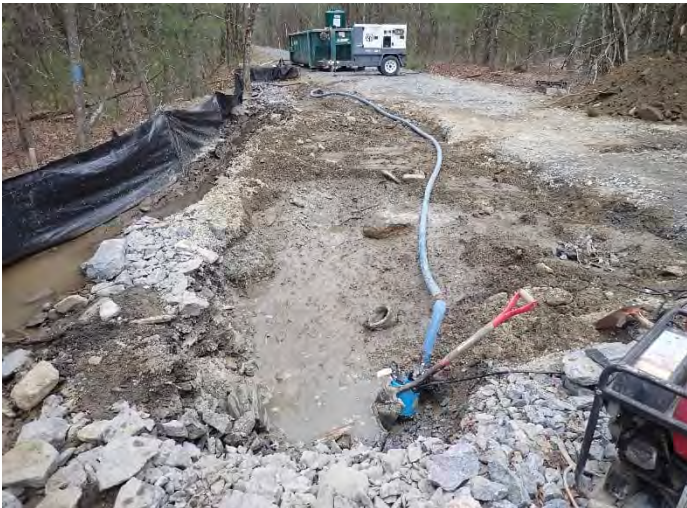
PHOTOGRAPHIC LOG	
Client Name: Eversource		Site Location: Sudbury to Hudson Transmission Reliability Project	Town: Hudson
Photo No.: 1	Date: 4/18/2024

Description: View of area being pumped at work operation near MH #12 within segment 5. This is the location of dewatering water prior to treatment. Water appeared to be turbid. Facing east.

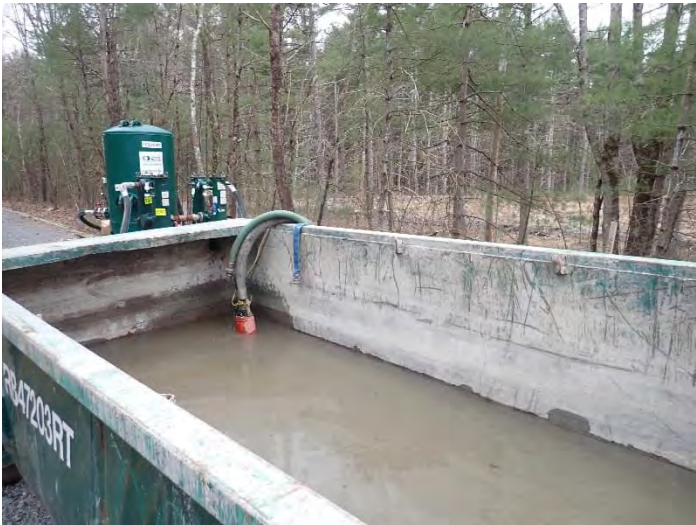
PHOTOGRAPHIC LOG	
Client Name: Eversource		Site Location: Sudbury to Hudson Transmission Reliability Project	Town: Hudson
Photo No.: 2	Date: 4/18/2024

Description: View of water pumped into a frac tank. Water appeared to be turbid. Facing east.

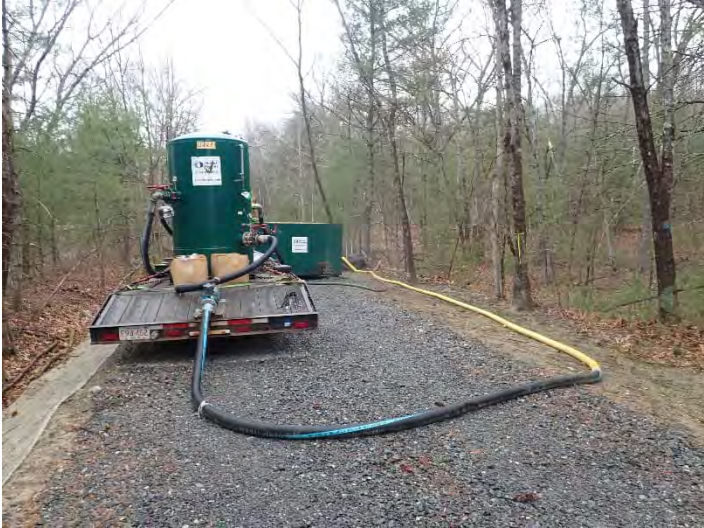
PHOTOGRAPHIC LOG	
Client Name: Eversource		Site Location: Sudbury to Hudson Transmission Reliability Project	Town: Hudson
Photo No.: 3	Date: 4/18/2024

Description: View of filtration tank. Facing west.

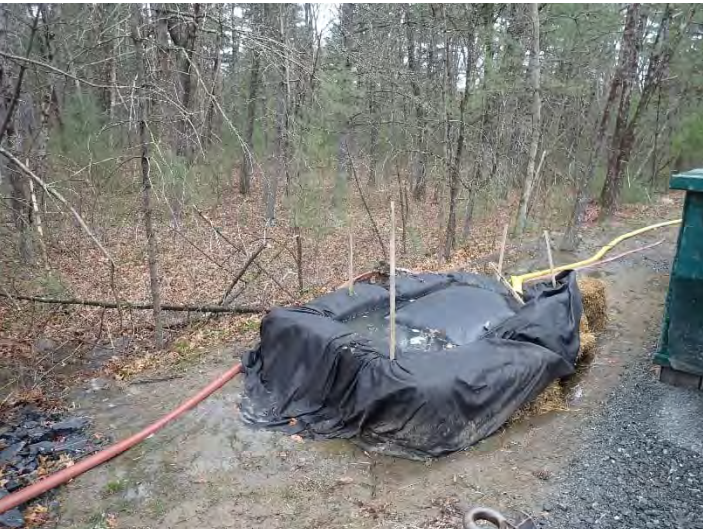
PHOTOGRAPHIC LOG	
Client Name: Eversource		Site Location: Sudbury to Hudson Transmission Reliability Project	Town: Hudson
Photo No.: 4	Date: 4/18/2024

Description: View of water discharging from dewatering basin associated with manhole #12. Discharge appeared clear and turbidity reading was below 50 NTUs. Discharge did not appear to reach any jurisdictional resource areas. Facing northeast.

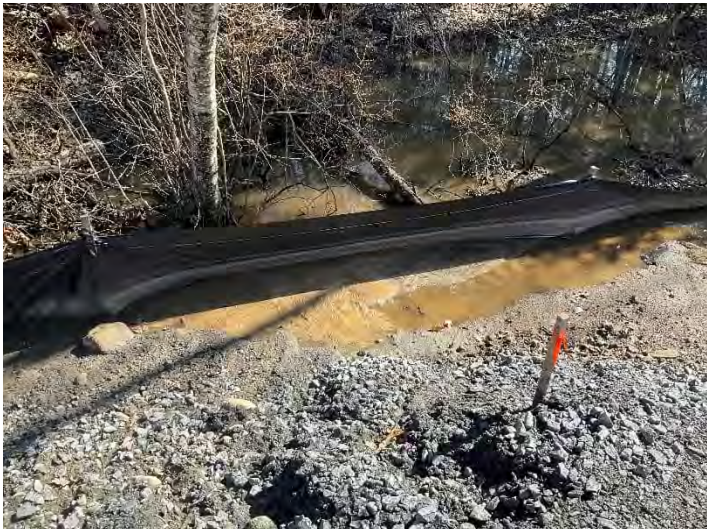
PHOTOGRAPHIC LOG	
Client Name: Eversource		Site Location: Sudbury to Hudson Transmission Reliability Project	Town: Hudson
Photo No.: 4	Date: 4/19/2024

Description: View of discharging water from corral. Discharge appeared turbid and cloudy. Turbidity reading was above 50 NTUs. Facing north.

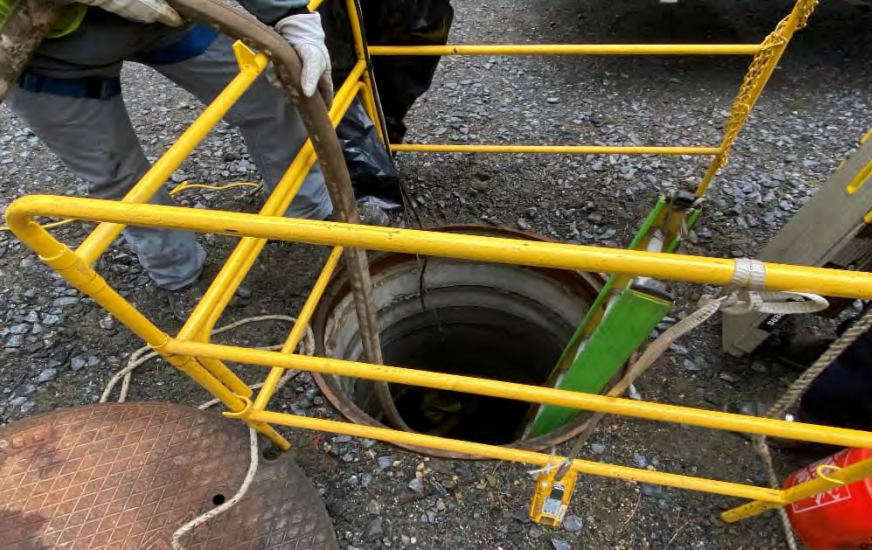
PHOTOGRAPHIC LOG	
Client Name: Eversource		Site Location: Sudbury to Hudson Transmission Reliability Project	Town: Sudbury
Photo No.: 1	Date: 4/19/2024

Description: View of area being pumped from manhole #18, segment 9, looking westward.

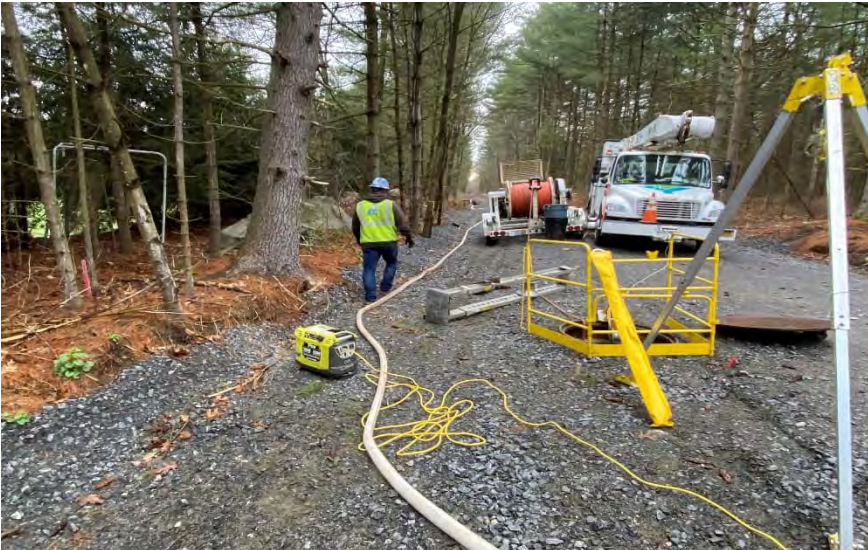
PHOTOGRAPHIC LOG	
Client Name: Eversource		Site Location: Sudbury to Hudson Transmission Reliability Project	Town: Sudbury
Photo No.: 2	Date: 4/19/2024

Description: Segment 9, manhole #18. View of dewatering operation. Looking eastward.

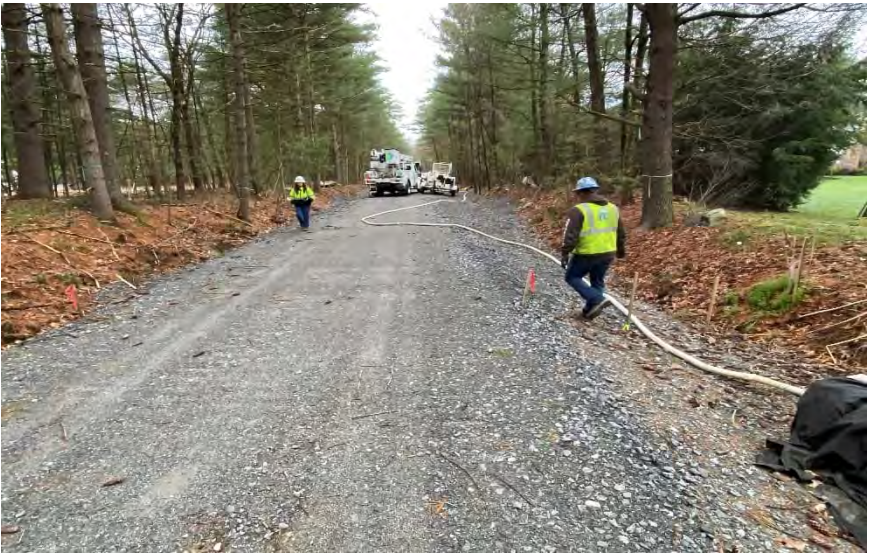
PHOTOGRAPHIC LOG	
Client Name: Eversource		Site Location: Sudbury to Hudson Transmission Reliability Project	Town: Sudbury
Photo No.: 3	Date: 4/19/2024

Description: Manhole #18, Segment 9. View of dewatering operation, looking westward.
