Weekly Environmental Compliance Summary

Sudbury to Hudson Transmission Reliability Project (USEPA Tracking # MAR1003UW)

Week of: April 29, 2024 to May 4, 2024

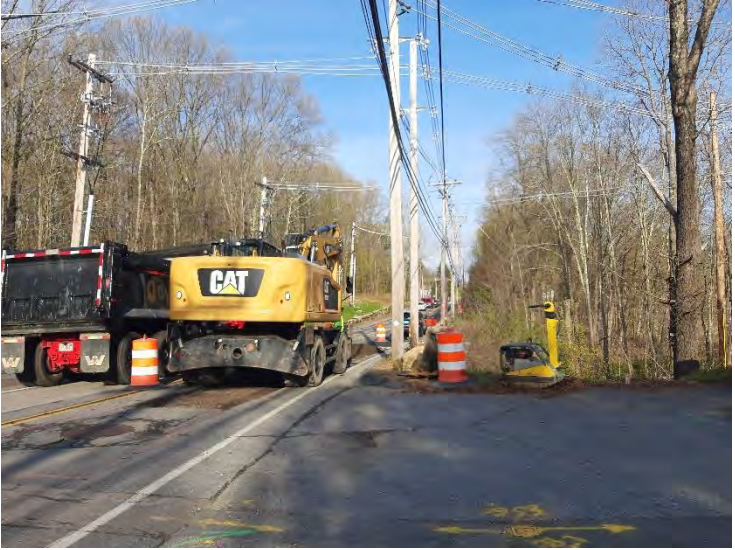
<p>PHOTOGRAPHIC LOG</p>	
<p>Client Name: Eversource</p>		<p>Site Location: Sudbury to Hudson Transmission Reliability Project</p>	<p>Town: Hudson</p>
<p>Photo No.: 2</p>	<p>Date: 4-29-24</p>

Sediment observed within Forest Ave roadway shoulder by Vinagro road work.

<p>Description:</p> <p>Vinagro work zone along Forest Ave, between Hudson Light and Power and Bonazzoli Ave, near 100 Forest Ave. Facing eastward.</p>

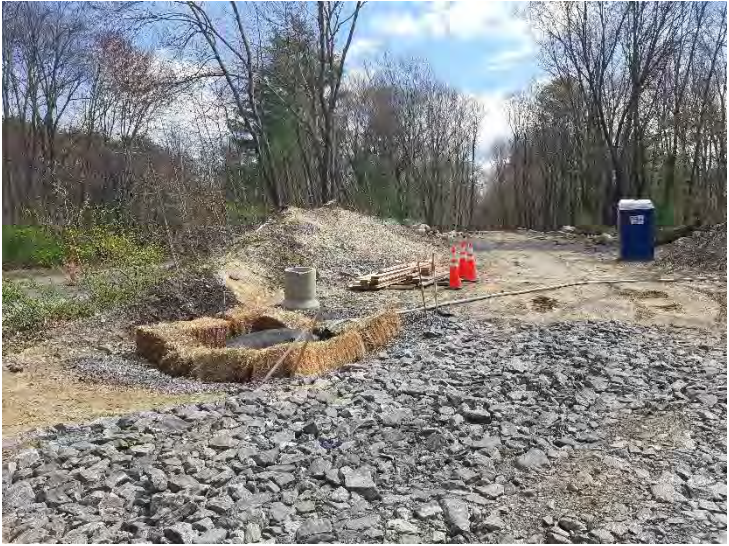
<p>PHOTOGRAPHIC LOG</p>	
<p>Client Name: Eversource</p>		<p>Site Location: Sudbury to Hudson Transmission Reliability Project</p>	<p>Town: Hudson</p>
<p>Photo No.: 5</p>	<p>Date: 4-29-24</p>

<p>Description:</p> <p>View of west end of segment 1, where dewatering corral for Bond's Wilkins Street work is set up. Below corral is a layer of gravel, below that is geotextile. Facing eastward.</p>

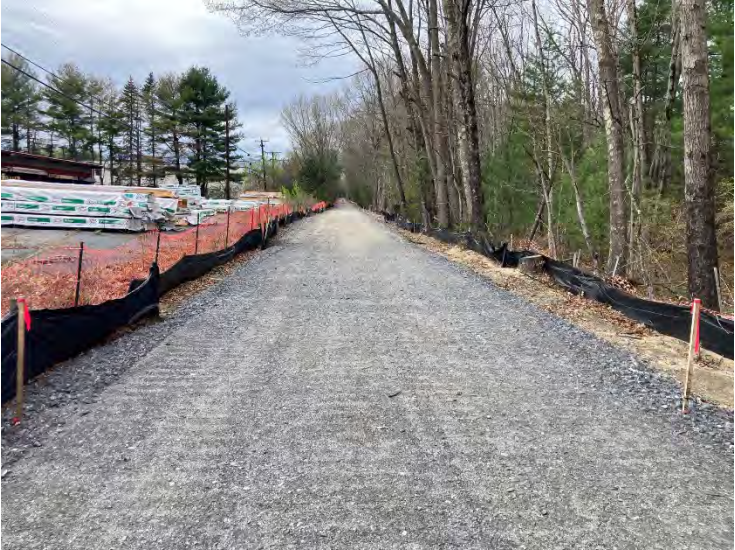
<p>PHOTOGRAPHIC LOG</p>	
<p>Client Name: Eversource</p>		<p>Site Location: Sudbury to Hudson Transmission Reliability Project</p>	<p>Town: Sudbury</p>
<p>Photo No.: 3</p>	<p>Date: 4/29/2024</p>

<p>Description: View of E&S controls in segment 11. Facing west.</p>

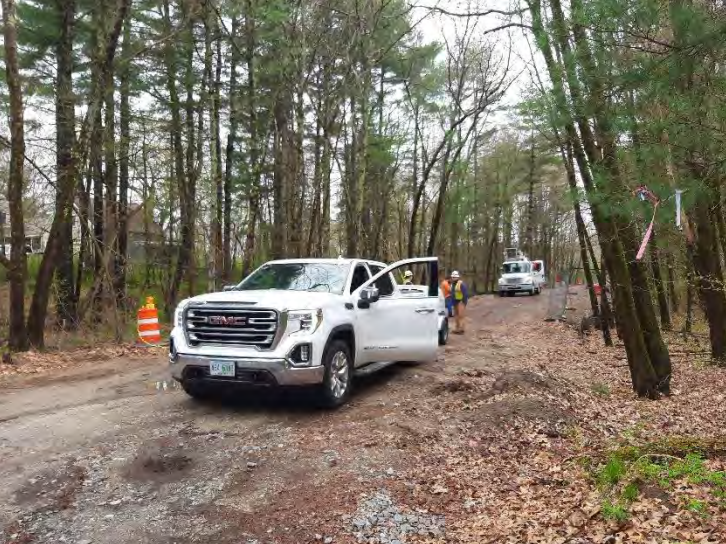
<p>PHOTOGRAPHIC LOG</p>	
<p>Client Name: Eversource</p>		<p>Site Location: Sudbury to Hudson Transmission Reliability Project</p>	<p>Town: Hudson</p>
<p>Photo No.: 6</p>	<p>Date: 4-30-24</p>

<p>Description:</p> <p>New Wave work area at manhole #13 in segment 5 retrieving mule tape that had recoiled into the duct, between MHs #13 (segment 5) and #14 (segment 6). Facing westward.</p>

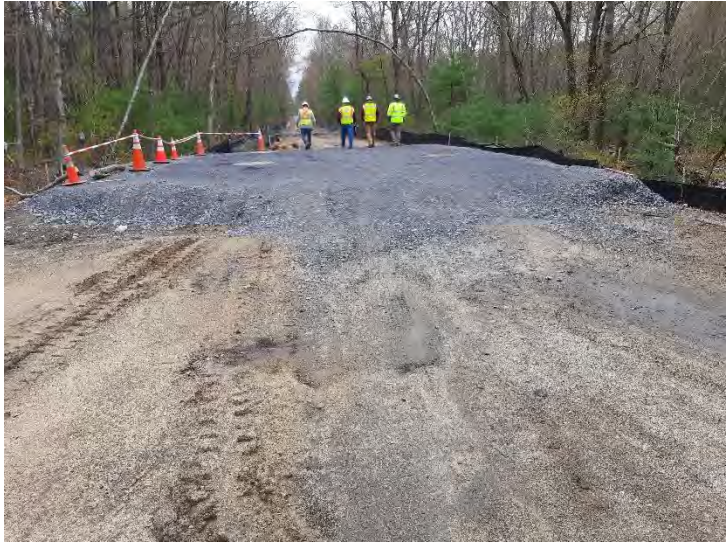
<p>PHOTOGRAPHIC LOG</p>	
<p>Client Name: Eversource</p>		<p>Site Location: Sudbury to Hudson Transmission Reliability Project</p>	<p>Town: Hudson</p>
<p>Photo No.: 7</p>	<p>Date: 5-2-24</p>

<p>Description:</p> <p>MH in #14 in segment 6. Segment is currently under Whippoorwill TOY restrictions. Joint project personnel walked ROW to observe width limitations. Facing eastward.</p>

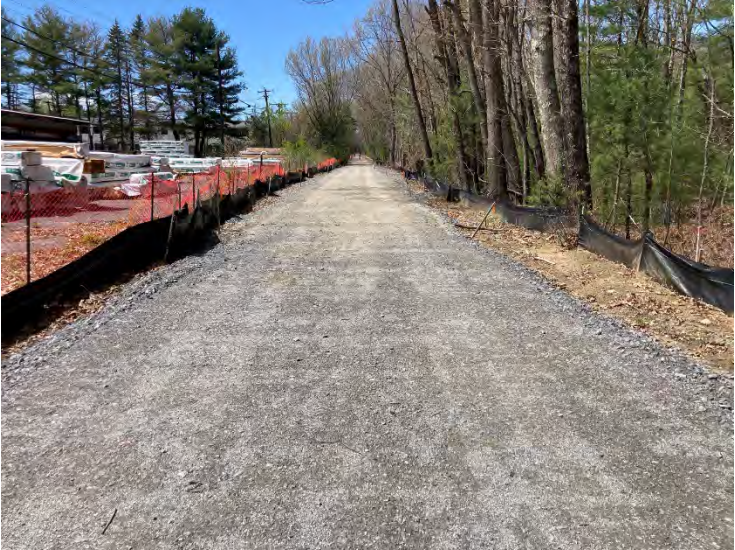
PHOTOGRAPHIC LOG	
Client Name: Eversource		Site Location: Sudbury to Hudson Transmission Reliability Project	Town: Sudbury
Photo No.: 3	Date: 5/02/2024

Description: View of E&S controls in segment 11. Facing west.

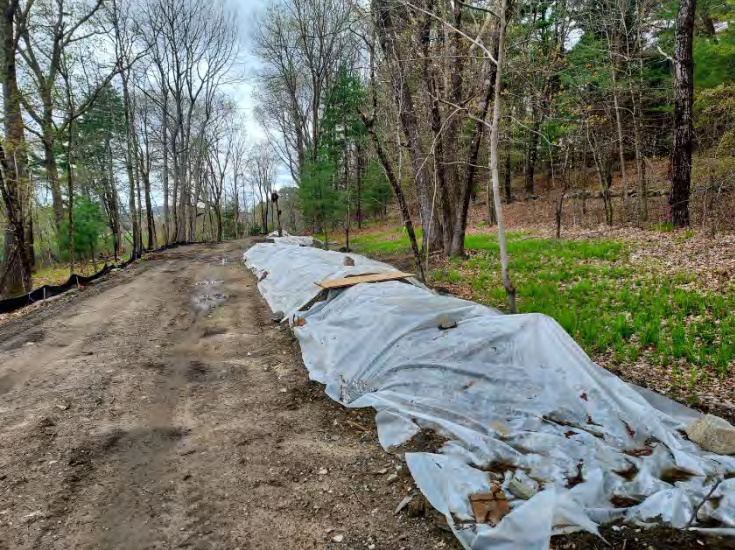
<p>PHOTOGRAPHIC LOG</p>	
<p>Client Name: Eversource</p>		<p>Site Location: Sudbury to Hudson Transmission Reliability Project</p>	<p>Town: Sudbury</p>
<p>Photo No.: 4</p>	<p>Date: 5/03/2024</p>

<p>Description: View of stockpile/ spoil berm in segment 14. Facing west.</p>

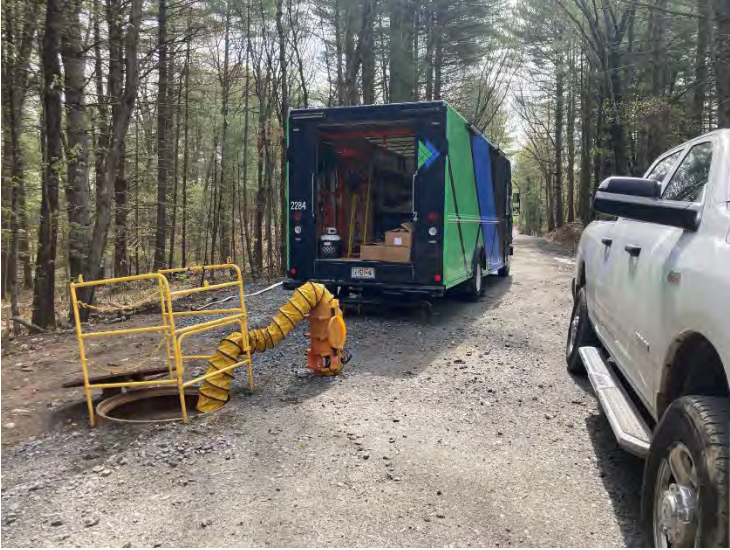
<p>PHOTOGRAPHIC LOG</p>	
<p>Client Name: Eversource</p>		<p>Site Location: Sudbury to Hudson Transmission Reliability Project</p>	<p>Town: Sudbury</p>
<p>Photo No.: 1</p>	<p>Date: 5/04/2024</p>

<p>Description: View of Haugland's work area at MH #17 in segment 8. Facing east.</p>

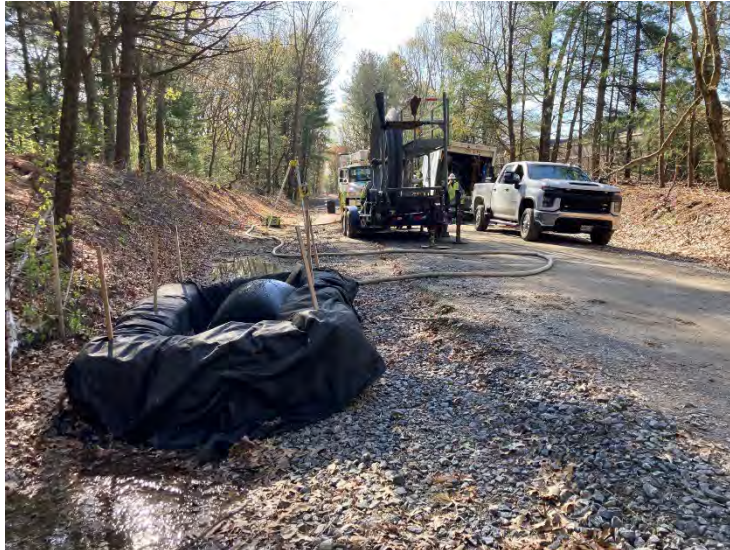
<p>PHOTOGRAPHIC LOG</p>	
<p>Client Name: Eversource</p>		<p>Site Location: Sudbury to Hudson Transmission Reliability Project</p>	<p>Town: Sudbury</p>
<p>Photo No.: 2</p>	<p>Date: 5/04/2024</p>

<p>Description: View of Haugland's work area and dewatering controls at MH #22 in segment 11. See additional dewatering report. Facing east.</p>

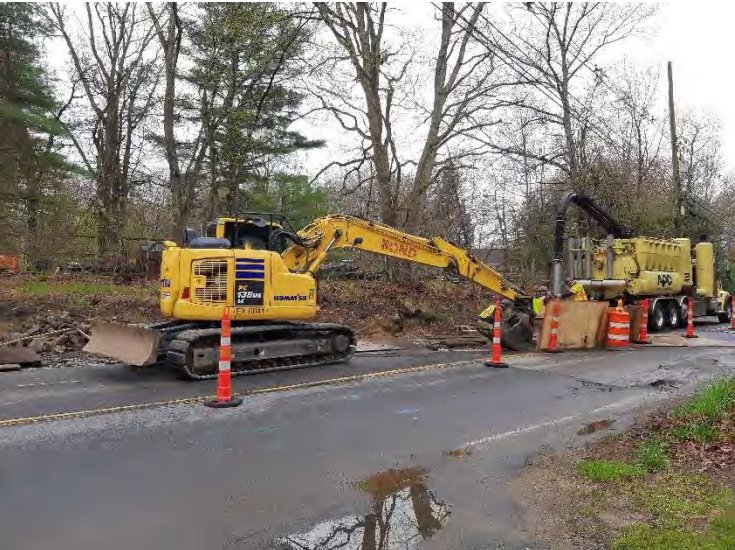
PHOTOGRAPHIC LOG	
Client Name: Eversource		Site Location: Sudbury to Hudson Transmission Reliability Project	Town: Hudson
Photo No.: 2	Date: 5-1-24

Description: Bond excavation and vac truck work within Wilkins Street near segment 1, looking southward.

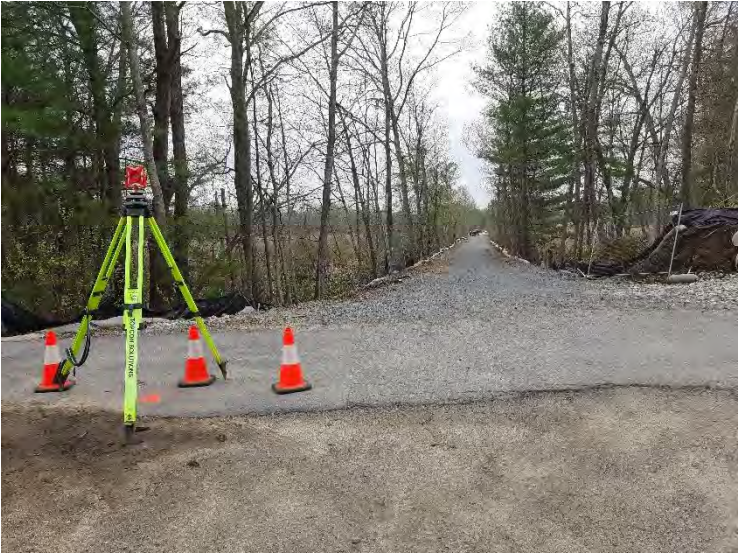
PHOTOGRAPHIC LOG	
Client Name: Eversource		Site Location: Sudbury to Hudson Transmission Reliability Project	Town: Hudson
Photo No.: 3	Date: 5-1-24

Description: ET&L conducting survey work in segment 2, looking eastward.

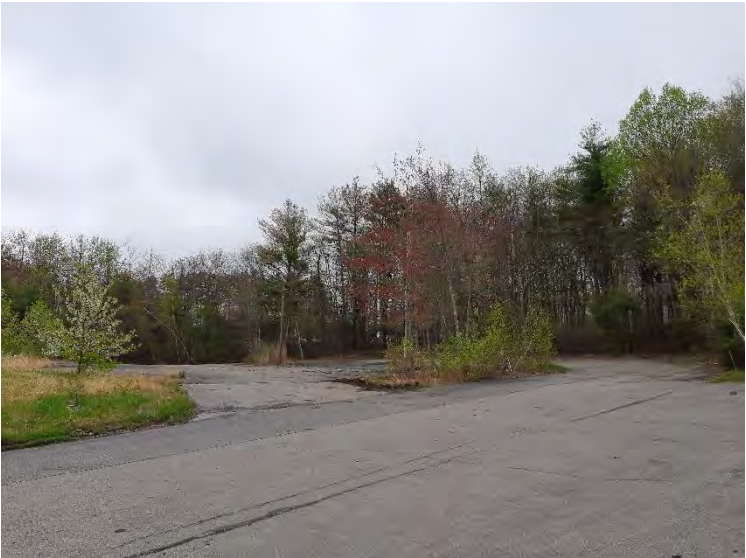
PHOTOGRAPHIC LOG	
Client Name: Eversource		Site Location: Sudbury to Hudson Transmission Reliability Project	Town: Hudson
Photo No.: 4	Date: 5-1-24

Description: Former location of the 555 Main Street (ET&L) laydown yard. Laydown yard has been demobilized since previous SWPPP inspection. Looking northward.

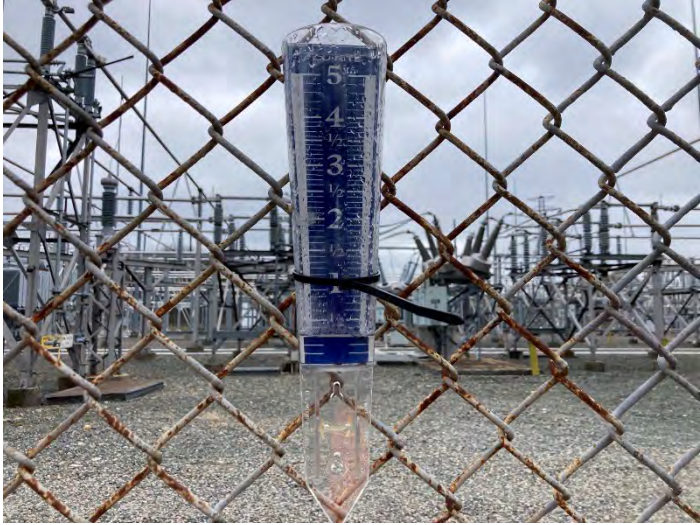
PHOTOGRAPHIC LOG	
Client Name: Eversource	Site Location: Sudbury to Hudson Transmission Reliability Project	Town: Sudbury	
Photo No.: 1	Date: 5-01-2024

Description: View of rain gauge at Sudbury Substation. 0.3" observed in gauge. Facing south.

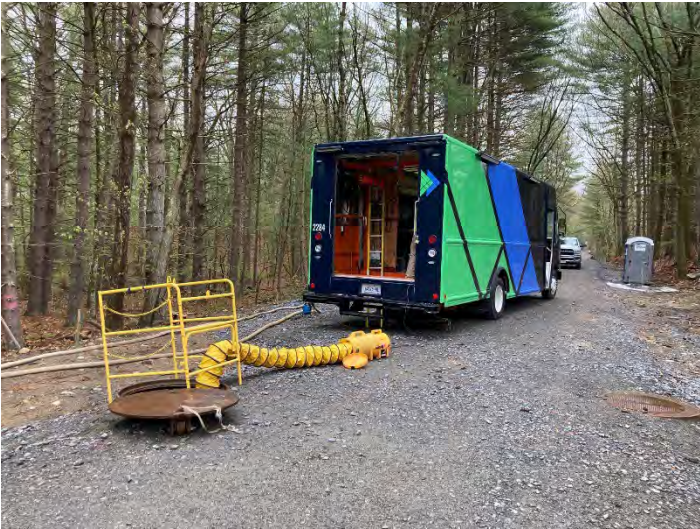
PHOTOGRAPHIC LOG	
Client Name: Eversource	Site Location: Sudbury to Hudson Transmission Reliability Project	Town: Sudbury	
Photo No.: 2	Date: 5-01-2024

Description: View of Haugland splicing crew working at MH #17 in segment 8. See additional dewatering inspection report. Facing east.

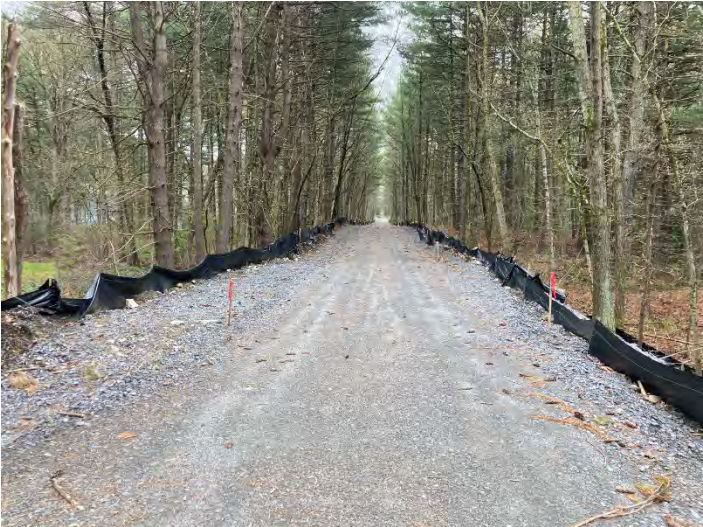
Client Name: Eversource		Site Location: Sudbury to Hudson Transmission Reliability Project	Town: Sudbury
Photo No.: 3	Date: 5-01-2024

Description: View of syncoated silt fence in segment 9. Facing west.

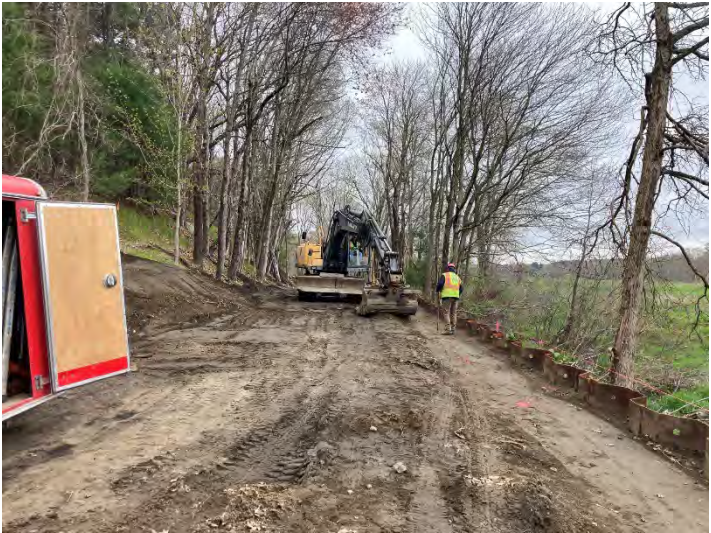
PHOTOGRAPHIC LOG	
Client Name: Eversource		Site Location: Sudbury to Hudson Transmission Reliability Project	Town: Sudbury
Photo No.: 6	Date: 5-01-2024

Description: View of ET&L working at sheetwall in segment 14. Facing east.

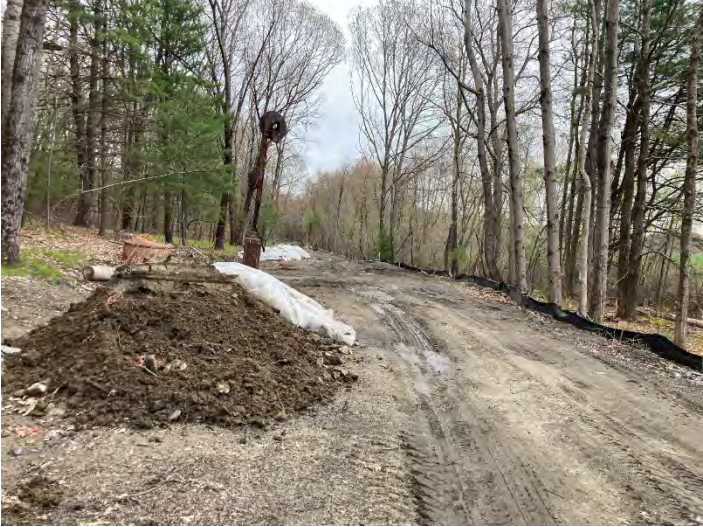
PHOTOGRAPHIC LOG	
Client Name: Eversource		Site Location: Sudbury to Hudson Transmission Reliability Project	Town: Sudbury
Photo No.: 7	Date: 5-01-2024

Description: View of stockpile/spoil berm at Sta. #738 in segment 14. Stockpile/berm now active as of 5-01-2024. Facing east.

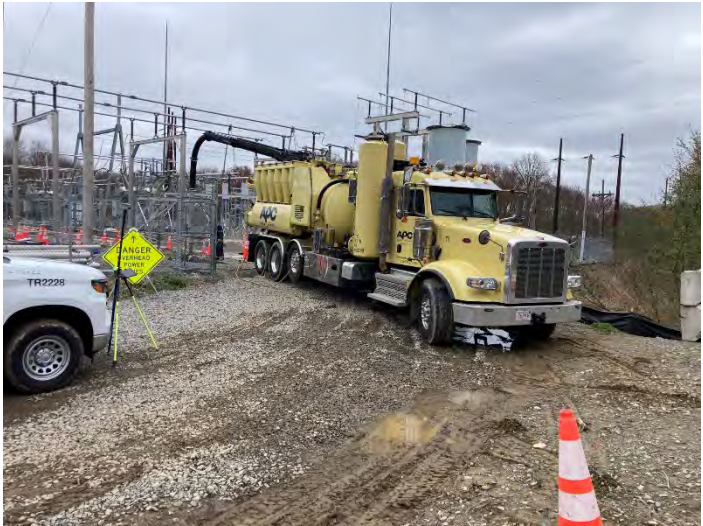
PHOTOGRAPHIC LOG	
Client Name: Eversource		Site Location: Sudbury to Hudson Transmission Reliability Project	Town: Sudbury
Photo No.: 8	Date: 5-01-2024

Description: View of Bond working within Sudbury Substation. Facing southeast.

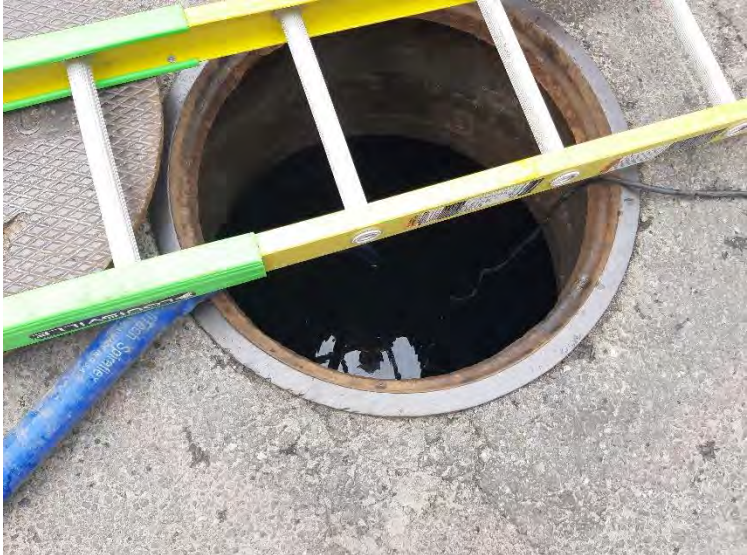
PHOTOGRAPHIC LOG	
Client Name: Eversource		Site Location: Sudbury to Hudson Transmission Reliability Project	Town: Hudson
Photo No.: 1	Date: 4/29/2024

Description: View of area being pumped from manhole in Forest Ave roadway, near Hudson Light and Power. Vault is located in stretch of Forest Ave between project manholes #1 and #2. Looking southward.

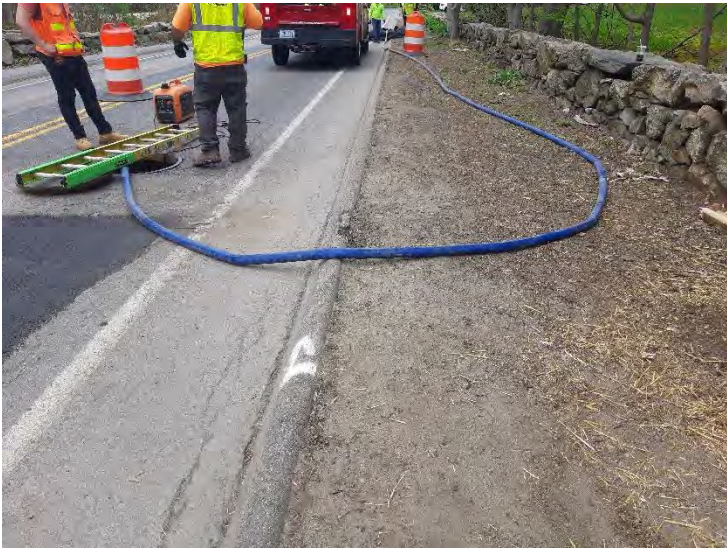
PHOTOGRAPHIC LOG	
Client Name: Eversource		Site Location: Sudbury to Hudson Transmission Reliability Project	Town: Hudson
Photo No.: 2	Date: 4/29/2024

Description: Manhole in Forest Ave roadway, near Hudson Light and Power. Vault is located in stretch of Forest Ave between project manholes #1 and #2. View of dewatering operation. Looking eastward.

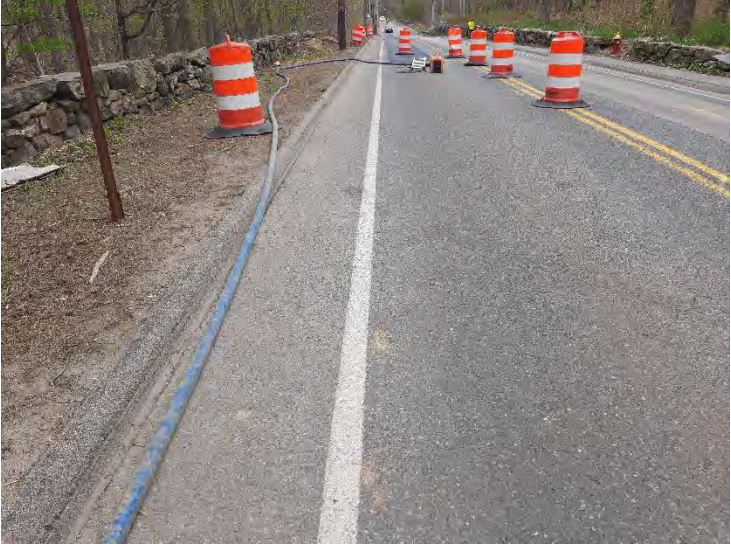
PHOTOGRAPHIC LOG	
Client Name: Eversource		Site Location: Sudbury to Hudson Transmission Reliability Project	Town: Hudson
Photo No.: 3	Date: 4/29/2024

Description: Manhole in Forest Ave roadway, near Hudson Light and Power. Vault is located in stretch of Forest Ave between project manholes #1 and #2. View of dewatering operation, looking westward.

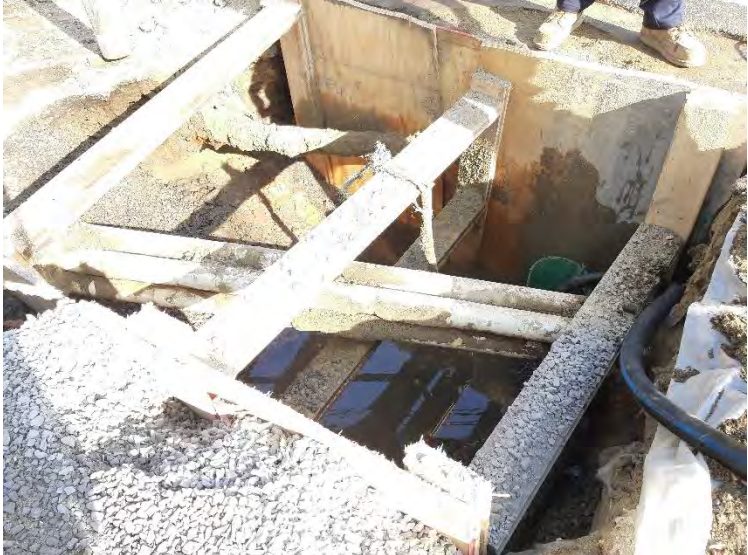
PHOTOGRAPHIC LOG	
Client Name: Eversource		Site Location: Sudbury to Hudson Transmission Reliability Project	
Town: Hudson			
Photo No.: 1	Date: 4/29/2024

Description: View of area being pumped Wilkins Street trench, near segment 1. Looking southward.

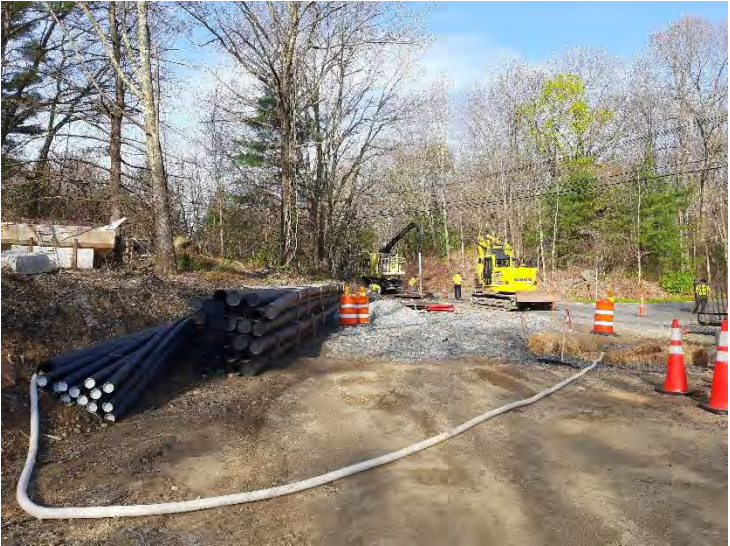
PHOTOGRAPHIC LOG	
Client Name: Eversource		Site Location: Sudbury to Hudson Transmission Reliability Project	
Town: Hudson			
Photo No.: 2	Date: 4/29/2024

Description: Wilkins Street trench work near segment 1. View of dewatering operation. Looking westward.

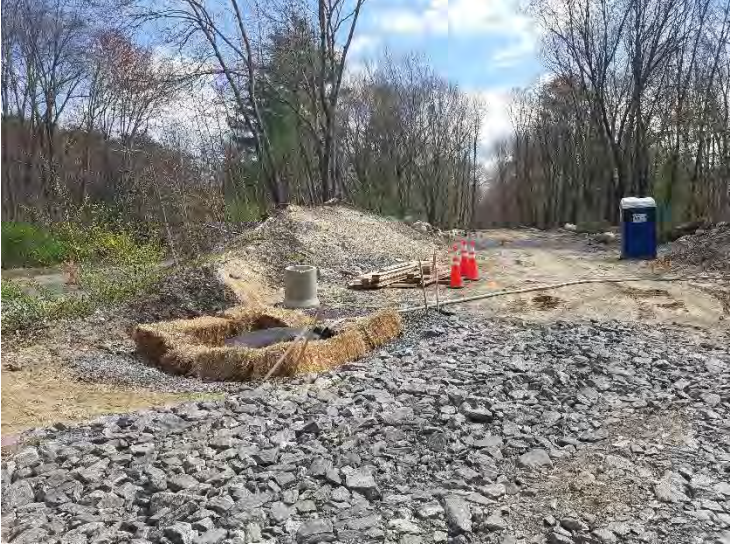
PHOTOGRAPHIC LOG	
Client Name: Eversource		Site Location: Sudbury to Hudson Transmission Reliability Project	Town: Hudson
Photo No.: 3	Date: 4/29/2024

Description: Wilkins Street trench work near segment 1. View of dewatering operation. Looking eastward.

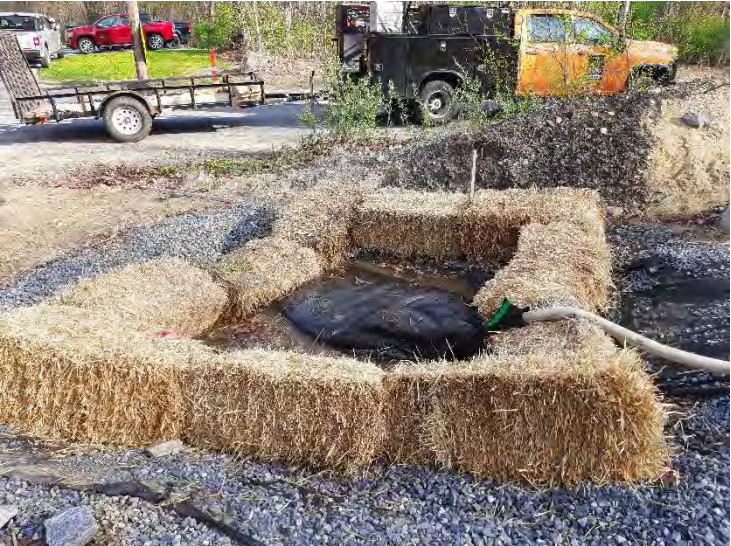
PHOTOGRAPHIC LOG	
Client Name: Eversource		Site Location: Sudbury to Hudson Transmission Reliability Project	Town: Hudson
Photo No.: 4	Date: 4/29/2024

Description: Wilkins Street trench work near segment 1. View of discharge bag/corral, looking northward. Water discharged to drain below gravel and geotextile layers.

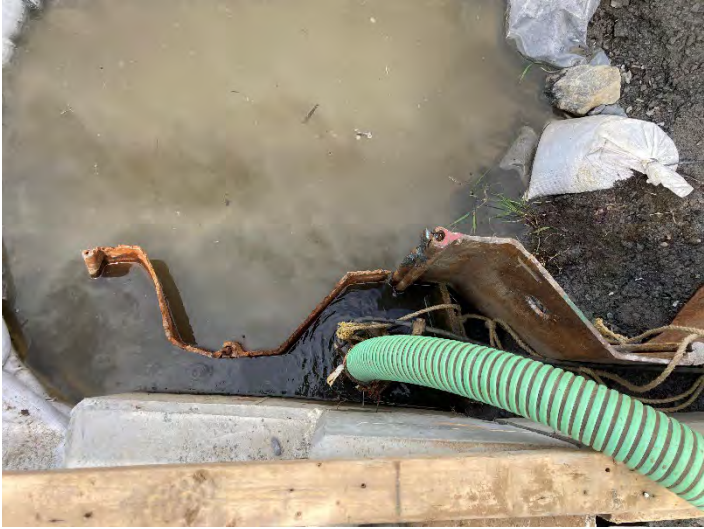
PHOTOGRAPHIC LOG	
Client Name: Eversource		Site Location: Sudbury to Hudson Transmission Reliability Project	Town: Sudbury
Photo No.: 1	Date: 4/29/2024

Description: View of pump in cofferdam at bridge 127 off Hop Brook. Water appeared turbid prior to treatment.

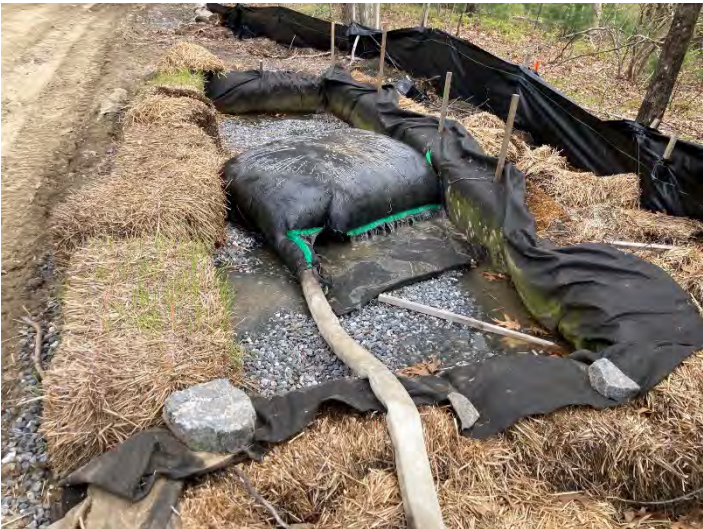
PHOTOGRAPHIC LOG	
Client Name: Eversource		Site Location: Sudbury to Hudson Transmission Reliability Project	Town: Sudbury
Photo No.: 2	Date: 4/29/2024

Description: View of dewatering controls (straw bale corral with filter fabric, stone, and silt bag). Facing east.

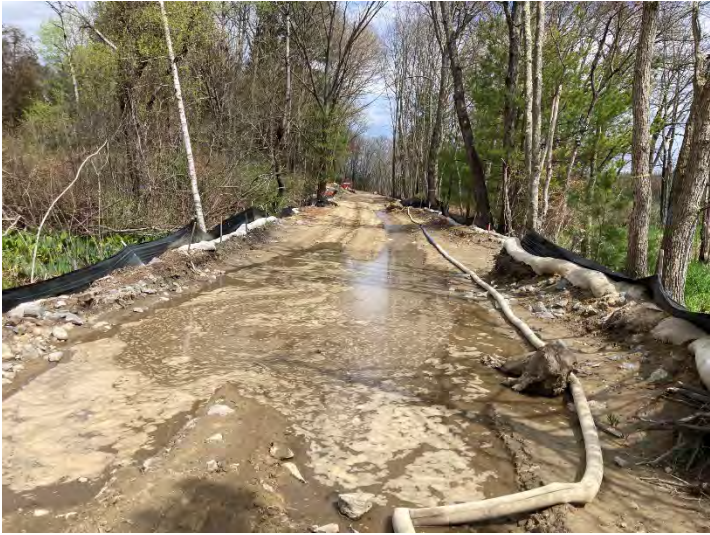
PHOTOGRAPHIC LOG	
Client Name: Eversource		Site Location: Sudbury to Hudson Transmission Reliability Project	Town: Sudbury
Photo No.: 4	Date: 4/29/2024

Description: Additional view of discharge from controls. Discharge appeared turbid and turbidity reading was higher than 50 NTUs. Discharge believed to be reaching wetlands. See additional corrective action log. Facing east.

Section A – Dewatering Discharges (CGP Part 4.6.3) Complete this section <u>within 24 hours</u> of completing the inspection. (If necessary, complete additional inspection reports for each separate inspection location.)	
Inspector Information	
Inspector Name: Ariel Leclerc	Title: Compliance Monitor, CESSWI, QCIS, QPSWPPP
Company Name: SWCA Environmental Consultants	Email: ariel.leclerc@swca.com
Address: 153 Cordaville Road, Suite 130, Southborough, MA 01772	Phone Number: 401-496-8471
Inspection Details	
Inspection Date: 4/29/2024	Inspection Location: Bridge 127 work off Hop Brook- Segment 14
Discharge Start Time: 2:05pm	Discharge End Time: 2:40pm
Rate of Discharge (gallons per day): 188,640 (131 gallons per minute)	Corrective Action Required? ¹ <input checked="" type="checkbox"/> Yes <input type="checkbox"/> No
Describe Indicators of Pollutant Discharge at Point of Dewatering Discharge: ¹ Dewatering setup to corral/bag within work area east of the bridge 127 work in segment 14. Dewatering conducted to remove water from cofferdam off Hop Brook. Discharge from corral believed to be reaching wetlands. Discharge appeared turbid. Turbidity sampling conducted and reading was higher than 50 NTUs. Dewatering discharge stopped on 4/29 and has not resumed. Dewatering controls at bridge 127 in segment 14 will need to be assessed prior to resuming pumping operation at this location. See additional corrective action log.

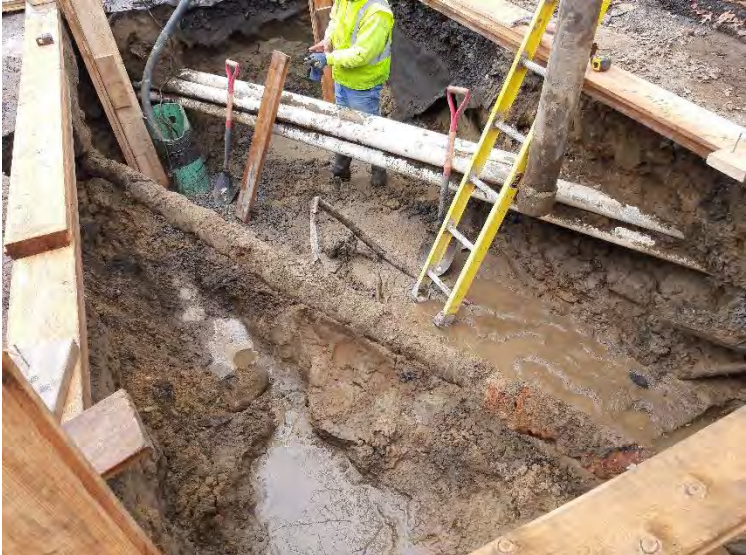
PHOTOGRAPHIC LOG	
Client Name: Eversource		Site Location: Sudbury to Hudson Transmission Reliability Project	Town: Hudson
Photo No.: 1	Date: 4/30/2024

Description: View of area being pumped Wilkins Street trench, near segment 1. Looking eastward.

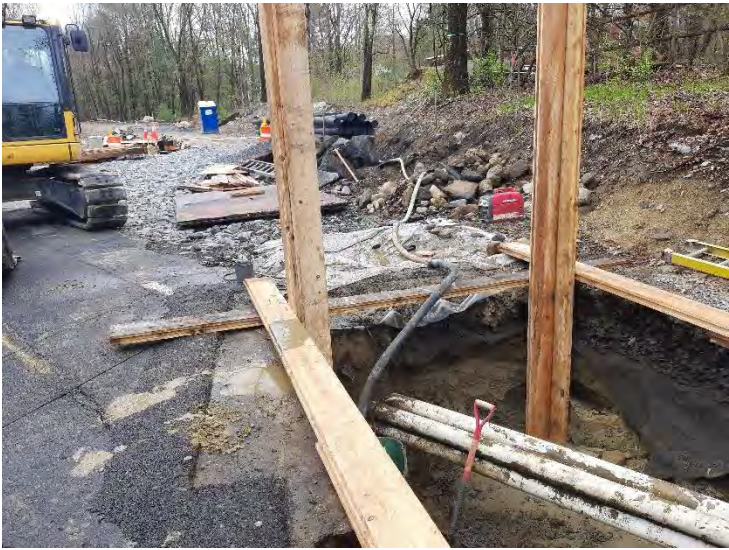
PHOTOGRAPHIC LOG	
Client Name: Eversource		Site Location: Sudbury to Hudson Transmission Reliability Project	Town: Hudson
Photo No.: 2	Date: 4/30/2024

Description: Wilkins Street trench work near segment 1. View of dewatering operation. Looking eastward.

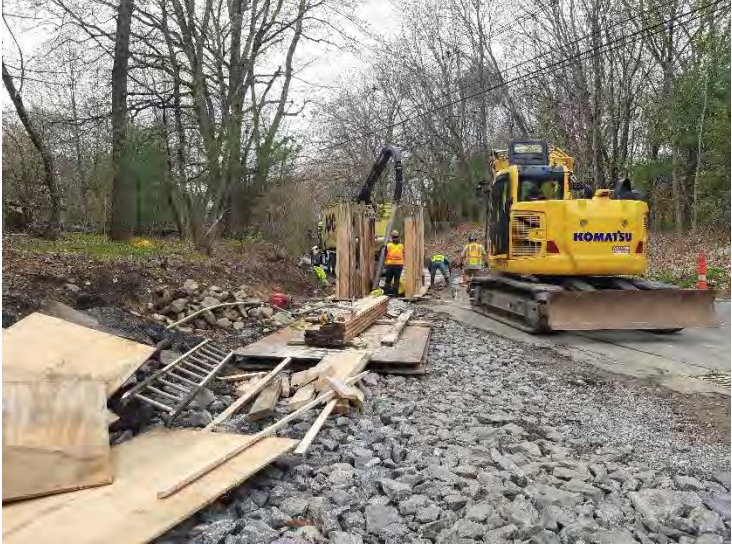
PHOTOGRAPHIC LOG	
Client Name: Eversource		Site Location: Sudbury to Hudson Transmission Reliability Project	Town: Hudson
Photo No.: 3	Date: 4/30/2024

Description: Wilkins Street trench work near segment 1. View of dewatering operation. Looking westward.

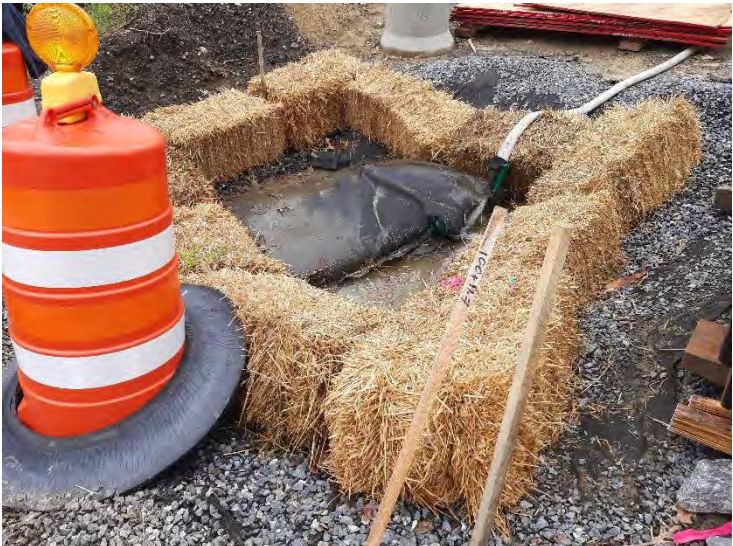
PHOTOGRAPHIC LOG	
Client Name: Eversource		Site Location: Sudbury to Hudson Transmission Reliability Project	Town: Hudson
Photo No.: 4	Date: 4/30/2024

Description: Wilkins Street trench work near segment 1. View of discharge bag/corral, looking eastward. Water discharged to drain below gravel and geotextile layers.

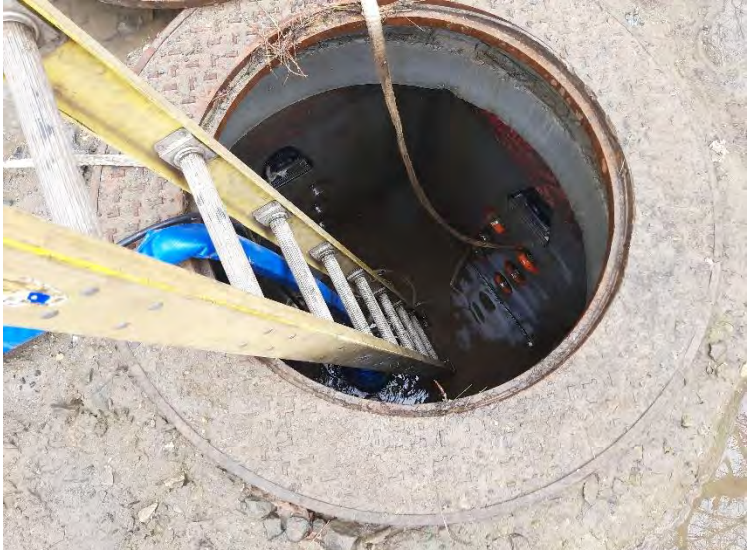
PHOTOGRAPHIC LOG	
Client Name: Eversource		Site Location: Sudbury to Hudson Transmission Reliability Project	
Town: Hudson			
Photo No.: 1	Date: 4/30/2024

Description: View of area being pumped at manhole #9, segment 3. Looking eastward.

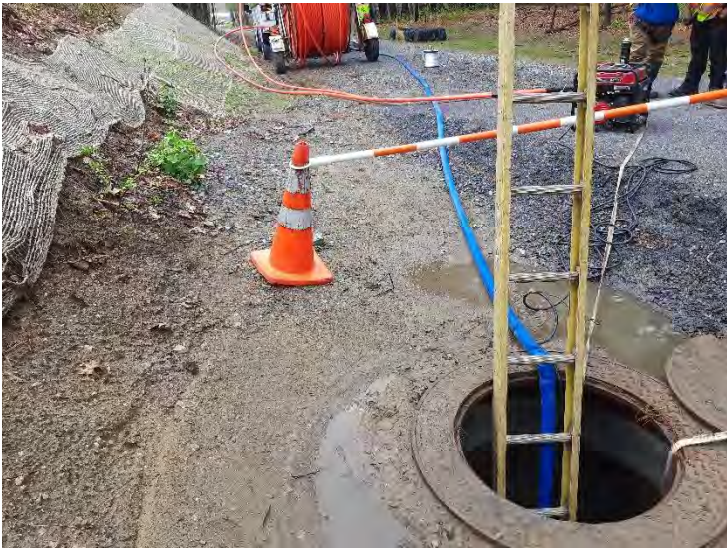
PHOTOGRAPHIC LOG	
Client Name: Eversource		Site Location: Sudbury to Hudson Transmission Reliability Project	
Town: Hudson			
Photo No.: 2	Date: 4/30/2024

Description: Manhole #9 in segment 3. View of dewatering operation. Looking northward.

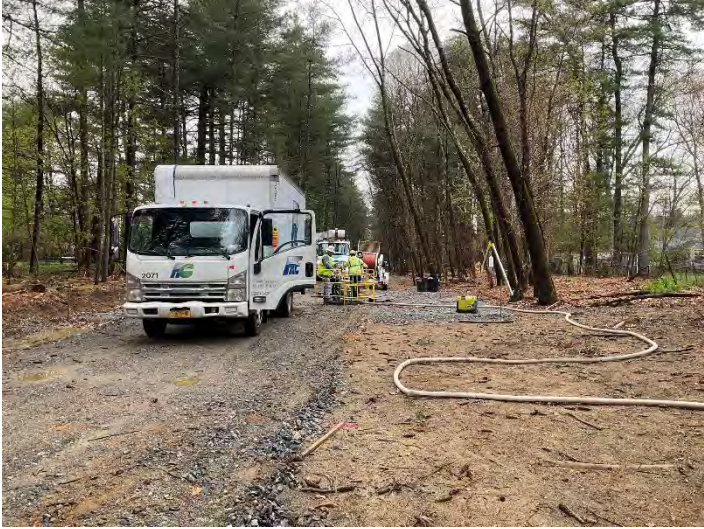
PHOTOGRAPHIC LOG	
Client Name: Eversource		Site Location: Sudbury to Hudson Transmission Reliability Project	Town: Sudbury
Photo No.: 1	Date: 4/30/2024

Description: View of Haugland working at MH #21. Facing west.

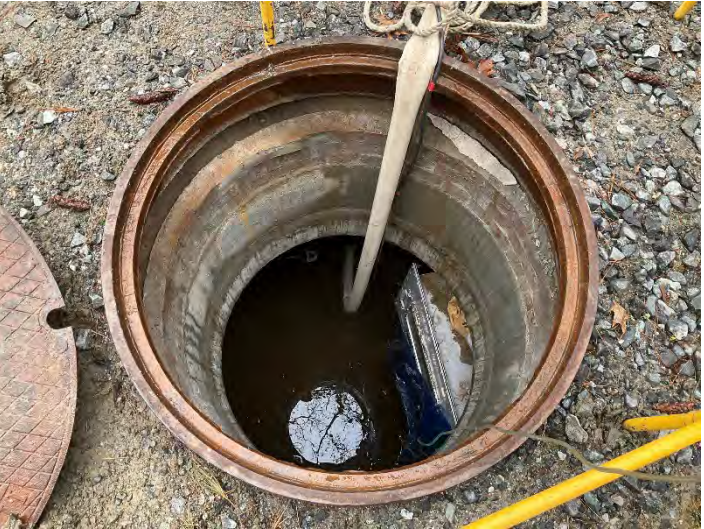
PHOTOGRAPHIC LOG	
Client Name: Eversource		Site Location: Sudbury to Hudson Transmission Reliability Project	Town: Sudbury
Photo No.: 2	Date: 4/30/2024

Description: View of pump in MH #21. Water appeared mostly clear prior to treatment.

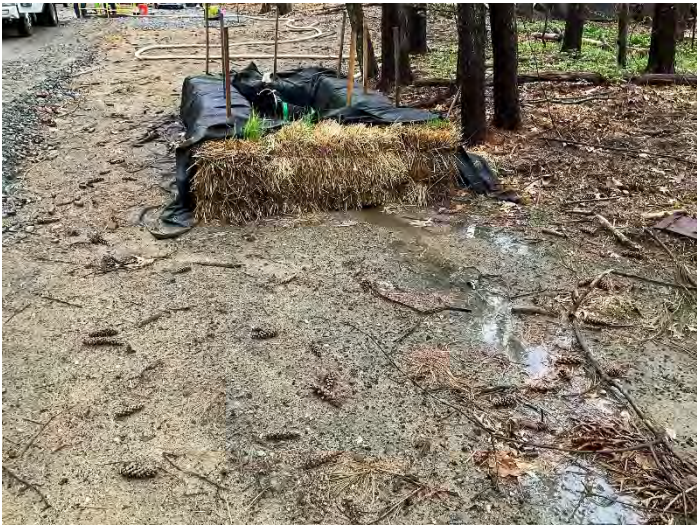
PHOTOGRAPHIC LOG	
Client Name: Eversource		Site Location: Sudbury to Hudson Transmission Reliability Project	
Town: Sudbury			
Photo No.: 4	Date: 4/30/2024

Description: View of dewatering controls (straw bale corral with filter fabric and silt bag) and discharge from corral. Discharge appeared clear and turbidity was below 50 NTUs. Discharge did not reach any jurisdictional areas. Facing west.

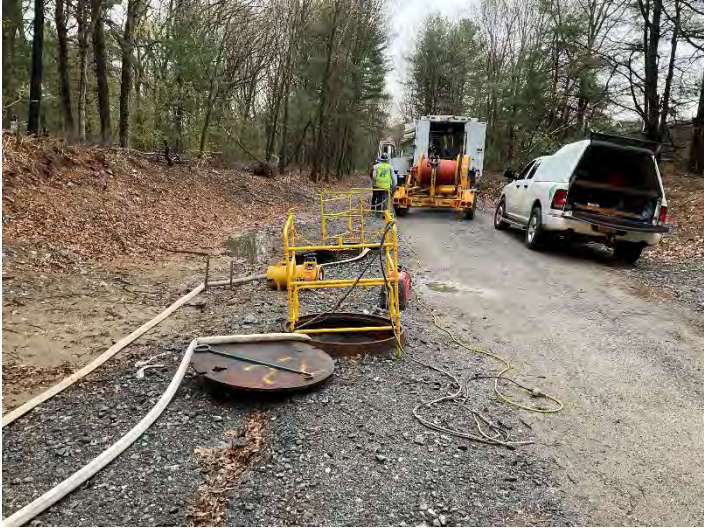
PHOTOGRAPHIC LOG	
Client Name: Eversource		Site Location: Sudbury to Hudson Transmission Reliability Project	Town: Sudbury
Photo No.: 1	Date: 4/30/2024

Description: View of Haugland working at MH #22. Facing east.

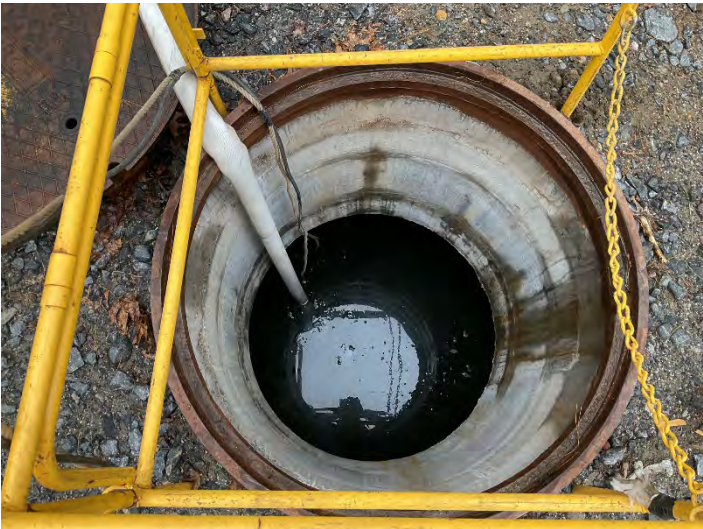
PHOTOGRAPHIC LOG	
Client Name: Eversource		Site Location: Sudbury to Hudson Transmission Reliability Project	Town: Sudbury
Photo No.: 2	Date: 4/30/2024

Description: View of pump in MH #22. Water appeared mostly clear prior to treatment.

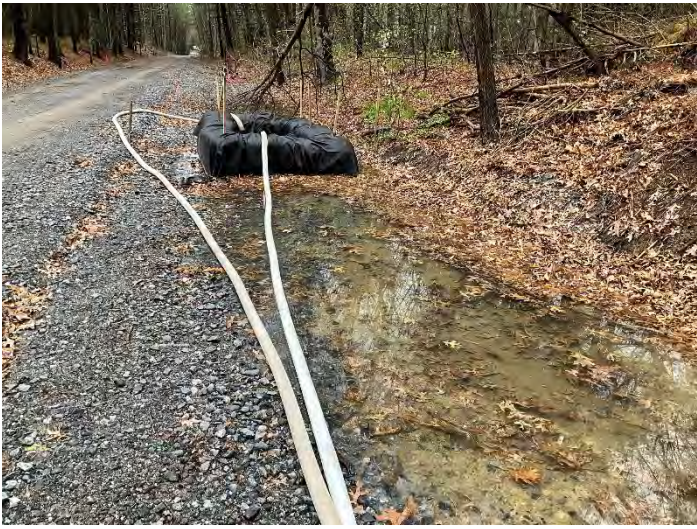
Epsilon <small>ASSOCIATES INC.</small>		PHOTOGRAPHIC LOG	
Client Name: Eversource		Site Location: Sudbury to Hudson Transmission Reliability Project	Town: Sudbury
Photo No.: 4	Date: 4/30/2024

Description: View of dewatering controls (straw bale corral with filter fabric and silt bags) and discharge from corral. Discharge appeared clear and turbidity was below 50 NTUs. Discharge did not reach any jurisdictional areas. Facing west.

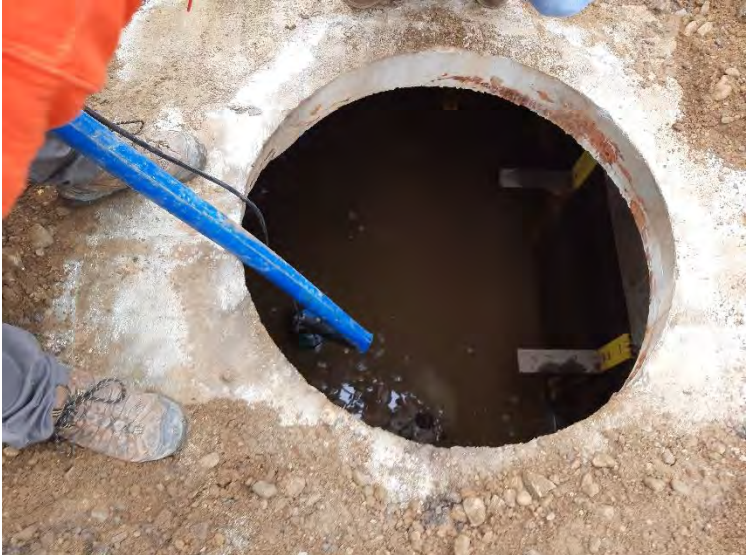
PHOTOGRAPHIC LOG	
Client Name: Eversource		Site Location: Sudbury to Hudson Transmission Reliability Project	Town: Hudson
Photo No.: 1	Date: 5/1/2024

Description: View of area being pumped from manhole in Forest Ave, between project MH #1 and MH #2 near 100 Forest Ave. Looking southward.

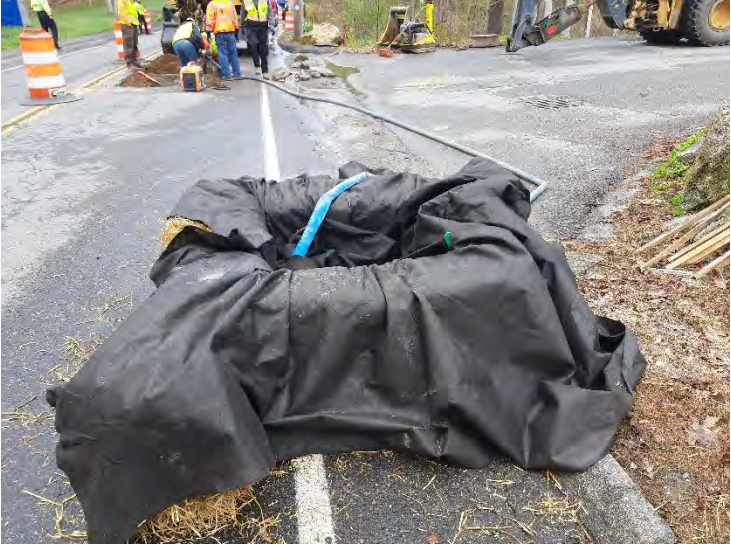
PHOTOGRAPHIC LOG	
Client Name: Eversource		Site Location: Sudbury to Hudson Transmission Reliability Project	Town: Hudson
Photo No.: 3	Date: 5/1/2024

Description: Manhole in Forest Ave, between project MH #1 and MH #2 near 100 Forest Ave. View of dewatering operation, looking eastward.

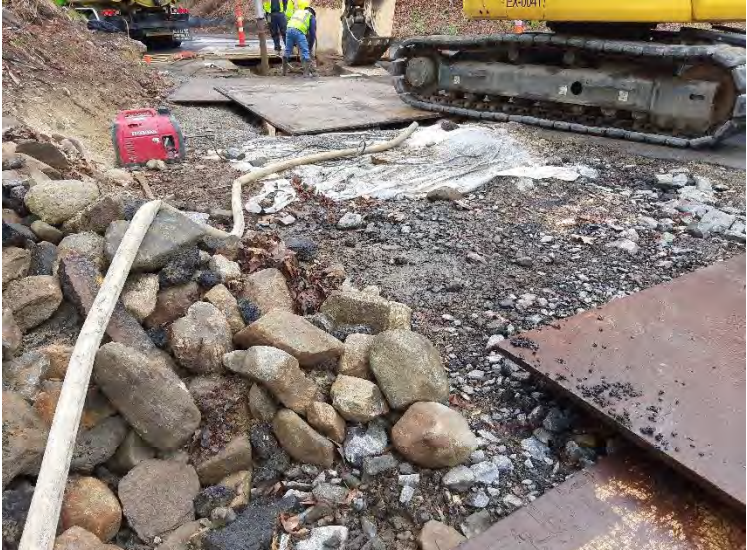
PHOTOGRAPHIC LOG	
Client Name: Eversource		Site Location: Sudbury to Hudson Transmission Reliability Project	
Town: Hudson			
Photo No.: 1	Date: 5/1/2024

Description: View of area being pumped, Wilkins Street trench, near segment 1. Looking westward.

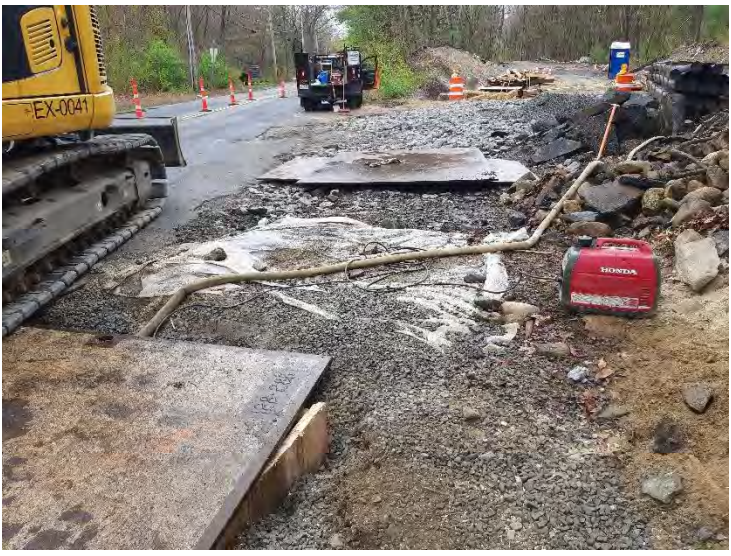
PHOTOGRAPHIC LOG	
Client Name: Eversource		Site Location: Sudbury to Hudson Transmission Reliability Project	
Town: Hudson			
Photo No.: 2	Date: 5/1/2024

Description: Wilkins Street trench work near segment 1. View of dewatering operation. Looking eastward.

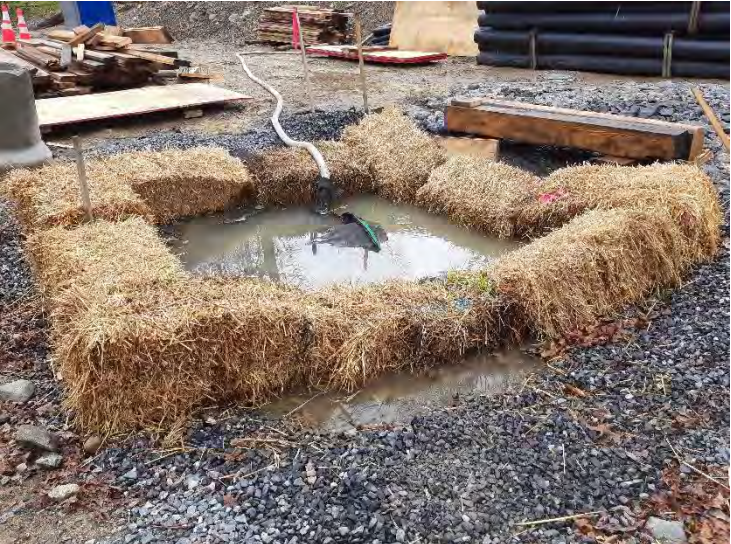
PHOTOGRAPHIC LOG	
Client Name: Eversource		Site Location: Sudbury to Hudson Transmission Reliability Project	Town: Hudson
Photo No.: 4	Date: 5/1/2024

Description: Wilkins Street trench work near segment 1. View of discharge bag/corral, looking eastward. Water discharged to drain below gravel and geotextile layers. Sample obtained outside corral.

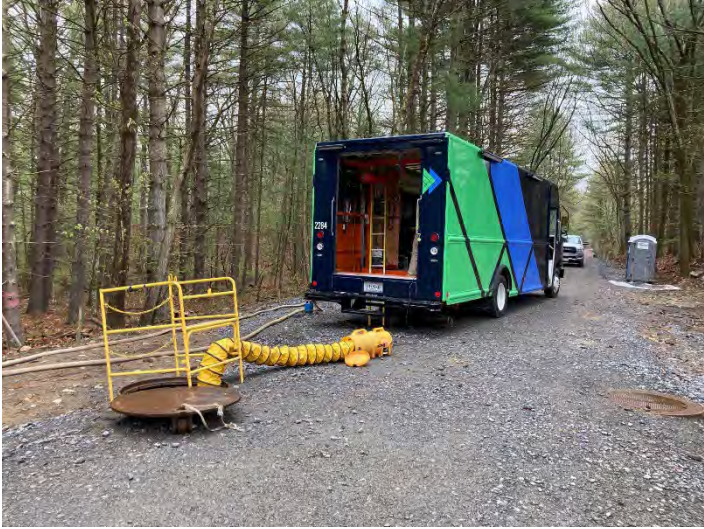
PHOTOGRAPHIC LOG	
Client Name: Eversource		Site Location: Sudbury to Hudson Transmission Reliability Project	Town: Sudbury
Photo No.: 1	Date: 5/01/2024

Description: View of Haugland working at MH #17 in segment 8. Facing east.

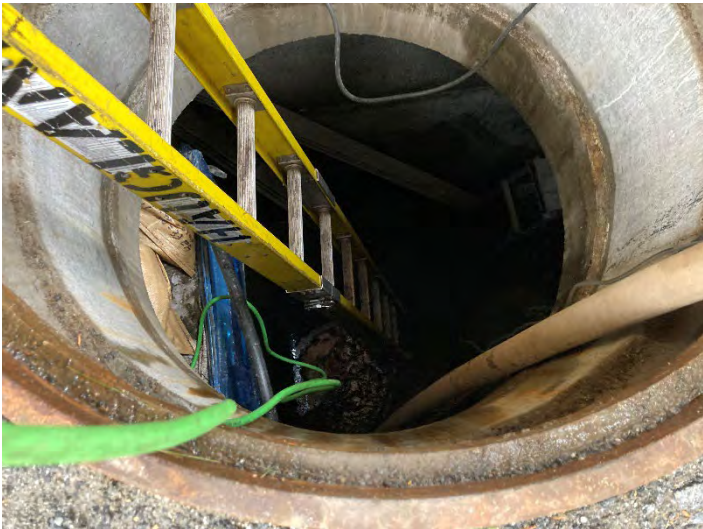
PHOTOGRAPHIC LOG	
Client Name: Eversource		Site Location: Sudbury to Hudson Transmission Reliability Project	Town: Sudbury
Photo No.: 2	Date: 5/01/2024

Description: View of pump in MH #17. Water appeared mostly clear prior to treatment.
