Weekly Environmental Compliance Summary

Sudbury to Hudson Transmission Reliability Project (USEPA Tracking # MAR1003UW)

Week of: April 29, 2024 to May 4, 2024

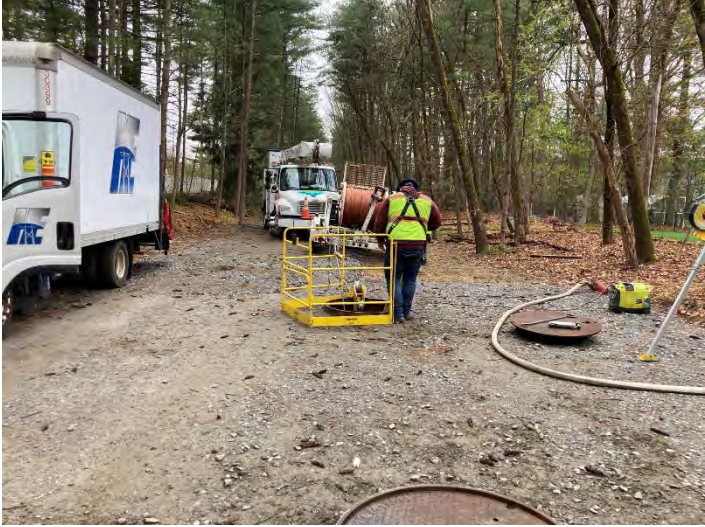
PHOTOGRAPHIC LOG	
Client Name: Eversource		Site Location: Sudbury to Hudson Transmission Reliability Project	Town: Sudbury
Photo No.: 1	Date: 5/01/2024

Description: View of Haugland working at MH #21. Facing west.

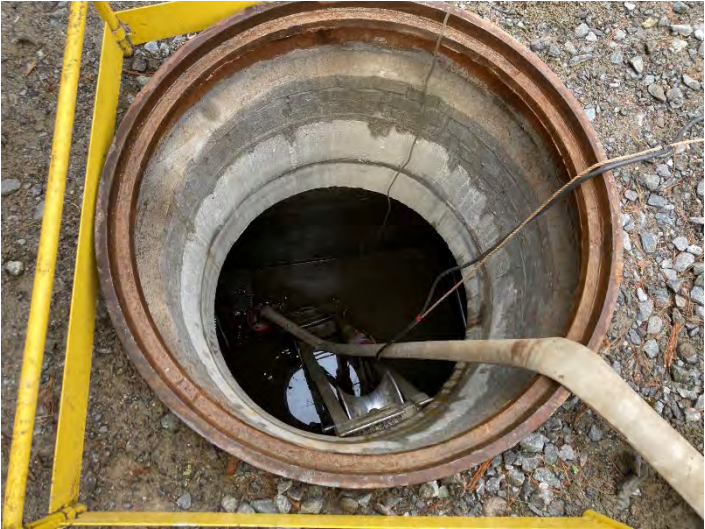
PHOTOGRAPHIC LOG	
Client Name: Eversource		Site Location: Sudbury to Hudson Transmission Reliability Project	Town: Sudbury
Photo No.: 2	Date: 5/01/2024

Description: View of pump in MH #21. Water appeared mostly clear prior to treatment.

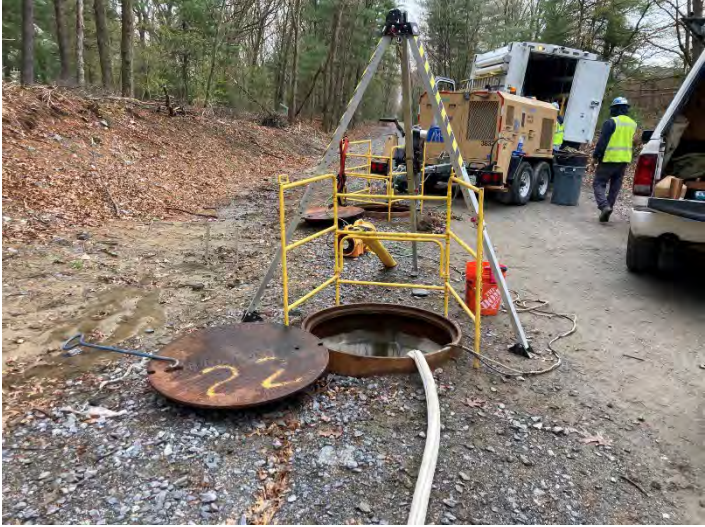
PHOTOGRAPHIC LOG	
Client Name: Eversource		Site Location: Sudbury to Hudson Transmission Reliability Project	Town: Sudbury
Photo No.: 1	Date: 5/01/2024

Description: View of Haugland working at MH #22. Facing east.

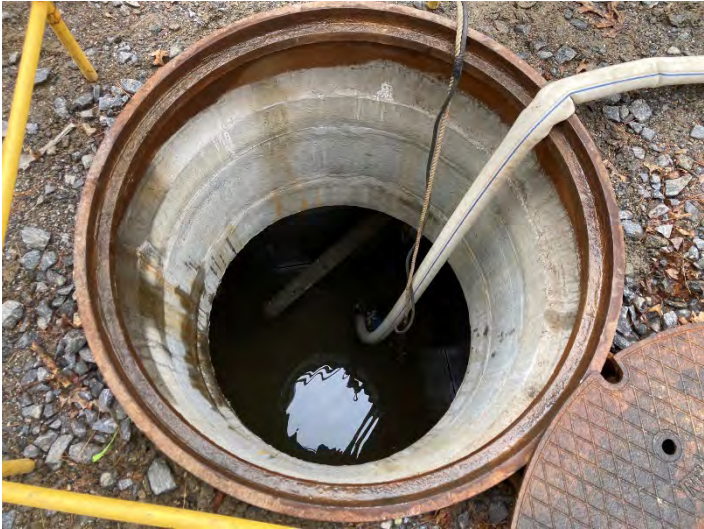
PHOTOGRAPHIC LOG	
Client Name: Eversource		Site Location: Sudbury to Hudson Transmission Reliability Project	Town: Sudbury
Photo No.: 2	Date: 5/01/2024

Description: View of pump in MH #22. Water appeared mostly clear prior to treatment.

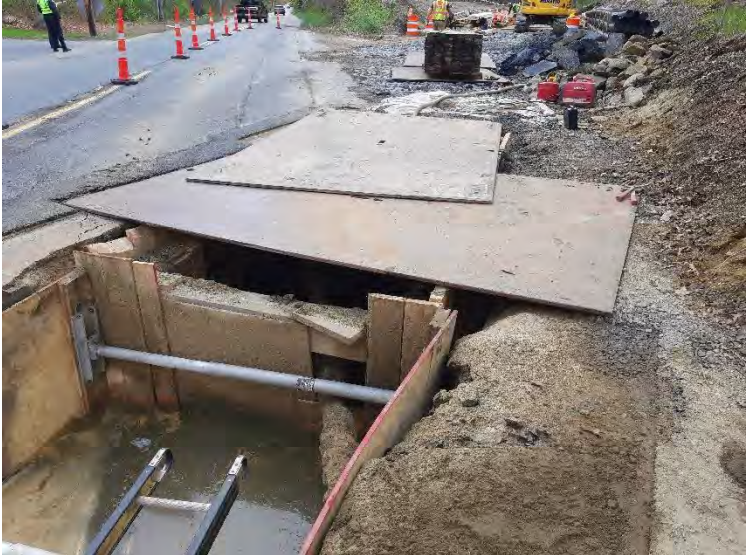
PHOTOGRAPHIC LOG	
Client Name: Eversource		Site Location: Sudbury to Hudson Transmission Reliability Project	
Town: Hudson			
Photo No.: 1	Date: 5/2/2024

Description: View of area being pumped, Wilkins Street trench, near segment 1. Looking eastward.

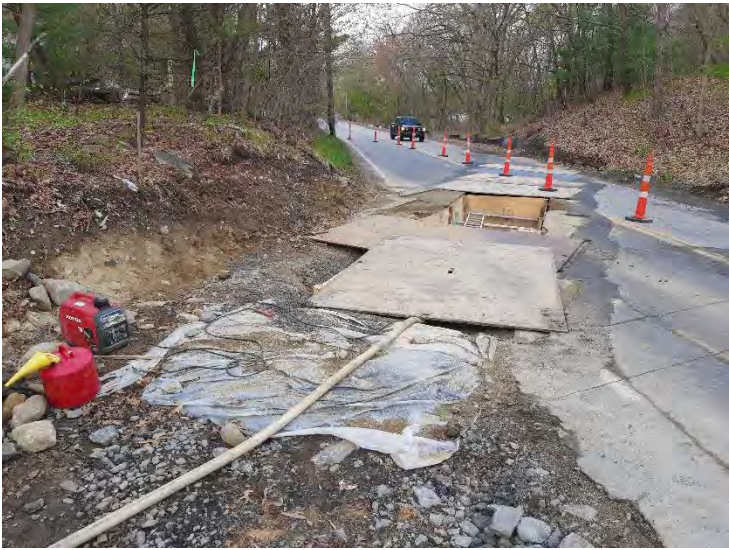
PHOTOGRAPHIC LOG	
Client Name: Eversource		Site Location: Sudbury to Hudson Transmission Reliability Project	
Town: Hudson			
Photo No.: 2	Date: 5/2/2024

Description: Wilkins Street trench work near segment 1. View of dewatering operation. Looking westward.

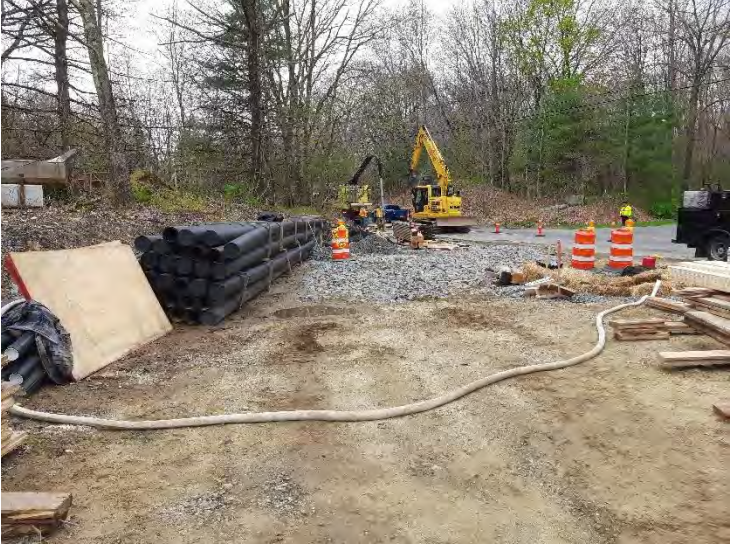
PHOTOGRAPHIC LOG	
Client Name: Eversource		Site Location: Sudbury to Hudson Transmission Reliability Project	
Town: Hudson			
Photo No.: 3	Date: 5/2/2024

Description: Wilkins Street trench work near segment 1. View of dewatering operation. Looking westward.

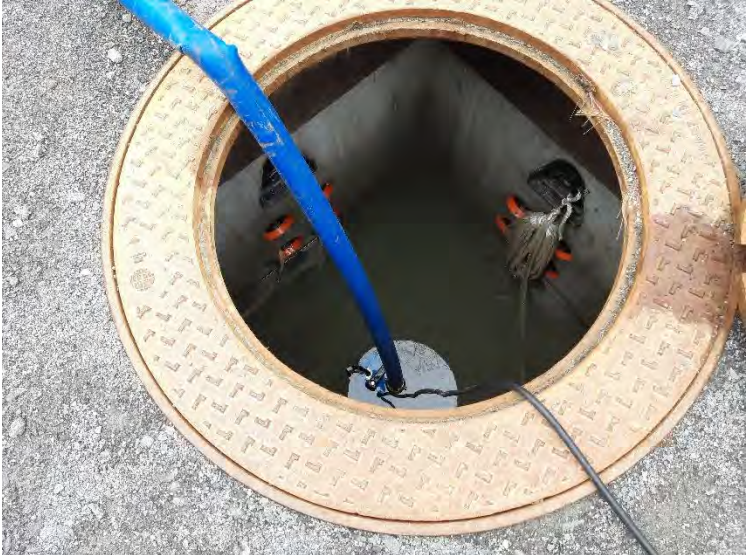
Epsilon <small>ASSOCIATES INC.</small>		PHOTOGRAPHIC LOG	
Client Name: Eversource		Site Location: Sudbury to Hudson Transmission Reliability Project	Town: Hudson
Photo No.: 1	Date: 5/2/2024

Description: View of area being pumped from communications MH #3 in segment 2. Looking southward.

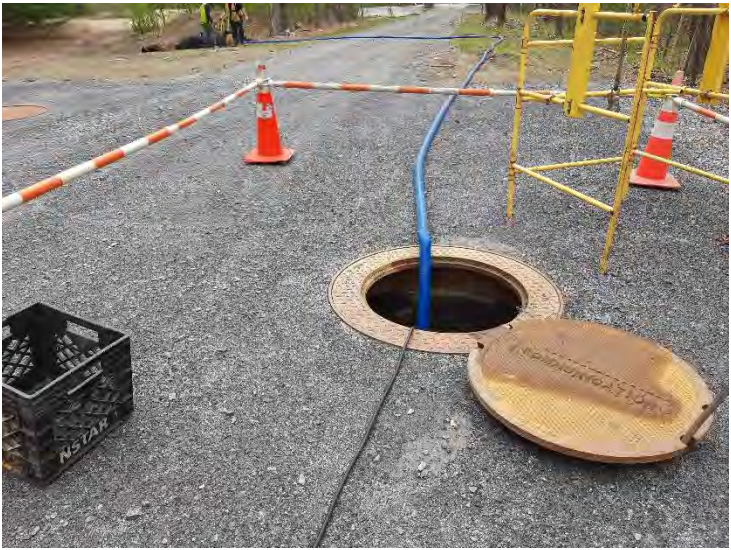
Epsilon <small>ASSOCIATES INC.</small>		PHOTOGRAPHIC LOG	
Client Name: Eversource		Site Location: Sudbury to Hudson Transmission Reliability Project	Town: Hudson
Photo No.: 2	Date: 5/2/2024

Description: Communications MH #3 in segment 2. View of dewatering operation. Looking eastward.

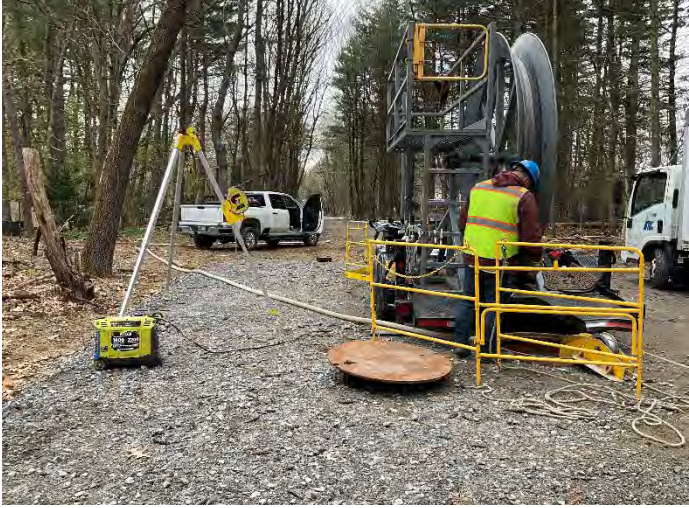
PHOTOGRAPHIC LOG	
Client Name: Eversource		Site Location: Sudbury to Hudson Transmission Reliability Project	
Town: Sudbury			
Photo No.: 1	Date: 5/2/2024

Description: View of Haugland working at MH #21 in segment 10. Facing east.

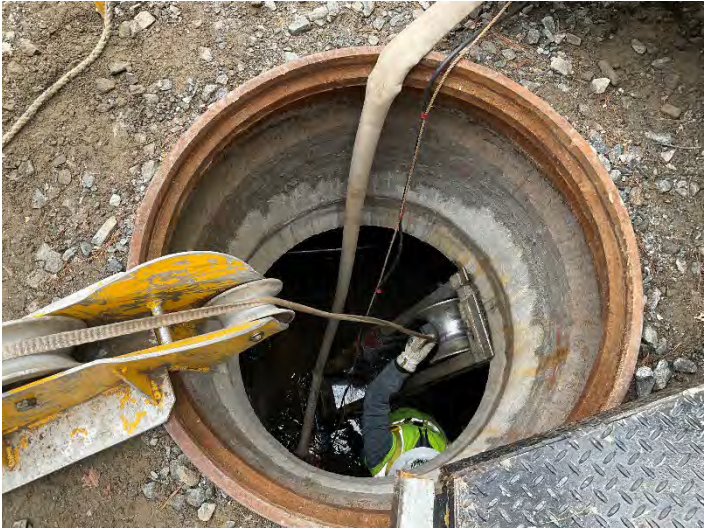
PHOTOGRAPHIC LOG	
Client Name: Eversource		Site Location: Sudbury to Hudson Transmission Reliability Project	
Town: Sudbury			
Photo No.: 2	Date: 5/2/2024

Description: View of pump in MH #21. Water appeared mostly clear prior to treatment.

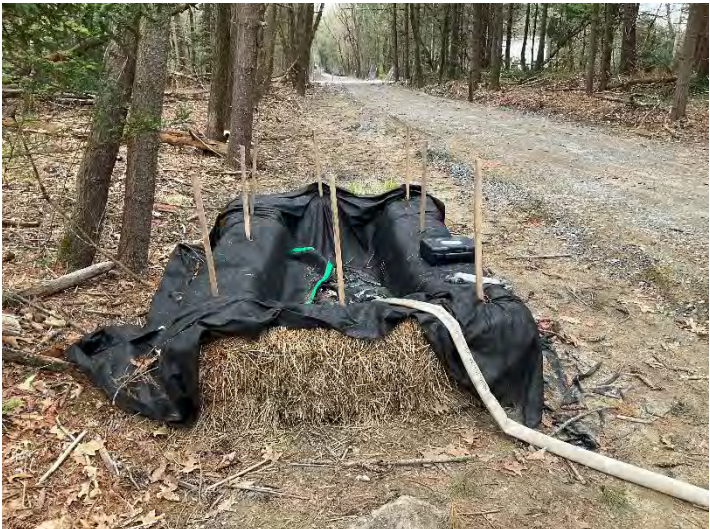
PHOTOGRAPHIC LOG	
Client Name: Eversource		Site Location: Sudbury to Hudson Transmission Reliability Project	Town: Sudbury
Photo No.: 4	Date: 5/2/2024

Description: Another view of dewatering controls (straw bale corral with filter fabric and silt bag). Discharge did not leave the corral and appeared to be clear. No sample was taken. Facing east.

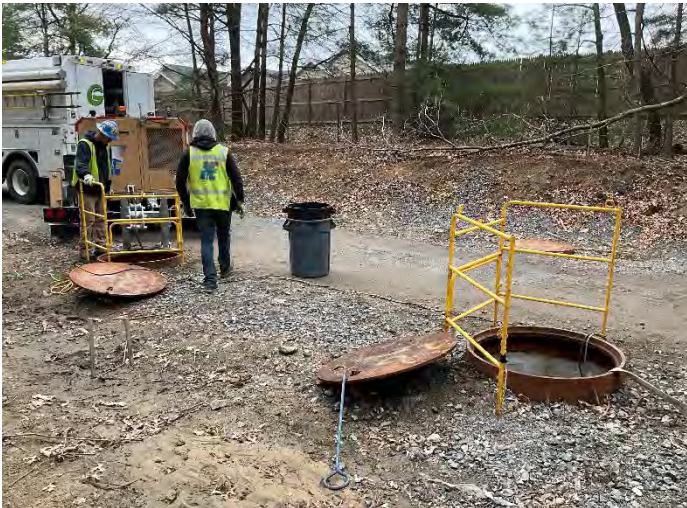
Epsilon <small>ASSOCIATES INC.</small>		PHOTOGRAPHIC LOG	
Client Name: Eversource		Site Location: Sudbury to Hudson Transmission Reliability Project	Town: Sudbury
Photo No.: 1	Date: 5/2/2024

Description: View of Haugland working at MH #22 in segment 11. Facing southeast.

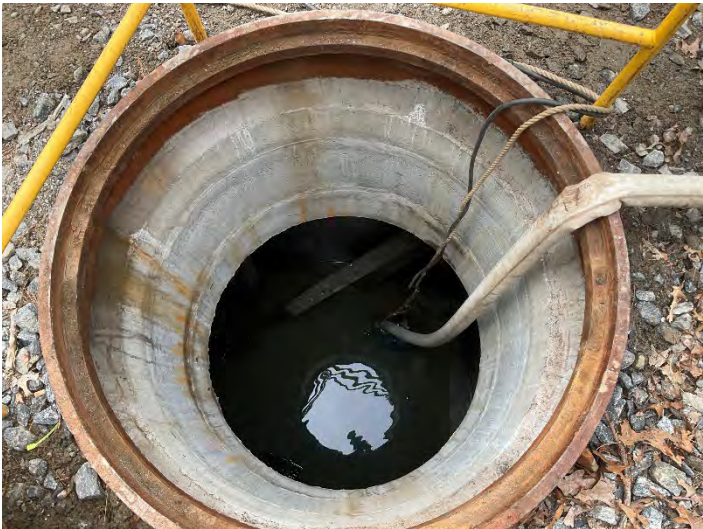
Epsilon <small>ASSOCIATES INC.</small>		PHOTOGRAPHIC LOG	
Client Name: Eversource		Site Location: Sudbury to Hudson Transmission Reliability Project	Town: Sudbury
Photo No.: 2	Date: 5/2/2024

Description: View of pump in MH #22. Water appeared mostly clear prior to treatment.

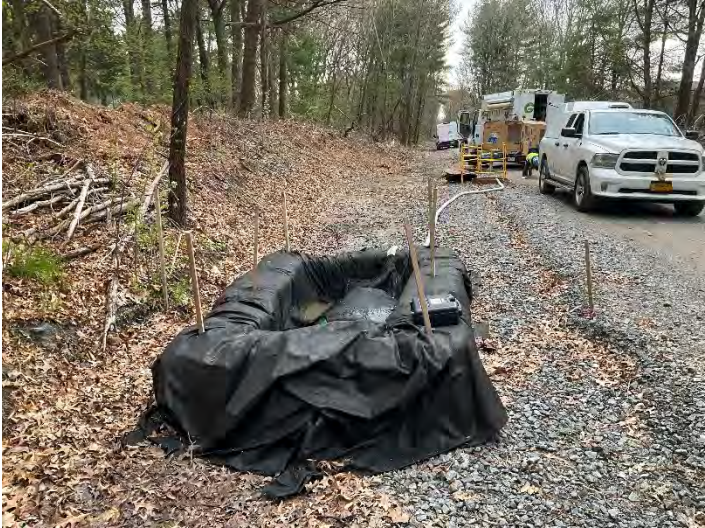
PHOTOGRAPHIC LOG	
Client Name: Eversource		Site Location: Sudbury to Hudson Transmission Reliability Project	Town: Sudbury
Photo No.: 3	Date: 5/2/2024

Description: View of dewatering controls (straw bale corral with filter fabric and silt bag). Facing east.

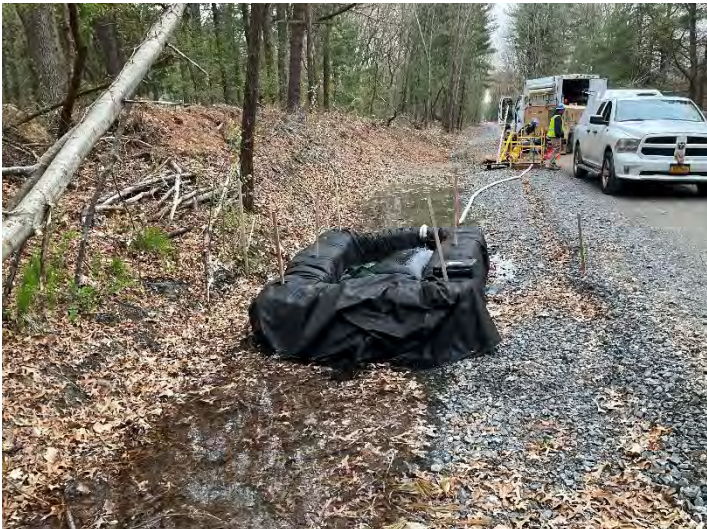
PHOTOGRAPHIC LOG	
Client Name: Eversource		Site Location: Sudbury to Hudson Transmission Reliability Project	Town: Sudbury
Photo No.: 4	Date: 5/2/2024

Description: Another view of dewatering controls (straw bale corral with filter fabric and silt bag) and discharge from corral. Discharge appeared clear and turbidity reading was below 50 NTUs. Discharge did not appear to reach any jurisdictional resource areas. Facing east.

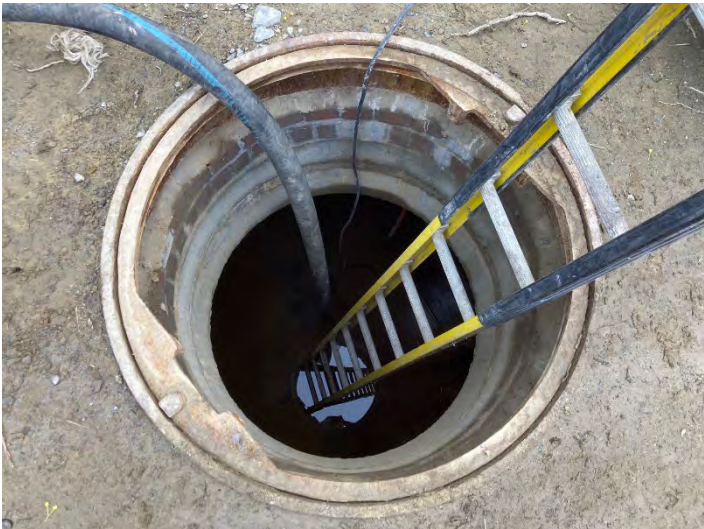
Epsilon <small>ASSOCIATES INC.</small>		PHOTOGRAPHIC LOG	
Client Name: Eversource		Site Location: Sudbury to Hudson Transmission Reliability Project	Town: Sudbury
Photo No.: 2	Date: 5/02/2024

Description: View of pump in MH #28. Water appeared mostly clear prior to treatment.

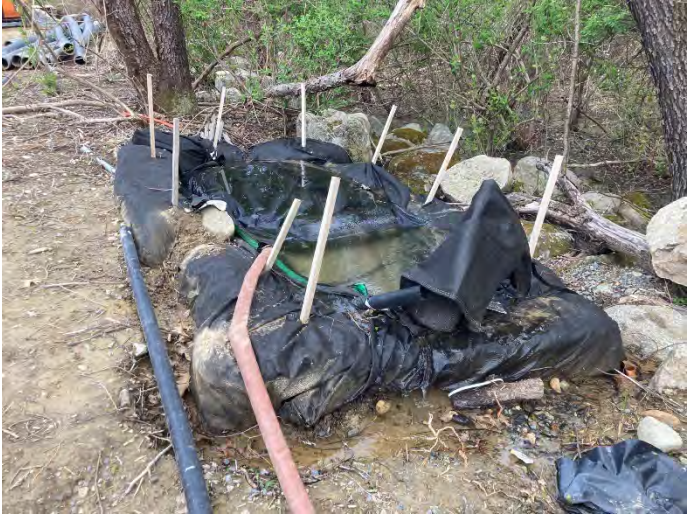
PHOTOGRAPHIC LOG	
Client Name: Eversource		Site Location: Sudbury to Hudson Transmission Reliability Project	Town: Sudbury
Photo No.: 3	Date: 5/02/2024

Description: View of dewatering controls (straw bale corral with filter fabric and silt bag). Facing south.

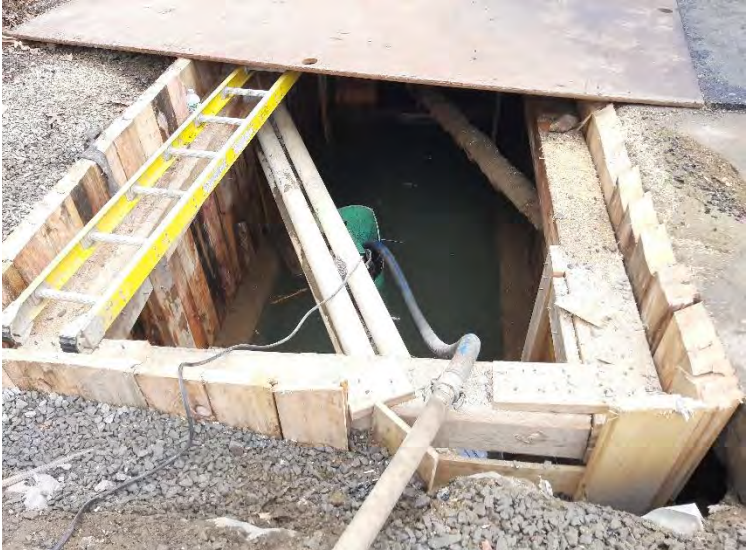
PHOTOGRAPHIC LOG	
Client Name: Eversource		Site Location: Sudbury to Hudson Transmission Reliability Project	Town: Hudson
Photo No.: 1	Date: 5/3/2024

Description: View of area being pumped, Wilkins Street trench, near segment 1. Looking west.

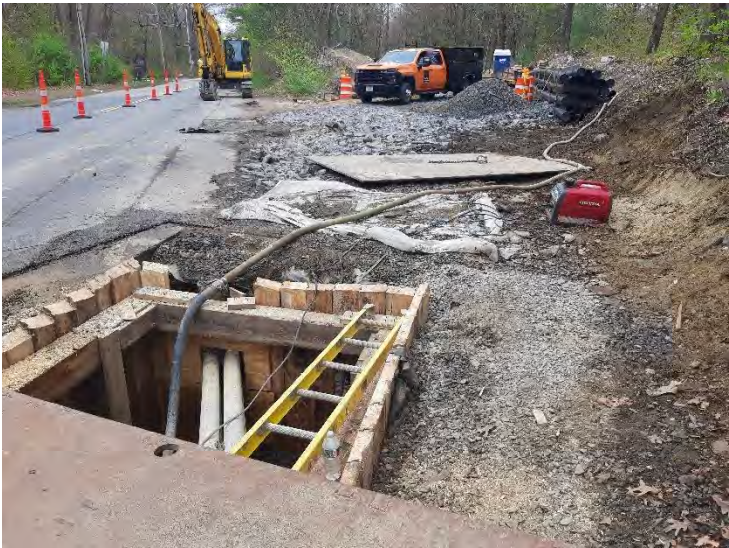
PHOTOGRAPHIC LOG	
Client Name: Eversource		Site Location: Sudbury to Hudson Transmission Reliability Project	Town: Hudson
Photo No.: 2	Date: 5/3/2024

Description: Wilkins Street trench work near segment 1. View of dewatering operation. Looking east.

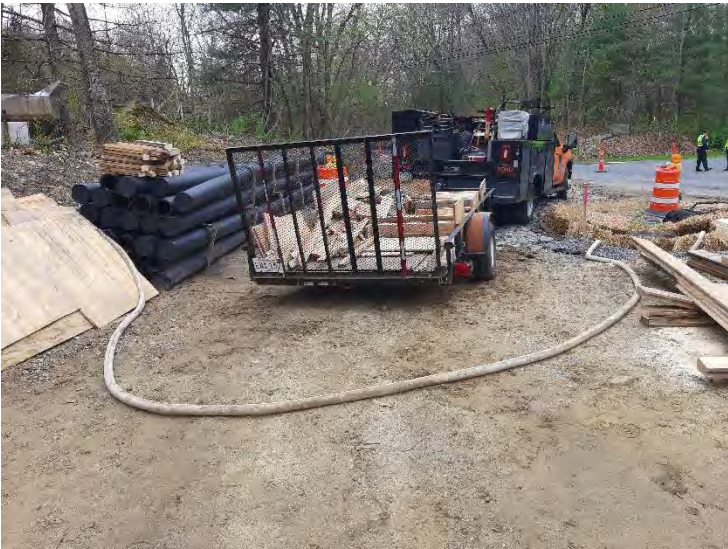
Epsilon <small>ASSOCIATES INC.</small>		PHOTOGRAPHIC LOG	
Client Name: Eversource		Site Location: Sudbury to Hudson Transmission Reliability Project	Town: Hudson
Photo No.: 3	Date: 5/3/2024

Description: Wilkins Street trench work near segment 1. View of dewatering operation. Looking west.

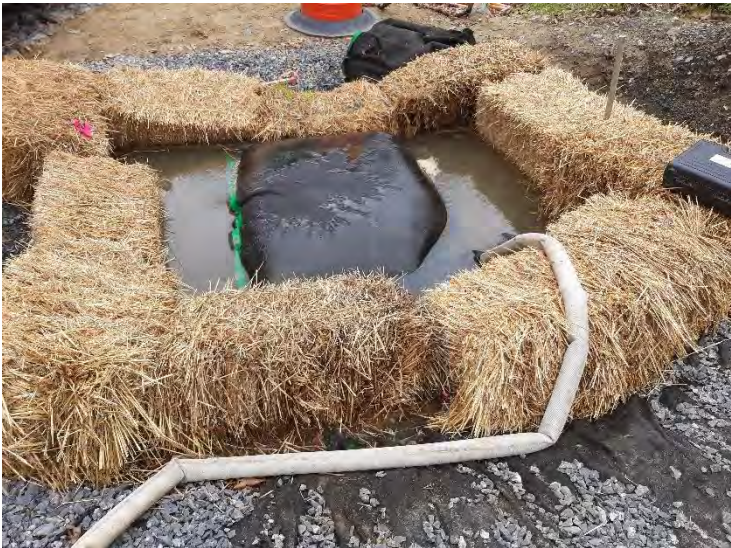
Epsilon <small>ASSOCIATES INC.</small>		PHOTOGRAPHIC LOG	
Client Name: Eversource		Site Location: Sudbury to Hudson Transmission Reliability Project	Town: Hudson
Photo No.: 4	Date: 5/3/2024

Description: Wilkins Street trench work near segment 1. View of discharge bag/corral, looking west. Water discharged to drain below gravel and geotextile layers.

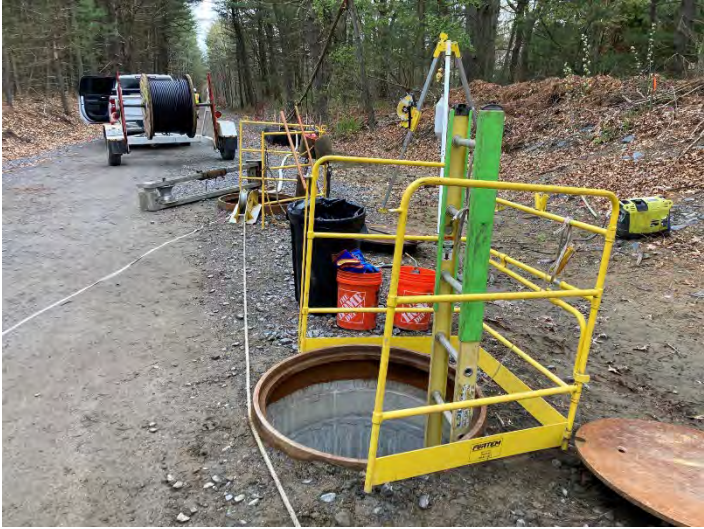
PHOTOGRAPHIC LOG	
Client Name: Eversource		Site Location: Sudbury to Hudson Transmission Reliability Project	Town: Sudbury
Photo No.: 1	Date: 5/03/2024

Description: View of Haugland working at MH #22. Facing west.

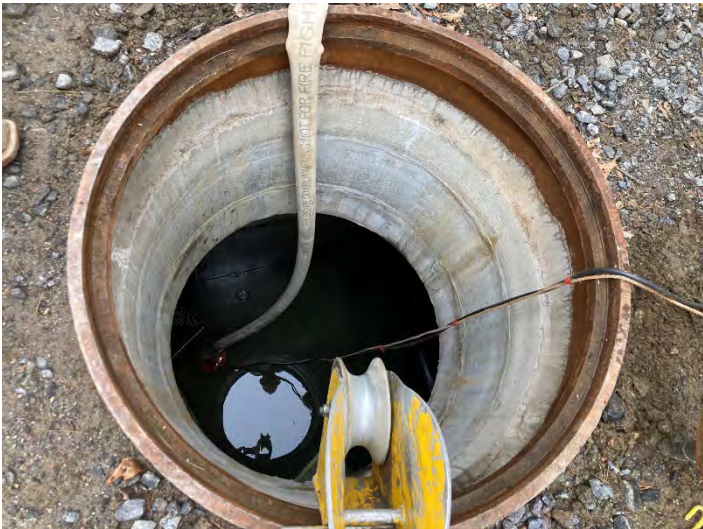
PHOTOGRAPHIC LOG	
Client Name: Eversource		Site Location: Sudbury to Hudson Transmission Reliability Project	Town: Sudbury
Photo No.: 2	Date: 5/03/2024

Description: View of pump in MH #22. Water appeared mostly clear prior to treatment.

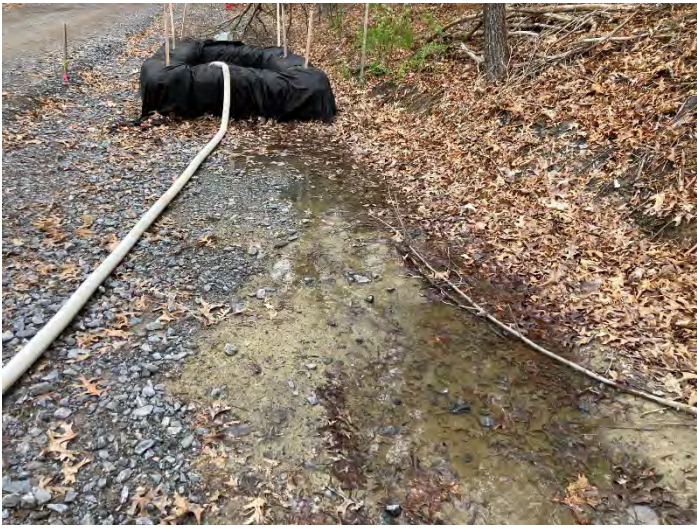
PHOTOGRAPHIC LOG	
Client Name: Eversource		Site Location: Sudbury to Hudson Transmission Reliability Project	Town: Sudbury
Photo No.: 4	Date: 5/03/2024

Description: View of dewatering controls (straw bale corral with filter fabric and silt bag) and discharge from corral. Discharge appeared clear and turbidity was below 50 NTUs. Discharge did not reach any jurisdictional areas. Facing west.

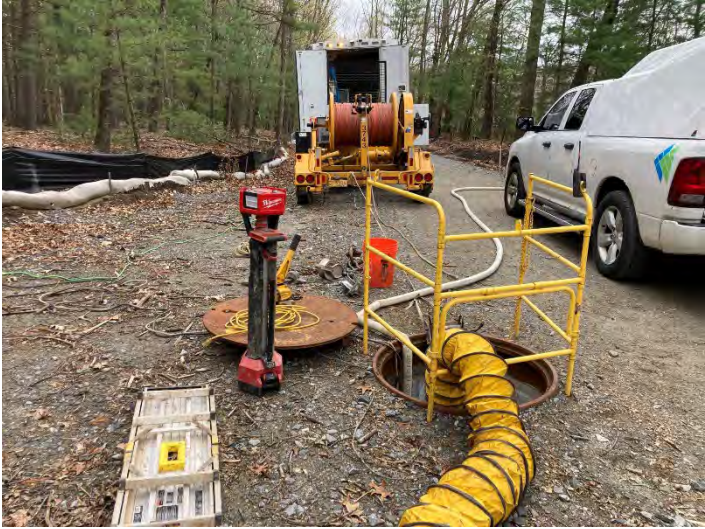
PHOTOGRAPHIC LOG	
Client Name: Eversource		Site Location: Sudbury to Hudson Transmission Reliability Project	Town: Sudbury
Photo No.: 1	Date: 5/03/2024

Description: View of Haugland working at MH #23. Facing east.

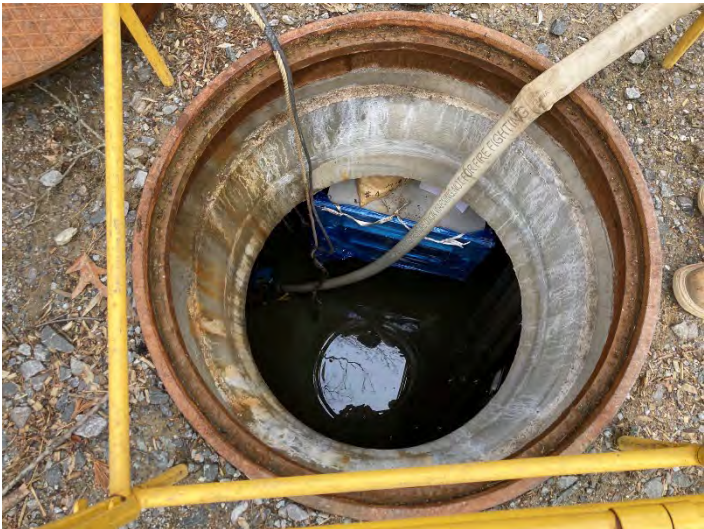
PHOTOGRAPHIC LOG	
Client Name: Eversource		Site Location: Sudbury to Hudson Transmission Reliability Project	Town: Sudbury
Photo No.: 2	Date: 5/03/2024

Description: View of pump in MH #23. Water appeared mostly clear prior to treatment.

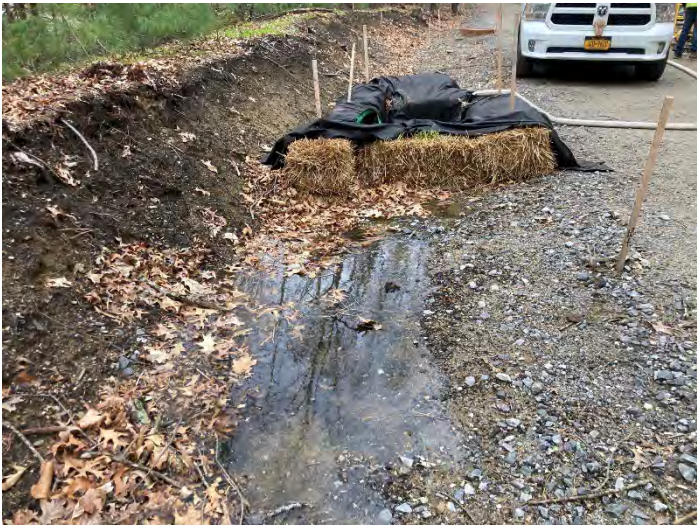
PHOTOGRAPHIC LOG	
Client Name: Eversource		Site Location: Sudbury to Hudson Transmission Reliability Project	Town: Sudbury
Photo No.: 4	Date: 5/03/2024

Description: View of dewatering controls (straw bale corral with filter fabric and silt bag) and discharge from corral. Discharge appeared clear and turbidity was below 50 NTUs. Discharge did not reach any jurisdictional areas. Facing west.

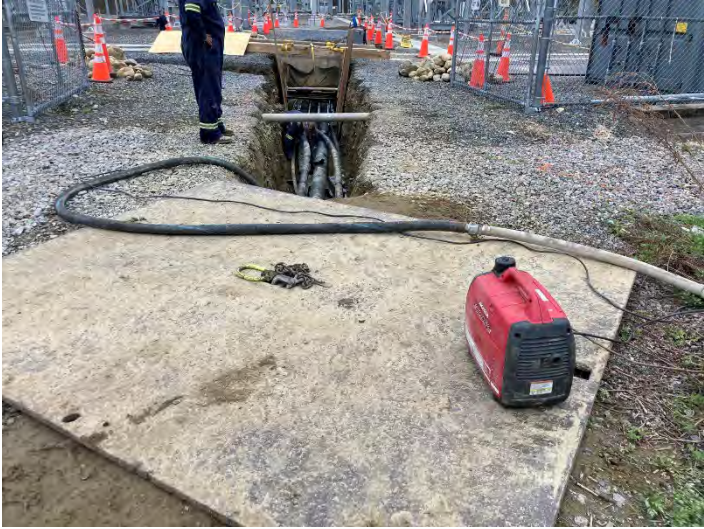
PHOTOGRAPHIC LOG	
Client Name: Eversource		Site Location: Sudbury to Hudson Transmission Reliability Project	Town: Sudbury
Photo No.: 1	Date: 5/03/2024

Description: View of Bond's pumping operation within Sudbury Substation. Facing east.

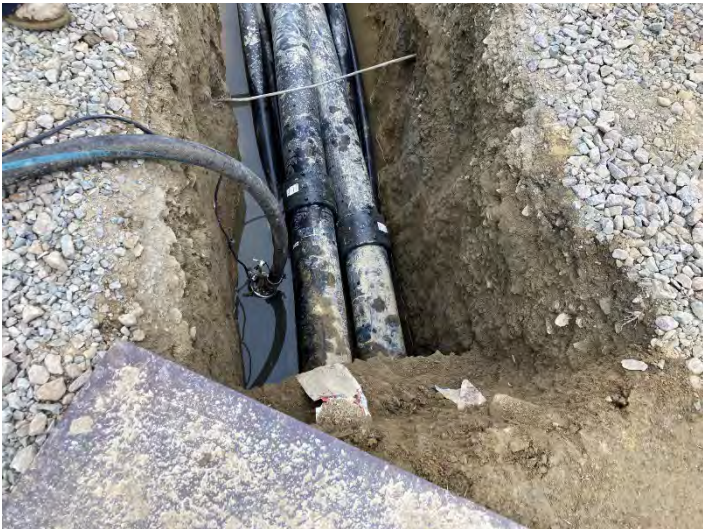
PHOTOGRAPHIC LOG	
Client Name: Eversource		Site Location: Sudbury to Hudson Transmission Reliability Project	Town: Sudbury
Photo No.: 2	Date: 5/03/2024

Description: View of pump in trench. Water appeared slightly turbid prior to treatment.

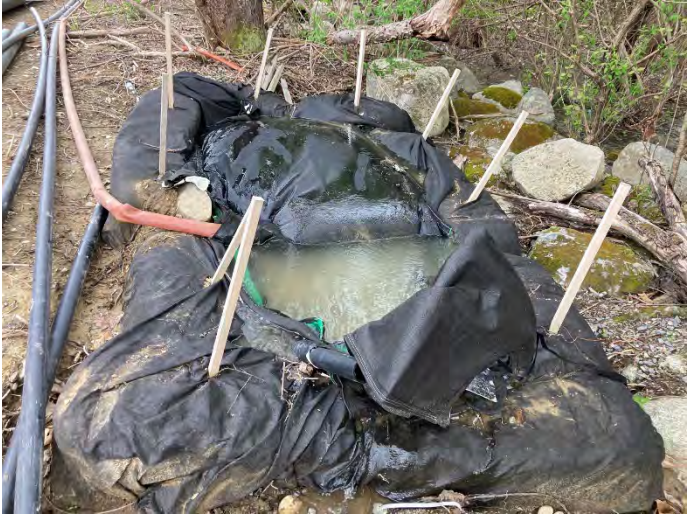
PHOTOGRAPHIC LOG	
Client Name: Eversource		Site Location: Sudbury to Hudson Transmission Reliability Project	
Town: Sudbury			
Photo No.: 3	Date: 5/03/2024

Description: View of dewatering controls (straw bale corral with filter fabric and silt bag). Facing south.

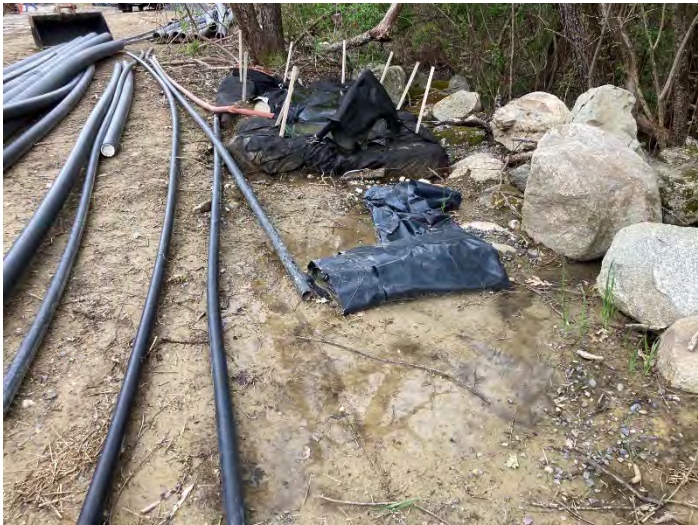
PHOTOGRAPHIC LOG	
Client Name: Eversource		Site Location: Sudbury to Hudson Transmission Reliability Project	
Town: Sudbury			
Photo No.: 4	Date: 5/03/2024

Description: View of dewatering controls (straw bale corral with filter fabric and silt bag) and discharge from corral. Discharge appeared slightly turbid, but turbidity reading was below 50 NTUs. Discharge did not appear to reach any jurisdictional resource areas. Facing south.

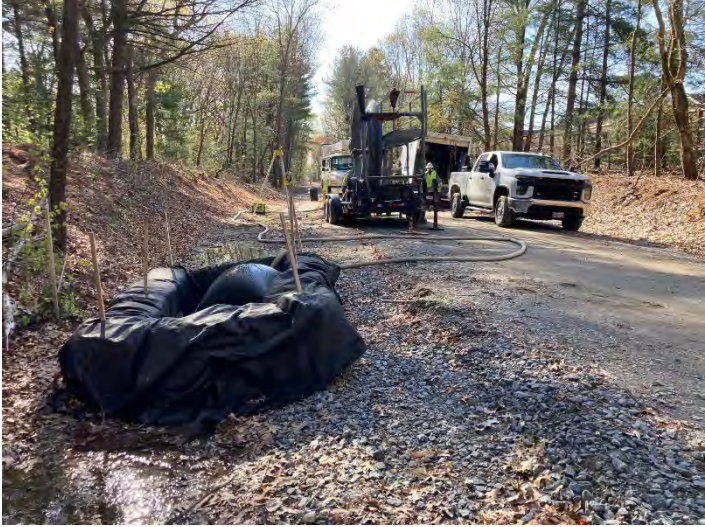
PHOTOGRAPHIC LOG	
Client Name: Eversource		Site Location: Sudbury to Hudson Transmission Reliability Project	Town: Sudbury
Photo No.: 1	Date: 5/04/2024

Description: View of Haugland working at MH #22. Facing east.

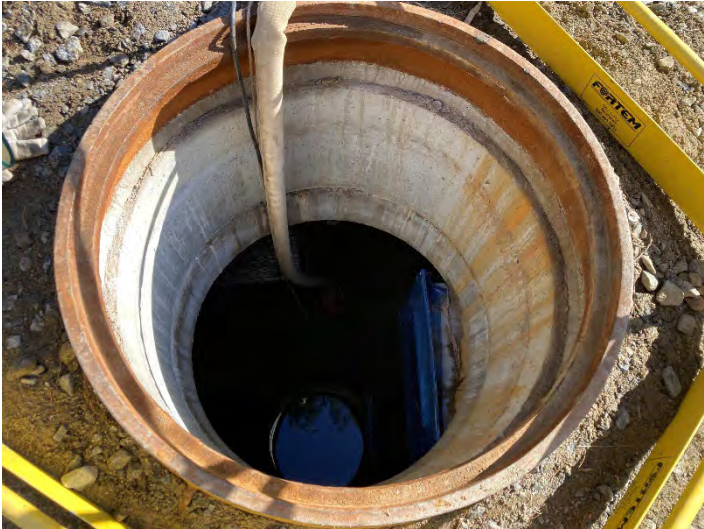
PHOTOGRAPHIC LOG	
Client Name: Eversource		Site Location: Sudbury to Hudson Transmission Reliability Project	Town: Sudbury
Photo No.: 2	Date: 5/04/2024

Description: View of pump in MH #22. Water appeared mostly clear prior to treatment.
