Weekly Environmental Compliance Summary

Sudbury to Hudson Transmission Reliability Project (USEPA Tracking # MAR1003UW)

Sudbury, Hudson, and Stow, MA

Week of: May 13, 2024 to May 18, 2024

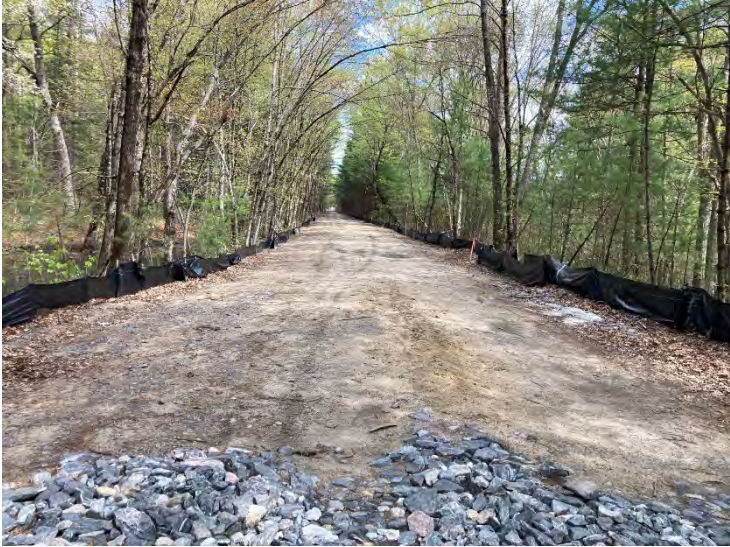
PHOTOGRAPHIC LOG	
Client Name: Eversource		Site Location: Sudbury to Hudson Transmission Reliability Project	Town: Hudson
Photo No.: 5	Date: 5/13/2024

Description: View of segment 6 from entrance at White Pond Rd. Facing east.

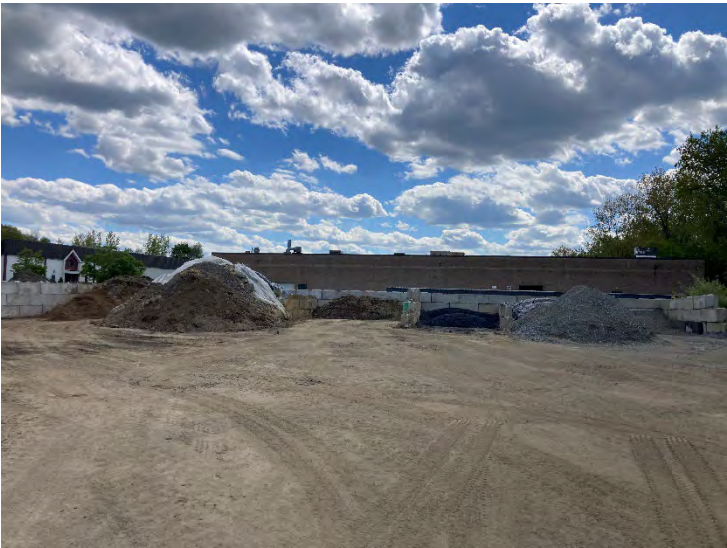
PHOTOGRAPHIC LOG	
Client Name: Eversource		Site Location: Sudbury to Hudson Transmission Reliability Project	Town: Hudson
Photo No.: 6	Date: 5/13/2024

Description: View of Bonazzoli laydown yard. Facing southwest.

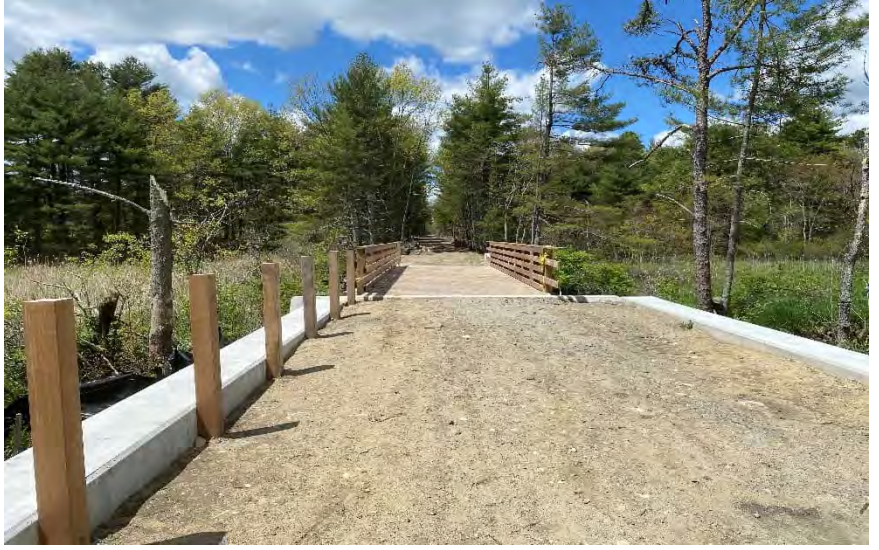
<p>PHOTOGRAPHIC LOG</p>	
<p>Client Name: Eversource</p>		<p>Site Location: Sudbury to Hudson Transmission Reliability Project</p>	<p>Town: Sudbury</p>
<p>Photo No.: 4</p>	<p>Date: 5-13-24</p>

<p>Description:</p> <p>Work area within segment 8, bridge 128, existing erosion control, looking westward.</p>

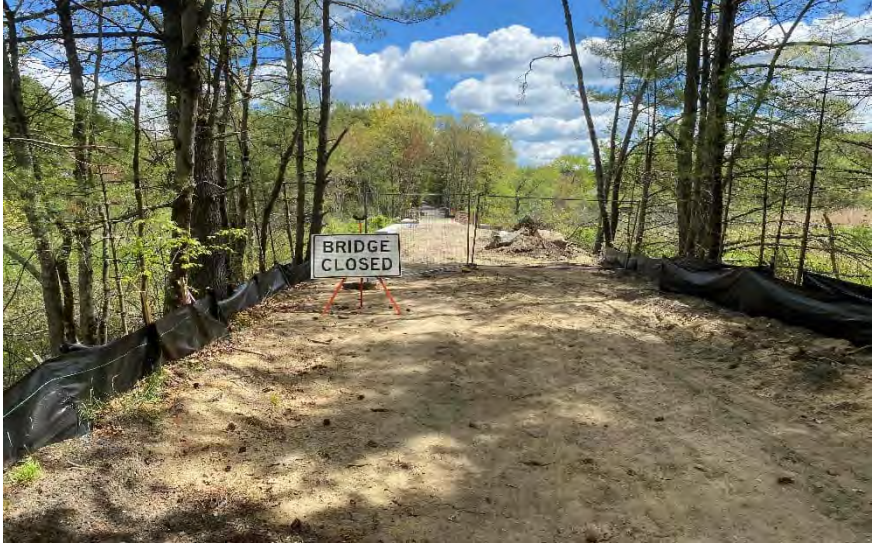
<p>PHOTOGRAPHIC LOG</p>	
<p>Client Name: Eversource</p>		<p>Site Location: Sudbury to Hudson Transmission Reliability Project</p>	<p>Town: Sudbury</p>
<p>Photo No.: 5</p>	<p>Date: 5-13-24</p>

<p>Description:</p> <p>Work area within Segment 7, existing erosion control, looking eastward.</p>

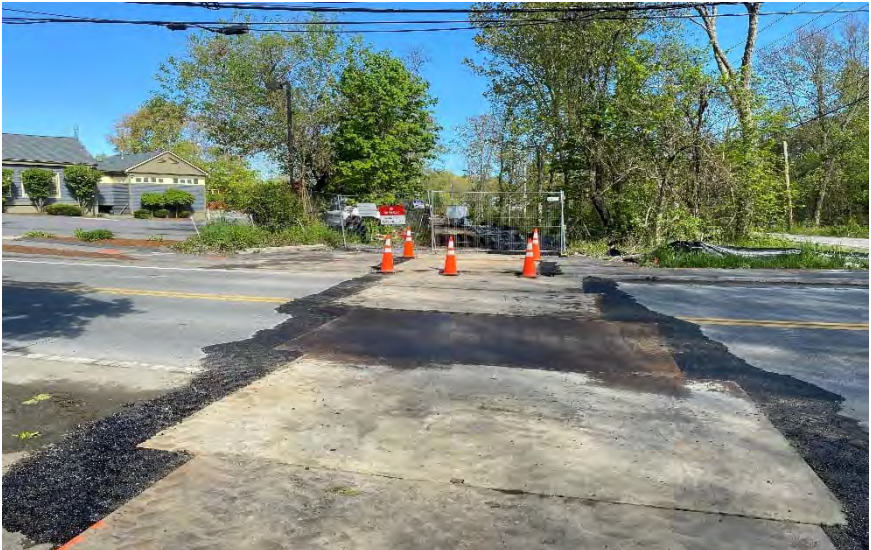
<p>PHOTOGRAPHIC LOG</p>	
<p>Client Name: Eversource</p>		<p>Site Location: Sudbury to Hudson Transmission Reliability Project</p>	<p>Town: Sudbury</p>
<p>Photo No.: 7</p>	<p>Date: 5-13-24</p>

<p>Description:</p> <p>Work area at Boston Post Road (conduit work performed at night), looking westward.</p>

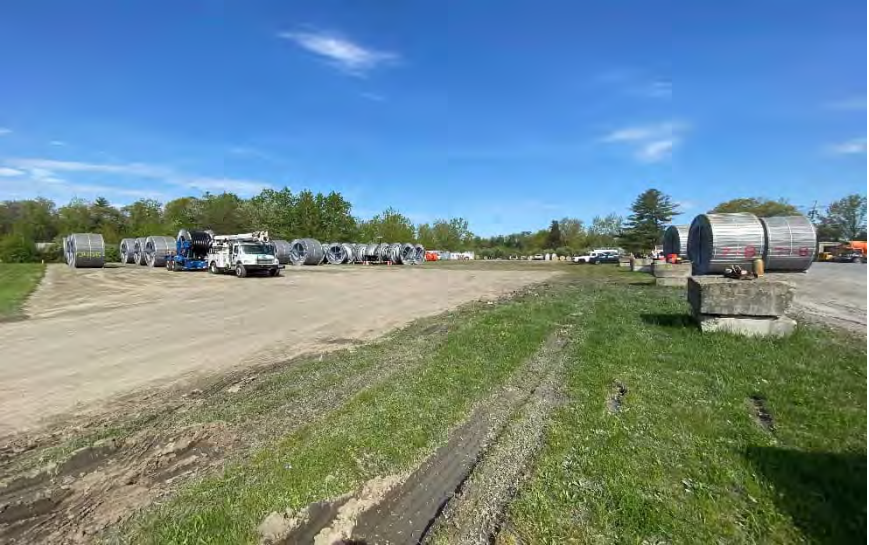
<p align="center">PHOTOGRAPHIC LOG</p>	
<p>Client Name: Eversource</p>		<p>Site Location: Sudbury to Hudson Transmission Reliability Project</p>	<p>Town: Hudson</p>
<p>Photo No.: 1</p>	<p>Date: 5-14-24</p>

<p>Description:</p> <p>Work area within Haugland laydown yard, stored cable on reels, looking eastward.</p>

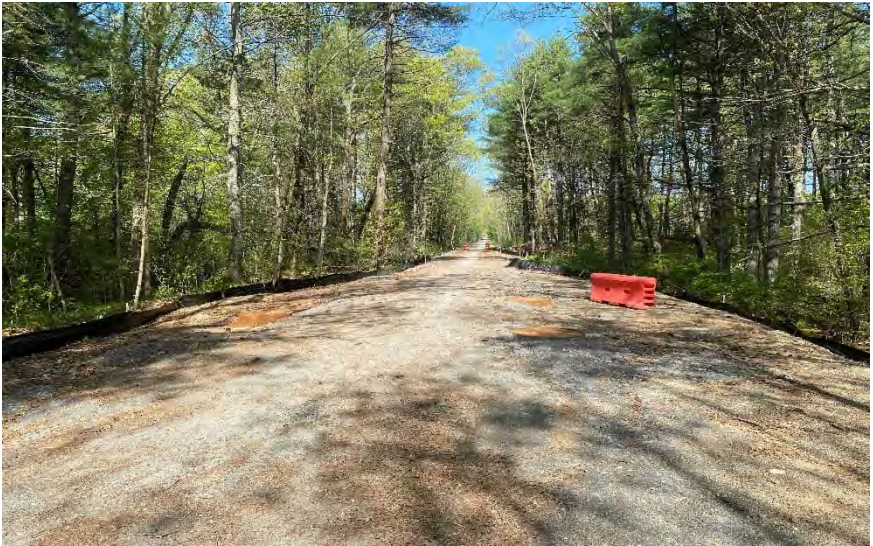
<p>PHOTOGRAPHIC LOG</p>	
<p>Client Name: Eversource</p>		<p>Site Location: Sudbury to Hudson Transmission Reliability Project</p>	<p>Town: Hudson</p>
<p>Photo No.: 4</p>	<p>Date: 5-14-24</p>

<p>Description:</p> <p>Work area within segment 5, manhole #13, existing erosion control, looking westward.</p>

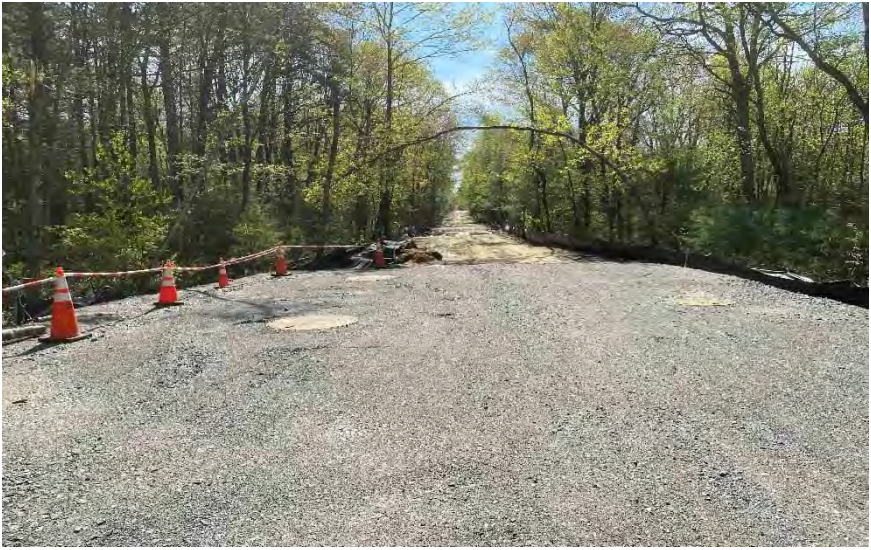
<p>PHOTOGRAPHIC LOG</p>	
<p>Client Name: Eversource</p>		<p>Site Location: Sudbury to Hudson Transmission Reliability Project</p>	<p>Town: Hudson</p>
<p>Photo No.: 5</p>	<p>Date: 5-14-24</p>

<p>Description:</p> <p>Work area within segment 6, manhole #14, existing erosion control, looking eastward.</p>

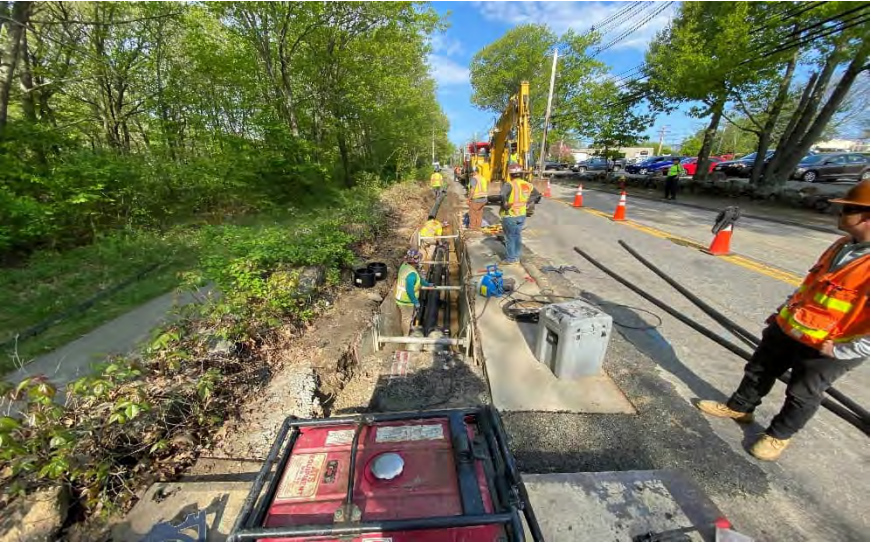
<p>PHOTOGRAPHIC LOG</p>	
<p>Client Name: Eversource</p>		<p>Site Location: Sudbury to Hudson Transmission Reliability Project</p>	<p>Town: Hudson</p>
<p>Photo No.: 6</p>	<p>Date: 5-14-24</p>

<p>Description:</p> <p>Work area within Forest Avenue, conduit work, looking southward.</p>

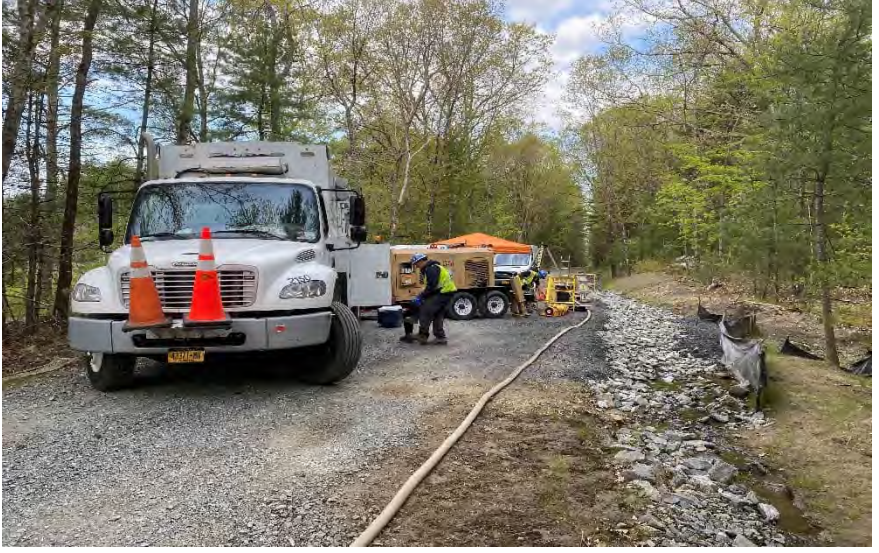
PHOTOGRAPHIC LOG	
Client Name: Eversource		Site Location: Sudbury to Hudson Transmission Reliability Project	
Photo No.: 7 Date: 5-14-24

Description: Work area within segment 5 at manhole #12, wire pulling work, looking westward.

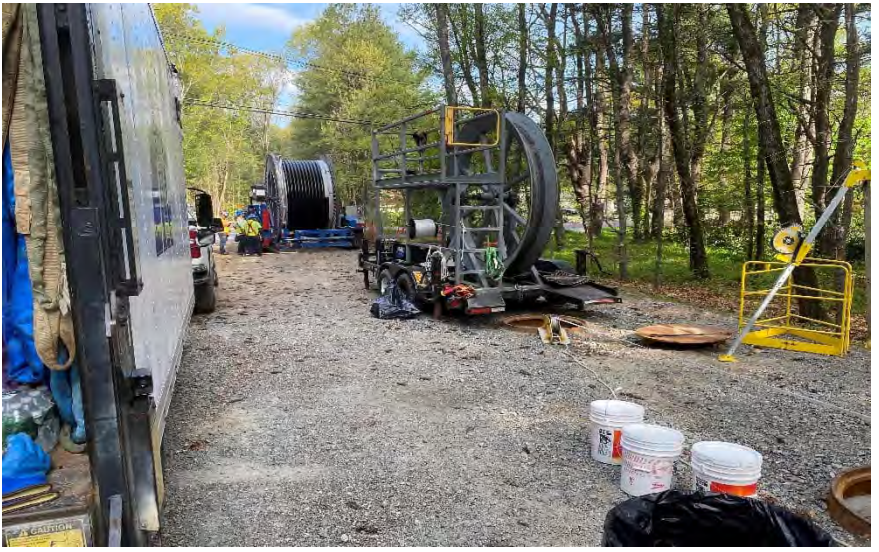
PHOTOGRAPHIC LOG	
Client Name: Eversource		Site Location: Sudbury to Hudson Transmission Reliability Project	
Photo No.: 8 Date: 5-14-24

Description: Work area within segment 5 at manhole #11, wire pulling work, looking westward.

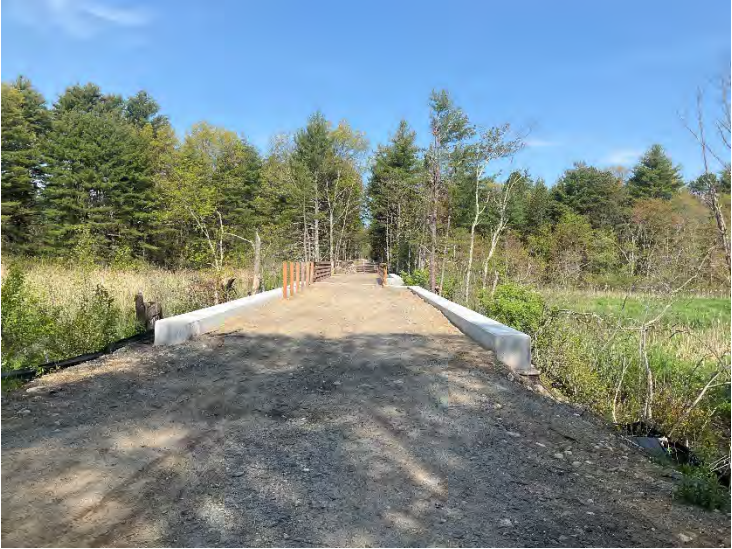
Epsilon ASSOCIATES INC.		PHOTOGRAPHIC LOG	
Client Name: Eversource		Site Location: Sudbury to Hudson Transmission Reliability Project	Town: Sudbury
Photo No.: 1	Date: 5/14/2024

Description: View of bridge 128. Facing west.

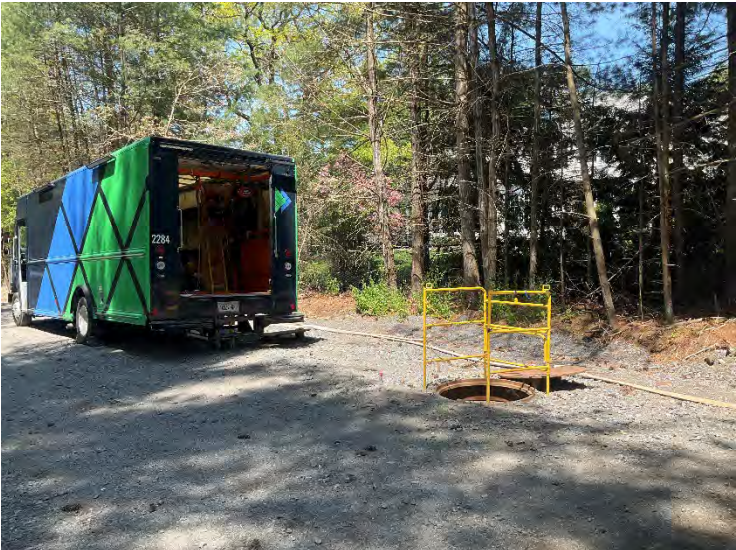
Epsilon ASSOCIATES INC.		PHOTOGRAPHIC LOG	
Client Name: Eversource		Site Location: Sudbury to Hudson Transmission Reliability Project	Town: Sudbury
Photo No.: 2	Date: 5/14/2024

Description: View of Haugland splicing crew working at MH #18 in segment 9. Facing north.

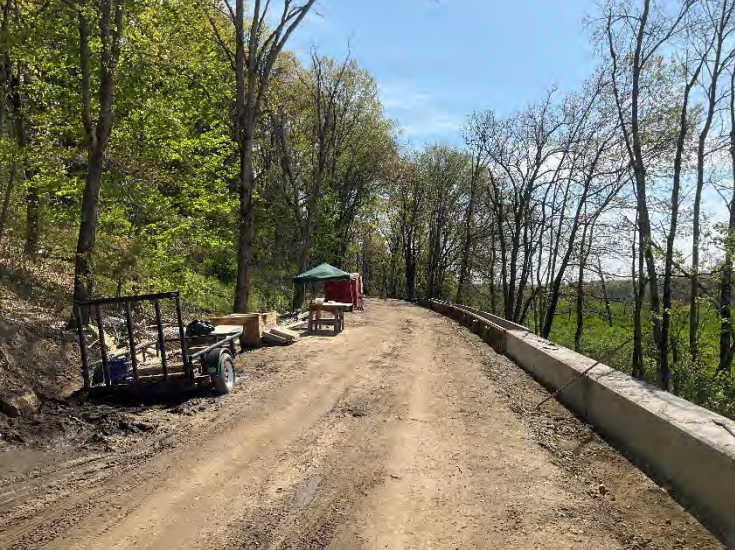
PHOTOGRAPHIC LOG	
Client Name: Eversource		Site Location: Sudbury to Hudson Transmission Reliability Project	Town: Sudbury
Photo No.: 4	Date: 5/14/2024

Description: View of ET&L work area in segment 14 at sheetwall 13. Facing east.

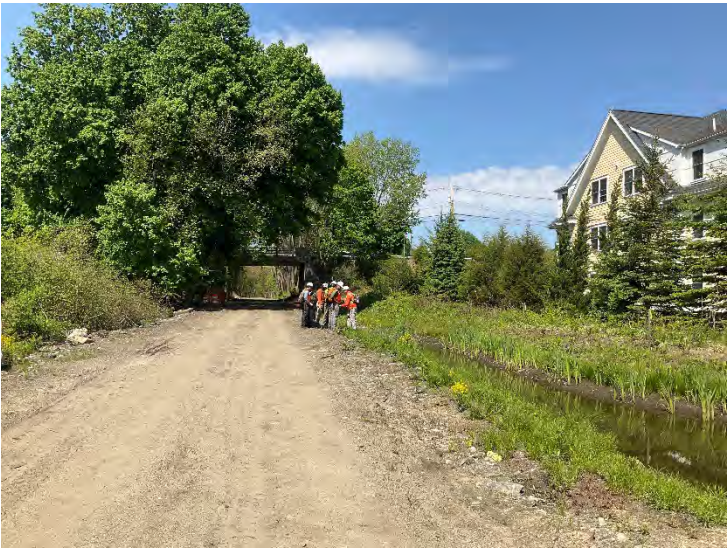
PHOTOGRAPHIC LOG	
Client Name: Eversource		Site Location: Sudbury to Hudson Transmission Reliability Project	Town: Sudbury
Photo No.: 6	Date: 5/14/2024

Description: View of SWCA removing invasive plant species in segment 14. Facing west.

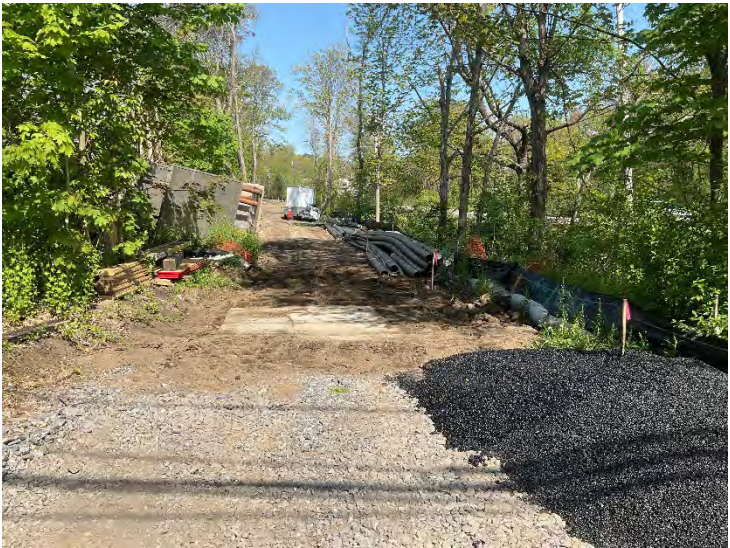
PHOTOGRAPHIC LOG	
Client Name: Eversource		Site Location: Sudbury to Hudson Transmission Reliability Project	Town: Sudbury
Photo No.: 8	Date: 5/14/2024

Description: View of construction entrance to segment 12. Facing northwest.

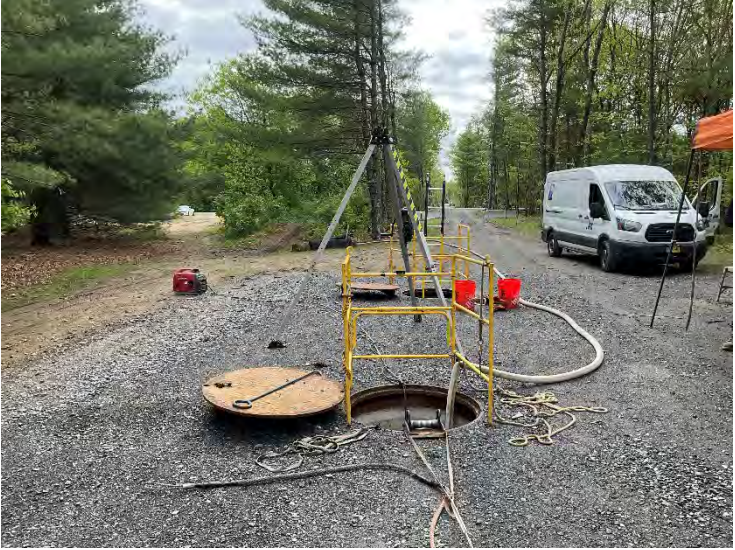
<p align="center">PHOTOGRAPHIC LOG</p>	
<p>Client Name: Eversource</p>		<p>Site Location: Sudbury to Hudson Transmission Reliability Project</p>	<p>Town: Hudson</p>
<p>Photo No.: 1</p>	<p>Date: 5-17-24</p>

<p>Description:</p> <p>View of Haugland work area at manhole (MH) #7 in segment 2. See additional dewatering inspection reports. Facing east.</p>

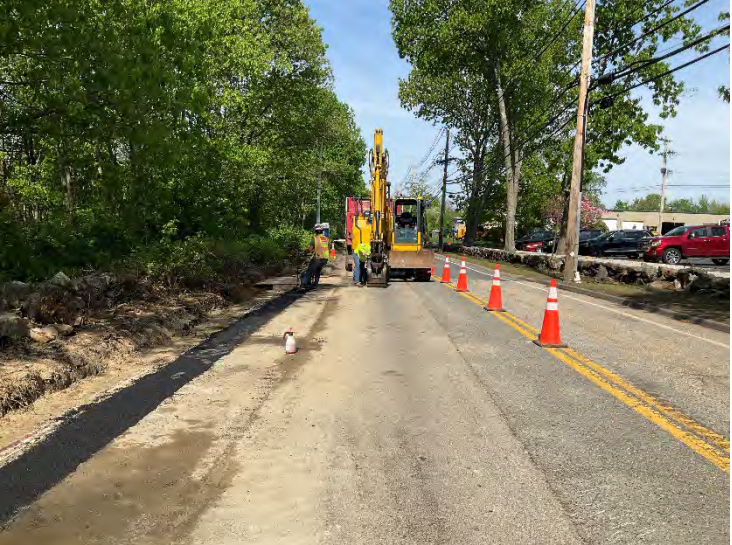
PHOTOGRAPHIC LOG	
Client Name: Eversource		Site Location: Sudbury to Hudson Transmission Reliability Project	Town: Hudson
Photo No.: 3	Date: 5-17-24

Description: View of Bond working in Forest Ave near MH #2 paving. Facing west.

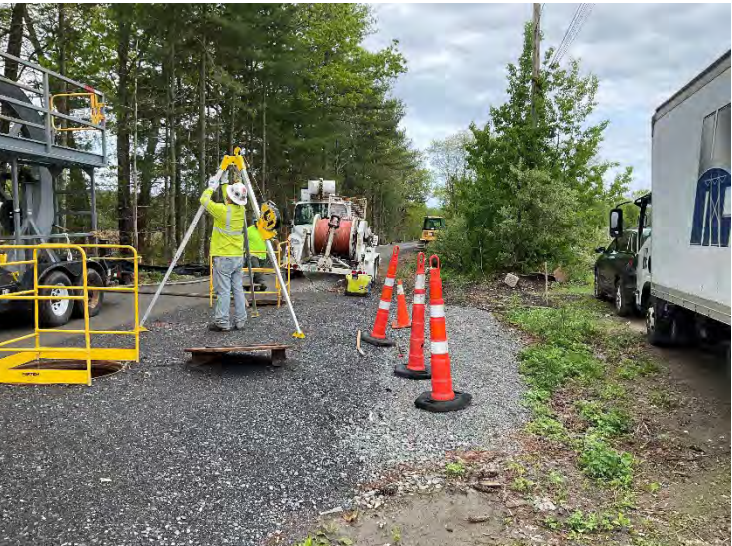
PHOTOGRAPHIC LOG	
Client Name: Eversource		Site Location: Sudbury to Hudson Transmission Reliability Project	Town: Hudson
Photo No.: 4	Date: 5-17-24

Description: View of Haugland working in segment 3 at MH #8. Facing west.

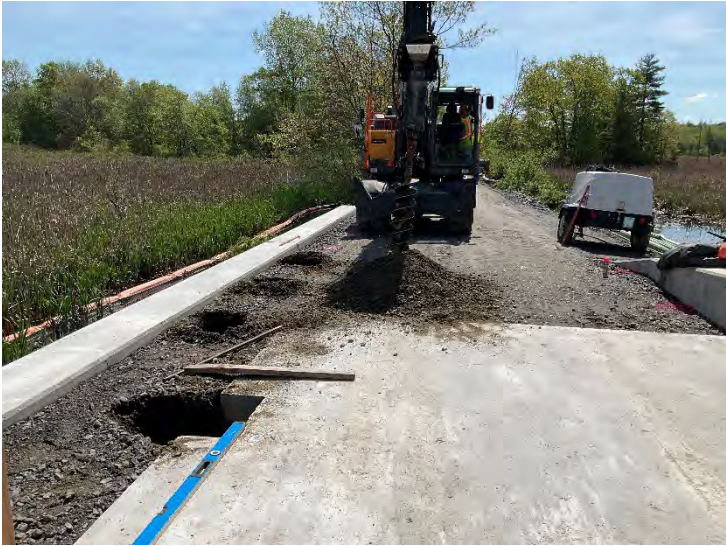
<p align="center">PHOTOGRAPHIC LOG</p>	
<p>Client Name: Eversource</p>		<p>Site Location: Sudbury to Hudson Transmission Reliability Project</p>	<p>Town: Hudson</p>
<p>Photo No.: 5</p>	<p>Date: 5-17-24</p>

<p>Description:</p> <p>View of ET&L working at Bridge 130 drilling fence post holes. Facing east.</p>

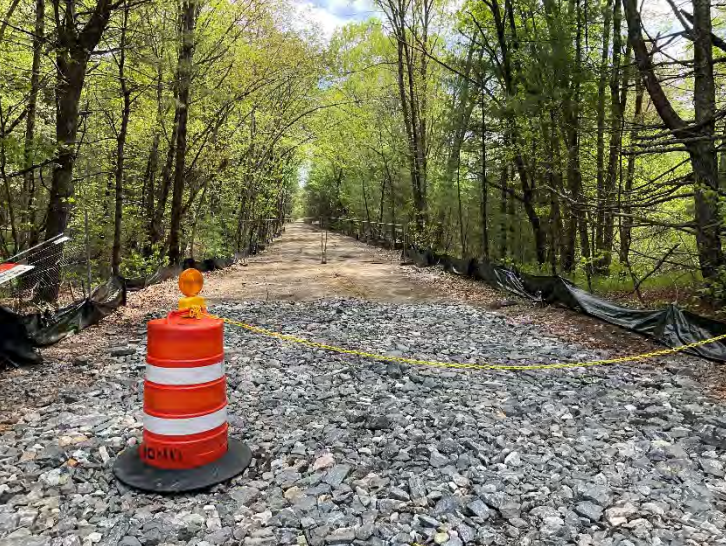
<p align="center">PHOTOGRAPHIC LOG</p>	
<p>Client Name: Eversource</p>		<p>Site Location: Sudbury to Hudson Transmission Reliability Project</p>	<p>Town: Hudson</p>
<p>Photo No.: 6</p>	<p>Date: 5-17-24</p>

<p>Description:</p> <p>View of construction entrance to segment 6. Facing east.</p>

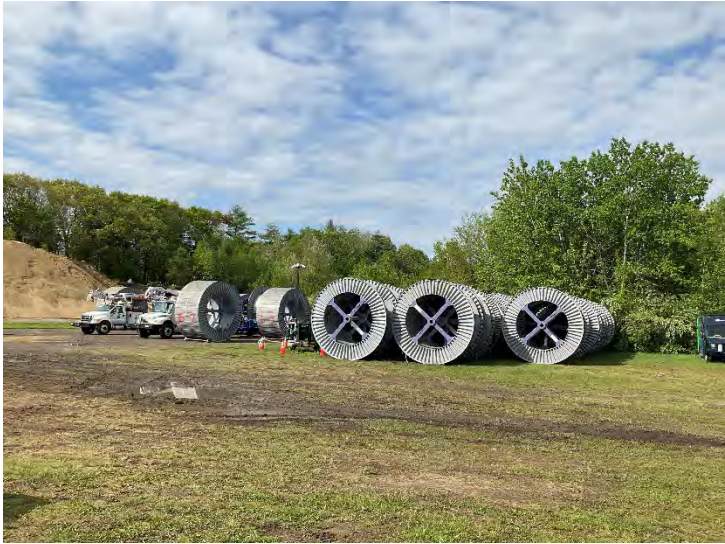
<p>PHOTOGRAPHIC LOG</p>	
<p>Client Name: Eversource</p>		<p>Site Location: Sudbury to Hudson Transmission Reliability Project</p>	<p>Town: Hudson</p>
<p>Photo No.: 7</p>	<p>Date: 5-17-24</p>

<p>Description: View of Haugland laydown yard. Facing southwest.</p>

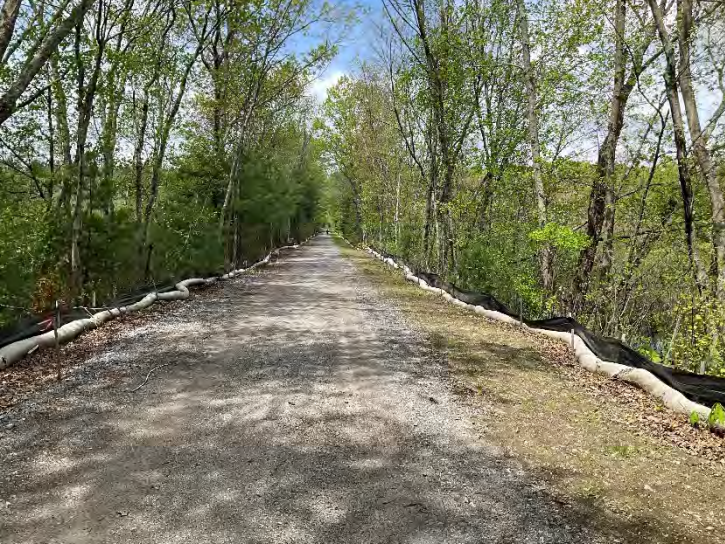
<p>PHOTOGRAPHIC LOG</p>	
<p>Client Name: Eversource</p>		<p>Site Location: Sudbury to Hudson Transmission Reliability Project</p>	<p>Town: Hudson</p>
<p>Photo No.: 8</p>	<p>Date: 5-17-24</p>

<p>Description: View of E&S controls in segment 5. Facing west.</p>

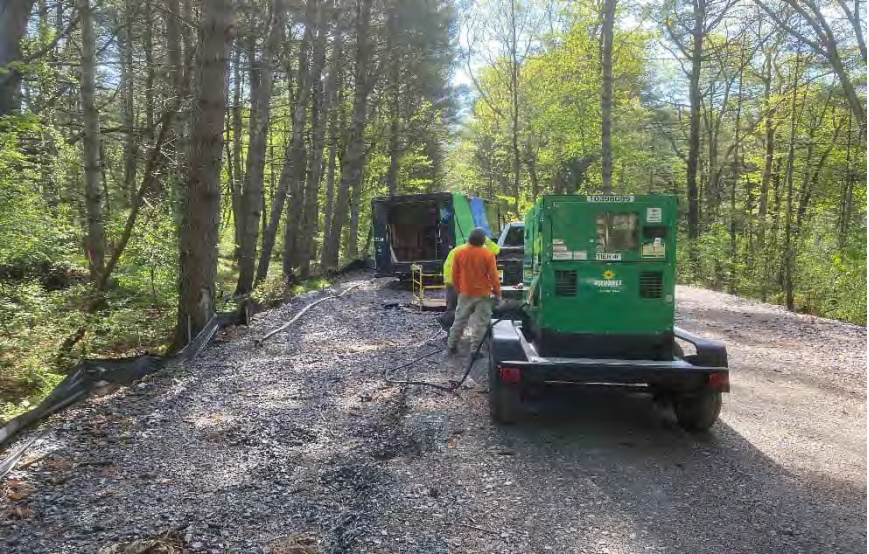
<p align="center">PHOTOGRAPHIC LOG</p>	
<p>Client Name: Eversource</p>		<p>Site Location: Sudbury to Hudson Transmission Reliability Project</p>	<p>Town: Sudbury</p>
<p>Photo No.: 1</p>	<p>Date: 5-17-24</p>

<p>Description:</p> <p>Work area within Segment 9, Haugland conducting splicing within handhole #19, existing erosion control, looking westward.</p>

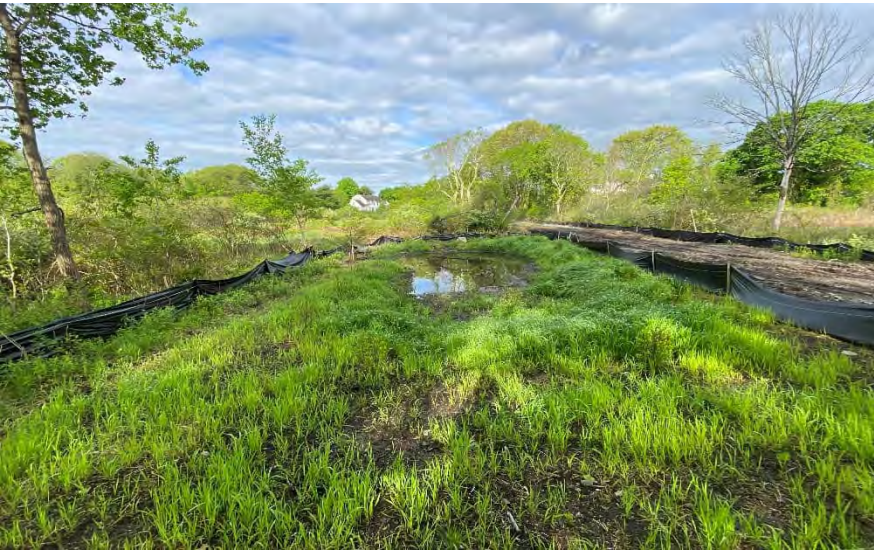
<p align="center">PHOTOGRAPHIC LOG</p>	
<p>Client Name: Eversource</p>		<p>Site Location: Sudbury to Hudson Transmission Reliability Project</p>	<p>Town: Sudbury</p>
<p>Photo No.: 2</p>	<p>Date: 5-17-24</p>

<p>Description:</p> <p>Work area within segment 14, Wetland replication area, existing erosion control, looking westward.</p>

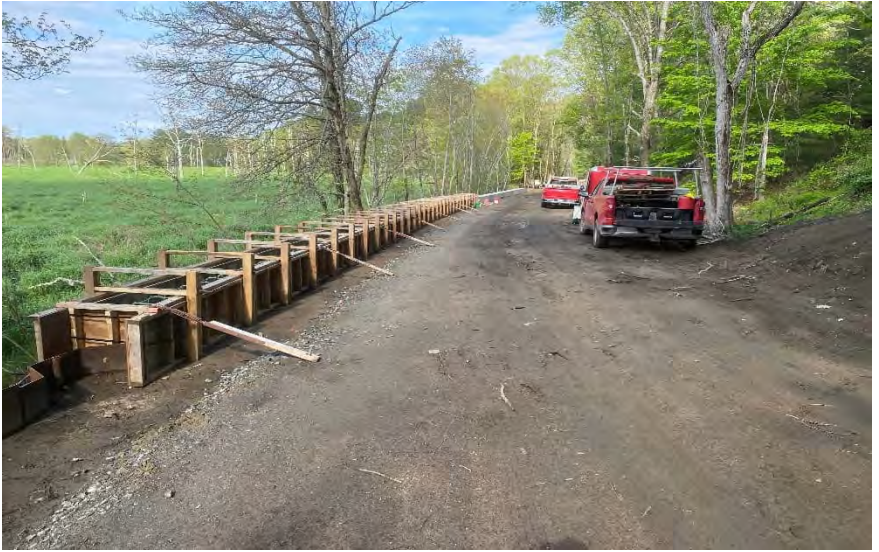
<p>PHOTOGRAPHIC LOG</p>	
<p>Client Name: Eversource</p>		<p>Site Location: Sudbury to Hudson Transmission Reliability Project</p>	<p>Town: Sudbury</p>
<p>Photo No.: 3</p>	<p>Date: 5-17-24</p>

<p>Description:</p> <p>Work area within segment 14, ET&L adding concrete capping to sheeting wall 13, existing erosion control, looking westward.</p>

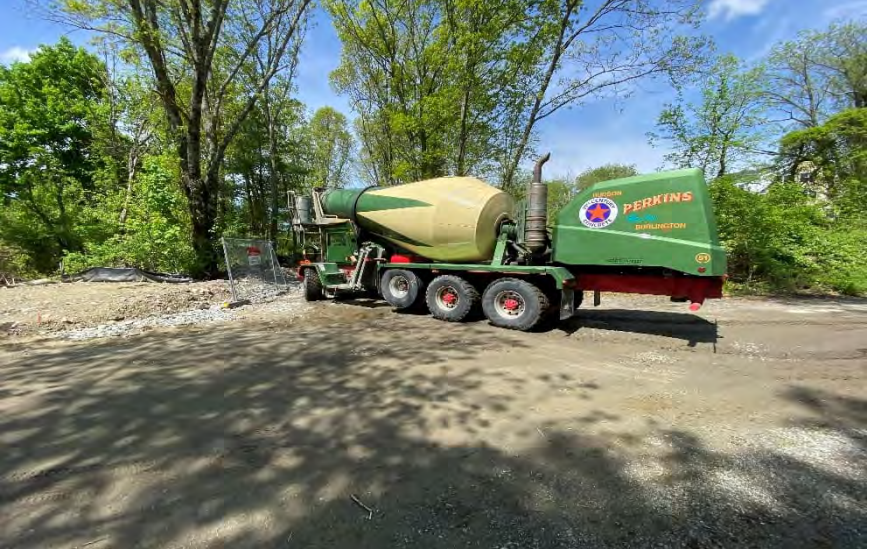
<p>PHOTOGRAPHIC LOG</p>	
<p>Client Name: Eversource</p>		<p>Site Location: Sudbury to Hudson Transmission Reliability Project</p>	<p>Town: Sudbury</p>
<p>Photo No.: 5</p>	<p>Date: 5-17-24</p>

<p>Description:</p> <p>Work area within Segment 14, concrete for capping at wall 13, looking westward.</p>

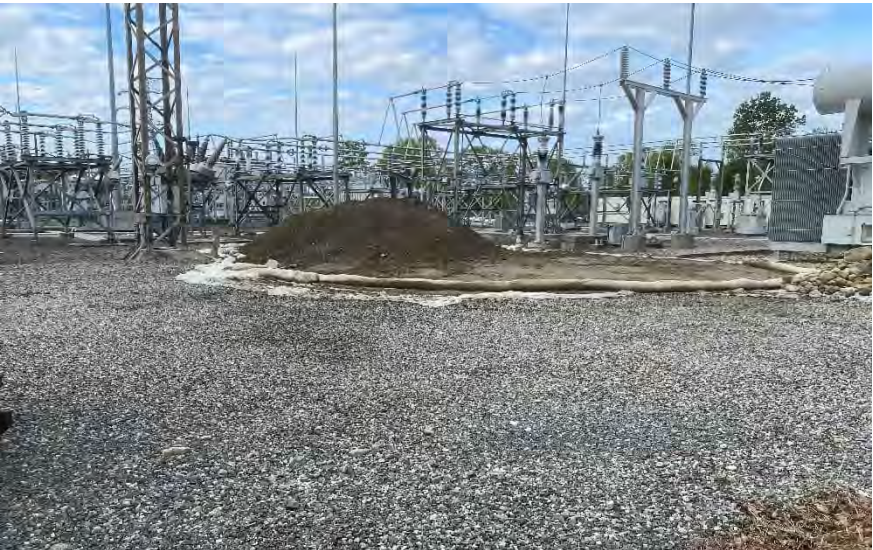
<p>PHOTOGRAPHIC LOG</p>	
<p>Client Name: Eversource</p>		<p>Site Location: Sudbury to Hudson Transmission Reliability Project</p>	<p>Town: Sudbury</p>
<p>Photo No.: 6</p>	<p>Date: 5-17-24</p>

<p>Description:</p> <p>Work area within substation, newly placed spoil pile, existing erosion control (compost tubing), looking southward.</p>

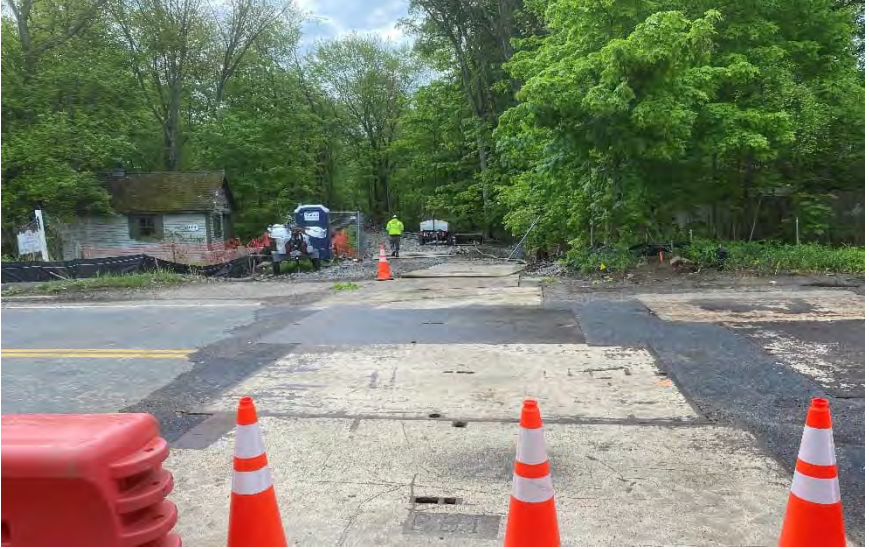
<p>PHOTOGRAPHIC LOG</p>	
<p>Client Name: Eversource</p>		<p>Site Location: Sudbury to Hudson Transmission Reliability Project</p>	<p>Town: Sudbury</p>
<p>Photo No.: 7</p>	<p>Date: 5-17-24</p>

<p>Description:</p> <p>Work area at Boston Post Road (conduit work performed at night), looking eastward.</p>

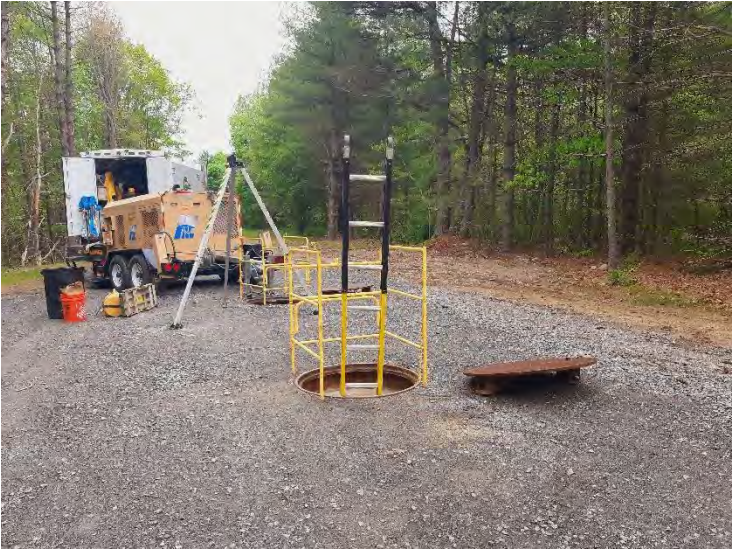
<p>PHOTOGRAPHIC LOG</p>	
<p>Client Name: Eversource</p>		<p>Site Location: Sudbury to Hudson Transmission Reliability Project</p>	<p>Town: Hudson</p>
<p>Photo No.: 1</p>	<p>Date: 5-18-24</p>

<p>Description:</p> <p>Work area within segment 2, manhole #7 work (cable pulling). Looking westward.</p>

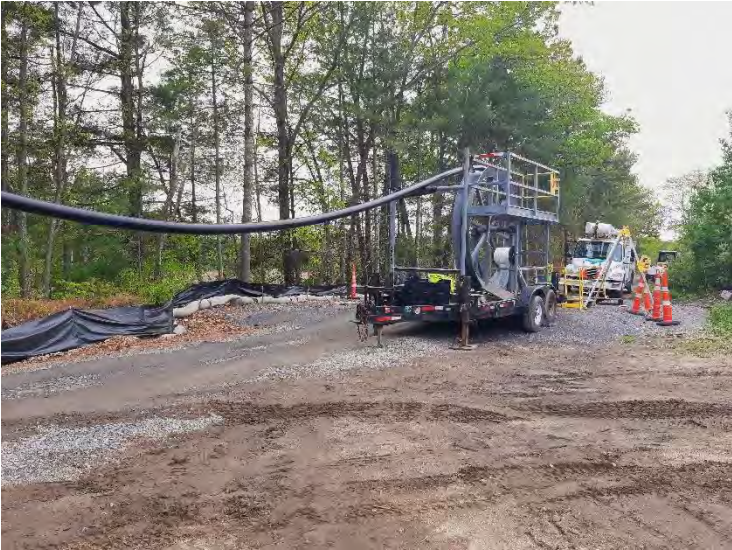
<p>PHOTOGRAPHIC LOG</p>	
<p>Client Name: Eversource</p>		<p>Site Location: Sudbury to Hudson Transmission Reliability Project</p>	<p>Town: Hudson</p>
<p>Photo No.: 2</p>	<p>Date: 5-18-24</p>

<p>Description:</p> <p>Work area within segment 3, manhole #8 work (cable pulling). Looking westward.</p>

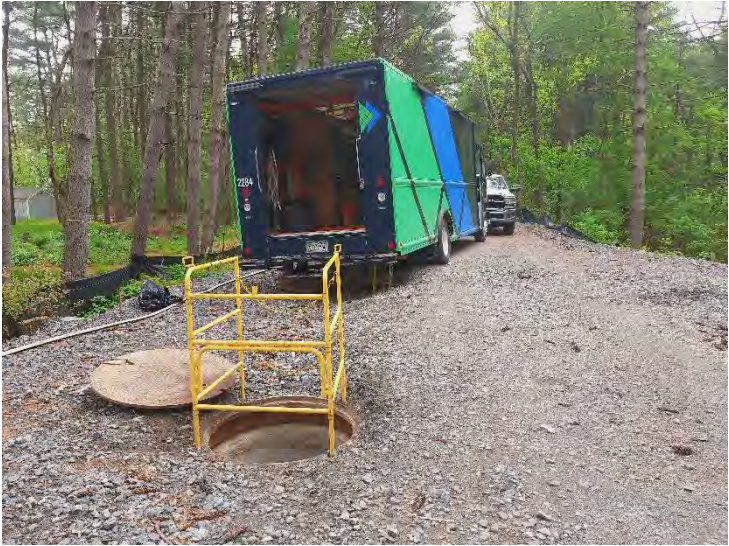
<p align="right">PHOTOGRAPHIC LOG</p>	
<p>Client Name: Eversource</p>		<p>Site Location: Sudbury to Hudson Transmission Reliability Project</p>	<p>Town: Sudbury</p>
<p>Photo No.: 3</p>	<p>Date: 5-18-24</p>

<p>Description:</p> <p>Work area within segment 9, manhole #19 work (clipping and splicing). Looking eastward.</p>

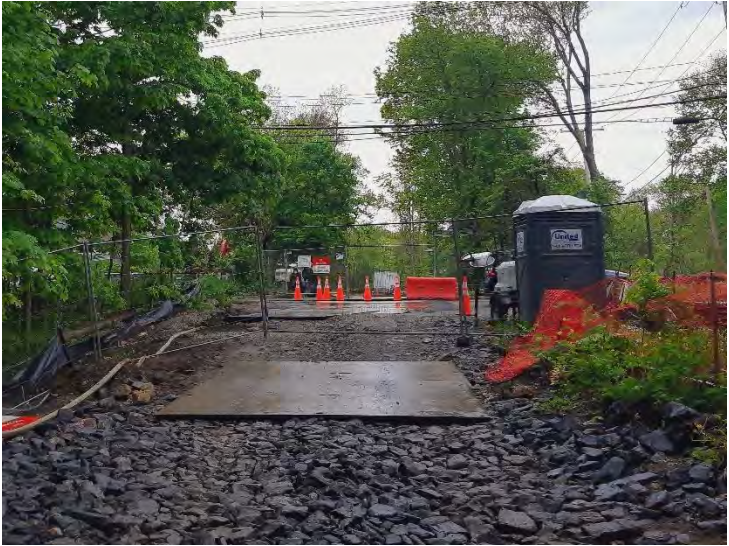
<p align="right">PHOTOGRAPHIC LOG</p>	
<p>Client Name: Eversource</p>		<p>Site Location: Sudbury to Hudson Transmission Reliability Project</p>	<p>Town: Sudbury</p>
<p>Photo No.: 4</p>	<p>Date: 5-18-24</p>

<p>Description:</p> <p>Boston Post Road crossing, between segments 12 and 13. Only dewatering conducted. Dewatering inspection conducted by SWCA. Looking westward.</p>

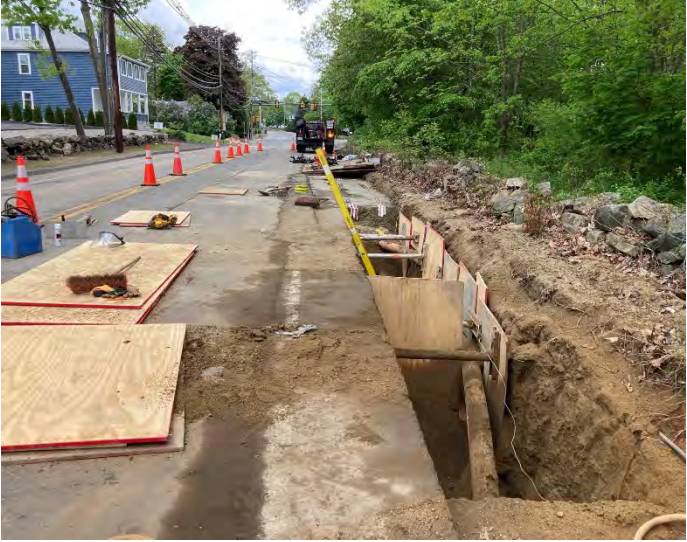
PHOTOGRAPHIC LOG	
Client Name: Eversource		Site Location: Sudbury to Hudson Transmission Reliability Project	Town: Hudson
Photo No.: 1	Date: 5-15-2024

Description: View of Bond working on Forest Ave. Facing north.

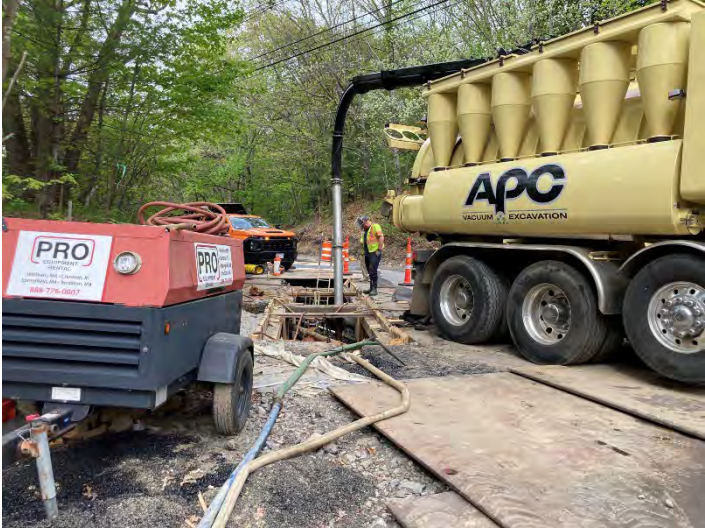
PHOTOGRAPHIC LOG	
Client Name: Eversource		Site Location: Sudbury to Hudson Transmission Reliability Project	Town: Hudson
Photo No.: 2	Date: 5-15-2024

Description: View of Bond working on Wilkins St. Facing southwest.

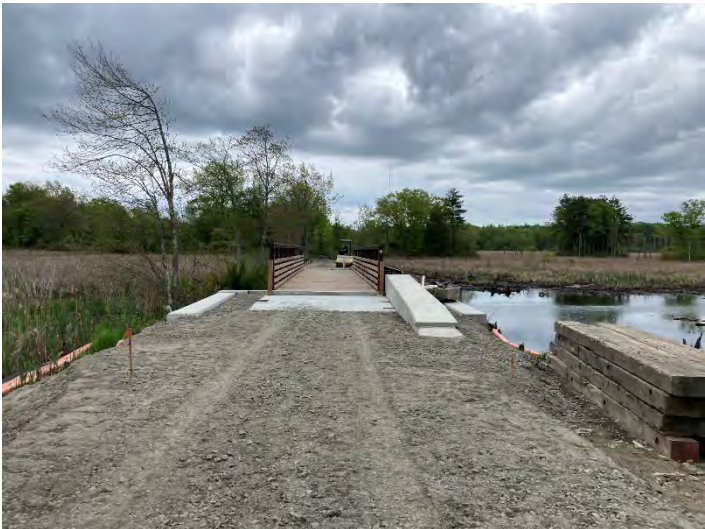
Epsilon ASSOCIATES INC.		PHOTOGRAPHIC LOG	
Client Name: Eversource		Site Location: Sudbury to Hudson Transmission Reliability Project	Town: Hudson
Photo No.: 4	Date: 5-15-2024

Description: View of bridge 130. Facing east.

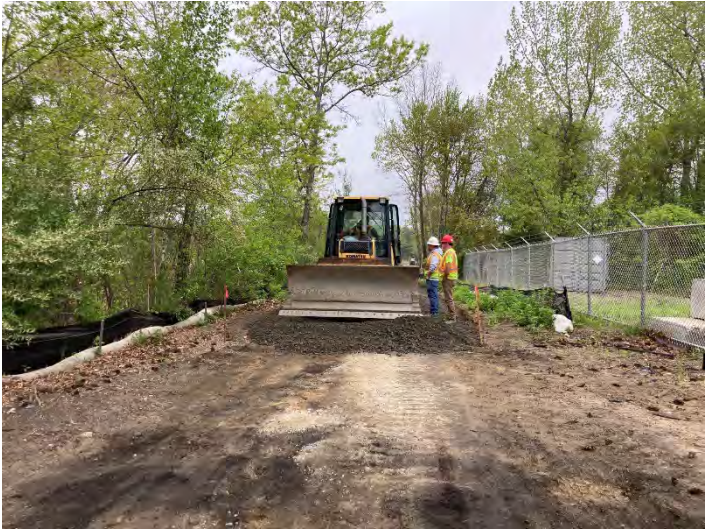
Epsilon ASSOCIATES INC.		PHOTOGRAPHIC LOG	
Client Name: Eversource		Site Location: Sudbury to Hudson Transmission Reliability Project	Town: Hudson
Photo No.: 5	Date: 5-15-2024

Description: View of ET&L spreading gravel in segment 3 near bridge 130. Facing west.

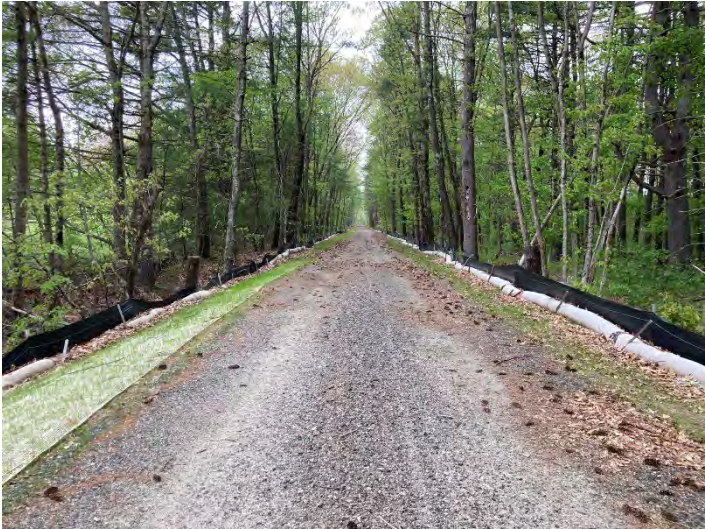
Epsilon ASSOCIATES INC.		PHOTOGRAPHIC LOG	
Client Name: Eversource		Site Location: Sudbury to Hudson Transmission Reliability Project	Town: Hudson
Photo No.: 6	Date: 5-15-2024

Description: View of E&S controls in segment 4. Hydroseed applied in late 2023 is germinating. Facing west.

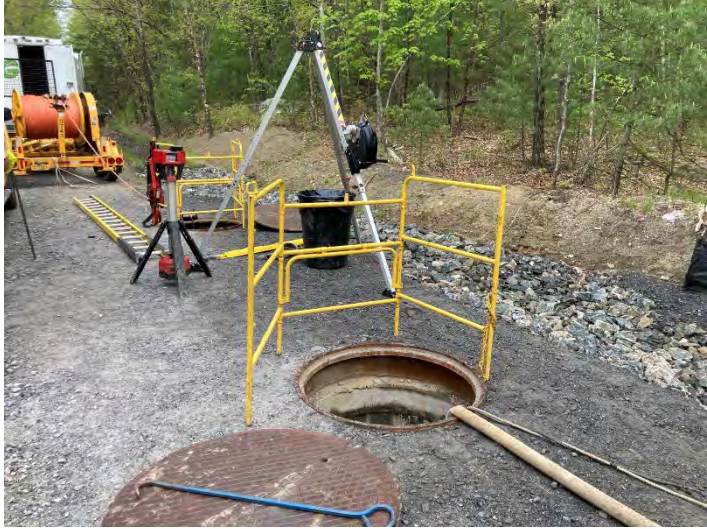
PHOTOGRAPHIC LOG	
Client Name: Eversource		Site Location: Sudbury to Hudson Transmission Reliability Project	Town: Hudson
Photo No.: 7	Date: 5-15-2024

Description: View of Haugland working at MH #12 in segment 5. See additional dewatering inspection reports. Facing west.

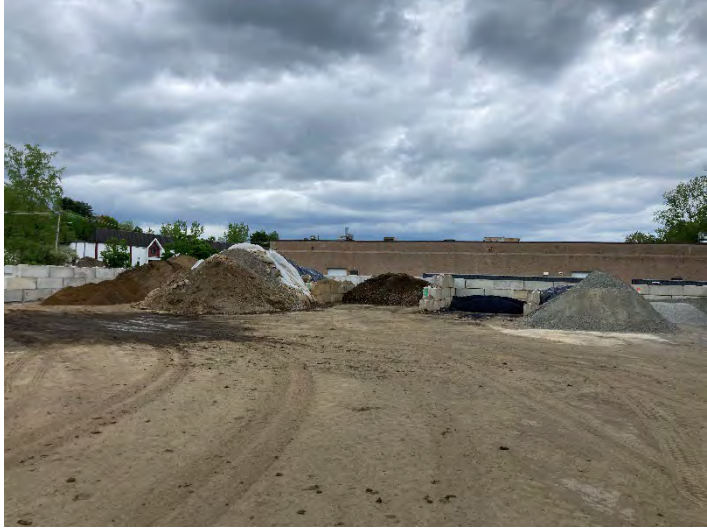
PHOTOGRAPHIC LOG	
Client Name: Eversource		Site Location: Sudbury to Hudson Transmission Reliability Project	Town: Hudson
Photo No.: 8	Date: 5-15-2024

Description: View of Bonazzoli laydown yard. Facing southwest.

4. Silt Fencing at laydown yards (25 Stowe Ct and 17 Bonazzoli Avenue)	<input type="checkbox"/> Yes <input checked="" type="checkbox"/> No	N/A	<input type="checkbox"/> Yes <input checked="" type="checkbox"/> No	N/A	Silt fence at Bonazzoli laydown yard is in good condition.

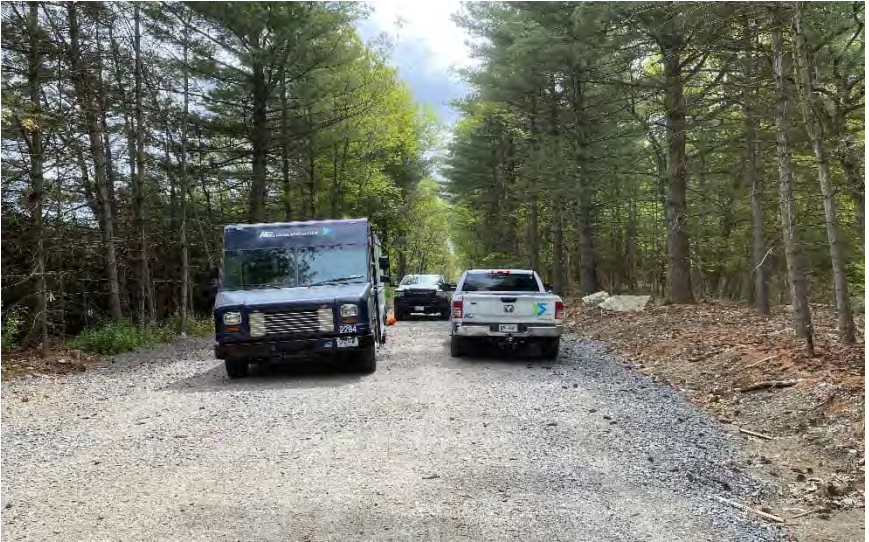
PHOTOGRAPHIC LOG	
Client Name: Eversource		Site Location: Sudbury to Hudson Transmission Reliability Project	Town: Sudbury
Photo No.: 1	Date: 5-15-24

Description: Work area within segment 9 (manhole #18), splicing, looking eastward.

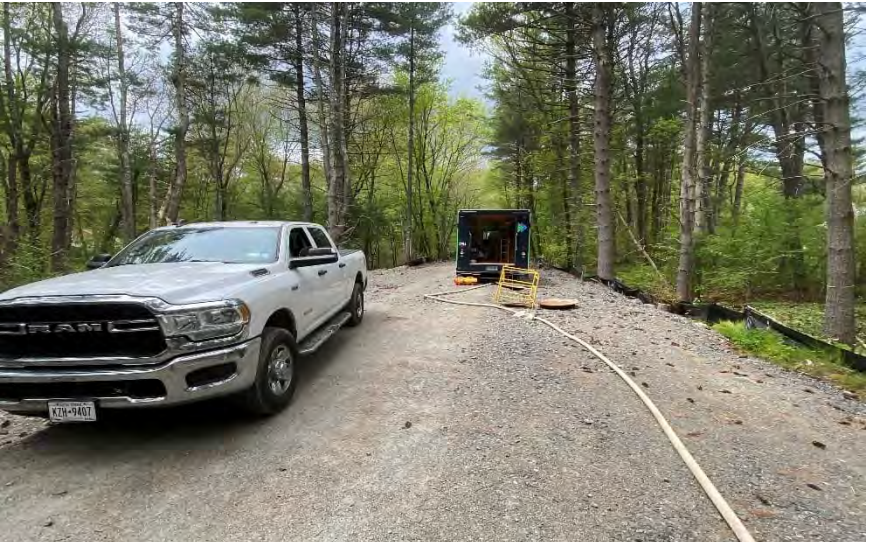
PHOTOGRAPHIC LOG	
Client Name: Eversource		Site Location: Sudbury to Hudson Transmission Reliability Project	Town: Sudbury
Photo No.: 2	Date: 5-15-24

Description: Work area within segment 9 (manhole #19), splicing, looking westward.

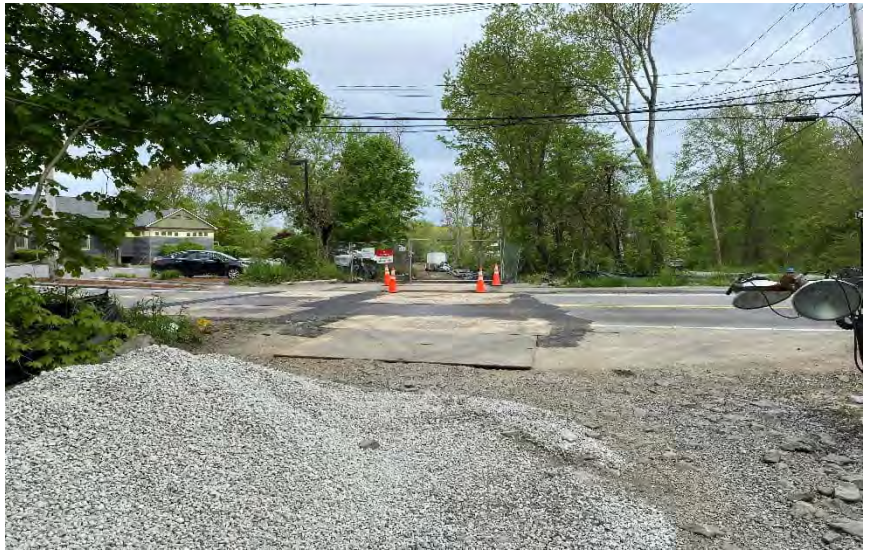
PHOTOGRAPHIC LOG	
Client Name: Eversource		Site Location: Sudbury to Hudson Transmission Reliability Project	Town: Sudbury
Photo No.: 4	Date: 5-15-24

Description: Work area within Boston Post Road (conduit work conducted at night), existing erosion control, looking westward.

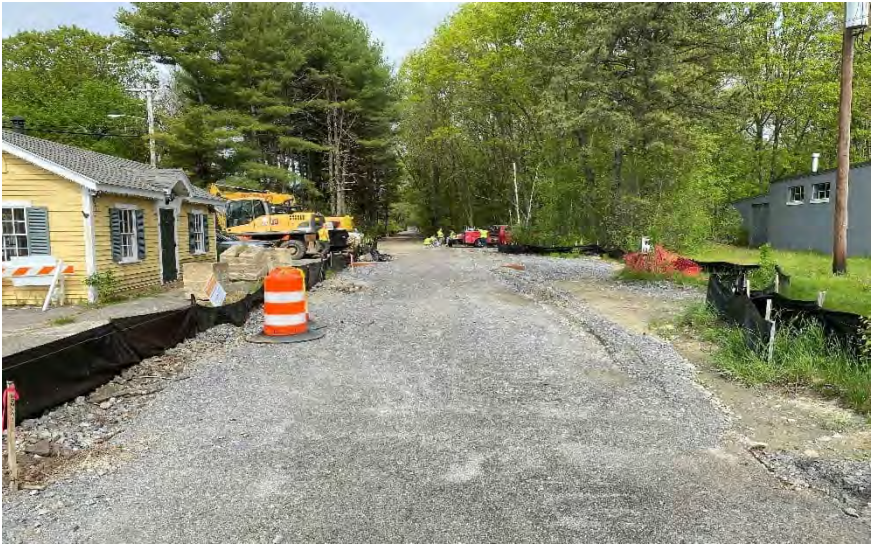
PHOTOGRAPHIC LOG	
Client Name: Eversource		Site Location: Sudbury to Hudson Transmission Reliability Project	Town: Sudbury
Photo No.: 6	Date: 5-15-24

Description: Work area within segment 11, existing erosion control, looking westward.

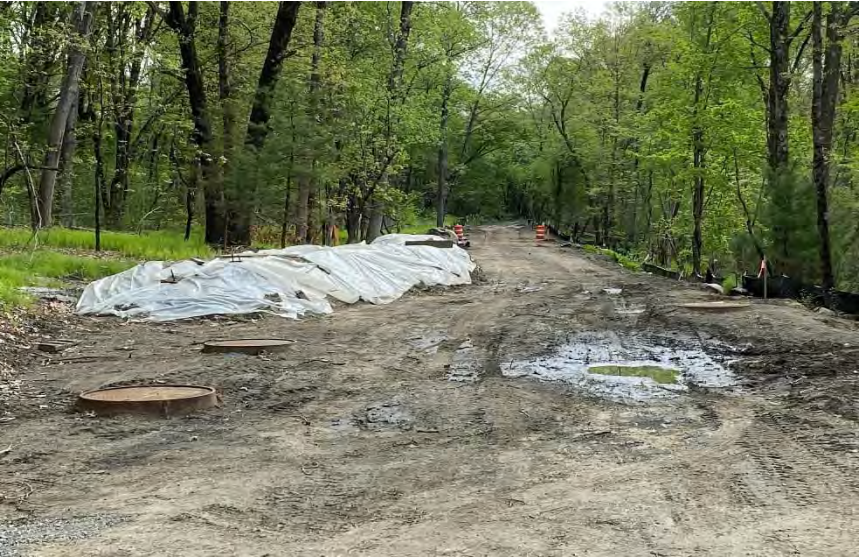
PHOTOGRAPHIC LOG	
Client Name: Eversource		Site Location: Sudbury to Hudson Transmission Reliability Project	Town: Sudbury
Photo No.: 7	Date: 5-15-24

Spoil Berm noted within segment 14, berm created 3-8-24. See photo #7.

Description: Work area within segment 14, covered spoil pile, existing erosion control, looking eastward.
