Weekly Environmental Compliance Summary

Sudbury to Hudson Transmission Reliability Project (USEPA Tracking # MAR1003UW)

Sudbury, Hudson, and Stow, MA

Week of: May 13, 2024 to May 18, 2024

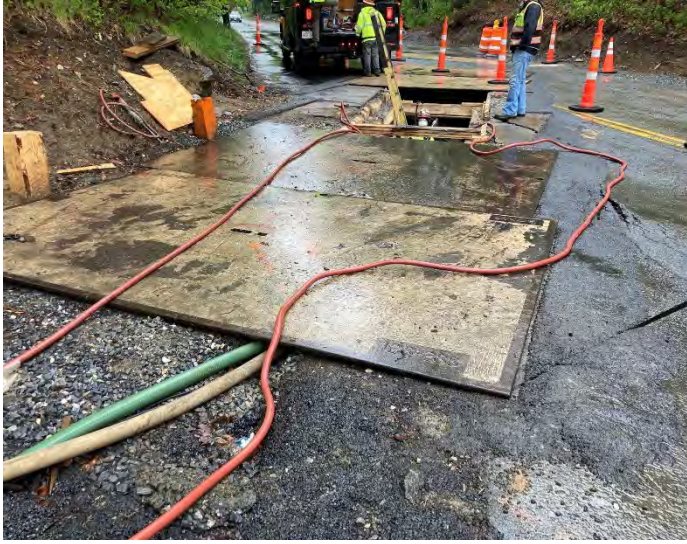
PHOTOGRAPHIC LOG	
Client Name: Eversource		Site Location: Sudbury to Hudson Transmission Reliability Project	Town: Hudson
Photo No.: 1	Date: 5-16-2024

Description: View of Bond working on Wilkins St. Facing southwest.

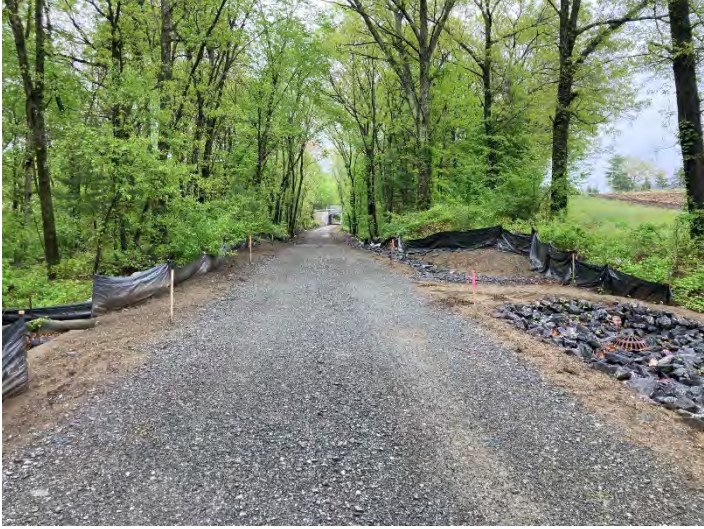
PHOTOGRAPHIC LOG	
Client Name: Eversource		Site Location: Sudbury to Hudson Transmission Reliability Project	Town: Stow
Photo No.: 2	Date: 5-16-2024

Description: View of Drainage Structures 5 and 6 and E&S controls in segment 1. Facing east.

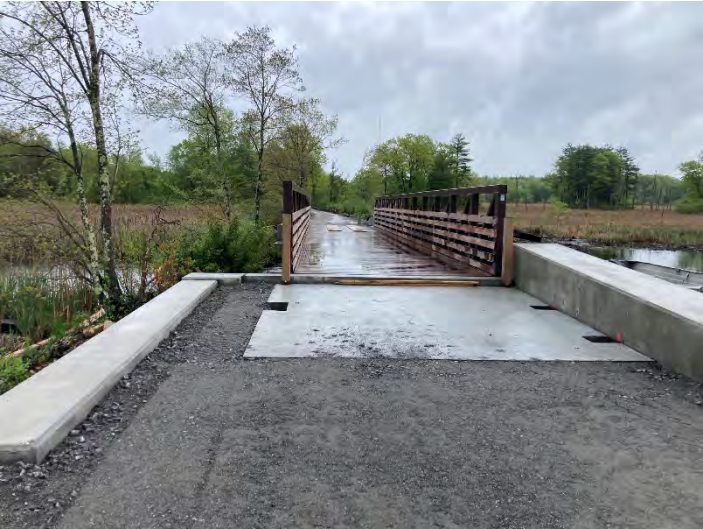
Epsilon ASSOCIATES INC.		PHOTOGRAPHIC LOG	
Client Name: Eversource		Site Location: Sudbury to Hudson Transmission Reliability Project	Town: Hudson
Photo No.: 3	Date: 5-16-2024

Description: View of bridge 130. Facing east.

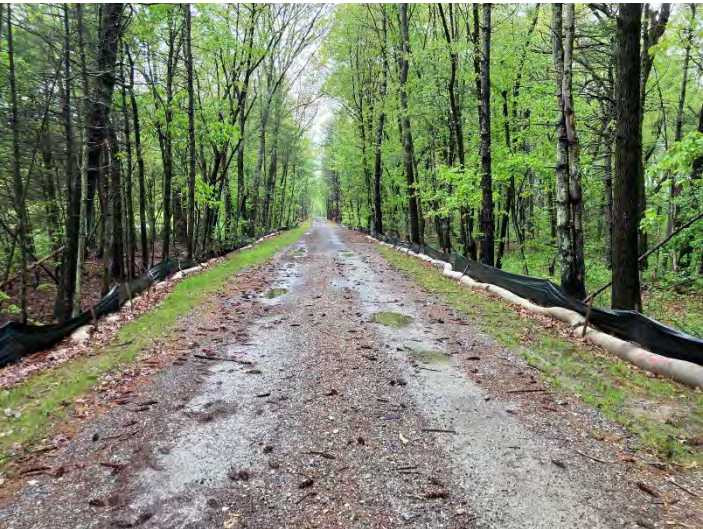
Epsilon ASSOCIATES INC.		PHOTOGRAPHIC LOG	
Client Name: Eversource		Site Location: Sudbury to Hudson Transmission Reliability Project	Town: Hudson
Photo No.: 4	Date: 5-16-2024

Description: View of E&S controls in segment 4. Hydroseed applied in late 2023 is germinating. Facing west.

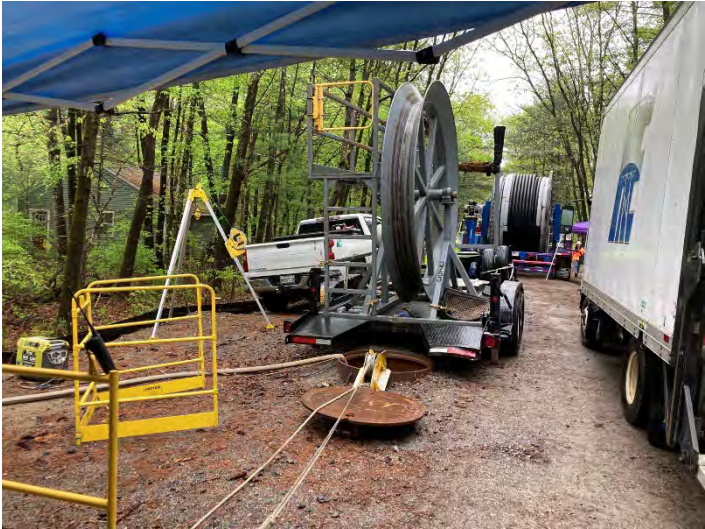
Epsilon ASSOCIATES INC.		PHOTOGRAPHIC LOG	
Client Name: Eversource		Site Location: Sudbury to Hudson Transmission Reliability Project	Town: Hudson
Photo No.: 5	Date: 5-16-2024

Description: View of Haugland working at MH #13 in segment 5. See additional dewatering inspection reports. Facing east.

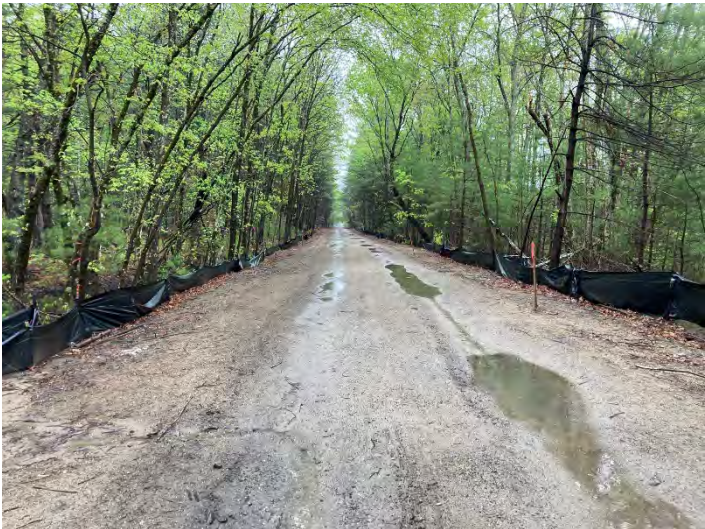
Epsilon ASSOCIATES INC.		PHOTOGRAPHIC LOG	
Client Name: Eversource		Site Location: Sudbury to Hudson Transmission Reliability Project	Town: Hudson
Photo No.: 6	Date: 5-16-2024

Description: View of E&S controls in segment 6. Facing east.

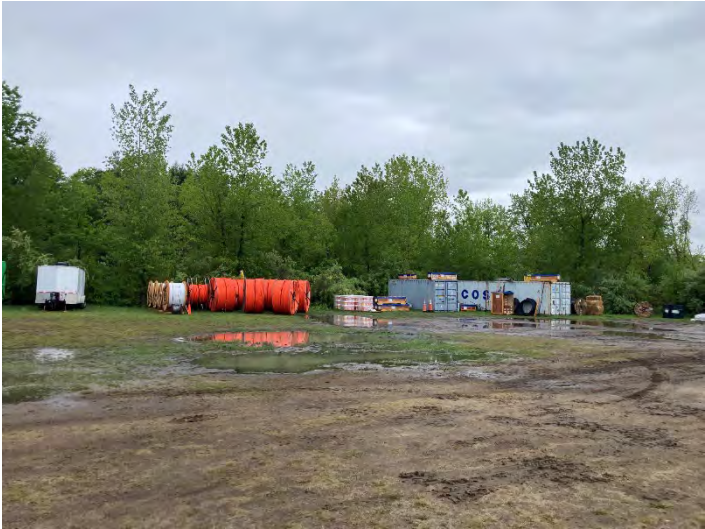
Epsilon ASSOCIATES INC.		PHOTOGRAPHIC LOG	
Client Name: Eversource		Site Location: Sudbury to Hudson Transmission Reliability Project	Town: Hudson
Photo No.: 7	Date: 5-16-2024

Description: View of Haugland's laydown yard on Perkins property. Facing west.

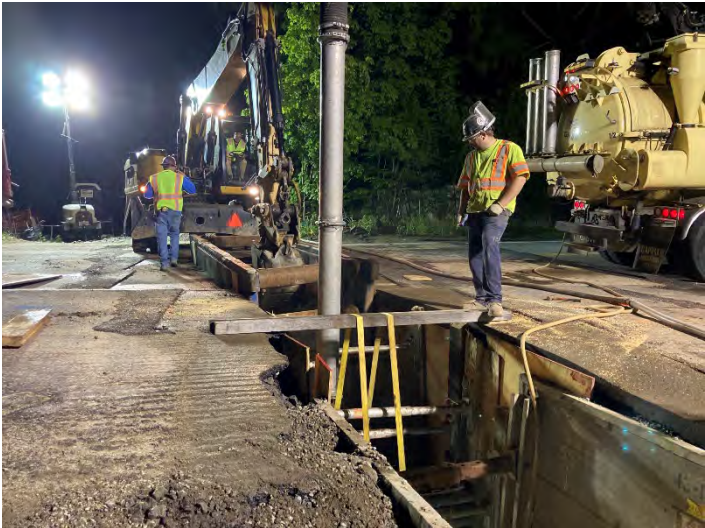
Epsilon ASSOCIATES INC.		PHOTOGRAPHIC LOG	
Client Name: Eversource		Site Location: Sudbury to Hudson Transmission Reliability Project	Town: Sudbury
Photo No.: 8	Date: 5-16-2024

Description: View of Bond's night work at Boston Post Rd crossing. See additional dewatering inspection report. Facing east.

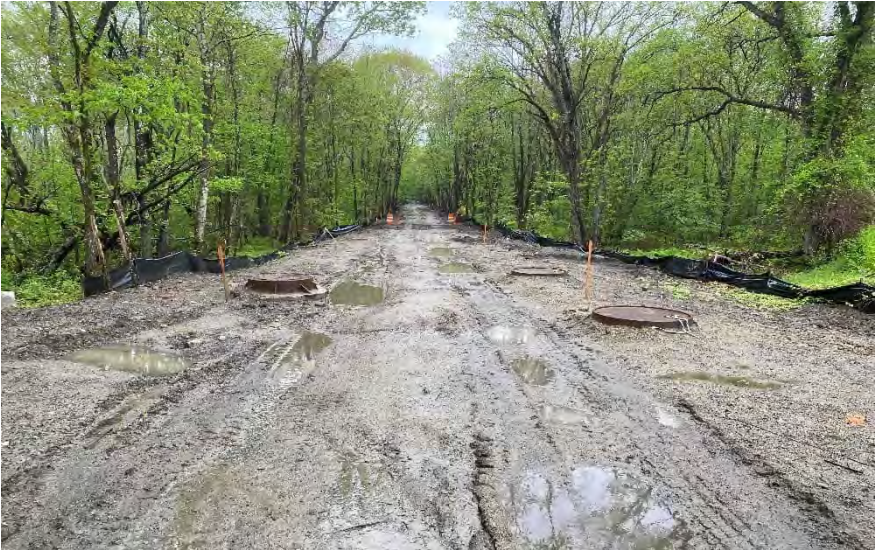
PHOTOGRAPHIC LOG	
Client Name: Eversource		Site Location: Sudbury to Hudson Transmission Reliability Project	Town: Sudbury
Photo No.: 1	Date: 5-16-24

Description: Work area within segment 14 (manhole #27), existing erosion control, looking westward.

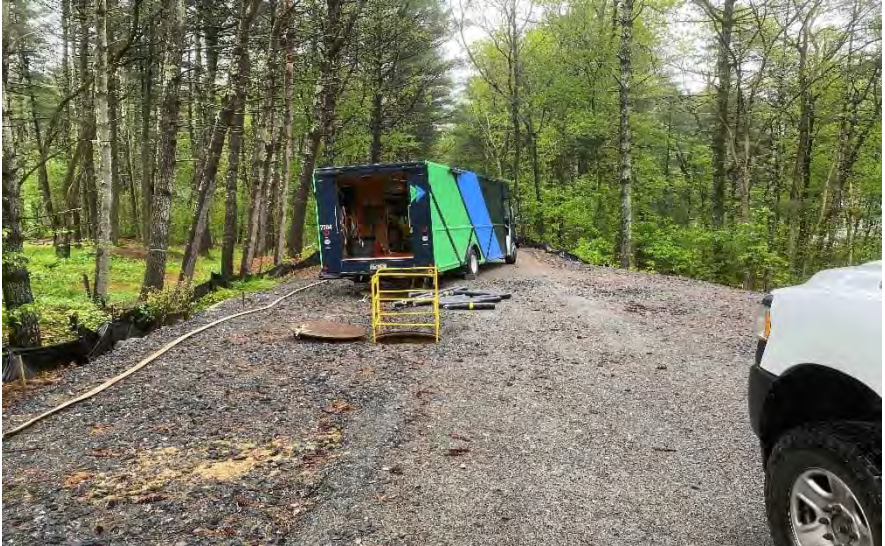
PHOTOGRAPHIC LOG	
Client Name: Eversource		Site Location: Sudbury to Hudson Transmission Reliability Project	Town: Sudbury
Photo No.: 2	Date: 5-16-24

Description: Work area within segment 9 (manhole #19), splicing, looking eastward.

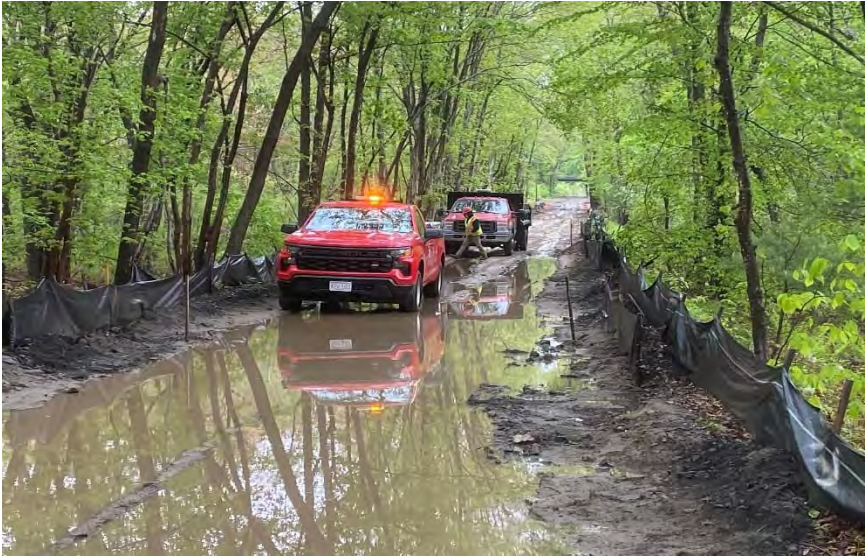
PHOTOGRAPHIC LOG	
Client Name: Eversource		Site Location: Sudbury to Hudson Transmission Reliability Project	Town: Sudbury
Photo No.: 3	Date: 5-16-24

Description: Work area within segment 14, site cleanup, existing erosion control, looking eastward.

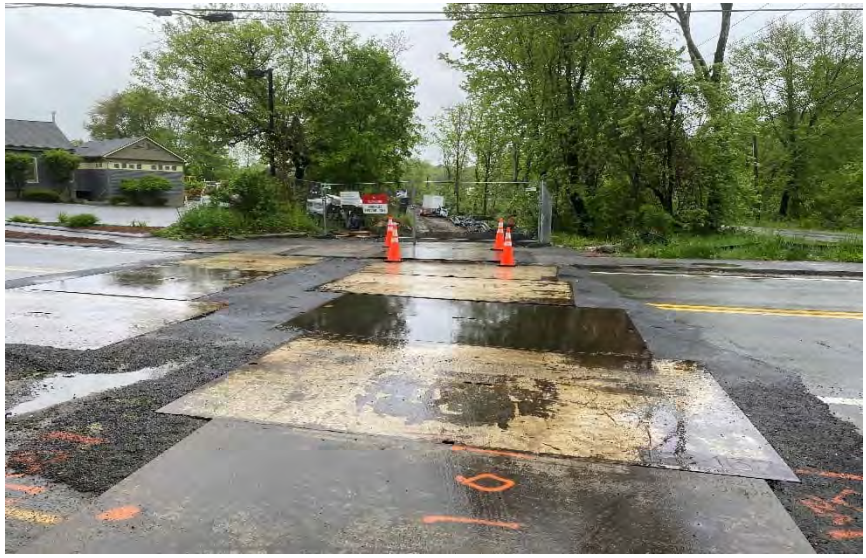
PHOTOGRAPHIC LOG	
Client Name: Eversource		Site Location: Sudbury to Hudson Transmission Reliability Project	Town: Sudbury
Photo No.: 4	Date: 5-16-24

Description: Work area within Boston Post Road (conduit work conducted at night), existing erosion control, looking westward.

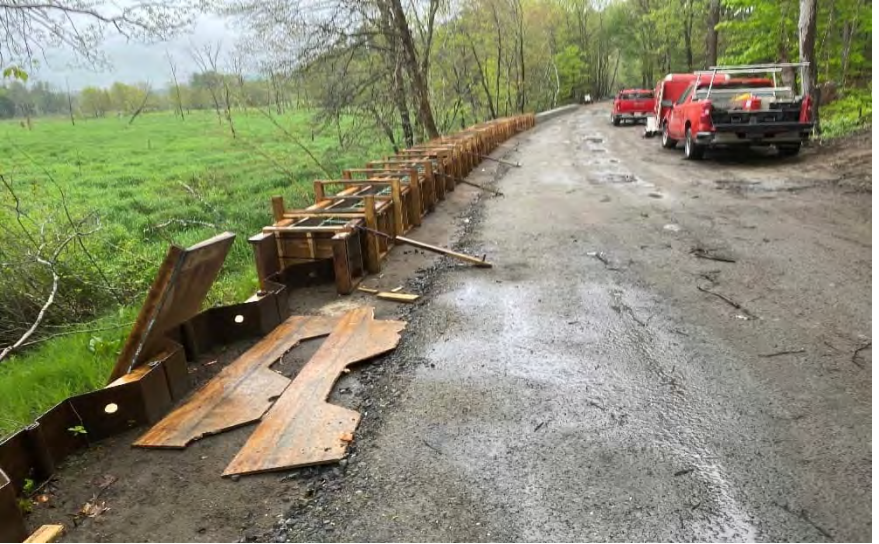
PHOTOGRAPHIC LOG	
Client Name: Eversource		Site Location: Sudbury to Hudson Transmission Reliability Project	Town: Sudbury
Photo No.: 5	Date: 5-16-24

Description: Work area within Segment 14, concrete capping of sheeting, looking westward.

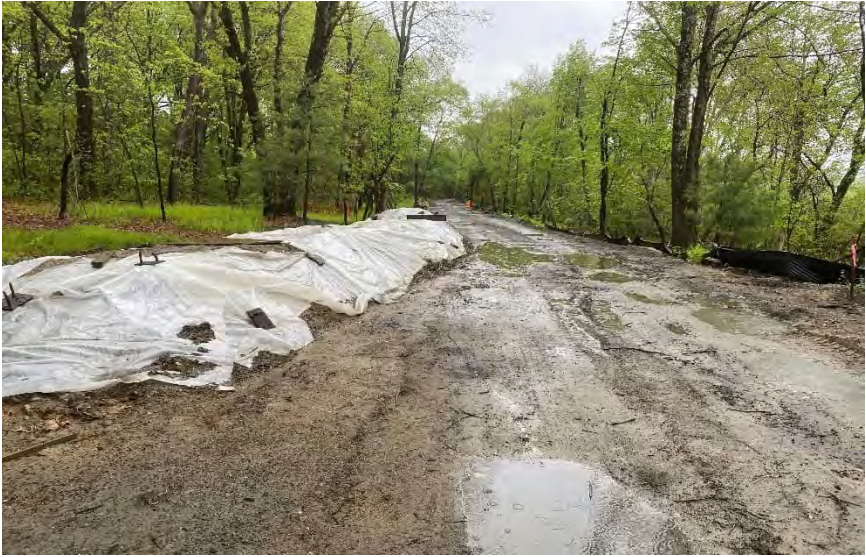
PHOTOGRAPHIC LOG	
Client Name: Eversource		Site Location: Sudbury to Hudson Transmission Reliability Project	Town: Sudbury
Photo No.: 7	Date: 5-16-24

Description: Work area within segment 14, covered spoil pile, existing erosion control, looking eastward.

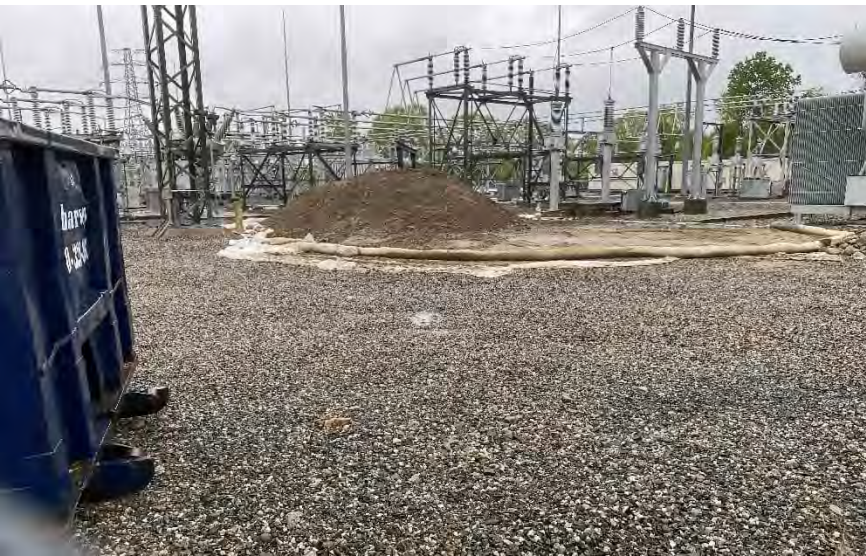
PHOTOGRAPHIC LOG	
Client Name: Eversource		Site Location: Sudbury to Hudson Transmission Reliability Project	Town: Sudbury
Photo No.: 8	Date: 5-16-24

Description: Spoils generated within substation stockpiled with erosion control (compost tubing) surrounding piles, looking southward.

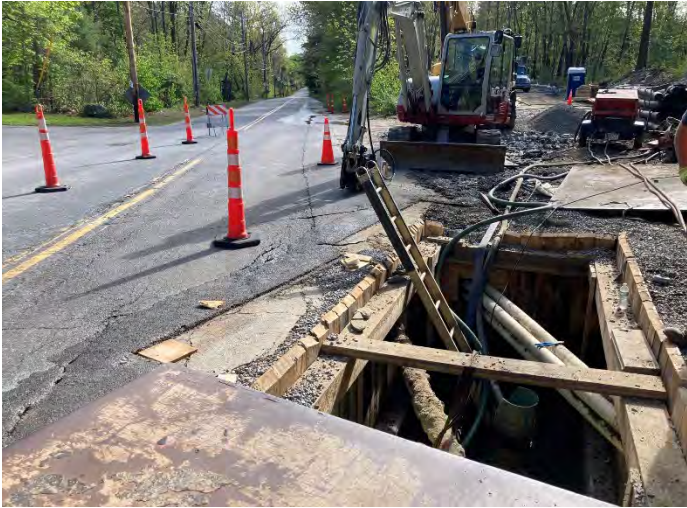
PHOTOGRAPHIC LOG	
Client Name: Eversource		Site Location: Sudbury to Hudson Transmission Reliability Project	Town: Hudson
Photo No.: 1	Date: 5/13/2024

Description: View of Bond working on Wilkins Street. Facing northeast.

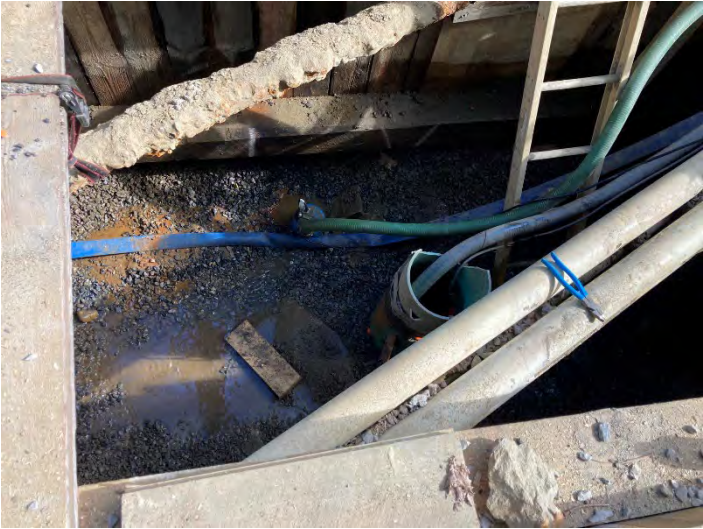
PHOTOGRAPHIC LOG	
Client Name: Eversource		Site Location: Sudbury to Hudson Transmission Reliability Project	Town: Hudson
Photo No.: 2	Date: 5/13/2024

Description: View of pumps in trench within Wilkins Street. Water appeared slightly turbid prior to treatment.

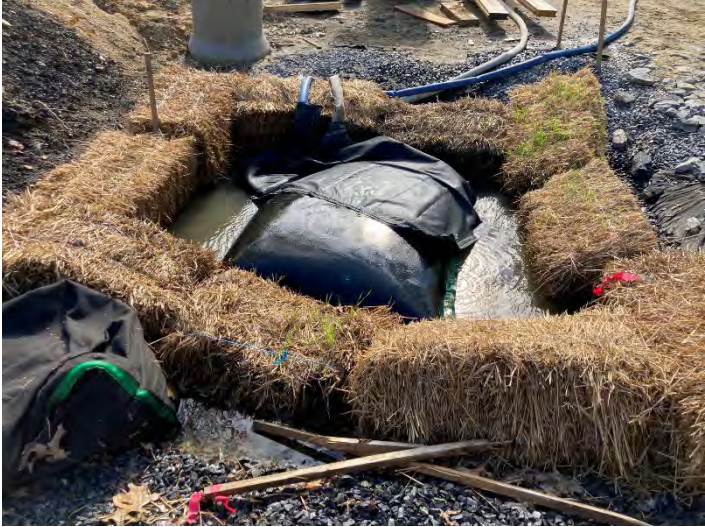
PHOTOGRAPHIC LOG	
Client Name: Eversource		Site Location: Sudbury to Hudson Transmission Reliability Project	Town: Hudson
Photo No.: 3	Date: 5/13/2024

Description: View of dewatering controls (straw bale corral with filter fabric and silt bag). Facing east.

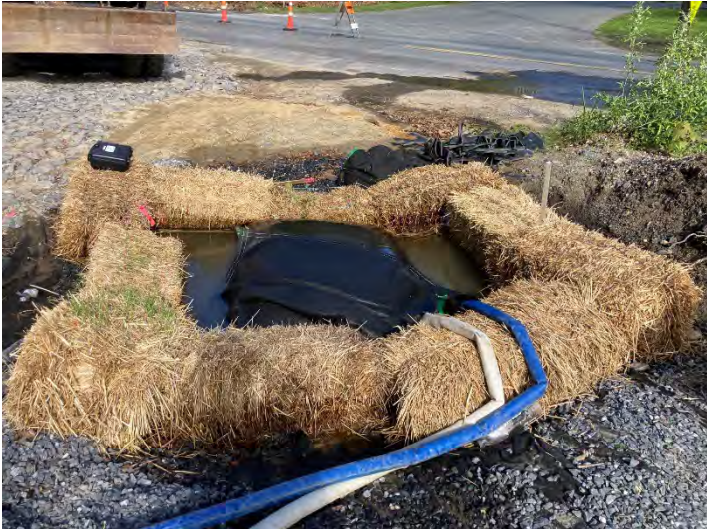
PHOTOGRAPHIC LOG	
Client Name: Eversource		Site Location: Sudbury to Hudson Transmission Reliability Project	Town: Hudson
Photo No.: 4	Date: 5/13/2024

Description: Additional view of dewatering controls and discharge. Discharge appeared slightly turbid, but turbidity reading was below 50 NTUs. Facing west.

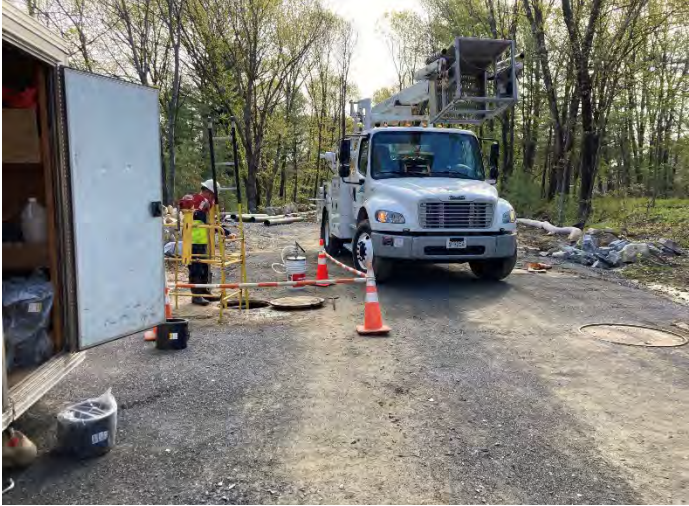
PHOTOGRAPHIC LOG	
Client Name: Eversource		Site Location: Sudbury to Hudson Transmission Reliability Project	
Town: Hudson			
Photo No.: 1	Date: 5/13/2024

Description: View of New Wave working at HH #5 in segment 1. Facing east.

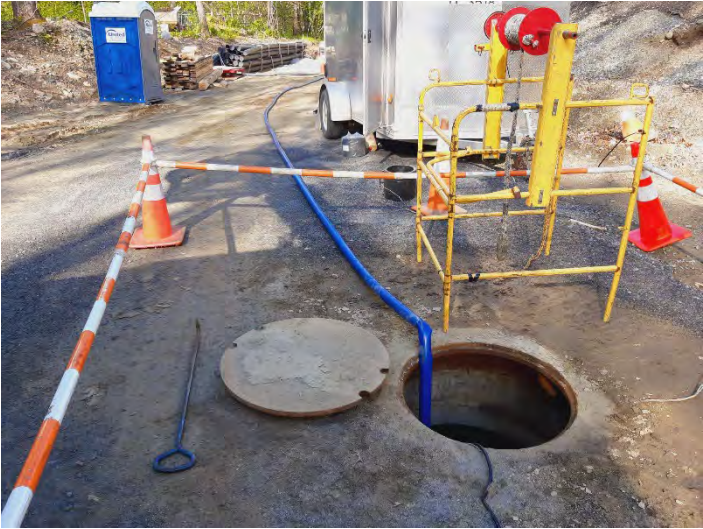
PHOTOGRAPHIC LOG	
Client Name: Eversource		Site Location: Sudbury to Hudson Transmission Reliability Project	
Town: Hudson			
Photo No.: 2	Date: 5/13/2024

Description: View of pumping operation at HH #5. Facing west.

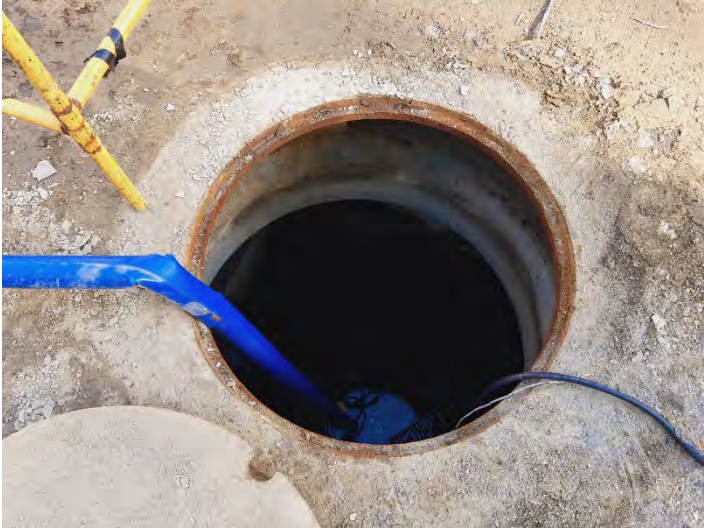
PHOTOGRAPHIC LOG	
Client Name: Eversource		Site Location: Sudbury to Hudson Transmission Reliability Project	
Town: Hudson			
Photo No.: 3	Date: 5/13/2024

Description: View of pump in HH #5. Water appeared clear prior to treatment.

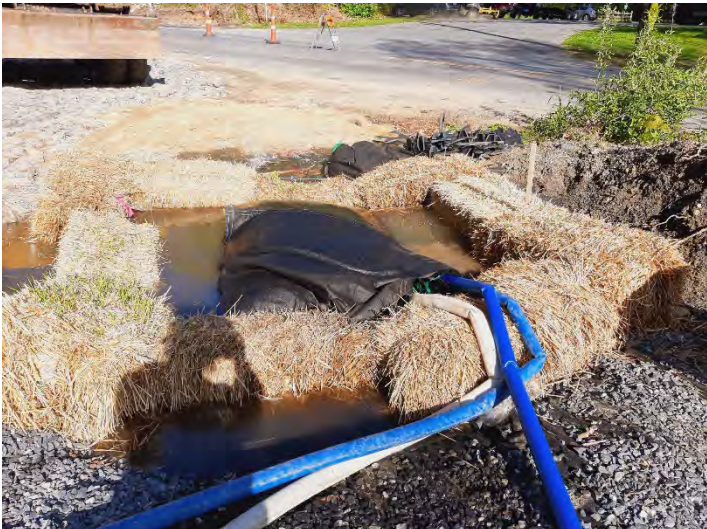
PHOTOGRAPHIC LOG	
Client Name: Eversource		Site Location: Sudbury to Hudson Transmission Reliability Project	
Town: Hudson			
Photo No.: 4	Date: 5/13/2024

Description: View of dewatering controls (straw bale corral with filter fabric and silt bag) and discharge. Discharge appeared slightly turbid, but turbidity reading was below 50 NTUs. Facing west.

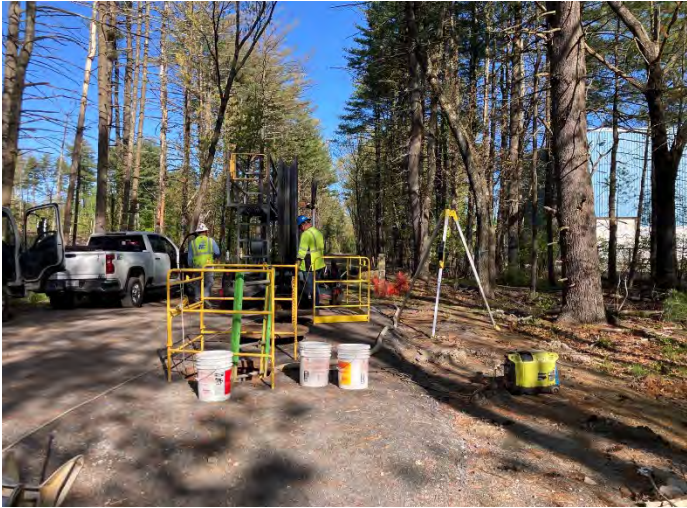
PHOTOGRAPHIC LOG	
Client Name: Eversource		Site Location: Sudbury to Hudson Transmission Reliability Project	Town: Hudson
Photo No.: 1	Date: 5/13/2024

Description: View of Haugland's work area at MH #10 in segment 4. Facing west.

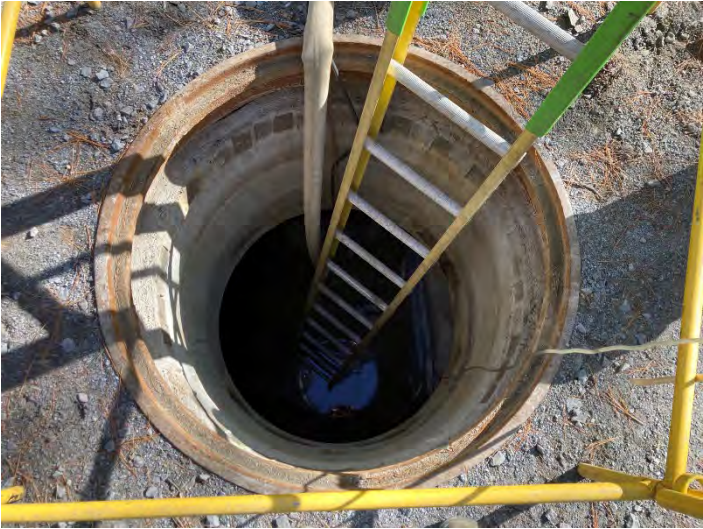
PHOTOGRAPHIC LOG	
Client Name: Eversource		Site Location: Sudbury to Hudson Transmission Reliability Project	Town: Hudson
Photo No.: 2	Date: 5/13/2024

Description: View of pump in MH #10. Water appeared clear prior to treatment.

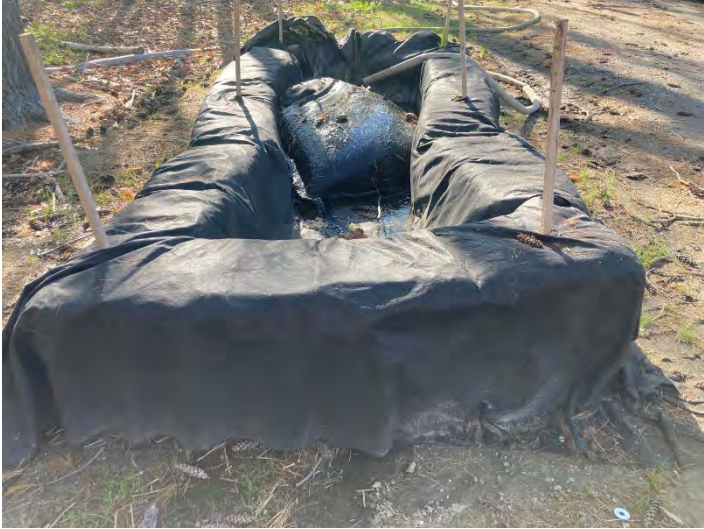
PHOTOGRAPHIC LOG	
Client Name: Eversource		Site Location: Sudbury to Hudson Transmission Reliability Project	
Town: Hudson			
Photo No.: 3	Date: 5/13/2024

Description: View of dewatering controls (straw bale corral with filter fabric and silt bag). Facing east.

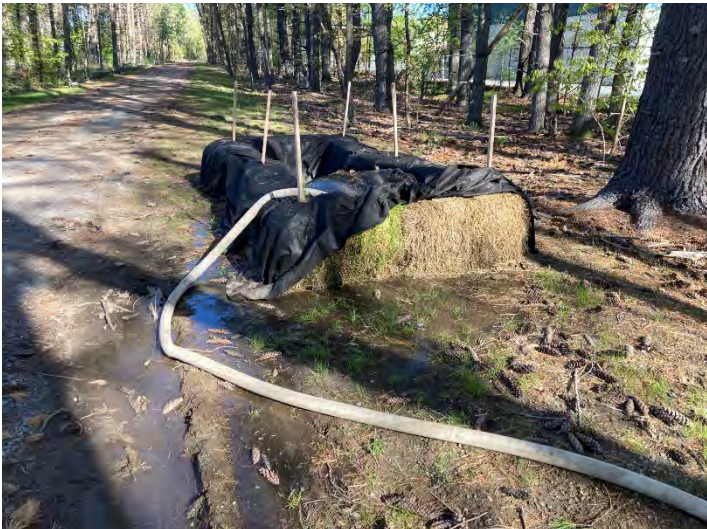
PHOTOGRAPHIC LOG	
Client Name: Eversource		Site Location: Sudbury to Hudson Transmission Reliability Project	
Town: Hudson			
Photo No.: 4	Date: 5/13/2024

Description: View of water discharging from corral. Discharge appeared clear and turbidity reading was below 50 NTUs. Discharge did not appear to reach any jurisdictional resource areas. Facing west.

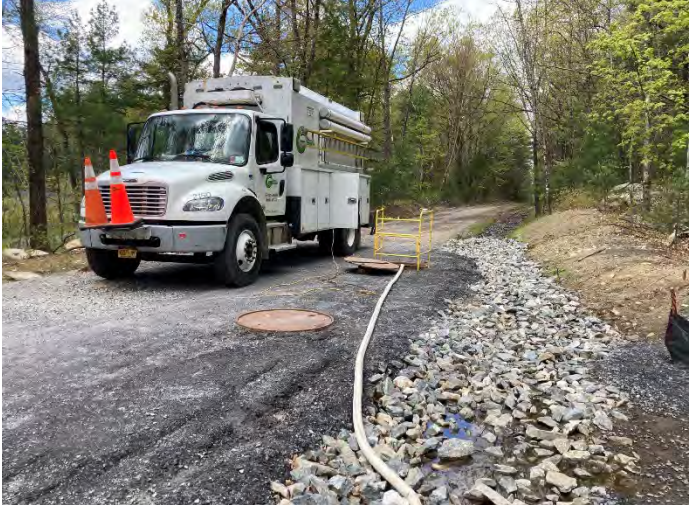
PHOTOGRAPHIC LOG		
Client Name: Eversource		Site Location: Sudbury to Hudson Transmission Reliability Project		Town: Hudson
Photo No.: 1	Date: 5/13/2024

Description: View of Haugland's work area at MH #12 in segment 5. Facing west.

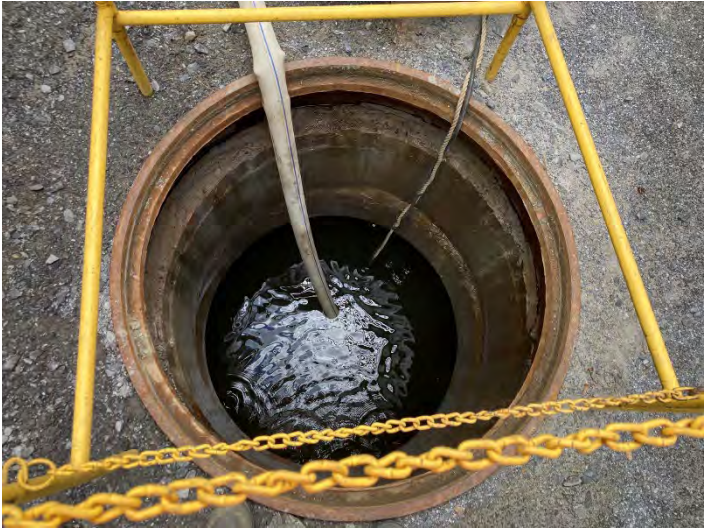
PHOTOGRAPHIC LOG		
Client Name: Eversource		Site Location: Sudbury to Hudson Transmission Reliability Project		Town: Hudson
Photo No.: 2	Date: 5/13/2024

Description: View of pump in MH #12. Water appeared clear prior to treatment.

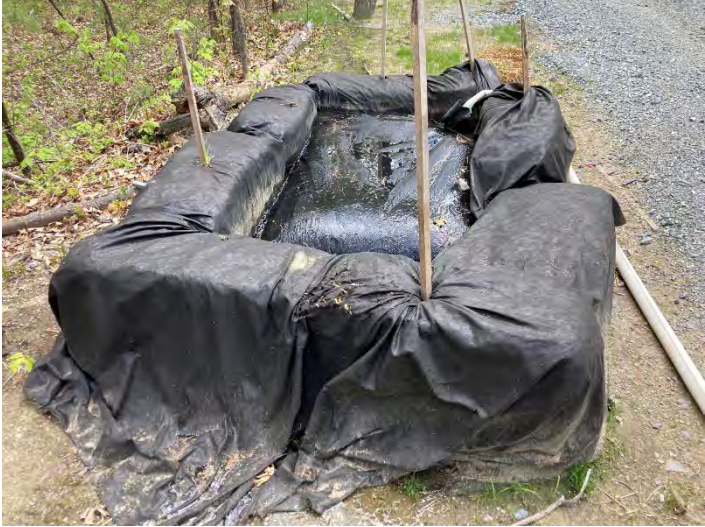
PHOTOGRAPHIC LOG	
Client Name: Eversource		Site Location: Sudbury to Hudson Transmission Reliability Project	
Town: Hudson			
Photo No.: 3	Date: 5/13/2024

Description: View of dewatering controls (straw bale corral with filter fabric and silt bag). Facing east.

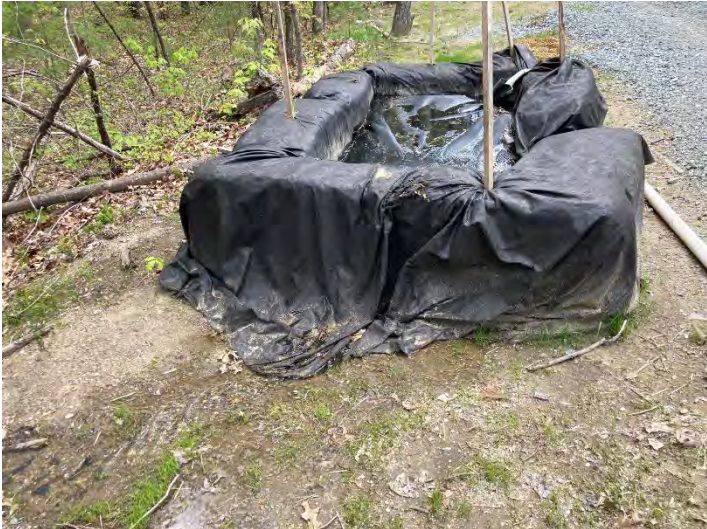
PHOTOGRAPHIC LOG	
Client Name: Eversource		Site Location: Sudbury to Hudson Transmission Reliability Project	
Town: Hudson			
Photo No.: 4	Date: 5/13/2024

Description: View of water discharging from corral. Discharge appeared clear and turbidity reading was below 50 NTUs. Discharge did not appear to reach any jurisdictional resource areas. Facing east.

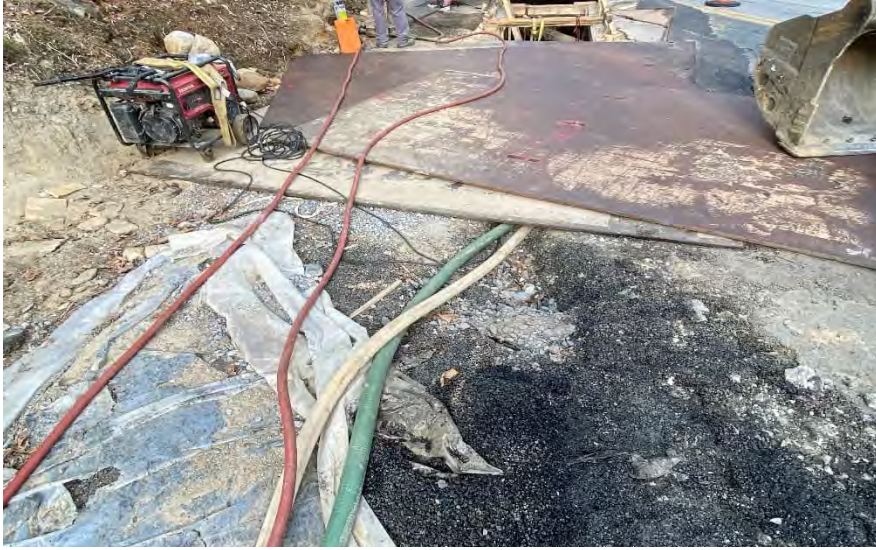
PHOTOGRAPHIC LOG	
Client Name: Eversource		Site Location: Sudbury to Hudson Transmission Reliability Project	Town: Hudson
Photo No.: 1	Date: 5/14/2024

Description: View of area being pumped from trench across Wilkins Street.

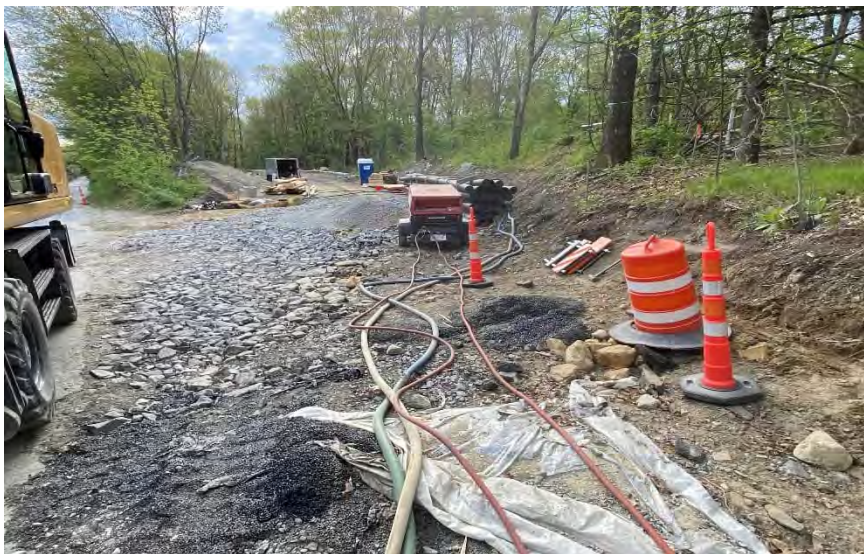
Description: Wilkins Street trench. View of dewatering operation. Looking eastward.

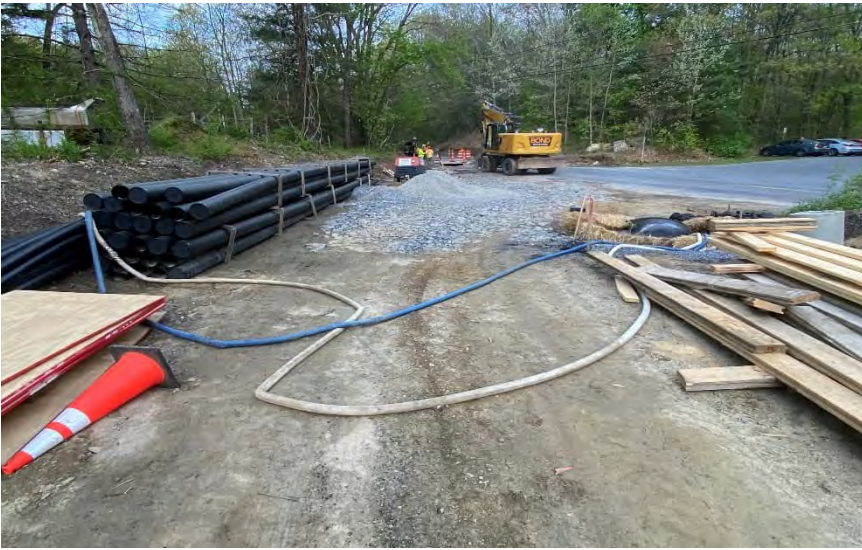
Description: Wilkins Street trench. View of dewatering operation, looking westward.

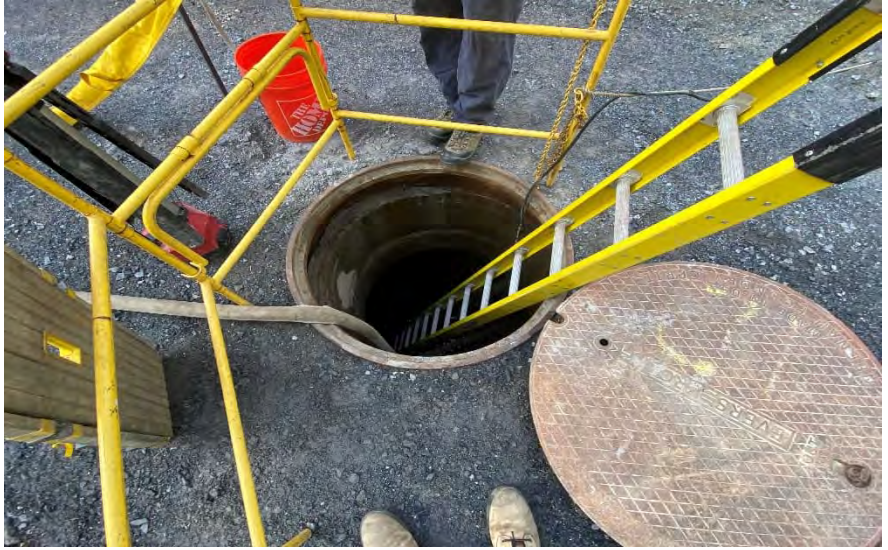
Description: View of area being pumped from manhole #12, segment 5.

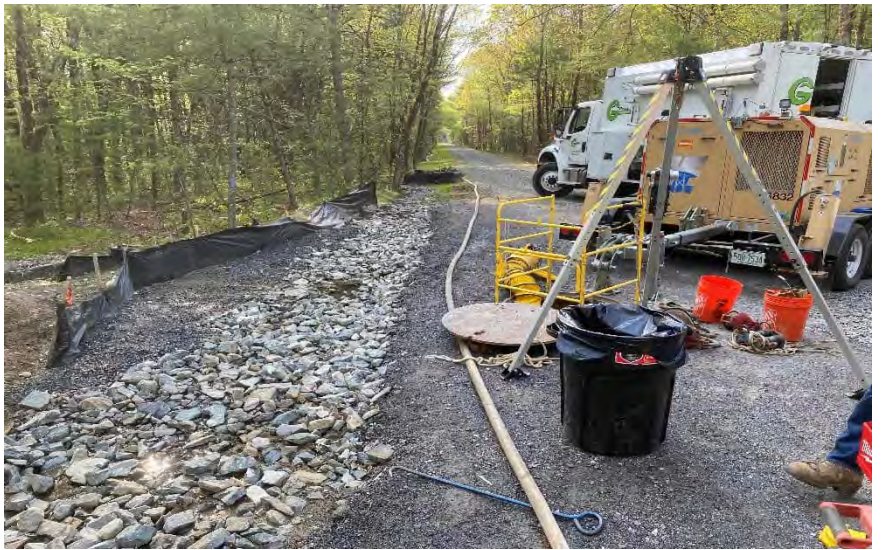
Description: Manhole #12. View of dewatering operation. Looking eastward.

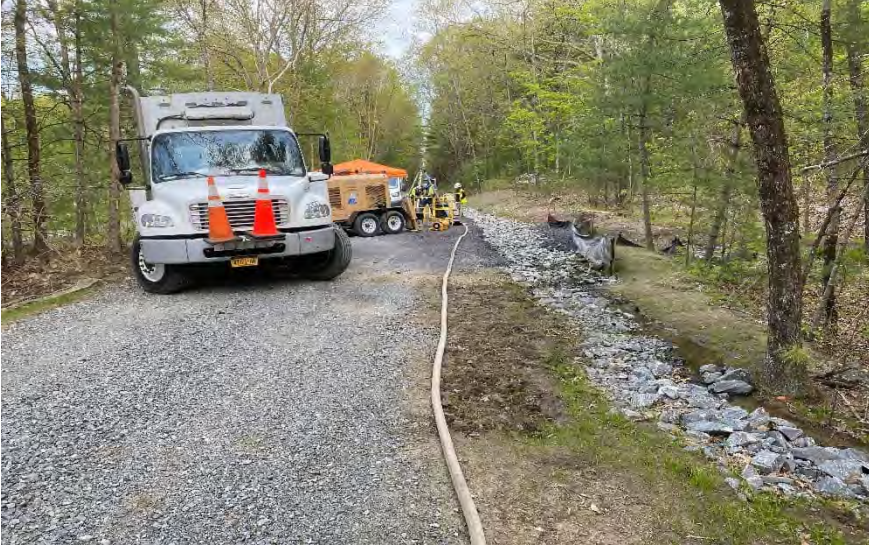
Description: Manhole #12. View of dewatering operation, looking westward.

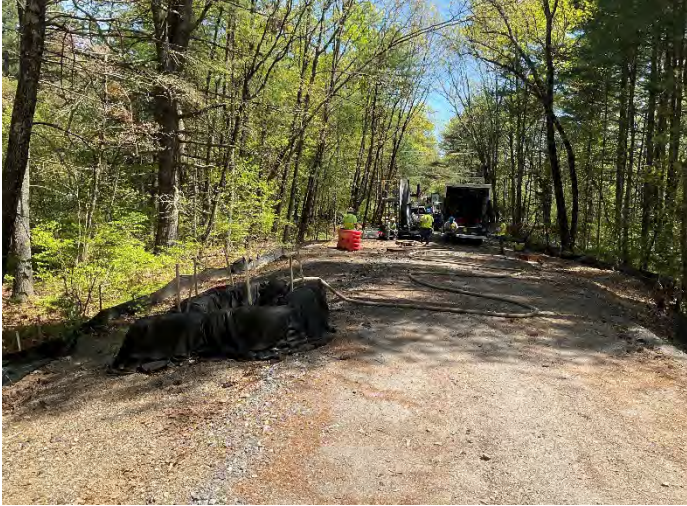
Description: View of Haugland work area within segment 5. Facing east.

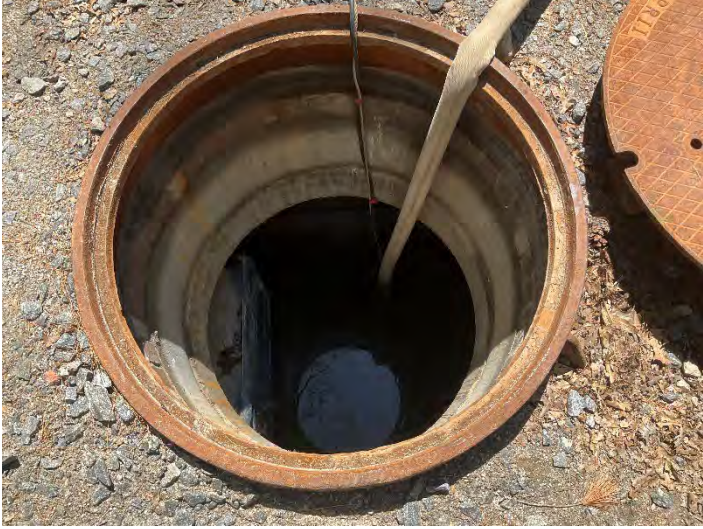
Description: View of pump in MH #13. Water appeared clear prior to treatment.

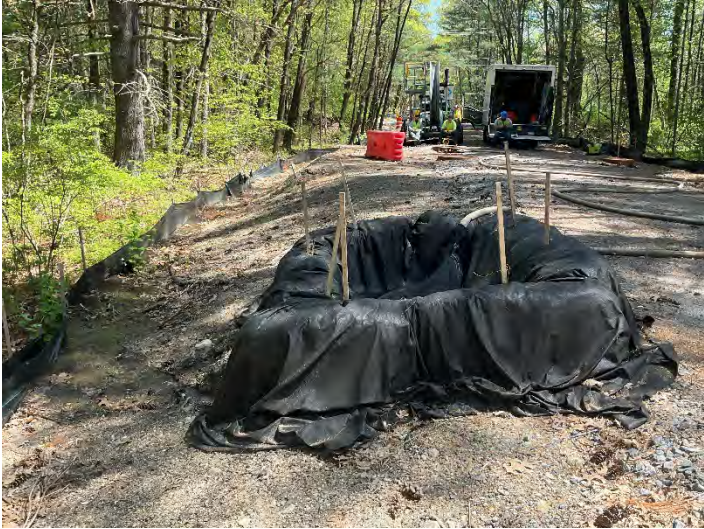
Description: View of dewatering controls (straw bale corral with filter fabric and silt bag). Facing east.

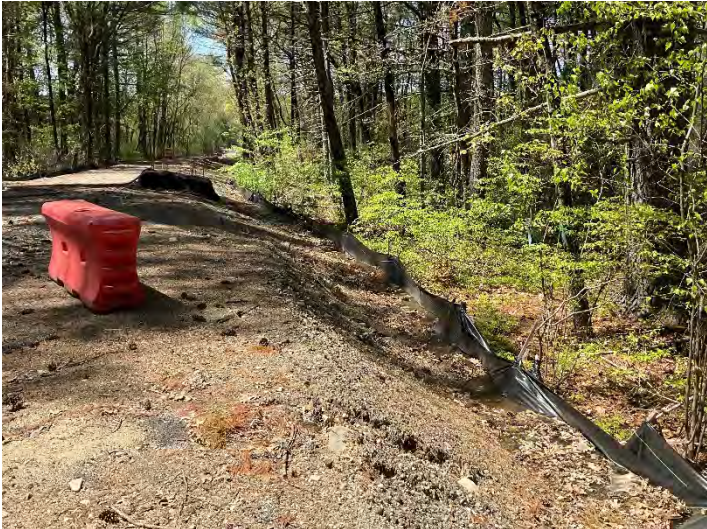
Description: View of discharging water from corral. Discharge appeared clear and turbidity reading was below 50 NTUs. Discharge did not appear to reach any jurisdictional resource areas. Facing west.

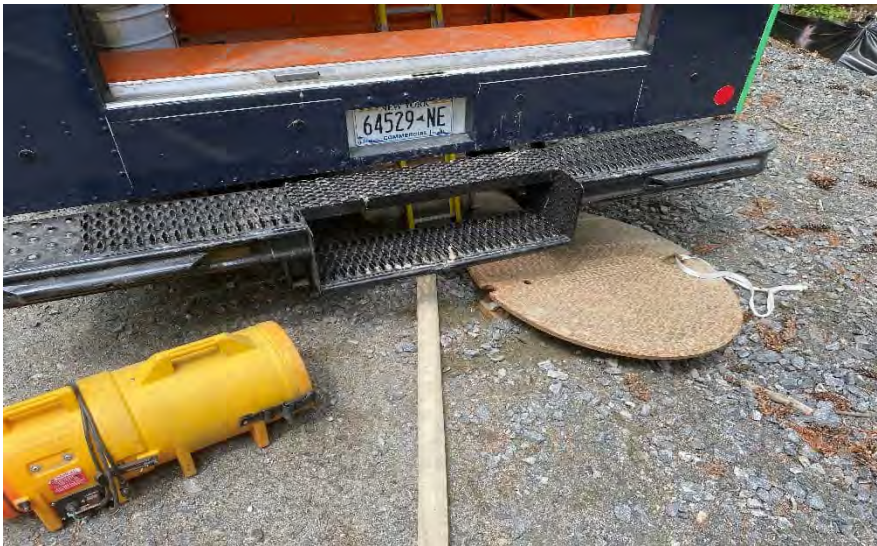
Description: View of area being pumped from manhole #19, segment 9.

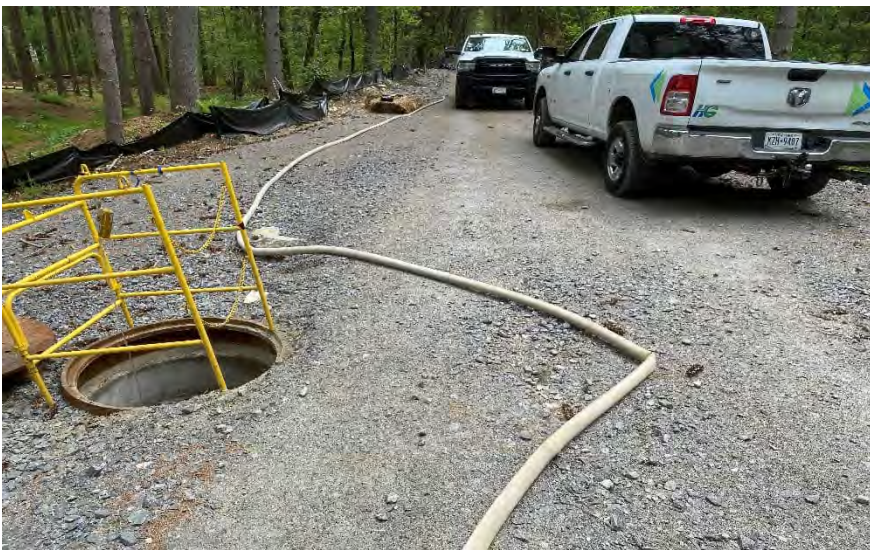
Description: Manhole #19. View of dewatering operation. Looking eastward.

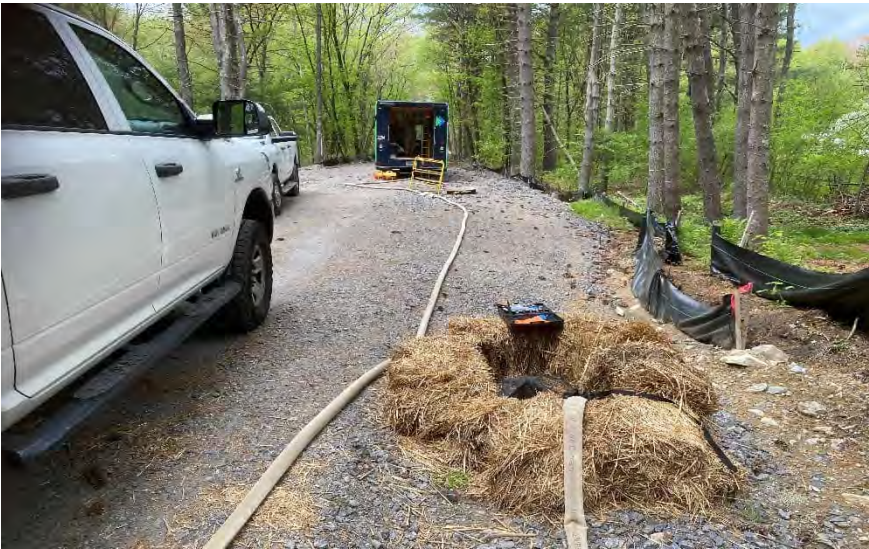
Description: Manhole #19. View of dewatering operation, looking westward.

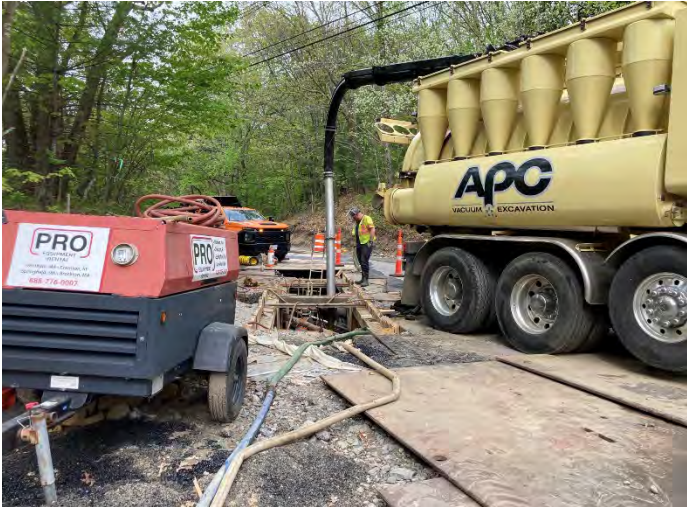
Description: View of Bond working on Wilkins Street. Facing southwest.

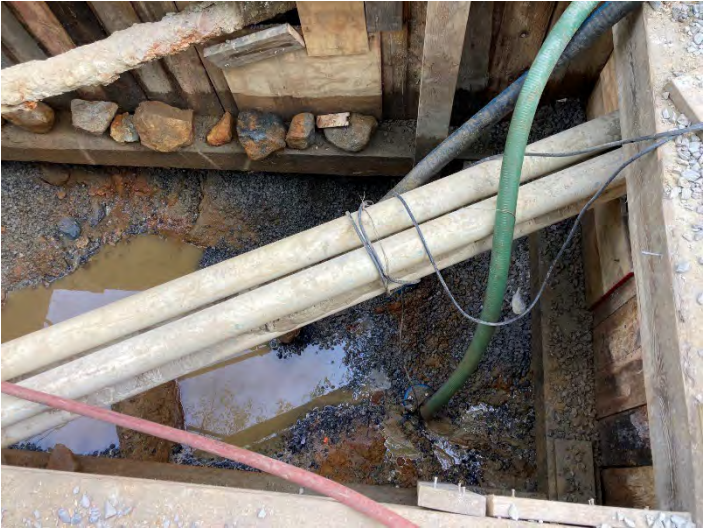
Description: View of pumps in trench within Wilkins Street. Water appeared turbid prior to treatment.

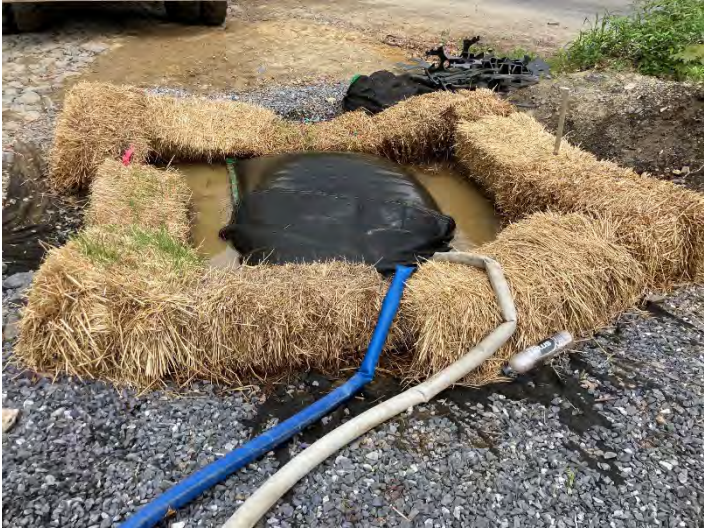
Description: View of dewatering controls (straw bale corral with filter fabric and silt bag). Facing west.

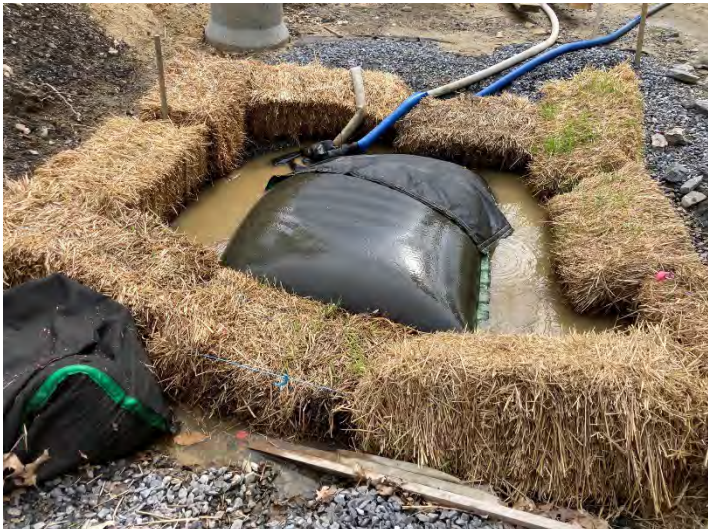
Description: Additional view of dewatering controls and discharge. Discharge appeared slightly turbid and turbidity reading was above 50 NTUs. Facing east.

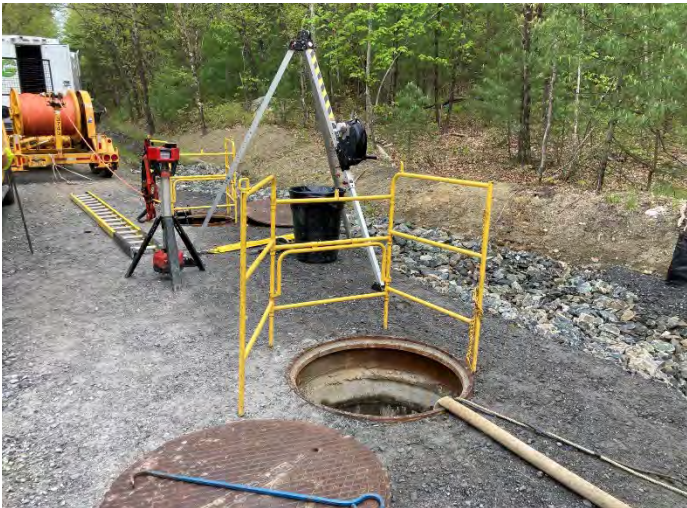
Description: View of Haugland's work area at MH #12 in segment 5. Facing northwest.

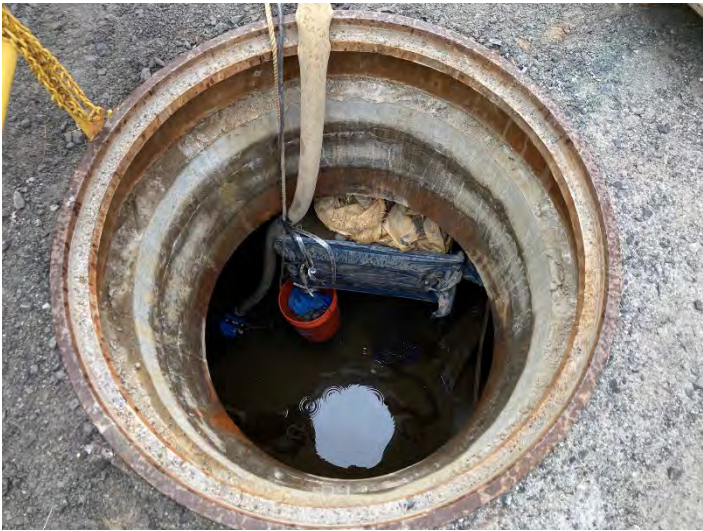
Description: View of pump in MH #12. Water appeared clear prior to treatment.
