Weekly Environmental Compliance Summary

Sudbury to Hudson Transmission Reliability Project (USEPA Tracking # MAR1003UW)

Sudbury, Hudson, and Stow, MA

Week of: May 13, 2024 to May 18, 2024

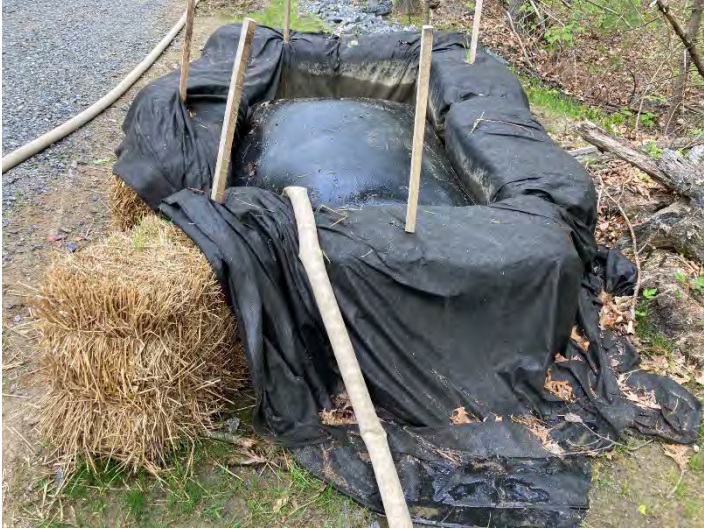
Description: View of dewatering controls (straw bale corral with filter fabric and silt bag). Facing west.

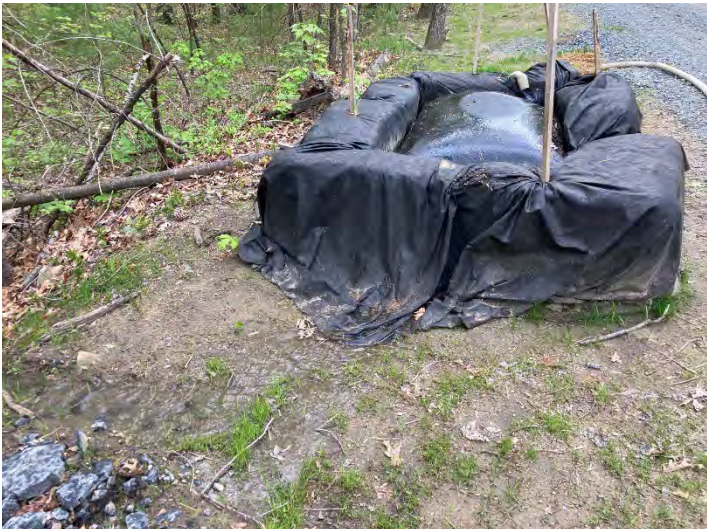
Description: View of water discharging from corral. Discharge appeared clear and turbidity reading was below 50 NTUs. Discharge did not appear to reach any jurisdictional resource areas. Facing east.

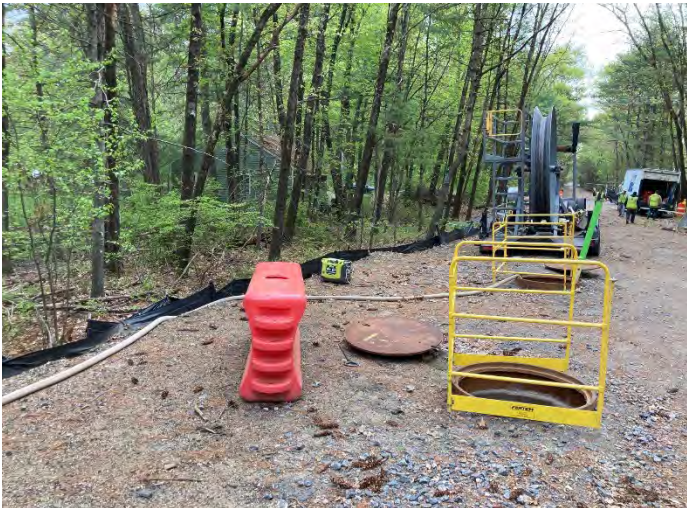
Description: View of Haugland's work area at MH #13 in segment 5. Facing east.

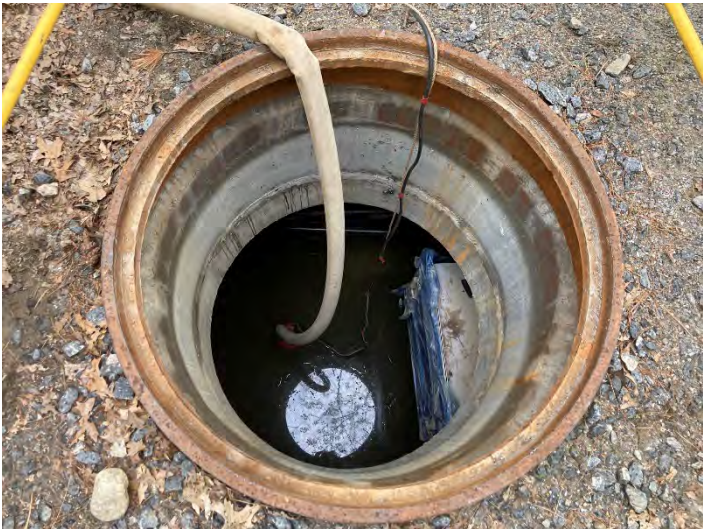
Description: View of pump in MH #13. Water appeared clear prior to treatment.

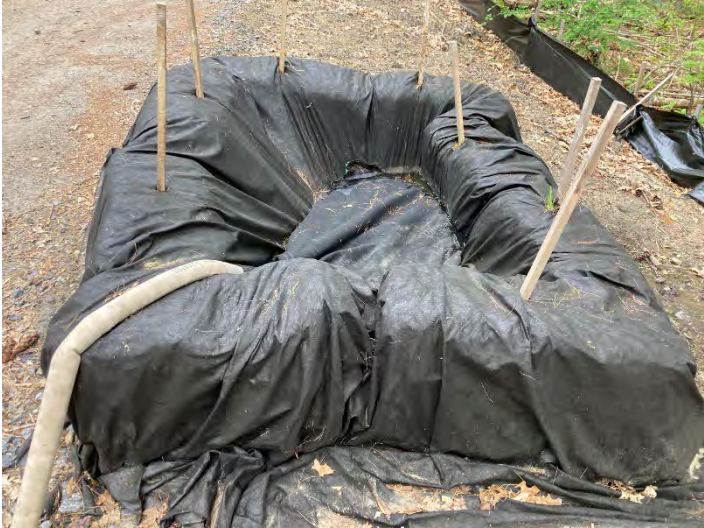
Description: View of dewatering controls (straw bale corral with filter fabric and silt bag). Facing west.

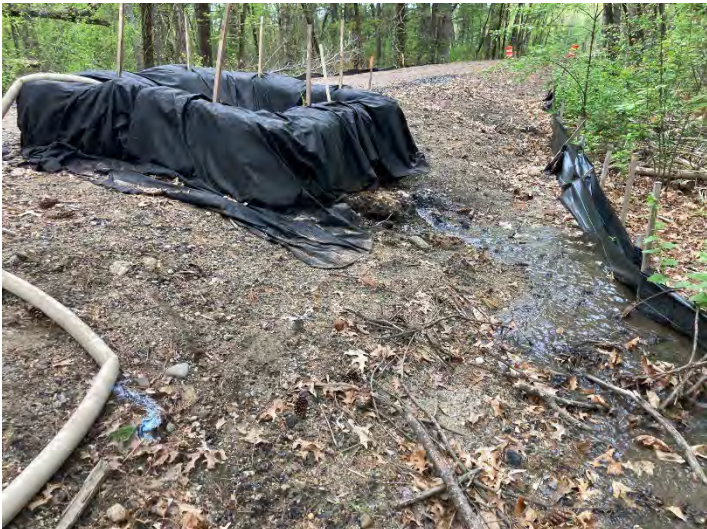
Description: View of discharging water from corral. Discharge appeared clear and turbidity reading was below 50 NTUs. Discharge did not appear to reach any jurisdictional resource areas. Facing west.

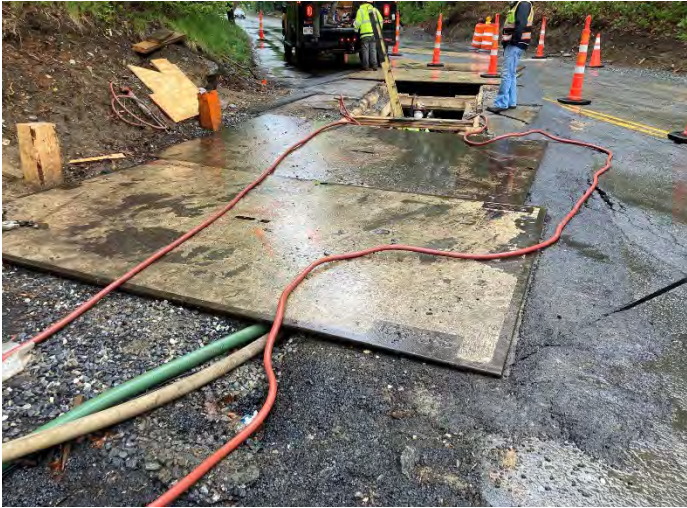
Description: View of Bond working on Wilkins Street. Facing southwest.

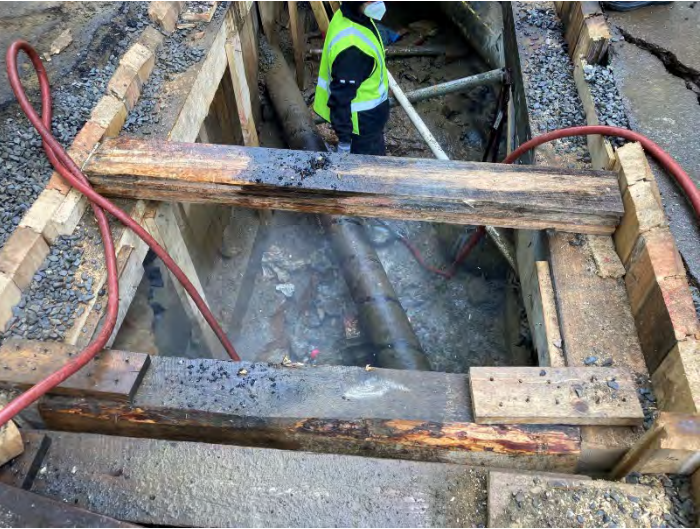
Description: View of water in trench within Wilkins Street. Water appeared turbid prior to treatment.

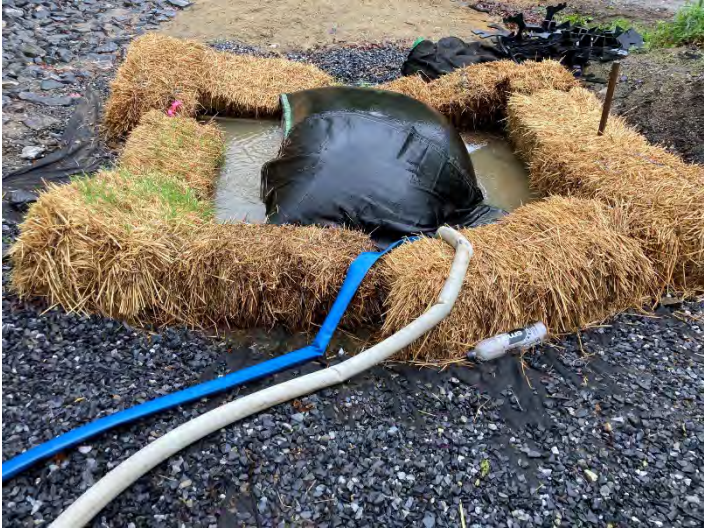
Description: View of dewatering controls (straw bale corral with filter fabric and silt bag). Facing west.

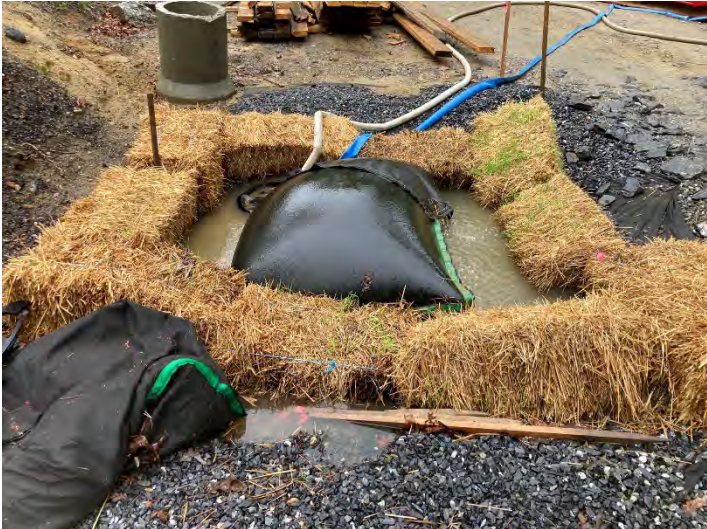
Description: Additional view of dewatering controls and discharge. Discharge appeared slightly turbid and turbidity reading was above 50 NTUs. Facing east.

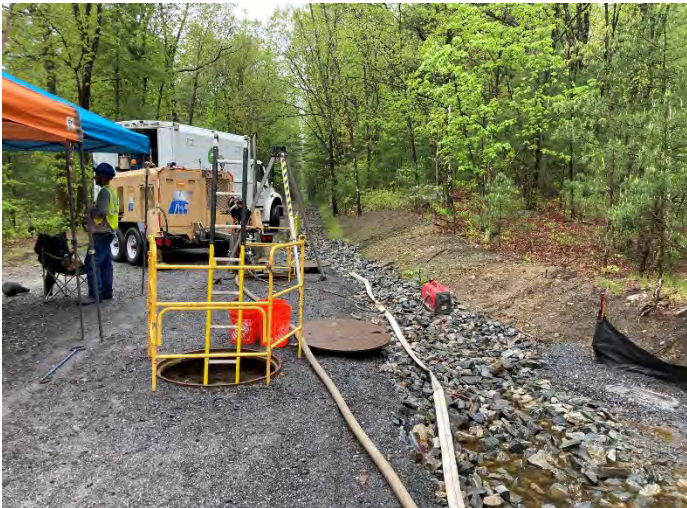
Description: View of Haugland's work area at MH #12 in segment 5. Facing west.

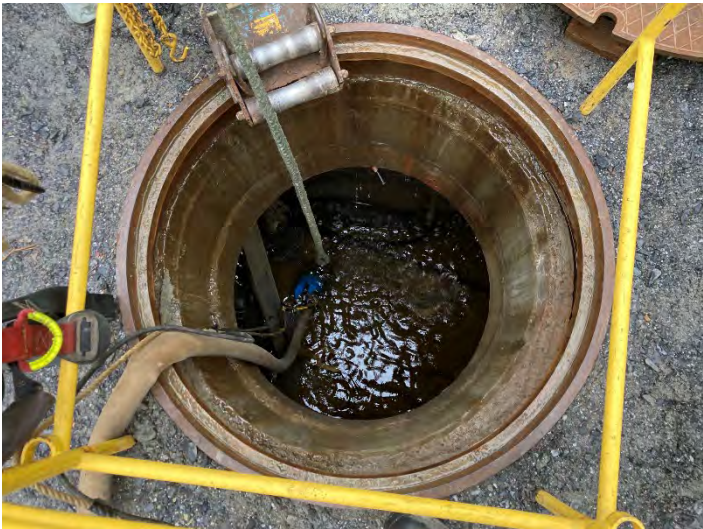
Description: View of pump in MH #12. Water appeared clear prior to treatment.

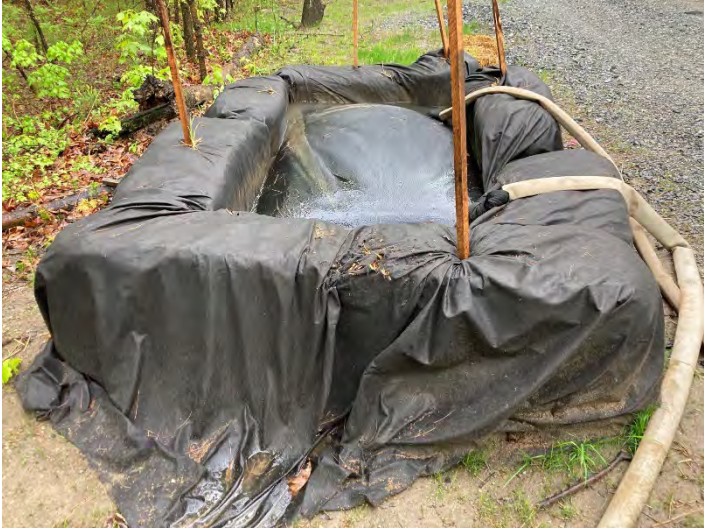
Description: View of dewatering controls (straw bale corral with filter fabric and silt bag). Facing east.

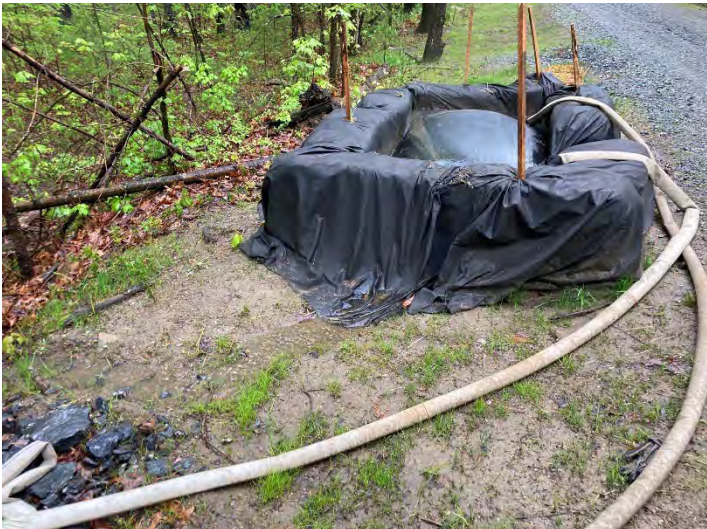
Description: View of water discharging from corral. Discharge appeared clear and turbidity reading was below 50 NTUs. Discharge did not appear to reach any jurisdictional resource areas. Facing east.

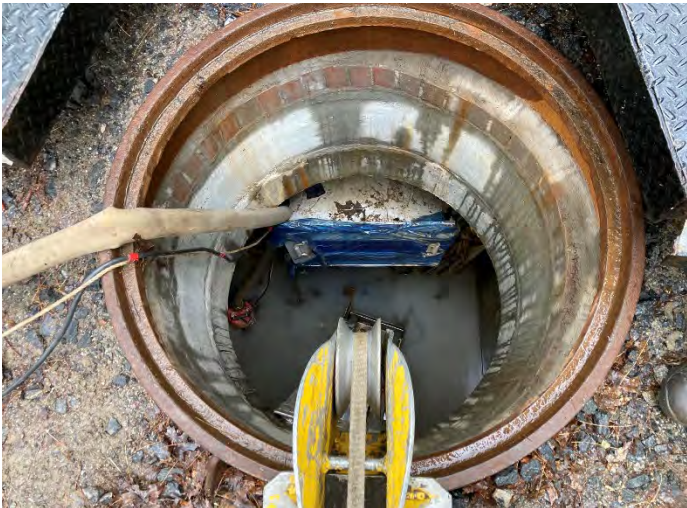
Description: View of pump in MH #13. Water appeared turbid/cloudy and chalky prior to treatment. This is likely due to Polywater cable lubricant being used for cable pull.

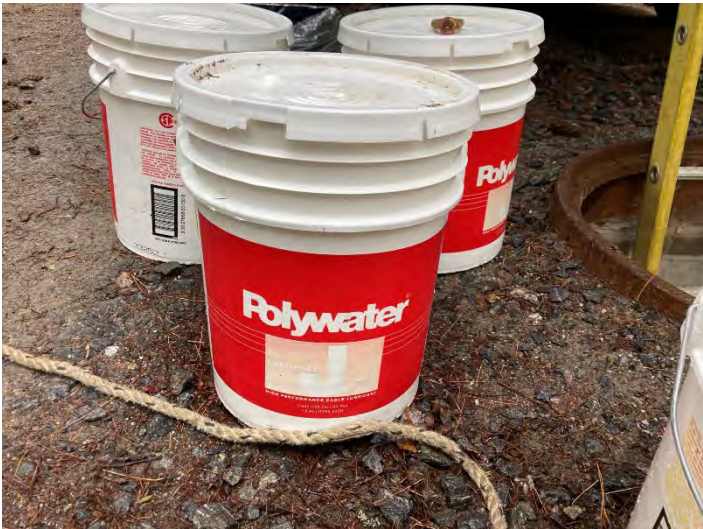
Description: View of Polywater cable lubricant containers near MH #13. Per Haugland personnel and Polywater website, lubricant is environmentally safe. Facing west.

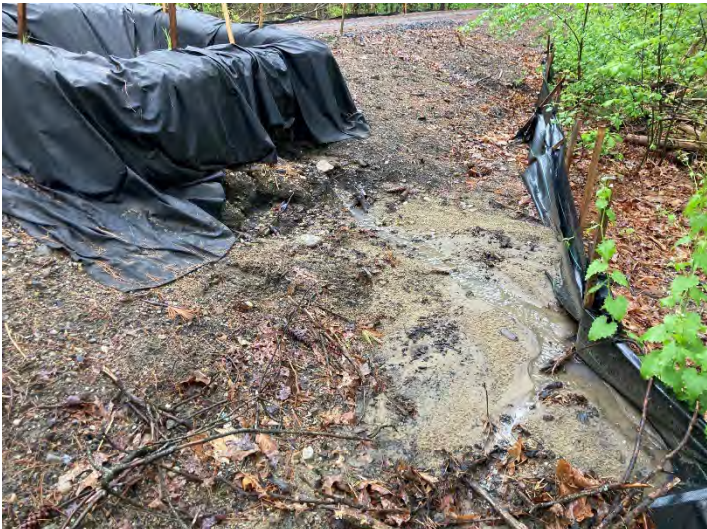
Description: View of discharging water from corral. Discharge appeared turbid/cloudy and chalky. Turbidity reading was above 50 NTUs, but discharge did not appear to reach any jurisdictional resource areas. Facing west.

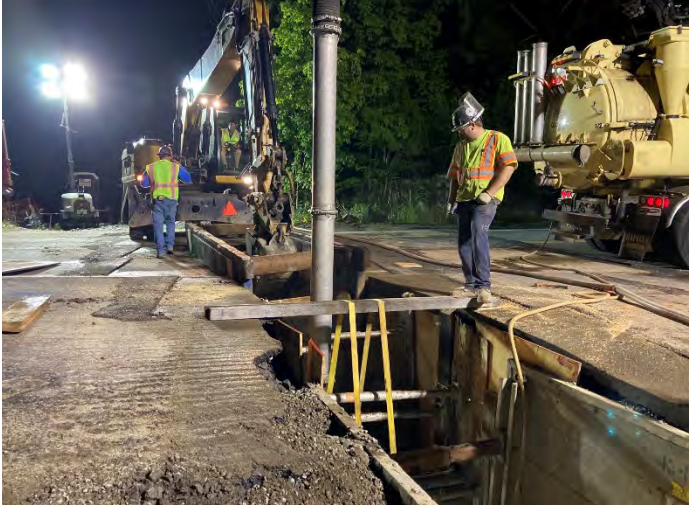
PHOTOGRAPHIC LOG		
Client Name: Eversource		Site Location: Sudbury to Hudson Transmission Reliability Project		Town: Sudbury
Photo No.: 1	Date: 5/16/2024

Description: View of Bond working on Boston Post Rd. Facing east.

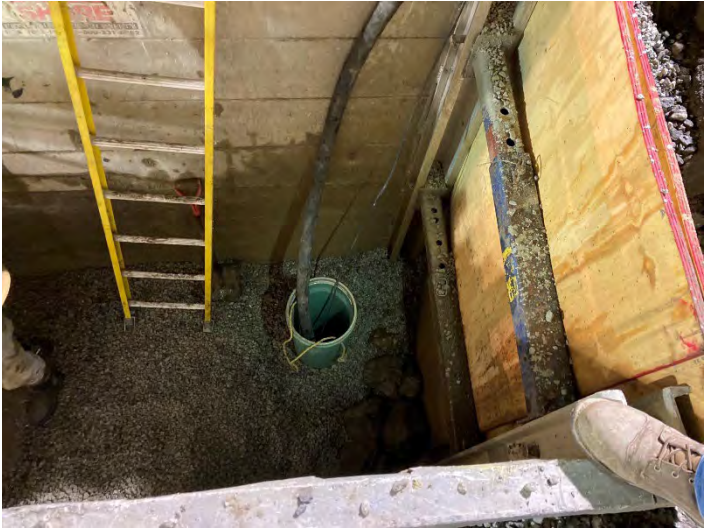
PHOTOGRAPHIC LOG		
Client Name: Eversource		Site Location: Sudbury to Hudson Transmission Reliability Project		Town: Sudbury
Photo No.: 2	Date: 5/16/2024

Description: View of pump in trench. Water appeared turbid prior to treatment.

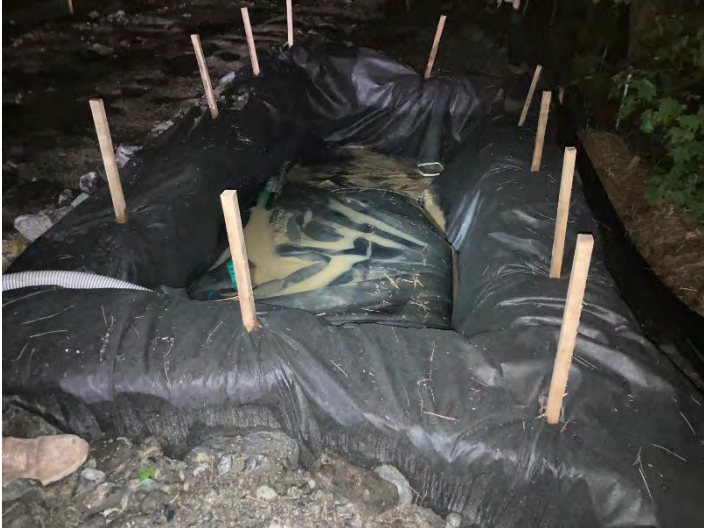
PHOTOGRAPHIC LOG	
Client Name: Eversource		Site Location: Sudbury to Hudson Transmission Reliability Project	
Town: Sudbury			
Photo No.: 3	Date: 5/16/2024

Description: View of dewatering controls (straw bale corral with filter fabric and silt bag) in segment 13. Facing east.

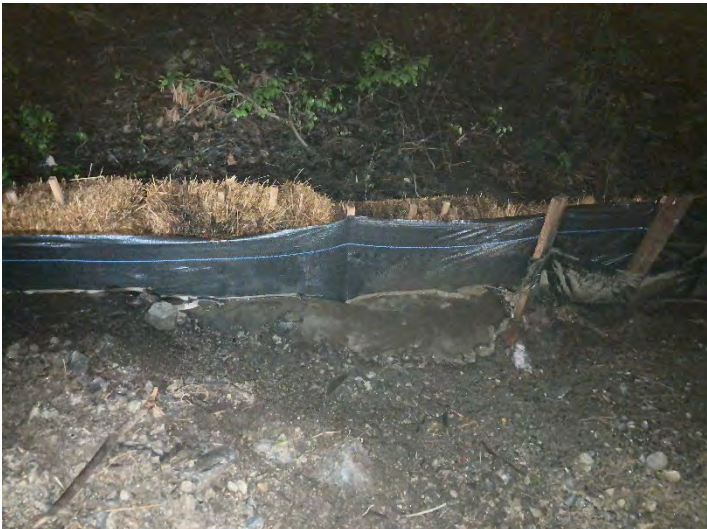
PHOTOGRAPHIC LOG	
Client Name: Eversource		Site Location: Sudbury to Hudson Transmission Reliability Project	
Town: Sudbury			
Photo No.: 4	Date: 5/16/2024

Description: View of water discharging from corral. Discharge appeared turbid. Turbidity reading was above 50 NTUs, but discharge did not appear to reach any jurisdictional resource areas. Facing south.

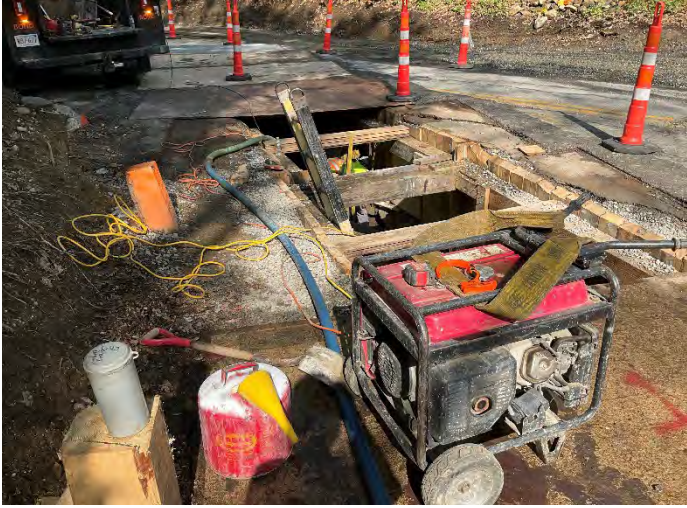
PHOTOGRAPHIC LOG	
Client Name: Eversource		Site Location: Sudbury to Hudson Transmission Reliability Project	Town: Hudson
Photo No.: 1	Date: 5/17/2024

Description: View of Bond working on Wilkins Street trenching. Facing west.

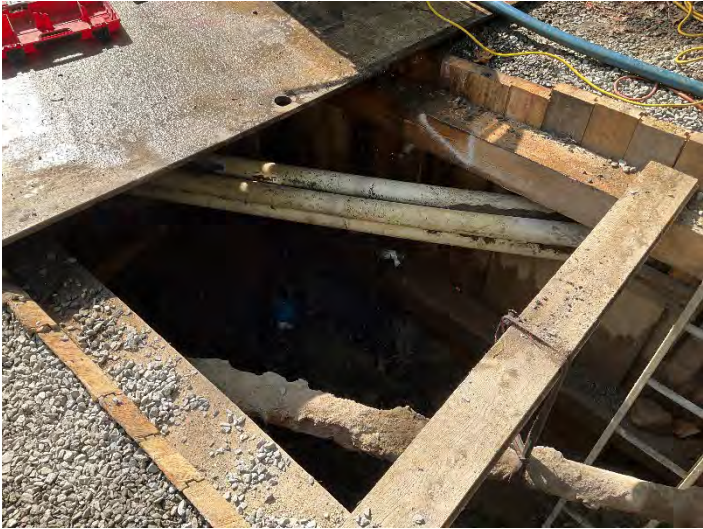
PHOTOGRAPHIC LOG	
Client Name: Eversource		Site Location: Sudbury to Hudson Transmission Reliability Project	Town: Hudson
Photo No.: 2	Date: 5/17/2024

Description: View of pump in trench within Wilkins Street. Water appeared cloudy prior to treatment.

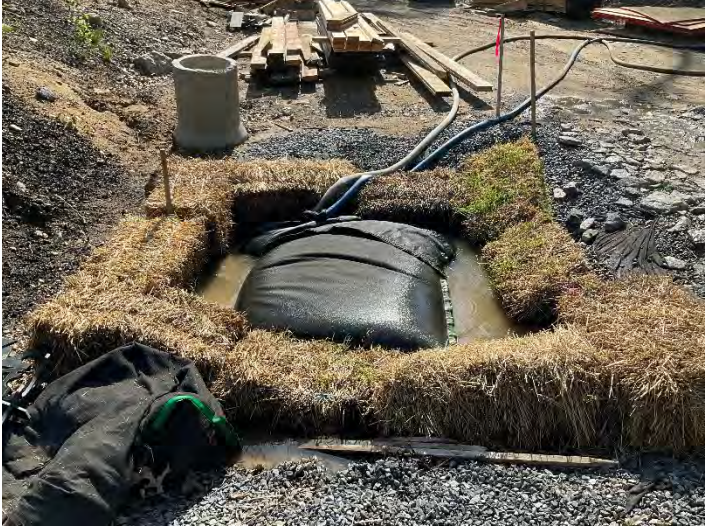
PHOTOGRAPHIC LOG	
Client Name: Eversource		Site Location: Sudbury to Hudson Transmission Reliability Project	Town: Hudson
Photo No.: 3	Date: 5/17/2024

Description: View of dewatering controls (straw bale corral with filter fabric and silt bag). Facing east.

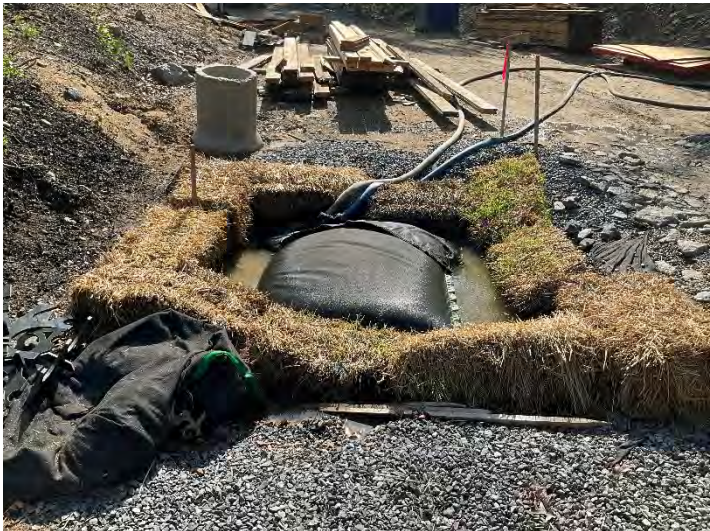
PHOTOGRAPHIC LOG	
Client Name: Eversource		Site Location: Sudbury to Hudson Transmission Reliability Project	Town: Hudson
Photo No.: 4	Date: 5/17/2024

Description: View of discharging water from corral. Discharge appeared turbid and turbidity reading was above 50 NTUs. Water was being discharged to catch basin underneath filter fabric. Facing east.

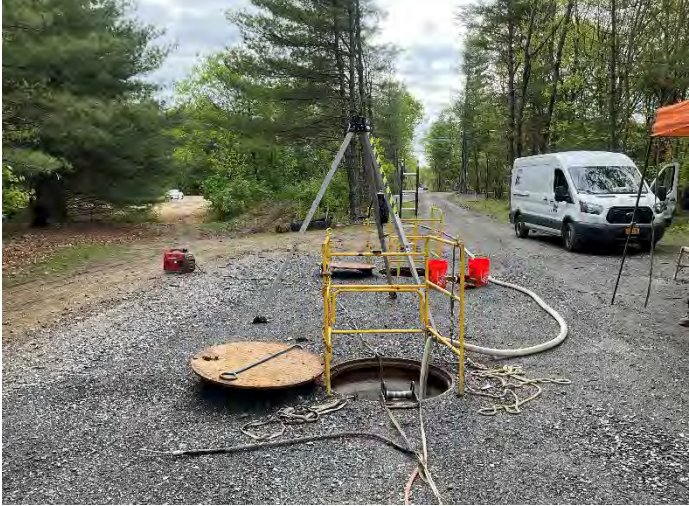
PHOTOGRAPHIC LOG	
Client Name: Eversource		Site Location: Sudbury to Hudson Transmission Reliability Project	Town: Hudson
Photo No.: 1	Date: 5/17/2024

Description: View of Haugland workspace in segment 2 at MH #7 swabbing and installing GCC. Facing east.

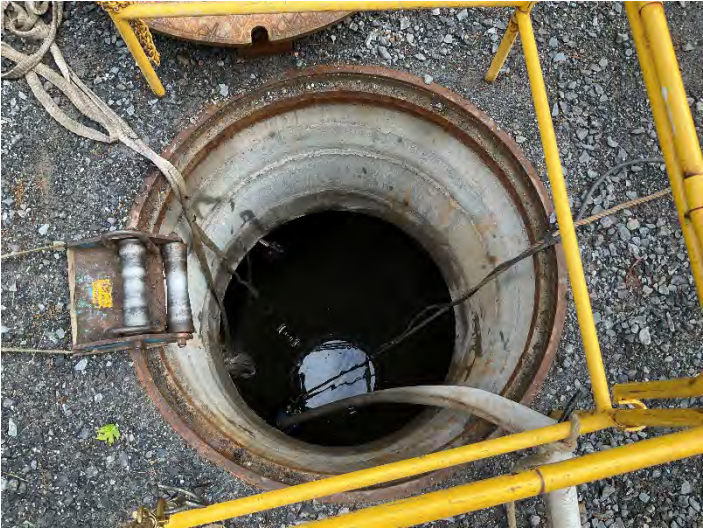
PHOTOGRAPHIC LOG	
Client Name: Eversource		Site Location: Sudbury to Hudson Transmission Reliability Project	Town: Hudson
Photo No.: 2	Date: 5/17/2024

Description: View of pump in MH #7. Water appeared clear prior to treatment.

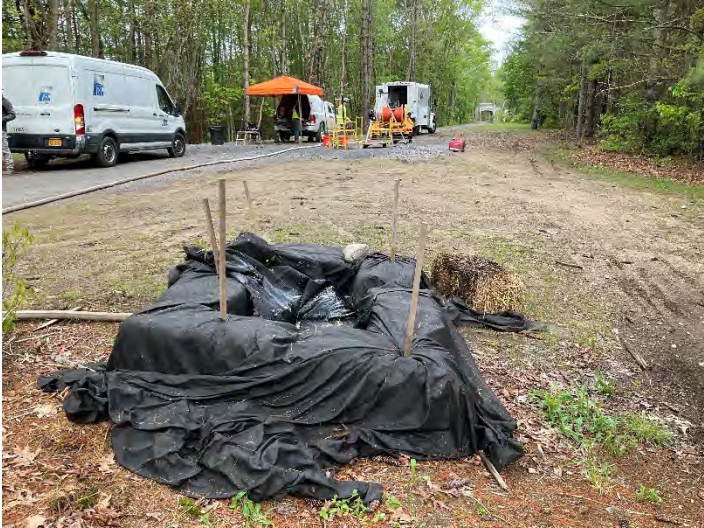
PHOTOGRAPHIC LOG	
Client Name: Eversource		Site Location: Sudbury to Hudson Transmission Reliability Project	
Town: Hudson			
Photo No.: 3	Date: 5/17/2024

Description: View of dewatering controls (straw bale corral with filter fabric and silt bag). Facing west.

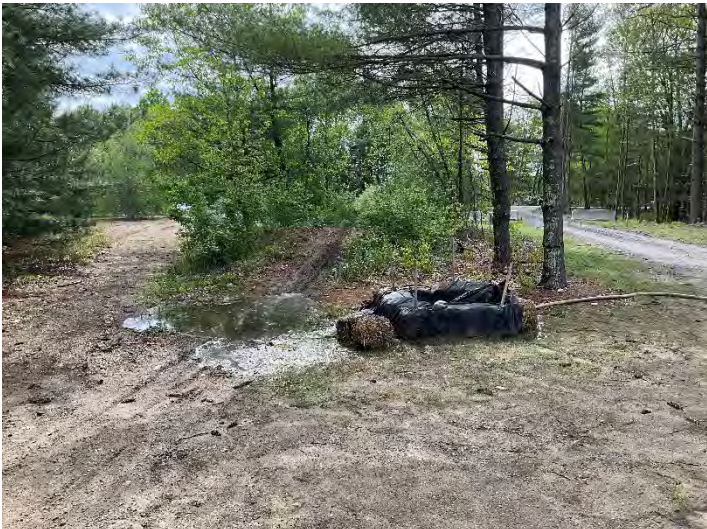
PHOTOGRAPHIC LOG	
Client Name: Eversource		Site Location: Sudbury to Hudson Transmission Reliability Project	
Town: Hudson			
Photo No.: 4	Date: 5/17/2024

Description: View of discharging water from corral. Discharge appeared clear and turbidity reading was below 50 NTUs. Discharge did not appear to reach any jurisdictional resource areas. Facing east.

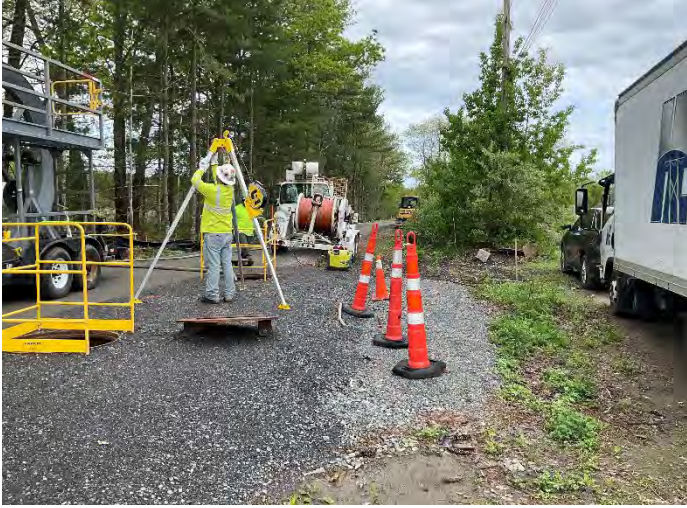
PHOTOGRAPHIC LOG	
Client Name: Eversource		Site Location: Sudbury to Hudson Transmission Reliability Project	Town: Hudson
Photo No.: 1	Date: 5/17/2024

Description: View of Haugland workspace in segment 3 at MH #8. Facing west.

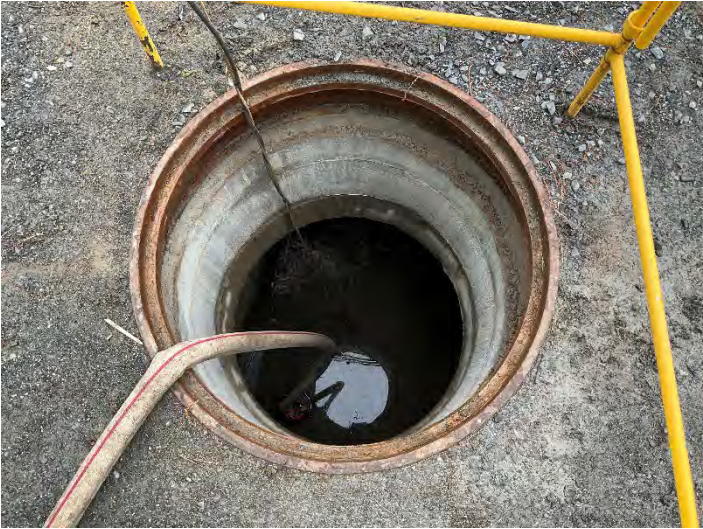
PHOTOGRAPHIC LOG	
Client Name: Eversource		Site Location: Sudbury to Hudson Transmission Reliability Project	Town: Hudson
Photo No.: 2	Date: 5/17/2024

Description: View of pump in MH #8. Water appeared clear prior to treatment.

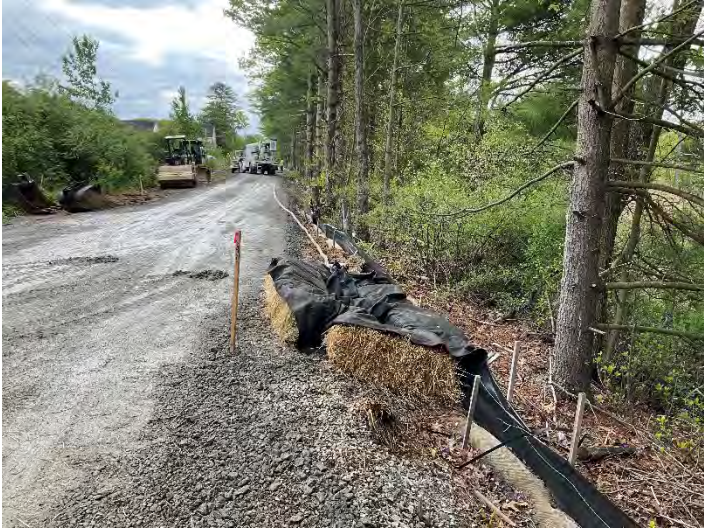
PHOTOGRAPHIC LOG	
Client Name: Eversource		Site Location: Sudbury to Hudson Transmission Reliability Project	
		Town: Hudson	
Photo No.: 3	Date: 5/17/2024

Description: View of dewatering controls (straw bale corral with filter fabric and silt bag). Facing east.

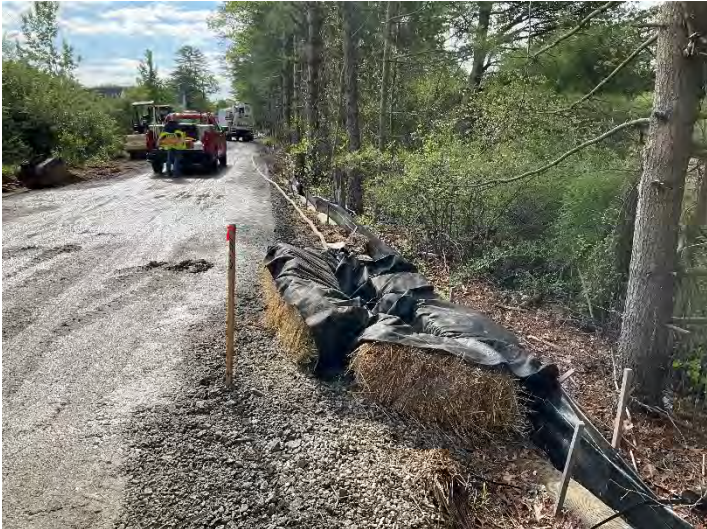
PHOTOGRAPHIC LOG	
Client Name: Eversource		Site Location: Sudbury to Hudson Transmission Reliability Project	
		Town: Hudson	
Photo No.: 4	Date: 5/17/2024

Description: View of dewatering controls (straw bale corral with filter fabric and silt bag). Discharge did not leave the corral and appeared to be clear. No sample taken. Facing east.

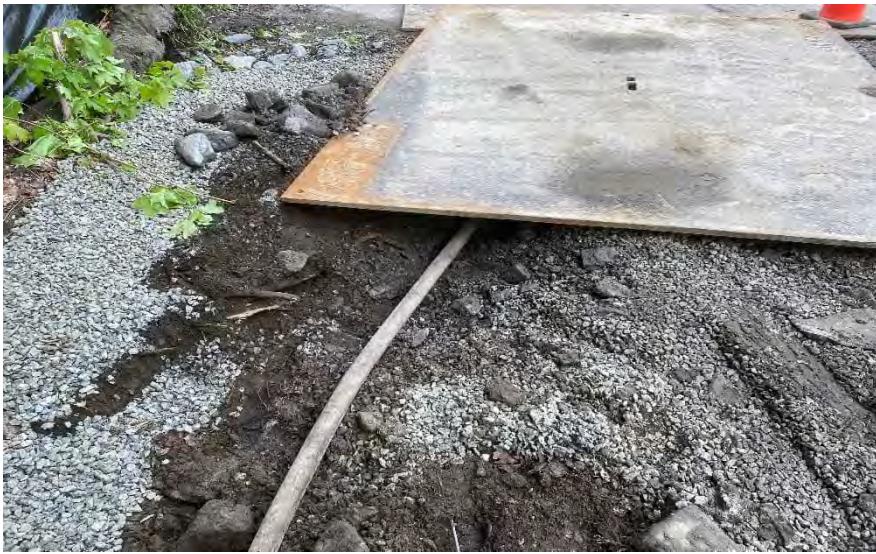
PHOTOGRAPHIC LOG	
Client Name: Eversource		Site Location: Sudbury to Hudson Transmission Reliability Project	Town: Sudbury
Photo No.: 1	Date: 5/17/2024

Description: View of area being pumped from trench across Boston Post Road.

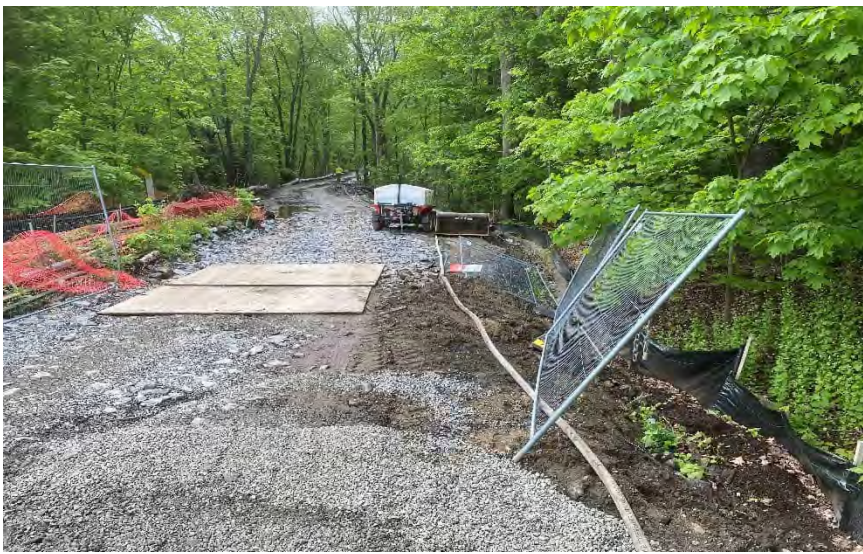
PHOTOGRAPHIC LOG	
Client Name: Eversource		Site Location: Sudbury to Hudson Transmission Reliability Project	Town: Sudbury
Photo No.: 2	Date: 5/17/2024

Description: Boston Post Road trench. View of dewatering operation. Looking eastward.

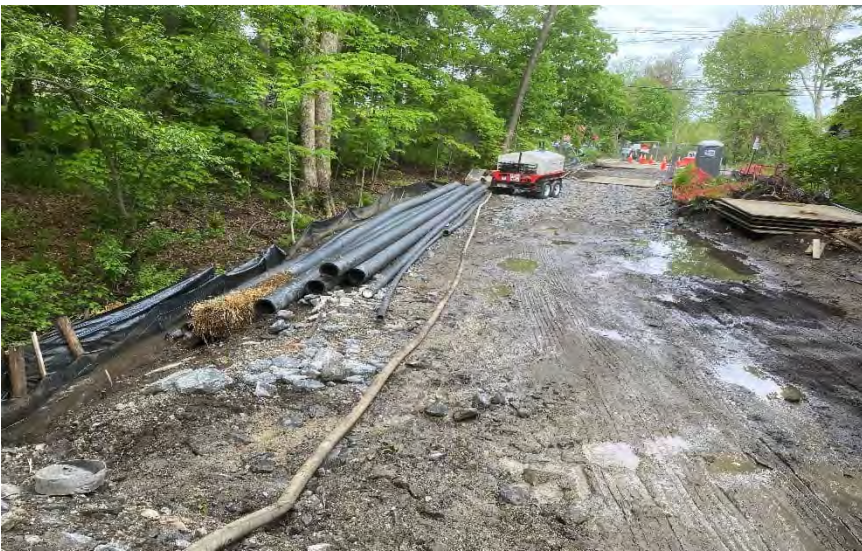
PHOTOGRAPHIC LOG	
Client Name: Eversource		Site Location: Sudbury to Hudson Transmission Reliability Project	Town: Sudbury
Photo No.: 3	Date: 5/17/2024

Description: Boston Post Road trench. View of dewatering operation, looking westward.

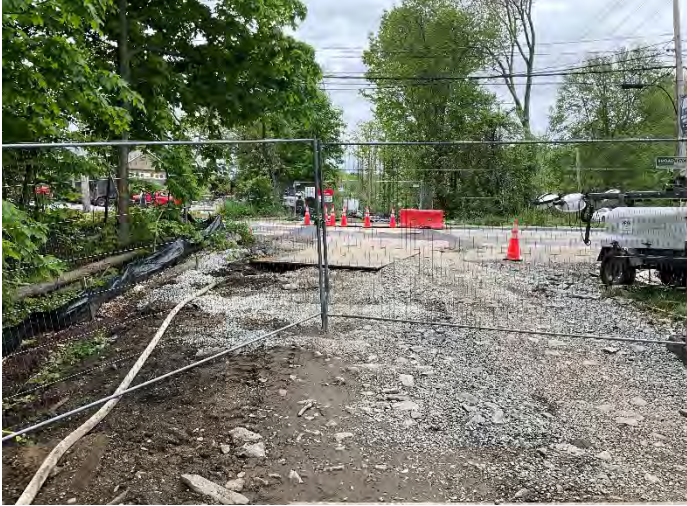
PHOTOGRAPHIC LOG	
Client Name: Eversource		Site Location: Sudbury to Hudson Transmission Reliability Project	Town: Sudbury
Photo No.: 1	Date: 5/18/2024

Description: View of Boston Post Road work area. Dewatering 24/7 to corral in Segment 13. Facing west.

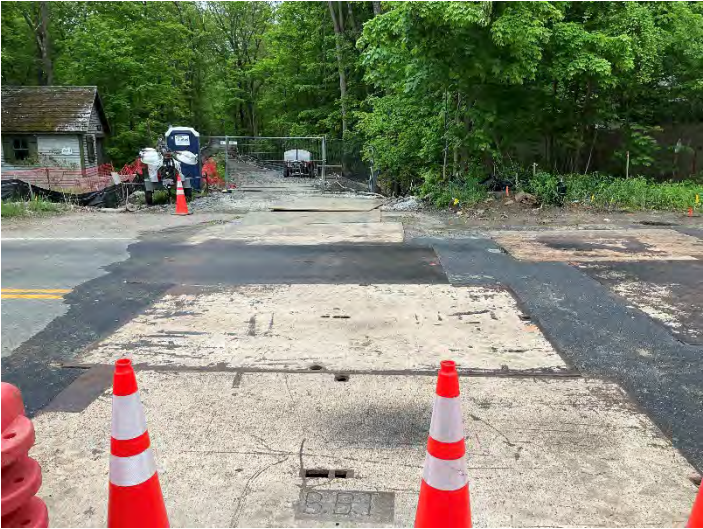
PHOTOGRAPHIC LOG	
Client Name: Eversource		Site Location: Sudbury to Hudson Transmission Reliability Project	Town: Sudbury
Photo No.: 2	Date: 5/18/2024

Description: View of steel plates covering trench and pump within Boston Post Road. Facing east.

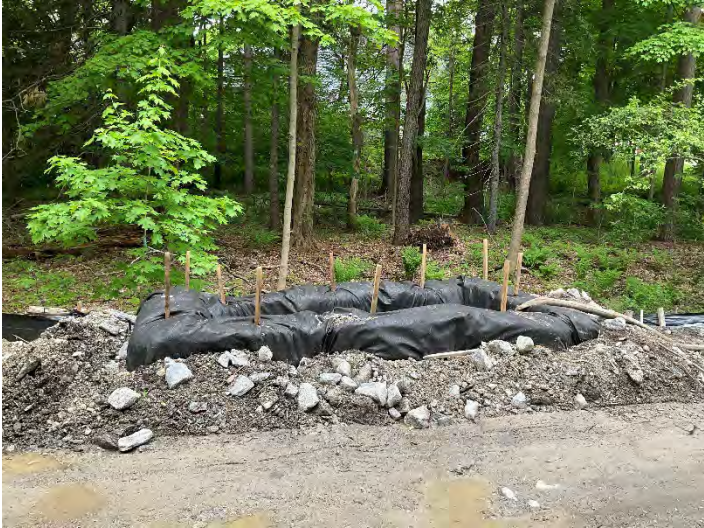
PHOTOGRAPHIC LOG	
Client Name: Eversource		Site Location: Sudbury to Hudson Transmission Reliability Project	
Town: Sudbury			
Photo No.: 3	Date: 5/18/2024

Description: View of dewatering controls (straw bale corral with filter fabric and silt bag). Facing south.

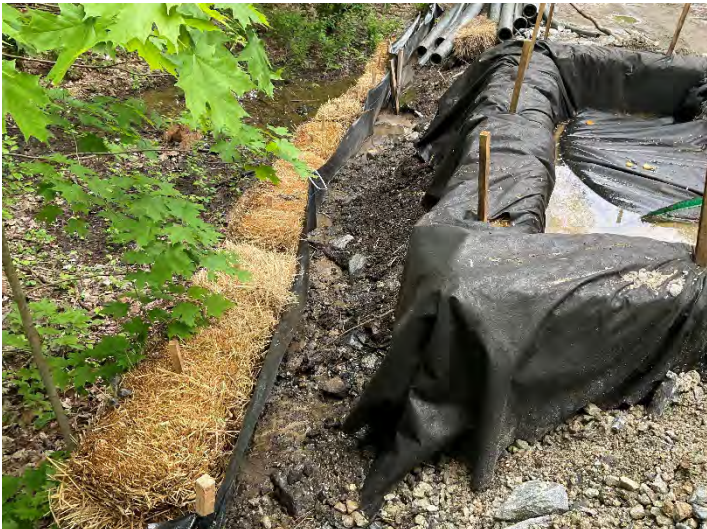
PHOTOGRAPHIC LOG	
Client Name: Eversource		Site Location: Sudbury to Hudson Transmission Reliability Project	
Town: Sudbury			
Photo No.: 4	Date: 5/18/2024

Description: View of discharging water from corral. Discharge appeared clear but was picking up sediment from right of way as it traveled towards silt fencing. Turbidity reading was below 50 NTUs. Discharge did not appear to reach any jurisdictional resource areas. Facing west.
