Weekly Environmental Compliance Summary

Sudbury to Hudson Transmission Reliability Project (USEPA Tracking # MAR1003UW)

Week of: May 28, 2024 to June 1, 2024

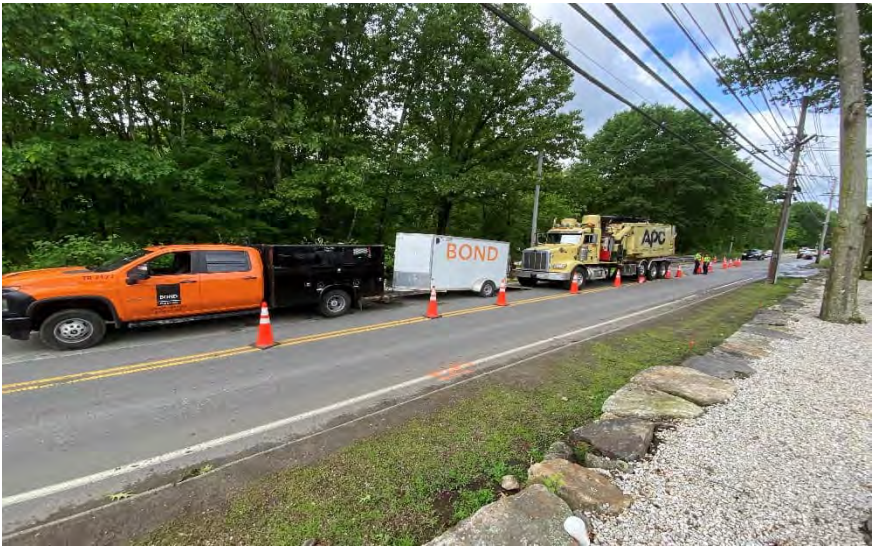
<p>PHOTOGRAPHIC LOG</p>	
<p>Client Name: Eversource</p>		<p>Site Location: Sudbury to Hudson Transmission Reliability Project</p>	<p>Town: Hudson</p>
<p>Photo No.: 6</p>	<p>Date: 5-28-24</p>

<p>Description:</p> <p>Work area within Forest Avenue, conduit work, looking southward.</p>

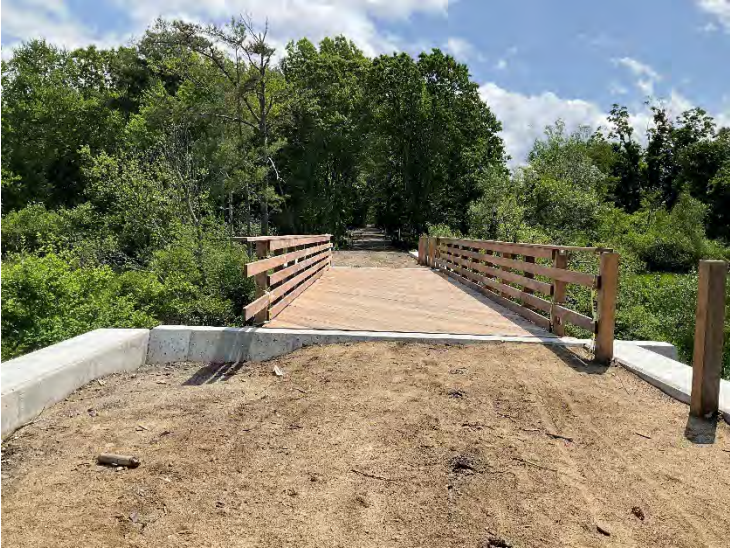
PHOTOGRAPHIC LOG	
Client Name: Eversource		Site Location: Sudbury to Hudson Transmission Reliability Project	Town: Sudbury
Photo No.: 1	Date: 5/28/2024

Description: View of bridge 128. Facing west.

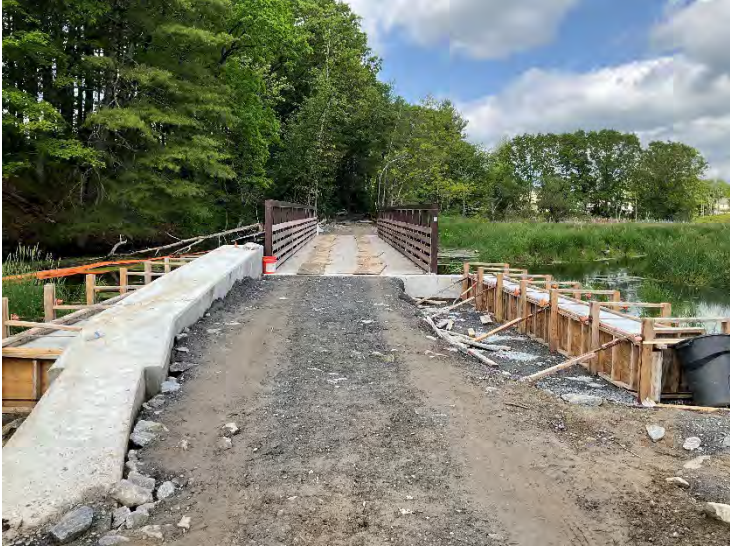
PHOTOGRAPHIC LOG	
Client Name: Eversource		Site Location: Sudbury to Hudson Transmission Reliability Project	Town: Sudbury
Photo No.: 5	Date: 5/28/2024

Description: View of ET&L's work area at bridge 127. Facing west.

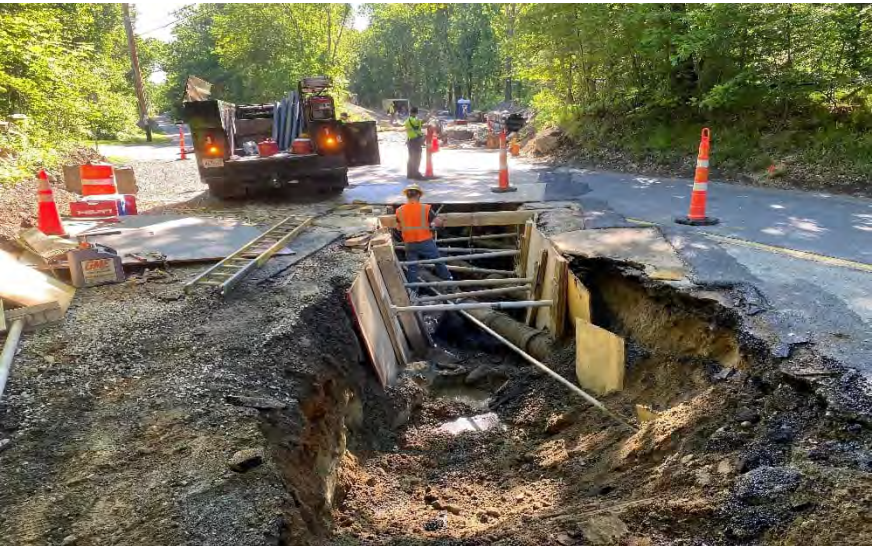
<p align="center">PHOTOGRAPHIC LOG</p>	
<p>Client Name: Eversource</p>		<p>Site Location: Sudbury to Hudson Transmission Reliability Project</p>	<p>Town: Hudson</p>
<p>Photo No.: 2</p>	<p>Date: 5-29-24</p>

<p>Description:</p> <p>Work area within Wilkins Street, ledge removal for conduit work, looking eastward.</p>

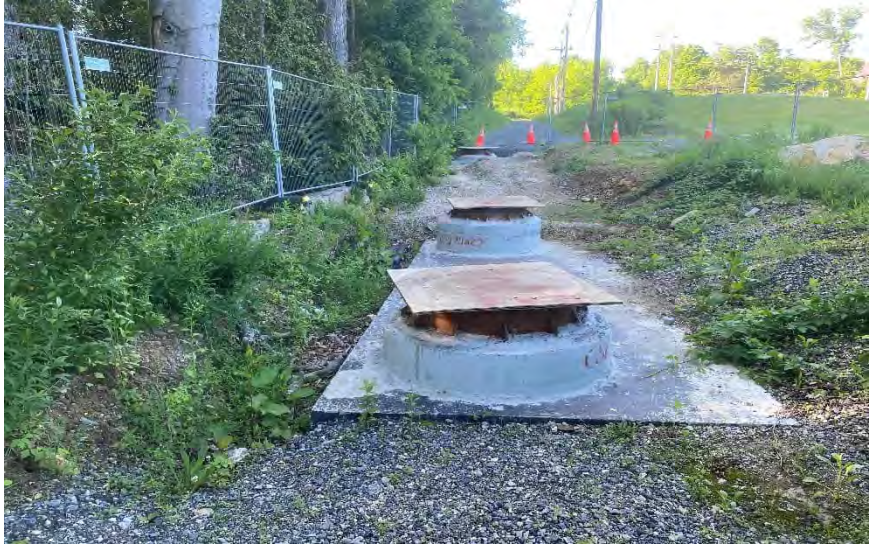
<p align="center">PHOTOGRAPHIC LOG</p>	
<p>Client Name: Eversource</p>		<p>Site Location: Sudbury to Hudson Transmission Reliability Project</p>	<p>Town: Hudson</p>
<p>Photo No.: 4</p>	<p>Date: 5-29-24</p>

<p>Description:</p> <p>Work area at manhole #1, near Hudson Power & Light facility off Forest Avenue, looking eastward.</p>

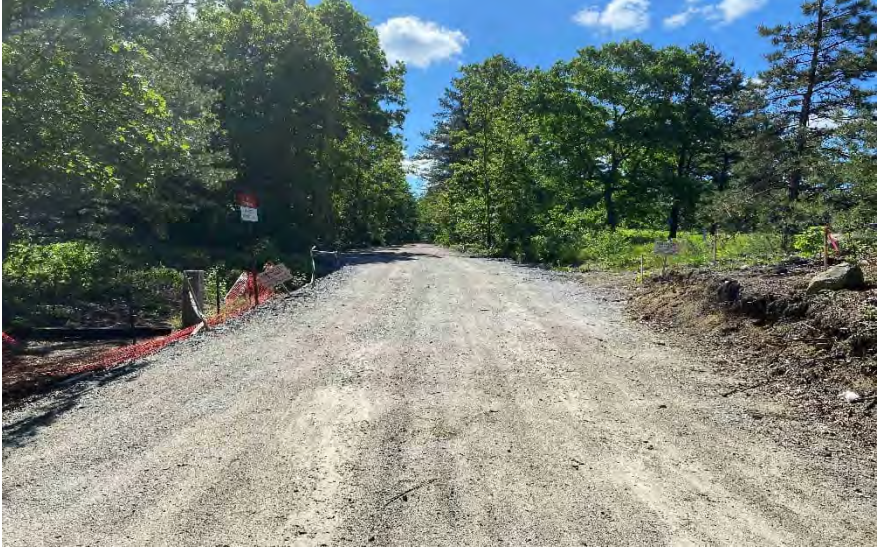
<p>PHOTOGRAPHIC LOG</p>	
<p>Client Name: Eversource</p>		<p>Site Location: Sudbury to Hudson Transmission Reliability Project</p>	<p>Town: Hudson</p>
<p>Photo No.: 5</p>	<p>Date: 5-29-24</p>

<p>Description:</p> <p>Work area within segment 6, at Hudson-Sudbury town line, existing erosion control, looking eastward.</p>

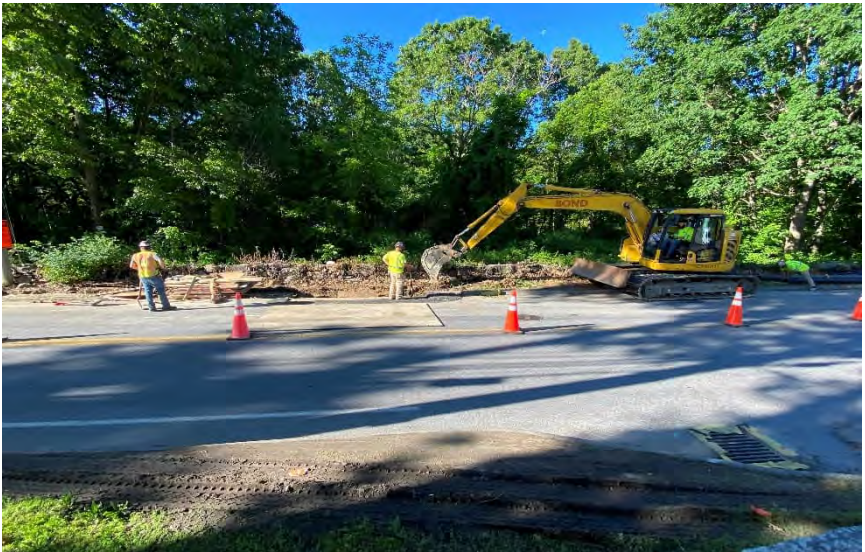
<p>PHOTOGRAPHIC LOG</p>	
<p>Client Name: Eversource</p>		<p>Site Location: Sudbury to Hudson Transmission Reliability Project</p>	<p>Town: Hudson</p>
<p>Photo No.: 6</p>	<p>Date: 5-29-24</p>

<p>Description:</p> <p>Work area within Forest Avenue, conduit work, looking eastward.</p>

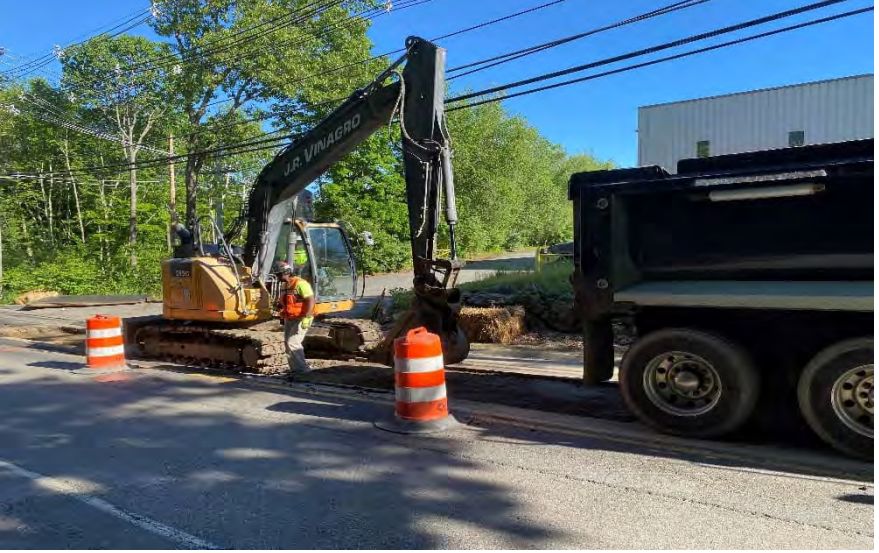
<p>PHOTOGRAPHIC LOG</p>	
<p>Client Name: Eversource</p>		<p>Site Location: Sudbury to Hudson Transmission Reliability Project</p>	<p>Town: Hudson</p>
<p>Photo No.: 7</p>	<p>Date: 5-29-24</p>

<p>Description: Work area within Forest Avenue, conduit removal work, looking westward.</p>

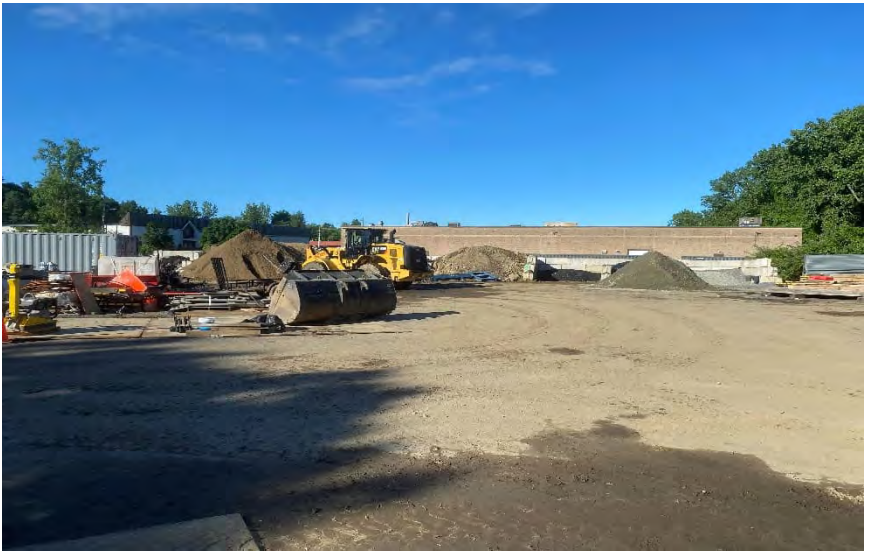
<p>PHOTOGRAPHIC LOG</p>	
<p>Client Name: Eversource</p>		<p>Site Location: Sudbury to Hudson Transmission Reliability Project</p>	<p>Town: Hudson</p>
<p>Photo No.: 8</p>	<p>Date: 5-29-24</p>

<p>Description: Bonazzoli laydown yard, looking westward.</p>

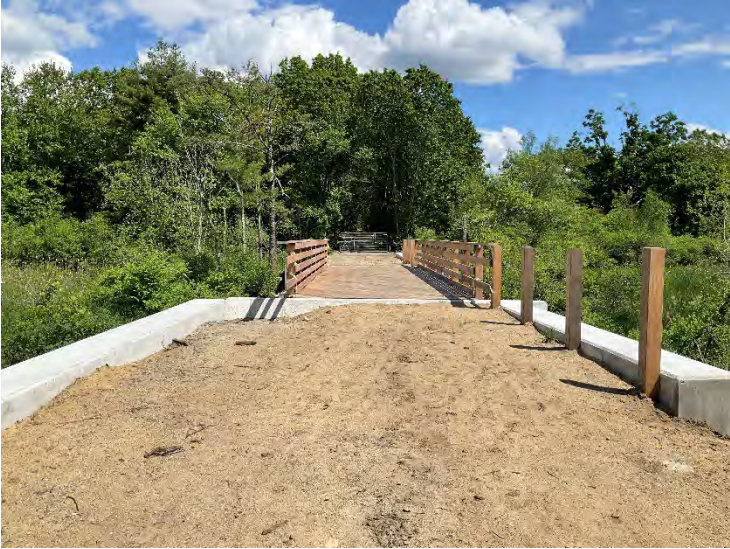
PHOTOGRAPHIC LOG	
Client Name: Eversource		Site Location: Sudbury to Hudson Transmission Reliability Project	Town: Sudbury
Photo No.: 1	Date: 5/29/2024

Description: View of bridge 128. Facing west.

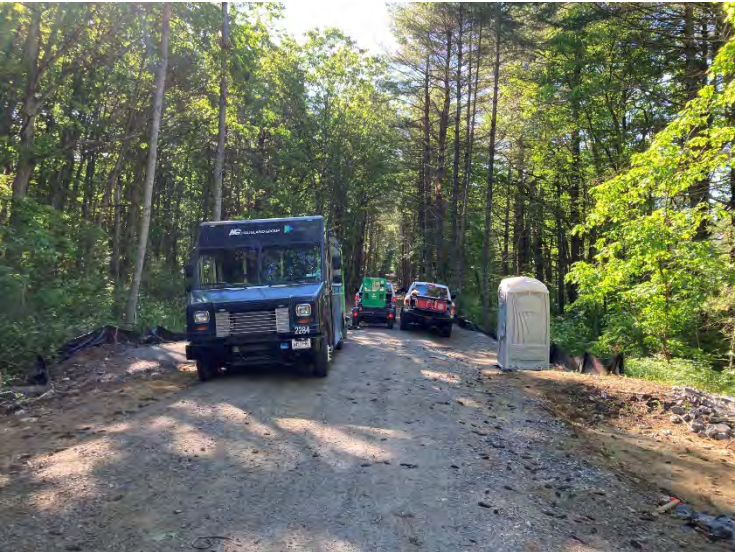
PHOTOGRAPHIC LOG	
Client Name: Eversource		Site Location: Sudbury to Hudson Transmission Reliability Project	Town: Sudbury
Photo No.: 2	Date: 5/29/2024

Description: View of Haugland splicing crew working at MH #20 in segment 10. Facing east.

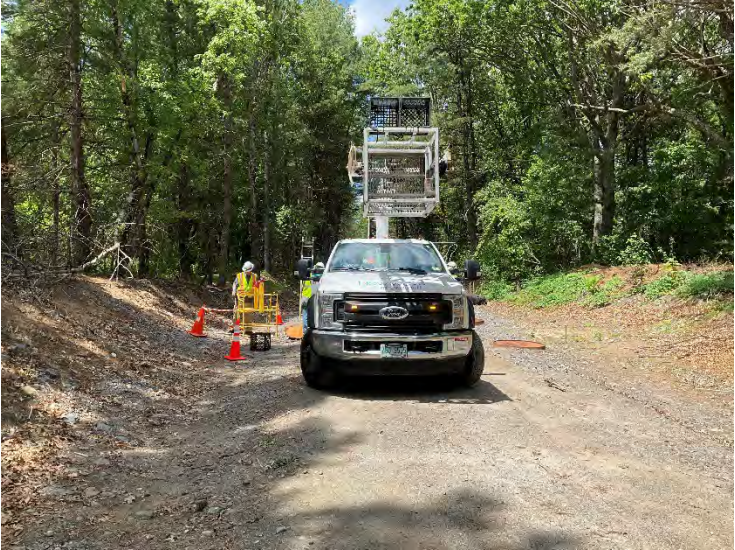
<p>PHOTOGRAPHIC LOG</p>	
<p>Client Name: Eversource</p>		<p>Site Location: Sudbury to Hudson Transmission Reliability Project</p>	<p>Town: Sudbury</p>
<p>Photo No.: 3</p>	<p>Date: 5/29/2024</p>

<p>Description: View of New Wave working at MH #23 in segment 11. Facing west.</p>

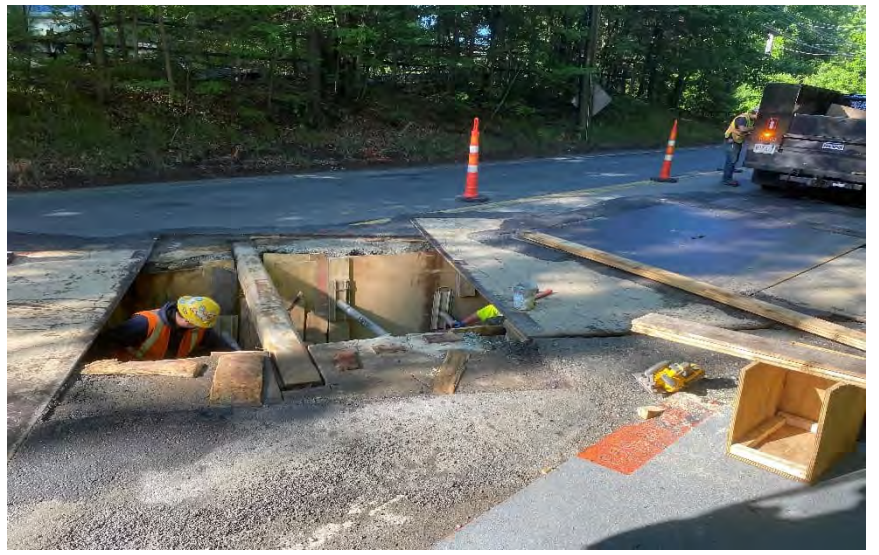
<p align="center">PHOTOGRAPHIC LOG</p>	
<p>Client Name: Eversource</p>		<p>Site Location: Sudbury to Hudson Transmission Reliability Project</p>	<p>Town: Hudson</p>
<p>Photo No.: 2</p>	<p>Date: 5-31-24</p>

<p>Description:</p> <p>Work area within Wilkins Street, ledge removal for conduit work, looking westward.</p>

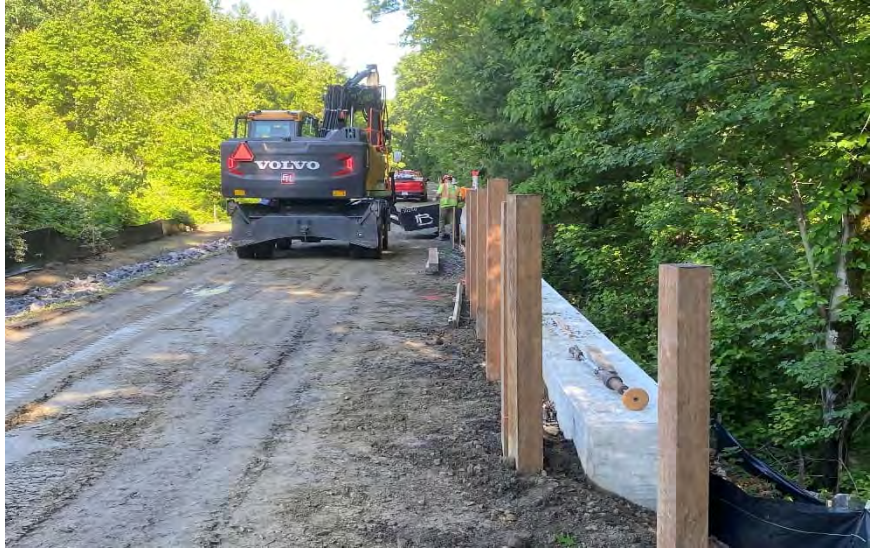
<p>PHOTOGRAPHIC LOG</p>	
<p>Client Name: Eversource</p>		<p>Site Location: Sudbury to Hudson Transmission Reliability Project</p>	<p>Town: Hudson</p>
<p>Photo No.: 4</p>	<p>Date: 5-31-24</p>

<p>Description:</p> <p>Work area within segment 1, wall work, existing erosion control, looking westward.</p>

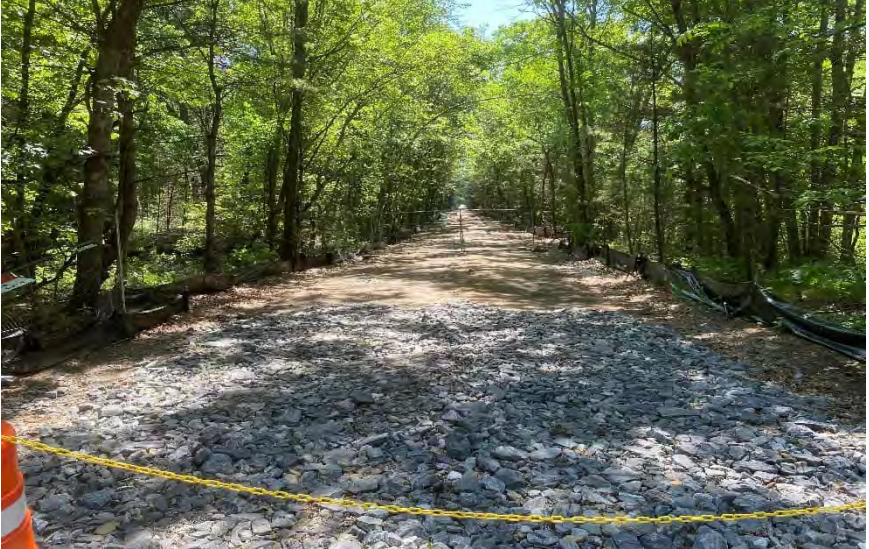
<p>PHOTOGRAPHIC LOG</p>	
<p>Client Name: Eversource</p>		<p>Site Location: Sudbury to Hudson Transmission Reliability Project</p>	<p>Town: Hudson</p>
<p>Photo No.: 5</p>	<p>Date: 5-31-24</p>

<p>Description:</p> <p>Work area within segment 6, existing erosion control, looking eastward.</p>

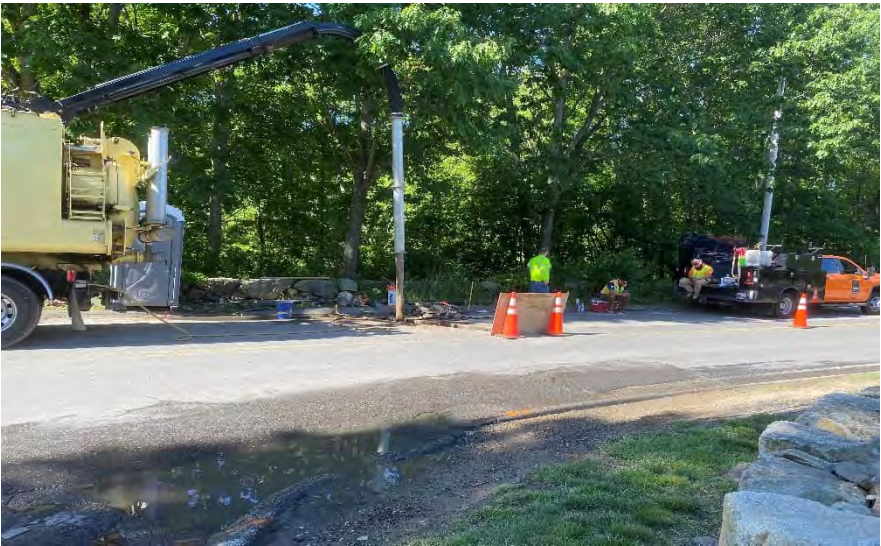
<p>PHOTOGRAPHIC LOG</p>	
<p>Client Name: Eversource</p>		<p>Site Location: Sudbury to Hudson Transmission Reliability Project</p>	<p>Town: Hudson</p>
<p>Photo No.: 6</p>	<p>Date: 5-31-24</p>

<p>Description:</p> <p>Work area within Forest Avenue, conduit work, looking westward.</p>

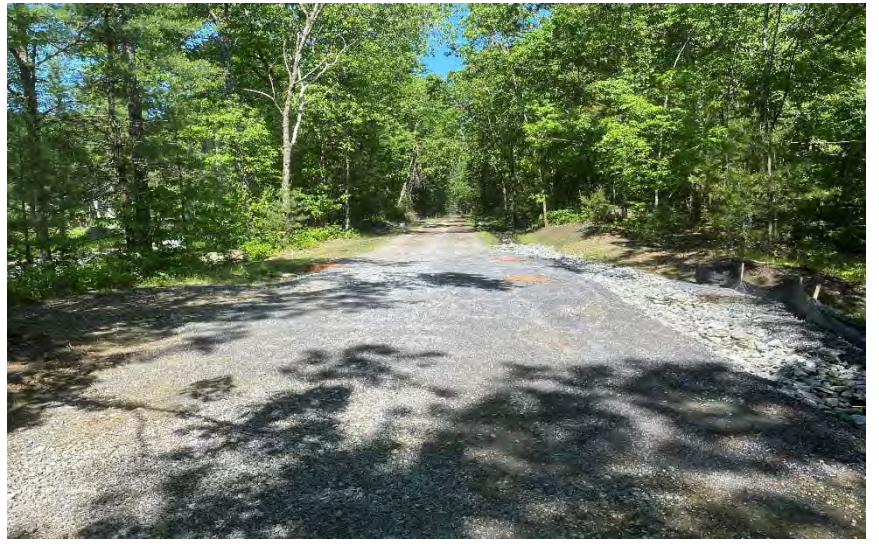
<p>PHOTOGRAPHIC LOG</p>	
<p>Client Name: Eversource</p>		<p>Site Location: Sudbury to Hudson Transmission Reliability Project</p>	<p>Town: Hudson</p>
<p>Photo No.: 8</p>	<p>Date: 5-31-24</p>

<p>Description: Work area within segment 5 – manhole #12, existing erosion control, looking westward.</p>

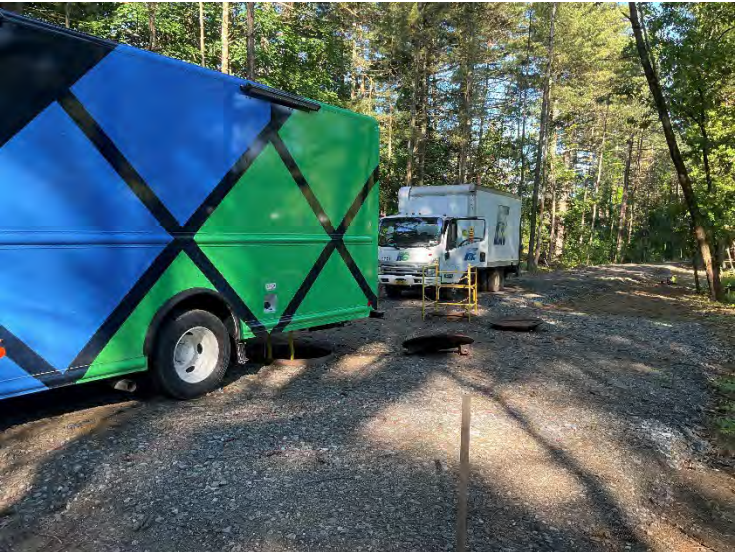
PHOTOGRAPHIC LOG	
Client Name: Eversource		Site Location: Sudbury to Hudson Transmission Reliability Project	Town: Sudbury
Photo No.: 2	Date: 5/31/2024

Description: View of Haugland splicing crew working at MH #21 in segment 10. Facing west.

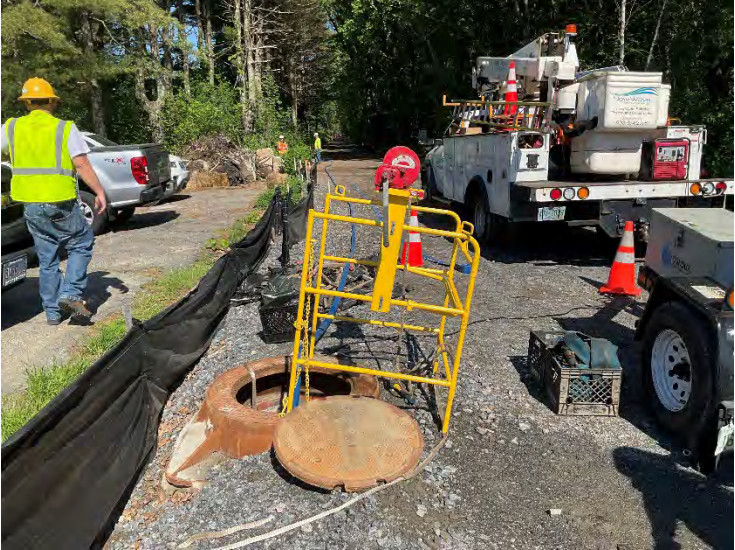
<p>PHOTOGRAPHIC LOG</p>	
<p>Client Name: Eversource</p>		<p>Site Location: Sudbury to Hudson Transmission Reliability Project</p>	<p>Town: Sudbury</p>
<p>Photo No.: 3</p>	<p>Date: 5/31/2024</p>

<p>Description: View of New Wave working at MH #24 in segment 11. See additional dewatering inspection report. Facing west.</p>

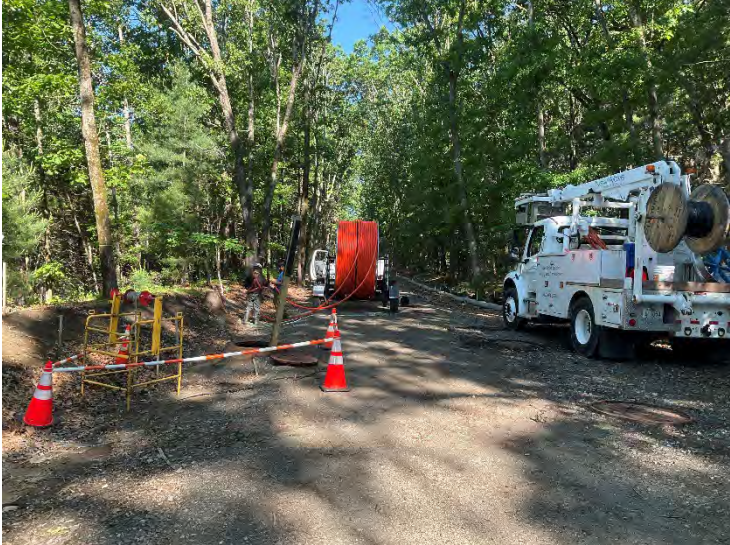
PHOTOGRAPHIC LOG	
Client Name: Eversource		Site Location: Sudbury to Hudson Transmission Reliability Project	Town: Sudbury
Photo No.: 5	Date: 5/31/2024

Description: View of New Wave at HH #23 in segment 11 installing fiber optic cables. Facing west.

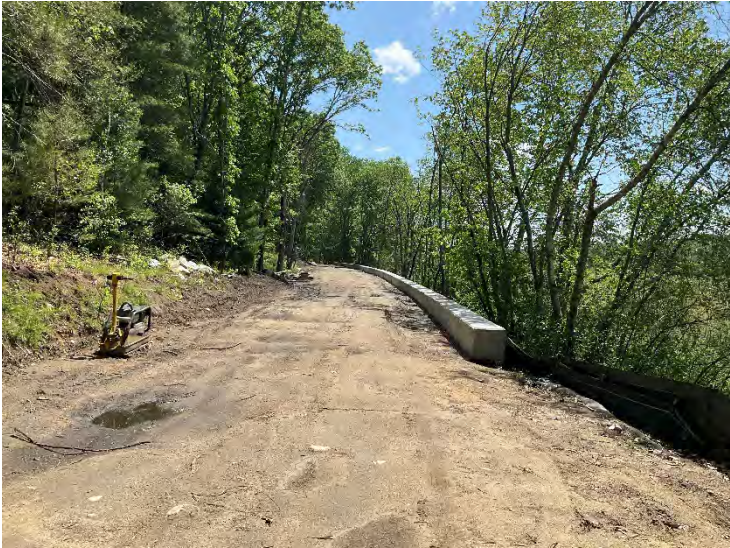
<p>PHOTOGRAPHIC LOG</p>	
<p>Client Name: Eversource</p>		<p>Site Location: Sudbury to Hudson Transmission Reliability Project</p>	<p>Town: Sudbury</p>
<p>Photo No.: 7</p>	<p>Date: 5/31/2024</p>

<p>Description: View of wall 13 in segment 14. ET&L active in segment 14 restaking right-of-way for widening and hardening of access road. Facing east.</p>

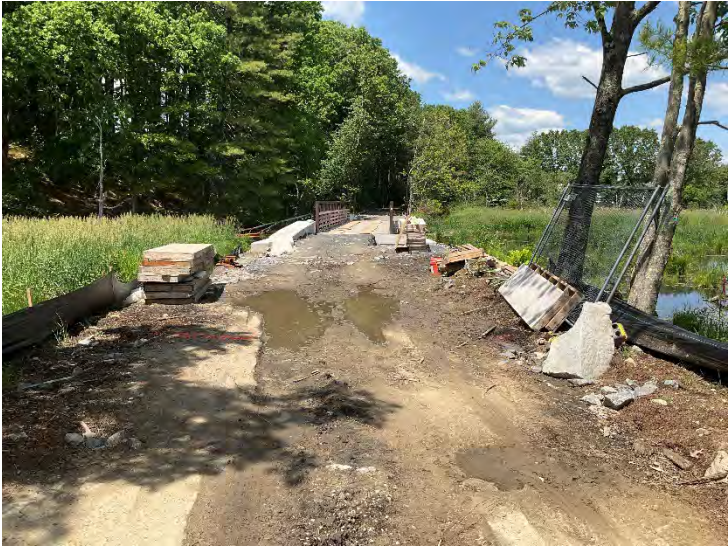
<p>PHOTOGRAPHIC LOG</p>	
<p>Client Name: Eversource</p>		<p>Site Location: Sudbury to Hudson Transmission Reliability Project</p>	<p>Town: Sudbury</p>
<p>Photo No.: 8</p>	<p>Date: 5/31/2024</p>

<p>Description: View of bridge 127. Facing west.</p>

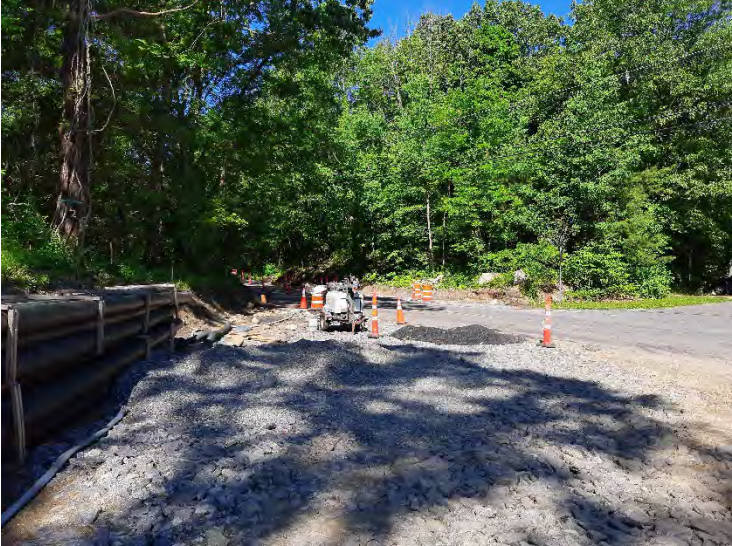
<p>PHOTOGRAPHIC LOG</p>	
<p>Client Name: Eversource</p>		<p>Site Location: Sudbury to Hudson Transmission Reliability Project</p>	<p>Town: Hudson</p>
<p>Photo No.: 1</p>	<p>Date: 5-1-24</p>

<p>Description:</p> <p>Wilkins Street roadwork by Segment 1. No weekend dewatering. Looking westward.</p>

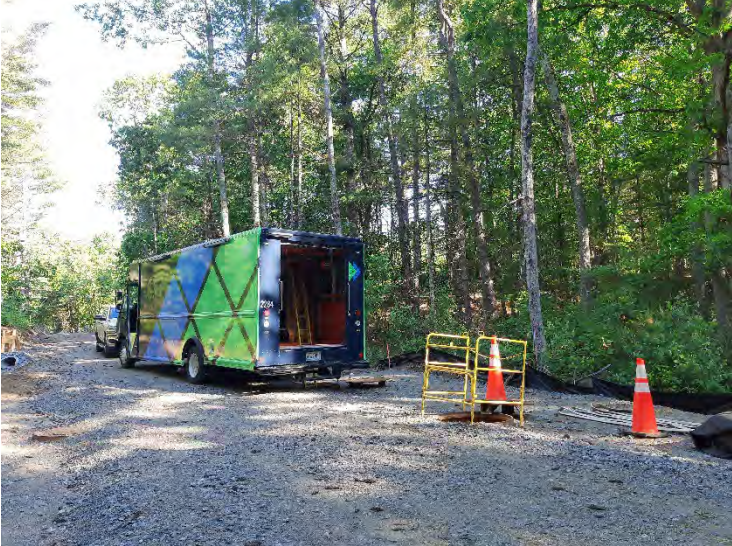
<p>PHOTOGRAPHIC LOG</p>	
<p>Client Name: Eversource</p>		<p>Site Location: Sudbury to Hudson Transmission Reliability Project</p>	<p>Town: Sudbury</p>
<p>Photo No.: 2</p>	<p>Date: 6-1-24</p>

<p>Description:</p> <p>Work area within segment 10, manhole #20 work (cable clipping and splicing). Looking westward.</p>

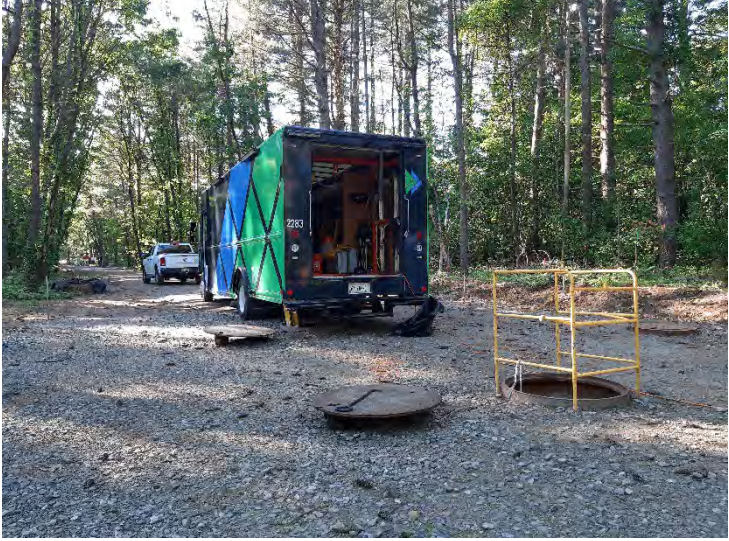
<p>PHOTOGRAPHIC LOG</p>	
<p>Client Name: Eversource</p>		<p>Site Location: Sudbury to Hudson Transmission Reliability Project</p>	<p>Town: Sudbury</p>
<p>Photo No.: 3</p>	<p>Date: 6-1-24</p>

<p>Description:</p> <p>Work area within segment 10, manhole #21 work (cable clipping and splicing). Looking eastward.</p>

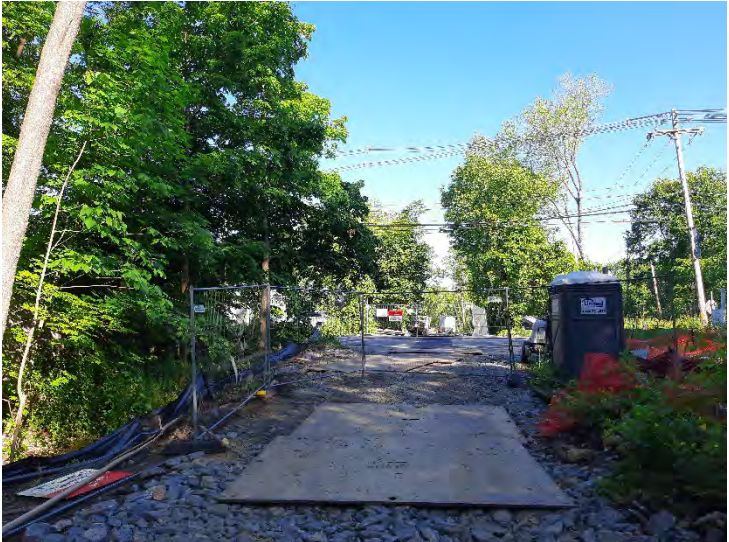
<p>PHOTOGRAPHIC LOG</p>	
<p>Client Name: Eversource</p>		<p>Site Location: Sudbury to Hudson Transmission Reliability Project</p>	<p>Town: Sudbury</p>
<p>Photo No.: 4</p>	<p>Date: 6-1-24</p>

<p>Description:</p> <p>Boston Post Road crossing, between segments 12 and 13. No weekend dewatering. Looking westward.</p>

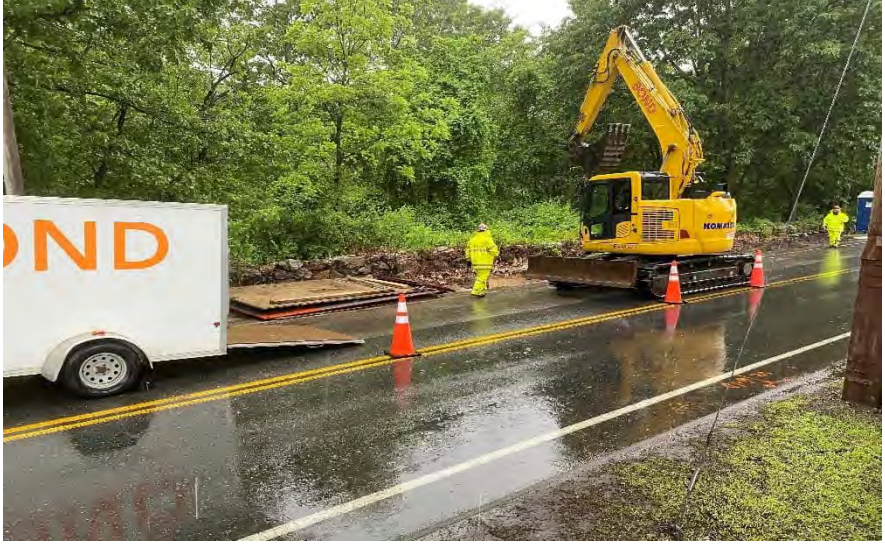
PHOTOGRAPHIC LOG	
Client Name: Eversource		Site Location: Sudbury to Hudson Transmission Reliability Project	Town: Hudson
Photo No.: 2	Date: 5-30-24

Description: Bond conducting conduit work within Forest Avenue near manhole #2, looking southward.

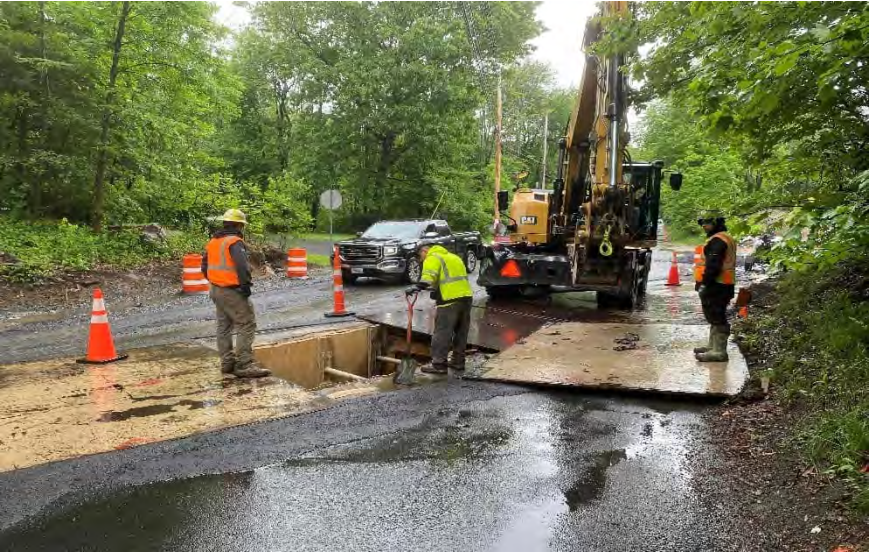
PHOTOGRAPHIC LOG	
Client Name: Eversource		Site Location: Sudbury to Hudson Transmission Reliability Project	Town: Hudson
Photo No.: 3	Date: 5-30-24

Description: Ledge removal work within Wilkins Street, looking westward.

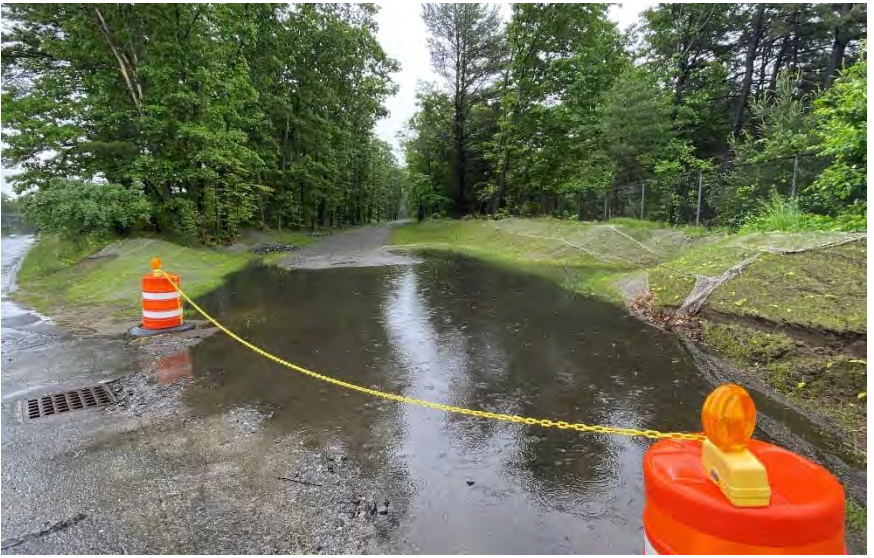
PHOTOGRAPHIC LOG	
Client Name: Eversource		Site Location: Sudbury to Hudson Transmission Reliability Project	Town: Hudson
Photo No.: 4	Date: 5-30-24

Description: Work area within segment 4 at Main Street, existing erosion control, looking eastward.

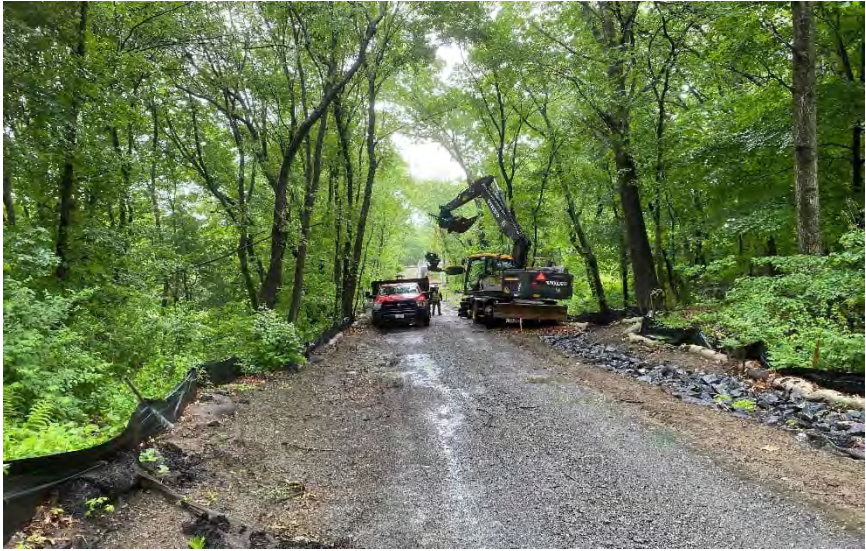
PHOTOGRAPHIC LOG	
Client Name: Eversource		Site Location: Sudbury to Hudson Transmission Reliability Project	Town: Hudson
Photo No.: 7	Date: 5-30-24

Description: Work area within segment 1, ET&L preparing for wall work, existing erosion control, looking eastward.

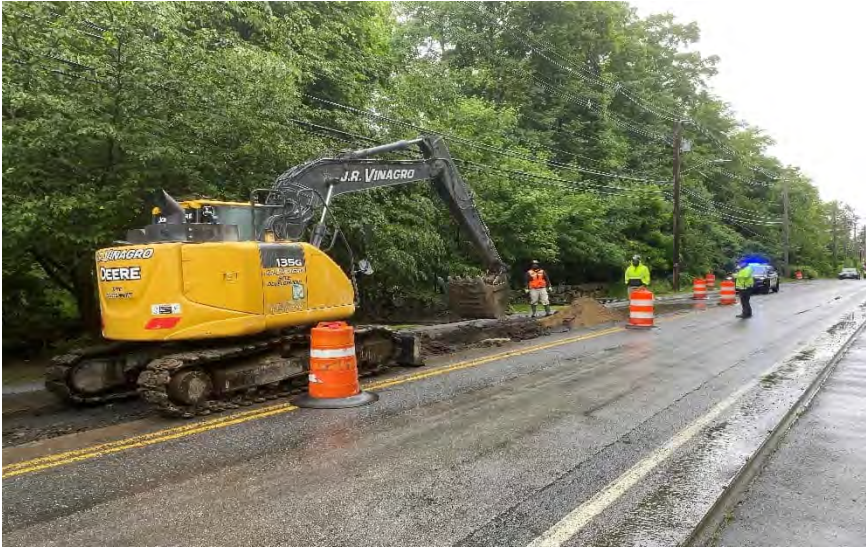
PHOTOGRAPHIC LOG	
Client Name: Eversource		Site Location: Sudbury to Hudson Transmission Reliability Project	Town: Hudson
Photo No.: 8	Date: 5-30-24

Description: Vinagro conducting conduit removal work within Forest Avenue, looking northward.

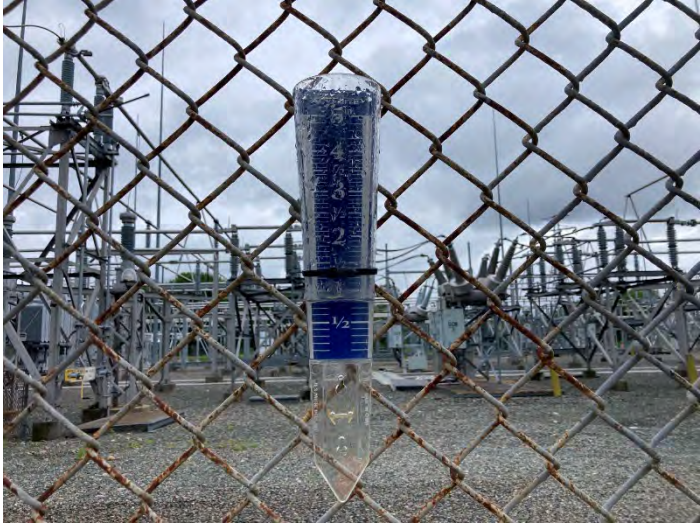
PHOTOGRAPHIC LOG	
Client Name: Eversource		Site Location: Sudbury to Hudson Transmission Reliability Project	Town: Sudbury
Photo No.: 1	Date: 5-30-2024

Description: View of rain gauge at Sudbury Substation. 0.80" observed in gauge. Facing south.

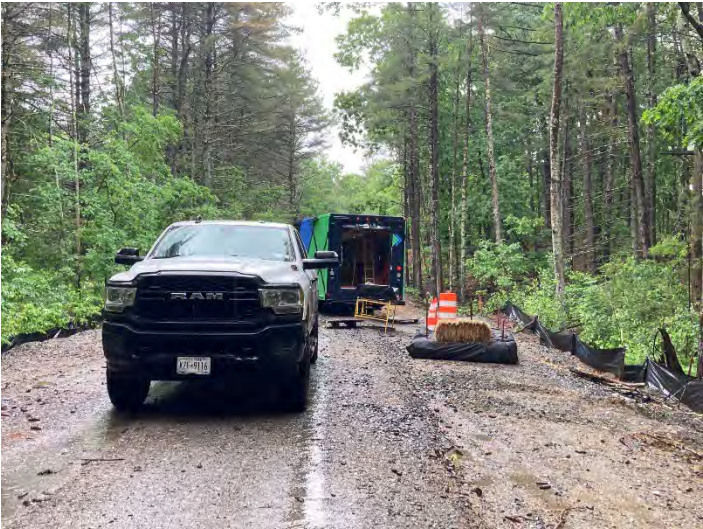
Epsilon ASSOCIATES INC.		PHOTOGRAPHIC LOG	
Client Name: Eversource		Site Location: Sudbury to Hudson Transmission Reliability Project	Town: Sudbury
Photo No.: 3	Date: 5-30-2024

Description: View of Haugland splicing crew working at MH #20 in segment 10. Facing west.

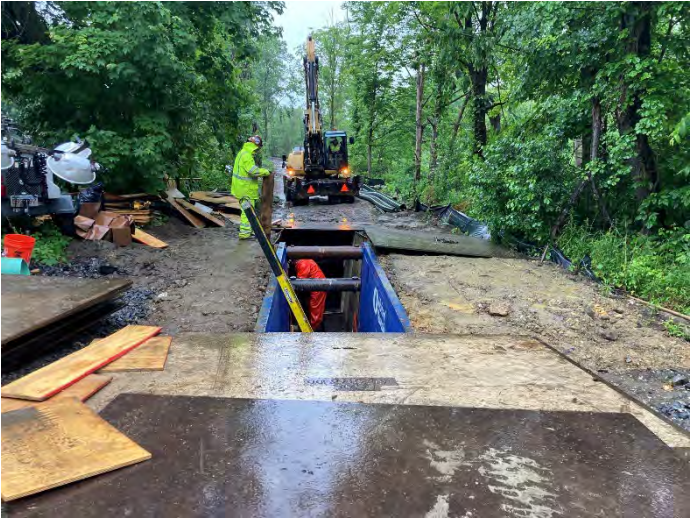
Epsilon ASSOCIATES INC.		PHOTOGRAPHIC LOG	
Client Name: Eversource		Site Location: Sudbury to Hudson Transmission Reliability Project	Town: Sudbury
Photo No.: 5	Date: 5-30-2024

Description: View of Bond working at Boston Post Rd crossing. See additional dewatering inspection report. Facing west.

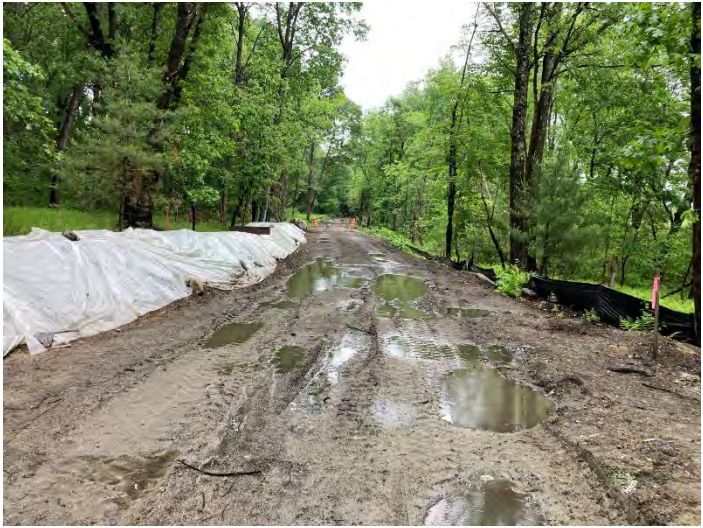
Epsilon ASSOCIATES INC.		PHOTOGRAPHIC LOG	
Client Name: Eversource		Site Location: Sudbury to Hudson Transmission Reliability Project	Town: Sudbury
Photo No.: 8	Date: 5-30-2024

Description: View of stockpiles/spoil berm in segment 14. Facing east.

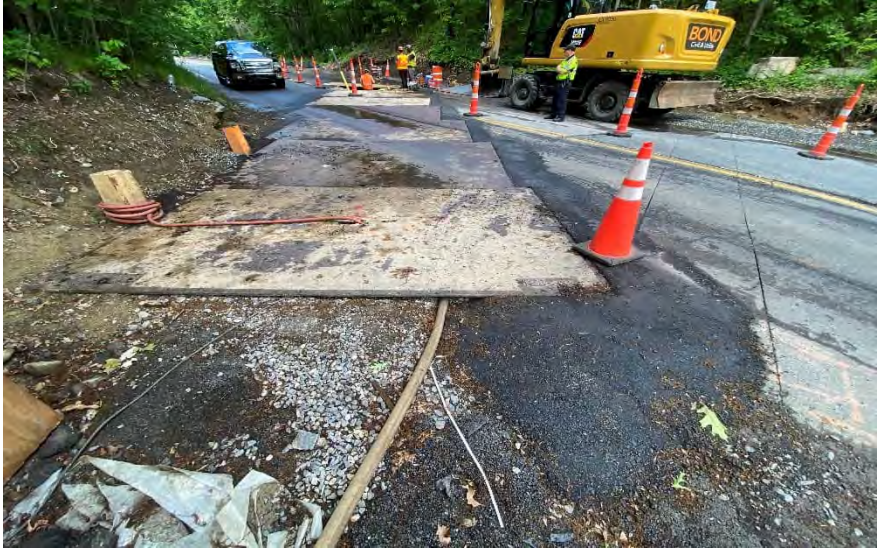
<h2 style="margin: 0;">PHOTOGRAPHIC LOG</h2>	
Client Name: Eversource		Site Location: Sudbury to Hudson Transmission Reliability Project	
Town: Hudson			
Photo No.: 1	Date: 5/28/2024

Description: View of area being pumped from trench across Wilkins Street.

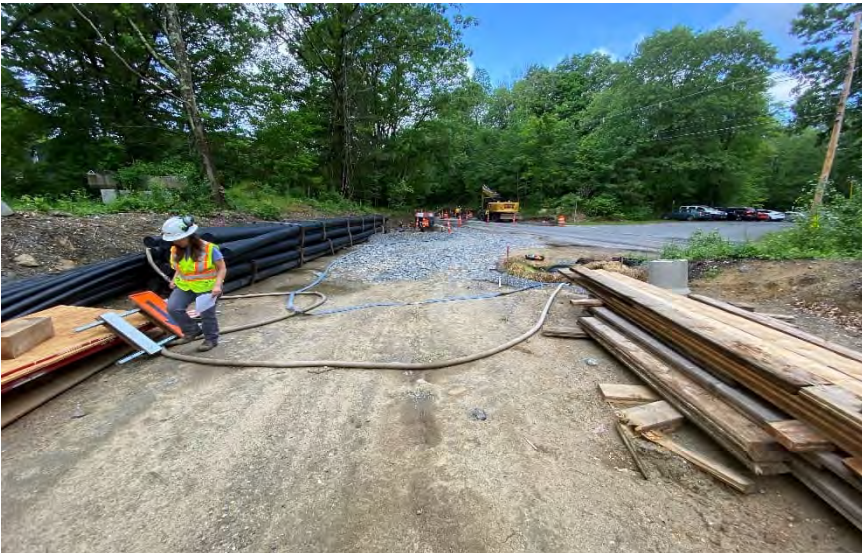
PHOTOGRAPHIC LOG	
Client Name: Eversource		Site Location: Sudbury to Hudson Transmission Reliability Project	
Town: Hudson			
Photo No.: 3	Date: 5/28/2024

Description: Wilkins Street trench. View of dewatering operation, looking westward.

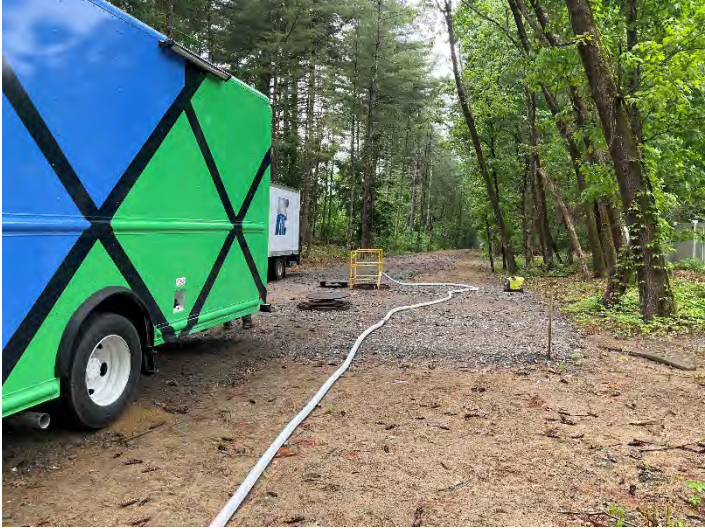
Epsilon <small>ASSOCIATES INC.</small>		PHOTOGRAPHIC LOG	
Client Name: Eversource		Site Location: Sudbury to Hudson Transmission Reliability Project	Town: Sudbury
Photo No.: 1	Date: 5/28/2024

Description: View of Haugland working at MH #21. Facing west.

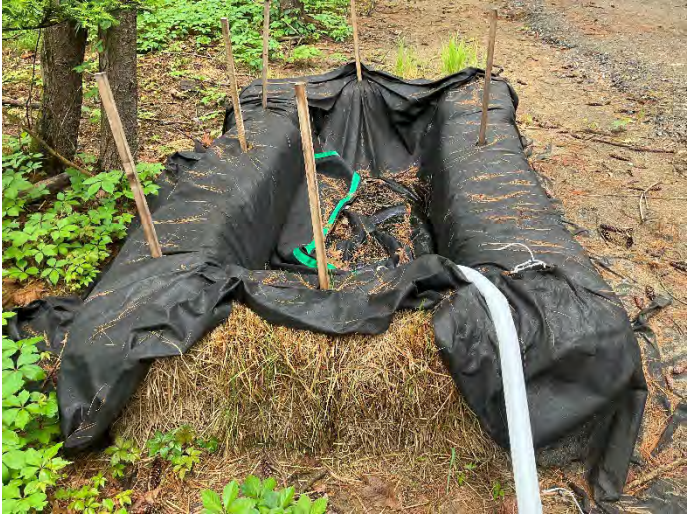
PHOTOGRAPHIC LOG	
Client Name: Eversource		Site Location: Sudbury to Hudson Transmission Reliability Project	Town: Sudbury
Photo No.: 3	Date: 5/28/2024

Description: View of dewatering controls (straw bale corral with filter fabric and silt bag). Facing east.

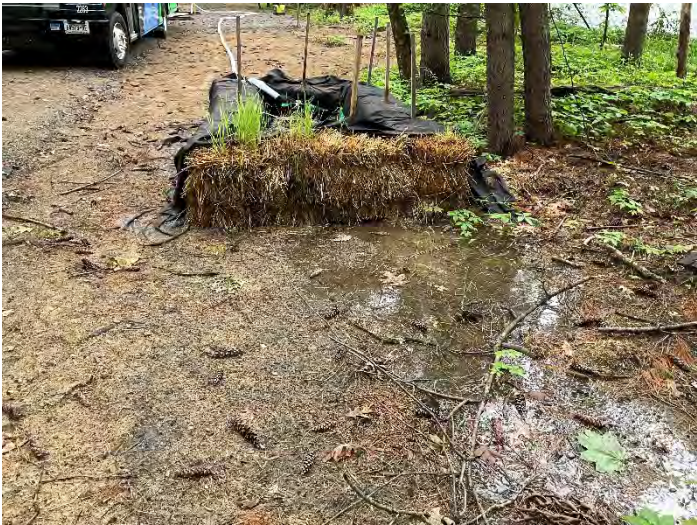
PHOTOGRAPHIC LOG	
Client Name: Eversource		Site Location: Sudbury to Hudson Transmission Reliability Project	Town: Sudbury
Photo No.: 4	Date: 5/28/2024

Description: Additional view of dewatering controls (straw bale corral with filter fabric and silt bag) and discharge from corral. Discharge appeared clear and turbidity reading was below 50 NTUs. Discharge did not appear to reach any jurisdictional resource areas. Facing west.

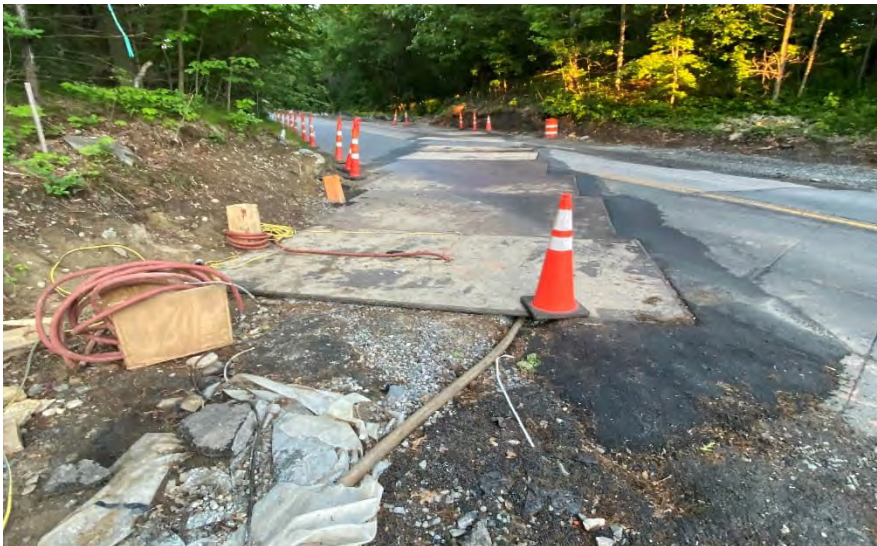
PHOTOGRAPHIC LOG	
Client Name: Eversource		Site Location: Sudbury to Hudson Transmission Reliability Project	Town: Hudson
Photo No.: 1	Date: 5/29/2024

Description: View of area being pumped from trench across Wilkins Street.

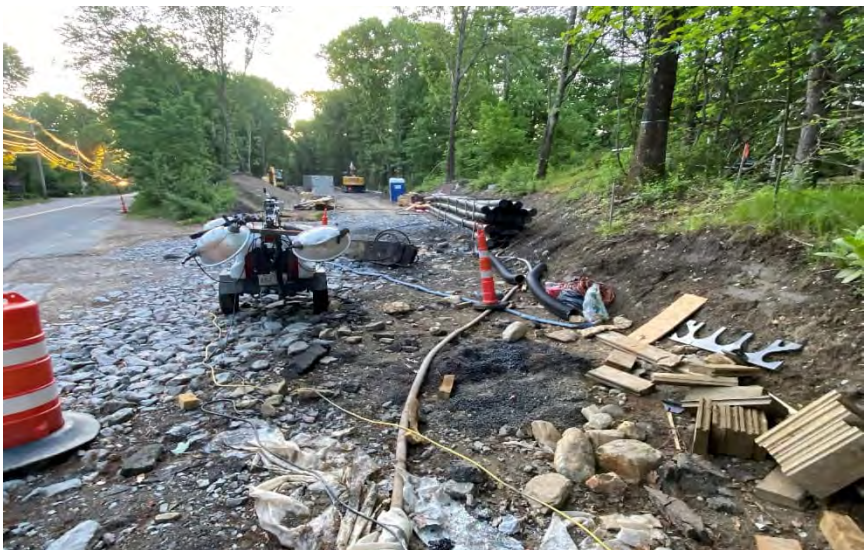
PHOTOGRAPHIC LOG	
Client Name: Eversource		Site Location: Sudbury to Hudson Transmission Reliability Project	Town: Hudson
Photo No.: 2	Date: 5/29/2024

Description: Wilkins Street trench. View of dewatering operation. Looking eastward.

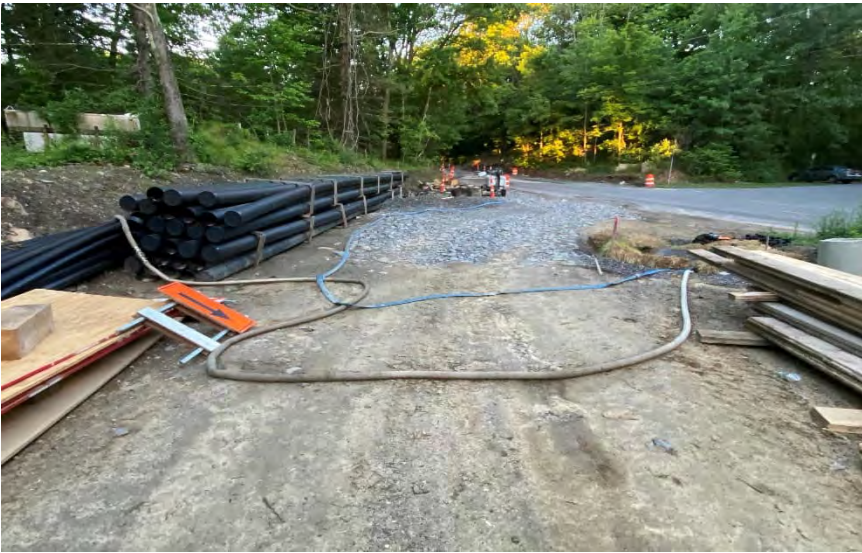
PHOTOGRAPHIC LOG	
Client Name: Eversource		Site Location: Sudbury to Hudson Transmission Reliability Project	Town: Hudson
Photo No.: 3	Date: 5/29/2024

Description: Wilkins Street trench. View of dewatering operation, looking westward.

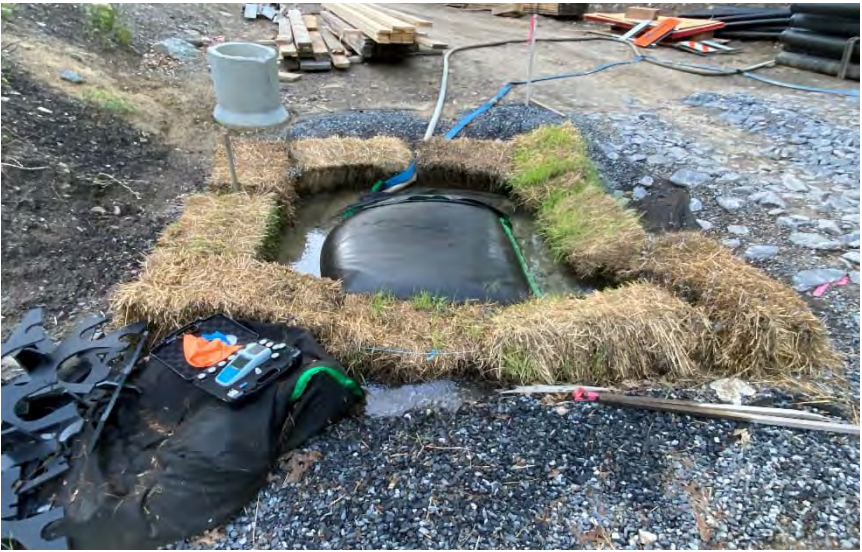
PHOTOGRAPHIC LOG	
Client Name: Eversource		Site Location: Sudbury to Hudson Transmission Reliability Project	Town: Hudson
Photo No.: 4	Date: 5/29/2024

Description: Wilkins Street trench. View of discharge bag/corral, looking eastward. Water from bag/corral discharged to underlying catch basin.

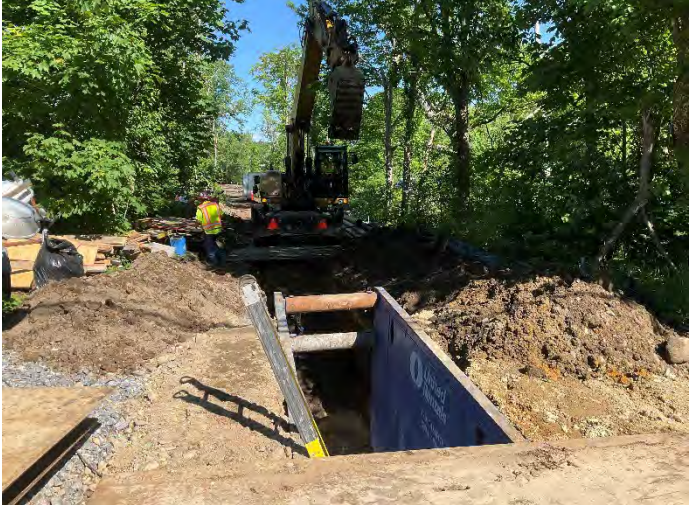
PHOTOGRAPHIC LOG	
Client Name: Eversource		Site Location: Sudbury to Hudson Transmission Reliability Project	Town: Sudbury
Photo No.: 1	Date: 5/29/2024

Description: View of Bond working at Boston Post Road crossing. Facing west.
