Weekly Environmental Compliance Summary

Sudbury to Hudson Transmission Reliability Project (USEPA Tracking # MAR1003UW)

Week of: May 28, 2024 to June 1, 2024

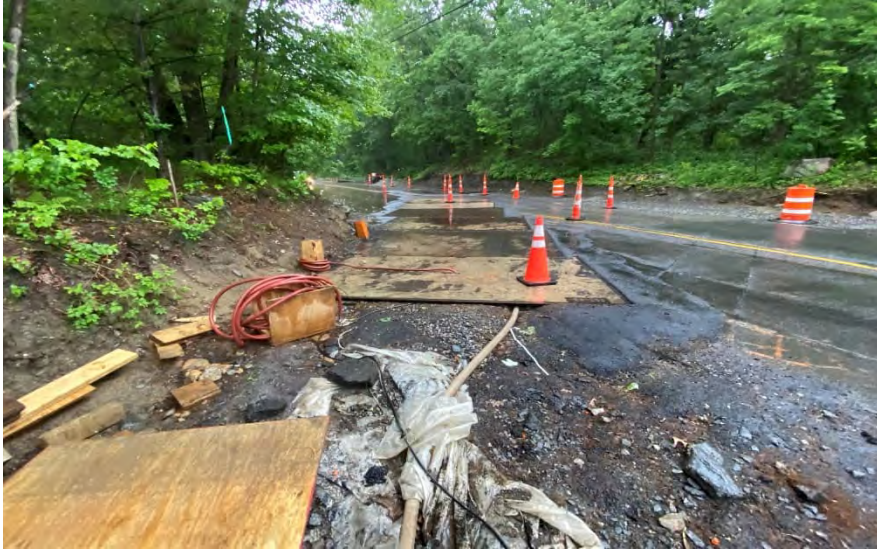
PHOTOGRAPHIC LOG	
Client Name: Eversource		Site Location: Sudbury to Hudson Transmission Reliability Project	Town: Hudson
Photo No.: 1	Date: 5/30/2024

Description: View of area being pumped from trench across Wilkins Street.

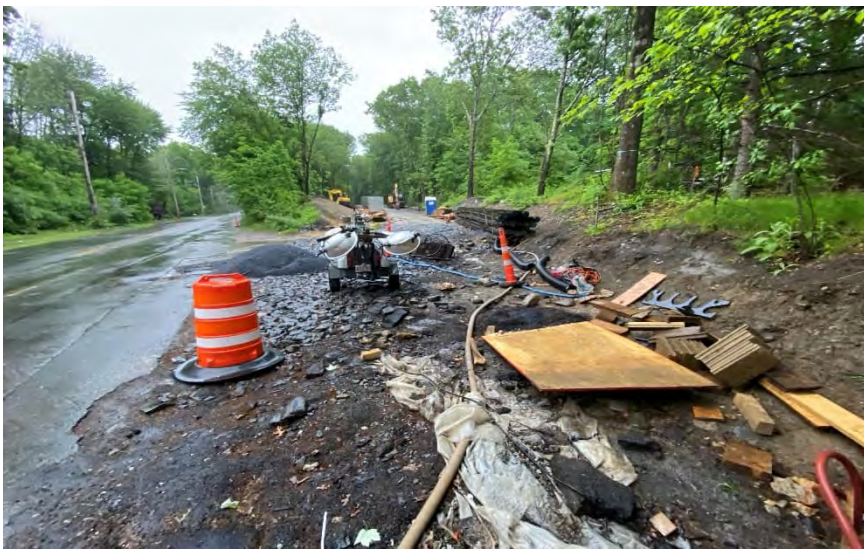
PHOTOGRAPHIC LOG	
Client Name: Eversource		Site Location: Sudbury to Hudson Transmission Reliability Project	Town: Hudson
Photo No.: 2	Date: 5/30/2024

Description: Wilkins Street trench. View of dewatering operation. Looking eastward.

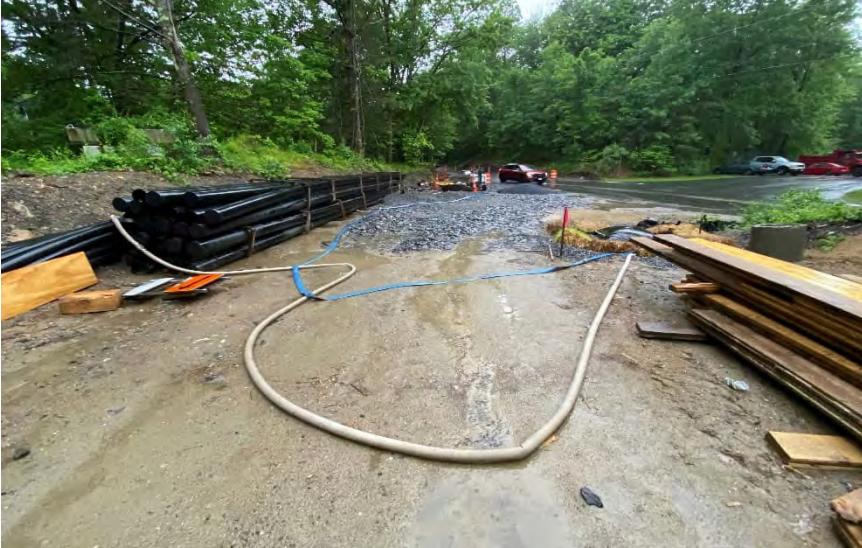
<h2 style="margin: 0;">PHOTOGRAPHIC LOG</h2>	
Client Name: Eversource		Site Location: Sudbury to Hudson Transmission Reliability Project	Town: Hudson
Photo No.: 3	Date: 5/30/2024

Description: Wilkins Street trench. View of dewatering operation, looking westward.

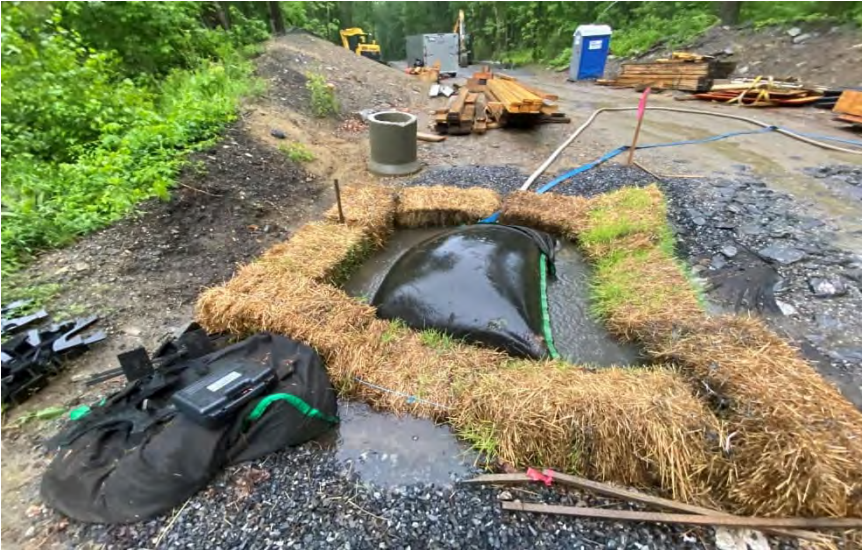
<h2 style="margin: 0;">PHOTOGRAPHIC LOG</h2>	
Client Name: Eversource		Site Location: Sudbury to Hudson Transmission Reliability Project	Town: Hudson
Photo No.: 4	Date: 5/30/2024

Description: Wilkins Street trench. View of discharge bag/corral, looking eastward. Water from bag/corral discharged to underlying catch basin.

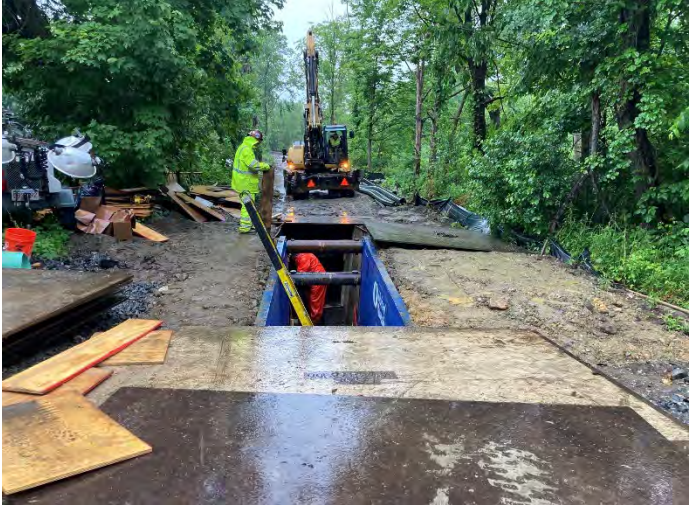
PHOTOGRAPHIC LOG	
Client Name: Eversource		Site Location: Sudbury to Hudson Transmission Reliability Project	Town: Sudbury
Photo No.: 1	Date: 5/30/2024

Description: View of Bond working at Boston Post Road crossing. Facing west.

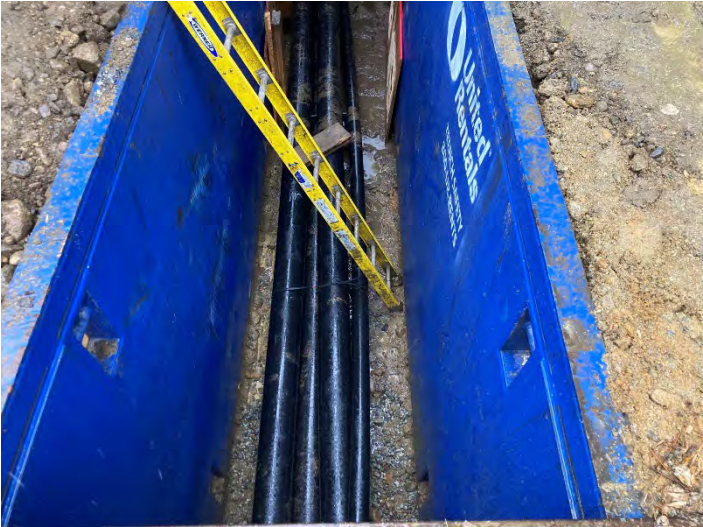
PHOTOGRAPHIC LOG	
Client Name: Eversource		Site Location: Sudbury to Hudson Transmission Reliability Project	Town: Sudbury
Photo No.: 2	Date: 5/30/2024

Description: View of water in trench. Water appeared slightly turbid prior to treatment.

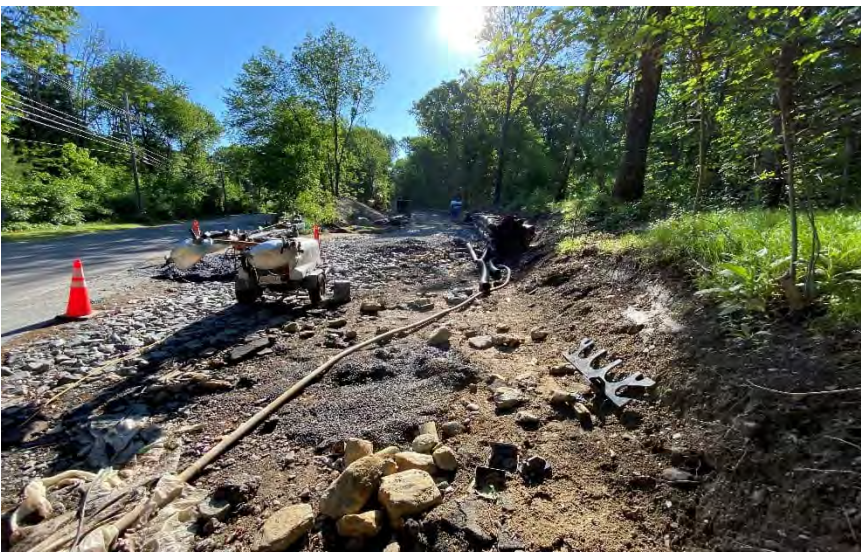
PHOTOGRAPHIC LOG	
Client Name: Eversource		Site Location: Sudbury to Hudson Transmission Reliability Project	Town: Hudson
Photo No.: 2	Date: 5/31/2024

Description: Wilkins Street trench. View of dewatering operation. Looking eastward.

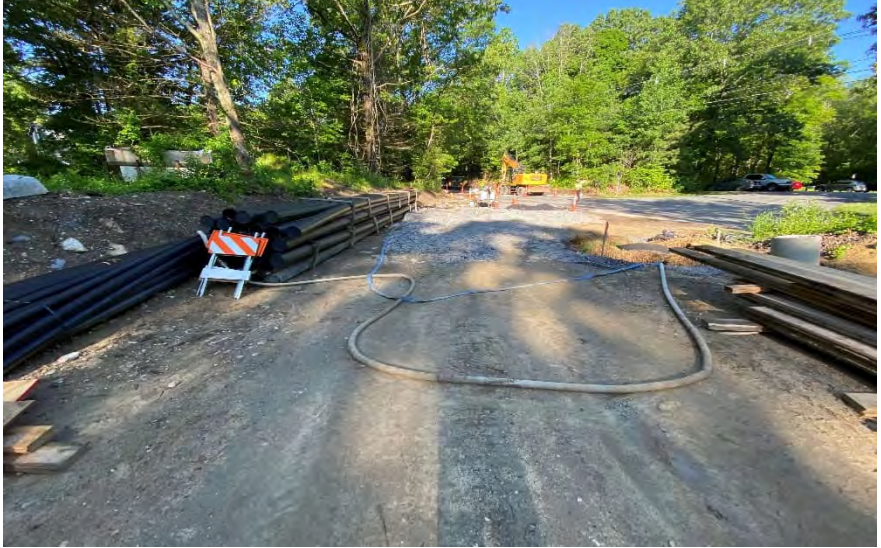
PHOTOGRAPHIC LOG	
Client Name: Eversource		Site Location: Sudbury to Hudson Transmission Reliability Project	Town: Hudson
Photo No.: 3	Date: 5/31/2024

Description: Wilkins Street trench. View of dewatering operation, looking westward.

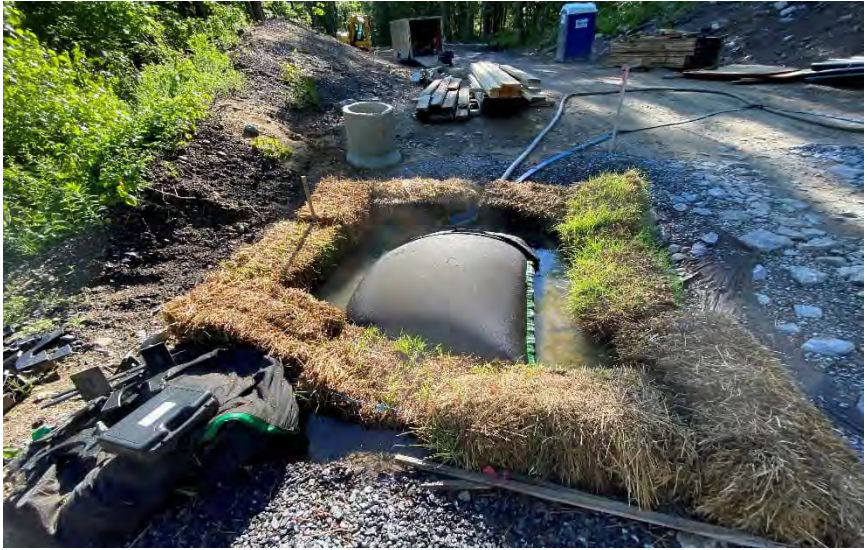
PHOTOGRAPHIC LOG	
Client Name: Eversource		Site Location: Sudbury to Hudson Transmission Reliability Project	Town: Hudson
Photo No.: 4	Date: 5/31/2024

Description: Wilkins Street trench. View of discharge bag/corral, looking eastward. Water from bag/corral discharged to underlying catch basin.

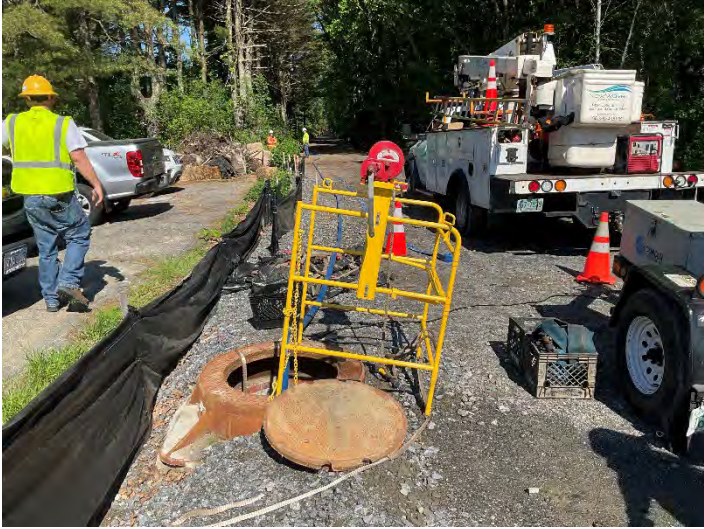
PHOTOGRAPHIC LOG	
Client Name: Eversource		Site Location: Sudbury to Hudson Transmission Reliability Project	Town: Sudbury
Photo No.: 1	Date: 5/31/2024

Description: View of New Wave working at HH #24. Facing west.

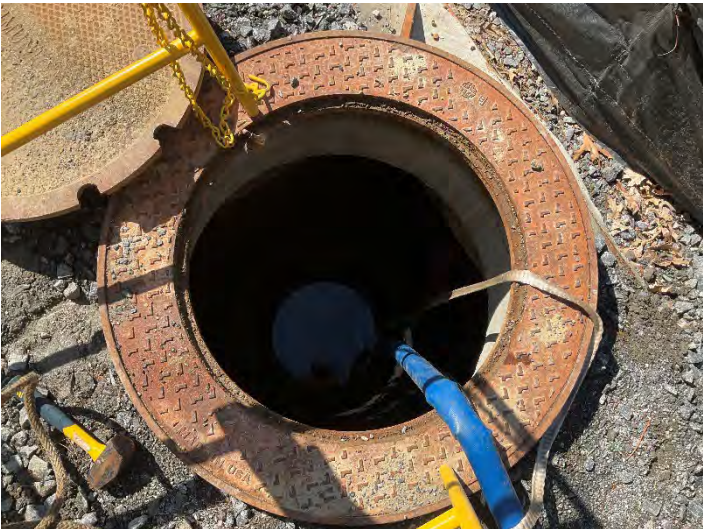
PHOTOGRAPHIC LOG	
Client Name: Eversource		Site Location: Sudbury to Hudson Transmission Reliability Project	Town: Sudbury
Photo No.: 2	Date: 5/31/2024

Description: View of handhole in HH #24. Water appeared clear prior to treatment.

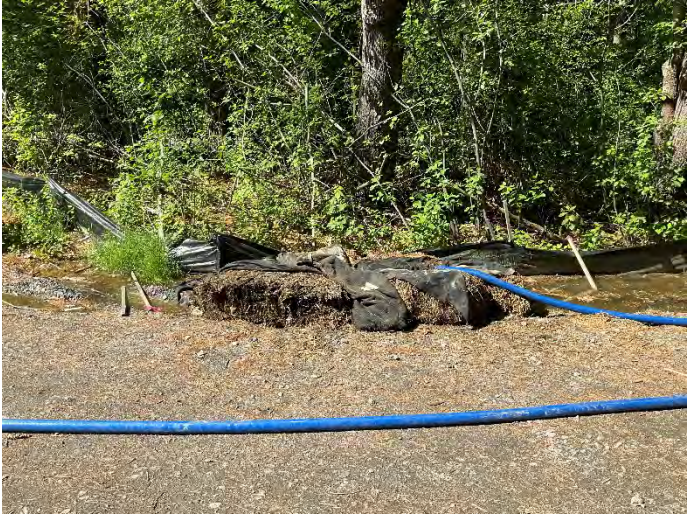
PHOTOGRAPHIC LOG	
Client Name: Eversource		Site Location: Sudbury to Hudson Transmission Reliability Project	Town: Sudbury
Photo No.: 3	Date: 5/31/2024

Description: View of dewatering controls (straw bale corral with filter fabric and silt bag). Facing south.

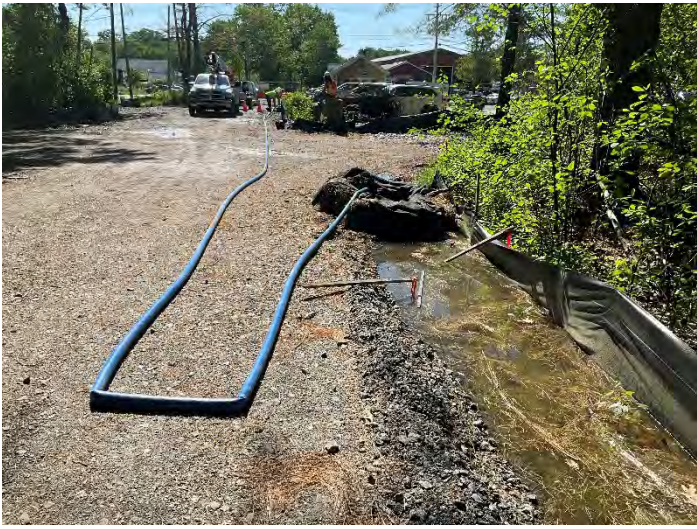
PHOTOGRAPHIC LOG	
Client Name: Eversource		Site Location: Sudbury to Hudson Transmission Reliability Project	Town: Sudbury
Photo No.: 4	Date: 5/31/2024

Description: View of dewatering controls (straw bale corral with filter fabric and silt bag) and discharge from corral. Discharge appeared clear and turbidity was below 50 NTUs. Discharge did not reach any jurisdictional areas. Facing east.
