Weekly Environmental Compliance Summary

Sudbury to Hudson Transmission Reliability Project (USEPA Tracking # MAR1003UW)

Sudbury, Hudson, and Stow, MA

Week of: June 3, 2024 to June 8, 2024

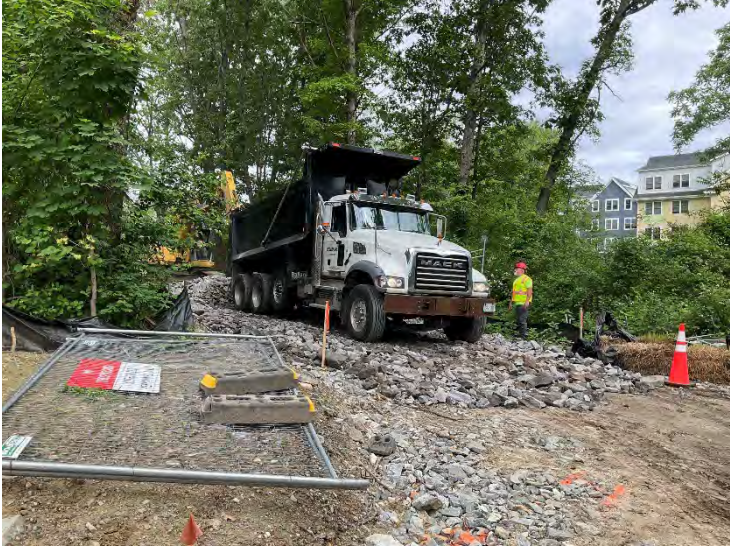
<p>PHOTOGRAPHIC LOG</p>	
<p>Client Name: Eversource</p>		<p>Site Location: Sudbury to Hudson Transmission Reliability Project</p>	<p>Town: Sudbury</p>
<p>Photo No.: 5</p>	<p>Date: 6/03/2024</p>

<p>Description: View of ET&L performing hardening work in segment 14. Spotter was present. Facing northwest.</p>

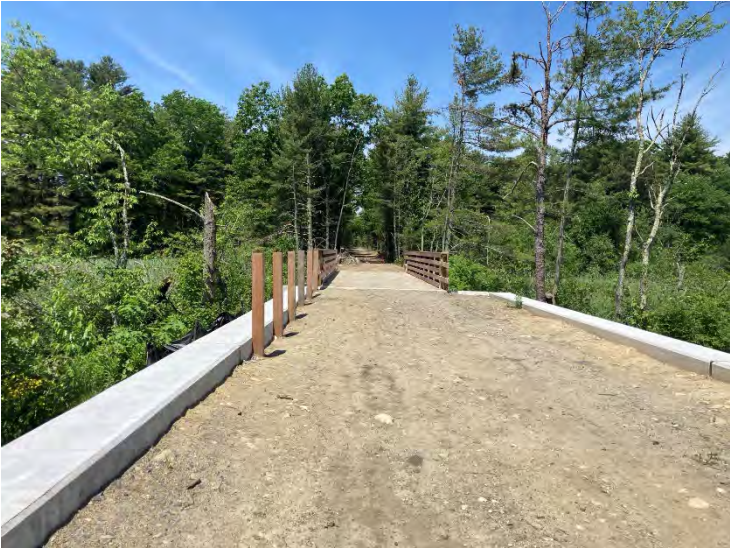
PHOTOGRAPHIC LOG	
Client Name: Eversource		Site Location: Sudbury to Hudson Transmission Reliability Project	Town: Sudbury
Photo No.: 1	Date: 6/04/2024

Description: View of bridge 128. Facing east.

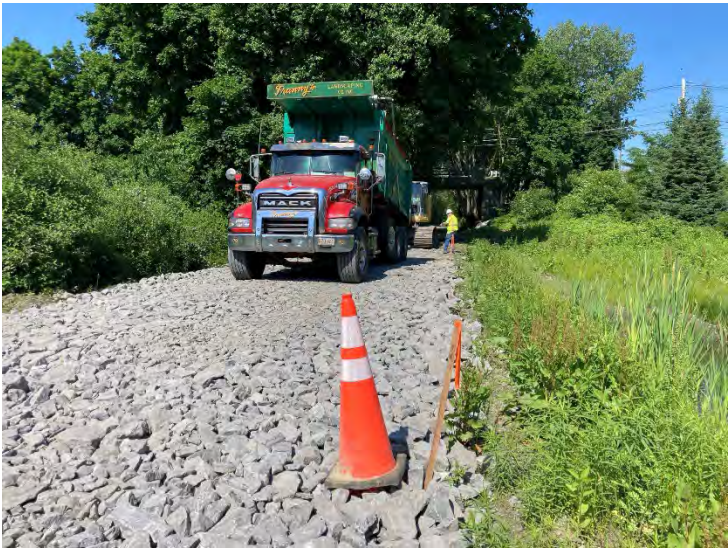
PHOTOGRAPHIC LOG	
Client Name: Eversource		Site Location: Sudbury to Hudson Transmission Reliability Project	Town: Sudbury
Photo No.: 6	Date: 6/04/2024

Description: View of ET&L performing hardening work in segment 14. Spotter was present. Facing west.

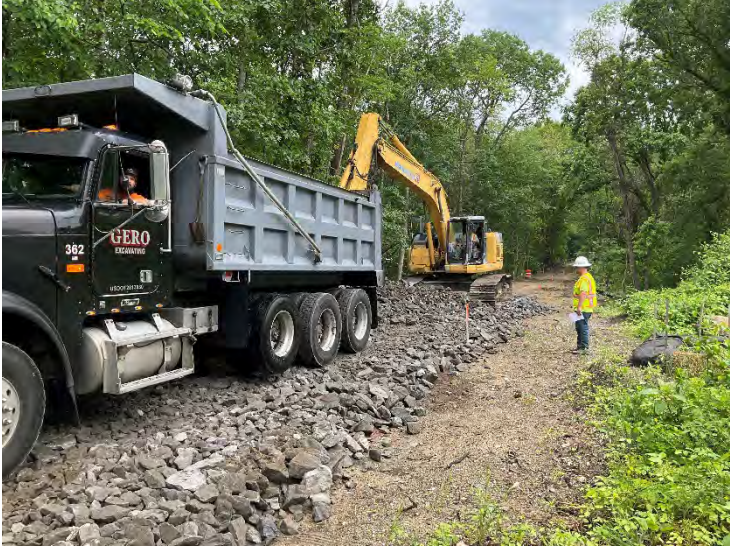
<p>PHOTOGRAPHIC LOG</p>	
<p>Client Name: Eversource</p>		<p>Site Location: Sudbury to Hudson Transmission Reliability Project</p>	<p>Town: Sudbury</p>
<p>Photo No.: 5</p>	<p>Date: 6/05/2024</p>

<p>Description: View of ET&L performing hardening work in segment 14. Facing west.</p>

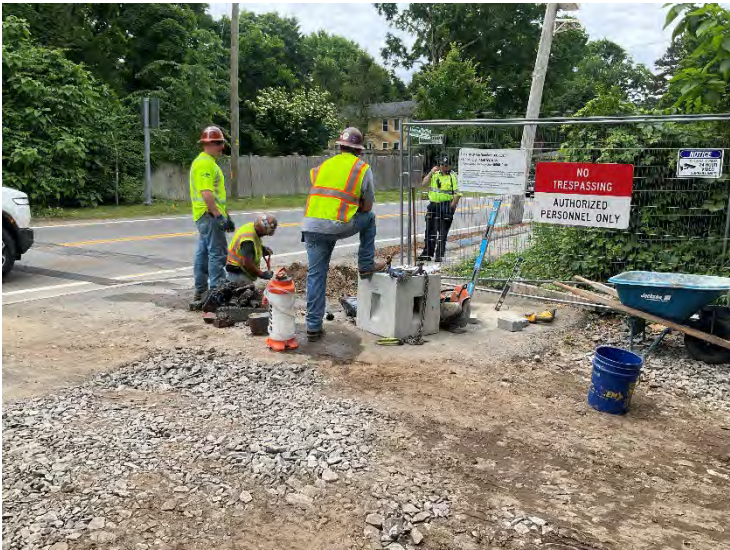
<p>PHOTOGRAPHIC LOG</p>	
<p>Client Name: Eversource</p>		<p>Site Location: Sudbury to Hudson Transmission Reliability Project</p>	<p>Town: Sudbury</p>
<p>Photo No.: 4</p>	<p>Date: 6/7/2024</p>

<p>Description: View of Bond installing handhole at entrance to segment 12 on Boston Post Road. Facing north.</p>

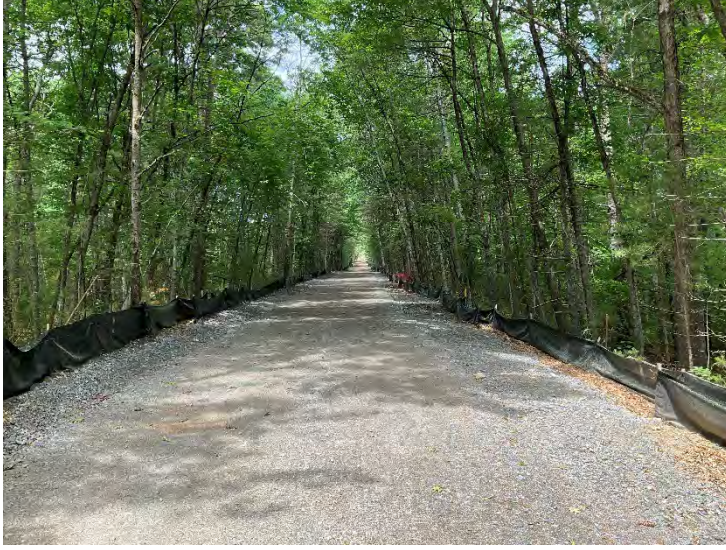
<p align="right">PHOTOGRAPHIC LOG</p>	
<p>Client Name: Eversource</p>		<p>Site Location: Sudbury to Hudson Transmission Reliability Project</p>	<p>Town: Sudbury</p>
<p>Photo No.: 6</p>	<p>Date: 6/7/2024</p>

<p>Description: View of E&S controls in segment 8. Facing west.</p>

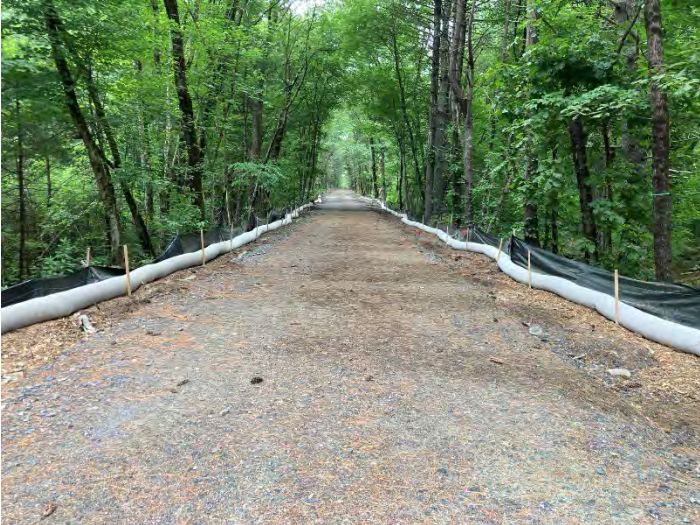
PHOTOGRAPHIC LOG	
Client Name: Eversource		Site Location: Sudbury to Hudson Transmission Reliability Project	Town: Sudbury
Photo No.: 2	Date: 6-06-2024

Description: View of E&S controls in segment 9. Facing west.

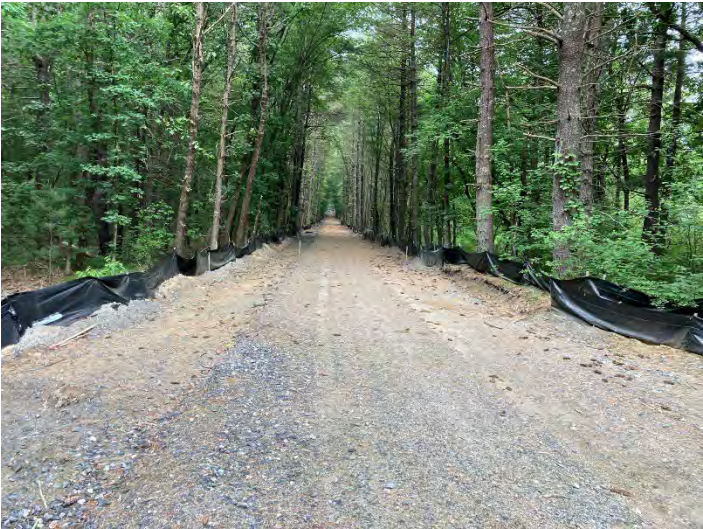
Epsilon ASSOCIATES INC.		PHOTOGRAPHIC LOG	
Client Name: Eversource		Site Location: Sudbury to Hudson Transmission Reliability Project	Town: Sudbury
Photo No.: 3	Date: 6-06-2024

Description: View of E&S contolrs in segment 10. Facing east.

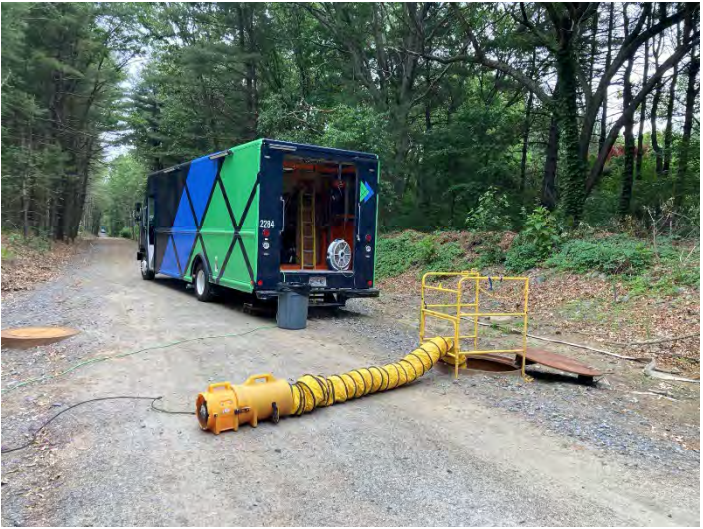
Epsilon ASSOCIATES INC.		PHOTOGRAPHIC LOG	
Client Name: Eversource		Site Location: Sudbury to Hudson Transmission Reliability Project	Town: Sudbury
Photo No.: 4	Date: 6-06-2024

Description: View of Haugland splicing crew working at MH #22 in segment 11. Facing west.

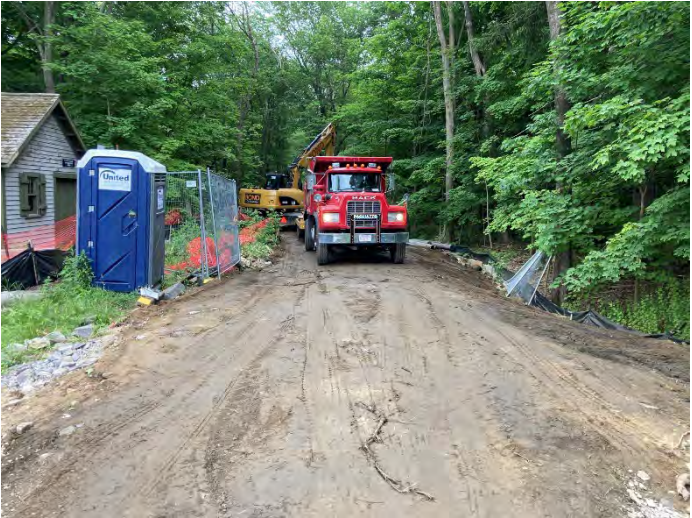
Epsilon ASSOCIATES INC.		PHOTOGRAPHIC LOG	
Client Name: Eversource		Site Location: Sudbury to Hudson Transmission Reliability Project	Town: Sudbury
Photo No.: 5	Date: 6-06-2024

Description: View of Bond working at Boston Post Rd crossing. Facing east.

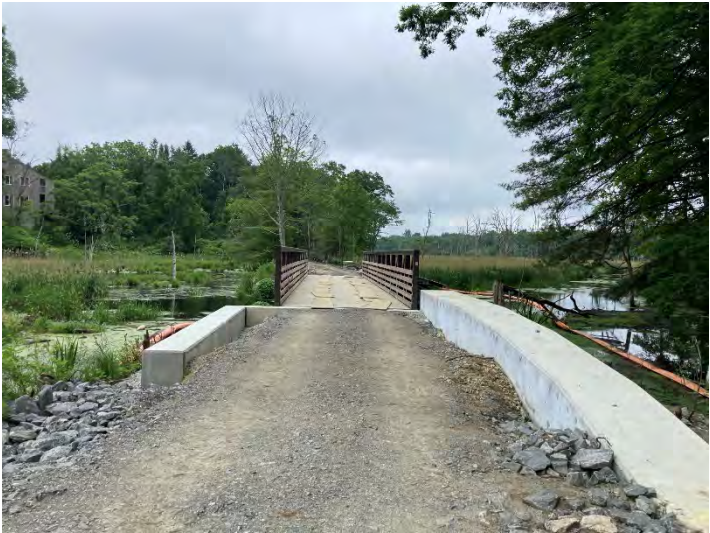
Epsilon ASSOCIATES INC.		PHOTOGRAPHIC LOG	
Client Name: Eversource		Site Location: Sudbury to Hudson Transmission Reliability Project	Town: Sudbury
Photo No.: 6	Date: 6-06-2024

Description: View of bridge 127 area. Facing east.

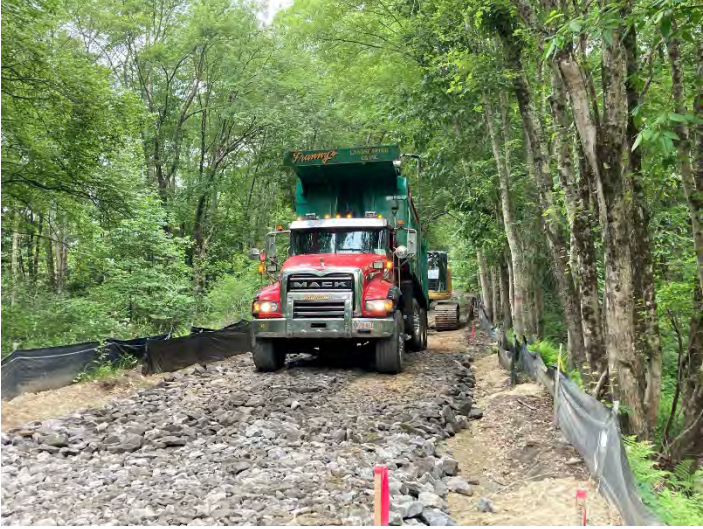
PHOTOGRAPHIC LOG	
Client Name: Eversource		Site Location: Sudbury to Hudson Transmission Reliability Project	Town: Sudbury
Photo No.: 7	Date: 6-06-2024

Description: View of ET&L performing hardening work in segment 14. Spotter was present. Facing west.

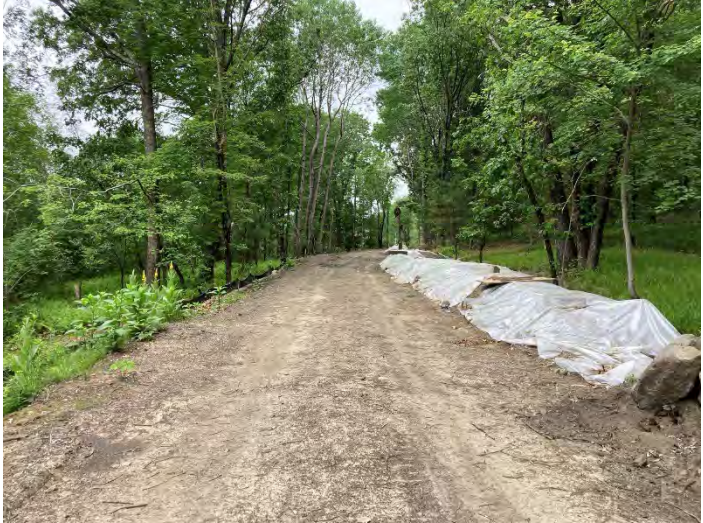
PHOTOGRAPHIC LOG	
Client Name: Eversource		Site Location: Sudbury to Hudson Transmission Reliability Project	Town: Sudbury
Photo No.: 8	Date: 6-06-2024

Description: View of stockpiles/spoil berm in segment 14. Facing west.

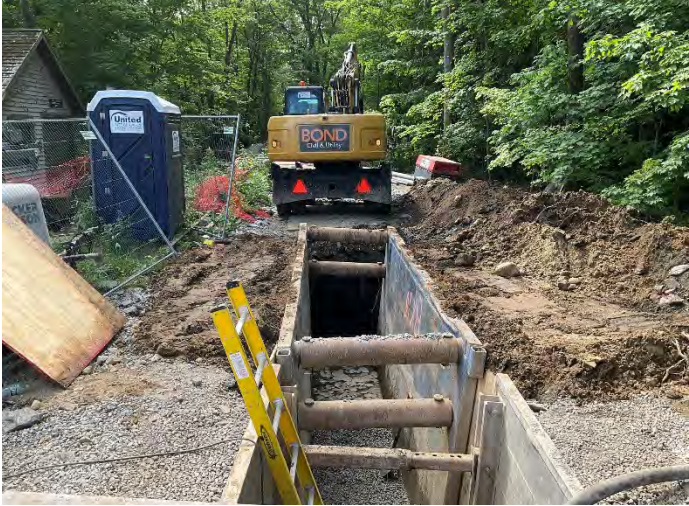
PHOTOGRAPHIC LOG	
Client Name: Eversource		Site Location: Sudbury to Hudson Transmission Reliability Project	Town: Sudbury
Photo No.: 1	Date: 6/03/2024

Description: View of Bond working at Boston Post Road crossing. Facing east.

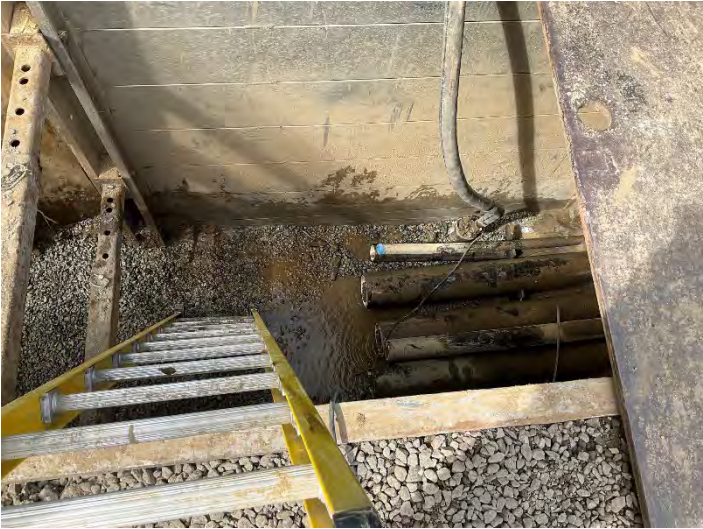
PHOTOGRAPHIC LOG	
Client Name: Eversource		Site Location: Sudbury to Hudson Transmission Reliability Project	Town: Sudbury
Photo No.: 2	Date: 6/03/2024

Description: View of pump in trench. Water appeared turbid prior to treatment.

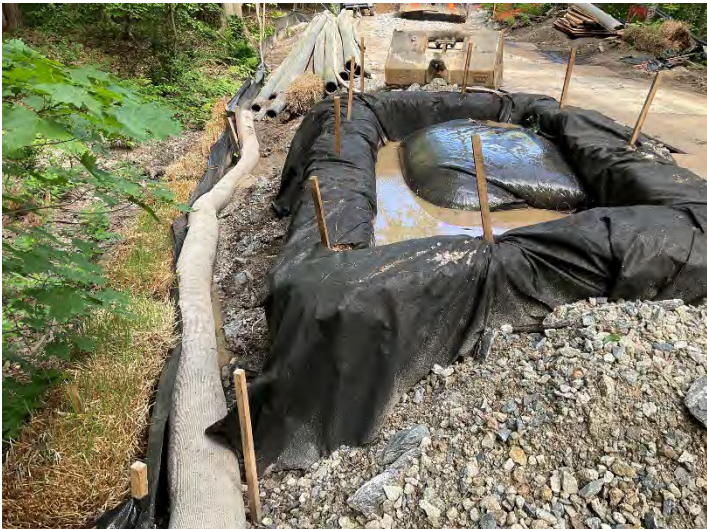
PHOTOGRAPHIC LOG	
Client Name: Eversource		Site Location: Sudbury to Hudson Transmission Reliability Project	Town: Sudbury
Photo No.: 4	Date: 6/03/2024

Description: View of water discharging from corral. Discharge appeared turbid. Turbidity reading was higher than 50 NTUs, but discharge did not appear to leave the site or reach any jurisdictional resource areas. Facing west.

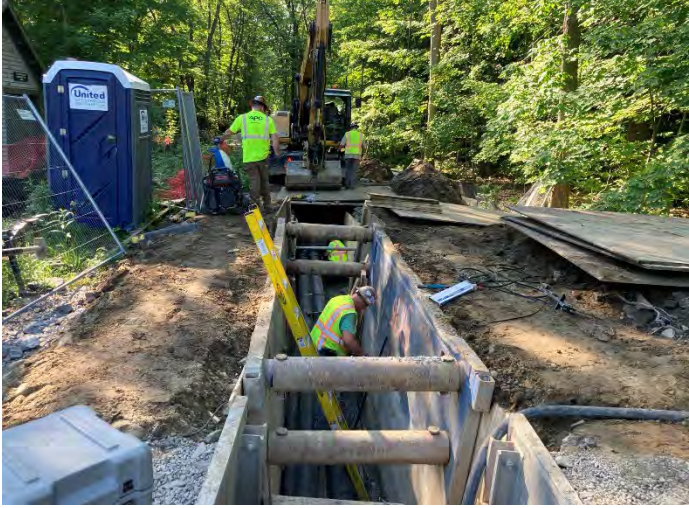
PHOTOGRAPHIC LOG	
Client Name: Eversource		Site Location: Sudbury to Hudson Transmission Reliability Project	Town: Sudbury
Photo No.: 1	Date: 6/04/2024

Description: View of Bond working at Boston Post Road crossing. Facing east.

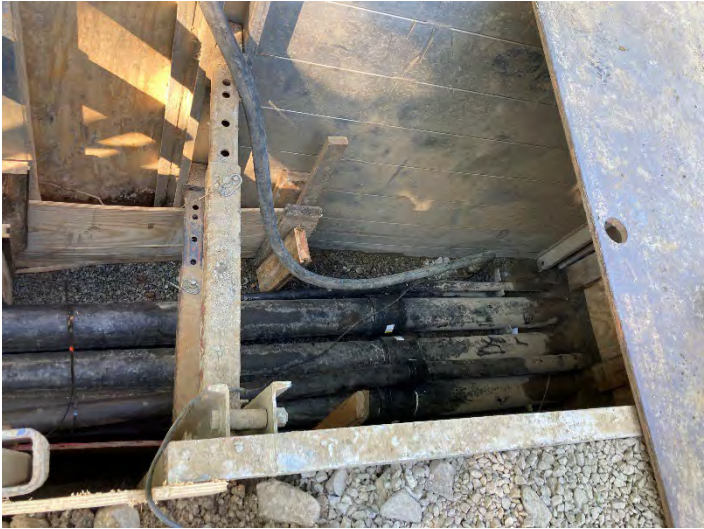
PHOTOGRAPHIC LOG	
Client Name: Eversource		Site Location: Sudbury to Hudson Transmission Reliability Project	Town: Sudbury
Photo No.: 2	Date: 6/04/2024

Description: View of pump in trench. Unable to visualize water prior to treatment.

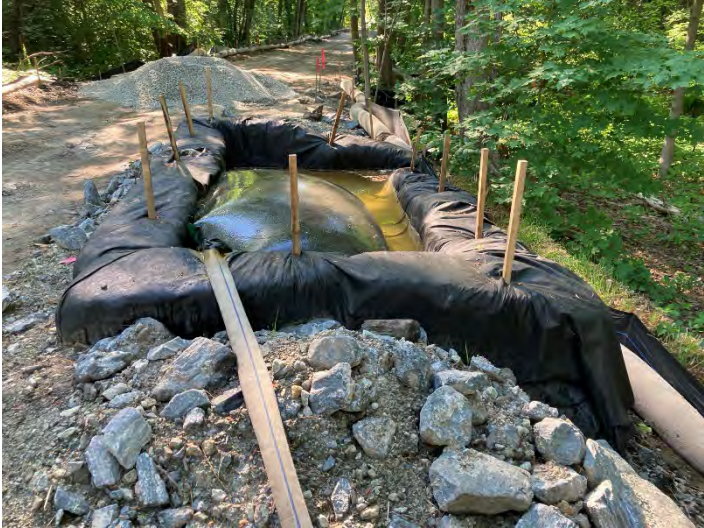
PHOTOGRAPHIC LOG	
Client Name: Eversource		Site Location: Sudbury to Hudson Transmission Reliability Project	Town: Sudbury
Photo No.: 3	Date: 6/04/2024

Description: View of dewatering controls (straw bale corral with filter fabric and silt bag) in segment 13. Facing east.

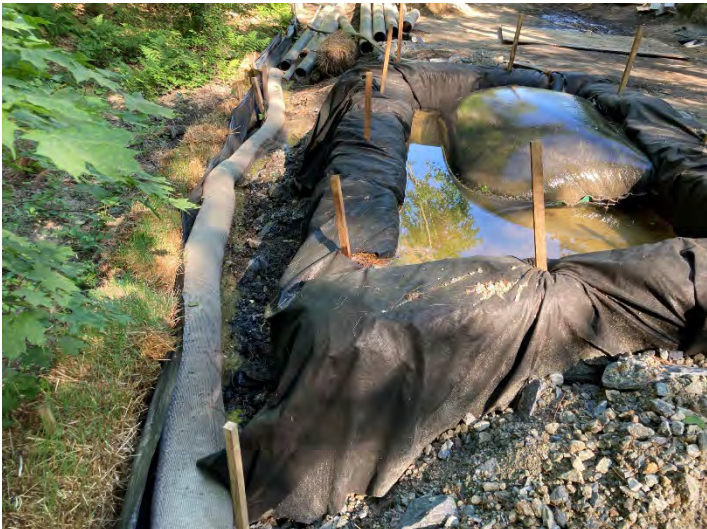
PHOTOGRAPHIC LOG	
Client Name: Eversource		Site Location: Sudbury to Hudson Transmission Reliability Project	Town: Sudbury
Photo No.: 4	Date: 6/04/2024

Description: View of water discharging from corral. Discharge appeared clear and turbidity reading was below 50 NTUs. Discharge did not appear to reach any jurisdictional resource areas. Facing west.

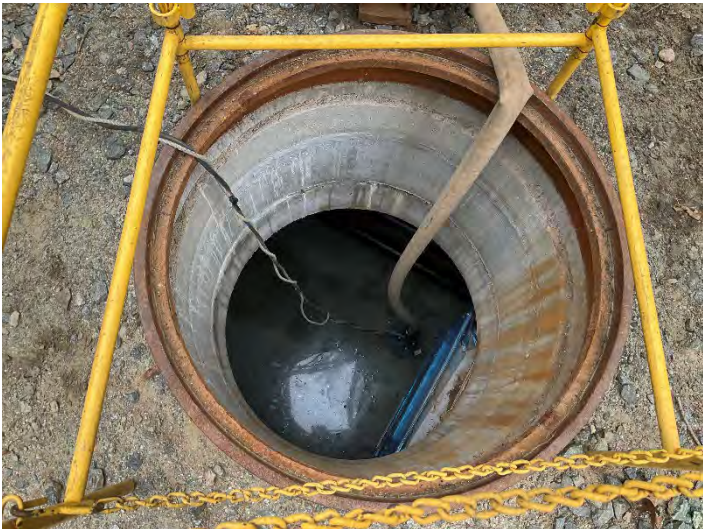
PHOTOGRAPHIC LOG	
Client Name: Eversource		Site Location: Sudbury to Hudson Transmission Reliability Project	Town: Sudbury
Photo No.: 2	Date: 6/05/2024

Description: View of pump in MH #22. Water appeared mostly clear prior to treatment.

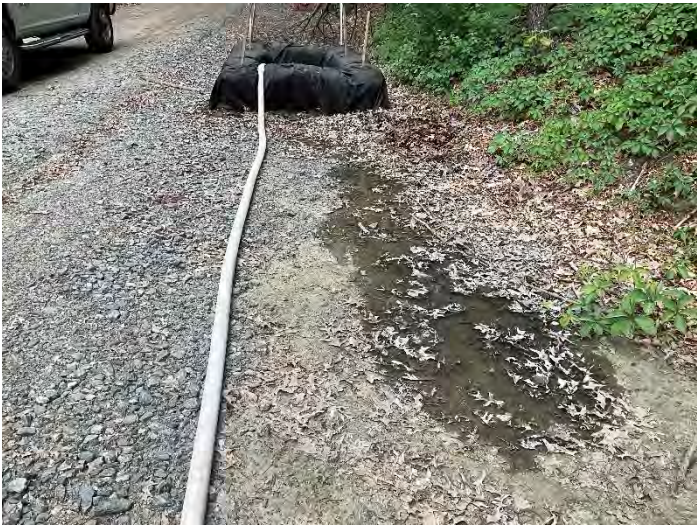
PHOTOGRAPHIC LOG	
Client Name: Eversource		Site Location: Sudbury to Hudson Transmission Reliability Project	
		Town: Sudbury	
Photo No.: 4	Date: 6/05/2024

Description: Additional view of dewatering controls (straw bale corral with filter fabric and silt bag) and discharge from corral. Discharge appeared mostly clear and turbidity reading was below 50 NTUs. Discharge did not appear to reach any jurisdictional resource areas. Facing west.

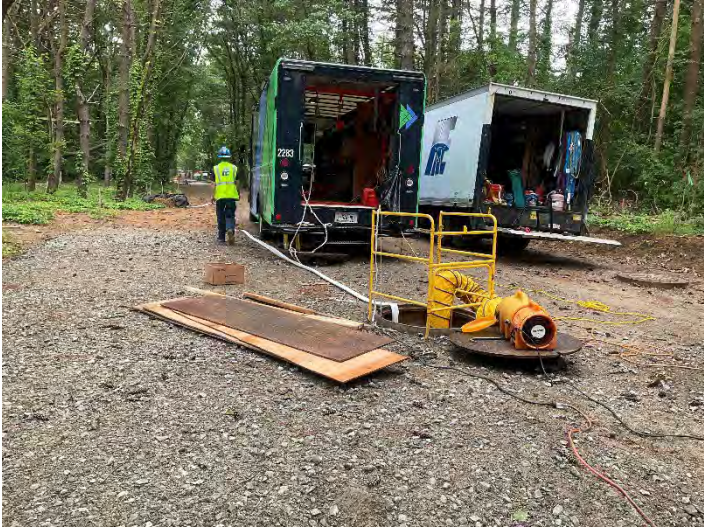
PHOTOGRAPHIC LOG	
Client Name: Eversource		Site Location: Sudbury to Hudson Transmission Reliability Project	Town: Sudbury
Photo No.: 1	Date: 6/7/2024

Description: View of Haugland working at MH #21. Facing east.

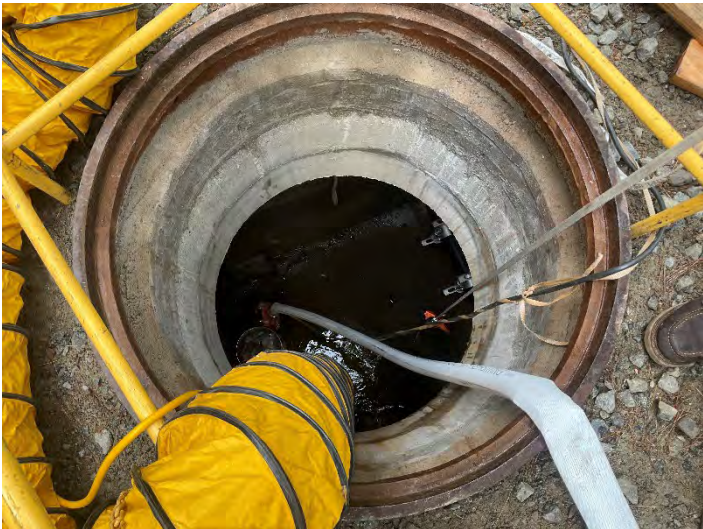
PHOTOGRAPHIC LOG	
Client Name: Eversource		Site Location: Sudbury to Hudson Transmission Reliability Project	Town: Sudbury
Photo No.: 2	Date: 6/7/2024

Description: View of MH #22. Water appeared clear prior to treatment.

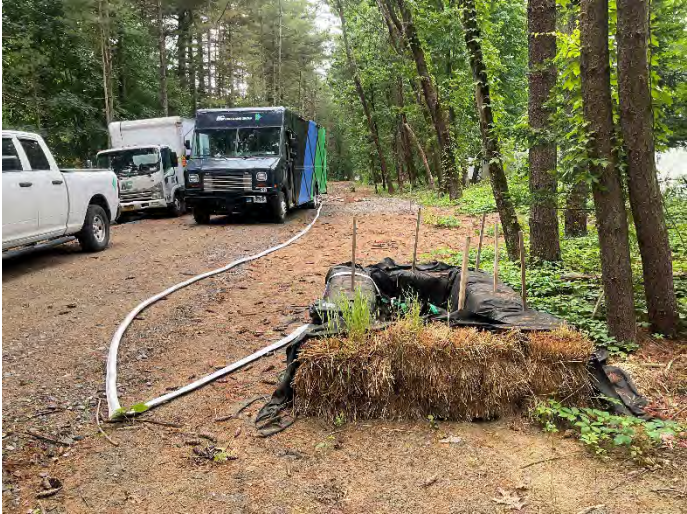
PHOTOGRAPHIC LOG	
Client Name: Eversource		Site Location: Sudbury to Hudson Transmission Reliability Project	
Town: Sudbury			
Photo No.: 3	Date: 6/7/2024

Description: View of dewatering controls (straw bale corral with filter fabric and silt bag). Facing west.

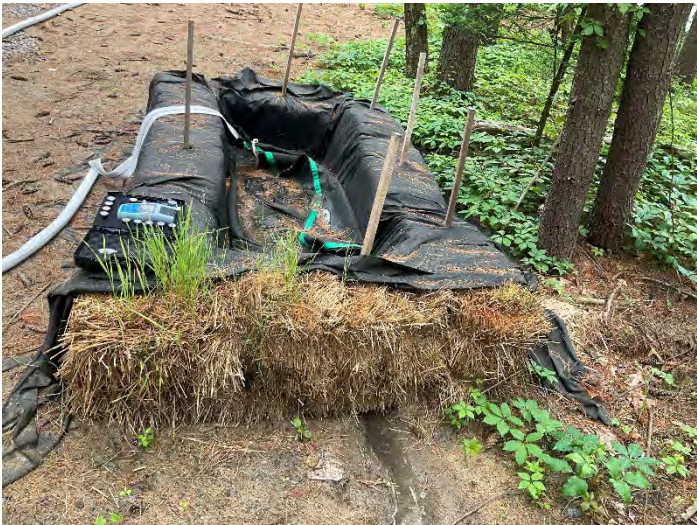
PHOTOGRAPHIC LOG	
Client Name: Eversource		Site Location: Sudbury to Hudson Transmission Reliability Project	
Town: Sudbury			
Photo No.: 4	Date: 6/7/2024

Description: View of dewatering controls (straw bale corral with filter fabric and silt bag) and discharge from corral. Discharge appeared clear but turbidity was above 50 NTUs. Discharge appeared to be picking up sediment from outside corral. Discharge did not reach any jurisdictional areas. Facing west.

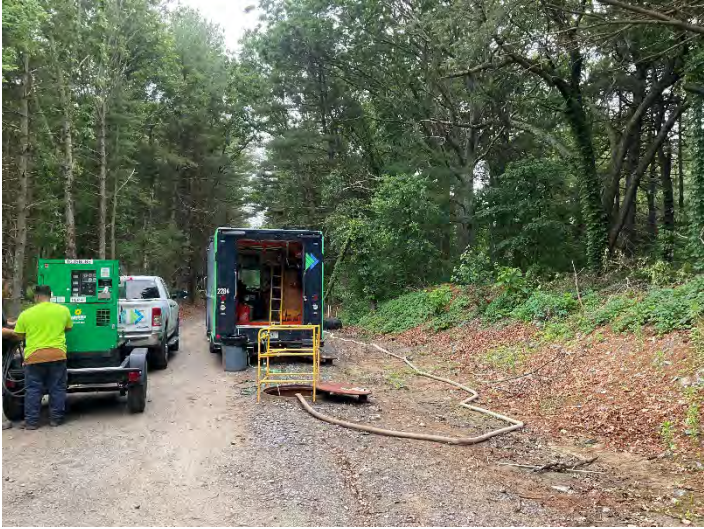
PHOTOGRAPHIC LOG		
Client Name: Eversource		Site Location: Sudbury to Hudson Transmission Reliability Project		Town: Sudbury
Photo No.: 1	Date: 6/7/2024

Description: View of Haugland working at MH #22. Facing east.

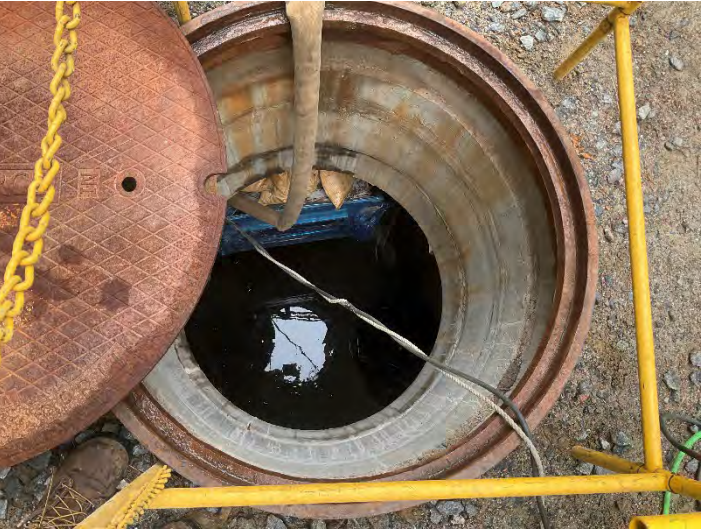
PHOTOGRAPHIC LOG		
Client Name: Eversource		Site Location: Sudbury to Hudson Transmission Reliability Project		Town: Sudbury
Photo No.: 2	Date: 6/7/2024

Description: View of MH #22. Water appeared clear prior to treatment.
