Weekly Environmental Compliance Summary

Sudbury to Hudson Transmission Reliability Project (USEPA Tracking # MAR1003UW)

Week of: June 10, 2024 to June 15, 2024

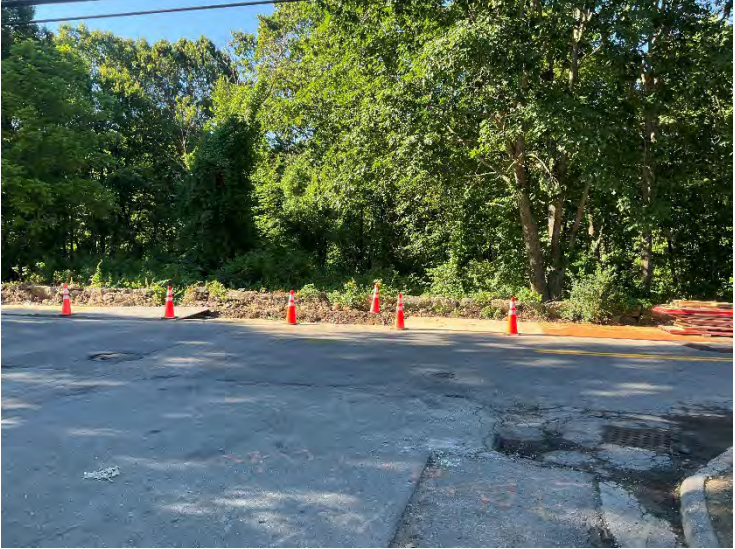
<p>Description:</p> <p>View of Bond work area and staging along Forest Avenue by MH #2. This area is currently inactive due to safety standdown. Facing east.</p>

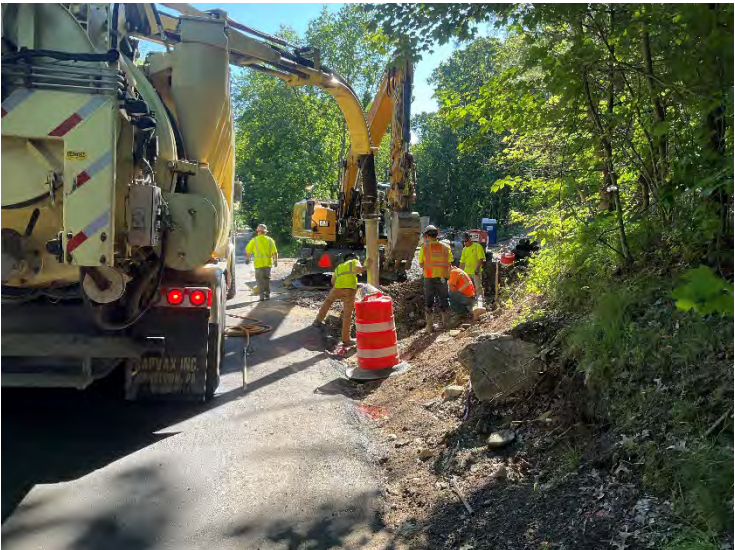
<p>Description:</p> <p>View of Bond working within Wilkins Street at the entrance to segment 1. See additional dewatering report. Facing west.</p>

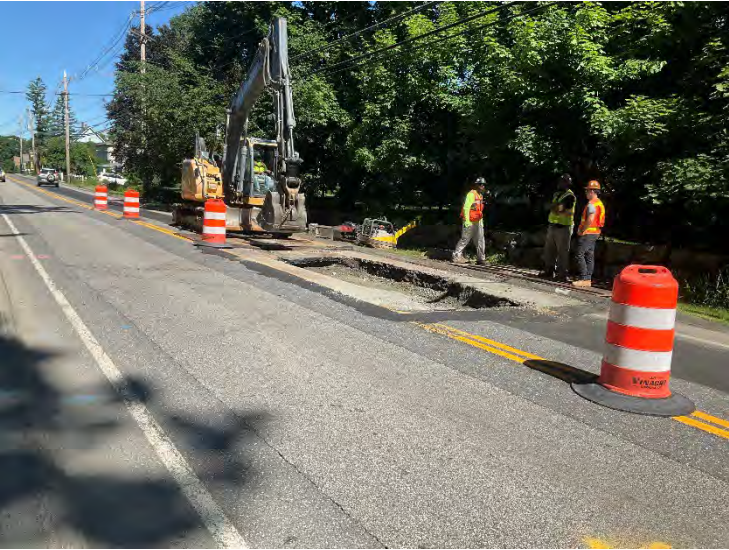
<p>Description:</p> <p>View of Vinagro work area in Forest Avenue removing abandoned manholes. Steel plates in roadway were removed and area paved. Facing west.</p>

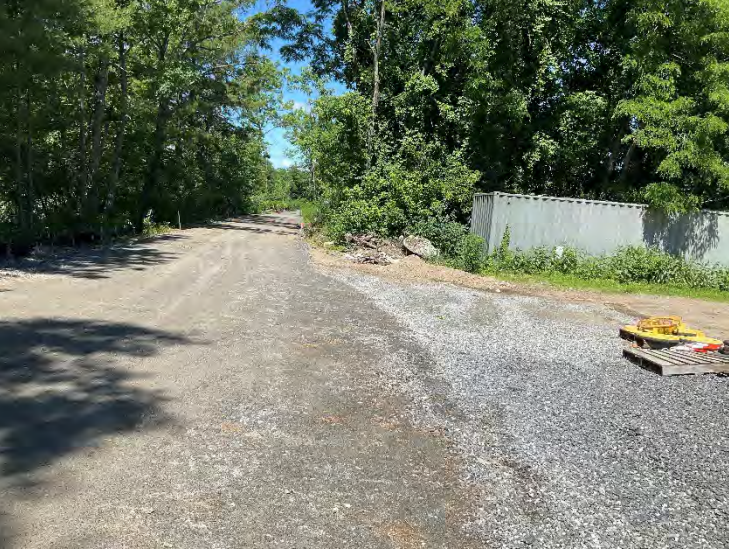
<p>Description:</p> <p>View of spoil stockpile located in segment 3. Facing west.</p>

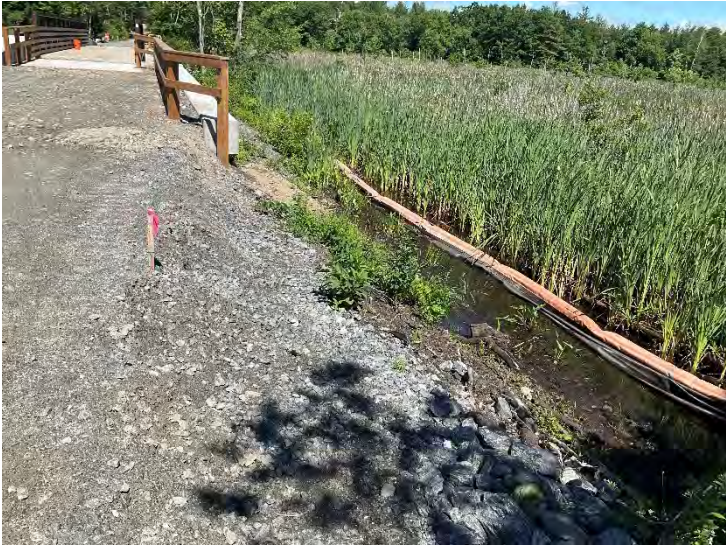
<p>Description: View of turbidity curtain in segment 3 at Bridge 130. Facing east.</p>

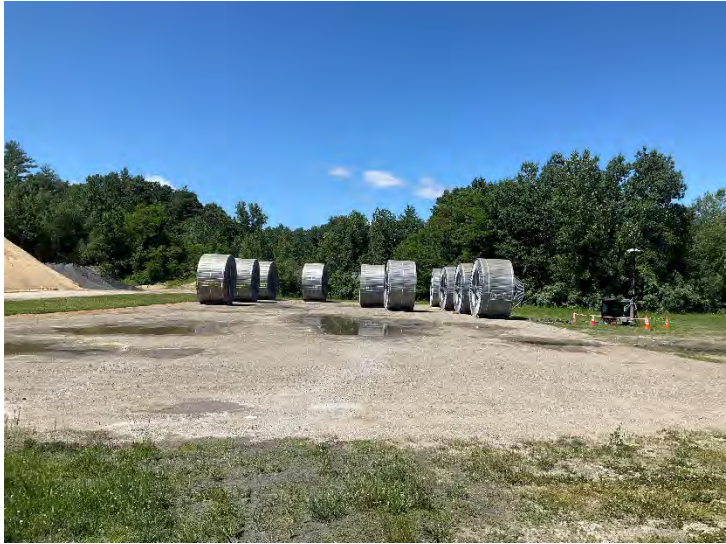
<p>Description:</p> <p>View of Haugland laydown yard. Facing southwest.</p>

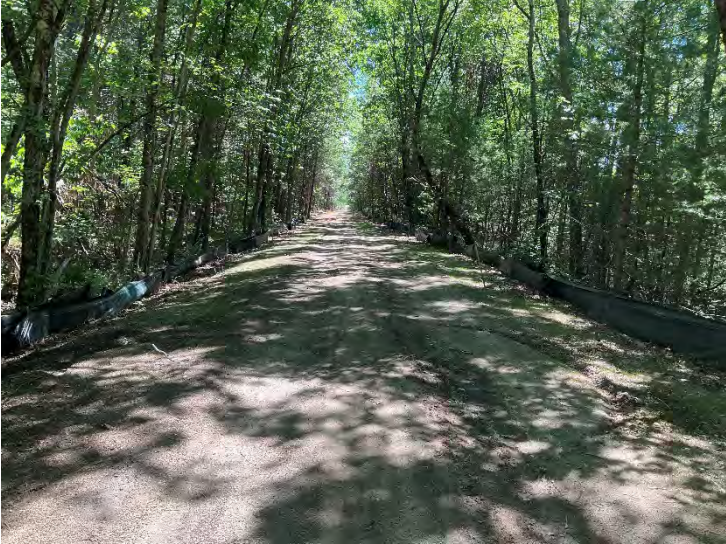
<p>Description:</p> <p>View of E&S controls in segment 6. Facing west.</p>

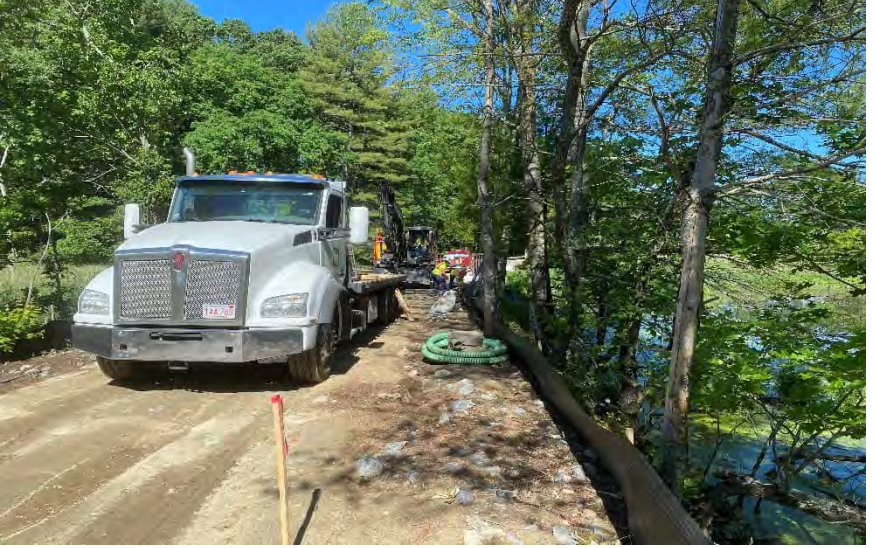
Description: Work area within segment 14, ET&L working at bridge 127, existing erosion control, looking westward.

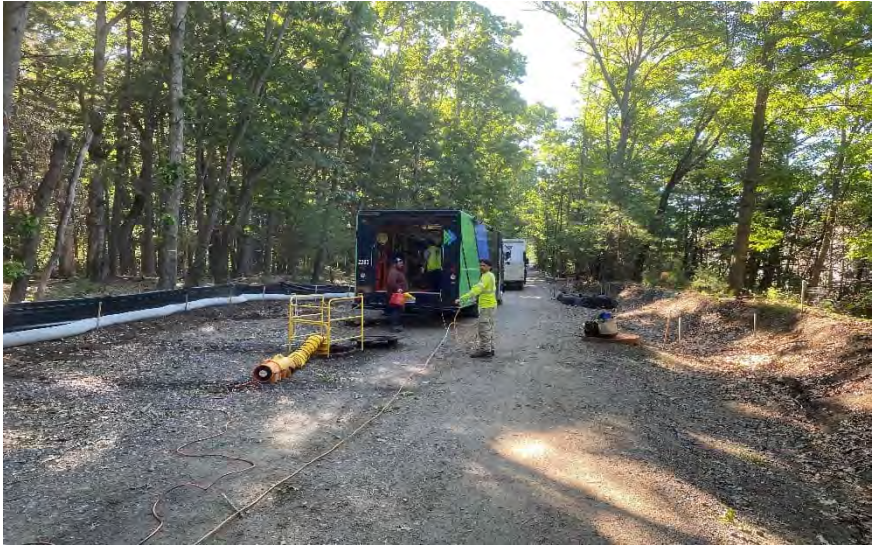
<p>Description:</p> <p>Work area within segment 11, Haugland splicing at manhole #22, existing erosion control, looking eastward.</p>

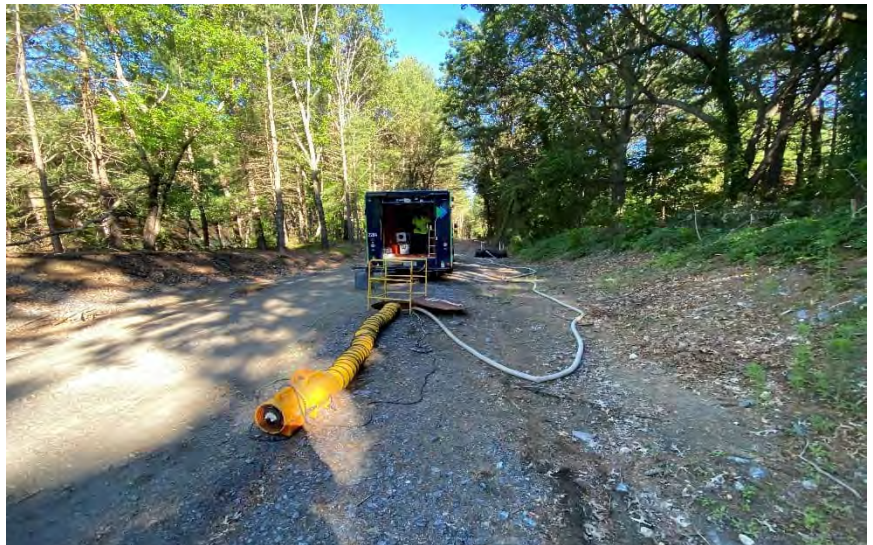
<p>Description:</p> <p>Work area within segment 11, Haugland splicing at manhole #23, existing erosion control, looking westward.</p>

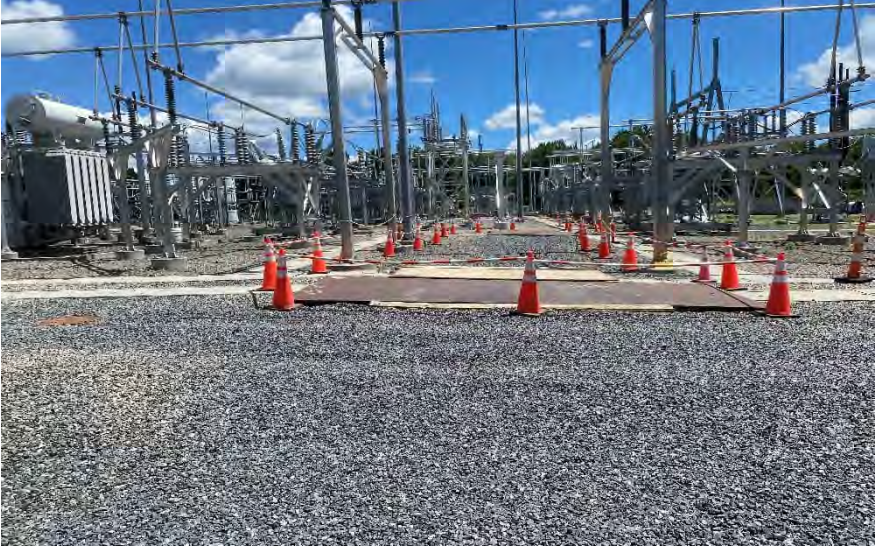
Description: Work area at substation, conduit work, looking eastward.

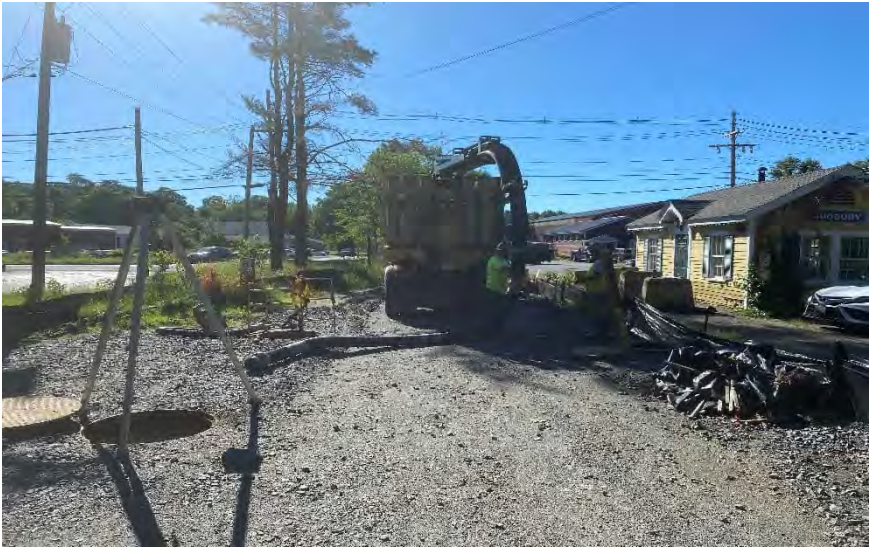
<p>Description:</p> <p>Work area within segment 11, manhole #24, proofing, existing erosion control, looking eastward.</p>

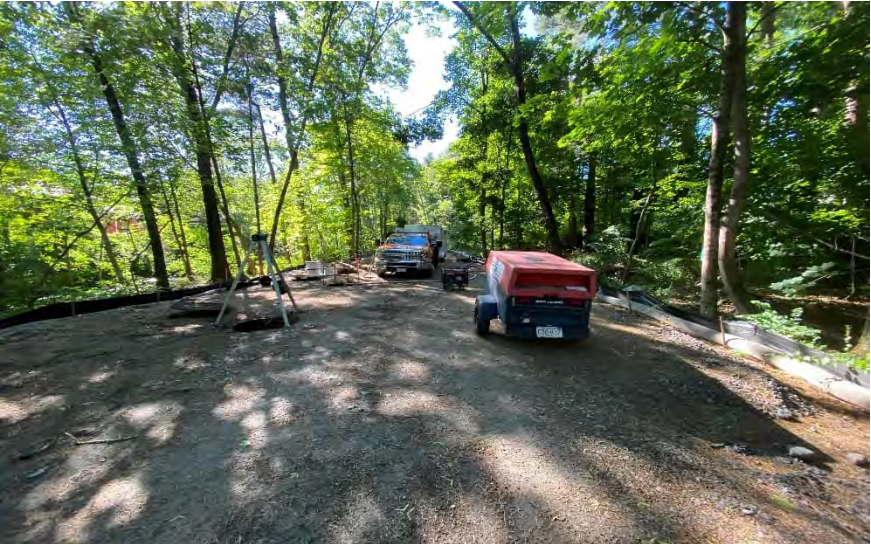
<p>Description:</p> <p>Work area within segment 13, manhole #25, proofing, existing erosion control, looking eastward.</p>

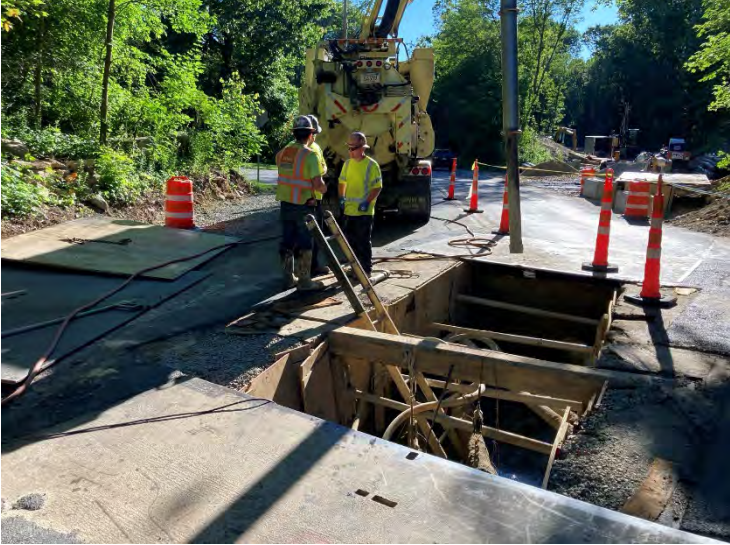
Description: View of Bond working in Wilkins St near entrance to segment 1. See additional dewatering inspection report. Facing northeast.

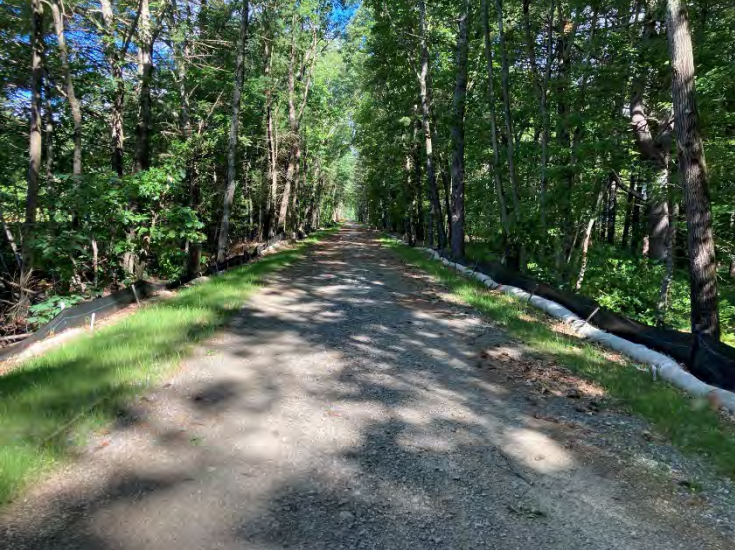
Description: View of E&S controls in segment 4. Facing west.

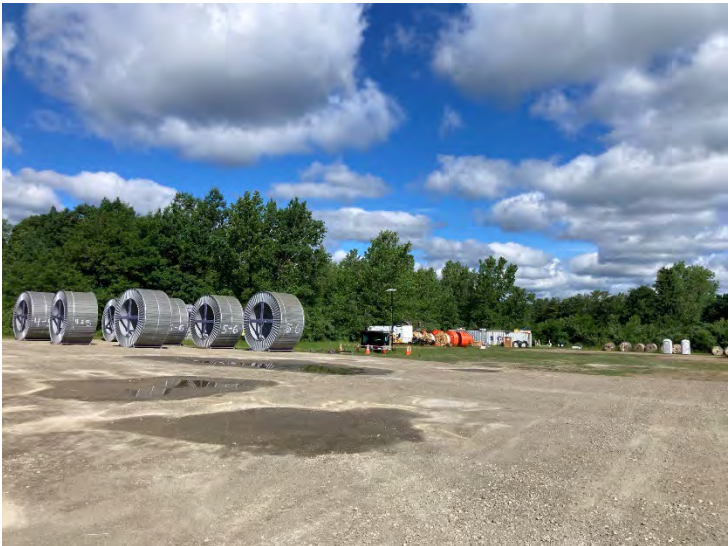
Description: View of Haugland's laydown yard. Facing northwest.

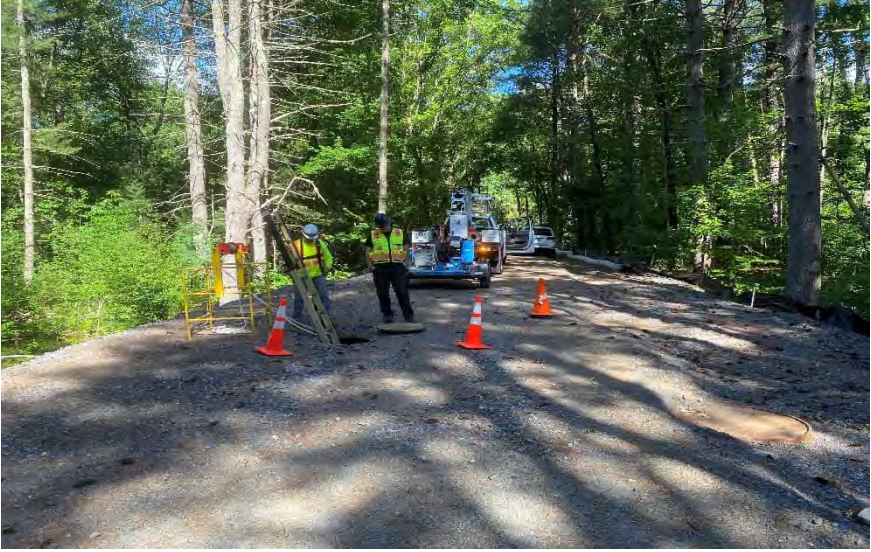
<p>Description:</p> <p>Work area within Segment 9, Handhole #19, running fiber optics, existing erosion control, looking westward.</p>

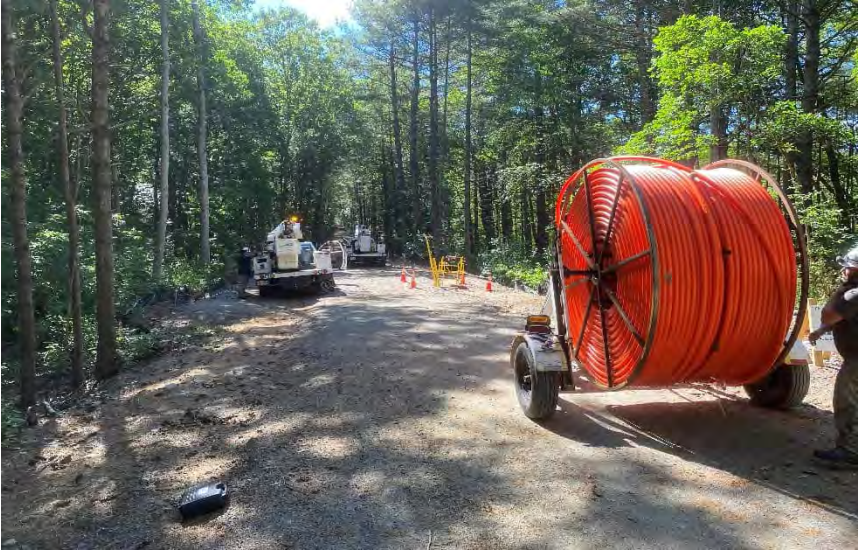
<p>Description:</p> <p>Work area within Segment 10, Handhole #20, running fiber optics, existing erosion control, looking eastward.</p>

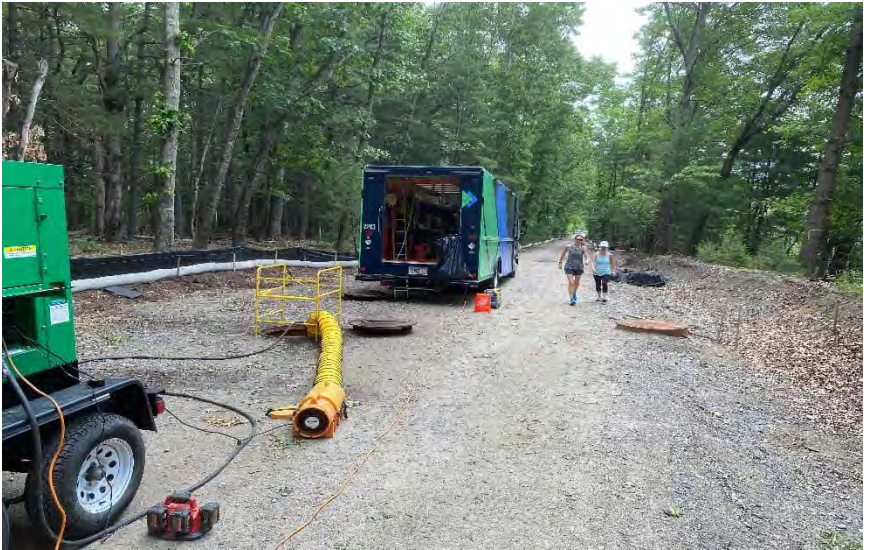
<p>Description:</p> <p>Work area within segment 11, Haugland splicing at manhole #23, existing erosion control, looking eastward.</p>

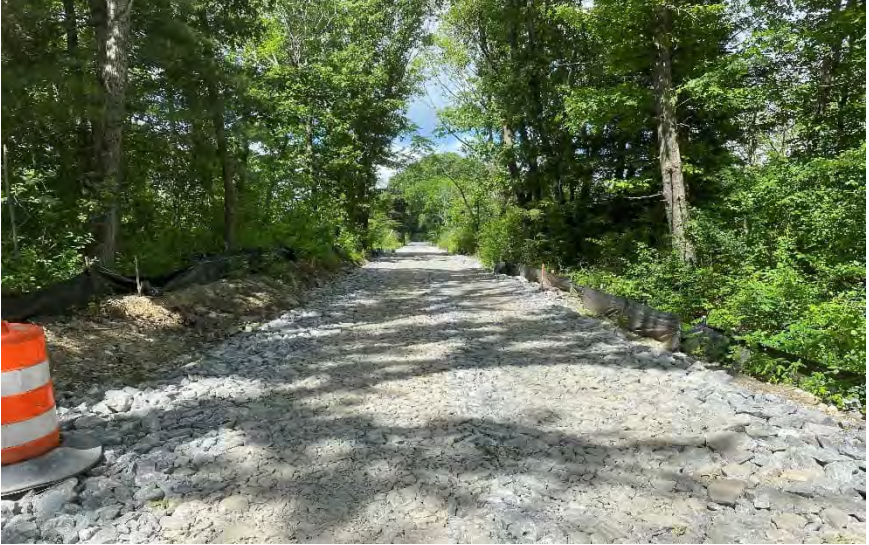
<p>Description:</p> <p>Work area within segment 14, hardening, existing erosion control, looking eastward.</p>

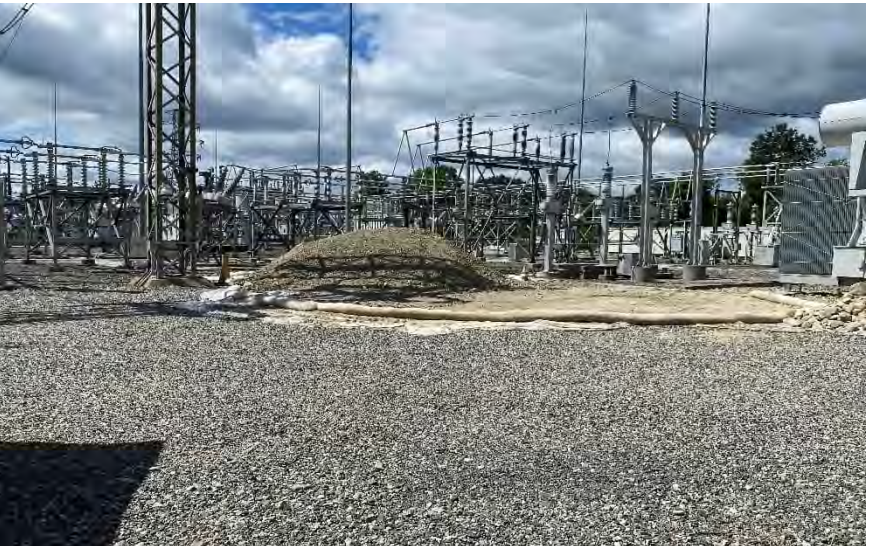
<p>Description:</p> <p>Work area within substation, newly placed spoil pile, existing erosion control (compost tubing), looking southward.</p>

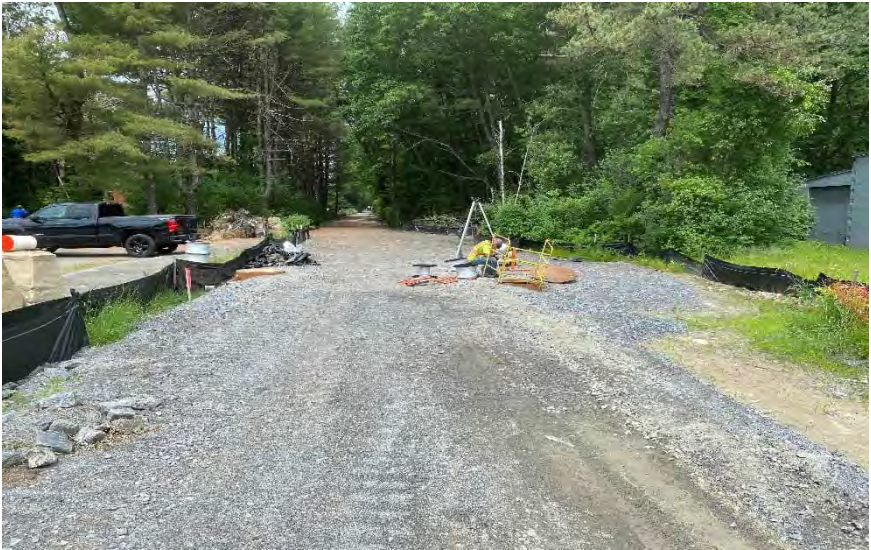
<p>Description:</p> <p>Work area within segment 11, manhole #24, proofing, existing erosion control, looking westward.</p>

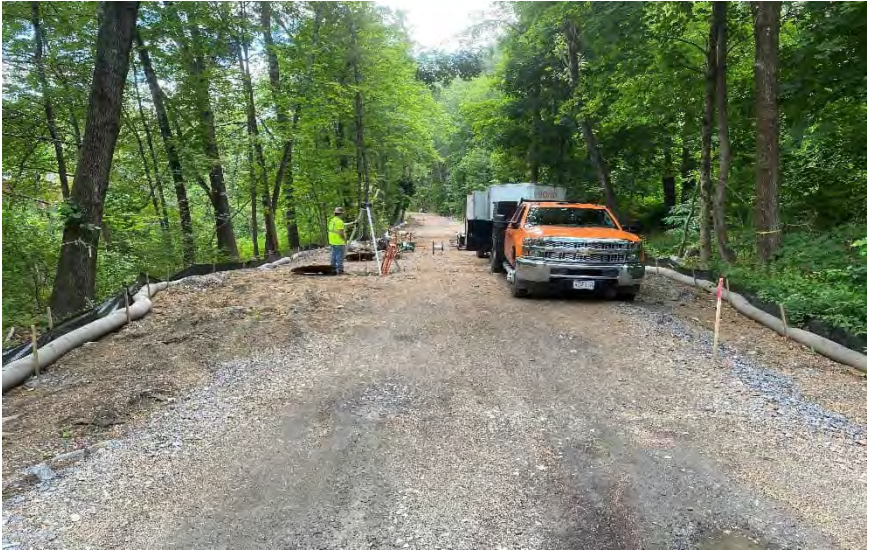
<p>Description:</p> <p>Work area within segment 13, manhole #25, proofing, existing erosion control, looking eastward.</p>

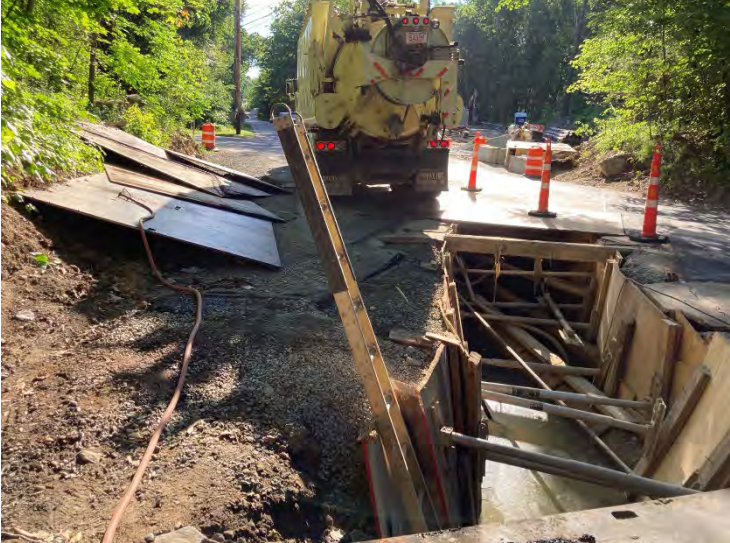
<p>Description: View of Bond working in Wilkins St near entrance to segment 1. See additional dewatering inspection report. Facing northeast.</p>

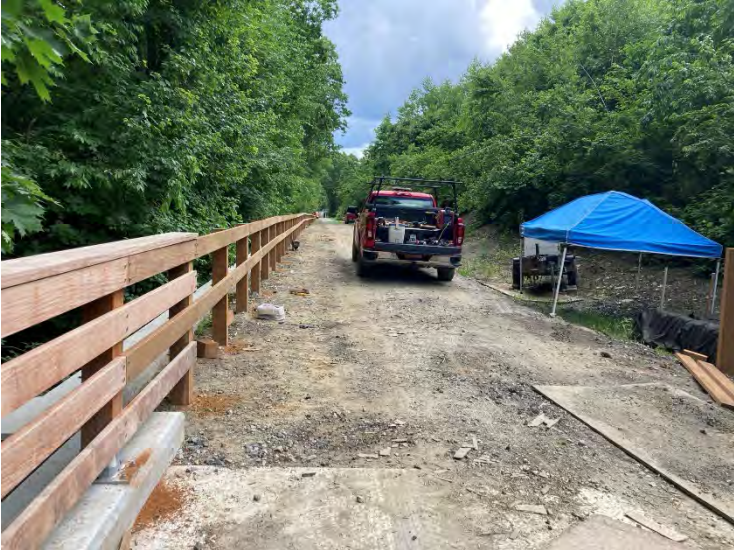
<p>Description: View of ET&L's work area at walls 1 and 2 in segment 1. Facing east.</p>

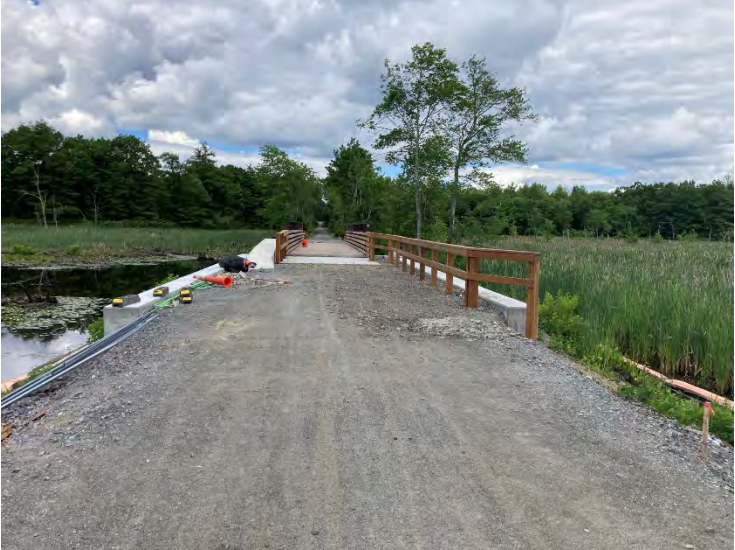
Description: View of bridge 130. Facing west.

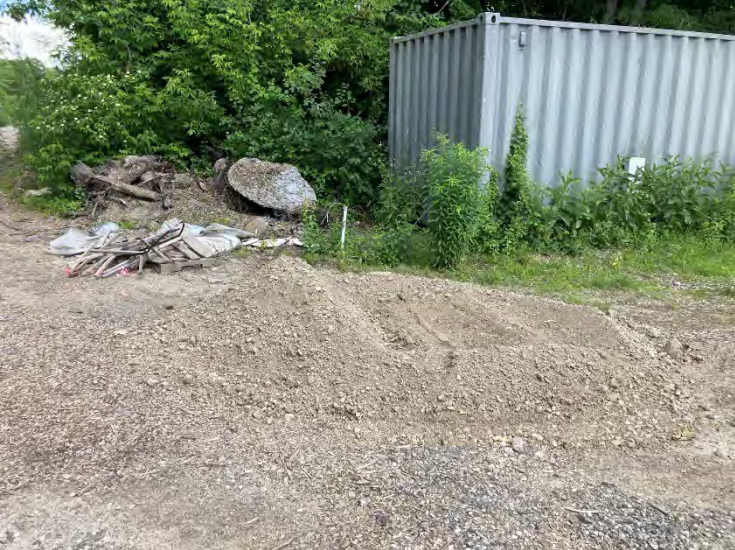
Description: View of small spoil stockpile in segment 3. Facing west.

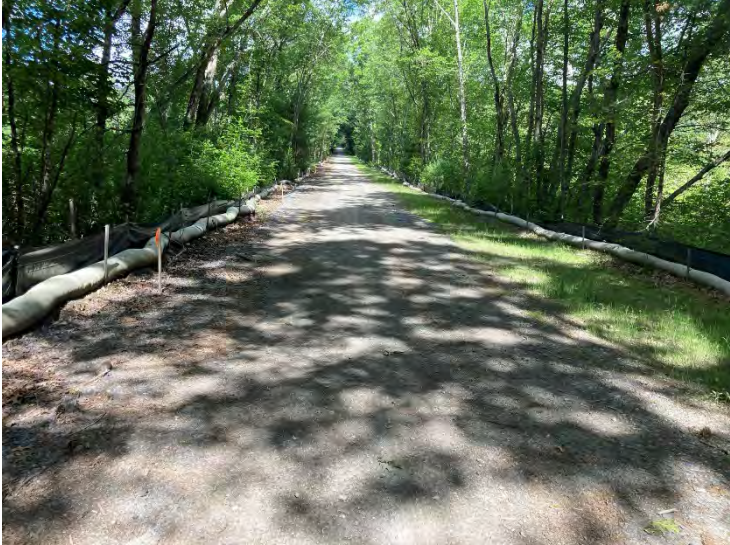
Description: View of E&S controls in segment 5. Facing west.

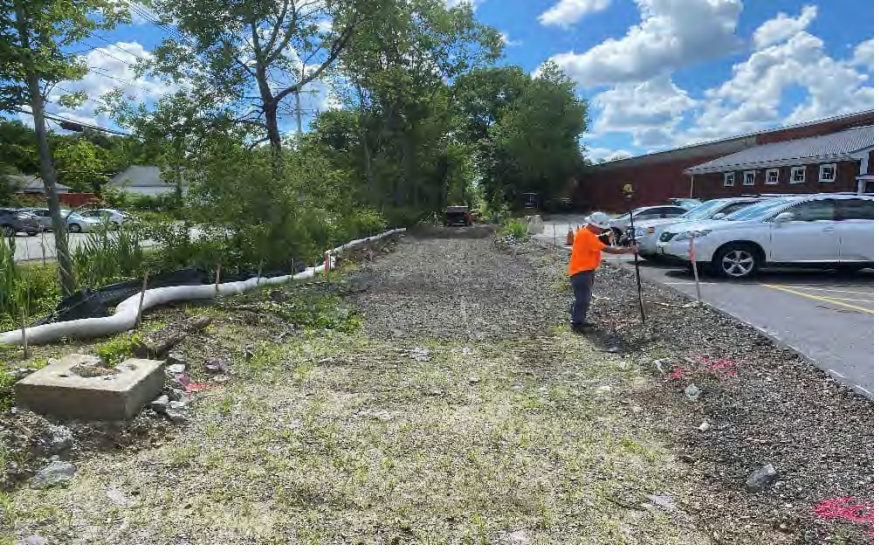
Description: Work area within Segment 12, survey work, existing erosion control, looking eastward.

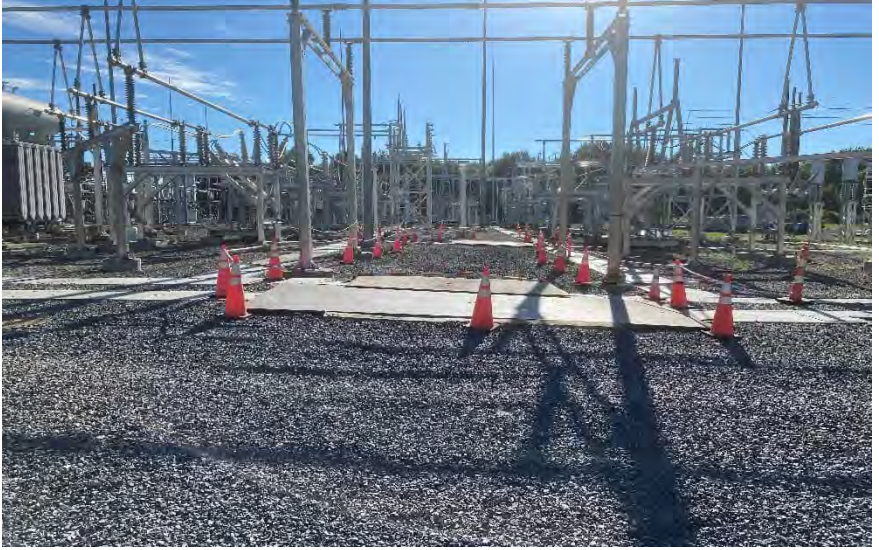
Description: Work area within substation, conduit work area, looking eastward.

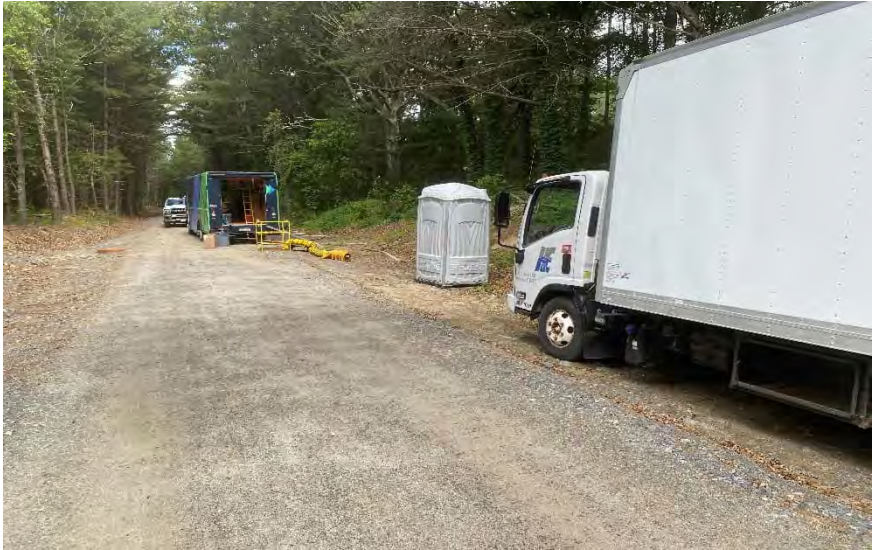
<p>Description:</p> <p>Work area within segment 11, Haugland splicing at manhole #22, existing erosion control, looking westward.</p>

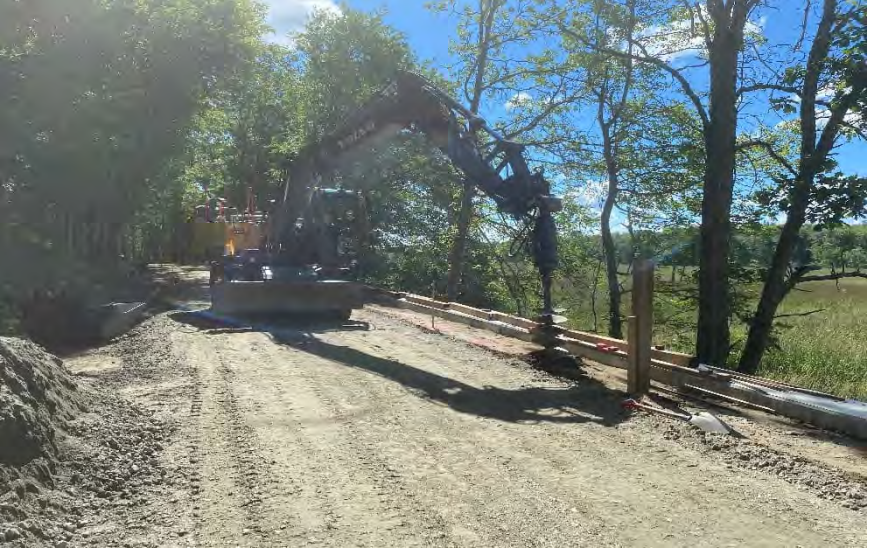
Description: Work area within segment 14, wall work, existing erosion control, looking eastward.

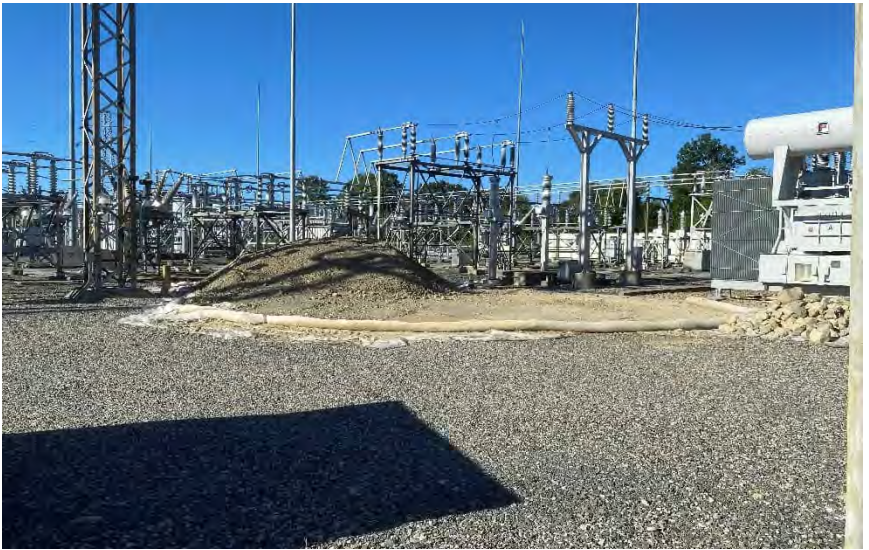
Description: Work area within substation, newly placed spoil pile, existing erosion control (compost tubing), looking southward.

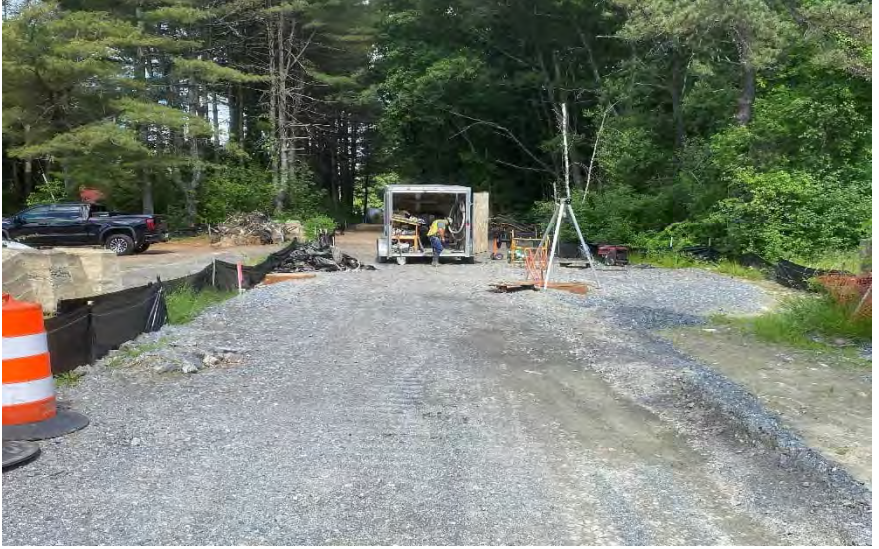
<p>Description:</p> <p>Work area within segment 11, manhole #24, proofing, existing erosion control, looking westward.</p>

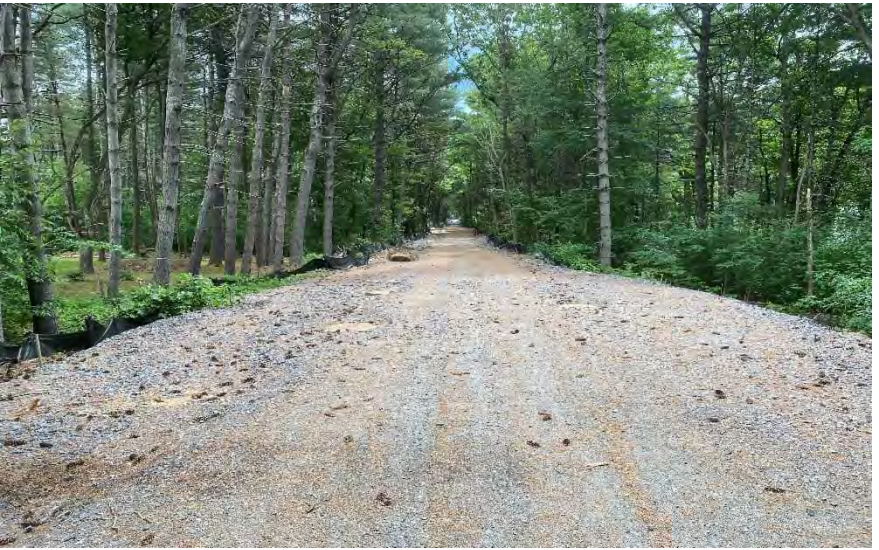
<p>Description:</p> <p>Work area within segment 9, manhole #19, existing erosion control, looking eastward.</p>

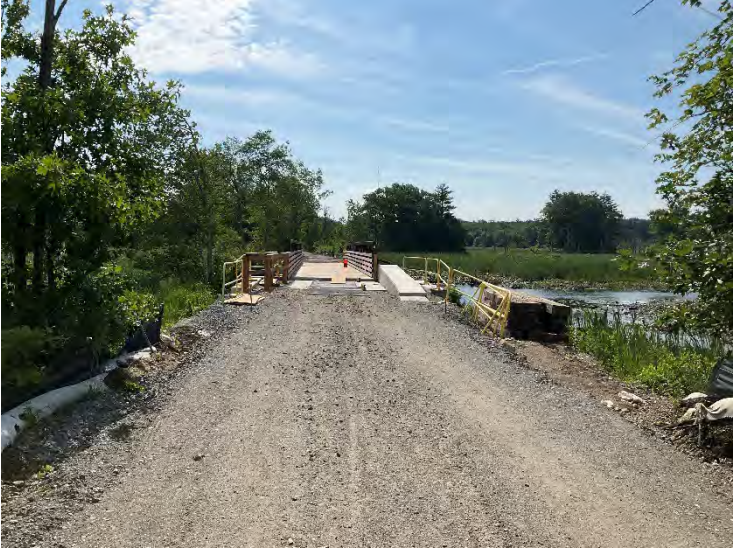
<p>Description:</p> <p>View of Bridge 130 from segment 2. Facing east.</p>

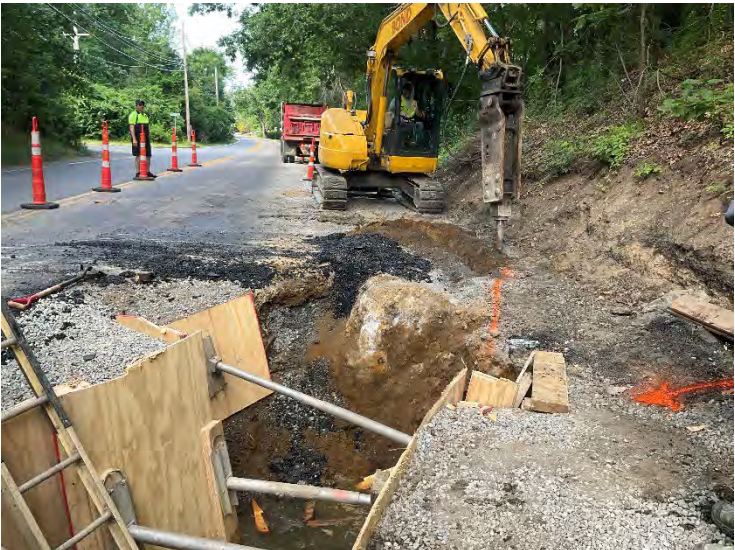
<p>Description:</p> <p>View of Bond trenching within Wilkins Street at the entrance to segment 1. See additional dewatering report. Facing west.</p>

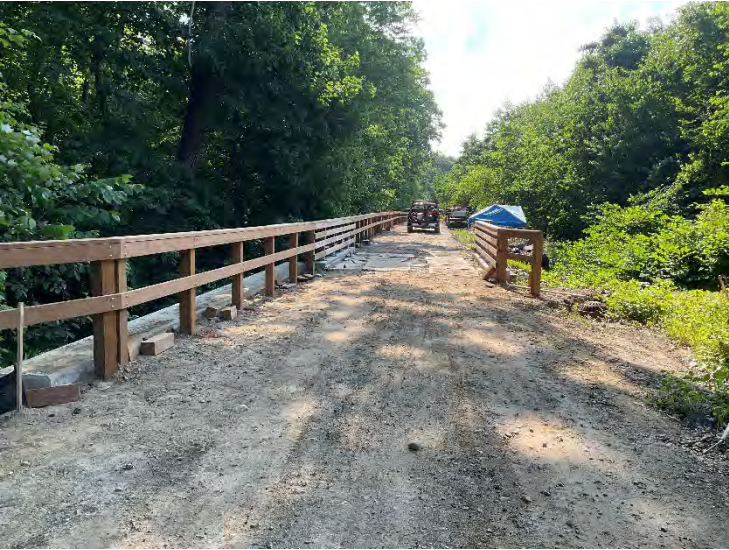
<p>Description:</p> <p>View of ET&L installing railings at walls #1 & #2 in segment 1. Facing east.</p>

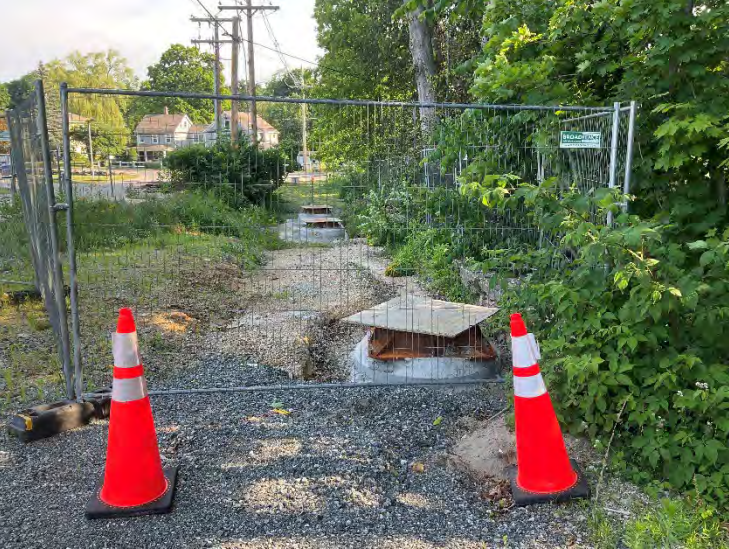
<p align="center">PHOTOGRAPHIC LOG</p>	
<p>Client Name: Eversource</p>		<p>Site Location: Sudbury to Hudson Transmission Reliability Project</p>	<p>Town: Hudson</p>
<p>Photo No.: 4</p>	<p>Date: 6-14-24</p>

<p>Description:</p> <p>View of MH#1. Facing north.</p>

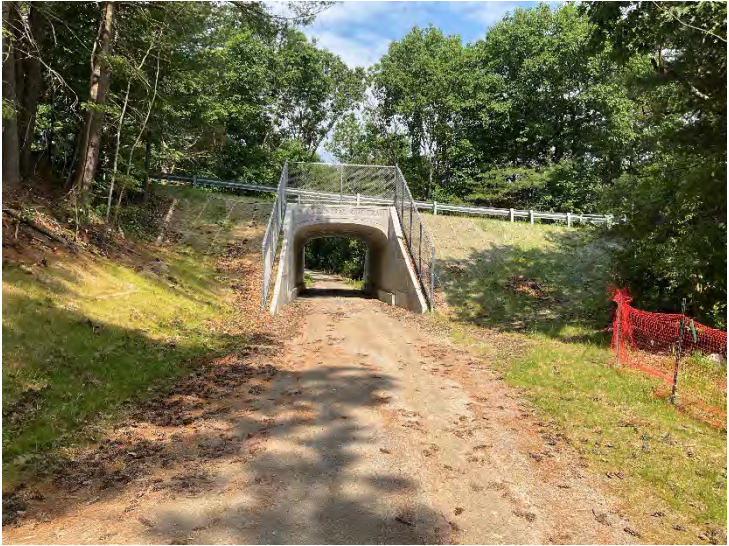
Epsilon ASSOCIATES INC.		PHOTOGRAPHIC LOG	
Client Name: Eversource		Site Location: Sudbury to Hudson Transmission Reliability Project	Town: Hudson
Photo No.: 5	Date: 6-14-24

Description: View of hydroseeding matting at Chestnut Street underpass in segment 2. Facing west.

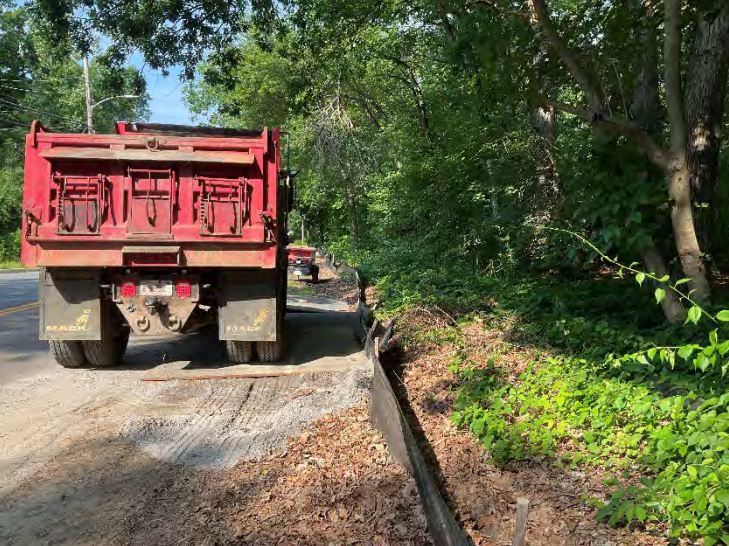
Epsilon ASSOCIATES INC.		PHOTOGRAPHIC LOG	
Client Name: Eversource		Site Location: Sudbury to Hudson Transmission Reliability Project	Town: Hudson
Photo No.: 6	Date: 6-14-24

Description: View of installed silt fencing along Wilkins Street by Bond work area. Facing west.

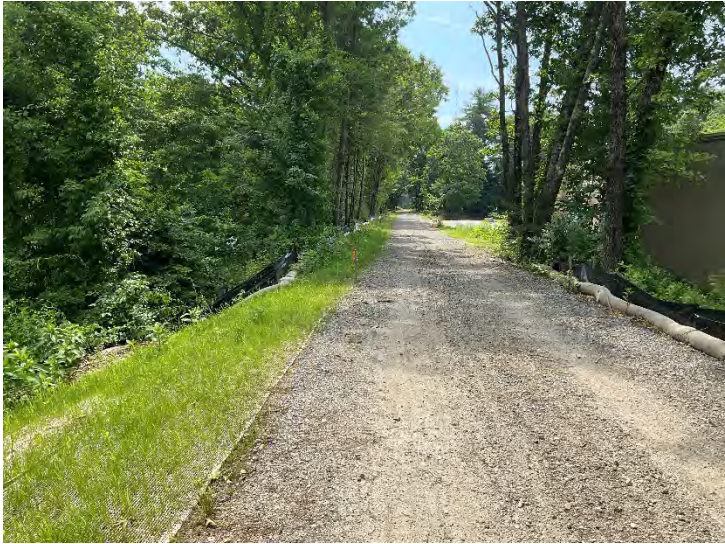
PHOTOGRAPHIC LOG	
Client Name: Eversource		Site Location: Sudbury to Hudson Transmission Reliability Project	Town: Hudson
Photo No.: 7	Date: 6-14-24

Description: View of E&S controls in segment 3. Facing east.

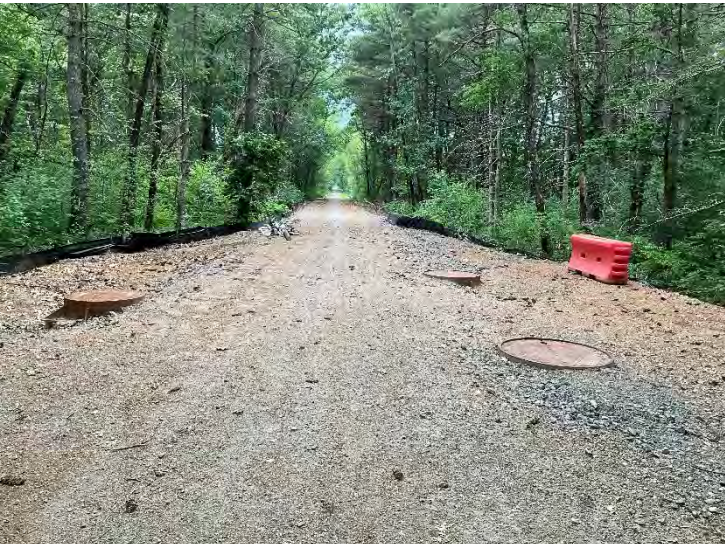
PHOTOGRAPHIC LOG	
Client Name: Eversource		Site Location: Sudbury to Hudson Transmission Reliability Project	Town: Hudson
Photo No.: 8	Date: 6-14-24

Description: View of E&S controls in segment 5 by MH#13. Facing west.

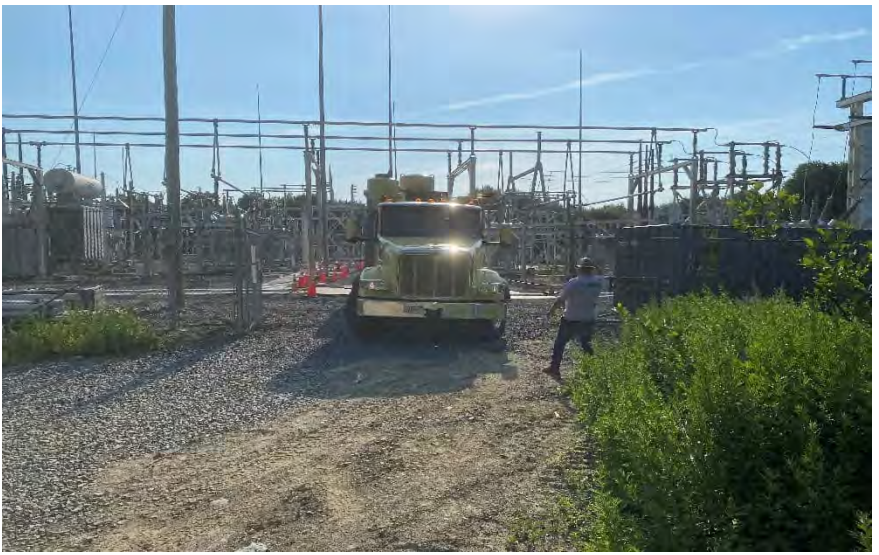
<p>PHOTOGRAPHIC LOG</p>	
<p>Client Name: Eversource</p>		<p>Site Location: Sudbury to Hudson Transmission Reliability Project</p>	<p>Town: Sudbury</p>
<p>Photo No.: 2</p>	<p>Date: 6-14-24</p>

<p>Description:</p> <p>Work area within substation, conduit work, looking eastward.</p>

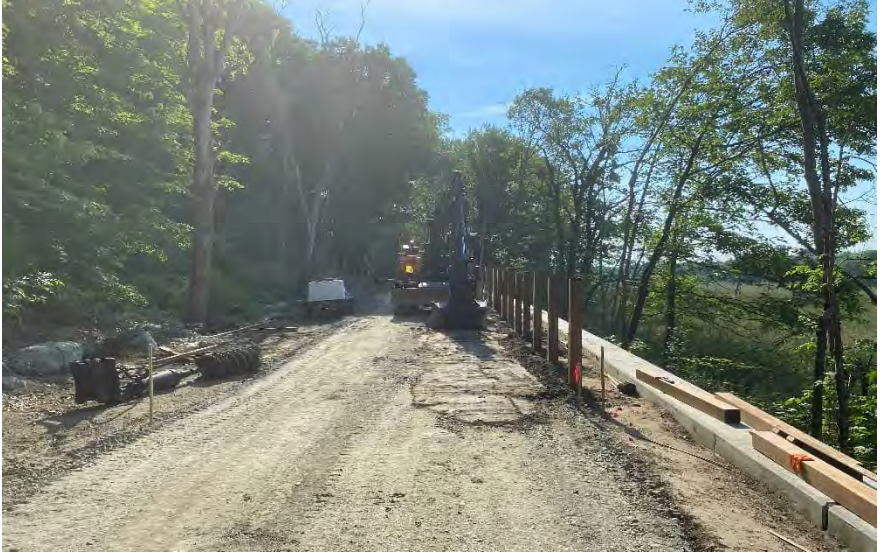
<p>PHOTOGRAPHIC LOG</p>	
<p>Client Name: Eversource</p>		<p>Site Location: Sudbury to Hudson Transmission Reliability Project</p>	<p>Town: Sudbury</p>
<p>Photo No.: 5</p>	<p>Date: 6-14-24</p>

<p>Description:</p> <p>Work area within segment 14, wall work, existing erosion control, looking eastward.</p>

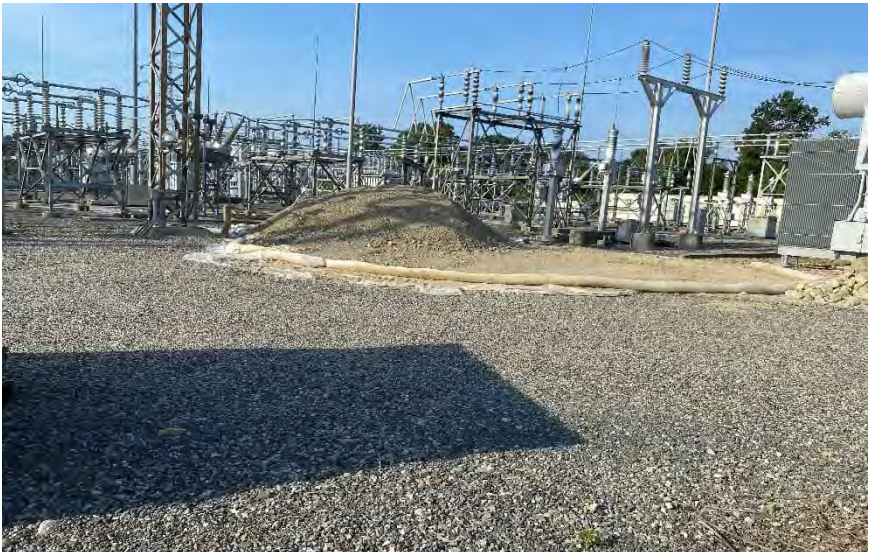
<p>PHOTOGRAPHIC LOG</p>	
<p>Client Name: Eversource</p>		<p>Site Location: Sudbury to Hudson Transmission Reliability Project</p>	<p>Town: Sudbury</p>
<p>Photo No.: 6</p>	<p>Date: 6-14-24</p>

Identify presence of stockpiles and document when placed and when removed (week maximum for stockpiles) Yes No
Spoil pile just at eastern end of segment 14, southern side just off work area, noted today (6-14-2024).

<p>Description:</p> <p>Work area within substation, newly placed spoil pile, existing erosion control (compost tubing), looking southward.</p>

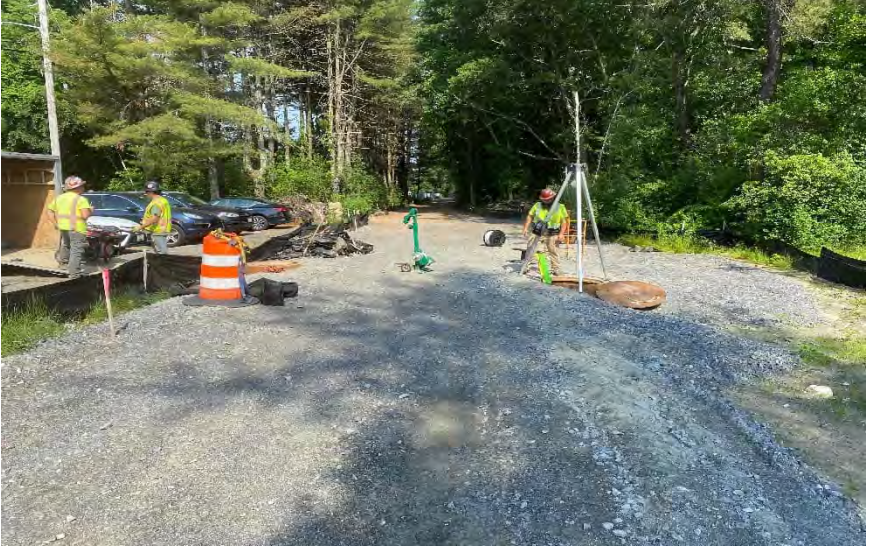
PHOTOGRAPHIC LOG	
Client Name: Eversource		Site Location: Sudbury to Hudson Transmission Reliability Project	Town: Sudbury
Photo No.: 7	Date: 6-14-24

Description: Work area within segment 11, manhole #24, proofing, existing erosion control, looking westward.

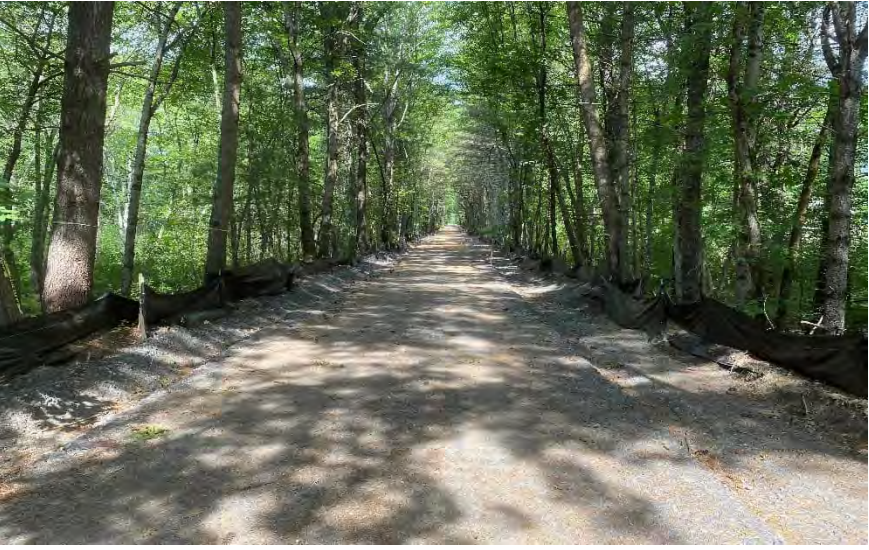
PHOTOGRAPHIC LOG	
Client Name: Eversource		Site Location: Sudbury to Hudson Transmission Reliability Project	Town: Sudbury
Photo No.: 8	Date: 6-14-24

Description: Work area within segment 9, existing erosion control, looking westward.
