Weekly Environmental Compliance Summary

Sudbury to Hudson Transmission Reliability Project (USEPA Tracking # MAR1003UW)

Week of: June 10, 2024 to June 15, 2024

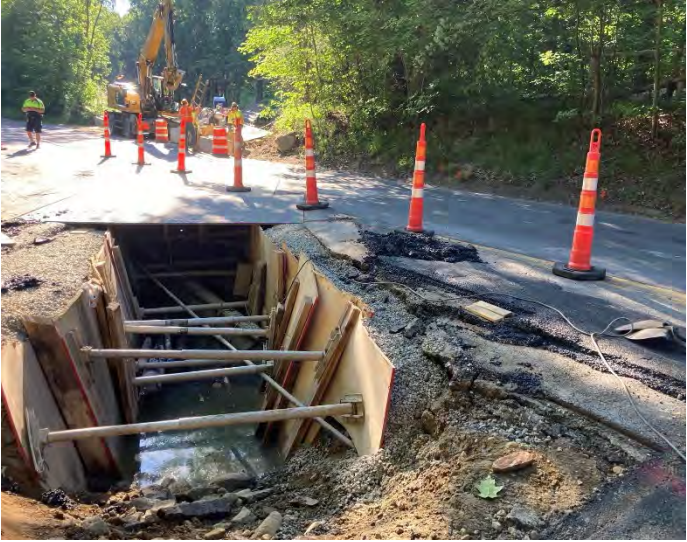
PHOTOGRAPHIC LOG	
Client Name: Eversource		Site Location: Sudbury to Hudson Transmission Reliability Project	Town: Hudson
Photo No.: 1	Date: 6-13-2024

Description: View of Bond working on Wilkins St. See additional dewatering inspection report. Facing east.

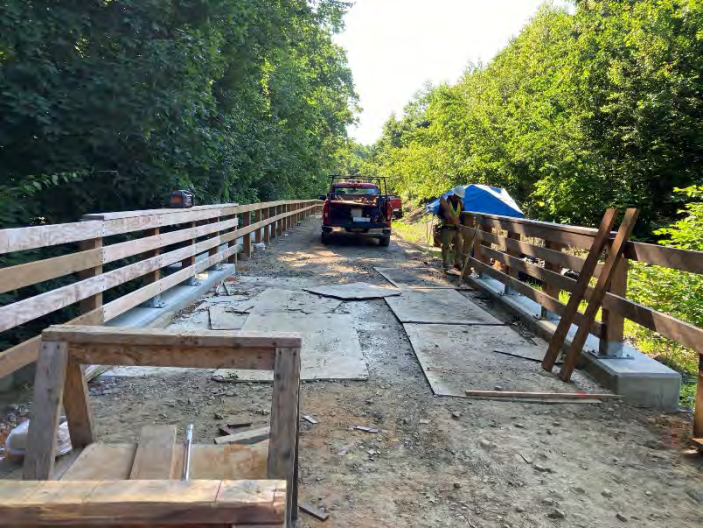
PHOTOGRAPHIC LOG	
Client Name: Eversource		Site Location: Sudbury to Hudson Transmission Reliability Project	Town: Hudson
Photo No.: 2	Date: 6-13-2024

Description: View of ET&L working at walls #1 and #2 in segment 1. Facing east.

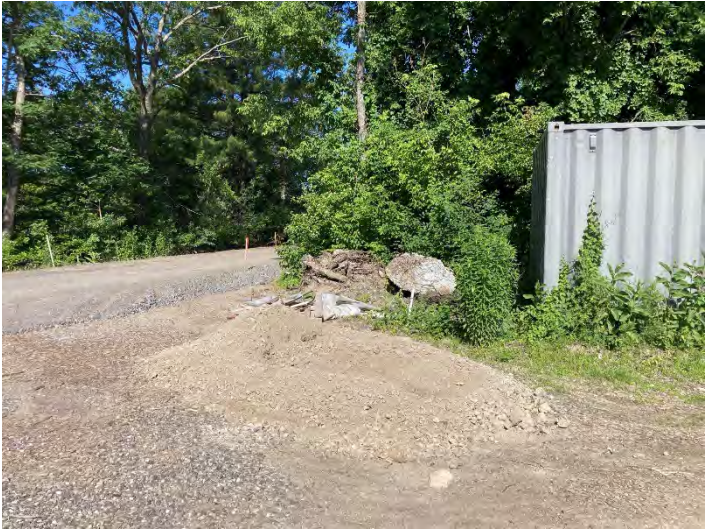
Epsilon ASSOCIATES INC.		PHOTOGRAPHIC LOG	
Client Name: Eversource		Site Location: Sudbury to Hudson Transmission Reliability Project	Town: Hudson
Photo No.: 3	Date: 6-13-2024

Description: View of small spoil stockpile in segment 3. Pile is scheduled to be removed 6/17/2024. Facing southwest.

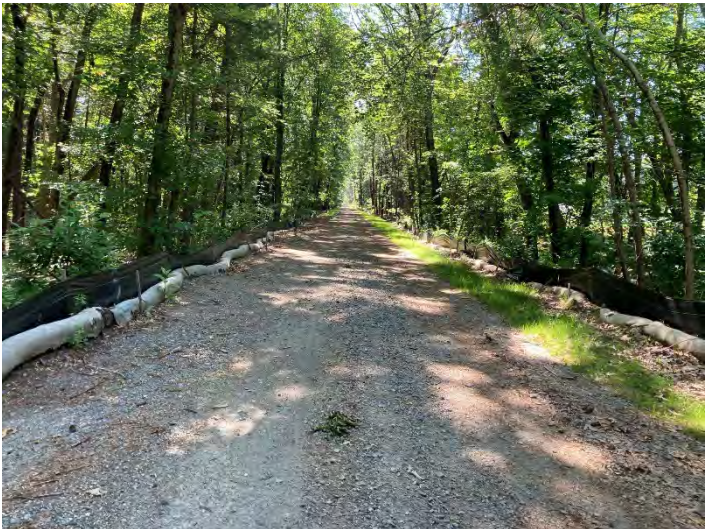
Epsilon ASSOCIATES INC.		PHOTOGRAPHIC LOG	
Client Name: Eversource		Site Location: Sudbury to Hudson Transmission Reliability Project	Town: Hudson
Photo No.: 4	Date: 6-13-2024

Description: View of E&S controls in segment 4. Facing east.

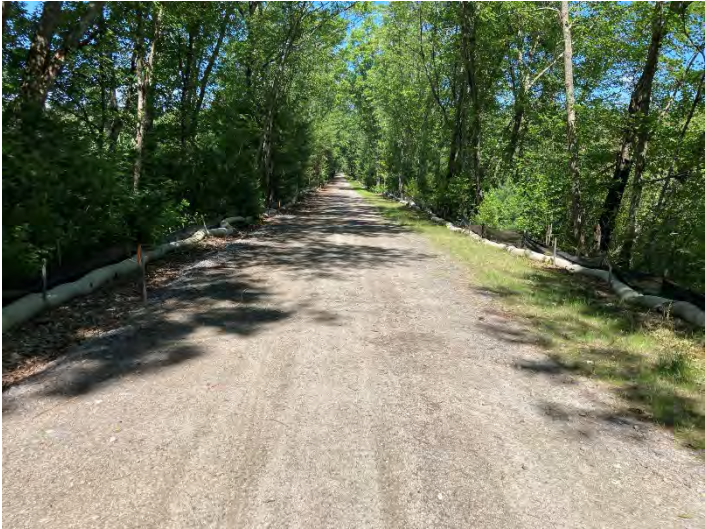
Epsilon ASSOCIATES INC.		PHOTOGRAPHIC LOG	
Client Name: Eversource		Site Location: Sudbury to Hudson Transmission Reliability Project	Town: Hudson
Photo No.: 5	Date: 6-13-2024

Description: View of E&S controls in segment 5. Facing west.

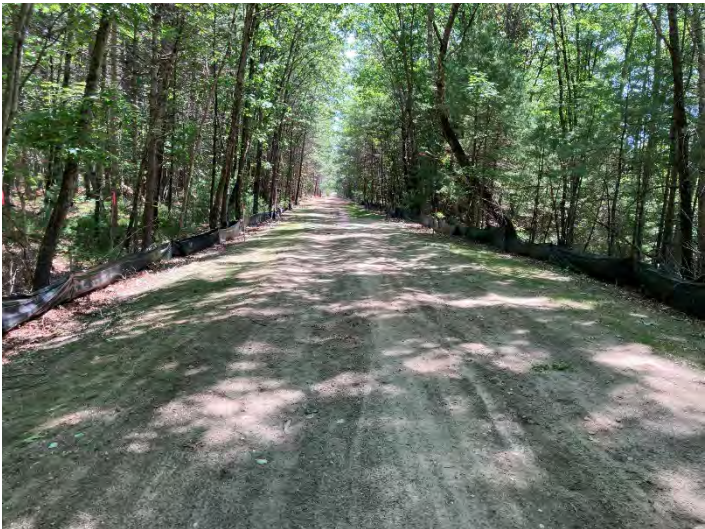
Epsilon ASSOCIATES INC.		PHOTOGRAPHIC LOG	
Client Name: Eversource		Site Location: Sudbury to Hudson Transmission Reliability Project	Town: Hudson
Photo No.: 6	Date: 6-13-2024

Description: View of E&S controls in segment 6. Seeded areas are beginning to vegetate. Facing east.

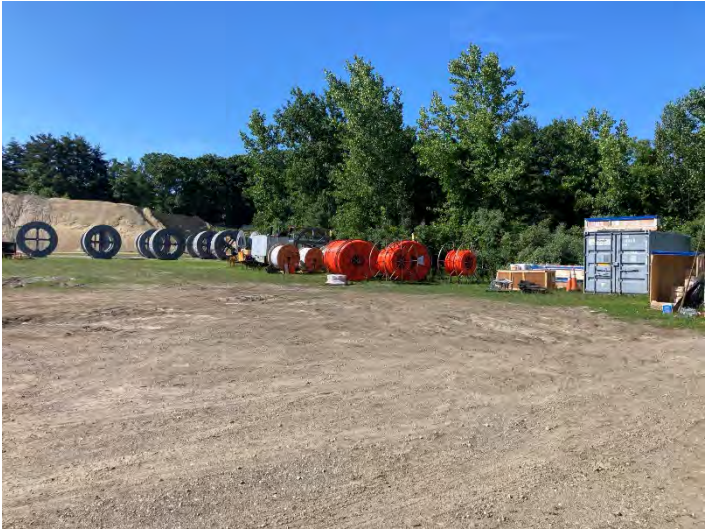
PHOTOGRAPHIC LOG	
Client Name: Eversource		Site Location: Sudbury to Hudson Transmission Reliability Project	Town: Hudson
Photo No.: 7	Date: 6-13-2024

Description: View of Haugland's laydown yard on Perkins property. Facing southwest.

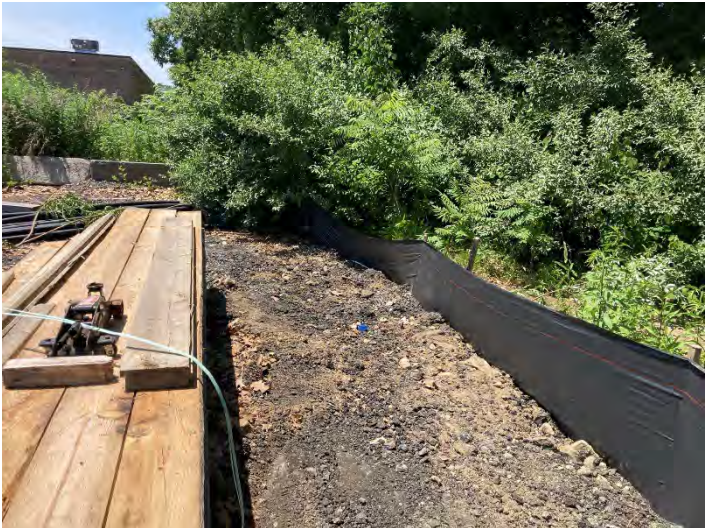
PHOTOGRAPHIC LOG	
Client Name: Eversource		Site Location: Sudbury to Hudson Transmission Reliability Project	Town: Hudson
Photo No.: 8	Date: 6-13-2024

4. Silt Fencing at laydown yards (25 Stowe Ct and 17 Bonazzoli Avenue)	<input type="checkbox"/> Yes <input checked="" type="checkbox"/> No	N/A	<input type="checkbox"/> Yes <input checked="" type="checkbox"/> No	N/A	Silt fence at Bonazzoli laydown yard is in good condition.

Description: View of new row of silt fence at Bonazzoli laydown yard. Silt fence has been properly entrenched. Old row of silt fence has been removed. Facing southwest.

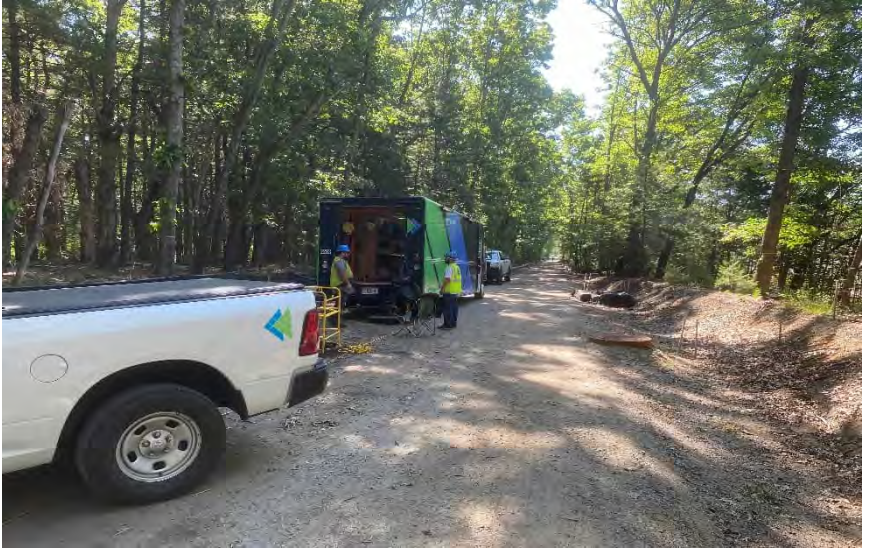
PHOTOGRAPHIC LOG	
Client Name: Eversource		Site Location: Sudbury to Hudson Transmission Reliability Project	Town: Sudbury
Photo No.: 2	Date: 6-13-24

Description: Work area within segment 11 (manhole #23), splicing, looking eastward.

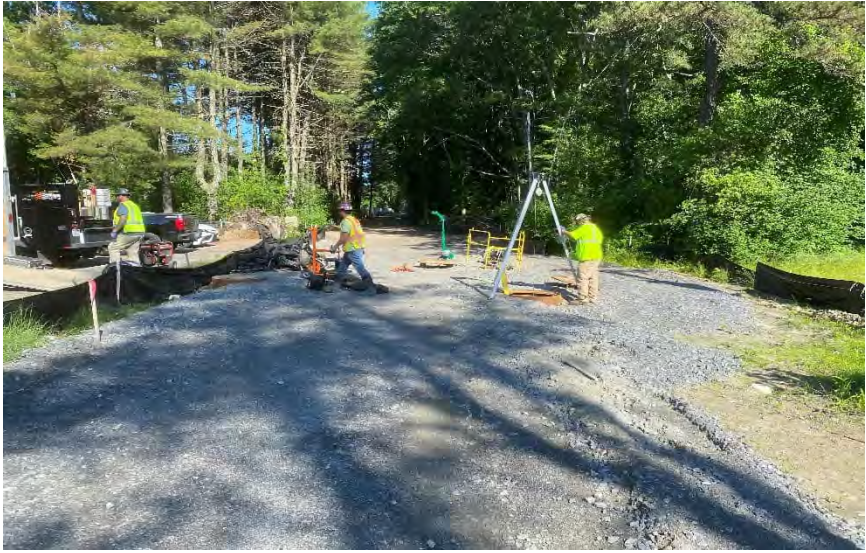
PHOTOGRAPHIC LOG	
Client Name: Eversource		Site Location: Sudbury to Hudson Transmission Reliability Project	Town: Sudbury
Photo No.: 3	Date: 6-13-24

Description: Work area within segment 11 (manhole #24), proofing, existing erosion control, looking westward.

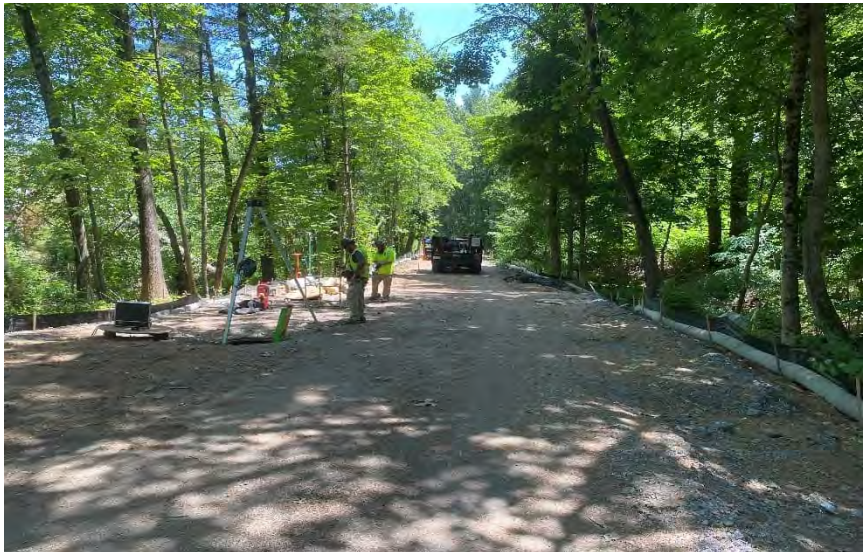
PHOTOGRAPHIC LOG	
Client Name: Eversource		Site Location: Sudbury to Hudson Transmission Reliability Project	Town: Sudbury
Photo No.: 4	Date: 6-13-24

Description: Work area within segment 13 (manhole #25), proofing, existing erosion control, looking eastward.

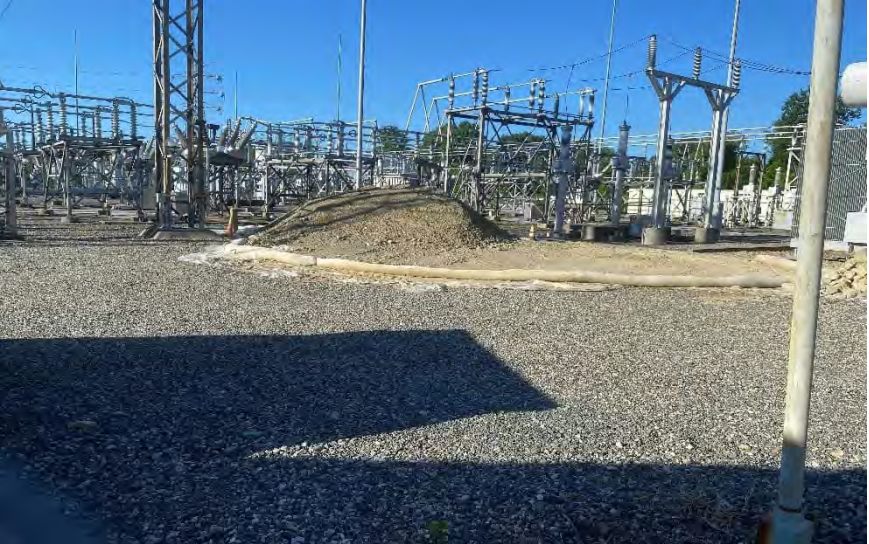
PHOTOGRAPHIC LOG	
Client Name: Eversource		Site Location: Sudbury to Hudson Transmission Reliability Project	Town: Sudbury
Photo No.: 5	Date: 6-13-24

Description: Work area within substation, spoil pile with compost tubes surrounding pile, looking southward.

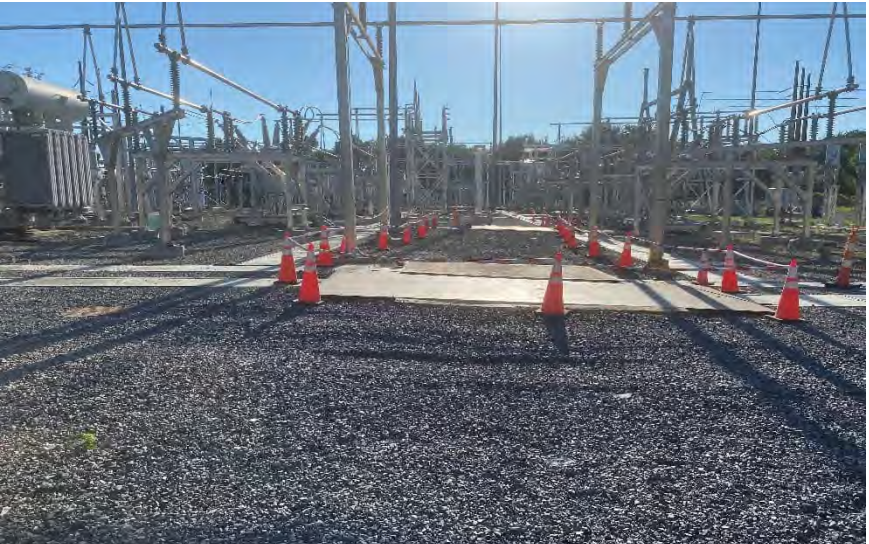
PHOTOGRAPHIC LOG	
Client Name: Eversource		Site Location: Sudbury to Hudson Transmission Reliability Project	Town: Sudbury
Photo No.: 6	Date: 6-13-24

Description: Work area within substation, conduit work area, looking eastward.

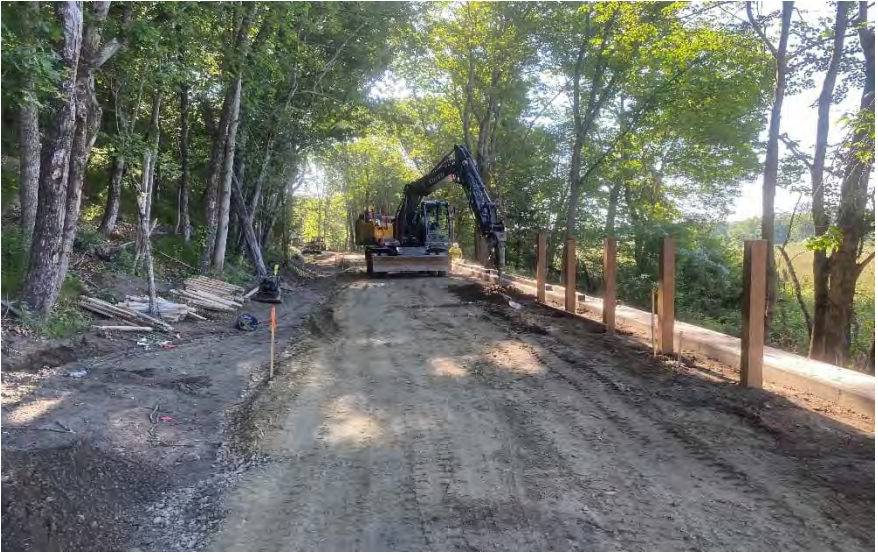
PHOTOGRAPHIC LOG	
Client Name: Eversource		Site Location: Sudbury to Hudson Transmission Reliability Project	Town: Sudbury
Photo No.: 7	Date: 6-13-24

Description: Work area within segment 14, wall work, existing erosion control, looking eastward.

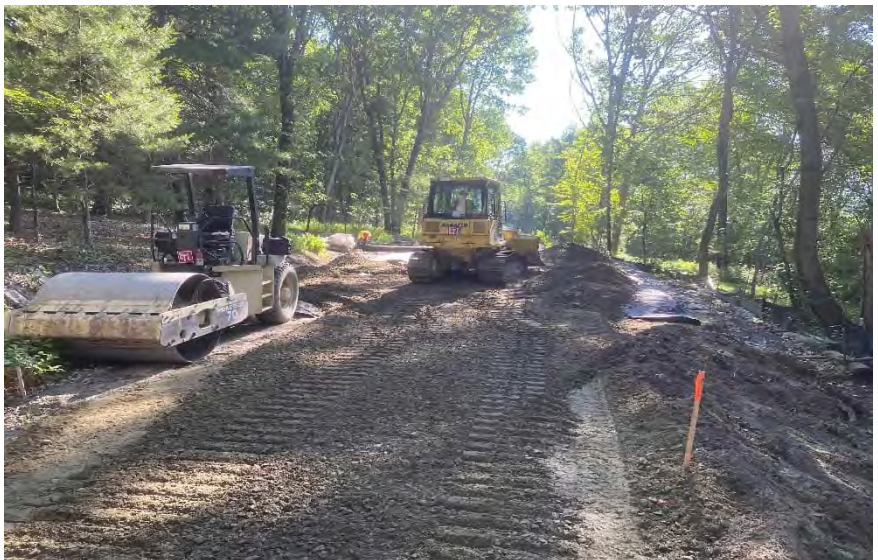
PHOTOGRAPHIC LOG	
Client Name: Eversource		Site Location: Sudbury to Hudson Transmission Reliability Project	Town: Sudbury
Photo No.: 8	Date: 6-13-24

Description: Work area within segment 14 (manhole #26),grading work, existing erosion control, looking eastward.

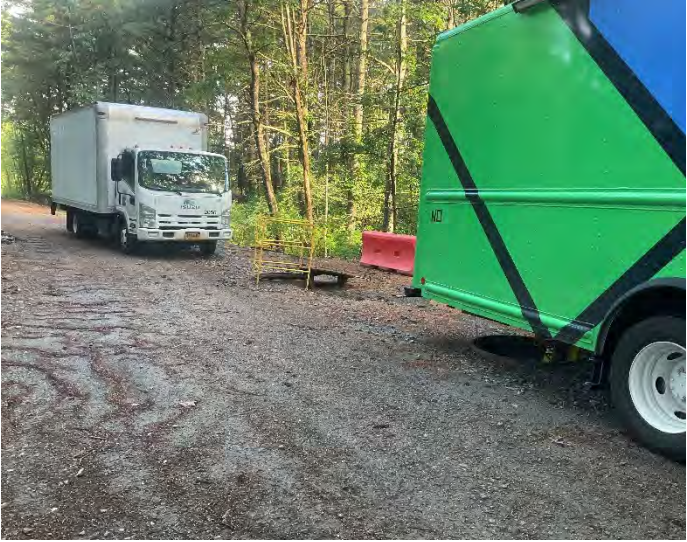
PHOTOGRAPHIC LOG	
Client Name: Eversource		Site Location: Sudbury to Hudson Transmission Reliability Project	Town: Hudson
Photo No.: 1	Date: 6-15-2024

Description: View of Haugland cable splicers working at MH #13. See additional dewatering inspection report. Facing northwest.

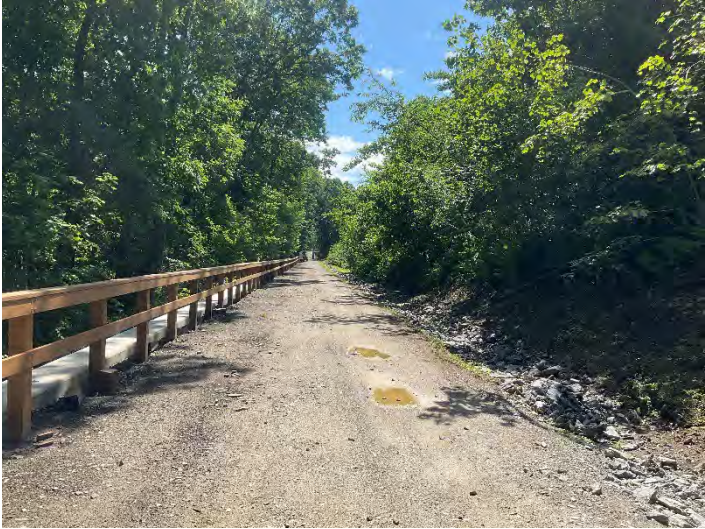
PHOTOGRAPHIC LOG	
Client Name: Eversource		Site Location: Sudbury to Hudson Transmission Reliability Project	Town: Hudson
Photo No.: 2	Date: 6-15-2024

Description: View of ET&L work area at walls #1 and #2 in segment 1. No activity today. Facing east.

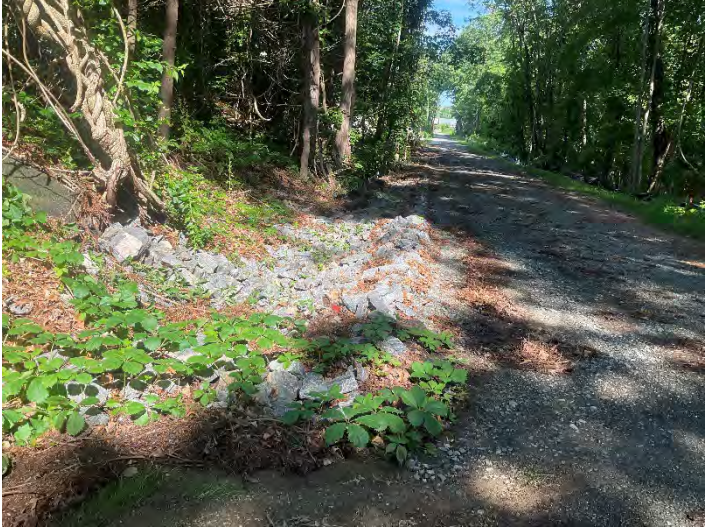
PHOTOGRAPHIC LOG	
Client Name: Eversource		Site Location: Sudbury to Hudson Transmission Reliability Project	Town: Hudson
Photo No.: 3	Date: 6-15-2024

Description: View of rock lined swale and rock check dams installed and operating properly in segment 3. Facing west.

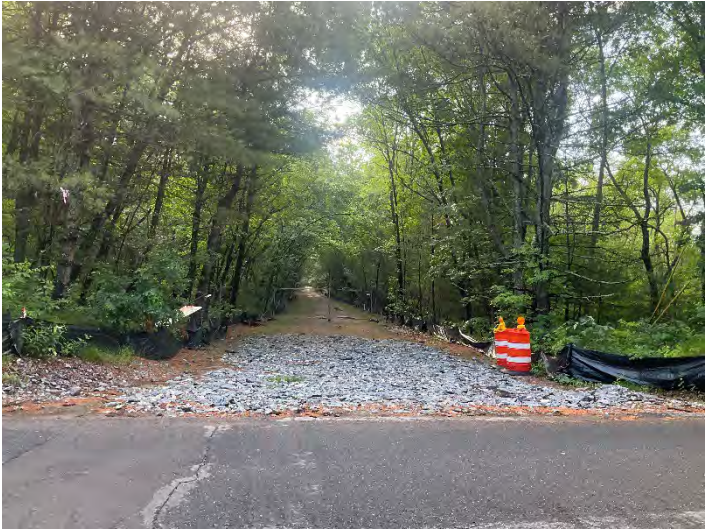
PHOTOGRAPHIC LOG	
Client Name: Eversource		Site Location: Sudbury to Hudson Transmission Reliability Project	Town: Hudson
Photo No.: 4	Date: 6-15-2024

Description: View of construction entrance pad to segment 6. Facing east.

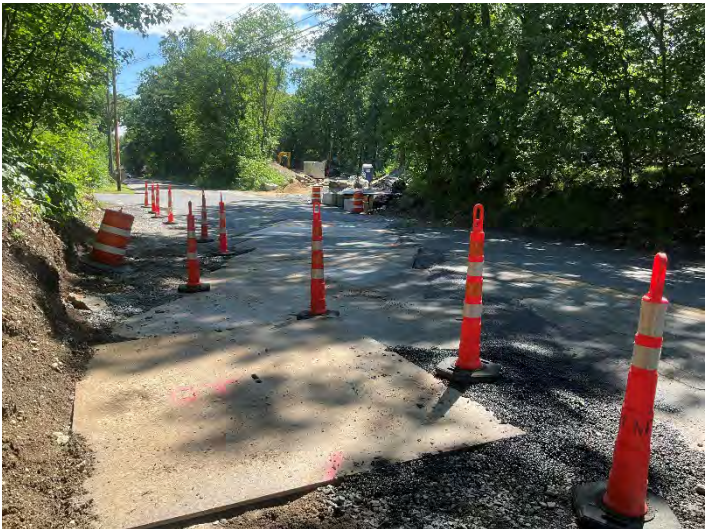
Epsilon ASSOCIATES INC.		PHOTOGRAPHIC LOG	
Client Name: Eversource		Site Location: Sudbury to Hudson Transmission Reliability Project	Town: Hudson
Photo No.: 6	Date: 6-15-2024

Description: View of Bond work area on Wilkins Street at construction entrance to segment 1. No activity today. Facing east.

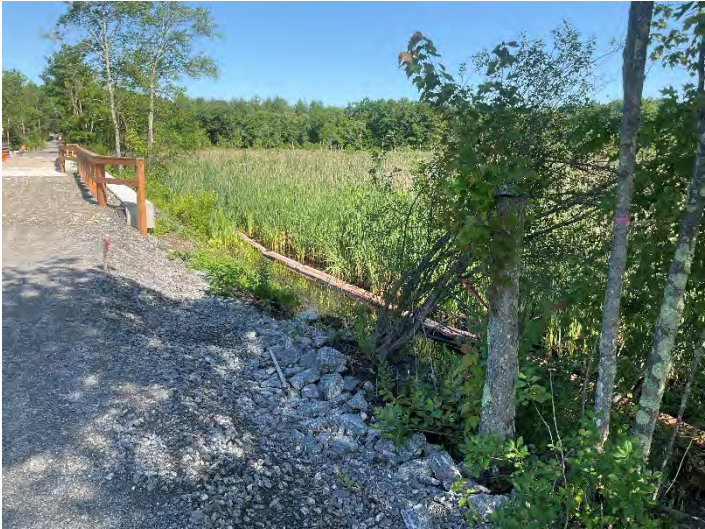
PHOTOGRAPHIC LOG	
Client Name: Eversource		Site Location: Sudbury to Hudson Transmission Reliability Project	Town: Hudson
Photo No.: 7	Date: 6-15-2024

Description: View of turbidity curtain at Bridge 130 from segment 3. Facing northwest.

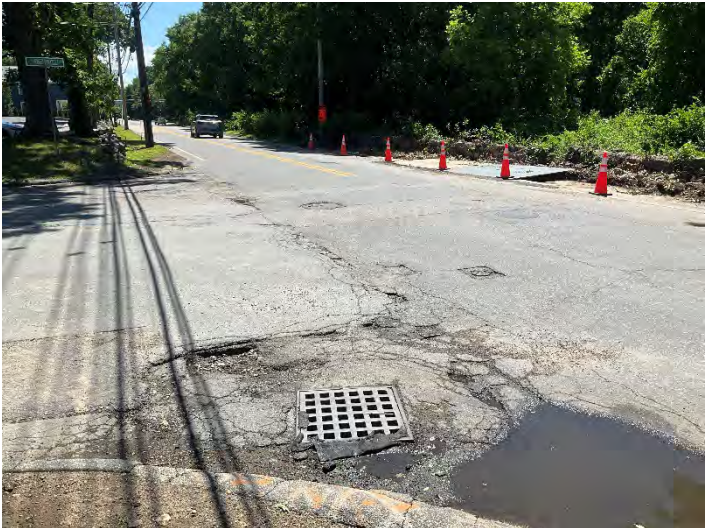
PHOTOGRAPHIC LOG	
Client Name: Eversource		Site Location: Sudbury to Hudson Transmission Reliability Project	Town: Hudson
Photo No.: 8	Date: 6-15-2024

Description: View of installed silt sacks on Forest Avenue by MH #2. Facing southeast.

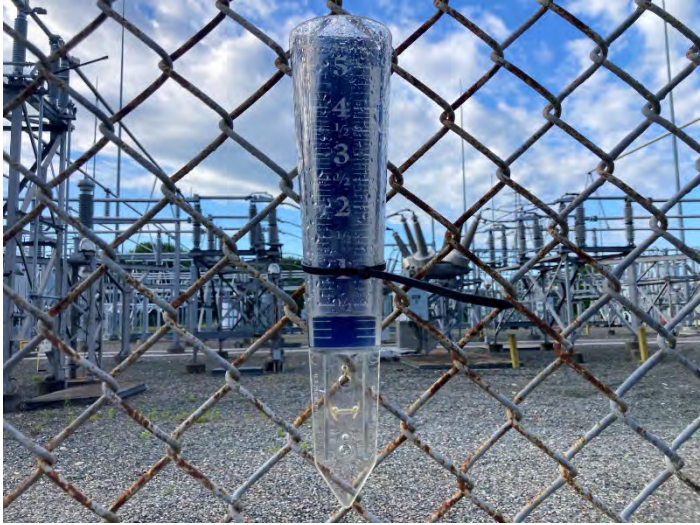
PHOTOGRAPHIC LOG	
Client Name: Eversource		Site Location: Sudbury to Hudson Transmission Reliability Project	Town: Sudbury
Photo No.: 1	Date: 6-15-2024

Description: View of rain gauge at Sudbury Substation. 0.35" observed in gauge at 7:30am. Facing south.

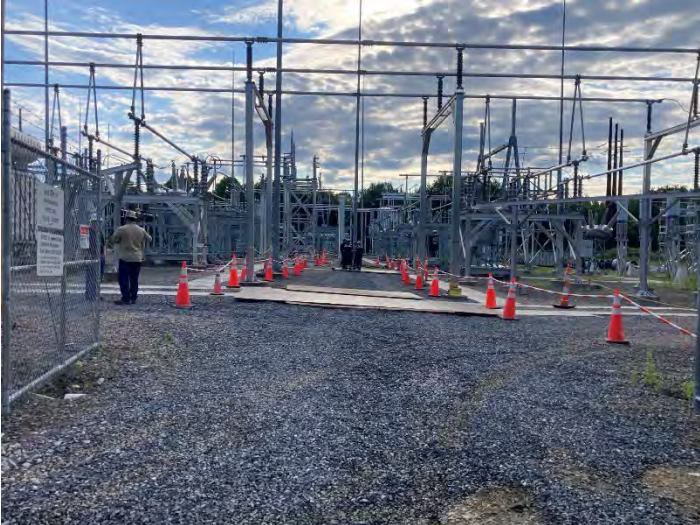
PHOTOGRAPHIC LOG	
Client Name: Eversource		Site Location: Sudbury to Hudson Transmission Reliability Project	Town: Sudbury
Photo No.: 2	Date: 6-15-2024

Description: View of Bond working within Sudbury Substation. Facing east.

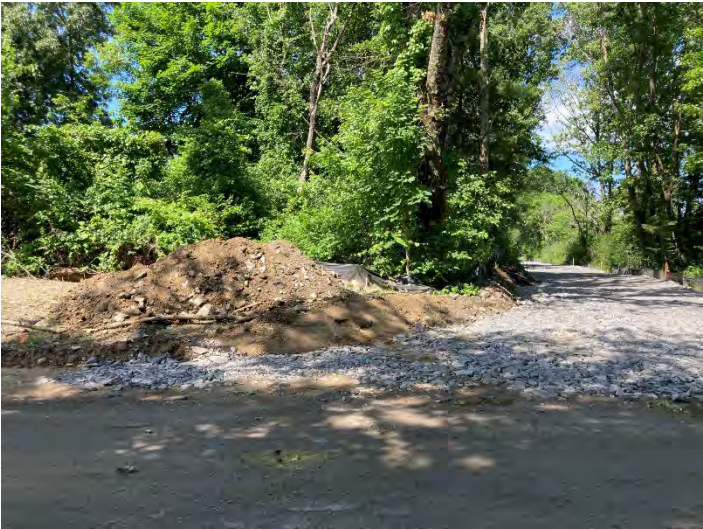
Epsilon ASSOCIATES INC.		PHOTOGRAPHIC LOG	
Client Name: Eversource		Site Location: Sudbury to Hudson Transmission Reliability Project	Town: Sudbury
Photo No.: 3	Date: 6-15-2024

Description: View of small spoil stockpile at entrance to segment 14 near Sudbury Substation. Facing west.

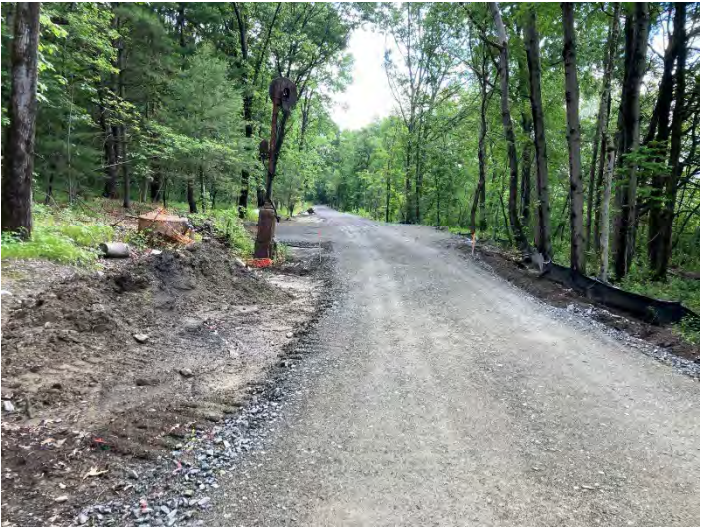
Epsilon ASSOCIATES INC.		PHOTOGRAPHIC LOG	
Client Name: Eversource		Site Location: Sudbury to Hudson Transmission Reliability Project	Town: Sudbury
Photo No.: 4	Date: 6-15-2024

Description: View of what remains of stockpiles/spoil berm in segment 14. Facing east.

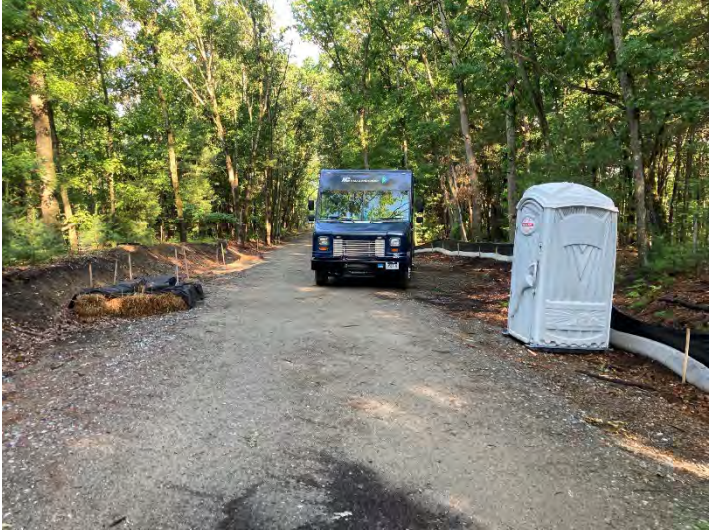
Epsilon ASSOCIATES INC.		PHOTOGRAPHIC LOG	
Client Name: Eversource		Site Location: Sudbury to Hudson Transmission Reliability Project	Town: Sudbury
Photo No.: 6	Date: 6-15-2024

Description: View of Haugland splicing crew working at MH #23 in segment 11. Facing west.

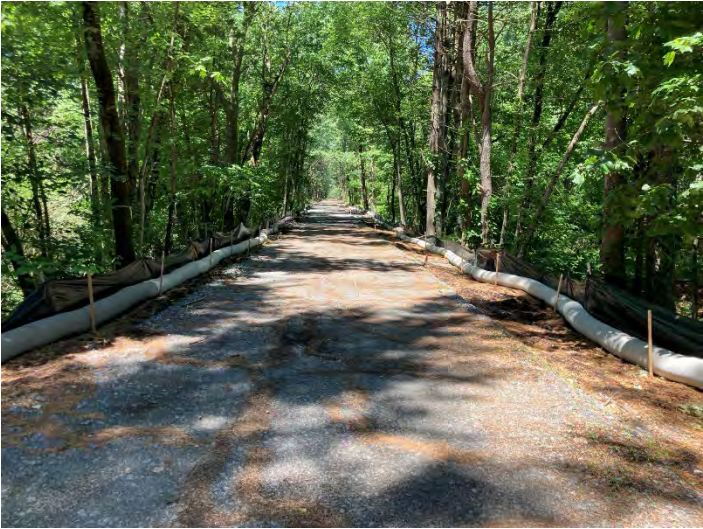
Epsilon ASSOCIATES INC.		PHOTOGRAPHIC LOG	
Client Name: Eversource		Site Location: Sudbury to Hudson Transmission Reliability Project	Town: Sudbury
Photo No.: 7	Date: 6-15-2024

Description: View of E&S controls in segment 9. Facing west.

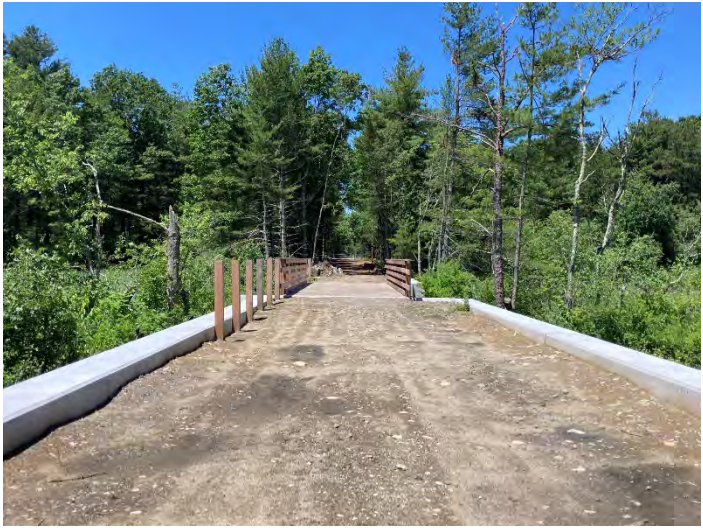
Epsilon ASSOCIATES INC.		PHOTOGRAPHIC LOG	
Client Name: Eversource		Site Location: Sudbury to Hudson Transmission Reliability Project	Town: Sudbury
Photo No.: 8	Date: 6-15-2024

Description: View of bridge 128. Facing west.

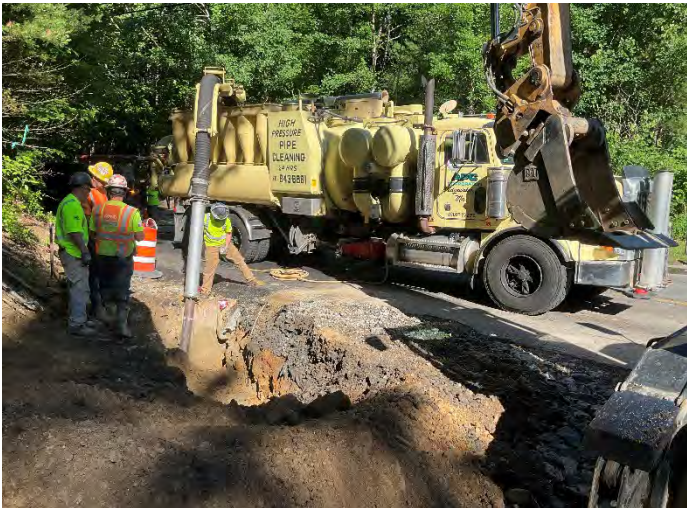
PHOTOGRAPHIC LOG	
Client Name: Eversource		Site Location: Sudbury to Hudson Transmission Reliability Project	
Town: Hudson			
Photo No.: 1	Date: 6/10/2024

Description: View of Bond working on Wilkins Street. Facing west.

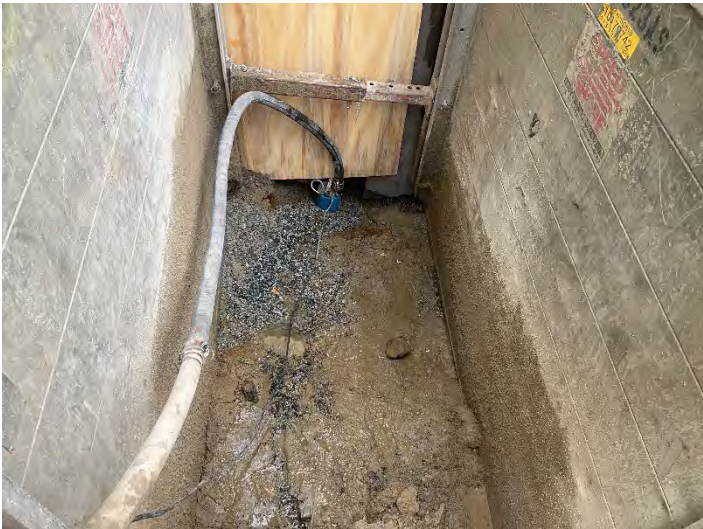
PHOTOGRAPHIC LOG	
Client Name: Eversource		Site Location: Sudbury to Hudson Transmission Reliability Project	
Town: Hudson			
Photo No.: 2	Date: 6/10/2024

Description: View of pump in trench within Wilkins Street. Water appeared mostly clear prior to treatment.

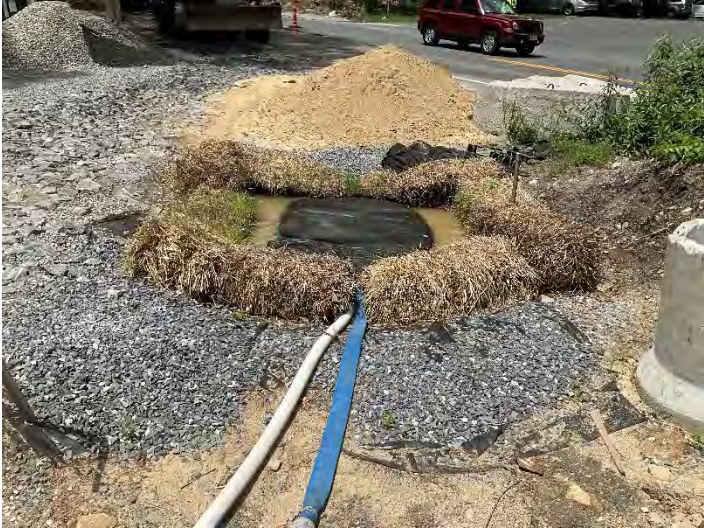
PHOTOGRAPHIC LOG	
Client Name: Eversource		Site Location: Sudbury to Hudson Transmission Reliability Project	Town: Hudson
Photo No.: 3	Date: 6/10/2024

Description: View of dewatering controls (straw bale corral with filter fabric and silt bag). Facing west.

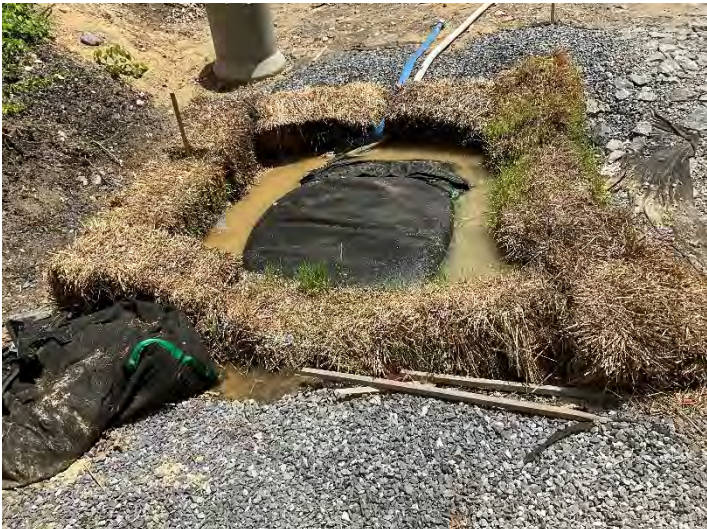
PHOTOGRAPHIC LOG	
Client Name: Eversource		Site Location: Sudbury to Hudson Transmission Reliability Project	Town: Hudson
Photo No.: 4	Date: 6/10/2024

Description: View of discharging water from corral. Discharge appeared turbid and turbidity reading was above 50 NTUs. Water was being discharged to catch basin underneath filter fabric. Facing east.

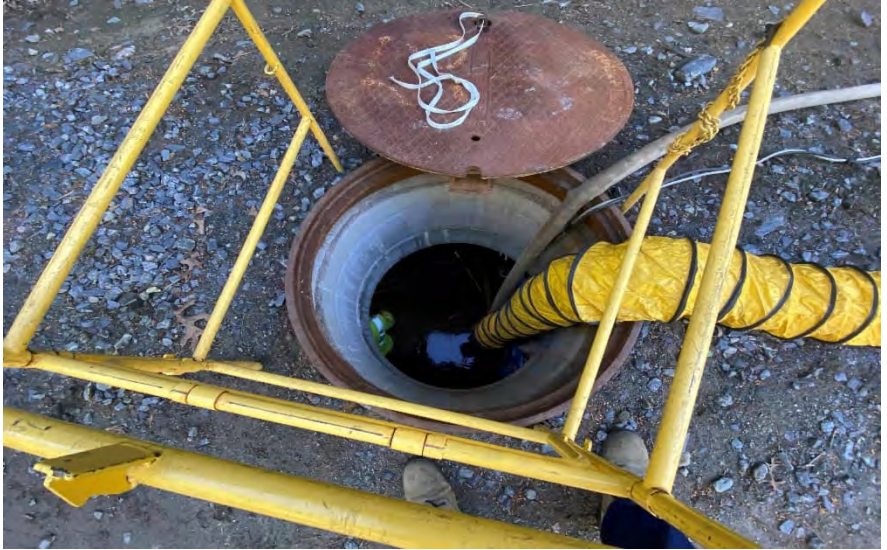
PHOTOGRAPHIC LOG	
Client Name: Eversource		Site Location: Sudbury to Hudson Transmission Reliability Project	Town: Sudbury
Photo No.: 1	Date: 6/10/2024

Description: View of manhole #22 within Segment 11 being pumped.

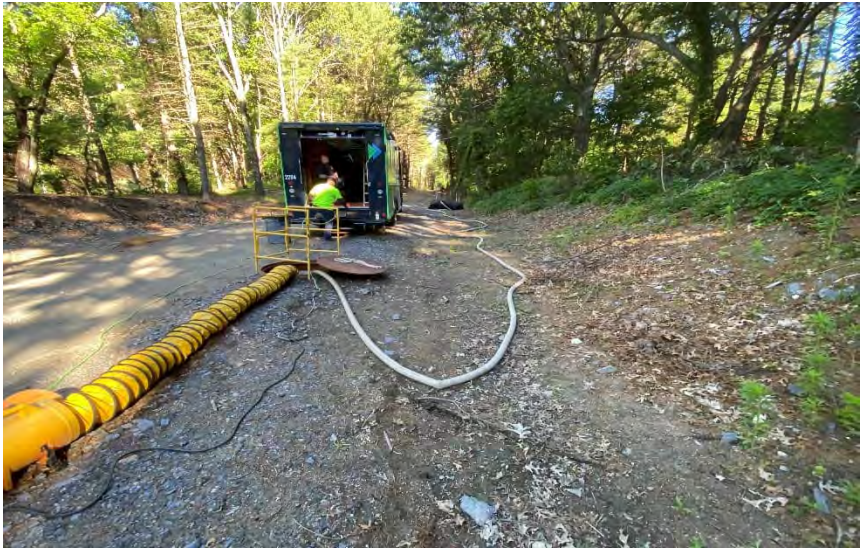
PHOTOGRAPHIC LOG	
Client Name: Eversource		Site Location: Sudbury to Hudson Transmission Reliability Project	Town: Sudbury
Photo No.: 2	Date: 6/10/2024

Description: Manhole #22. View of dewatering operation, looking westward.

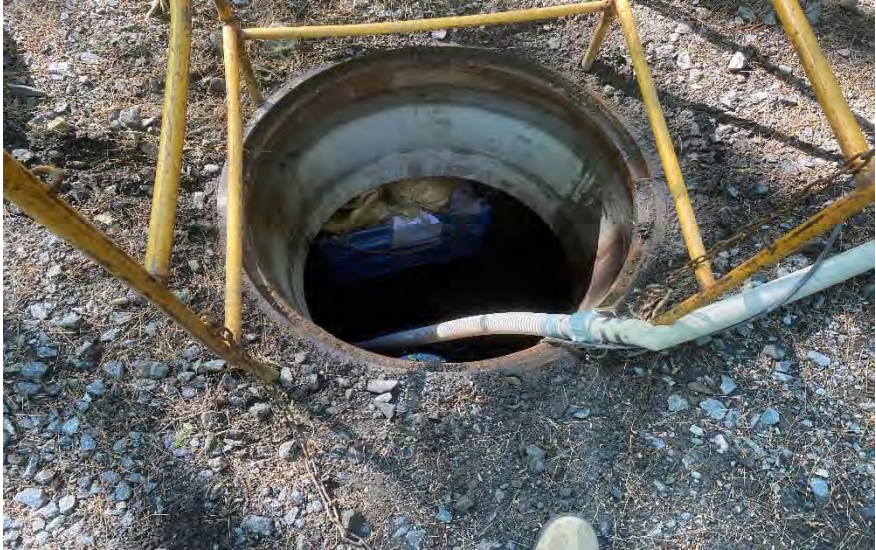
PHOTOGRAPHIC LOG	
Client Name: Eversource		Site Location: Sudbury to Hudson Transmission Reliability Project	Town: Sudbury
Photo No.: 1	Date: 6/10/2024

Description: View of area being pumped from Manhole #25.

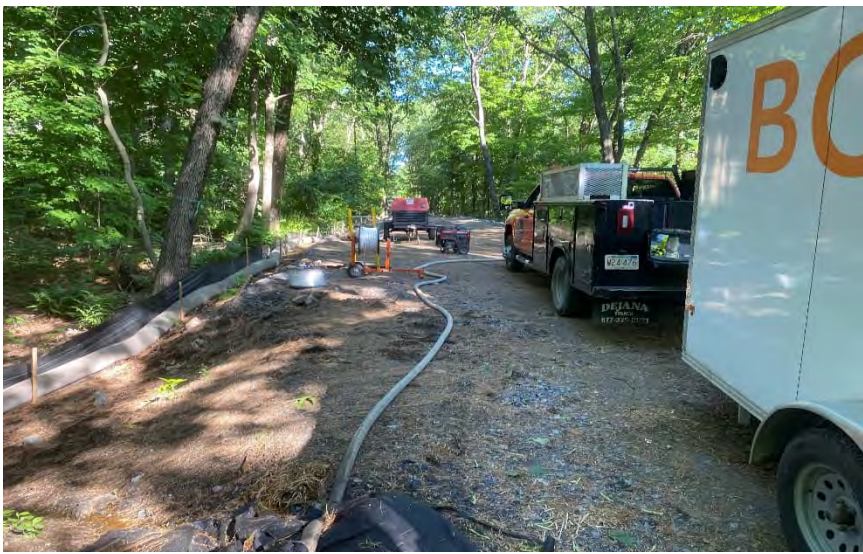
PHOTOGRAPHIC LOG	
Client Name: Eversource		Site Location: Sudbury to Hudson Transmission Reliability Project	Town: Sudbury
Photo No.: 2	Date: 6/10/2024

Description: Manhole #25. View of dewatering operation. Looking eastward.

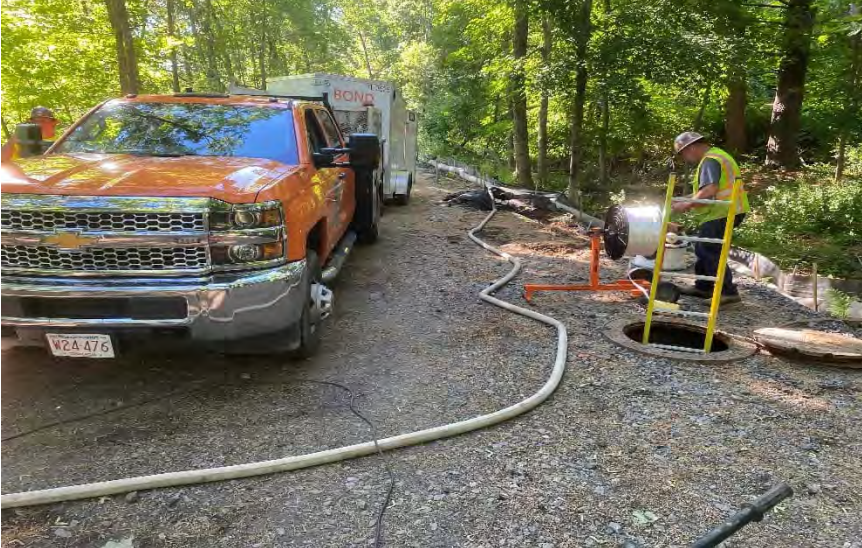
PHOTOGRAPHIC LOG	
Client Name: Eversource		Site Location: Sudbury to Hudson Transmission Reliability Project	Town: Sudbury
Photo No.: 3	Date: 6/10/2024

Description: Manhole #25. View of dewatering operation, looking eastward.

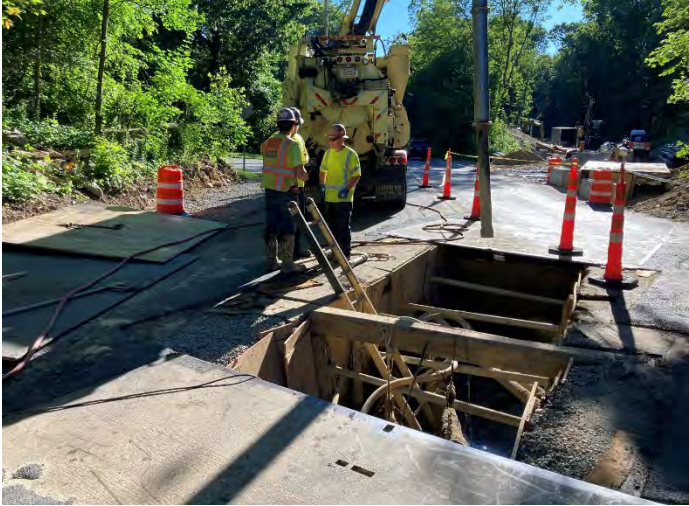
PHOTOGRAPHIC LOG	
Client Name: Eversource		Site Location: Sudbury to Hudson Transmission Reliability Project	
Town: Hudson			
Photo No.: 1	Date: 6/11/2024

Description: View of Bond working on Wilkins Street. Facing northeast.

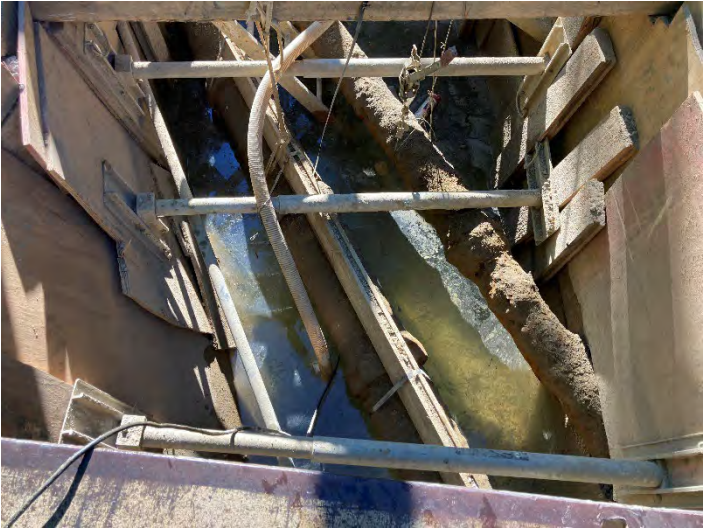
PHOTOGRAPHIC LOG	
Client Name: Eversource		Site Location: Sudbury to Hudson Transmission Reliability Project	
Town: Hudson			
Photo No.: 2	Date: 6/11/2024

Description: View of water in trench within Wilkins Street. Water appeared mostly clear prior to treatment.

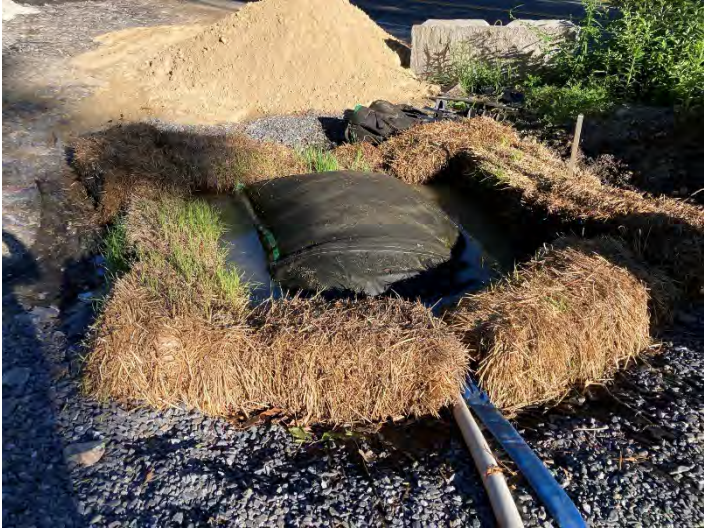
PHOTOGRAPHIC LOG	
Client Name: Eversource		Site Location: Sudbury to Hudson Transmission Reliability Project	Town: Hudson
Photo No.: 3	Date: 6/11/2024

Description: View of dewatering controls (straw bale corral with filter fabric and silt bag). Facing west.

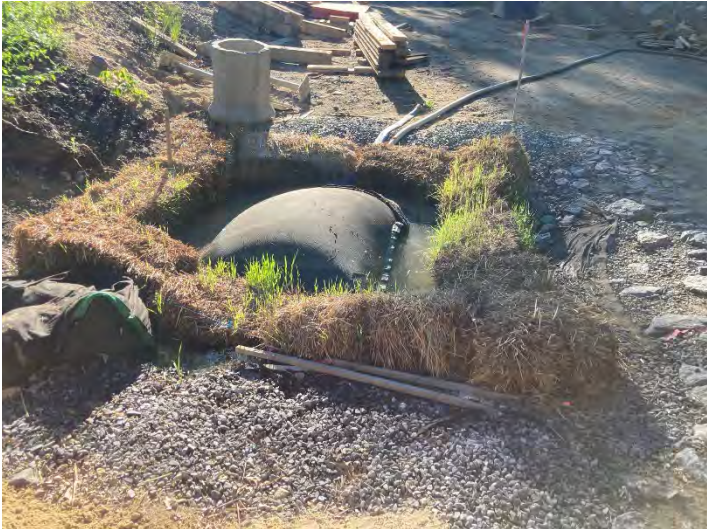
PHOTOGRAPHIC LOG	
Client Name: Eversource		Site Location: Sudbury to Hudson Transmission Reliability Project	Town: Hudson
Photo No.: 4	Date: 6/11/2024

Description: Additional view of dewatering controls and discharge. Discharge appeared mostly clear and turbidity reading was below 50 NTUs. Facing east.

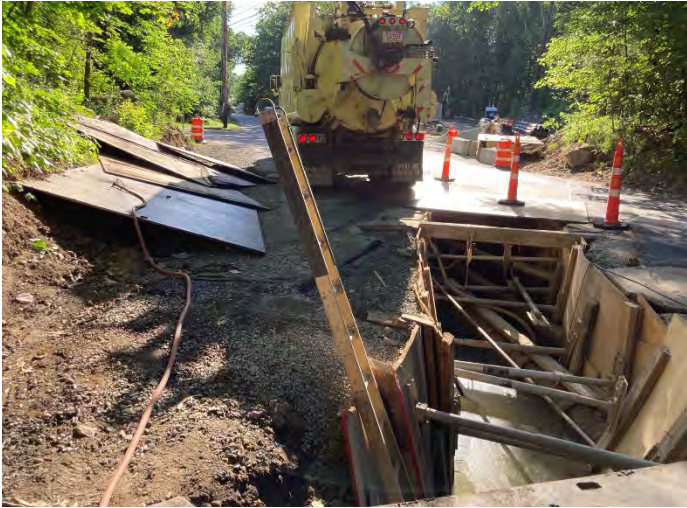
PHOTOGRAPHIC LOG	
Client Name: Eversource		Site Location: Sudbury to Hudson Transmission Reliability Project	Town: Hudson
Photo No.: 1	Date: 6/12/2024

Description: View of Bond working on Wilkins Street. Facing northeast.

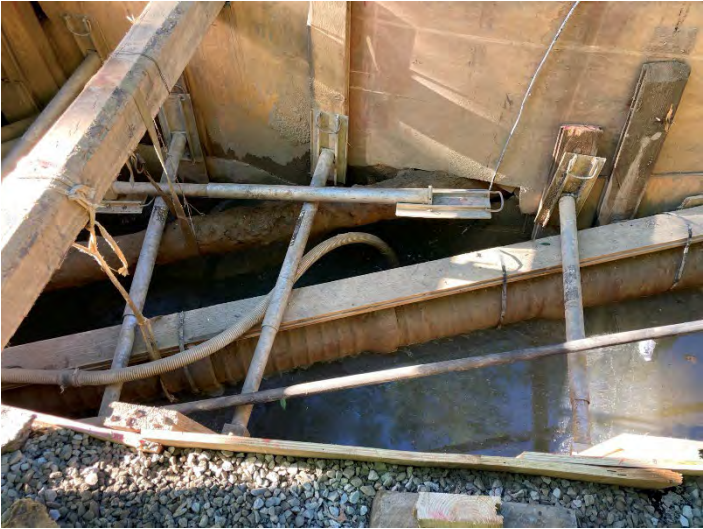
PHOTOGRAPHIC LOG	
Client Name: Eversource		Site Location: Sudbury to Hudson Transmission Reliability Project	Town: Hudson
Photo No.: 2	Date: 6/12/2024

Description: View of water in trench within Wilkins Street. Water appeared mostly clear prior to treatment.

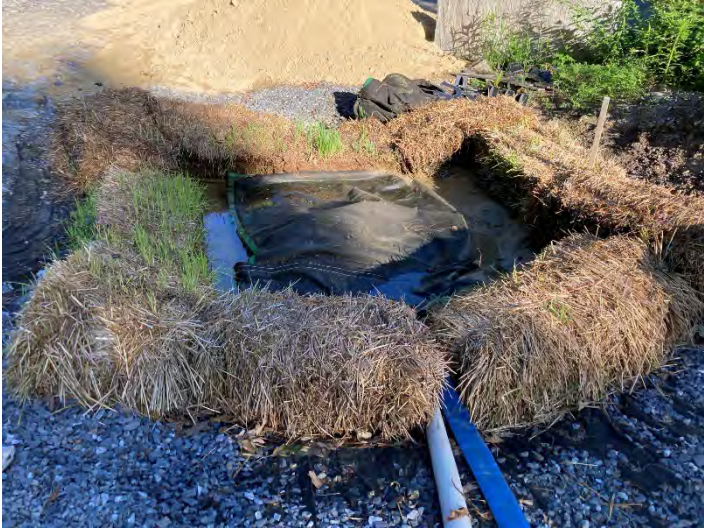
PHOTOGRAPHIC LOG	
Client Name: Eversource		Site Location: Sudbury to Hudson Transmission Reliability Project	Town: Hudson
Photo No.: 3	Date: 6/12/2024

Description: View of dewatering controls (straw bale corral with filter fabric and silt bag). Facing west.

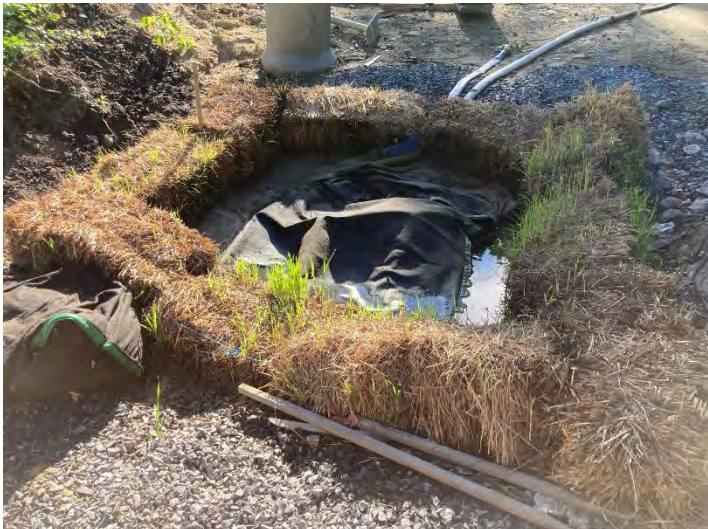
PHOTOGRAPHIC LOG	
Client Name: Eversource		Site Location: Sudbury to Hudson Transmission Reliability Project	Town: Hudson
Photo No.: 4	Date: 6/12/2024

Description: Additional view of dewatering controls and discharge. Discharge appeared mostly clear and turbidity reading was below 50 NTUs. Facing east.

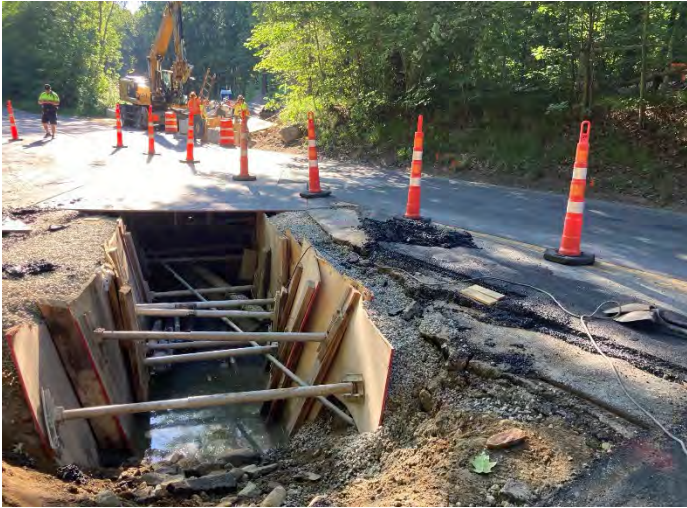
PHOTOGRAPHIC LOG		
Client Name: Eversource		Site Location: Sudbury to Hudson Transmission Reliability Project		Town: Hudson
Photo No.: 1	Date: 6/13/2024

Description: View of Bond working on Wilkins Street. Facing northeast.

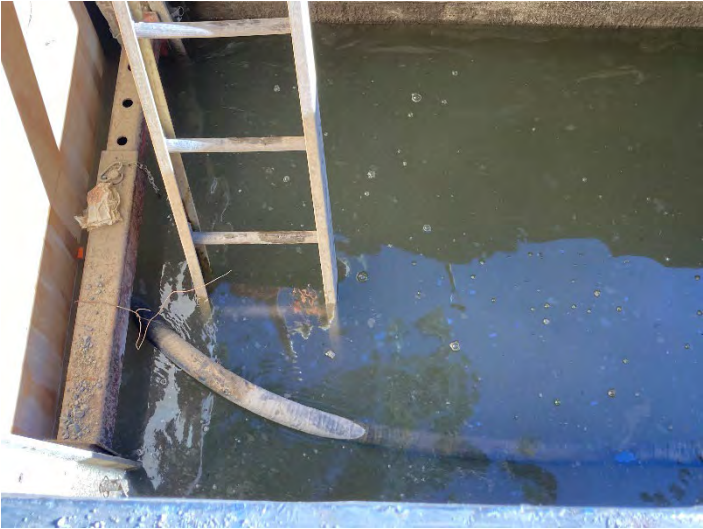
PHOTOGRAPHIC LOG		
Client Name: Eversource		Site Location: Sudbury to Hudson Transmission Reliability Project		Town: Hudson
Photo No.: 2	Date: 6/13/2024

Description: View of water in trench within Wilkins Street. Water appeared slightly turbid prior to treatment.

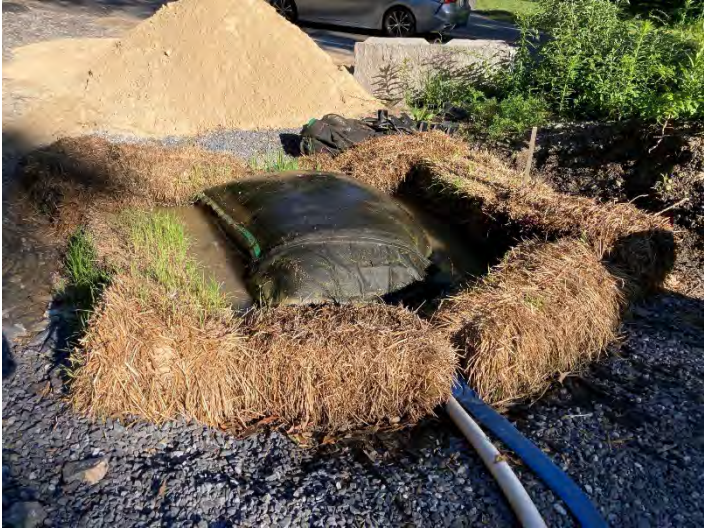
PHOTOGRAPHIC LOG	
Client Name: Eversource		Site Location: Sudbury to Hudson Transmission Reliability Project	Town: Hudson
Photo No.: 3	Date: 6/13/2024

Description: View of dewatering controls (straw bale corral with filter fabric and silt bag). Facing west.
