Weekly Environmental Compliance Summary

Sudbury to Hudson Transmission Reliability Project (USEPA Tracking # MAR1003UW)

Week of: June 10, 2024 to June 15, 2024

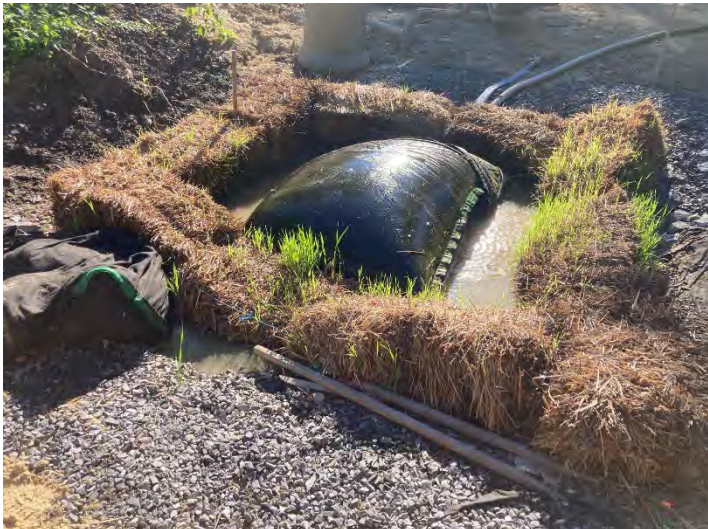
PHOTOGRAPHIC LOG	
Client Name: Eversource		Site Location: Sudbury to Hudson Transmission Reliability Project	Town: Hudson
Photo No.: 4	Date: 6/13/2024

Description: Additional view of dewatering controls and discharge. Discharge appeared turbid and turbidity reading was higher than 50 NTUs. Facing east.

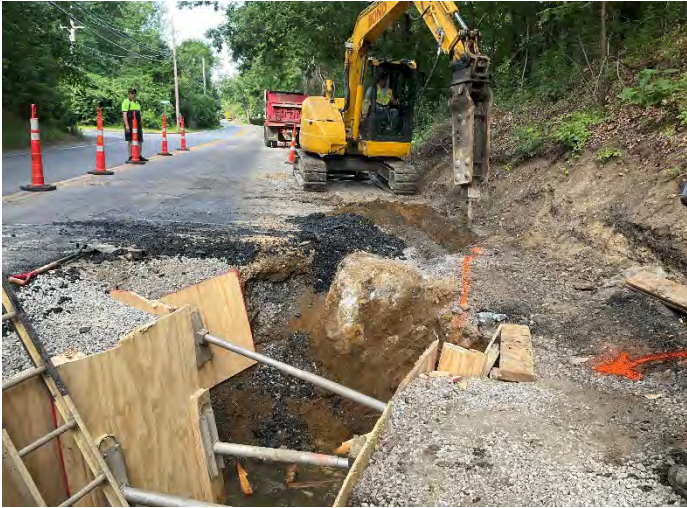
PHOTOGRAPHIC LOG	
Client Name: Eversource		Site Location: Sudbury to Hudson Transmission Reliability Project	
Town: Hudson		Photo No.: 1 Date: 6/14/2024	
Description: View of Bond working on Wilkins Street. Facing west.

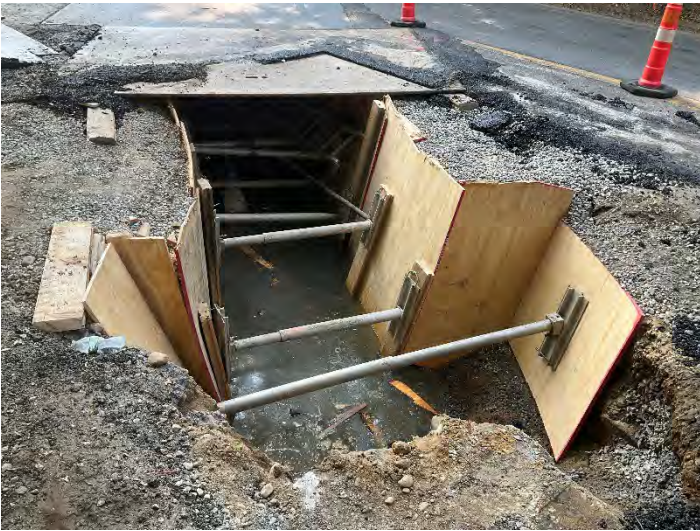
PHOTOGRAPHIC LOG	
Client Name: Eversource		Site Location: Sudbury to Hudson Transmission Reliability Project	
Town: Hudson		Photo No.: 2 Date: 6/14/2024	
Description: View of pump in trench within Wilkins Street. Water appeared mostly clear prior to treatment.

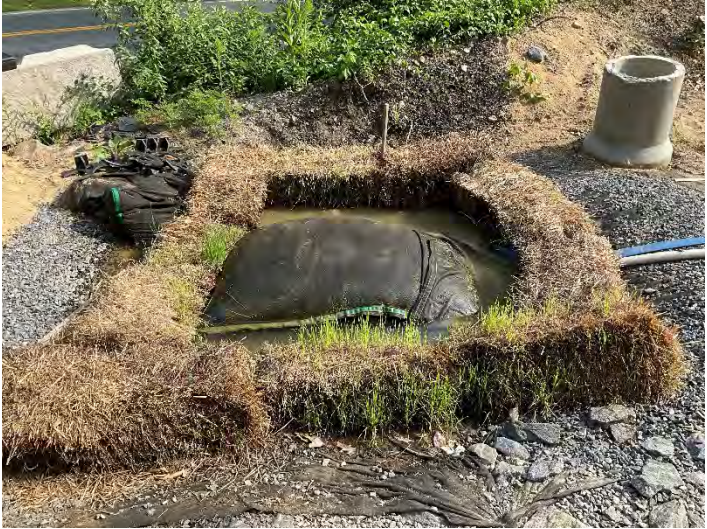
PHOTOGRAPHIC LOG		
Client Name: Eversource		Site Location: Sudbury to Hudson Transmission Reliability Project		Town: Hudson
Photo No.: 3	Date: 6/14/2024

Description: View of dewatering controls (straw bale corral with filter fabric and silt bag). Facing north.

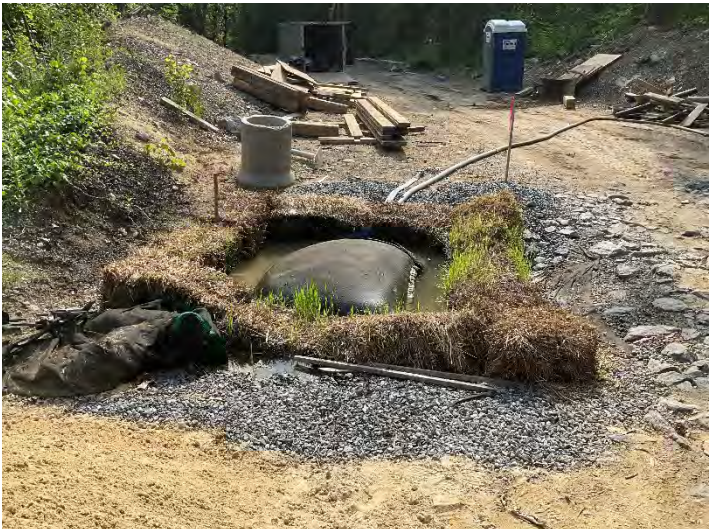
PHOTOGRAPHIC LOG		
Client Name: Eversource		Site Location: Sudbury to Hudson Transmission Reliability Project		Town: Hudson
Photo No.: 4	Date: 6/14/2024

Description: View of discharging water from corral. Discharge appeared to be clear, sediment from previous dewatering's has settled at the bottom of the corral. Turbidity reading was below 50 NTUs. Water was being discharged to catch basin underneath filter fabric. Facing east.

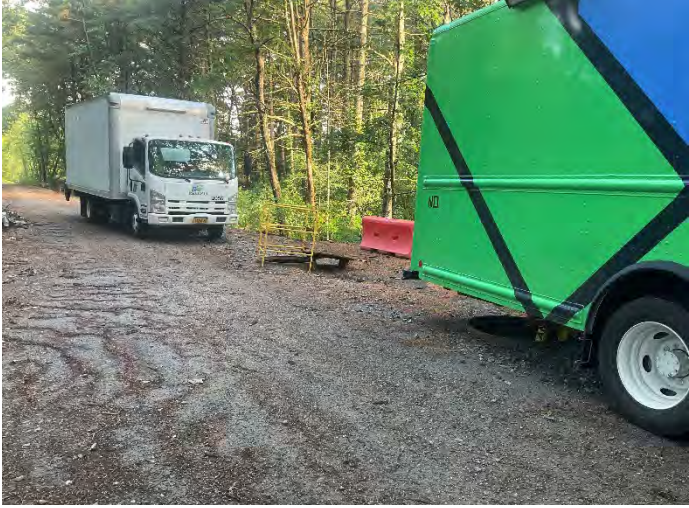
PHOTOGRAPHIC LOG	
Client Name: Eversource		Site Location: Sudbury to Hudson Transmission Reliability Project	Town: Hudson
Photo No.: 1	Date: 6/15/2024

Description: View of Haugland cable splicers at MH #13 in segment 5. Facing northwest.

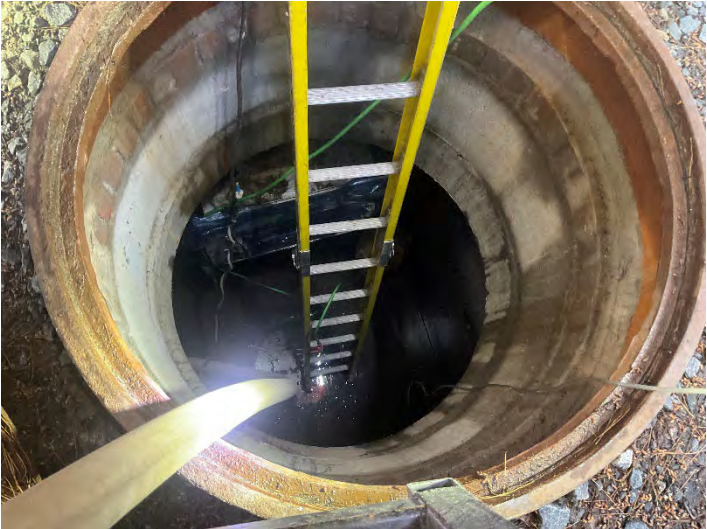
PHOTOGRAPHIC LOG	
Client Name: Eversource		Site Location: Sudbury to Hudson Transmission Reliability Project	Town: Hudson
Photo No.: 2	Date: 6/15/2024

Description: View of pump in MH #13. Water appeared clear prior to treatment.

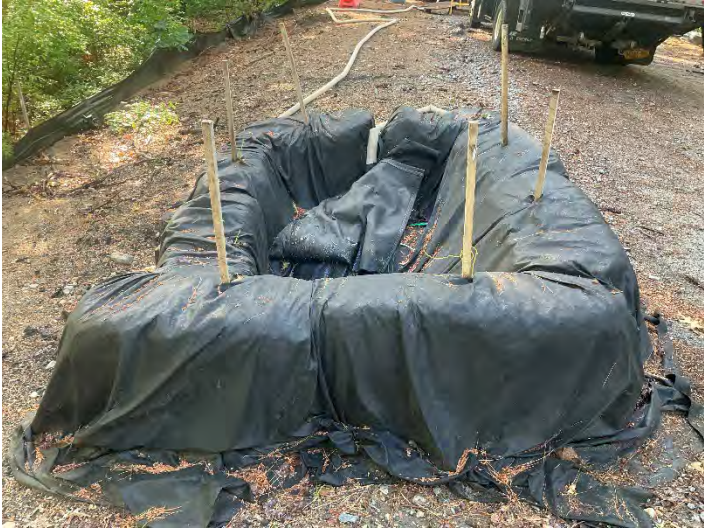
PHOTOGRAPHIC LOG	
Client Name: Eversource		Site Location: Sudbury to Hudson Transmission Reliability Project	Town: Hudson
Photo No.: 3	Date: 6/15/2024

Description: View of dewatering controls (straw bale corral with filter fabric and silt bag). Facing east.

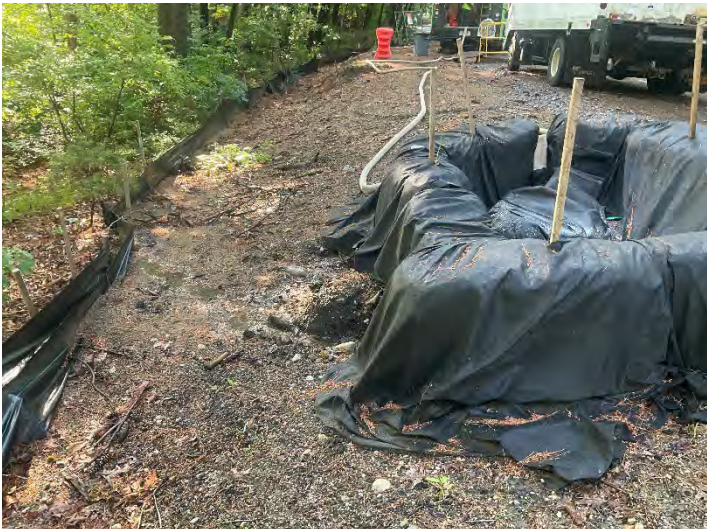
PHOTOGRAPHIC LOG	
Client Name: Eversource		Site Location: Sudbury to Hudson Transmission Reliability Project	Town: Hudson
Photo No.: 4	Date: 6/15/2024

Description: View of discharging water from corral. Discharge appeared mostly clear but turbidity reading was slightly above 50 NTUs. Discharge did not appear to reach any jurisdictional resource areas. Facing east.
