Weekly Environmental Compliance Summary

Sudbury to Hudson Transmission Reliability Project (USEPA Tracking # MAR1003UW)

Sudbury, Hudson, and Stow, MA

Week of: June 17, 2024 to June 22, 2024

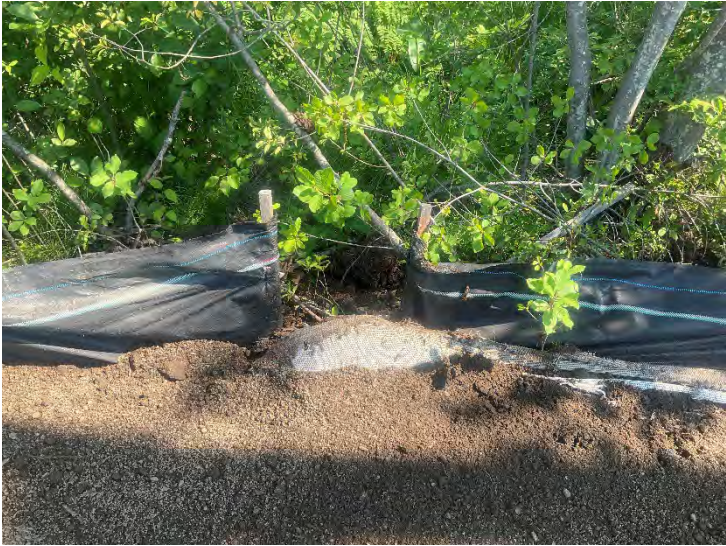
<p>PHOTOGRAPHIC LOG</p>	
<p>Client Name: Eversource</p>		<p>Site Location: Sudbury to Hudson Transmission Reliability Project</p>	<p>Town: Hudson</p>
<p>Photo No.: 5</p>	<p>Date: 6-18-24</p>

Gap within silt fencing in segment 3 to be repaired.

<p>Description: View of gap within silt fencing by ET&L work area in segment 3. Facing north.</p>

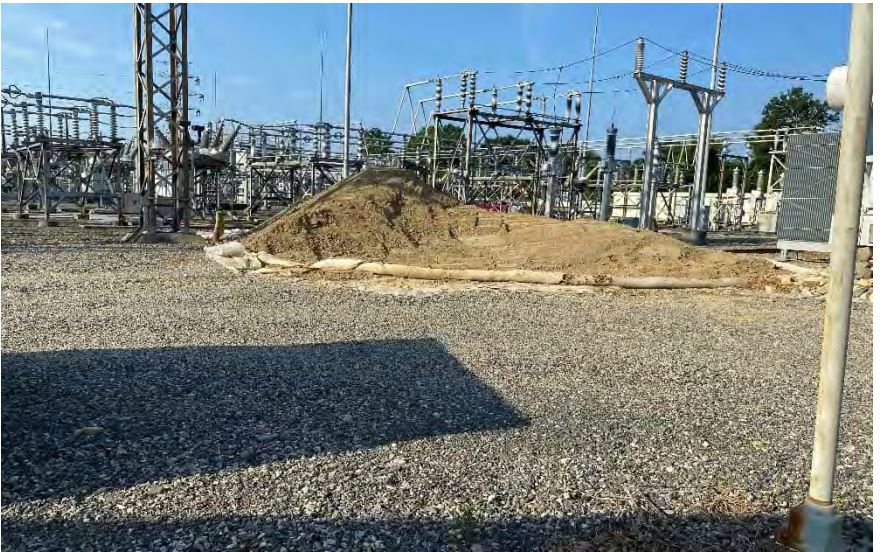
PHOTOGRAPHIC LOG	
Client Name: Eversource		Site Location: Sudbury to Hudson Transmission Reliability Project	Town: Sudbury
Photo No.: 6	Date: 6-20-24

Description: Work area within substation, newly placed spoil pile, existing erosion control (compost tubing), looking southward.

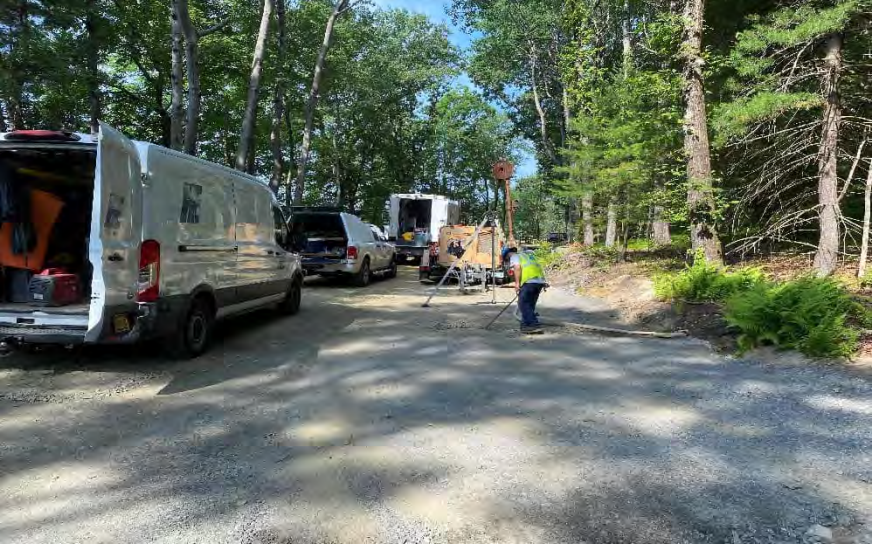
PHOTOGRAPHIC LOG	
Client Name: Eversource		Site Location: Sudbury to Hudson Transmission Reliability Project	Town: Sudbury
Photo No.: 7	Date: 6-20-24

Description: Work area within segment 14, manhole #26, wire pulling work, existing erosion control, looking westward.

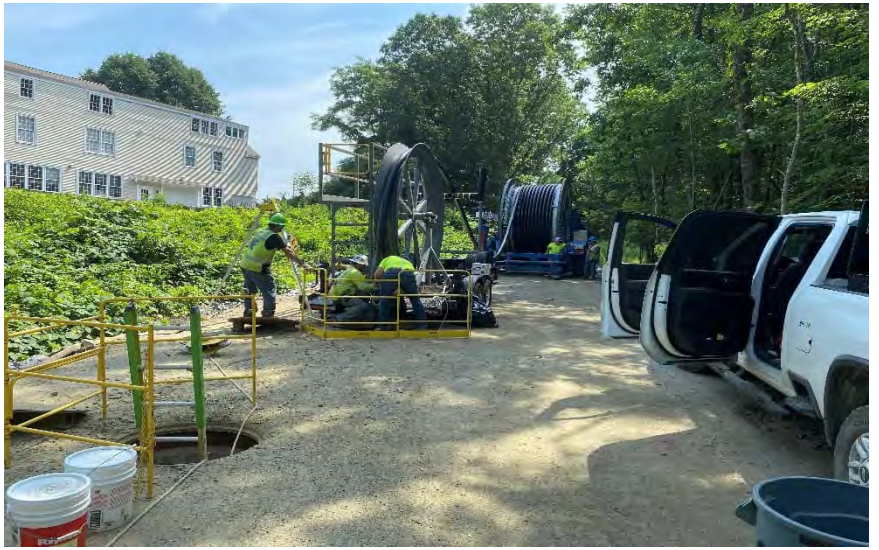
PHOTOGRAPHIC LOG	
Client Name: Eversource		Site Location: Sudbury to Hudson Transmission Reliability Project	Town: Sudbury
Photo No.: 8	Date: 6-20-24

Description: Work area within segment 14, manhole #27, wire pulling work, existing erosion control, looking eastward.

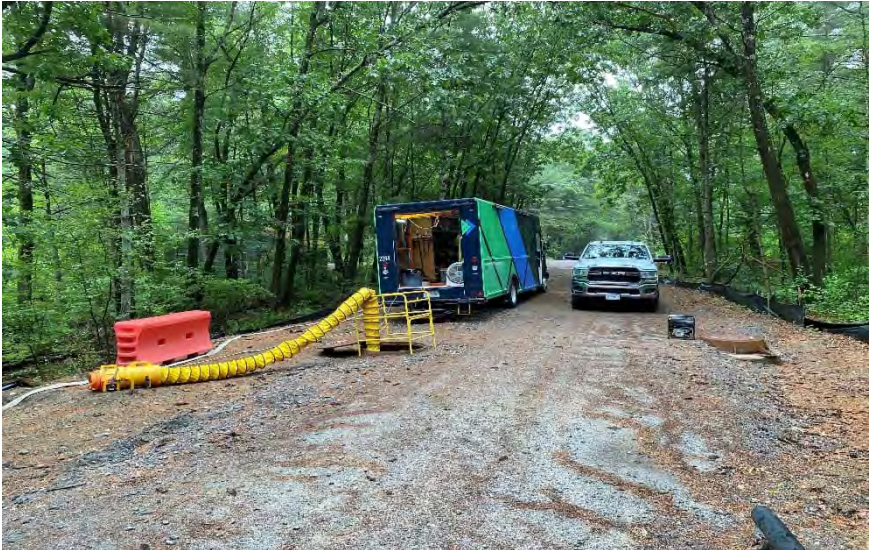
<p>PHOTOGRAPHIC LOG</p>	
<p>Client Name: Eversource</p>		<p>Site Location: Sudbury to Hudson Transmission Reliability Project</p>	<p>Town: Hudson</p>
<p>Photo No.: 3</p>	<p>Date: 6-22-24</p>

<p>Description:</p> <p>Haugland splicing at manhole #13, looking eastward.</p>

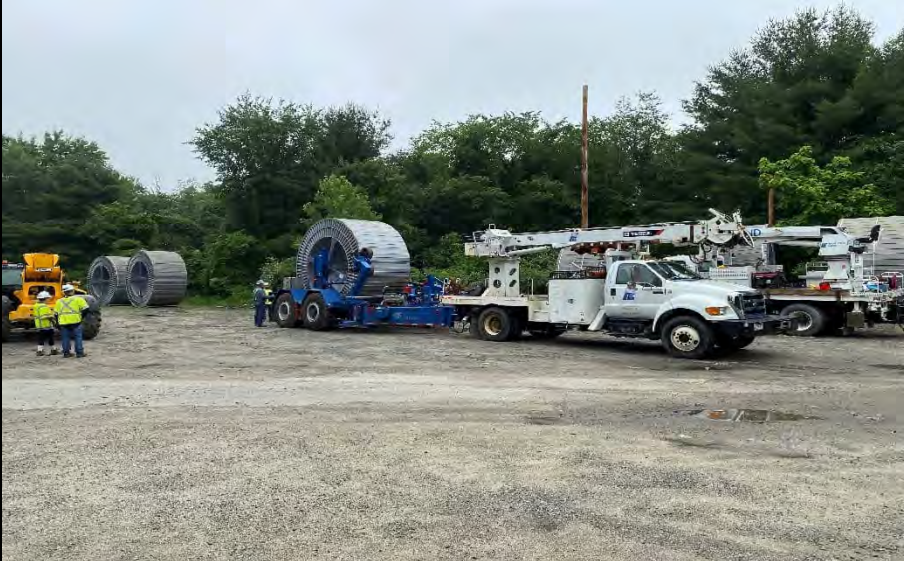
<p>PHOTOGRAPHIC LOG</p>	
<p>Client Name: Eversource</p>		<p>Site Location: Sudbury to Hudson Transmission Reliability Project</p>	<p>Town: Sudbury</p>
<p>Photo No.: 4</p>	<p>Date: 6-22-24</p>

<p>Description:</p> <p>Work area outside substation, loading mirk with wire/reel, looking eastward.</p>

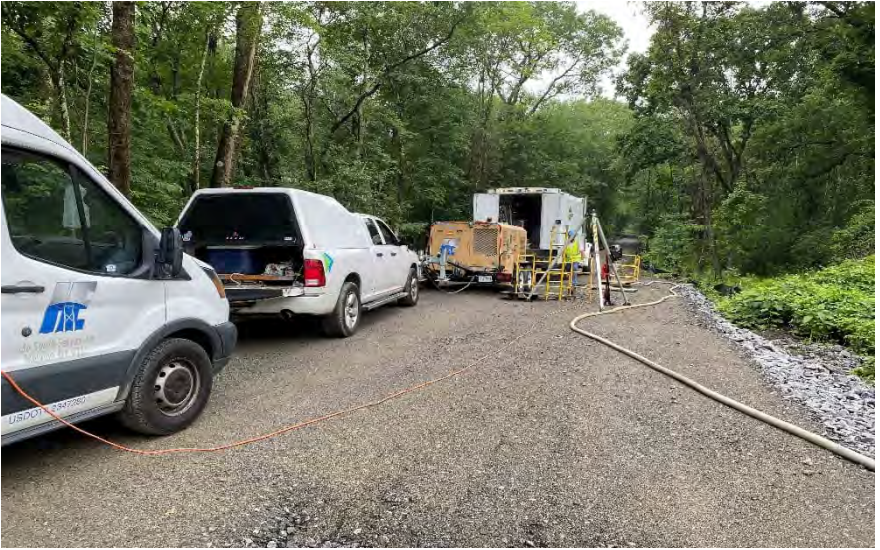
<p>PHOTOGRAPHIC LOG</p>	
<p>Client Name: Eversource</p>		<p>Site Location: Sudbury to Hudson Transmission Reliability Project</p>	<p>Town: Sudbury</p>
<p>Photo No.: 5</p>	<p>Date: 6-22-24</p>

<p>Description:</p> <p>Haugland pulling wire at manhole #27, looking westward.</p>

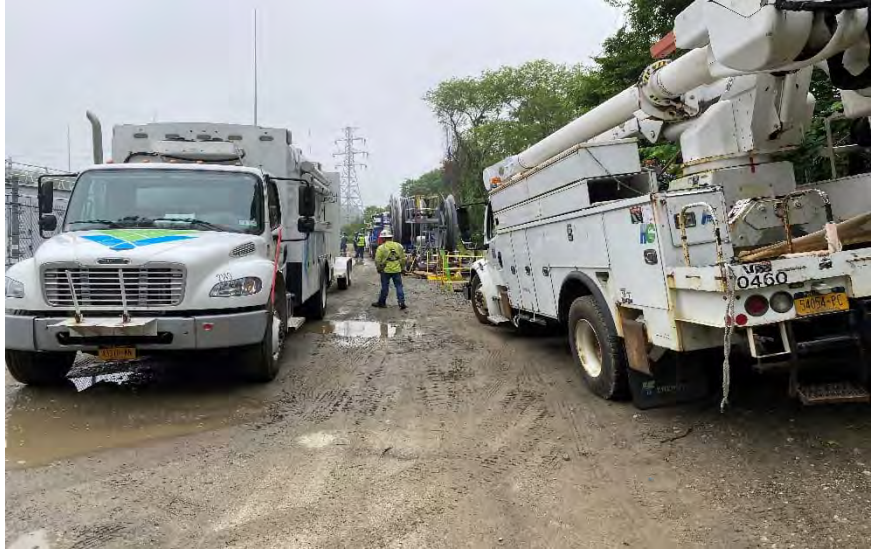
<p>PHOTOGRAPHIC LOG</p>	
<p>Client Name: Eversource</p>		<p>Site Location: Sudbury to Hudson Transmission Reliability Project</p>	<p>Town: Sudbury</p>
<p>Photo No.: 6</p>	<p>Date: 6-22-24</p>

<p>Description:</p> <p>Haugland pulling wire at manhole #28, looking eastward.</p>

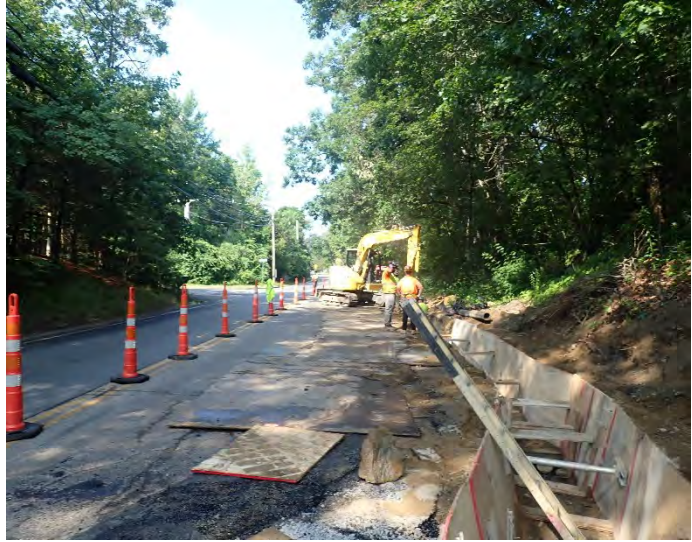
PHOTOGRAPHIC LOG	
Client Name: Eversource		Site Location: Sudbury to Hudson Transmission Reliability Project	Town: Hudson
Photo No.: 1	Date: 6-21-2024

Description: View of Bond crew working on Wilkins Street at entrance to segment 1. Facing southwest.

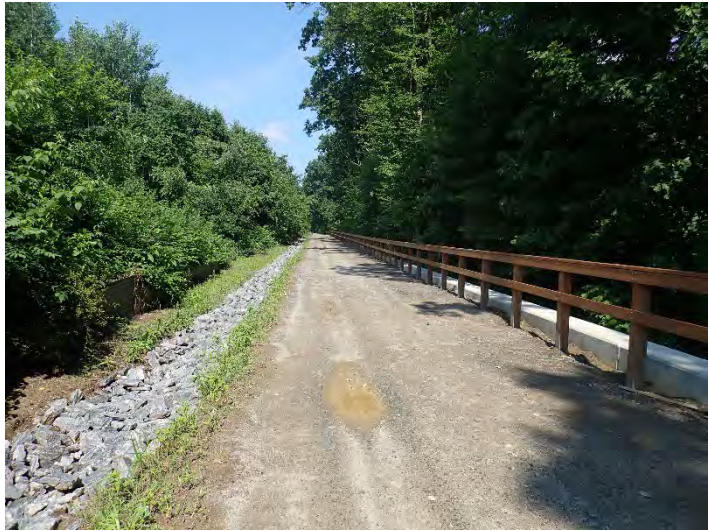
PHOTOGRAPHIC LOG	
Client Name: Eversource		Site Location: Sudbury to Hudson Transmission Reliability Project	Town: Hudson
Photo No.: 2	Date: 6-21-2024

Description: View of railing and rock lined swale in segment 1. Facing west.

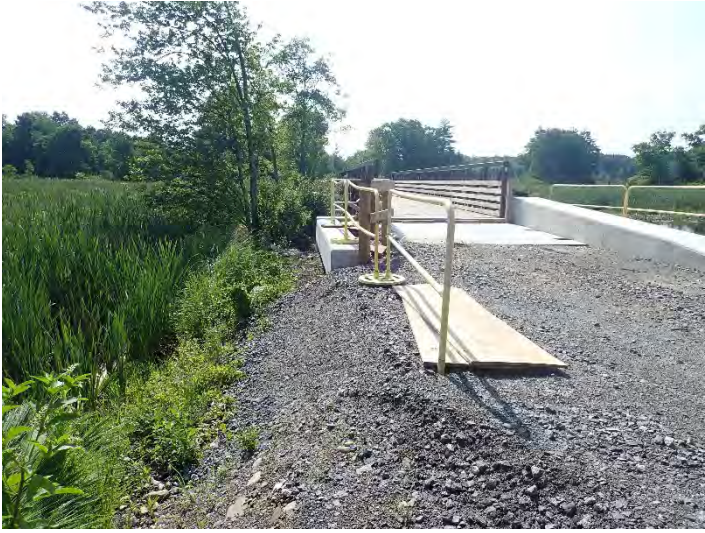
PHOTOGRAPHIC LOG	
Client Name: Eversource		Site Location: Sudbury to Hudson Transmission Reliability Project	Town: Hudson
Photo No.: 3	Date: 6-21-2024

Description: View of Bridge 130 and northwestern slope down towards the wetland. Facing east.

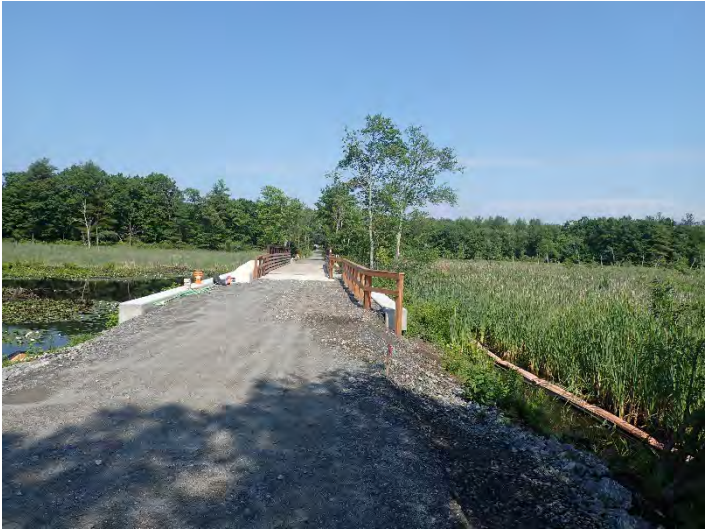
PHOTOGRAPHIC LOG	
Client Name: Eversource		Site Location: Sudbury to Hudson Transmission Reliability Project	Town: Hudson
Photo No.: 4	Date: 6-21-2024

Description: Another view of Bridge 130, turbidity curtain, and northeastern slope down towards the wetland. Facing west.

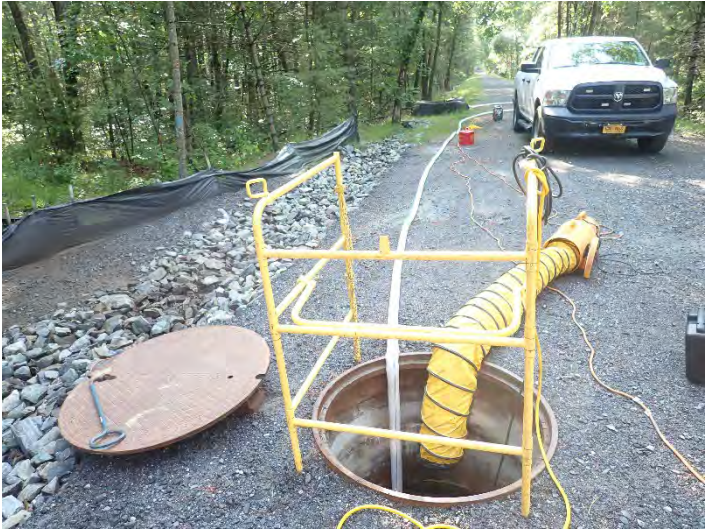
Epsilon ASSOCIATES INC.		PHOTOGRAPHIC LOG	
Client Name: Eversource		Site Location: Sudbury to Hudson Transmission Reliability Project	Town: Hudson
Photo No.: 5	Date: 6-21-2024

Description: View of Haugland crew working at MH#12 in segment 5. Facing east.

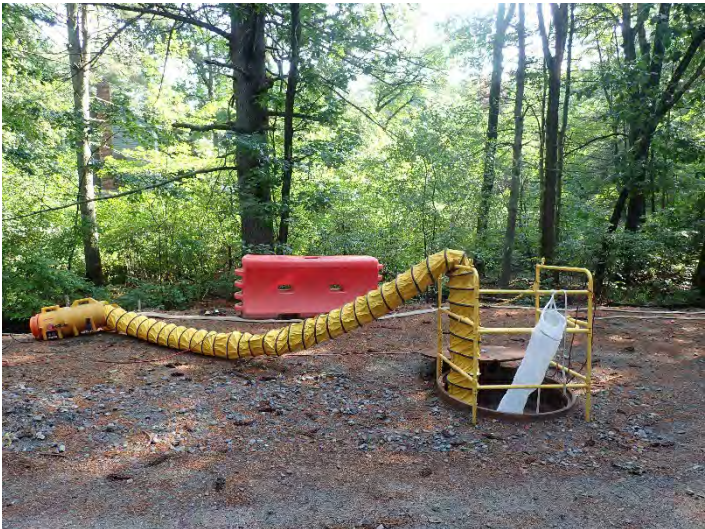
Epsilon ASSOCIATES INC.		PHOTOGRAPHIC LOG	
Client Name: Eversource		Site Location: Sudbury to Hudson Transmission Reliability Project	Town: Hudson
Photo No.: 6	Date: 6-21-2024

Description: View of Haugland crew working at MH#13 in segment 5. Facing north.

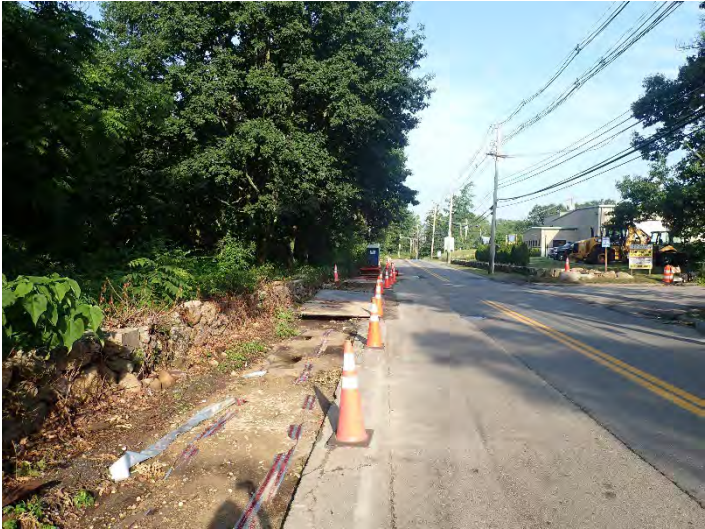
Epsilon ASSOCIATES INC.		PHOTOGRAPHIC LOG	
Client Name: Eversource		Site Location: Sudbury to Hudson Transmission Reliability Project	Town: Hudson
Photo No.: 7	Date: 6-21-2024

Description: View of Forest Avenue. No active work in the area. Facing west.

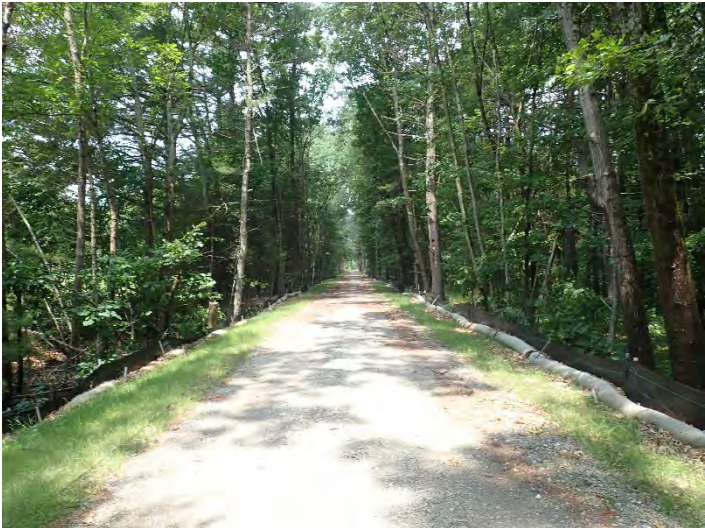
Epsilon ASSOCIATES INC.		PHOTOGRAPHIC LOG	
Client Name: Eversource		Site Location: Sudbury to Hudson Transmission Reliability Project	Town: Hudson
Photo No.: 8	Date: 6-21-2024

Description: View of E&S controls in Segment 4. Facing west.

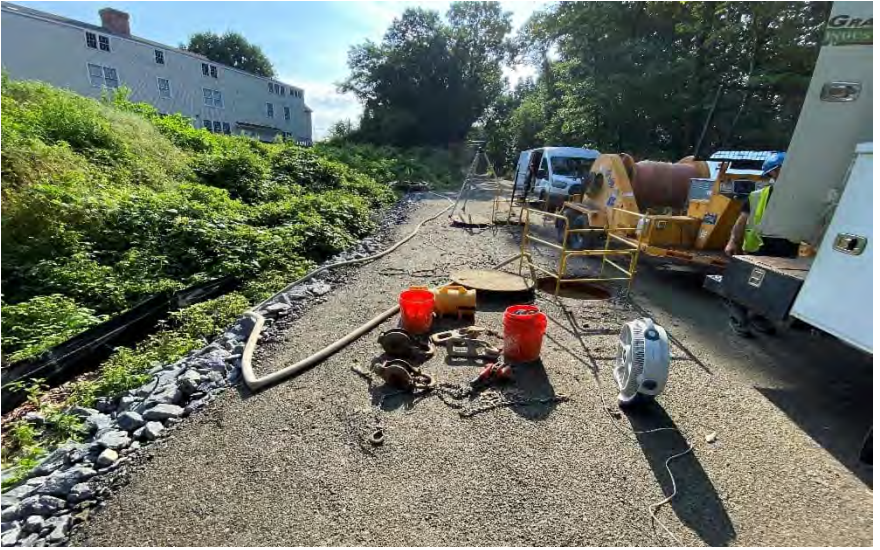
PHOTOGRAPHIC LOG	
Client Name: Eversource		Site Location: Sudbury to Hudson Transmission Reliability Project	Town: Sudbury
Photo No.: 1	Date: 6-21-24

Description: Work area within segment 14 (manhole #27), wire work, looking eastward.

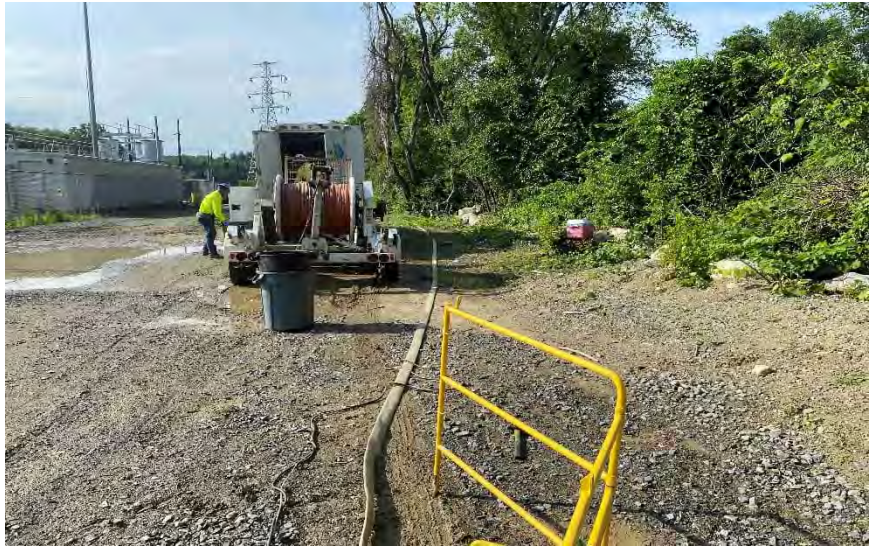
PHOTOGRAPHIC LOG	
Client Name: Eversource		Site Location: Sudbury to Hudson Transmission Reliability Project	Town: Sudbury
Photo No.: 2	Date: 6-21-24

Description: Work area outside substation (manhole #28), wire work, looking eastward.

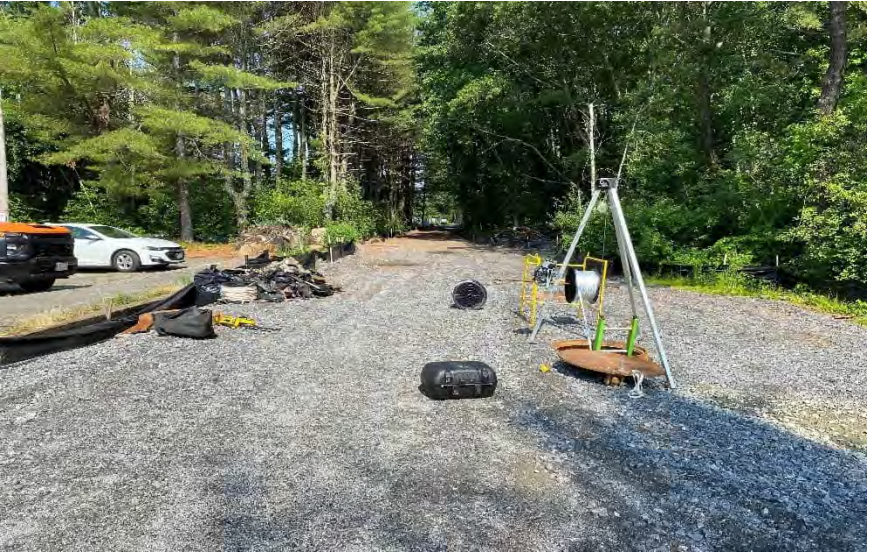
PHOTOGRAPHIC LOG	
Client Name: Eversource		Site Location: Sudbury to Hudson Transmission Reliability Project	Town: Sudbury
Photo No.: 3	Date: 6-21-24

Description: Work area within segment 11 (manhole #24), proofing, existing erosion control, looking westward.

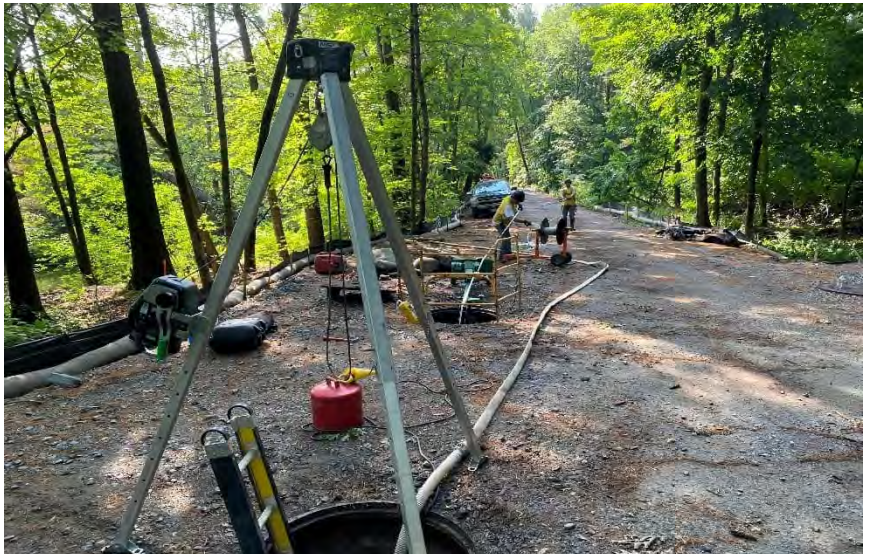
PHOTOGRAPHIC LOG	
Client Name: Eversource		Site Location: Sudbury to Hudson Transmission Reliability Project	Town: Sudbury
Photo No.: 4	Date: 6-21-24

Description: Work area within segment 13 (manhole #25), proofing, existing erosion control, looking eastward.

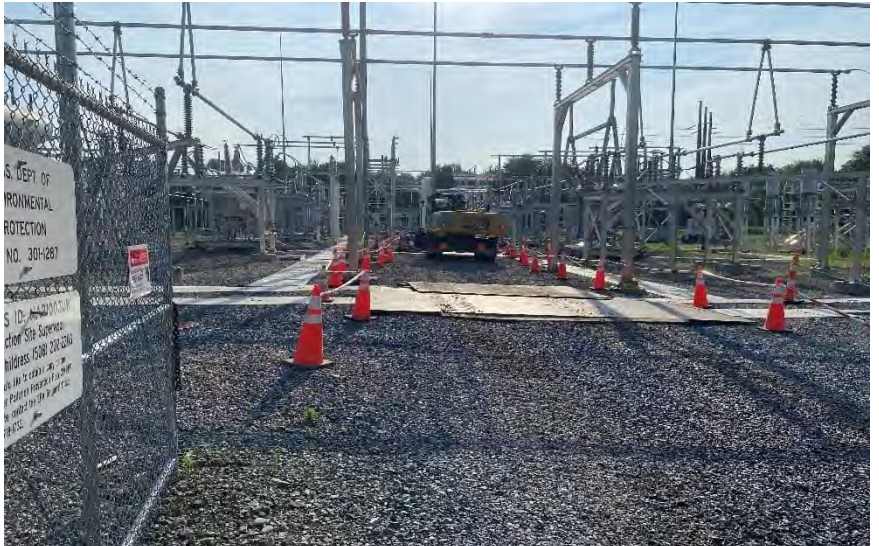
PHOTOGRAPHIC LOG	
Client Name: Eversource		Site Location: Sudbury to Hudson Transmission Reliability Project	Town: Sudbury
Photo No.: 6	Date: 6-21-24

Description: Work area within substation, conduit work area, looking eastward.

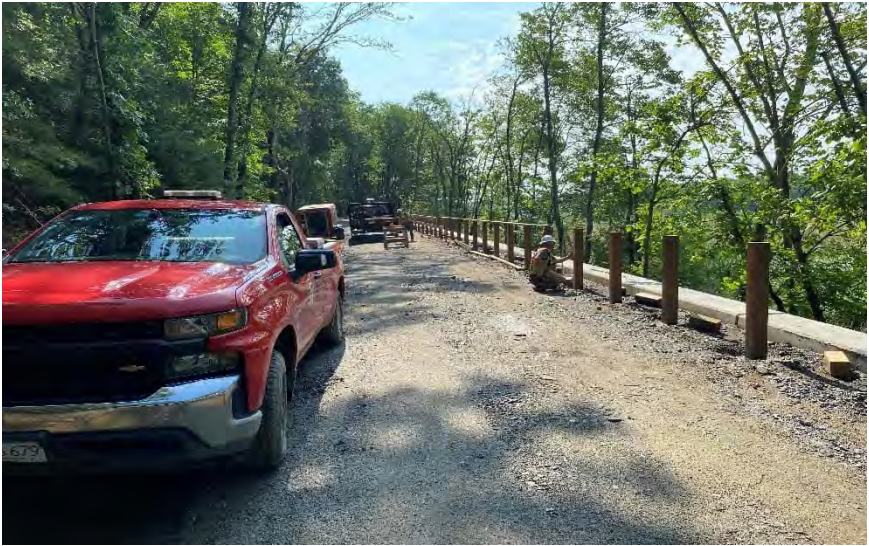
PHOTOGRAPHIC LOG	
Client Name: Eversource		Site Location: Sudbury to Hudson Transmission Reliability Project	Town: Sudbury
Photo No.: 7	Date: 6-21-24

Description: Work area within segment 14, wall work, existing erosion control, looking eastward.

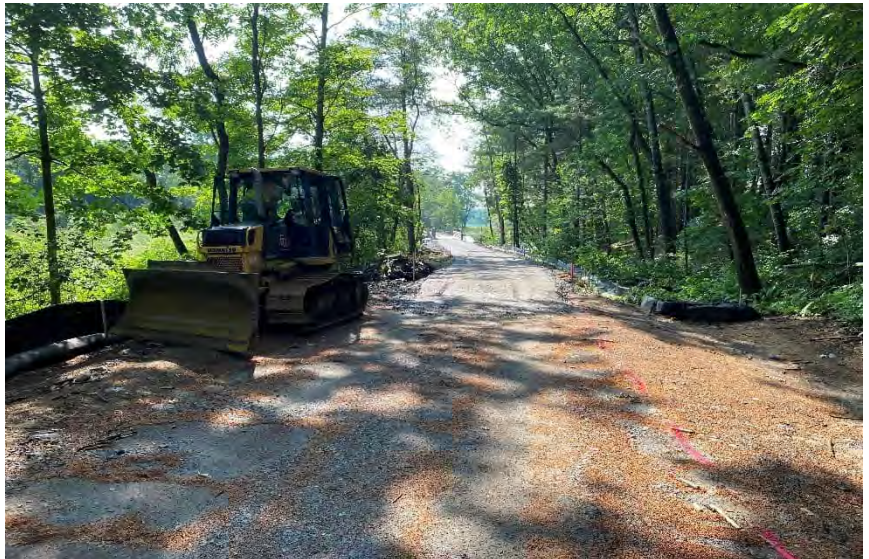
PHOTOGRAPHIC LOG	
Client Name: Eversource		Site Location: Sudbury to Hudson Transmission Reliability Project	Town: Sudbury
Photo No.: 8	Date: 6-21-24

Description: Work area within segment 13 grading work, existing erosion control, looking eastward.

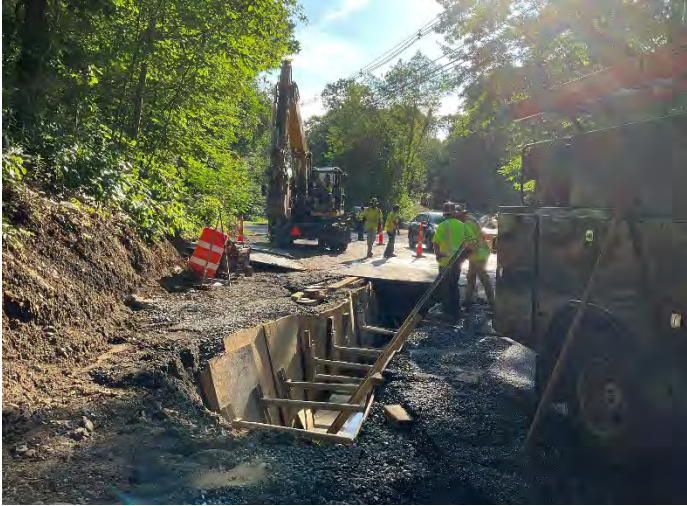
PHOTOGRAPHIC LOG		
Client Name: Eversource		Site Location: Sudbury to Hudson Transmission Reliability Project		Town: Hudson
Photo No.: 1	Date: 6/17/2024

Description: View of Bond working on Wilkins Street. Facing northeast.

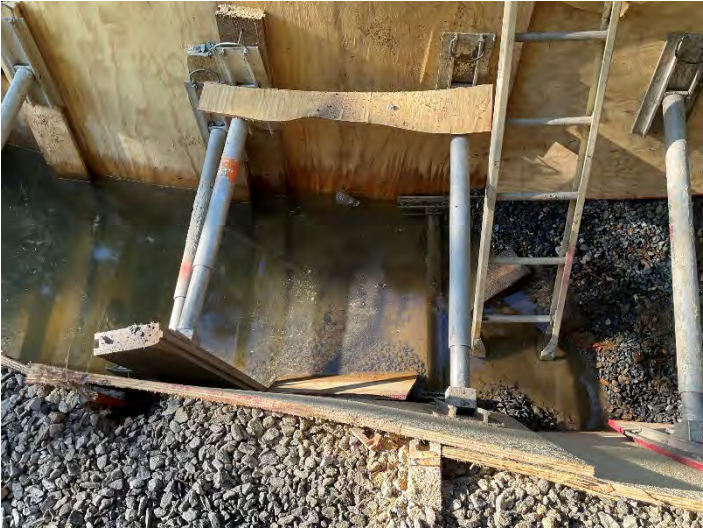
PHOTOGRAPHIC LOG		
Client Name: Eversource		Site Location: Sudbury to Hudson Transmission Reliability Project		Town: Hudson
Photo No.: 2	Date: 6/17/2024

Description: View of water in trench within Wilkins Street. Water appeared mostly clear prior to treatment.

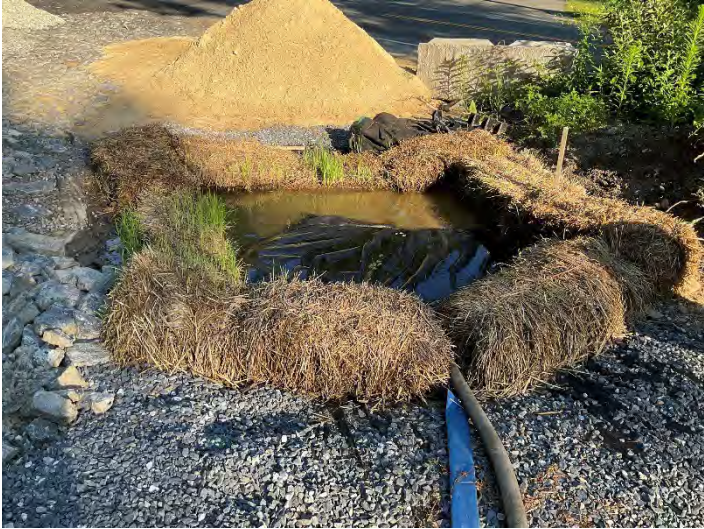
PHOTOGRAPHIC LOG	
Client Name: Eversource		Site Location: Sudbury to Hudson Transmission Reliability Project	
		Town: Hudson	
Photo No.: 3	Date: 6/17/2024

Description: View of dewatering controls (straw bale corral with filter fabric and silt bag). Facing west.

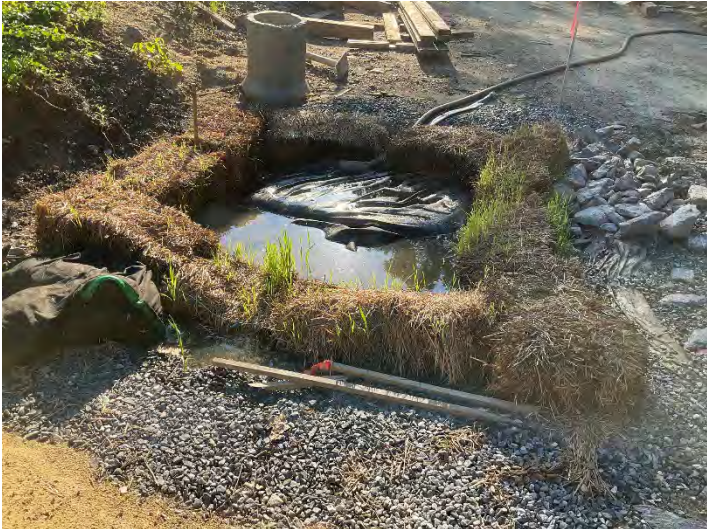
PHOTOGRAPHIC LOG	
Client Name: Eversource		Site Location: Sudbury to Hudson Transmission Reliability Project	
		Town: Hudson	
Photo No.: 4	Date: 6/17/2024

Description: Additional view of dewatering controls and discharge. Discharge appeared clear and turbidity reading was below 50 NTUs. Facing east.

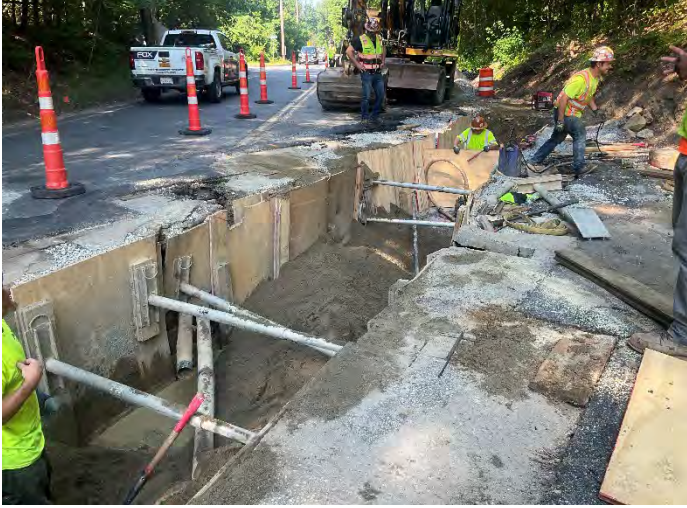
PHOTOGRAPHIC LOG	
Client Name: Eversource		Site Location: Sudbury to Hudson Transmission Reliability Project	Town: Hudson
Photo No.: 1	Date: 6/18/2024

Description: View of Bond working on Wilkins Street. Facing south.

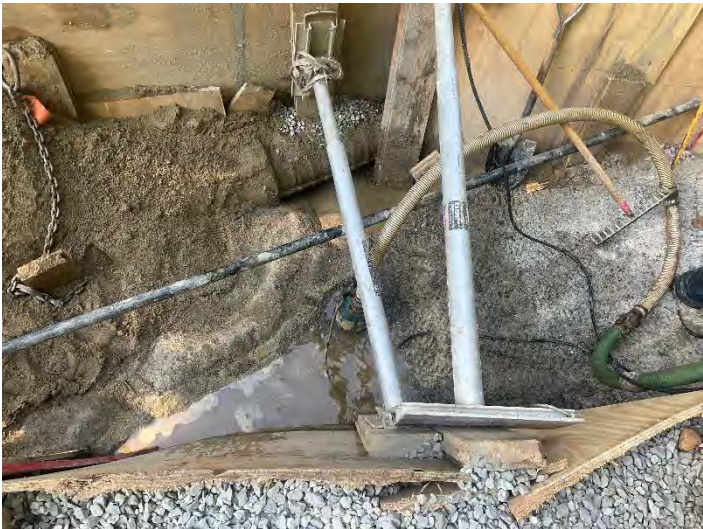
PHOTOGRAPHIC LOG	
Client Name: Eversource		Site Location: Sudbury to Hudson Transmission Reliability Project	Town: Hudson
Photo No.: 2	Date: 6/18/2024

Description: View of pump in trench within Wilkins Street. Water appeared mostly clear prior to treatment.

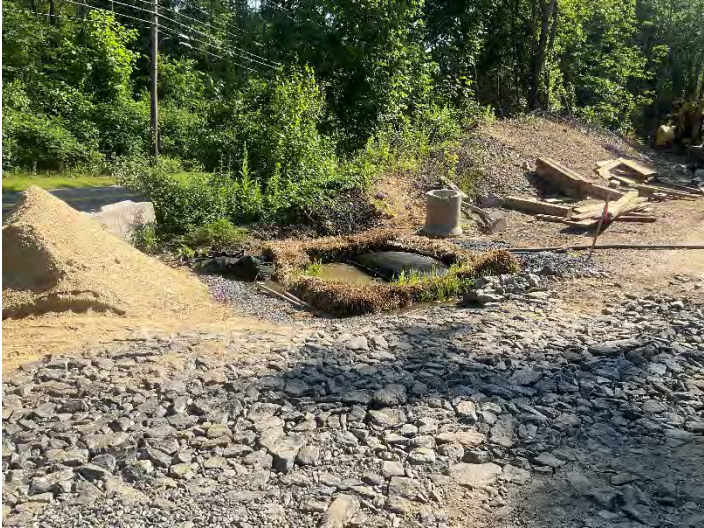
PHOTOGRAPHIC LOG	
Client Name: Eversource		Site Location: Sudbury to Hudson Transmission Reliability Project	
Town: Hudson			
Photo No.: 3	Date: 6/18/2024

Description: View of dewatering controls (straw bale corral with filter fabric and silt bag). Facing north.

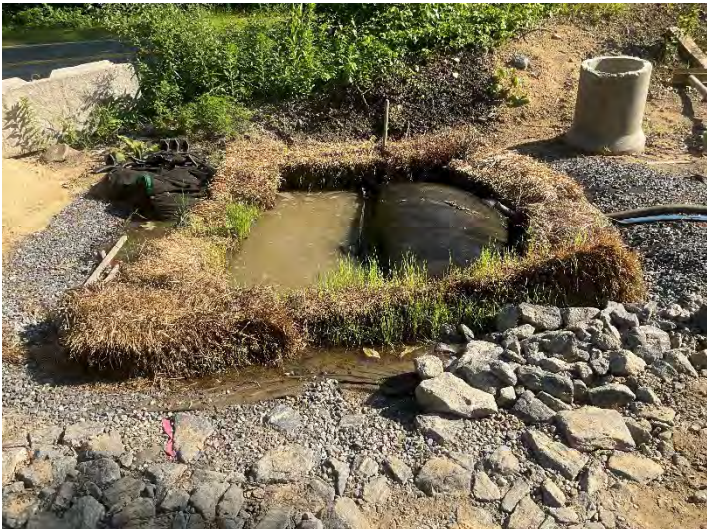
PHOTOGRAPHIC LOG	
Client Name: Eversource		Site Location: Sudbury to Hudson Transmission Reliability Project	
Town: Hudson			
Photo No.: 4	Date: 6/18/2024

Description: View of discharging water from corral. Discharge appeared to be clear and turbidity reading was below 50 NTUs. Water was being discharged to catch basin underneath filter fabric. Facing north.

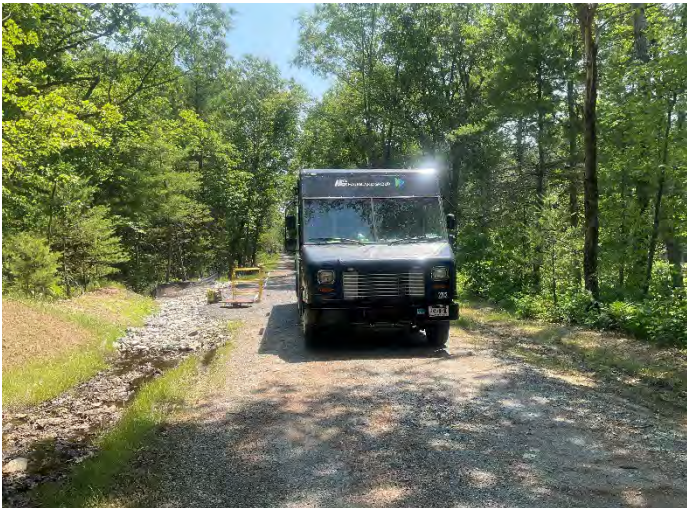
PHOTOGRAPHIC LOG	
Client Name: Eversource		Site Location: Sudbury to Hudson Transmission Reliability Project	Town: Hudson
Photo No.: 1	Date: 6/18/2024

Description: View of Haugland working at MH #12 within segment 5. Facing east.

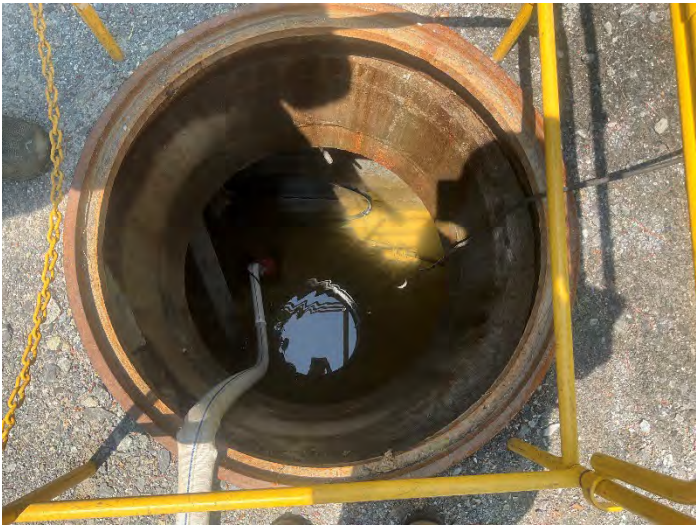
PHOTOGRAPHIC LOG	
Client Name: Eversource		Site Location: Sudbury to Hudson Transmission Reliability Project	Town: Hudson
Photo No.: 2	Date: 6/18/2024

Description: View of pump in MH #12. Water appeared clear prior to treatment.

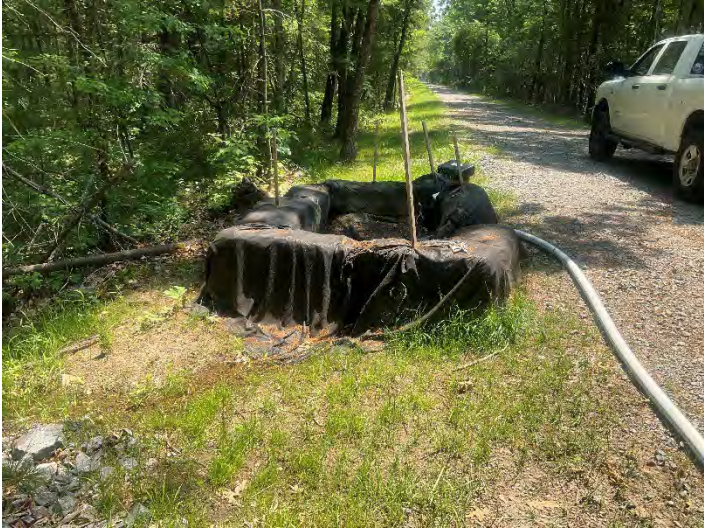
PHOTOGRAPHIC LOG		
Client Name: Eversource		Site Location: Sudbury to Hudson Transmission Reliability Project		Town: Hudson
Photo No.: 3	Date: 6/18/2024

Description: View of dewatering controls (straw bale corral with filter fabric and silt bag). Facing east.

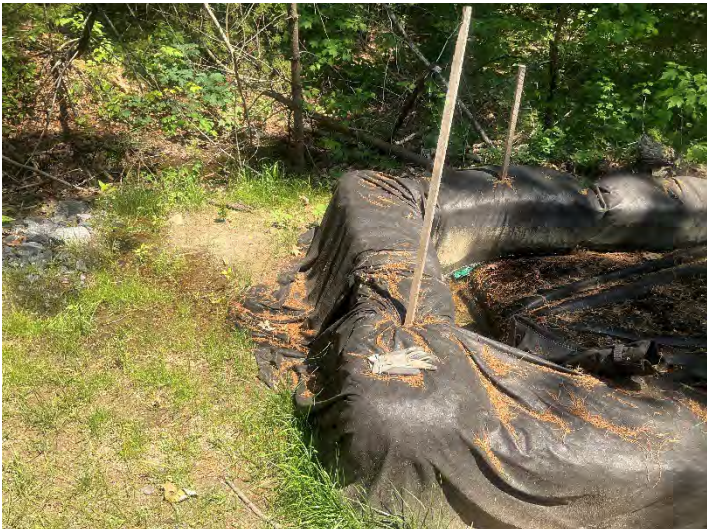
PHOTOGRAPHIC LOG		
Client Name: Eversource		Site Location: Sudbury to Hudson Transmission Reliability Project		Town: Hudson
Photo No.: 4	Date: 6/18/2024

Description: View of dewatering controls (straw bale corral with filter fabric and silt bag) and discharge from corral. Discharge appeared clear and turbidity reading was below 50 NTUs. Discharge did not appear to reach any jurisdictional resource areas. Facing north.

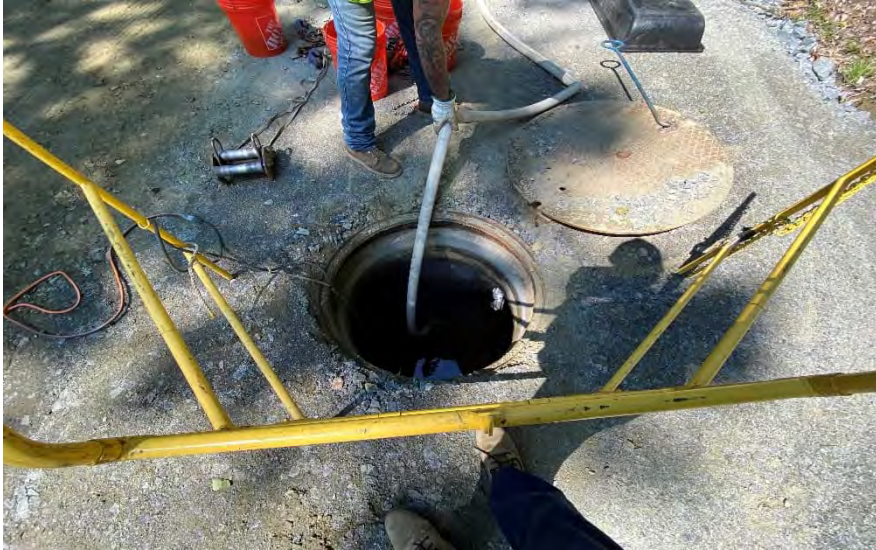
PHOTOGRAPHIC LOG	
Client Name: Eversource		Site Location: Sudbury to Hudson Transmission Reliability Project	Town: Sudbury
Photo No.: 1	Date: 6/18/2024

Description: View of area being pumped from manhole #26, segment 14.

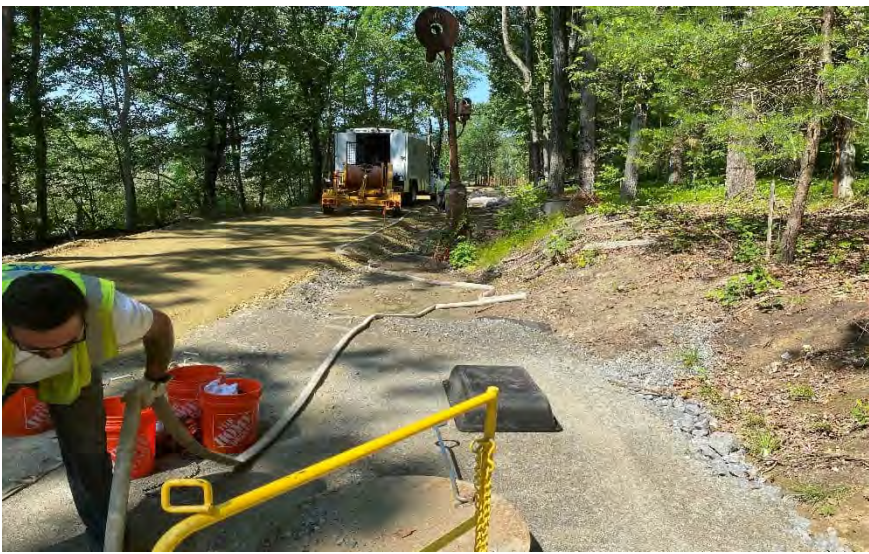
PHOTOGRAPHIC LOG	
Client Name: Eversource		Site Location: Sudbury to Hudson Transmission Reliability Project	Town: Sudbury
Photo No.: 2	Date: 6/18/2024

Description: Manhole #26. View of dewatering operation. Looking westward.

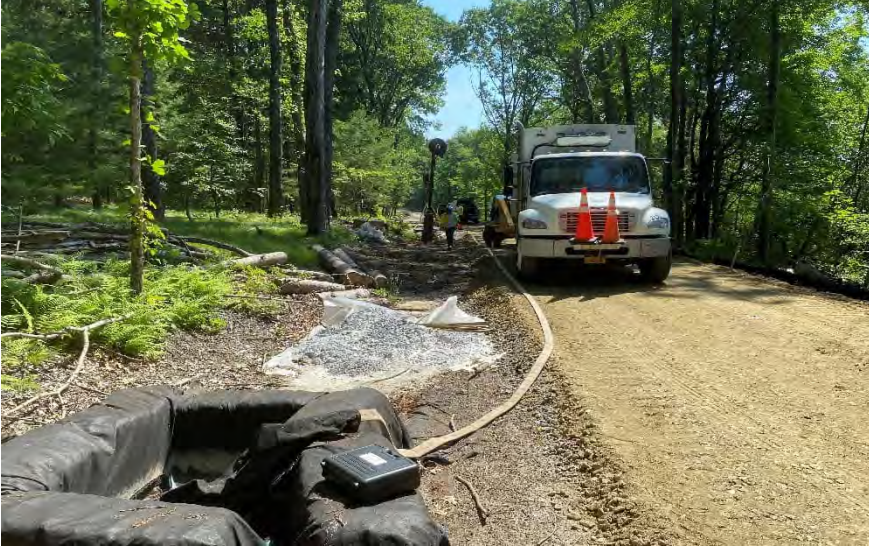
PHOTOGRAPHIC LOG	
Client Name: Eversource		Site Location: Sudbury to Hudson Transmission Reliability Project	Town: Sudbury
Photo No.: 3	Date: 6/18/2024

Description: Manhole #26. View of dewatering operation, looking eastward.

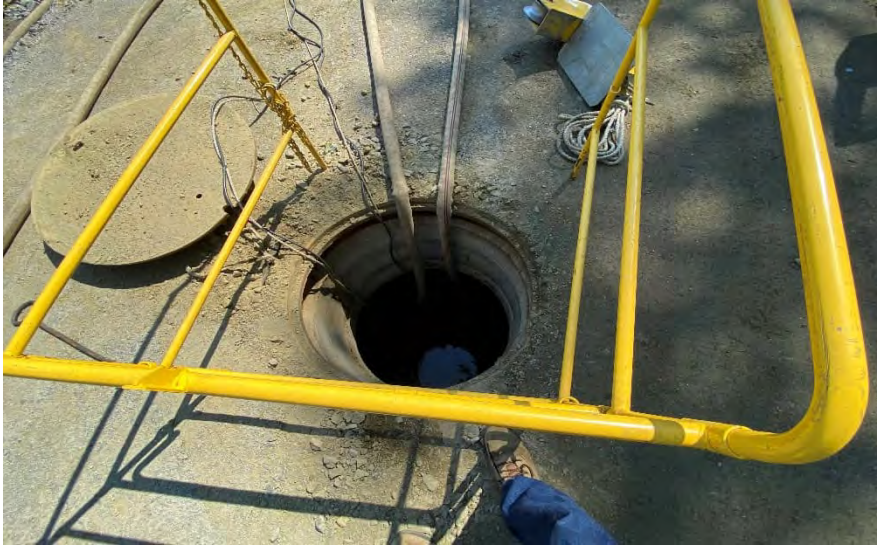
PHOTOGRAPHIC LOG	
Client Name: Eversource		Site Location: Sudbury to Hudson Transmission Reliability Project	Town: Sudbury
Photo No.: 1	Date: 6/18/2024

Description: View of area being pumped from manhole #27, segment 14.

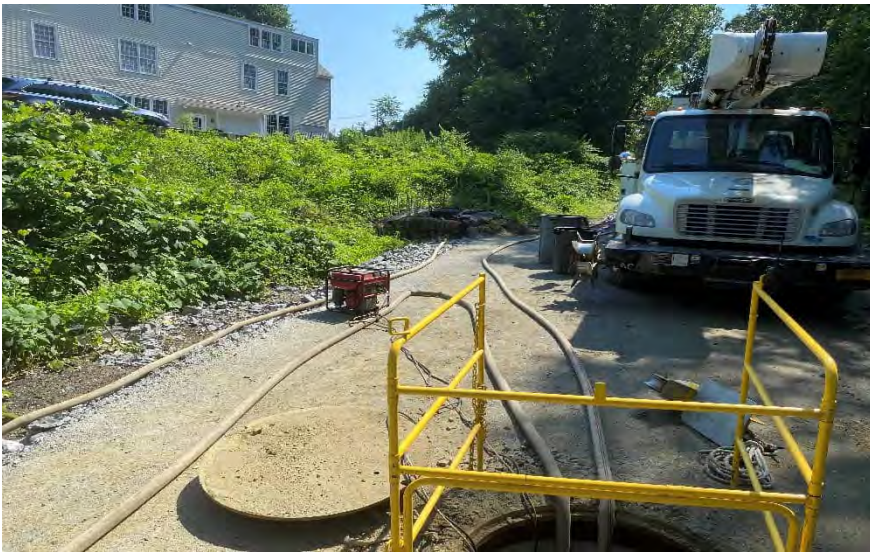
PHOTOGRAPHIC LOG	
Client Name: Eversource		Site Location: Sudbury to Hudson Transmission Reliability Project	Town: Sudbury
Photo No.: 2	Date: 6/18/2024

Description: Manhole #27. View of dewatering operation. Looking eastward.

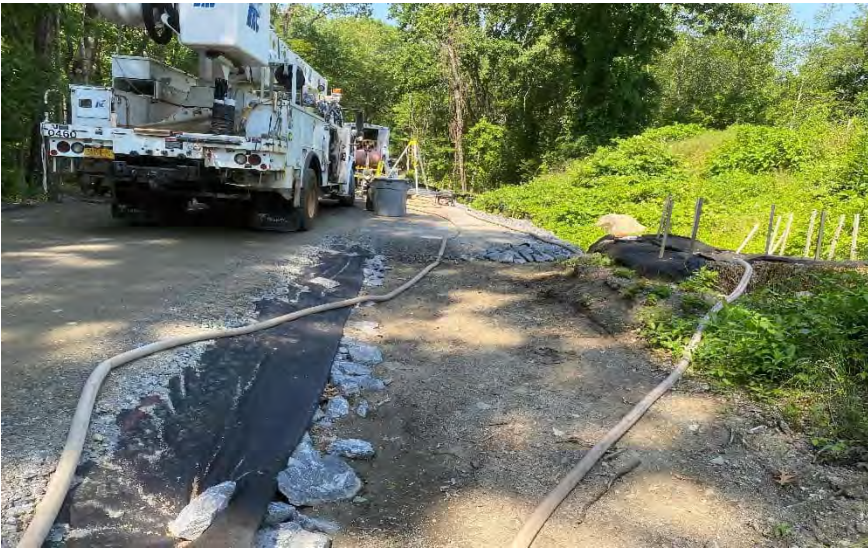
PHOTOGRAPHIC LOG	
Client Name: Eversource		Site Location: Sudbury to Hudson Transmission Reliability Project	Town: Sudbury
Photo No.: 3	Date: 6/18/2024

Description: Manhole #27. View of dewatering operation, looking westward.

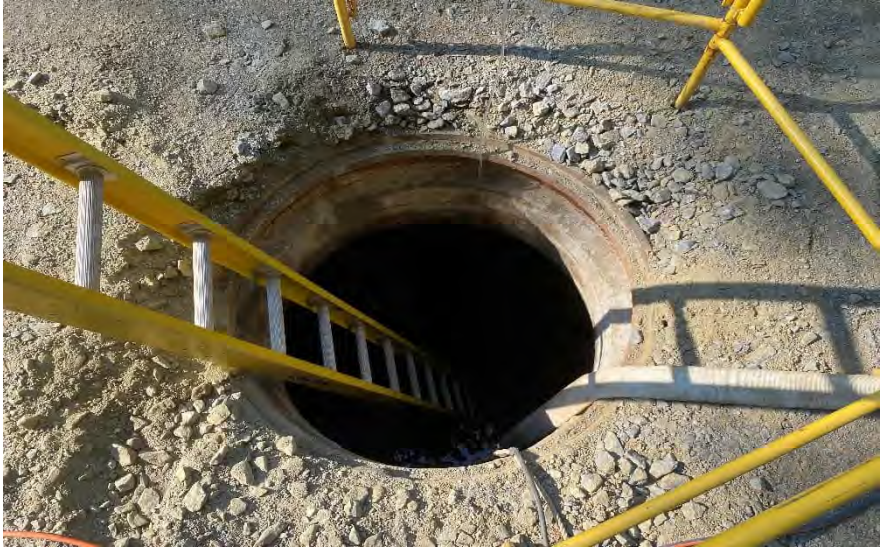
PHOTOGRAPHIC LOG	
Client Name: Eversource		Site Location: Sudbury to Hudson Transmission Reliability Project	Town: Sudbury
Photo No.: 1	Date: 6/19/2024

Description: View of area being pumped from manhole #26, segment 14.

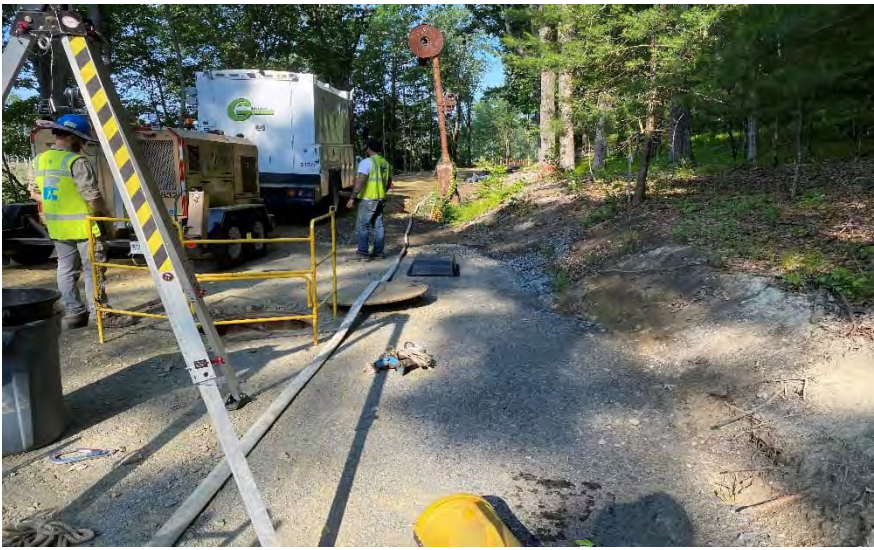
PHOTOGRAPHIC LOG	
Client Name: Eversource		Site Location: Sudbury to Hudson Transmission Reliability Project	Town: Sudbury
Photo No.: 2	Date: 6/19/2024

Description: Sewer Hole #26. View of dewatering operation. Looking westward.

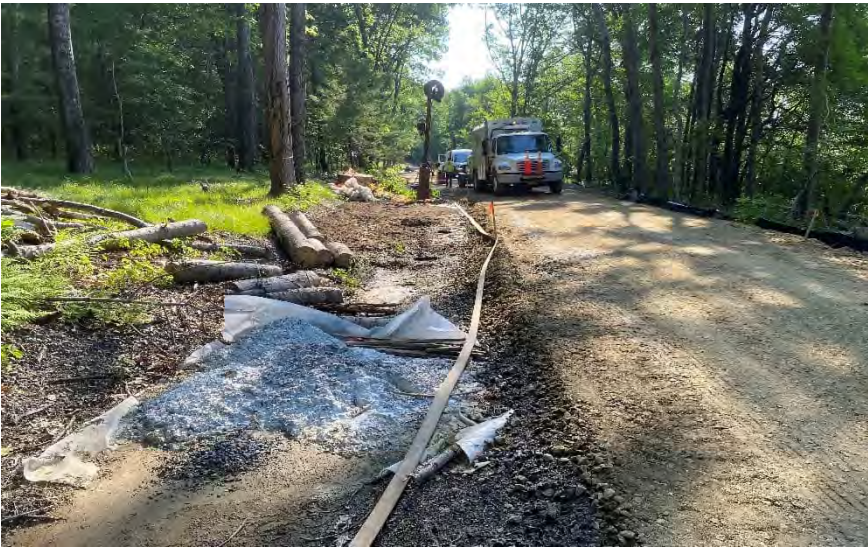
PHOTOGRAPHIC LOG	
Client Name: Eversource		Site Location: Sudbury to Hudson Transmission Reliability Project	Town: Sudbury
Photo No.: 3	Date: 6/19/2024

Description: Sewer Hole #26. View of dewatering operation, looking eastward.

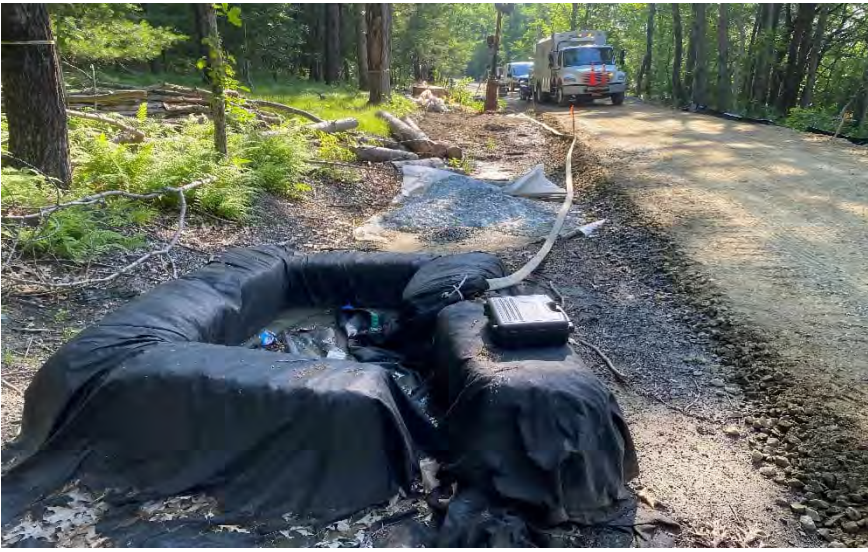
PHOTOGRAPHIC LOG	
Client Name: Eversource		Site Location: Sudbury to Hudson Transmission Reliability Project	Town: Sudbury
Photo No.: 4	Date: 6/19/2024

Description: Sewer Hole #26. View of discharge bag/corral, looking eastward. Water from bag/corral discharged to adjacent area.
