Weekly Environmental Compliance Summary

Sudbury to Hudson Transmission Reliability Project (USEPA Tracking # MAR1003UW)

Sudbury, Hudson, and Stow, MA

Week of: June 17, 2024 to June 22, 2024

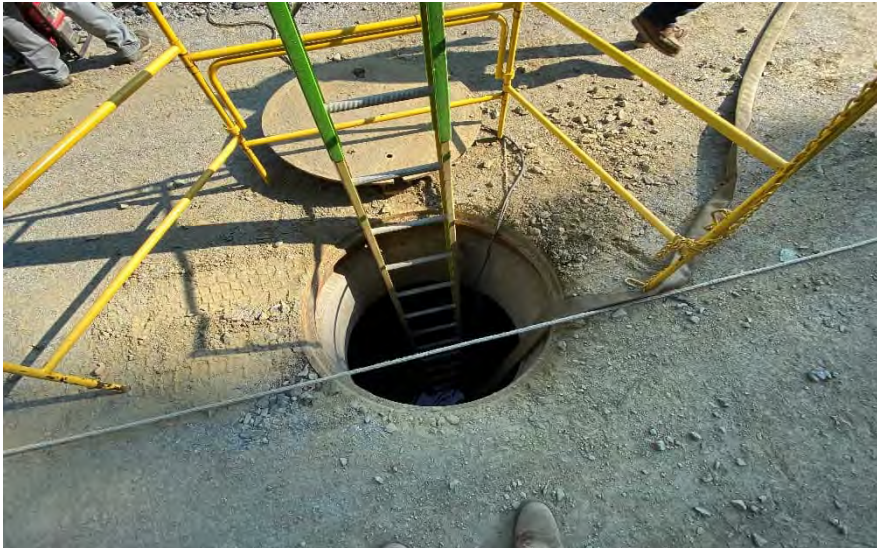
PHOTOGRAPHIC LOG	
Client Name: Eversource		Site Location: Sudbury to Hudson Transmission Reliability Project	Town: Sudbury
Photo No.: 1	Date: 6/19/2024

Description: View of area being pumped from manhole #27, segment 14.

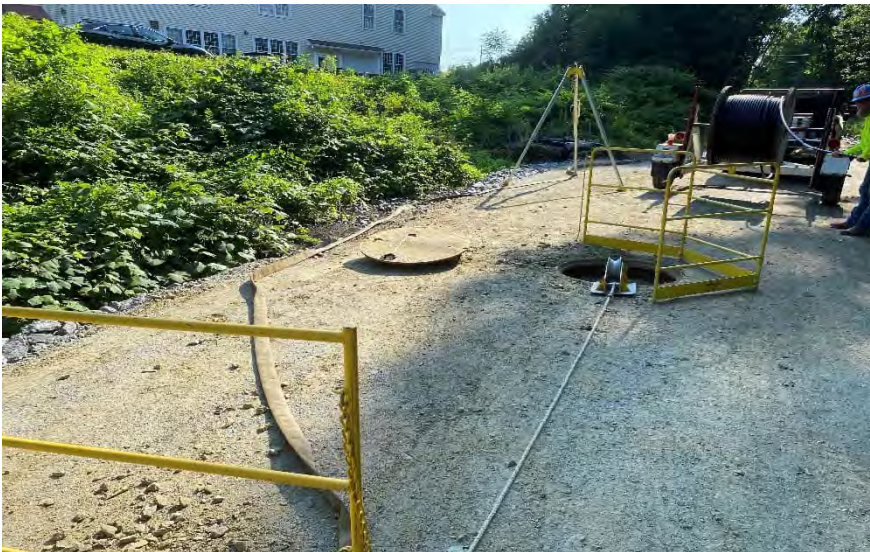
PHOTOGRAPHIC LOG	
Client Name: Eversource		Site Location: Sudbury to Hudson Transmission Reliability Project	Town: Sudbury
Photo No.: 2	Date: 6/19/2024

Description: Manhole #27. View of dewatering operation. Looking eastward.

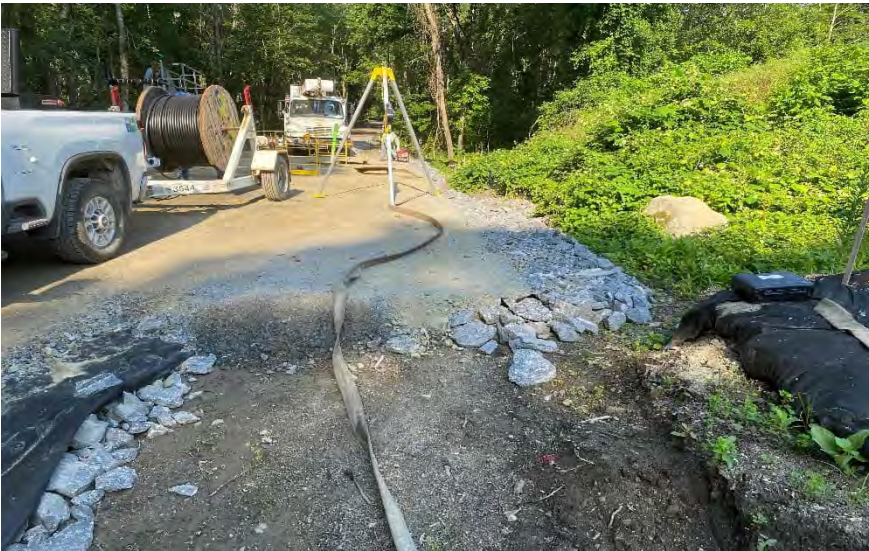
PHOTOGRAPHIC LOG	
Client Name: Eversource		Site Location: Sudbury to Hudson Transmission Reliability Project	Town: Sudbury
Photo No.: 3	Date: 6/19/2024

Description: Manhole #27. View of dewatering operation, looking westward.

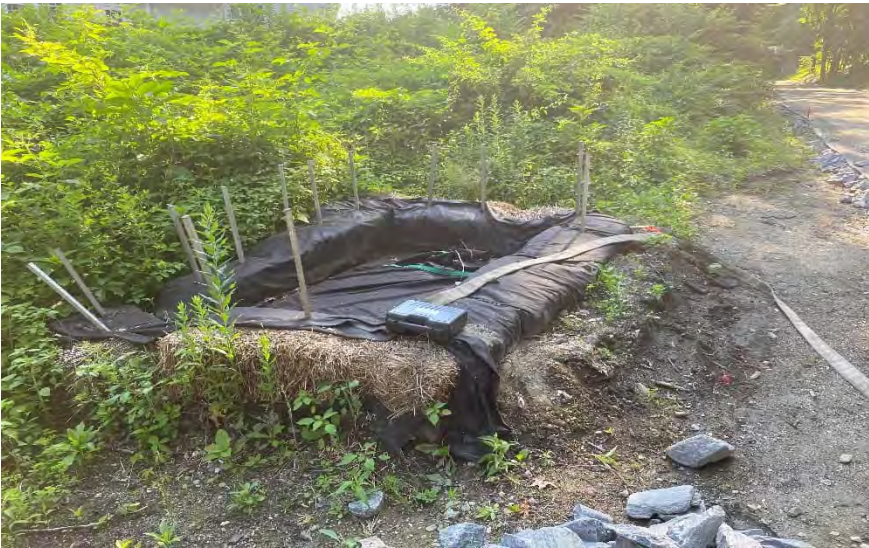
PHOTOGRAPHIC LOG	
Client Name: Eversource		Site Location: Sudbury to Hudson Transmission Reliability Project	Town: Sudbury
Photo No.: 4	Date: 6/19/2024

Description: Manhole #27. View of discharge bag/corral, looking eastward. Water from bag/corral discharged to adjacent area.

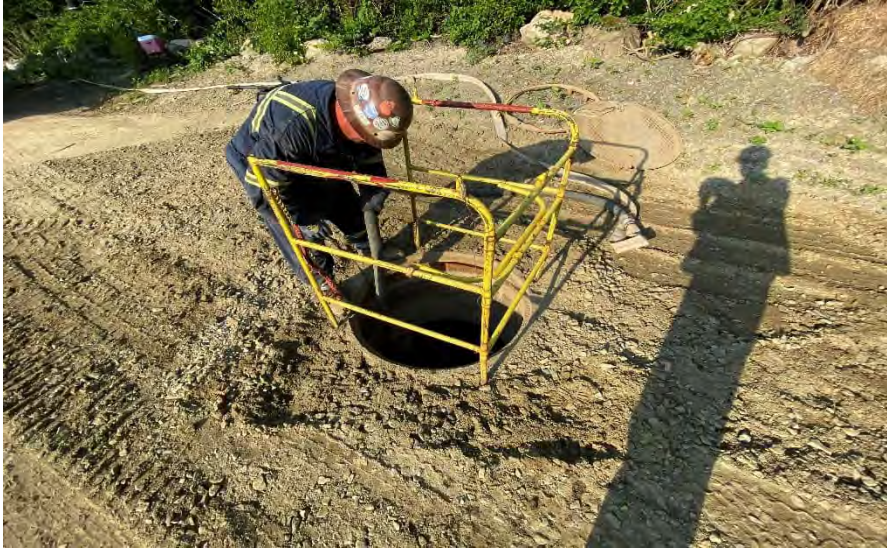
PHOTOGRAPHIC LOG	
Client Name: Eversource		Site Location: Sudbury to Hudson Transmission Reliability Project	Town: Sudbury
Photo No.: 1	Date: 6/20/2024

Description: View of area being pumped from Manhole #28.

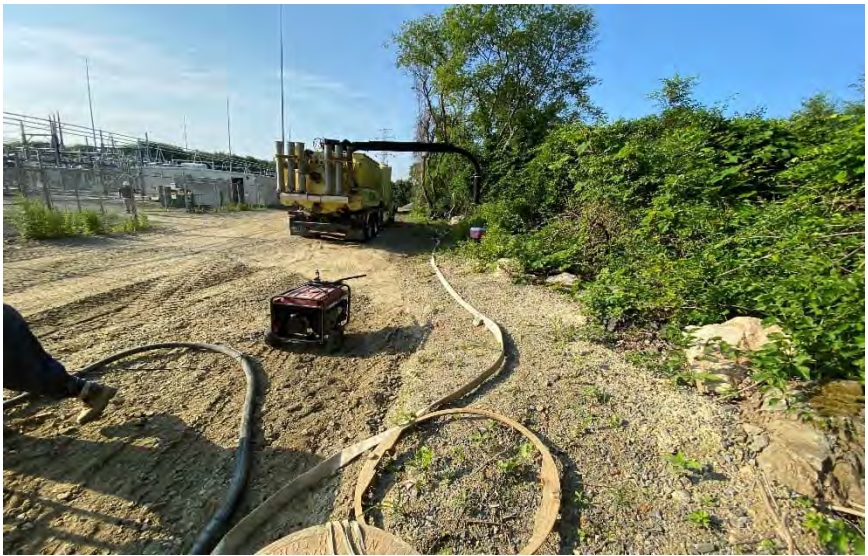
PHOTOGRAPHIC LOG	
Client Name: Eversource		Site Location: Sudbury to Hudson Transmission Reliability Project	Town: Sudbury
Photo No.: 2	Date: 6/20/2024

Description: Manhole #28. View of dewatering operation. Looking eastward.

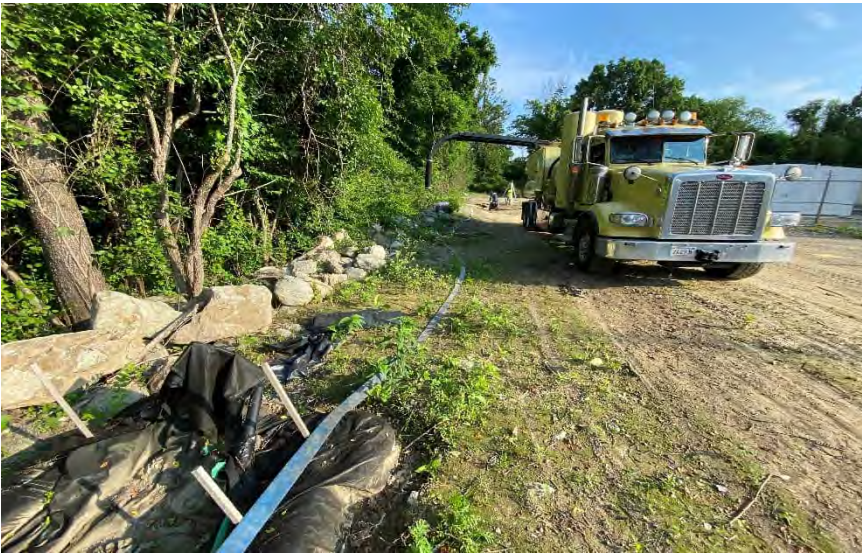
PHOTOGRAPHIC LOG	
Client Name: Eversource		Site Location: Sudbury to Hudson Transmission Reliability Project	Town: Sudbury
Photo No.: 3	Date: 6/20/2024

Description: Manhole #28. View of dewatering operation, looking westward.

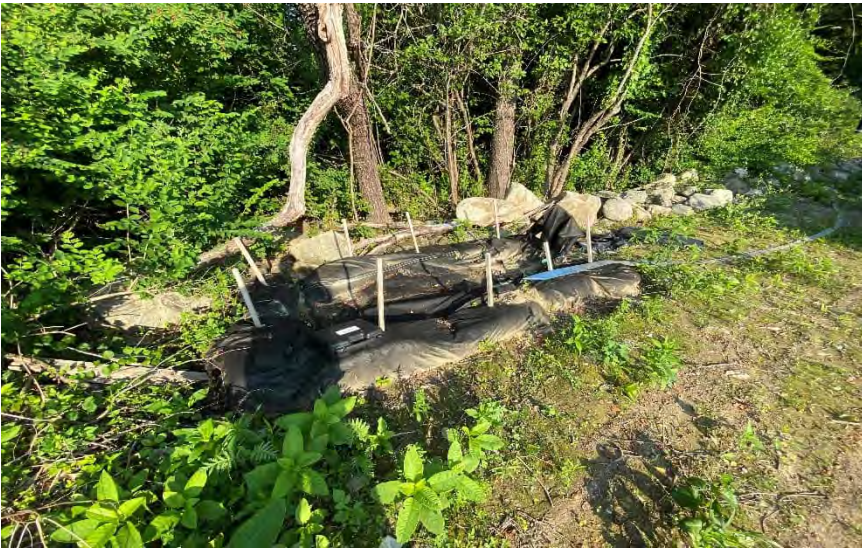
PHOTOGRAPHIC LOG	
Client Name: Eversource		Site Location: Sudbury to Hudson Transmission Reliability Project	Town: Sudbury
Photo No.: 4	Date: 6/20/2024

Description: Manhole #28. View of discharge bag/corral, looking westward. Water from bag/corral discharged to adjacent area.

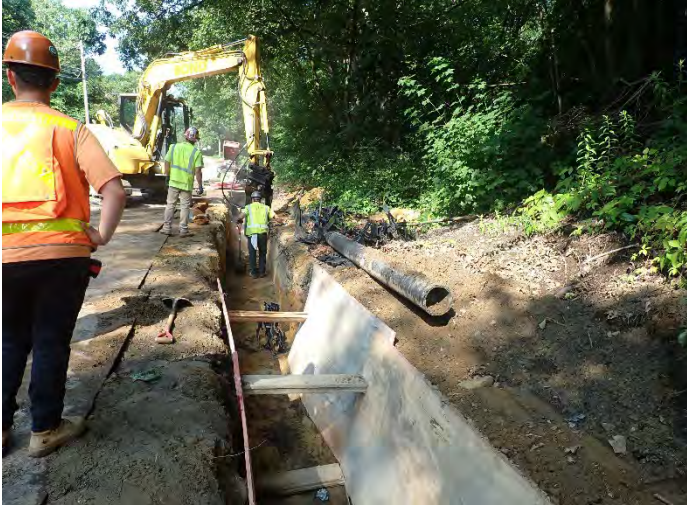
PHOTOGRAPHIC LOG		
Client Name: Eversource		Site Location: Sudbury to Hudson Transmission Reliability Project		Town: Hudson
Photo No.: 1	Date: 6/21/2024

Description: View of Bond working on Wilkins Street. Facing southwest.

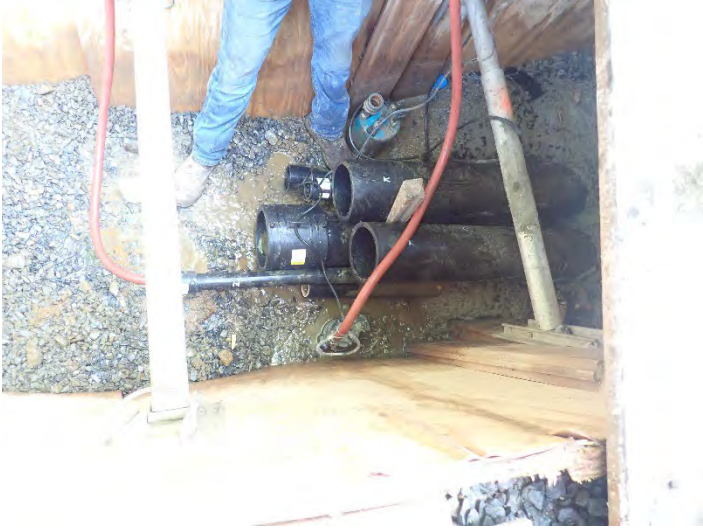
PHOTOGRAPHIC LOG		
Client Name: Eversource		Site Location: Sudbury to Hudson Transmission Reliability Project		Town: Hudson
Photo No.: 2	Date: 6/21/2024

Description: View of water in trench within Wilkins Street. Water appeared partly turbid prior to treatment.

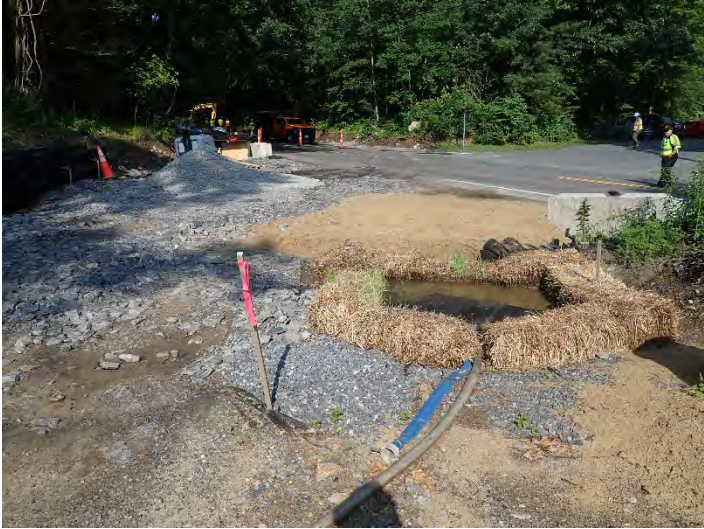
PHOTOGRAPHIC LOG	
Client Name: Eversource		Site Location: Sudbury to Hudson Transmission Reliability Project	Town: Hudson
Photo No.: 3	Date: 6/21/2024

Description: View of dewatering controls (straw bale corral with filter fabric and silt bag). Facing west.

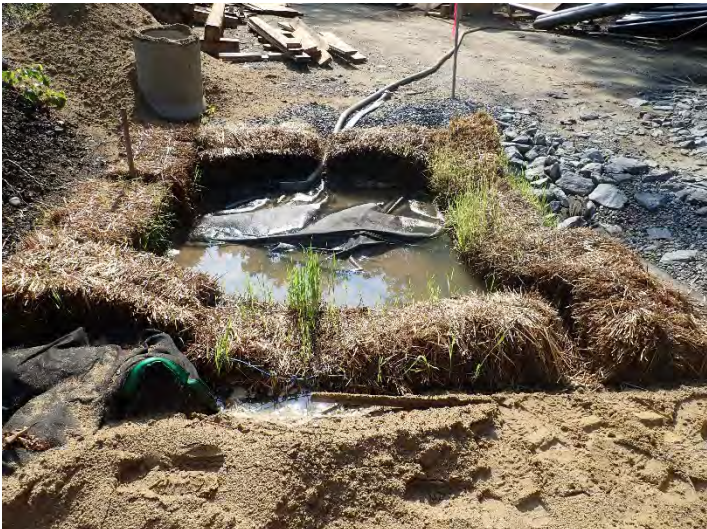
PHOTOGRAPHIC LOG	
Client Name: Eversource		Site Location: Sudbury to Hudson Transmission Reliability Project	Town: Hudson
Photo No.: 4	Date: 6/21/2024

Description: Additional view of dewatering controls and discharge. Discharge appeared clear and turbidity reading was below 50 NTUs. Facing east.

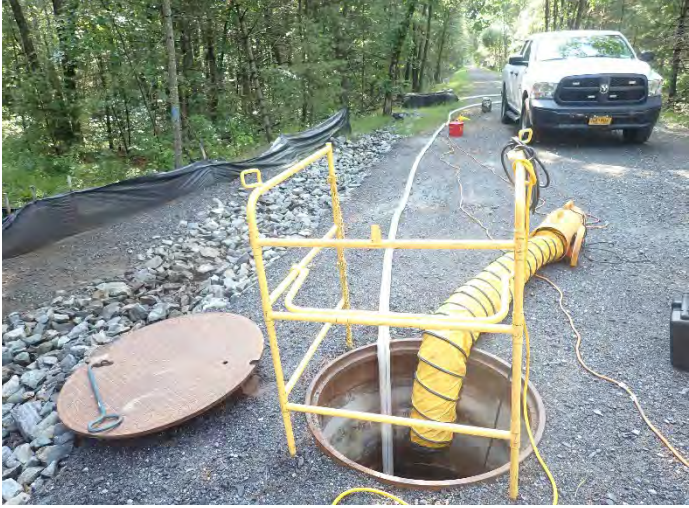
PHOTOGRAPHIC LOG		
Client Name: Eversource		Site Location: Sudbury to Hudson Transmission Reliability Project		Town: Hudson
Photo No.: 1	Date: 6/21/2024

Description: View of Haugland working at MH# 12 in segment 5. Facing east.

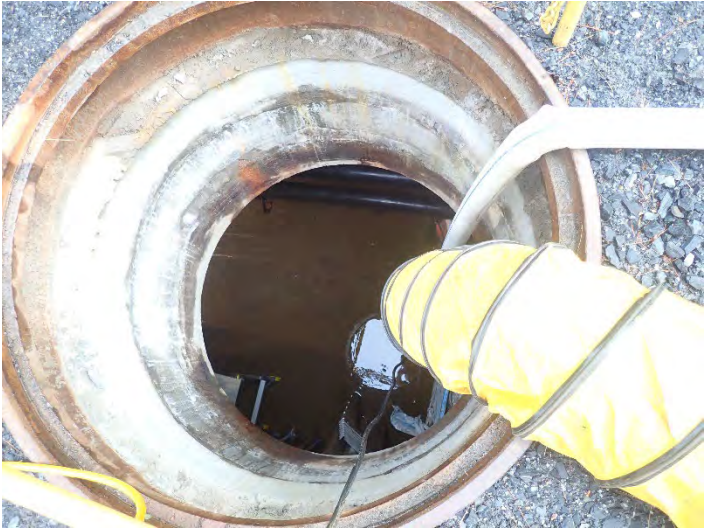
PHOTOGRAPHIC LOG		
Client Name: Eversource		Site Location: Sudbury to Hudson Transmission Reliability Project		Town: Hudson
Photo No.: 2	Date: 6/21/2024

Description: View of water within MH #12. Water appeared clear prior to treatment.

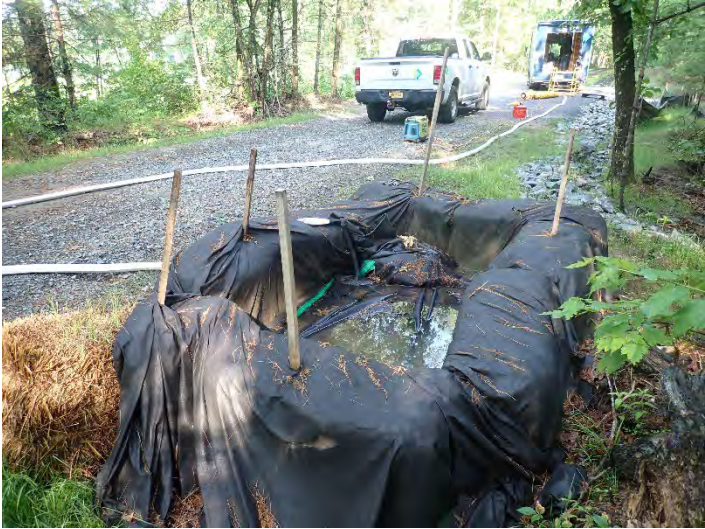
PHOTOGRAPHIC LOG	
Client Name: Eversource		Site Location: Sudbury to Hudson Transmission Reliability Project	
		Town: Hudson	
Photo No.: 3	Date: 6/21/2024

Description: View of dewatering controls (straw bale corral with filter fabric and silt bag). Facing west.

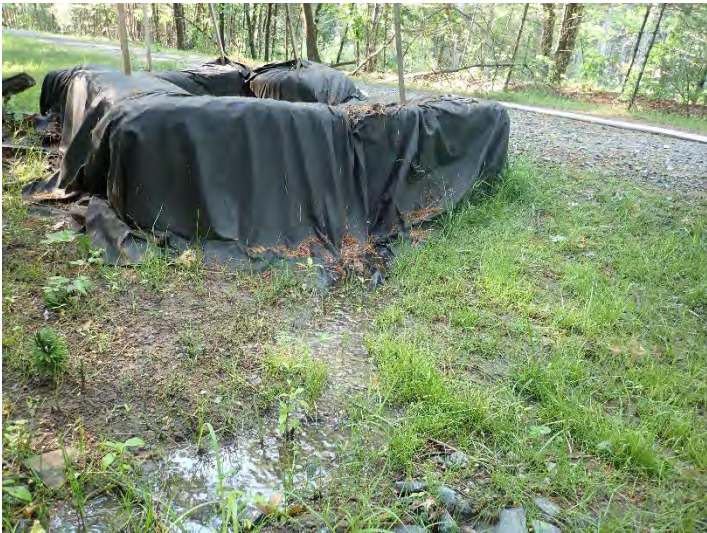
PHOTOGRAPHIC LOG	
Client Name: Eversource		Site Location: Sudbury to Hudson Transmission Reliability Project	
		Town: Hudson	
Photo No.: 4	Date: 6/21/2024

Description: Additional view of dewatering controls and discharge. Discharge appeared clear and turbidity reading was below 50 NTUs. Facing east.

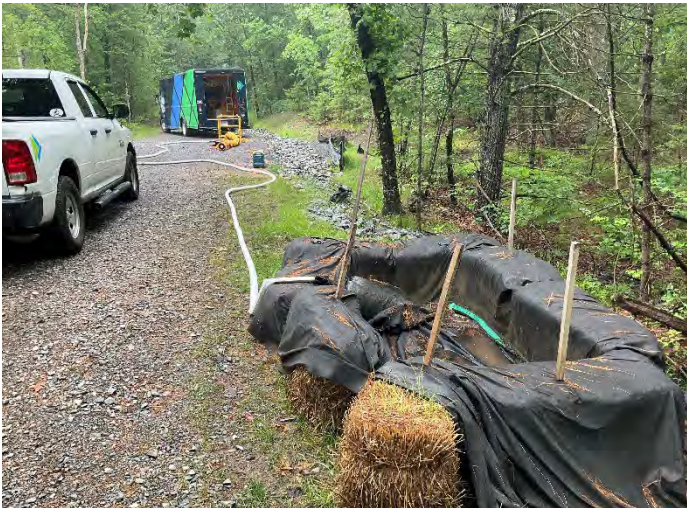
PHOTOGRAPHIC LOG	
Client Name: Eversource		Site Location: Sudbury to Hudson Transmission Reliability Project	Town: Hudson
Photo No.: 1	Date: 6/22/2024

Description: View of Haugland working at Manhole 12. Facing west.

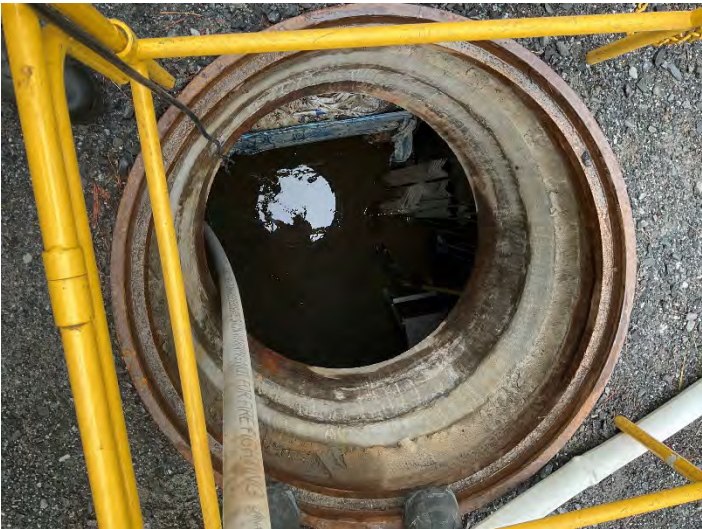
PHOTOGRAPHIC LOG	
Client Name: Eversource		Site Location: Sudbury to Hudson Transmission Reliability Project	Town: Hudson
Photo No.: 2	Date: 6/22/2024

Description: View of water in Manhole 12. Water appeared mostly clear prior to treatment.

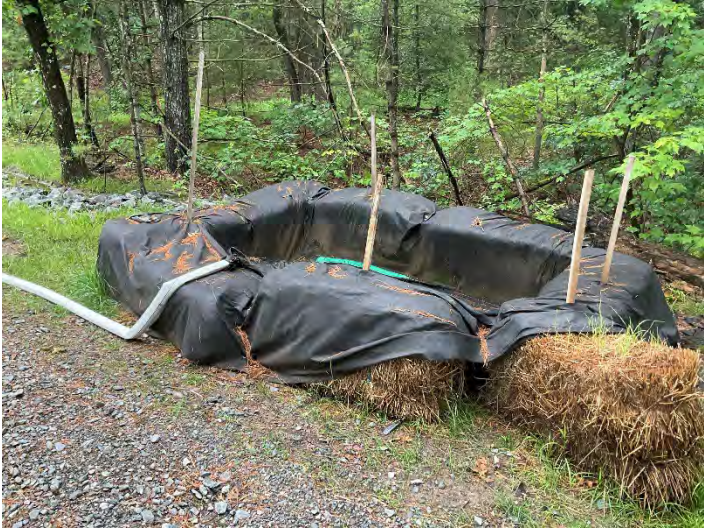
PHOTOGRAPHIC LOG	
Client Name: Eversource		Site Location: Sudbury to Hudson Transmission Reliability Project	Town: Hudson
Photo No.: 3	Date: 6/22/2024

Description: View of dewatering controls (straw bale corral with filter fabric and silt bag). Facing north.

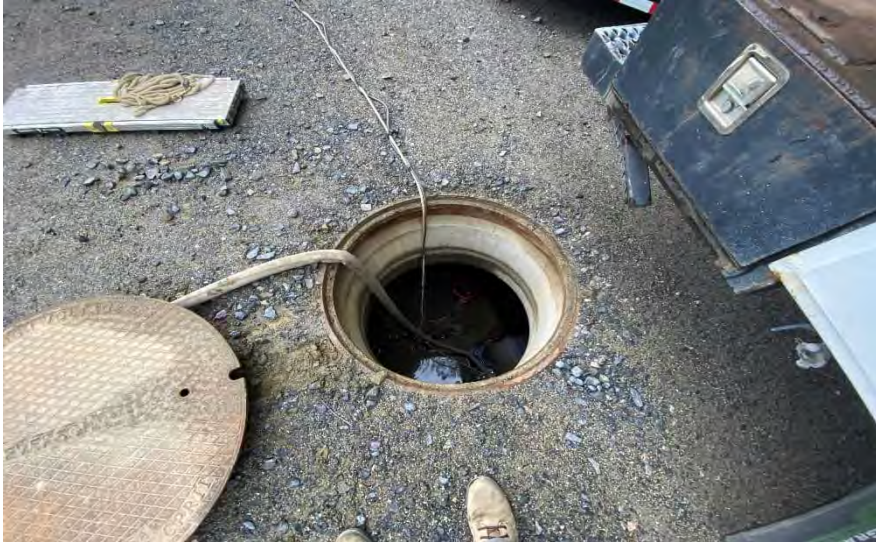
PHOTOGRAPHIC LOG	
Client Name: Eversource		Site Location: Sudbury to Hudson Transmission Reliability Project	Town: Sudbury
Photo No.: 1	Date: 6/22/2024

Description: View of area being pumped from manhole #27, segment 14.

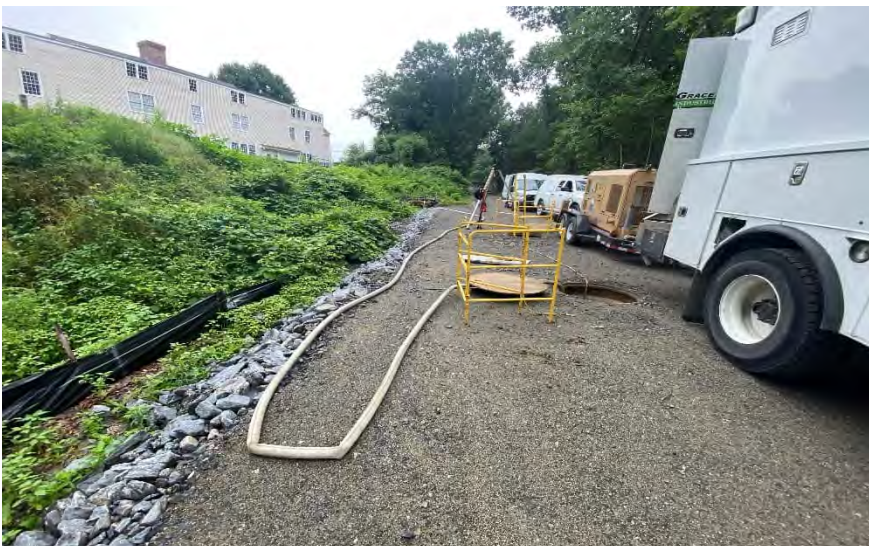
PHOTOGRAPHIC LOG	
Client Name: Eversource		Site Location: Sudbury to Hudson Transmission Reliability Project	Town: Sudbury
Photo No.: 2	Date: 6/22/2024

Description: Manhole #27. View of dewatering operation. Looking eastward.

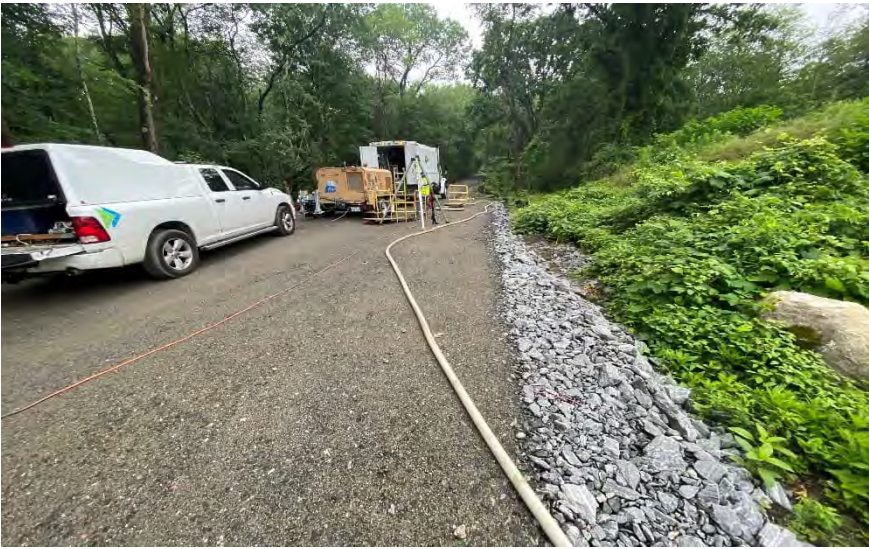
PHOTOGRAPHIC LOG	
Client Name: Eversource		Site Location: Sudbury to Hudson Transmission Reliability Project	Town: Sudbury
Photo No.: 3	Date: 6/22/2024

Description: Manhole #27. View of dewatering operation, looking westward.

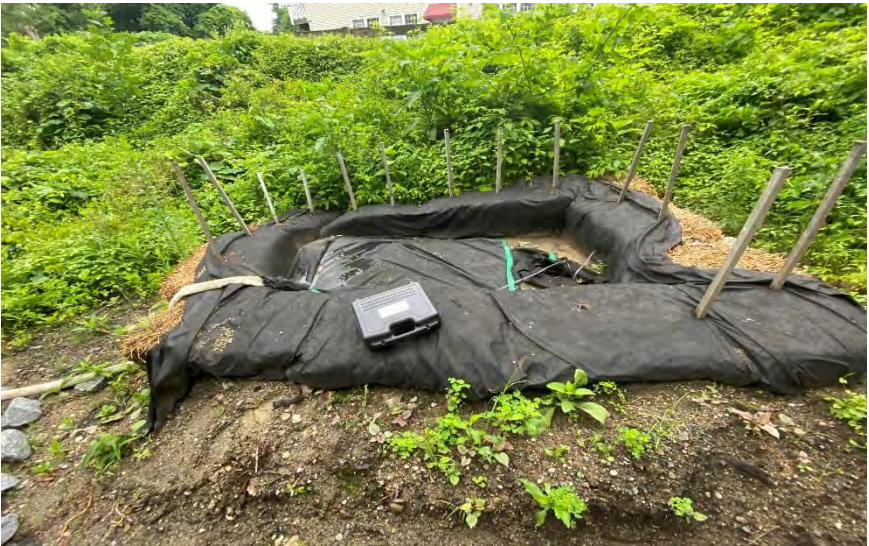
PHOTOGRAPHIC LOG	
Client Name: Eversource		Site Location: Sudbury to Hudson Transmission Reliability Project	Town: Sudbury
Photo No.: 4	Date: 6/22/2024

Description: Manhole #27. View of discharge bag/corral, looking westward. Water from bag/corral discharged to adjacent area.

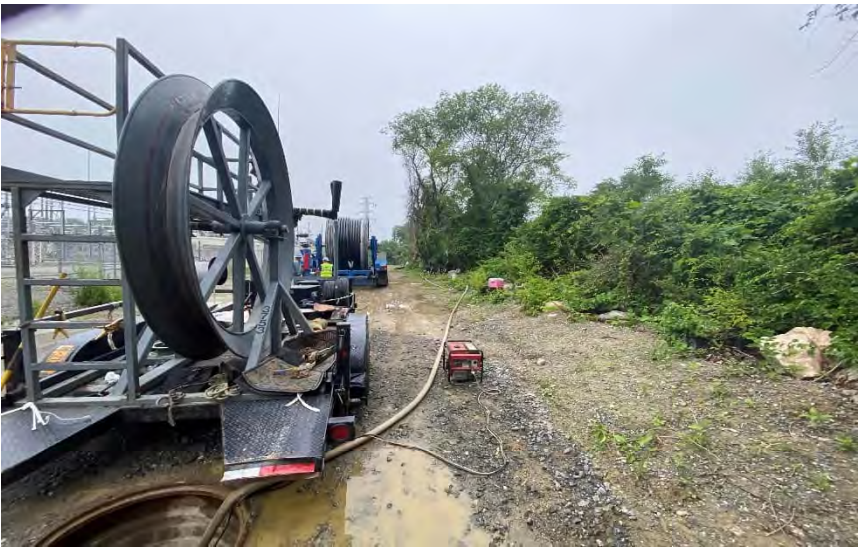
PHOTOGRAPHIC LOG	
Client Name: Eversource		Site Location: Sudbury to Hudson Transmission Reliability Project	Town: Sudbury
Photo No.: 2	Date: 6/22/2024

Description: Manhole #28. View of dewatering operation. Looking eastward.
