Weekly Environmental Compliance Summary

Sudbury to Hudson Transmission Reliability Project (USEPA Tracking # MAR1003UW)

Week of: June 24, 2024 to June 29, 2024

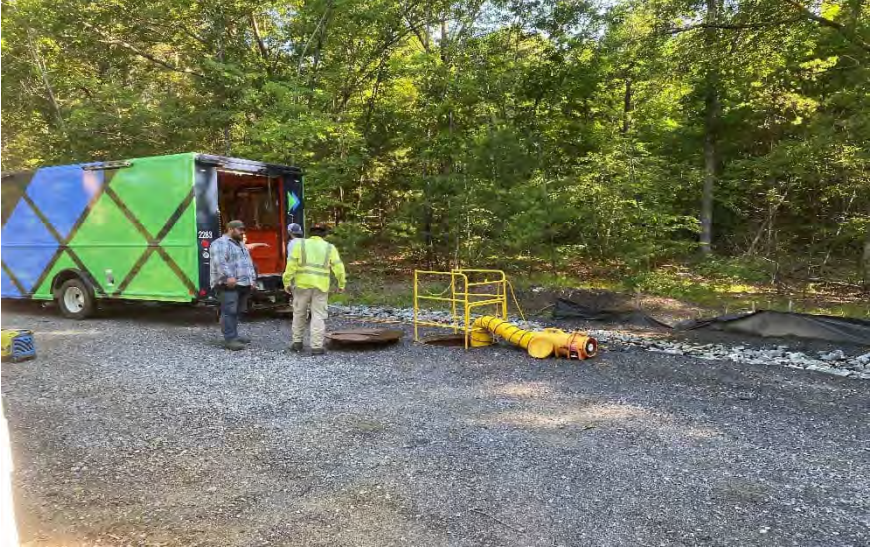
PHOTOGRAPHIC LOG	
Client Name: Eversource		Site Location: Sudbury to Hudson Transmission Reliability Project	Town: Hudson
Photo No.: 5	Date: 6-25-24

Description: Work area within segment 5 near manhole #12, existing erosion control, looking westward.

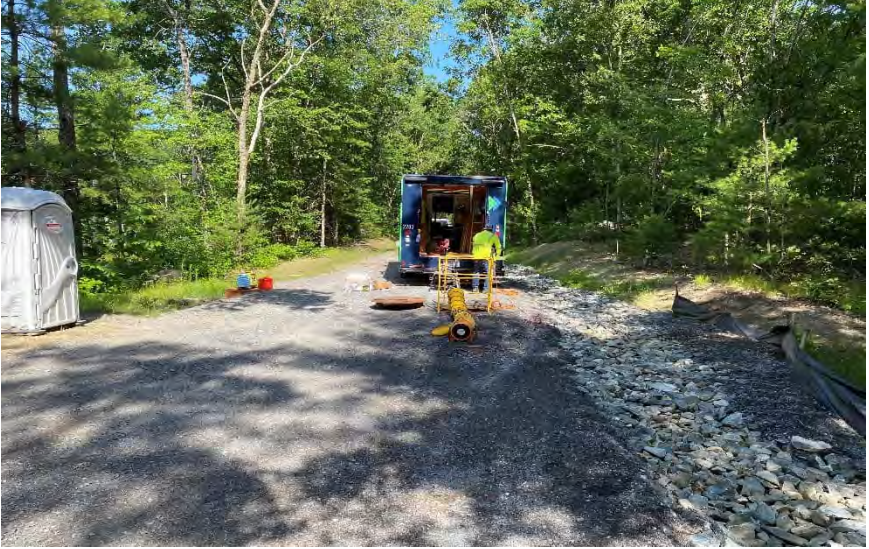
PHOTOGRAPHIC LOG	
Client Name: Eversource		Site Location: Sudbury to Hudson Transmission Reliability Project	Town: Hudson
Photo No.: 5	Date: 6-26-24

Description: Work area within segment 5 near manhole #12, existing erosion control, looking westward.

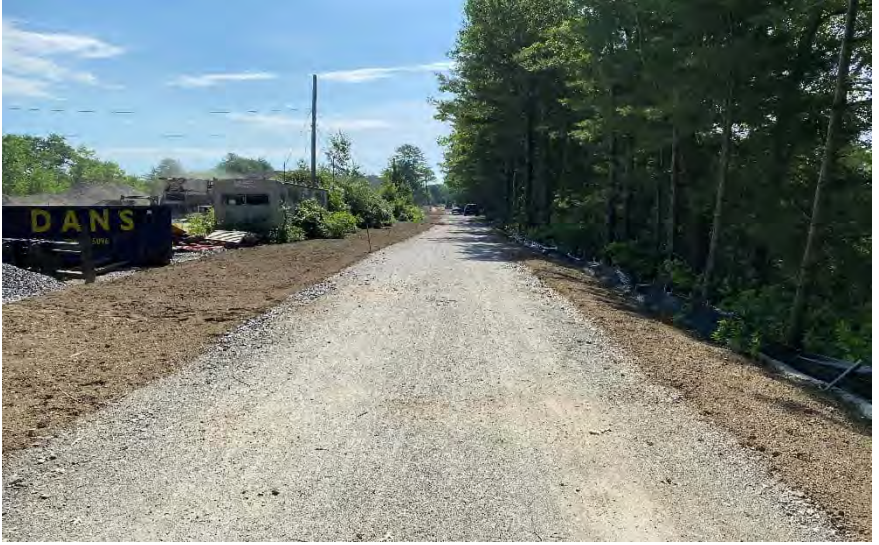
PHOTOGRAPHIC LOG	
Client Name: Eversource		Site Location: Sudbury to Hudson Transmission Reliability Project	Town: Hudson
Photo No.: 7	Date: 6-26-24

Description: Work area within Segment 3, recently placed loam on shoulders off work area, existing erosion control, looking eastward.

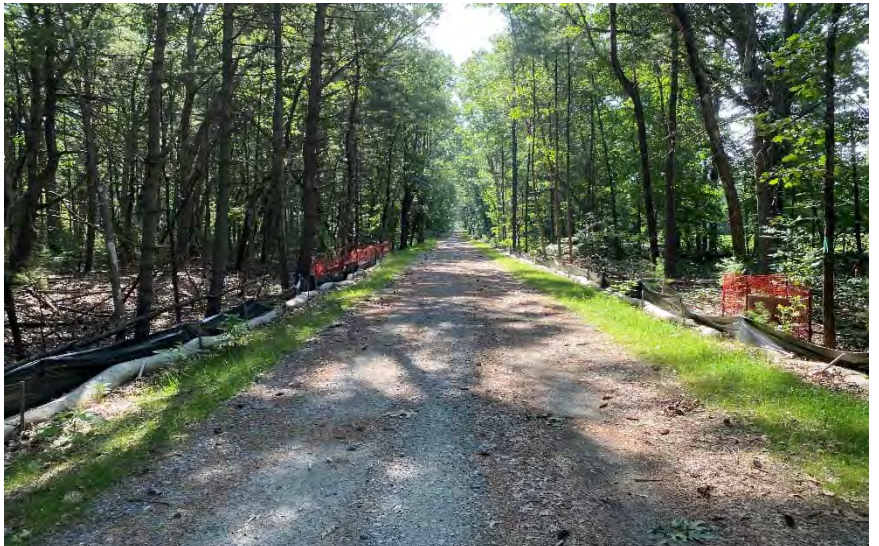
PHOTOGRAPHIC LOG	
Client Name: Eversource		Site Location: Sudbury to Hudson Transmission Reliability Project	Town: Hudson
Photo No.: 8	Date: 6-26-24

Description: Work area within segment 4, existing erosion control, looking eastward.

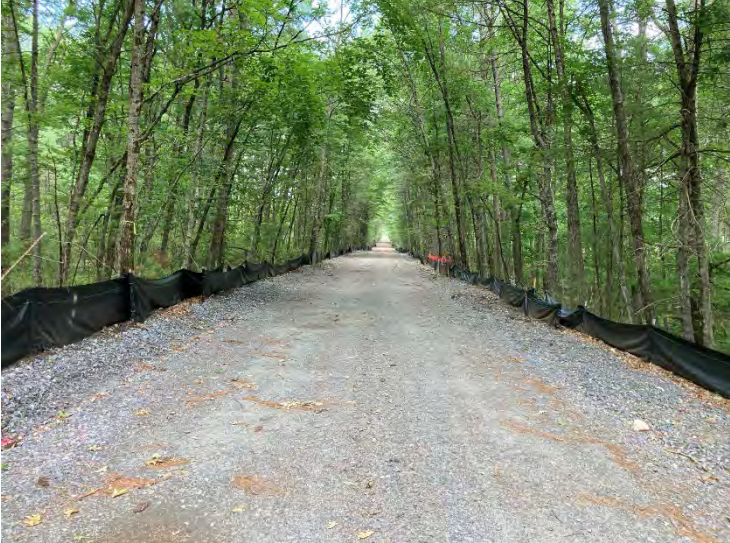
PHOTOGRAPHIC LOG	
Client Name: Eversource		Site Location: Sudbury to Hudson Transmission Reliability Project	Town: Sudbury
Photo No.: 1	Date: 6/26/2024

Description: View of E&S controls in segment 8. Facing east.

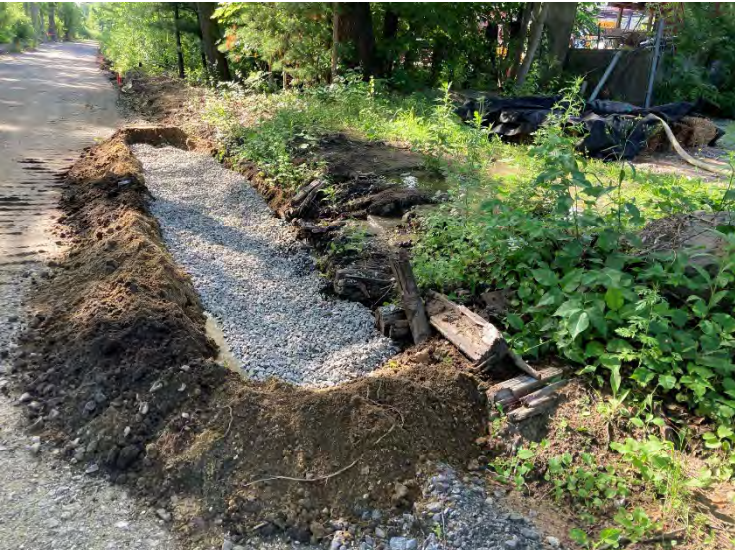
PHOTOGRAPHIC LOG	
Client Name: Eversource		Site Location: Sudbury to Hudson Transmission Reliability Project	Town: Sudbury
Photo No.: 4	Date: 6/26/2024

Description: View of dewatering controls used for pumping operation in segment 12. See additional dewatering inspection report. Facing east.

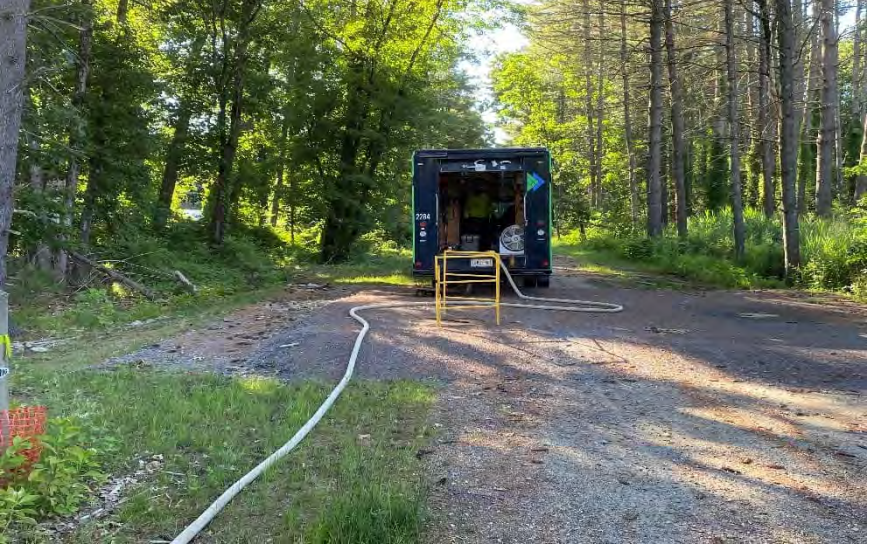
<p>PHOTOGRAPHIC LOG</p>	
<p>Client Name: Eversource</p>		<p>Site Location: Sudbury to Hudson Transmission Reliability Project</p>	<p>Town: Hudson</p>
<p>Photo No.: 5</p>	<p>Date: 6-28-24</p>

<p>Description:</p> <p>Work area within segment 4 near manhole #10, existing erosion control, looking westward.</p>

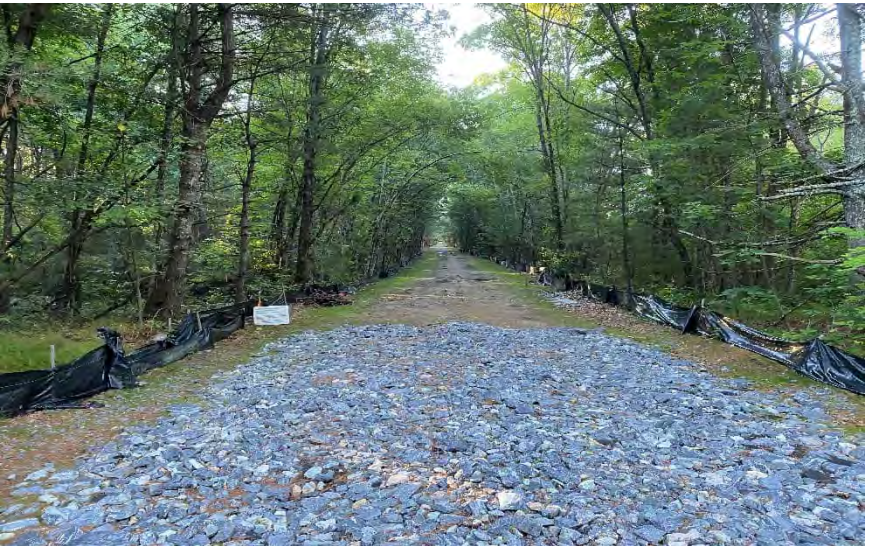
<p>PHOTOGRAPHIC LOG</p>	
<p>Client Name: Eversource</p>		<p>Site Location: Sudbury to Hudson Transmission Reliability Project</p>	<p>Town: Hudson</p>
<p>Photo No.: 6</p>	<p>Date: 6-28-24</p>

<p>Description:</p> <p>Work area within segment 6, existing erosion control, looking eastward.</p>

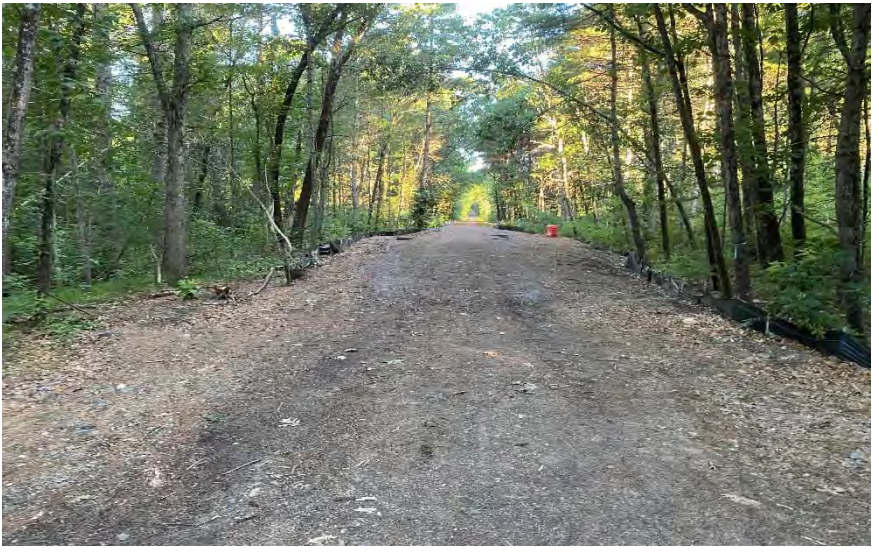
<p>PHOTOGRAPHIC LOG</p>	
<p>Client Name: Eversource</p>		<p>Site Location: Sudbury to Hudson Transmission Reliability Project</p>	<p>Town: Hudson</p>
<p>Photo No.: 8</p>	<p>Date: 6-28-24</p>

<p>Description:</p> <p>Work area within segment 5, existing erosion control, looking westward.</p>

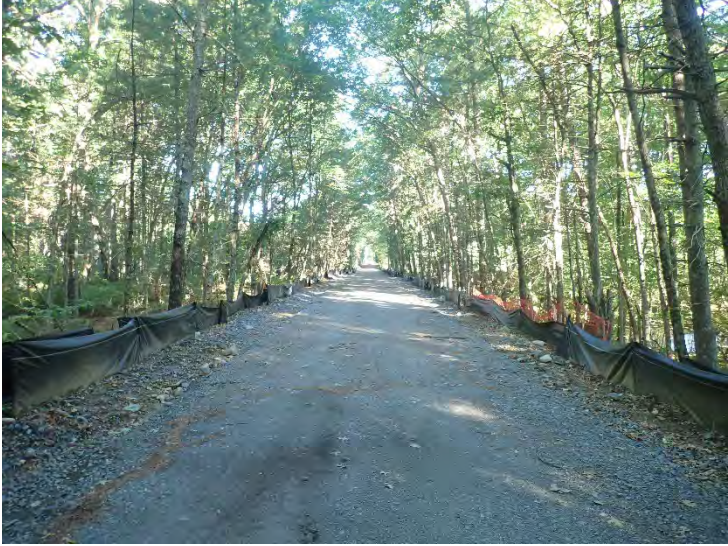
PHOTOGRAPHIC LOG	
Client Name: Eversource		Site Location: Sudbury to Hudson Transmission Reliability Project	Town: Sudbury
Photo No.: 7	Date: 6/26/2024

Description: View of silt fencing in segment 8. Facing west.

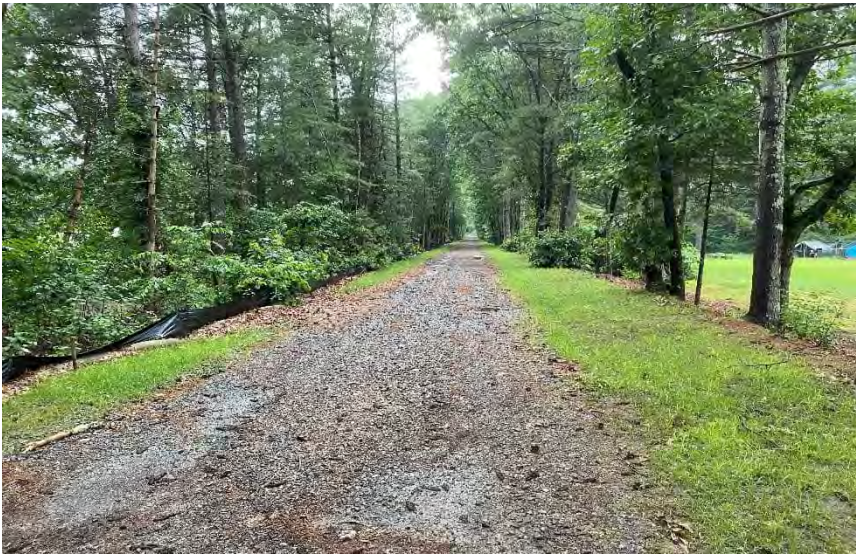
PHOTOGRAPHIC LOG	
Client Name: Eversource		Site Location: Sudbury to Hudson Transmission Reliability Project	Town: Hudson
Photo No.: 4	Date: 6-27-24

Description: Work area within segment 4, existing erosion control, looking westward.

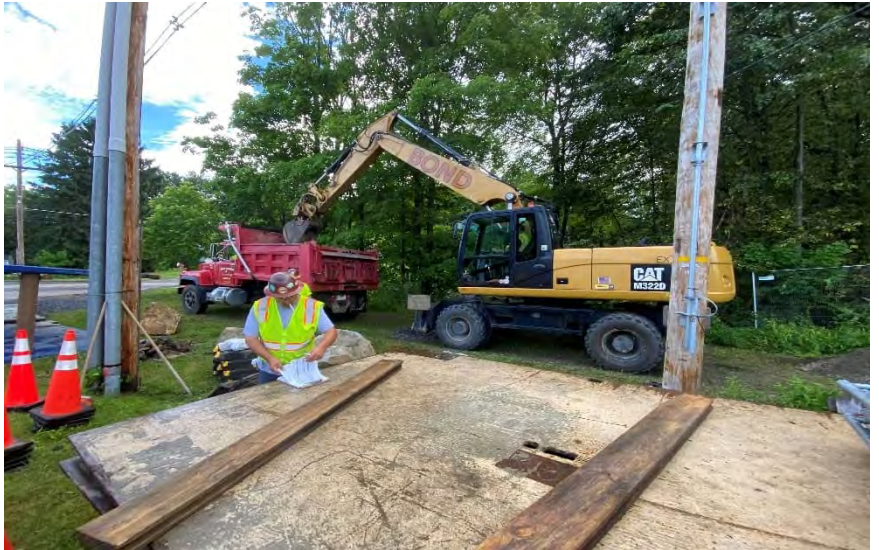
PHOTOGRAPHIC LOG	
Client Name: Eversource		Site Location: Sudbury to Hudson Transmission Reliability Project	Town: Hudson
Photo No.: 6	Date: 6-27-24

Description: Manhole #1 area adjacent to Hudson Light & Power facility off Forest Avenue, conduit work, looking westward.

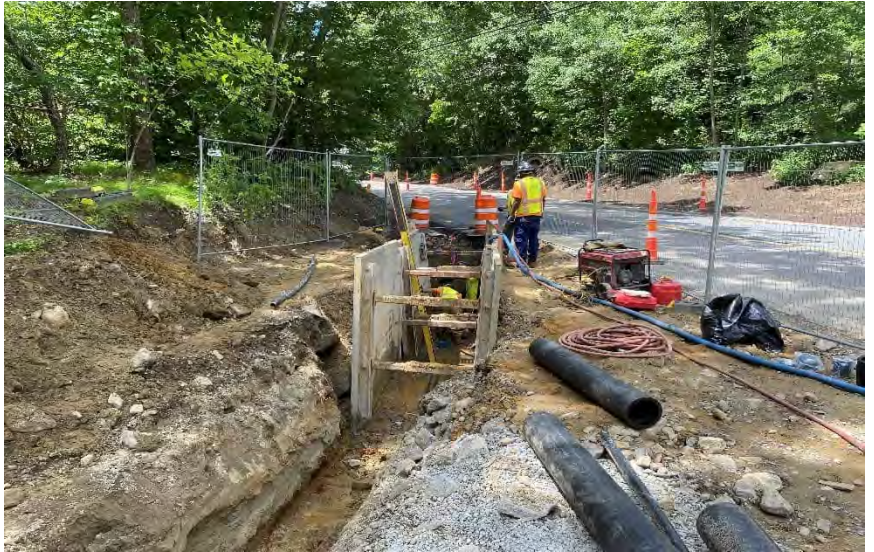
PHOTOGRAPHIC LOG	
Client Name: Eversource		Site Location: Sudbury to Hudson Transmission Reliability Project	Town: Hudson
Photo No.: 8	Date: 6-27-24

Description: Bond conducting conduit work off Wilkins Street, looking westward.

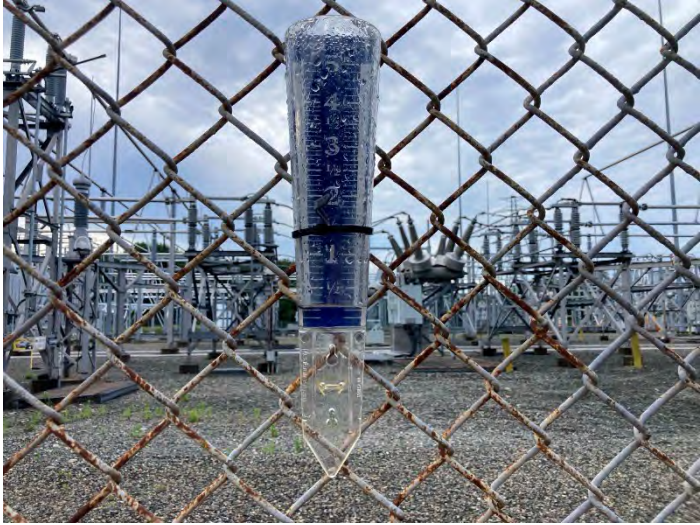
PHOTOGRAPHIC LOG	
Client Name: Eversource		Site Location: Sudbury to Hudson Transmission Reliability Project	Town: Sudbury
Photo No.: 1	Date: 6-27-2024

Description: View of rain gauge at Sudbury substation. 0.25" observed in gauge. Facing south.

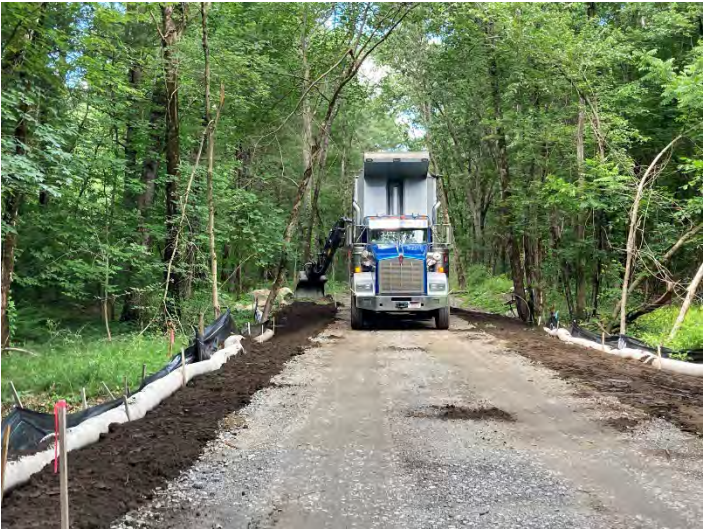
Epsilon ASSOCIATES INC.		PHOTOGRAPHIC LOG	
Client Name: Eversource		Site Location: Sudbury to Hudson Transmission Reliability Project	Town: Sudbury
Photo No.: 3	Date: 6-27-2024

Description: View of ET&L applying loam and E&S controls in segment 9. Facing west.

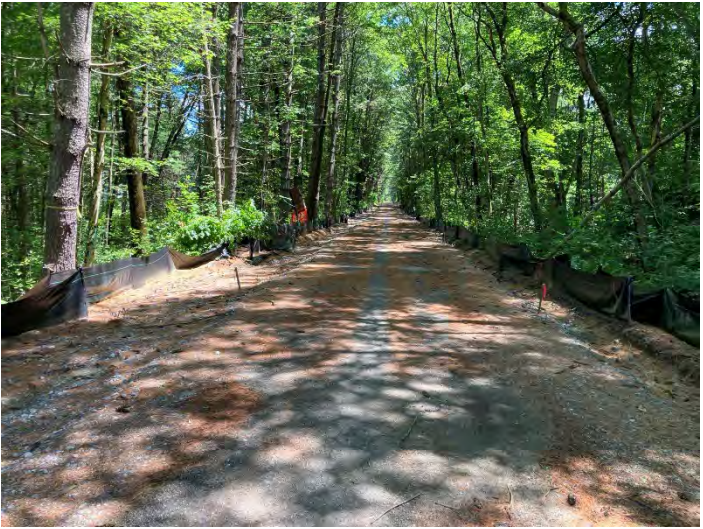
Epsilon ASSOCIATES INC.		PHOTOGRAPHIC LOG	
Client Name: Eversource		Site Location: Sudbury to Hudson Transmission Reliability Project	Town: Sudbury
Photo No.: 4	Date: 6-27-2024

Description: View of E&S controls in segment 10. Facing east.

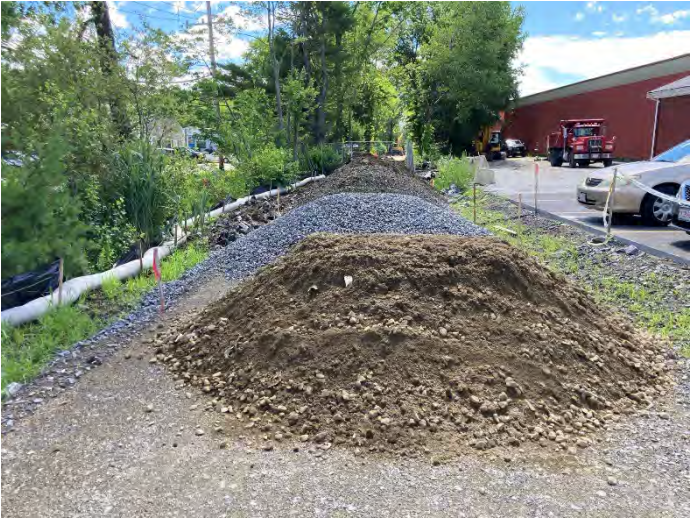
Epsilon ASSOCIATES INC.		PHOTOGRAPHIC LOG	
Client Name: Eversource		Site Location: Sudbury to Hudson Transmission Reliability Project	Town: Sudbury
Photo No.: 5	Date: 6-27-2024

Identify presence of stockpiles and document when placed and when removed (week maximum for stockpiles) Yes No
Spoil stockpiles present at west end of segment 12. Noted 6-25-2024.

Description: View of E&S controls and spoil stockpiles at west end of segment 12. Facing east.

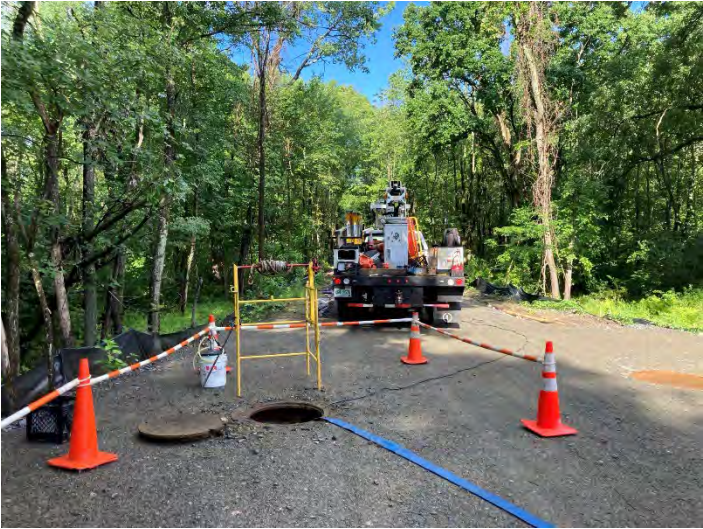
PHOTOGRAPHIC LOG	
Client Name: Eversource		Site Location: Sudbury to Hudson Transmission Reliability Project	Town: Sudbury
Photo No.: 7	Date: 6-27-2024

Description: View of New Wave working at HH #27 in segment 14. See additional dewatering inspection report. Facing west.

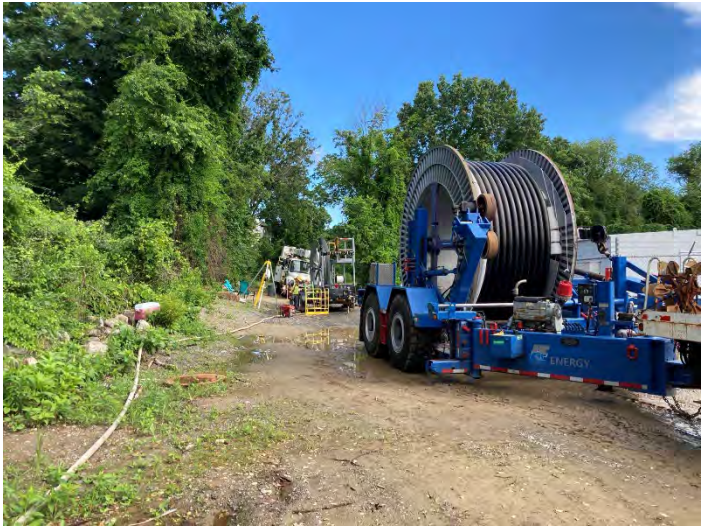
PHOTOGRAPHIC LOG	
Client Name: Eversource		Site Location: Sudbury to Hudson Transmission Reliability Project	Town: Sudbury
Photo No.: 8	Date: 6-27-2024

Description: View of Haugland working at MH #28 outside of Sudbury substation. See additional dewatering inspection report. Facing north.

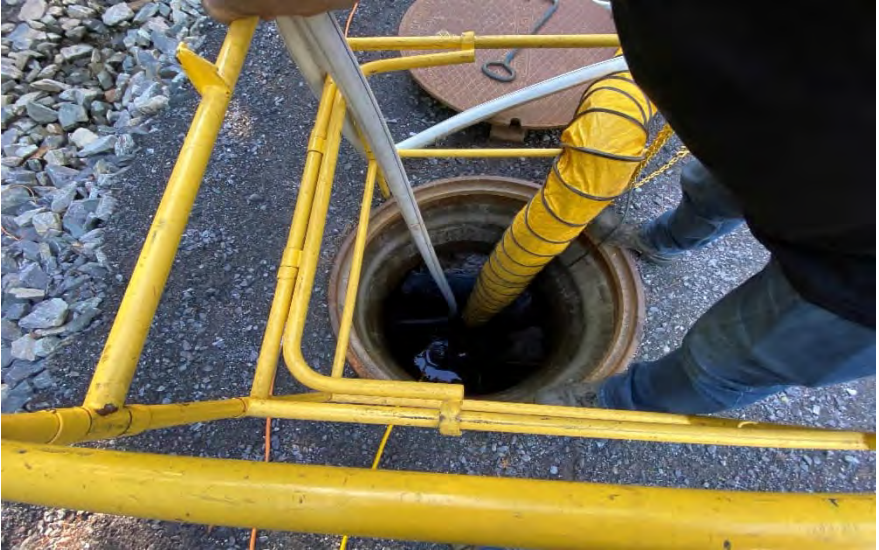
PHOTOGRAPHIC LOG	
Client Name: Eversource		Site Location: Sudbury to Hudson Transmission Reliability Project	Town: Hudson
Photo No.: 1	Date: 6/24/2024

Description: View of area being pumped from manhole #12, Segment 5.

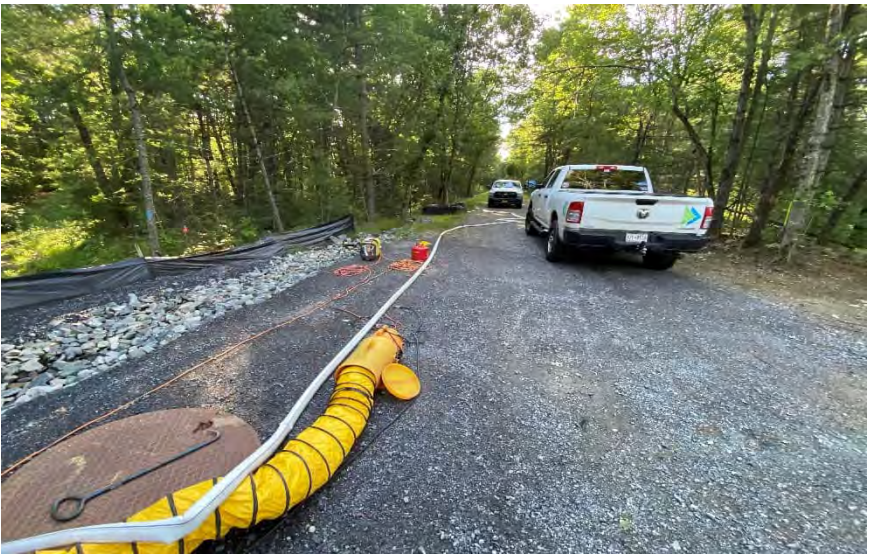
PHOTOGRAPHIC LOG	
Client Name: Eversource		Site Location: Sudbury to Hudson Transmission Reliability Project	Town: Hudson
Photo No.: 2	Date: 6/24/2024

Description: Manhole #12. View of dewatering operation. Looking eastward.

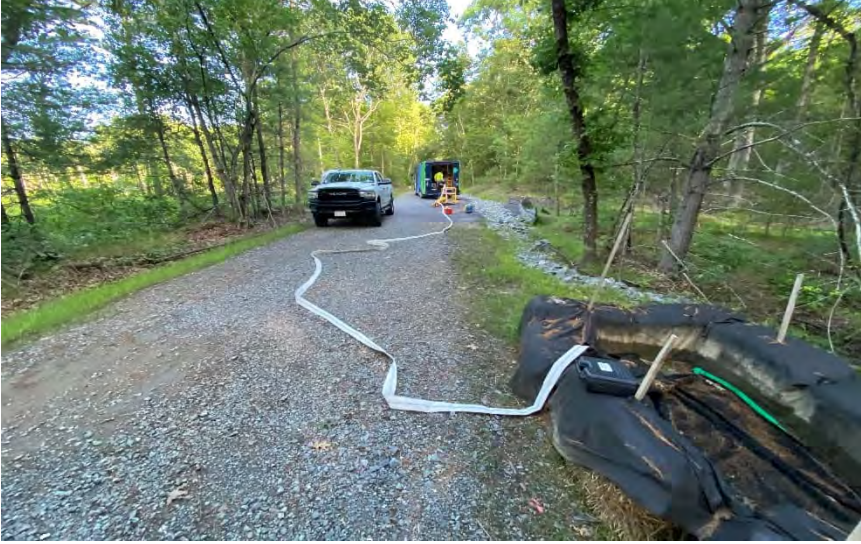
PHOTOGRAPHIC LOG	
Client Name: Eversource		Site Location: Sudbury to Hudson Transmission Reliability Project	Town: Hudson
Photo No.: 3	Date: 6/24/2024

Description: Manhole #12. View of dewatering operation, looking westward.

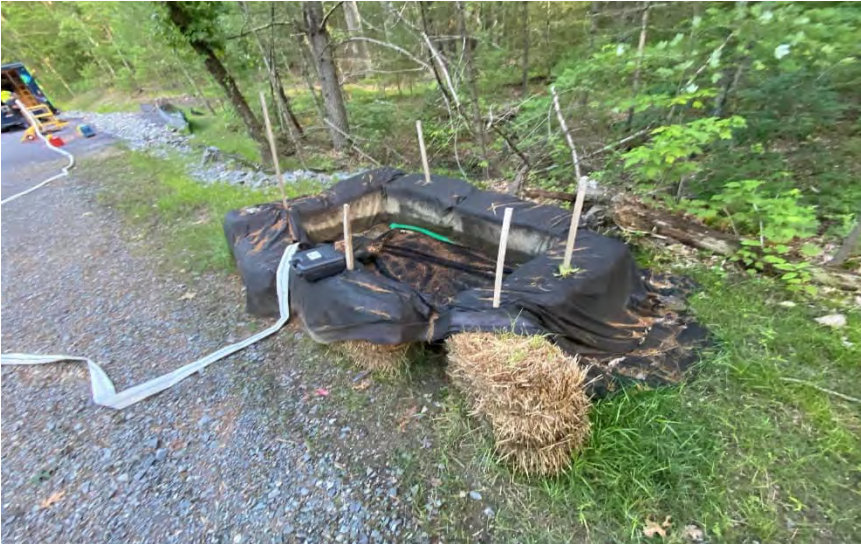
PHOTOGRAPHIC LOG	
Client Name: Eversource		Site Location: Sudbury to Hudson Transmission Reliability Project	Town: Hudson
Photo No.: 4	Date: 6/24/2024

Description: Manhole #12. View of discharge bag/corral, looking westward. Water from bag/corral discharged to adjacent area.

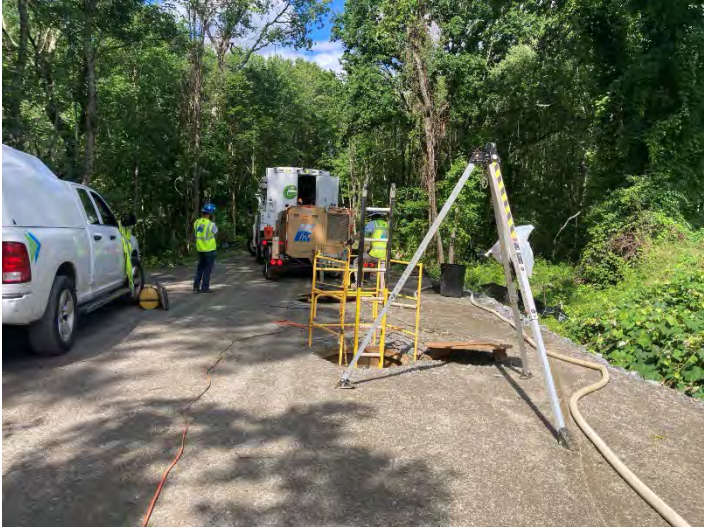
PHOTOGRAPHIC LOG		
Client Name: Eversource		Site Location: Sudbury to Hudson Transmission Reliability Project		Town: Sudbury
Photo No.: 1	Date: 6/24/2024

Description: View of Haugland working at MH #27 in segment 14. Facing west.

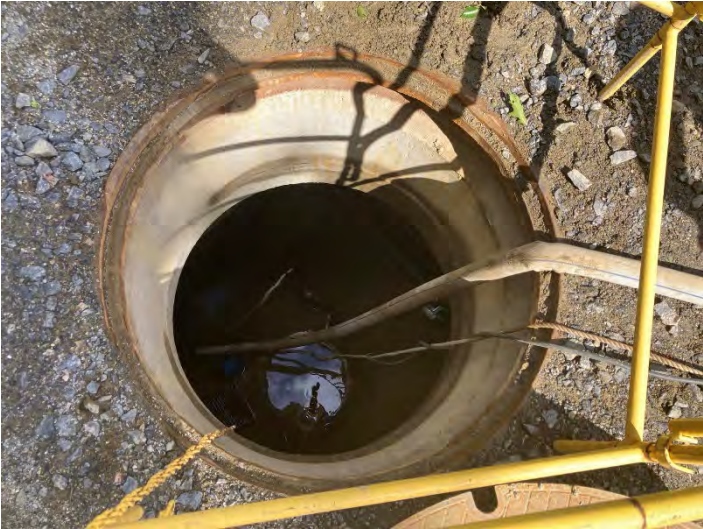
PHOTOGRAPHIC LOG		
Client Name: Eversource		Site Location: Sudbury to Hudson Transmission Reliability Project		Town: Sudbury
Photo No.: 2	Date: 6/24/2024

Description: View of pump in MH #27. Water appeared mostly clear prior to treatment.

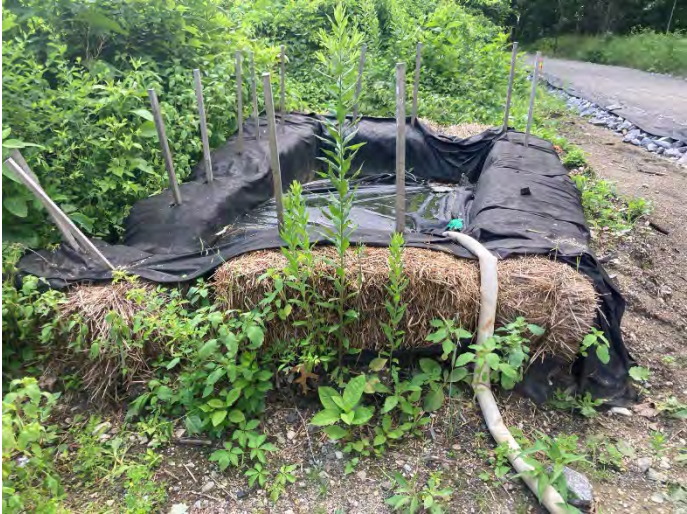
PHOTOGRAPHIC LOG	
Client Name: Eversource		Site Location: Sudbury to Hudson Transmission Reliability Project	
Town: Sudbury			
Photo No.: 3	Date: 6/24/2024

Description: View of dewatering controls (straw bale corral with filter fabric and silt bag). Facing east.

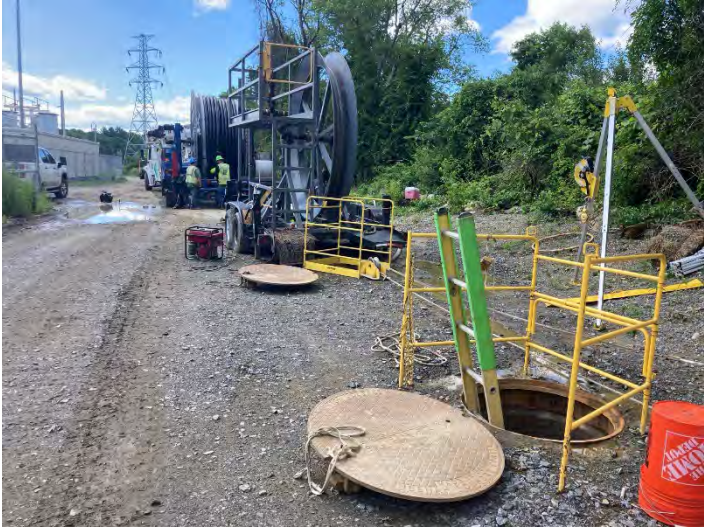
PHOTOGRAPHIC LOG	
Client Name: Eversource		Site Location: Sudbury to Hudson Transmission Reliability Project	
		Town: Sudbury	
Photo No.: 1	Date: 6/24/2024

Description: View of Haugland working at MH #28 outside of Sudbury Substation. Facing south.

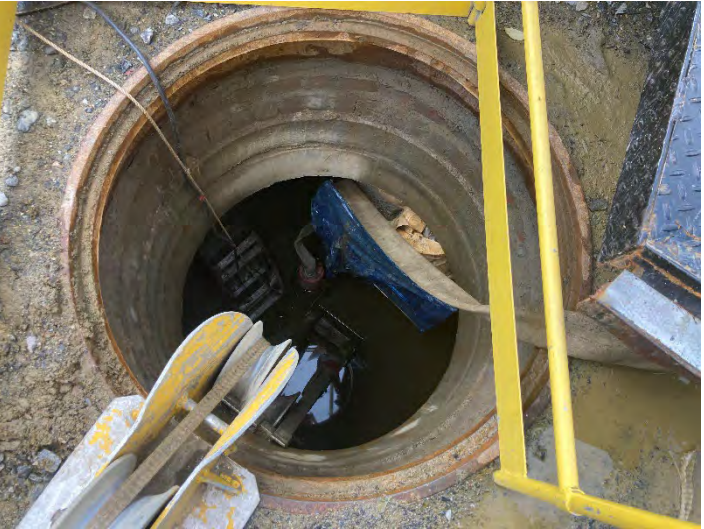
PHOTOGRAPHIC LOG	
Client Name: Eversource		Site Location: Sudbury to Hudson Transmission Reliability Project	
		Town: Sudbury	
Photo No.: 2	Date: 6/24/2024

Description: View of pump in MH #28. Water appeared mostly clear prior to treatment.

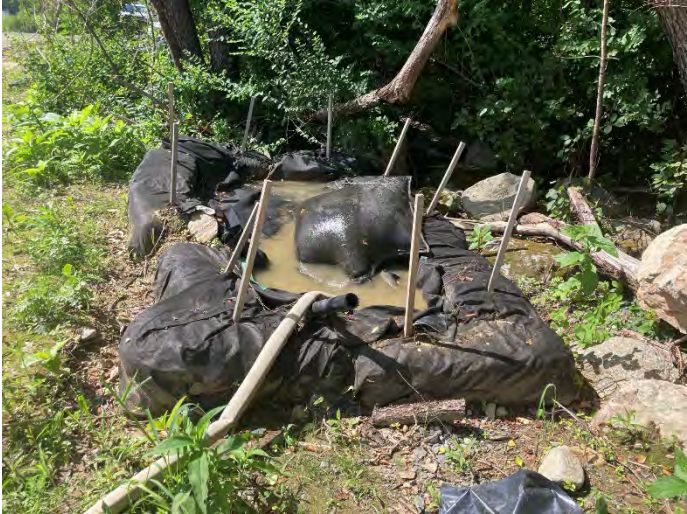
PHOTOGRAPHIC LOG	
Client Name: Eversource		Site Location: Sudbury to Hudson Transmission Reliability Project	
		Town: Sudbury	
Photo No.: 3	Date: 6/24/2024

Description: View of dewatering controls (straw bale corral with filter fabric and silt bag). Facing south.

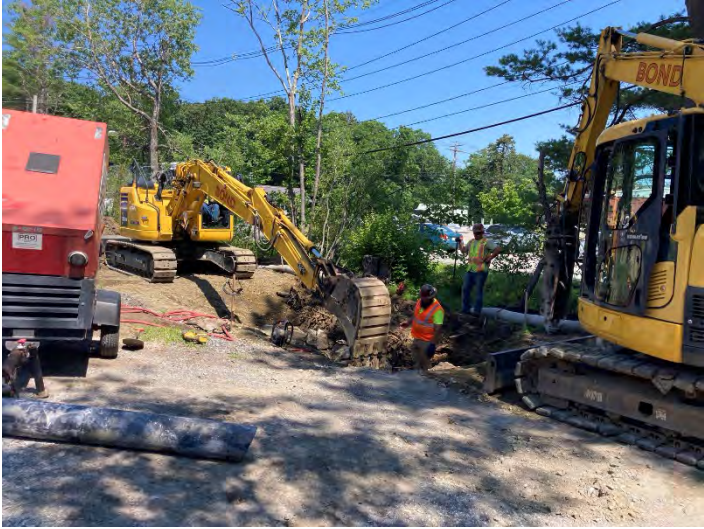
PHOTOGRAPHIC LOG	
Client Name: Eversource		Site Location: Sudbury to Hudson Transmission Reliability Project	Town: Sudbury
Photo No.: 1	Date: 6/25/2024

Description: View of Bond working in segment 12. Facing northwest.

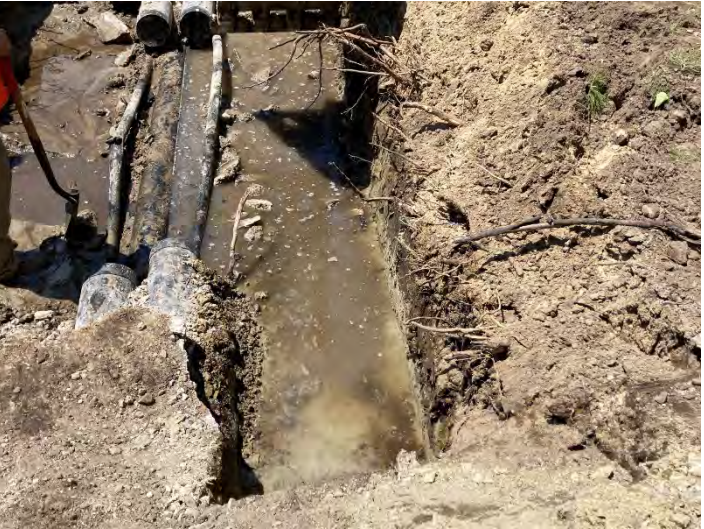
PHOTOGRAPHIC LOG	
Client Name: Eversource		Site Location: Sudbury to Hudson Transmission Reliability Project	Town: Sudbury
Photo No.: 2	Date: 6/25/2024

Description: View of water in trench. Water appeared turbid prior to treatment.

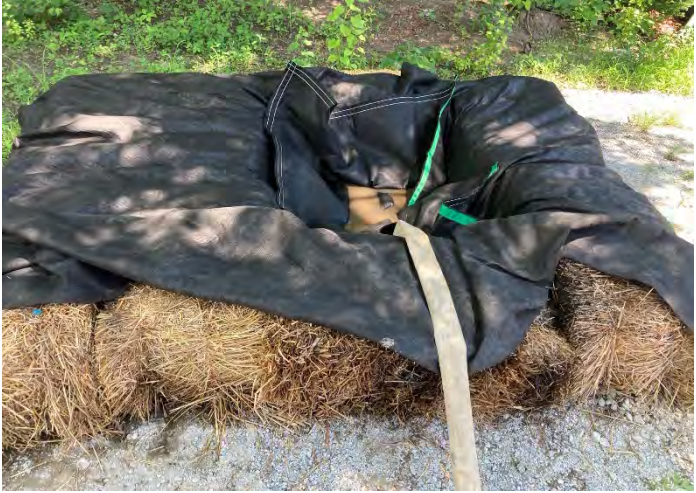
PHOTOGRAPHIC LOG	
Client Name: Eversource		Site Location: Sudbury to Hudson Transmission Reliability Project	Town: Sudbury
Photo No.: 3	Date: 6/25/2024

Description: View of dewatering controls (straw bale corral with filter fabric and silt bag). Facing east.

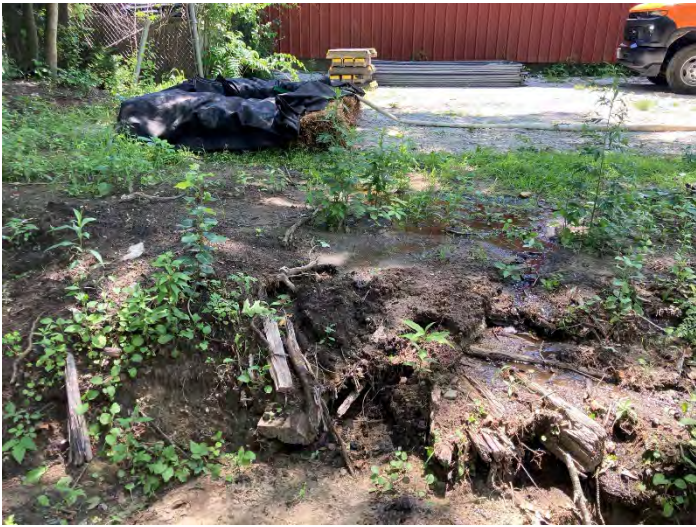
PHOTOGRAPHIC LOG	
Client Name: Eversource		Site Location: Sudbury to Hudson Transmission Reliability Project	Town: Sudbury
Photo No.: 4	Date: 6/25/2024

Description: View of discharge from corral. Discharge from corral appeared turbid and turbidity reading was higher than 50 NTUs. Discharge was traveling towards the adjacent stream channel so pump was turned off. Water did not appear to reach channel. Additional measures will be added before pumping resumes. Facing south.

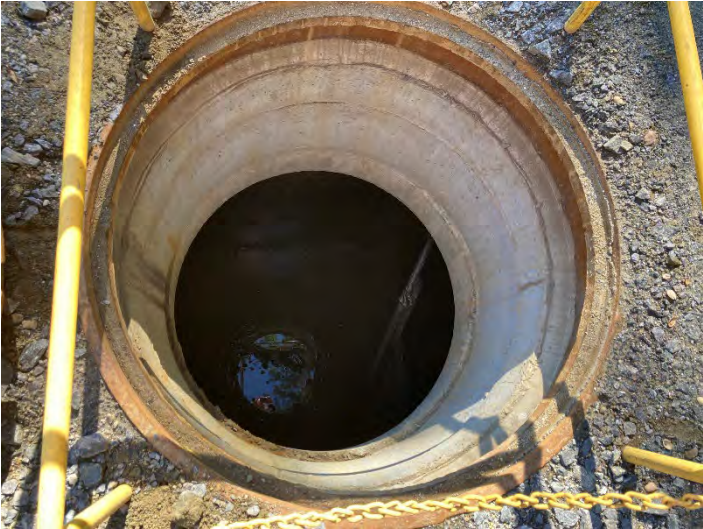
PHOTOGRAPHIC LOG	
Client Name: Eversource		Site Location: Sudbury to Hudson Transmission Reliability Project	
		Town: Sudbury	
Photo No.: 2	Date: 6/25/2024

Description: View of pump in MH #27. Water appeared mostly clear prior to treatment.

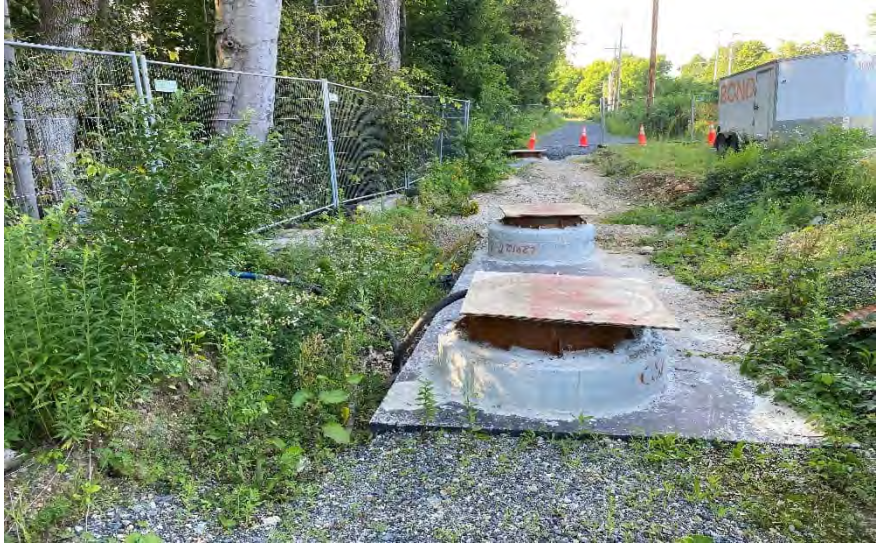
PHOTOGRAPHIC LOG	
Client Name: Eversource		Site Location: Sudbury to Hudson Transmission Reliability Project	
Town: Hudson			
Photo No.: 1	Date: 6/26/2024

Description: View of area being pumped from Manhole #1, looking eastward.

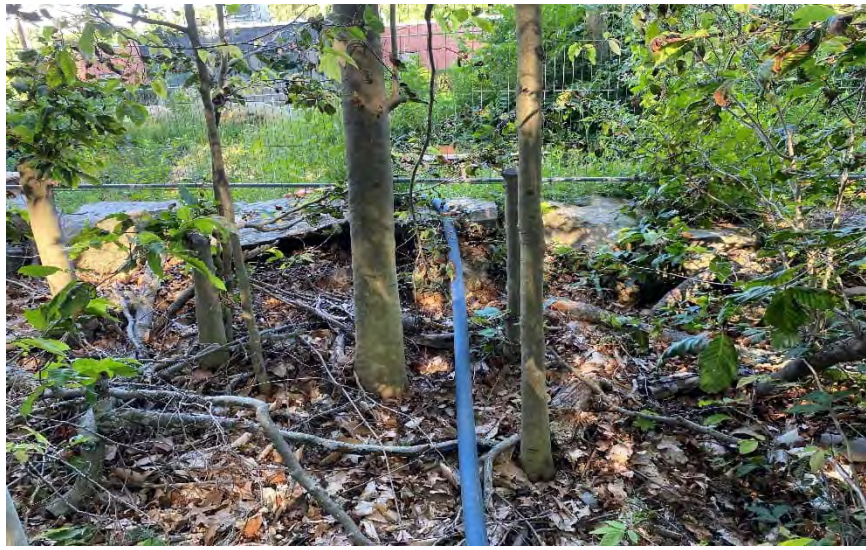
PHOTOGRAPHIC LOG	
Client Name: Eversource		Site Location: Sudbury to Hudson Transmission Reliability Project	
Town: Hudson			
Photo No.: 2	Date: 6/26/2024

Description: Manhole #1. View of dewatering operation. Looking eastward.

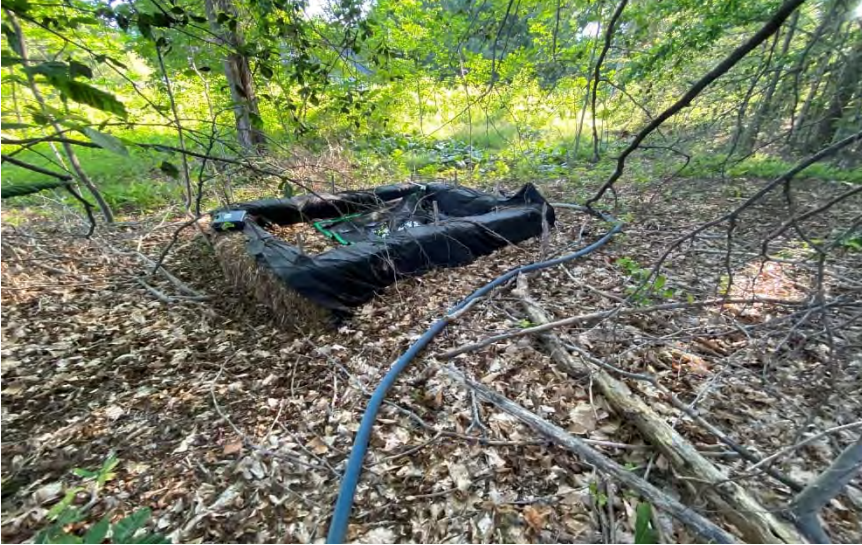
PHOTOGRAPHIC LOG	
Client Name: Eversource		Site Location: Sudbury to Hudson Transmission Reliability Project	Town: Hudson
Photo No.: 3	Date: 6/26/2024

Description: Manhole #1. View of dewatering operation, looking westward.

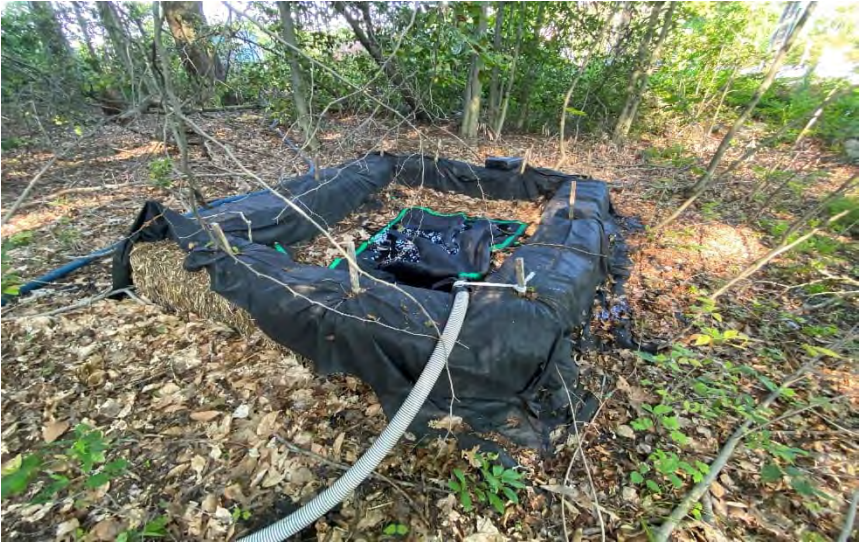
PHOTOGRAPHIC LOG	
Client Name: Eversource		Site Location: Sudbury to Hudson Transmission Reliability Project	Town: Hudson
Photo No.: 4	Date: 6/26/2024

Description: Manhole #1. View of discharge bag/corral, looking eastward. Water from bag/corral discharged to adjacent area & eventually to town drainage system.

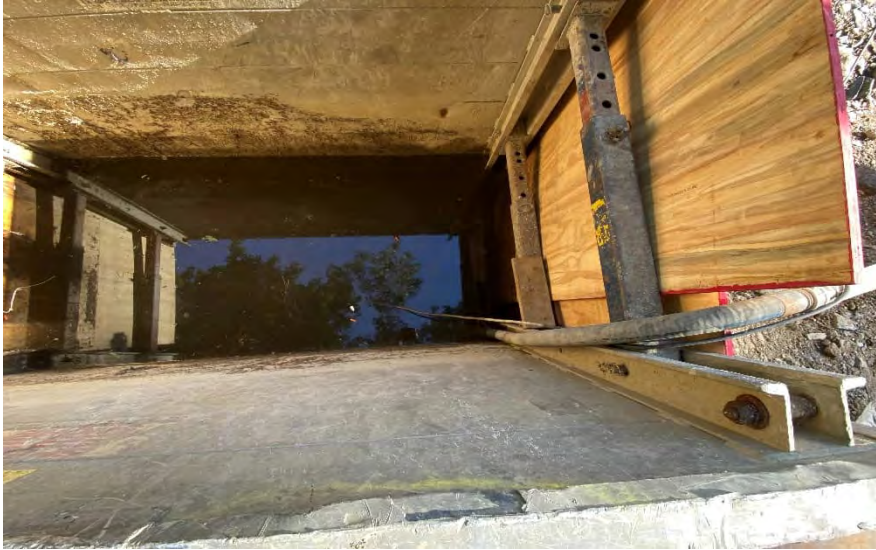
PHOTOGRAPHIC LOG	
Client Name: Eversource		Site Location: Sudbury to Hudson Transmission Reliability Project	Town: Hudson
Photo No.: 1	Date: 6/26/2024

Description: View of area being pumped from trench within segment 1 adjacent to Wilkins Street.

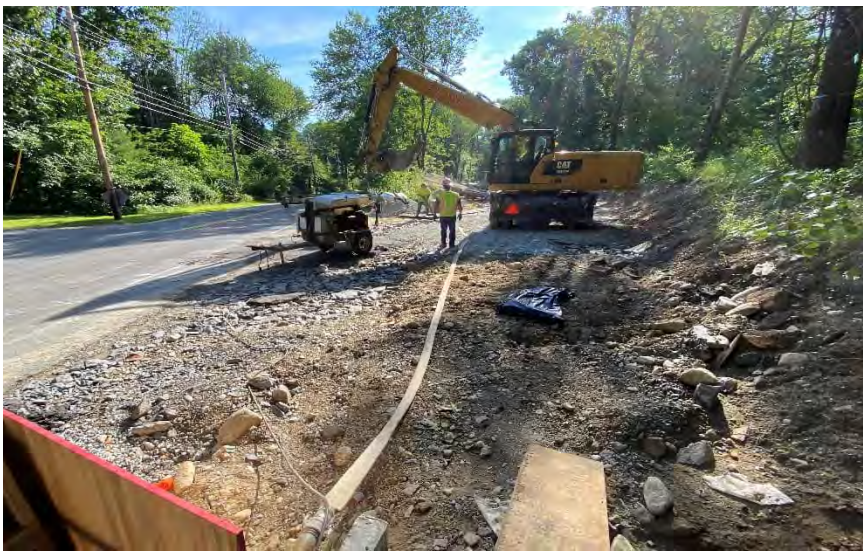
PHOTOGRAPHIC LOG	
Client Name: Eversource		Site Location: Sudbury to Hudson Transmission Reliability Project	Town: Hudson
Photo No.: 2	Date: 6/26/2024

Description: Wilkins Street trench. View of dewatering operation. Looking eastward.

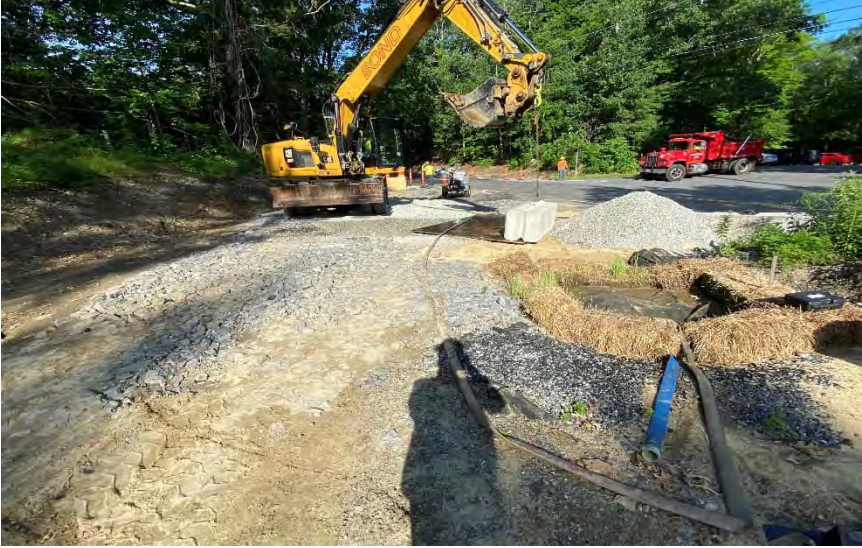
PHOTOGRAPHIC LOG	
Client Name: Eversource		Site Location: Sudbury to Hudson Transmission Reliability Project	Town: Hudson
Photo No.: 3	Date: 6/26/2024

Description: Wilkins Street trench. View of dewatering operation, looking westward.

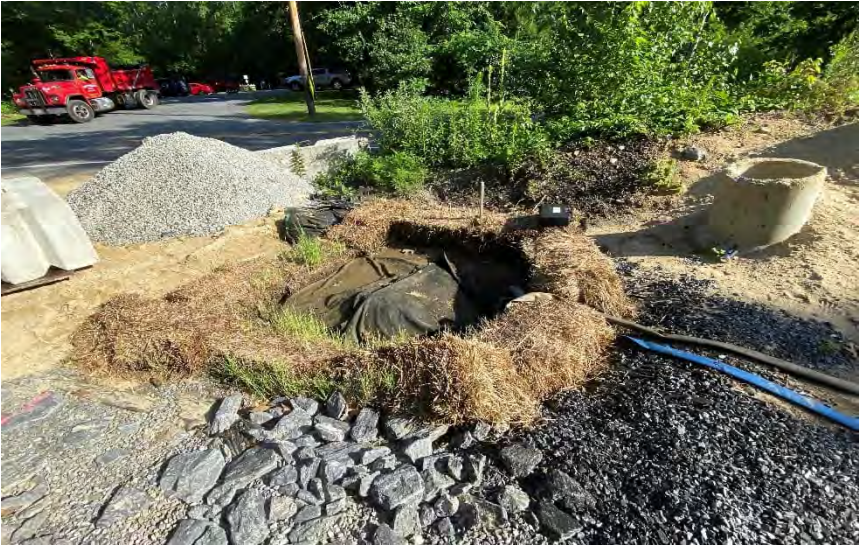
PHOTOGRAPHIC LOG	
Client Name: Eversource		Site Location: Sudbury to Hudson Transmission Reliability Project	Town: Hudson
Photo No.: 4	Date: 6/26/2024

Description: Wilkins Street trench. View of discharge bag/corral, looking eastward. Water from bag/corral discharged to underlying catch basin.

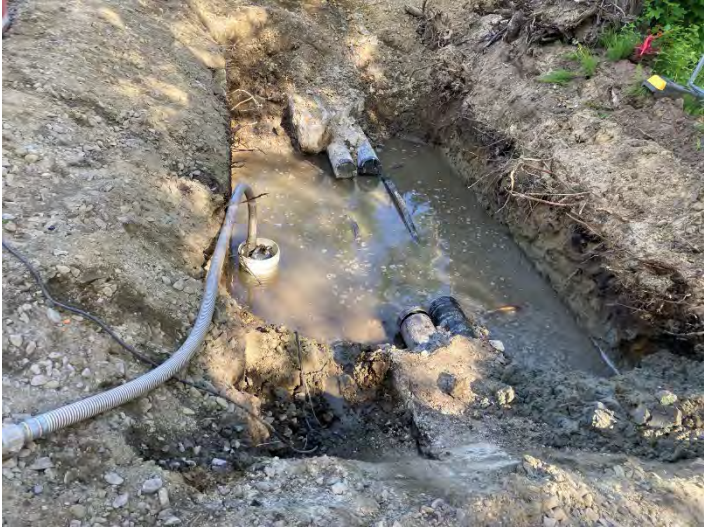
PHOTOGRAPHIC LOG	
Client Name: Eversource		Site Location: Sudbury to Hudson Transmission Reliability Project	
		Town: Sudbury	
Photo No.: 1	Date: 6/26/2024

Description: View of pump in trench. Water appeared turbid prior to treatment. Facing west.

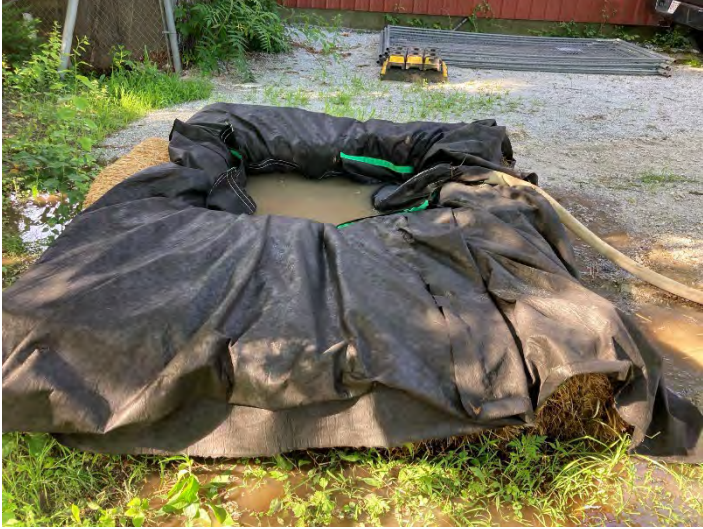
PHOTOGRAPHIC LOG	
Client Name: Eversource		Site Location: Sudbury to Hudson Transmission Reliability Project	
		Town: Sudbury	
Photo No.: 2	Date: 6/26/2024

Description: View of dewatering controls (straw bale corral with filter fabric and silt bag). Facing south.

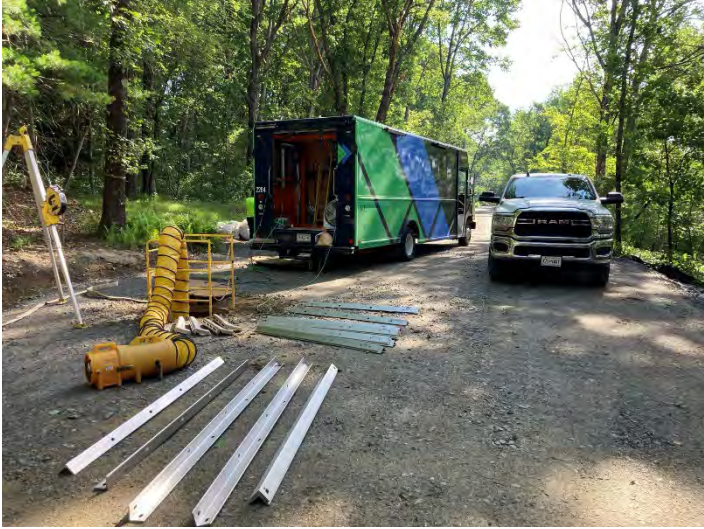
PHOTOGRAPHIC LOG	
Client Name: Eversource		Site Location: Sudbury to Hudson Transmission Reliability Project	Town: Sudbury
Photo No.: 1	Date: 6/26/2024

Description: View of Haugland working at MH #26 in segment 14. Facing east.

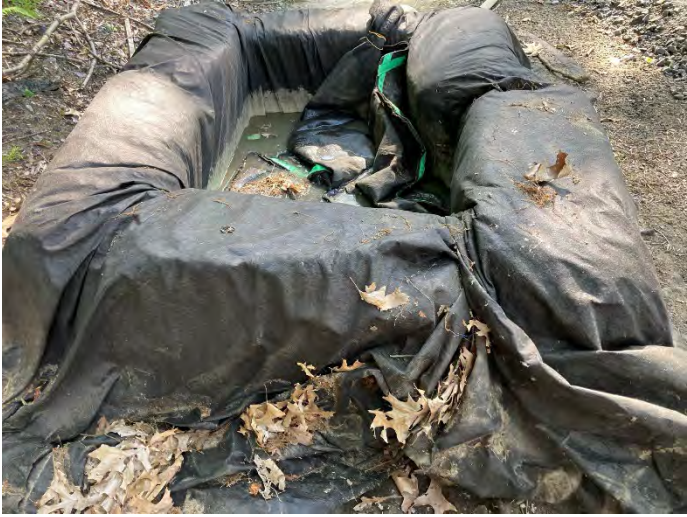
PHOTOGRAPHIC LOG	
Client Name: Eversource		Site Location: Sudbury to Hudson Transmission Reliability Project	Town: Sudbury
Photo No.: 3	Date: 6/26/2024

Description: View of dewatering controls (straw bale corral with filter fabric and silt bag). Facing east.
