Weekly Environmental Compliance Summary

Sudbury to Hudson Transmission Reliability Project (USEPA Tracking # MAR1003UW)

Week of: June 24, 2024 to June 29, 2024

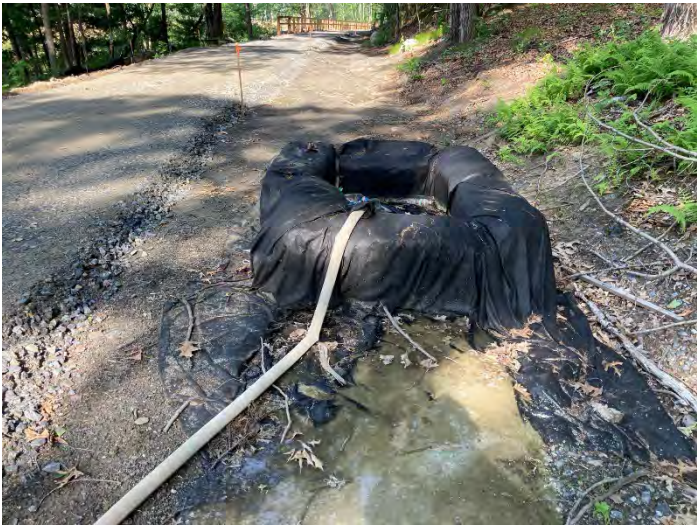
PHOTOGRAPHIC LOG	
Client Name: Eversource		Site Location: Sudbury to Hudson Transmission Reliability Project	Town: Sudbury
Photo No.: 4	Date: 6/26/2024

Description: View of discharge form corral. Discharge appeared turbid and turbidity reading was higher than 50 NTUs. Water appeared to pick up sediment and debris from ground. Discharge did not appear to reach any jurisdictional resource areas. Facing west.

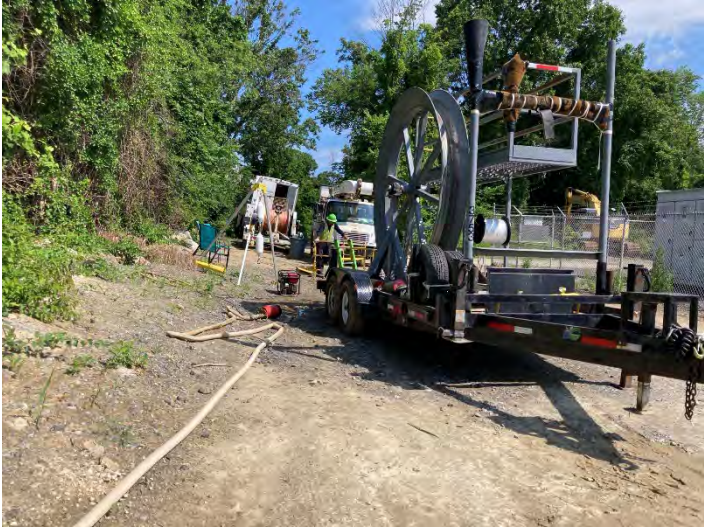
PHOTOGRAPHIC LOG	
Client Name: Eversource		Site Location: Sudbury to Hudson Transmission Reliability Project	
Town: Sudbury			
Photo No.: 1	Date: 6/26/2024

Description: View of Haugland working at MH #28 outside of Sudbury Substation. Facing north.

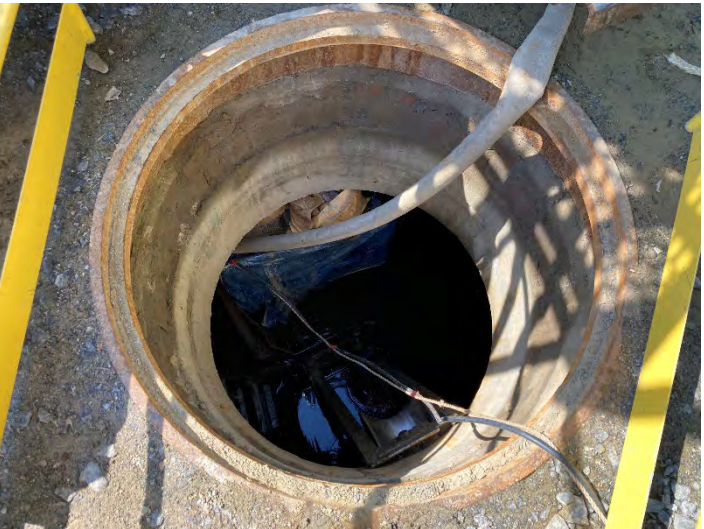
PHOTOGRAPHIC LOG	
Client Name: Eversource		Site Location: Sudbury to Hudson Transmission Reliability Project	
Town: Sudbury			
Photo No.: 2	Date: 6/26/2024

Description: View of pump in MH #28. Water appeared mostly clear prior to treatment.

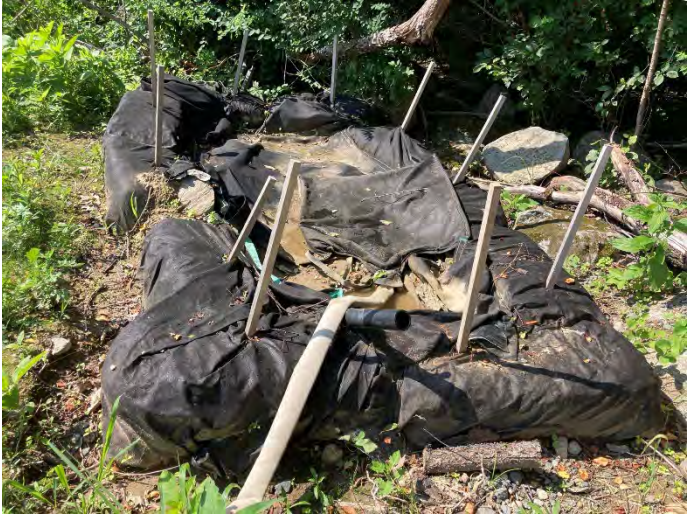
PHOTOGRAPHIC LOG	
Client Name: Eversource		Site Location: Sudbury to Hudson Transmission Reliability Project	Town: Sudbury
Photo No.: 3	Date: 6/26/2024

Description: View of dewatering controls (straw bale corral with filter fabric and silt bag). Facing south.

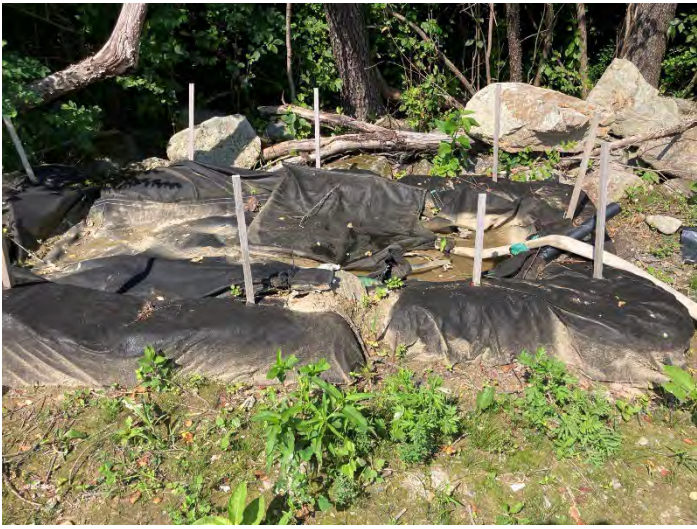
PHOTOGRAPHIC LOG	
Client Name: Eversource		Site Location: Sudbury to Hudson Transmission Reliability Project	Town: Sudbury
Photo No.: 4	Date: 6/26/2024

Description: Additional view of dewatering controls (straw bale corral with filter fabric and silt bag). Only a small amount of water was pumped. Water did not leave corral and no sample was collected. Facing west.

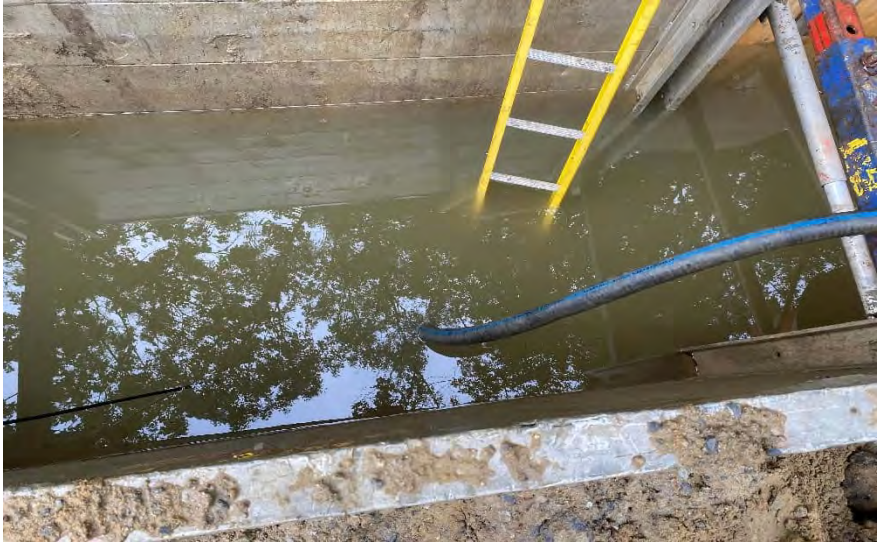
PHOTOGRAPHIC LOG	
Client Name: Eversource		Site Location: Sudbury to Hudson Transmission Reliability Project	Town: Hudson
Photo No.: 1	Date: 6/27/2024

Description: View of area being pumped from trench within segment 1 adjacent to Wilkins Street.

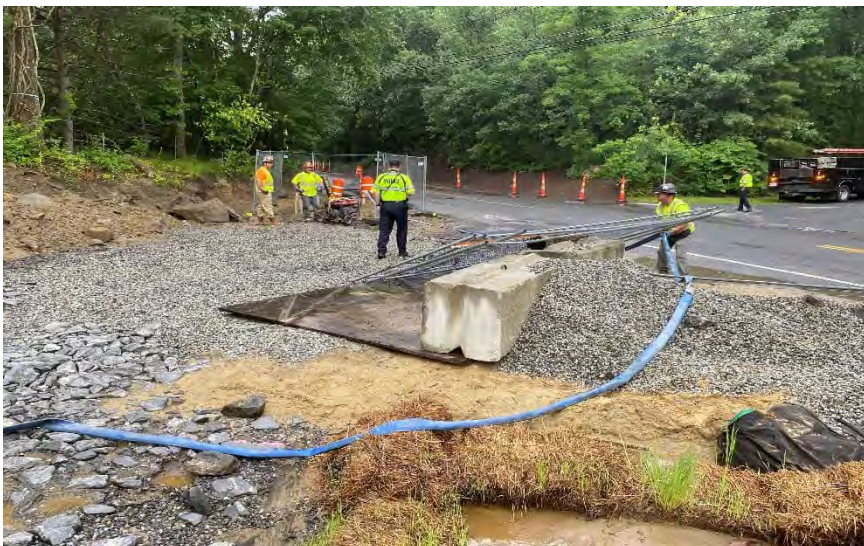
PHOTOGRAPHIC LOG	
Client Name: Eversource		Site Location: Sudbury to Hudson Transmission Reliability Project	Town: Hudson
Photo No.: 2	Date: 6/27/2024

Description: Wilkins Street trench. View of dewatering operation. Looking westward.

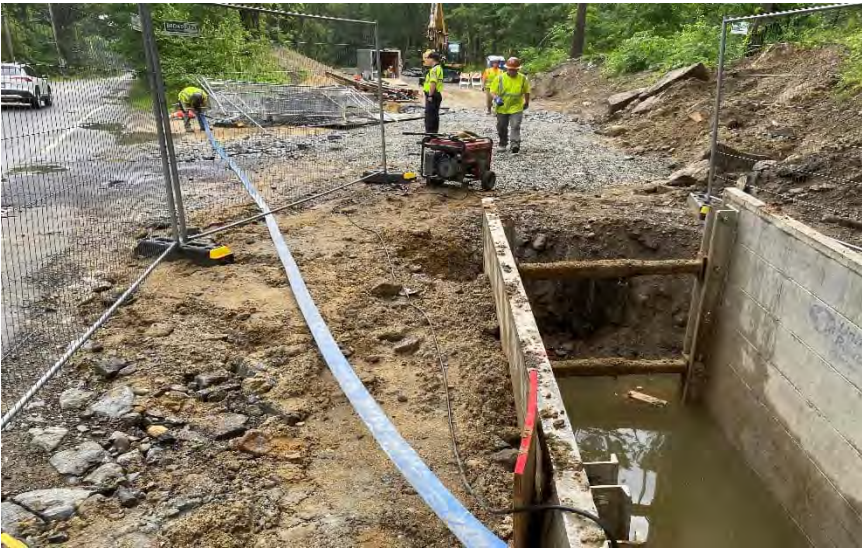
PHOTOGRAPHIC LOG	
Client Name: Eversource		Site Location: Sudbury to Hudson Transmission Reliability Project	Town: Hudson
Photo No.: 3	Date: 6/27/2024

Description: Wilkins Street trench. View of dewatering operation, looking eastward.

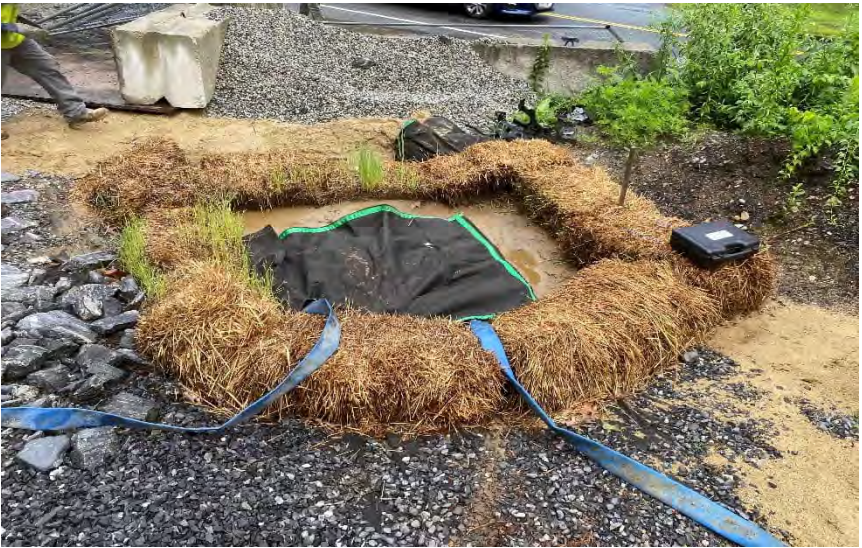
PHOTOGRAPHIC LOG	
Client Name: Eversource		Site Location: Sudbury to Hudson Transmission Reliability Project	Town: Hudson
Photo No.: 4	Date: 6/27/2024

Description: Wilkins Street trench. View of discharge bag/corral, looking westward. Water from bag/corral discharged to underlying catch basin.

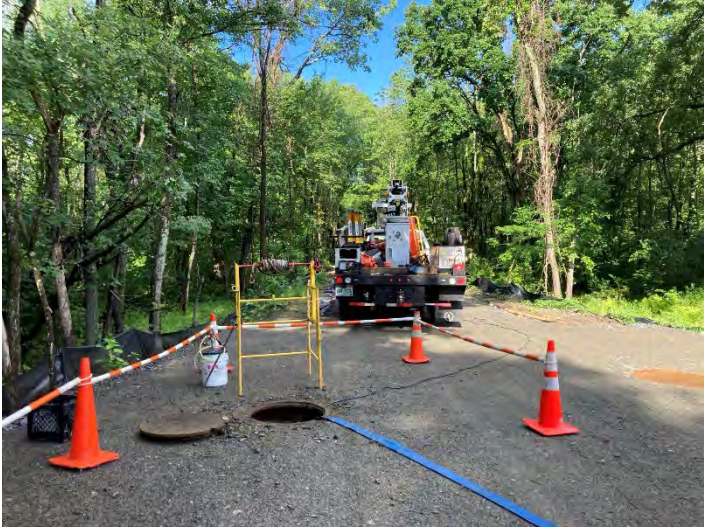
PHOTOGRAPHIC LOG	
Client Name: Eversource		Site Location: Sudbury to Hudson Transmission Reliability Project	Town: Sudbury
Photo No.: 1	Date: 6/27/2024

Description: View of New Wave working at HH #27 in segment 14. Facing west.

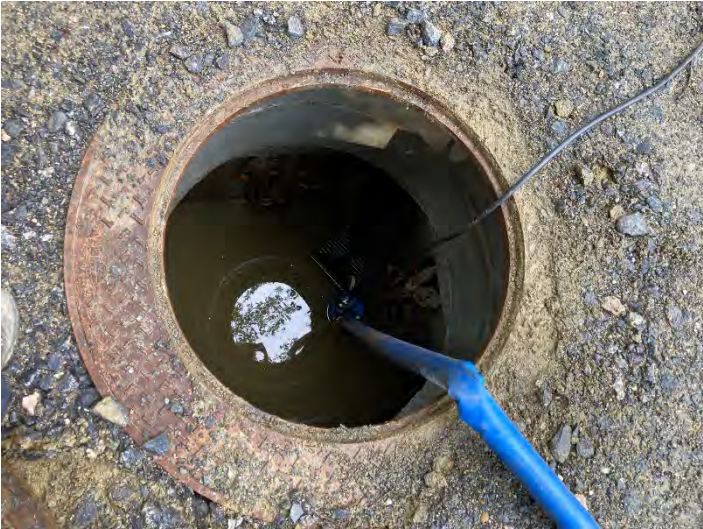
PHOTOGRAPHIC LOG	
Client Name: Eversource		Site Location: Sudbury to Hudson Transmission Reliability Project	Town: Sudbury
Photo No.: 2	Date: 6/27/2024

Description: View of pump in HH #27. Water appeared slightly turbid prior to treatment.

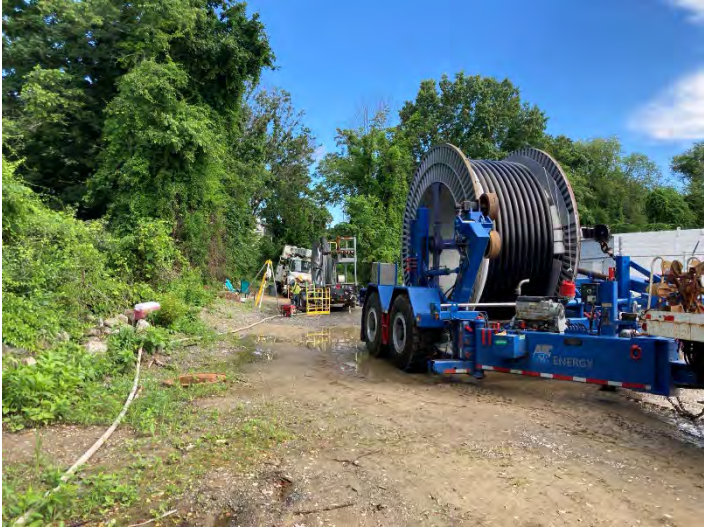
PHOTOGRAPHIC LOG	
Client Name: Eversource		Site Location: Sudbury to Hudson Transmission Reliability Project	Town: Sudbury
Photo No.: 1	Date: 6/27/2024

Description: View of Haugland working at MH #28 outside of Sudbury Substation. Facing north.

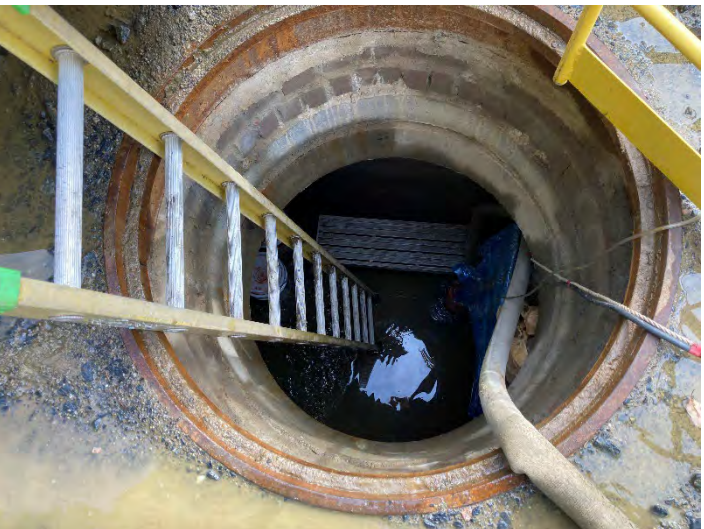
PHOTOGRAPHIC LOG	
Client Name: Eversource		Site Location: Sudbury to Hudson Transmission Reliability Project	Town: Sudbury
Photo No.: 2	Date: 6/27/2024

Description: View of pump in MH #28. Water appeared mostly clear prior to treatment.

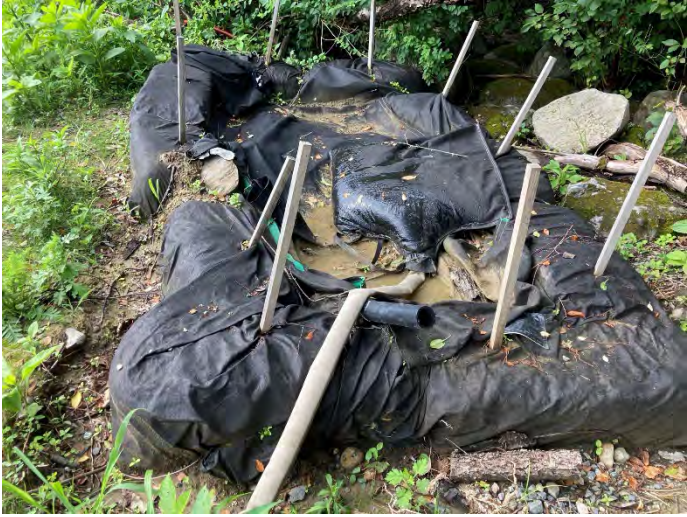
PHOTOGRAPHIC LOG	
Client Name: Eversource		Site Location: Sudbury to Hudson Transmission Reliability Project	Town: Sudbury
Photo No.: 3	Date: 6/27/2024

Description: View of dewatering controls (straw bale corral with filter fabric and silt bag). Facing south.

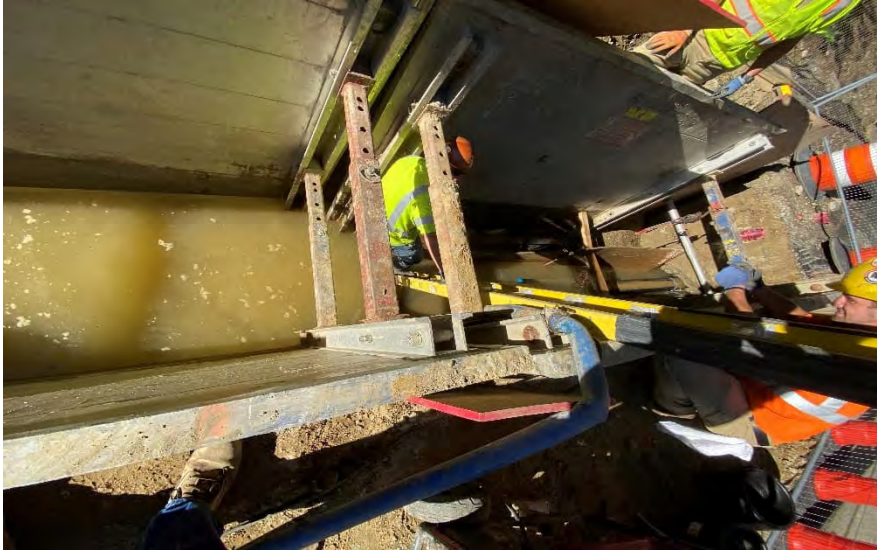
PHOTOGRAPHIC LOG	
Client Name: Eversource		Site Location: Sudbury to Hudson Transmission Reliability Project	Town: Hudson
Photo No.: 1	Date: 6/28/2024

Description: View of area being pumped from trench within segment 1 adjacent to Wilkins Street.

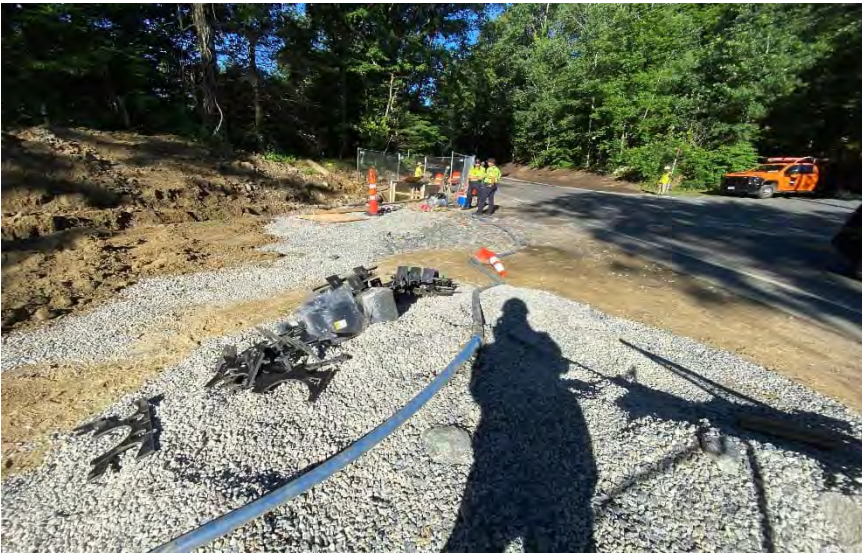
PHOTOGRAPHIC LOG	
Client Name: Eversource		Site Location: Sudbury to Hudson Transmission Reliability Project	Town: Hudson
Photo No.: 3	Date: 6/28/2024

Description: Wilkins Street trench. View of dewatering operation, looking westward.

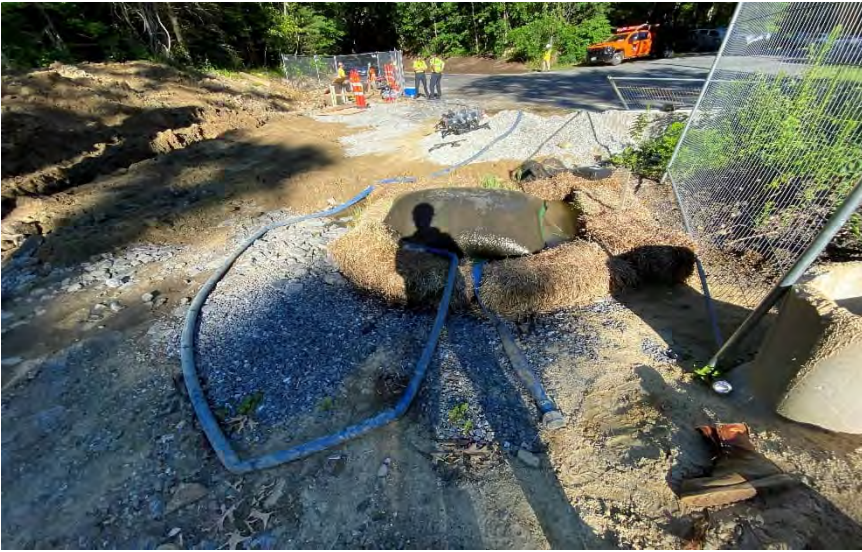
PHOTOGRAPHIC LOG	
Client Name: Eversource		Site Location: Sudbury to Hudson Transmission Reliability Project	Town: Hudson
Photo No.: 4	Date: 6/28/2024

Description: Wilkins Street trench. View of discharge bag/corral, looking westward. Water from bag/corral discharged to underlying catch basin.

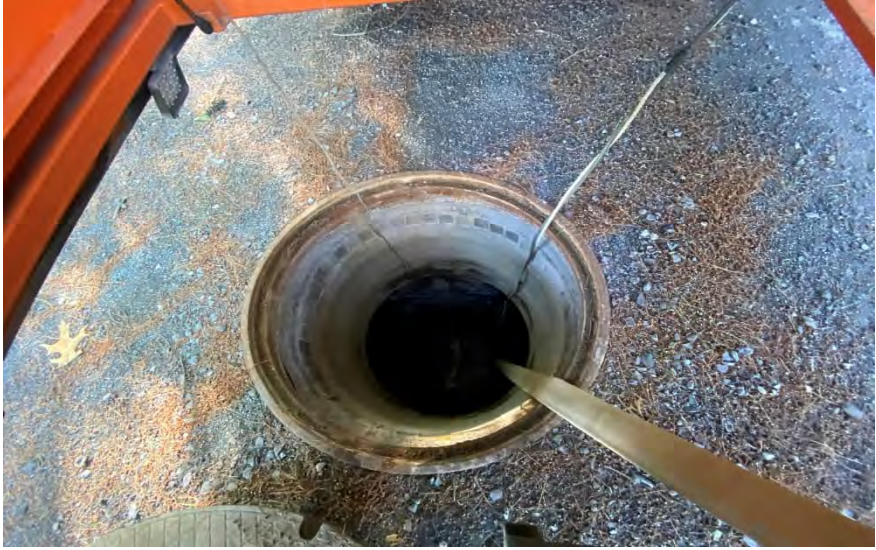
PHOTOGRAPHIC LOG	
Client Name: Eversource		Site Location: Sudbury to Hudson Transmission Reliability Project	Town: Hudson
Photo No.: 1	Date: 6/28/2024

Description: View of area being pumped from manhole #10, Segment 4.

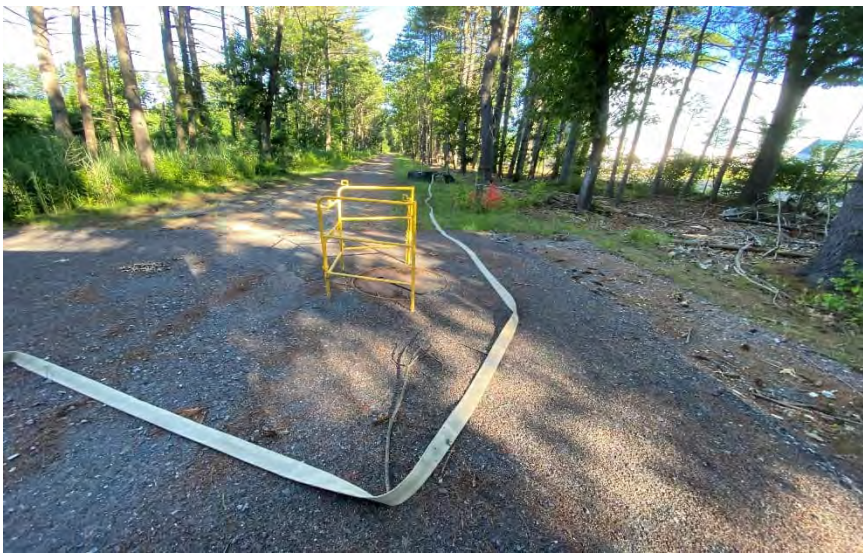
PHOTOGRAPHIC LOG	
Client Name: Eversource		Site Location: Sudbury to Hudson Transmission Reliability Project	Town: Hudson
Photo No.: 2	Date: 6/28/2024

Description: Manhole #10. View of dewatering operation. Looking westward.

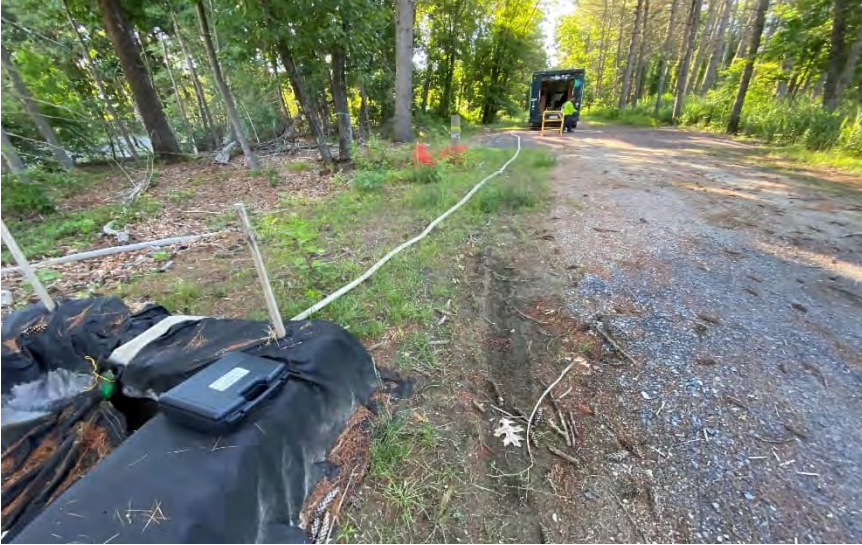
PHOTOGRAPHIC LOG	
Client Name: Eversource		Site Location: Sudbury to Hudson Transmission Reliability Project	
Town: Hudson			
Photo No.: 3	Date: 6/28/2024

Description: Manhole #10. View of dewatering operation, looking eastward.

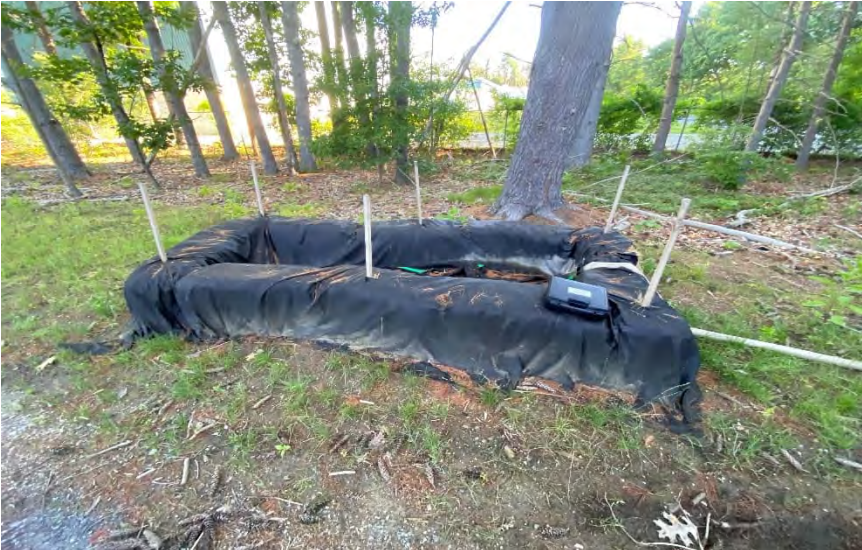
PHOTOGRAPHIC LOG	
Client Name: Eversource		Site Location: Sudbury to Hudson Transmission Reliability Project	
Town: Hudson			
Photo No.: 4	Date: 6/28/2024

Description: Manhole #10. View of discharge bag/corral, looking eastward. Water from bag/corral discharged to adjacent area.

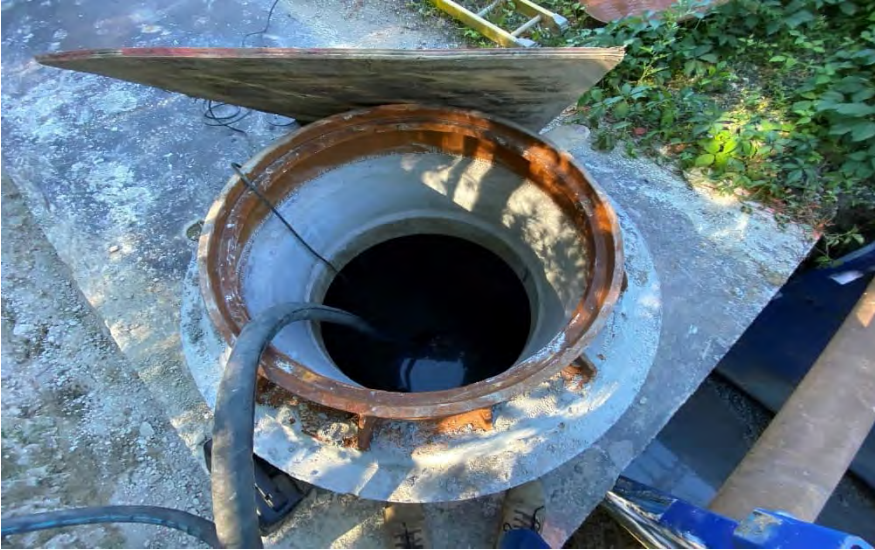
PHOTOGRAPHIC LOG	
Client Name: Eversource		Site Location: Sudbury to Hudson Transmission Reliability Project	Town: Hudson
Photo No.: 1	Date: 6/28/2024

Description: View of area being pumped from Manhole #1, looking eastward.

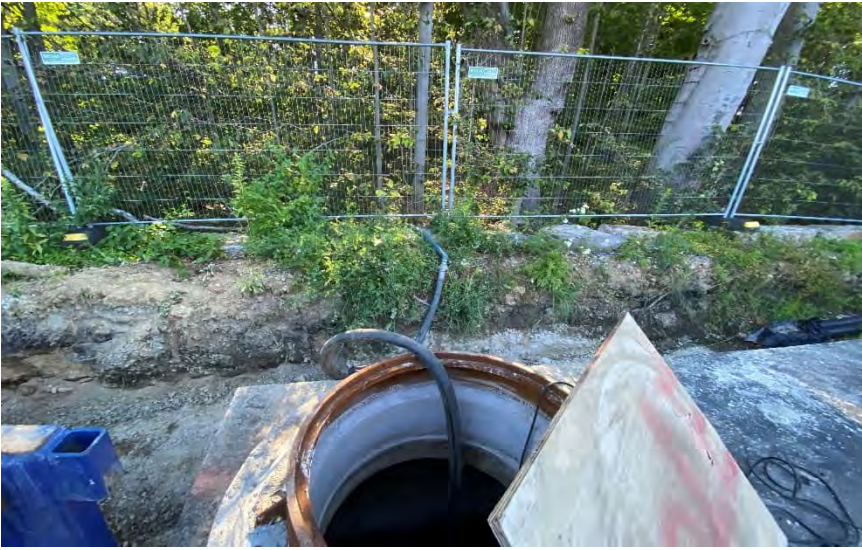
PHOTOGRAPHIC LOG	
Client Name: Eversource		Site Location: Sudbury to Hudson Transmission Reliability Project	Town: Hudson
Photo No.: 2	Date: 6/28/2024

Description: Manhole #1. View of dewatering operation. Looking westward.

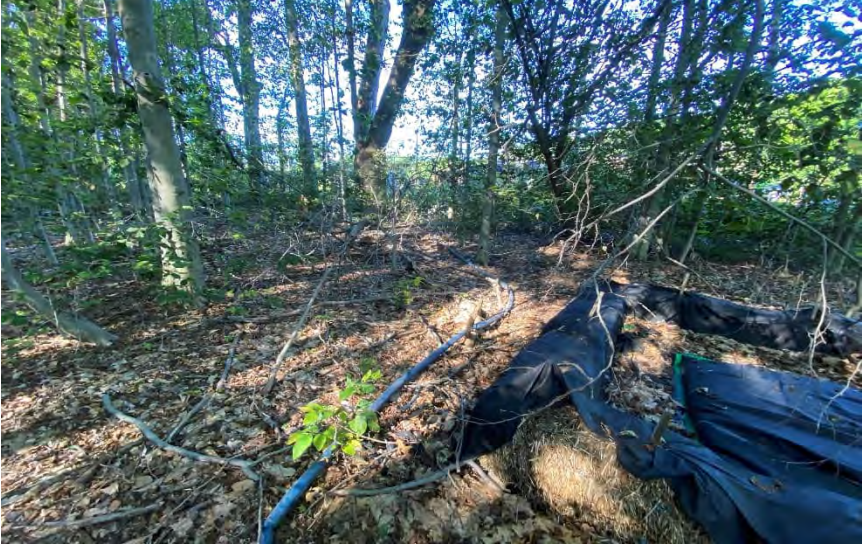
PHOTOGRAPHIC LOG	
Client Name: Eversource		Site Location: Sudbury to Hudson Transmission Reliability Project	Town: Hudson
Photo No.: 3	Date: 6/28/2024

Description: Manhole #1. View of dewatering operation, looking eastward.

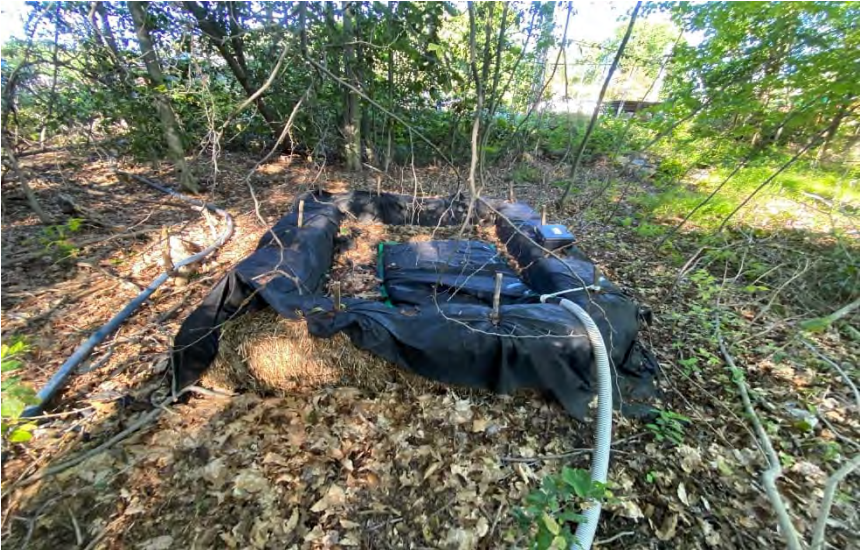
PHOTOGRAPHIC LOG	
Client Name: Eversource		Site Location: Sudbury to Hudson Transmission Reliability Project	Town: Hudson
Photo No.: 4	Date: 6/28/2024

Description: Manhole #1. View of discharge bag/corral, looking eastward. Water from bag/corral discharged to adjacent area & eventually to town drainage system.

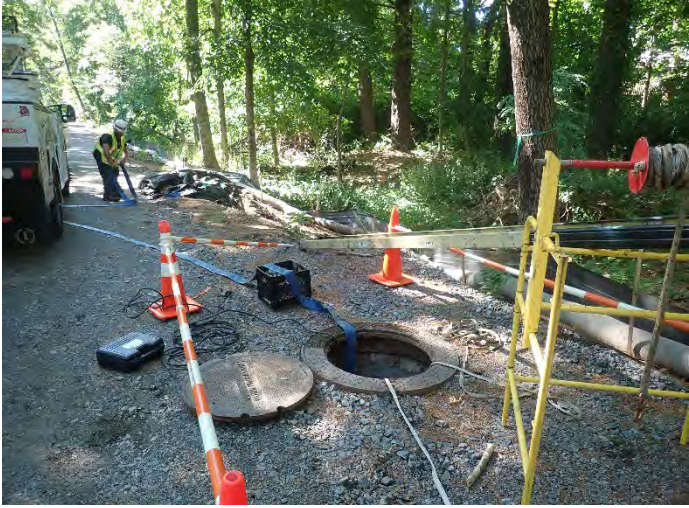
PHOTOGRAPHIC LOG	
Client Name: Eversource		Site Location: Sudbury to Hudson Transmission Reliability Project	Town: Hudson
Photo No.: 1	Date: 6/28/2024

Description: View of New Wave working at MH# 25 in Segment 13. Facing east.

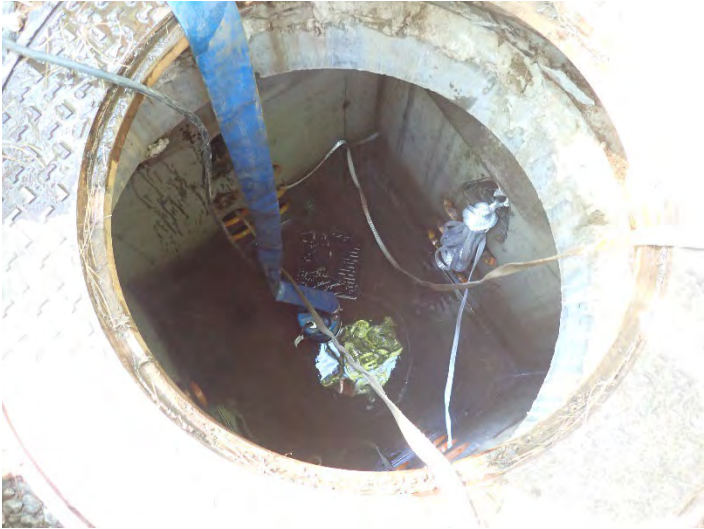
PHOTOGRAPHIC LOG	
Client Name: Eversource		Site Location: Sudbury to Hudson Transmission Reliability Project	Town: Hudson
Photo No.: 2	Date: 6/28/2024

Description: View of water within MH#25. Water appeared slightly turbid prior to treatment.

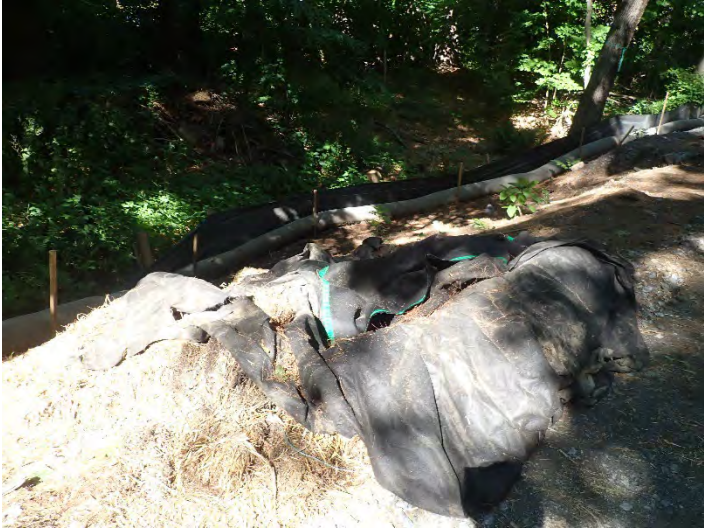
PHOTOGRAPHIC LOG	
Client Name: Eversource		Site Location: Sudbury to Hudson Transmission Reliability Project	Town: Hudson
Photo No.: 3	Date: 6/28/2024

Description: View of dewatering controls (straw bale corral with filter fabric and silt bag). Facing west.

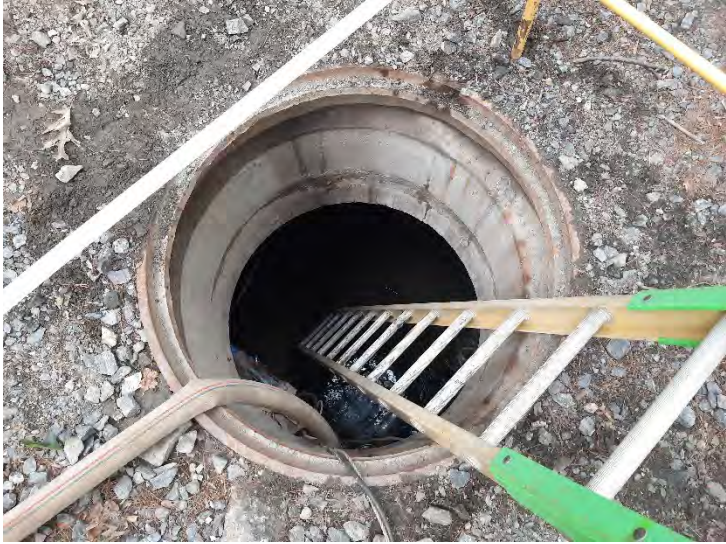
PHOTOGRAPHIC LOG	
Client Name: Eversource		Site Location: Sudbury to Hudson Transmission Reliability Project	Town: Sudbury
Photo No.: 1	Date: 6/29/2024

Description: View of area being pumped from manhole #25, segment 13. Facing southward, looking down.

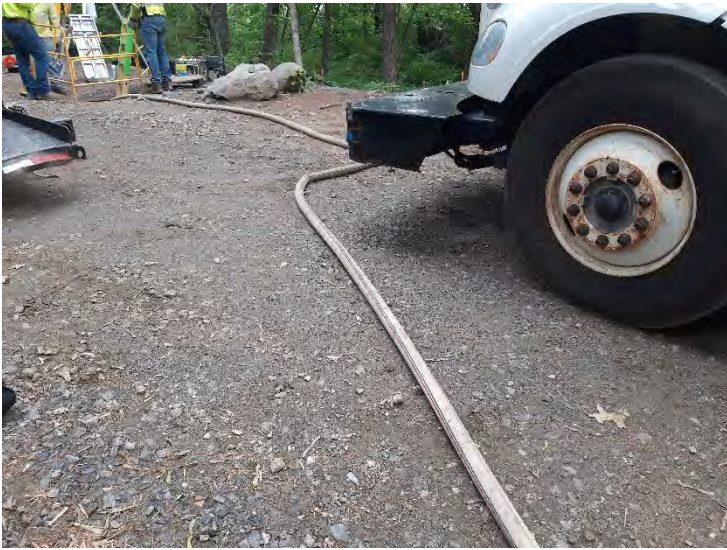
PHOTOGRAPHIC LOG	
Client Name: Eversource		Site Location: Sudbury to Hudson Transmission Reliability Project	Town: Sudbury
Photo No.: 2	Date: 6/29/2024

Description: Manhole #25. View of dewatering operation. Looking westward.

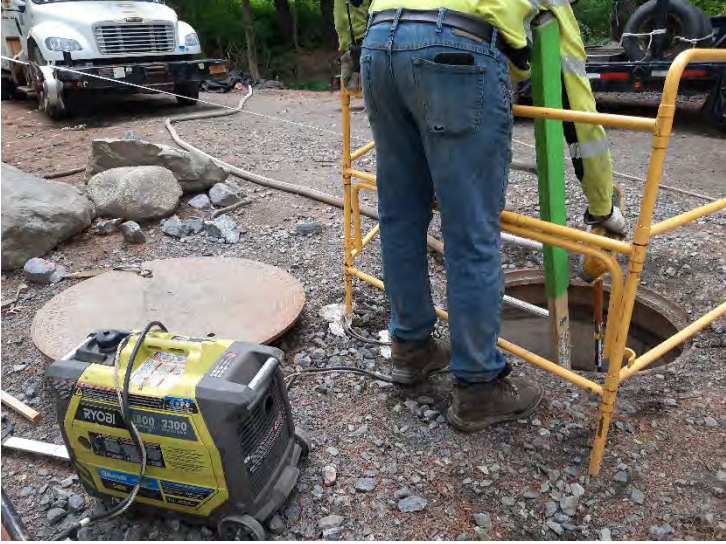
PHOTOGRAPHIC LOG	
Client Name: Eversource		Site Location: Sudbury to Hudson Transmission Reliability Project	Town: Sudbury
Photo No.: 3	Date: 6/29/2024

Description: Manhole #25. View of dewatering operation, looking eastward.

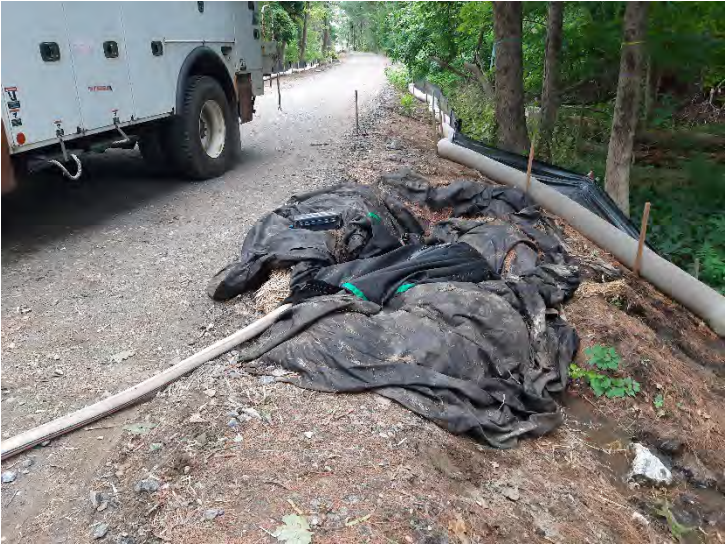
PHOTOGRAPHIC LOG	
Client Name: Eversource		Site Location: Sudbury to Hudson Transmission Reliability Project	Town: Sudbury
Photo No.: 4	Date: 6/29/2024

Description: Manhole #25. View of discharge bag/corral, looking eastward. Water from bag/corral discharged to adjacent area. Flow from corral picking up sediment along slope.

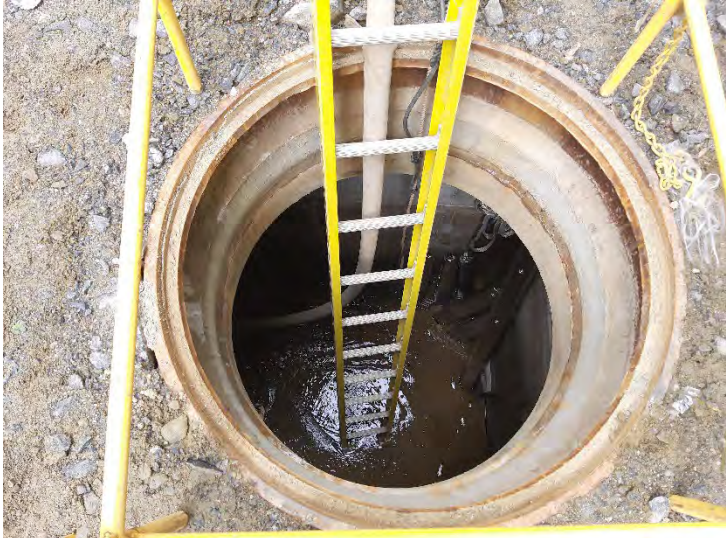
PHOTOGRAPHIC LOG	
Client Name: Eversource		Site Location: Sudbury to Hudson Transmission Reliability Project	
Town: Sudbury			
Photo No.: 1	Date: 6/29/2024

Description: View of area being pumped from manhole #26, segment 14. Facing eastward, looking down.

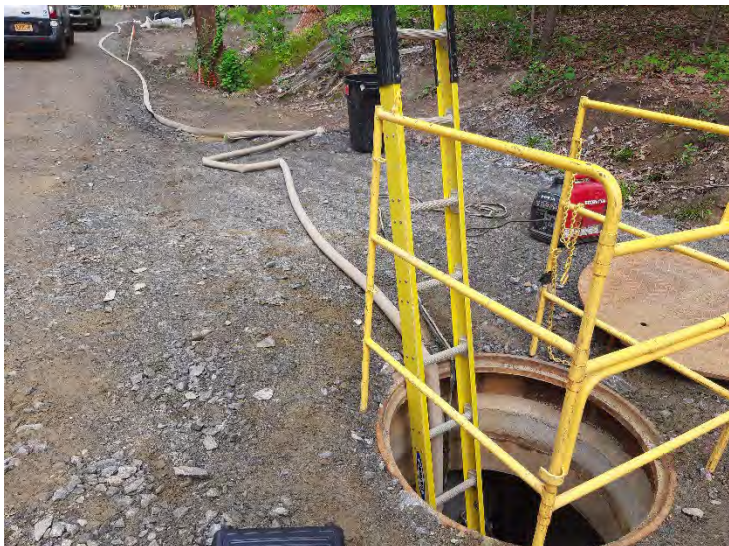
PHOTOGRAPHIC LOG	
Client Name: Eversource		Site Location: Sudbury to Hudson Transmission Reliability Project	
Town: Sudbury			
Photo No.: 2	Date: 6/29/2024

Description: Manhole #26. View of dewatering operation. Low volume of water in manhole resulted in slow progress through hose to corral. Looking westward.
