**Weekly Environmental Compliance Summary**

**Sudbury to Hudson Transmission Reliability Project (USEPA Tracking # MAR1003UW)**

Sudbury, Hudson, and Stow, MA

Week of: July 8, 2024 to July 13, 2024

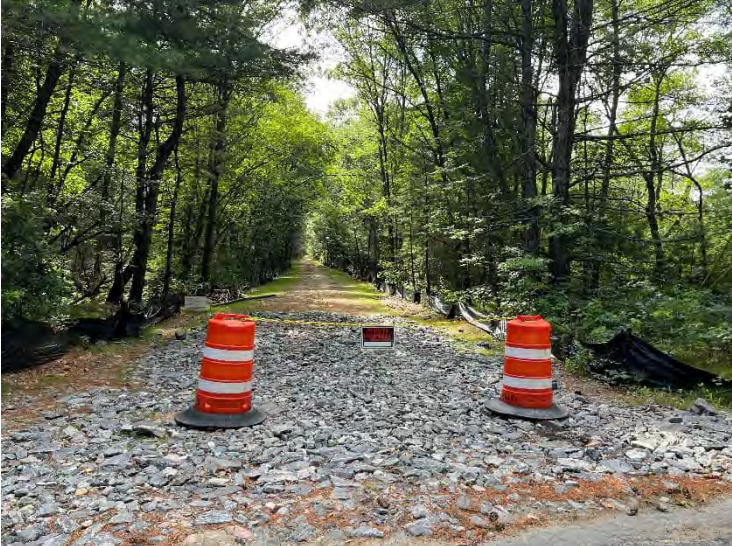
<p>PHOTOGRAPHIC LOG</p>	
<p>Client Name: Eversource</p>		<p>Site Location: Sudbury to Hudson Transmission Reliability Project</p>	<p>Town: Hudson</p>
<p>Photo No.: 6</p>	<p>Date: 7-12-24</p>

<p>Description: View of construction entrance &amp; E&amp;S controls to segment 6. Chained barrels with private property signs added to construction entrances to segments. Facing east.</p>

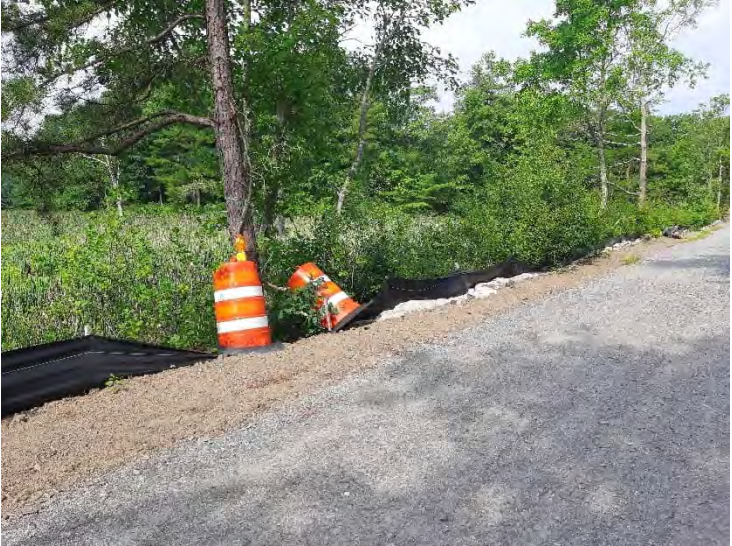
PHOTOGRAPHIC LOG	
Client Name: Eversource		Site Location: Sudbury to Hudson Transmission Reliability Project	Town: Hudson
Photo No.: 12	Date: 7-9-24

2. Silt Fencing on ROW within Hudson.	<input checked="" type="checkbox"/> Yes <input type="checkbox"/> No	N/A	<input type="checkbox"/> Yes <input checked="" type="checkbox"/> No	N/A	Silt fencing is installed within segments 1 - 6. E&S repairs in progress per full punch list that was submitted to project contractors.  Silt fencing near STA 99 in segment 1 partially toppled by sediment, excess sediment removal needed.  Construction barrels atop silt fencing roughly near STA 122 in segment 2 should be removed.

Description:  Silt fence roughly near STA 122 in segment 2 on south side of ROW, barrels on silt fence, routine maintenance. Contractor notified. Site traffic using ROW further east. Looking westward.

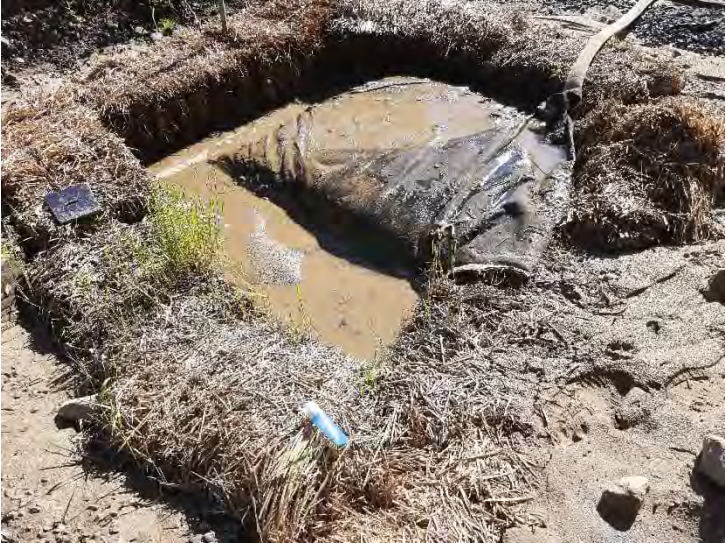
<b>PHOTOGRAPHIC LOG</b>	
Client Name: Eversource		Site Location: Sudbury to Hudson Transmission Reliability Project	Town: Hudson
Photo No.: 4	Date: 7/8/2024

Description: Manhole #5. View of discharge bag/corral, looking eastward. Water from bag/corral discharged to catch basin below. Significant amount of pre-existing sediment in and around corral.

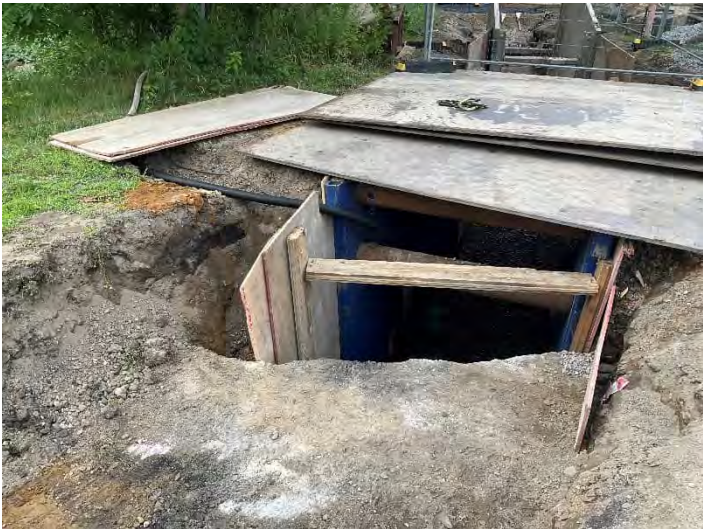
<b>PHOTOGRAPHIC LOG</b>	
Client Name: Eversource		Site Location: Sudbury to Hudson Transmission Reliability Project	Town: Hudson
Photo No.: 2	Date: 7/10/2024

Description: View of pump in trench at entrance to Hudson Light and Power on Forest Avenue. Water appeared clear prior to treatment.

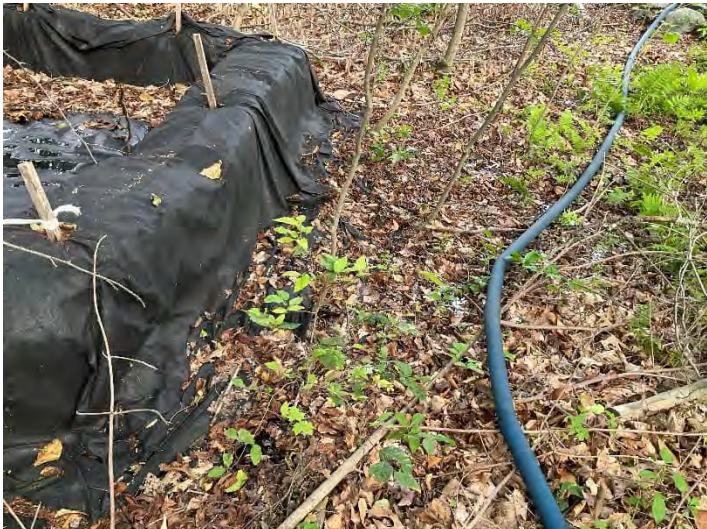
<b>PHOTOGRAPHIC LOG</b>	
Client Name: Eversource		Site Location: Sudbury to Hudson Transmission Reliability Project	Town: Hudson
Photo No.: 4	Date: 7/10/2024

Description: View of discharging water from corral. Discharge appeared to be clear and turbidity reading was <50 NTUs. Facing east.

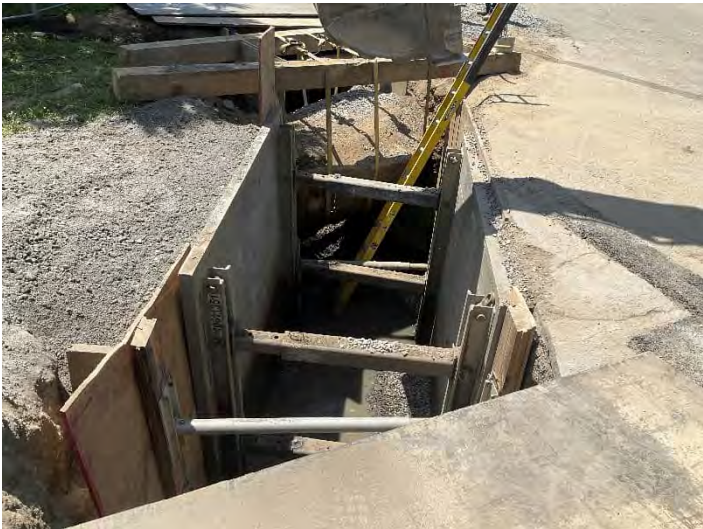
<b>PHOTOGRAPHIC LOG</b>	
Client Name: Eversource		Site Location: Sudbury to Hudson Transmission Reliability Project	Town: Hudson
Photo No.: 2	Date: 7/11/2024

Description: View of pump in trench at entrance to Hudson Light and Power on Forest Avenue. Water appeared clear prior to treatment.

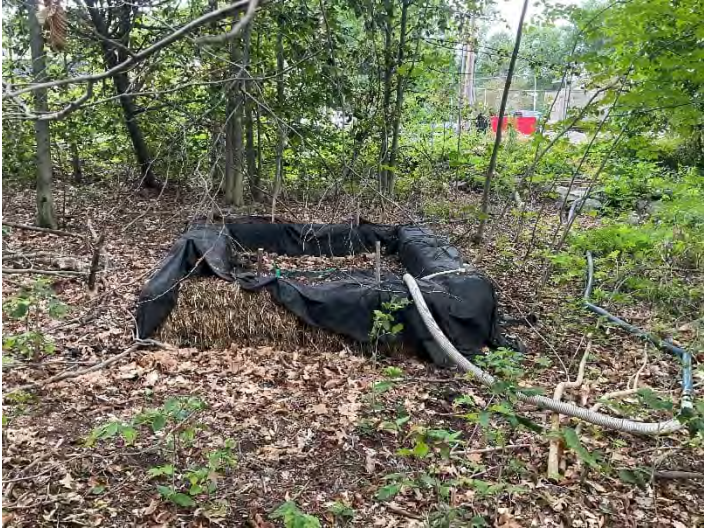
Description: View of dewatering controls (straw bale corral with filter fabric and silt bag). Facing south.

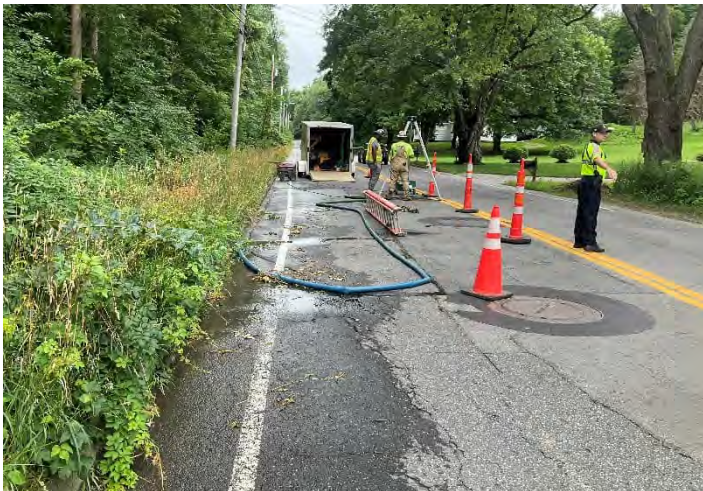
Description: View of Bond work area at MH#4 for conduit work. Facing southwest.

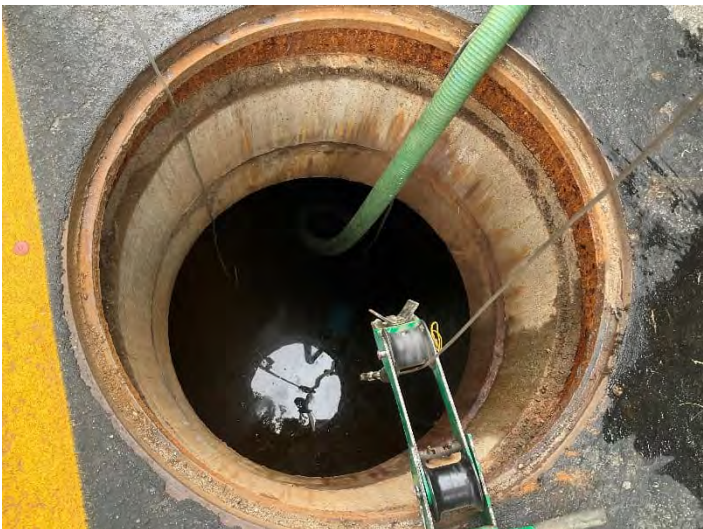
Description: View of pump in MH#4 on Forest Avenue. Water appeared clear prior to treatment.

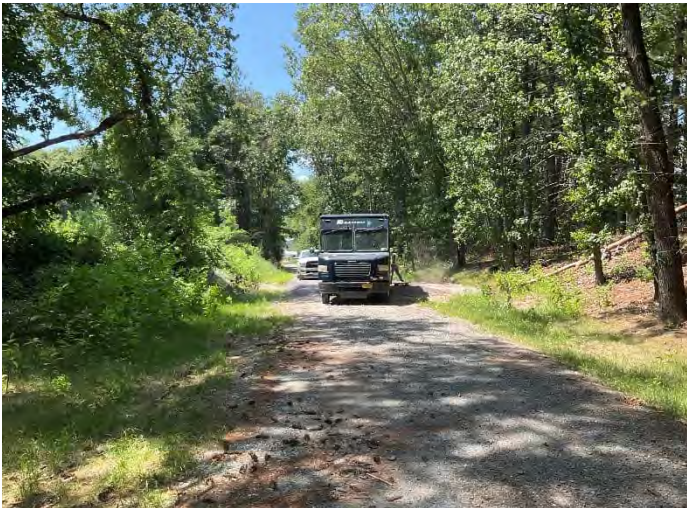
Description: View of Haugland cable splicers at MH #9 in segment 3. Facing west.

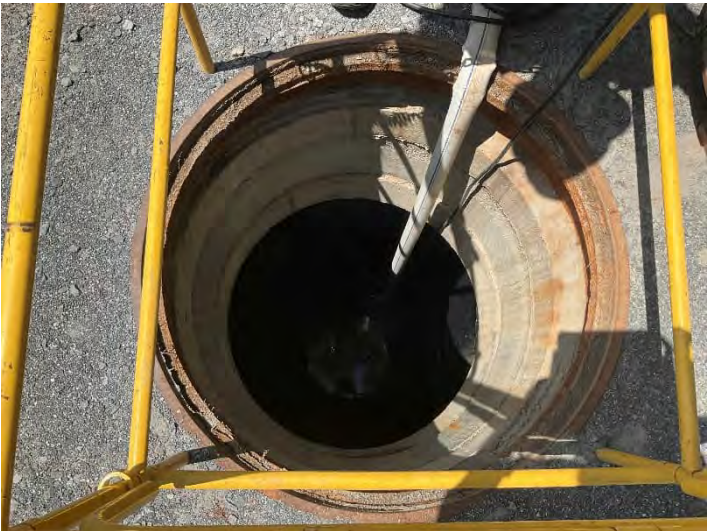
Description: View of pump in MH #9. Water appeared clear prior to treatment.

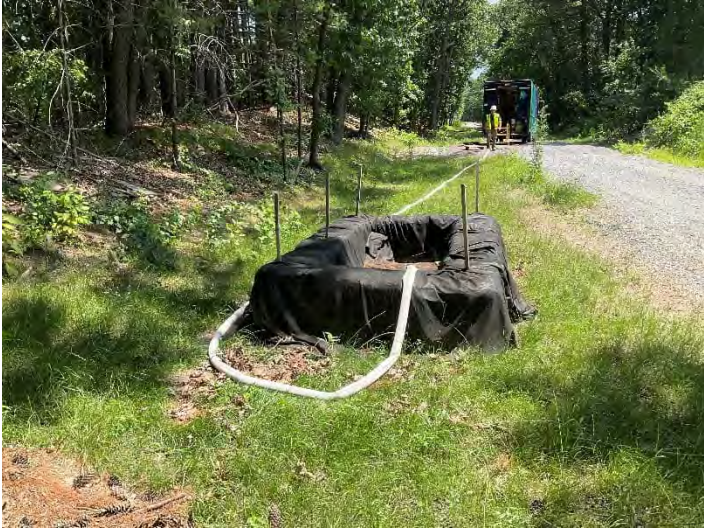
Description: View of dewatering controls (straw bale corral with filter fabric and silt bag). Facing east.

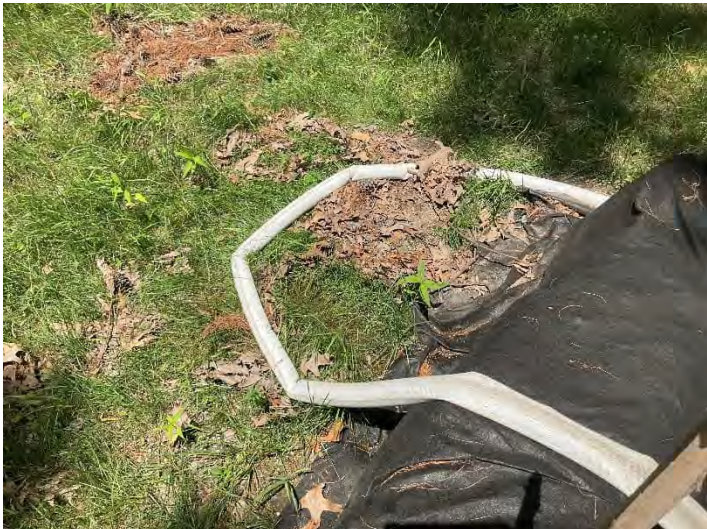
Description: View of discharging water from corral. Discharge appeared clear and turbidity reading was below 50 NTUs. Discharge did not appear to reach any jurisdictional resource areas.

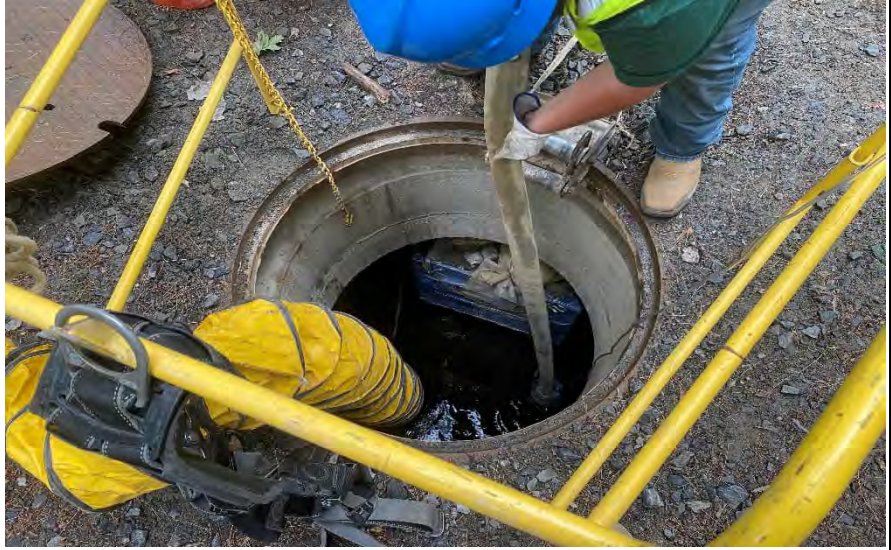
Photo No.: 1  
Date: 7/11/2024

Description:  
View of area being pumped from manhole #25, Segment 13.

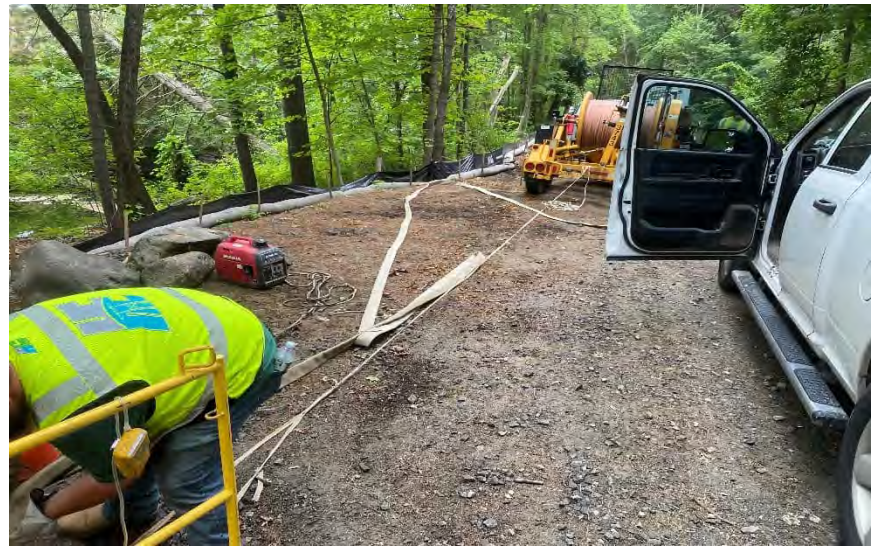
Photo No.: 2  
Date: 7/11/2024

Description:  
Manhole #25. View of dewatering operation. Looking eastward.

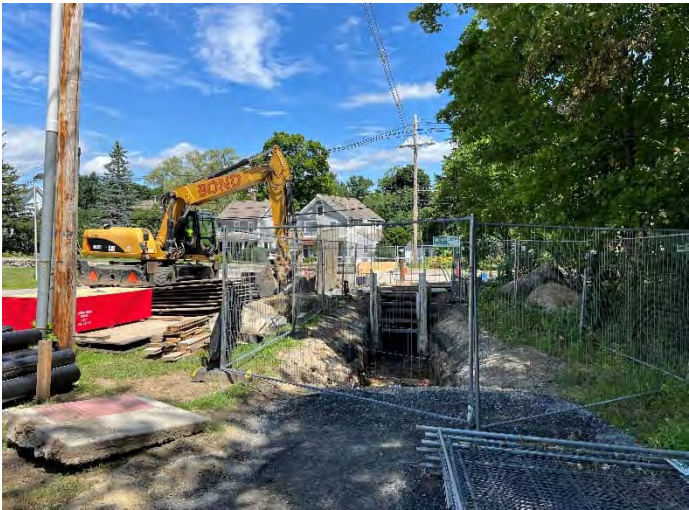
Description: View of MH#1 and surrounding Bond workspace. Bond trenching for conduit work. Facing west.

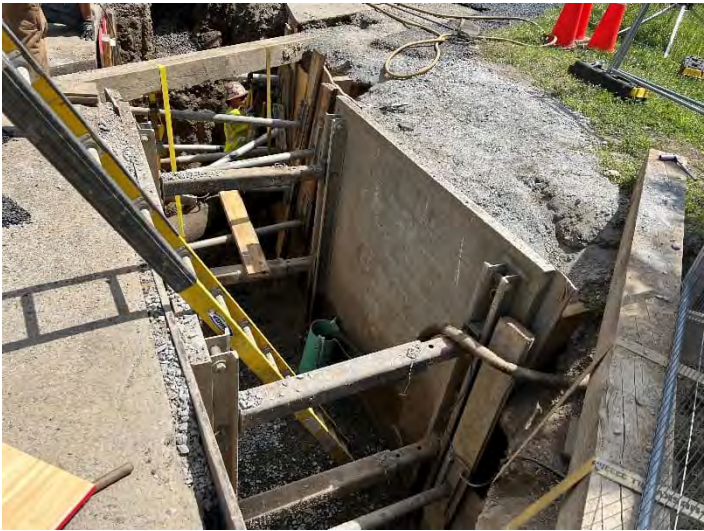
Description: View of pump in trench at entrance to Hudson Light and Power on Forest Avenue. Water appeared turbid prior to treatment.

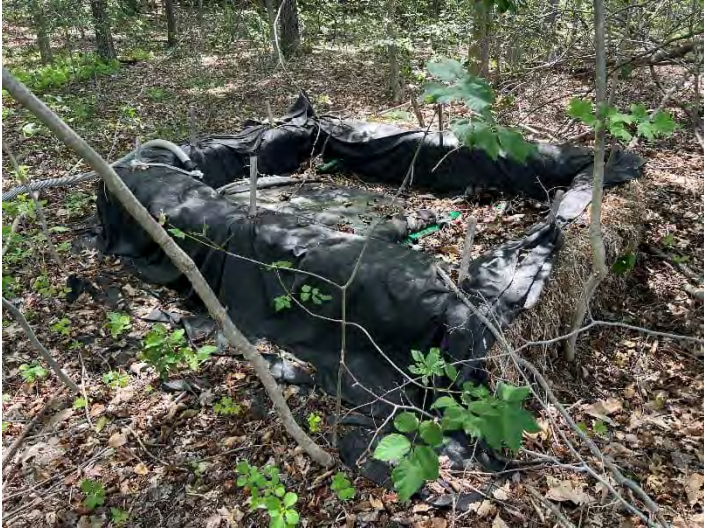
Description: View of dewatering controls (straw bale corral with filter fabric and silt bag). Facing southeast.

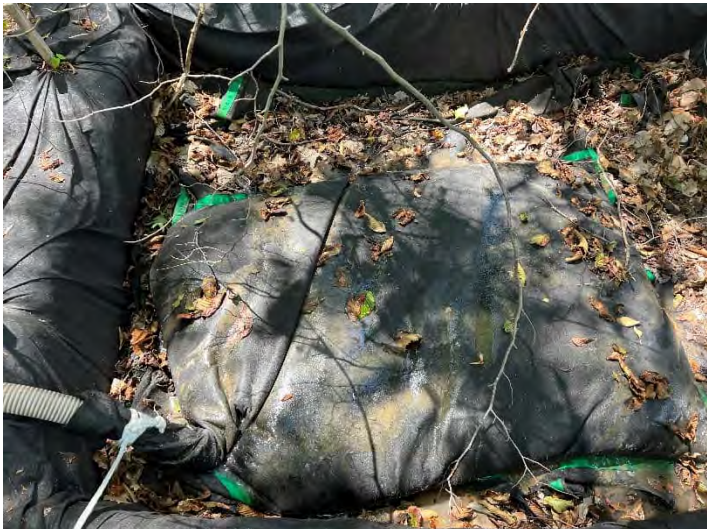
Description: View of discharging water within corral. Discharge was not leaving corral at time of dewatering inspection. Sample taken from within corral. Turbidity reading was above 50 NTUs. Sediment is starting to accumulate within corral from constant dewatering.

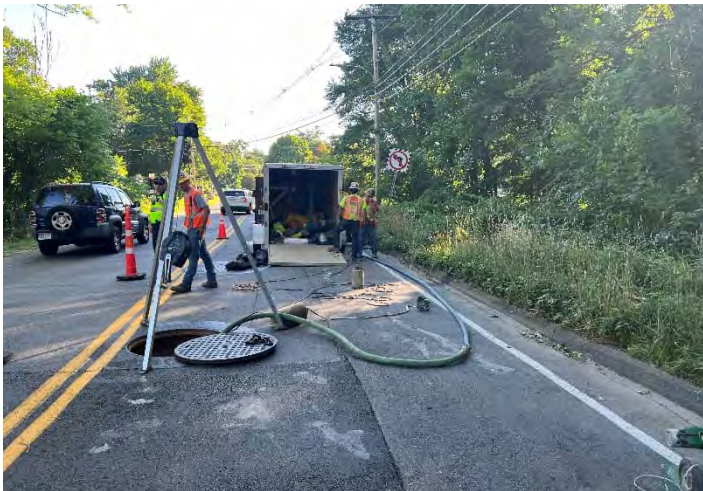
Description: View of Bond work area at MH#4 for conduit work. Facing northwest.

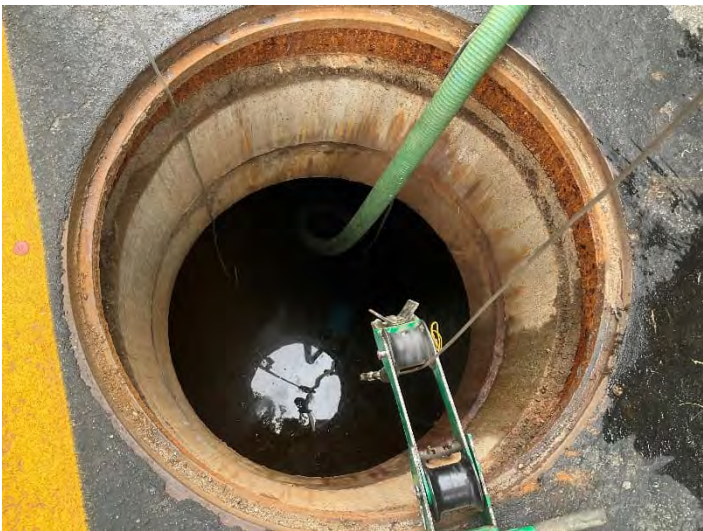
Description: View of pump in MH#4 on Forest Avenue. Water appeared clear prior to treatment.

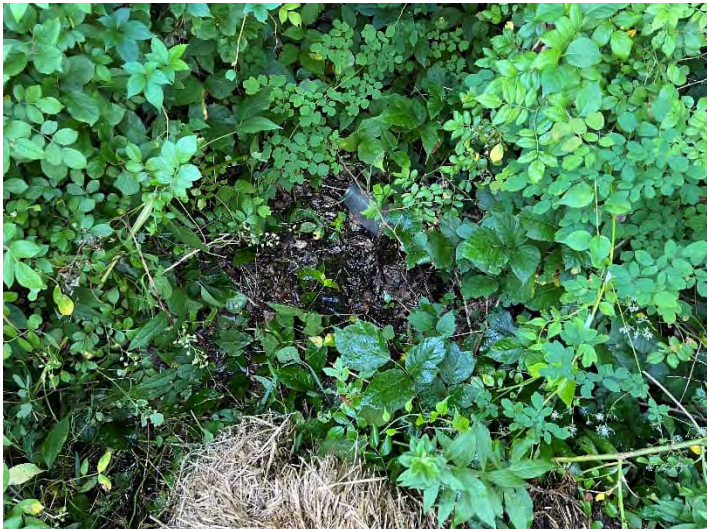
Description: View of discharging water from corral. Discharge appeared to be clear and turbidity reading was below 50 NTUs.

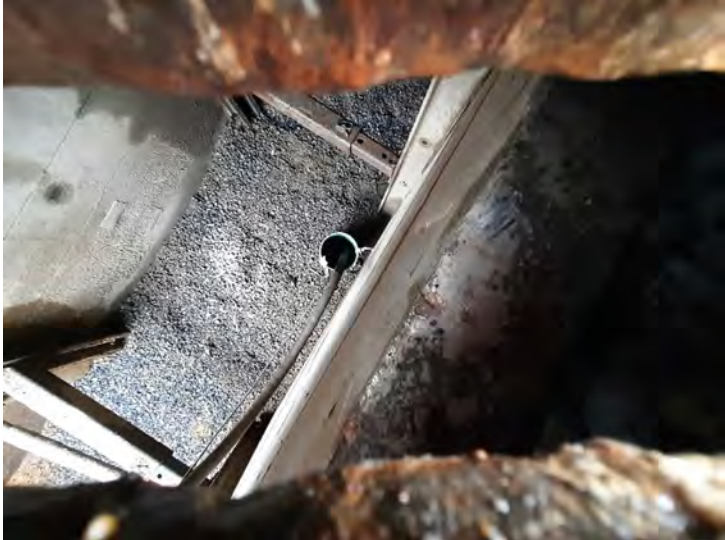
Description: View of area being pumped from the trench beside manhole #1, near Hudson Light & Power. Facing westward, looking down.

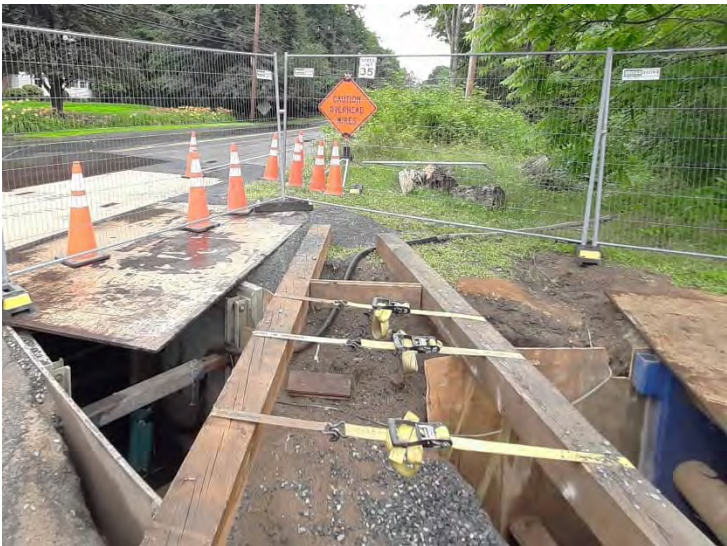
Description: Trench beside manhole #1. View of dewatering operation. Looking eastward.

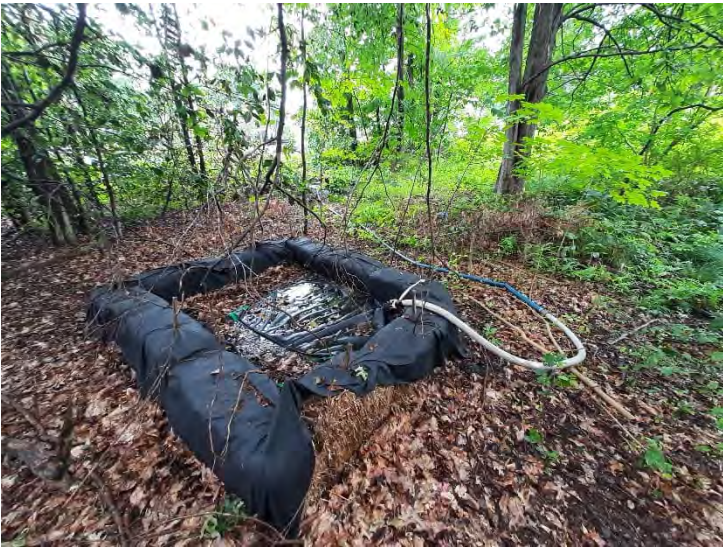
Description: View of dewatering operation associated with trench by manhole #1, looking northward. Work zone and area being dewatered on opposite trees in upper center of image.

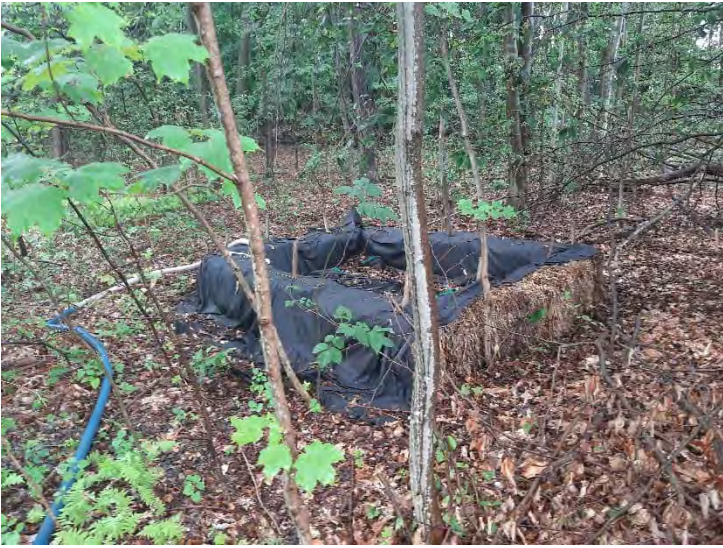
Description: Dewatering setup associated with trench near manhole #1. View of discharge bag/corral, looking southward. Water from bag/corral remaining within corral.

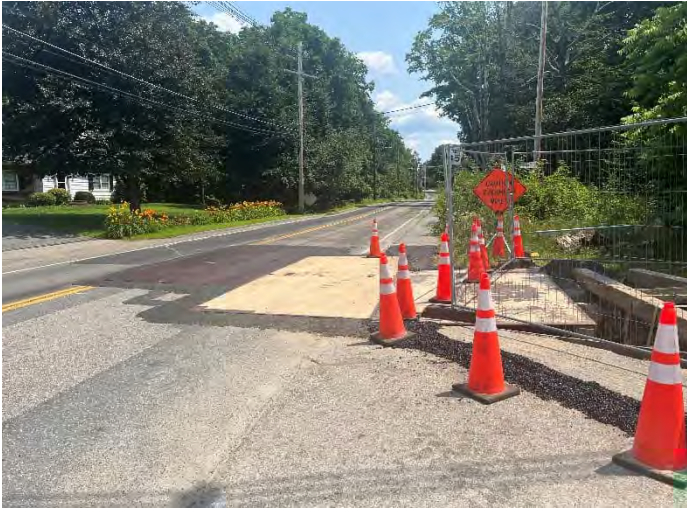
Description: View of Bond workspace at Hudson Light & Power by MH#1. Pump running 24/7 while conduit work continues. No active construction today. Facing east.

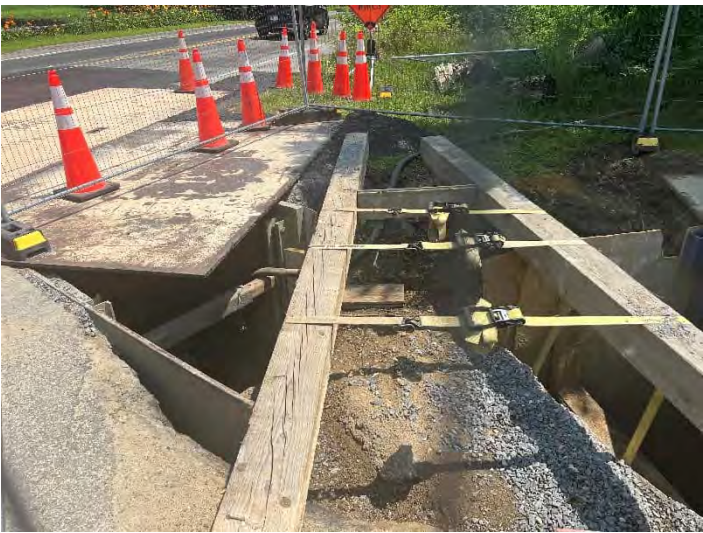
Description: View of pump in trench at entrance to Hudson Light and Power on Forest Avenue. Pump located within trench under steel plates within gated work area. Facing east.

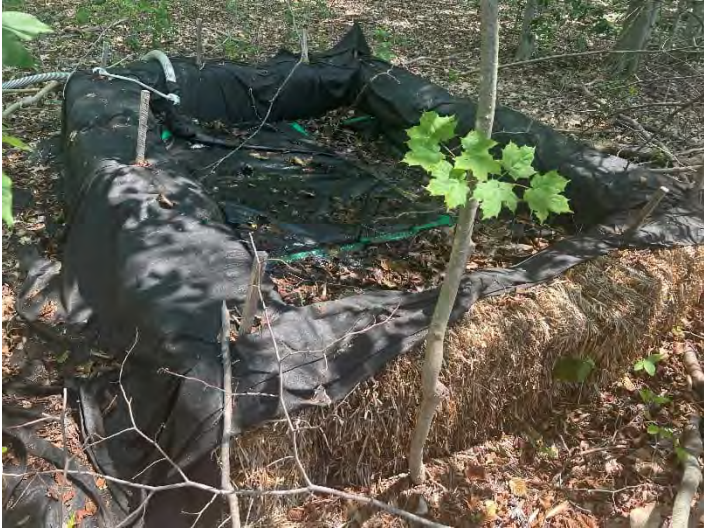
Description: View of dewatering controls (straw bale corral with filter fabric and silt bag). Facing southeast.

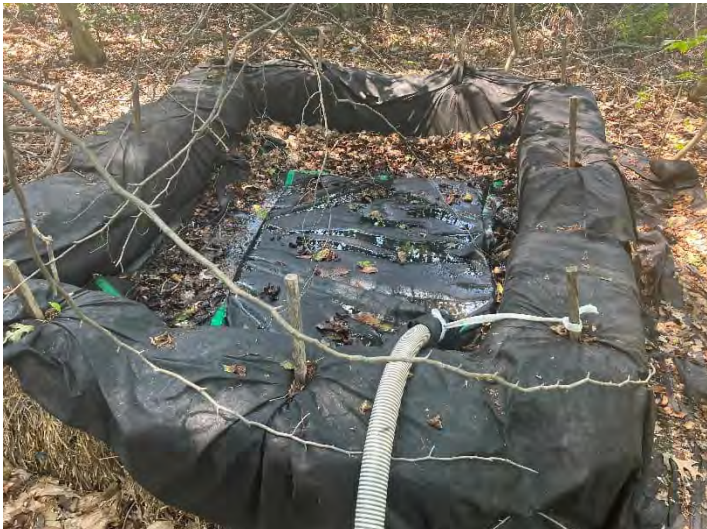
Description: View of discharging water within corral. Discharge was not leaving corral at time of dewatering inspection. Sample taken from within corral. Discharge appeared clear and turbidity reading was below 50 NTUs. Facing west.
