Weekly Environmental Compliance Summary

Sudbury to Hudson Transmission Reliability Project (USEPA Tracking # MAR1003UW)

Week of: July 15, 2024 to July 20, 2024

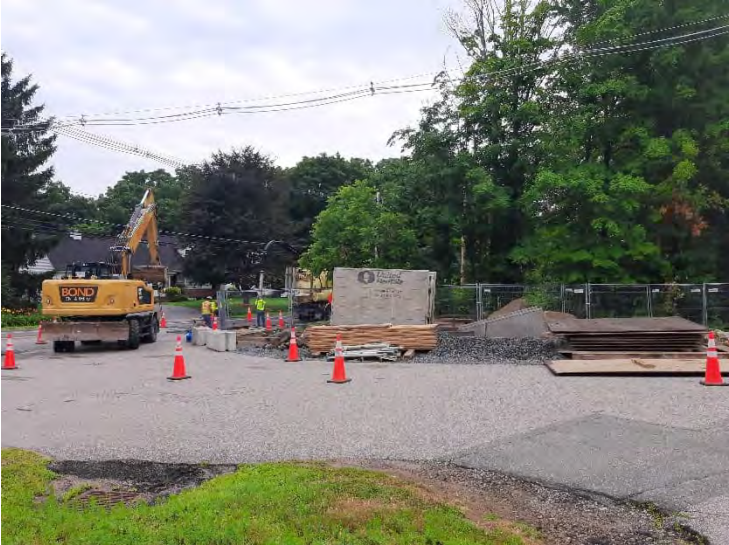
<p>PHOTOGRAPHIC LOG</p>	
<p>Client Name: Eversource</p>		<p>Site Location: Sudbury to Hudson Transmission Reliability Project</p>	<p>Town: Hudson</p>
<p>Photo No.: 1</p>	<p>Date: 7-15-24</p>

<p>Description:</p> <p>Work area at manhole #1, next to Forest Ave and Hudson Light & Power. Vac truck assisting trenching activities. Looking eastward.</p>

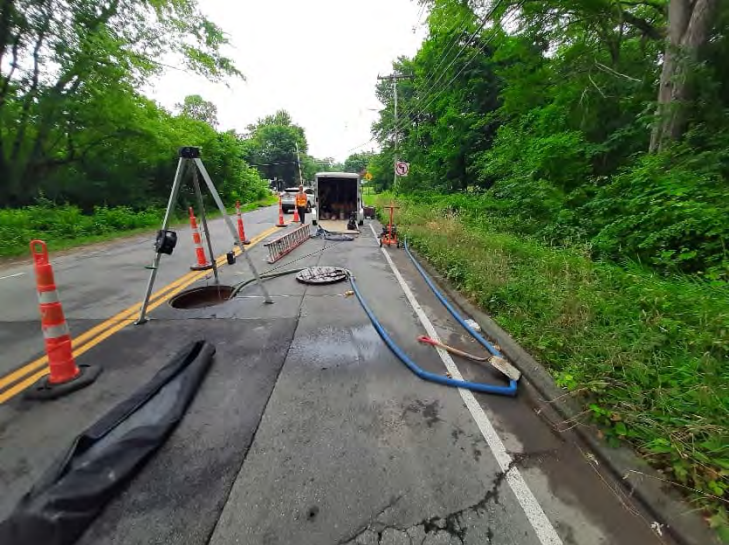
<p>PHOTOGRAPHIC LOG</p>	
<p>Client Name: Eversource</p>		<p>Site Location: Sudbury to Hudson Transmission Reliability Project</p>	<p>Town: Hudson</p>
<p>Photo No.: 2</p>	<p>Date: 7-15-24</p>

<p>Description:</p> <p>Work area in Forest Ave, swab and mandrel at manhole #4, attempting to clear obstructions between manholes #4 and #5. Looking eastward.</p>

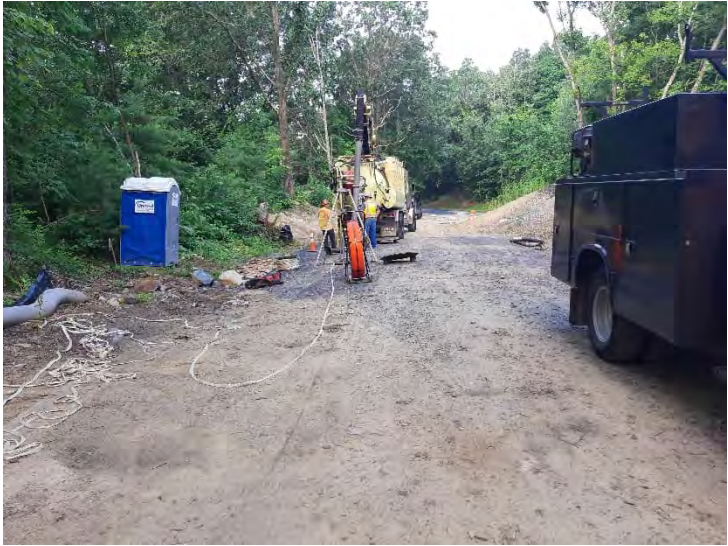
<p>PHOTOGRAPHIC LOG</p>	
<p>Client Name: Eversource</p>		<p>Site Location: Sudbury to Hudson Transmission Reliability Project</p>	<p>Town: Hudson</p>
<p>Photo No.: 3</p>	<p>Date: 7-15-24</p>

<p>Description:</p> <p>Work area within segment 1, swab and mandrel at manhole #5, attempting to clear obstructions between manholes #4 and \$5. Looking westward.</p>

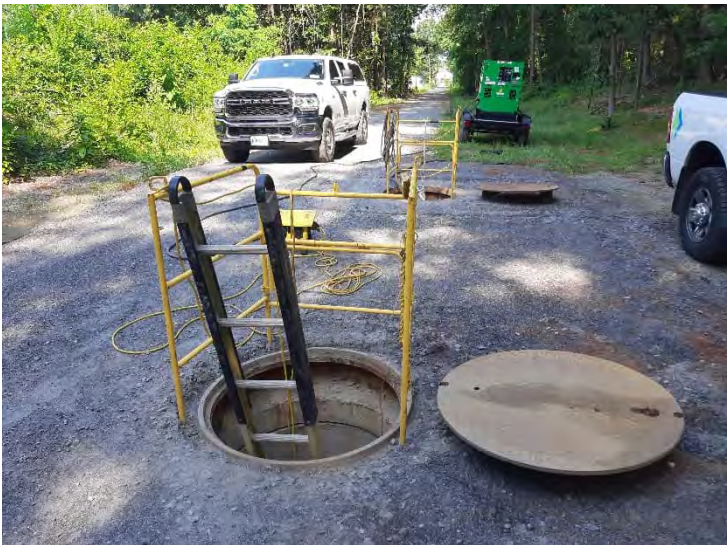
<p>PHOTOGRAPHIC LOG</p>	
<p>Client Name: Eversource</p>		<p>Site Location: Sudbury to Hudson Transmission Reliability Project</p>	<p>Town: Hudson</p>
<p>Photo No.: 4</p>	<p>Date: 7-15-24</p>

<p>Description:</p> <p>Work area within segment 3, crimping and splicing at manhole #9, looking westward.</p>

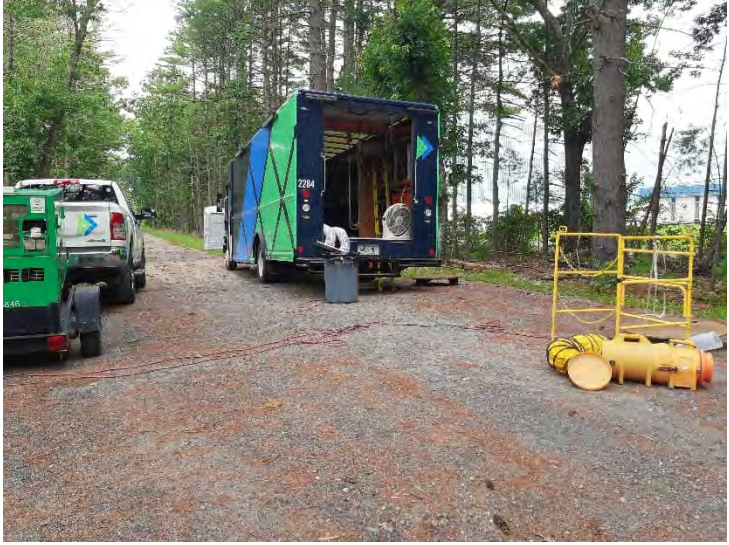
<p>PHOTOGRAPHIC LOG</p>	
<p>Client Name: Eversource</p>		<p>Site Location: Sudbury to Hudson Transmission Reliability Project</p>	<p>Town: Hudson</p>
<p>Photo No.: 5</p>	<p>Date: 7-15-24</p>

<p>Description: Work area within segment 4, crimping and splicing at manhole #10, looking westward.</p>

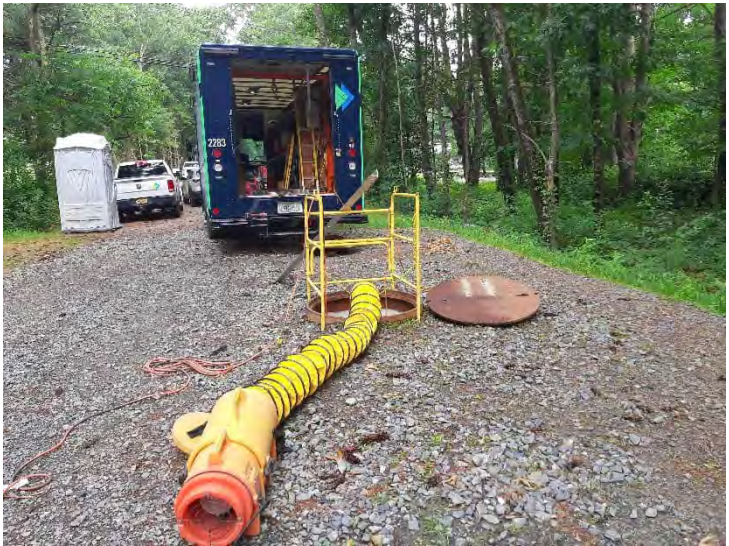
<p>PHOTOGRAPHIC LOG</p>	
<p>Client Name: Eversource</p>		<p>Site Location: Sudbury to Hudson Transmission Reliability Project</p>	<p>Town: Hudson</p>
<p>Photo No.: 6</p>	<p>Date: 7-15-24</p>

<p>Description: Work area within segment 5, crimping and splicing at manhole #11, looking westward.</p>

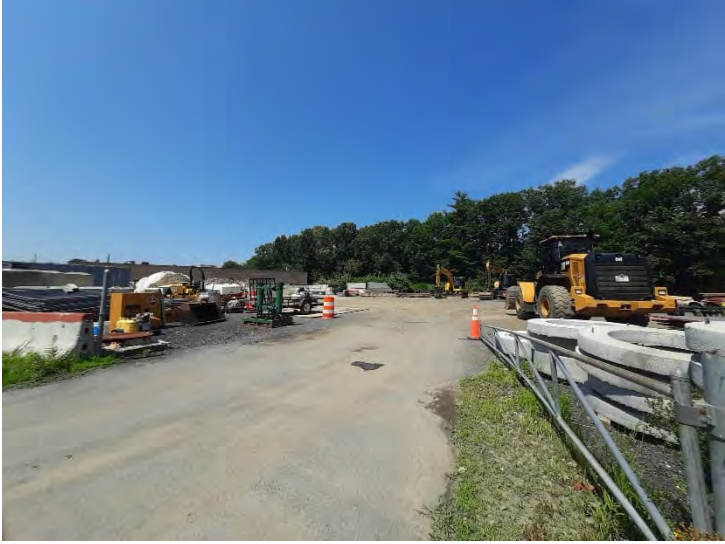
<p>PHOTOGRAPHIC LOG</p>	
<p>Client Name: Eversource</p>		<p>Site Location: Sudbury to Hudson Transmission Reliability Project</p>	<p>Town: Hudson</p>
<p>Photo No.: 8</p>	<p>Date: 7-15-24</p>

<p>Description:</p> <p>Activity in Bonazzoli laydown yard, working around stockpiles, looking westward.</p>

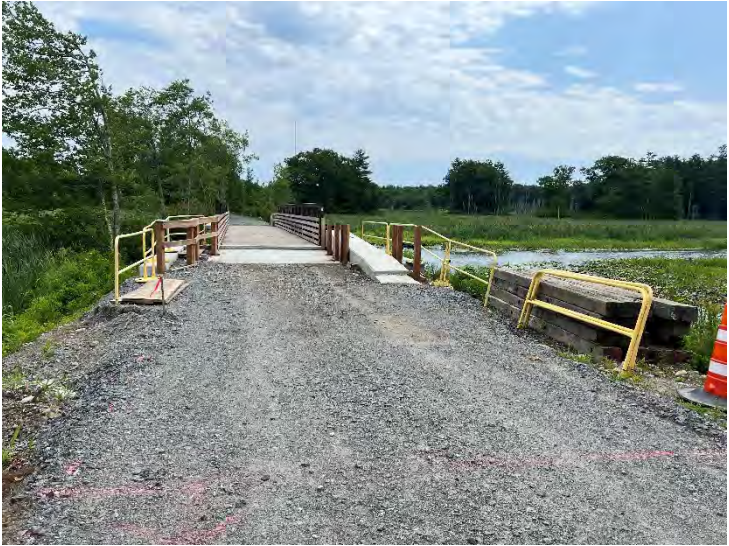
<p>PHOTOGRAPHIC LOG</p>	
<p>Client Name: Eversource</p>		<p>Site Location: Sudbury to Hudson Transmission Reliability Project</p>	<p>Town: Hudson</p>
<p>Photo No.: 5</p>	<p>Date: 7-17-24</p>

<p>Description: View of Bridge 130. Facing east.</p>

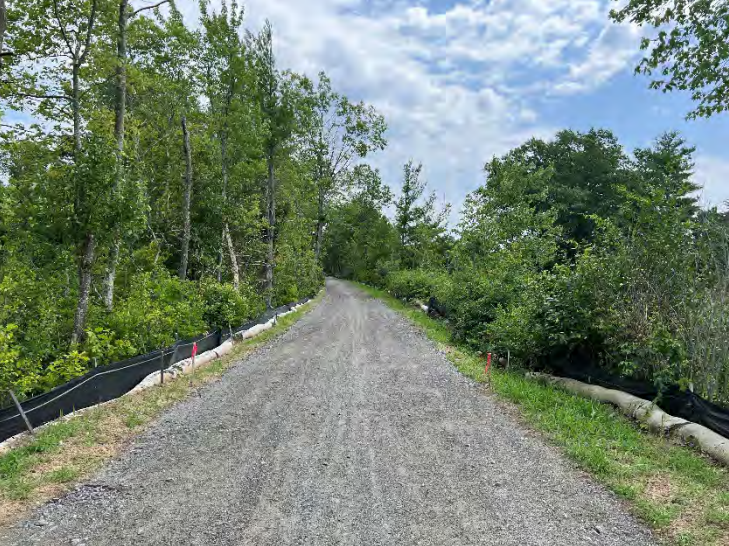
<p>PHOTOGRAPHIC LOG</p>	
<p>Client Name: Eversource</p>		<p>Site Location: Sudbury to Hudson Transmission Reliability Project</p>	<p>Town: Hudson</p>
<p>Photo No.: 6</p>	<p>Date: 7-17-24</p>

<p>Description: View of E&S controls in segment 3. Facing east.</p>

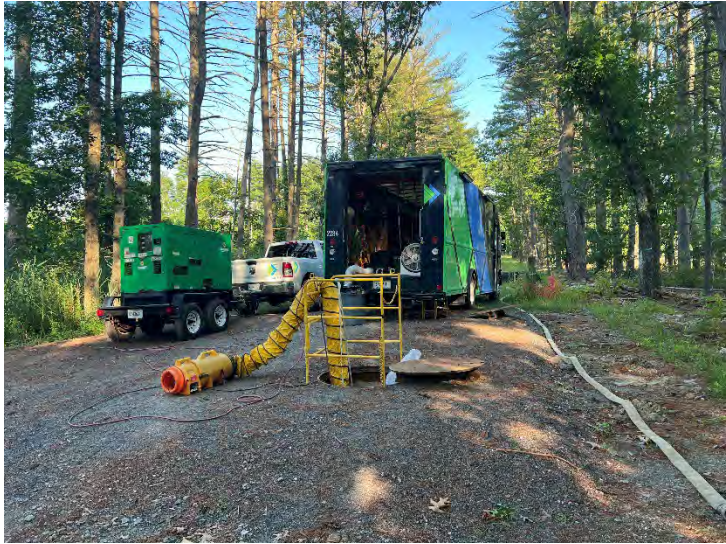
<p>PHOTOGRAPHIC LOG</p>	
<p>Client Name: Eversource</p>		<p>Site Location: Sudbury to Hudson Transmission Reliability Project</p>	<p>Town: Hudson</p>
<p>Photo No.: 7</p>	<p>Date: 7-17-24</p>

<p>Description:</p> <p>View of Haugland work area splicing at MH #10 in segment 4. Facing west.</p>

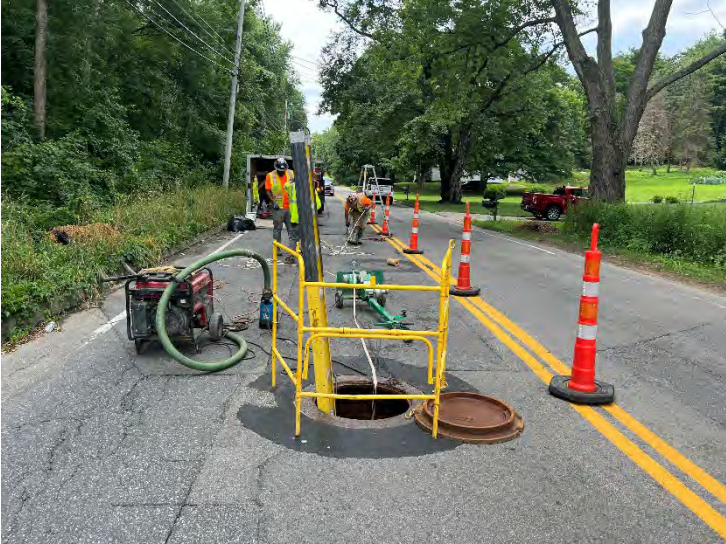
<p>PHOTOGRAPHIC LOG</p>	
<p>Client Name: Eversource</p>		<p>Site Location: Sudbury to Hudson Transmission Reliability Project</p>	<p>Town: Hudson</p>
<p>Photo No.: 8</p>	<p>Date: 7-17-24</p>

<p>Description:</p> <p>View of Bond at MH #4 in Forest Ave proofing. See additional dewatering report. Facing southwest.</p>

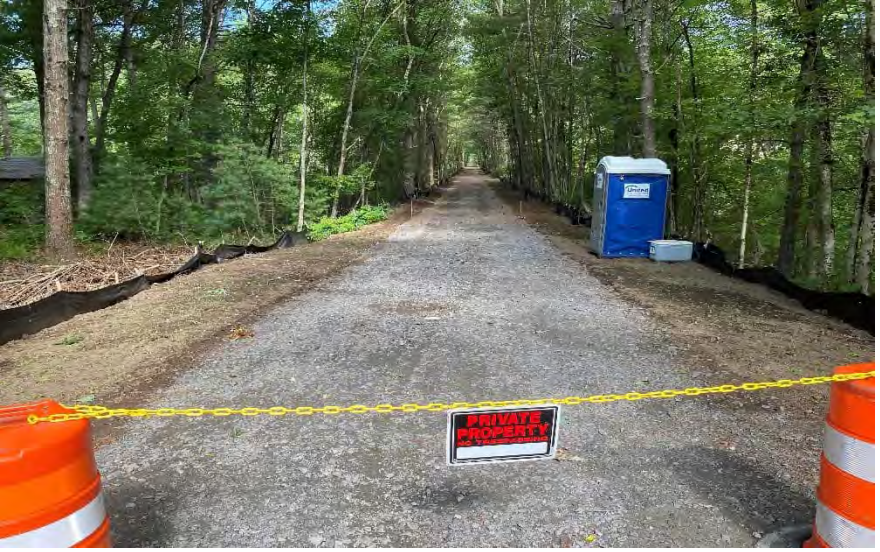
PHOTOGRAPHIC LOG	
Client Name: Eversource		Site Location: Sudbury to Hudson Transmission Reliability Project	Town: Sudbury
Photo No.: 1	Date: 7-17-24

Description: Work area within segment 9, existing erosion control, looking westward.

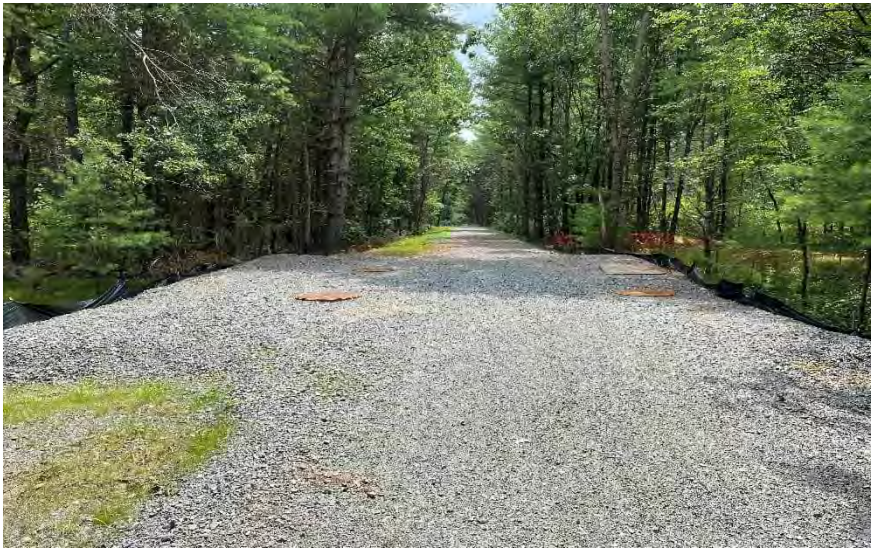
PHOTOGRAPHIC LOG	
Client Name: Eversource		Site Location: Sudbury to Hudson Transmission Reliability Project	Town: Sudbury
Photo No.: 2	Date: 7-17-24

Description: Work area within segment 7, manhole #15, existing erosion control, looking eastward.

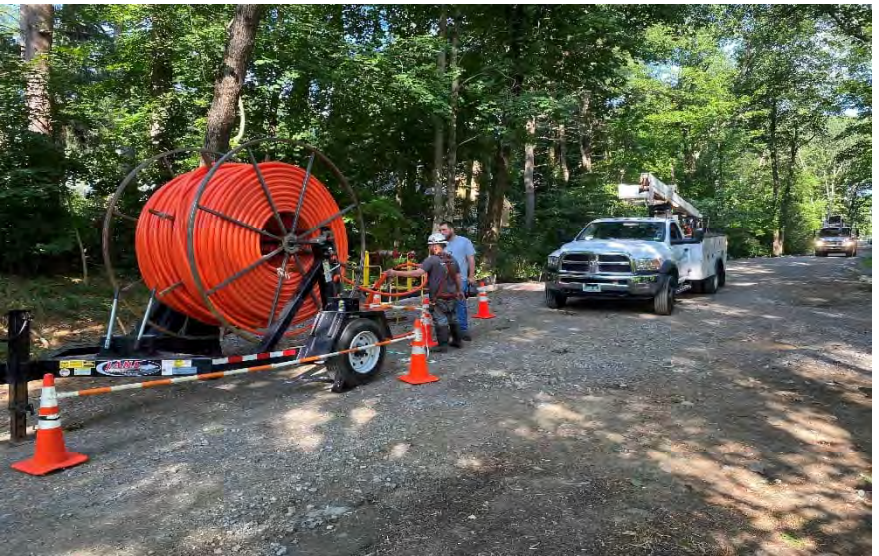
<p align="center">PHOTOGRAPHIC LOG</p>	
<p>Client Name: Eversource</p>		<p>Site Location: Sudbury to Hudson Transmission Reliability Project</p>	<p>Town: Sudbury</p>
<p>Photo No.: 4</p>	<p>Date: 7-17-24</p>

<p>Description:</p> <p>Work area within segment 13, hand hole #25, fiber optic work, existing erosion control, looking westward.</p>

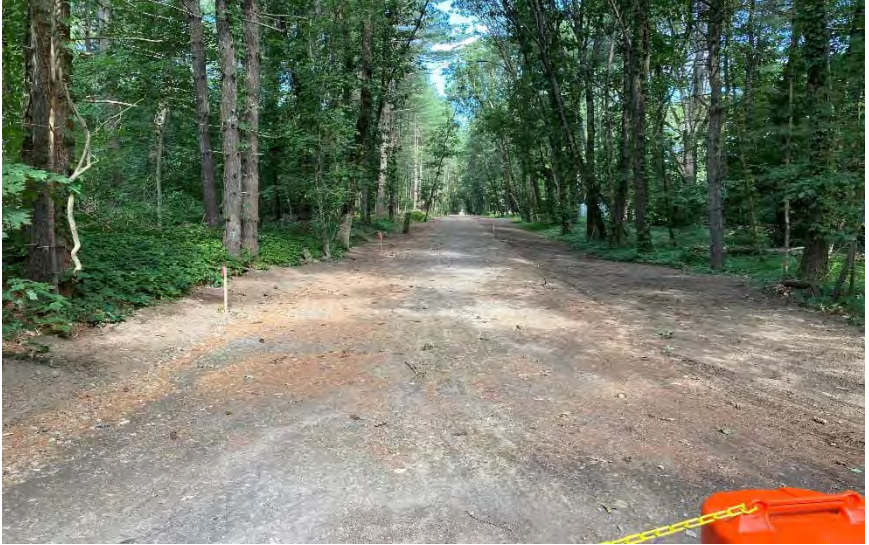
<p>PHOTOGRAPHIC LOG</p>	
<p>Client Name: Eversource</p>		<p>Site Location: Sudbury to Hudson Transmission Reliability Project</p>	<p>Town: Sudbury</p>
<p>Photo No.: 5</p>	<p>Date: 7-17-24</p>

<p>Description:</p> <p>Work area within segment 10, recent hydroseeding, looking westward.</p>

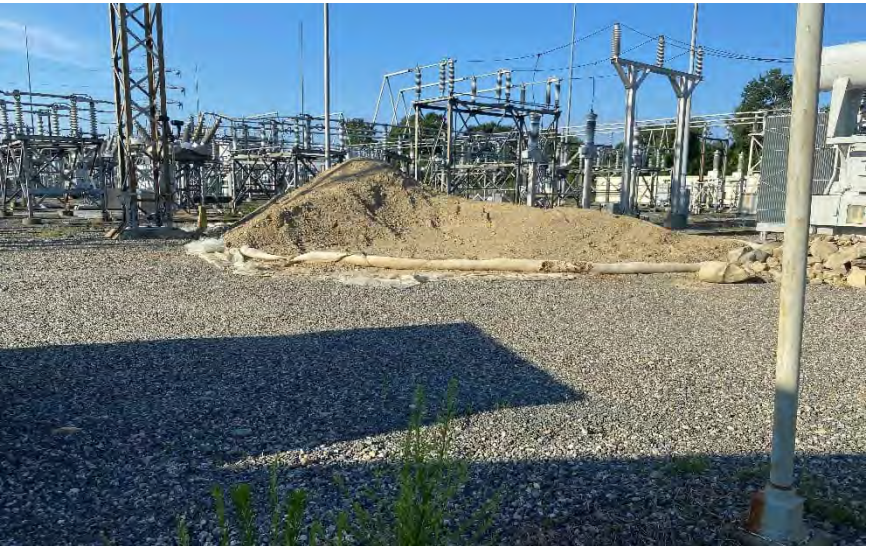
<p>PHOTOGRAPHIC LOG</p>	
<p>Client Name: Eversource</p>		<p>Site Location: Sudbury to Hudson Transmission Reliability Project</p>	<p>Town: Sudbury</p>
<p>Photo No.: 6</p>	<p>Date: 7-17-24</p>

<p>Description:</p> <p>Work area within substation, newly placed spoil pile, existing erosion control (compost tubing), looking southward.</p>

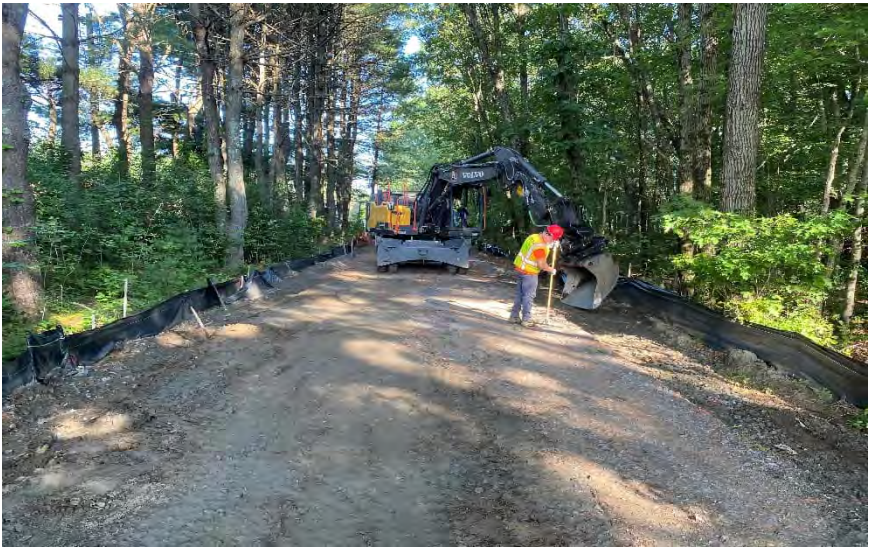
<p>PHOTOGRAPHIC LOG</p>	
<p>Client Name: Eversource</p>		<p>Site Location: Sudbury to Hudson Transmission Reliability Project</p>	<p>Town: Sudbury</p>
<p>Photo No.: 8</p>	<p>Date: 7-17-24</p>

<p>Description:</p> <p>Work area within segment 11, loam being added to work area shoulders, existing erosion control, looking westward.</p>

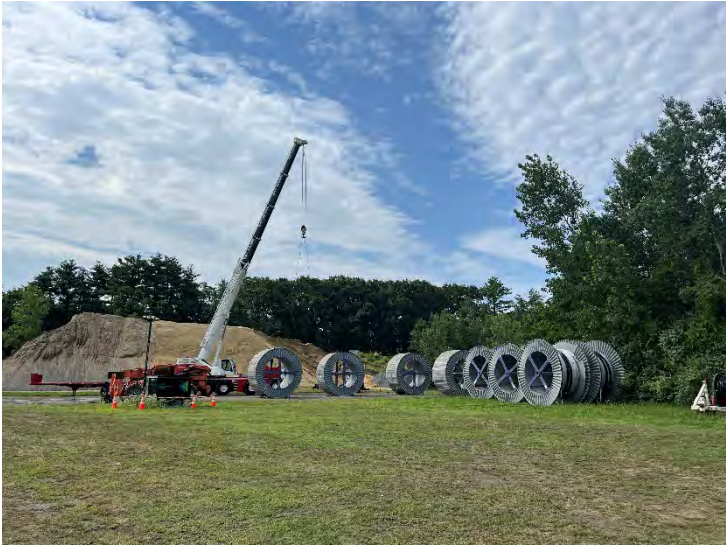
<p>PHOTOGRAPHIC LOG</p>	
<p>Client Name: Eversource</p>		<p>Site Location: Sudbury to Hudson Transmission Reliability Project</p>	<p>Town: Hudson</p>
<p>Photo No.: 5</p>	<p>Date: 7-18-24</p>

<p>Description: View of stored cable reels. Haugland and New Wave active within laydown yard. Facing south.</p>

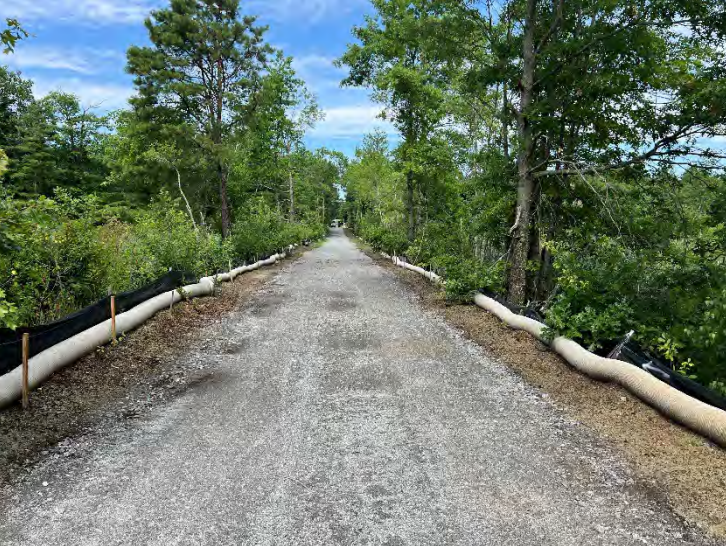
<p>PHOTOGRAPHIC LOG</p>	
<p>Client Name: Eversource</p>		<p>Site Location: Sudbury to Hudson Transmission Reliability Project</p>	<p>Town: Hudson</p>
<p>Photo No.: 6</p>	<p>Date: 7-18-24</p>

<p>Description: View of E&S controls in segment 2. Facing west.</p>

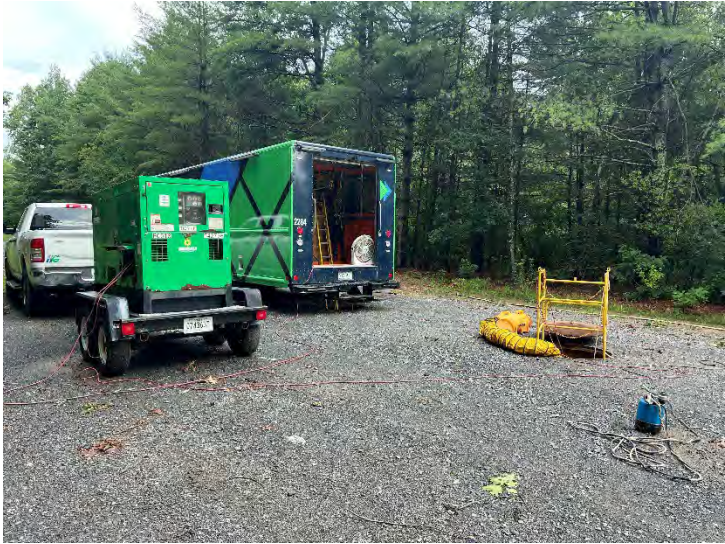
<p>PHOTOGRAPHIC LOG</p>	
<p>Client Name: Eversource</p>		<p>Site Location: Sudbury to Hudson Transmission Reliability Project</p>	<p>Town: Hudson</p>
<p>Photo No.: 7</p>	<p>Date: 7-18-24</p>

<p>Description:</p> <p>View of Haugland work area splicing at MH #7 in segment 2. Facing northwest.</p>

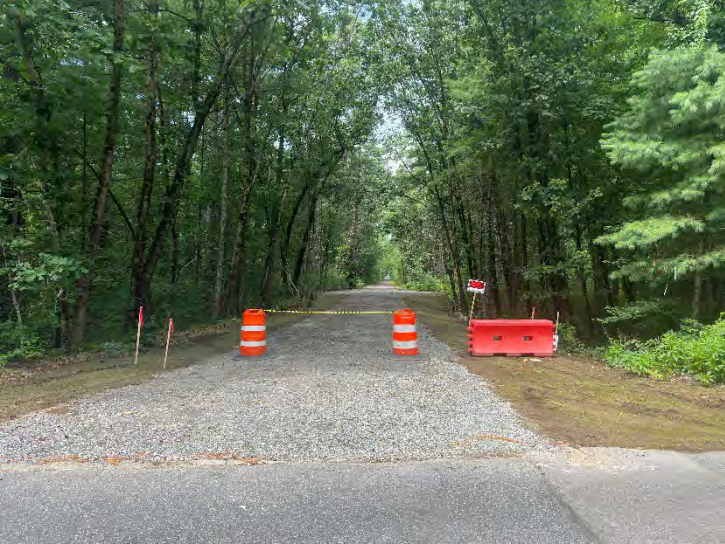
<p>PHOTOGRAPHIC LOG</p>	
<p>Client Name: Eversource</p>		<p>Site Location: Sudbury to Hudson Transmission Reliability Project</p>	<p>Town: Hudson</p>
<p>Photo No.: 8</p>	<p>Date: 7-18-24</p>

<p>Description:</p> <p>View of construction entrance to segment 5. Facing west.</p>

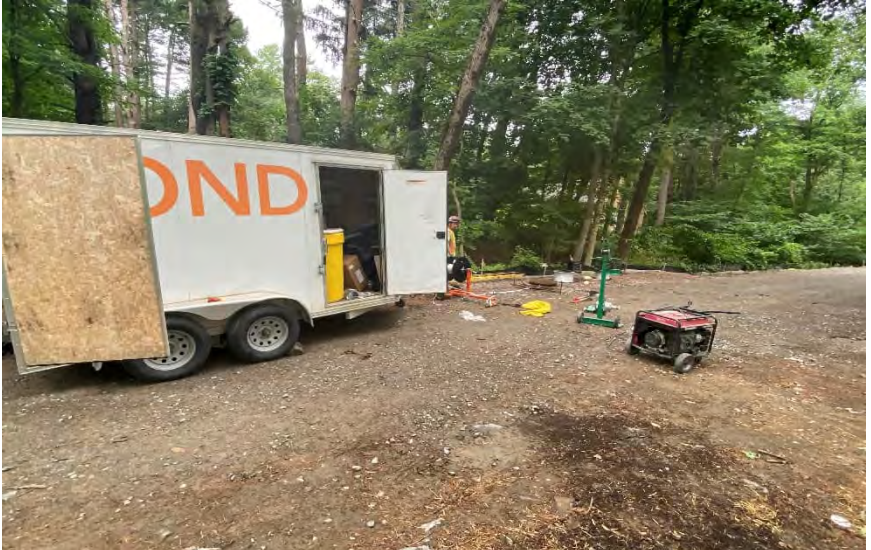
PHOTOGRAPHIC LOG	
Client Name: Eversource		Site Location: Sudbury to Hudson Transmission Reliability Project	Town: Sudbury
Photo No.: 4	Date: 7-18-24

Description: Work area within segment 13, hand hole #25, proofing of handhole, existing erosion control, looking westward.

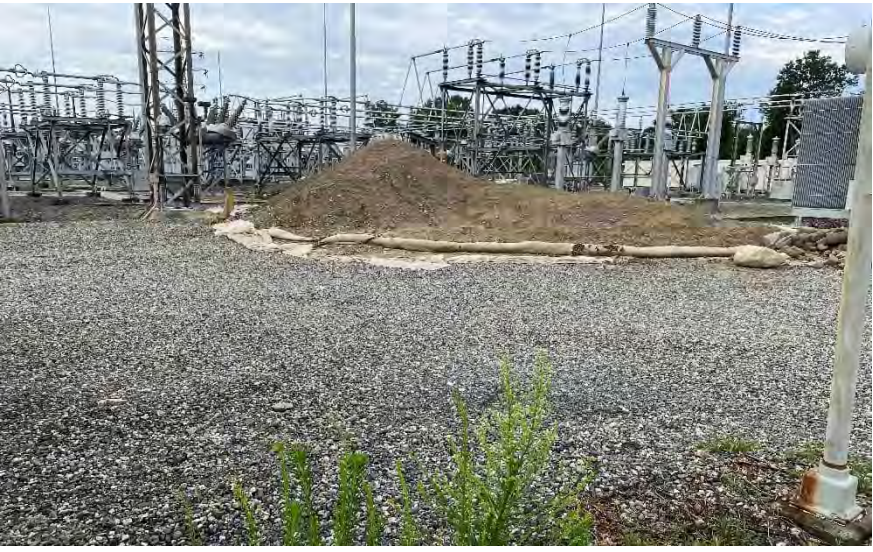
<p align="right">PHOTOGRAPHIC LOG</p>	
Client Name: Eversource		Site Location: Sudbury to Hudson Transmission Reliability Project	Town: Sudbury
Photo No.: 6	Date: 7-18-24

Description: Work area within substation, newly placed spoil pile, existing erosion control (compost tubing), looking southward.

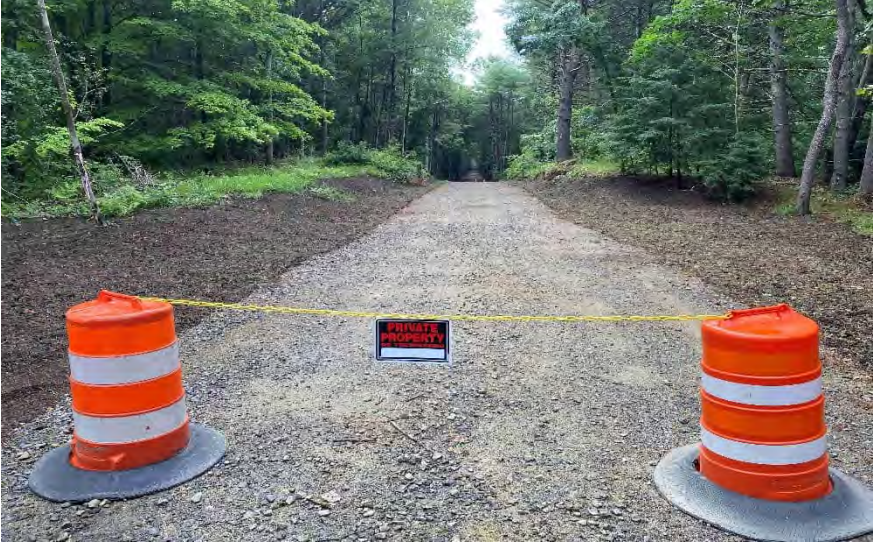
<p>PHOTOGRAPHIC LOG</p>	
<p>Client Name: Eversource</p>		<p>Site Location: Sudbury to Hudson Transmission Reliability Project</p>	<p>Town: Sudbury</p>
<p>Photo No.: 7</p>	<p>Date: 7-18-24</p>

<p>Description:</p> <p>Work area within segment 9, recently placed loam, existing erosion control, looking eastward.</p>

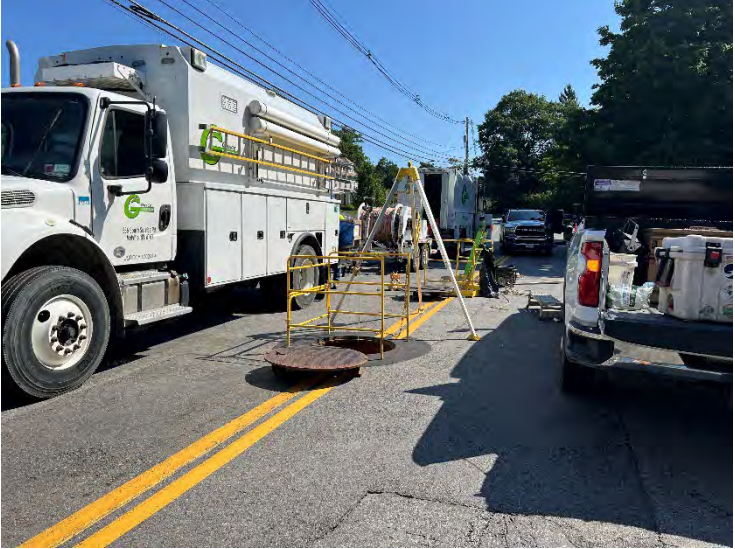
<p align="right">PHOTOGRAPHIC LOG</p>	
Client Name: Eversource		Site Location: Sudbury to Hudson Transmission Reliability Project	Town: Hudson
Photo No.: 1	Date: 7-19-24

Description: View of Haugland cable pullers at MH #3 on Forest Ave. Crew racking within MH in preparation for swabbing and installing cable. See additional dewatering report. Facing northeast.

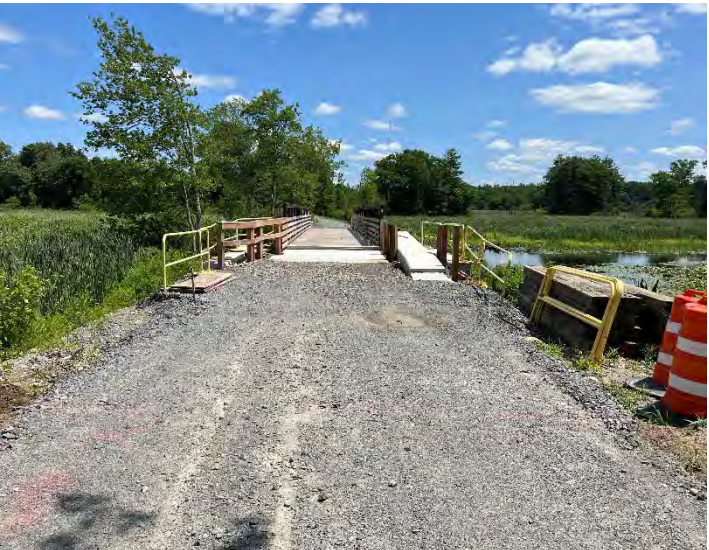
<p align="right">PHOTOGRAPHIC LOG</p>	
Client Name: Eversource		Site Location: Sudbury to Hudson Transmission Reliability Project	Town: Hudson
Photo No.: 2	Date: 7-19-24

Description: View of Bridge 130. Facing east.

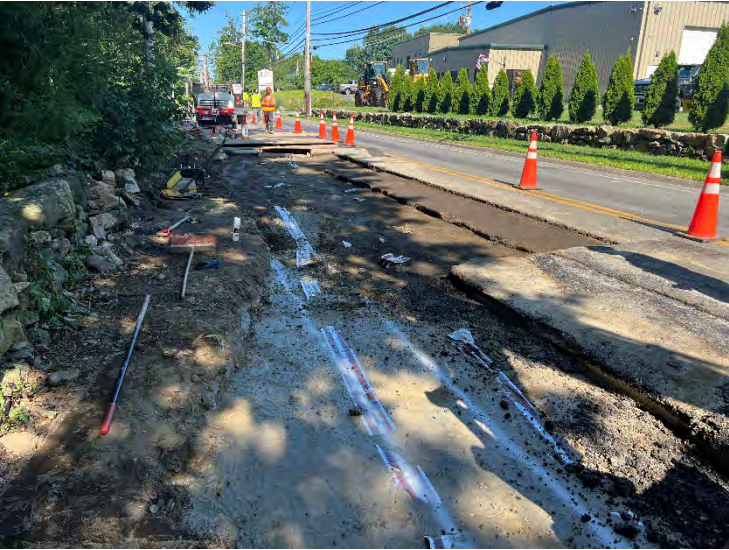
<p>PHOTOGRAPHIC LOG</p>	
<p>Client Name: Eversource</p>		<p>Site Location: Sudbury to Hudson Transmission Reliability Project</p>	<p>Town: Hudson</p>
<p>Photo No.: 3</p>	<p>Date: 7-19-24</p>

<p>Description:</p> <p>View of Bond work area on Forest Ave by MH #2 paving. Facing west.</p>

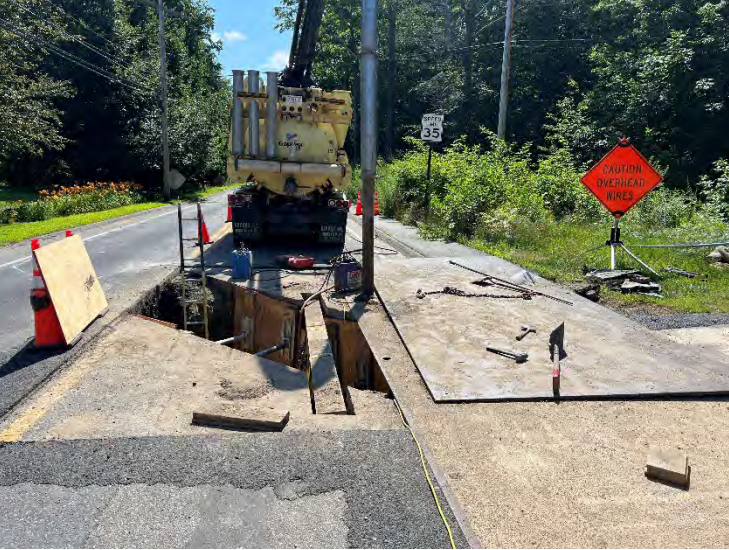
<p>PHOTOGRAPHIC LOG</p>	
<p>Client Name: Eversource</p>		<p>Site Location: Sudbury to Hudson Transmission Reliability Project</p>	<p>Town: Hudson</p>
<p>Photo No.: 4</p>	<p>Date: 7-19-24</p>

<p>Description:</p> <p>View of Bond work area by MH #1 within Forest Ave. See additional dewatering report. Facing east.</p>

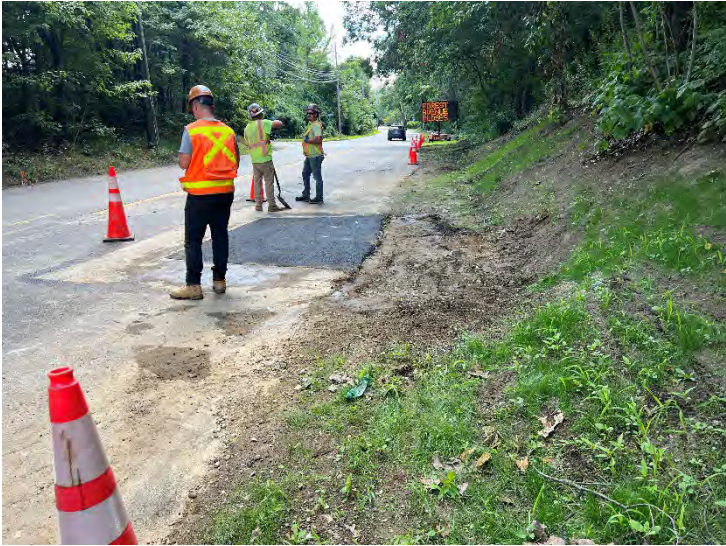
<p>PHOTOGRAPHIC LOG</p>	
<p>Client Name: Eversource</p>		<p>Site Location: Sudbury to Hudson Transmission Reliability Project</p>	<p>Town: Hudson</p>
<p>Photo No.: 5</p>	<p>Date: 7-19-24</p>

<p>Description: View of paving on Wilkins Street by entrance to segment 1. Facing southwest.</p>

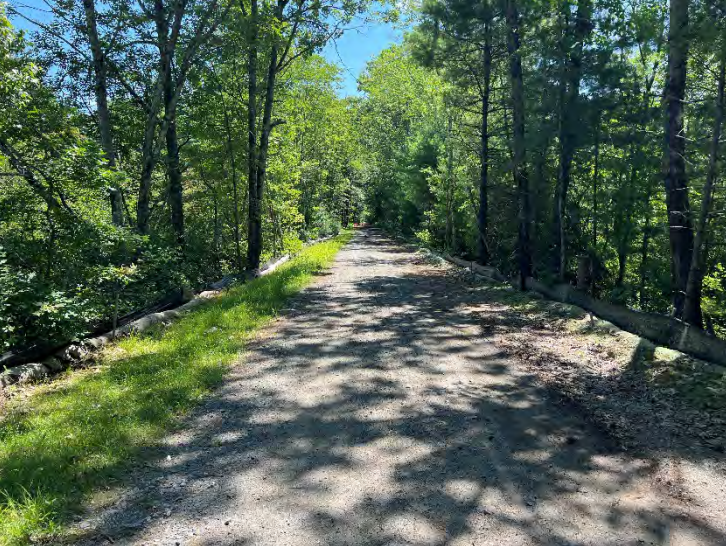
<p>PHOTOGRAPHIC LOG</p>	
<p>Client Name: Eversource</p>		<p>Site Location: Sudbury to Hudson Transmission Reliability Project</p>	<p>Town: Hudson</p>
<p>Photo No.: 6</p>	<p>Date: 7-19-24</p>

<p>Description: View of E&S controls in segment 5. Facing east.</p>

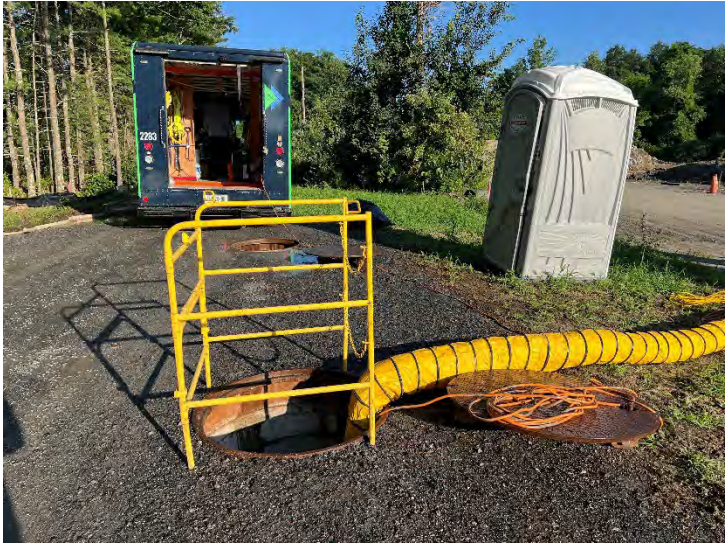
<p>PHOTOGRAPHIC LOG</p>	
<p>Client Name: Eversource</p>		<p>Site Location: Sudbury to Hudson Transmission Reliability Project</p>	<p>Town: Hudson</p>
<p>Photo No.: 7</p>	<p>Date: 7-19-24</p>

<p>Description:</p> <p>View of Haugland work area splicing at MH #7 in segment 2. Facing east.</p>

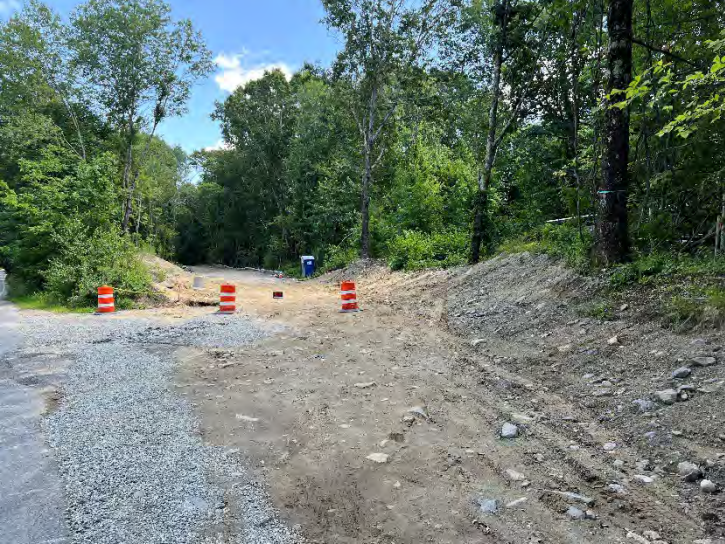
<p>PHOTOGRAPHIC LOG</p>	
<p>Client Name: Eversource</p>		<p>Site Location: Sudbury to Hudson Transmission Reliability Project</p>	<p>Town: Hudson</p>
<p>Photo No.: 8</p>	<p>Date: 7-19-24</p>

<p>Description:</p> <p>View of construction entrance to segment 1. Facing east.</p>

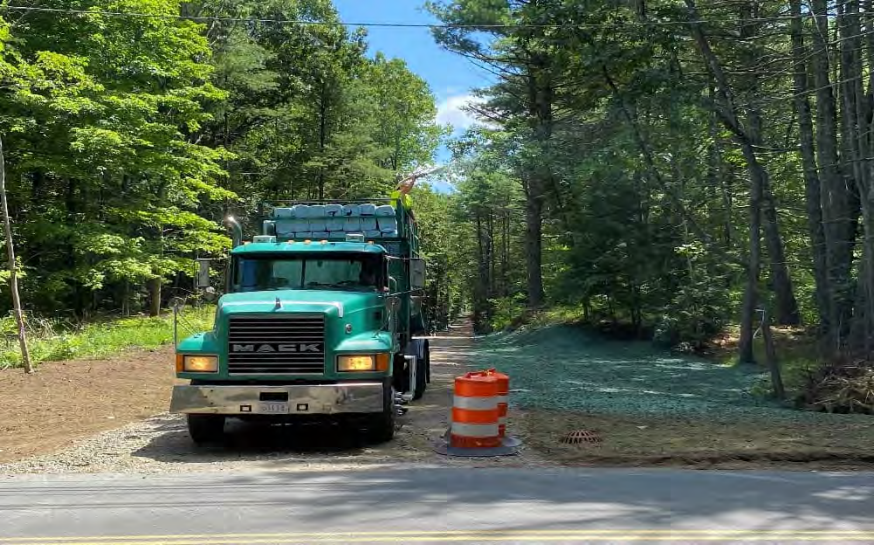
<p>PHOTOGRAPHIC LOG</p>	
<p>Client Name: Eversource</p>		<p>Site Location: Sudbury to Hudson Transmission Reliability Project</p>	<p>Town: Sudbury</p>
<p>Photo No.: 1</p>	<p>Date: 7-19-24</p>

<p>Description:</p> <p>Work area within segment 10, hydroseeding, looking eastward.</p>

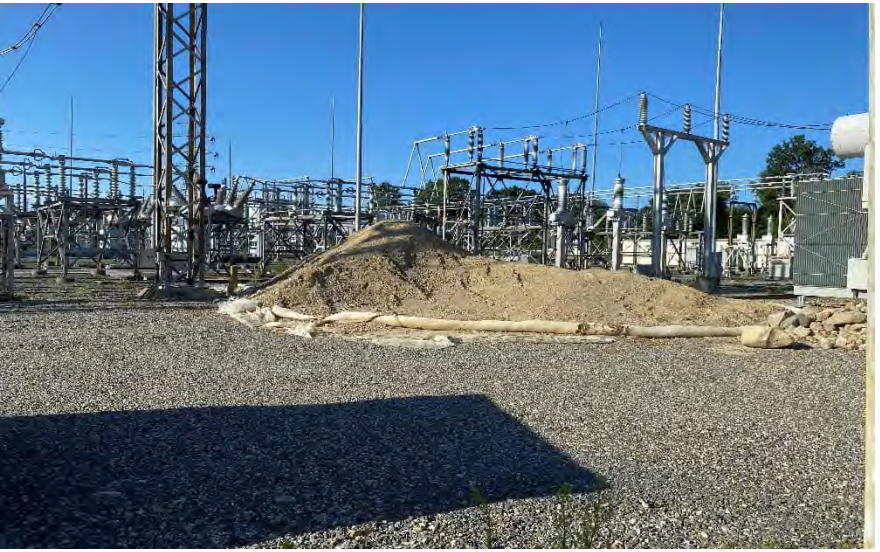
PHOTOGRAPHIC LOG	
Client Name: Eversource		Site Location: Sudbury to Hudson Transmission Reliability Project	Town: Sudbury
Photo No.: 6	Date: 7-19-24

Description: Work area within substation, newly placed spoil pile, existing erosion control (compost tubing), looking southward.

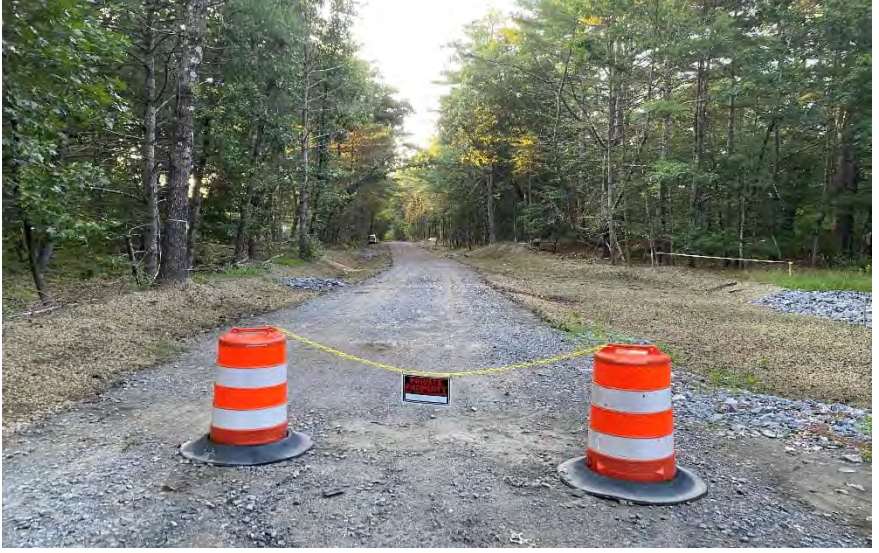
PHOTOGRAPHIC LOG	
Client Name: Eversource		Site Location: Sudbury to Hudson Transmission Reliability Project	Town: Sudbury
Photo No.: 7	Date: 7-19-24

Description: Work area within segment 9, recently placed loam, existing erosion control, looking eastward.

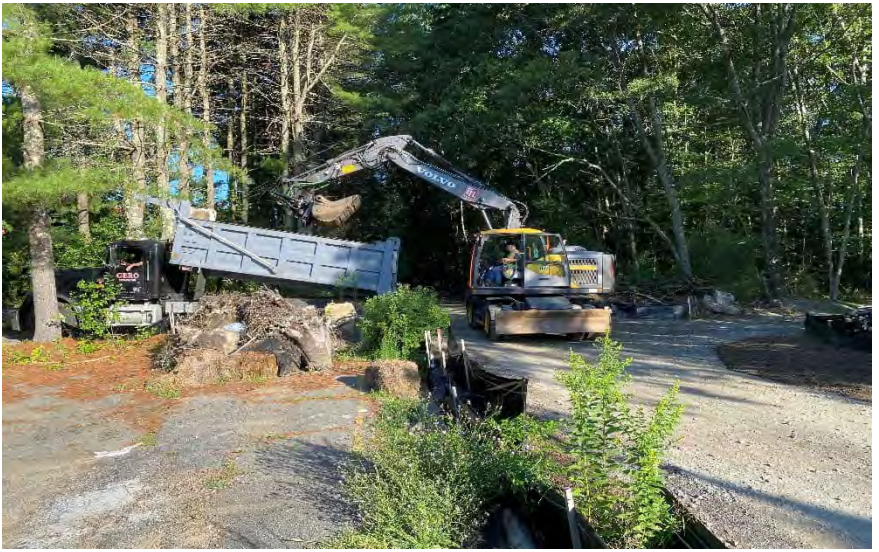
PHOTOGRAPHIC LOG	
Client Name: Eversource		Site Location: Sudbury to Hudson Transmission Reliability Project	Town: Sudbury
Photo No.: 8	Date: 7-19-24

Description: Work area within segment 11, loam being added to work area shoulders, existing erosion control, looking westward.

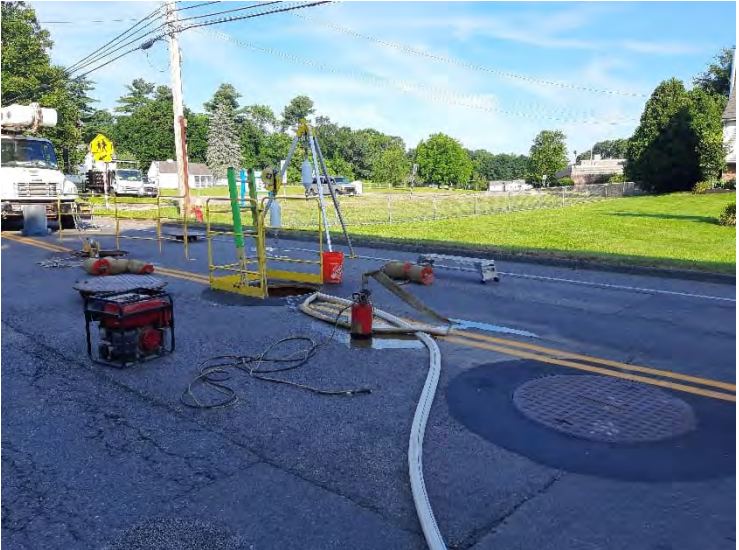
<p>PHOTOGRAPHIC LOG</p>	
<p>Client Name: Eversource</p>		<p>Site Location: Sudbury to Hudson Transmission Reliability Project</p>	<p>Town: Hudson</p>
<p>Photo No.: 1</p>	<p>Date: 7-20-24</p>

<p>Description:</p> <p>Work area at manhole #3 (Forest Ave near Forest Ave Elementary School). Haugland swabbing and mandreling to manhole #4, looking westward.</p>

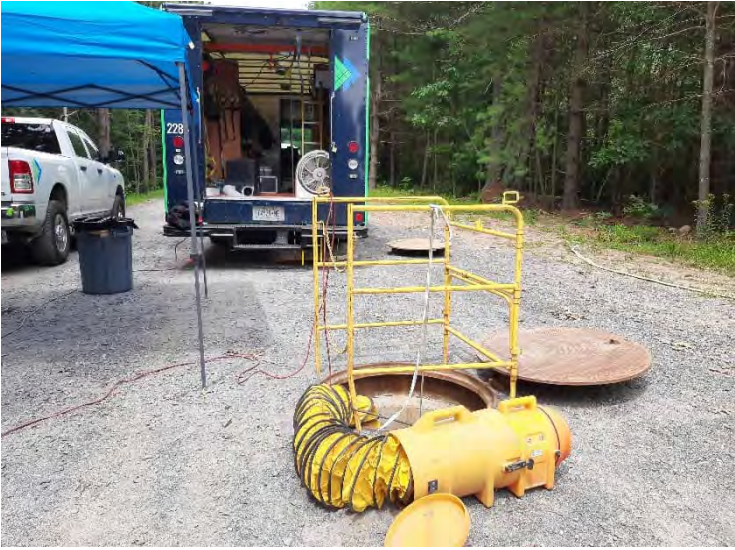
<p>PHOTOGRAPHIC LOG</p>	
<p>Client Name: Eversource</p>		<p>Site Location: Sudbury to Hudson Transmission Reliability Project</p>	<p>Town: Hudson</p>
<p>Photo No.: 3</p>	<p>Date: 7-20-24</p>

<p>Description:</p> <p>Haugland crimping and splicing at manhole #7 (segment 2), looking westward.</p>

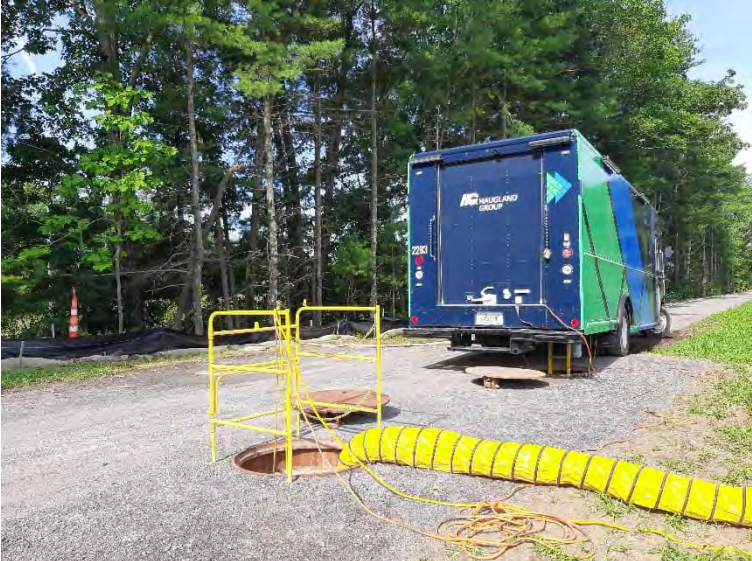
<p>PHOTOGRAPHIC LOG</p>	
<p>Client Name: Eversource</p>		<p>Site Location: Sudbury to Hudson Transmission Reliability Project</p>	<p>Town: Hudson</p>
<p>Photo No.: 4</p>	<p>Date: 7-20-24</p>

<p>Description:</p> <p>Haugland crimping and splicing at manhole #8 (segment 3). Looking westward.</p>

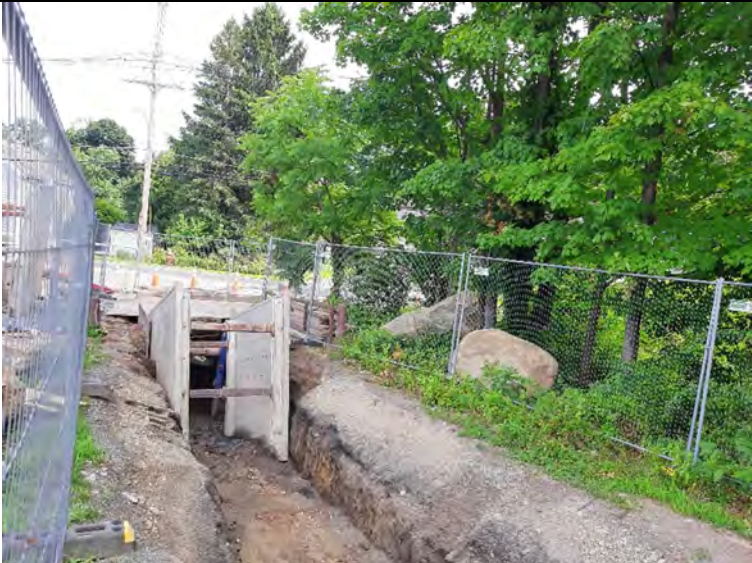
<p>PHOTOGRAPHIC LOG</p>	
<p>Client Name: Eversource</p>		<p>Site Location: Sudbury to Hudson Transmission Reliability Project</p>	<p>Town: Hudson</p>
<p>Photo No.: 6</p>	<p>Date: 7-20-24</p>

<p>Description:</p> <p>Manhole #1 work area (near Hudson Light and Power). Work area inactive for the weekend, over-weekend dewatering, looking northward.</p>

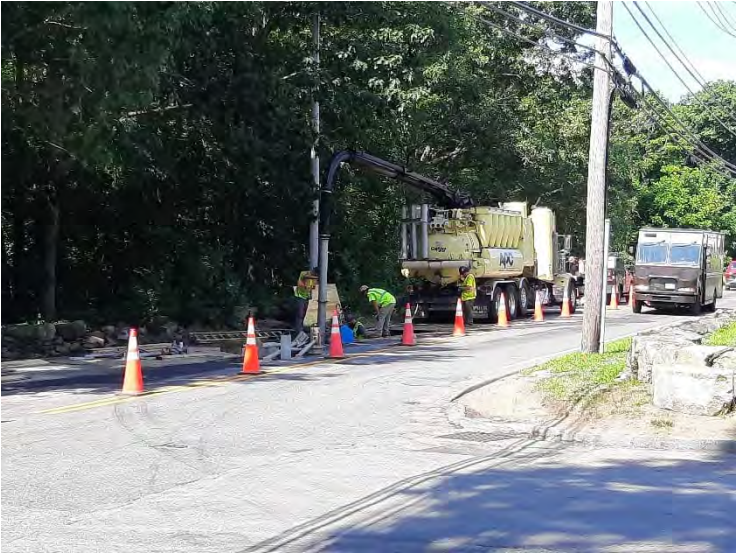
PHOTOGRAPHIC LOG	
Client Name: Eversource		Site Location: Sudbury to Hudson Transmission Reliability Project	Town: Hudson
Photo No.: 3	Date: 7-16-24

Description: Work area in Forest Ave between MH #2 and MH #1, near Bonazzoli Ave, installing conduit. Looking westward.

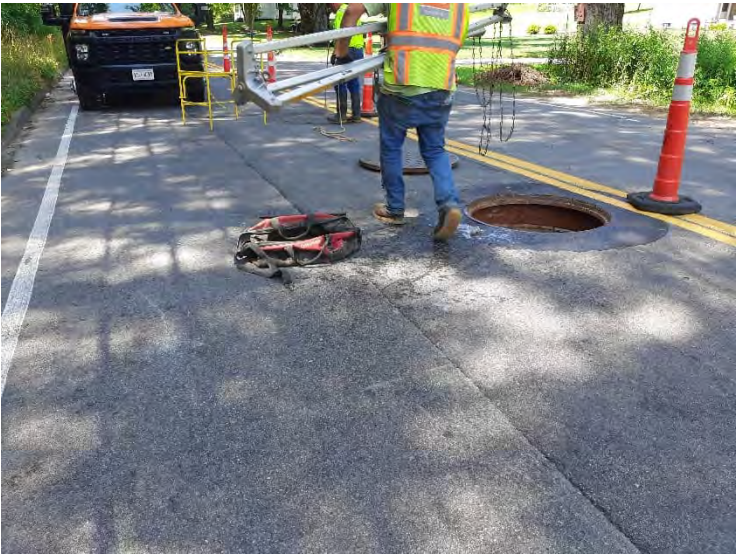
PHOTOGRAPHIC LOG	
Client Name: Eversource		Site Location: Sudbury to Hudson Transmission Reliability Project	Town: Hudson
Photo No.: 4	Date: 7-16-24

Description: Work area at MH #4 near 156 Forest Ave, temporary work zone to assist conduit clearing activities stationed at MH #5. Looking southward.

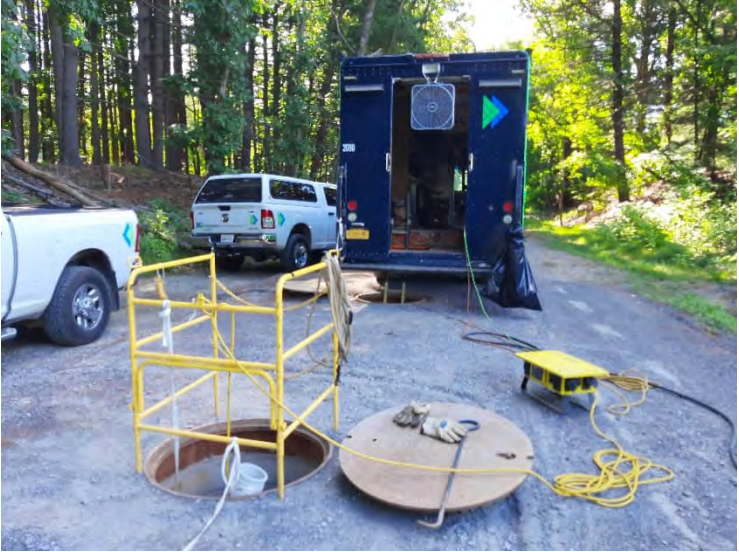
Client Name: Eversource		Site Location: Sudbury to Hudson Transmission Reliability Project	Town: Hudson
Photo No.: 11	Date: 7-16-24

Description: Work area at MH #9 (segment 3), crimping and splicing, looking eastward.

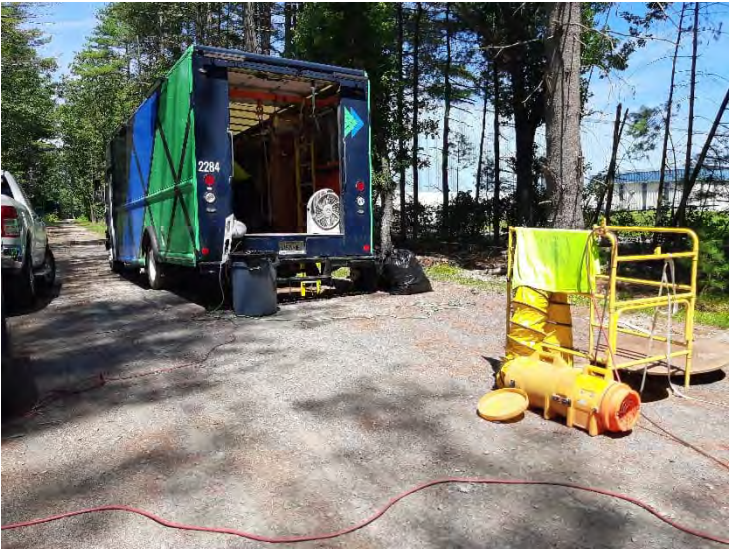
PHOTOGRAPHIC LOG	
Client Name: Eversource		Site Location: Sudbury to Hudson Transmission Reliability Project	Town: Hudson
Photo No.: 12	Date: 7-16-24

Description: Work area at MH #10 (segment 4), crimping and splicing, looking westward.

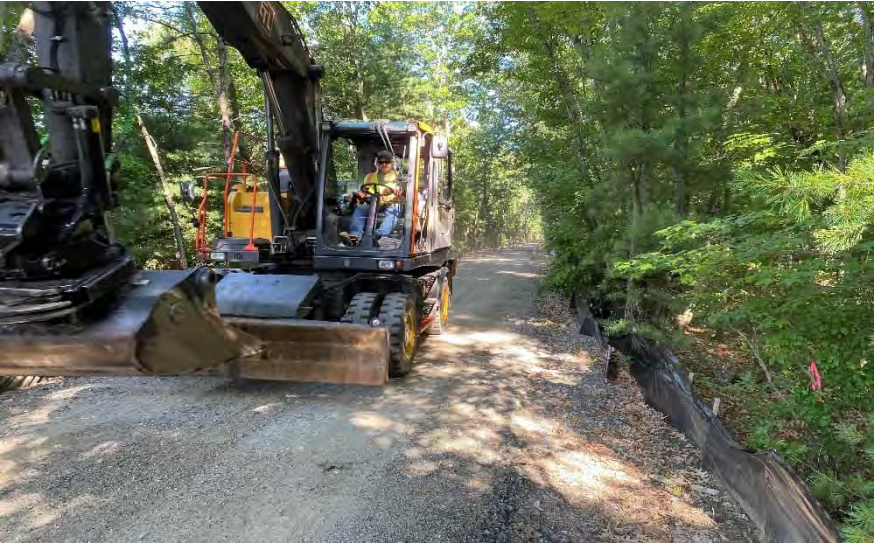
PHOTOGRAPHIC LOG	
Client Name: Eversource		Site Location: Sudbury to Hudson Transmission Reliability Project	Town: Sudbury
Photo No.: 1	Date: 7-16-24

Description: Work area within segment 11, adding loam to shoulders, looking westward.
