Weekly Environmental Compliance Summary

Sudbury to Hudson Transmission Reliability Project (USEPA Tracking # MAR1003UW)

Week of: July 15, 2024 to July 20, 2024

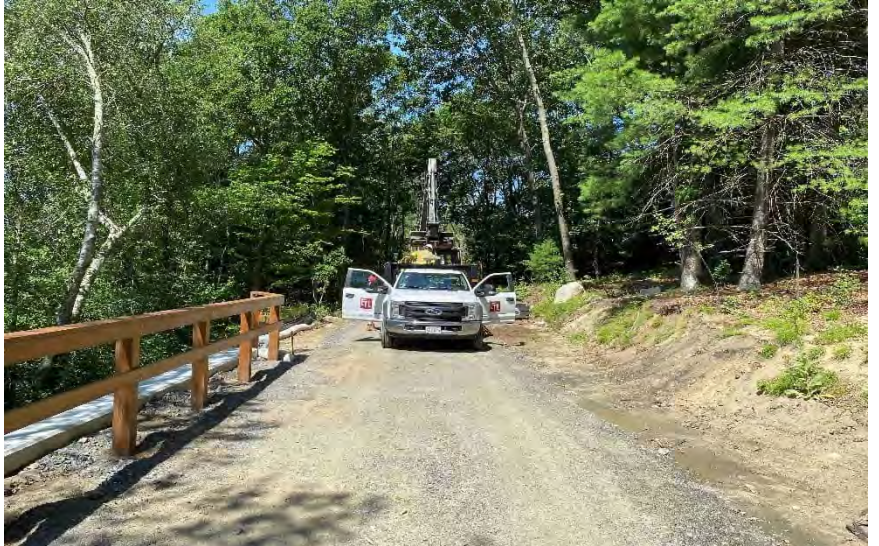
PHOTOGRAPHIC LOG	
Client Name: Eversource		Site Location: Sudbury to Hudson Transmission Reliability Project	Town: Sudbury
Photo No.: 2	Date: 7-16-24

Description: Work area within segment 14, cleanup, existing erosion control, looking westward.

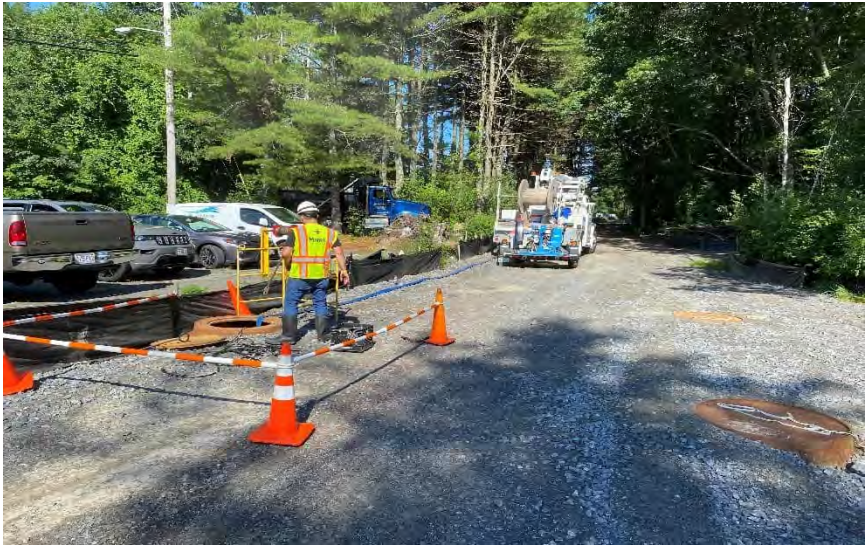
PHOTOGRAPHIC LOG	
Client Name: Eversource		Site Location: Sudbury to Hudson Transmission Reliability Project	Town: Sudbury
Photo No.: 3	Date: 7-16-24

Description: Work area within segment 11 (handhole #24), fiber optic work, existing erosion control, looking westward.

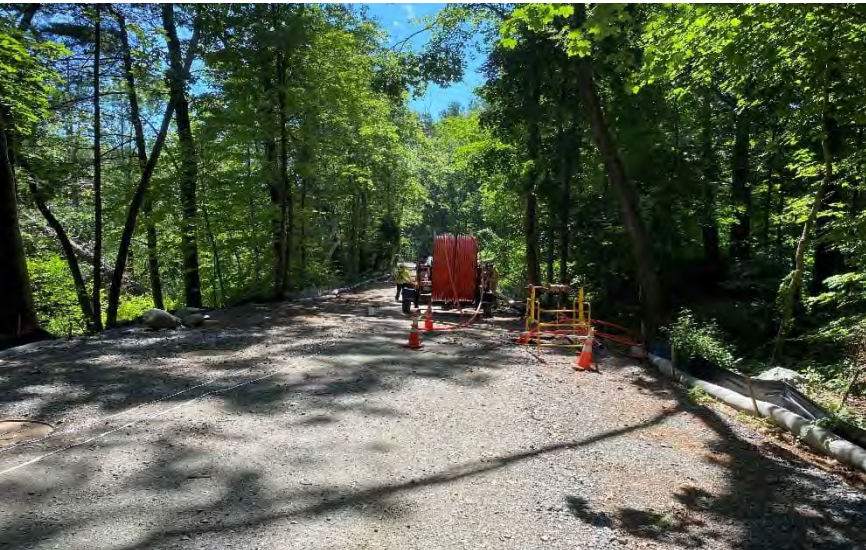
PHOTOGRAPHIC LOG	
Client Name: Eversource		Site Location: Sudbury to Hudson Transmission Reliability Project	Town: Sudbury
Photo No.: 4	Date: 7-16-24

Description: Work area within segment 13 (handhole #25), fiber optic work, existing erosion control, looking eastward.

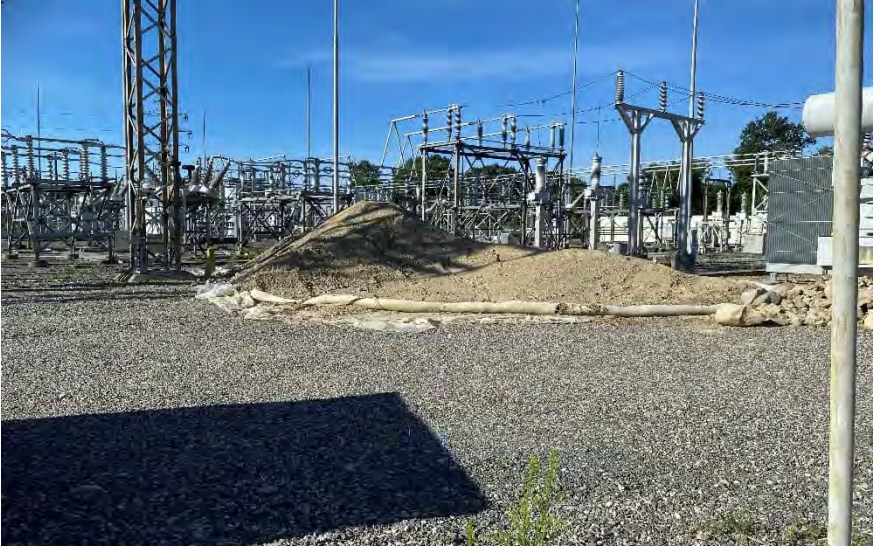
PHOTOGRAPHIC LOG	
Client Name: Eversource		Site Location: Sudbury to Hudson Transmission Reliability Project	Town: Sudbury
Photo No.: 5	Date: 7-16-24

Description: Work area within substation, spoil pile with compost tubes surrounding pile, looking southward.

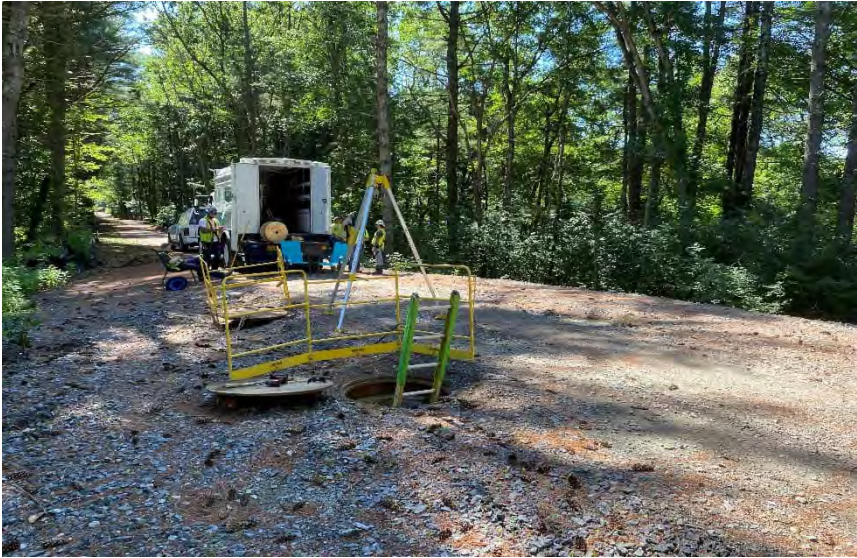
PHOTOGRAPHIC LOG	
Client Name: Eversource		Site Location: Sudbury to Hudson Transmission Reliability Project	Town: Sudbury
Photo No.: 7	Date: 7-16-24

Description: Work area within segment 9, manhole #19 area, splicing activity, existing erosion control, looking eastward.

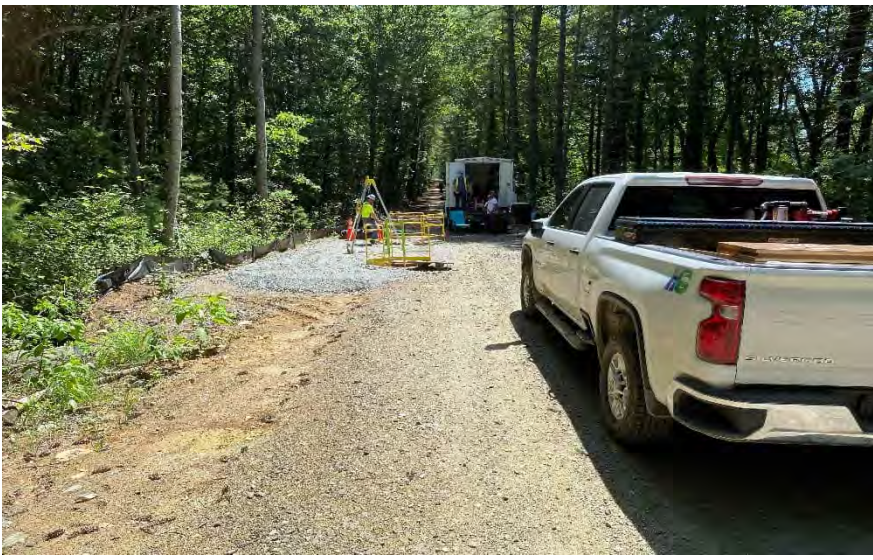
PHOTOGRAPHIC LOG	
Client Name: Eversource		Site Location: Sudbury to Hudson Transmission Reliability Project	Town: Sudbury
Photo No.: 8	Date: 7-16-24

Description: Work area within segment 10, manhole #20 area, splicing activity, existing erosion control, looking eastward.

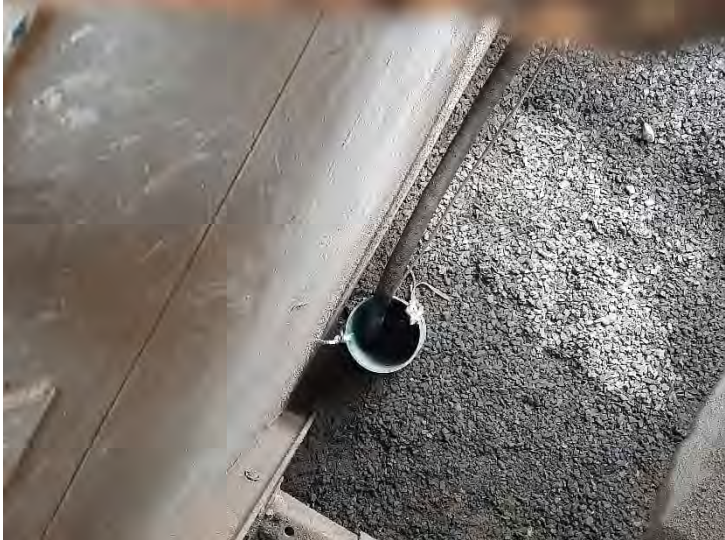
PHOTOGRAPHIC LOG	
Client Name: Eversource		Site Location: Sudbury to Hudson Transmission Reliability Project	Town: Hudson
Photo No.: 1	Date: 7/15/2024

Description: View of area being pumped from the trench beside manhole #1, near Hudson Light & Power. Facing southward, looking down through gap in steel plate.

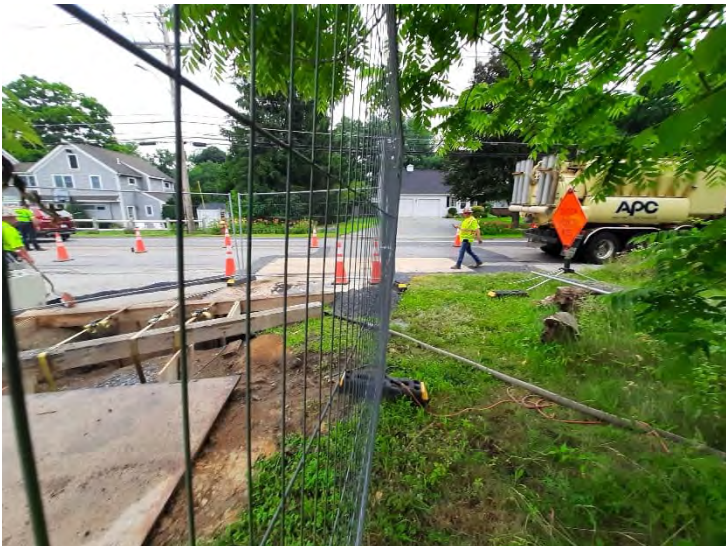
PHOTOGRAPHIC LOG	
Client Name: Eversource		Site Location: Sudbury to Hudson Transmission Reliability Project	Town: Hudson
Photo No.: 2	Date: 7/15/2024

Description: Trench beside manhole #1. View of dewatering operation. Looking northward.

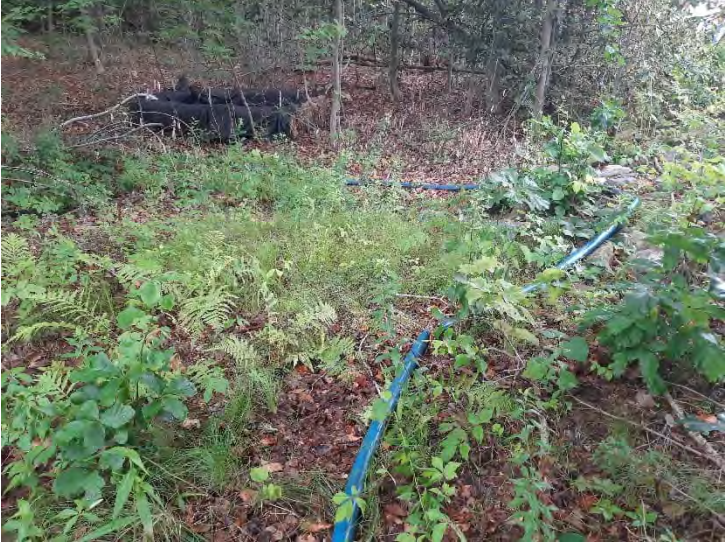
PHOTOGRAPHIC LOG	
Client Name: Eversource		Site Location: Sudbury to Hudson Transmission Reliability Project	
Town: Hudson			
Photo No.: 3	Date: 7/15/2024

Description: View of dewatering operation associated with trench by manhole #1, looking southward.

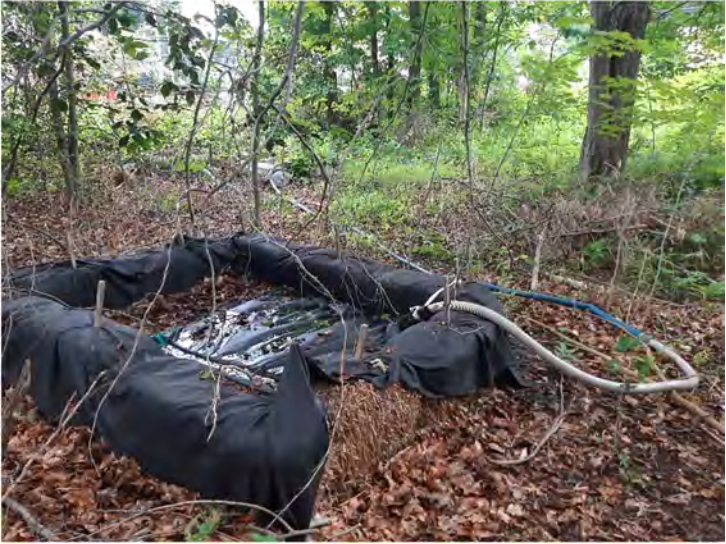
PHOTOGRAPHIC LOG	
Client Name: Eversource		Site Location: Sudbury to Hudson Transmission Reliability Project	
Town: Hudson			
Photo No.: 4	Date: 7/15/2024

Description: Dewatering setup associated with trench near manhole #1. View of discharge bag/corral, looking northward. No visible discharge of water out of the corral.

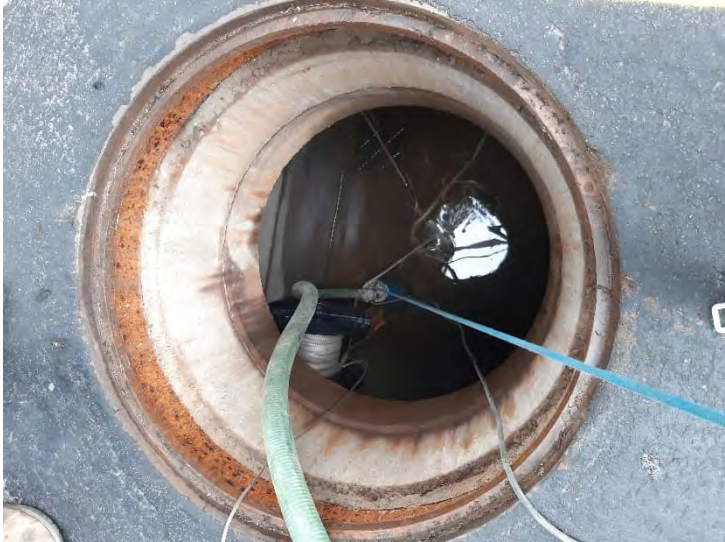
PHOTOGRAPHIC LOG	
Client Name: Eversource		Site Location: Sudbury to Hudson Transmission Reliability Project	Town: Hudson
Photo No.: 1	Date: 7/15/2024

Description: View of area being pumped manhole #4, near 156 Forest Ave. Facing westward, looking down.

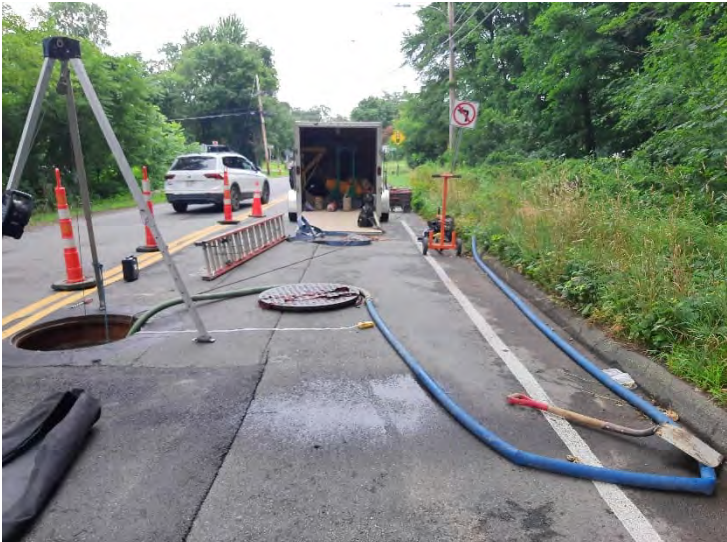
PHOTOGRAPHIC LOG	
Client Name: Eversource		Site Location: Sudbury to Hudson Transmission Reliability Project	Town: Hudson
Photo No.: 2	Date: 7/15/2024

Description: Manhole #4. View of dewatering operation. Looking northward.

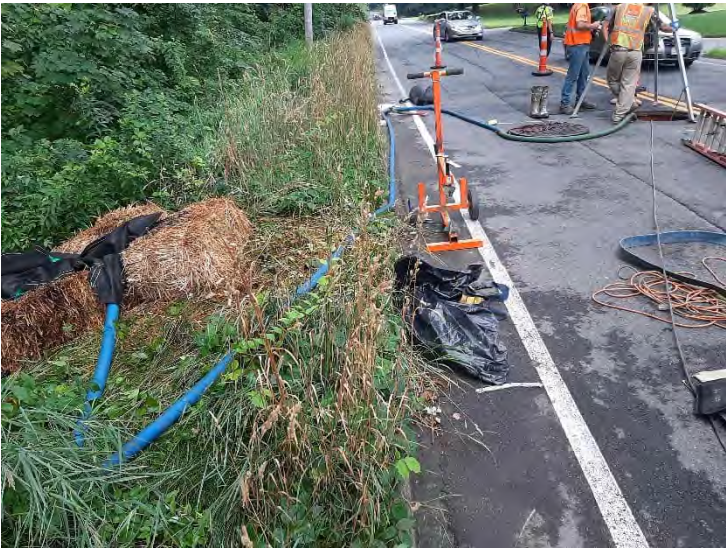
PHOTOGRAPHIC LOG	
Client Name: Eversource		Site Location: Sudbury to Hudson Transmission Reliability Project	
Town: Hudson			
Photo No.: 3	Date: 7/15/2024

Description: Manhole #4. View of dewatering operation. Looking southward

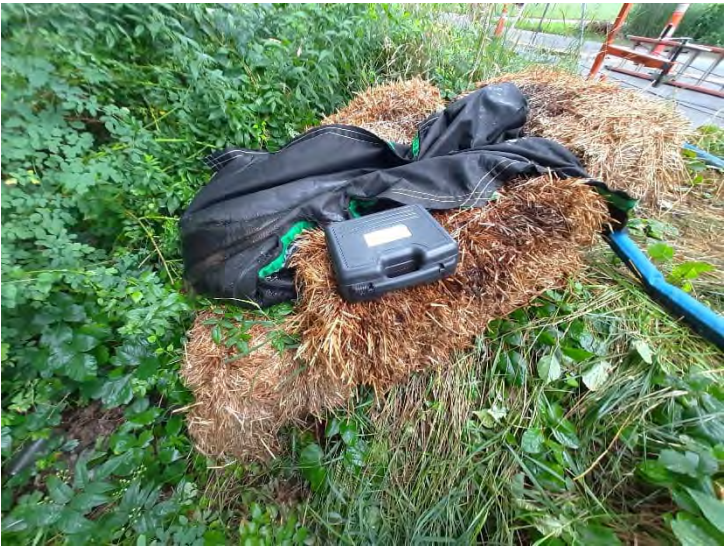
PHOTOGRAPHIC LOG	
Client Name: Eversource		Site Location: Sudbury to Hudson Transmission Reliability Project	
Town: Hudson			
Photo No.: 4	Date: 7/15/2024

Description: Dewatering setup associated with manhole #4. View of discharge bag/corral, looking southward. Water from bag/corral discharging downhill to adjacent area.

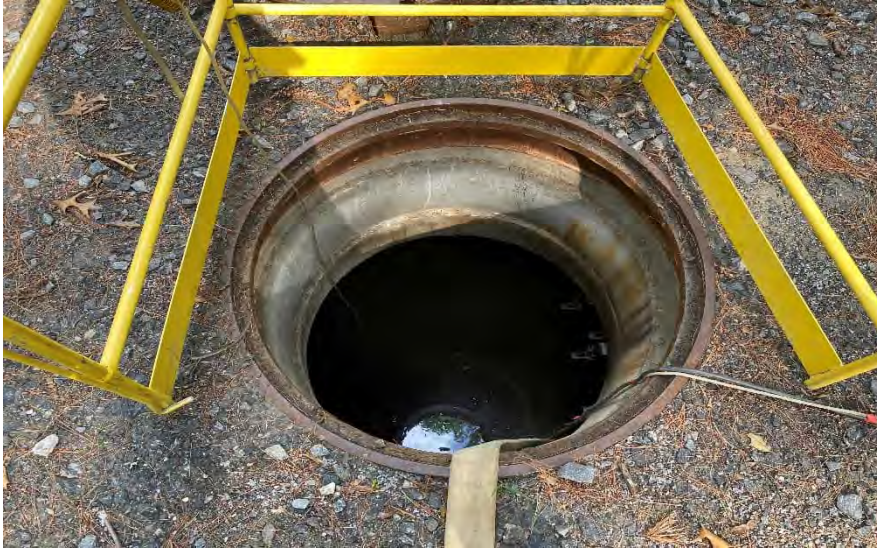
PHOTOGRAPHIC LOG	
Client Name: Eversource		Site Location: Sudbury to Hudson Transmission Reliability Project	Town: Sudbury
Photo No.: 1	Date: 7/15/2024

Description: View of area being pumped from manhole #17, Segment 8.

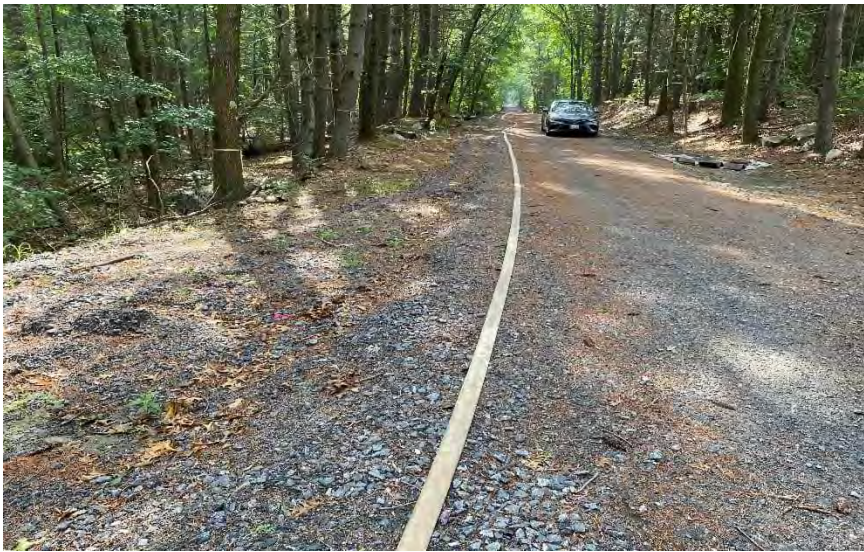
PHOTOGRAPHIC LOG	
Client Name: Eversource		Site Location: Sudbury to Hudson Transmission Reliability Project	Town: Sudbury
Photo No.: 2	Date: 7/15/2024

Description: Manhole #17. View of dewatering operation. Looking eastward.

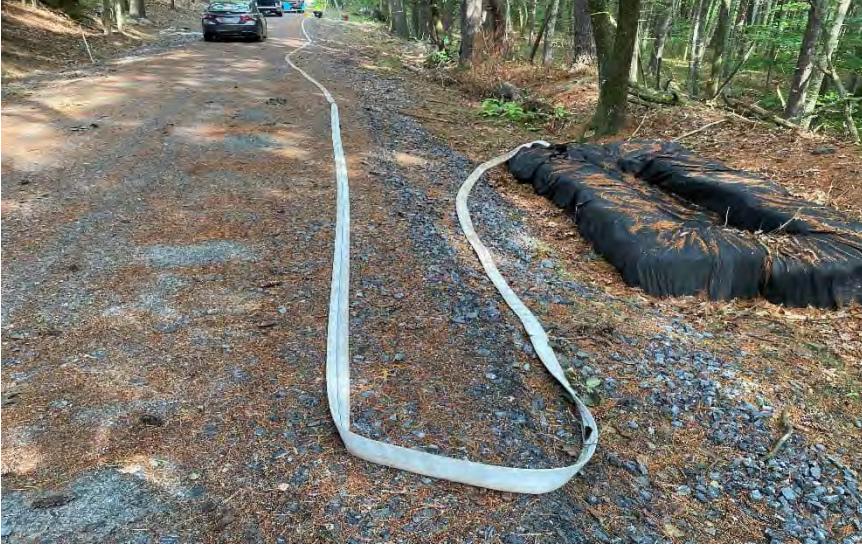
PHOTOGRAPHIC LOG	
Client Name: Eversource		Site Location: Sudbury to Hudson Transmission Reliability Project	Town: Sudbury
Photo No.: 3	Date: 7/15/2024

Description: Manhole #17. View of dewatering operation, looking westward.

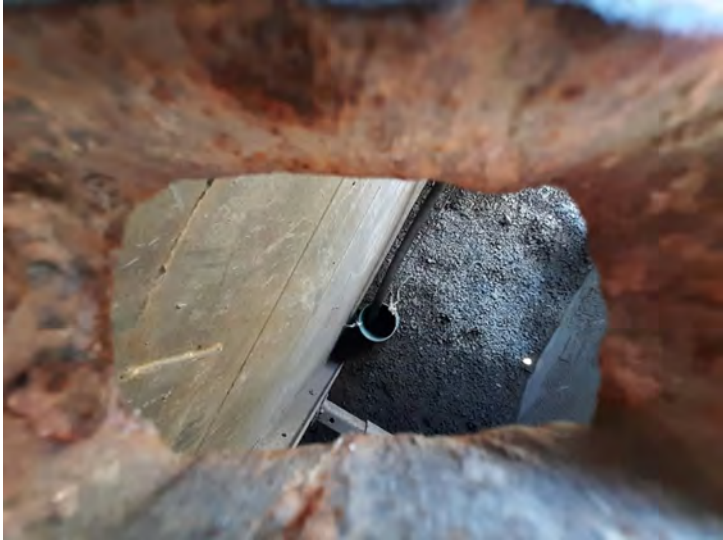
PHOTOGRAPHIC LOG	
Client Name: Eversource		Site Location: Sudbury to Hudson Transmission Reliability Project	Town: Hudson
Photo No.: 1	Date: 7/16/2024

Description: View of area being pumped from the trench beside manhole #1, near Hudson Light & Power. Facing southward, looking down through gap in steel plate.

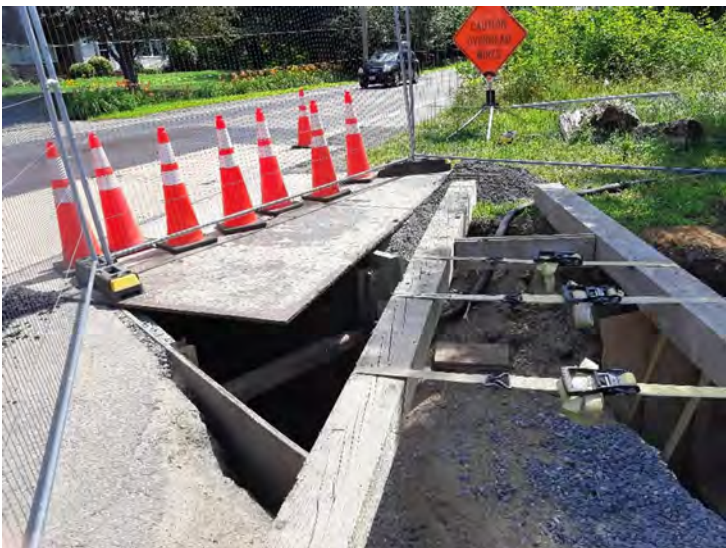
PHOTOGRAPHIC LOG	
Client Name: Eversource		Site Location: Sudbury to Hudson Transmission Reliability Project	Town: Hudson
Photo No.: 2	Date: 7/16/2024

Description: Trench beside manhole #1. View of dewatering operation. Looking eastward.

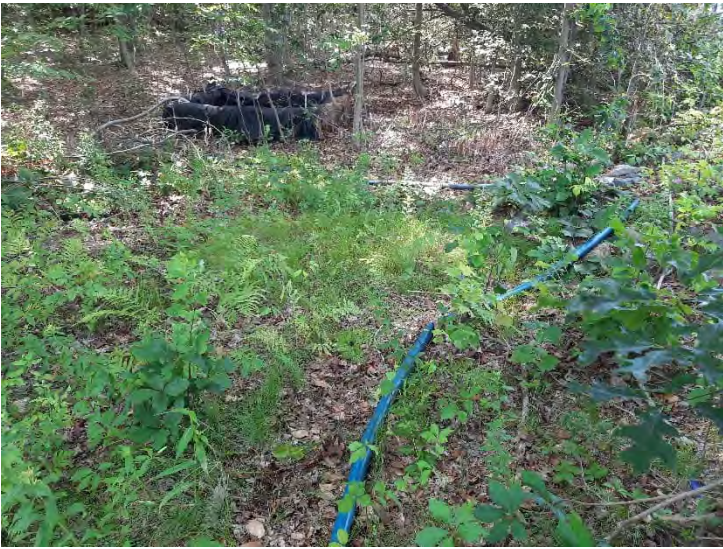
PHOTOGRAPHIC LOG	
Client Name: Eversource		Site Location: Sudbury to Hudson Transmission Reliability Project	Town: Hudson
Photo No.: 3	Date: 7/16/2024

Description: View of dewatering operation associated with trench by manhole #1, looking southward.

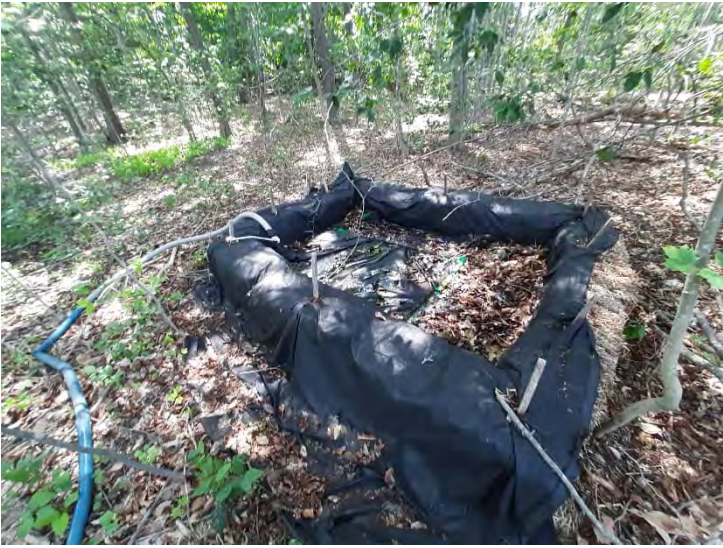
PHOTOGRAPHIC LOG	
Client Name: Eversource		Site Location: Sudbury to Hudson Transmission Reliability Project	Town: Hudson
Photo No.: 4	Date: 7/16/2024

Description: Dewatering setup associated with trench near manhole #1. View of discharge bag/corral, looking southward. No visible discharge of water out of the corral.

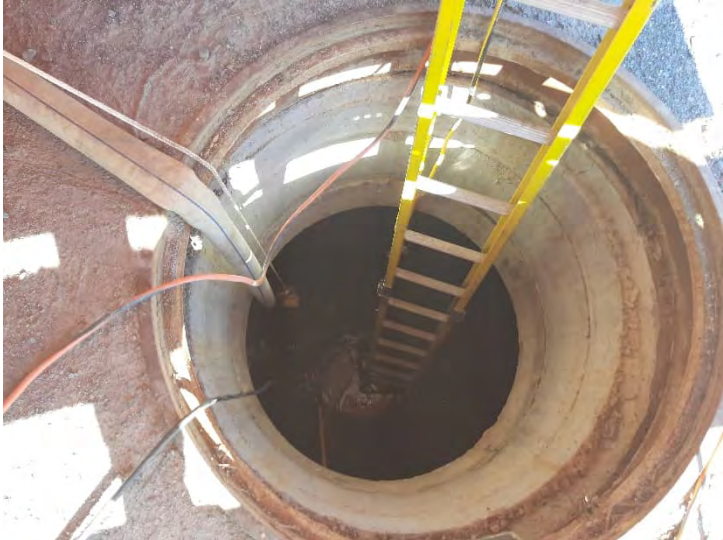
PHOTOGRAPHIC LOG	
Client Name: Eversource		Site Location: Sudbury to Hudson Transmission Reliability Project	Town: Hudson
Photo No.: 1	Date: 7/16/2024

Description: Manhole #8 (segment 3), view of area being dewatered. Facing westward, looking down.

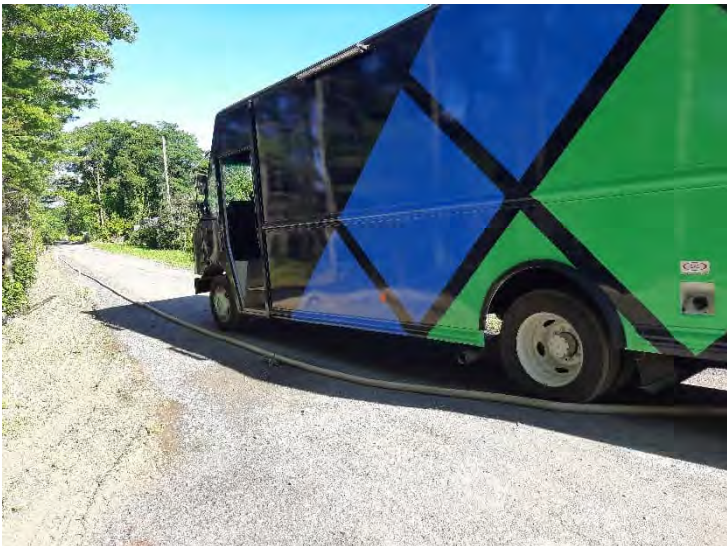
PHOTOGRAPHIC LOG	
Client Name: Eversource		Site Location: Sudbury to Hudson Transmission Reliability Project	Town: Hudson
Photo No.: 2	Date: 7/16/2024

Description: Manhole #8. View of dewatering operation. Looking westward.

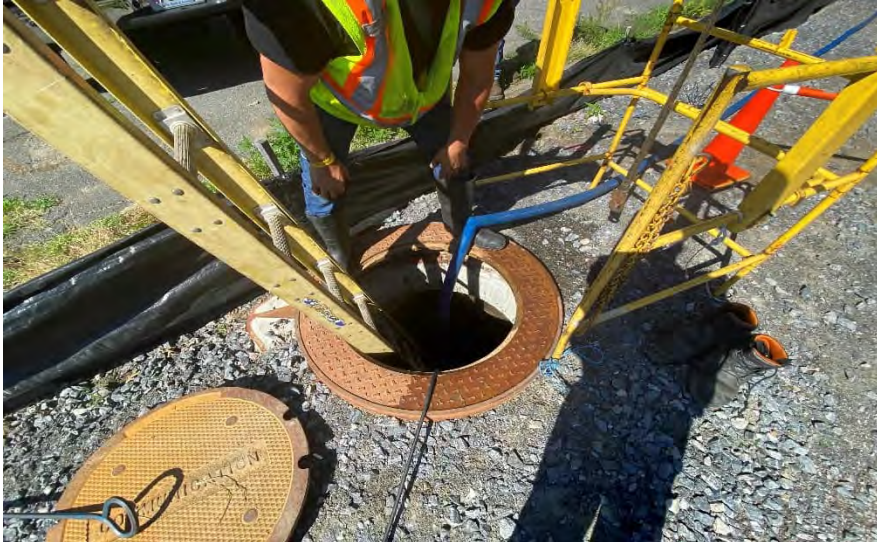
PHOTOGRAPHIC LOG	
Client Name: Eversource		Site Location: Sudbury to Hudson Transmission Reliability Project	Town: Sudbury
Photo No.: 1	Date: 7/16/2024

Description: View of area being pumped from handhole #24, segment 11.

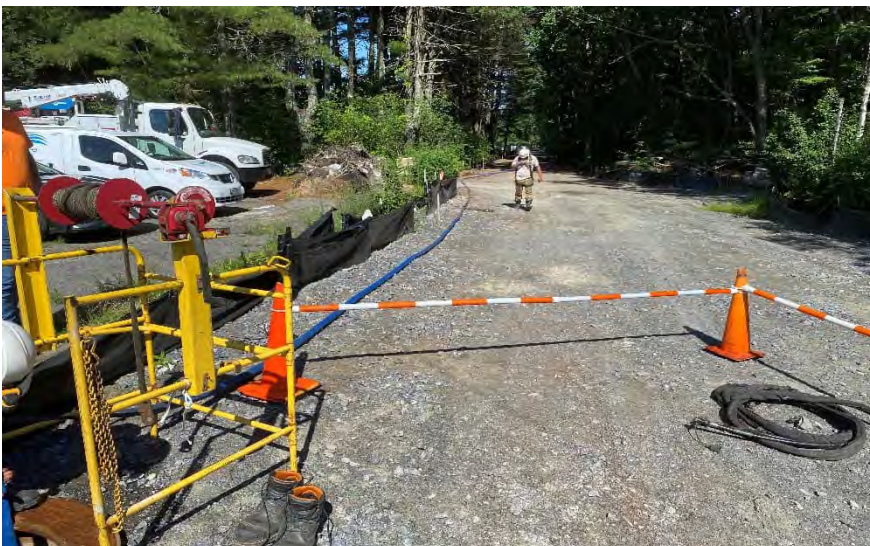
PHOTOGRAPHIC LOG	
Client Name: Eversource		Site Location: Sudbury to Hudson Transmission Reliability Project	Town: Sudbury
Photo No.: 2	Date: 7/16/2024

Description: Handhole #24. View of dewatering operation. Looking westward.

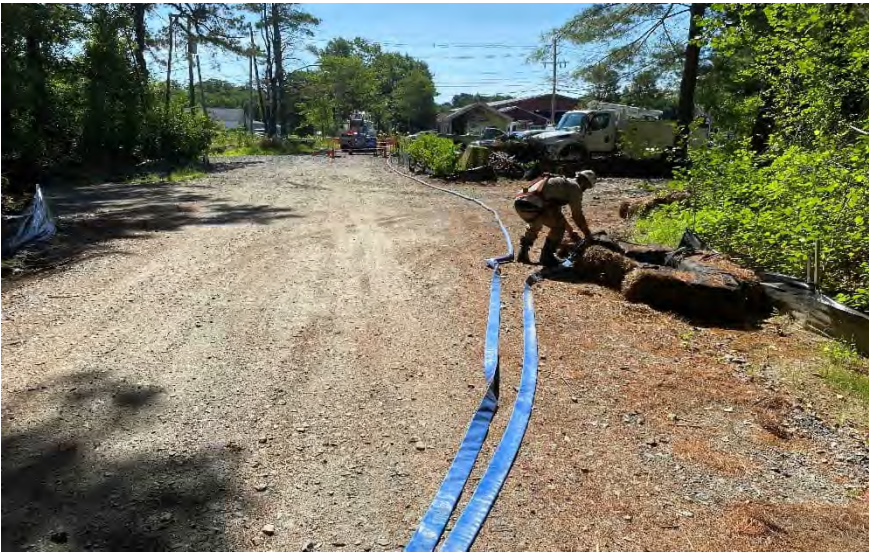
PHOTOGRAPHIC LOG	
Client Name: Eversource		Site Location: Sudbury to Hudson Transmission Reliability Project	Town: Sudbury
Photo No.: 3	Date: 7/16/2024

Description: Handhole #24. View of dewatering operation, looking eastward.

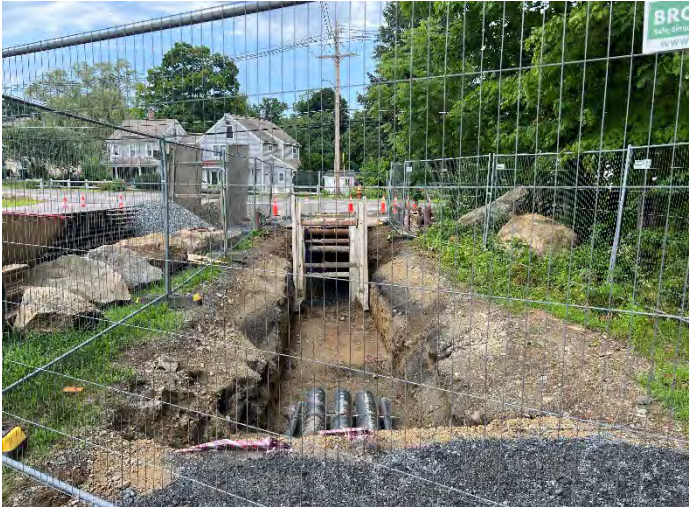
PHOTOGRAPHIC LOG	
Client Name: Eversource		Site Location: Sudbury to Hudson Transmission Reliability Project	
Town: Hudson			
Photo No.: 1	Date: 7/17/2024

Description: View of Bond workspace at Hudson Light & Power by MH#1. Pump running 24/7 while conduit work continues. No active construction today. Facing north.

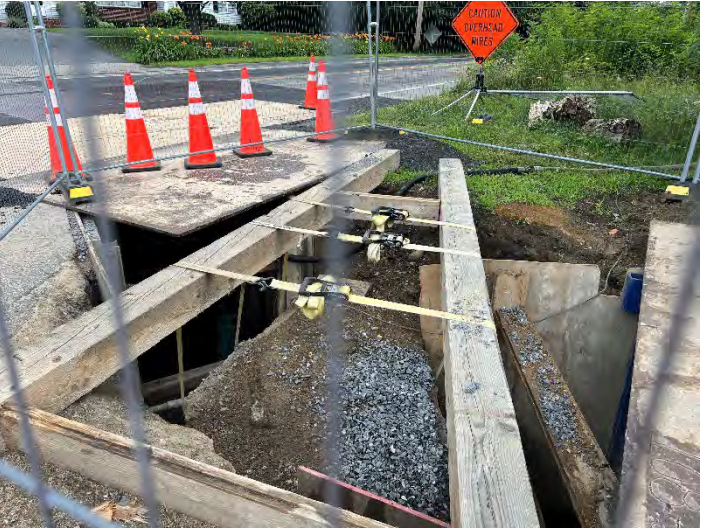
PHOTOGRAPHIC LOG	
Client Name: Eversource		Site Location: Sudbury to Hudson Transmission Reliability Project	
Town: Hudson			
Photo No.: 2	Date: 7/17/2024

Description: View of pump in trench at entrance to Hudson Light and Power on Forest Avenue. Pump located within trench under steel plates within gated work area. Facing northeast.

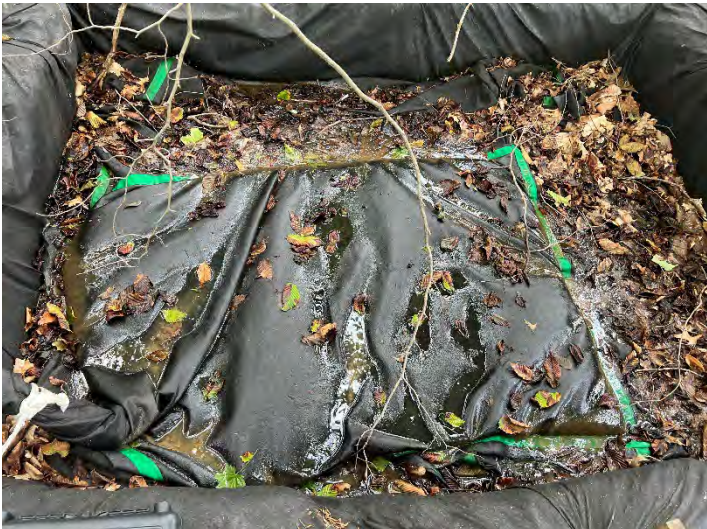
PHOTOGRAPHIC LOG	
Client Name: Eversource		Site Location: Sudbury to Hudson Transmission Reliability Project	
Town: Hudson			
Photo No.: 4	Date: 7/17/2024

Description: View of discharging water within corral. Discharge was not leaving corral at time of dewatering inspection. Sample taken from within corral. Discharge appeared clear and turbidity reading was below 50 NTUs.

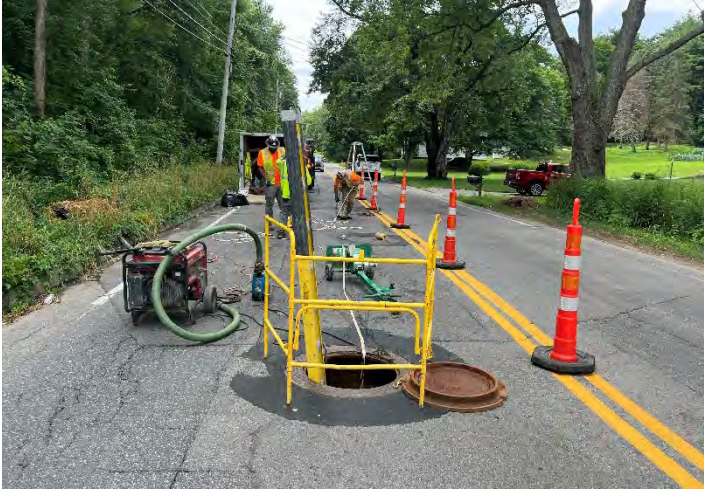
PHOTOGRAPHIC LOG	
Client Name: Eversource		Site Location: Sudbury to Hudson Transmission Reliability Project	Town: Hudson
Photo No.: 1	Date: 7/17/2024

Description: View of Bond work area at MH#4 for conduit proofing. Facing southwest.

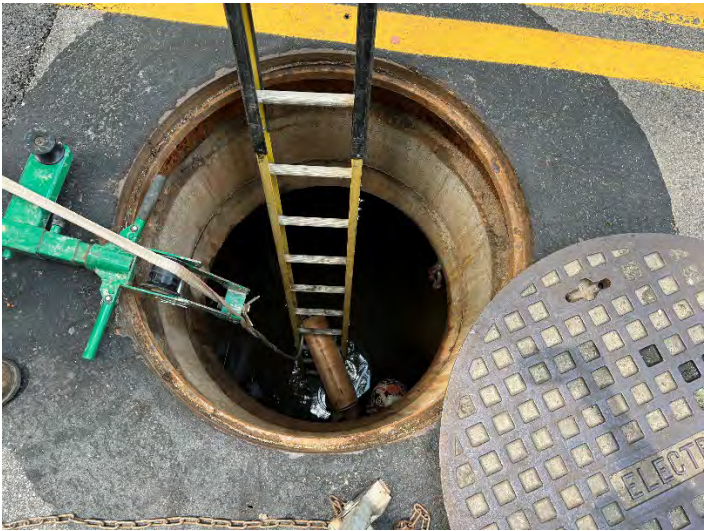
PHOTOGRAPHIC LOG	
Client Name: Eversource		Site Location: Sudbury to Hudson Transmission Reliability Project	Town: Hudson
Photo No.: 2	Date: 7/17/2024

Description: View of water to be pumped from MH#4 on Forest Avenue. Water appeared clear prior to treatment.

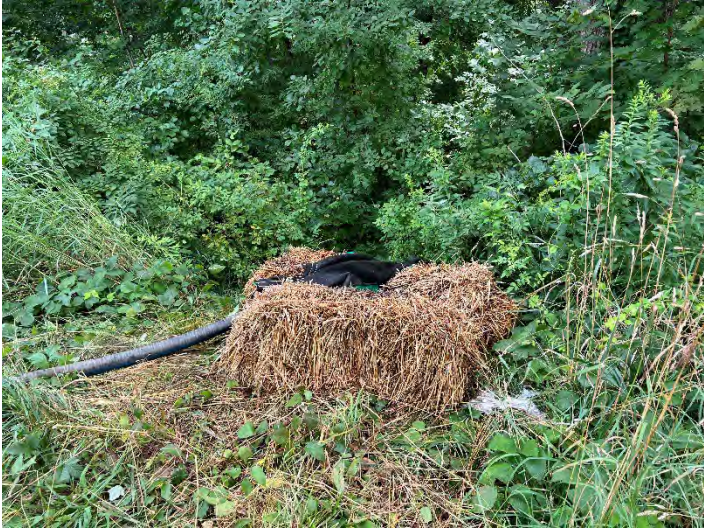
PHOTOGRAPHIC LOG	
Client Name: Eversource		Site Location: Sudbury to Hudson Transmission Reliability Project	Town: Hudson
Photo No.: 3	Date: 7/17/2024

Description: View of dewatering controls (straw bale corral with silt bag). Facing southeast.

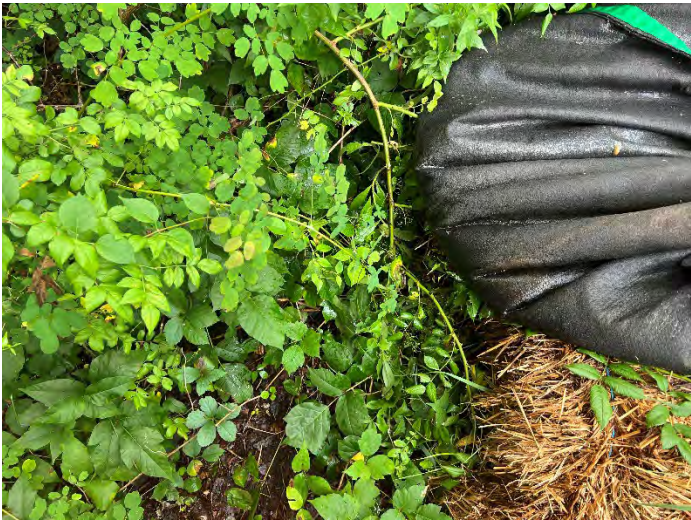
PHOTOGRAPHIC LOG	
Client Name: Eversource		Site Location: Sudbury to Hudson Transmission Reliability Project	Town: Hudson
Photo No.: 4	Date: 7/17/2024

Description: View of discharging water from corral. Discharge appeared to be clear and turbidity reading was below 50 NTUs.

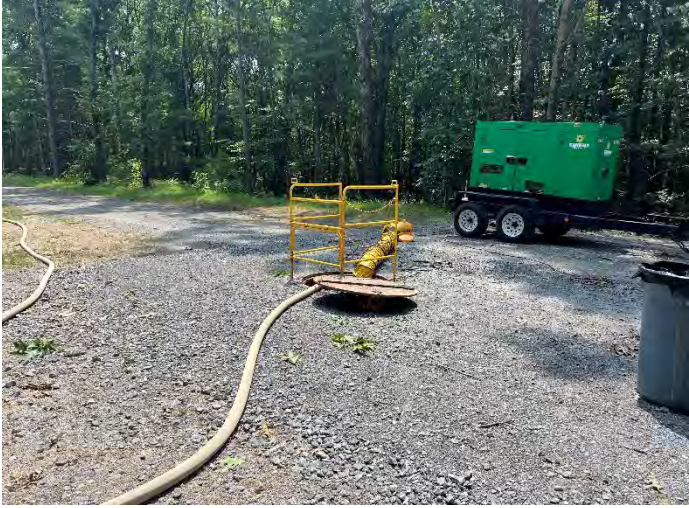
PHOTOGRAPHIC LOG	
Client Name: Eversource		Site Location: Sudbury to Hudson Transmission Reliability Project	
Town: Hudson			
Photo No.: 1	Date: 7/17/2024

Description: View of Haugland workspace in segment 2 at MH #7. Facing northeast.

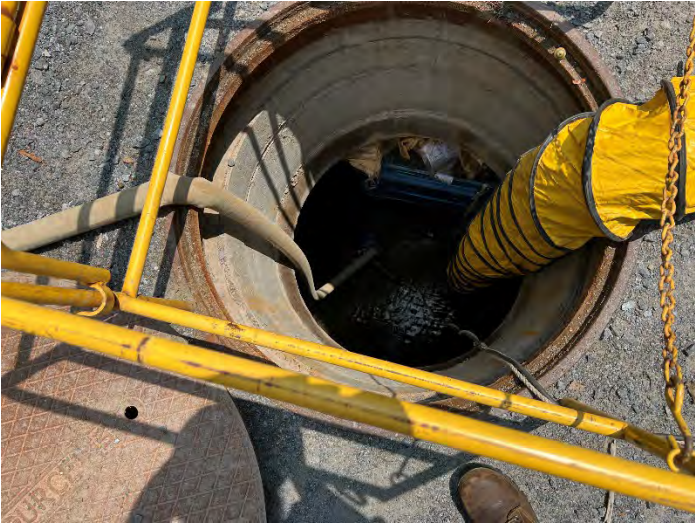
PHOTOGRAPHIC LOG	
Client Name: Eversource		Site Location: Sudbury to Hudson Transmission Reliability Project	
Town: Hudson			
Photo No.: 2	Date: 7/17/2024

Description: View of pump in MH #7. Water appeared to be clear prior to treatment.

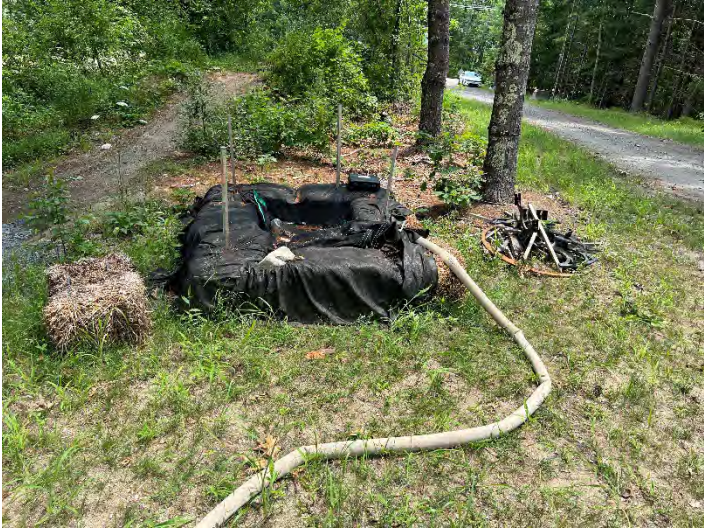
PHOTOGRAPHIC LOG	
Client Name: Eversource		Site Location: Sudbury to Hudson Transmission Reliability Project	
Town: Hudson			
Photo No.: 3	Date: 7/17/2024

Description: View of dewatering controls (straw bale corral with filter fabric and silt bag). Facing east.

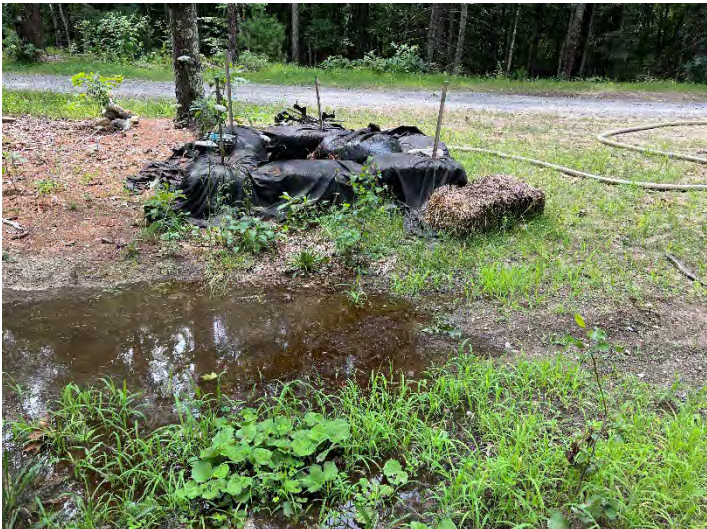
PHOTOGRAPHIC LOG	
Client Name: Eversource		Site Location: Sudbury to Hudson Transmission Reliability Project	
Town: Hudson			
Photo No.: 4	Date: 7/17/2024

Description: View of discharging water from corral. Discharge appeared to be mostly clear, with brown coloration in northwest portion of discharge from dissolved organic material. Turbidity reading was below 50 NTUs. Discharge did not appear to reach any jurisdictional resource areas. Facing south.

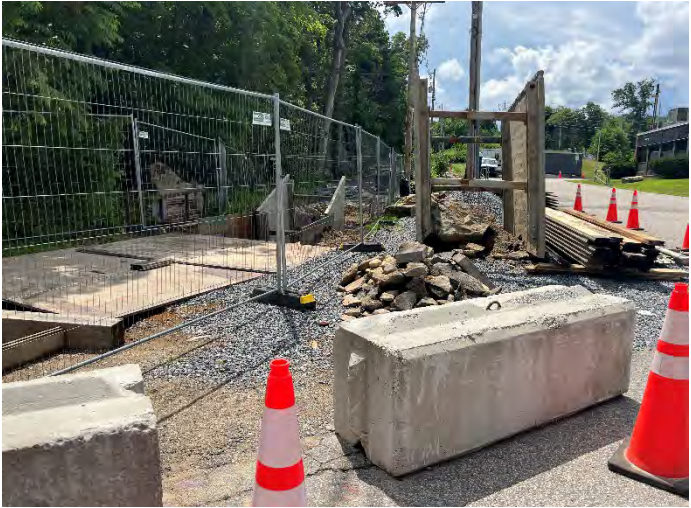
PHOTOGRAPHIC LOG	
Client Name: Eversource		Site Location: Sudbury to Hudson Transmission Reliability Project	Town: Hudson
Photo No.: 1	Date: 7/18/2024

Description: View of Bond workspace at Hudson Light & Power by MH#1. Pump running 24/7 while conduit work continues. No active construction today. Facing south.

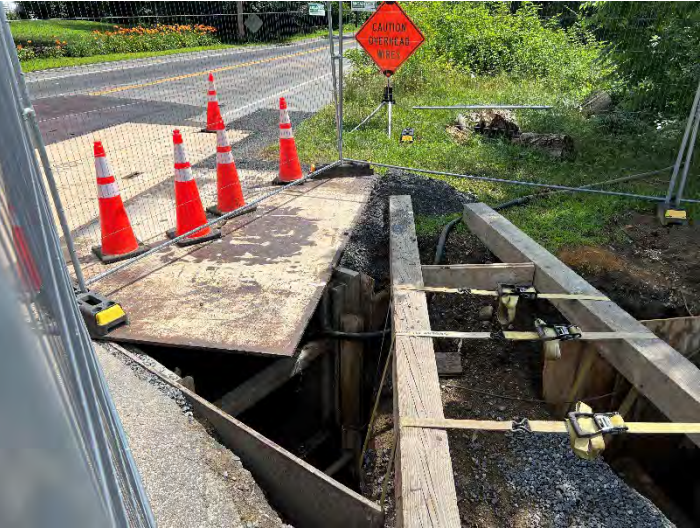
PHOTOGRAPHIC LOG	
Client Name: Eversource		Site Location: Sudbury to Hudson Transmission Reliability Project	Town: Hudson
Photo No.: 2	Date: 7/18/2024

Description: View of pump in trench at entrance to Hudson Light and Power on Forest Avenue. Pump located within trench under steel plates within gated work area. Facing northeast.

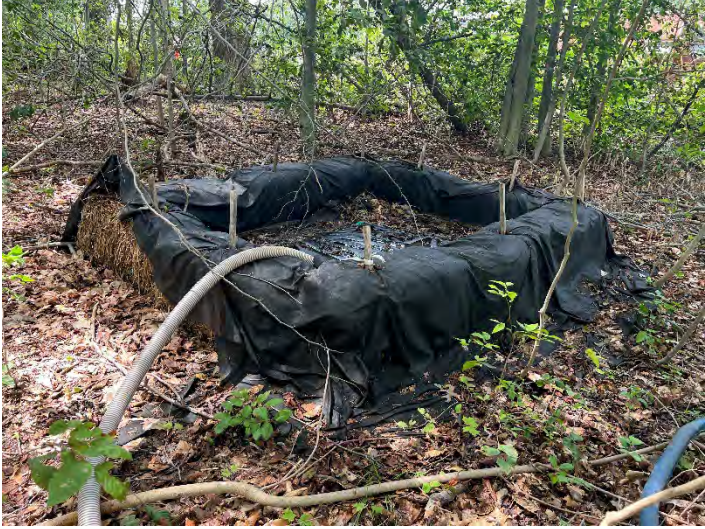
PHOTOGRAPHIC LOG	
Client Name: Eversource		Site Location: Sudbury to Hudson Transmission Reliability Project	
Town: Hudson			
Photo No.: 3	Date: 7/18/2024

Description: View of dewatering controls (straw bale corral with filter fabric and silt bag). Facing southwest.

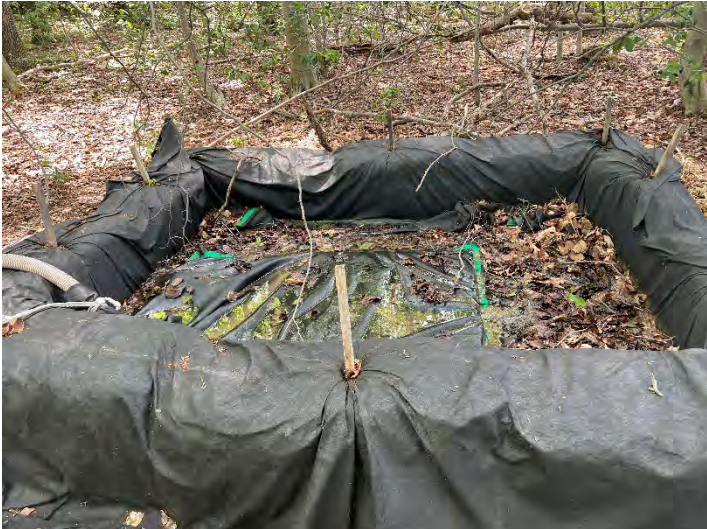
PHOTOGRAPHIC LOG	
Client Name: Eversource		Site Location: Sudbury to Hudson Transmission Reliability Project	
Town: Hudson			
Photo No.: 4	Date: 7/18/2024

Description: View of discharging water within corral. Discharge was not leaving corral at time of dewatering inspection. Sample taken from within corral. Discharge appeared clear and turbidity reading was below 50 NTUs. Facing south.

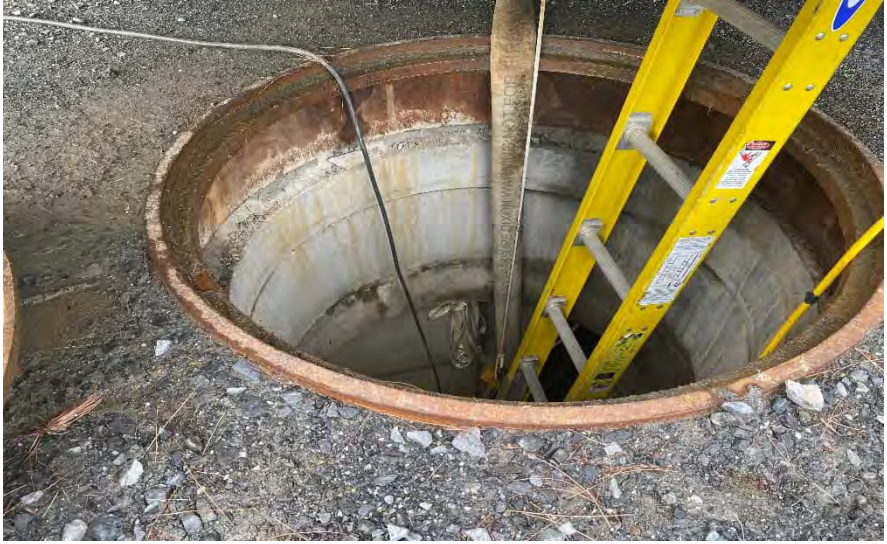
PHOTOGRAPHIC LOG	
Client Name: Eversource		Site Location: Sudbury to Hudson Transmission Reliability Project	Town: Hudson
Photo No.: 1	Date: 7/18/2024

Description: View of area being pumped from manhole #8, Segment 3.

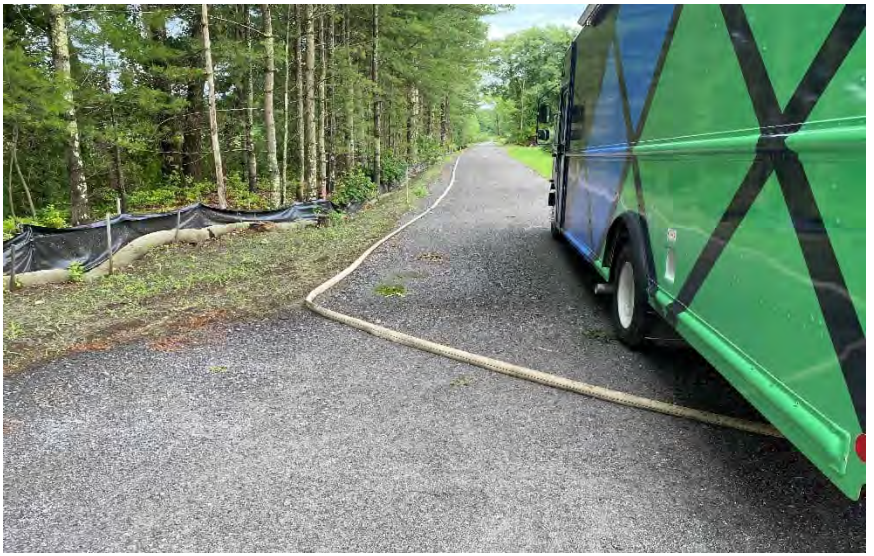
PHOTOGRAPHIC LOG	
Client Name: Eversource		Site Location: Sudbury to Hudson Transmission Reliability Project	Town: Hudson
Photo No.: 2	Date: 7/18/2024

Description: Manhole #8. View of dewatering operation. Looking westward.

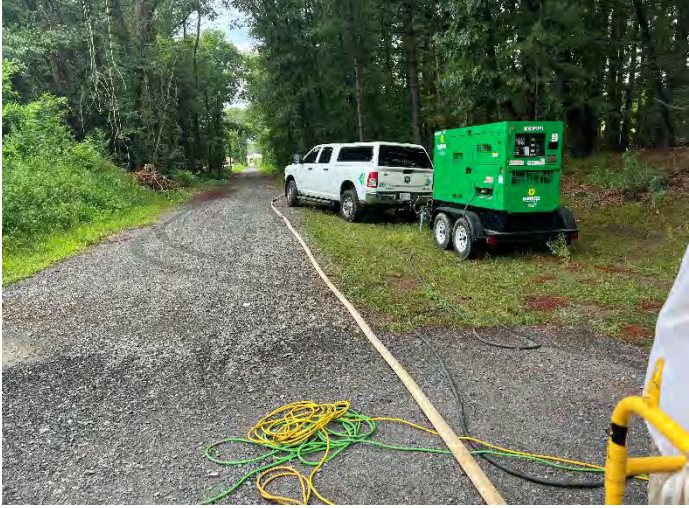
PHOTOGRAPHIC LOG	
Client Name: Eversource		Site Location: Sudbury to Hudson Transmission Reliability Project	
Town: Hudson			
Photo No.: 1	Date: 7/18/2024

Description: View of Haugland workspace in segment 3 at MH #9. Facing west.

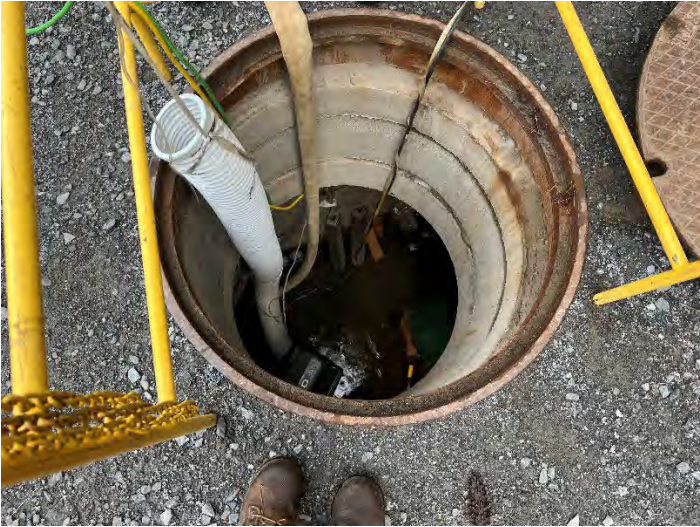
PHOTOGRAPHIC LOG	
Client Name: Eversource		Site Location: Sudbury to Hudson Transmission Reliability Project	
Town: Hudson			
Photo No.: 2	Date: 7/18/2024

Description: View of pump in MH #9. Water appeared to be clear prior to treatment.

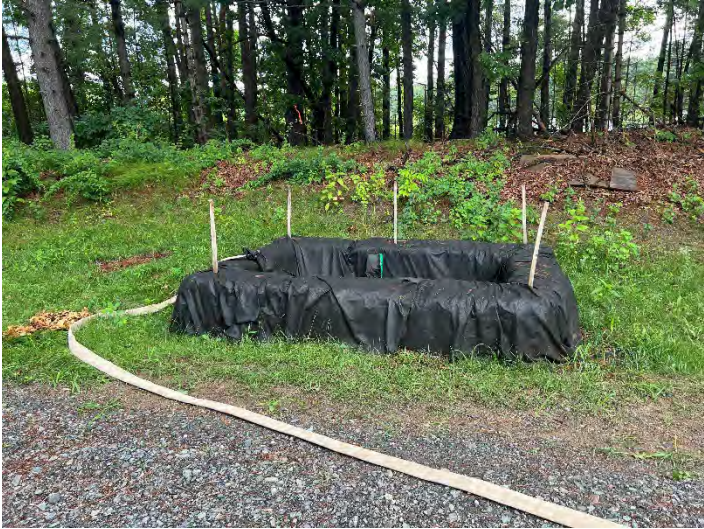
PHOTOGRAPHIC LOG		
Client Name: Eversource		Site Location: Sudbury to Hudson Transmission Reliability Project		Town: Hudson
Photo No.: 3	Date: 7/18/2024

Description: View of dewatering controls (straw bale corral with filter fabric and silt bag). Facing north.

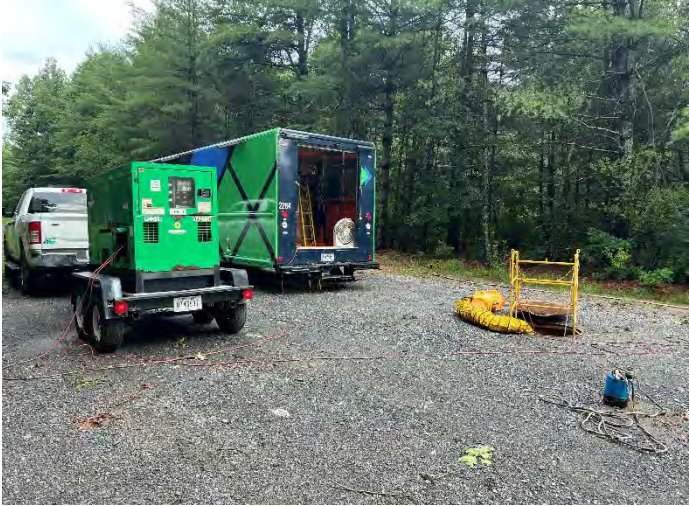
PHOTOGRAPHIC LOG		
Client Name: Eversource		Site Location: Sudbury to Hudson Transmission Reliability Project		Town: Hudson
Photo No.: 1	Date: 7/18/2024

Description: View of Haugland workspace in segment 2 at MH #7. Facing northwest.
