Weekly Environmental Compliance Summary

Sudbury to Hudson Transmission Reliability Project (USEPA Tracking # MAR1003UW)

Week of: July 15, 2024 to July 20, 2024

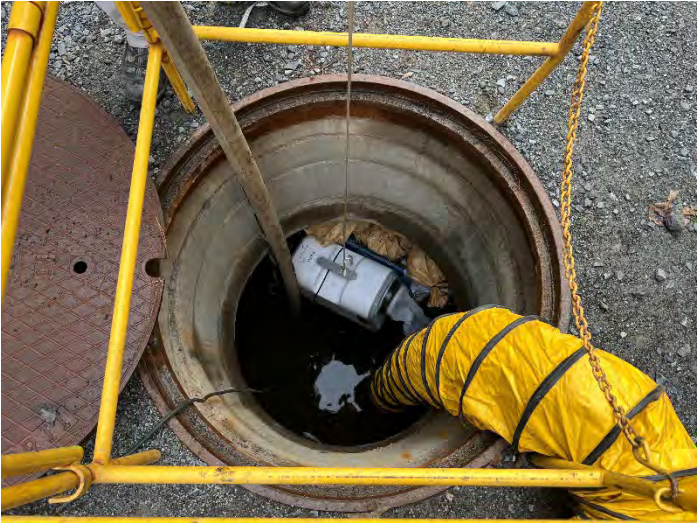
PHOTOGRAPHIC LOG		
Client Name: Eversource		Site Location: Sudbury to Hudson Transmission Reliability Project		Town: Hudson
Photo No.: 2	Date: 7/18/2024

Description: View of pump in MH #7. Water appeared to be clear prior to treatment.

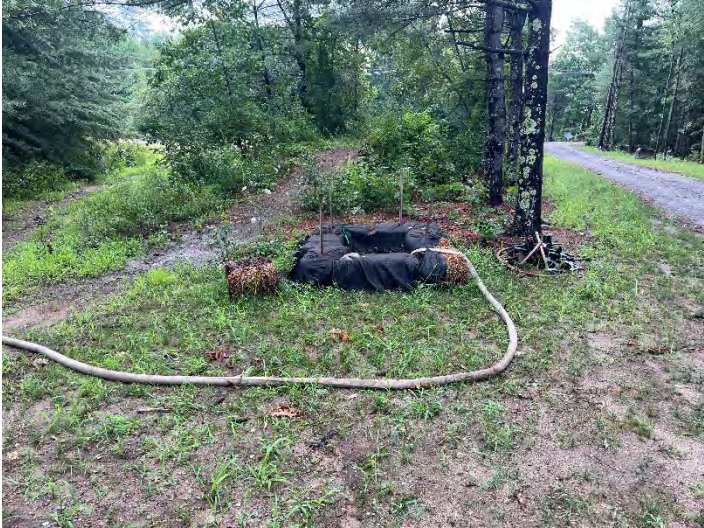
PHOTOGRAPHIC LOG		
Client Name: Eversource		Site Location: Sudbury to Hudson Transmission Reliability Project		Town: Hudson
Photo No.: 3	Date: 7/18/2024

Description: View of dewatering controls (straw bale corral with filter fabric and silt bag). Facing east.

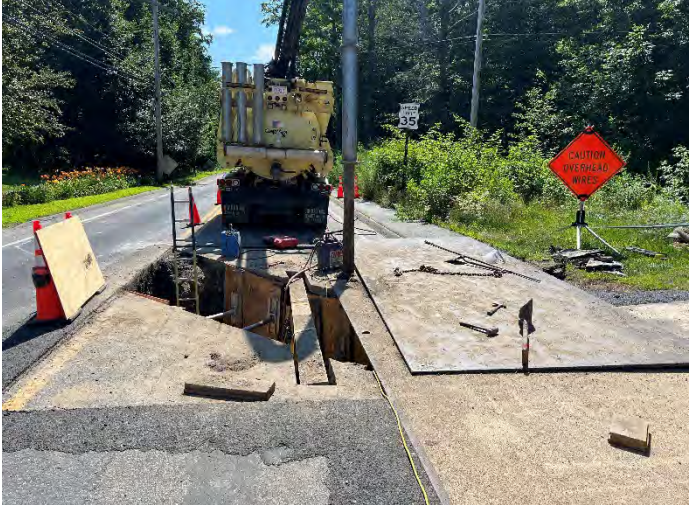
PHOTOGRAPHIC LOG	
Client Name: Eversource		Site Location: Sudbury to Hudson Transmission Reliability Project	Town: Hudson
Photo No.: 1	Date: 7/19/2024

Description: View of Bond workspace at Hudson Light & Power by MH#1. Pump running 24/7 while conduit work continues. Facing east.

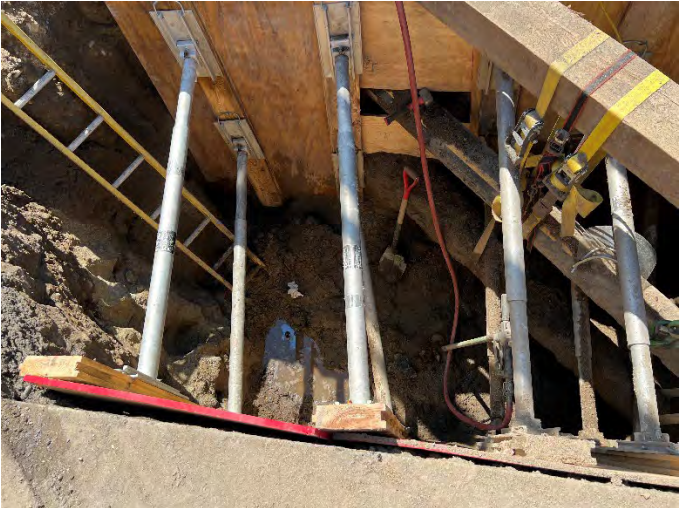
PHOTOGRAPHIC LOG	
Client Name: Eversource		Site Location: Sudbury to Hudson Transmission Reliability Project	Town: Hudson
Photo No.: 2	Date: 7/19/2024

Description: View of trench at entrance to Hudson Light and Power on Forest Avenue. Pump located within trench under steel plates within gated work area.

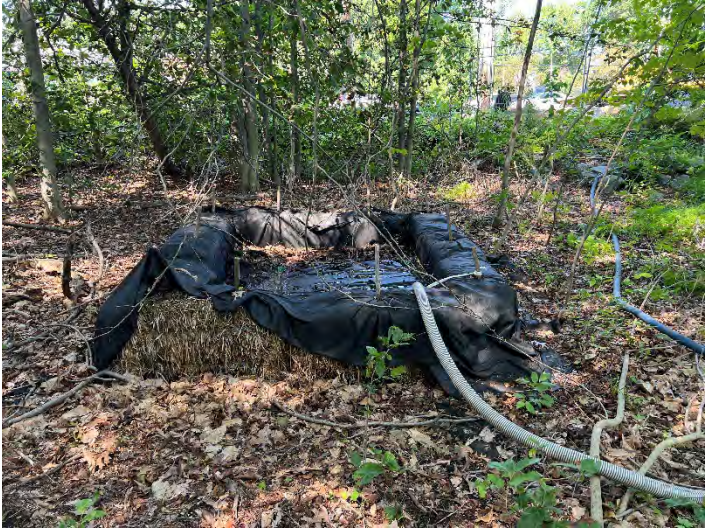
PHOTOGRAPHIC LOG	
Client Name: Eversource		Site Location: Sudbury to Hudson Transmission Reliability Project	Town: Hudson
Photo No.: 3	Date: 7/19/2024

Description: View of dewatering controls (straw bale corral with filter fabric and silt bag). Facing west.

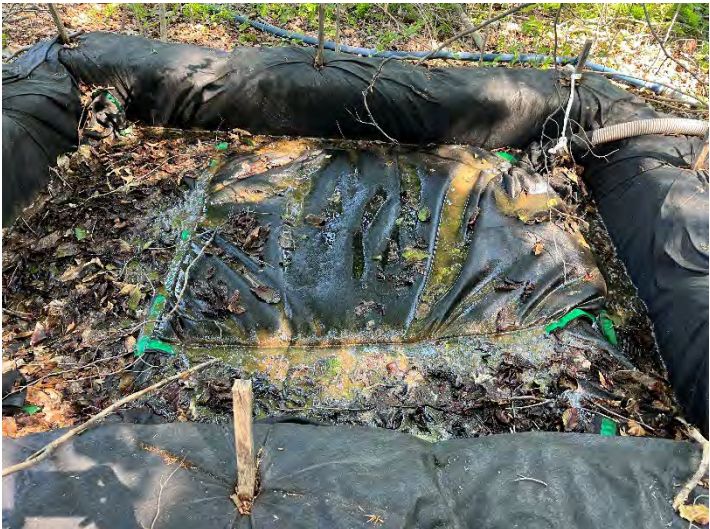
PHOTOGRAPHIC LOG	
Client Name: Eversource		Site Location: Sudbury to Hudson Transmission Reliability Project	Town: Hudson
Photo No.: 4	Date: 7/19/2024

Description: View of discharging water within corral. Discharge was not leaving corral at time of dewatering inspection. Sample taken from within corral. Discharge appeared clear although sediment is starting to accumulate within corral. Turbidity reading was below 50 NTUs.

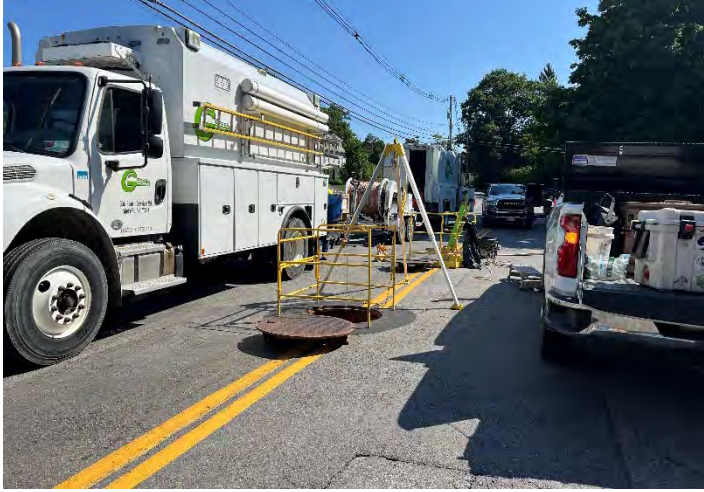
PHOTOGRAPHIC LOG	
Client Name: Eversource		Site Location: Sudbury to Hudson Transmission Reliability Project	Town: Hudson
Photo No.: 1	Date: 7/19/2024

Description: View of Haugland work area at MH#3 on Forest Ave. Facing northeast.

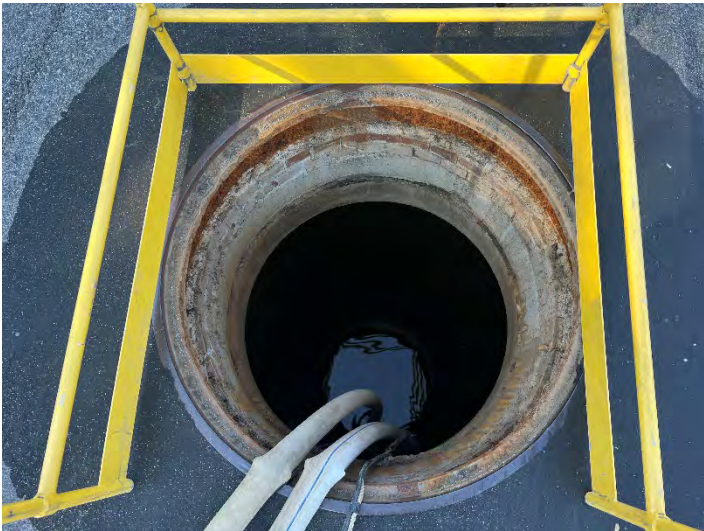
PHOTOGRAPHIC LOG	
Client Name: Eversource		Site Location: Sudbury to Hudson Transmission Reliability Project	Town: Hudson
Photo No.: 2	Date: 7/19/2024

Description: View of water to be pumped from MH#3 on Forest Avenue. Water appeared clear prior to treatment.

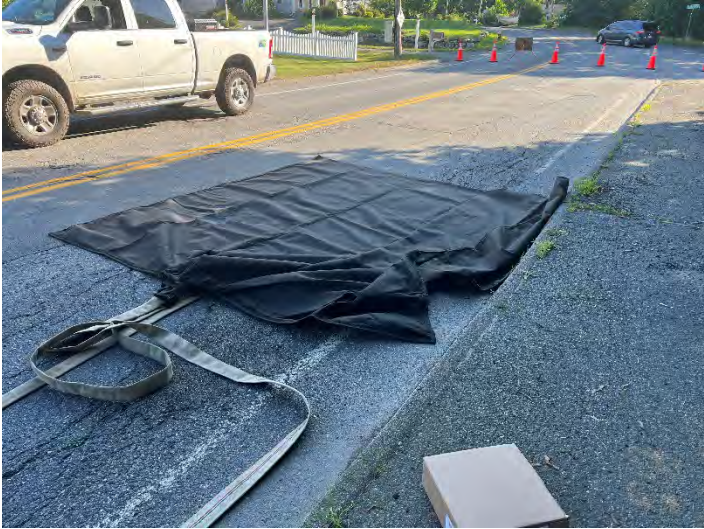
PHOTOGRAPHIC LOG	
Client Name: Eversource		Site Location: Sudbury to Hudson Transmission Reliability Project	Town: Hudson
Photo No.: 3	Date: 7/19/2024

Description: View of dewatering controls (filter bag with second filter bag underneath covering catch basin). Facing north.

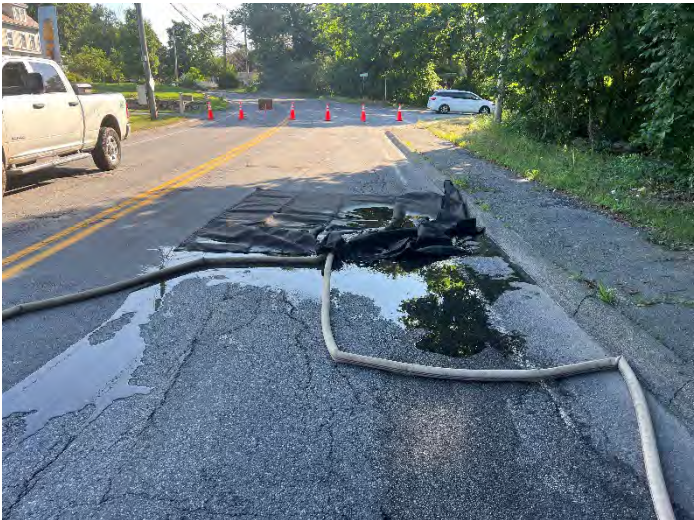
PHOTOGRAPHIC LOG	
Client Name: Eversource		Site Location: Sudbury to Hudson Transmission Reliability Project	Town: Hudson
Photo No.: 4	Date: 7/19/2024

Description: View of discharging water from filter bag to catch basin. Discharge appeared to be clear and turbidity reading was below 50 NTUs. Facing northeast.

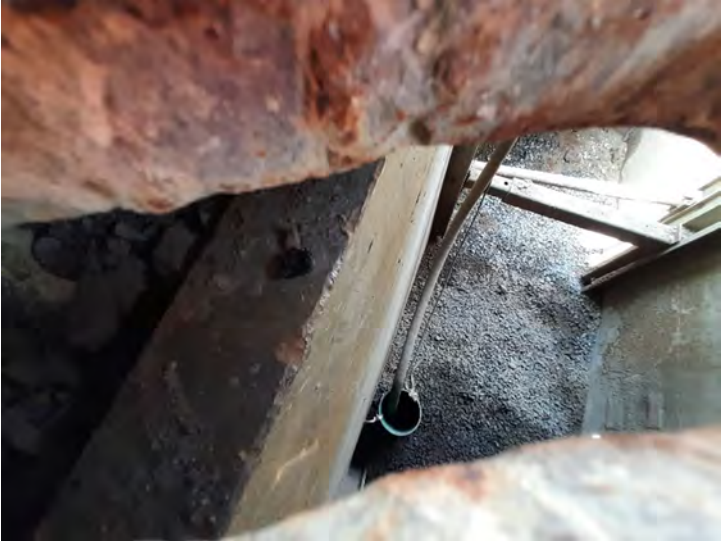
PHOTOGRAPHIC LOG	
Client Name: Eversource		Site Location: Sudbury to Hudson Transmission Reliability Project	Town: Hudson
Photo No.: 1	Date: 7/20/2024

Description: View of area being pumped from the trench beside manhole #1, near Hudson Light & Power. Facing southward, looking down through gap in steel plate.

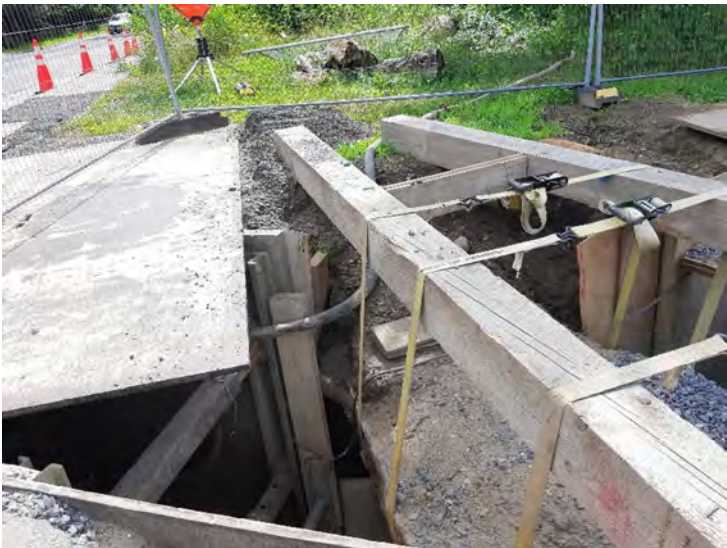
PHOTOGRAPHIC LOG	
Client Name: Eversource		Site Location: Sudbury to Hudson Transmission Reliability Project	Town: Hudson
Photo No.: 2	Date: 7/20/2024

Description: Trench beside manhole #1. View of dewatering operation. Looking eastward.

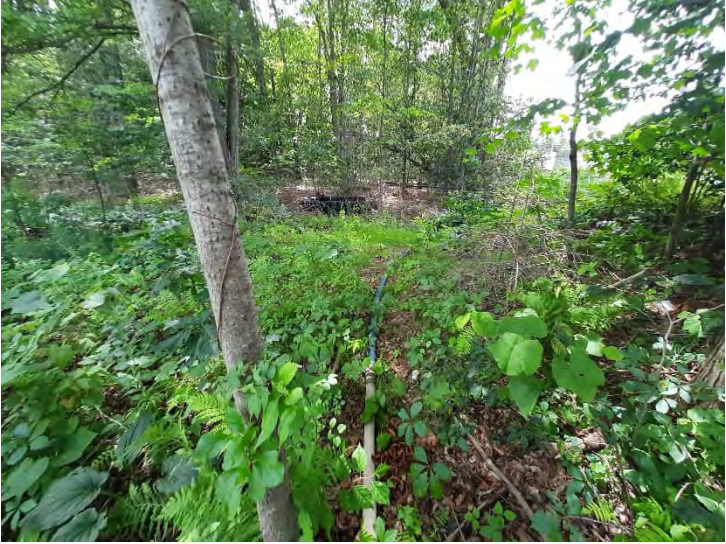
PHOTOGRAPHIC LOG	
Client Name: Eversource		Site Location: Sudbury to Hudson Transmission Reliability Project	Town: Hudson
Photo No.: 3	Date: 7/20/2024

Description: View of dewatering operation associated with trench by manhole #1, looking southward.

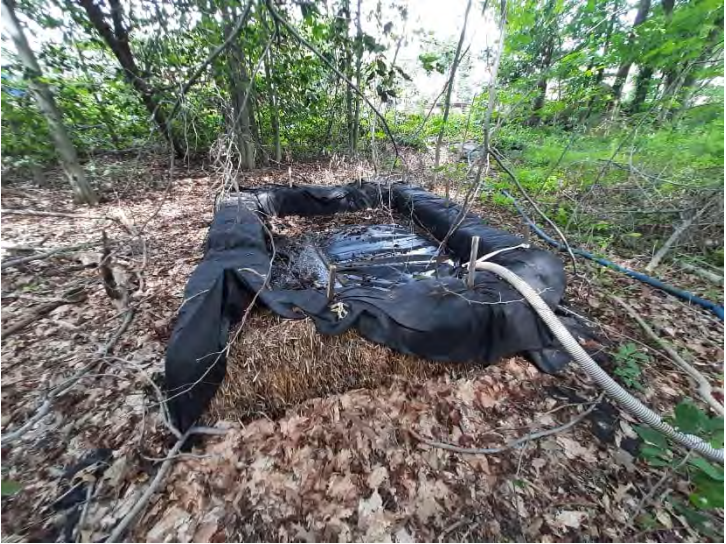
PHOTOGRAPHIC LOG	
Client Name: Eversource		Site Location: Sudbury to Hudson Transmission Reliability Project	Town: Hudson
Photo No.: 4	Date: 7/20/2024

Description: Dewatering setup associated with trench near manhole #1. View of discharge bag/corral, looking northward. No visible discharge of water out of the corral.

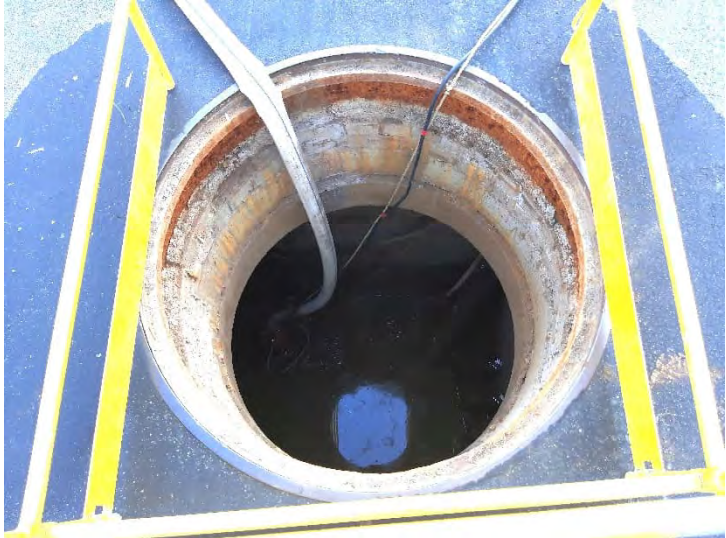
PHOTOGRAPHIC LOG	
Client Name: Eversource		Site Location: Sudbury to Hudson Transmission Reliability Project	Town: Hudson
Photo No.: 1	Date: 7/20/2024

Description: Manhole #3, view of area being pumped. Facing northeastward, looking down.

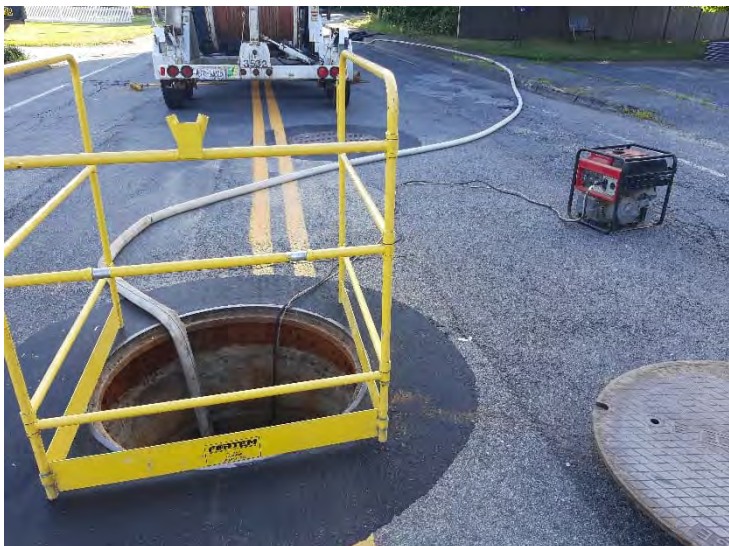
PHOTOGRAPHIC LOG	
Client Name: Eversource		Site Location: Sudbury to Hudson Transmission Reliability Project	Town: Hudson
Photo No.: 2	Date: 7/20/2024

Description: Manhole #3. View of dewatering operation. Looking northeastward.

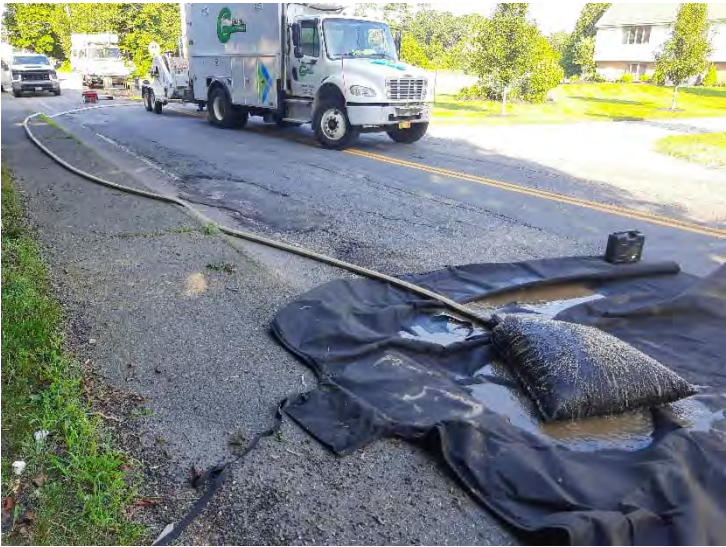
PHOTOGRAPHIC LOG	
Client Name: Eversource		Site Location: Sudbury to Hudson Transmission Reliability Project	Town: Hudson
Photo No.: 3	Date: 7/20/2024

Description: Manhole #3. View of dewatering operation, looking southwestward.

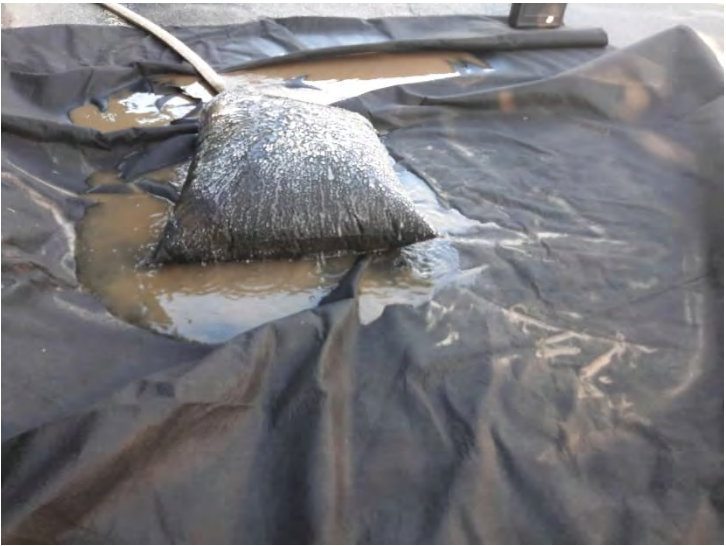
PHOTOGRAPHIC LOG	
Client Name: Eversource		Site Location: Sudbury to Hudson Transmission Reliability Project	Town: Hudson
Photo No.: 4	Date: 7/20/2024

Section A – Dewatering Discharges (CGP Part 4.6.3) Complete this section <u>within 24 hours</u> of completing the inspection. (If necessary, complete additional inspection reports for each separate inspection location.)	
Inspector Information	
Inspector Name: Mary Toner, EPA (CGP) Site Inspector.	Title: Biologist I
Company Name: AECOM	Email: mary.toner@aecom.com
Address: 9 Jonathan Bourne Drive, Pocasset, MA 02559	Phone Number: 774-255-0331
Inspection Details	
Inspection Date: 7/20/2024	Inspection Location: Manhole #3, near Forest Avenue Elementary School
Discharge Start Time: 07:45 AM	Discharge End Time: 07:56 AM
Rate of Discharge (gallons per day): 105,120 (73 gallons per minute).	Corrective Action Required? ¹ <input type="checkbox"/> Yes <input checked="" type="checkbox"/> No
Describe Indicators of Pollutant Discharge at Point of Dewatering Discharge: ¹	
Turbidity sampling conducted, dewatering setup to remove water from manhole #3 in Forest Ave, near Forest Ave Elementary School. Dewatering conducted into a filter bag atop another, larger filter bag, in turn atop a storm drain. Turbidity sampling > 50 NTUs. Sampled water atop larger filter bag due to difficulty accessing storm drain. Water entering drain appeared clearer than water atop filter bags.

Description: Manhole #3 dewatering setup. View of discharge bag and underlying filter bag. Looking southwestward. Water entering storm drain under bottom filter bag visibly clearer than water atop bags.

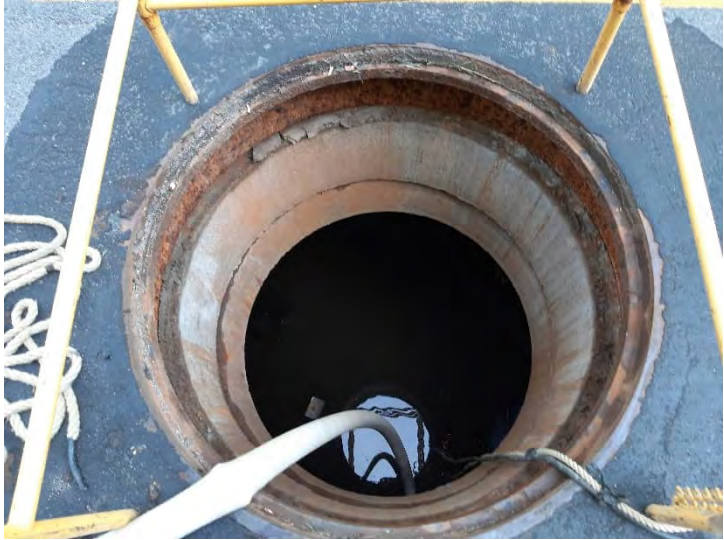
PHOTOGRAPHIC LOG	
Client Name: Eversource		Site Location: Sudbury to Hudson Transmission Reliability Project	Town: Hudson
Photo No.: 1	Date: 7/20/2024

Description: Manhole #4, view of area being pumped. Facing westward, looking down.

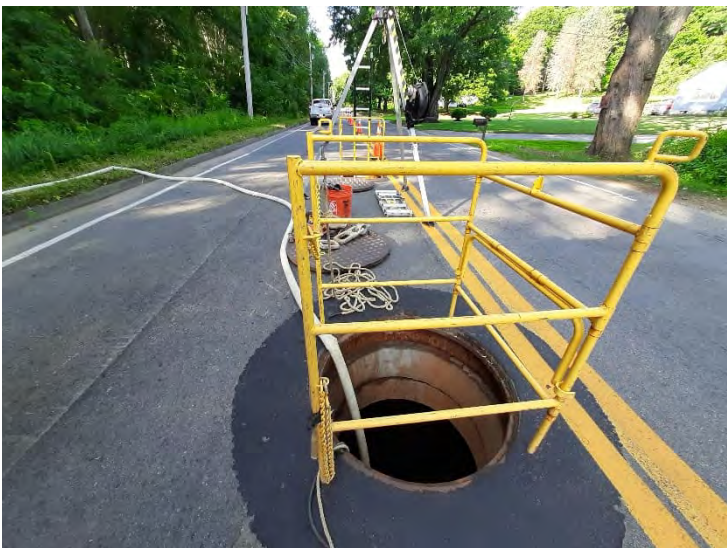
PHOTOGRAPHIC LOG	
Client Name: Eversource		Site Location: Sudbury to Hudson Transmission Reliability Project	Town: Hudson
Photo No.: 2	Date: 7/20/2024

Description: Manhole #4. View of dewatering operation, looking southward.

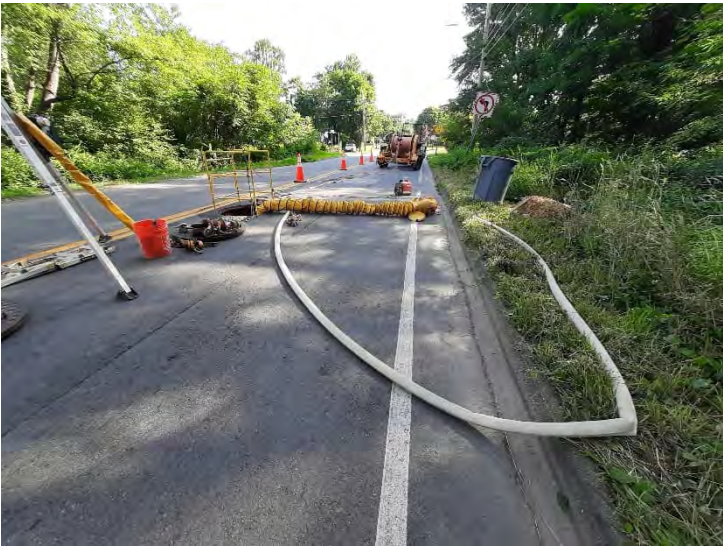
PHOTOGRAPHIC LOG	
Client Name: Eversource		Site Location: Sudbury to Hudson Transmission Reliability Project	Town: Hudson
Photo No.: 3	Date: 7/20/2024

Description: Manhole #4. View of dewatering operation, looking northward.

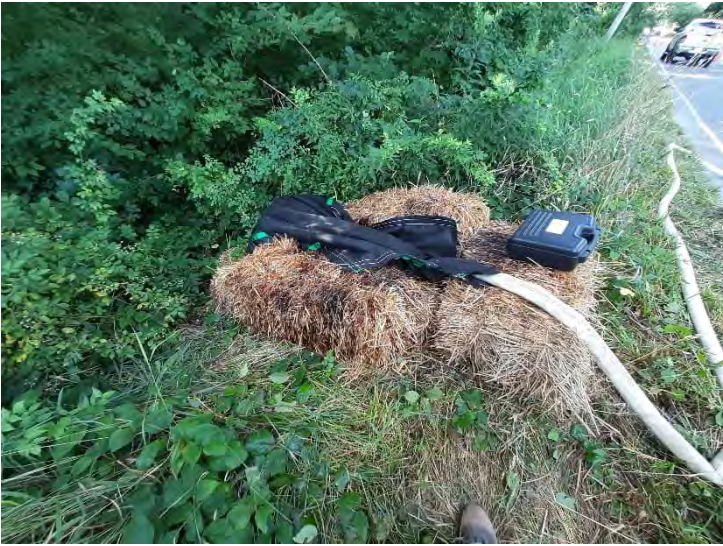
PHOTOGRAPHIC LOG	
Client Name: Eversource		Site Location: Sudbury to Hudson Transmission Reliability Project	Town: Hudson
Photo No.: 4	Date: 7/20/2024

Section A – Dewatering Discharges (CGP Part 4.6.3) Complete this section <u>within 24 hours</u> of completing the inspection. (If necessary, complete additional inspection reports for each separate inspection location.)	
Inspector Information	
Inspector Name: Mary Toner, EPA (CGP) Site Inspector.	Title: Biologist I
Company Name: AECOM	Email: mary.toner@aecom.com
Address: 9 Jonathan Bourne Drive, Pocasset, MA 02559	Phone Number: 774-255-0331
Inspection Details	
Inspection Date: 7/20/2024	Inspection Location: Manhole #4 (near 156 Forest Ave)
Discharge Start Time: 08:00 AM	Discharge End Time: 08:45 AM
Rate of Discharge (gallons per day): 105,120 (73 gallons per minute).	Corrective Action Required? ¹ <input type="checkbox"/> Yes <input checked="" type="checkbox"/> No
Describe Indicators of Pollutant Discharge at Point of Dewatering Discharge: ¹ Turbidity sampling conducted, dewatering setup to discharge from manhole #4, within Forest Ave. Turbidity sampling < 50 NTUs. Water from the corral discharged to adjacent low-lying area.

Description: Dewatering setup associated with manhole #4. View of discharge bag/corral, looking southward. Water from bag/corral discharging downhill to adjacent area.

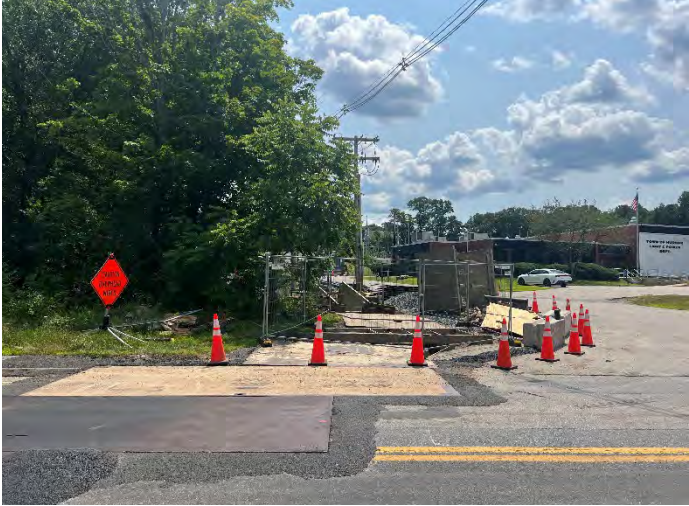
PHOTOGRAPHIC LOG	
Client Name: Eversource		Site Location: Sudbury to Hudson Transmission Reliability Project	Town: Hudson
Photo No.: 1	Date: 7/21/2024

Description: View of Bond workspace at Hudson Light & Power by MH#1. Pump running 24/7 while conduit work continues. No active construction today. Facing south.

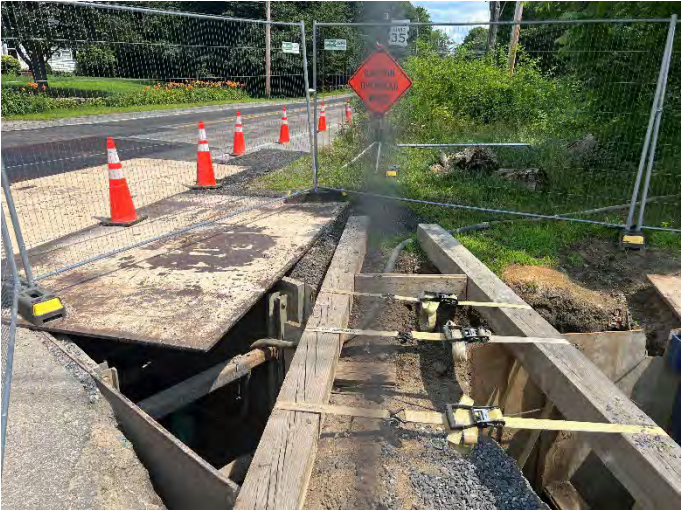
PHOTOGRAPHIC LOG	
Client Name: Eversource		Site Location: Sudbury to Hudson Transmission Reliability Project	Town: Hudson
Photo No.: 2	Date: 7/19/2024

Description: View of trench at entrance to Hudson Light and Power on Forest Avenue. Pump located within trench under steel plates within gated work area.

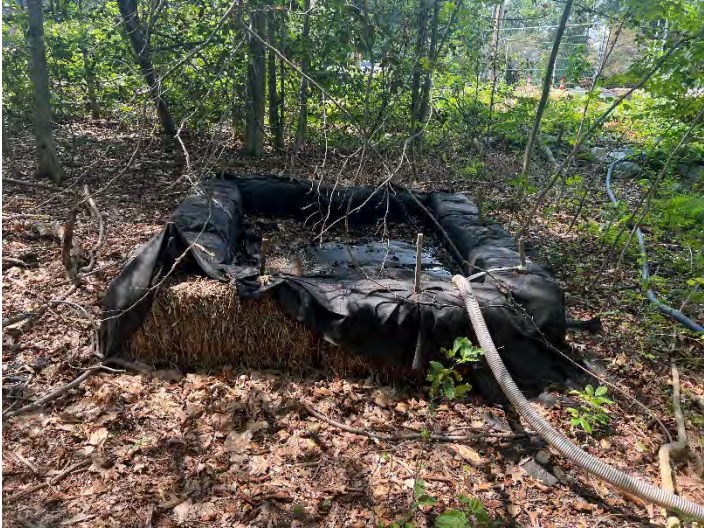
PHOTOGRAPHIC LOG	
Client Name: Eversource		Site Location: Sudbury to Hudson Transmission Reliability Project	Town: Hudson
Photo No.: 3	Date: 7/21/2024

Description: View of dewatering controls (straw bale corral with filter fabric and silt bag). Facing west.

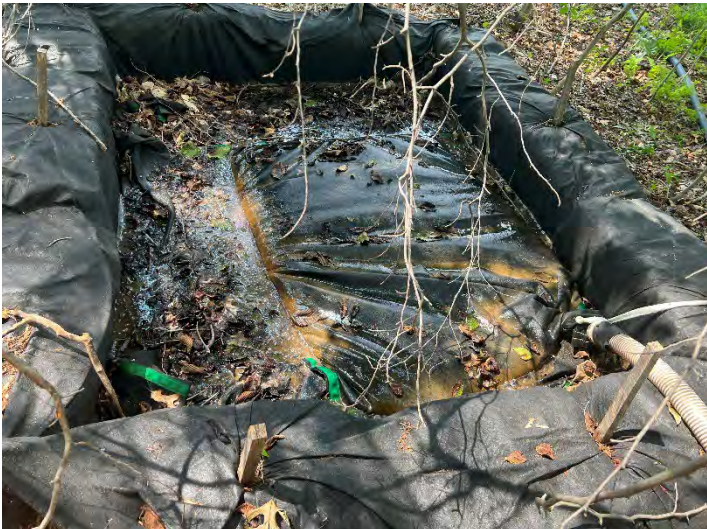
PHOTOGRAPHIC LOG	
Client Name: Eversource		Site Location: Sudbury to Hudson Transmission Reliability Project	Town: Hudson
Photo No.: 4	Date: 7/21/2024

Section A – Dewatering Discharges (CGP Part 4.6.3) Complete this section <u>within 24 hours</u> of completing the inspection. (If necessary, complete additional inspection reports for each separate inspection location.)	
Inspector Information	
Inspector Name: Emma Verville	Title: Compliance Monitor, EPA CGP Certified Inspector
Company Name: SWCA Environmental Consultants	Email: emma.verville@swca.com
Address: 153 Cordaville Road, Suite 130, Southborough, MA 01772	Phone Number: 603-717-5927
Inspection Details	
Inspection Date: 7/21/2024	Inspection Location: Trench at Manhole (MH) #1
Discharge Start Time: 12:00 am	Discharge End Time: 11:59 pm
Rate of Discharge (gallons per day): 105,120 (73 gallons per minute).	Corrective Action Required? ¹ <input type="checkbox"/> Yes <input checked="" type="checkbox"/> No
Describe Indicators of Pollutant Discharge at Point of Dewatering Discharge: ¹ Dewatering is necessary within trench at MH #1 for Bond to be able to perform conduit work. Pump is running 24/7 while work continues within trench. No active construction at the time of inspection. Dewatering setup to corral/bag south of trench. Discharge was not leaving corral at time of dewatering inspection, sample taken from within the corral. Water appeared to be slightly turbid and turbidity reading was above 50 NTUs. Sediment is starting to accumulate within the dewatering corral.

Description: View of discharging water within corral. Discharge was not leaving corral at time of dewatering inspection. Sample taken from within corral. Discharge appeared to be slightly turbid, and sediment is starting to accumulate within corral. Turbidity reading was above 50 NTUs.
