Weekly Environmental Compliance Summary

Sudbury to Hudson Transmission Reliability Project (USEPA Tracking # MAR1003UW)

Week of: July 22, 2024 to July 27, 2024

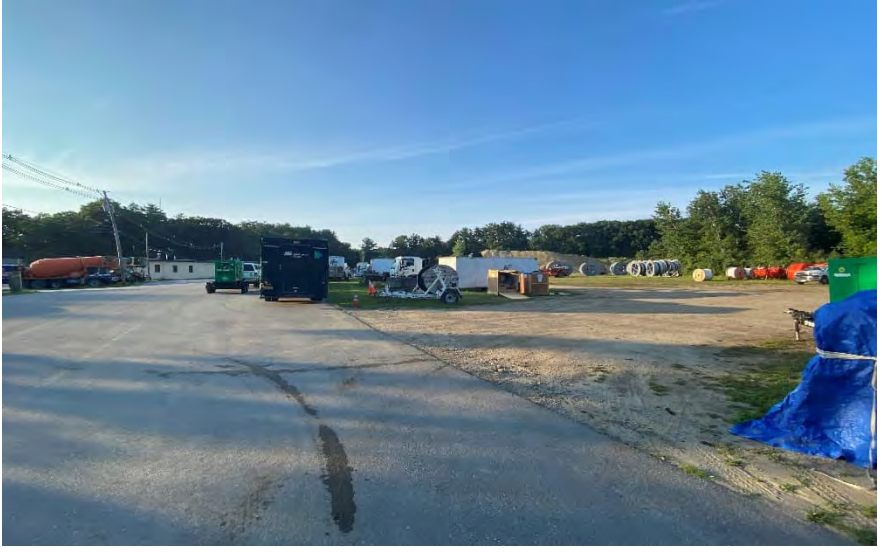
<p align="right">PHOTOGRAPHIC LOG</p>	
<p>Client Name: Eversource</p>		<p>Site Location: Sudbury to Hudson Transmission Reliability Project</p>	<p>Town: Hudson</p>
<p>Photo No.: 1</p>	<p>Date: 7-22-24</p>

<p>Description:</p> <p>Haugland laydown yard, stored wire on reels, looking westward.</p>

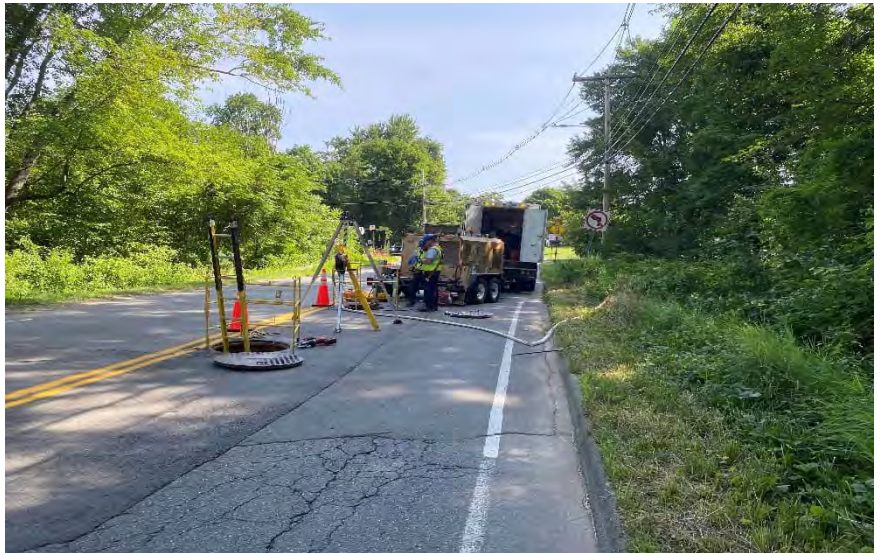
<p align="right">PHOTOGRAPHIC LOG</p>	
<p>Client Name: Eversource</p>		<p>Site Location: Sudbury to Hudson Transmission Reliability Project</p>	<p>Town: Hudson</p>
<p>Photo No.: 2</p>	<p>Date: 7-22-24</p>

<p>Description:</p> <p>Work area within Forest Avenue, wire pulling at manhole #4, looking northward.</p>

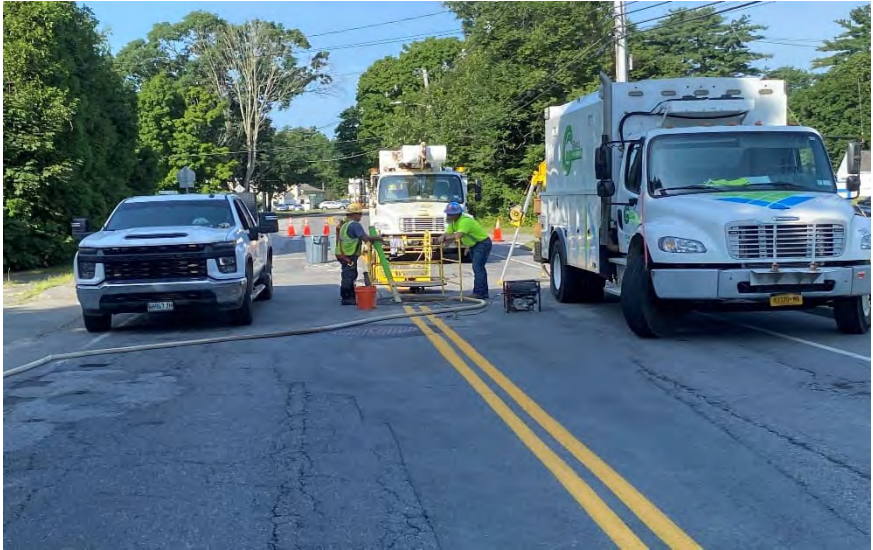
<p>PHOTOGRAPHIC LOG</p>	
<p>Client Name: Eversource</p>		<p>Site Location: Sudbury to Hudson Transmission Reliability Project</p>	<p>Town: Hudson</p>
<p>Photo No.: 3</p>	<p>Date: 7-22-24</p>

<p>Description:</p> <p>Work area within Forest Avenue, wire pulling at manhole #3, looking southward.</p>

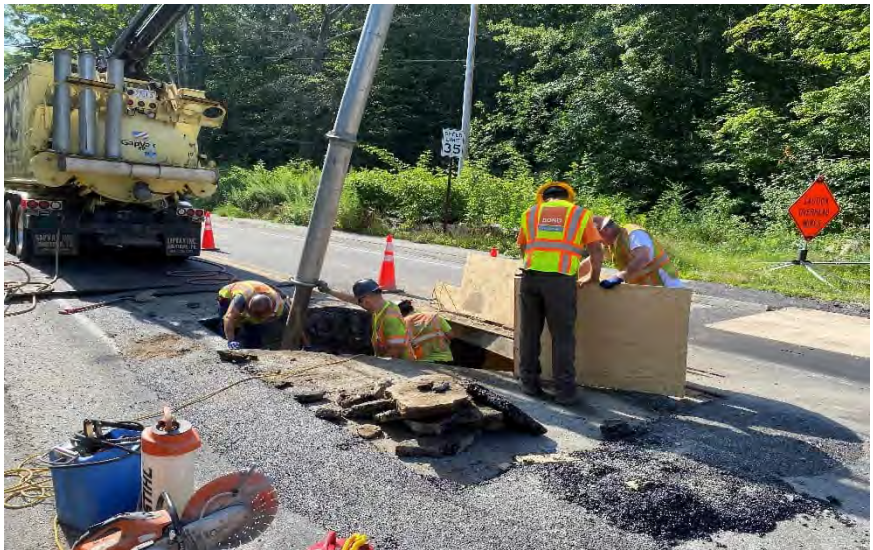
<p>PHOTOGRAPHIC LOG</p>	
<p>Client Name: Eversource</p>		<p>Site Location: Sudbury to Hudson Transmission Reliability Project</p>	<p>Town: Hudson</p>
<p>Photo No.: 4</p>	<p>Date: 7-22-24</p>

<p>Description:</p> <p>Conduit work near manhole #1, near Hudson Power & Light facility, looking westward.</p>

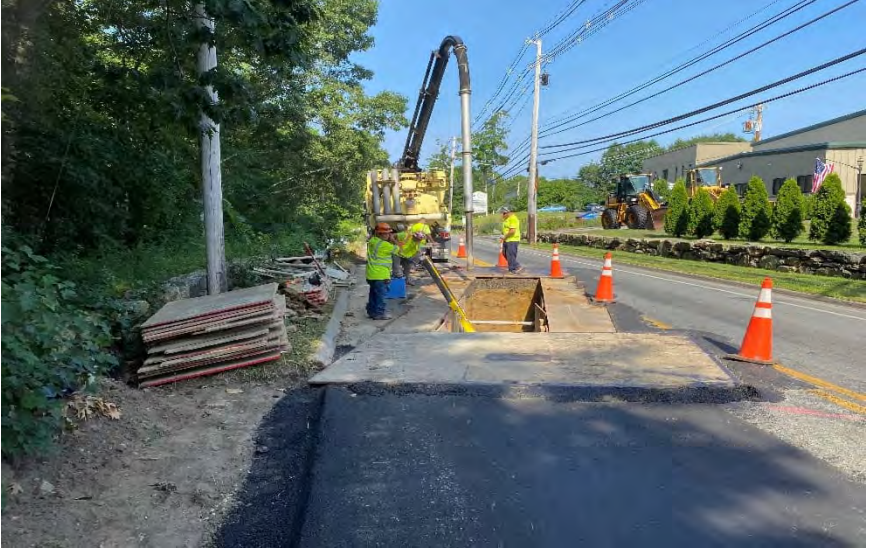
<p>PHOTOGRAPHIC LOG</p>	
<p>Client Name: Eversource</p>		<p>Site Location: Sudbury to Hudson Transmission Reliability Project</p>	<p>Town: Hudson</p>
<p>Photo No.: 5</p>	<p>Date: 7-22-24</p>

<p>Description:</p> <p>Conduit work near manhole #2, near Bonazolli Avenue intersection with Forest Ave., looking southward.</p>

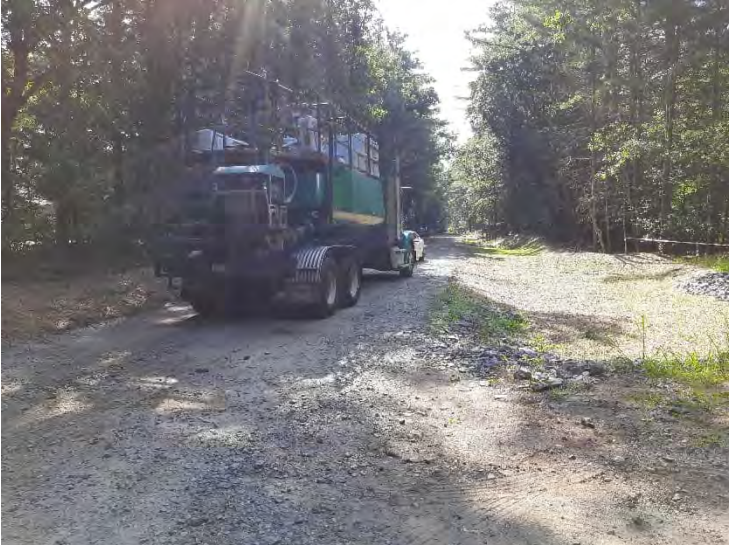
PHOTOGRAPHIC LOG	
Client Name: Eversource		Site Location: Sudbury to Hudson Transmission Reliability Project	Town: Sudbury
Photo No.: 1	Date: 7-22-24

Description: Work area within Segment 9, hydroseeding, looking eastward.

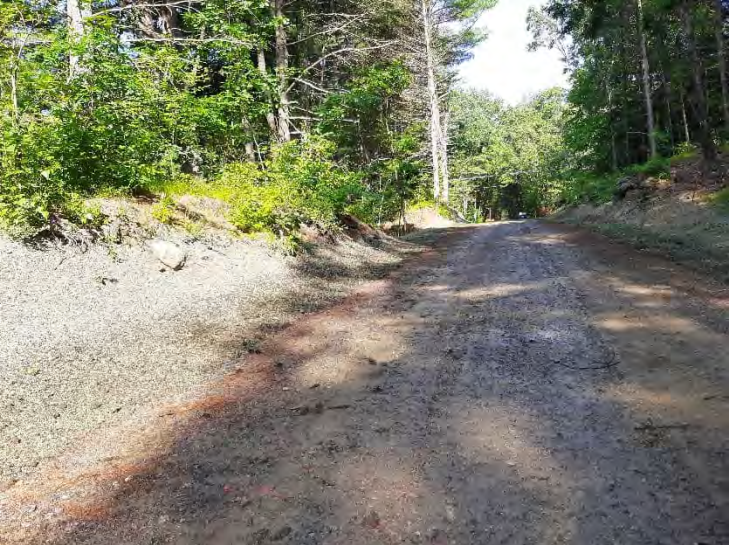
PHOTOGRAPHIC LOG	
Client Name: Eversource		Site Location: Sudbury to Hudson Transmission Reliability Project	Town: Sudbury
Photo No.: 2	Date: 7-22-24

Description: Work area within Segment 10, existing loam, recently watered, looking westward.

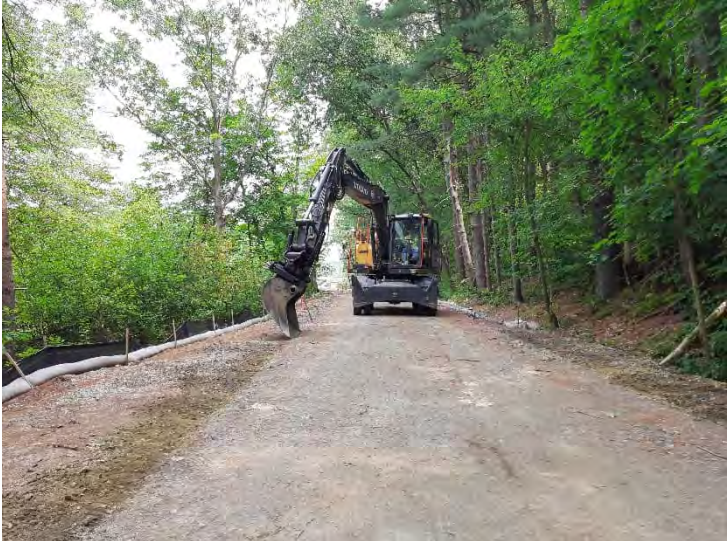
<p>PHOTOGRAPHIC LOG</p>	
<p>Client Name: Eversource</p>		<p>Site Location: Sudbury to Hudson Transmission Reliability Project</p>	<p>Town: Sudbury</p>
<p>Photo No.: 4</p>	<p>Date: 7-22-24</p>

<p>Description: Segment 13, ET&L preparing edges of ROW for loam and seed, existing erosion controls, looking eastward.</p>

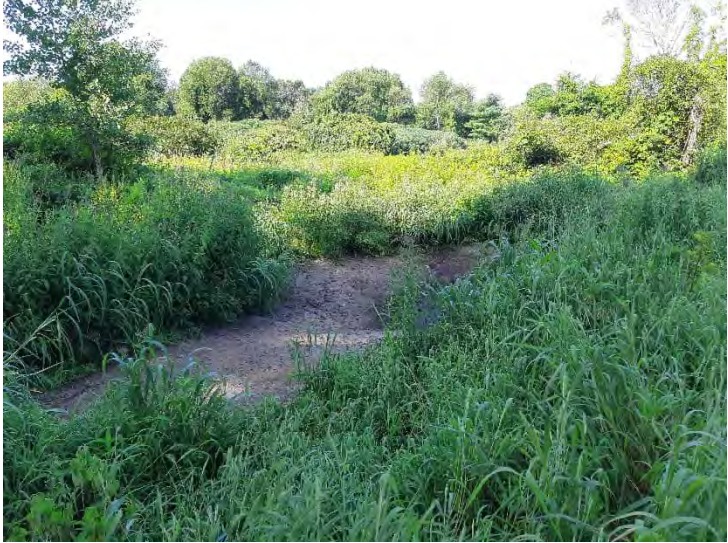
<p>PHOTOGRAPHIC LOG</p>	
<p>Client Name: Eversource</p>		<p>Site Location: Sudbury to Hudson Transmission Reliability Project</p>	<p>Town: Sudbury</p>
<p>Photo No.: 5</p>	<p>Date: 7-22-24</p>

<p>Description:</p> <p>Wetland replication area within Segment 14, low water level due to limited recent precipitation, looking westward.</p>

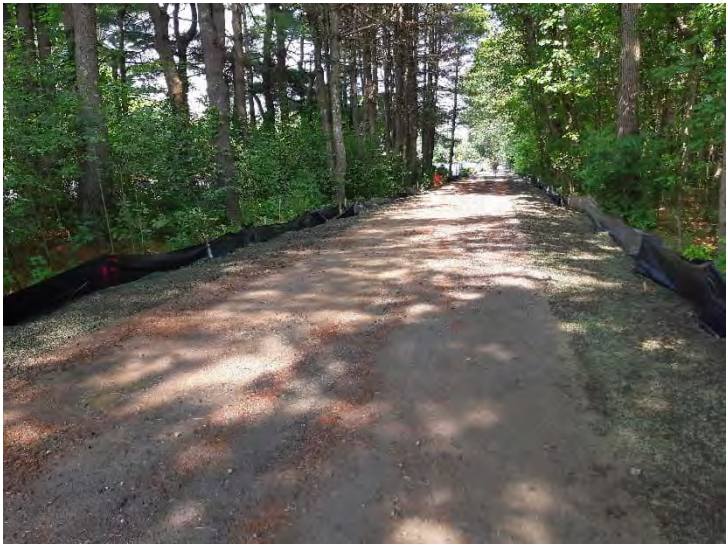
<p>PHOTOGRAPHIC LOG</p>	
<p>Client Name: Eversource</p>		<p>Site Location: Sudbury to Hudson Transmission Reliability Project</p>	<p>Town: Sudbury</p>
<p>Photo No.: 6</p>	<p>Date: 7-22-24</p>

<p>Description:</p> <p>Work area within Segment 11, existing hydroseed and erosion controls, recently watered, looking westward.</p>

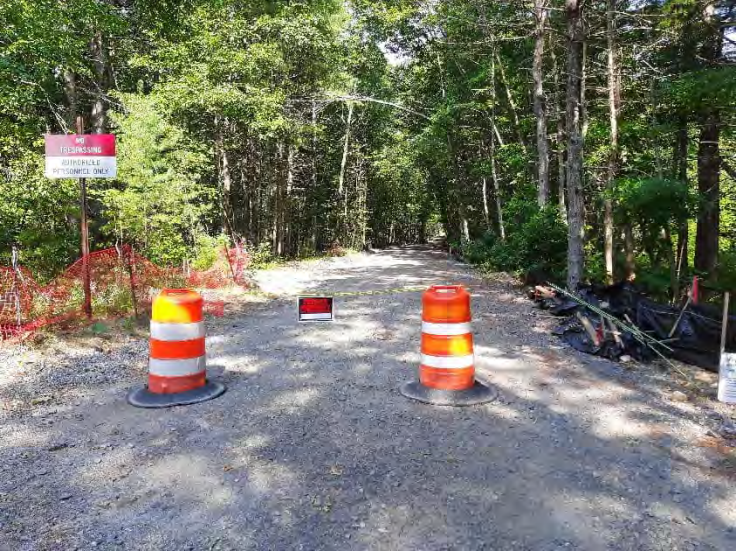
<p>PHOTOGRAPHIC LOG</p>	
<p>Client Name: Eversource</p>		<p>Site Location: Sudbury to Hudson Transmission Reliability Project</p>	<p>Town: Sudbury</p>
<p>Photo No.: 7</p>	<p>Date: 7-22-24</p>

<p>Description:</p> <p>Previous work area within Segment 8, no work in this segment today, looking westward.</p>

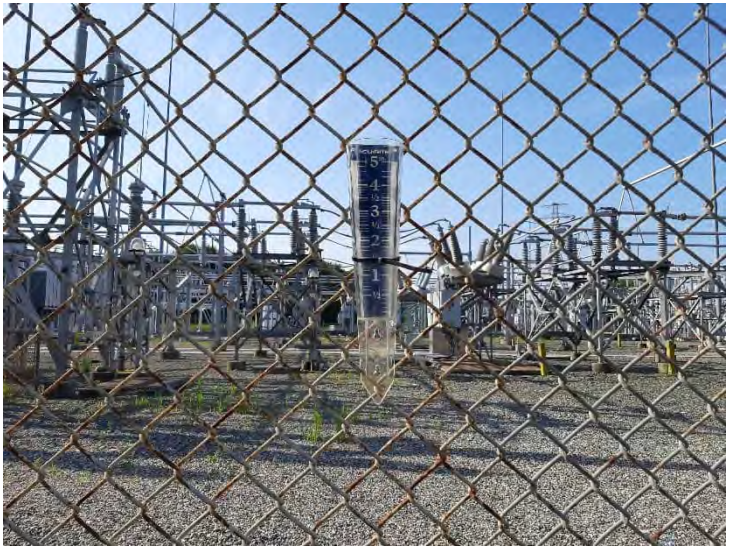
<p>PHOTOGRAPHIC LOG</p>	
<p>Client Name: Eversource</p>		<p>Site Location: Sudbury to Hudson Transmission Reliability Project</p>	<p>Town: Sudbury</p>
<p>Photo No.: 8</p>	<p>Date: 7-22-24</p>

<p>Description:</p> <p>Rain gauge at Sudbury Substation, no accumulated precipitation since last inspection on 7-20-24, looking southward.</p>

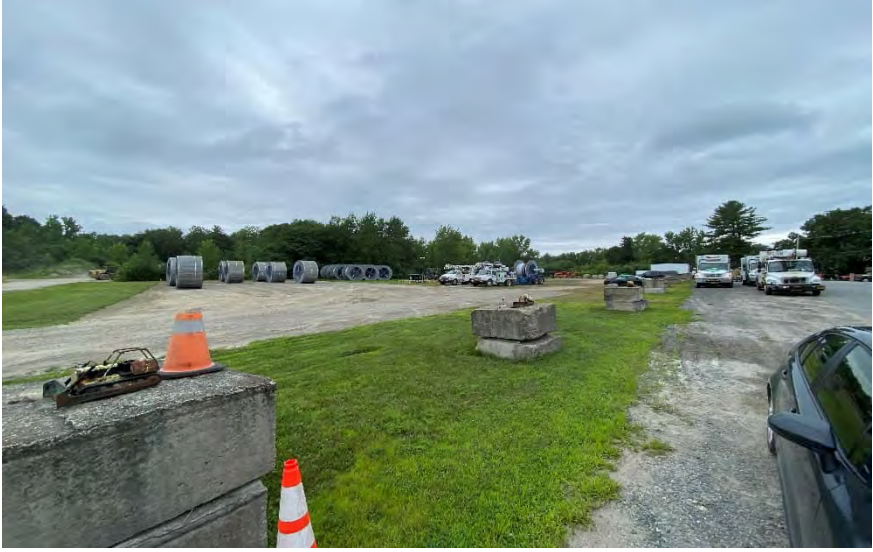
<p align="center">PHOTOGRAPHIC LOG</p>	
<p>Client Name: Eversource</p>		<p>Site Location: Sudbury to Hudson Transmission Reliability Project</p>	<p>Town: Hudson</p>
<p>Photo No.: 1</p>	<p>Date: 7-24-24</p>

<p>Description:</p> <p>Haugland laydown yard, stored wire on reels, looking eastward.</p>

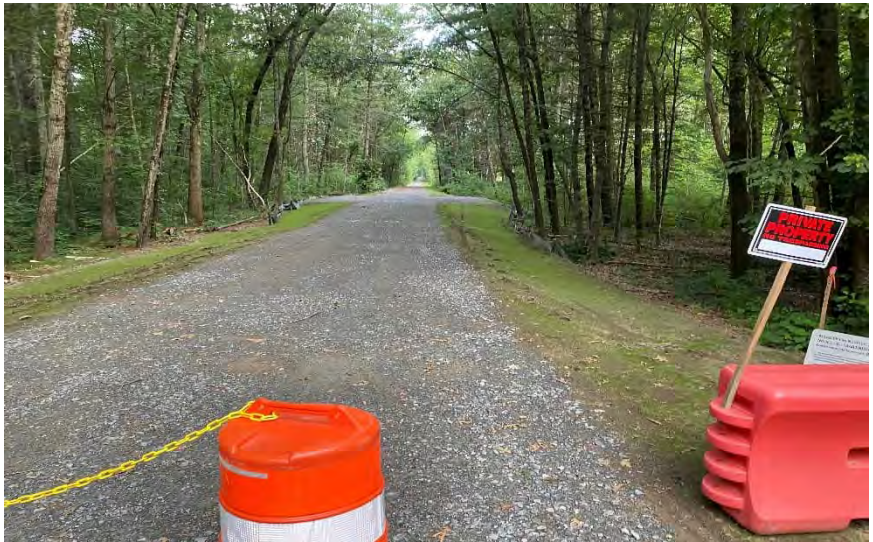
<p align="center">PHOTOGRAPHIC LOG</p>	
<p>Client Name: Eversource</p>		<p>Site Location: Sudbury to Hudson Transmission Reliability Project</p>	<p>Town: Hudson</p>
<p>Photo No.: 2</p>	<p>Date: 7-24-24</p>

<p>Description:</p> <p>Work area within segment 5, existing erosion control, looking westward.</p>

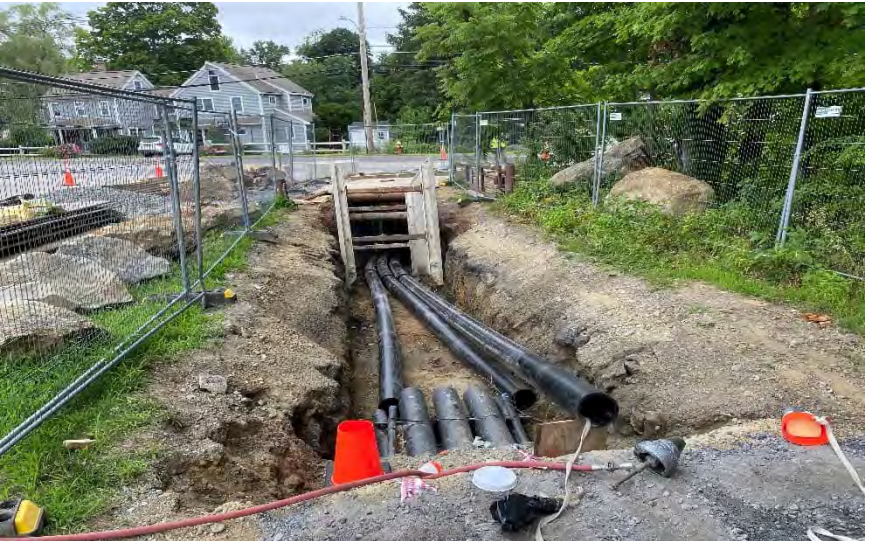
<p align="center">PHOTOGRAPHIC LOG</p>	
<p>Client Name: Eversource</p>		<p>Site Location: Sudbury to Hudson Transmission Reliability Project</p>	<p>Town: Hudson</p>
<p>Photo No.: 4</p>	<p>Date: 7-24-24</p>

<p>Description:</p> <p>Conduit work near manhole #1, near Hudson Power & Light facility, looking westward.</p>

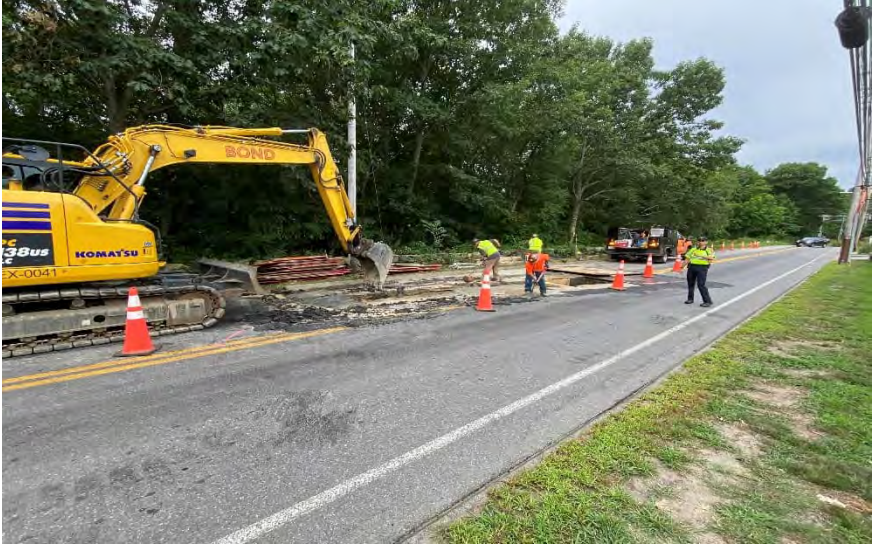
<p>PHOTOGRAPHIC LOG</p>	
<p>Client Name: Eversource</p>		<p>Site Location: Sudbury to Hudson Transmission Reliability Project</p>	<p>Town: Hudson</p>
<p>Photo No.: 5</p>	<p>Date: 7-24-24</p>

<p>Description:</p> <p>Conduit work near manhole #2, near Bonazolli Avenue intersection with Forest Ave., looking southward.</p>

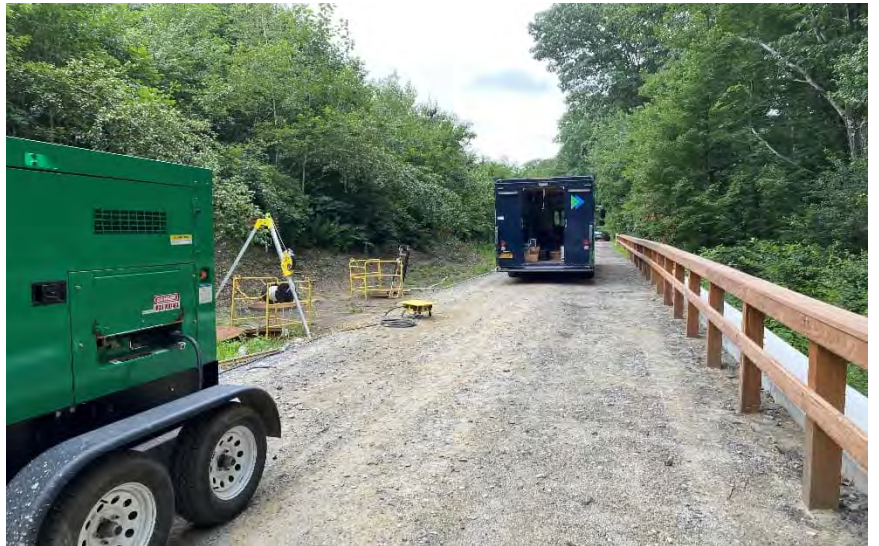
<p>PHOTOGRAPHIC LOG</p>	
<p>Client Name: Eversource</p>		<p>Site Location: Sudbury to Hudson Transmission Reliability Project</p>	<p>Town: Hudson</p>
<p>Photo No.: 6</p>	<p>Date: 7-24-24</p>

<p>Description:</p> <p>Work area within segment 1, manhole #6, clipping, existing erosion control, looking westward.</p>

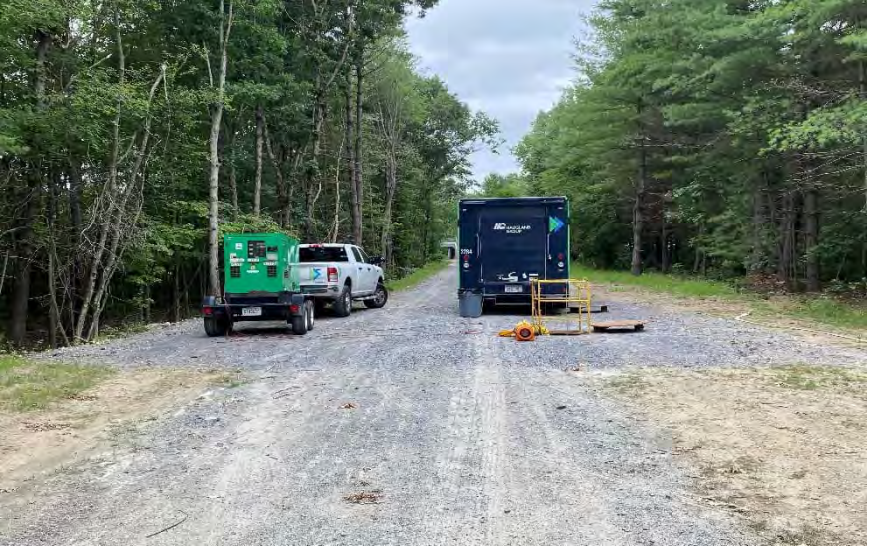
PHOTOGRAPHIC LOG	
Client Name: Eversource		Site Location: Sudbury to Hudson Transmission Reliability Project	Town: Hudson
Photo No.: 7	Date: 7-24-24

Description: Work area within segment 2, manhole #7, clipping, existing erosion control, looking westward

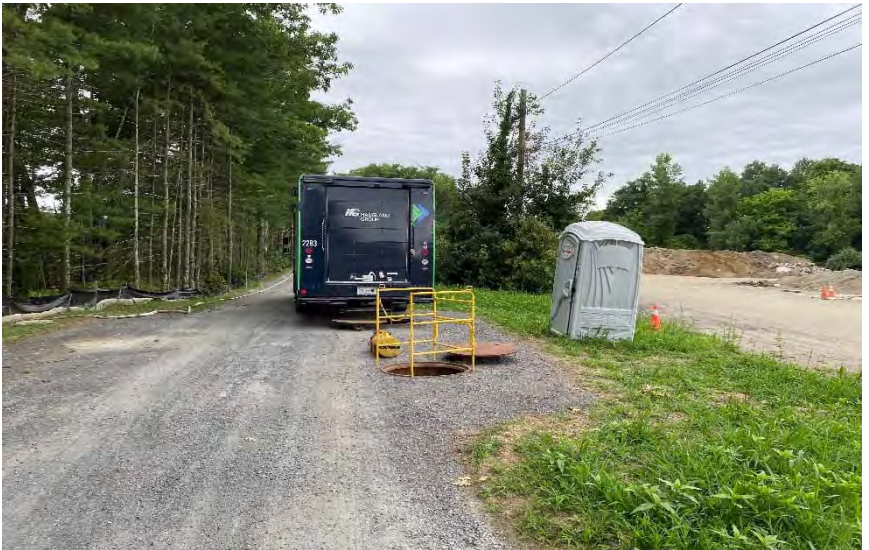
PHOTOGRAPHIC LOG	
Client Name: Eversource		Site Location: Sudbury to Hudson Transmission Reliability Project	Town: Hudson
Photo No.: 8	Date: 7-24-24

Description: Work area within segment 3, manhole #8, clipping, existing erosion control, looking westward

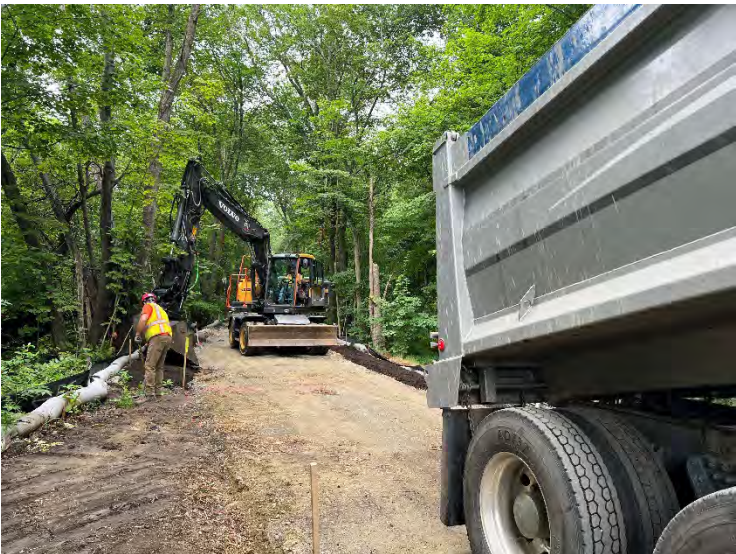
<p>PHOTOGRAPHIC LOG</p>	
<p>Client Name: Eversource</p>		<p>Site Location: Sudbury to Hudson Transmission Reliability Project</p>	<p>Town: Sudbury</p>
<p>Photo No.: 2</p>	<p>Date: 7/24/2024</p>

<p>Description: View of ET&L applying loam in segment 13. Facing east.</p>

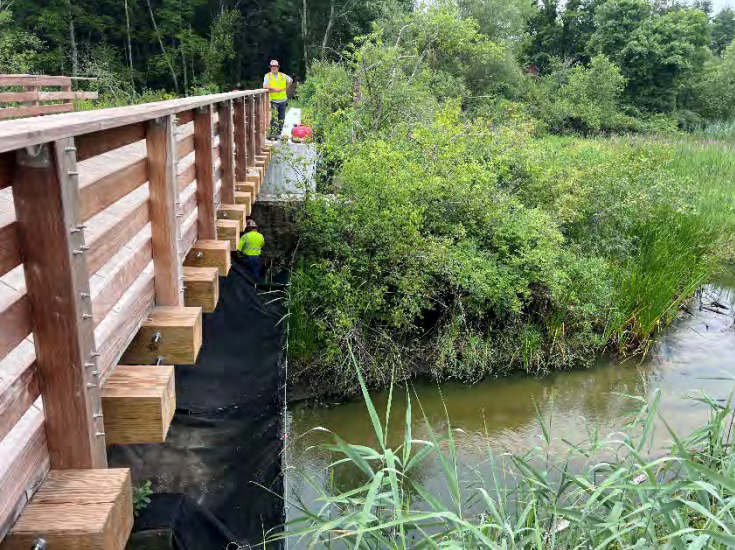
PHOTOGRAPHIC LOG	
Client Name: Eversource		Site Location: Sudbury to Hudson Transmission Reliability Project	Town: Sudbury
Photo No.: 4	Date: 7/24/2024

Description: View of Bond working at Bridge 128. Crew members parked at MH #17 and walked the rest of the way to the bridge. Facing east.

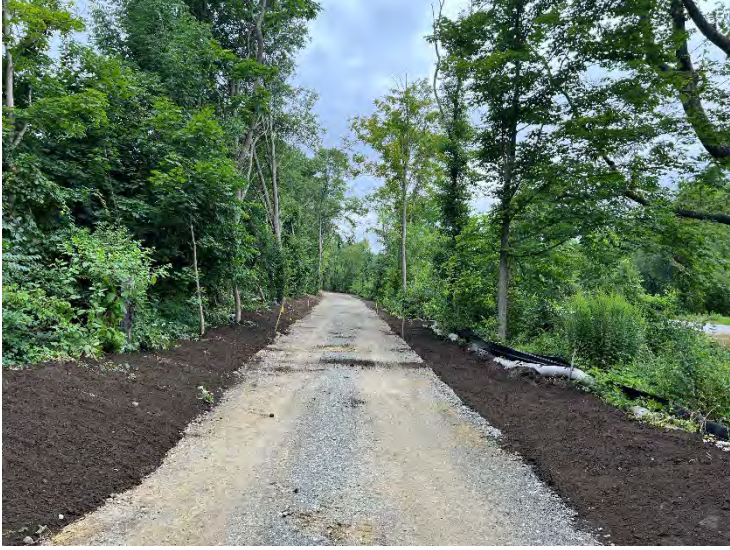
PHOTOGRAPHIC LOG	
Client Name: Eversource		Site Location: Sudbury to Hudson Transmission Reliability Project	Town: Sudbury
Photo No.: 5	Date: 7/24/2024

Description: View of applied loam in segment 12. Facing northwest.

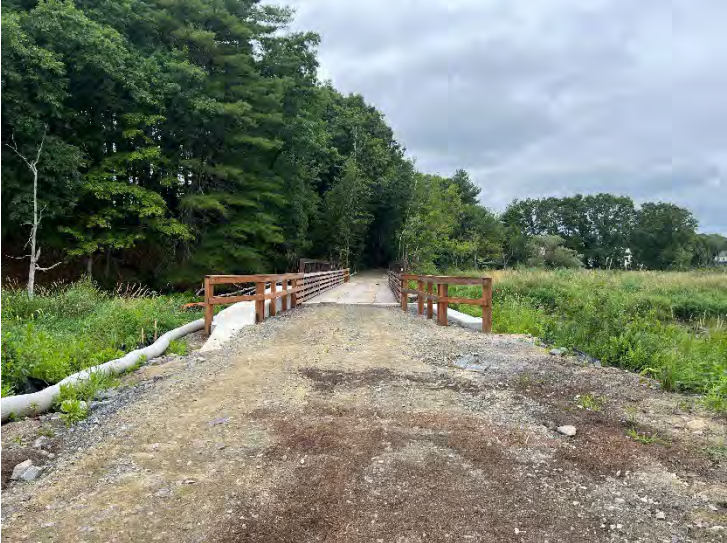
PHOTOGRAPHIC LOG	
Client Name: Eversource		Site Location: Sudbury to Hudson Transmission Reliability Project	Town: Sudbury
Photo No.: 6	Date: 7/24/2024

Description: View of Bridge 127. Facing west.

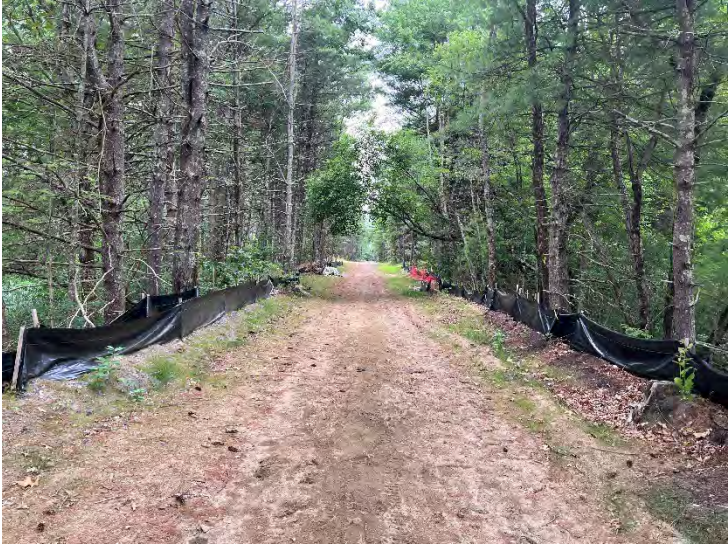
PHOTOGRAPHIC LOG	
Client Name: Eversource		Site Location: Sudbury to Hudson Transmission Reliability Project	Town: Sudbury
Photo No.: 8	Date: 7/24/2024

Description: View of E&S controls in segment 7. Facing west.

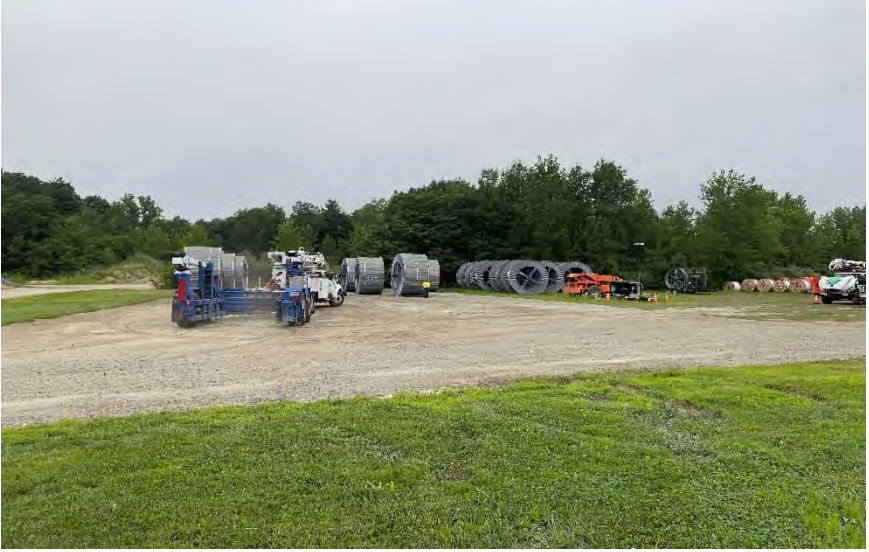
PHOTOGRAPHIC LOG	
Client Name: Eversource		Site Location: Sudbury to Hudson Transmission Reliability Project	Town: Hudson
Photo No.: 1	Date: 7-25-24

Description: Haugland laydown yard, stored wire on reels, looking westward.

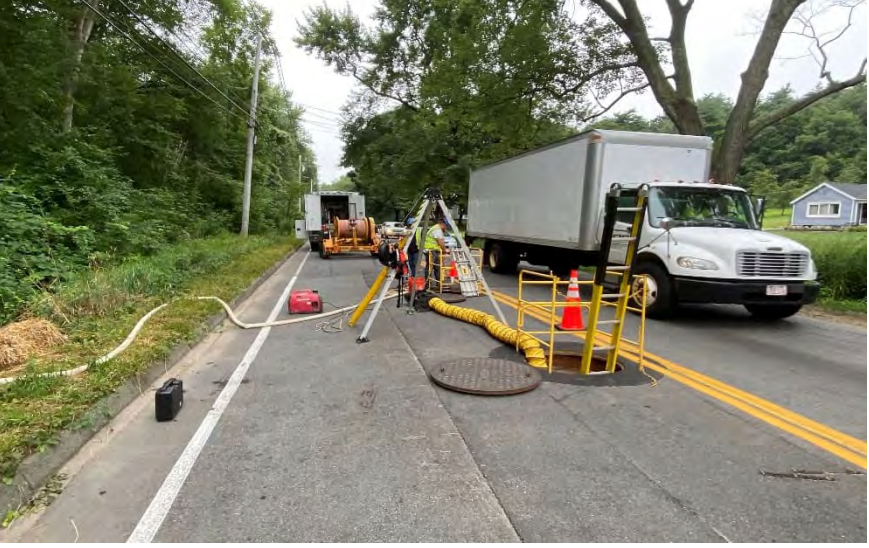
PHOTOGRAPHIC LOG	
Client Name: Eversource		Site Location: Sudbury to Hudson Transmission Reliability Project	Town: Hudson
Photo No.: 2	Date: 7-25-24

Description: Work area within Forest Avenue, wire pulling work, manhole #4, looking southward.

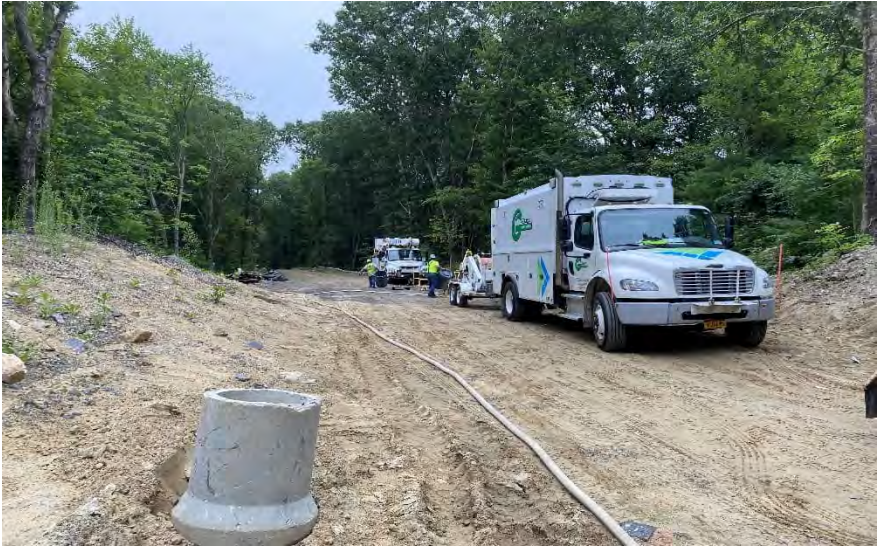
<p align="center">PHOTOGRAPHIC LOG</p>	
<p>Client Name: Eversource</p>		<p>Site Location: Sudbury to Hudson Transmission Reliability Project</p>	<p>Town: Hudson</p>
<p>Photo No.: 3</p>	<p>Date: 7-25-24</p>

<p>Description:</p> <p>Work area within Segment 1, wire pulling work, manhole #5, existing erosion control, looking eastward.</p>

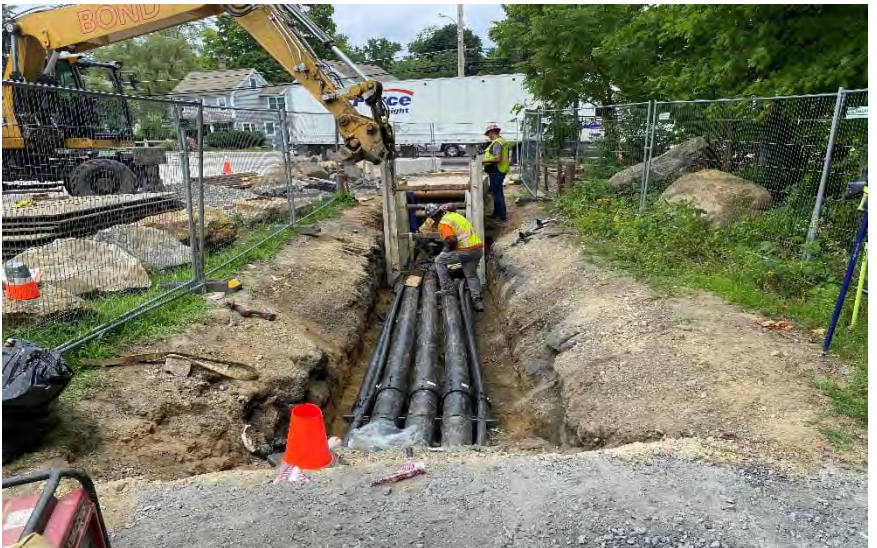
<p align="center">PHOTOGRAPHIC LOG</p>	
<p>Client Name: Eversource</p>		<p>Site Location: Sudbury to Hudson Transmission Reliability Project</p>	<p>Town: Hudson</p>
<p>Photo No.: 4</p>	<p>Date: 7-25-24</p>

<p>Description:</p> <p>Conduit work near manhole #1, near Hudson Power & Light facility, looking westward.</p>

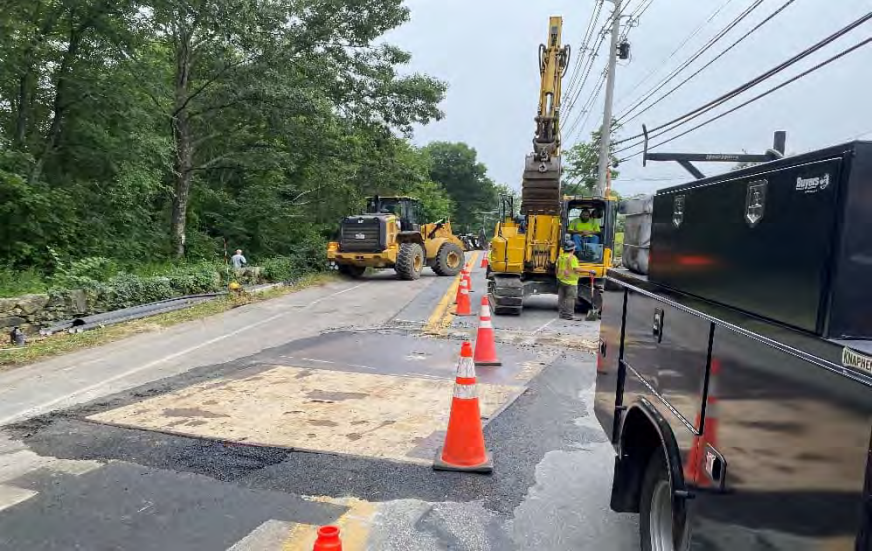
<p>PHOTOGRAPHIC LOG</p>	
<p>Client Name: Eversource</p>		<p>Site Location: Sudbury to Hudson Transmission Reliability Project</p>	<p>Town: Hudson</p>
<p>Photo No.: 5</p>	<p>Date: 7-25-24</p>

<p>Description: Conduit work near manhole #2, near Bonazolli Avenue intersection with Forest Ave., looking southward.</p>

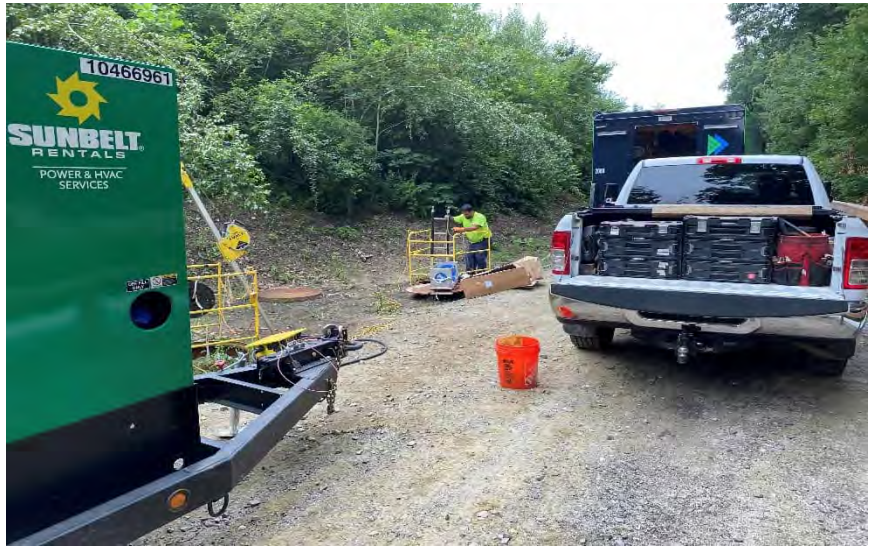
<p>PHOTOGRAPHIC LOG</p>	
<p>Client Name: Eversource</p>		<p>Site Location: Sudbury to Hudson Transmission Reliability Project</p>	<p>Town: Hudson</p>
<p>Photo No.: 6</p>	<p>Date: 7-25-24</p>

<p>Description: Work area within segment 1, manhole #6, clipping, existing erosion control, looking westward.</p>

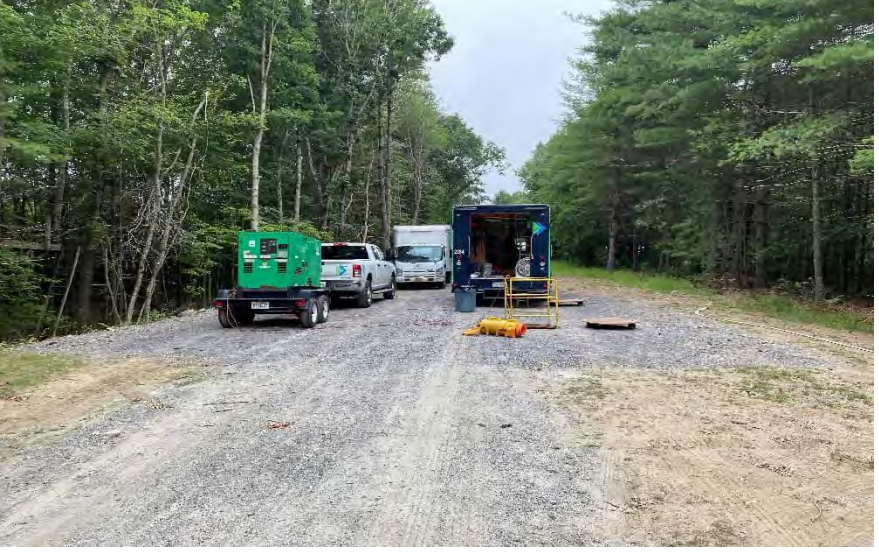
<p>PHOTOGRAPHIC LOG</p>	
<p>Client Name: Eversource</p>		<p>Site Location: Sudbury to Hudson Transmission Reliability Project</p>	<p>Town: Hudson</p>
<p>Photo No.: 7</p>	<p>Date: 7-25-24</p>

<p>Description:</p> <p>Work area within segment 2, manhole #7, clipping, existing erosion control, looking westward</p>

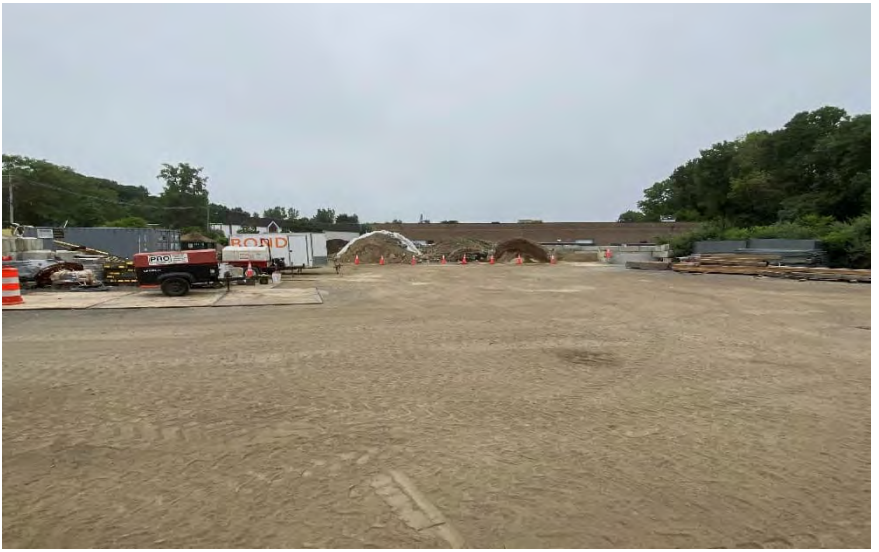
<p>PHOTOGRAPHIC LOG</p>	
<p>Client Name: Eversource</p>		<p>Site Location: Sudbury to Hudson Transmission Reliability Project</p>	<p>Town: Hudson</p>
<p>Photo No.: 8</p>	<p>Date: 7-25-24</p>

<p>Description:</p> <p>Bonazzoli laydown yard, stockpiled soils, looking westward</p>

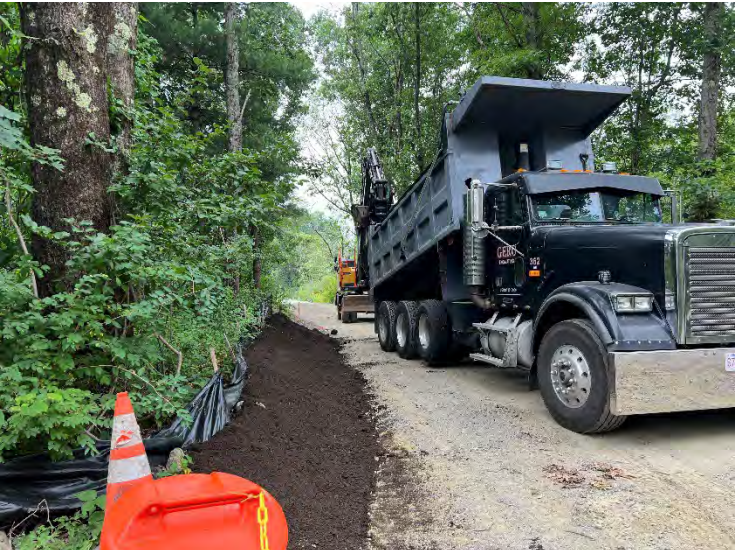
<p>PHOTOGRAPHIC LOG</p>	
<p>Client Name: Eversource</p>		<p>Site Location: Sudbury to Hudson Transmission Reliability Project</p>	<p>Town: Sudbury</p>
<p>Photo No.: 2</p>	<p>Date: 7/25/2024</p>

<p>Description: View of ET&L applying loam in segment 14. Facing west.</p>

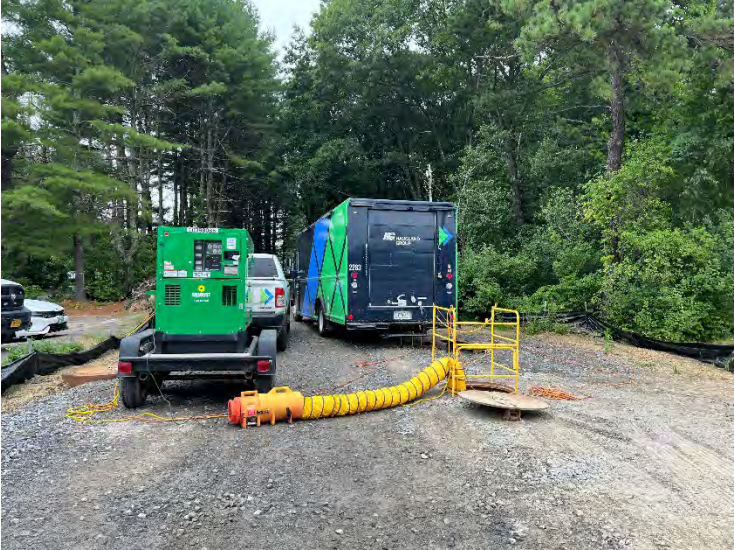
<p>PHOTOGRAPHIC LOG</p>	
<p>Client Name: Eversource</p>		<p>Site Location: Sudbury to Hudson Transmission Reliability Project</p>	<p>Town: Sudbury</p>
<p>Photo No.: 3</p>	<p>Date: 7/25/2024</p>

<p>Description: View of Haugland splicers at MH #24 in segment 11. Facing west.</p>

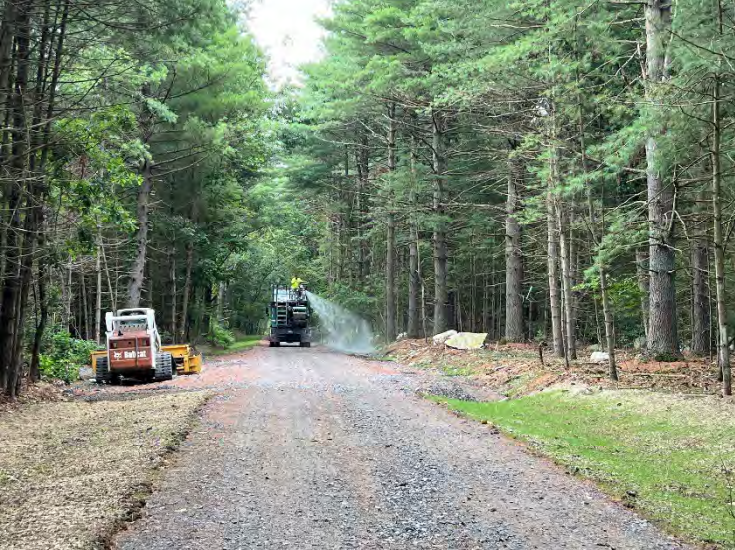
<p>PHOTOGRAPHIC LOG</p>	
<p>Client Name: Eversource</p>		<p>Site Location: Sudbury to Hudson Transmission Reliability Project</p>	<p>Town: Sudbury</p>
<p>Photo No.: 4</p>	<p>Date: 7/25/2024</p>

<p>Description: View of MON applying hydroseed in segment 9. Facing east.</p>

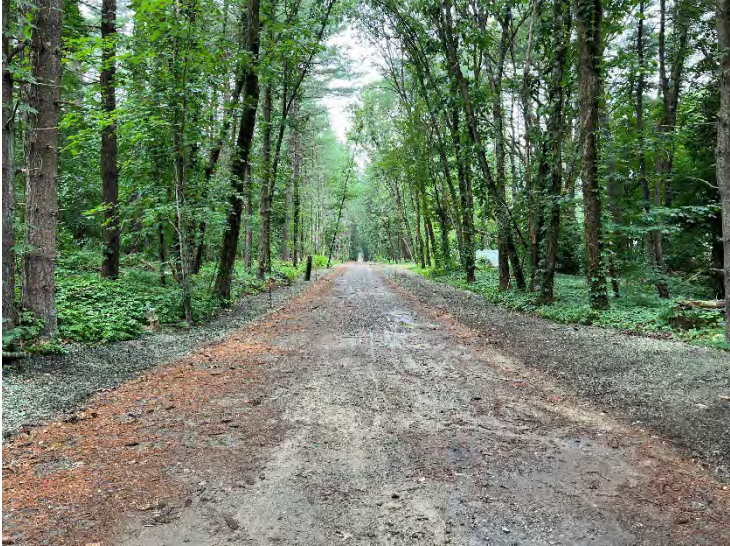
PHOTOGRAPHIC LOG	
Client Name: Eversource		Site Location: Sudbury to Hudson Transmission Reliability Project	Town: Sudbury
Photo No.: 5	Date: 7/25/2024

Description: View of hydroseed in segment 11. Facing east.

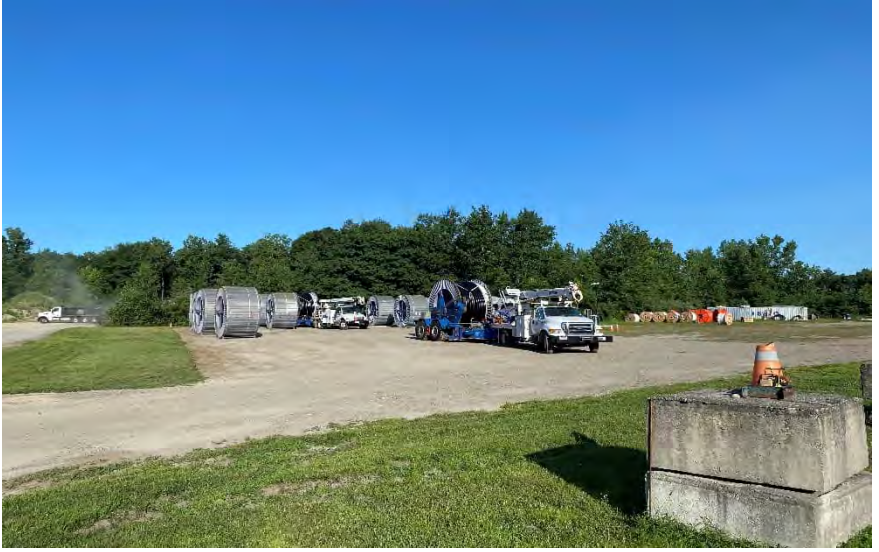
<p align="center">PHOTOGRAPHIC LOG</p>	
<p>Client Name: Eversource</p>		<p>Site Location: Sudbury to Hudson Transmission Reliability Project</p>	<p>Town: Hudson</p>
<p>Photo No.: 1</p>	<p>Date: 7-26-24</p>

<p>Description:</p> <p>Haugland laydown yard, stored wire on reels, looking westward.</p>

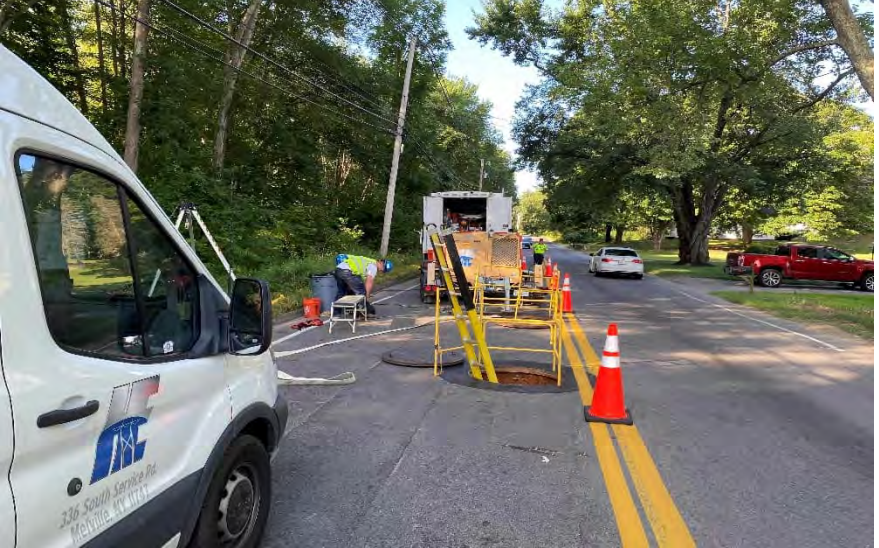
<p align="center">PHOTOGRAPHIC LOG</p>	
<p>Client Name: Eversource</p>		<p>Site Location: Sudbury to Hudson Transmission Reliability Project</p>	<p>Town: Hudson</p>
<p>Photo No.: 2</p>	<p>Date: 7-26-24</p>

<p>Description:</p> <p>Work area within Forest Avenue, wire pulling work, manhole #4, looking southward.</p>

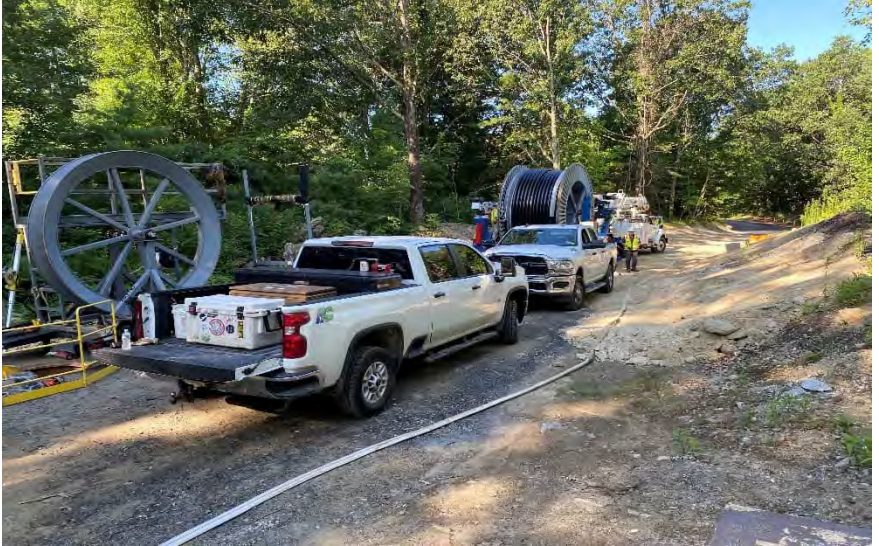
<p align="center">PHOTOGRAPHIC LOG</p>	
<p>Client Name: Eversource</p>		<p>Site Location: Sudbury to Hudson Transmission Reliability Project</p>	<p>Town: Hudson</p>
<p>Photo No.: 3</p>	<p>Date: 7-26-24</p>

<p>Description:</p> <p>Work area within Segment 1, wire pulling work, manhole #5, existing erosion control, looking westward.</p>

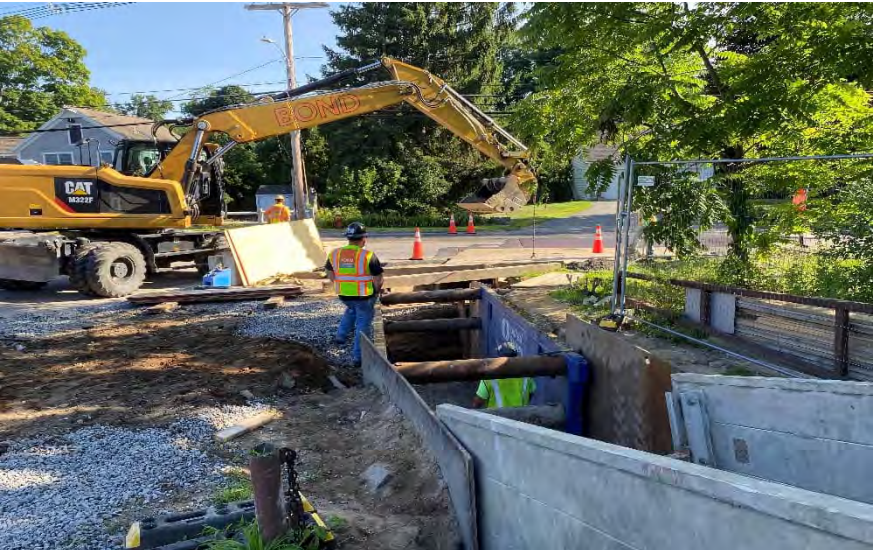
<p align="center">PHOTOGRAPHIC LOG</p>	
<p>Client Name: Eversource</p>		<p>Site Location: Sudbury to Hudson Transmission Reliability Project</p>	<p>Town: Hudson</p>
<p>Photo No.: 4</p>	<p>Date: 7-26-24</p>

<p>Description:</p> <p>Conduit work near manhole #1, near Hudson Power & Light facility, looking westward.</p>

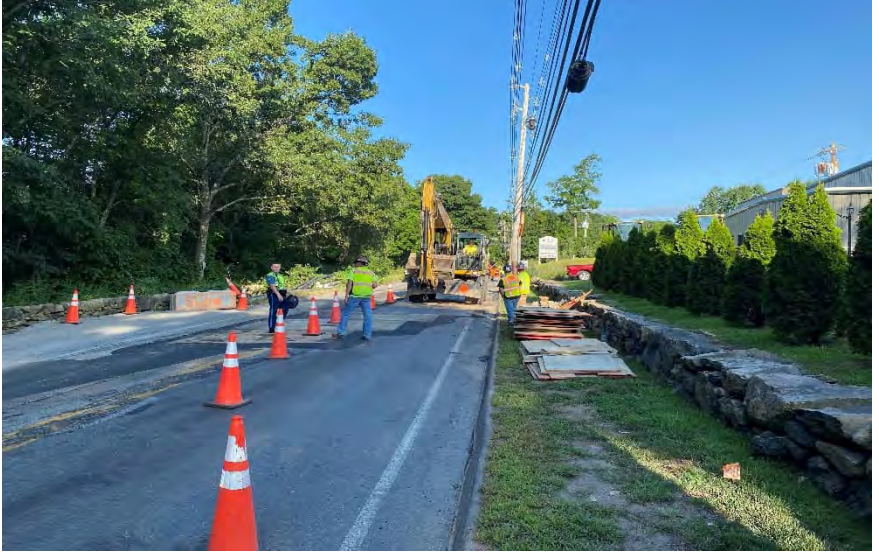
PHOTOGRAPHIC LOG	
Client Name: Eversource		Site Location: Sudbury to Hudson Transmission Reliability Project	Town: Hudson
Photo No.: 5	Date: 7-26-24

Description: Conduit work near manhole #2, near Bonazolli Avenue intersection with Forest Ave., looking southward.

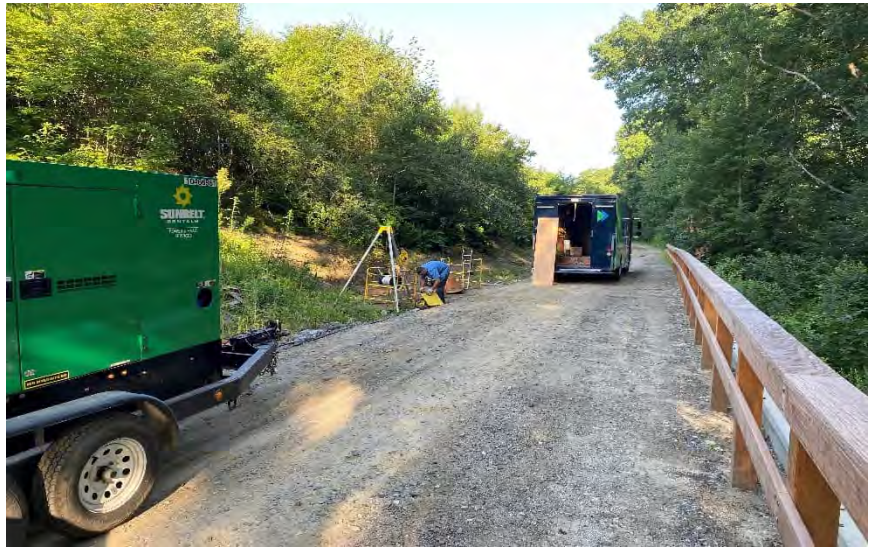
PHOTOGRAPHIC LOG	
Client Name: Eversource		Site Location: Sudbury to Hudson Transmission Reliability Project	Town: Hudson
Photo No.: 6	Date: 7-26-24

Description: Work area within segment 1, manhole #6, clipping, existing erosion control, looking westward.

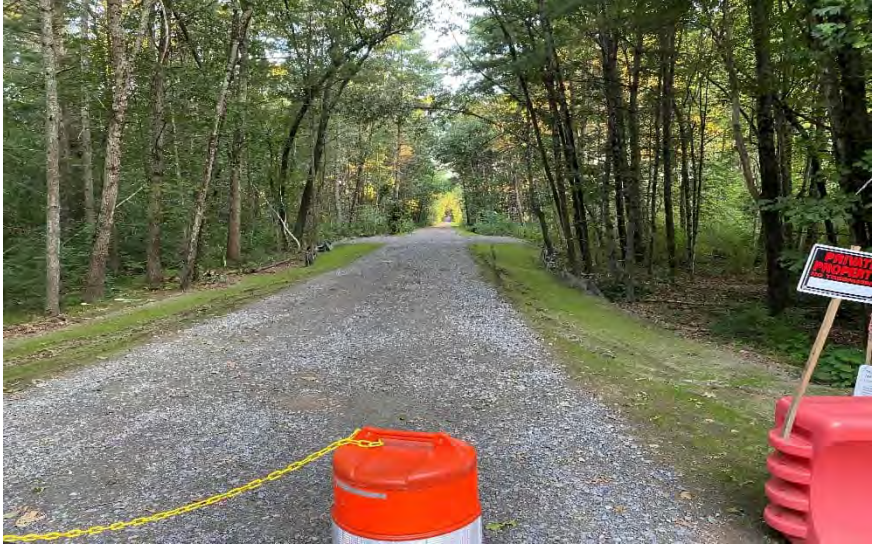
<p align="center">PHOTOGRAPHIC LOG</p>	
<p>Client Name: Eversource</p>		<p>Site Location: Sudbury to Hudson Transmission Reliability Project</p>	<p>Town: Hudson</p>
<p>Photo No.: 7</p>	<p>Date: 7-26-24</p>

<p>Description:</p> <p>Work area within segment 5, manhole #13 (background), existing erosion control, looking westward.</p>
