Weekly Environmental Compliance Summary

Sudbury to Hudson Transmission Reliability Project (USEPA Tracking # MAR1003UW)

Week of: July 22, 2024 to July 27, 2024

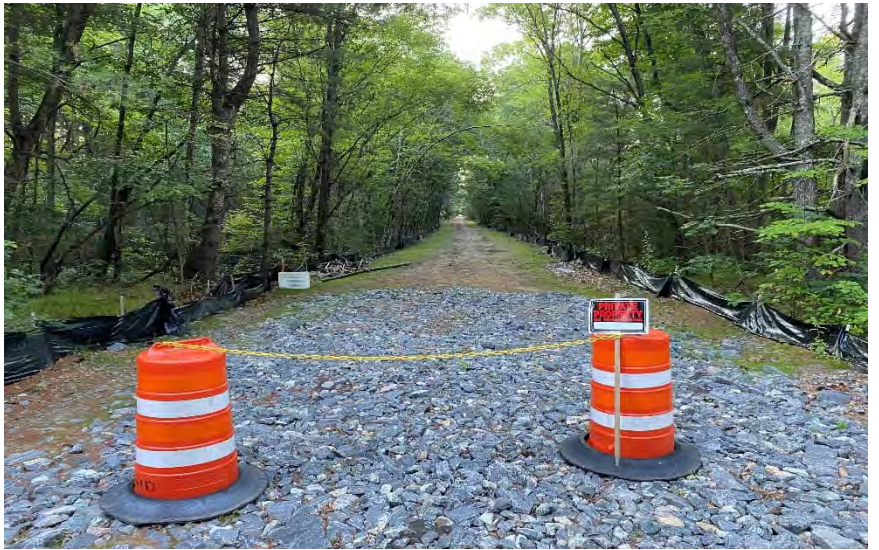
<p align="center">PHOTOGRAPHIC LOG</p>	
<p>Client Name: Eversource</p>		<p>Site Location: Sudbury to Hudson Transmission Reliability Project</p>	<p>Town: Hudson</p>
<p>Photo No.: 8</p>	<p>Date: 7-26-24</p>

<p>Description:</p> <p>Work area within segment 6, existing erosion control, looking eastward</p>

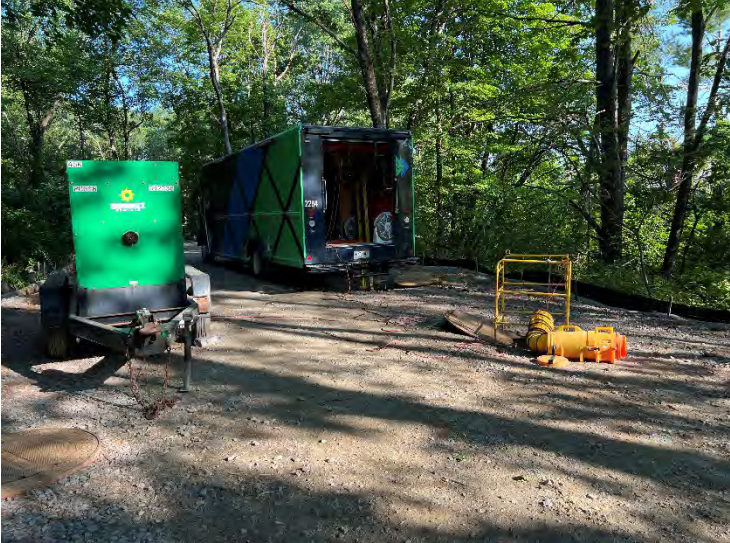
<p>PHOTOGRAPHIC LOG</p>	
<p>Client Name: Eversource</p>		<p>Site Location: Sudbury to Hudson Transmission Reliability Project</p>	<p>Town: Sudbury</p>
<p>Photo No.: 1</p>	<p>Date: 7/26/2024</p>

<p>Description: View of Haugland splicers at MH #25 in segment 13. Facing east.</p>

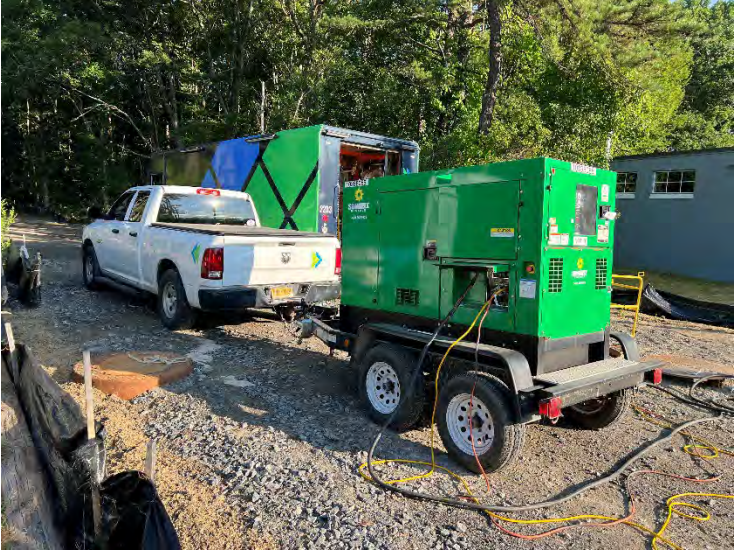
<p>PHOTOGRAPHIC LOG</p>	
<p>Client Name: Eversource</p>		<p>Site Location: Sudbury to Hudson Transmission Reliability Project</p>	<p>Town: Sudbury</p>
<p>Photo No.: 3</p>	<p>Date: 7/26/2024</p>

<p>Description: View of Haugland splicers at MH #24 in segment 11. Facing northwest.</p>

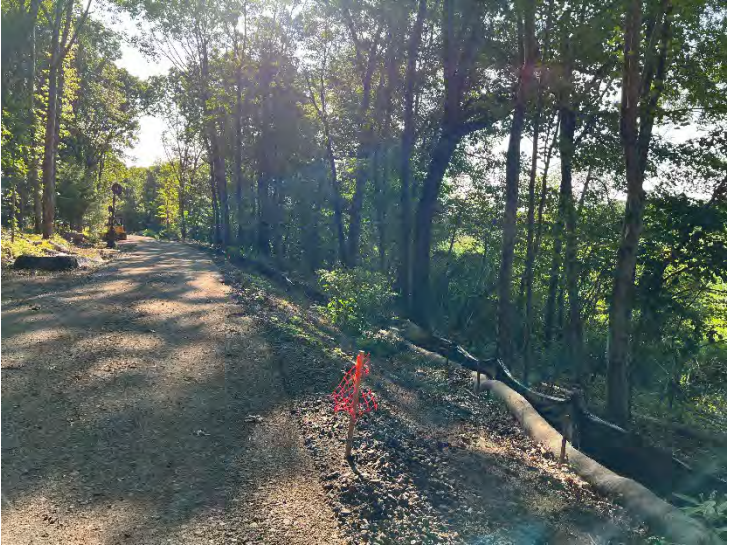
PHOTOGRAPHIC LOG	
Client Name: Eversource		Site Location: Sudbury to Hudson Transmission Reliability Project	Town: Sudbury
Photo No.: 6	Date: 7/26/2024

Description: View of E&S controls in segment 14. Facing west.

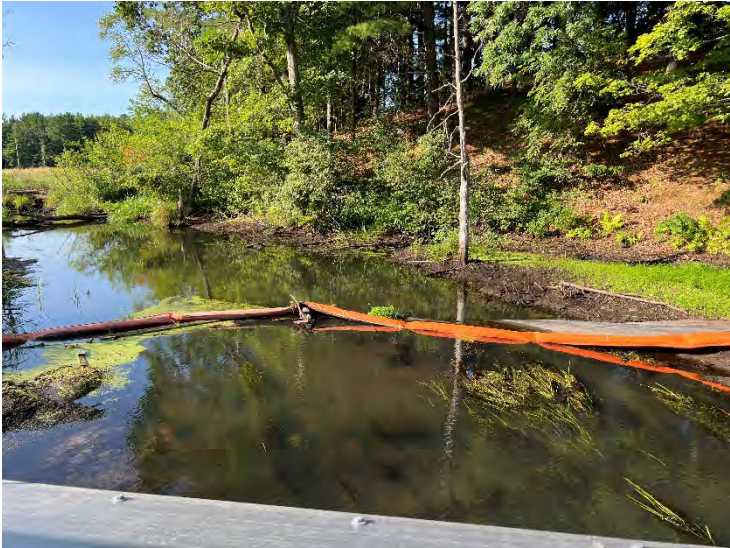
PHOTOGRAPHIC LOG	
Client Name: Eversource		Site Location: Sudbury to Hudson Transmission Reliability Project	Town: Sudbury
Photo No.: 7	Date: 7/26/2024

Description: View of turbidity curtain at Bridge 127. Facing south.

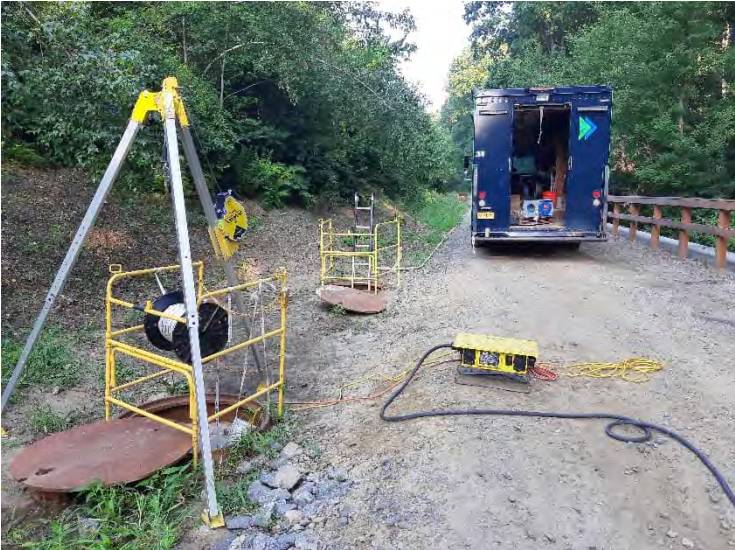
<p>PHOTOGRAPHIC LOG</p>	
<p>Client Name: Eversource</p>		<p>Site Location: Sudbury to Hudson Transmission Reliability Project</p>	<p>Town: Hudson</p>
<p>Photo No.: 1</p>	<p>Date: 7-27-24</p>

<p>Description:</p> <p>Work area at manhole #6 (Segment 1). Haugland crimping and splicing, looking westward.</p>

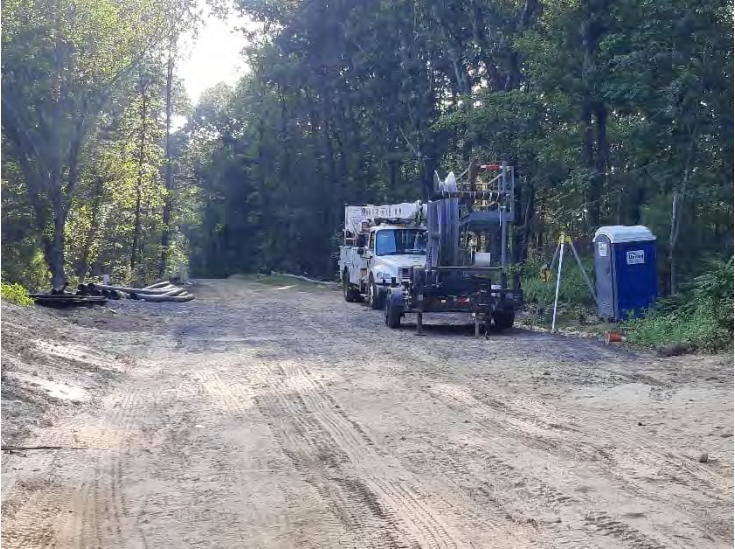
<p>PHOTOGRAPHIC LOG</p>	
<p>Client Name: Eversource</p>		<p>Site Location: Sudbury to Hudson Transmission Reliability Project</p>	<p>Town: Hudson</p>
<p>Photo No.: 2</p>	<p>Date: 7-27-24</p>

<p>Description:</p> <p>Previous work area at manhole #5 (Segment 1). Staged equipment from cable pulling, pending relocation by Haugland, looking eastward.</p>

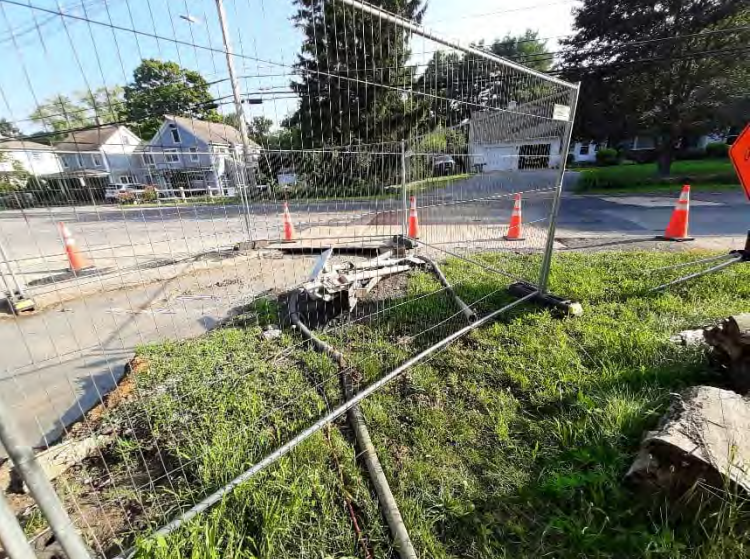
<p>PHOTOGRAPHIC LOG</p>	
<p>Client Name: Eversource</p>		<p>Site Location: Sudbury to Hudson Transmission Reliability Project</p>	<p>Town: Hudson</p>
<p>Photo No.: 4</p>	<p>Date: 7-27-24</p>

<p>Description:</p> <p>Work area at trench near manhole #1 (Forest Ave near Hudson Light & Power). Dewatering system has been disconnected, no weekend dewatering, looking northward.</p>

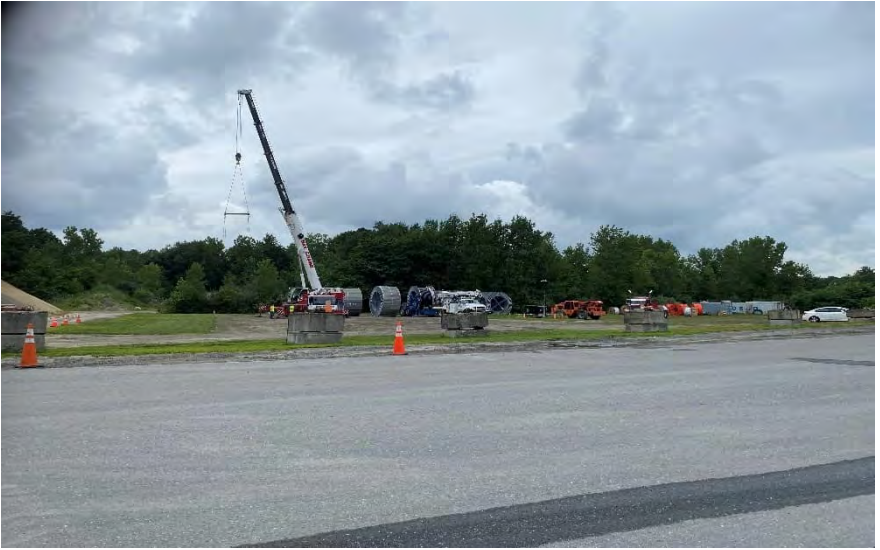
PHOTOGRAPHIC LOG	
Client Name: Eversource		Site Location: Sudbury to Hudson Transmission Reliability Project	Town: Hudson
Photo No.: 1	Date: 7-23-24

Description: Haugland laydown yard, stored wire on reels, looking westward.

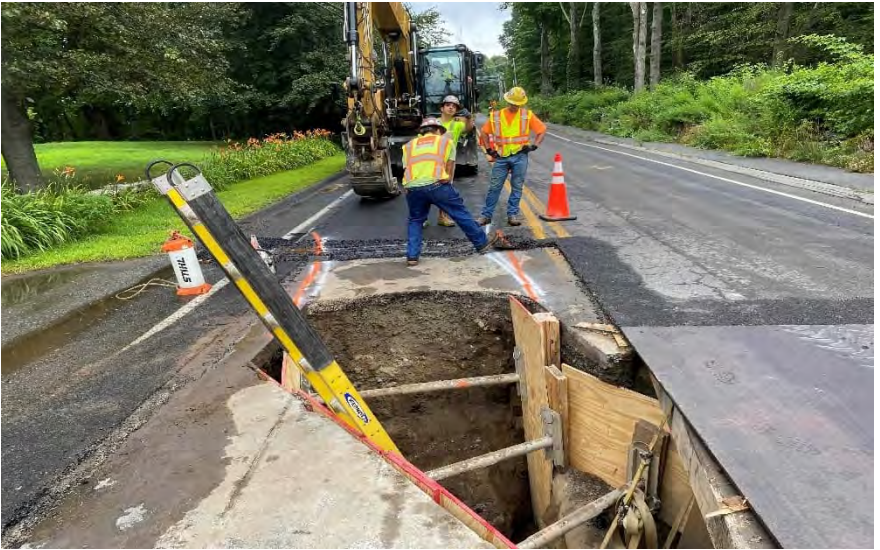
PHOTOGRAPHIC LOG	
Client Name: Eversource		Site Location: Sudbury to Hudson Transmission Reliability Project	Town: Hudson
Photo No.: 2	Date: 7-23-24

Description: Bond conducting conduit work within Forest Avenue near manhole #1, looking northward.

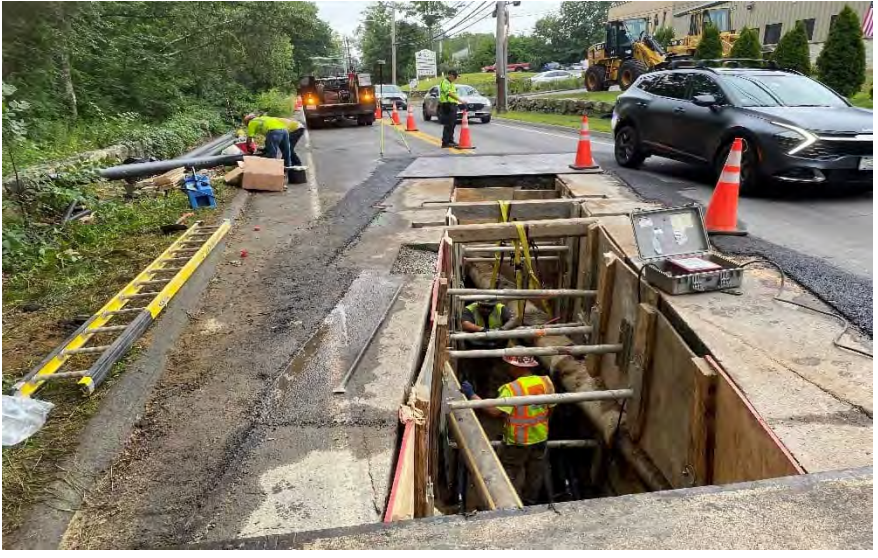
PHOTOGRAPHIC LOG	
Client Name: Eversource		Site Location: Sudbury to Hudson Transmission Reliability Project	Town: Hudson
Photo No.: 3	Date: 7-23-24

Description: Bond conducting conduit work within Forest Avenue near manhole #2, looking southward.

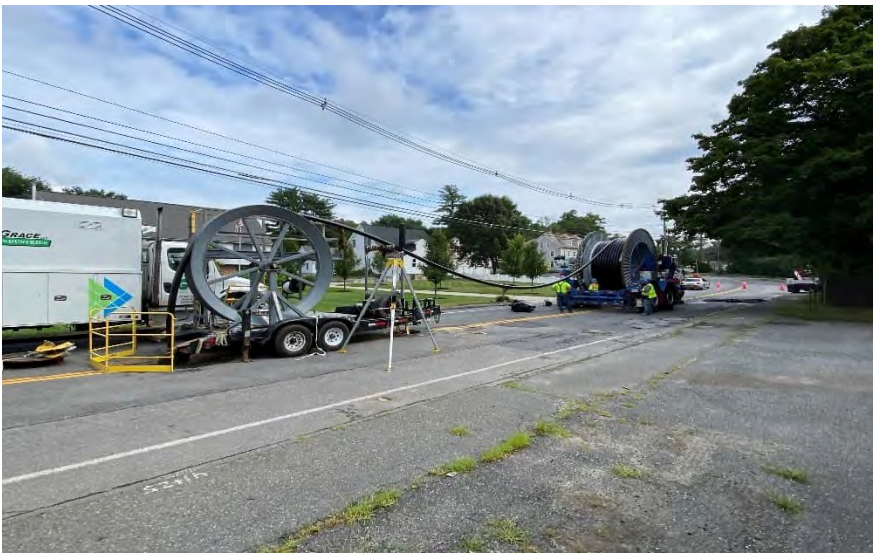
PHOTOGRAPHIC LOG	
Client Name: Eversource		Site Location: Sudbury to Hudson Transmission Reliability Project	Town: Hudson
Photo No.: 4	Date: 7-23-24

Description: Haugland pulling wire at manhole #3 within Forest Avenue, looking southward.

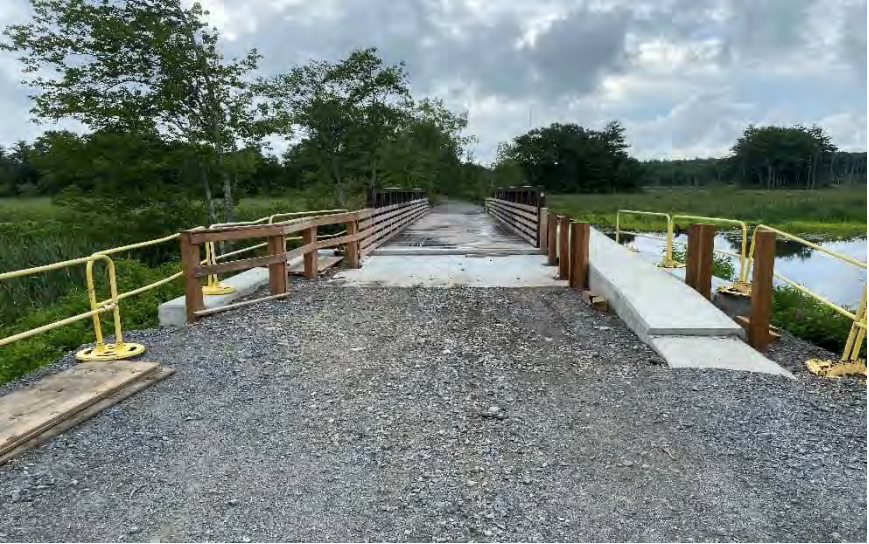
PHOTOGRAPHIC LOG	
Client Name: Eversource		Site Location: Sudbury to Hudson Transmission Reliability Project	Town: Hudson
Photo No.: 5	Date: 7-23-24

Description: Bridge 130 looking over Fort Meadow Brook from segment 2 to segment 3, existing erosion control, looking eastward.

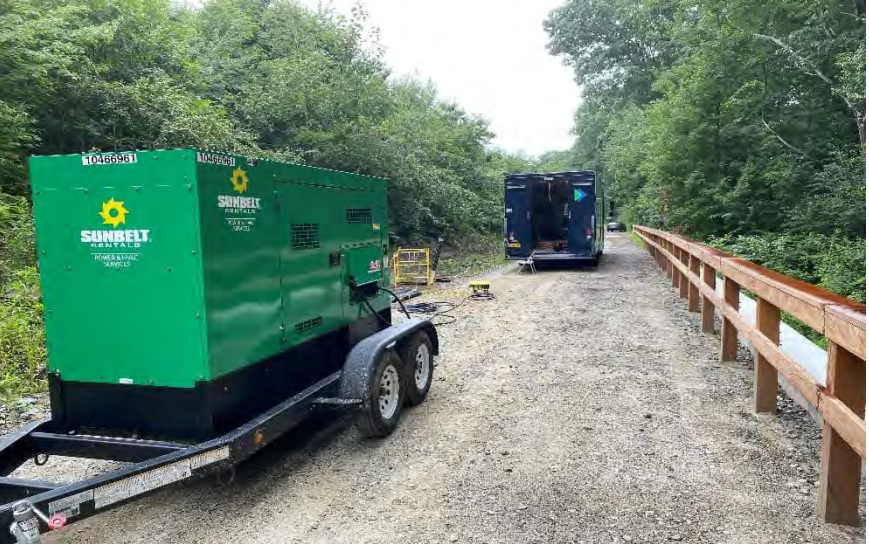
PHOTOGRAPHIC LOG	
Client Name: Eversource		Site Location: Sudbury to Hudson Transmission Reliability Project	Town: Hudson
Photo No.: 6	Date: 7-23-24

Description: Haugland splicing at manhole #6, segment 1, looking westward.

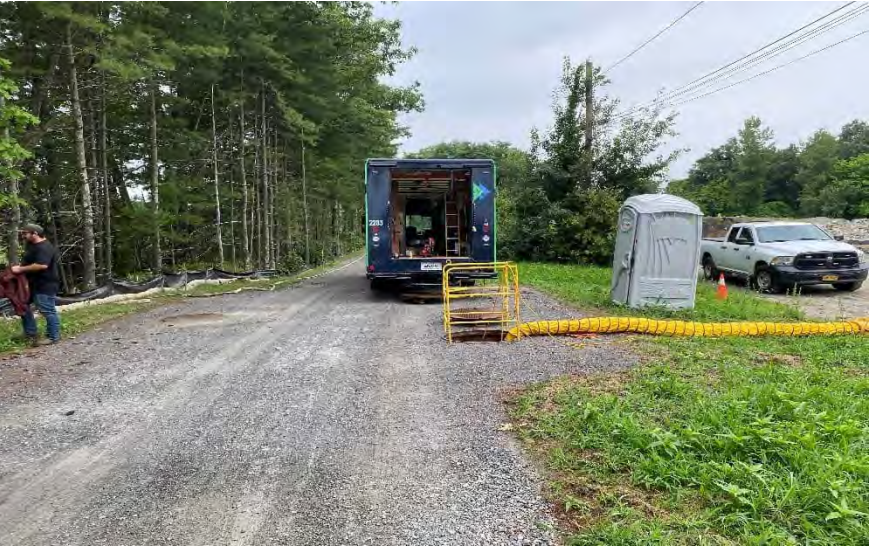
PHOTOGRAPHIC LOG	
Client Name: Eversource		Site Location: Sudbury to Hudson Transmission Reliability Project	Town: Hudson
Photo No.: 8	Date: 7-23-24

Description: Haugland splicing at manhole #8, segment 3, looking westward.

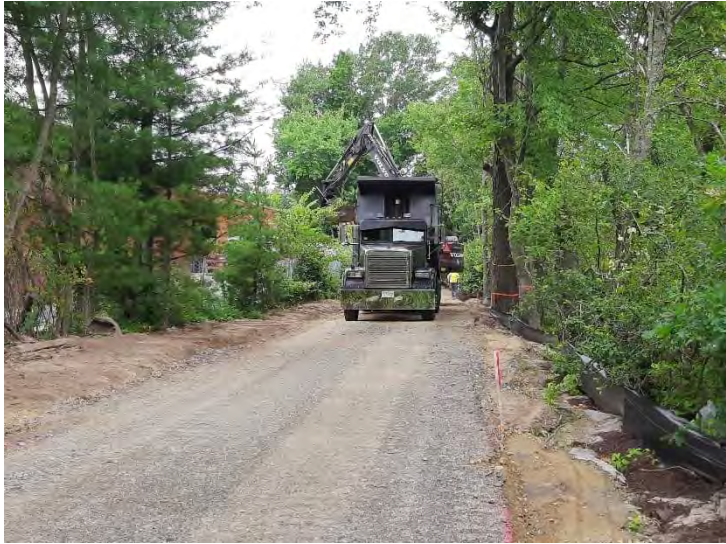
PHOTOGRAPHIC LOG	
Client Name: Eversource		Site Location: Sudbury to Hudson Transmission Reliability Project	Town: Sudbury
Photo No.: 1	Date: 7-23-24

Description: Work area within segment 12, adding loam to shoulders, looking westward.

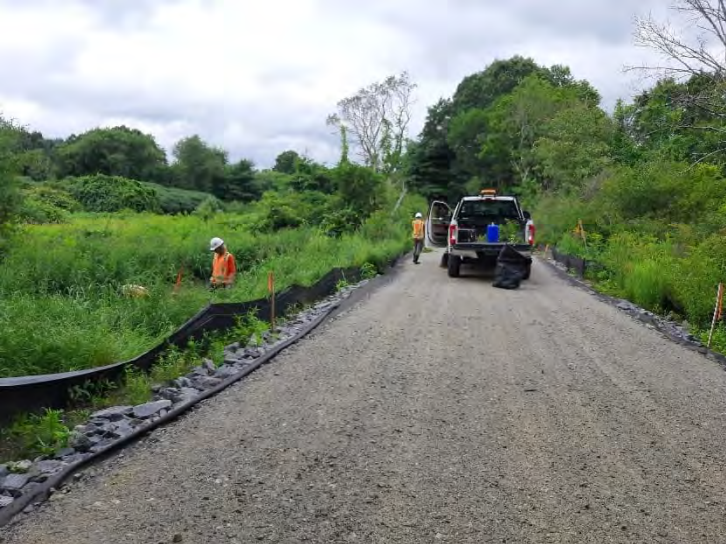
PHOTOGRAPHIC LOG	
Client Name: Eversource		Site Location: Sudbury to Hudson Transmission Reliability Project	Town: Sudbury
Photo No.: 2	Date: 7-23-24

Description: Wetland replication area within segment 14, manual invasives removal, existing erosion control, looking westward.

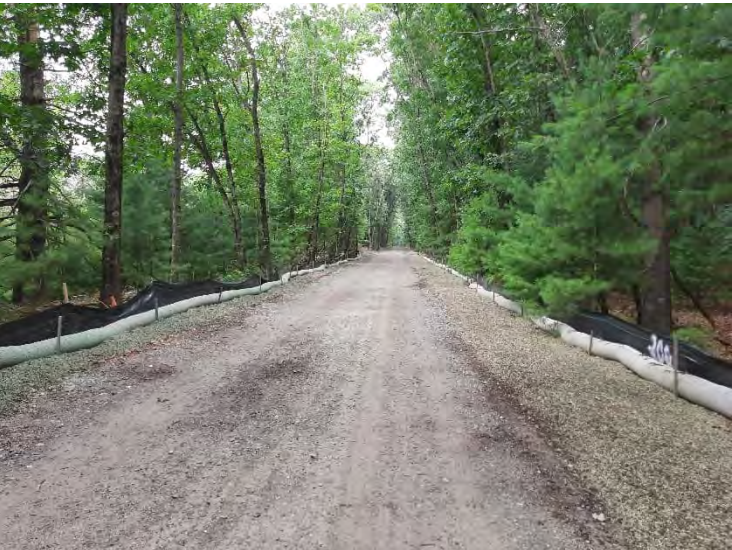
PHOTOGRAPHIC LOG	
Client Name: Eversource		Site Location: Sudbury to Hudson Transmission Reliability Project	Town: Sudbury
Photo No.: 4	Date: 7-23-24

Description: Work area within segment 11, existing erosion controls, recent hydroseed, looking westward.

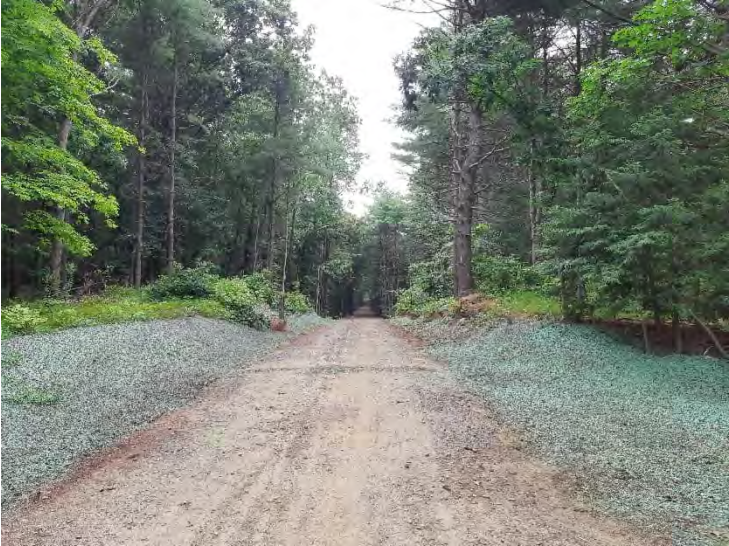
PHOTOGRAPHIC LOG	
Client Name: Eversource		Site Location: Sudbury to Hudson Transmission Reliability Project	Town: Sudbury
Photo No.: 5	Date: 7-23-24

Description: Work area within segment 10, recent (near, both sides) and existing (far, right side) hydroseed, looking eastward.

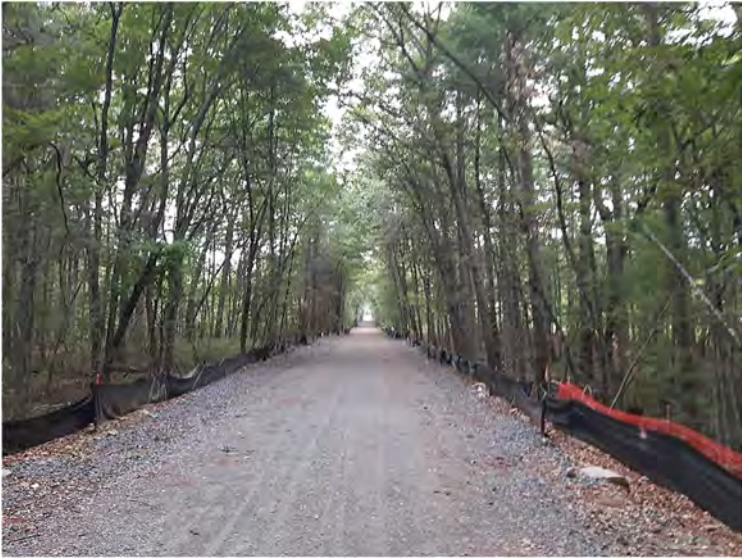
PHOTOGRAPHIC LOG	
Client Name: Eversource		Site Location: Sudbury to Hudson Transmission Reliability Project	Town: Sudbury
Photo No.: 7	Date: 7-23-24

Description: Previous work area within segment 8, existing erosion control, looking westward.

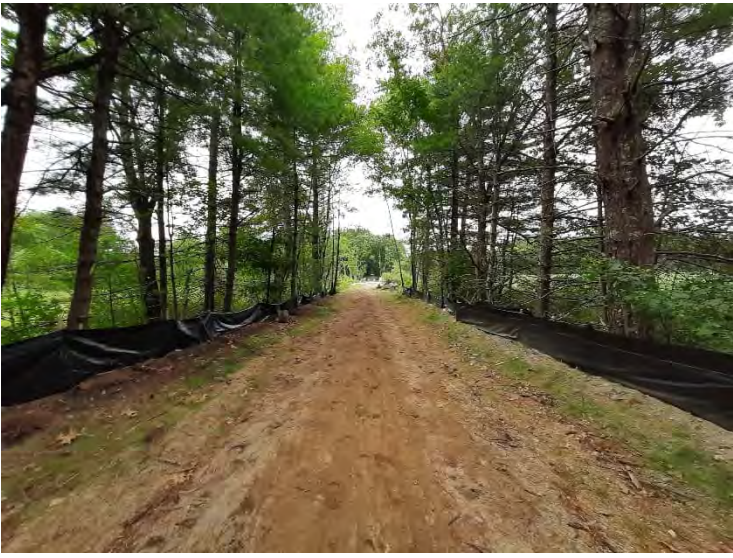
PHOTOGRAPHIC LOG	
Client Name: Eversource		Site Location: Sudbury to Hudson Transmission Reliability Project	Town: Sudbury
Photo No.: 8	Date: 7-23-24

Description: Work area within segment 7, existing erosion control, looking eastward.

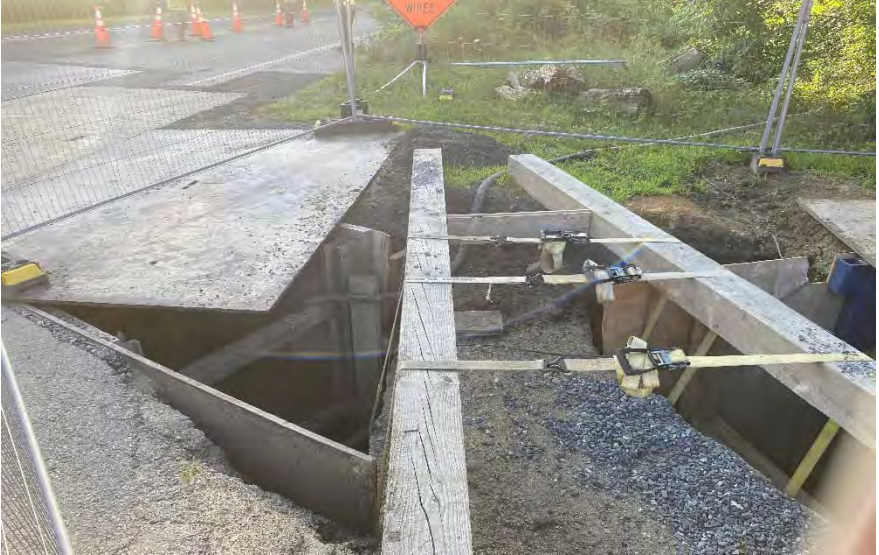
PHOTOGRAPHIC LOG	
Client Name: Eversource		Site Location: Sudbury to Hudson Transmission Reliability Project	Town: Hudson
Photo No.: 1	Date: 7/22/2024

Description: View of area being pumped from trench close to manhole #1 near Hudson Power & Light facility off Forest Avenue.

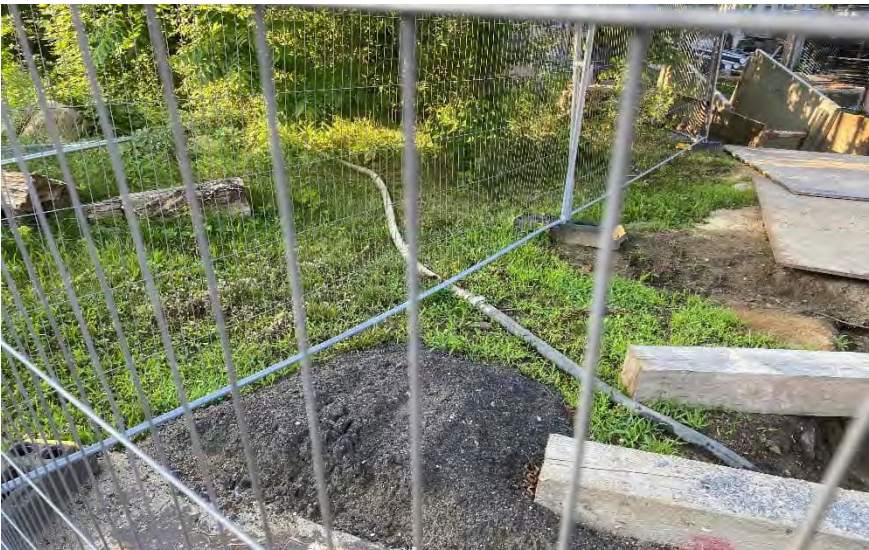
PHOTOGRAPHIC LOG	
Client Name: Eversource		Site Location: Sudbury to Hudson Transmission Reliability Project	Town: Hudson
Photo No.: 2	Date: 7/22/2024

Description: Near manhole #1. View of dewatering operation. Looking eastward.

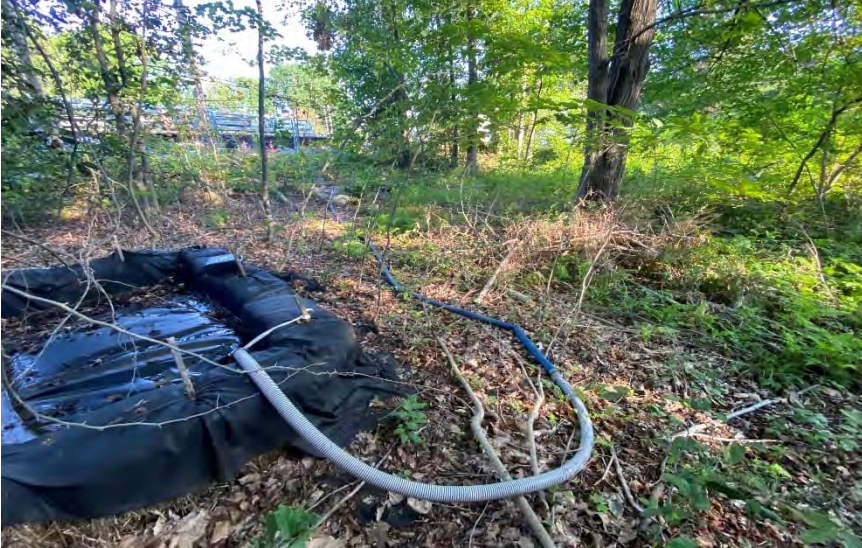
PHOTOGRAPHIC LOG	
Client Name: Eversource		Site Location: Sudbury to Hudson Transmission Reliability Project	Town: Hudson
Photo No.: 3	Date: 7/22/2024

Description: Near manhole #1. View of dewatering operation, looking southward.

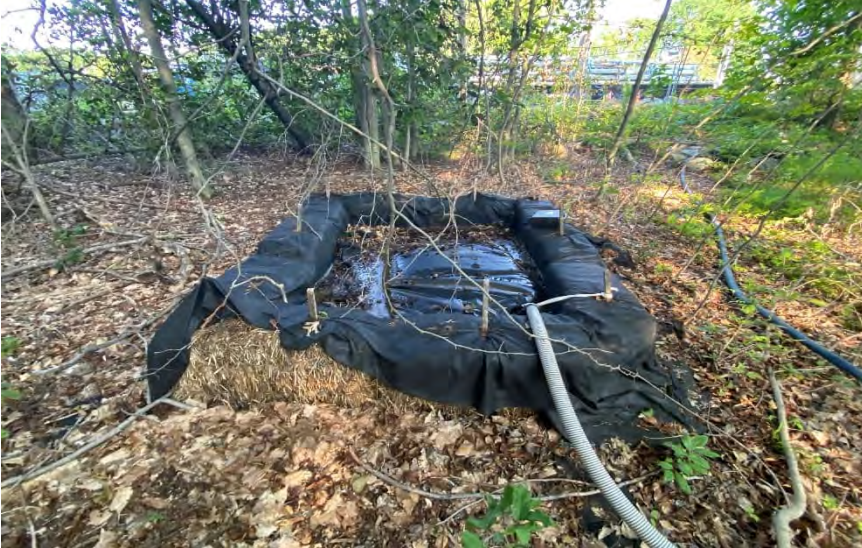
PHOTOGRAPHIC LOG	
Client Name: Eversource		Site Location: Sudbury to Hudson Transmission Reliability Project	Town: Hudson
Photo No.: 4	Date: 7/22/2024

Description: Near manhole #1. View of discharge bag/corral, looking southward. Water from bag/corral did not discharge to adjacent area.

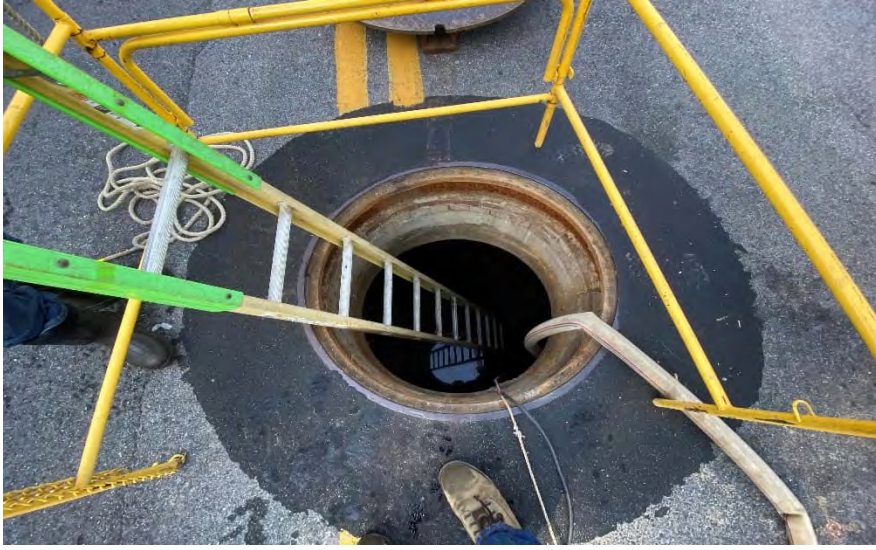
PHOTOGRAPHIC LOG	
Client Name: Eversource		Site Location: Sudbury to Hudson Transmission Reliability Project	Town: Hudson
Photo No.: 1	Date: 7/22/2024

Description: View of area being pumped from manhole #3 near Forest Ave. Elementary school within Forest Ave.

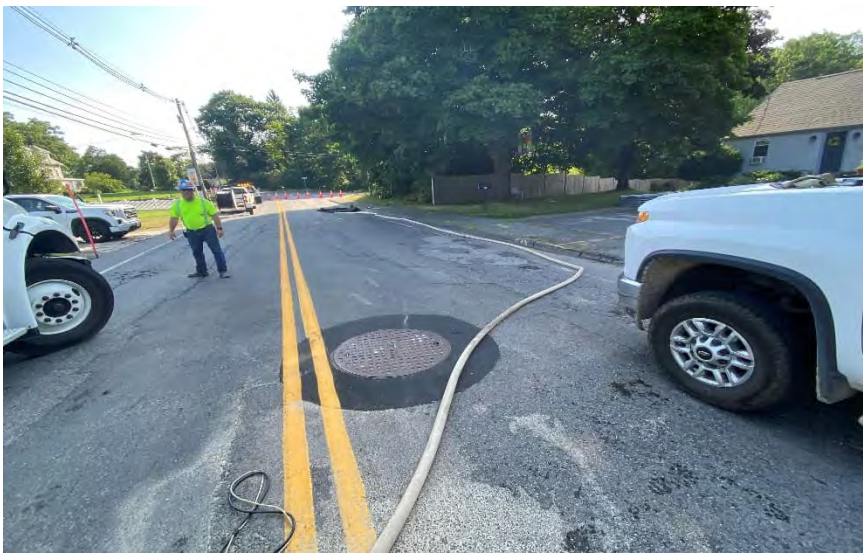
PHOTOGRAPHIC LOG	
Client Name: Eversource		Site Location: Sudbury to Hudson Transmission Reliability Project	Town: Hudson
Photo No.: 2	Date: 7/22/2024

Description: Manhole #3. View of dewatering operation. Looking westward.

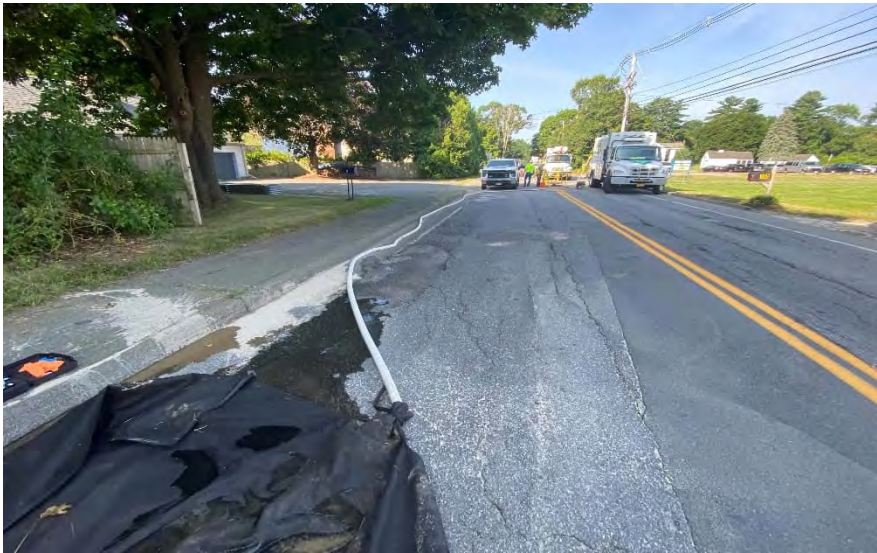
PHOTOGRAPHIC LOG	
Client Name: Eversource		Site Location: Sudbury to Hudson Transmission Reliability Project	Town: Hudson
Photo No.: 3	Date: 7/22/2024

Description: Manhole #3. View of dewatering operation, looking eastward.

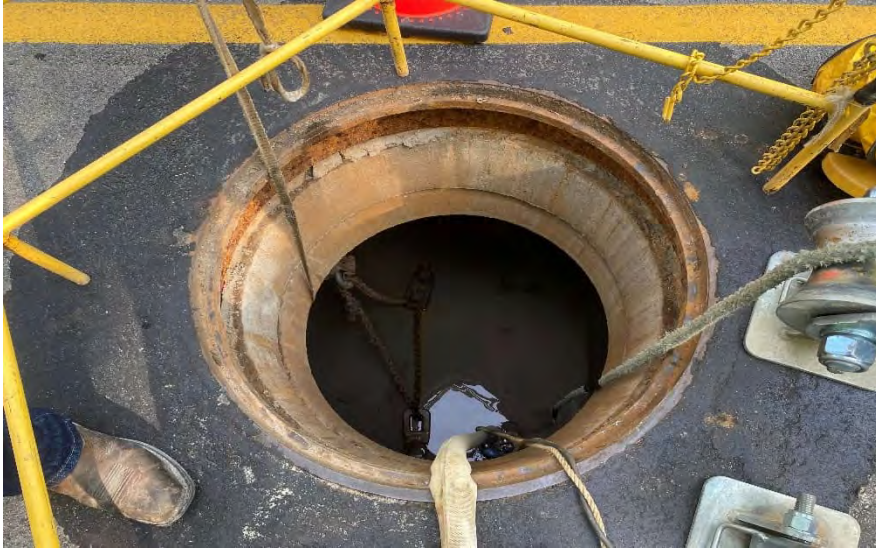
PHOTOGRAPHIC LOG	
Client Name: Eversource		Site Location: Sudbury to Hudson Transmission Reliability Project	Town: Hudson
Photo No.: 1	Date: 7/22/2024

Description: View of area being pumped from manhole #4 within Forest Ave.

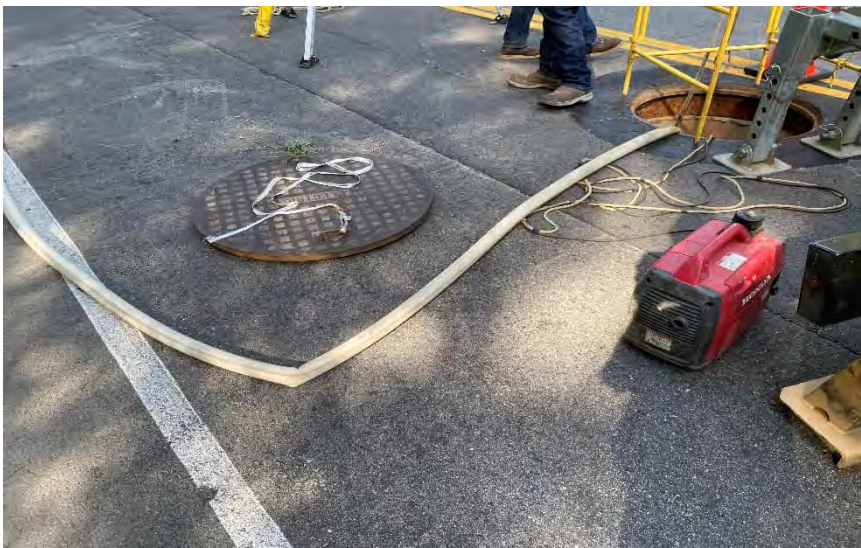
PHOTOGRAPHIC LOG	
Client Name: Eversource		Site Location: Sudbury to Hudson Transmission Reliability Project	Town: Hudson
Photo No.: 2	Date: 7/22/2024

Description: Manhole #4. View of dewatering operation. Looking eastward.

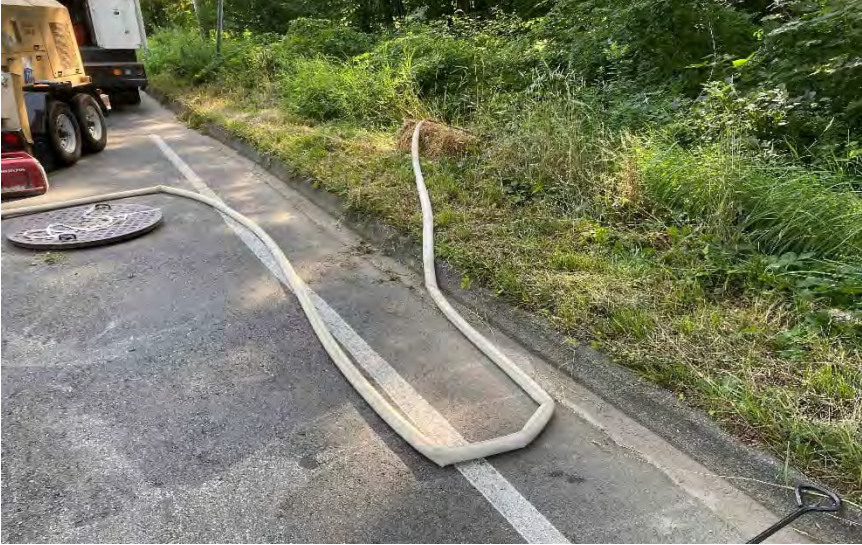
PHOTOGRAPHIC LOG	
Client Name: Eversource		Site Location: Sudbury to Hudson Transmission Reliability Project	Town: Hudson
Photo No.: 3	Date: 7/22/2024

Description: Manhole #4. View of dewatering operation, looking westward.

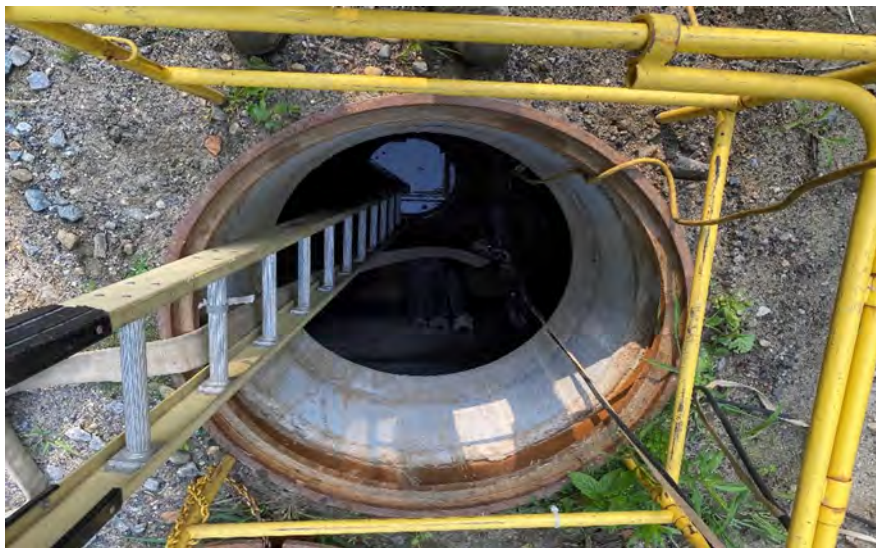
Photo No.: 1
Date: 7/22/2024

Description:
View of area being pumped from manhole #6, Segment 1.

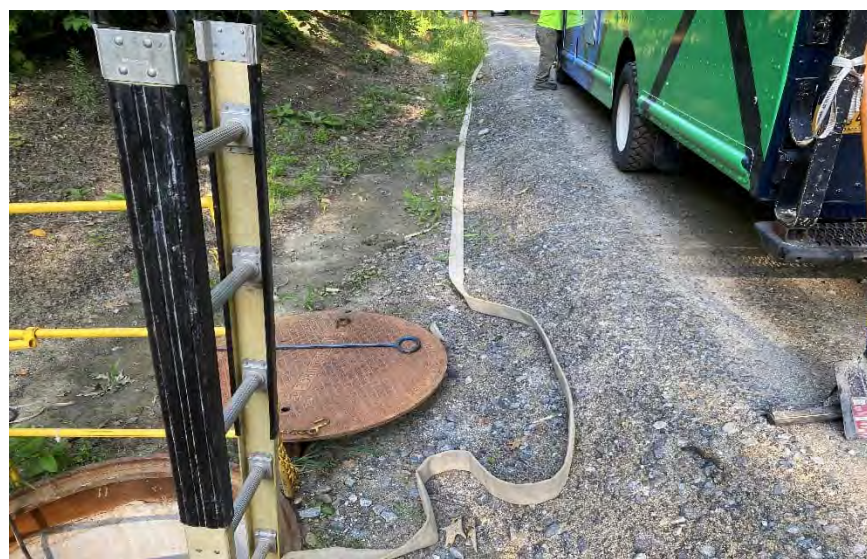
Photo No.: 2
Date: 7/22/2024

Description:
Manhole #6. View of dewatering operation. Looking westward.

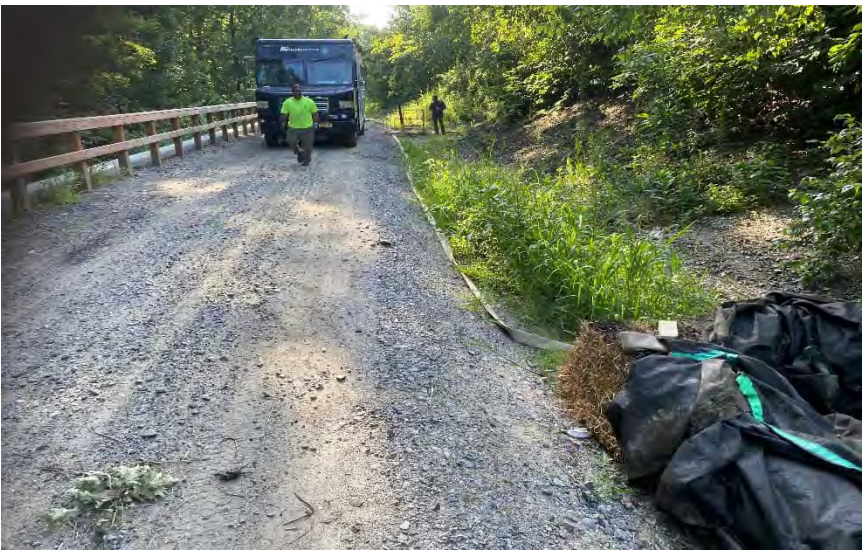
<h2 style="margin: 0;">PHOTOGRAPHIC LOG</h2>	
Client Name: Eversource		Site Location: Sudbury to Hudson Transmission Reliability Project	Town: Hudson
Photo No.: 3	Date: 7/22/2024

Description: Manhole #6. View of dewatering operation. Looking eastward.

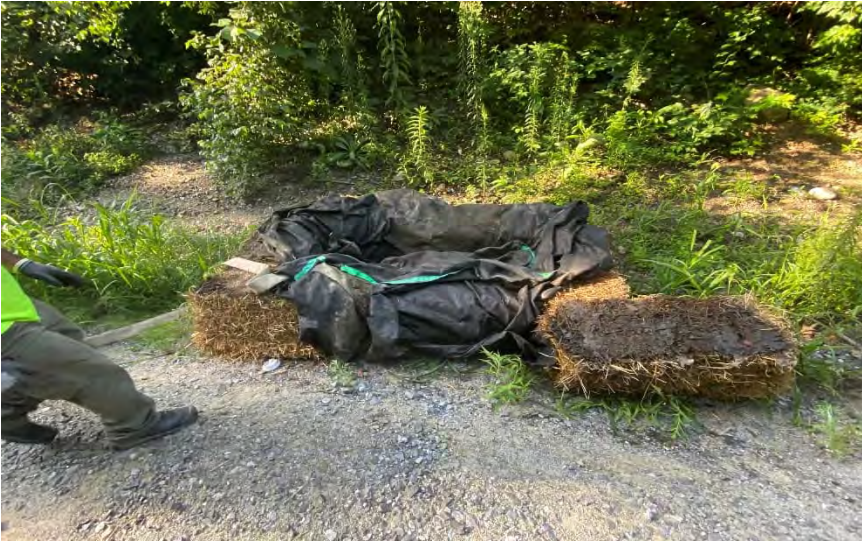
<h2 style="margin: 0;">PHOTOGRAPHIC LOG</h2>	
Client Name: Eversource		Site Location: Sudbury to Hudson Transmission Reliability Project	Town: Hudson
Photo No.: 4	Date: 7/22/2024

Description: Manhole #6. View of discharge bag/corral, looking westward. Water to bag/corral did not discharge to adjacent area.

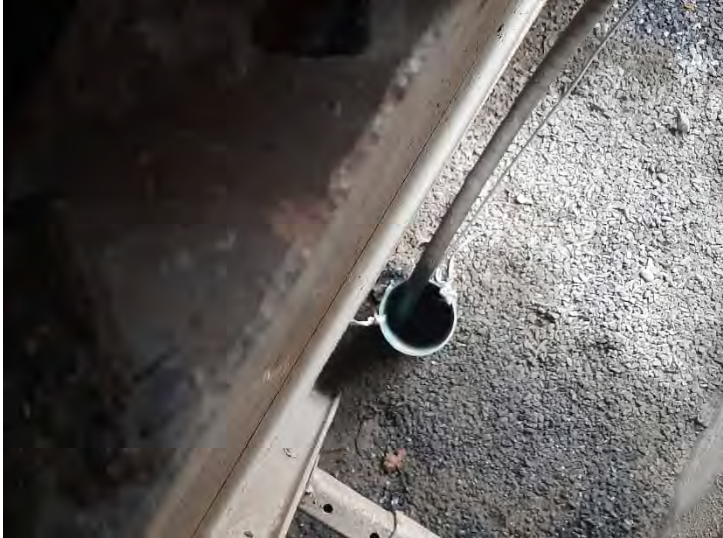
PHOTOGRAPHIC LOG	
Client Name: Eversource		Site Location: Sudbury to Hudson Transmission Reliability Project	Town: Hudson
Photo No.: 1	Date: 7/23/2024

Description: View of area being pumped from the trench beside manhole #1, near Hudson Light & Power. Facing southward, looking down through gap in steel plate.

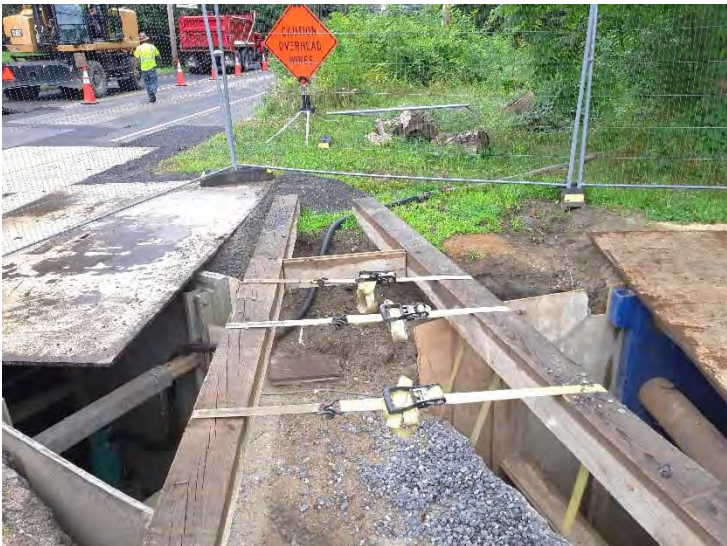
PHOTOGRAPHIC LOG	
Client Name: Eversource		Site Location: Sudbury to Hudson Transmission Reliability Project	Town: Hudson
Photo No.: 2	Date: 7/23/2024

Description: Trench beside manhole #1. View of dewatering operation. Looking westward.

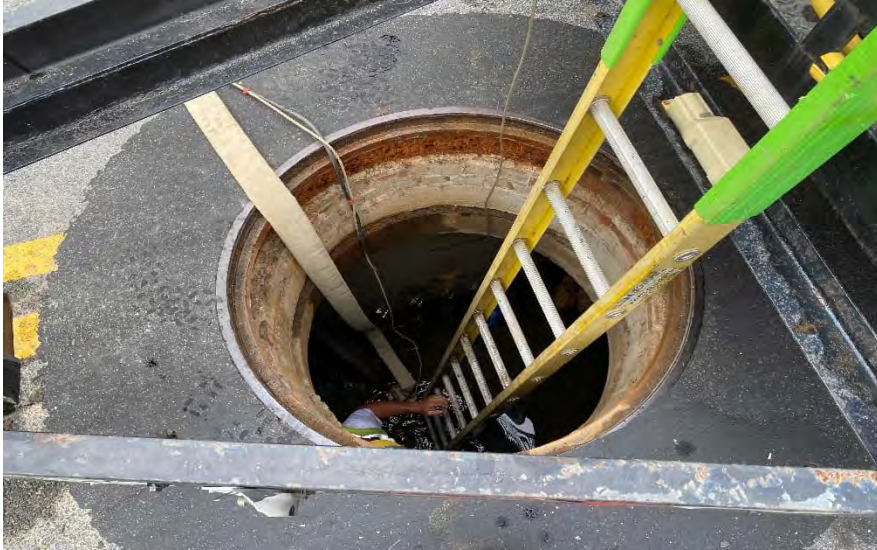
PHOTOGRAPHIC LOG	
Client Name: Eversource		Site Location: Sudbury to Hudson Transmission Reliability Project	Town: Hudson
Photo No.: 1	Date: 7/23/2024

Description: View of area being pumped from manhole #3 near Forest Ave. Elementary school within Forest Ave.

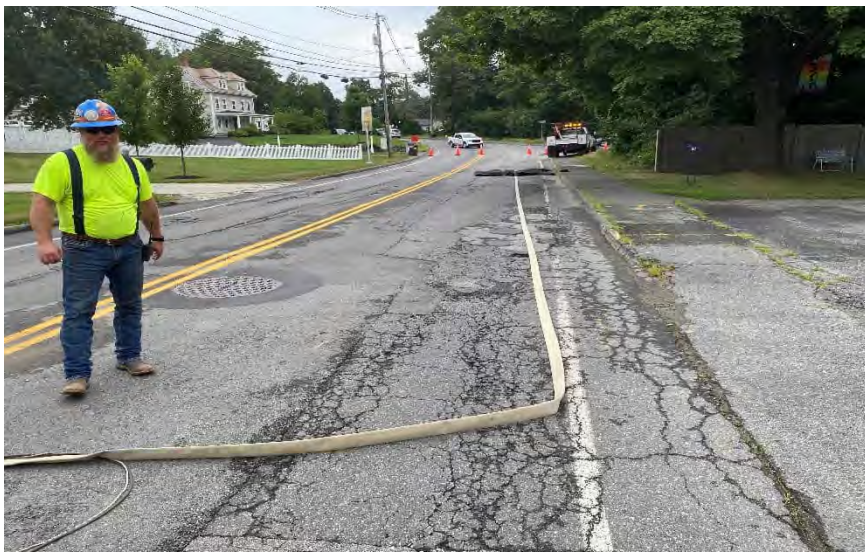
PHOTOGRAPHIC LOG	
Client Name: Eversource		Site Location: Sudbury to Hudson Transmission Reliability Project	Town: Hudson
Photo No.: 2	Date: 7/23/2024

Description: Manhole #3. View of dewatering operation. Looking northward.

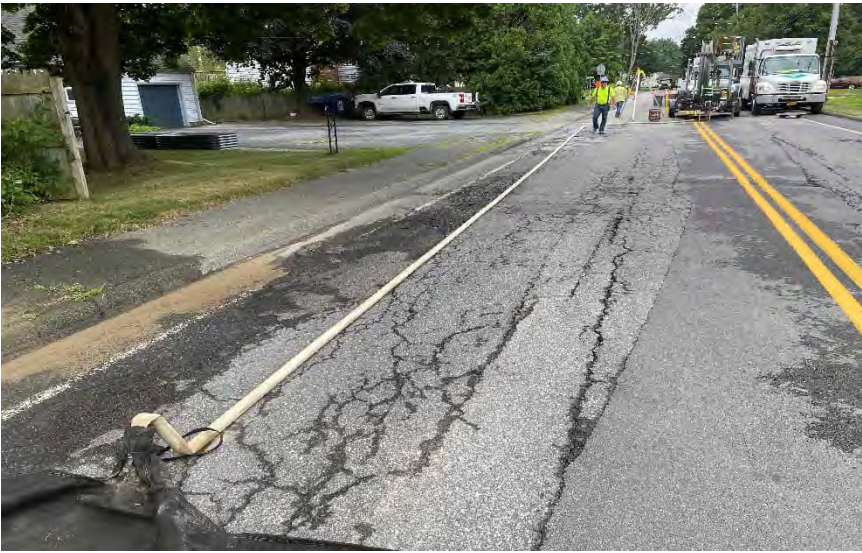
PHOTOGRAPHIC LOG	
Client Name: Eversource		Site Location: Sudbury to Hudson Transmission Reliability Project	Town: Hudson
Photo No.: 3	Date: 7/23/2024

Description: Manhole #3. View of dewatering operation, looking northward.

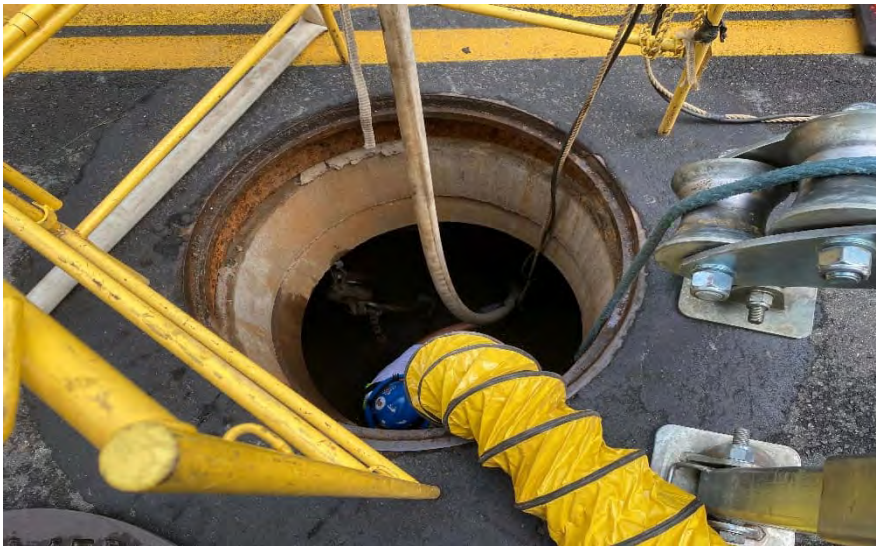
PHOTOGRAPHIC LOG	
Client Name: Eversource		Site Location: Sudbury to Hudson Transmission Reliability Project	Town: Hudson
Photo No.: 1	Date: 7/23/2024

Description: View of area being pumped from manhole #4 within Forest Ave.

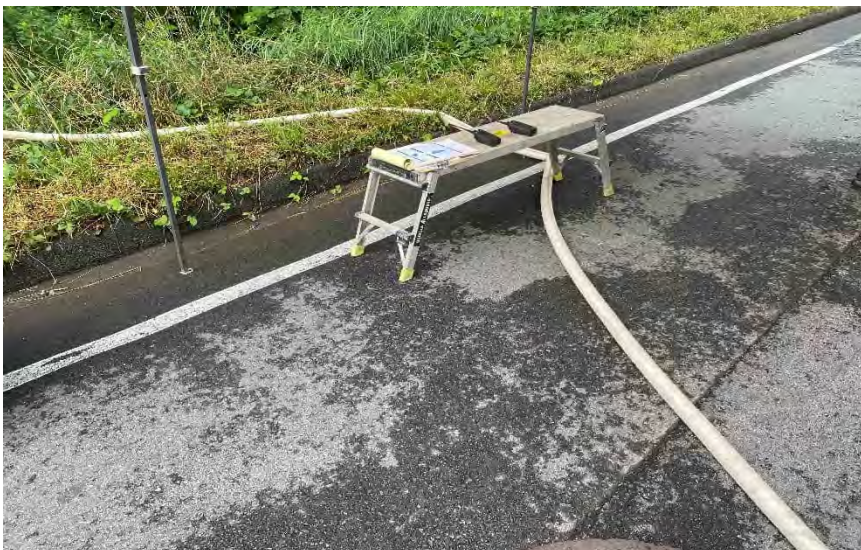
PHOTOGRAPHIC LOG	
Client Name: Eversource		Site Location: Sudbury to Hudson Transmission Reliability Project	Town: Hudson
Photo No.: 2	Date: 7/23/2024

Description: Manhole #4. View of dewatering operation. Looking eastward.

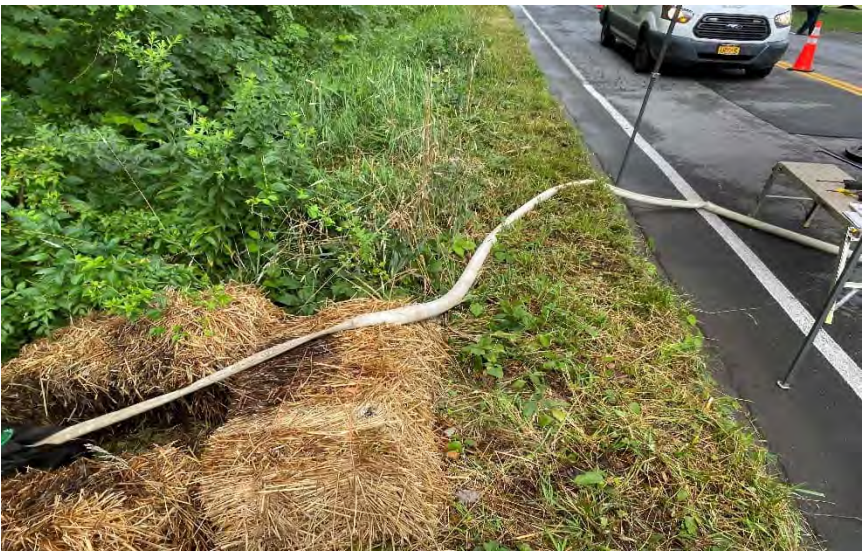
PHOTOGRAPHIC LOG	
Client Name: Eversource		Site Location: Sudbury to Hudson Transmission Reliability Project	Town: Hudson
Photo No.: 3	Date: 7/23/2024

Description: Manhole #4. View of dewatering operation, looking southward.

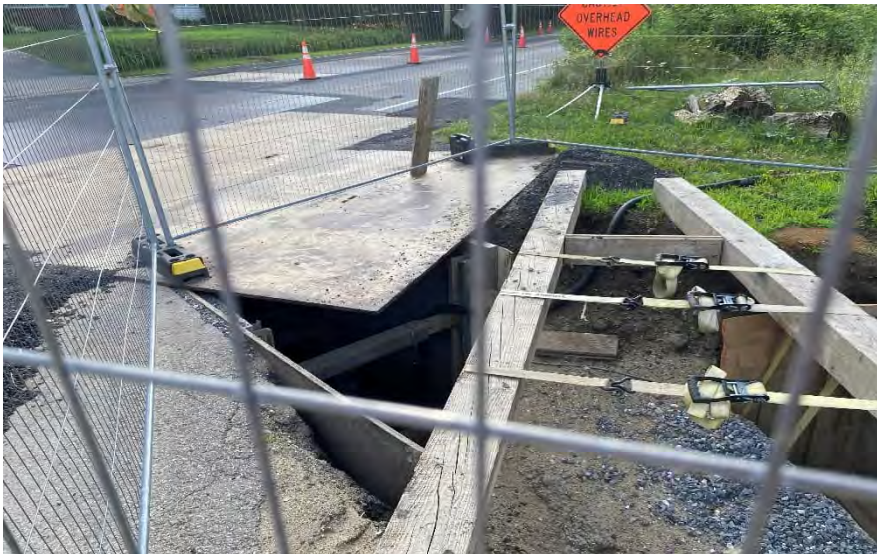
PHOTOGRAPHIC LOG	
Client Name: Eversource		Site Location: Sudbury to Hudson Transmission Reliability Project	Town: Hudson
Photo No.: 1	Date: 7/24/2024

Description: View of area being pumped from trench close to manhole #1 near Hudson Power & Light facility off Forest Avenue.
