Weekly Environmental Compliance Summary

Sudbury to Hudson Transmission Reliability Project (USEPA Tracking # MAR1003UW)

Week of: July 22, 2024 to July 27, 2024

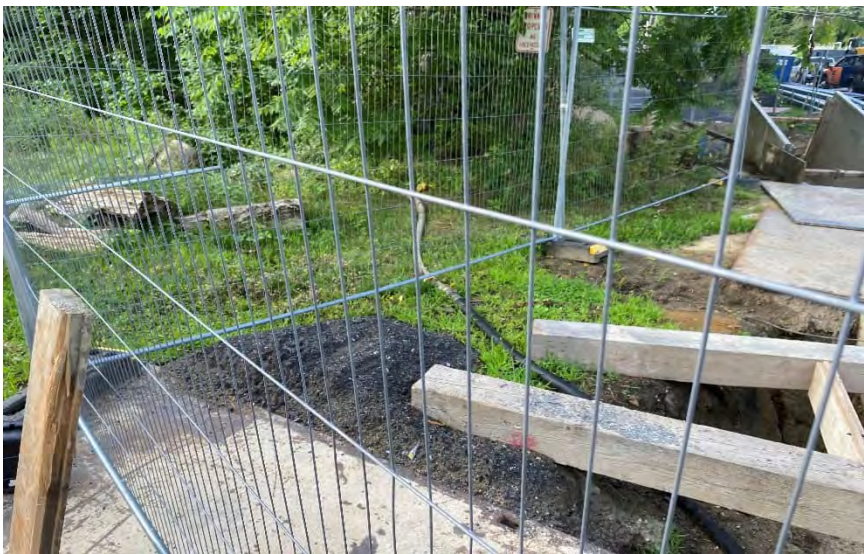
PHOTOGRAPHIC LOG	
Client Name: Eversource		Site Location: Sudbury to Hudson Transmission Reliability Project	Town: Hudson
Photo No.: 2	Date: 7/24/2024

Description: Near manhole #1. View of dewatering operation. Looking eastward.

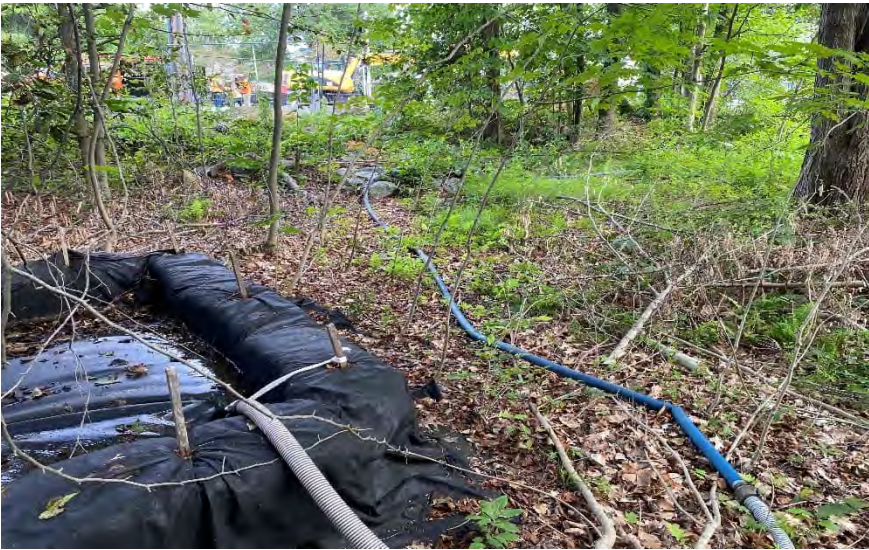
PHOTOGRAPHIC LOG	
Client Name: Eversource		Site Location: Sudbury to Hudson Transmission Reliability Project	Town: Hudson
Photo No.: 3	Date: 7/24/2024

Description: Near manhole #1. View of dewatering operation, looking southward.

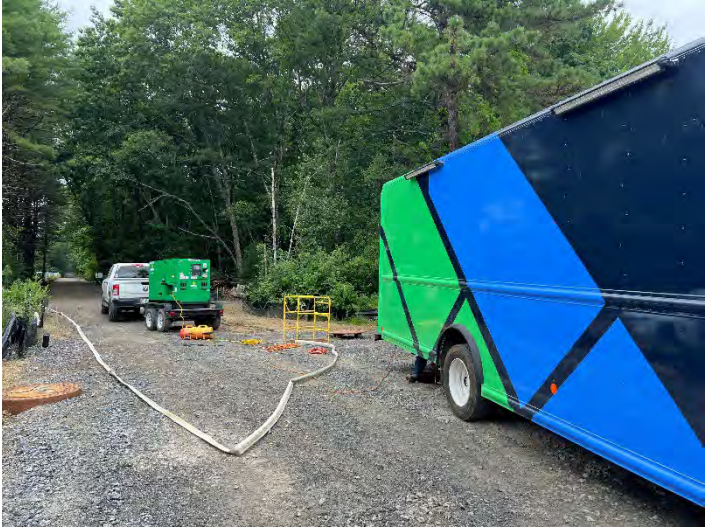
PHOTOGRAPHIC LOG		
Client Name: Eversource		Site Location: Sudbury to Hudson Transmission Reliability Project		Town: Sudbury
Photo No.: 1	Date: 7/24/2024

Description: View of Haugland cable splicers working at MH #24. Facing west.

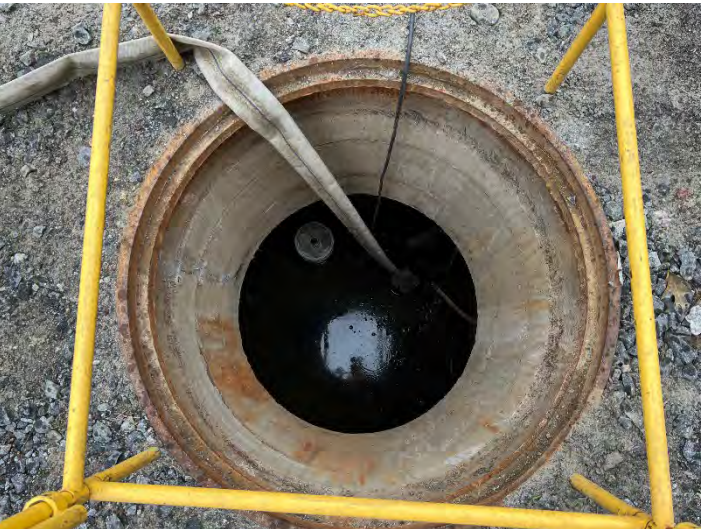
PHOTOGRAPHIC LOG		
Client Name: Eversource		Site Location: Sudbury to Hudson Transmission Reliability Project		Town: Sudbury
Photo No.: 2	Date: 7/24/2024

Description: View of pump in MH #24. Water appeared to be slightly turbid prior to treatment.

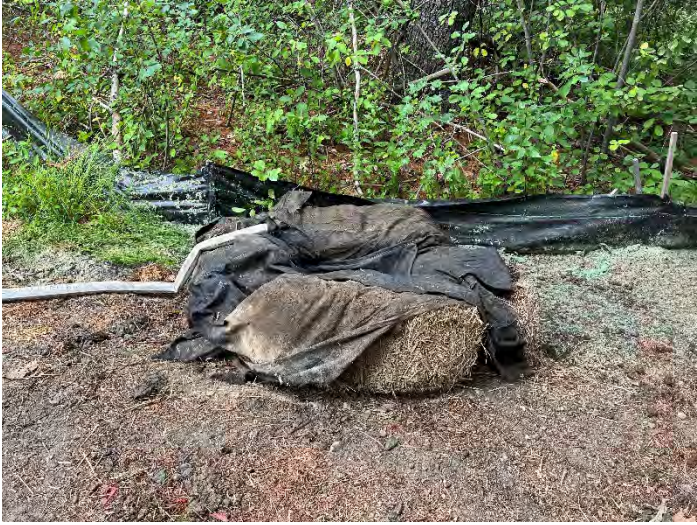
PHOTOGRAPHIC LOG	
Client Name: Eversource		Site Location: Sudbury to Hudson Transmission Reliability Project	Town: Sudbury
Photo No.: 3	Date: 7/24/2024

Description: View of dewatering controls (straw bale corral with filter fabric and silt bag). Facing south.

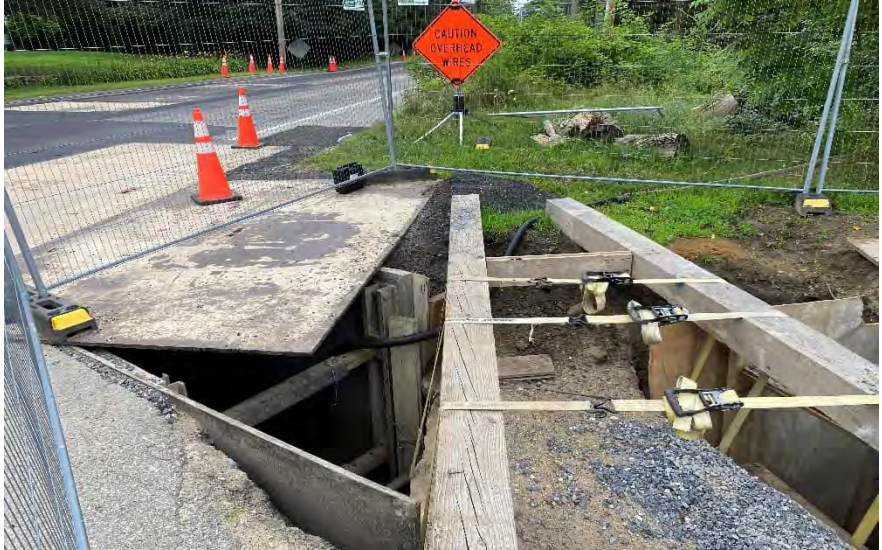
PHOTOGRAPHIC LOG	
Client Name: Eversource		Site Location: Sudbury to Hudson Transmission Reliability Project	Town: Hudson
Photo No.: 1	Date: 7/25/2024

Description: View of area being pumped from trench close to manhole #1 near Hudson Power & Light facility off Forest Avenue.

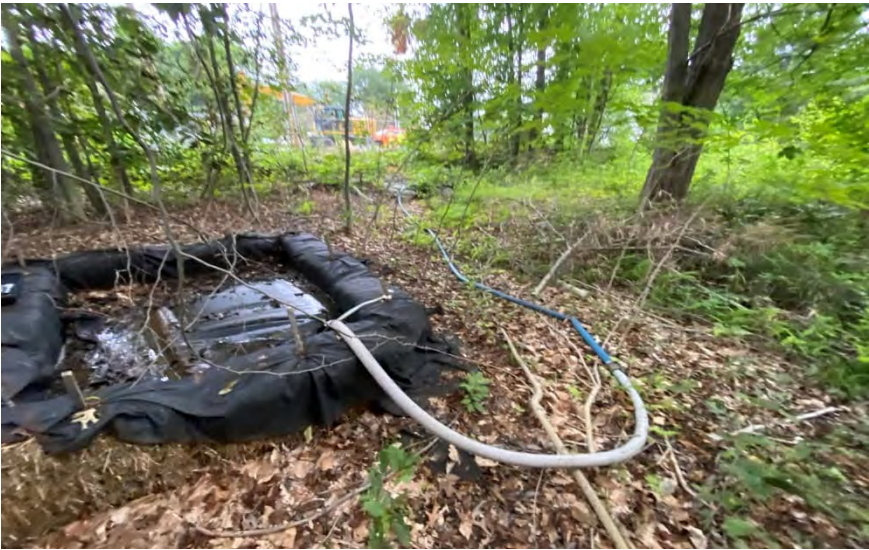
PHOTOGRAPHIC LOG	
Client Name: Eversource		Site Location: Sudbury to Hudson Transmission Reliability Project	Town: Hudson
Photo No.: 3	Date: 7/25/2024

Description: Near manhole #1. View of dewatering operation, looking southward.

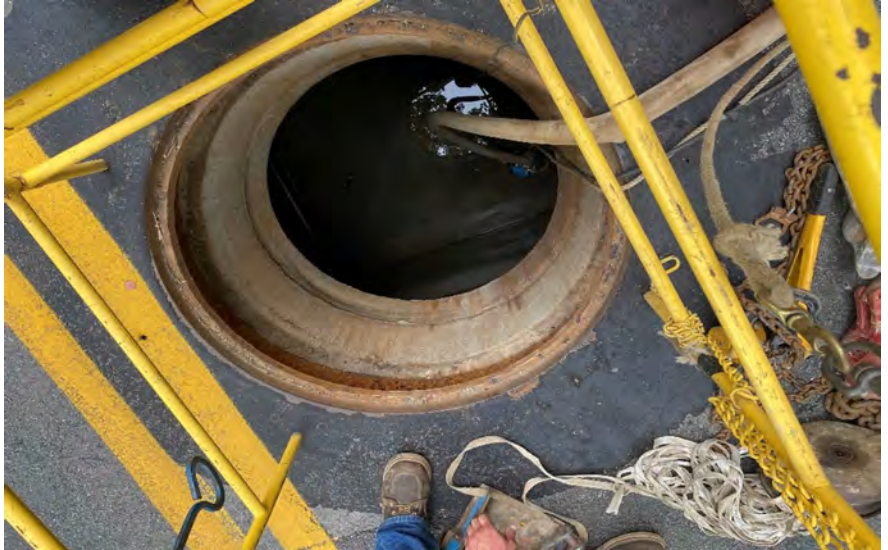
PHOTOGRAPHIC LOG	
Client Name: Eversource		Site Location: Sudbury to Hudson Transmission Reliability Project	Town: Hudson
Photo No.: 1	Date: 7/25/2024

Description: View of area being pumped from manhole #4 within Forest Ave.

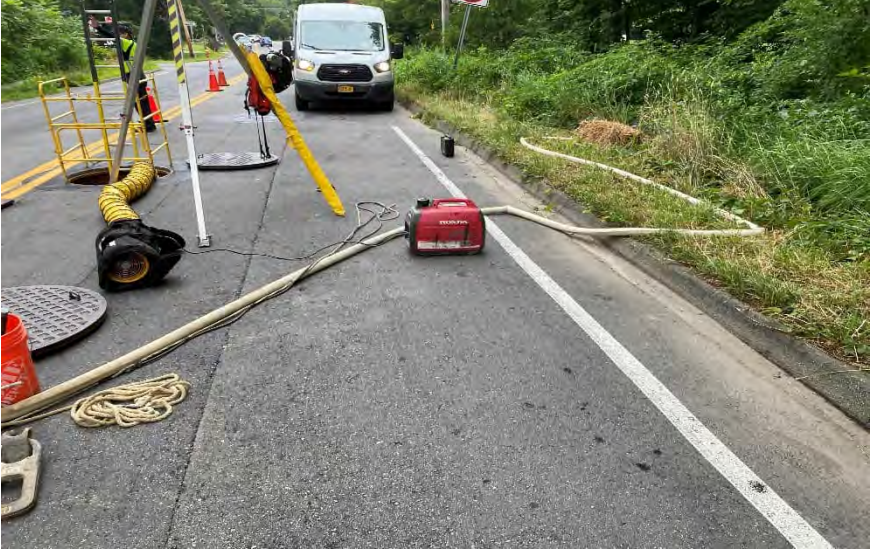
PHOTOGRAPHIC LOG	
Client Name: Eversource		Site Location: Sudbury to Hudson Transmission Reliability Project	Town: Hudson
Photo No.: 2	Date: 7/25/2024

Description: Manhole #4. View of dewatering operation. Looking northward.

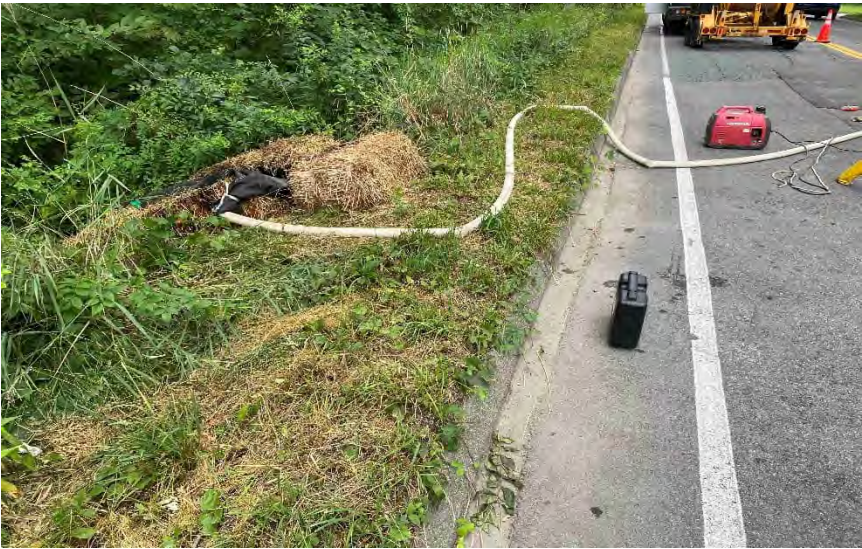
<h2 style="margin: 0;">PHOTOGRAPHIC LOG</h2>	
Client Name: Eversource		Site Location: Sudbury to Hudson Transmission Reliability Project	Town: Hudson
Photo No.: 3	Date: 7/25/2024

Description: Manhole #4. View of dewatering operation, looking southward.

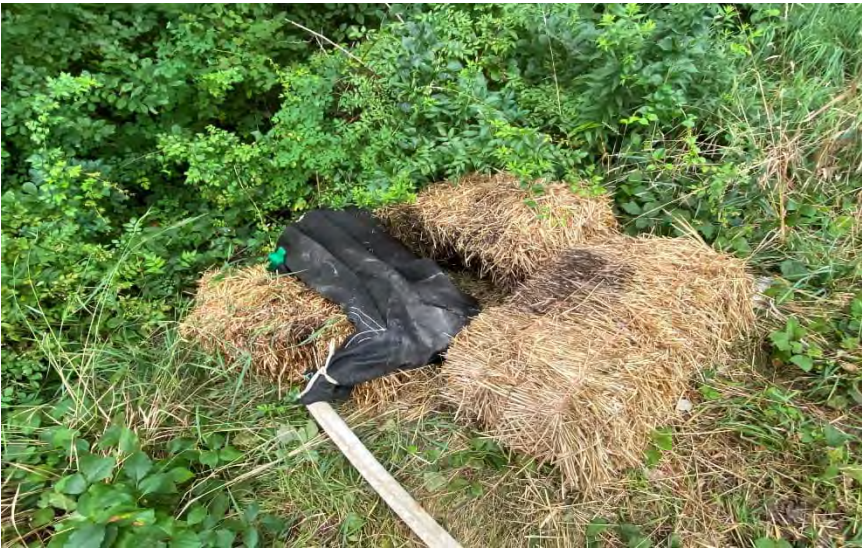
<h2 style="margin: 0;">PHOTOGRAPHIC LOG</h2>	
Client Name: Eversource		Site Location: Sudbury to Hudson Transmission Reliability Project	Town: Hudson
Photo No.: 4	Date: 7/25/2024

Description: Manhole #4. View of discharge bag/corral, looking eastward. Water from bag/corral discharged to adjacent vegetated area.

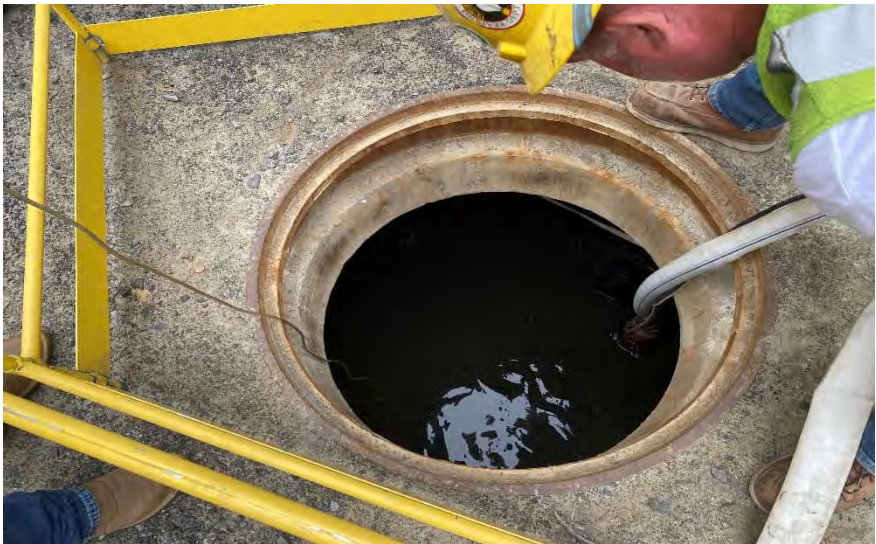
PHOTOGRAPHIC LOG	
Client Name: Eversource		Site Location: Sudbury to Hudson Transmission Reliability Project	Town: Hudson
Photo No.: 1	Date: 7/25/2024

Description: View of area being pumped from manhole #5, Segment 1.

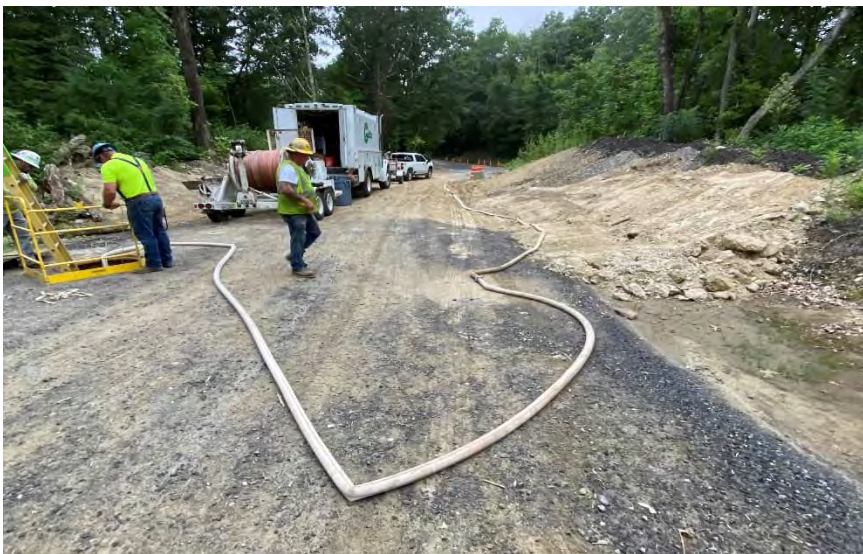
PHOTOGRAPHIC LOG	
Client Name: Eversource		Site Location: Sudbury to Hudson Transmission Reliability Project	Town: Hudson
Photo No.: 2	Date: 7/25/2024

Description: Manhole #5. View of dewatering operation. Looking westward.

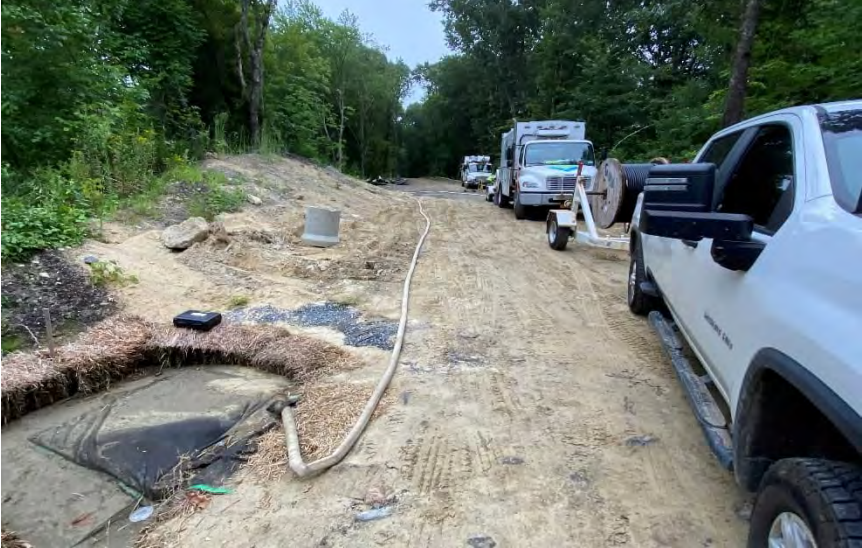
PHOTOGRAPHIC LOG	
Client Name: Eversource		Site Location: Sudbury to Hudson Transmission Reliability Project	Town: Hudson
Photo No.: 3	Date: 7/25/2024

Description: Manhole #5. View of dewatering operation. Looking eastward.

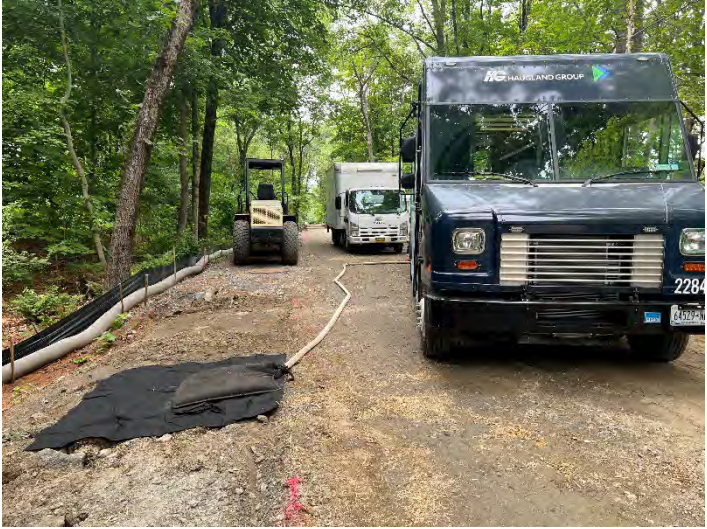
PHOTOGRAPHIC LOG	
Client Name: Eversource		Site Location: Sudbury to Hudson Transmission Reliability Project	
		Town: Sudbury	
Photo No.: 1	Date: 7/25/2024

Description: View of Haugland cable splicers working at MH #25. Facing west.

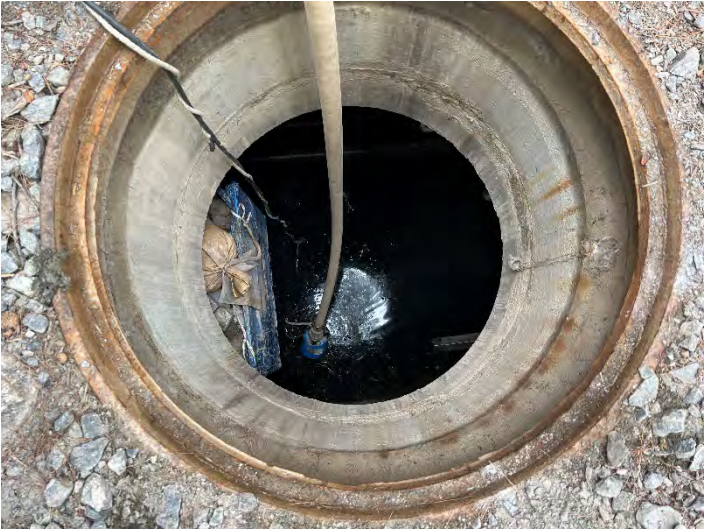
PHOTOGRAPHIC LOG	
Client Name: Eversource		Site Location: Sudbury to Hudson Transmission Reliability Project	
		Town: Sudbury	
Photo No.: 2	Date: 7/25/2024

Description: View of pump in MH #25. Water appeared to be turbid prior to treatment.

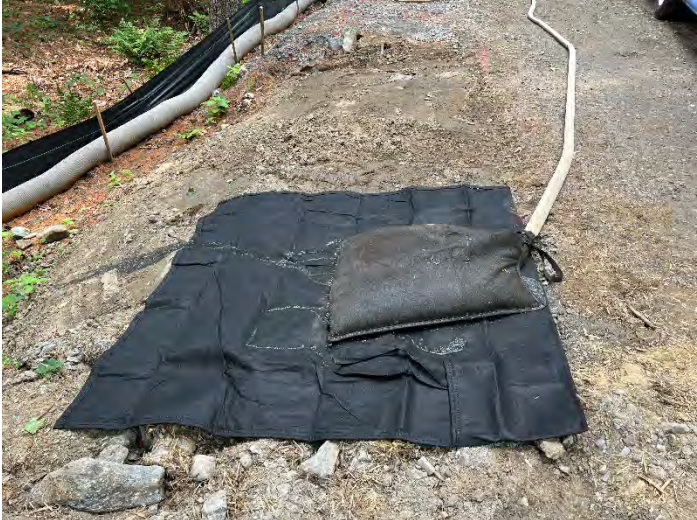
PHOTOGRAPHIC LOG		
Client Name: Eversource		Site Location: Sudbury to Hudson Transmission Reliability Project		Town: Sudbury
Photo No.: 3	Date: 7/25/2024

Description: View of dewatering controls (silt bag with a second silt bag underneath). Facing south.

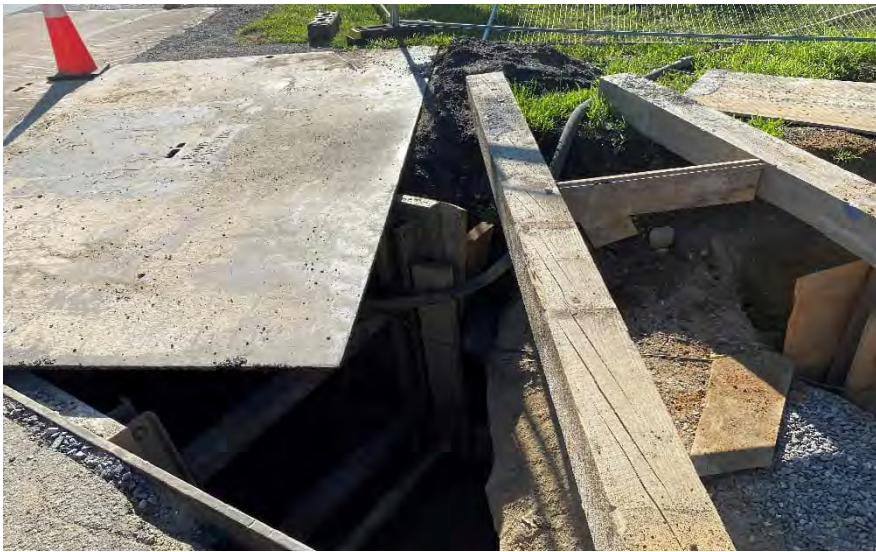
PHOTOGRAPHIC LOG	
Client Name: Eversource		Site Location: Sudbury to Hudson Transmission Reliability Project	Town: Hudson
Photo No.: 1	Date: 7/26/2024

Description: View of area being pumped from trench close to manhole #1 near Hudson Power & Light facility off Forest Avenue.

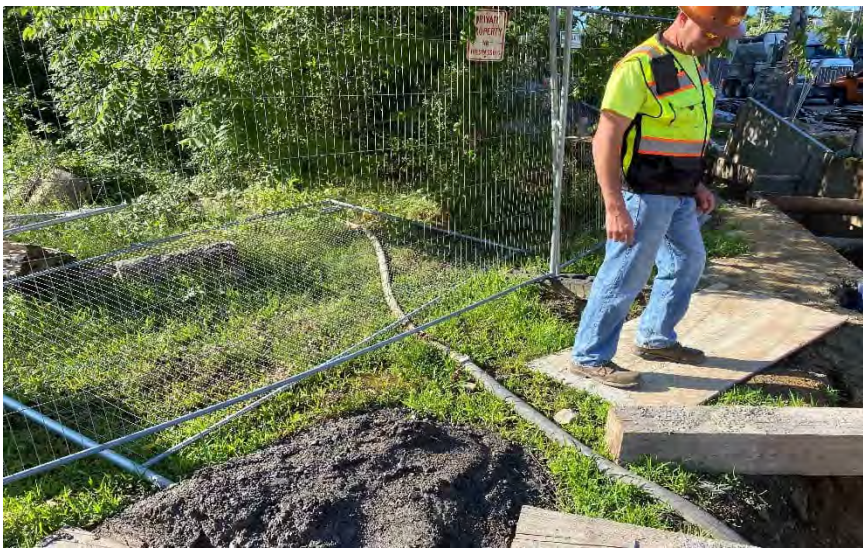
PHOTOGRAPHIC LOG	
Client Name: Eversource		Site Location: Sudbury to Hudson Transmission Reliability Project	Town: Hudson
Photo No.: 2	Date: 7/26/2024

Description: Near manhole #1. View of dewatering operation. Looking eastward.

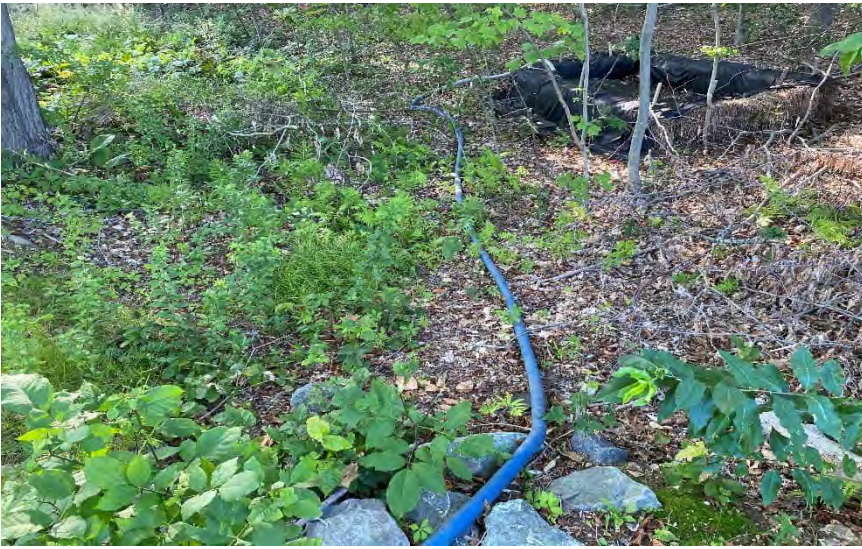
PHOTOGRAPHIC LOG	
Client Name: Eversource		Site Location: Sudbury to Hudson Transmission Reliability Project	Town: Hudson
Photo No.: 3	Date: 7/26/2024

Description: Near manhole #1. View of dewatering operation, looking eastward.

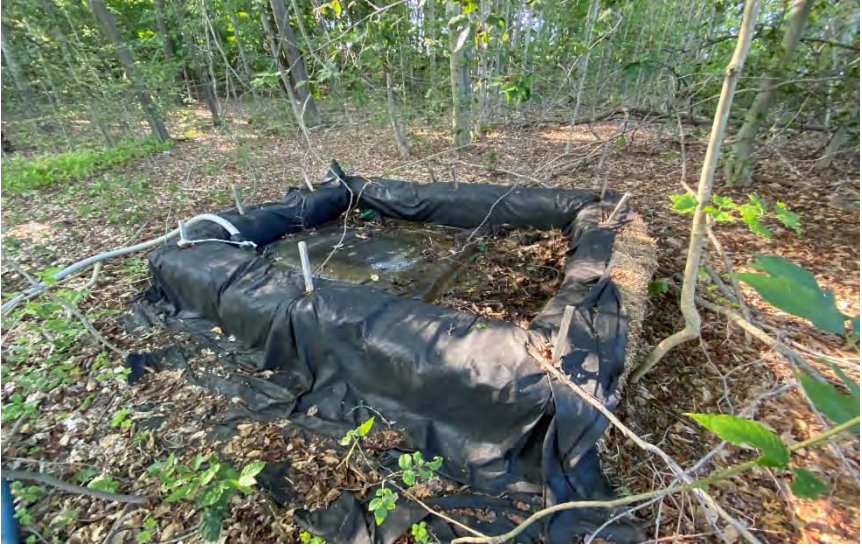
PHOTOGRAPHIC LOG	
Client Name: Eversource		Site Location: Sudbury to Hudson Transmission Reliability Project	Town: Hudson
Photo No.: 4	Date: 7/26/2024

Description: Near manhole #1. View of discharge bag/corral, looking eastward. Water from bag/corral did not discharge to adjacent area.

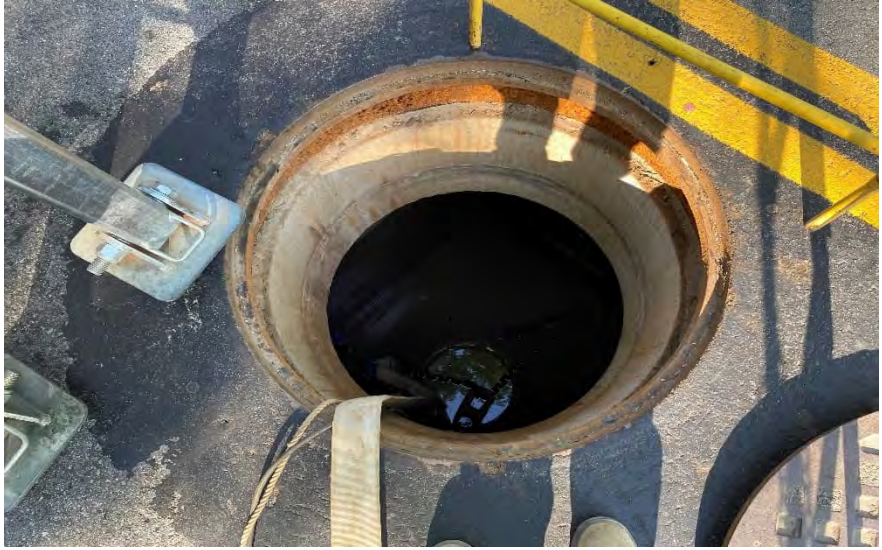
PHOTOGRAPHIC LOG	
Client Name: Eversource		Site Location: Sudbury to Hudson Transmission Reliability Project	Town: Hudson
Photo No.: 1	Date: 7/26/2024

Description: View of area being pumped from manhole #4 within Forest Ave.

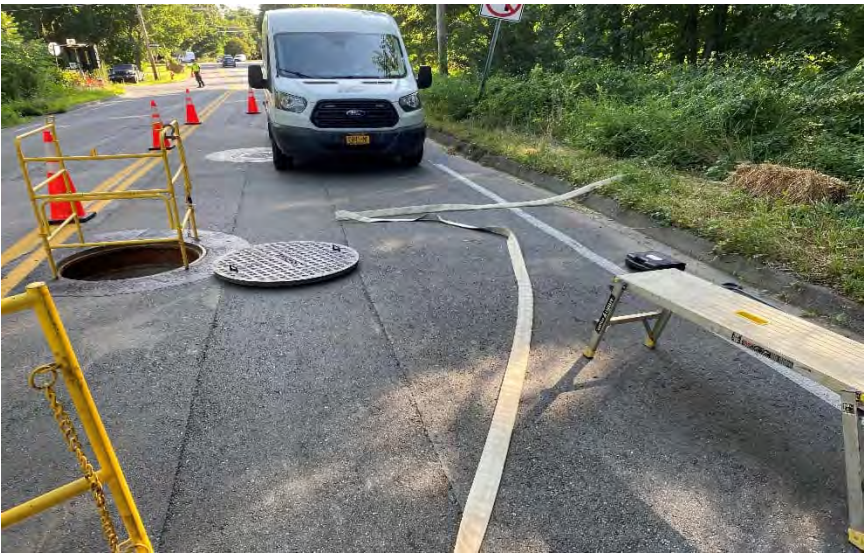
PHOTOGRAPHIC LOG	
Client Name: Eversource		Site Location: Sudbury to Hudson Transmission Reliability Project	Town: Hudson
Photo No.: 2	Date: 7/26/2024

Description: Manhole #4. View of dewatering operation. Looking northward.

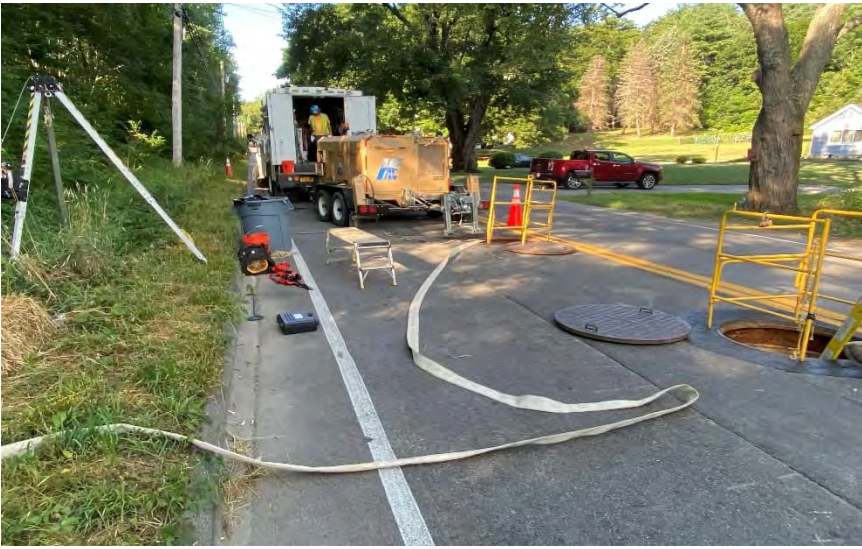
PHOTOGRAPHIC LOG	
Client Name: Eversource		Site Location: Sudbury to Hudson Transmission Reliability Project	Town: Hudson
Photo No.: 3	Date: 7/26/2024

Description: Manhole #4. View of dewatering operation, looking southward.

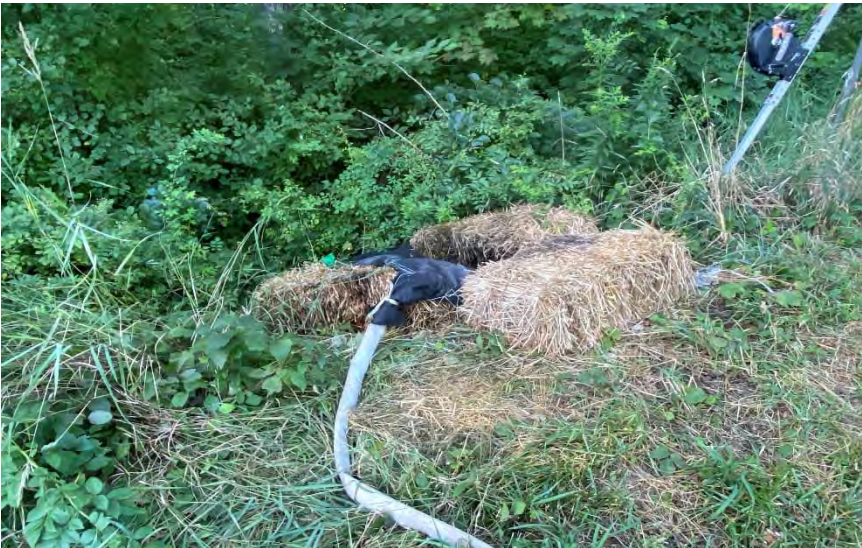
PHOTOGRAPHIC LOG	
Client Name: Eversource		Site Location: Sudbury to Hudson Transmission Reliability Project	Town: Hudson
Photo No.: 4	Date: 7/26/2024

Description: Manhole #4. View of discharge bag/corral, looking southward. Water from bag/corral discharged to adjacent vegetated area.
